Re: Revised Architectural Survey Report, MVP Southgate Project, Construct Interstate Pipeline, Rockingham and Alamance County, ER 18-1041

Thank you for your letter of October 11, 2019, transmitting the draft "Historic Architectural Survey for the MVP Southgate Pipeline Project". We have reviewed the report and offer the following comments.

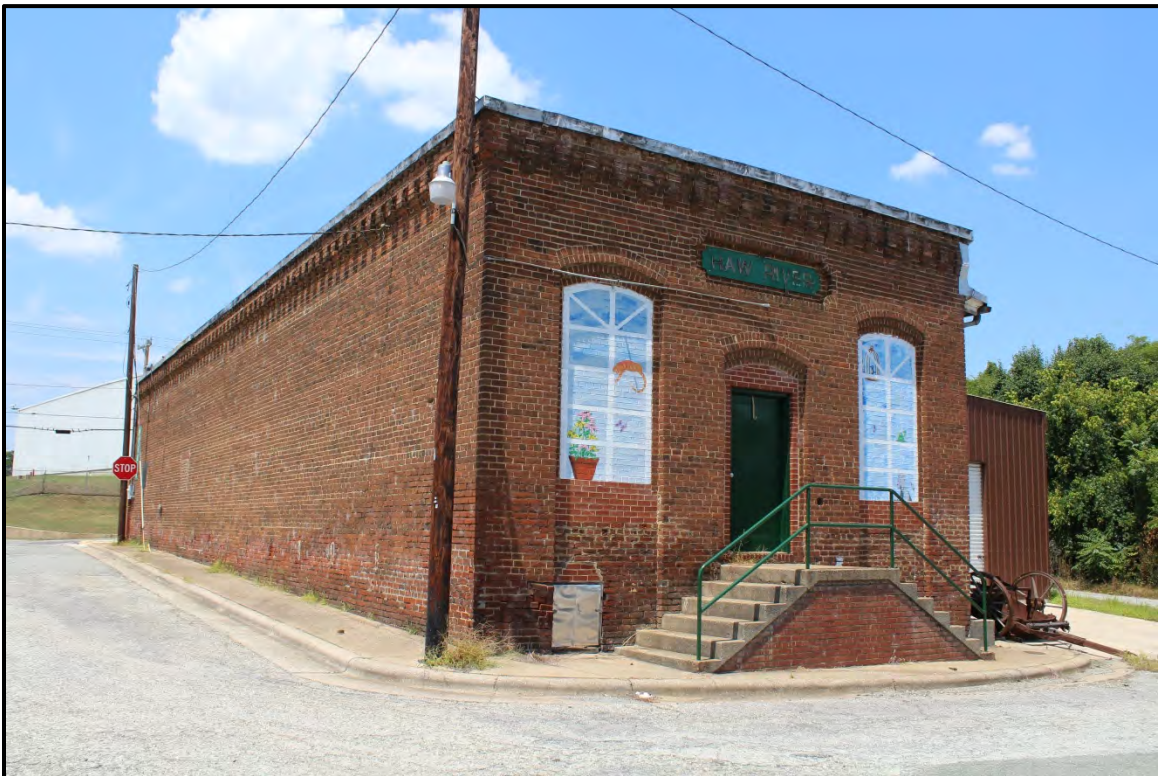
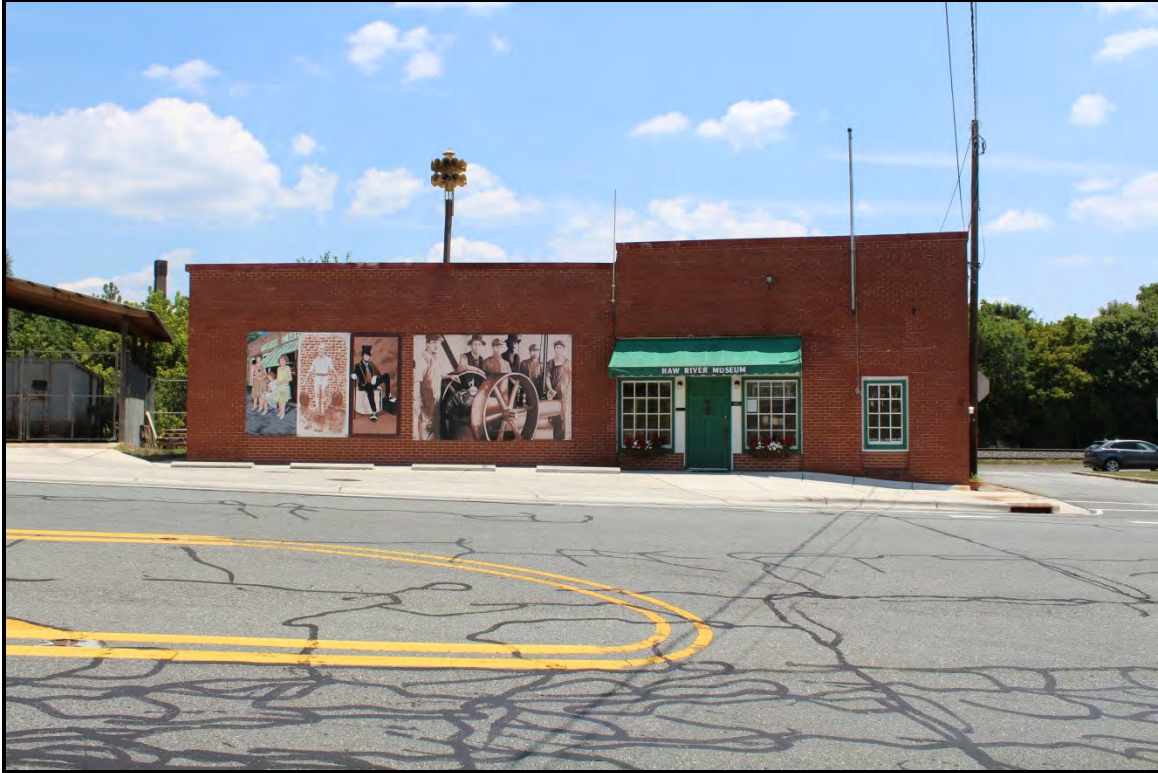
The one-story, brick-frame building features a flat roof, a brick exterior laid in common bond, and a continuous brick foundation. Fenestration includes double-hung 6/6 wood sashes and fixed 16-light vinyl sashes. Two original window openings have been infilled with brick. A brick and concrete staircase provide access to the building on the north elevation and a non-historic door has been installed on the west elevation.

NRHP Assessment. Architectural resource AM2596 does not exhibit a distinctive architectural style or workmanship. In addition, the building has been altered through the enclosure of original window openings and the alteration of the main entrance. Based on the lack of architectural merit, as well as the inability to associate the building and/or its original owner(s) with an important historical event or series of events, it is TRC's opinion that architectural resource AM2596 is not eligible for the NRHP.

Figure 6.207. Architectural resource AM2596; view is northeast and features the south and west elevations.

Figure 6.208. Architectural resource AM2596; view is southeast and features the north elevation.

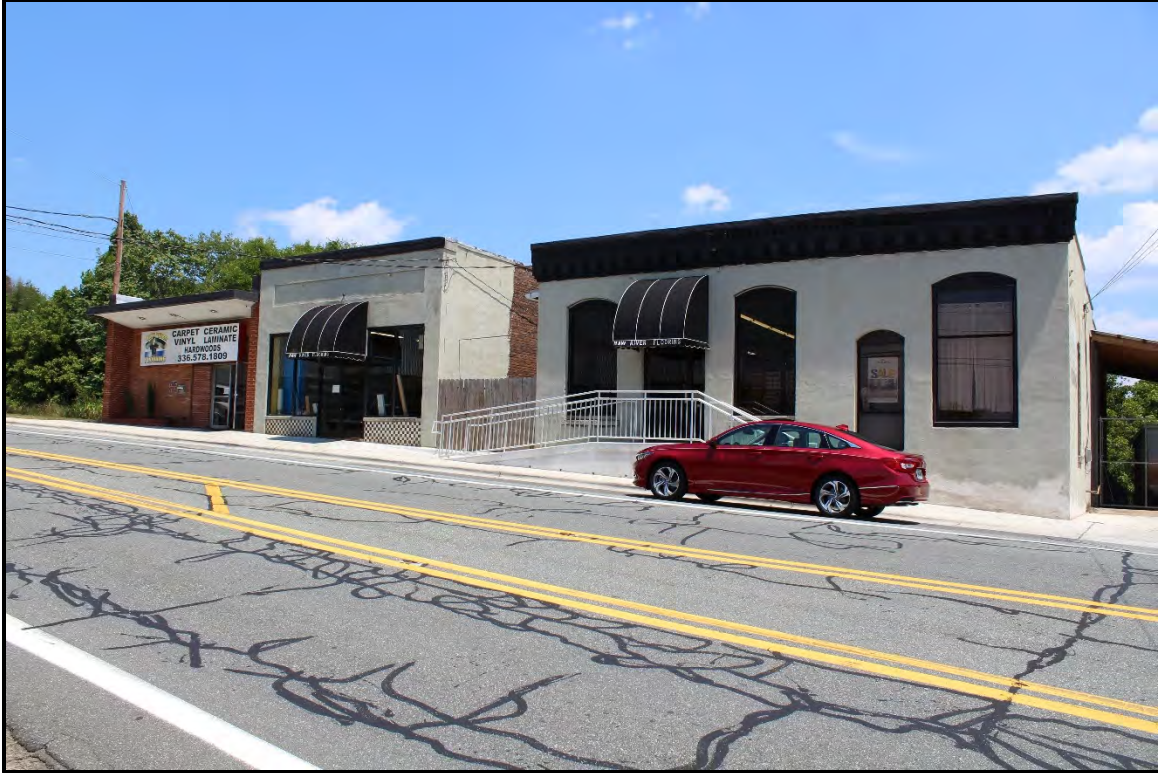
The exterior of the building's façade is sheathed with stucco and is marked with an off-center entrance that contains a metal-glass door. The main entrance is accessible via a modern concrete stoop containing a ramp on the north elevation and a set of steps on the south elevation. A fabric awning indicates that the building houses the "Haw River Flooring Company." The main entrance is flanked on either side by segmental arched window openings containing a two-light, fixed sash window set in a metal sash. Positioned south of the main entrance is a segmental arched door opening that has been filled with a single-pane window. Flanking this opening is an original segmental arched window with a two-light, fixed metal sash. The building is accented with a heavily articulated cornice marked with dentil molding.

NRHP Assessment. Architectural resource AM2597 does not exhibit a distinctive architectural style or workmanship. In addition, the building has been altered through the replacement of the original windows sashes and the modifications to the main entrance. Based on the lack of architectural merit, as well as the inability to associate the house and/or its original owner(s) with an important historical event or series of events, it is TRC's opinion that architectural resource AM2597 is not eligible for the NRHP.

Figure 6.209. Architectural resource AM2597; view is northeast and features the west elevation.

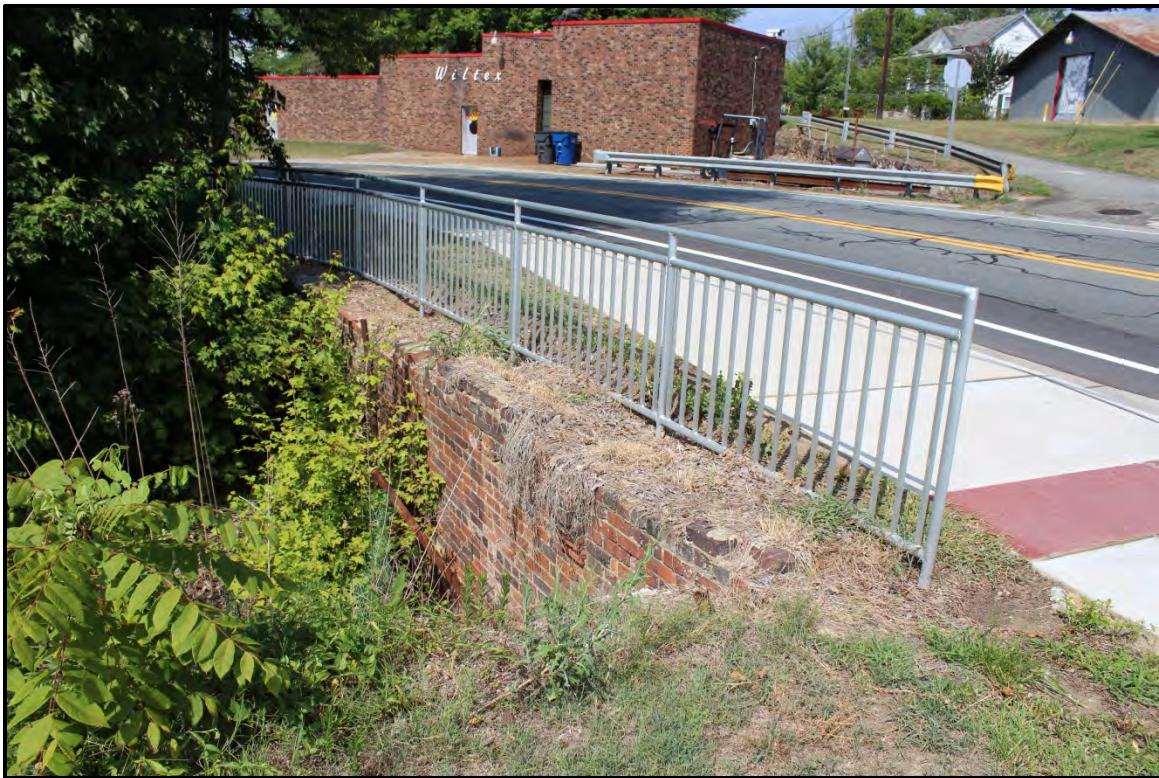
Description. Architectural resource AM2598 is a single-box culvert located along Main Street near the intersection with Gravel Street, Haw River 27258 (see Figures 1.2n1 and 1.2n2; Figure 6.210). The culvert appears to have been constructed ca. 1940. The structure is faced with brick and topped by a two-lane asphalt roadway that is bordered by a guard rail.

Figure 6.210. Architectural resource AM2598; view is northwest and features the south elevation.

NRHP Assessment. Architectural resource AM2598 does not exhibit a distinctive architectural style or workmanship. Based on the lack of architectural merit, as well as the inability to associate the culvert with an important historical event or series of events, it is TRC's opinion that architectural resource AM2598 is not eligible for the NRHP.

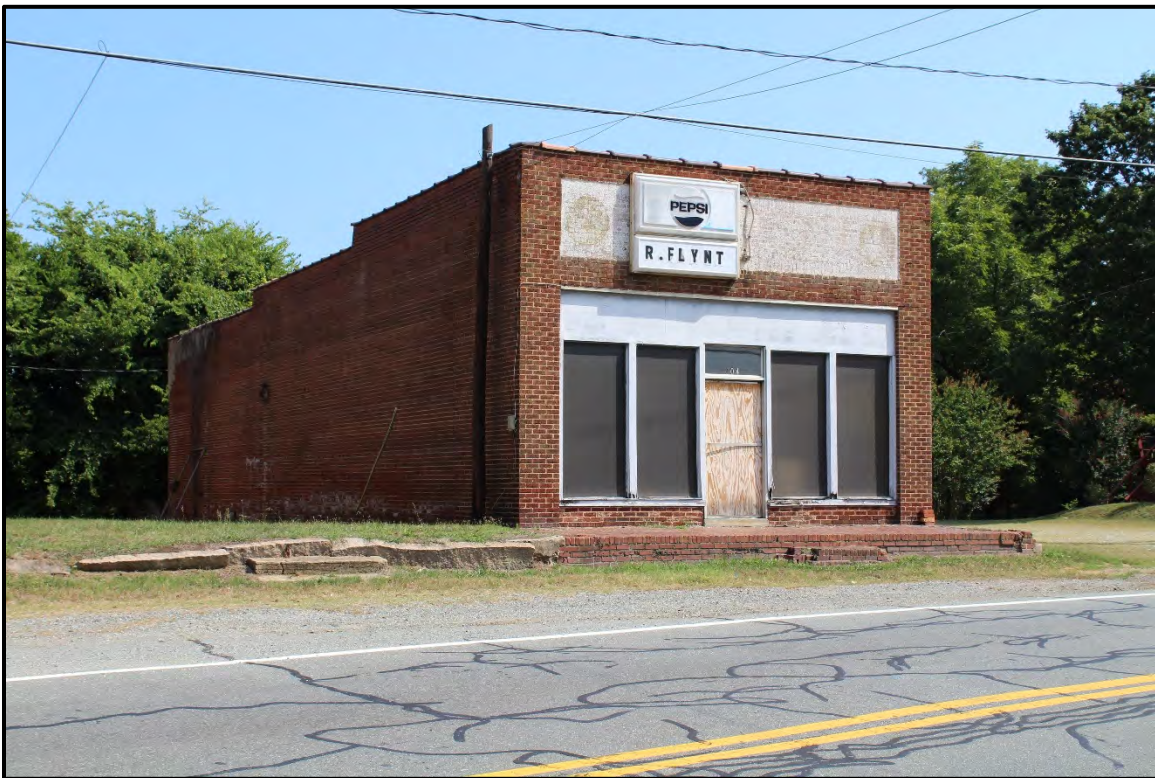
- 304 East Main Street (Parcel# 153241). Newly recorded architectural resource AM2590 (see above) has a reported construction date of 1920 (Alamance County, NC WebGIS 2018) (Figure 6.211). The building is locally known as the R. Flynt Building. This is a single-story brick commercial building with a rectangular layout. The building features a flat roof, terra cotta coping, and a brick foundation. The façade elevation contains a replaced storefront and a brick sidewalk. Located on the primary elevation is a modern Pepsi sign that reads “R. Flynt.”

Figure 6.211. Architectural resource AM1595; view is northwest featuring 304 East Main Street.

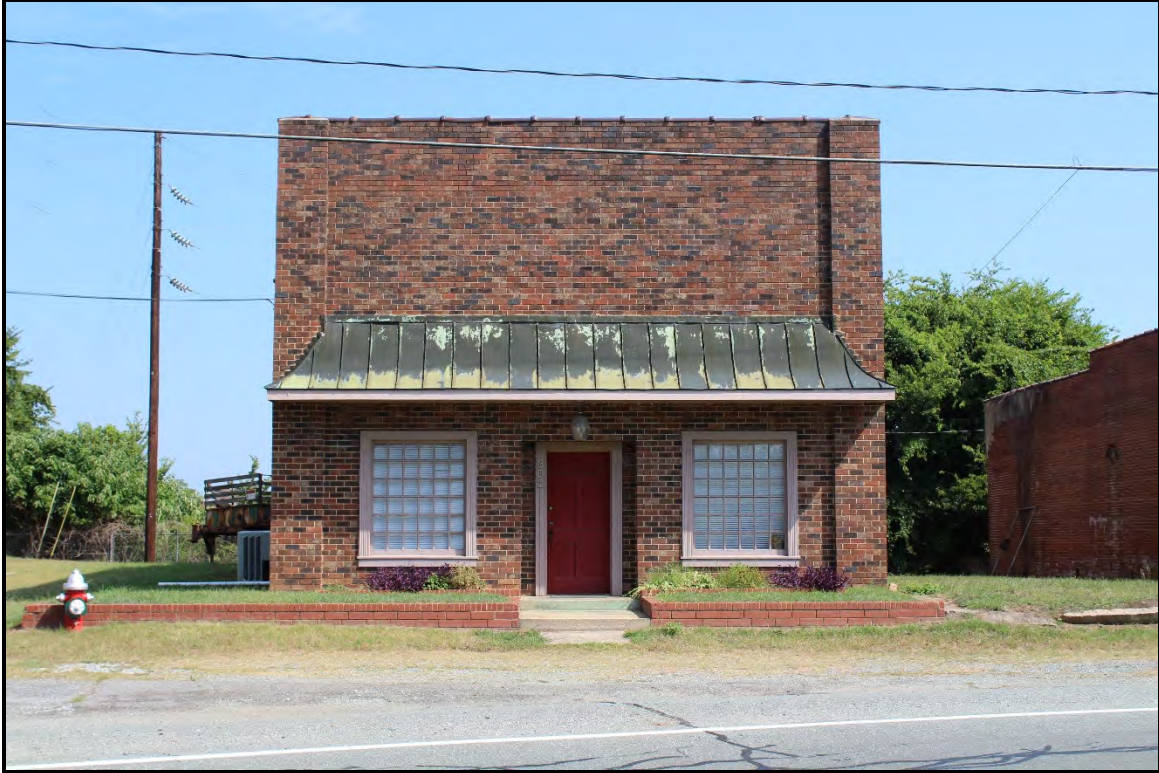
- 302 East Main Street (Parcel# 153237). Newly-recorded architectural resource AM2592 (see above) has a reported construction date of 1903 (Alamance County, NC WebGIS 2018) (Figure 6.212). This is a brick commercial building with a rectangular layout. Although the building was constructed in 1903, it is likely that the entire façade was remodeled at some point in the mid-twentieth century. The building features a flat roof, terra cotta coping, and a brick foundation. The primary elevation contains replaced wood sash store windows and the main entry is filled with a replaced door. Located on the façade elevation is a pent roof attached above the first-floor windows;

Figure 6.212. Architectural resource AM1595; view is northwest featuring 302 East Main Street.

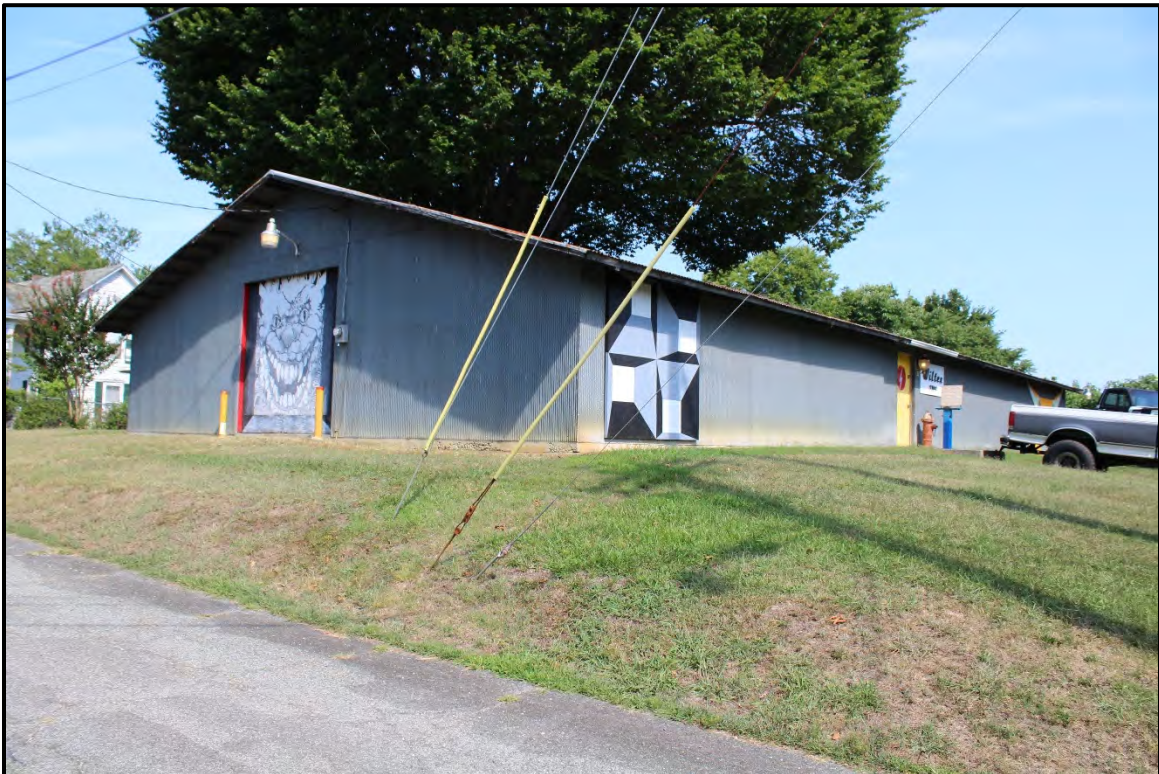
- 101 Gravel Street (Parcel# 153176). This building (newly recorded architectural resource AM2595; see above) is a warehouse that is reported to have been constructed in 1968 (Alamance County, NC WebGIS 2018). This one-story building that features a side-gabled roof covered with metal sheeting, an exterior clad with metal sheeting, and a continuous concrete foundation. Fenestration includes an overhead bay door on the south elevation and a pedestrian door on the east elevation (Figure 6.213);

Figure 6.213. Architectural resource AM1595; view is northwest featuring 101 Gravel Street.

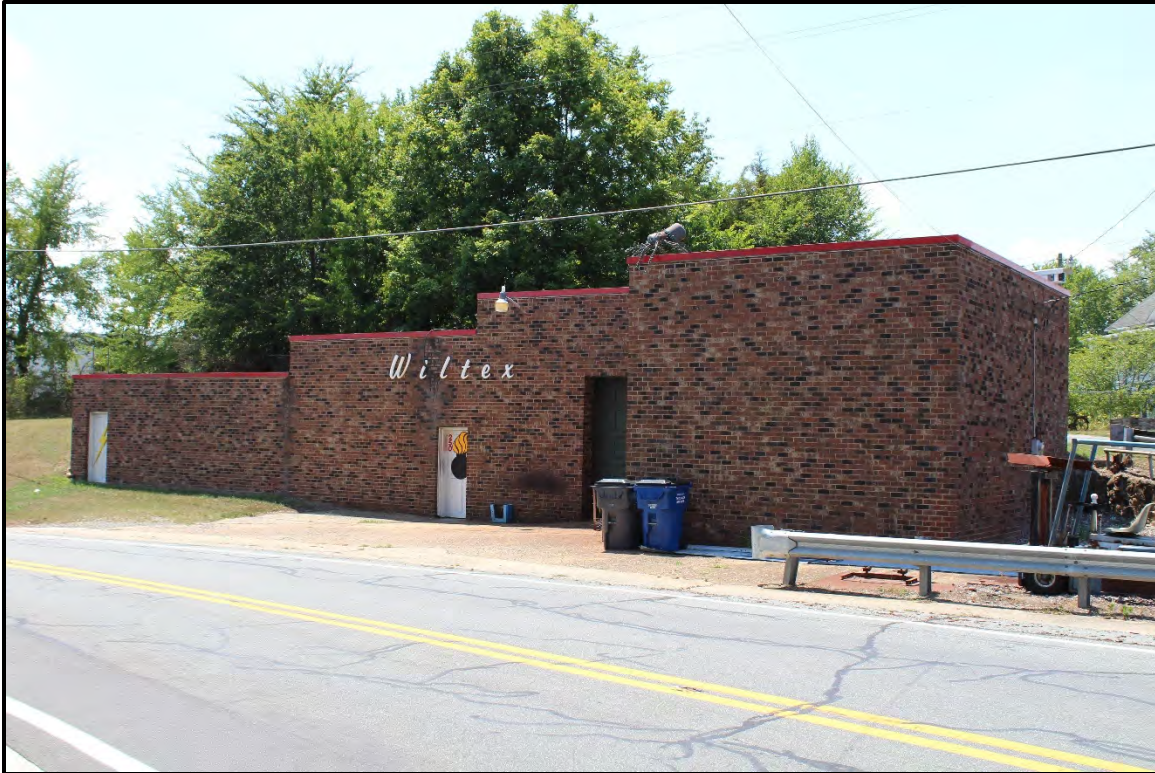
- 250 East Main Street (Parcel# 153175). Newly-recorded architectural resource AM2597 (see above) is a single-story commercial building that is reported to have been constructed in 1901 (Alamance County, NC WebGIS 2018). This building features a stepped flat roof, an exterior clad with a brick veneer, and a continuous brick foundation. The building’s east elevation includes three door openings that contain single leaf wood panel doors. In addition, the elevation includes a vehicle bay that contains an overhead wood panel door (Figure 6.214);

Figure 6.214. Architectural resource AM1595; view is northwest featuring 250 East Main Street.

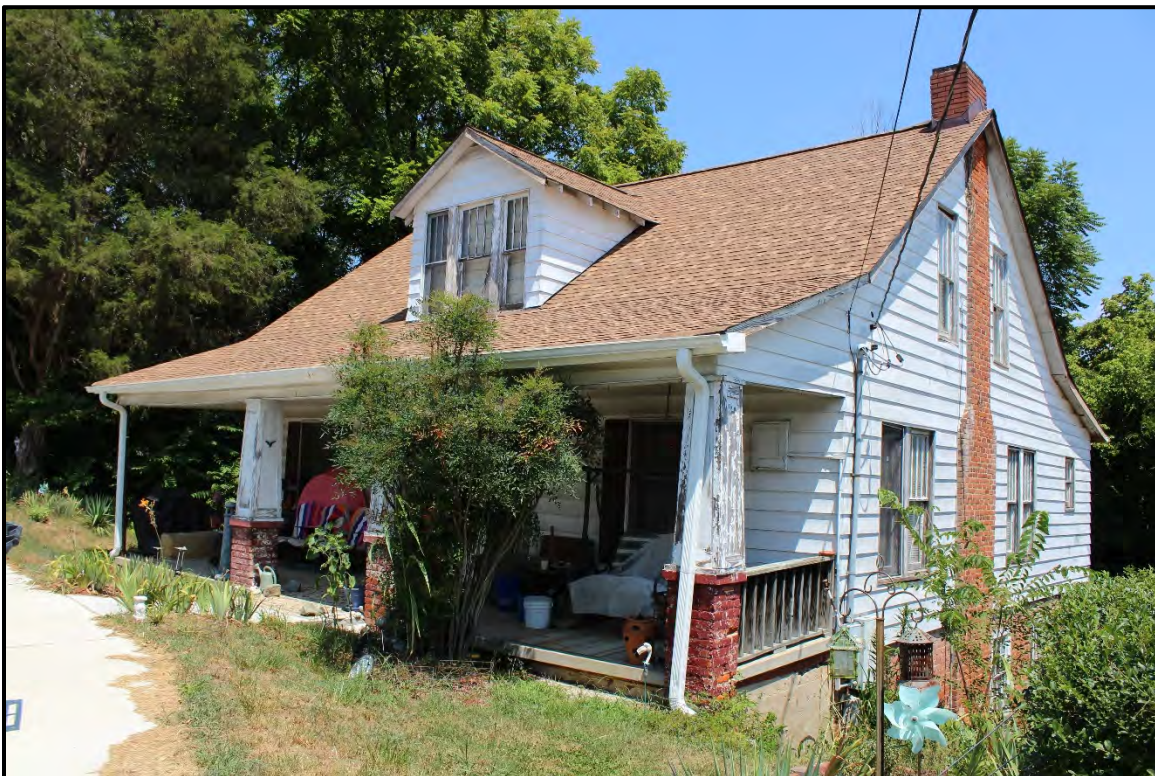
- 247 East Main Street (Parcel# 153240). Newly-recorded architectural resource AM2593 (see above) is a Craftsman Bungalow-style house that is reported to have been constructed in 1924 (Alamance County, NC WebGIS 2018). AM2593 is a one and one-half story house that features a side-gabled roof covered with asphalt shingles, an exterior end brick chimney, and an aluminum siding-clad exterior. Fenestration includes 4/1 double-hung wood sash windows. A full-width porch provides access to the main entrance and is integral with the main roof, which is partially supported by tapered wood columns set atop brick plinth blocks. The porch features a modern concrete block deck (Figure 6.215);

Figure 6.215. Architectural resource AM1595; view is northeast featuring 247 East Main Street.

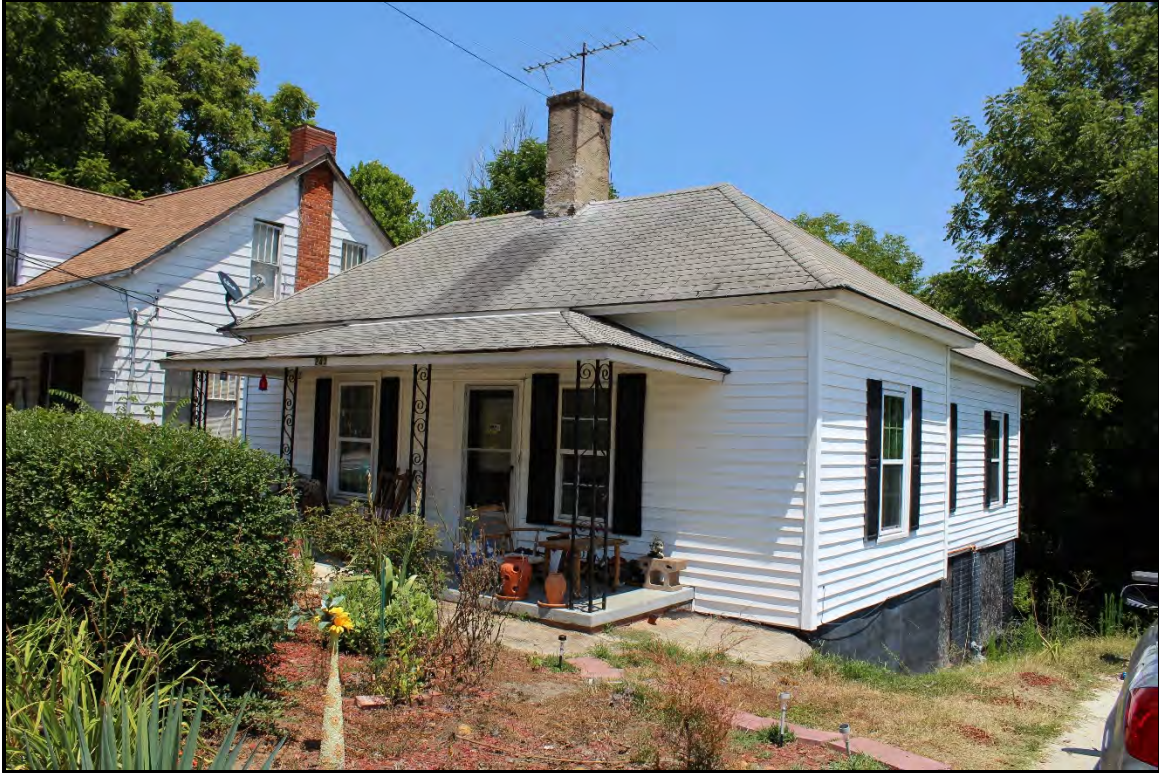
- 243 East Main Street (Parcel# 153239). Newly-recorded architectural resource AM2594 (see above) is a hipped-roof house that is reported to have been constructed in 1929 (Alamance County, NC WebGIS 2018). AM2594 is a one-story house that features a roof covered with asphalt shingles, an interior central concrete chimney, a vinyl siding-clad exterior, and a brick pier foundation with concrete block infill. Fenestration includes 6/6 double-hung vinyl sash windows. A reconstructed partial-width porch provides access to the main entrance and features a hipped roof that is supported by ornamental metal columns and a concrete slab deck (Figure 6.216);

Figure 6.216. Architectural resource AM1595; view is northeast featuring 243 East Main Street.

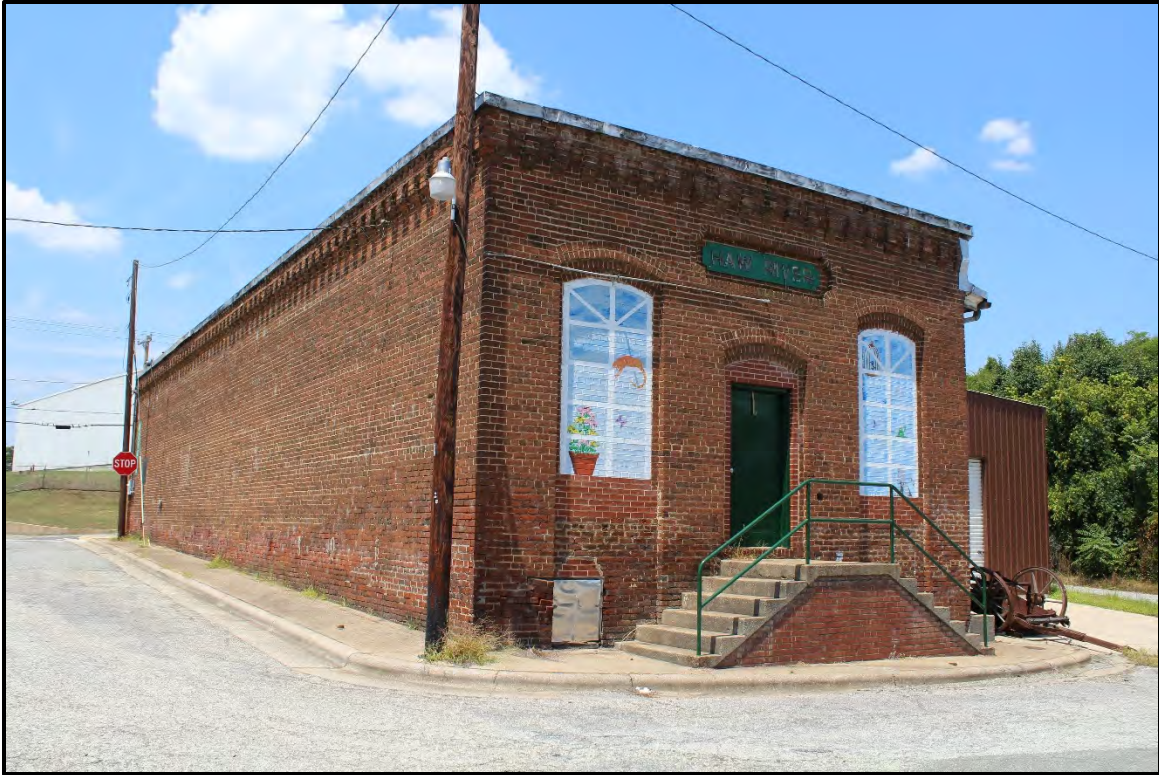
foundation. Fenestration includes double-hung 6/6 wood sashes and fixed 16-light vinyl sashes. Two original window openings have been infilled with brick. A brick and concrete staircase provide access to the building on the north elevation and a non-historic door has been installed on the west elevation (Figure 6.220).

Figure 6.220. Architectural resource AM1595; view is north featuring 201 East Main Street.

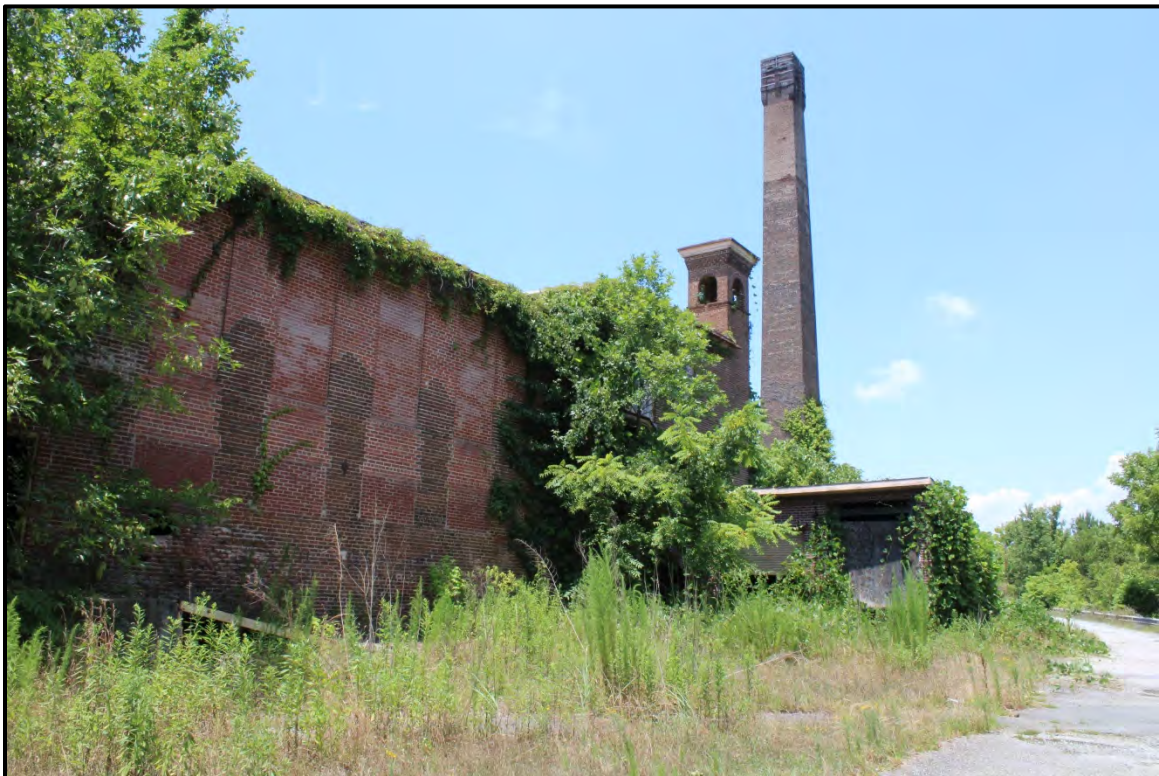
Figure 6.230. T.M. Holt Manufacturing Company; view is northwest featuring the mid-twentieth century additions to the 1892 mill building with the associated stair tower and smokestack.

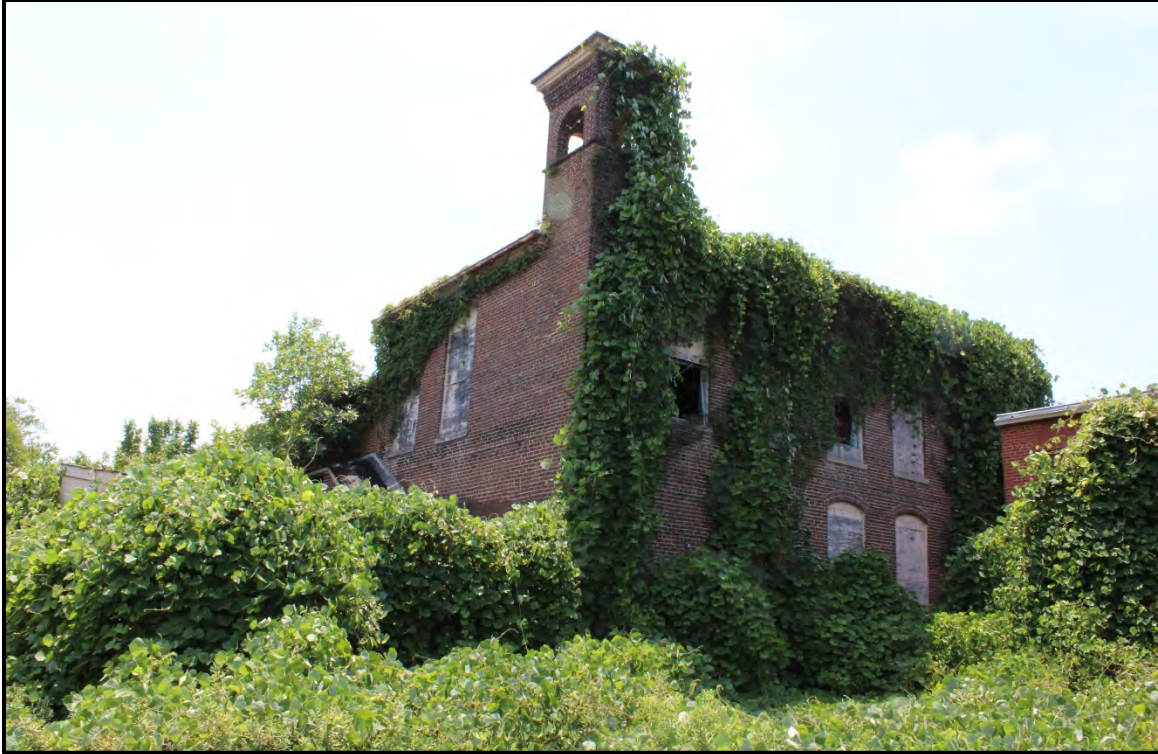
6.231 and 6.235). A review of historic images of the mill complex also revealed that the original 1892 mill (AM0203) was defined by a four-story brick tower that was capped with a pyramidal roof (Figures 6.238 and 6.239). The presence of a multi-story tower was a prominent feature of late nineteenth century mill architecture. At some point, likely coinciding with the construction of the 1950 and 1960 additions, the upper two floors of the tower were demolished and the remaining window openings enclosed with brick. Moreover, the original 1892 mill and subsequent 1897 addition have been significantly altered through the construction of mid-twentieth century additions, which obliterated the Praray-designed walls that were once a character-defining features of the primary façade of the 1897 addition (Figure 6.239). For the south and east (rear) elevations, these portions of the mill are concealed by metal panels that were applied in the late twentieth century (Figures 6.239 and 6.240).

Figure 6.231. T.M. Holt Manufacturing Company; view is southwest featuring the 1892 mill building with the associated stair tower and partially collapsed wall.

Due to the poor integrity of the mill complex resulting from significant deterioration and modern alterations, it is TRC's recommendation that architectural resource AM0203/AM1516 is not eligible for the NRHP. A review of a comprehensive architectural survey of Alamance County conducted in 2014 indicates that there are several other intact mill complexes, such as Glencoe Mill in Burlington and the nearby Granite Mill in Haw River, that retain a higher degree of integrity and serve as better examples of conveying Alamance County's textile history (ACHPC 2014).

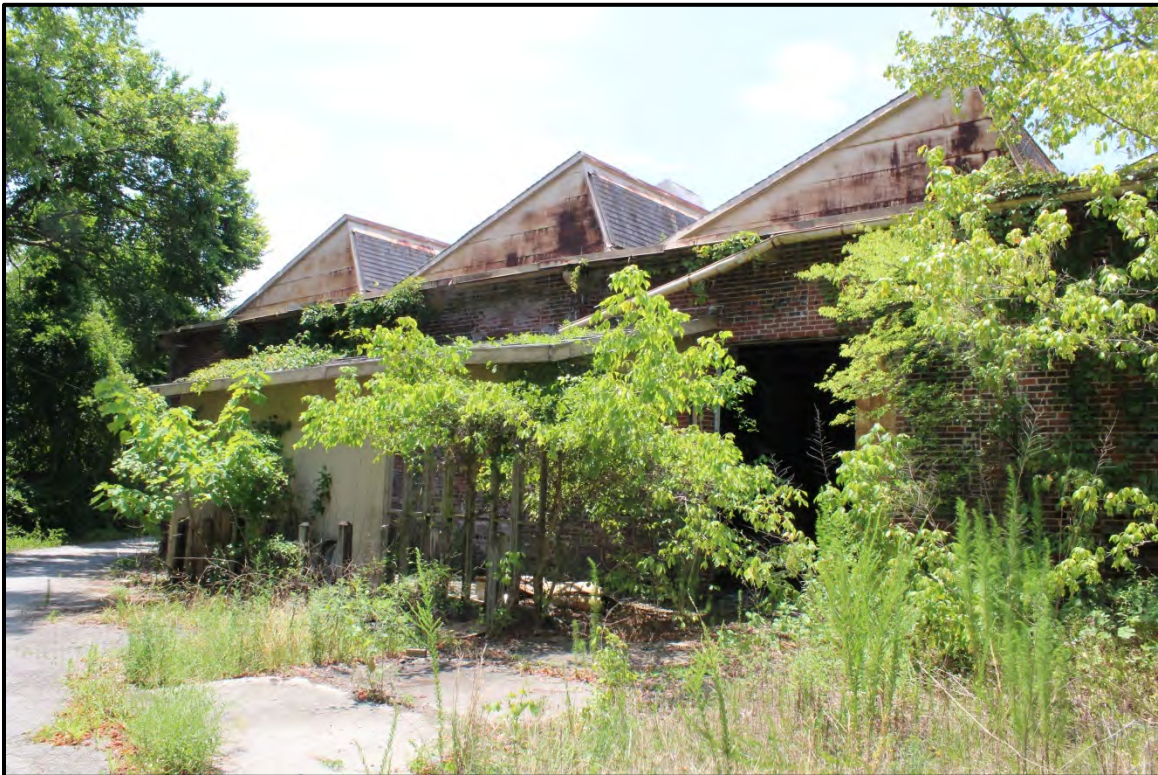
In 1934, the two-story Holt-Tabardrey Mill (AM1516) was constructed and attached to the north elevation of the 1892 mill building (Figures 6.236 and 6.239). This section of the complex was later modified through the construction of an addition on the east elevation in the 1960s (Figures 6.235). In the late twentieth century, the north elevation of both the 1934 mill and the 1960s addition were clad with exterior metal siding (Figure 6.236). Fenestration on the 1934 mill consists of four-light metal sash windows that are positioned along the east elevation, which is faced with a common bond brick exterior. Many of the original window openings, which are denoted with a concrete sill, have been enclosed with brick. The north elevation of the 1934 building includes a docking bay. Connected to a mid-twentieth century bay addition on the west elevation of AM1516, is an elevated walkway that spans the adjacent railroad connects to the Cora Mill (AM2407) (Figure 6.237). The walkway was constructed in 1928 to provide easy and safe access for plant employees to walk between the two mills (Fearnbach 2014).

Figure 6.235. T.M. Holt Manufacturing Company; view is northwest featuring the 1960s addition to the east elevation of the ca. 1934 Holt-Tabardrey Mill (AM1516).

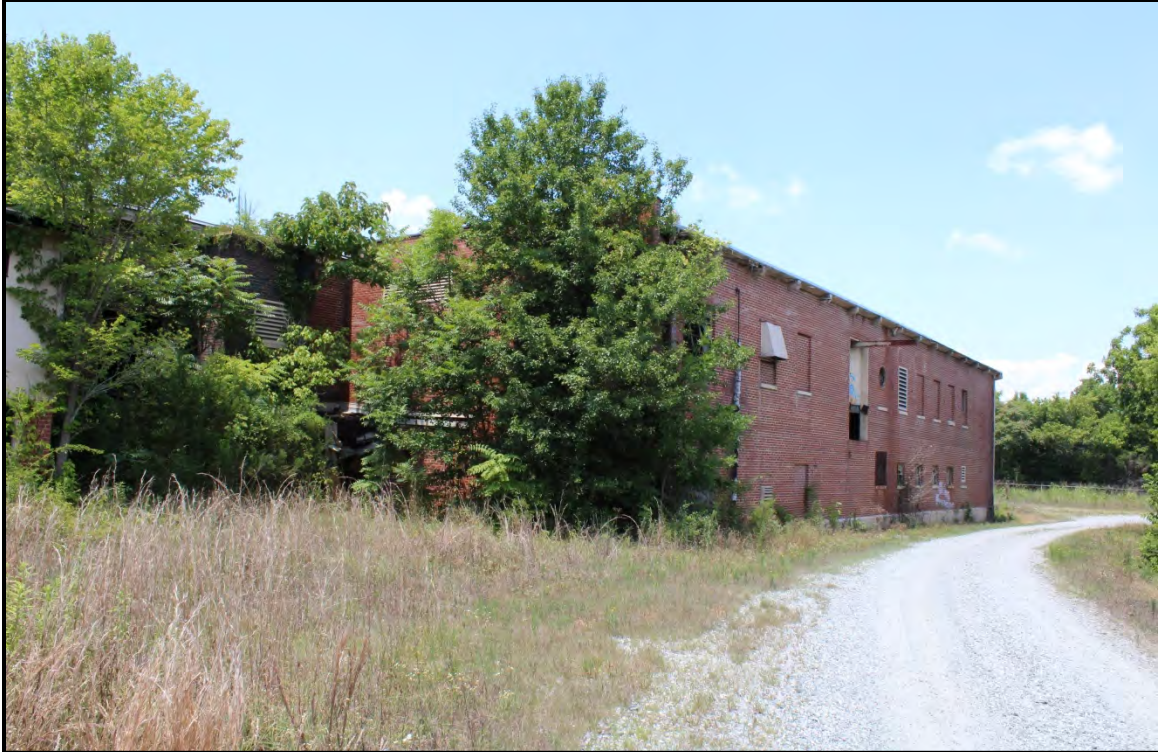
Figure 6.236. T.M. Holt Manufacturing Company; view is southwest featuring the north elevation of the ca. 1934 Holt-Tabardrey Mill (AM1516)

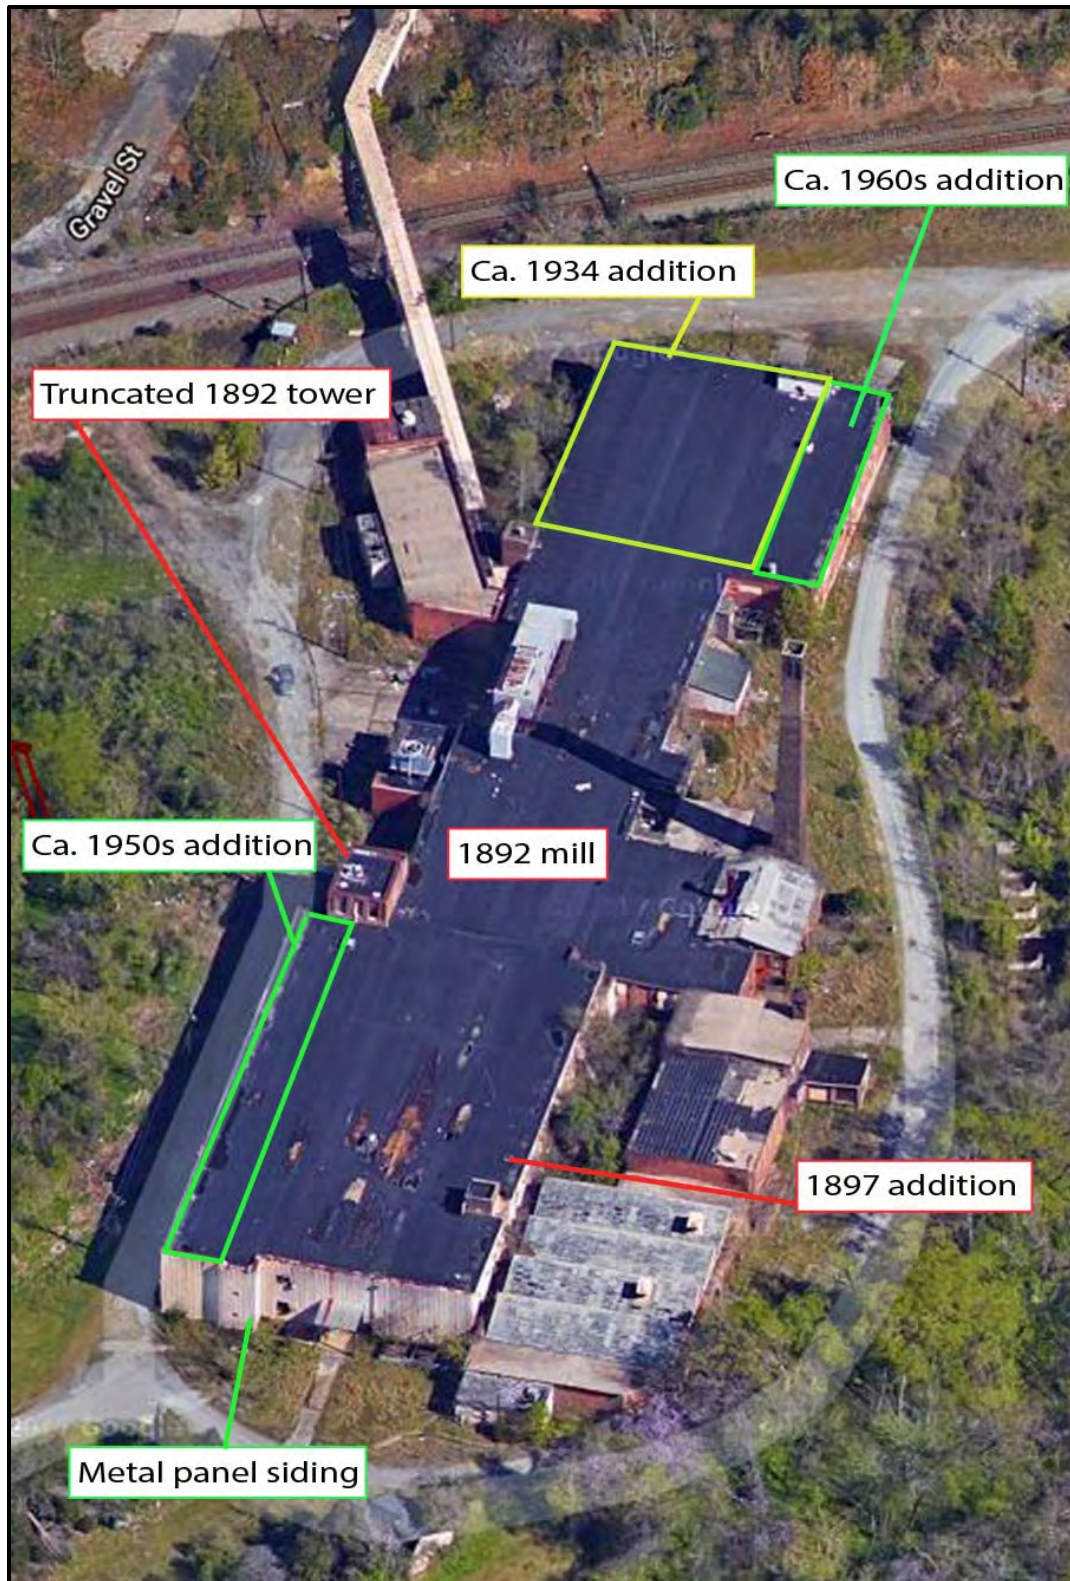
In 1897, a large multi-story addition was constructed and attached to the south end of the 1892 mill (Figure 6.239). The brick-frame addition featured the innovative Praray structural system, first developed in 1894 by Charles A. Praray and nicknamed “zigzag wall construction” due to the repeated left and right turns of the exterior wall lines. In traditional mill construction, the floor beams and rafters were supported by the exterior walls, which had to feature massive construction to carry the weight of the floors and mill equipment. This had the effect of making construction expensive and limited the number of windows that could be placed in the walls. The Praray system made it possible to separate the floor loads from the exterior wall construction (Kim et al. 2002). This structural system was cheaper to build, afforded greater space for windows on the exterior walls, and was easier to repair in case of fire (Kim et al. 2002). Although the 1897 addition is still standing, the west elevation that once featured the Praray walls were destroyed during the construction of a multi-story addition (Figure 6.239). The remaining south and west elevations of the 1897 addition are concealed with metal panel siding (Figure 6.240).

Figure 6.240. Current aerial view of the Holt-Tabardrey Mill depicting the metal panel siding applied to the south elevation and assorted alterations to the mill; view is north (image courtesy of Google Earth).

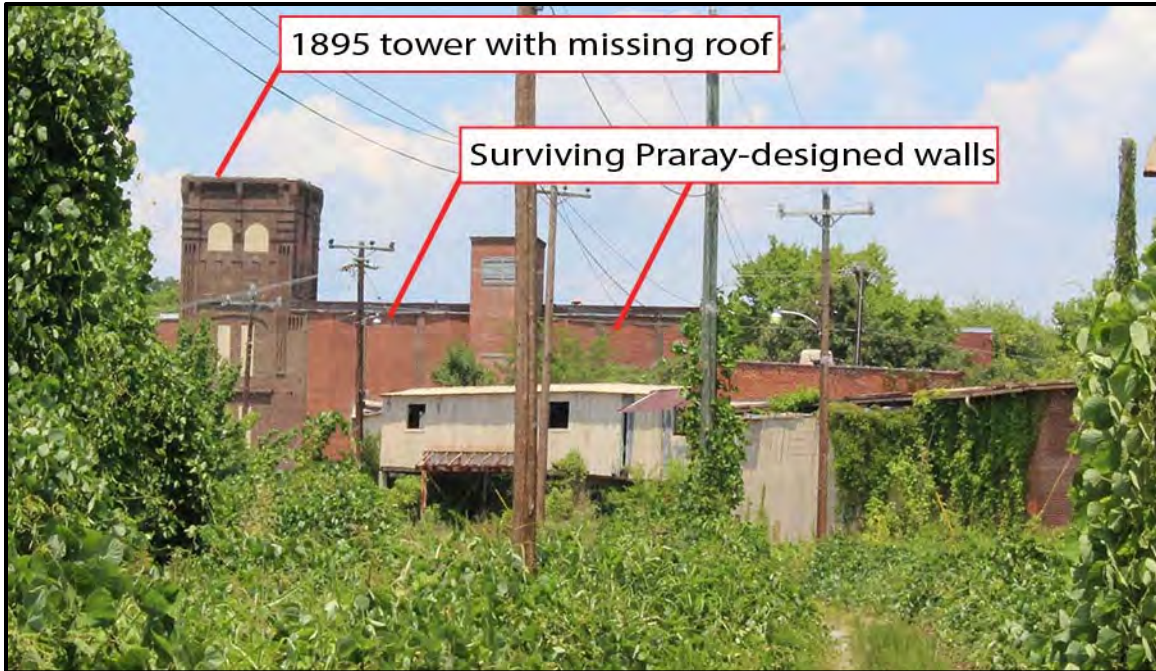
The Cora Mill is a three-story building with a built-up roof and a four-story staircase tower at the southwest corner. The building featured the innovative Praray structural system, first developed in 1894 by Charles A. Praray and nicknamed “zigzag wall construction” due to the repeated left and right turns of the exterior wall lines. In traditional mill construction, the floor beams and rafters were supported by the exterior walls, which had to feature massive construction to carry the weight of the floors and mill equipment. This had the effect of making construction expensive and limited the number of windows that could be placed in the walls. The Praray system made it possible to separate the floor loads from the exterior wall construction. “In my improved method of construction,” Praray wrote, “it is seen that the walls do not support the floors at all, nor the weight on the floors, but are wholly independent thereof. They serve simply to cover in or enclose the structure. They rest on their own foundation and serve to support the windows and carry their weight and no more” (Kim et al. 2002). This structural system was cheaper to build, afforded greater space for windows on the exterior walls, and was easier to repair in case of fire. The Selma Cotton Mill, located in Dallas County, Alabama, was constructed with Praray-designed walls and provides a visual example of how the exterior elevations of Cora Mill would have appeared following its construction (Figure 6.244). At Cora Mill, the original exterior Praray windows were removed and the bays completely enclosed with a brick veneer when air conditioning was installed in the mill during the 1970s (Kim et al. 2002) (Figures 6.241, 6.245–6.247, and 6.250).

Figure 6.241. Architectural resource AM2407 surviving tower and Praray walls on the south elevation; view is north from Holt-Tabardrey Mill (AM1516).

Due to the poor integrity of the mill complex resulting from significant deterioration and modern alterations, it is TRC's recommendation that architectural resource AM2407 is not eligible for the NRHP. A review of a comprehensive architectural survey of Alamance County conducted in 2014, indicates that there are several other intact mill complexes, such as Glencoe Mill in Burlington and the nearby Granite Mill in Haw River, that retain a higher degree of integrity and serve as better examples of Alamance County's textile history (ACHPC 2014).

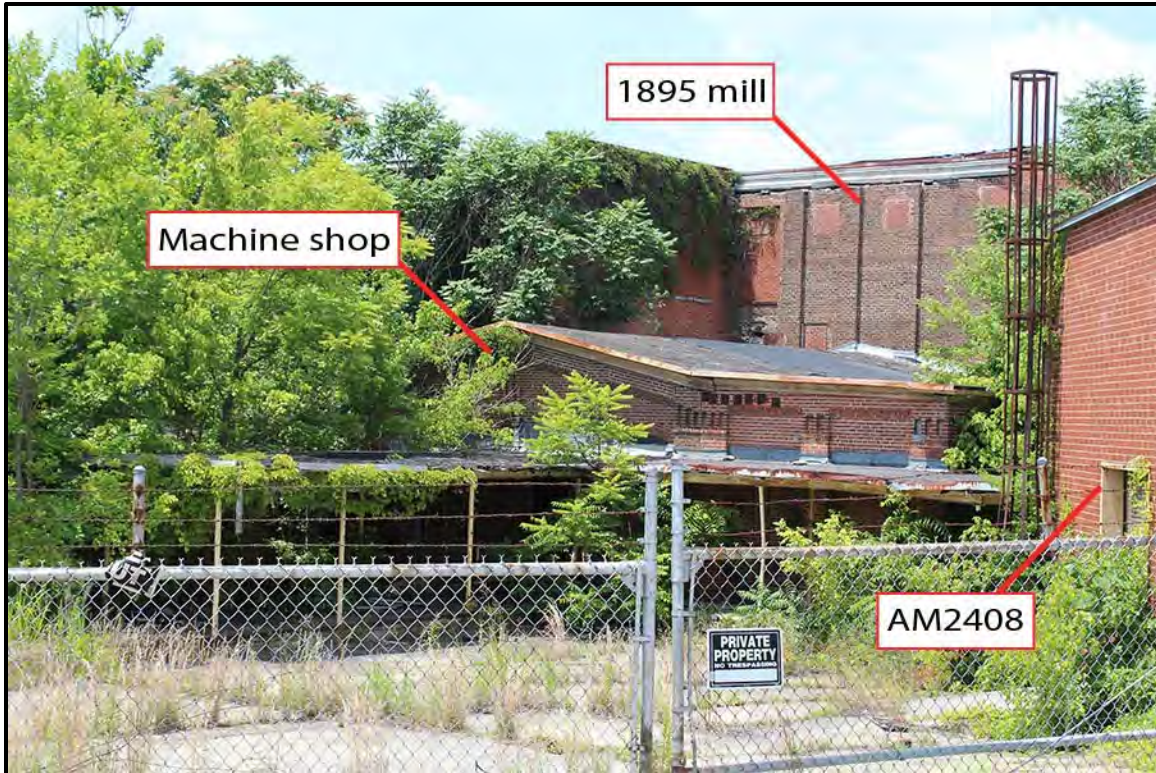
Located immediately northeast of the Cora Mill (AM2407) is AM2408, the Tabardrey Mills Warehouse, that was built in 1950 according to county tax records (Alamance County, NC WebGIS 2018) (see Figures 6.243 and 6.248–6.252). It has a built-up roof, a concrete panel exterior, a brick and concrete foundation, and a rectangular plan. The east façade along Stone Street features a board and batten exterior along a full-width, three-bay loading dock covered by a metal shed roof supported by square wood posts. The warehouse has no windows. There is a one-story brick addition on the south elevation with a flat roof.

Figure 6.243. Architectural resource AM2407; view is west featuring the northeast corner of mill building and attached machine shop.

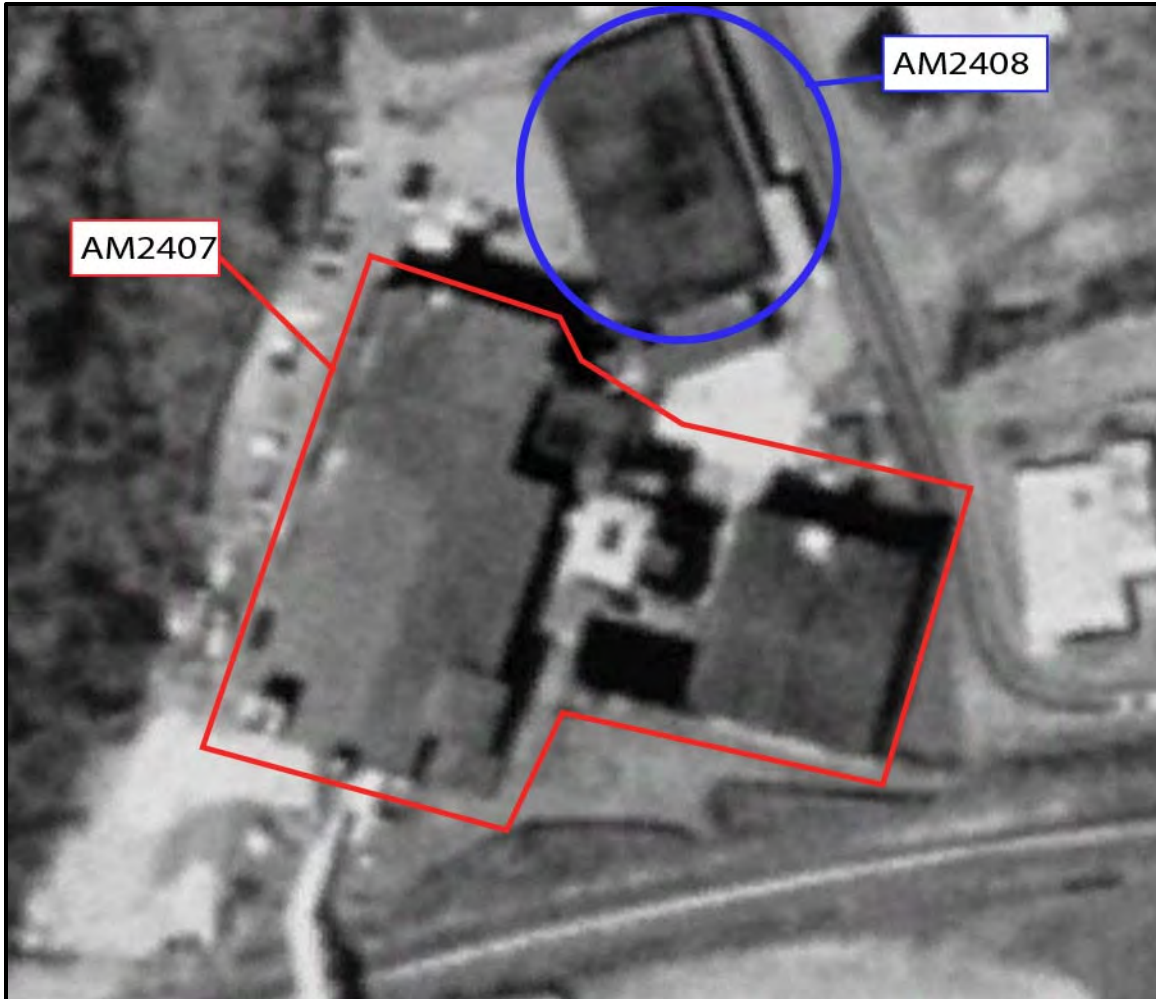
Figure 6.248. 1993 aerial image showing an intact Cora mill complex consisting of the mill and multi-story warehouses (image courtesy of Google Earth).
