Re: Revised Architectural Survey Report, MVP Southgate Project, Construct Interstate Pipeline, Rockingham and Alamance County, ER 18-1041

Thank you for your letter of October 11, 2019, transmitting the draft "Historic Architectural Survey for the MVP Southgate Pipeline Project". We have reviewed the report and offer the following comments.

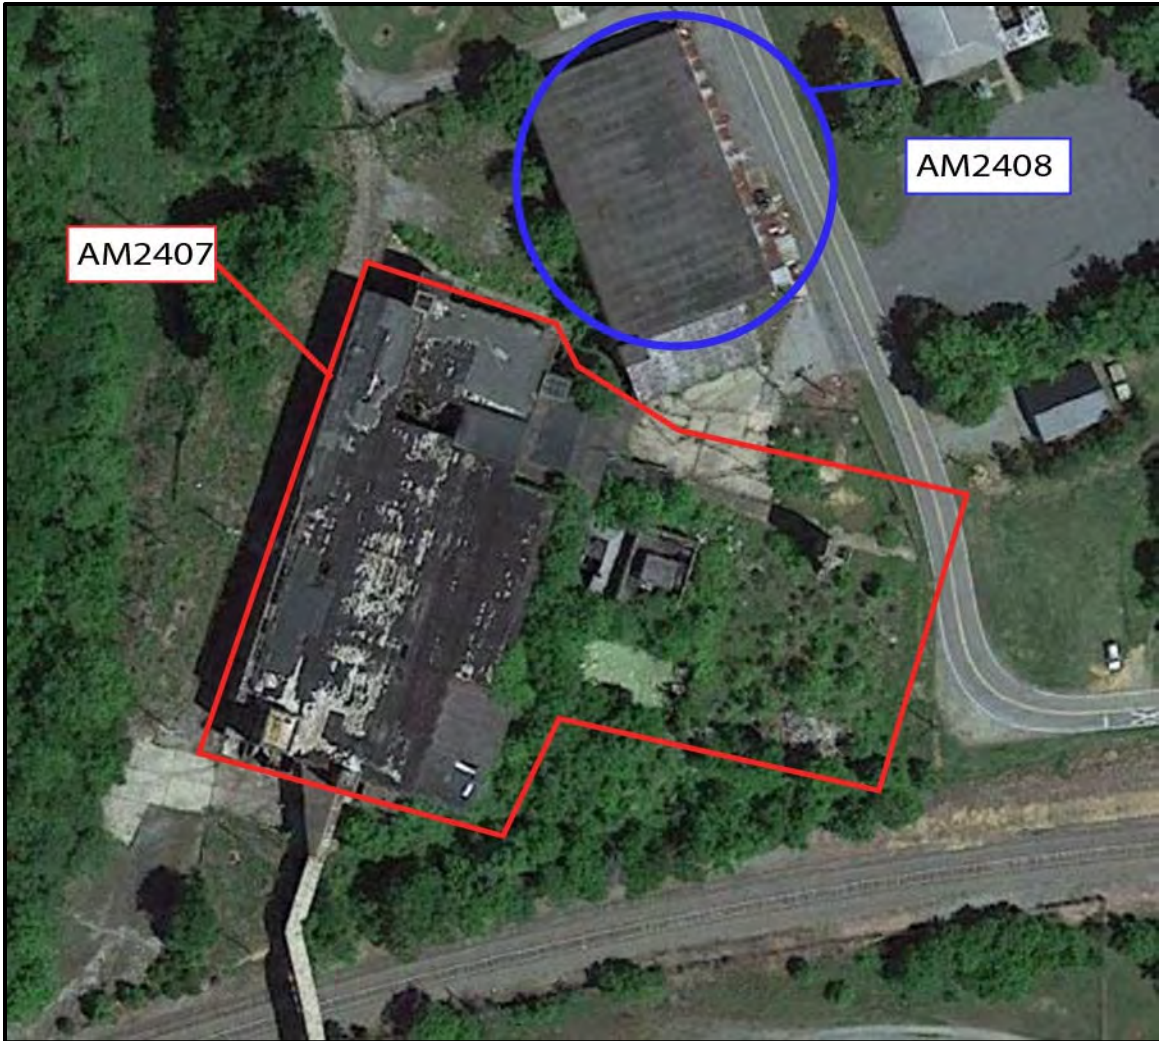
Located immediately northeast of the Cora Mill (AM2407) is AM2408, the Tabardrey Mills Warehouse, that was built in 1950 according to county tax records (Alamance County, NC WebGIS 2018) (see Figures 6.243 and 6.248–6.252). It has a built-up roof, a concrete panel exterior, a brick and concrete foundation, and a rectangular plan. The east façade along Stone Street features a board and batten exterior along a full-width, three-bay loading dock covered by a metal shed roof supported by square wood posts. The warehouse has no windows. There is a one-story brick addition on the south elevation with a flat roof.

Figure 6.249. 2017 aerial image of Cora Mill showing the results of recent demolition of the associated warehouses (image courtesy of Google Earth).

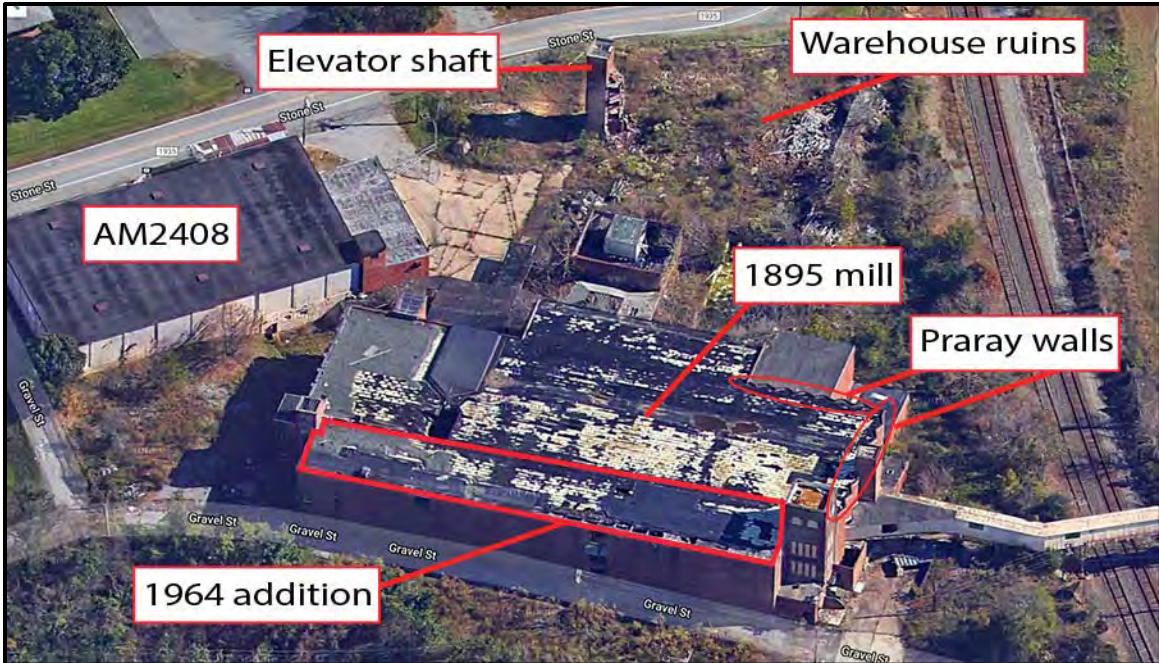
The Cora Mill is a three-story building with a built-up roof and a four-story staircase tower at the southwest corner. The building featured the innovative Praray structural system, first developed in 1894 by Charles A. Praray and nicknamed “zigzag wall construction” due to the repeated left and right turns of the exterior wall lines. In traditional mill construction, the floor beams and rafters were supported by the exterior walls, which had to feature massive construction to carry the weight of the floors and mill equipment. This had the effect of making construction expensive and limited the number of windows that could be placed in the walls. The Praray system made it possible to separate the floor loads from the exterior wall construction. “In my improved method of construction,” Praray wrote, “it is seen that the walls do not support the floors at all, nor the weight on the floors, but are wholly independent thereof. They serve simply to cover in or enclose the structure. They rest on their own foundation and serve to support the windows and carry their weight and no more” (Kim et al. 2002). This structural system was cheaper to build, afforded greater space for windows on the exterior walls, and was easier to repair in case of fire. The Selma Cotton Mill, located in Dallas County, Alabama, was constructed with Praray-designed walls and provides a visual example of how the exterior elevations of Cora Mill would have appeared following its construction (Figure 6.244). At Cora Mill, the original exterior Praray windows were removed and the bays completely enclosed with a brick veneer when air conditioning was installed in the mill during the 1970s (Kim et al. 2002) (Figures 6.241, 6.245–6.247, and 6.250).

Figure 6.250. Recent aerial imagery of AM2407 depicting the ruins of the associated warehouses, the surviving segments of the Praray walls, and the addition to the west elevation; view is east.

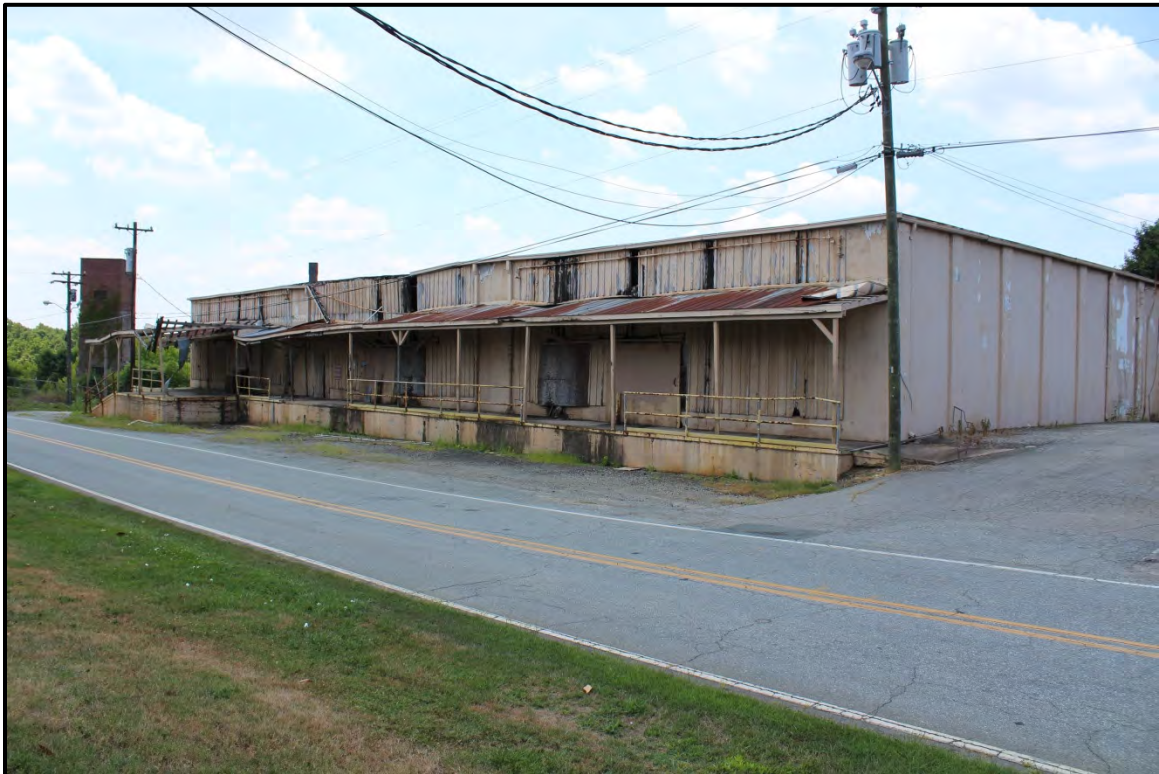
Figure 6.251. Architectural resource AM2408; view is southeast featuring the east and north elevations.

Resource AM2408 is a typical warehouse from the mid-twentieth century that does not exhibit a distinctive architectural style or workmanship. The property is not associated with important historical event(s) or person(s). Due to lack of historic and architectural significance, it is TRC's opinion that resource AM2408 is not eligible for the NRHP.

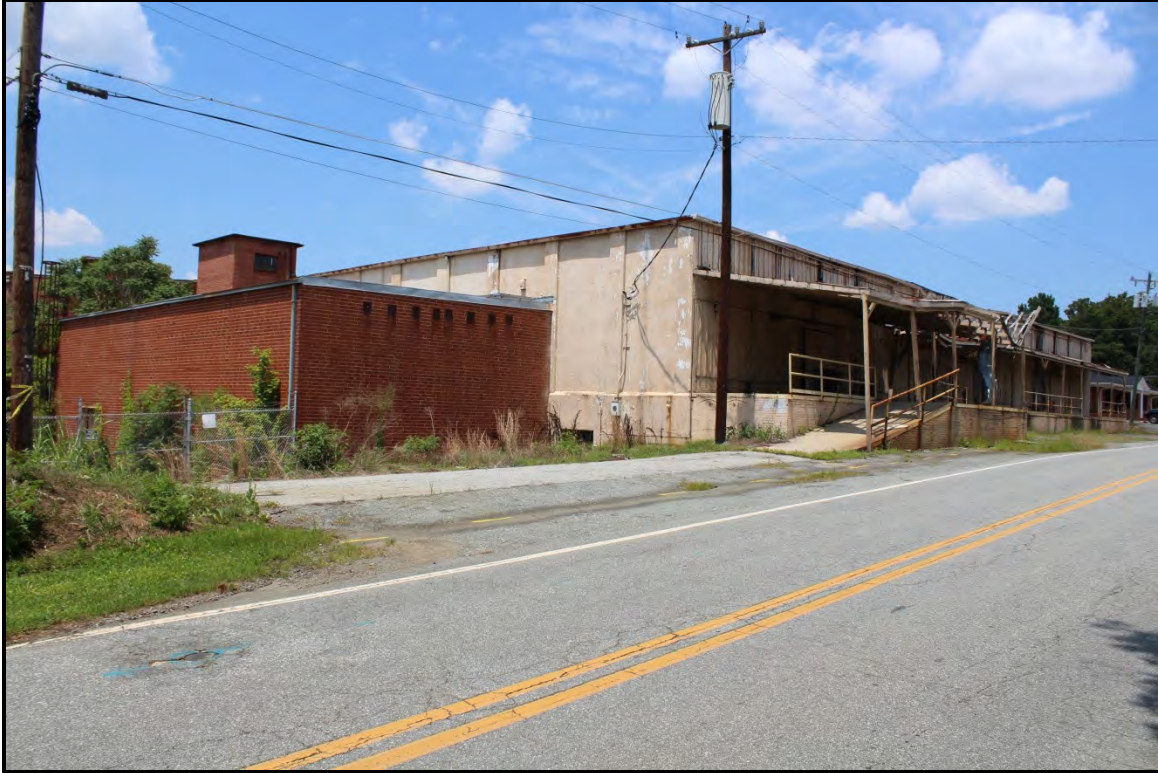
Figure 6.252. Architectural resource AM2408; view is northwest featuring the east and south elevations.

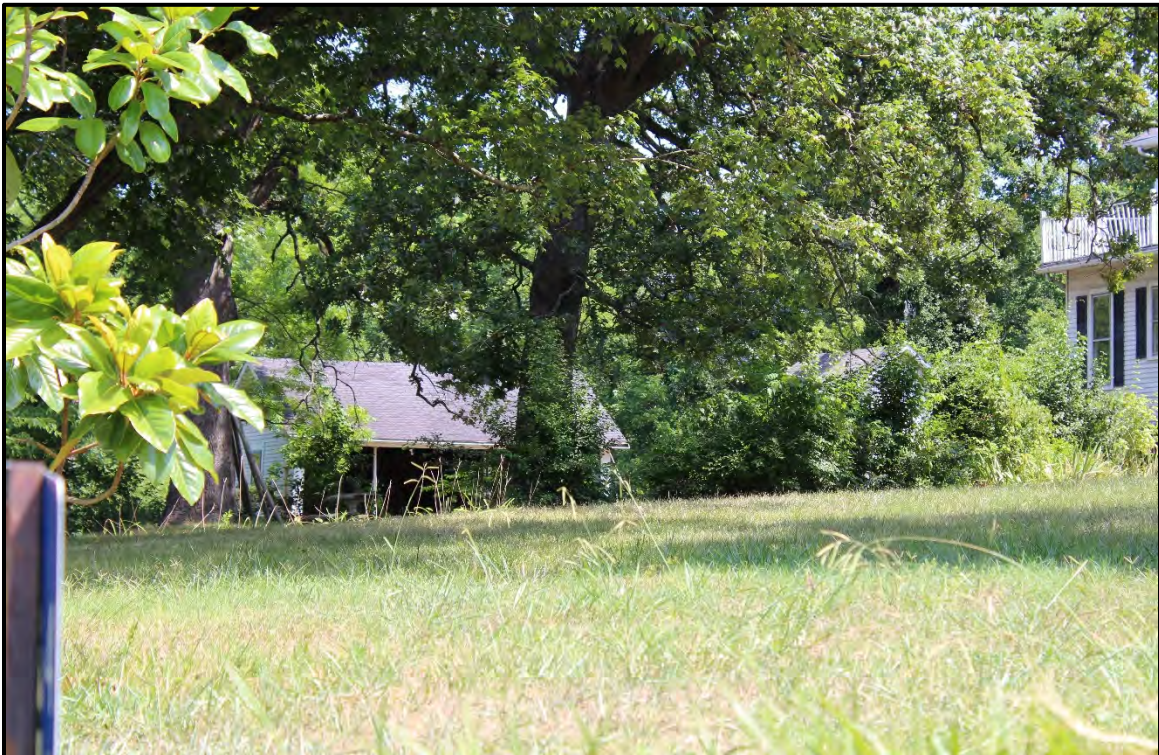
Figure 6.260. Architectural resource AM0350; view is northeast featuring the modern garage and the roof of an associated outbuilding.

Located west of the house is a modern multi-bay garage. The wood-frame building features a side-gabled roof covered with asphalt shingles and an exterior clad with vinyl siding. The roof of another outbuilding was visible from the public right-of-way, but its function is unknown (Figure 6.260).

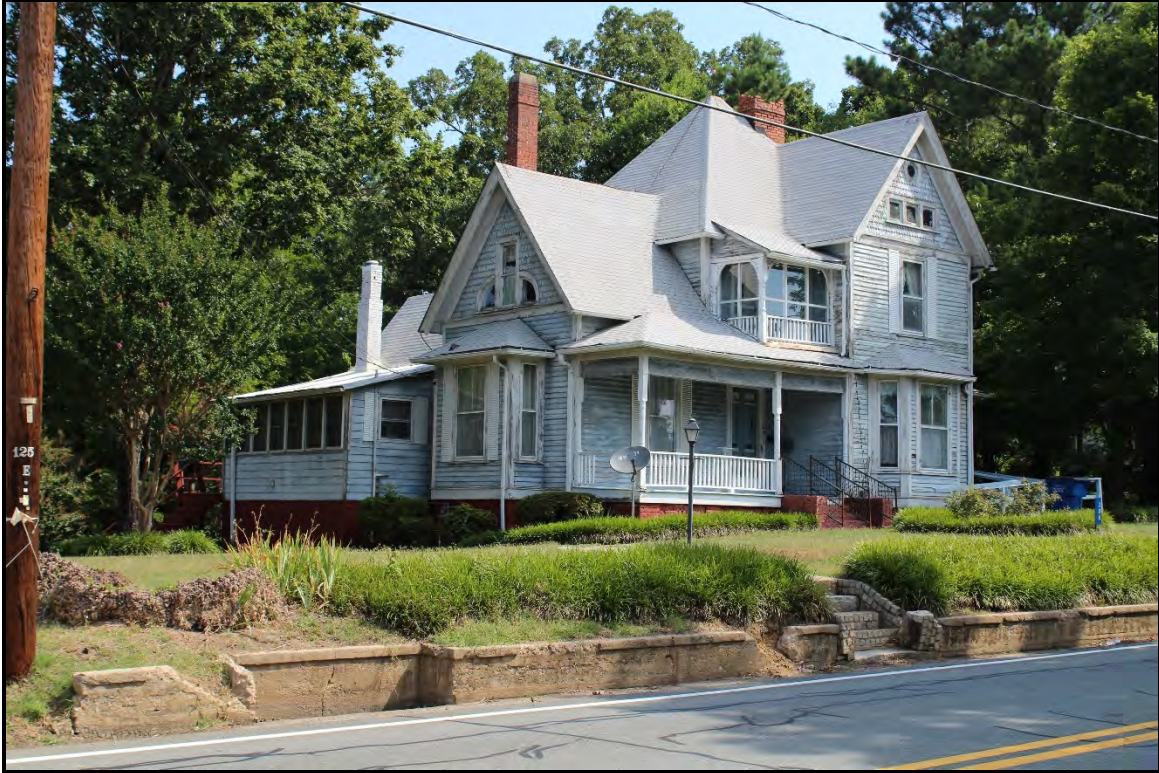
The two and one-half story, wood-frame building features steeply pitched hipped and gable roofs covered with asphalt shingles, two interior brick chimneys, an exterior clad with weatherboard siding, a foundation composed of brick, and 1/1 double-hung wood sash windows. Facing south, the façade is marked with a central door opening that contains a pair of paneled leaves. Each leaf includes a single glass pane. Flanking the door to the west is a window opening with vinyl shutters. A partial-width porch containing a wood deck provides access to the main entrance. The porch is capped by a hipped roof that is supported by two turned wood posts that appear to date to the original construction of the house. Photographs filed with the survey form indicate that decorative porch brackets were once attached to the posts, but these have been removed. Additionally, the wood balustrade and metal stair railings that are presently on the porch were installed sometime after 2002 (Barkhau 2002d). Situated above the entry porch is a sleeping porch that is accessible from the second story. The sleeping porch is enclosed with glass, but retains the original turned porch column and decorative brackets that are missing from the entry porch. A shed roof caps the sleeping porch. Situated east of the porches is a projecting gable bay that is accented with a canted bay on the first story. The canted bay is capped with a hipped roof covered with asphalt shingles, above which is a single window on the second story. Situated within the gable field of the half story is a band of three, square-shaped windows that contain single-pane wood sash. Clad with fish scale wood shingles, the gable field is pierced by a circular bull’s eye window.

Figure 6.262. Architectural resource AM0447; view is northeast featuring the façade and west elevation.

NRHP Assessment. Architectural resource AM0447 is an example of a late nineteenth century Queen Anne style house in which the exterior of the building has not been significantly altered since its construction in 1896. The interior of the house was not accessible at the time of the survey; as a result, TRC’s NRHP recommendation is based exclusively on the exterior condition of the house. Overall, the house retains a high degree of integrity through the retention of original character-defining details such as the window sashes, exterior fish scale wood siding, porch posts, and cornice trim woodwork. As the house has not been significantly altered, it retains its original scale and massing. Despite the construction of a one-story addition to the rear ell, the house retains its original scale and massing. As a result, TRC recommends AM0447 potentially eligible for the NRHP under Criterion C for its architectural significance as a representative example of a Queen Anne-style house with Eastlake detailing.

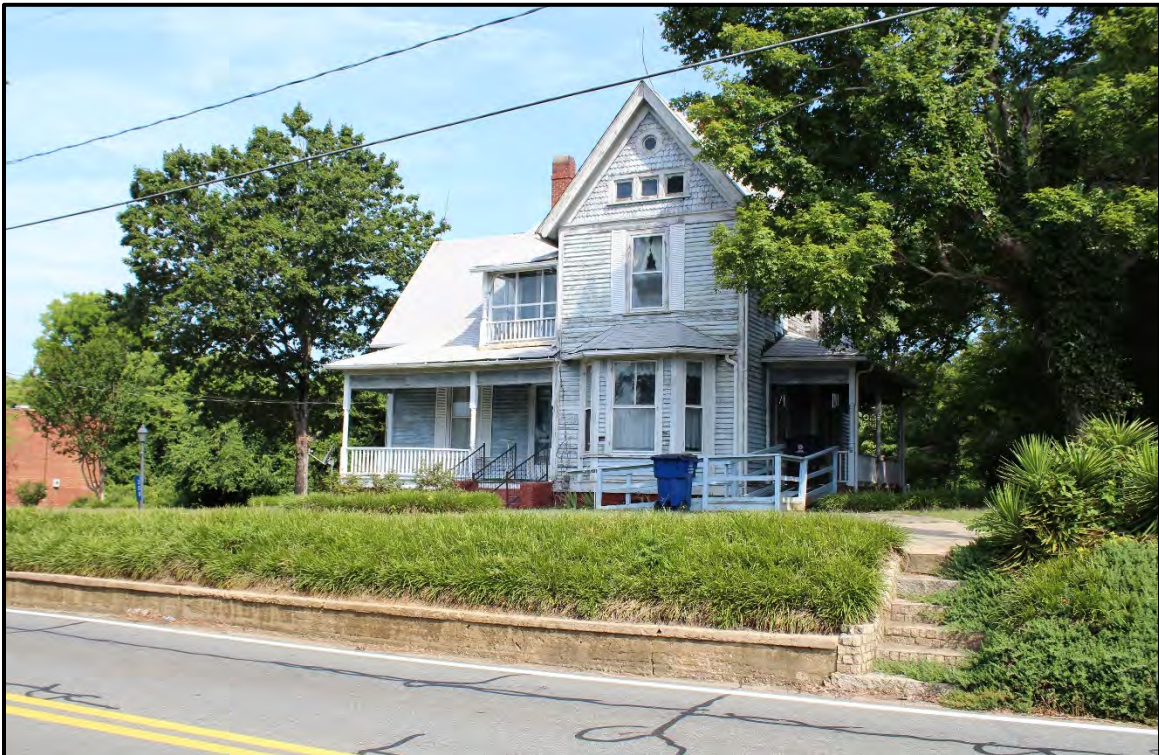
Highlighting the west elevation is a projecting hipped-roof bay window that contains a 2/2 double-hung wood sash window and two narrow window openings with 1/1 double-hung wood sashes. Located in the second story is a three-part window featuring a central 1/1 double-hung wood sash window that is flanked by quarter-round windows with a single light. Accenting the gable field are fish scale wood shingles.

From the public right-of-way, TRC was able to observe a ca. 1950 shed-roof addition attached to a rear ell. The shed addition is pierced by a series of windows containing 4/4 double-hung wood sashes and includes an interior brick flue.

Figure 6.263. Architectural resource AM0447; view is northwest featuring the façade and the east elevation.

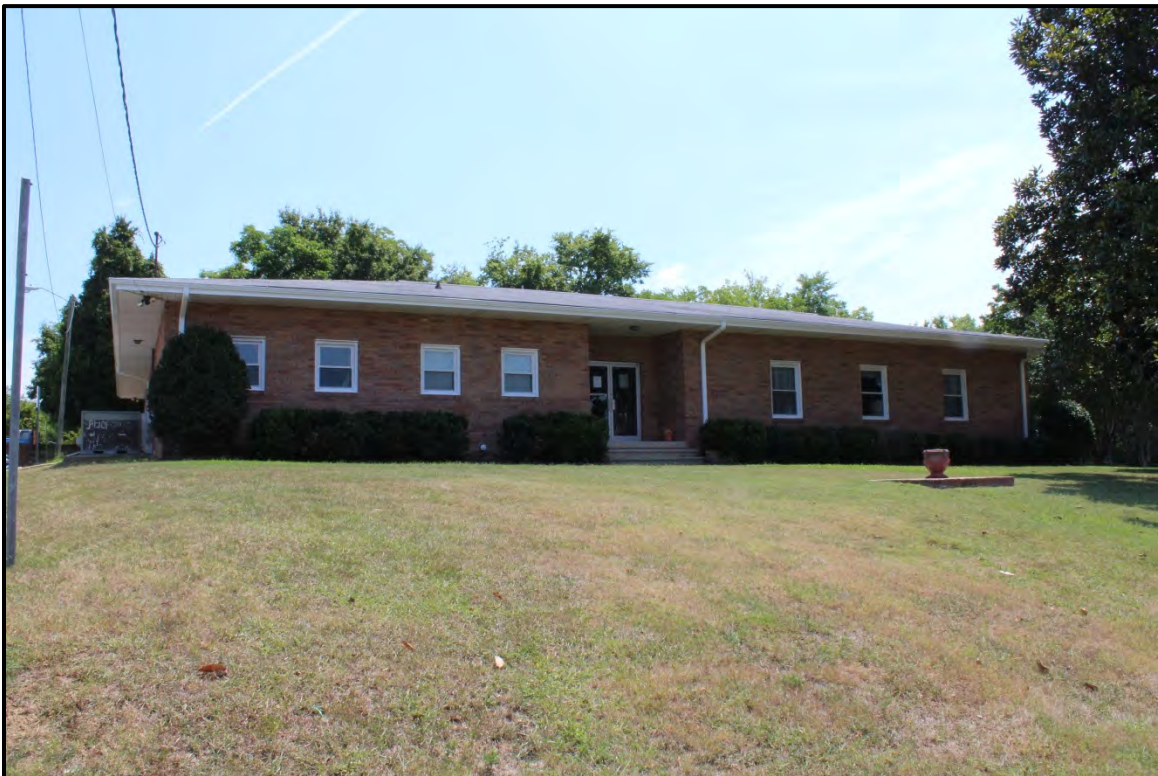
The one-story civic building features a hipped roof covered with asphalt shingles, a wood frame with a brick veneer-cladded exterior, and double hung 1/1 vinyl sash windows. Facing west, the façade is marked by a recessed central bay that contains the main entrance. The portico contains a concrete deck that leads to a pair of metal-glass doors. Flanking the center bay to the north are four windows. Three windows are positioned south of the central bay.

Figure 6.265. Architectural resource AM2599; view is east and features the façade.

NRHP Assessment. Architectural resource AM2599 does not exhibit a distinctive architectural style or workmanship. Based on the lack of architectural merit, as well as the inability to associate the house and/or its original owner(s) with an important historical event or series of events, it is TRC's opinion that architectural resource AM2599 is not eligible for the NRHP.

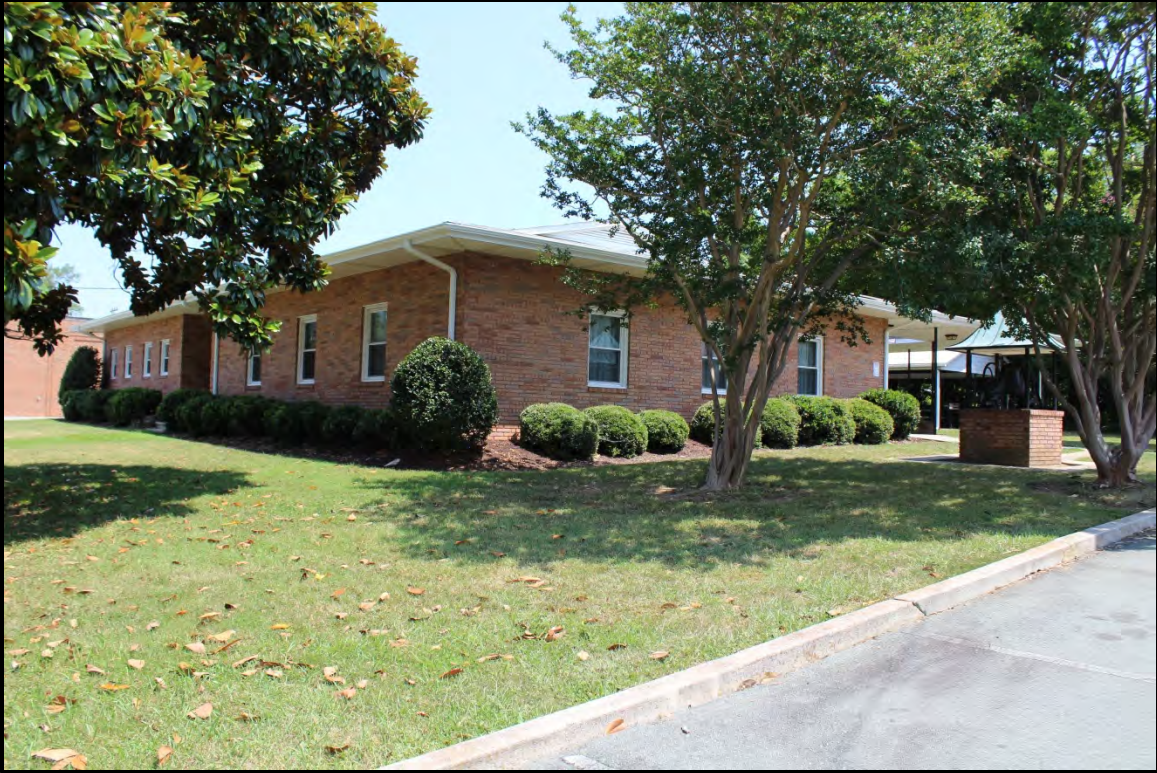
Figure 6.266. Architectural resource AM2599; view is northeast and features the façade and south elevation.

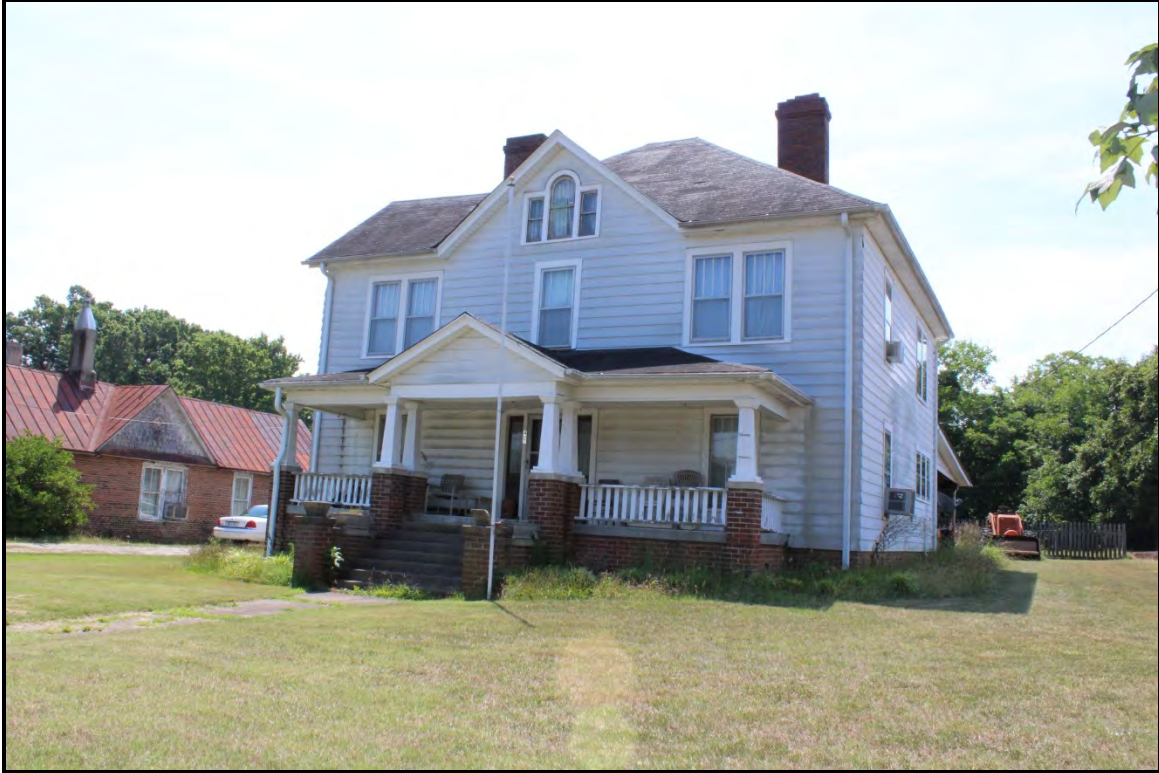
The two and one-half story, wood-frame house features a steeply-pitched roof covered with asphalt shingles, two interior brick chimneys, a wood frame with an aluminum siding-cladded exterior, a brick foundation, and double hung 4/1 wood sash windows. Facing north, the façade is marked by a central entrance that contains flanking sidelights. A full-width porch containing a concrete deck atop a brick foundation provides access to the main entrance. The porch is shielded by a hipped roof that is supported by a series of tapered wood posts atop brick plinth blocks. Highlighting the half-story is a centrally placed wall dormer that contains a three-part window with a central arch wood sash.

Figure 6.267. Architectural resource AM2600; view is southeast and features the façade and west elevation.

NRHP Assessment. Architectural resource AM2600 does not exhibit distinctive characteristics of architectural style or workmanship. In addition, the house has been altered through the application of aluminum siding and the construction of a ca. 1930-era bungalow-style porch to the façade, which occurred following the resource's period of significance, ca. 1920. TRC's survey also noted that a modern, one-story, full-width addition is attached to the south (rear) elevation. This addition is clad with aluminum siding and contains a shed-roof garage that is used to store heavy machinery. Based on the lack of architectural merit, as well as the inability to associate the house and/or its original owner(s) with an important historical event or series of events, it is TRC's opinion that architectural resource AM2600 is not eligible for the NRHP.

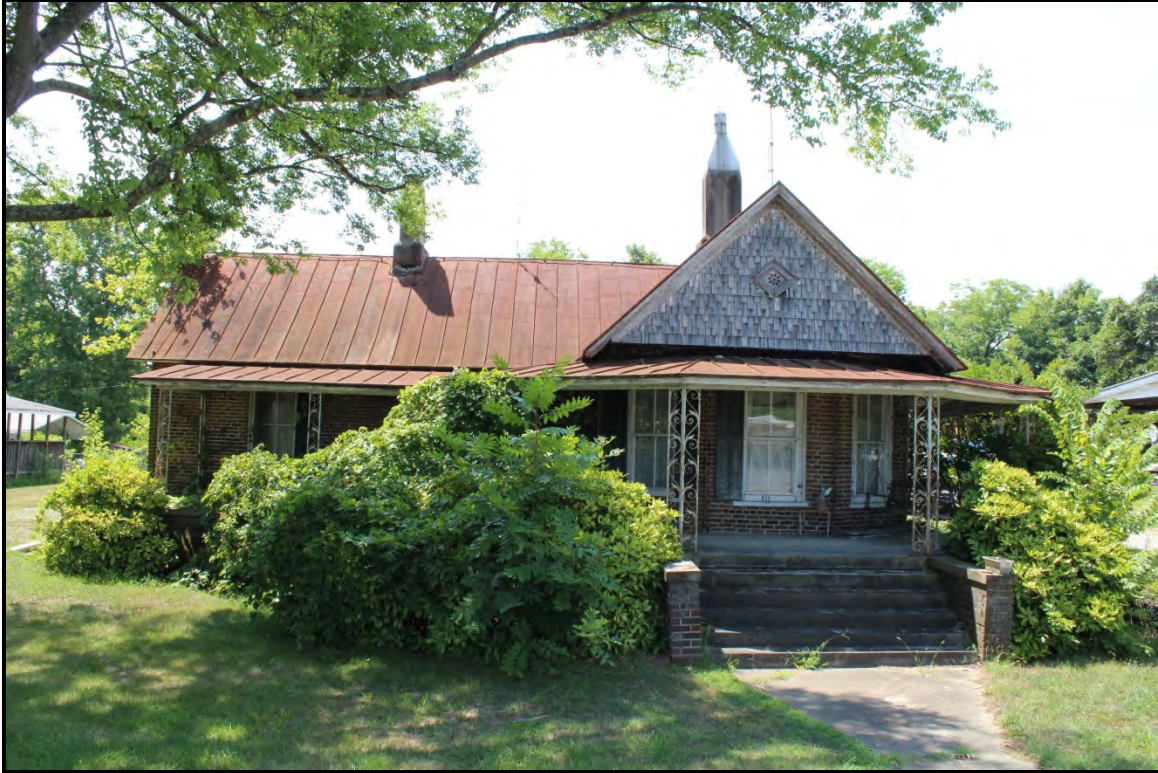
The one-story house features a side-gabled roof covered with standing seam metal, two brick chimneys parged with concrete, a brick frame with a common bond exterior, a brick foundation, and double hung 2/2 wood sash windows. Facing north, the façade reveals a centrally placed door that is flanked to the east by a single window and to the west by a canted bay that contains three windows. A wraparound porch containing a concrete deck atop a brick foundation provides access to the main entrance. The porch is shielded by a hipped roof that is supported by a series of decorative metal posts. Situated above the porch entry is a gable wall dormer that is sheathed with original staggered wood shingles and pierced by a diamond-shape, decorative wood attic vent.

Figure 6.268. Architectural resource AM2601; view is south and features the façade.

NRHP Assessment. Architectural resource AM2601 does not exhibit distinctive characteristics of architectural style or workmanship. In addition, the house has been altered through the construction of a mid-twentieth century wraparound porch to the façade, which occurred following the resource's period of significance, i.e. ca. 1912. Based on the lack of architectural merit, as well as the inability to associate the house and/or its original owner(s) with an important historical event or series of events, it is TRC's opinion that architectural resource AM2601 is not eligible for the NRHP.

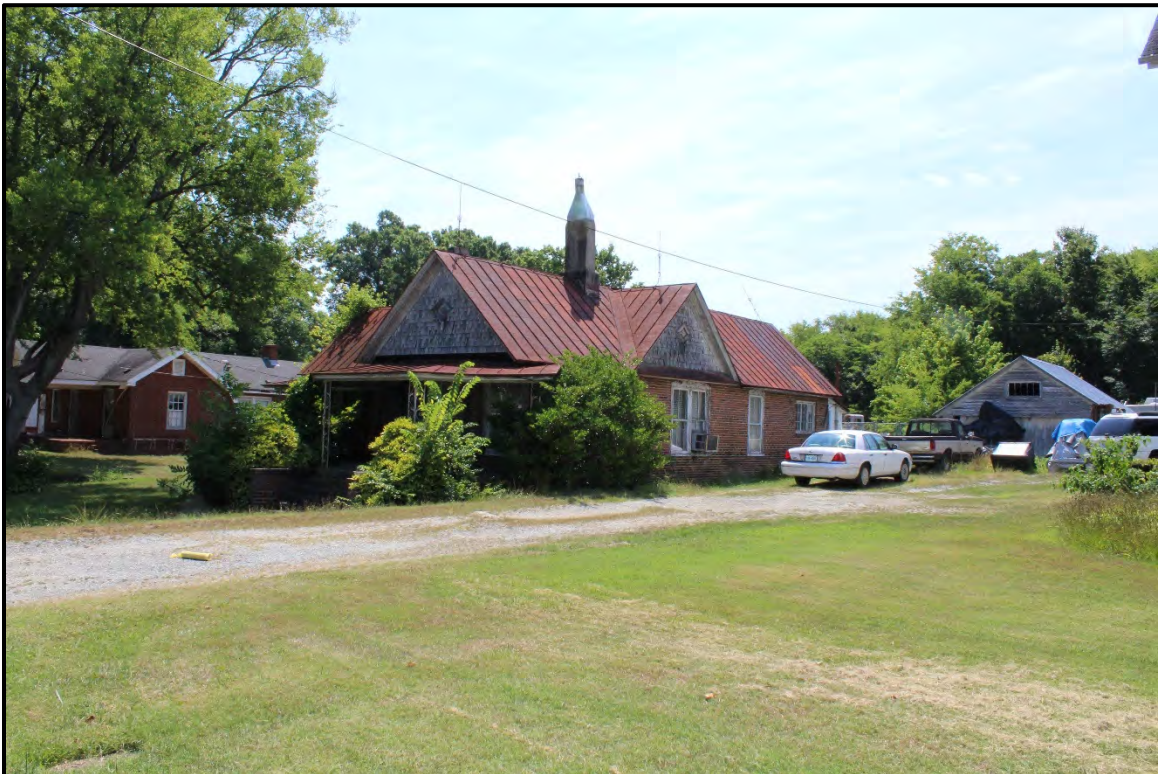
Located south of the house is a ca. 1920 garage. The wood-frame structure features a gable-front roof covered with standing seam metal and an exterior clad with weatherboard siding. Two vehicle bays are marked with sliding wood doors. Situated within the front-facing gable is a rectangular-shaped, five-light wood sash window (Figure 6.269).

Figure 6.269. Architectural resource AM2601; view is southeast and features the façade and west elevation of the house and the associated garage in the background.

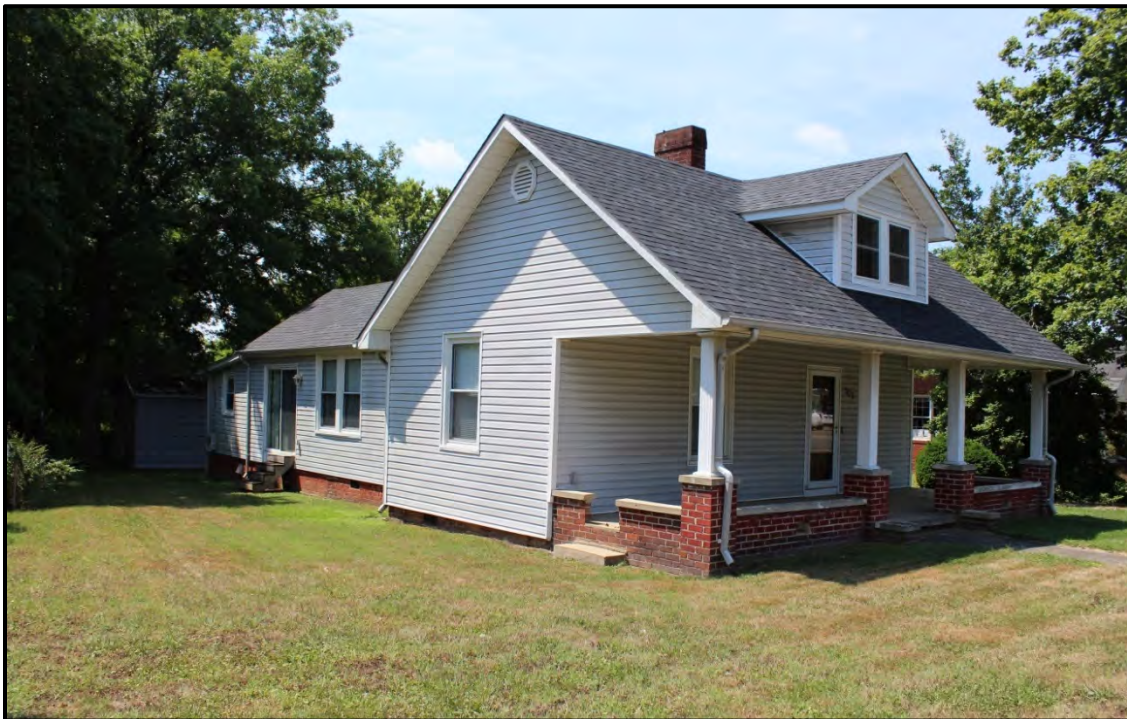
The one and one-half story, wood-frame building features a side-gabled roof covered with asphalt shingles, an interior brick chimney, a wood frame with a vinyl siding-cladded exterior, a brick foundation, and double hung 1/1 vinyl sash windows. Facing north, the façade is marked by an off-centered door that is flanked to the east by a single window. A full-width porch that is integral with the main roof and contains a concrete deck provides access to the main entrance. The porch is characterized by four square-shaped wood columns that contain fluting detailing. Each column rests atop a brick plinth block that is connected to a brick balustrade. Situated in the half story is a gable dormer that contains a pair of windows.

Figure 6.270. Architectural resource AM2602; view is southwest and features the façade and east elevation.

NRHP Assessment. Architectural resource AM2602 does not exhibit a distinctive architectural style or workmanship. In addition, the house has been altered through the application of vinyl siding and the replacement of the original window sashes. Based on the lack of architectural merit, as well as the inability to associate the house and/or its original owner(s) with an important historical event or series of events, it is TRC’s opinion that architectural resource AM2602 is not eligible for the NRHP.

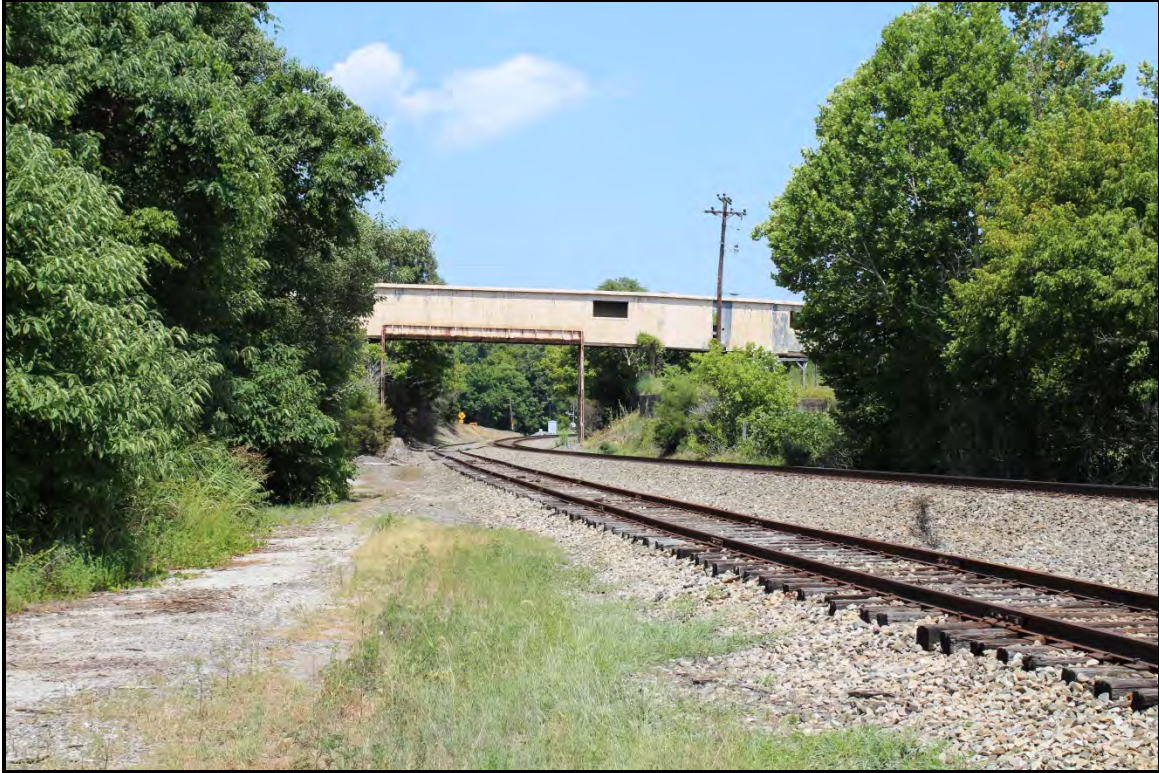
The railroad segment within the study area features a raised embankment covered with ballast that supports a modern track composed of wood cross ties and steel rails. The segment located within the architectural study area of Pipeline Corridor traverses an industrial area within the town of Haw River.

Figure 6.271. Architectural resource AM2603; view is east from architectural resource AM1516.

NRHP Evaluation. Architectural resource AM2603 is a segment of an early nineteenth century railroad bed that has been continuously altered through routine maintenance for more than a century. As an actively managed rail line, the railroad bed has received regular repairs that have resulted in the replacement of the original tracks, cross-ties and ballast. As such, no materials associated with the original construction of the railroad remain. For these reasons, it is TRC's opinion that architectural resource AM2603 is not eligible for the NRHP.

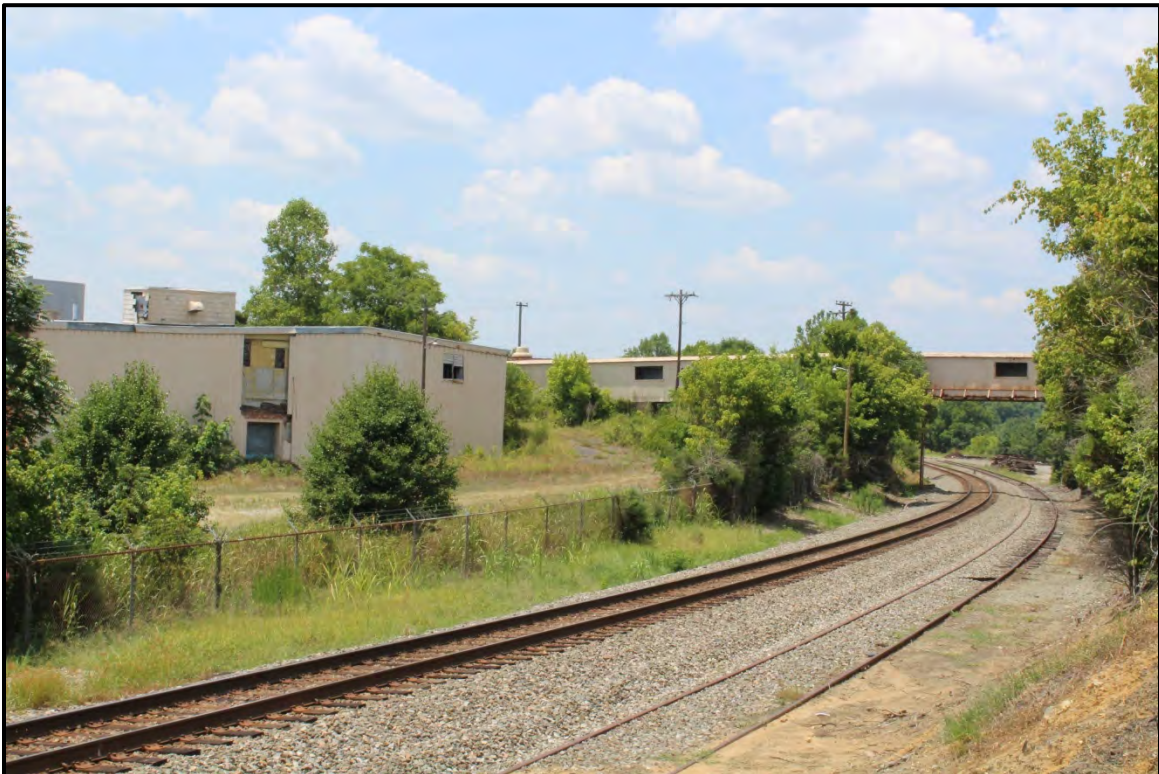
Figure 6.272. Architectural resource AM2603; view is west from architectural resource AM1516.

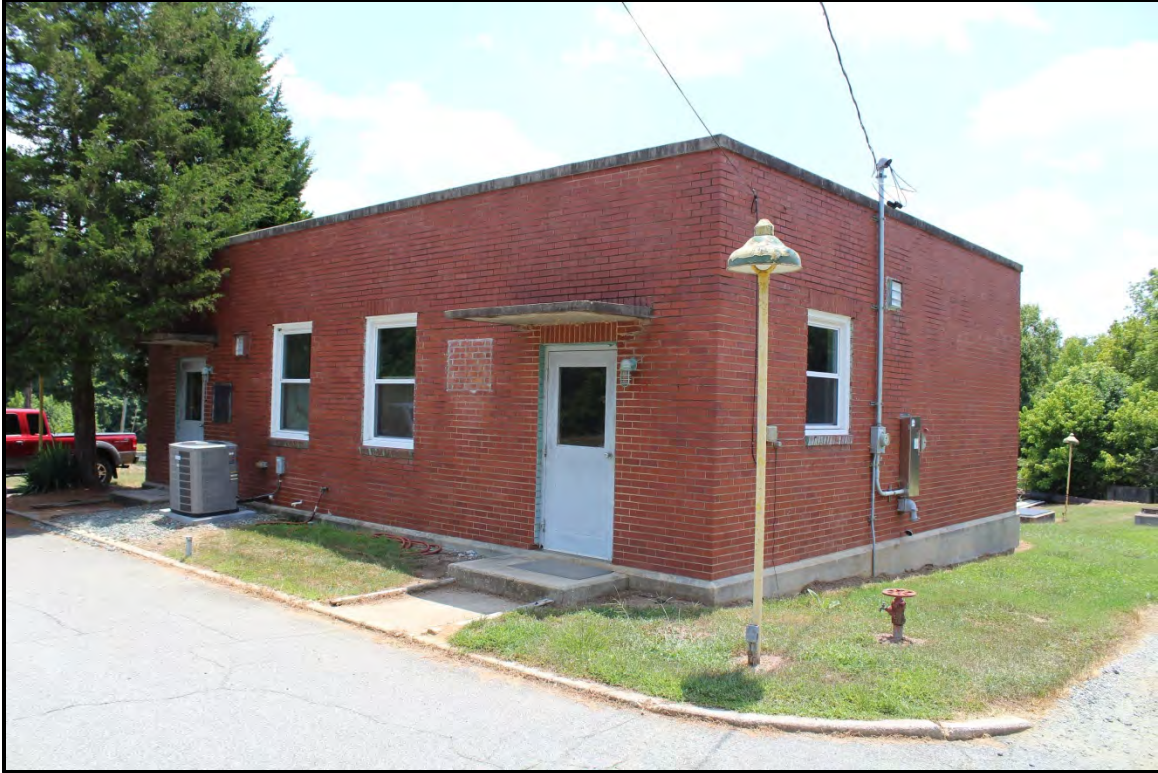
The complex is anchored by a single-story control building that features a flat roof, a masonry frame with a brick veneer-clad exterior, a raised concrete slab foundation, and double hung 1/1 vinyl sash windows. Facing northeast, the façade is marked by two symmetrically placed door openings that contain a metal leaf with a single-pane window. Each door opening is topped by a jack arch and a flat entry hood composed of concrete.

Figure 6.273. Architectural resource AM2604 control building; view is southeast and features the façade and west elevation.

NRHP Assessment. Architectural resource AM2604 does not exhibit a distinctive architectural style or workmanship. Based on the lack of architectural merit, as well as the inability to associate the facility with an important historical event or series of events, it is TRC's opinion that architectural resource AM2604 is not eligible for the NRHP.

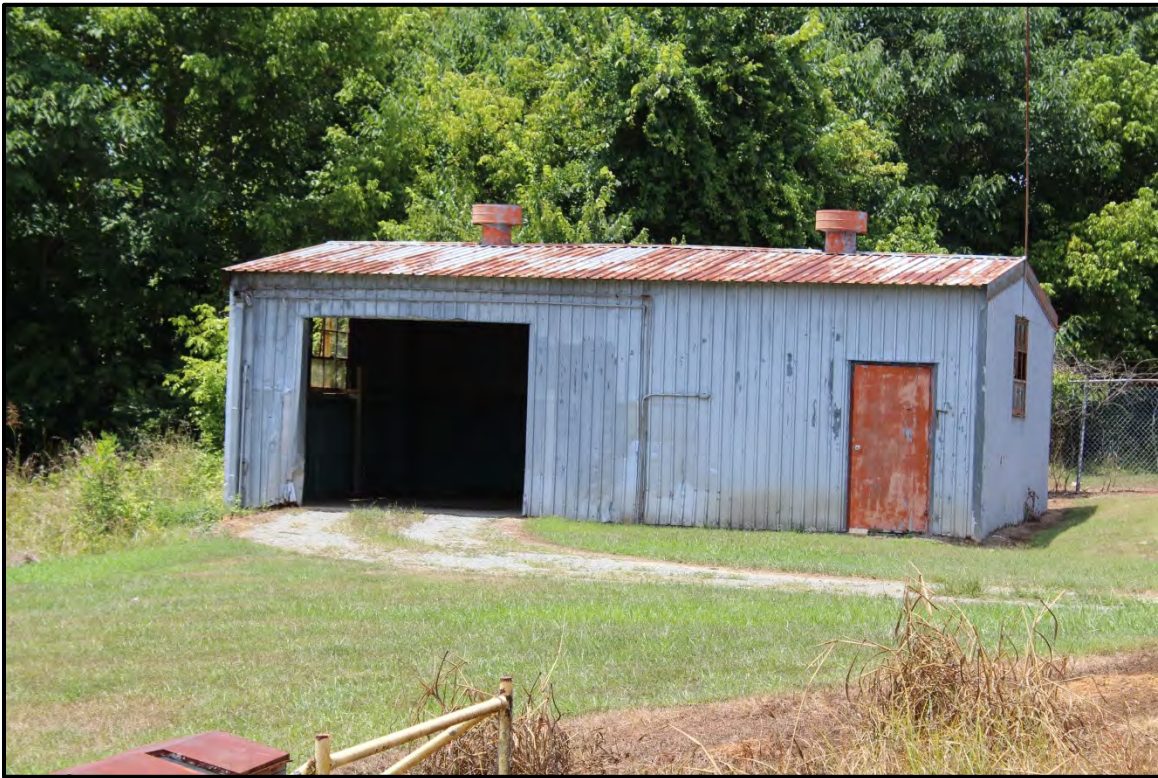
- A ca. 1961 maintenance garage. The wood-frame structure features a low-pitch side-gabled roof covered with standing seam metal, an exterior clad with metal, ribbed, siding, and a concrete slab foundation. The garage includes an open vehicle bay and a metal pedestrian door on the southeast elevation (Figure 6.274);
- A circular concrete sludge treatment tank (Figure 6.275);
- Four, rectangular-shaped concrete sediment tanks (Figure 6.276);

Figure 6.274. Architectural resource AM2604; view is southwest and features the maintenance garage.

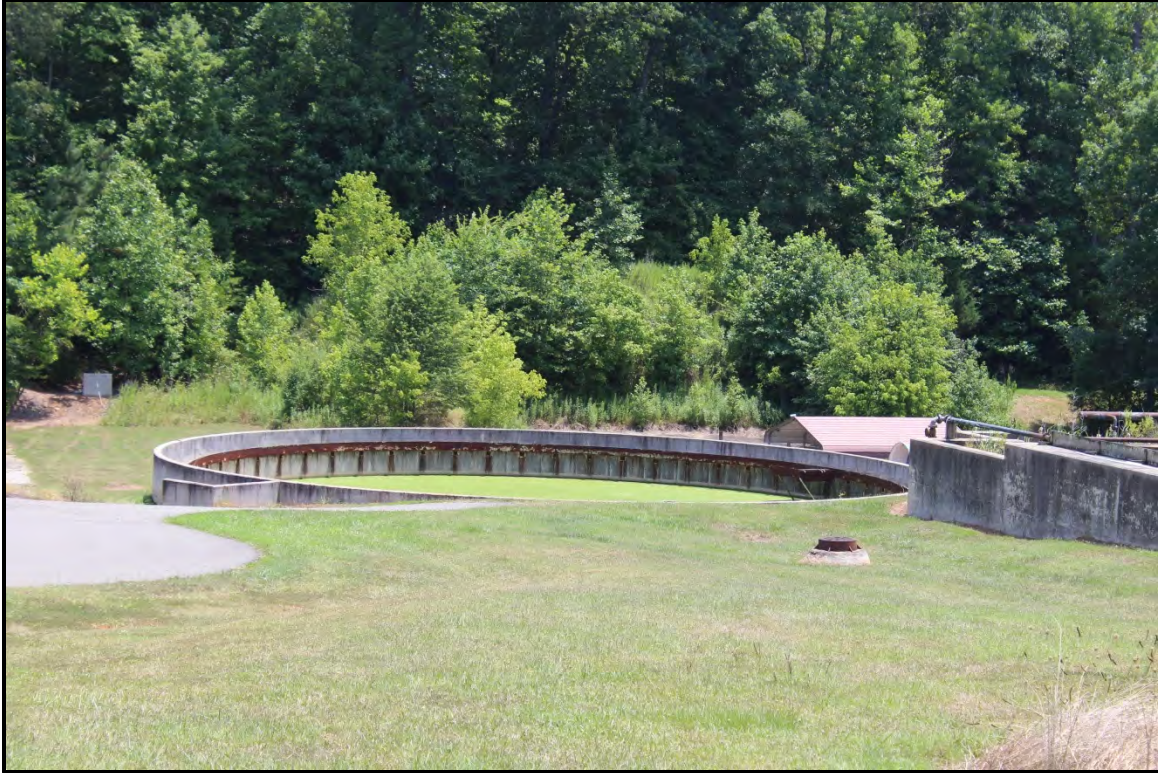
Figure 6.275. Architectural resource AM2604; view is southeast and features the sludge treatment tank.

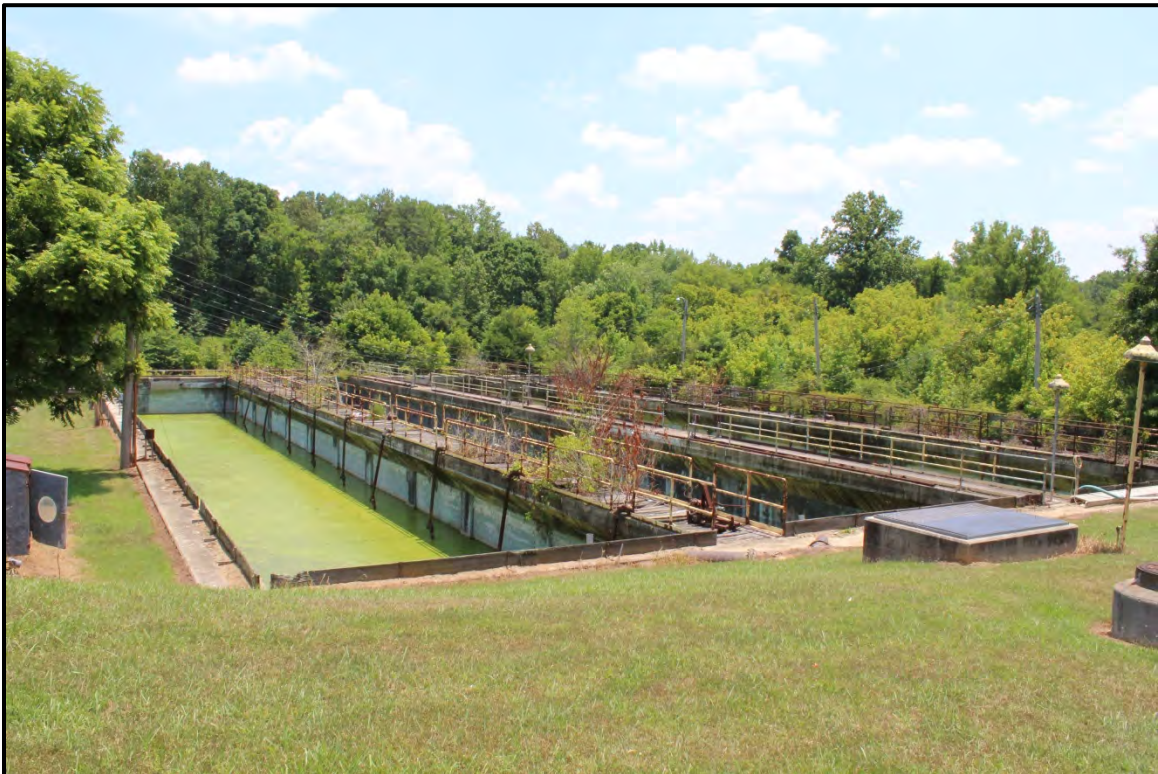
Figure 6.276. Architectural resource AM2604; view is southeast and features the sediment tanks.

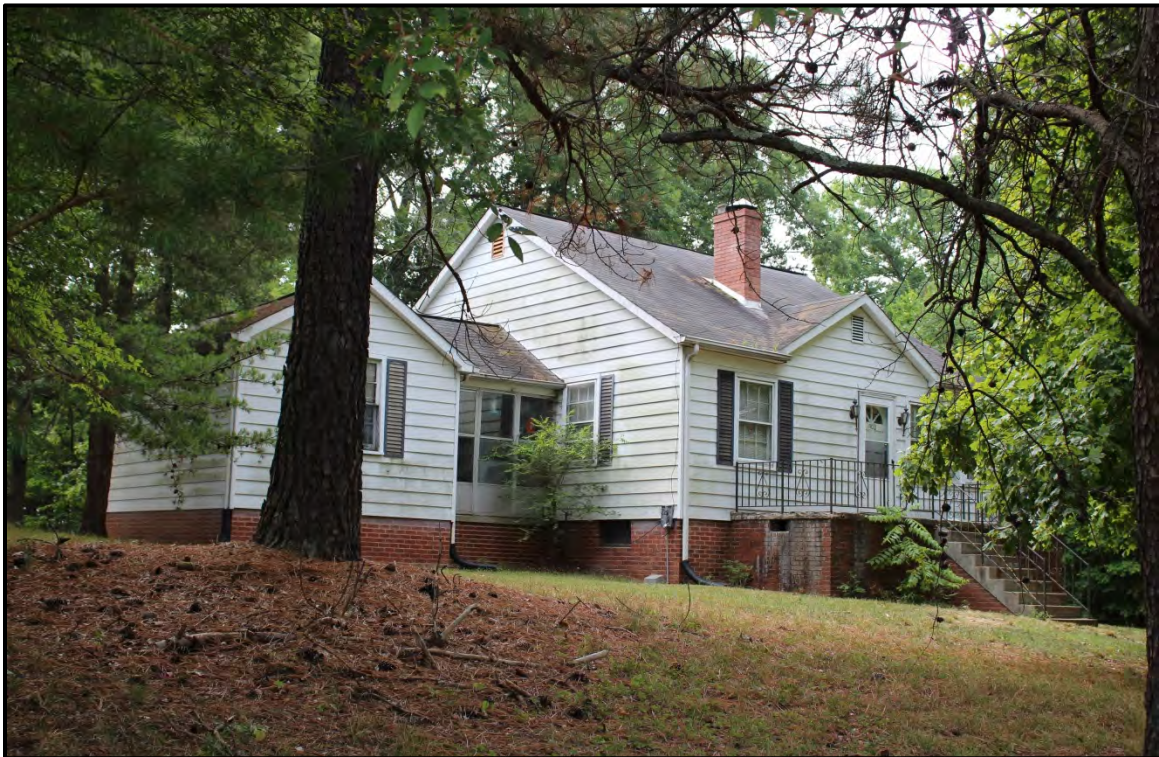
The one-story, wood-frame building features a side-gabled roof covered with asphalt shingles, an interior brick chimney, an exterior clad with aluminum siding, a brick foundation, and double hung 6/6 wood sash windows. Facing west, the façade is marked by a central door that is flanked on either side by a single window. Located above the door is a centrally placed gable wall dormer pierced with an aluminum vent. A partial-width porch with a concrete deck provides access to the main entrance. Attached to the north elevation is a building hyphen that connects the main block to a gable-front wing.

Figure 6.277. Architectural resource AM2605; view is southeast and features the façade and north elevation.

NRHP Assessment. Architectural resource AM2605 does not exhibit a distinctive architectural style or workmanship. In addition, the house has been altered through the application of aluminum siding. Based on the lack of architectural merit, as well as the inability to associate the house and/or its original owner(s) with an important historical event or series of events, it is TRC’s opinion that architectural resource AM2605 is not eligible for the NRHP.
