Re: Revised Architectural Survey Report, MVP Southgate Project, Construct Interstate Pipeline, Rockingham and Alamance County, ER 18-1041

Thank you for your letter of October 11, 2019, transmitting the draft "Historic Architectural Survey for the MVP Southgate Pipeline Project". We have reviewed the report and offer the following comments.

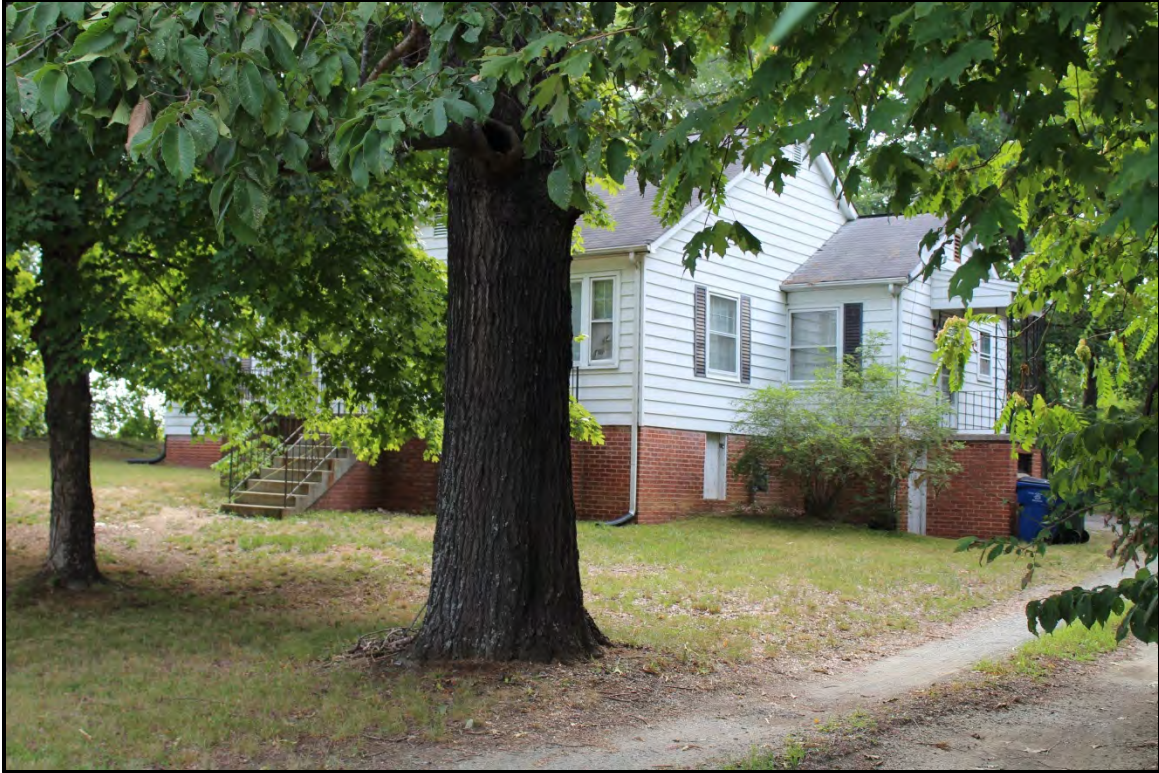
Figure 6.278. Architectural resource AM2605; view is northeast and features the façade and south elevation.

NRHP Assessment. Architectural resource AM2605 does not exhibit a distinctive architectural style or workmanship. In addition, the house has been altered through the application of aluminum siding. Based on the lack of architectural merit, as well as the inability to associate the house and/or its original owner(s) with an important historical event or series of events, it is TRC’s opinion that architectural resource AM2605 is not eligible for the NRHP.

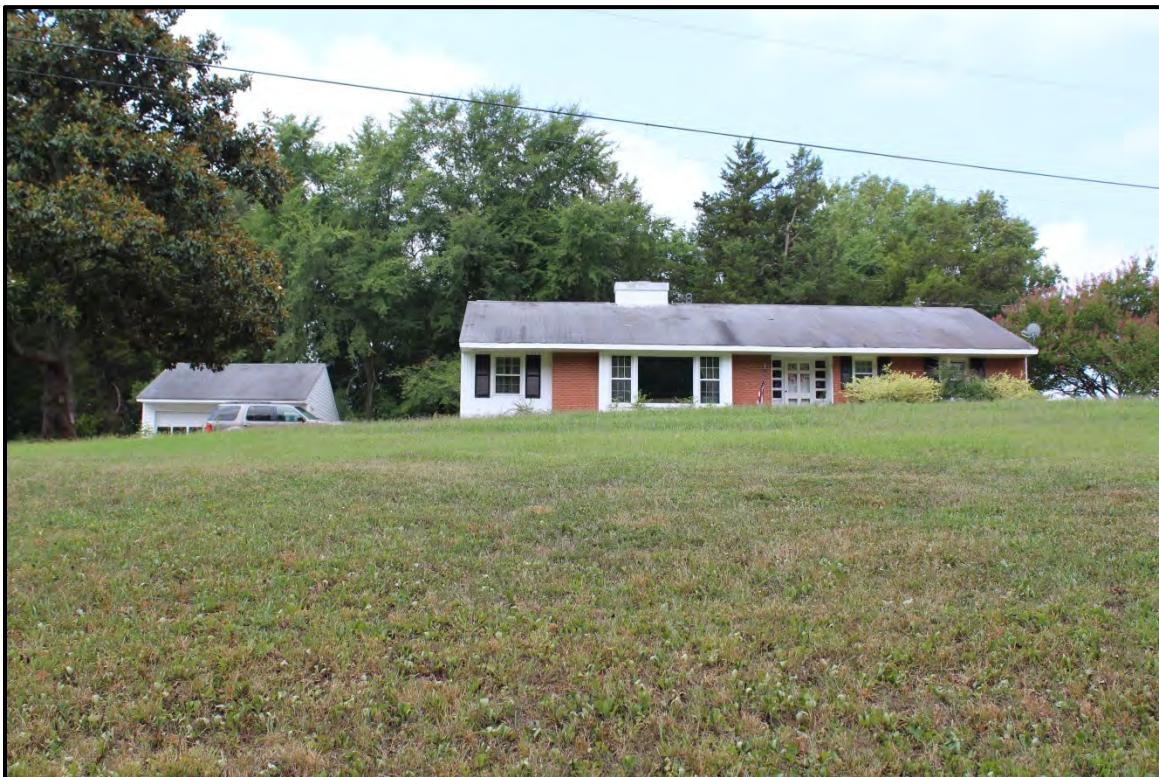
Located east of the house is a modern garage. The wood-frame structure features a side-gabled roof covered with asphalt shingles, an exterior clad with vinyl siding, and a single bay with an overhead metal door.

Figure 6.279. Architectural resource AM2607; view is southwest and features the house and associated garage.

NRHP Assessment. Architectural resource AM2607 does not exhibit a distinctive architectural style or workmanship. In addition, the house has been altered through the application of vinyl siding and the installation of vinyl sash windows. Due to its lack of architectural significance it is TRC's opinion that architectural resource AM2607 is not eligible for the NRHP.

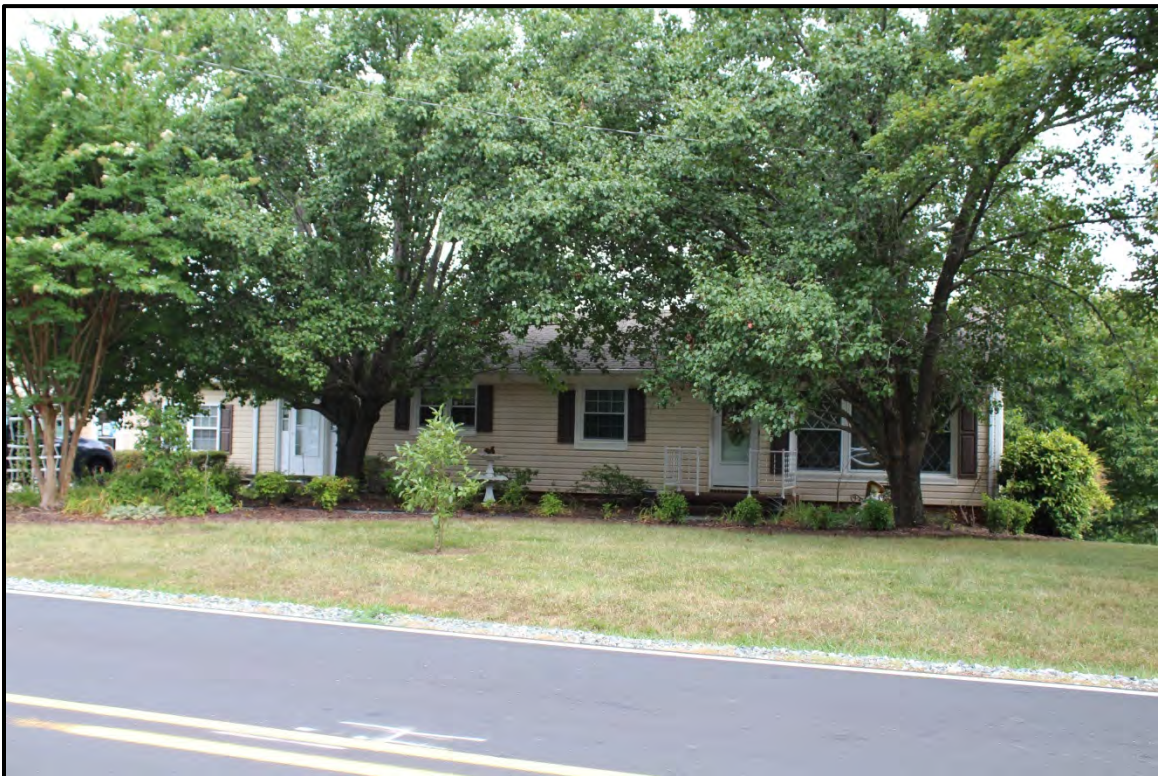
The wood-frame building features a side-gabled roof covered with asphalt shingles, an exterior clad with vinyl siding, and double hung 6/6 vinyl sash windows. Facing southeast, the façade is marked by two symmetrically placed entrances that are accessible via a concrete stoop. Attached to the southeast elevation is a modern double-bay garage.

Figure 6.280. Architectural resource AM2608; view is northwest and features the façade.

NRHP Assessment. Architectural resource AM2608 does not exhibit a distinctive architectural style or workmanship. In addition, the house has been altered through the application of vinyl siding and the installation of vinyl sash windows. Based on the lack of architectural merit, as well as the inability to associate the house and/or its original owner(s) with an important historical event or series of events, it is TRC's opinion that architectural resource AM2608 is not eligible for the NRHP.

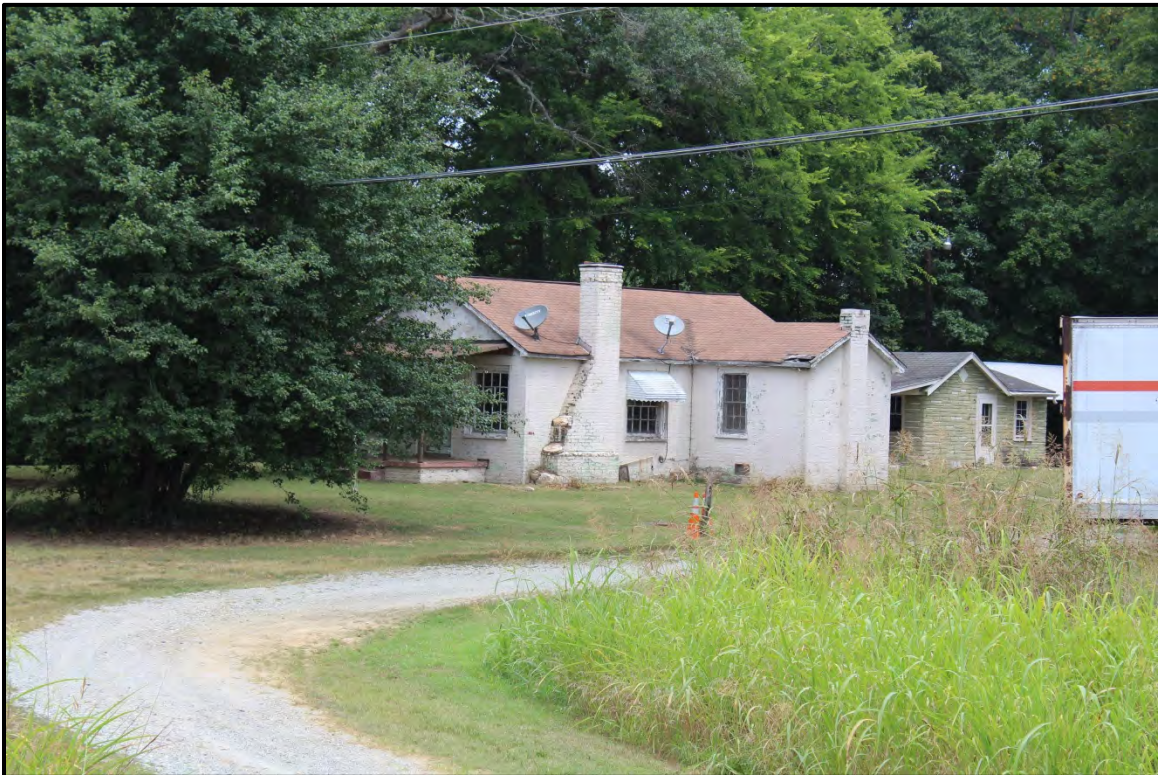
The one-story, wood-frame building features a side-gabled roof covered with asphalt shingles, an exterior clad with a brick veneer, and a brick foundation. Fenestration consists of double hung 6/6 wood sash windows and 12-light fixed wood sash. Facing southeast, the façade is marked by an exterior brick chimney. The main entrance to the house is located on the southwest elevation through a full-width porch that is covered by a shed roof. Attached to the eastern end of the façade is projecting gable-roof wing that includes a 6/6 double-hung wood sash window.

Figure 6.281. Architectural resource AM2609; view is north and features the façade and east elevation.

NRHP Assessment. Architectural resource AM2609 does not exhibit a distinctive architectural style or workmanship. Based on the lack of architectural merit, as well as the inability to associate the house and/or its original owner(s) with an important historical event or series of events, it is TRC's opinion that architectural resource AM2609 is not eligible for the NRHP.

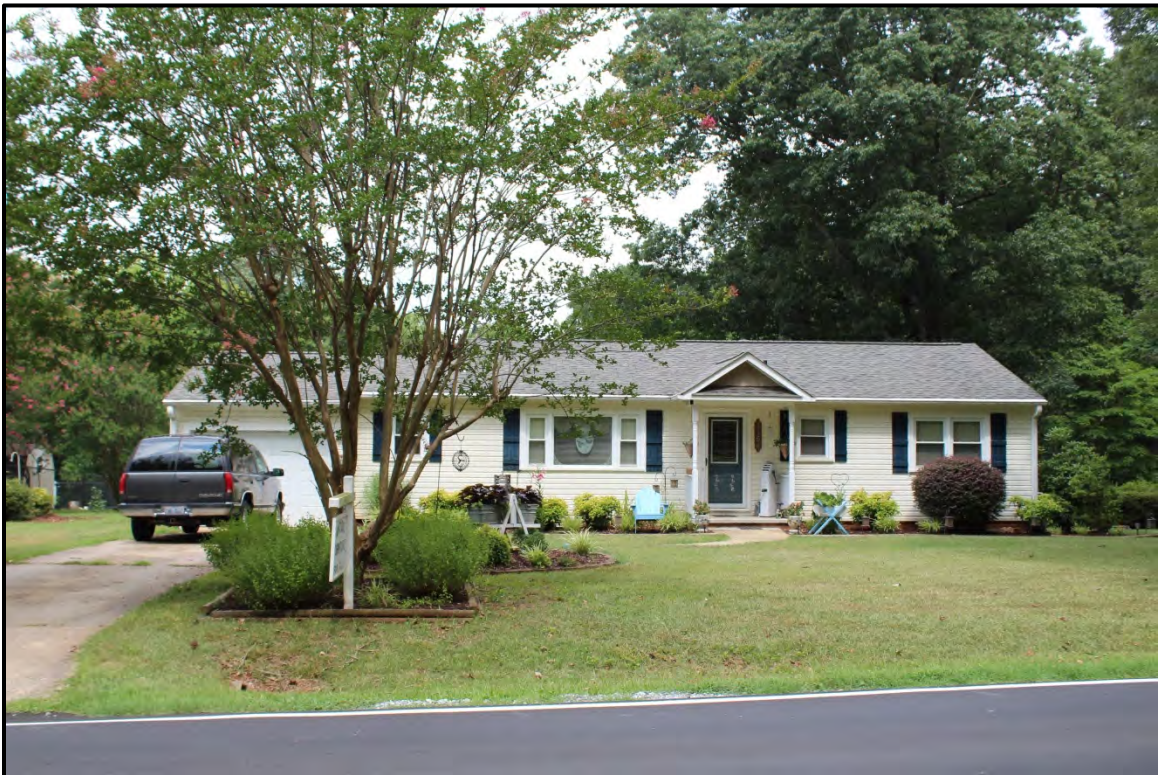
The wood-frame building features a side-gabled roof covered with asphalt shingles, an exterior clad with vinyl siding, and a brick foundation. Fenestration consists of double hung 1/1 vinyl sash windows. Facing southeast, the façade is marked by an off-centered door that is accessible via a modern single-bay stoop with a concrete deck. The entry stoop is shielded by a projecting gable roof that is supported by tuned columns composed of synthetic material. Attached to the south elevation is a single-bay garage that contains an overhead metal door.

Figure 6.282. Architectural resource AM2610; view is northwest and features the façade.

NRHP Assessment. Architectural resource AM2610 does not exhibit a distinctive architectural style or workmanship. In addition, the house has been altered through the application of vinyl siding and the replacement of the original window sashes. Based on the lack of architectural merit, as well as the inability to associate the house and/or its original owner(s) with an important historical event or series of events, it is TRC's opinion that architectural resource AM2610 is not eligible for the NRHP.

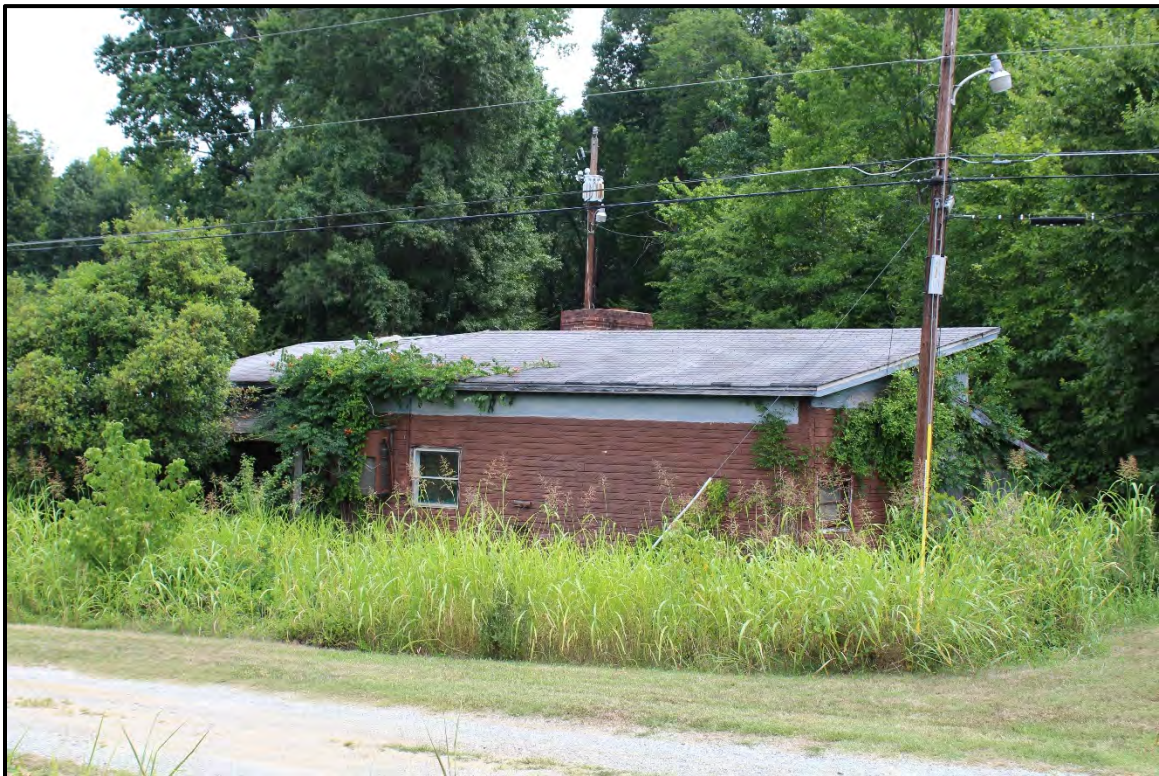
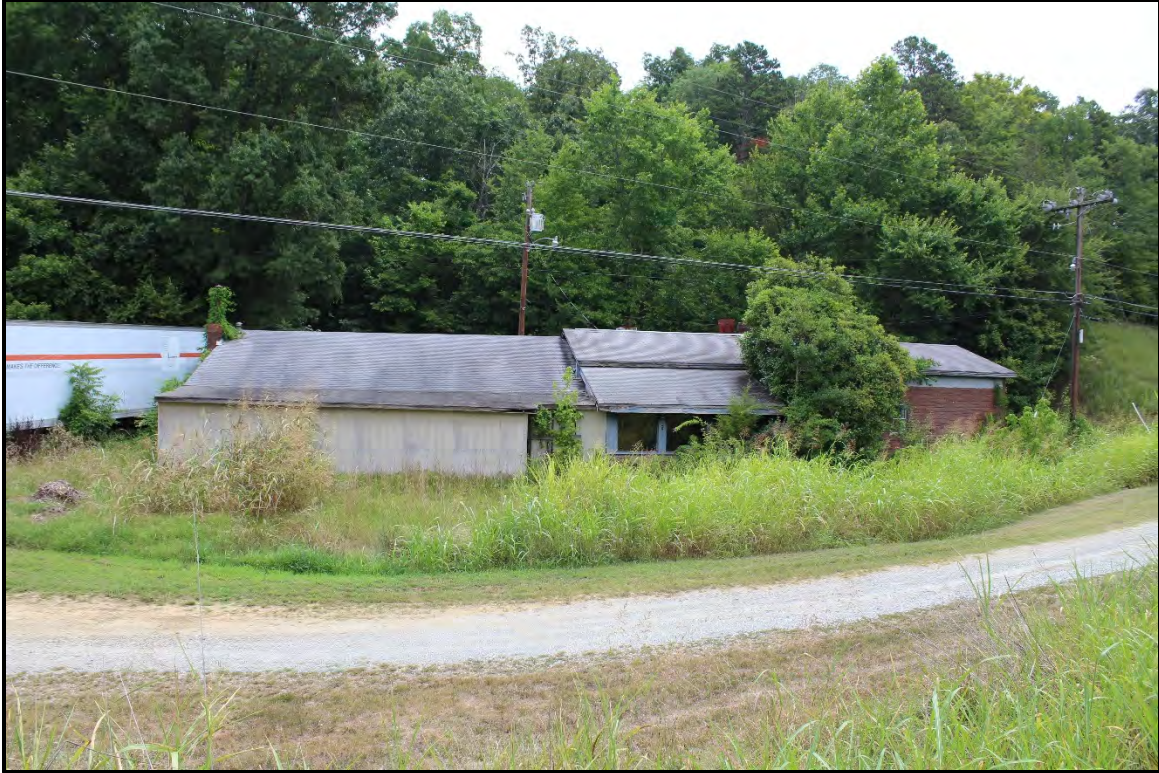
The one-story building features a shed roof covered with asphalt shingles, an exterior clad with stone veneer, an interior brick chimney, and an exterior end concrete block chimney. Fenestration includes double-hung, 1/1 wood sash and aluminum sash windows and three fixed wood sash windows. A gabled addition is attached to the north elevation and is clad with vertical wood planks.

Figure 6.284. Architectural resource AM2611; view is north and features the south and west elevations.

Figure 6.285. Architectural resource AM2611; view is northeast and features the west elevation.

NRHP Assessment. Architectural resource AM2611 does not exhibit a distinctive architectural style or workmanship. The property cannot be associated with important historical event(s) or person(s). Based on the lack of architectural merit, as well as the inability to associate the house and/or its original owner(s) with an important historical event or series of events, it is TRC's opinion that architectural resource AM2611 is not eligible for the NRHP.

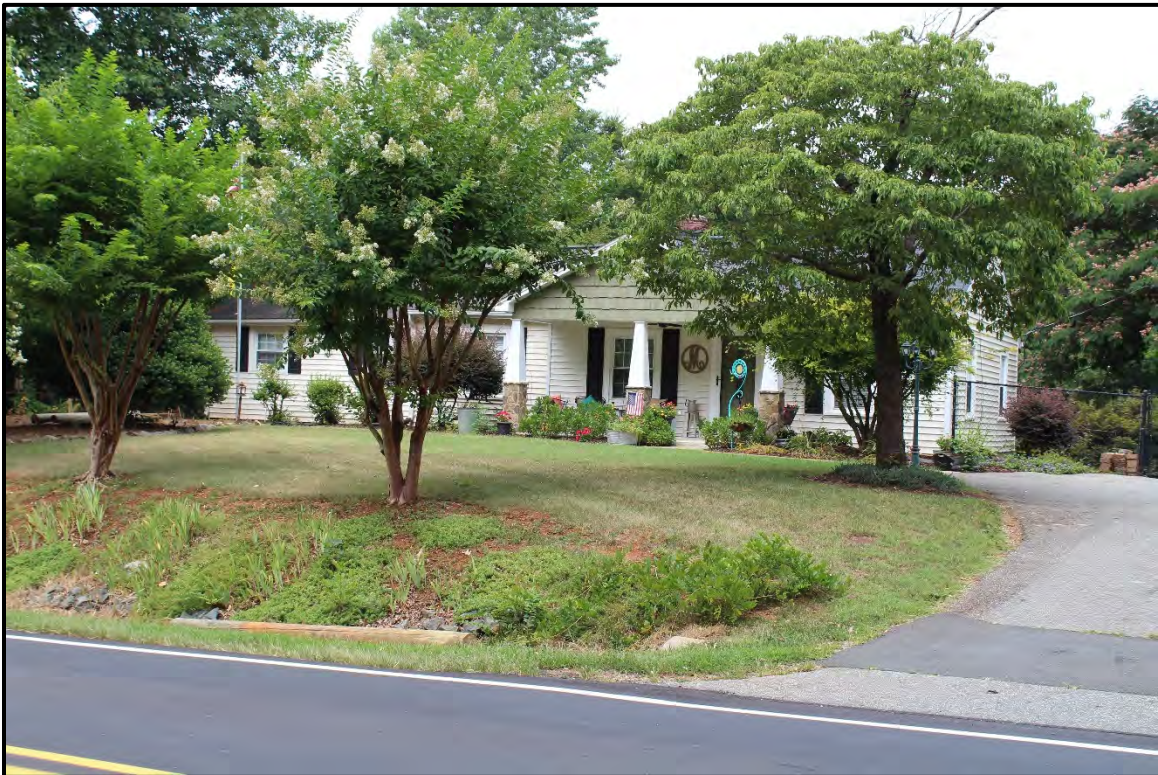
The one - -story, wood-frame building features a side-gabled roof covered with asphalt shingles, an exterior clad with vinyl siding, and an interior brick chimney. Fenestration includes double-hung, 6/6 vinyl sash windows. A reconstructed partial-width entry porch features a gabled roof supported by modern tapered wood columns set atop stone-vener clad plinth blocks and a concrete slab deck. A gabled addition is attached to the south elevation.

Figure 6.286. Architectural resource AM2612; view is southwest and features the façade and north elevation.

NRHP Assessment. Architectural resource AM2612 does not exhibit a distinctive architectural style or workmanship. In addition, the house has been altered through the application of vinyl siding and the installation of vinyl sash windows. Based on the lack of architectural merit, as well as the inability to associate the house and/or its original owner(s) with an important historical event or series of events, it is TRC's opinion that architectural resource AM2612 is not eligible for the NRHP.

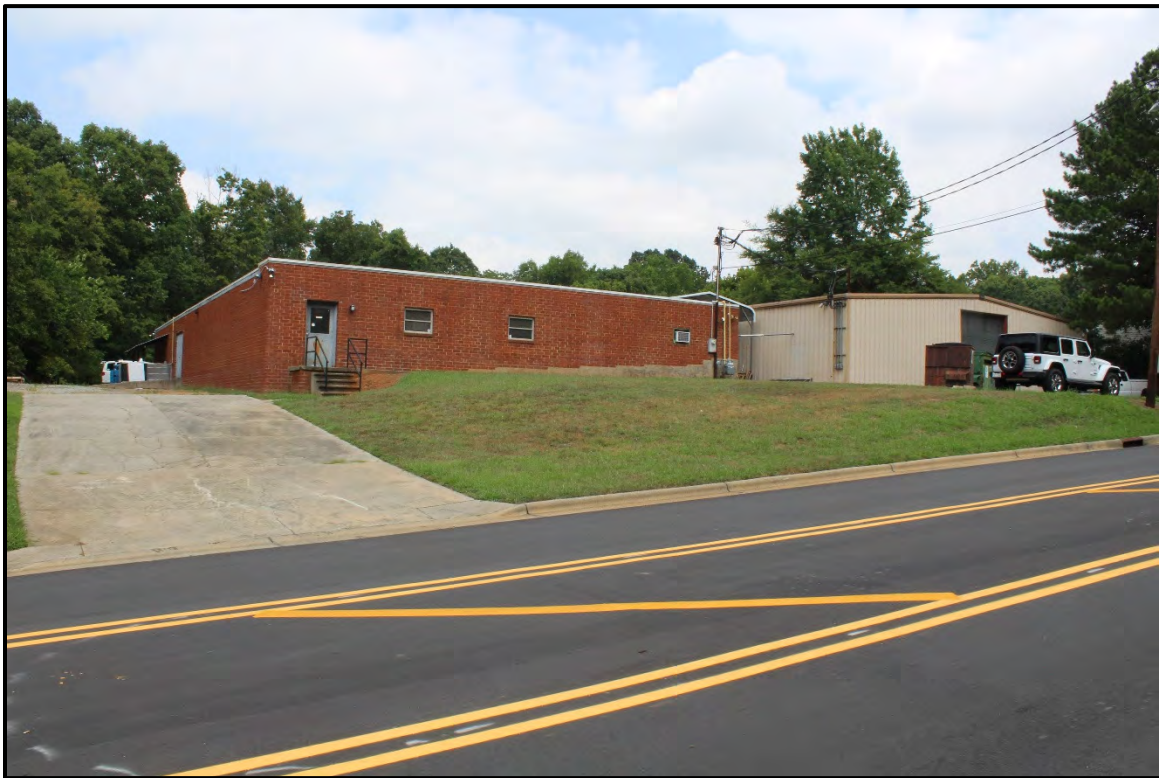
The one-story building features a flat metal roof, a steel frame, an exterior clad with brick veneer, and a continuous concrete foundation. Fenestration includes double-hung, 1/1 metal sash windows. A door on the east elevation serves as the main entrance and is accessed by a brick and concrete stoop topped by a simple metal railing. A loading ramp and door are located on the south elevation. Adjacent to the north is a modern metal-framed building that features a gabled roof and an exterior clad with metal sheeting.

Figure 6.287. Architectural resource AM2613; view is northwest and features the façade and south elevation.

NRHP Assessment. Architectural resource AM2613 does not exhibit a distinctive architectural style or workmanship. Based on the lack of architectural merit, as well as the inability to associate the house and/or its original owner(s) with an important historical event or series of events, it is TRC's opinion that architectural resource AM2613 is not eligible for the NRHP.

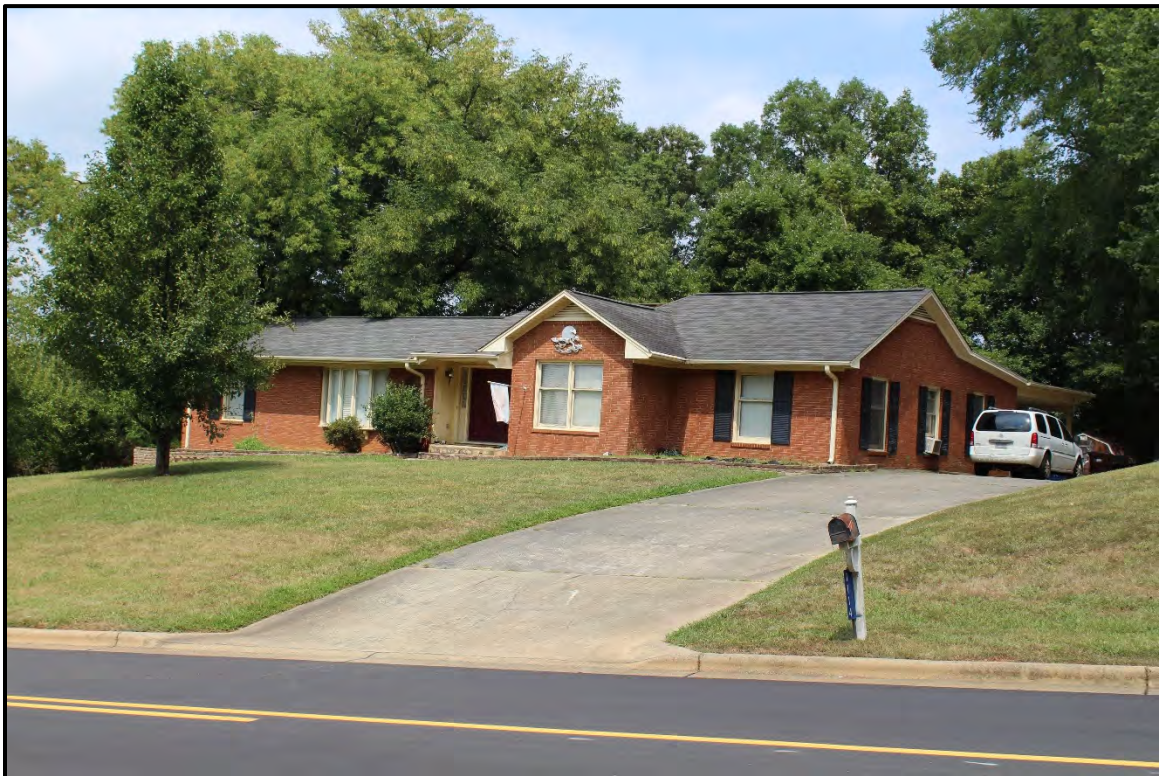
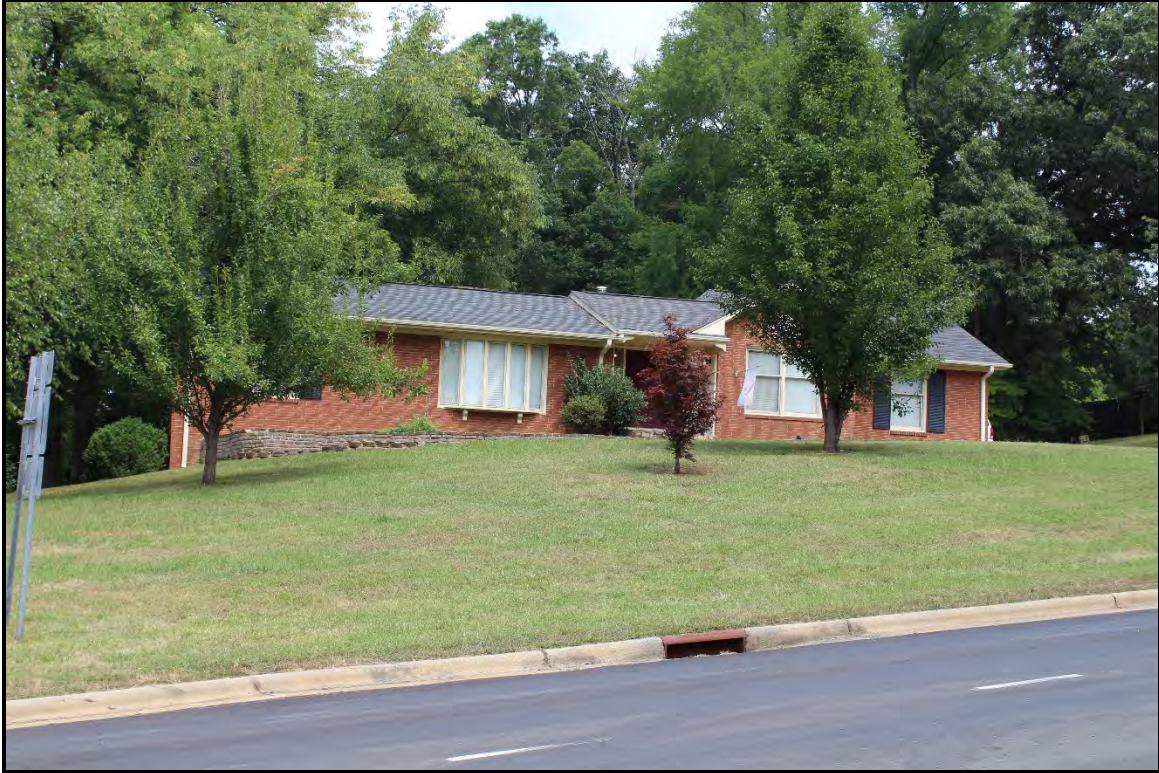
The wood-frame building features a side-gabled roof covered with asphalt shingles, an exterior clad with brick veneer, and a continuous brick foundation. Fenestration includes double-hung, 1/1 wood sash windows. Additionally, a bay window containing single-light wood casement sashes is located on a side-gabled wing attached to the south elevation. A stone veneer-clad stoop provides access to the recessed entrance. A modern shed-roofed carport is attached to the west (rear) elevation.

Figure 6.288. Architectural resource AM2614; view is southwest and features the façade and north elevation.

Figure 6.289. Architectural resource AM2614; view is west and features the façade.

NRHP Assessment. Architectural resource AM2614 does not exhibit a distinctive architectural style or workmanship. Based on the lack of architectural merit, as well as the inability to associate the house and/or its original owner(s) with an important historical event or series of events, it is TRC’s opinion that architectural resource AM2614 is not eligible for the NRHP.

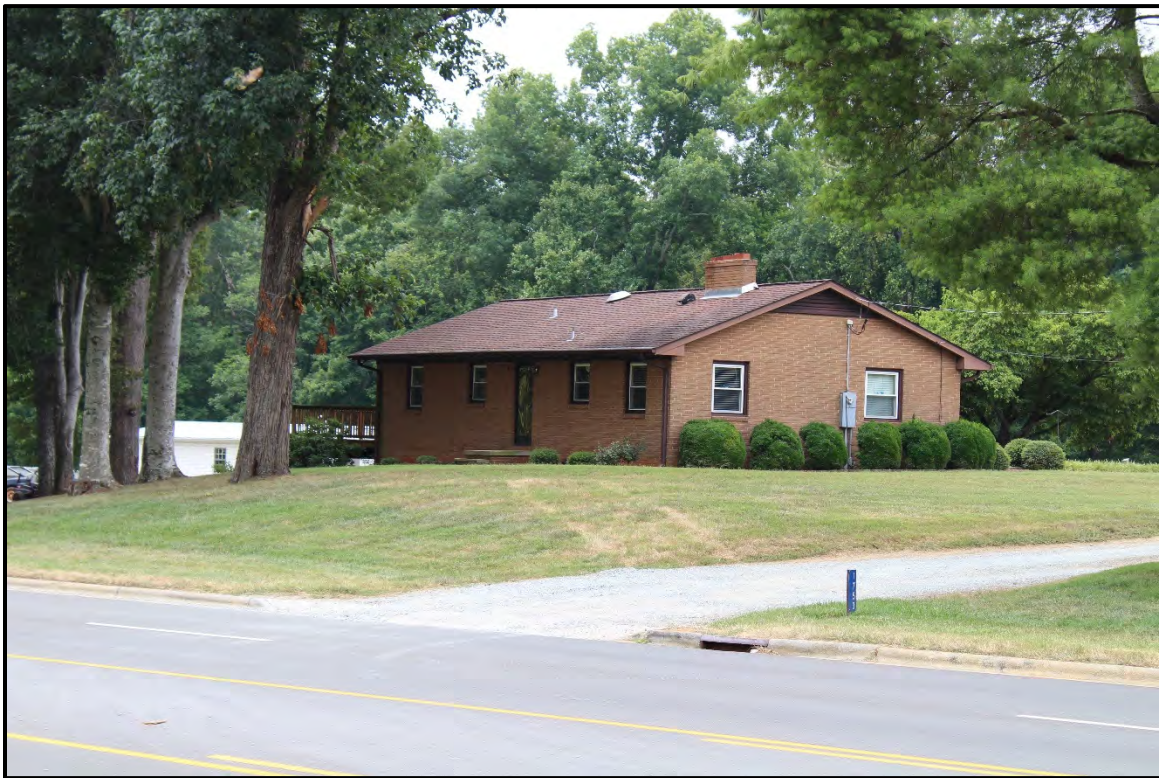
The wood-frame building features a side-gabled roof covered with asphalt shingles, an interior brick chimney, an exterior clad with brick veneer, and a continuous brick foundation. Fenestration includes double-hung, 1/1 vinyl sash windows. A brick and concrete stoop provides access to the main entrance. A modern wood deck is attached to the east elevation.

Figure 6.290. Architectural resource AM2615; view is southeast and features the façade and west elevation.

NRHP Assessment. Architectural resource AM2615 does not exhibit a distinctive architectural style or workmanship. In addition, the house has been altered through the installation of vinyl sash windows. Based on the lack of architectural merit, as well as the inability to associate the house and/or its original owner(s) with an important historical event or series of events, it is TRC's opinion that architectural resource AM2615 is not eligible for the NRHP.
