# North Carolina Department of Natural and Cultural Resources

State Historic Preservation Office

Revised Historic Architectural Survey for the MVP Southgate Pipeline Project, Rockingham and Alamance Counties, ER 18-1041

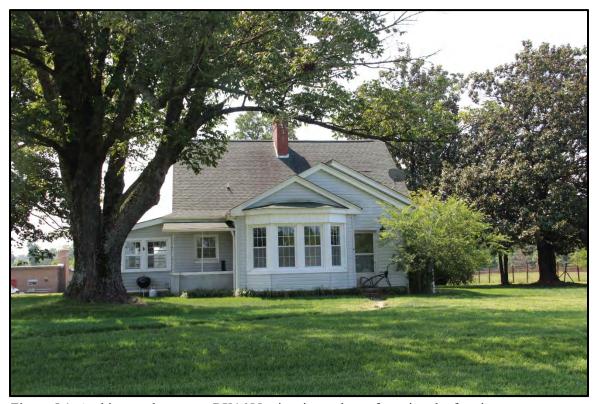
NRHP Assessment. Architectural resource RK1655 does not exhibit a distinctive architectural style or workmanship. In addition, the farmhouse has been altered through the replacement of the original window sashes, the application of vinyl siding, and the enclosure of the façade porch. As a result of the alterations to the farmhouse, the farm no longer conveys its original ca. 1940 appearance, thereby rendering the property ineligible for its agricultural associations. Based on the lack of architectural merit, as well as the inability to associate the farm and/or its original owner(s) with an important historical event or series of events, it is TRC's opinion that architectural resource RK1655 is not eligible for the NRHP.

Figure 5.1. Architectural resource RK1655; view is southeast featuring the façade.

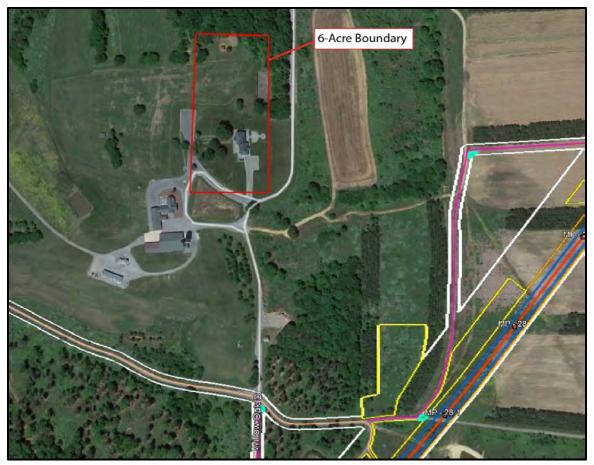
Assessment of Potential Effects. Based on current Project plans, the six-acre grounds immediately surrounding Willow Oaks containing the house, the Brodnax Family cemetery, and the ca. 1900 smokehouse are located approximately 0.17 miles northwest of proposed access road TA-RO-075, which is the nearest component of the Project to the architectural resource (Figure 5.38). From this area, visual lines-of-sight to the Project area will be partially obstructed by the existing terrain, which features rolling hills and mature tree growth located between the eastern edge of the property's unofficial NRHP boundary and the Project area (see Figure 5.25).

Figure 5.38. Aerial imagery of the Willow Oaks Plantation illustrating a 6-acre boundary encapsulating the plantation house, family cemetery, ca. 1900 smokehouse, and the original walkway to the main entrance (image courtesy of Google Earth).

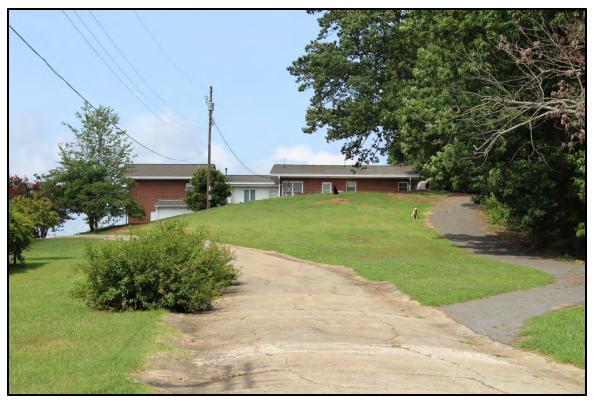
NRHP Assessment. Architectural resource RK1658 does not exhibit a distinctive architectural style or workmanship. In addition, the house has been altered through the replacement of the original window sashes and the construction of the two-story addition. Based on the lack of architectural merit, as well as the inability to associate the house and/or its original owner(s) with an important historical event or series of events, it is TRC's opinion that architectural resource RK1658 is not eligible for the NRHP.

Figure 5.40. Architectural resource RK1658; view is west featuring the façade of the 1957 house and the modern building hyphen that connects to the two-story addition.

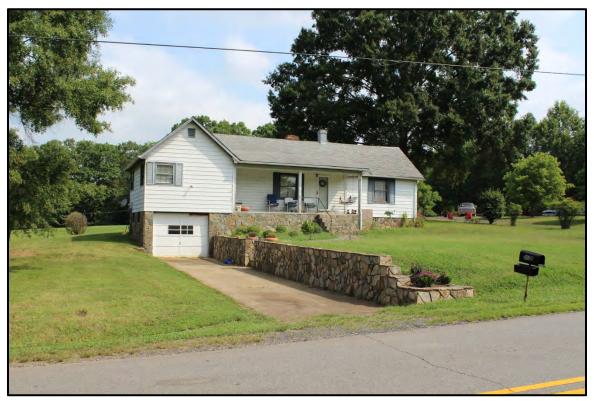
NRHP Assessment. Architectural resource RK1660 does not exhibit a distinctive architectural style or workmanship. In addition, the house has been altered through the application of vinyl siding and the addition of the front-gabled wing. Based on the lack of architectural merit, as well as the inability to associate the house and/or its original owner(s) with an important historical event or series of events, it is TRC's opinion that architectural resource RK1660 is not eligible for the NRHP.

Figure 5.43. Architectural resource RK1660; view is north featuring the façade.

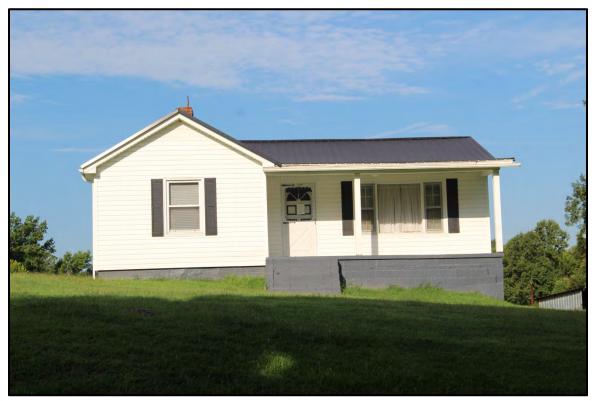
NRHP Assessment. Architectural resource RK1666 does not exhibit a distinctive architectural style or workmanship. In addition, the building's architectural integrity has been compromised through the application of synthetic siding and the replacement of original doors and windows. Based on the lack of architectural merit, as well as the inability to associate the house and/or its original owner(s) with an important historical event or series of events, it is TRC's opinion that architectural resource RK1666 is not eligible for the NRHP.

Figure 5.58. Architectural resource RK1666; view is southwest featuring the façade.

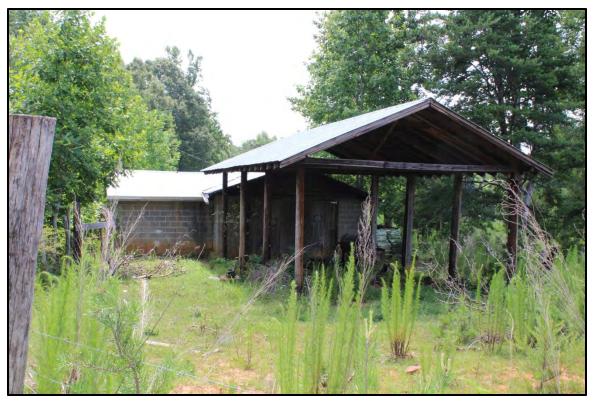
NRHP Assessment. Architectural resource RK1668 does not exhibit distinctive characteristics of architectural style or workmanship. Based on the lack of architectural merit or integrity, as well as the inability to associate the outbuilding and/or its original owner(s) with an important historical event or series of events, it is TRC's opinion that architectural resource RK1668 is not eligible for the NRHP.

Figure 5.60. Architectural resource RK1668; view is southeast featuring the primary façade and attached pole shed.

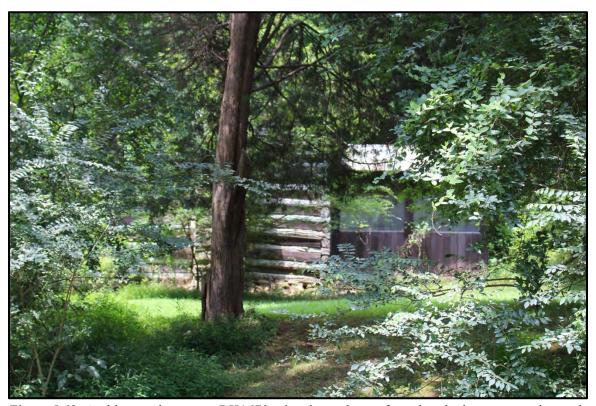
NRHP Assessment. Architectural resource RK1670 does not exhibit distinctive characteristics of architectural style or workmanship. Based on the lack of architectural merit and integrity, as well as the inability to associate the house and/or its original owner(s) with an important historical event or series of events, it is TRC's opinion that architectural resource RK1670 is not eligible for the NRHP.

Figure 5.63. Architectural resource RK1670; view is northwest featuring the log construction and north (rear) elevation gabled-roof porch addition.

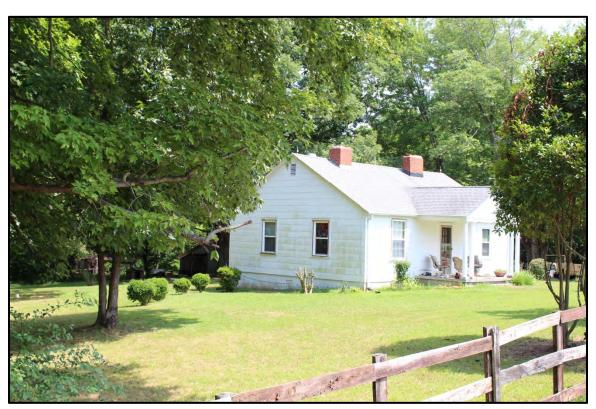
NRHP Assessment. Architectural resource RK1687 does not exhibit distinctive characteristics of architectural style or workmanship. In addition, the house has been altered through the installation of vinyl sashes. Based on the lack of architectural merit, as well as the inability to associate the house and/or its original owner(s) with an important historical event or series of events, it is TRC's opinion that architectural resource RK1687 is not eligible for the NRHP.

Figure 5.107. Architectural resource RK1687; view is southeast featuring the façade and north elevation.

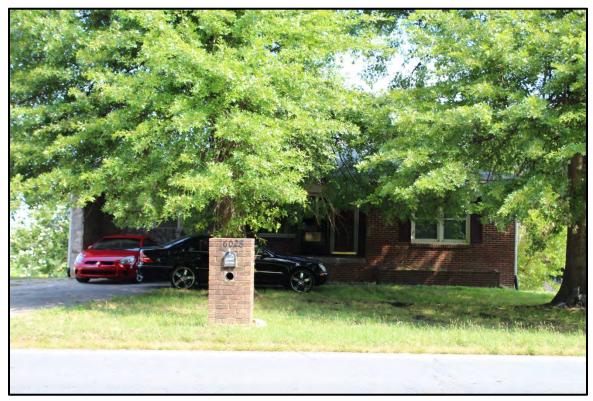
NRHP Assessment. Architectural resource RK1695 does not exhibit distinctive characteristics of architectural style or workmanship. In addition, the house has been altered through the replacement of the original window sashes and the enclosure of the carport. Based on the lack of architectural merit, as well as the inability to associate the house and/or its original owner(s) with an important historical event or series of events, it is TRC's opinion that architectural resource RK1695 is not eligible for the NRHP.

Figure 5.126. Architectural resource RK1695; view is northwest featuring the façade.

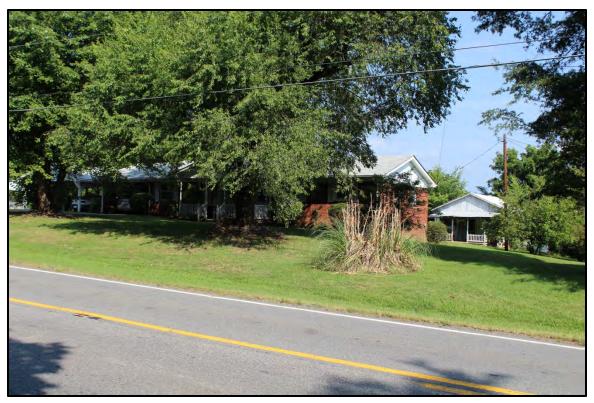
NRHP Assessment. Architectural resource RK1697 does not exhibit distinctive characteristics of architectural style or workmanship. In addition, the house has been altered through the construction of the façade porch. Based on the lack of architectural merit, as well as the inability to associate the house and/or its original owner(s) with an important historical event or series of events, it is TRC's opinion that architectural resource RK1697 is not eligible for the NRHP.

Figure 5.131. Architectural resource RK1697; view is southwest featuring the façade and secondary residence.

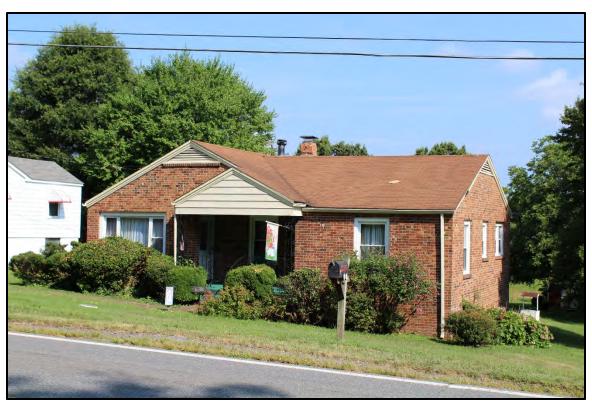
NRHP Assessment. Architectural resource RK1699 does not exhibit distinctive characteristics of architectural style or workmanship. In addition, the house has been altered through the replacement of the original window sashes and the application of aluminum siding to the gable fields. Based on the lack of architectural significance, as well as the inability to associate the house and/or its original owner(s) with an important historic event or series of events, it is TRC's opinion that architectural resource RK1699 is not eligible for the NRHP.

Figure 5.136. Architectural resource RK1699; oblique view north showing south façade and east elevation.

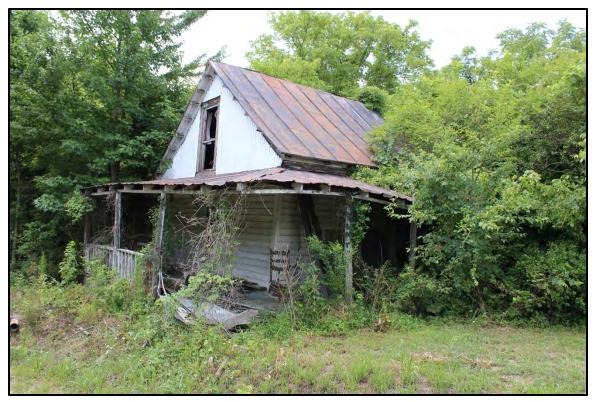
NRHP Assessment. Architectural resource RK1701 does not exhibit distinctive characteristics of architectural style or workmanship. In addition, the integrity of the resource is poor due to neglect, which has resulted in the loss original window sashes and the partial collapse of the building. Based on the lack of architectural significance and the inability to associate the house and/or its original owner(s) with one or more important historic events, it is TRC's opinion that architectural resource RK1701 is not eligible for the NRHP.

Figure 5.140. Architectural resource RK1701; oblique view south showing the exposed eastern gable end and porch.

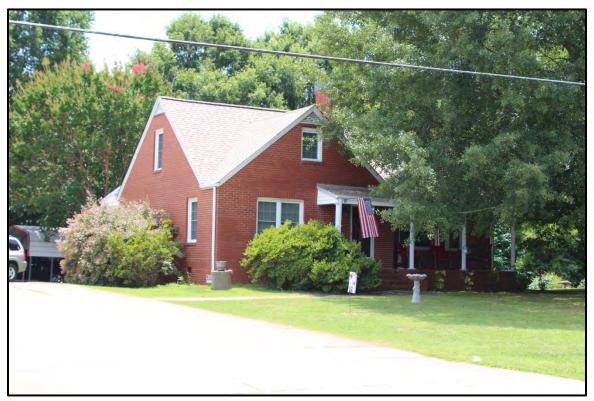
NRHP Assessment. Architectural resource RK1710 does not exhibit a distinctive architectural style or workmanship. In addition, the house has been altered through the replacement of the original window sashes and porch columns. Based on the lack of architectural merit, as well as the inability to associate the house and/or its original owner(s) with an important historical event or series of events, it is TRC's opinion that architectural resource RK1710 is not eligible for the NRHP.

Figure 5.162. Architectural resource RK1710; view is southwest featuring the façade and east elevation.

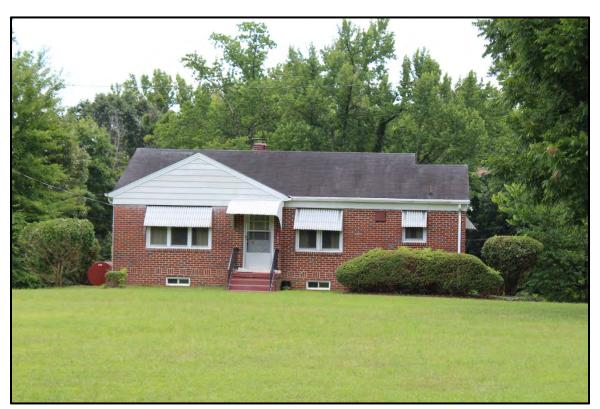
NRHP Assessment. Architectural resource RK1711 does not exhibit a distinctive architectural style or workmanship. In addition, the house has been altered through the application of aluminum siding on the projecting gable bay and the replacement of the original window sashes. Based on the lack of architectural merit, as well as the inability to associate the house and/or its original owner(s) with an important historical event or series of events, it is TRC's opinion that architectural resource RK1711 is not eligible for the NRHP.

Figure 5.163. Architectural resource RK1711; view is south featuring the façade.

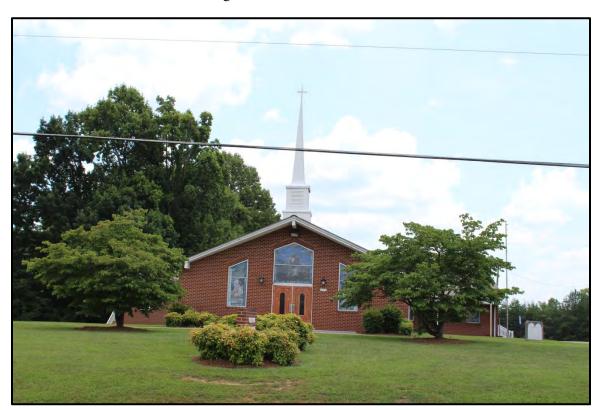
NRHP Assessment. Architectural resource RK1712 is a typical example of a mid-twentieth century church. In accordance with NRHP Criteria Consideration A, religious buildings are normally not eligible for the NRHP unless they derive their primary significance from architectural or artistic distinction or are considered to be of historical importance. The property cannot be associated with important historical event(s) or person(s). Due to lack of the historic and architectural significance it is TRC's opinion that architectural resource RK1712 is not eligible for the NRHP.

Figure 5.164. Architectural resource RK1712; view is south and features the façade.

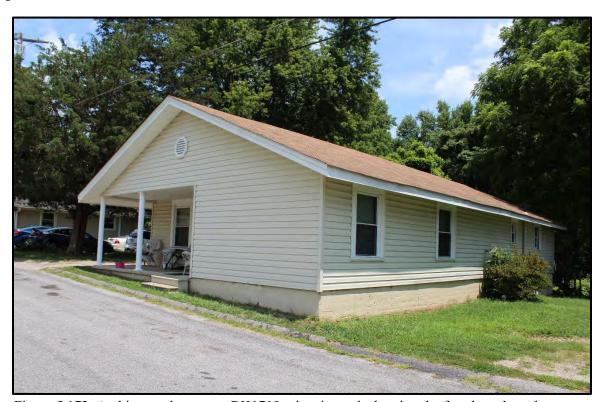
NRHP Assessment. Architectural resource RK1719 does not exhibit a distinctive architectural style or workmanship. In addition, the house has been altered through the application of vinyl siding, the replacement of the original window sashes, and the replacement of the porch columns. Based on the lack of architectural merit, as well as the inability to associate the house and/or its original owner(s) with an important historical event or series of events, it is TRC's opinion that architectural resource RK1719 is not eligible for the NRHP.

Figure 5.173. Architectural resource RK1719; view is north showing the façade and southeast elevation.

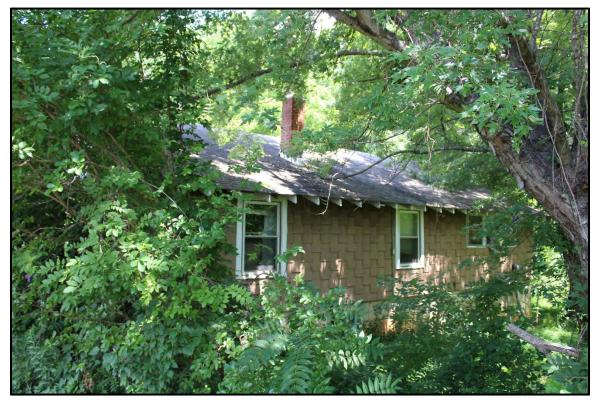
NRHP Assessment. Architectural resource RK1721 does not exhibit a distinctive architectural style or workmanship. In addition, the house has been altered through the replacement of the original window sashes and the application of asphalt shingle siding. Based on the lack of architectural merit, as well as the inability to associate the house and/or its original owner(s) with an important historical event or series of events, it is TRC's opinion that architectural resource RK1721 is not eligible for the NRHP.

Figure 5.177. Architectural resource RK1721; view is north featuring the southeast elevation.

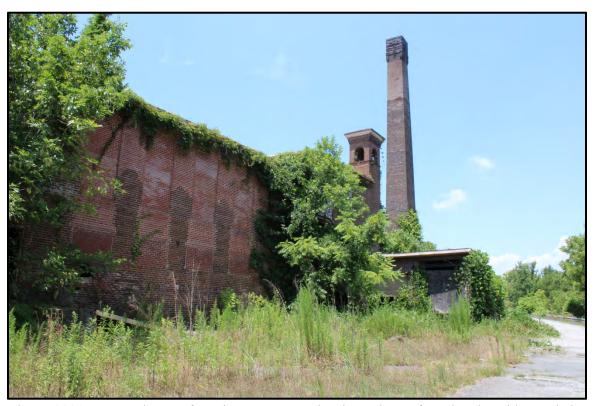
Figure 6.230. T.M. Holt Manufacturing Company; view is northwest featuring the mid-twentieth century additions to the 1892 mill building with the associated stair tower and smokestack.

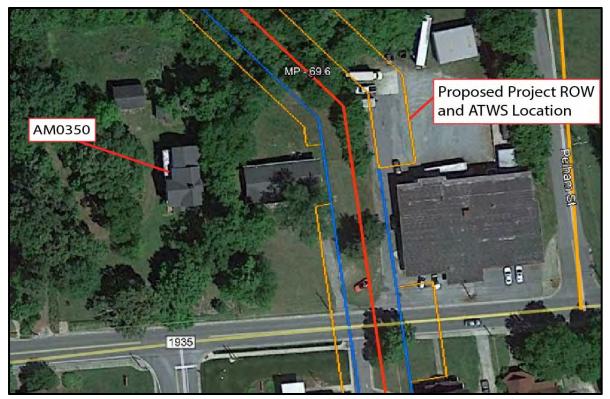
Figure 6.261. Aerial imagery illustrating the location of AM0350 relative to the proposed Project ROW (image courtesy of Google Earth).

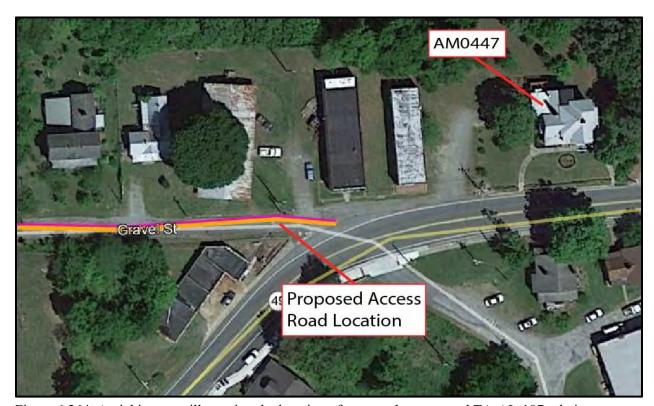
Figure 6.264. Aerial imagery illustrating the location of proposed access road TA-AL-187 relative to AM0447 (image courtesy of Google Earth).
