**North Carolina Department of Natural and Cultural Resources**  
**State Historic Preservation Office**

SUBJECT: Historic Structures Survey Report, Widen SR 1700 (Covered Bridge Road),  
W-5704E, PA 17-12-0004, Johnston County, ER 18-1248

STATE OF NORTH CAROLINA  
DEPARTMENT OF TRANSPORTATION

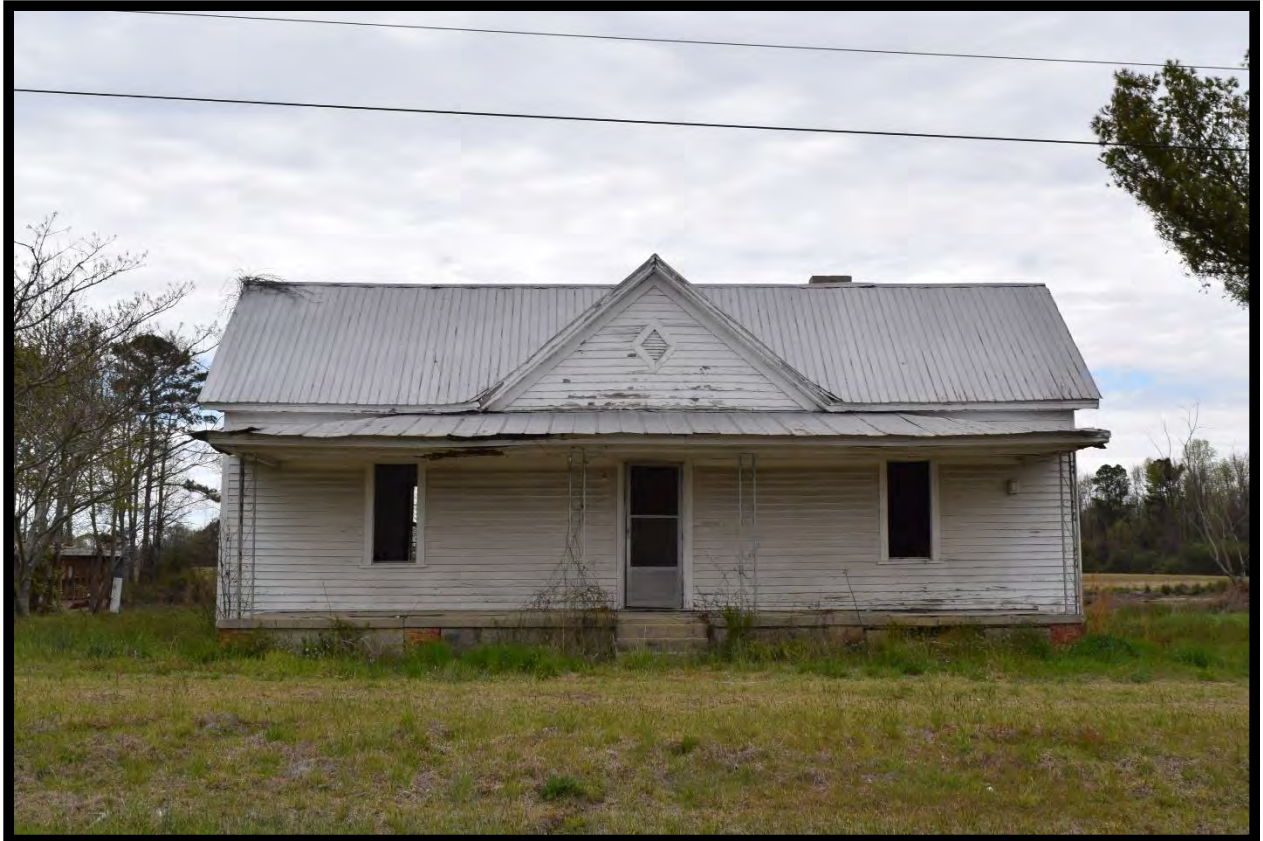
Figure 3: Barnes House, Looking North.

The Barnes House is a one-story, late nineteenth-century/early twentieth-century vernacular dwelling with a triple-A roof. It is clad in plain weatherboard siding, rests on brick piers with concrete block infill, with a standing-seam metal roof, and a full-width, hip-roofed porch supported by decorative metal posts. The porch shelters an entry door flanked by two windows, both of which are missing sashes (Figure 3).

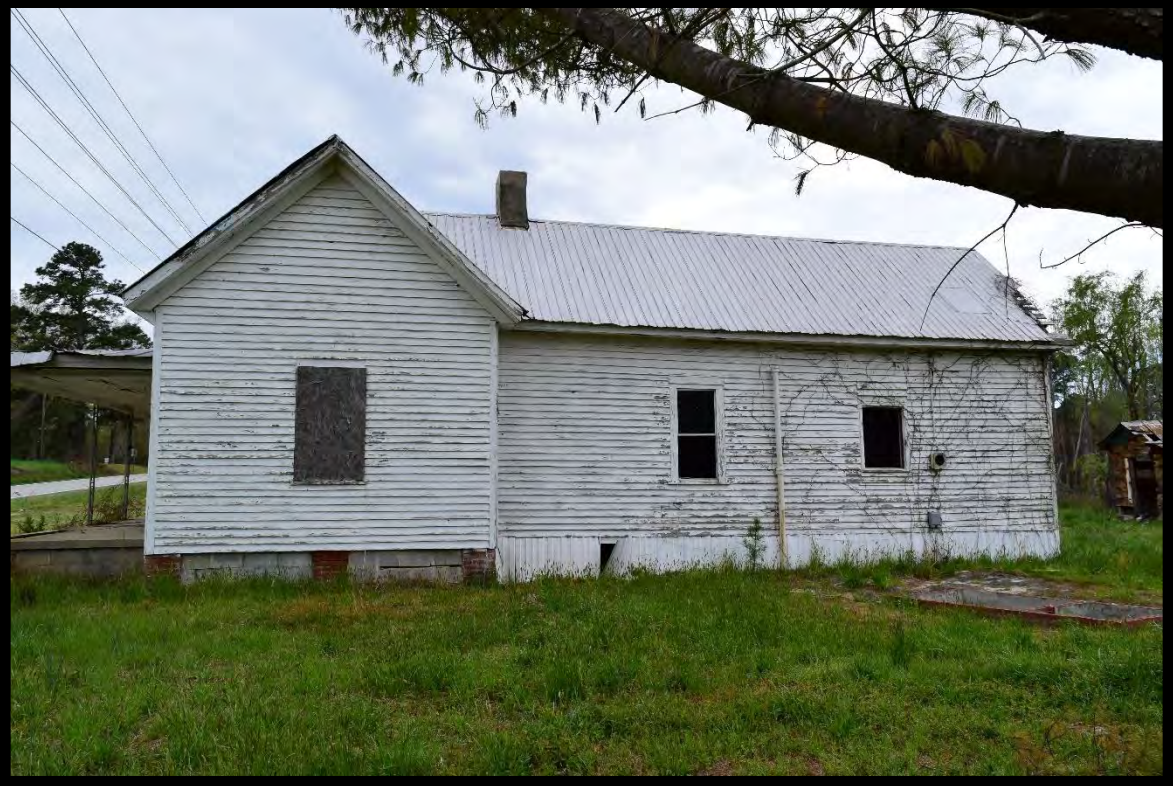
Figure 5: Barnes House, Looking West.

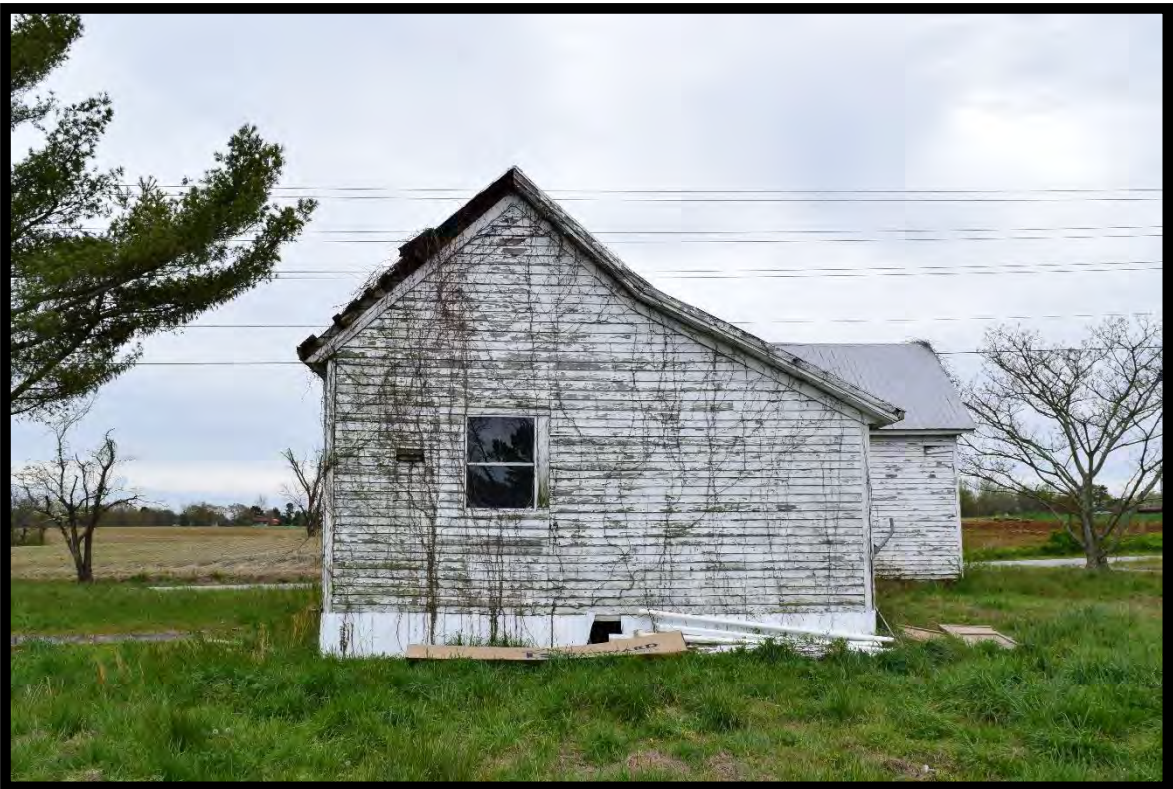
Figure 6: Barnes House, Looking South.

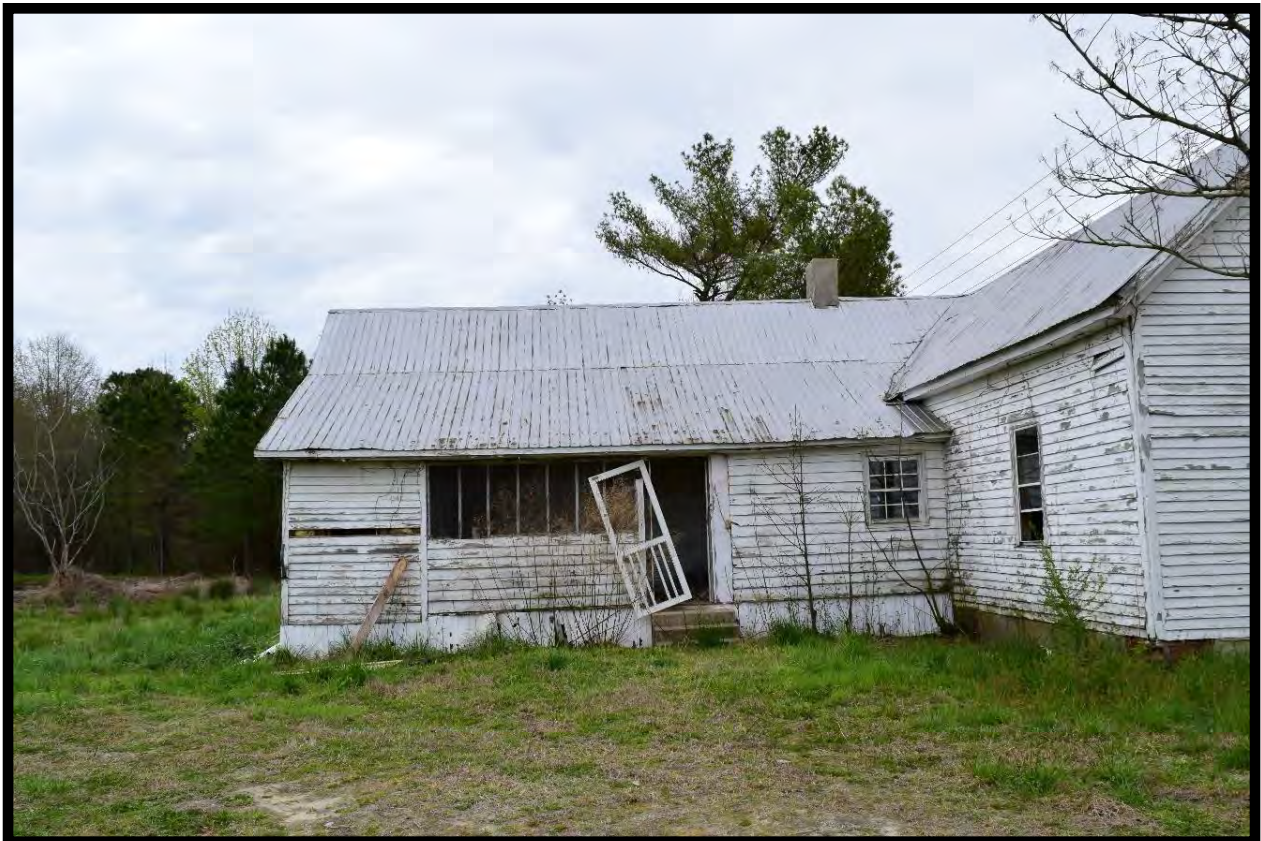
Figure 7: Barnes House, Looking East.

lights the porch. The ends of the shed-roofed section are also enclosed and accessed from the interior of the dwelling. The south end has a small six-over-six window with a wooden frame and vinyl dividers (cosmetic). A two-over-two, horizontal-pane, vinyl sash window exists on the north (rear) elevation of the main block of the dwelling and a small parged chimney rises from the juncture of the main block and rear ell (Figure 7). The west (side) elevation was once lit by a window that is now boarded over (Figure 8). Aside from the missing window sashes, the dwelling's roof also shows signs of disrepair, particularly on the northeast corner, and the ceiling of the porch is beginning to fall in (Figure 9).

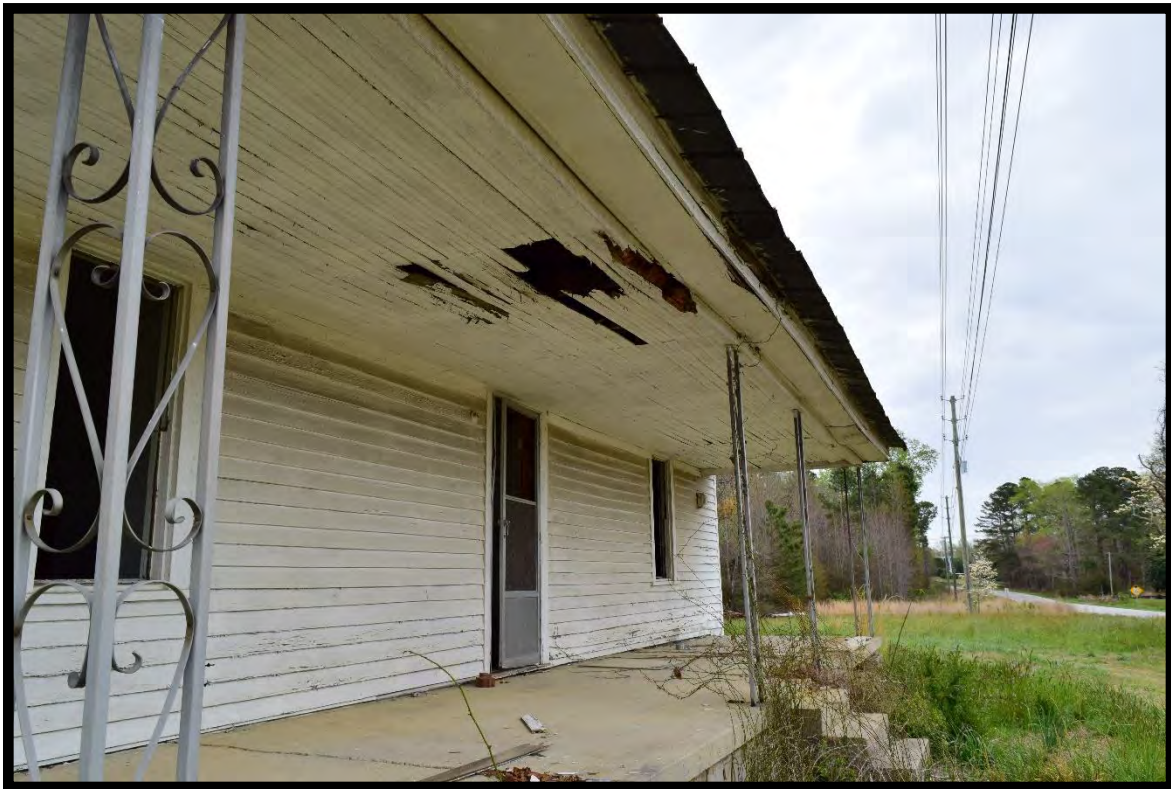
Figure 9: Barnes House, Ceiling of Porch.

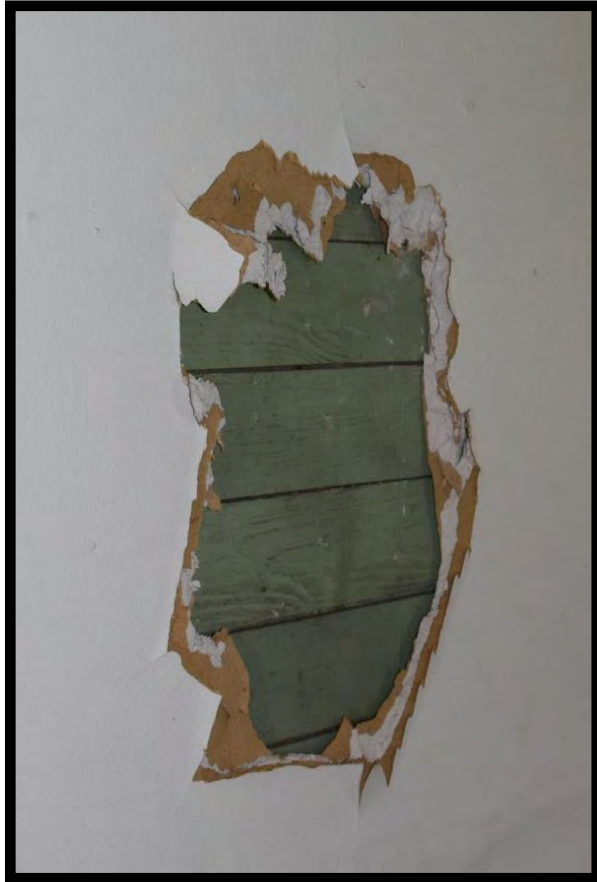
The main block of the dwelling has a center hall plan and the ell has two rooms that extend one from another. Missing drywall and framing elements reveal that the walls were once finished with flush boards (Figure 10). An interesting decorative element is an arched doorway between the hall and east room in the main block (Figure 11). The house, which is abandoned, is filled with various pieces of furniture in a state of disarray.

Figure 10: Barnes House, Exposed Flush Boards.

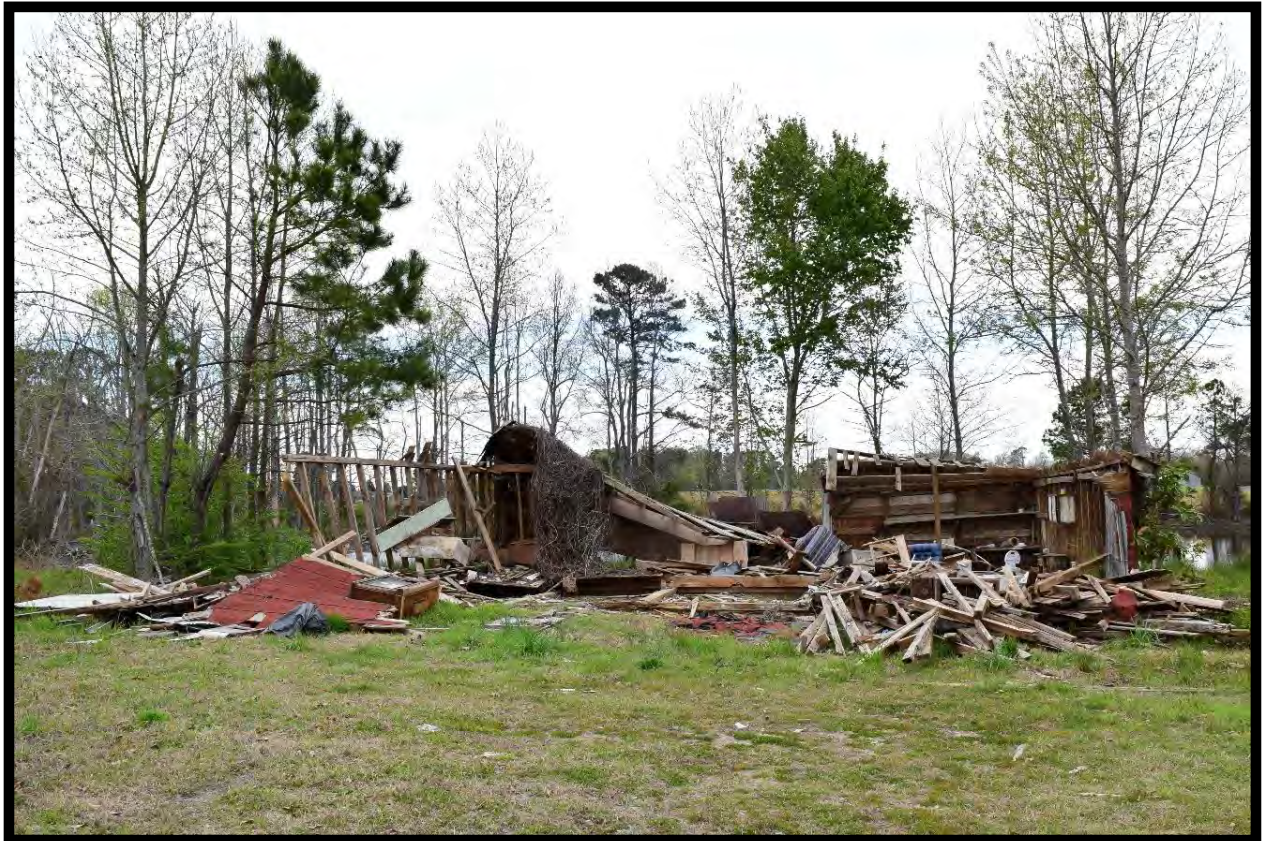
A number of agricultural buildings once surrounded the Barnes House including a gambrel roofed barn with machine shed side wings (Figure 12) and two tobacco barns which were photographed by Google Streetview in 2012 but are now in ruins. Still extant, though in poor condition, is a small gable-roofed shed that was clad in asphalt siding but has been stripped down to flush boards and framing (Figure 13). Along the eastern boundary of the property is a second collection of agricultural buildings, which seem to relate more to a 1960s dwelling that rests on a lot cut from the northeast corner of the parcel than to the Barnes House. The collection includes a metal clad tobacco barn that abuts a one-story gabled shed with three garage doors on its west elevation, and a tall open shed (Figure 14).

Figure 12: Barnes House, Ruins of Gambrel Roofed Barn.

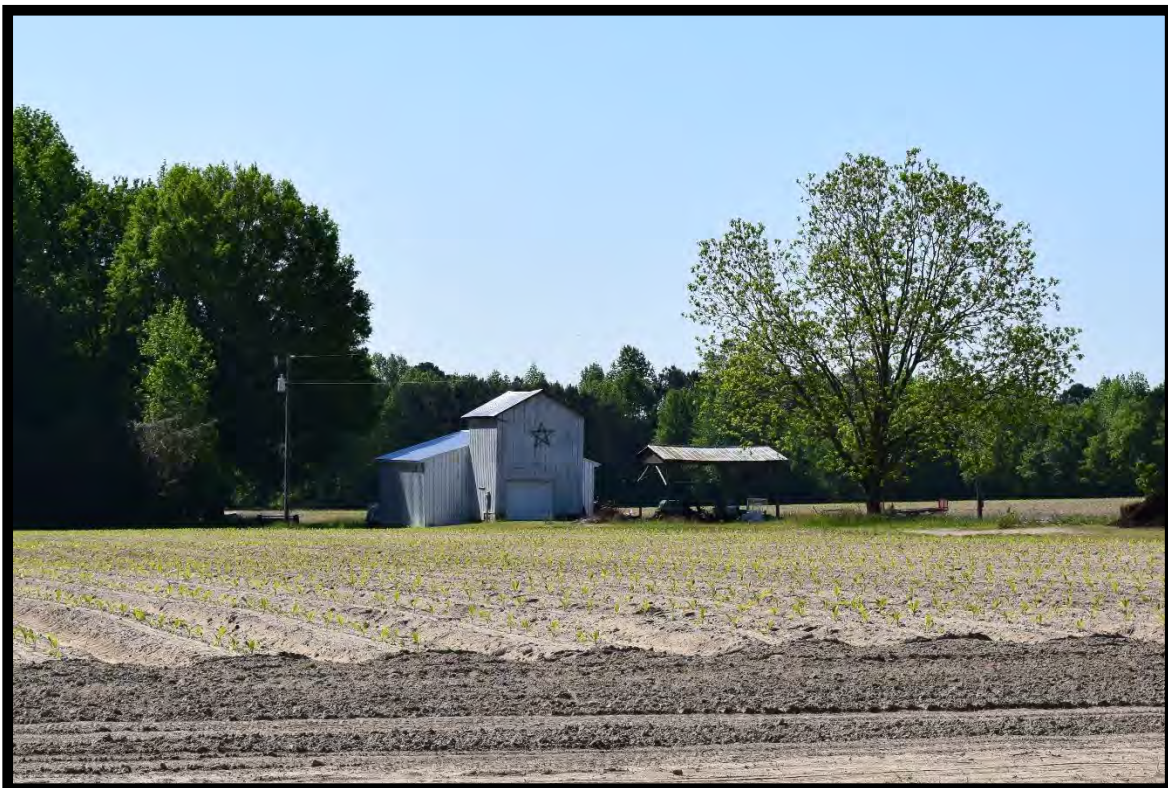
Figure 14: Barnes House, Tobacco Barn and Sheds.

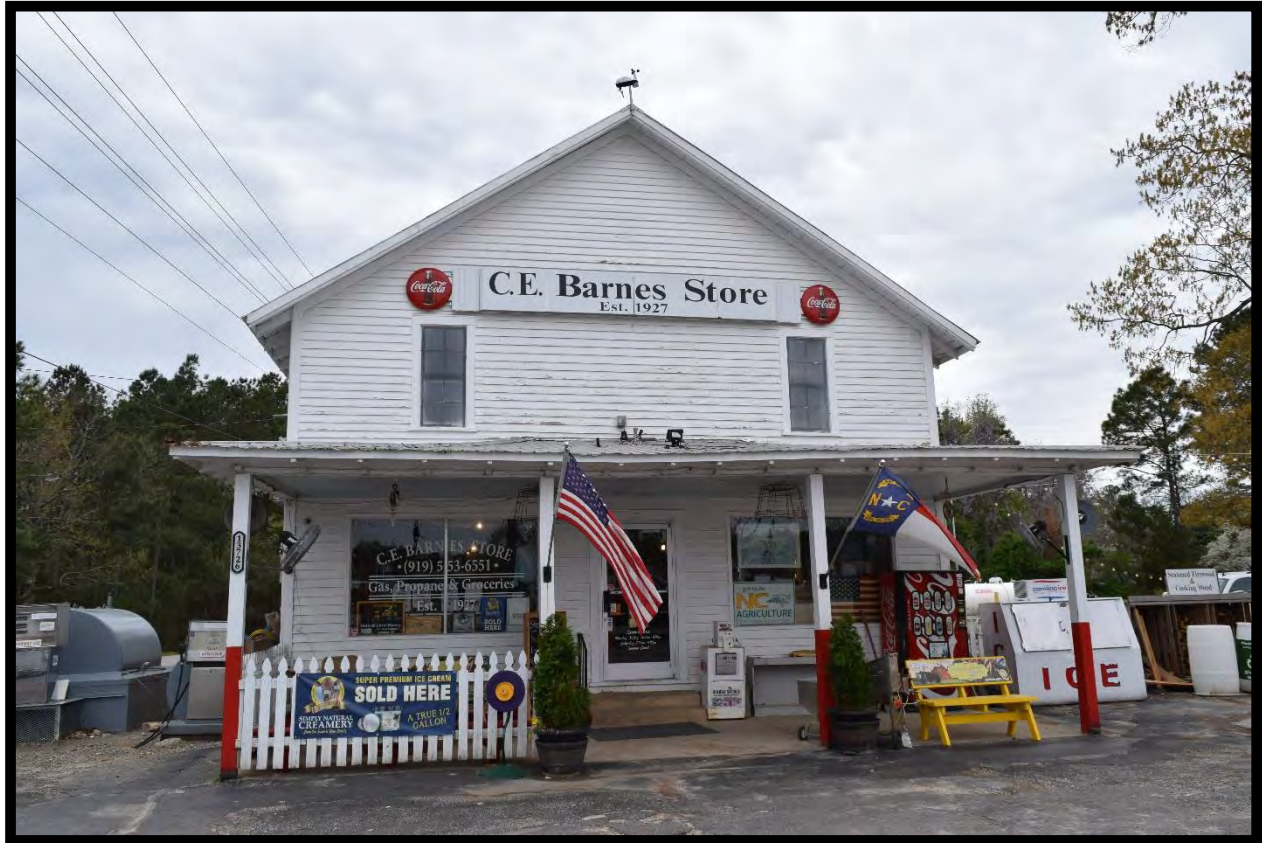
Figure 18: J. O. Barnes Store, Looking West.

The J. O. Barnes Store is a two-story, front-gabled store with plain wooden weatherboard siding and a standing-seam metal roof with exposed rafter tails. It has a brick foundation and a one-story, hip-roofed porch that spans the front elevation, is supported by plain square posts, and shelters an entry door flanked by large store-front windows, likely replacements. Above the porch are two windows with four-over-four wooden sashes, and a sign that reads “C. E. Barnes Store, Est. 1927” (Figure 18).

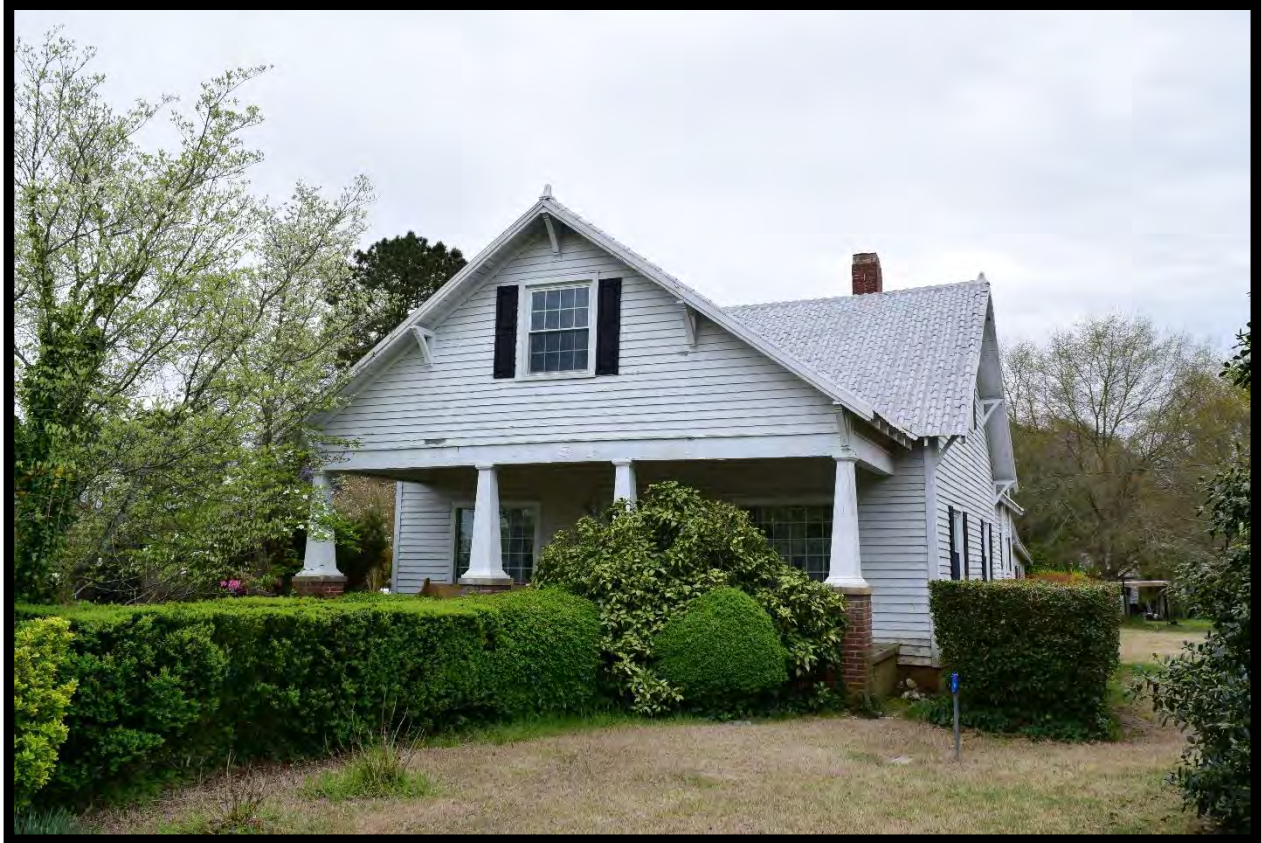
Figure 19: J. O. Barnes House, Looking West.

The J. O. Barnes House is a frame one-and-one-half story Craftsman-style dwelling clad in plain wooden weatherboard siding with a cross gabled roof covered by metal tiles that replicate the shape of terracotta tiles, and a brick foundation with concrete block infill. A large forward-facing gable extends over the front porch and is supported by battered box columns on brick piers. The porch shelters a modern entry door flanked by large, multi-paned, vinyl windows. In the front gable there is an eight-over-eight vinyl sash window. Simple brackets adorn each of the dwelling's four gables and exposed rafter tails are visible below the dwelling's eaves (Figure 19).

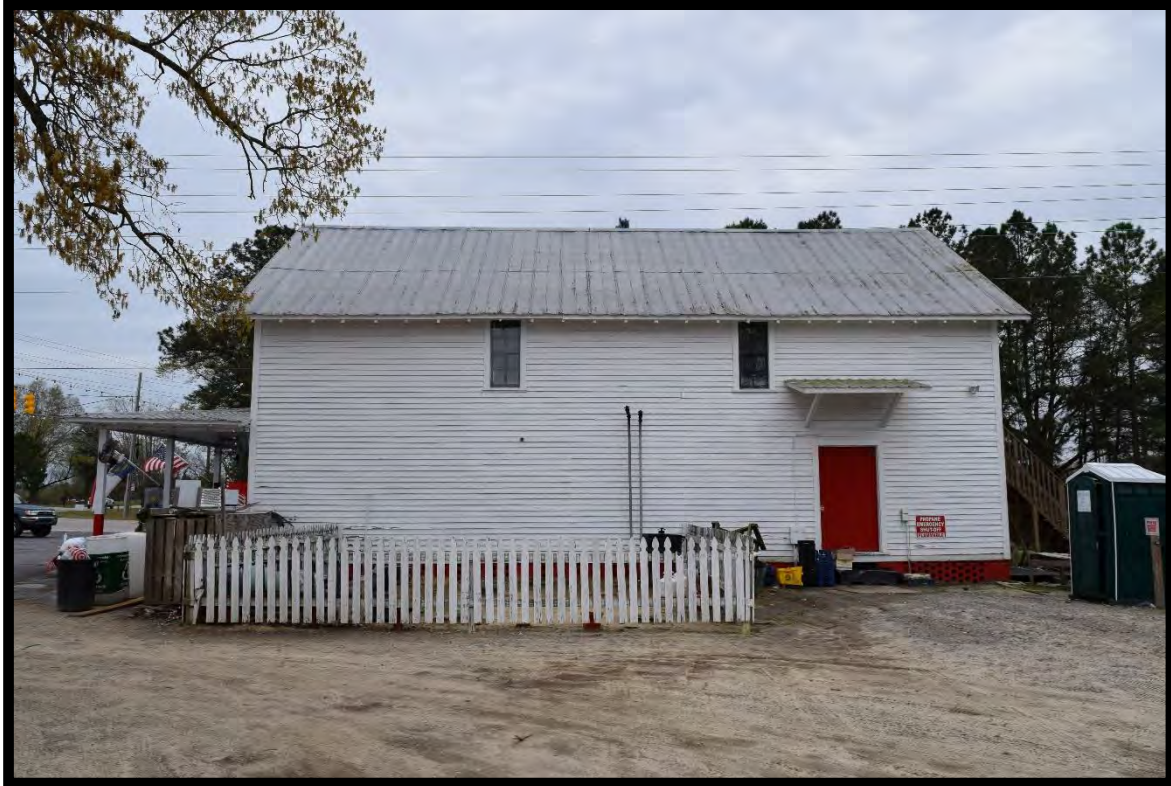
Figure 21: J. O. Barnes Store, Looking South.

The north (side) elevation contains a wooden door toward its west end that is sheltered by a shed roof and two four-over-four wooden sash windows light the second story (Figure 21). The west (rear) elevation has two large windows with bars on the first story and a wooden door flanked by four-over-four wooden sash windows with storm window covers on the second floor. The door is approached by a tall wooden staircase with a small landing at the top and sheltered by a shed roof (Figure 22). The south (side) elevation mirrors the north elevation with a wooden door sheltered by a shed roof at the rear and two four-over-four wooden windows across the second story. There is also an air conditioning unit with its own shed roof located near the front window and a brick chimney that rises from the south slope of the roof (Figure 23).

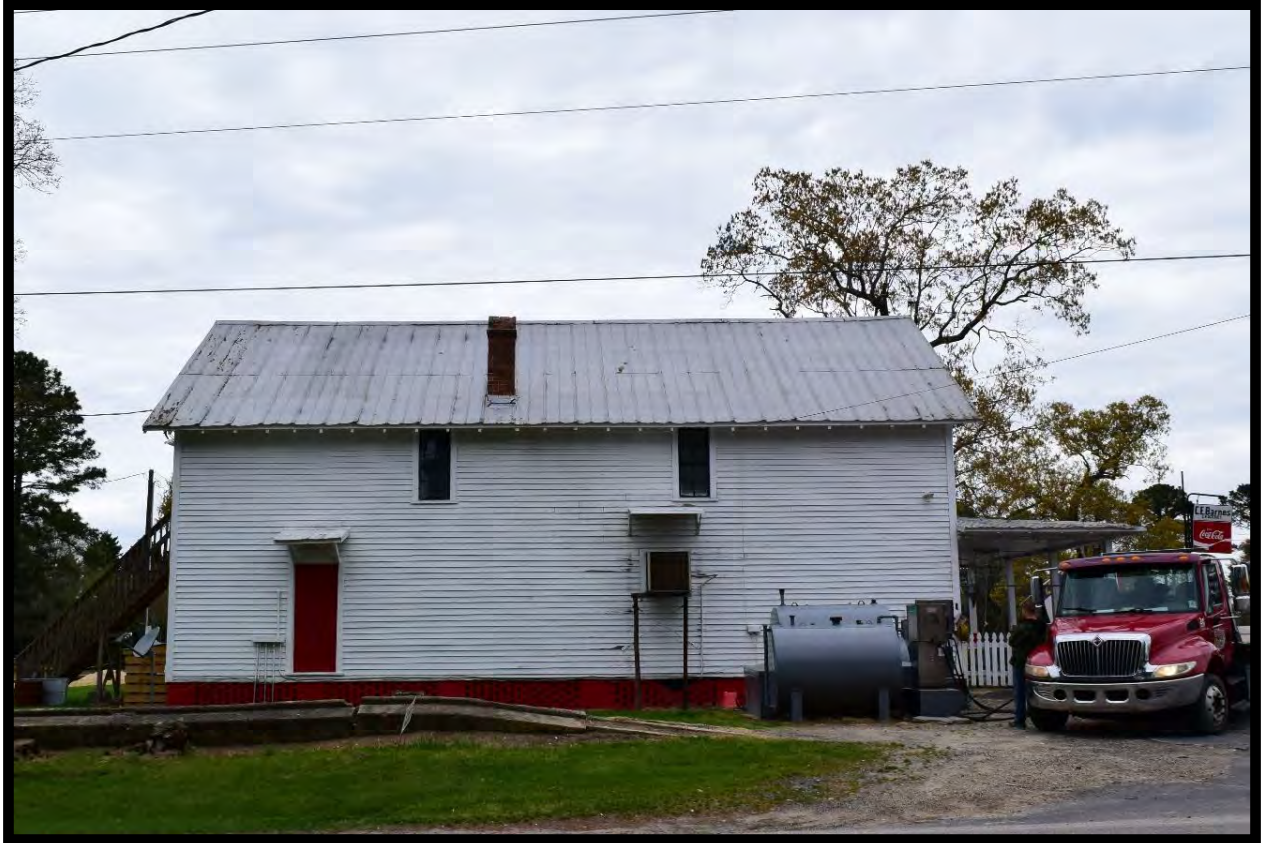
Figure 23: J. O. Barnes Store, Looking North.

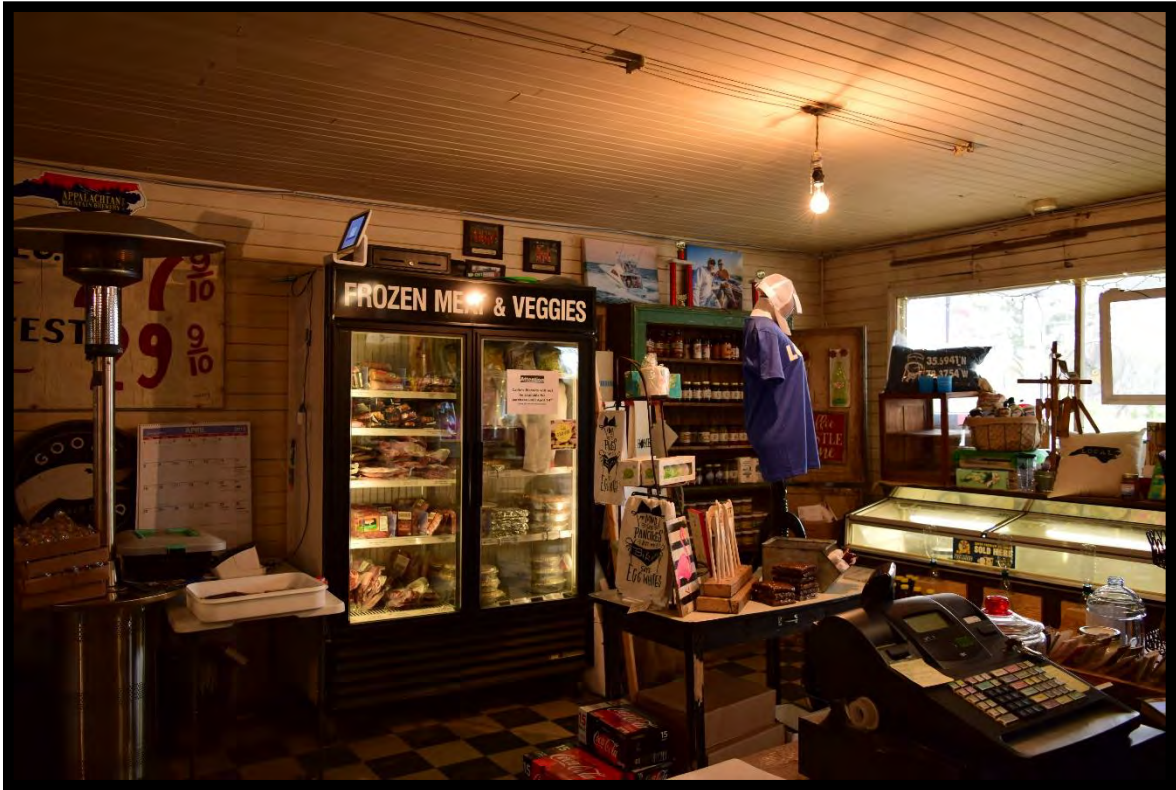
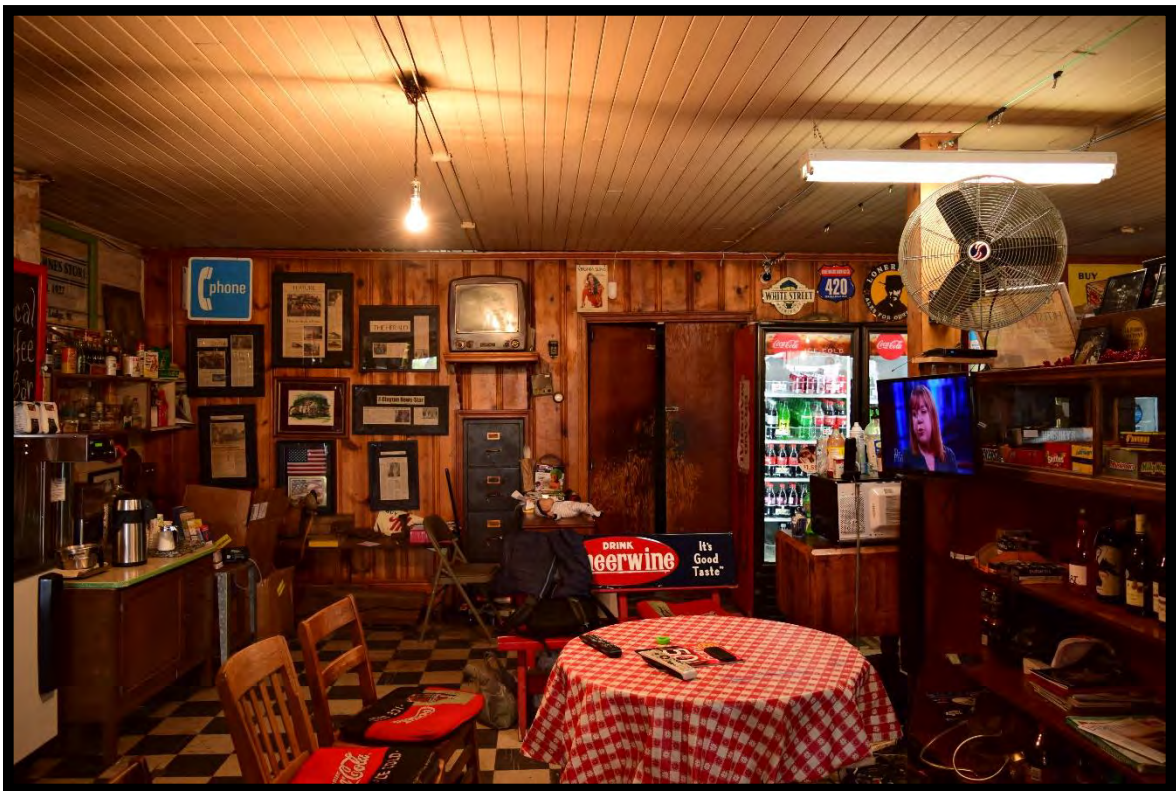
The store is still operated as a corner store with a focus on local goods. Flush boards and paneling cover the interior walls and ceiling while black and white asphalt tiles cover the floor. The space is filled with shelving, display cases and freezers, and a centrally placed checkout counter (Figures 24 and 25).

Figure 24: J. O. Barnes Store, Interior.

Figure 25: J. O. Barnes Store, Interior.

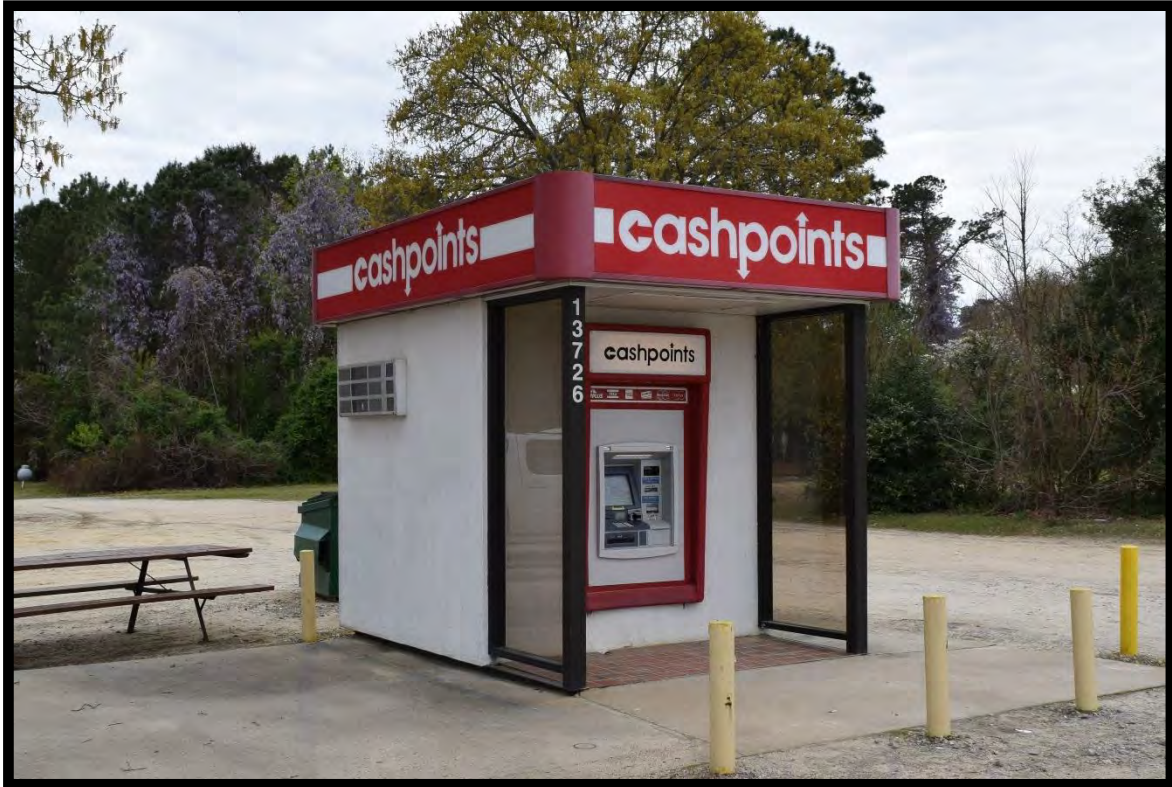
To the north of the store is a small walk-up ATM that faces east and rest on a concrete pad. Roughly square, the one-story structure is sheltered by a flat roof with an eye-catching red cornice that reads “Cashpoints” on each elevation and cantilevers over the ATM interface. Large glass panels in steel frames shelter the interface on the north and south (Figure 26).

Figure 26: J. O. Barnes Store, ATM, Looking Northwest.

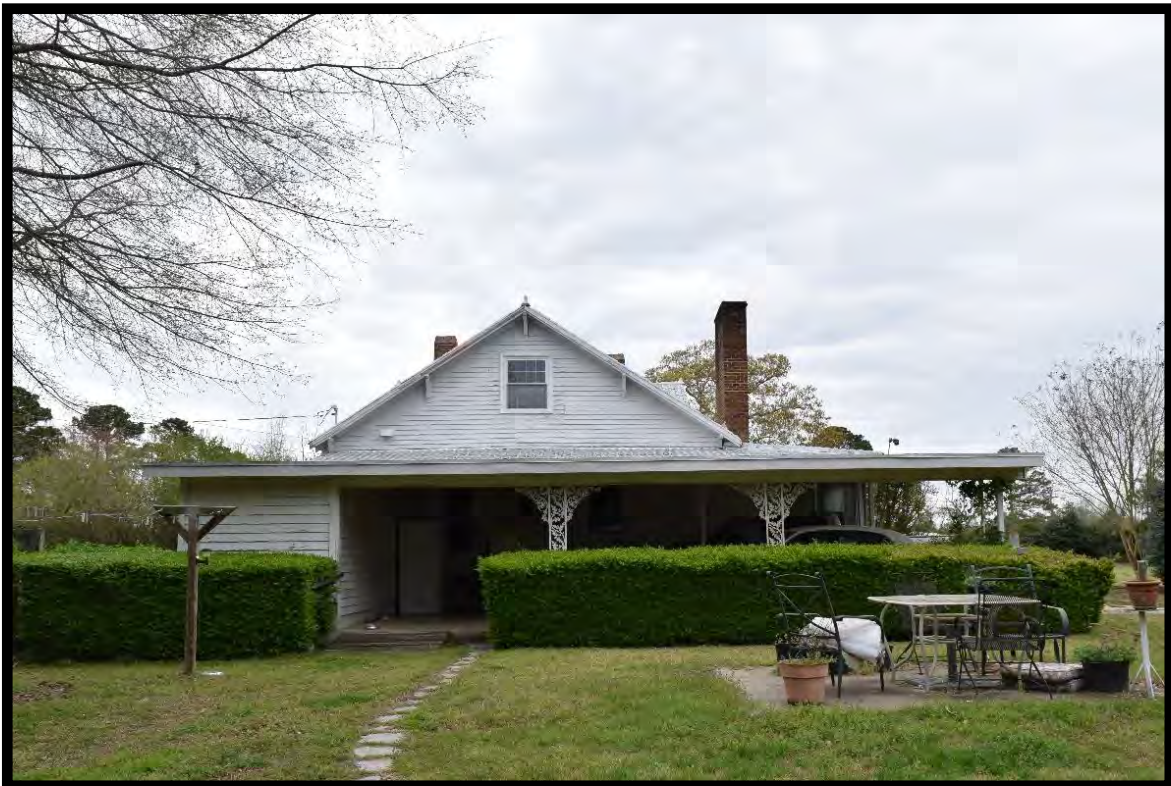
Figure 28: J. O. Barnes House, Looking East.

The west elevation is dominated by the carport which spans the full width of the rear elevation and is mostly open with a small portion of the north side enclosed. The carport shelters the west (rear) elevation of the enclosed porch which spans the width of the dwelling and contains an entry door, a six-over-six vinyl sash window, and large paired windows. Above the carport there is an eight-over-eight vinyl sash window surrounded by irregular siding that suggests it was originally a different size (Figure 28).

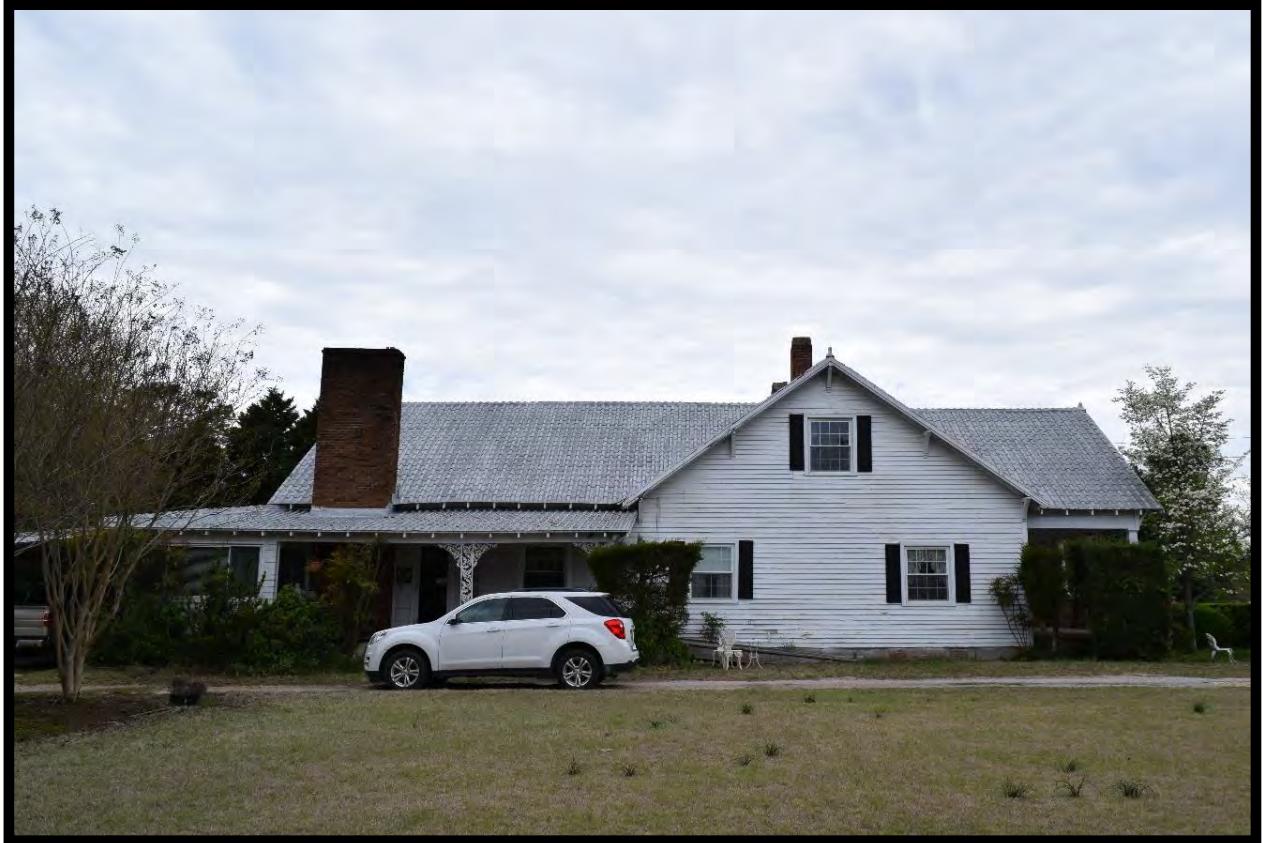
The entrance of the carport acts as the western section of the dwelling, while the rear porch wraps the southwest corner of the dwelling terminating at the point where the side gable begins to rise. The west end of the porch is still enclosed and has a large three-pane picture window, and the two bays to the east are open with decorative cast-iron supports and shelters an entry door flanked on the east by an eight-over-eight vinyl sash window. A wide, brick chimney east of the door also rises from the elevation, and large paired windows light the east elevation of the enclosed porch. East of the porch is a gable that is identical to the one of the north elevation (Figure 29).

Figure 29: J. O. Barnes House, Looking North.

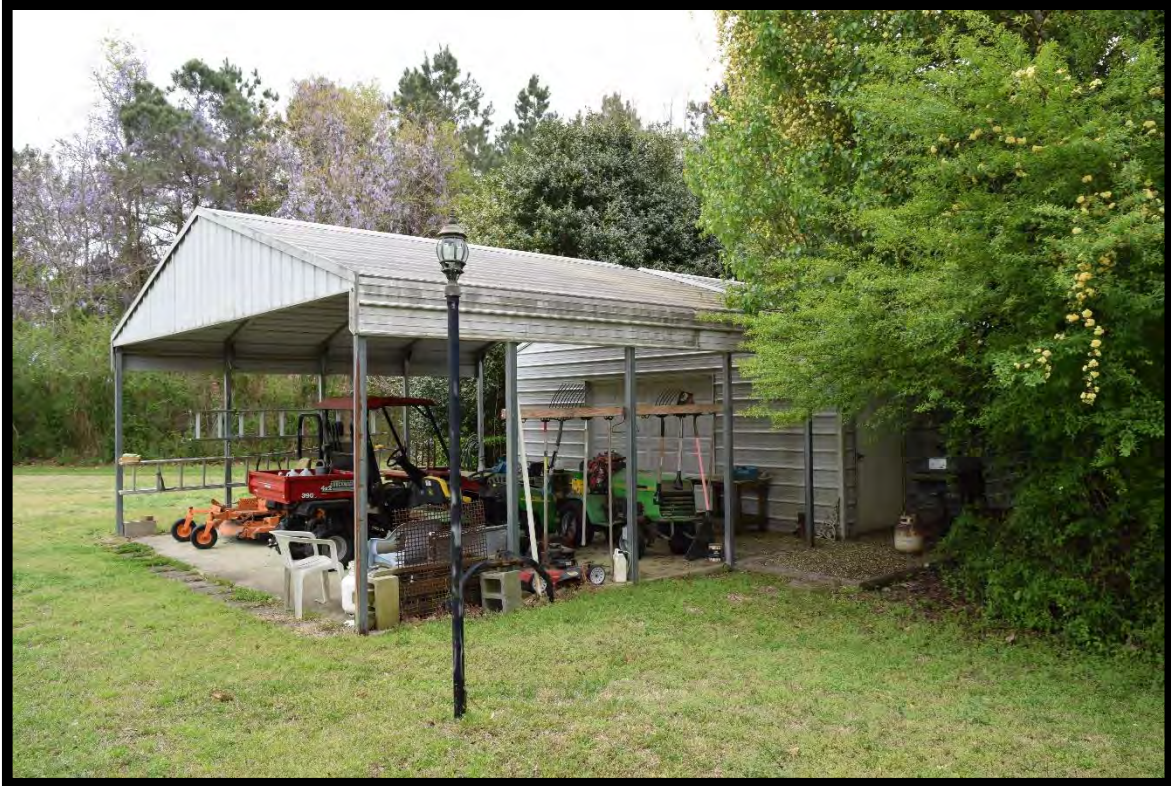
Figure 30: J. O. Barnes House, Garage and Carport.

A variety of outbuildings are located west of the dwelling. The first is a large metal-framed garage with a front-gabled roof and a garage door entrance on the east (front) elevation as well as an entry door on the north (side) elevation. A metal-framed carport that is roughly the same height, width, and form as the garage stands immediately in front of it (Figure 30).

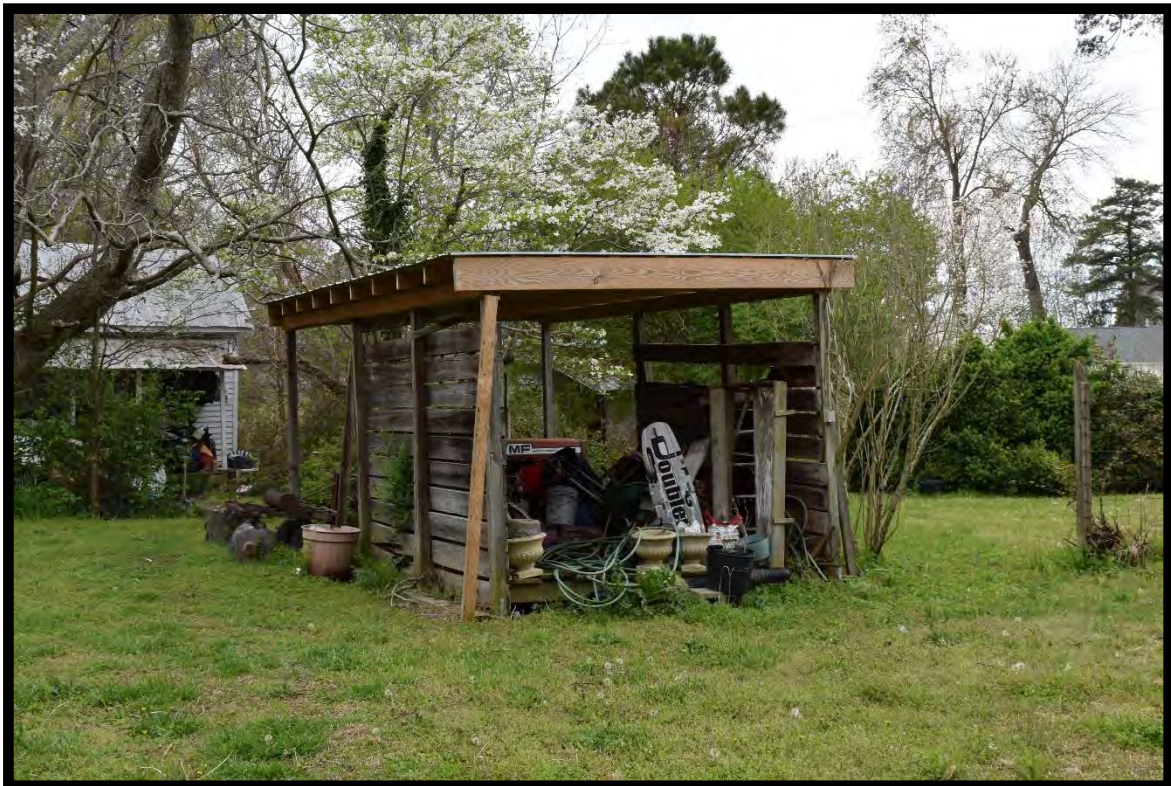
A frame structure stands northwest of the garage. It has a flat, standing seam metal roof and horizontal wooden planks create partial walls on the north and south sides (Figure 31).

Figure 31: J. O. Barnes House, Frame Structure.

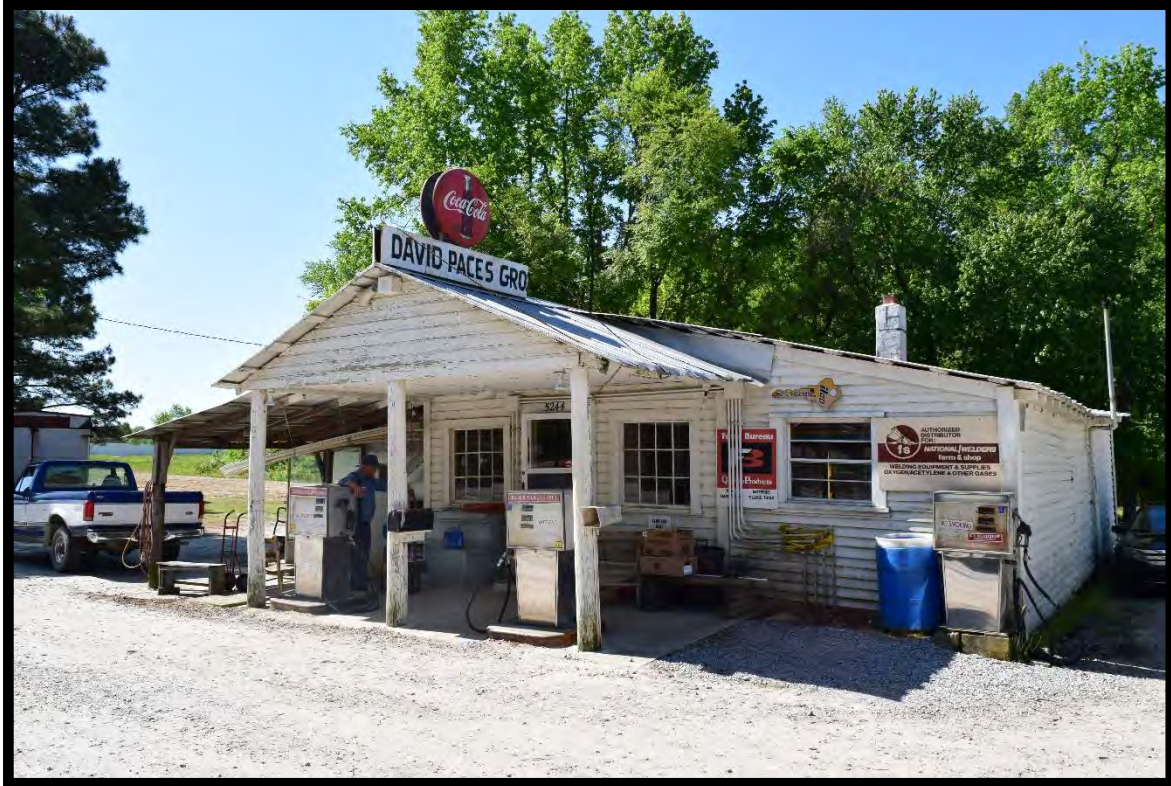
Figure 33: David Pace's Grocery Store, 5244 Covered Bridge Road, Clayton, NC.

Typical of the smaller stores in Johnston County is David Pace's Grocery Store, which is located less than two miles west of the J. O. Barnes Store on Covered Bridge Road (Figure 33). The one-story, weatherboard building was constructed in 1948, roughly 20 years after the J. O. Barnes Store, and has a projecting front gable that shelters two gas pumps, as well as a central entry door flanked by multi-pane replacement windows. The building, which faces north, has been expanded on the west with an integral, shed-roofed wing, and on the east with a shed-roofed porch, and has exposed rafter tails indicative of the Craftsman style. Like the J. O. Barnes Store, David Pace's Stores is still in operation and sells basic grocery store items in addition to gasoline. The store, however, is much smaller than the J. O. Barnes Store and representative of the growing popularity of the automobile in the mid-twentieth century rather than the center of activity in a small crossroads community.
