**North Carolina Department of Natural and Cultural Resources**  
**State Historic Preservation Office**

SUBJECT: Historic Structures Survey Report, Widen SR 1700 (Covered Bridge Road),  
W-5704E, PA 17-12-0004, Johnston County, ER 18-1248

STATE OF NORTH CAROLINA  
DEPARTMENT OF TRANSPORTATION

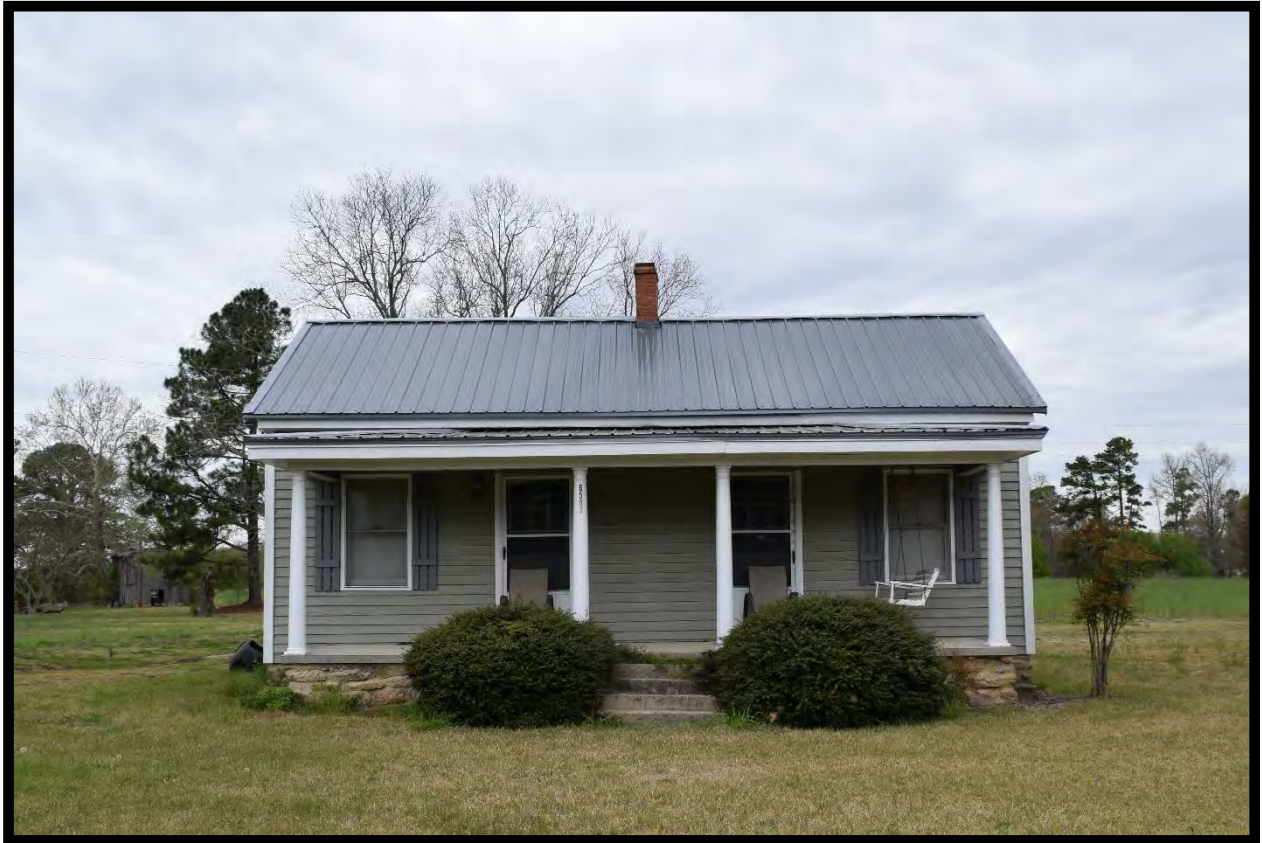
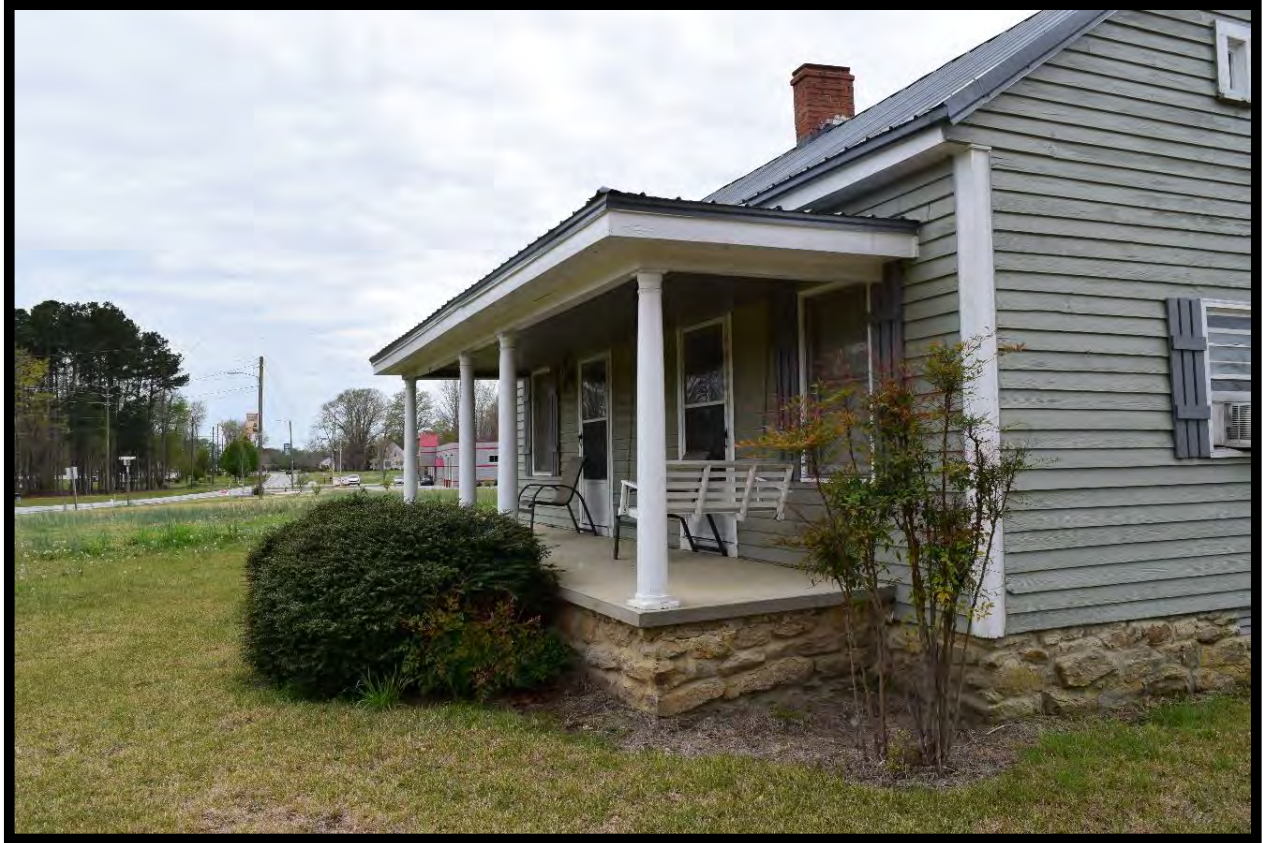
Figure 36: Wall House, Looking Northeast.

The Wall House is a one-story, side-gabled traditional/vernacular style cottage clad in plain, wooden weatherboard siding with a new metal roof and a field stone foundation. Its main block consists of two friendly rooms that are entered by separate front doors and have a shared central chimney. A shed-roofed section, possibly an enclosed porch, spans the rear elevation, and a gabled wing with a shed-roofed side porch extends from the center of the shed-roofed section. The wing, which originally served as a kitchen, was constructed as a separate structure and moved to meet the house, likely in the late nineteenth century.<sup>21</sup> A hip-roofed porch supported by thin Tuscan columns spans the south (front) elevation and shelters two entry doors with nine lights over panels that are flanked by one-over-one windows with wooden sashes. The porch itself is a concrete slab on a field stone foundation. The elevation is finished with simple cornerboards (Figures 36 and 38).

Figure 38: Wall House, Looking West.

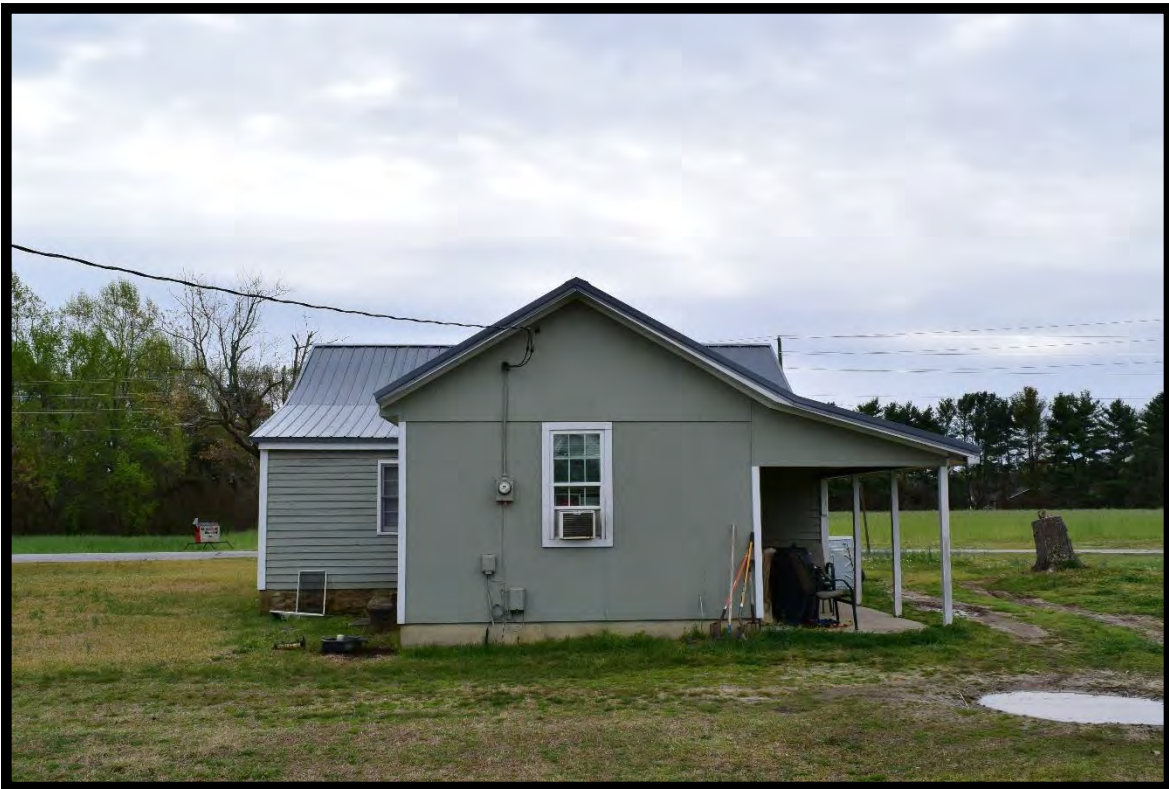
Figure 40: Wall House, Looking Southeast.

The north (rear) elevation appears as three parts—the east end of the shed-roofed section, the rear gable of the wing, and the side of a shed-roofed porch that spans the west elevation of the wing. The east end of the shed-roofed section contains a single off-center, two-over-two, horizontal-pane, wooden sash window, while the rear elevation of the wing, which is clad with a material made to look like vertical panels, has a single six-over-six vinyl sash window. Non-decorative cornerboards exist on the wing and are painted white to resemble those on the main block (Figures 40).

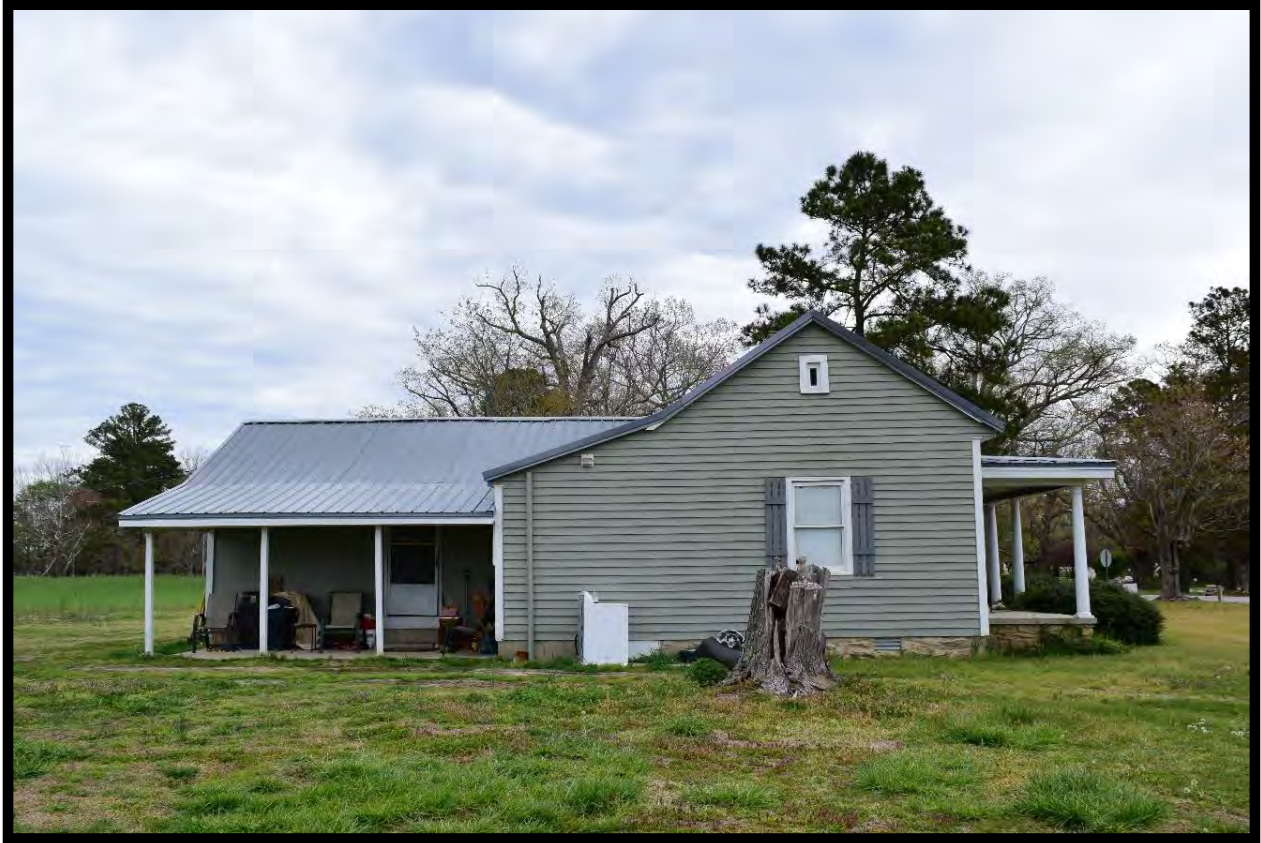
The west (side) elevation of the rear wing is spanned by a three-bay porch supported by plain square posts and shelters an off-center entry door. To the south, the dwelling has the same saltbox form, though mirrored, as the east elevation with a small attic vent and a single two-over-two, horizontal-pane, wooden sash window (Figures 41).

Figure 41: Wall House, Looking Northeast.

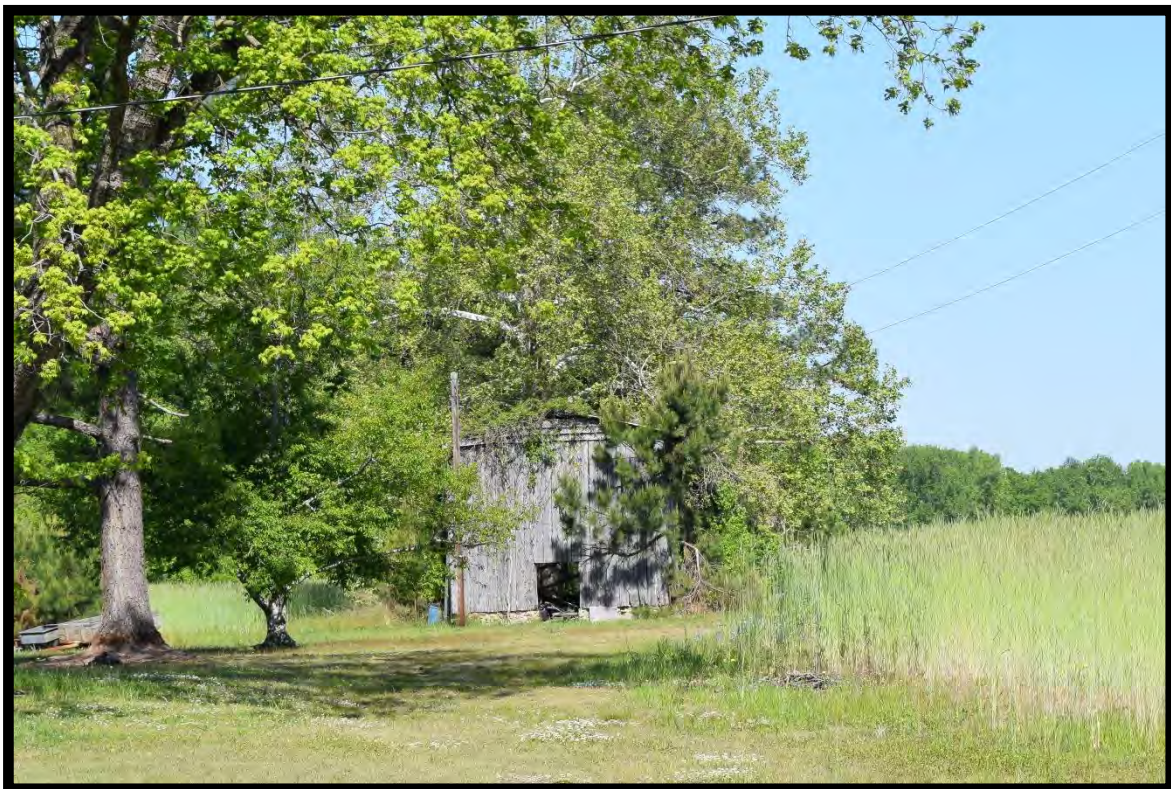
The frame barn has a gabled, metal roof, is clad in vertical boards, and rests on a stone foundation. It has entrances on its southeast (front) elevations (Figure 43).

Figure 43: Lyles-Harding House, Barn, Looking Northwest.

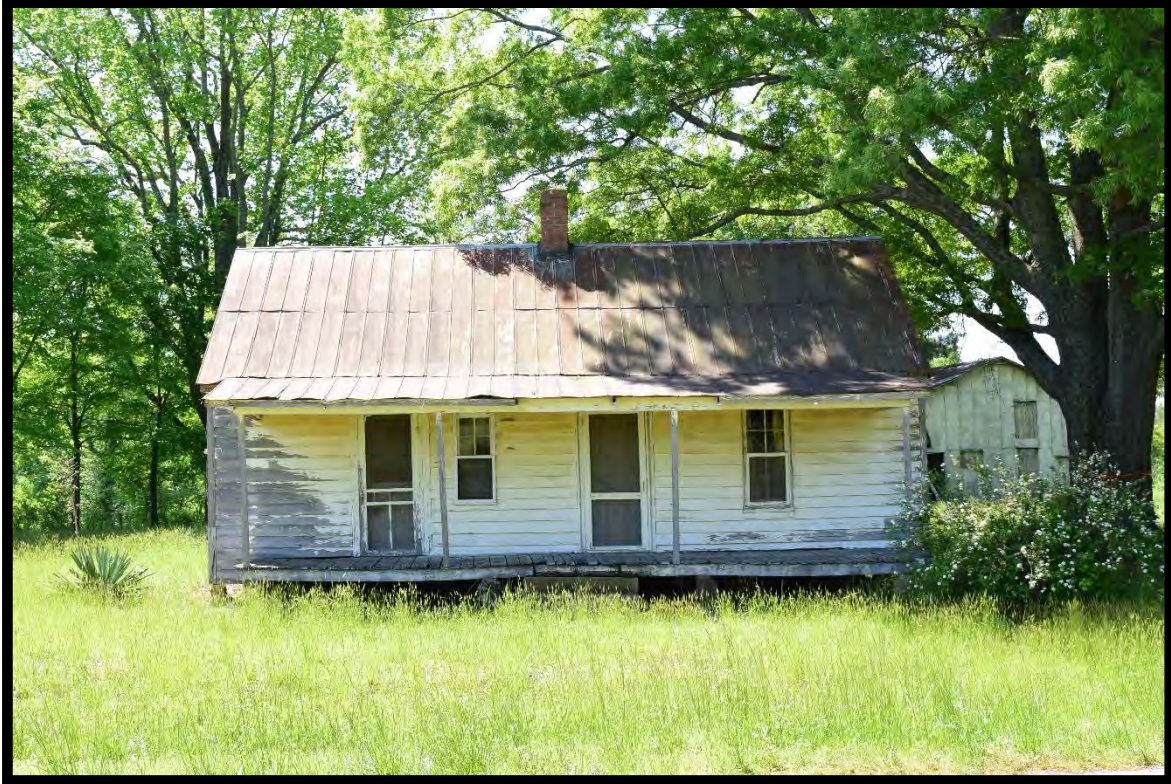
Figure 49: Farm Complex, 719 New Bethel Road (JT1702).

A similar resource that is better condition than those on Winston Road is located on New Bethel Road near Garner (JT1702). The dwelling, which also has a central chimney, displays an asymmetrical fenestration pattern—door, window, door, window—versus the Wall House’s symmetrical arrangement (Figure 49). Additionally, though the dwelling rests on a 36-acre farm complex with historic outbuildings, including several constructed of log, and retains much of its original materials, it was found to be ineligible for the NRHP due to its associated land no longer being farmed and the construction of a modern dwelling on the parcel.<sup>28</sup>

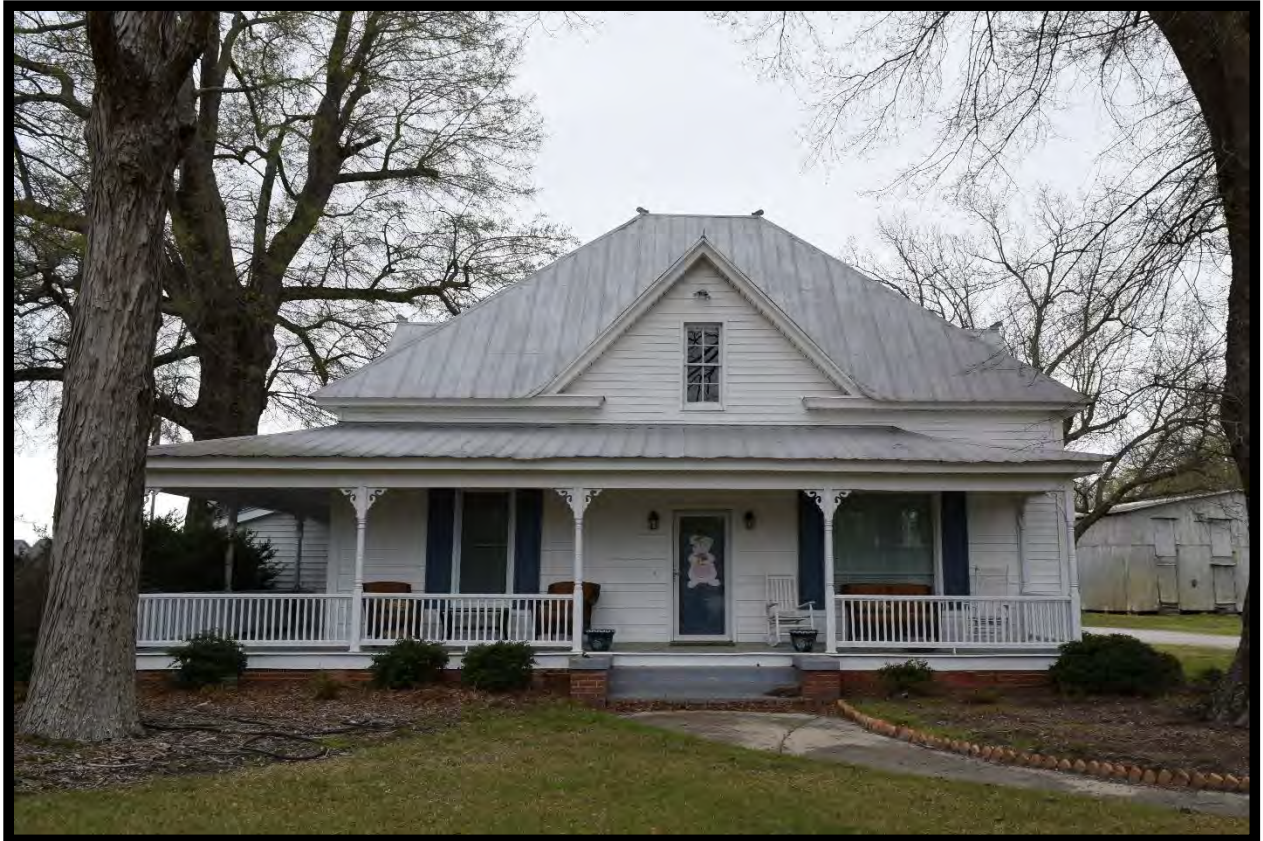
Figure 50: George Hinton House, Looking North.

The George Hinton House is a one-story Queen Anne-style dwelling with a steep, hipped roof with false gables on its front and side elevations. It is clad with vinyl siding, has a standing-seam metal roof, and rests on a brick foundation. A nearly full-width porch wraps the south (front) and west (side) elevations. It is supported by turned posts with decorative brackets and connected by a balustrade with square posts. The porch shelters a modern entry door flanked on the west by a six-over-six vinyl sash window and on the east by a multi-pane picture window that is also vinyl. A four-over-four wooden sash window lights the false gable and was once surrounded by decorative wooden shingles. Three chimneys once rose from the roof—one from each of the side slopes (east and west) and one from the center of the gabled wing (Figure 50).

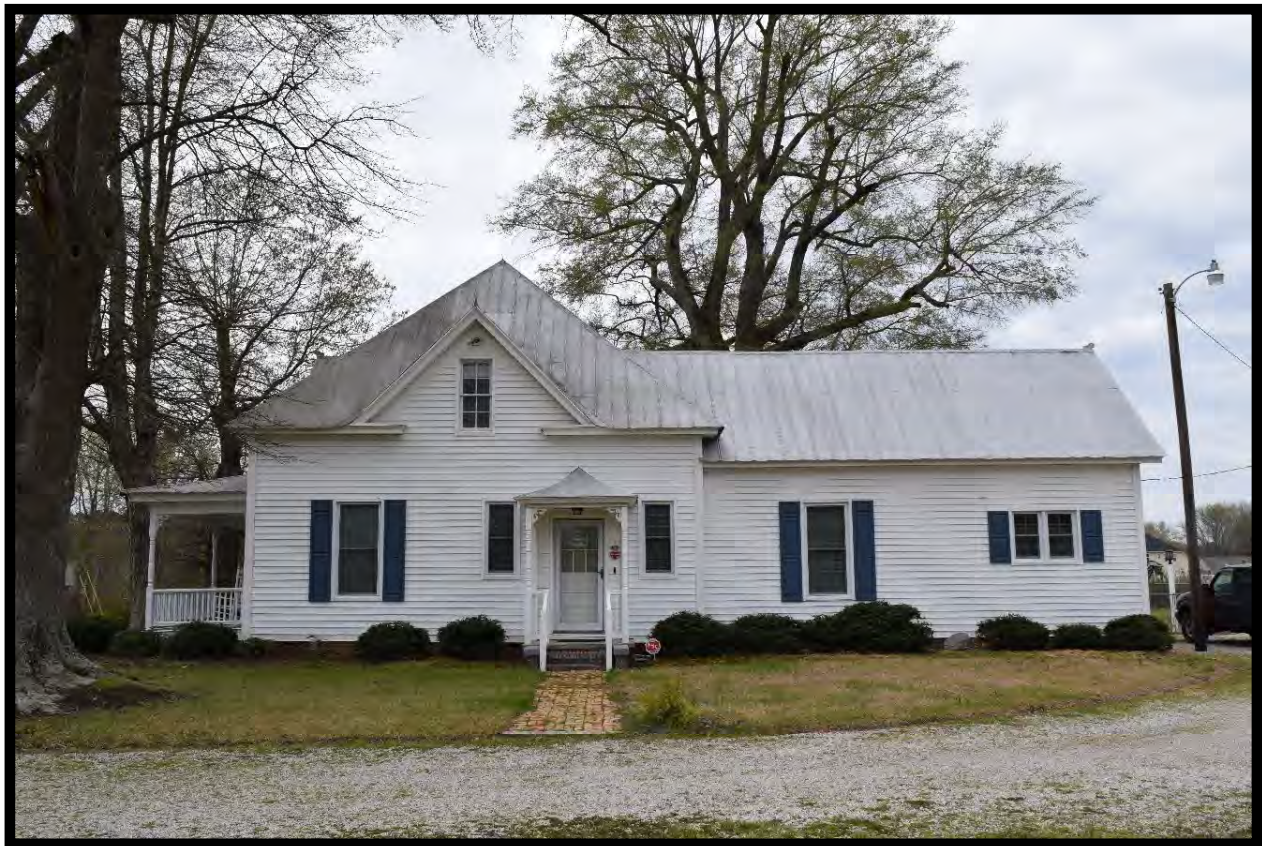
Figure 52: George Hinton House, Looking West.

small porch with posts, brackets, and balustrade similar to the front porch. The porch is flanked by small six-over-six vinyl sash windows. The side elevation of a rear gabled wing extends north of the main block of the dwelling. It contains a six-over-six vinyl sash window and paired four-over-four vinyl sash windows (Figure 52).

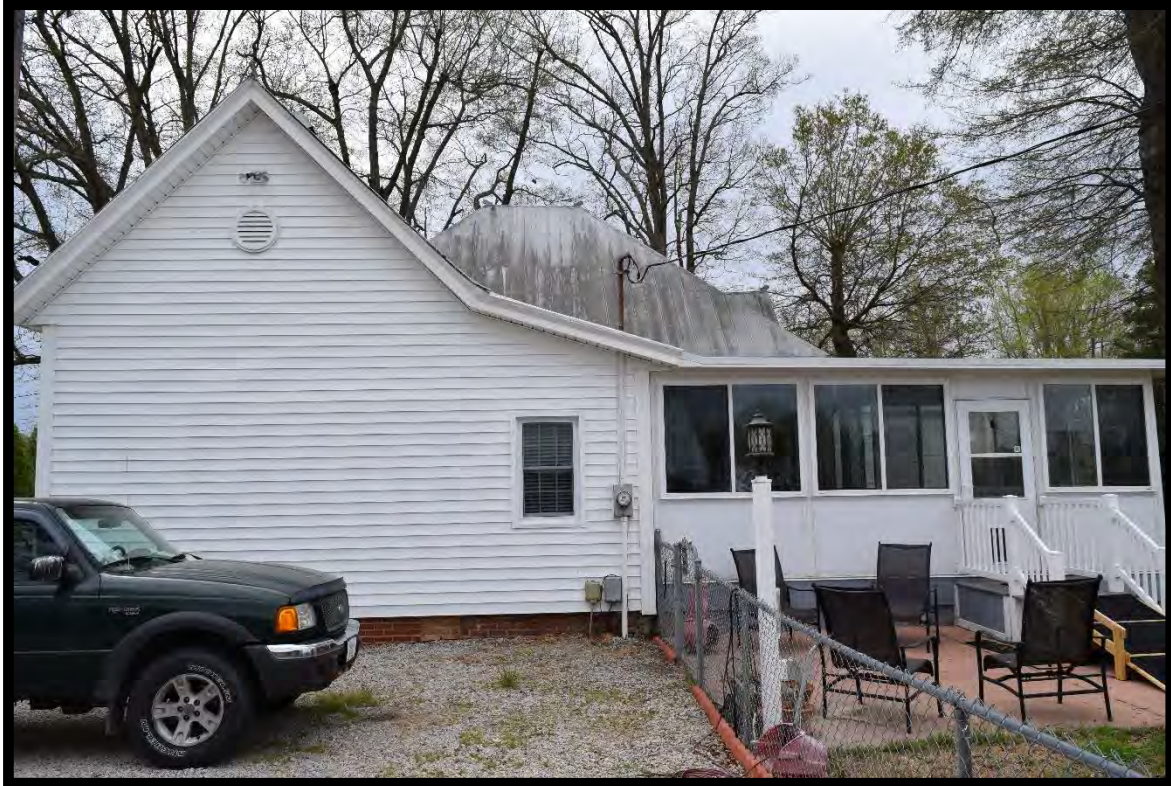
Figure 53: George Hinton House, Looking South.

The north (rear) elevation is dominated by the gabled wing, which has the shape of a saltbox, and a sun porch. The rear of the wing contains only a round attic vent and a six-over-six vinyl sash window below the shed-roofed section. The sun porch extends west and is lit by a ribbon of large windows that is broken by an entry door. The door is accessed by a ramp that covers a brief wooden staircase and has a simple balustrade (Figure 53).

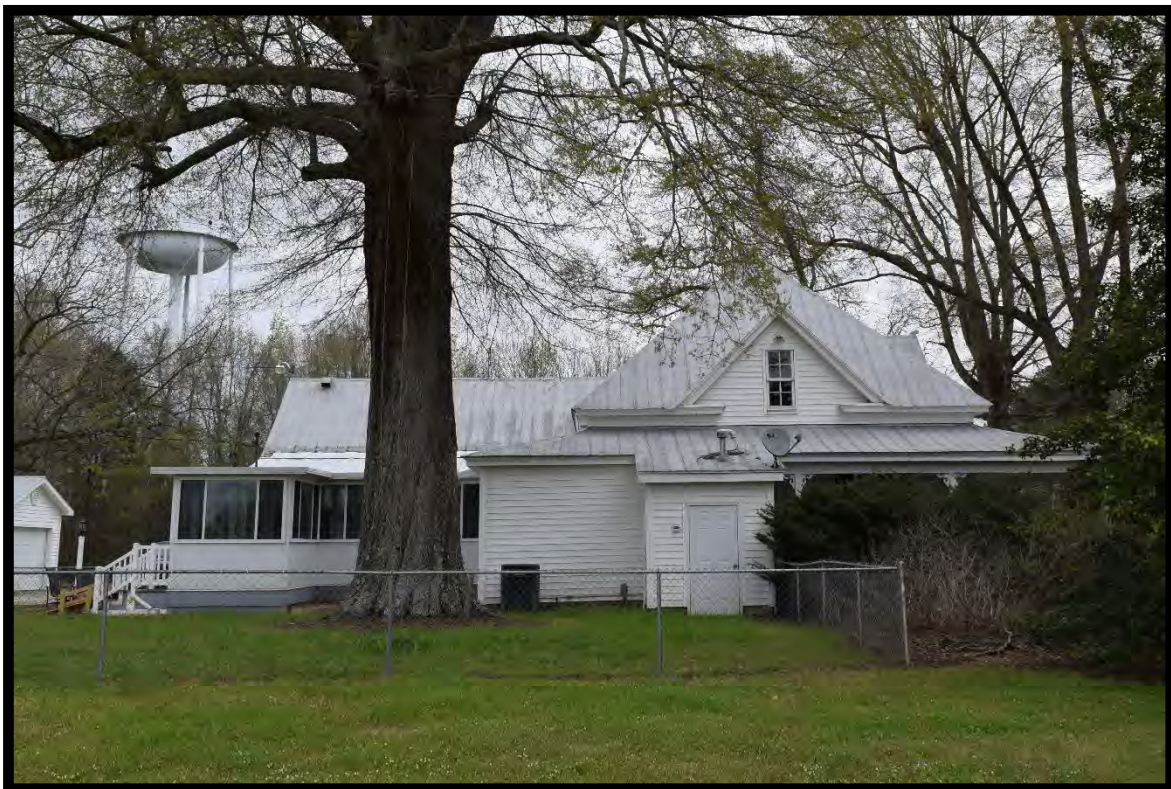
The west (side) elevation is more complex than the others. It begins on the north with the sunporch, which projects then recesses, and is lit by a continuous ribbon of large windows. The next section is composed of an enclosed portion of the wrap around porch, which wraps the northwest corner of the main block of the dwelling and has no windows, a small shed-roofed projection with a modern six-panel entry door, and the remaining, unaltered, portion of the wrap around porch. Above the porch is a third false gable and four-over-four wooden sash window (Figure 54).

Figure 54: George Hinton House, Looking East.

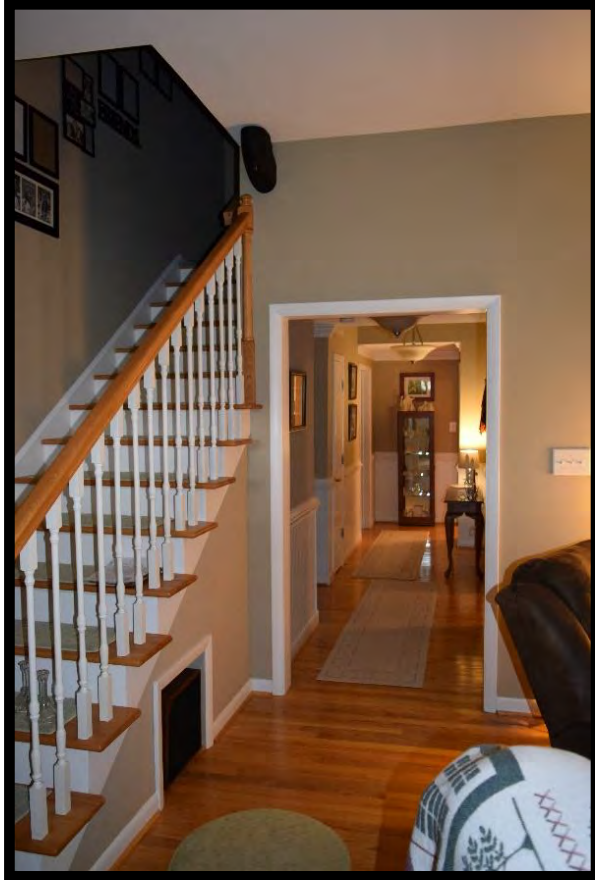
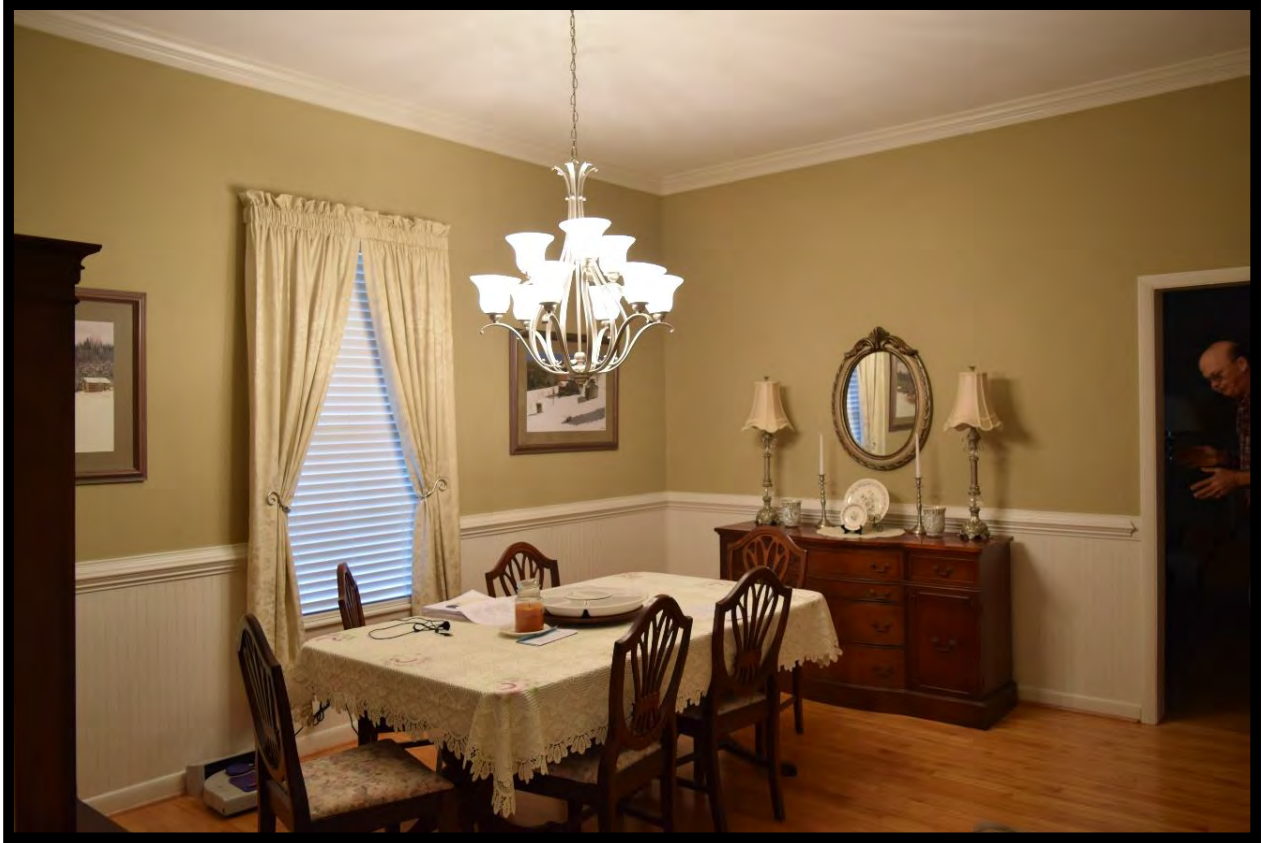
When originally constructed the George Hinton House had a double-pile, center-hall plan. This simple form, however, has been greatly altered to accommodate bedrooms, bathrooms, closets, and a kitchen. Specific alterations include reorienting the staircase to better access the attic, enclosing the rear of the wrap around porch to accommodate a master bathroom, closet, and laundry room, adding a rear wing for a kitchen, adding the sunporch, and truncating the fireplaces. Many of the dwelling's original doors and windows have also been replaced (Figures 55 through 57).

Figure 55: George Hinton House, Stair Hall.

Figure 56: George Hinton House, Location of Removed Chimney Stack.

Figure 57: George Hinton House, Dining Room.

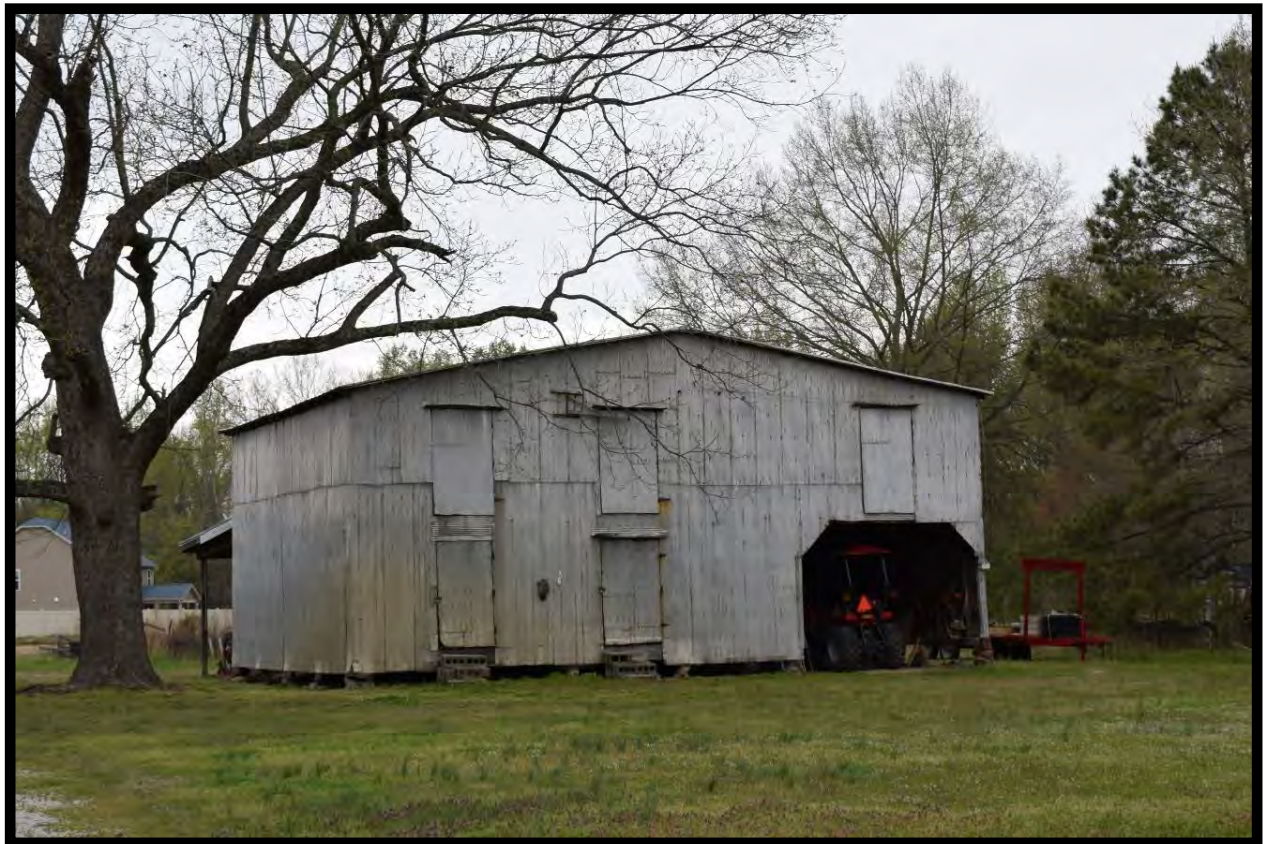
Figure 58: George Hinton House, Barn, Looking North.

A number of outbuildings exist behind the dwelling. The largest is a three-bay, gable-roofed barn clad with corrugated sheet metal and covered with a standing-seam metal roof. It has two entry doors, also clad with corrugated sheet metal, at the west and center of the south (front) elevation, and a large garage-like entrance with clipped-corners on the east side of the elevation. Loft doors are located above each of the first-story entrances and an open machine shed spans the north (rear) elevation (Figure 58).

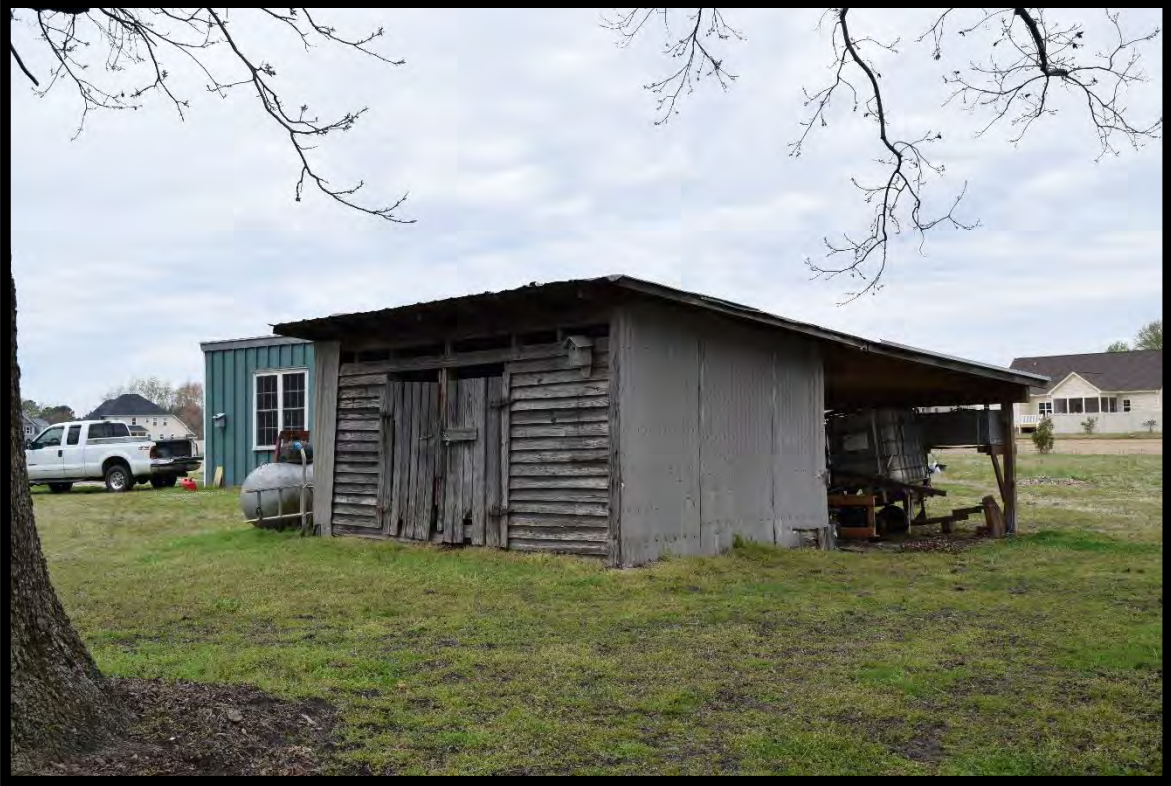
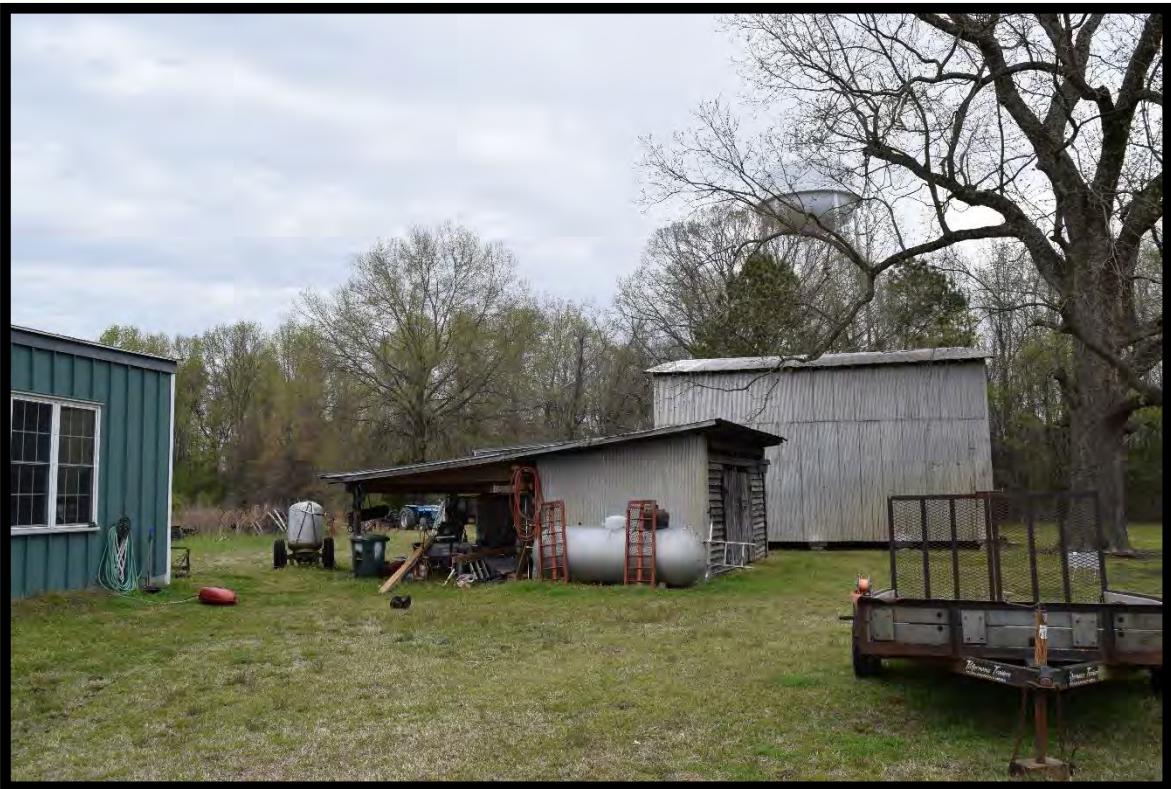
West of the barn is a small shed that was originally used as a mule stable. It has a standing-seam metal shed roof and double-leaf batten doors on its south (front) elevation. Its front elevation is clad with wooden weatherboard siding while its east and west (side) elevations are clad with corrugated metal. An open shed spans its north (rear) elevation (Figures 59 and 60).

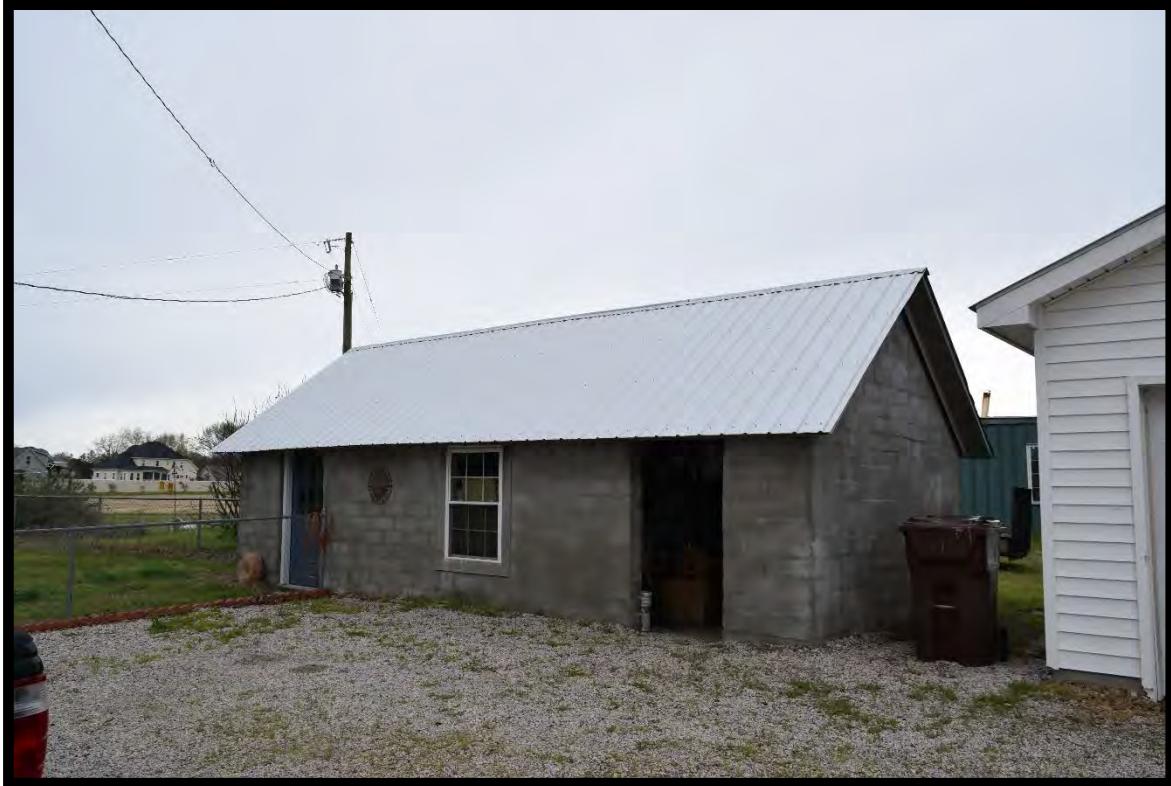
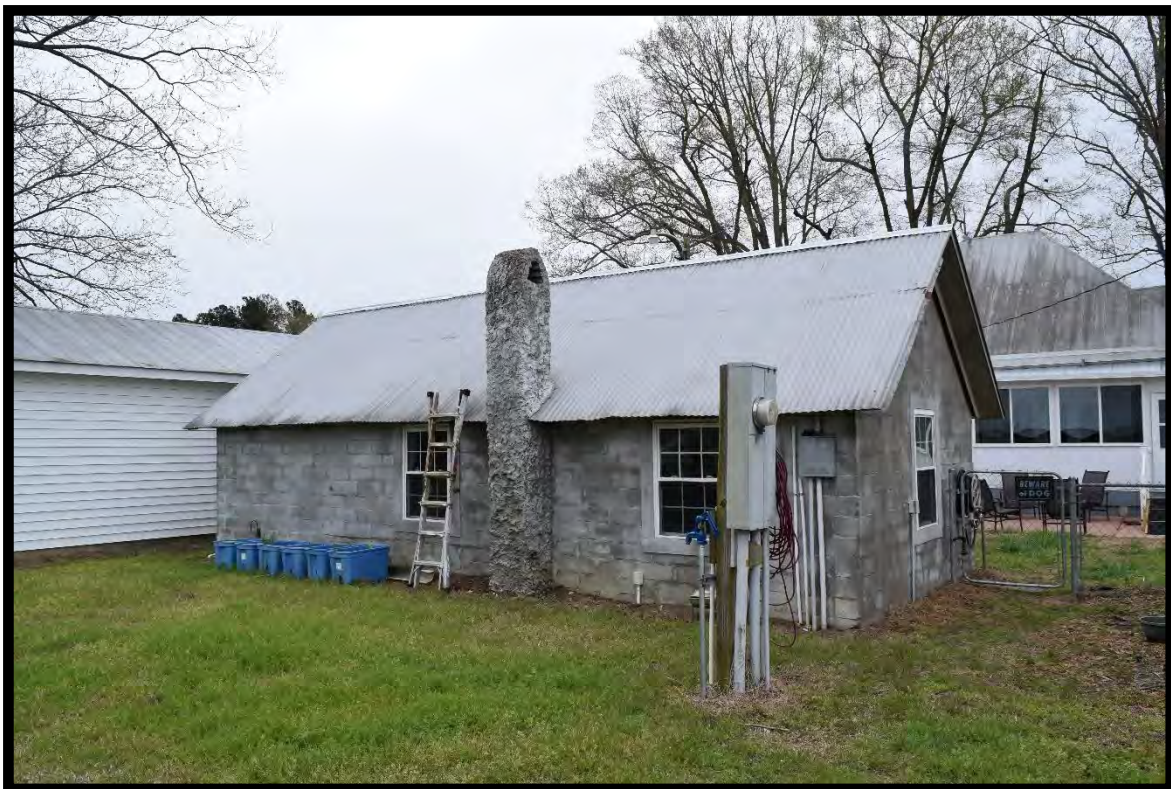
Directly behind the dwelling is a circa 1950 concrete block building that was used as a washhouse and smokehouse. It has a side-gabled, metal clad roof—standing-seam metal on the south side and corrugated on the north—and two entrances that flank a centered six-over-six vinyl sash window. Only one of the entrances, that on the west, has a door—six-panes over three horizontal panels. The north (rear) elevation of the dwelling is lit by two six-over-six vinyl sash windows that flank a chimney, and an additional six-over-six vinyl sash window lights the west (side) elevation (Figures 61 and 62).

Figure 61: George Hinton House, Washhouse/Smokehouse, Looking Northwest.

Figure 62: George Hinton House, Washhouse/Smokehouse, Looking Southeast.

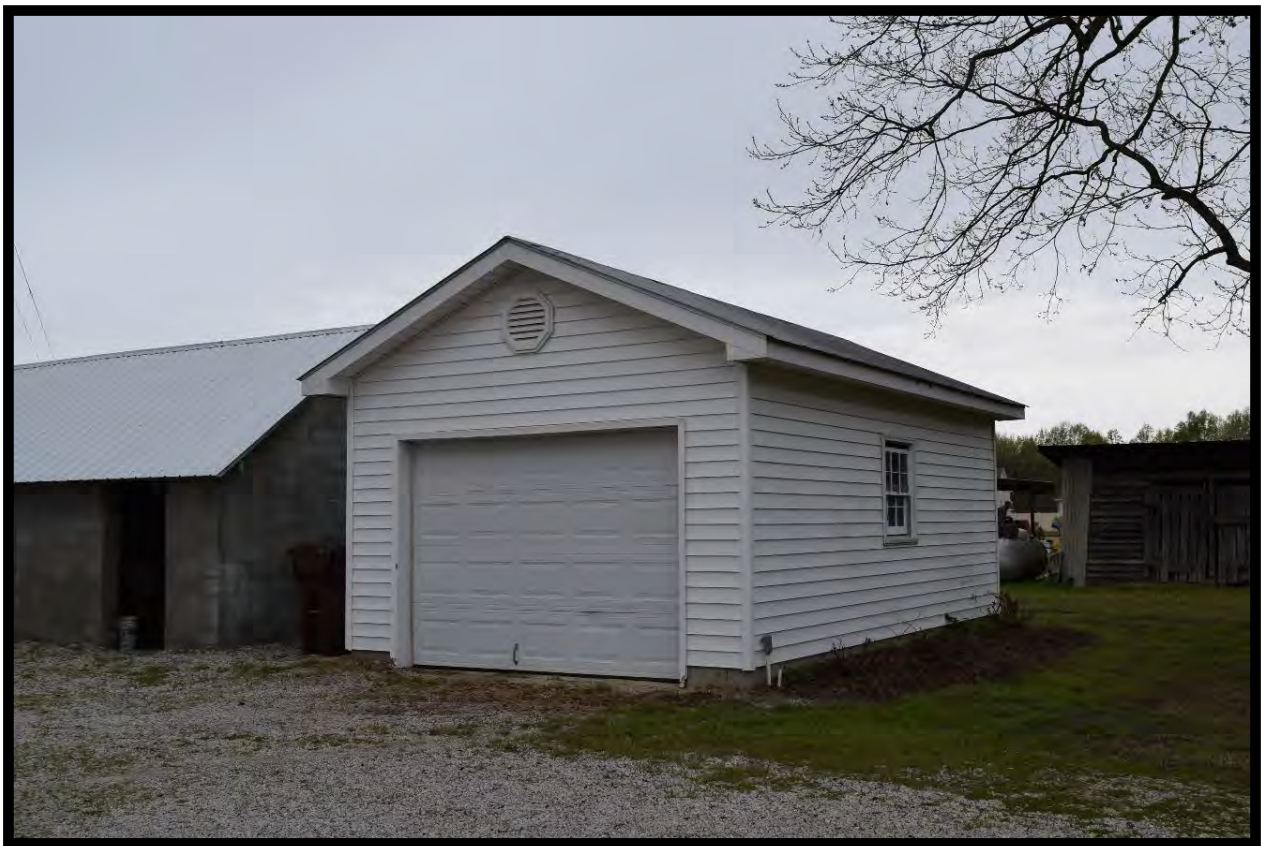
Also behind the dwelling is a front-gabled, vinyl-clad garage with a standing-seam metal roof and concrete block foundation. It has a modern garage door on the south (front) elevation and a six-over-six wooden sash window on the east (side) elevation (Figures 63).

Figure 63: George Hinton House, Garage, Looking Northwest.

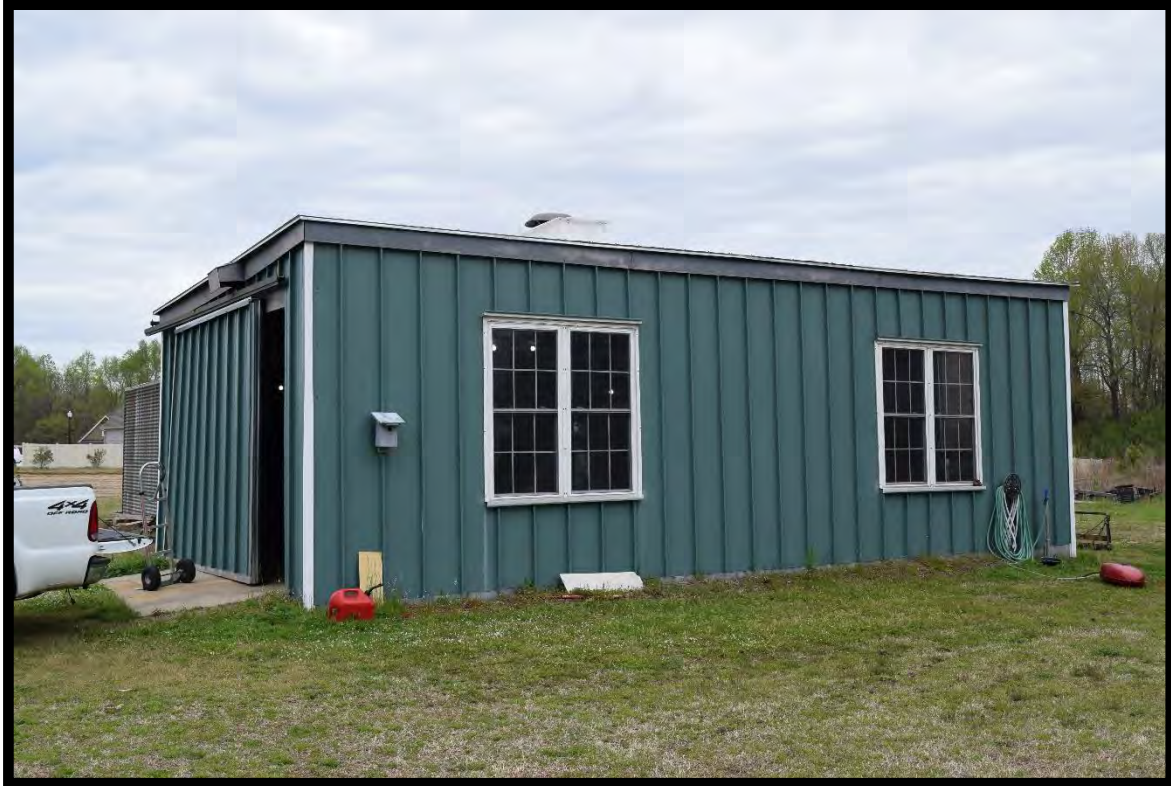
Figure 64: George Hinton House, Outbuilding, Looking North.

North of the garage is a flat-roofed outbuilding that is clad with vertical metal panels, has a sliding entry door on its south (front) elevation, and two paired six-over-six vinyl sash windows on its east (side) elevation (Figures 64).

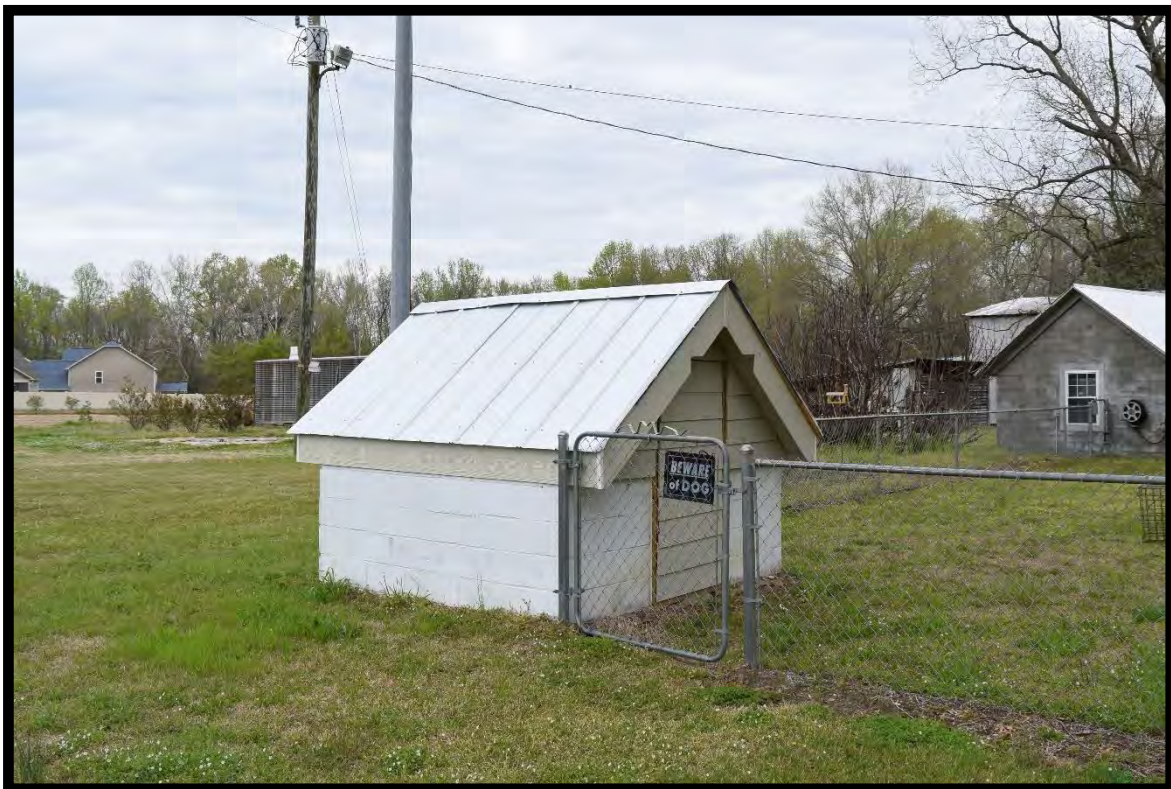
At the northwest corner of the fenced in area is a concrete block dog house. It has a gabled roof covered with standing-seam metal. The gables and door are covered with vinyl siding (Figures 65).

Figure 65: George Hinton House, Dog House, Looking North.

**Page 62 (Figure 65)** – the photo noted as a “Dog House” is actually a “well/pump house”.
