HISTORIC STRUCTURES SURVEY REPORT

**Proposed Replacement of Four Bridges Along the Blue Ridge Parkway in
Alleghany and Ashe Counties, North Carolina**

FHWA #BLRI 2A16-2D17

ER 18-2218

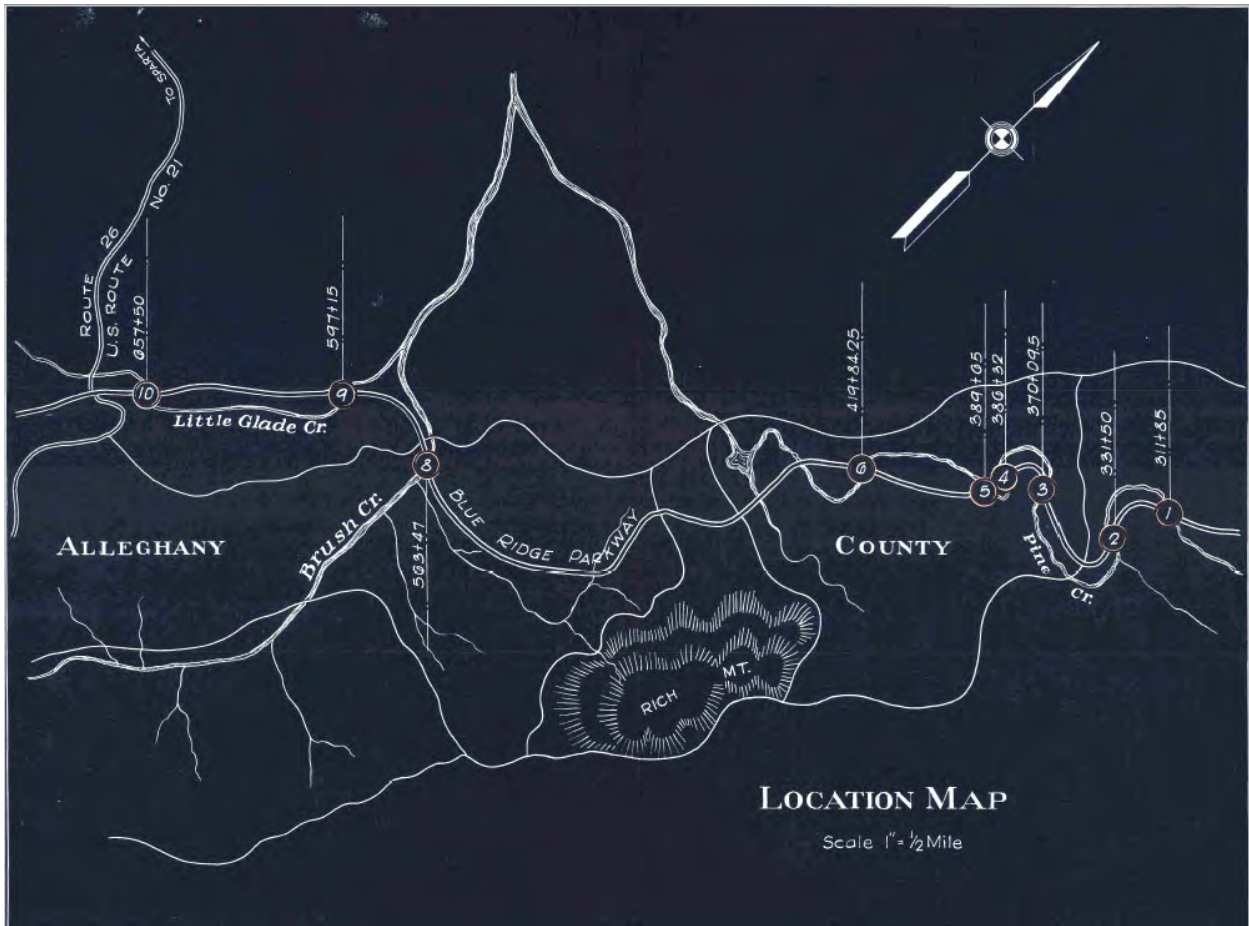
Figure 3. 1937 map showing the location of the Big Pine Creek Bridge #3 (Location 3), Big Pine Creek Bridge #6 (Location 6), and Brush Creek Bridge #1 (Location 8) (USDA BPR 1937).

Big Pine Creek Bridge #3 was constructed as part of Project 2-A-2, on Section 2-A of the Blue Ridge Parkway in Alleghany County, North Carolina (Figure 3). The project consisted of the construction of nine reinforced concrete and stone bridges with spans ranging from 25 to 74 feet, all of which were designed to “present a rustic appearance appropriate to the surrounding woodland country” (USDA BPR 1937:3).

Big Pine Creek Bridge #6 was constructed as part of Project 2-A-2, on Section 2-A of the Blue Ridge Parkway in Alleghany County, North Carolina (Figure 3). The project consisted of the construction of nine reinforced concrete and stone bridges with spans ranging from 25 to 74 feet, all of which were designed to “present a rustic appearance appropriate to the surrounding woodland country” (USDA BPR 1937:3).

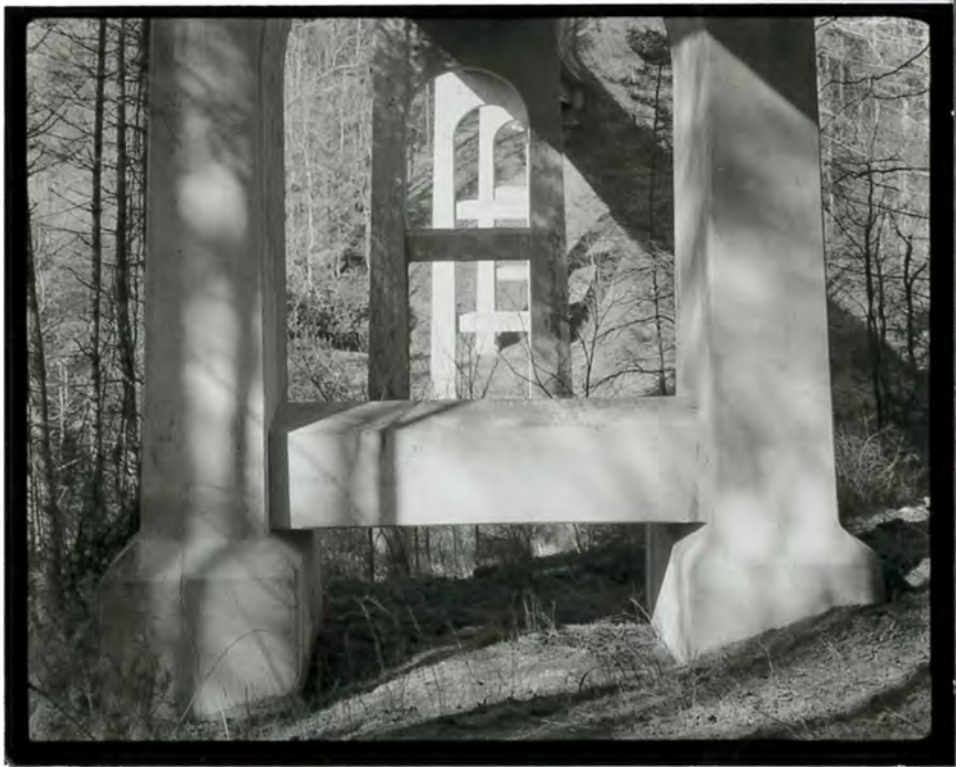
Photograph 1. Detail view of the bases of the piers of the Laurel Fork Viaduct, looking west (NC-42-B-1).

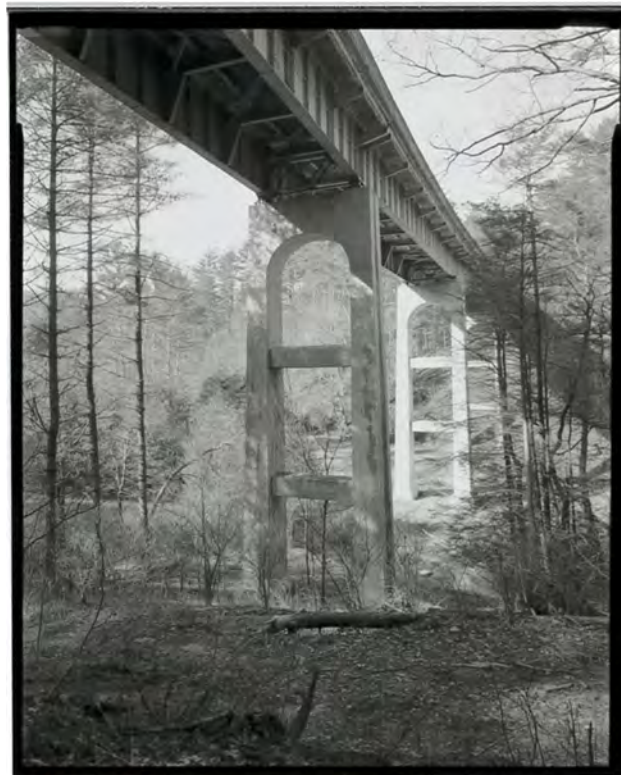
Photograph 2. Detail view of the piers of the Laurel Fork Viaduct, showing the girders and floor structure, looking southwest (NC-42-B-2).

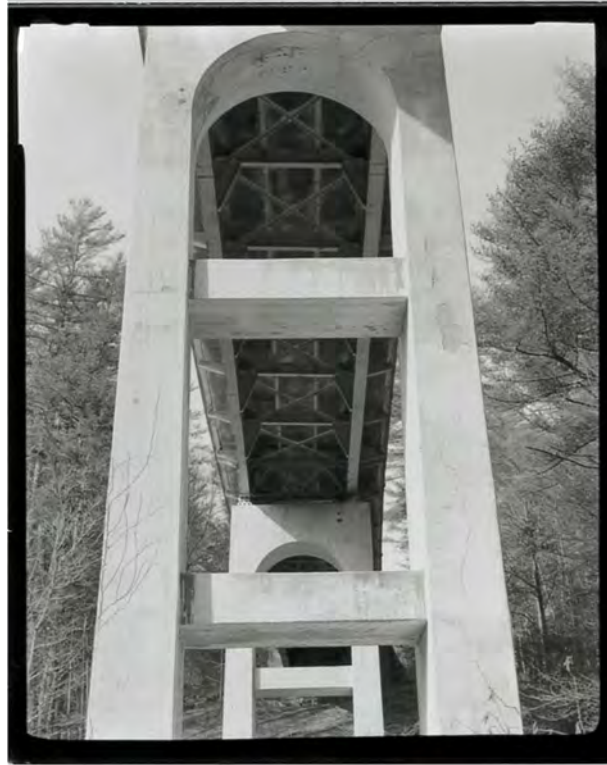
Photograph 3. View of the underside of the Laurel Fork Viaduct, showing the piers and girders, looking west-northwest (NC-42-B-3).

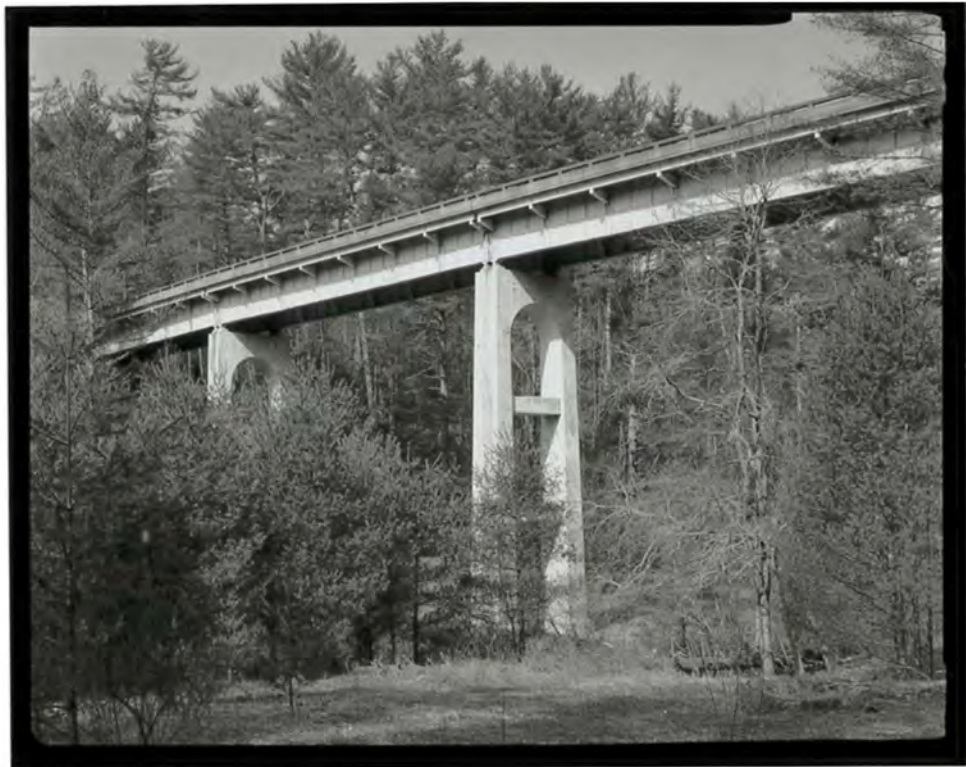
Photograph 4. South elevation of the Laurel Fork Viaduct, looking northwest (NC-42-B-4).

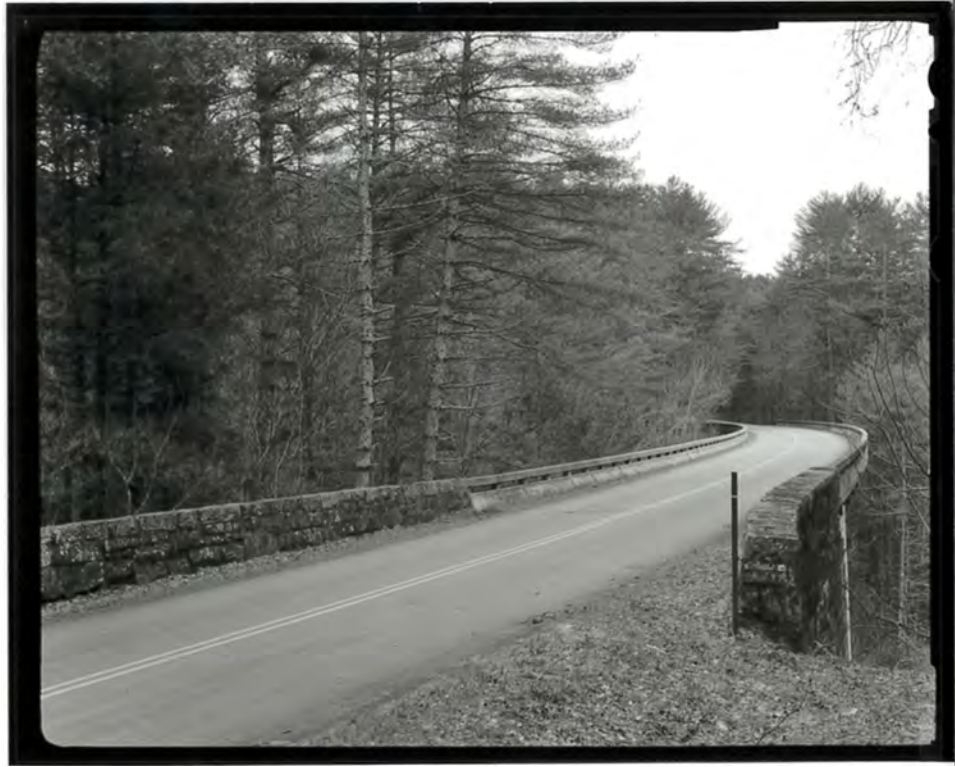
Photograph 5. View of the deck of the Laurel Fork Viaduct, looking east (NC-42-B-7).

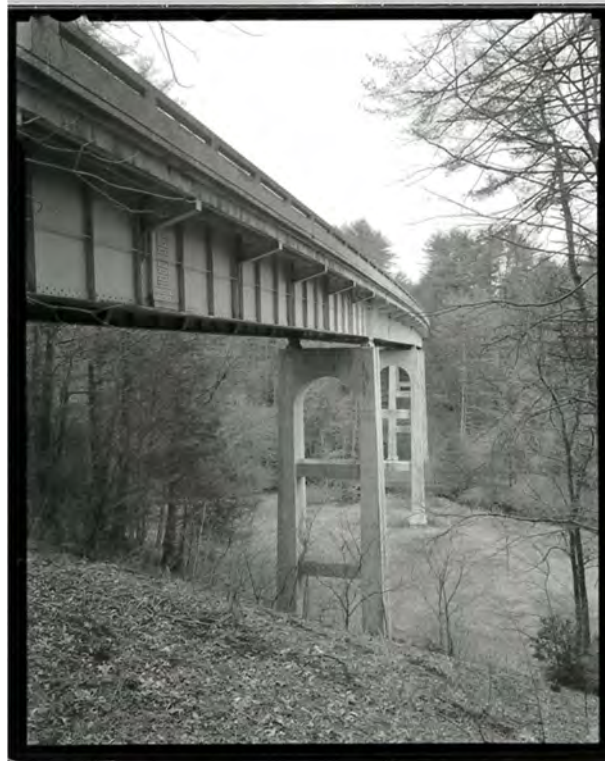
Photograph 6. Three-quarter view of the Laurel Fork Viaduct, showing the girders and piers, looking east (NC-42-B-8).

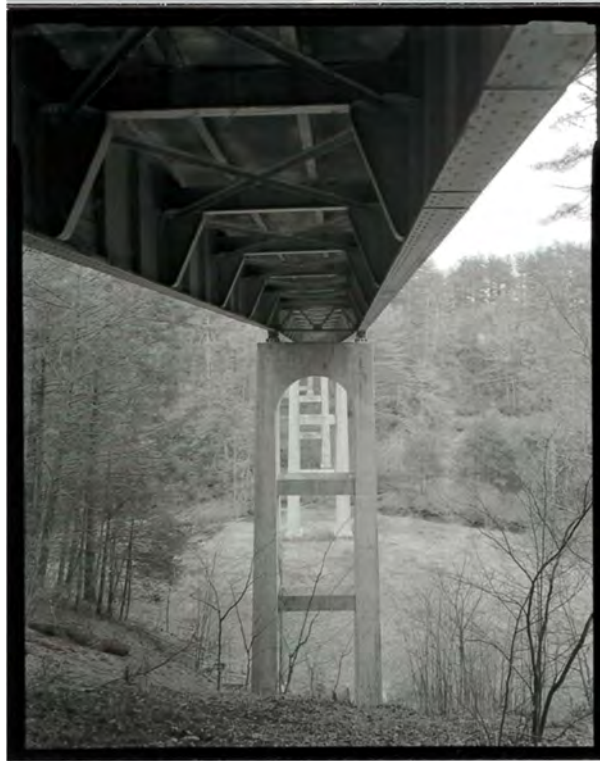
Photograph 7. Detail view of the girders of the Laurel Fork Viaduct, looking east-southeast (NC-42-B-9).

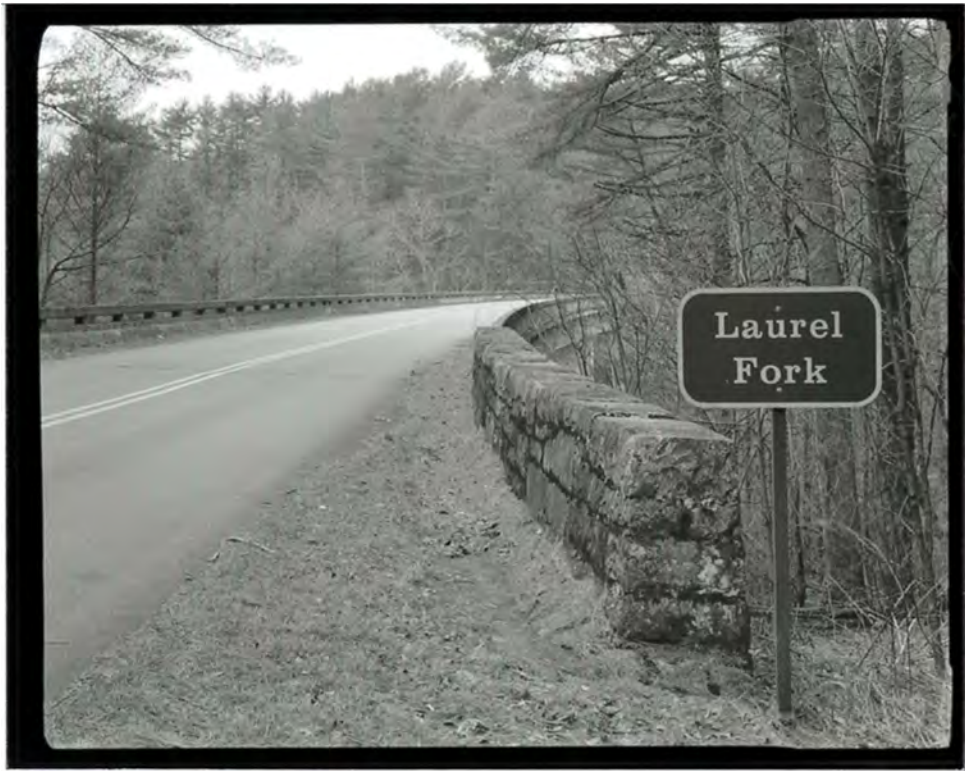
Photograph 8. View of the deck of the Laurel Fork Viaduct, looking west. The stone-faced parapet wall and concrete guardrail are visible (NC-42-B-11).

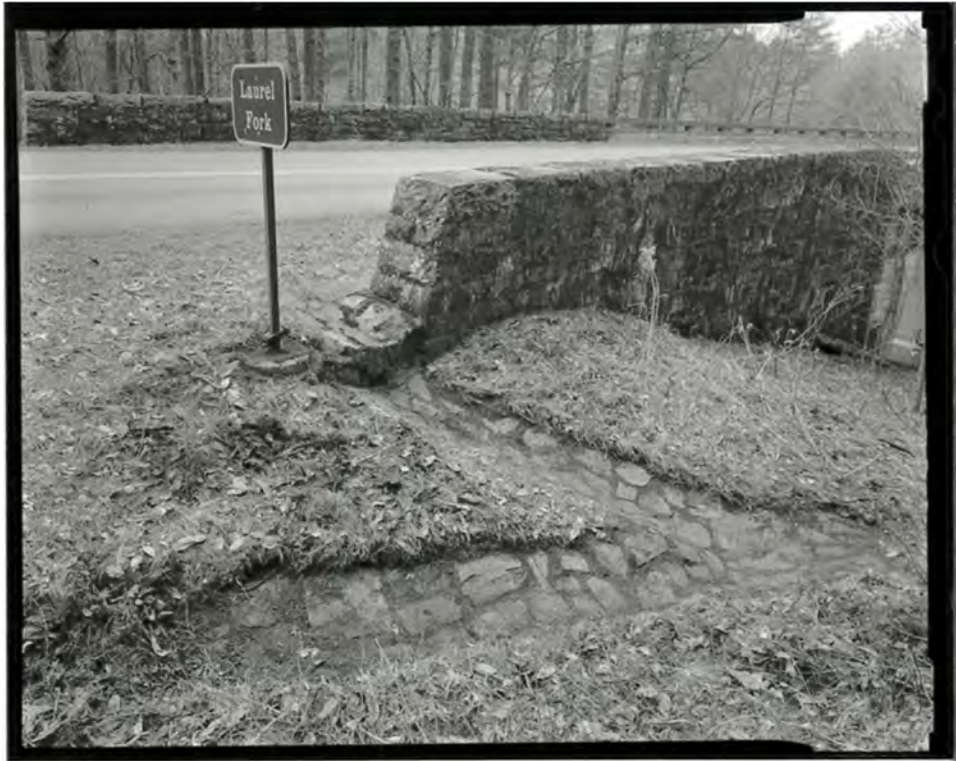
The abutments are constructed of cast-in-place reinforced concrete and are faced with rustic, quarry-faced stone veneer laid in a broken ashlar pattern, with the steel girders and concrete piers exposed, resulting in a modern, rather than rustic style overall. The finished surface of the concrete piers show the impressions of the 6-foot form boards. The deck is finished with a concrete guardrail consisting of a concrete curb with chamfered concrete posts and a concrete railing which extends out over the girders and are supported by steel brackets. The posts are spaced approximately every 10.7 feet on center. A stone-lined drainage channel runs from the northeast stone-faced parapet wall, draining water away (east and then north) from the bridge (Photograph 9).

Photograph 9. View of the stone-faced parapet wall and detail of a stone-lined drainage channel, looking southwest (NC-42-B-12)

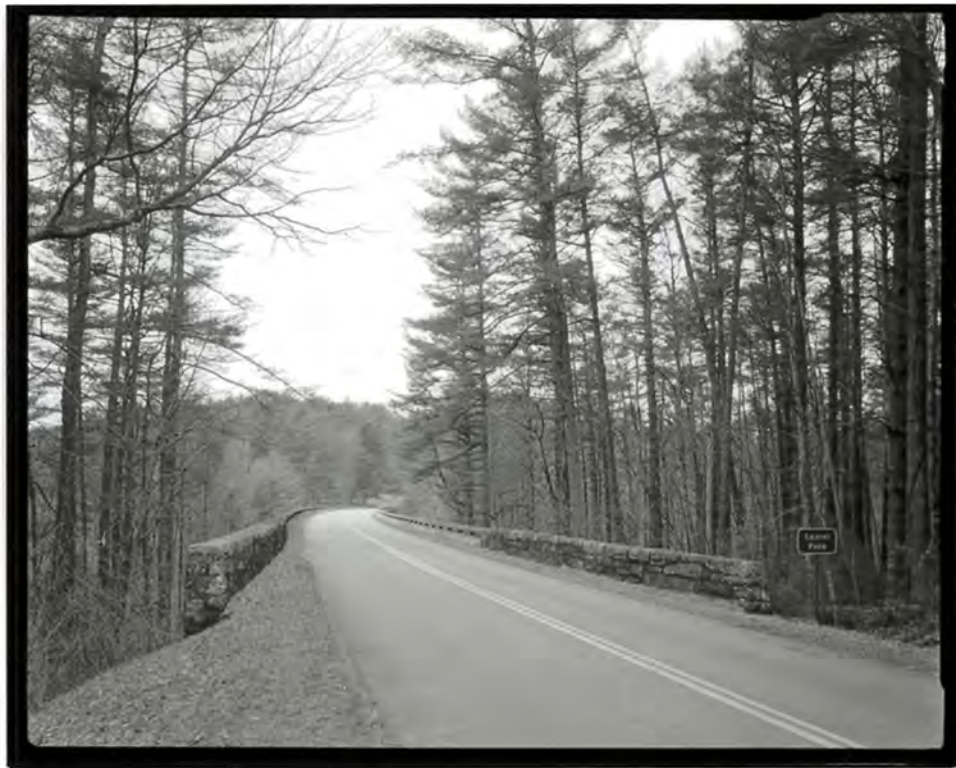
Photograph 10. View of the approach to the Laurel Fork Viaduct, showing the parapet, deck, and guardrails, looking west-northwest (NC-42-B-13).

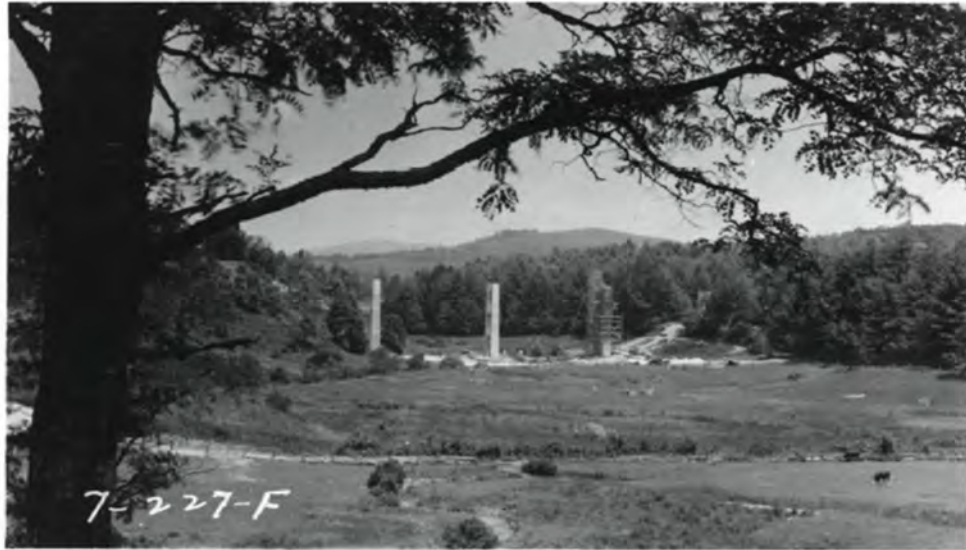
Figure 5. Photograph, ca. 1938, showing the construction of the piers for the Laurel Fork Viaduct (USDA BPR 1938).

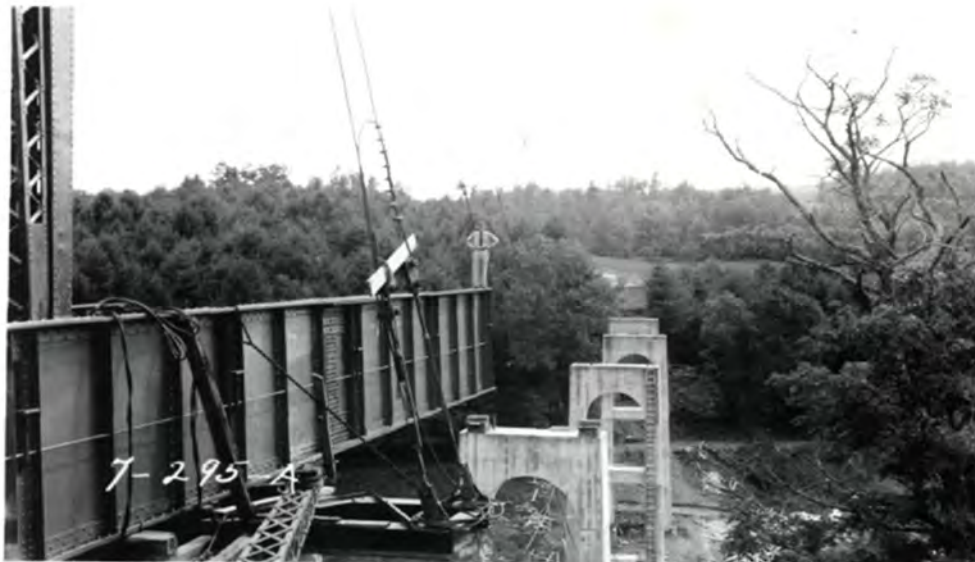
Figure 6. Photograph, ca. 1938, showing the erection of the girders for the Laurel Fork Viaduct (USDA BPR 1938).

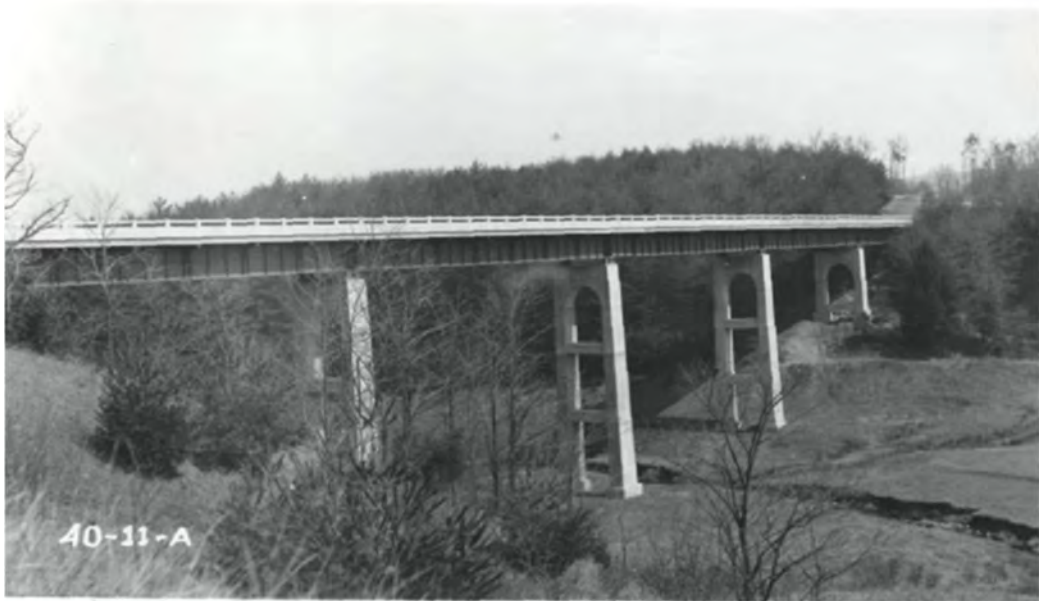
pre-cast while the curbs for the structure were being poured. The contractors erected the forms for the rail posts after the curbs were completed. The pre-cast rails were set into the forms, and the concrete for the posts was poured and allowed to cure for 28 days before the forms were disassembled. To provide damp proofing, the contractors applied tar to the back faces of the abutments and wing walls before backfilling using material excavated from road cut slopes from parkway construction. The bridge was completed by May 9, 1938 (USDA BPR 1938:9-9A; Figure 7).

Figure 7. Photograph, ca. 1938, showing the newly completed Laurel Fork Viaduct (USDA BPR 1938).

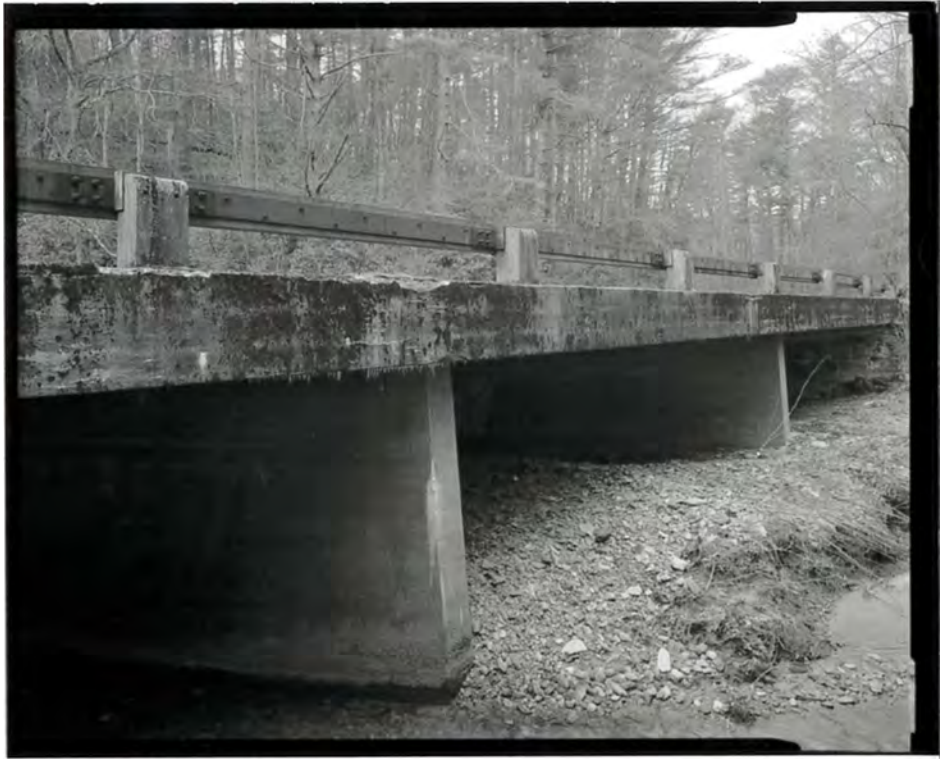
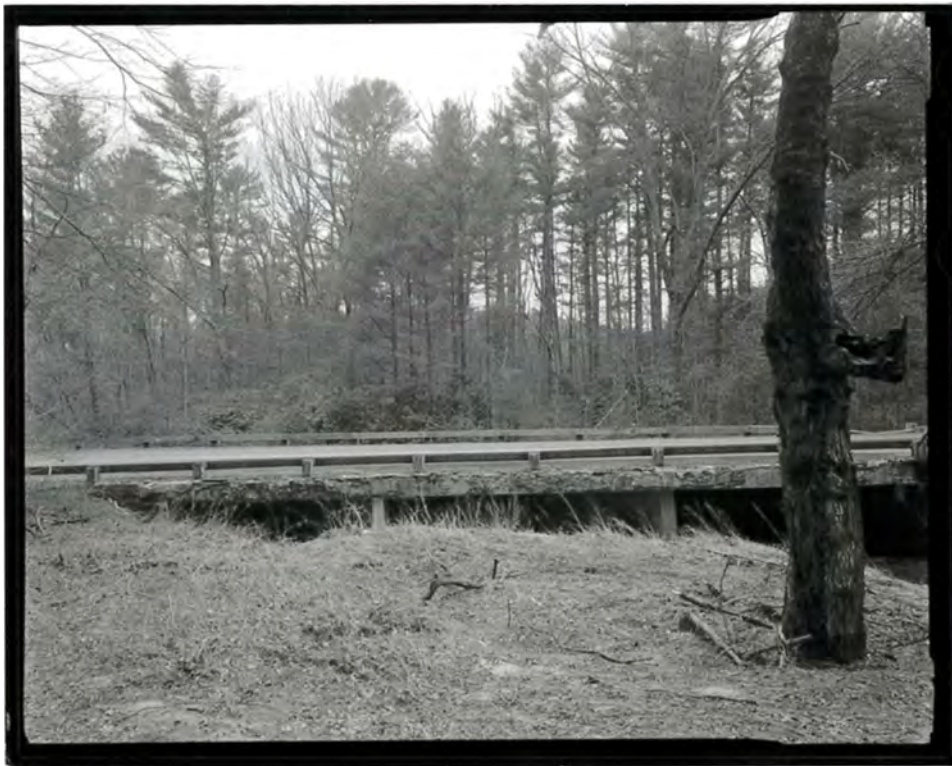
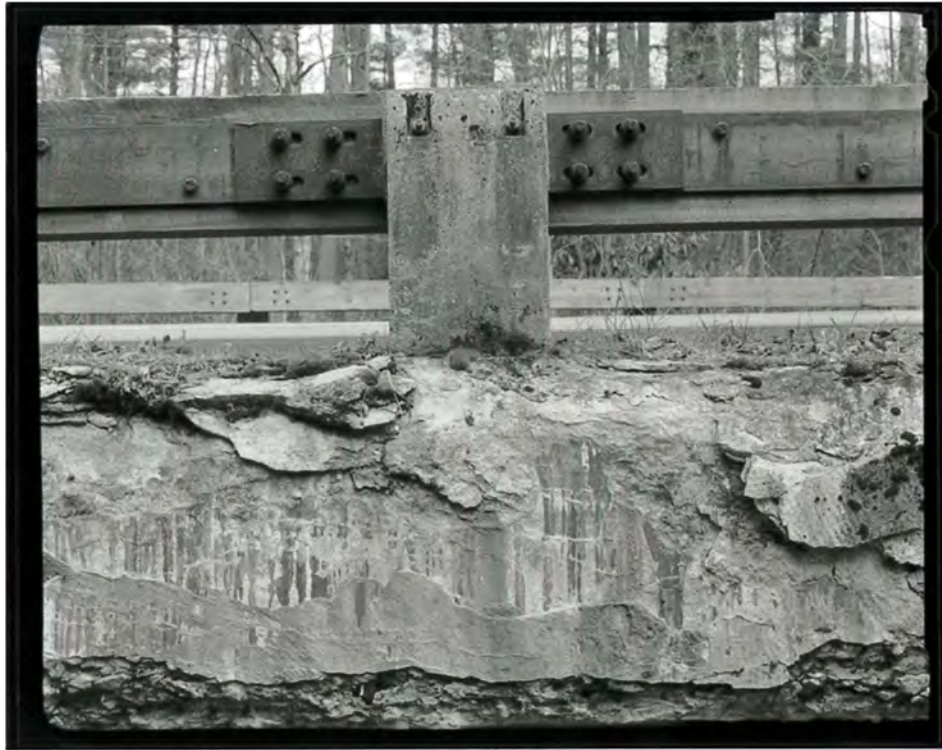
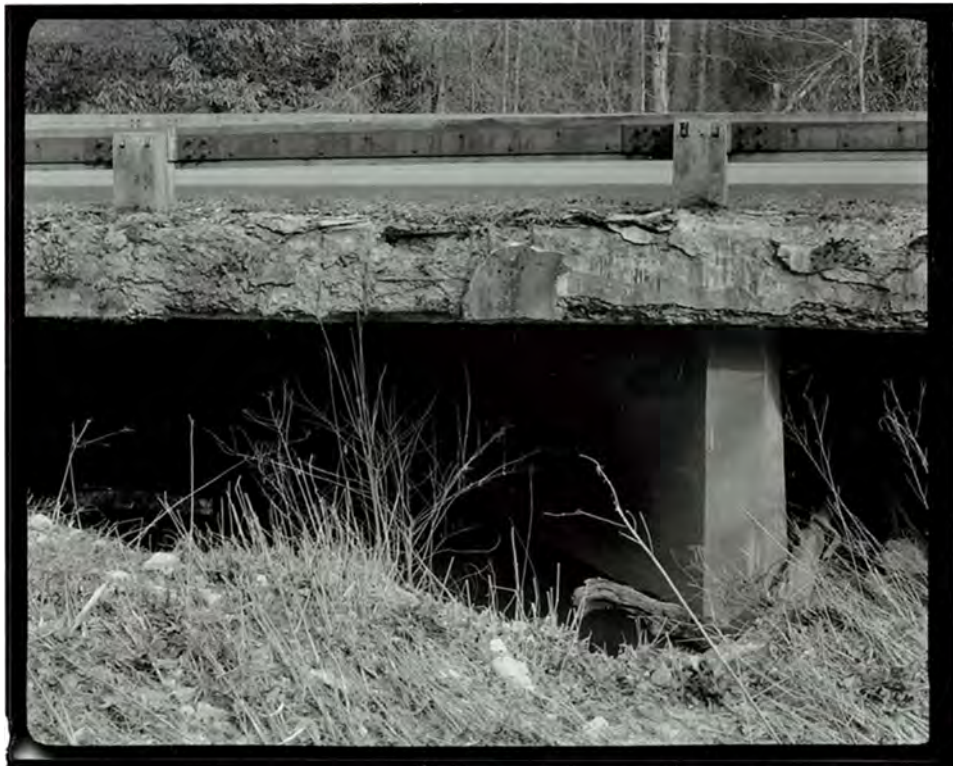
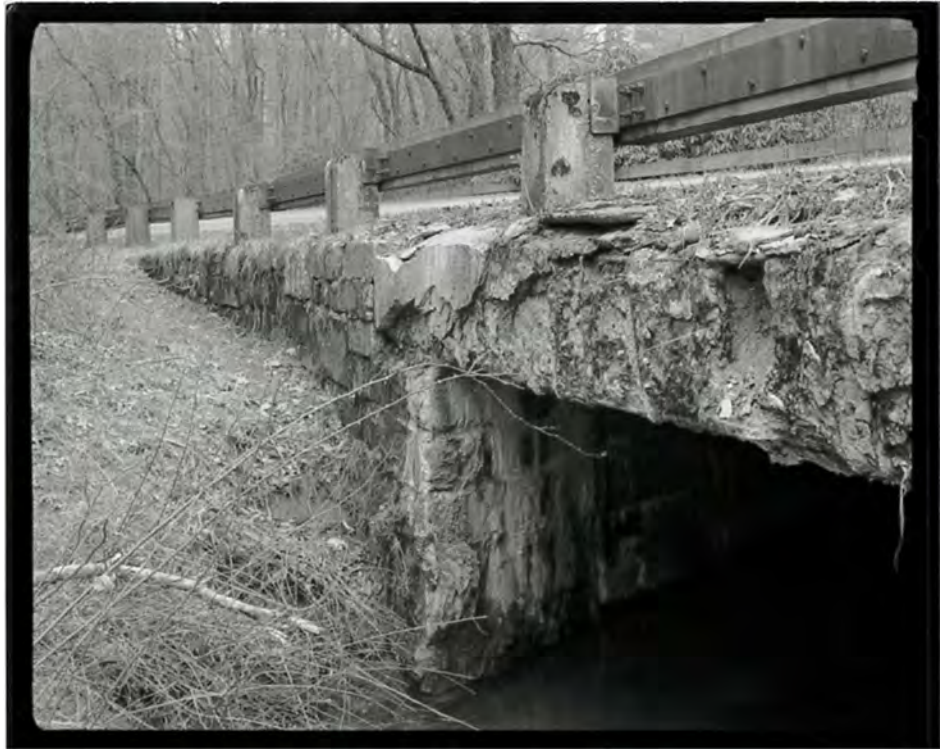
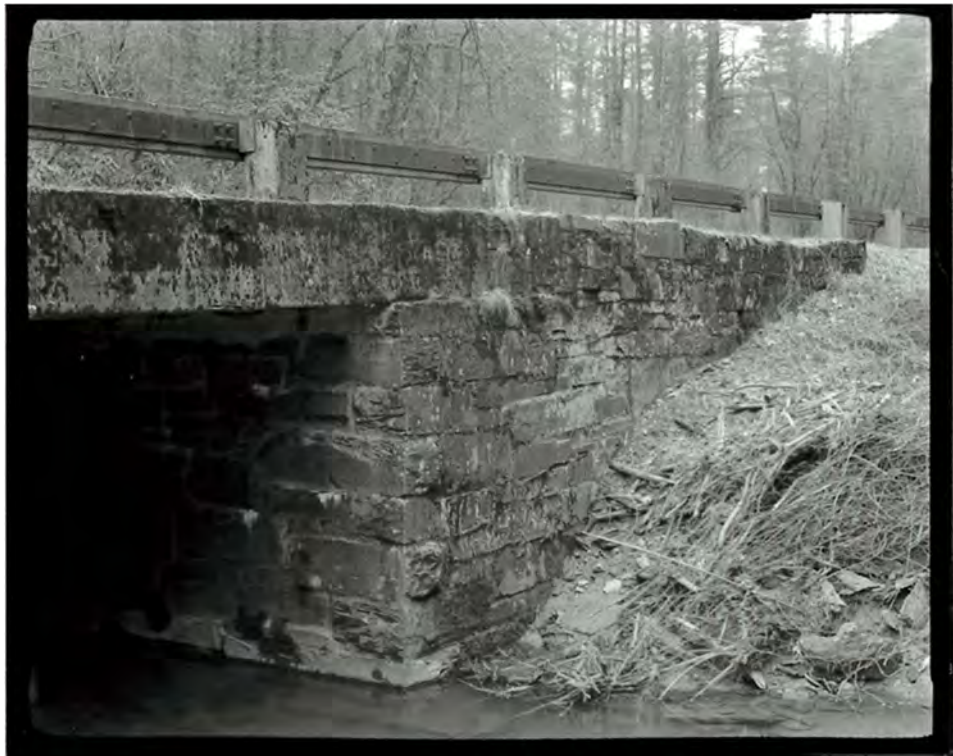
Big Pine Creek Bridge #3 is a three-span structure constructed on a 35°, 45 foot right forward skew. The bridge consists of a concrete slab deck supported by battered abutments and a skewed pair of narrow, board-formed, cast-in-place concrete piers. The abutments are constructed with a core of reinforced concrete clad in quarry-faced stone laid in an uncoursed, broken ashlar pattern. Unlike the majority of the bridges constructed in this section (2A), the concrete of the piers is exposed rather than clad in stone facing. The board-formed, cast-in-place concrete deck is set into a rabbet in each of the stone abutments, and the top of the concrete deck is flush with the top of the parapet walls. A guardrail extends from the roadway across the entire length of the bridge on both sides. The guardrail consists of heavy wooden planks bolted to steel plates anchored into poured concrete posts with a bullnose at the top edge on the stream-facing sides (Photographs 11-18).

Photograph 11. Three-quarter view of Big Pine Creek Bridge #3, looking west-southwest (NC-42-C-1).

Photograph 12. View of the Big Pine Creek Bridge #3, showing the south-facing elevation, looking north (NC-42-C-2).

Photograph 13. Detail view of Big Pine Creek Bridge #3, showing the deck and guardrail, looking north (NC-42-C-3).

Photograph 14. Detail view of Big Pine Creek Bridge #3, showing the pier and deck, looking west (NC-42-C-4).

Photograph 15. Detail view of Big Pine Creek Bridge #3, showing the south abutment, looking northwest (NC-42-C-5).

Photograph 16. Detail view of Big Pine Creek Bridge #3, showing the north abutment, looking east-northeast (NC-42-C-6).

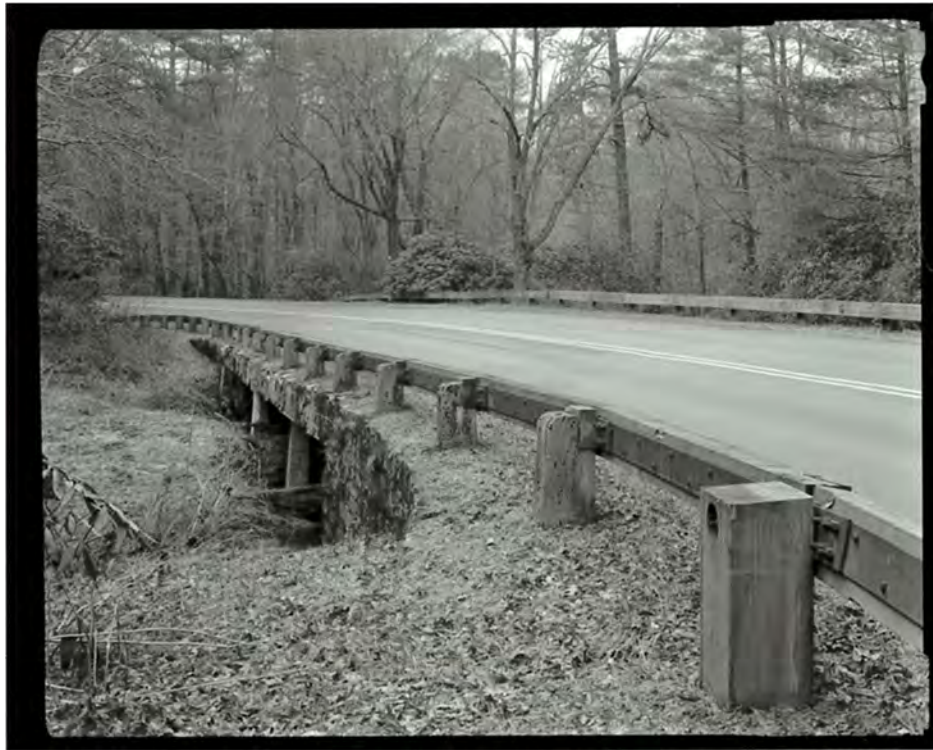
Photograph 17. View of the deck and guardrail of Big Pine Creek Bridge #3, looking west-northwest (NC-42-C-7).

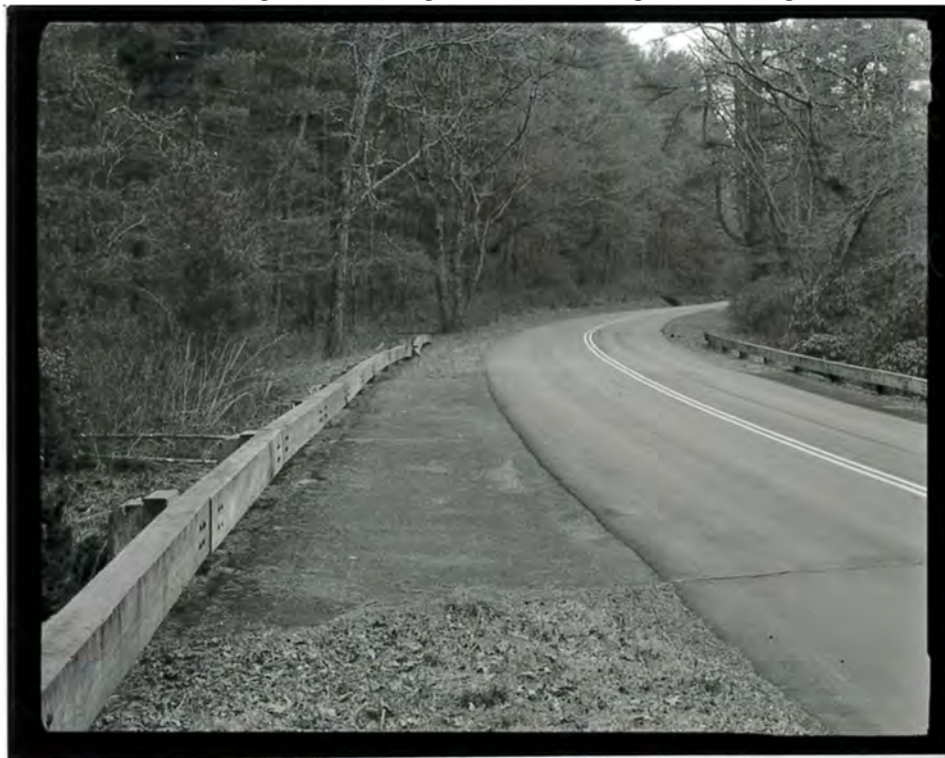
Photograph 18. View of Big Pine Creek Bridge #3, showing the bridge and asphalt shoulder, looking southeast (NC-42-C-8).

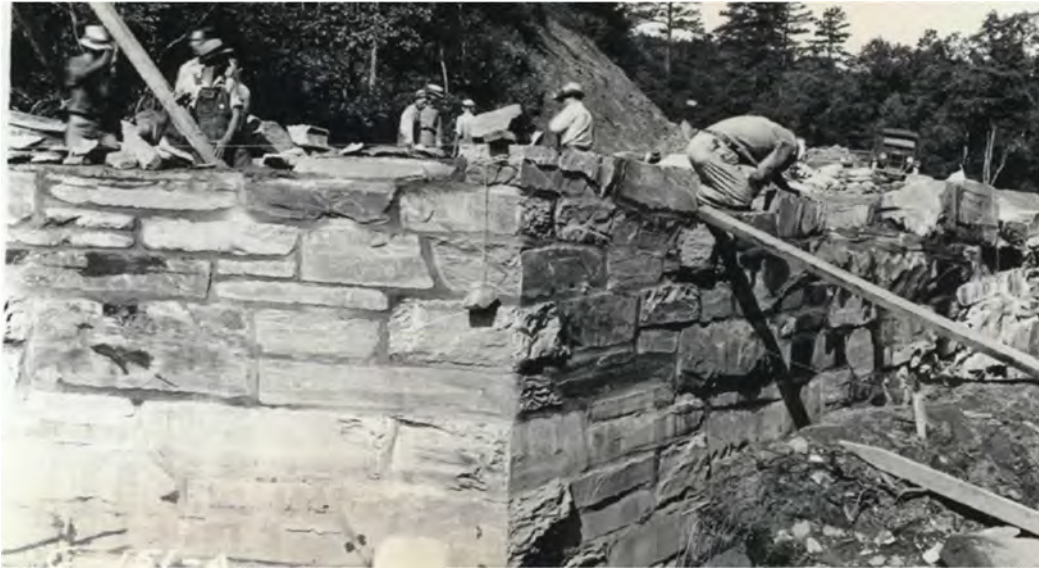
Figure 9. Photograph, ca. 1937, showing the construction of the abutment wings of Big Pine Creek Bridge #3 (USDA BPR 1937).

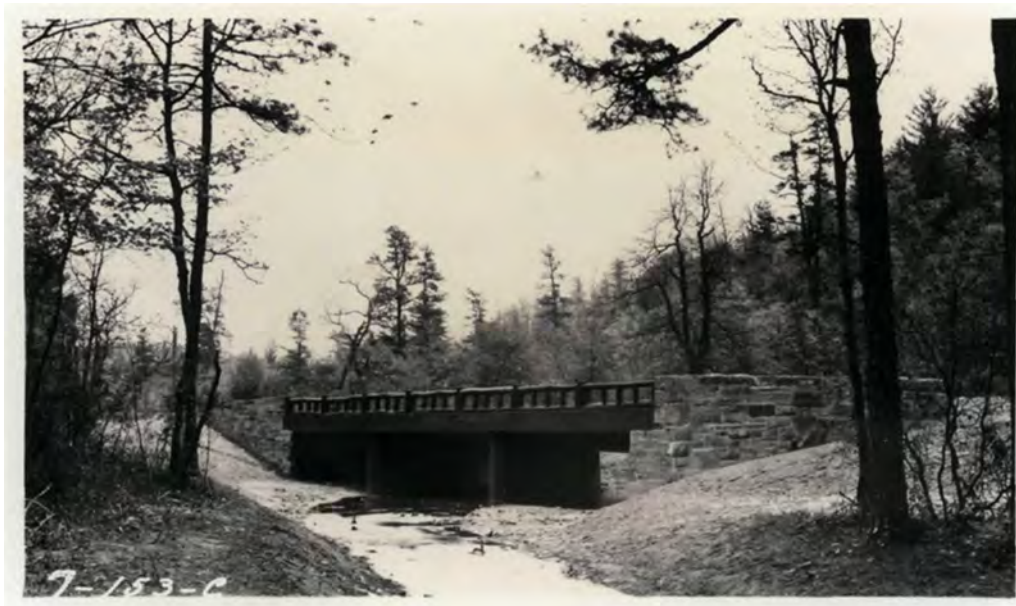
Figure 10. Photograph, ca. 1937, showing the newly completed Big Pine Creek Bridge #3 (USDA BPR 1937).

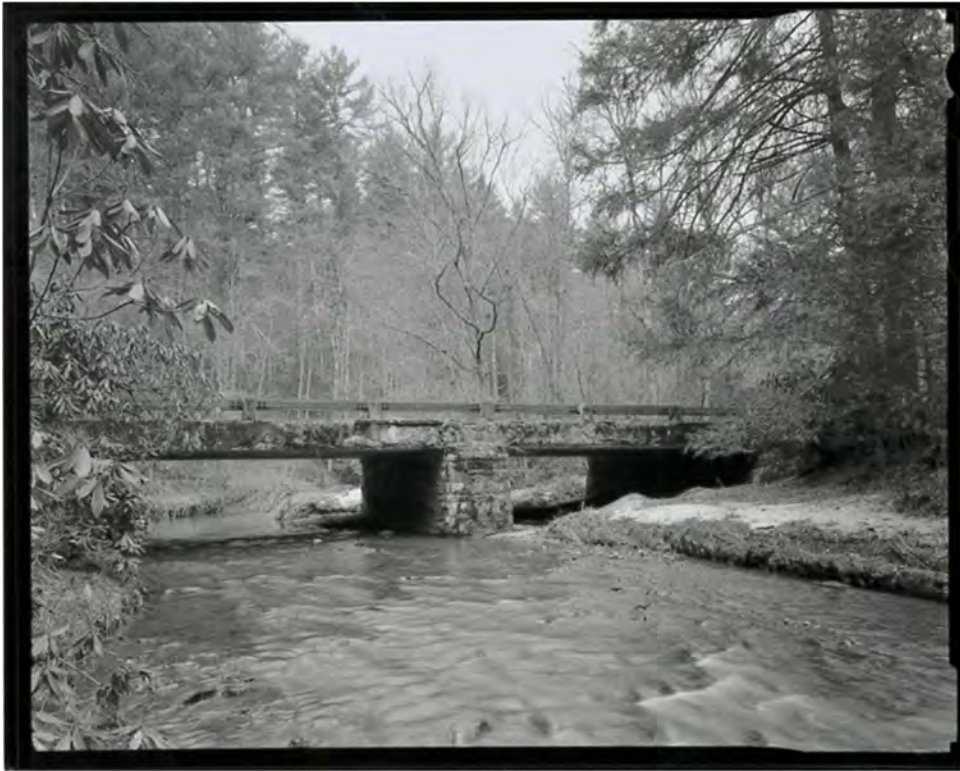
Photograph 19. View of Big Pine Creek Bridge #6, looking north-northeast (NC-42-D-1).

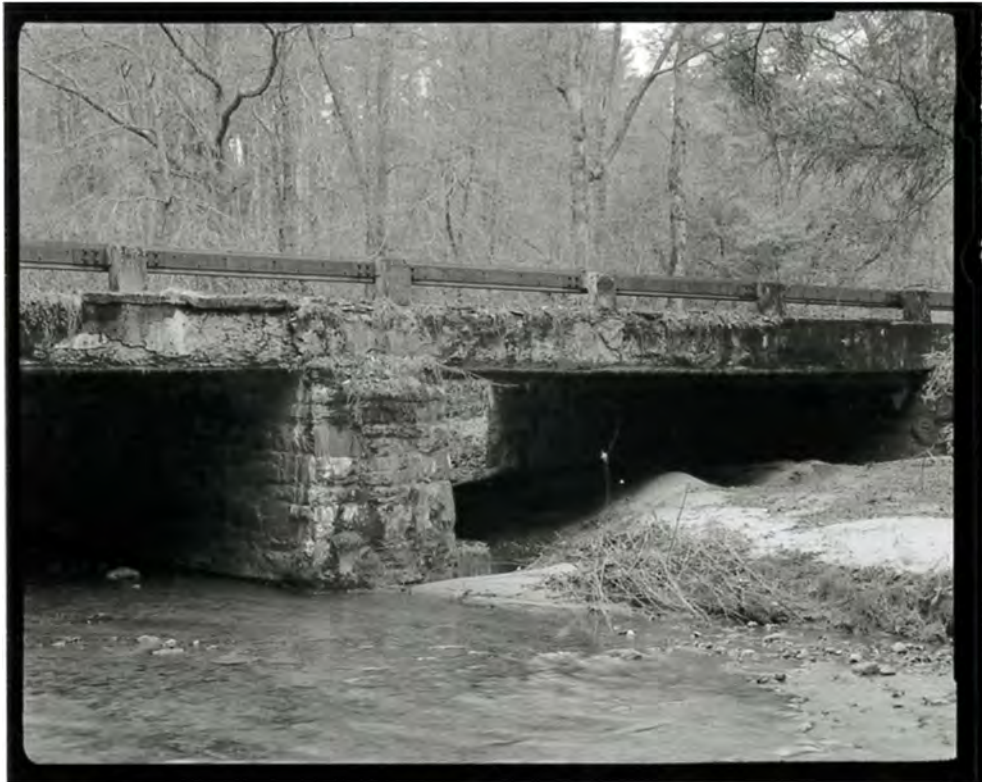
Photograph 20. View of Big Pine Creek Bridge #6, looking north-northwest (NC-42-D-2).

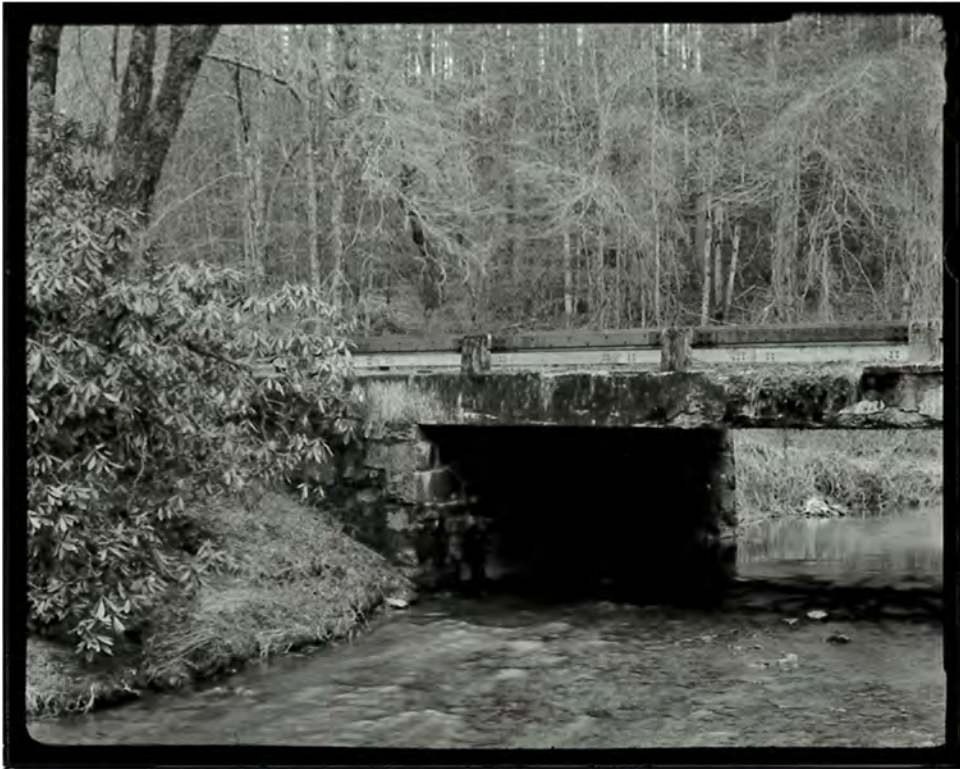
Photograph 21. View of Big Pine Creek Bridge #6, looking northwest (NC-42-D-3).

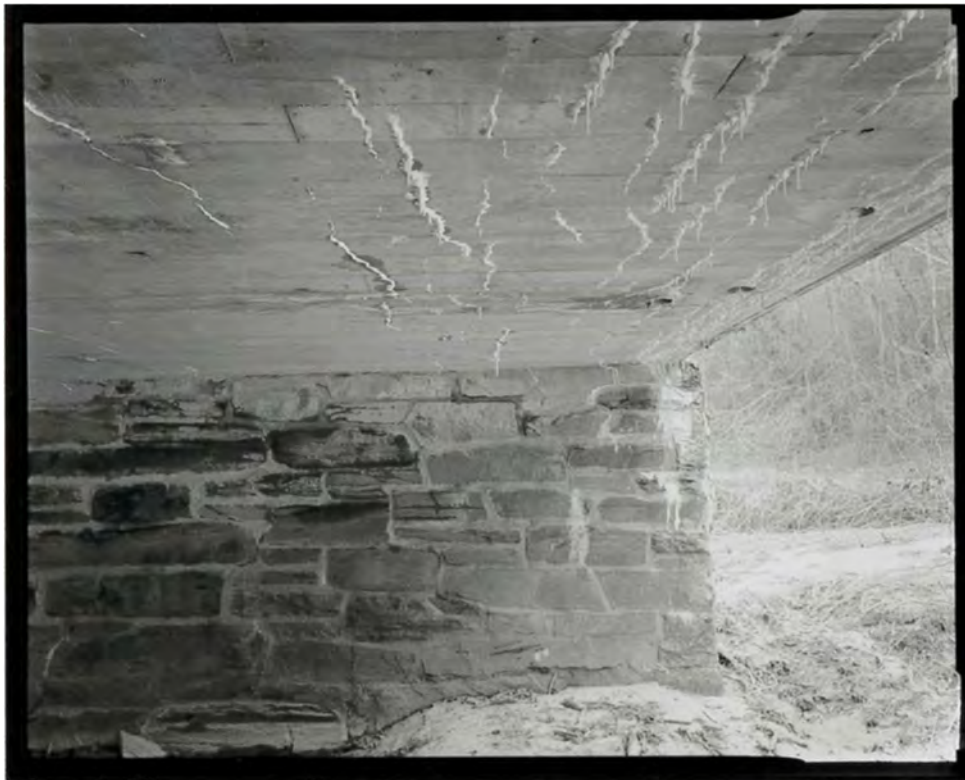
Photograph 22. Detail view of Big Pine Creek Bridge #6, showing the pier and underside of the deck, looking west (NC-42-D-4).

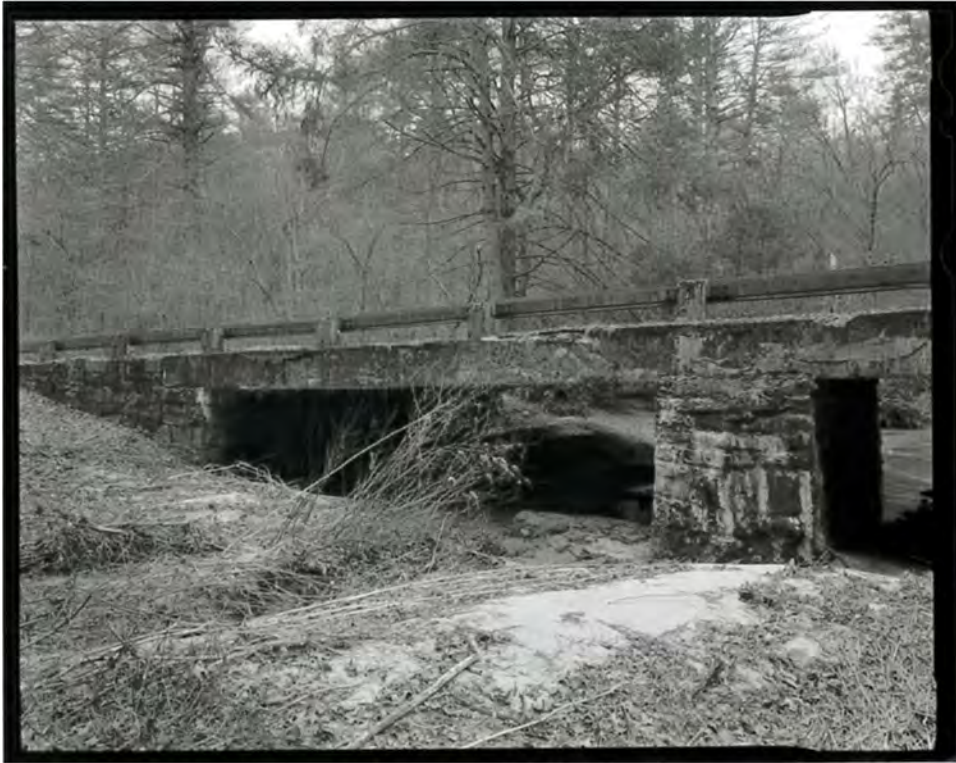
Photograph 23. Three-quarter view of Big Pine Creek Bridge #6, showing the north abutment, looking east-southeast (NC-42-D-5).

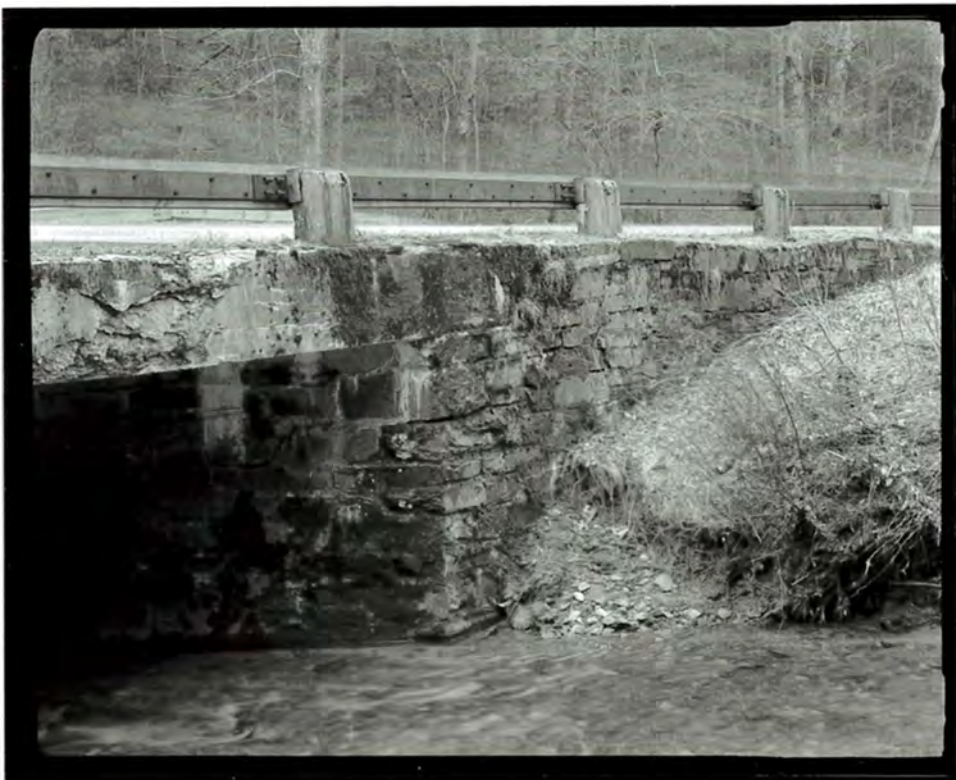
Photograph 24. Three-quarter view of Big Pine Creek Bridge #6, showing the south abutment, looking southwest (NC-42-D-6).

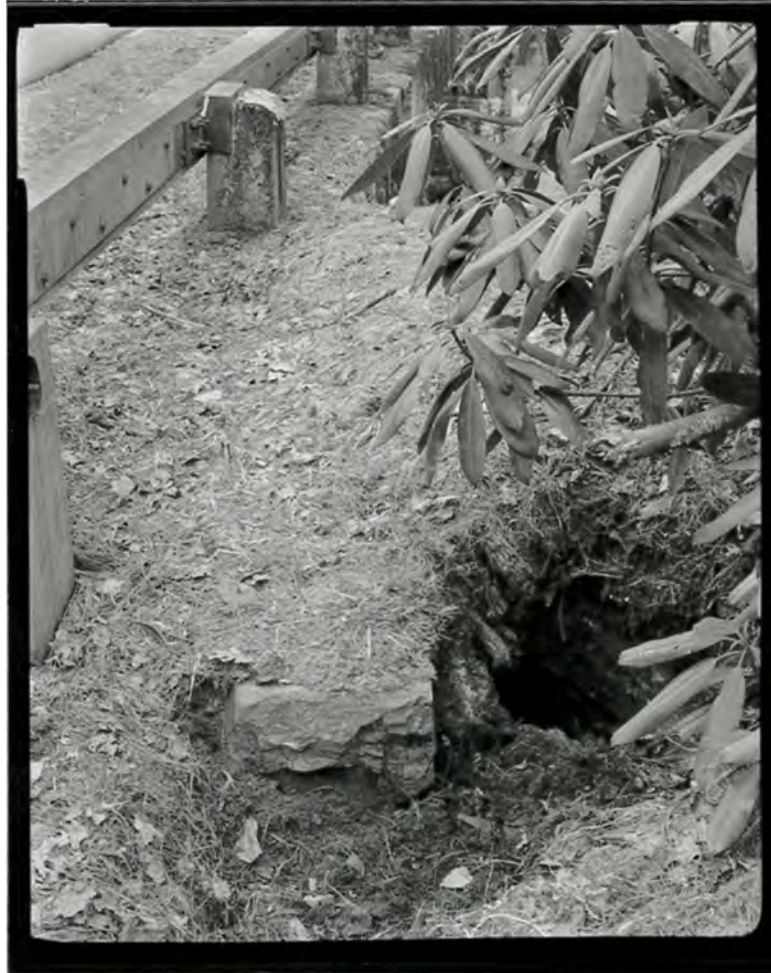
Photograph 25. View of Big Pine Creek Bridge #6, showing a stone drainage channel, looking northeast (NC-42-D-7).
