HISTORIC STRUCTURES SURVEY REPORT

**Proposed Replacement of Four Bridges Along the Blue Ridge Parkway in
Alleghany and Ashe Counties, North Carolina**

FHWA #BLRI 2A16-2D17

ER 18-2218

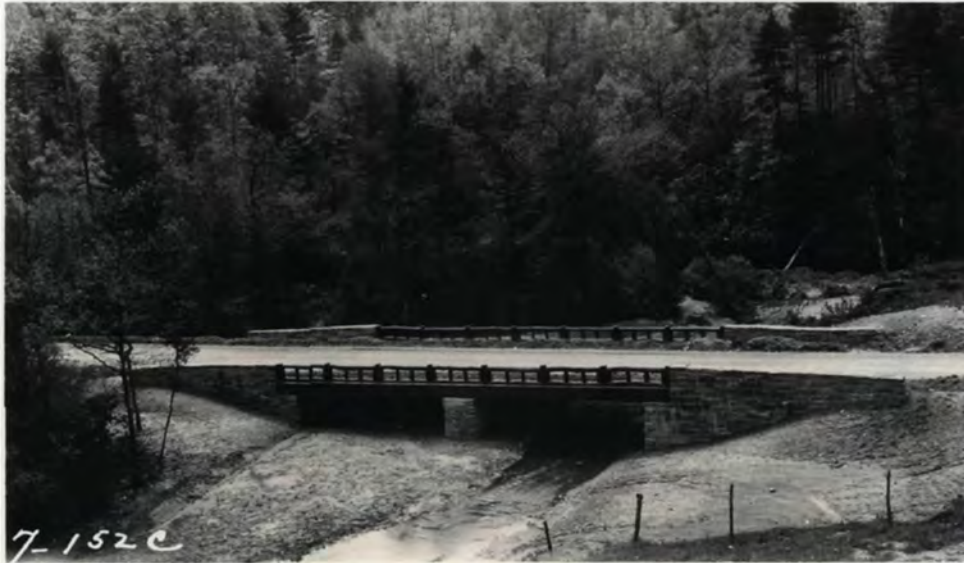
Simons-Mayrant Company, of Charleston, South Carolina, served as contractors for the project. Simons-Mayrant began work on the project in April of 1936, first excavating for the footings for Big Pine Creek Bridge #6 and three others. Work stalled for approximately one month, as the contractor “endeavored to find local sand that would pass specifications” and “found that satisfactory sand could not be obtained in the vicinity of this project.” Ultimately, sand was shipped to the project site, and work commenced with the laying of the stone masonry and pouring of concrete. The installation of the timber guard rails was the last of the work to be undertaken (USDA BPR 1937:5). The project was completed, inspected, and deemed satisfactory on April 27, 1937 (14; Figure 12).

Figure 12. Photograph, ca. 1937, showing the newly completed Big Pine Creek Bridge #6 (USDA BPR 1937).

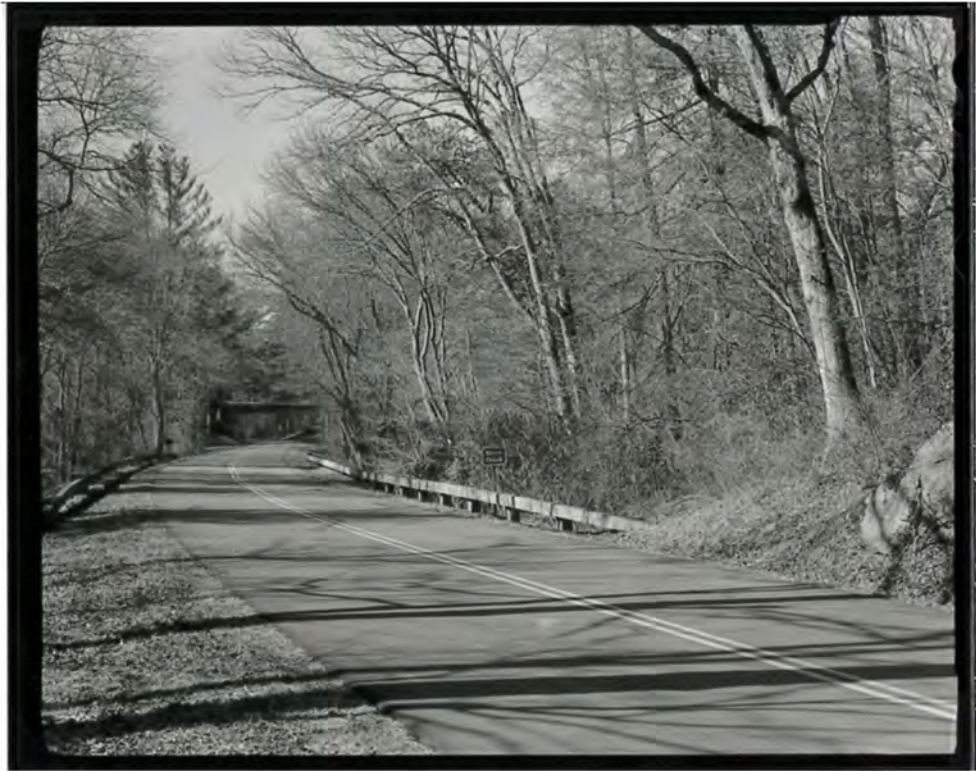
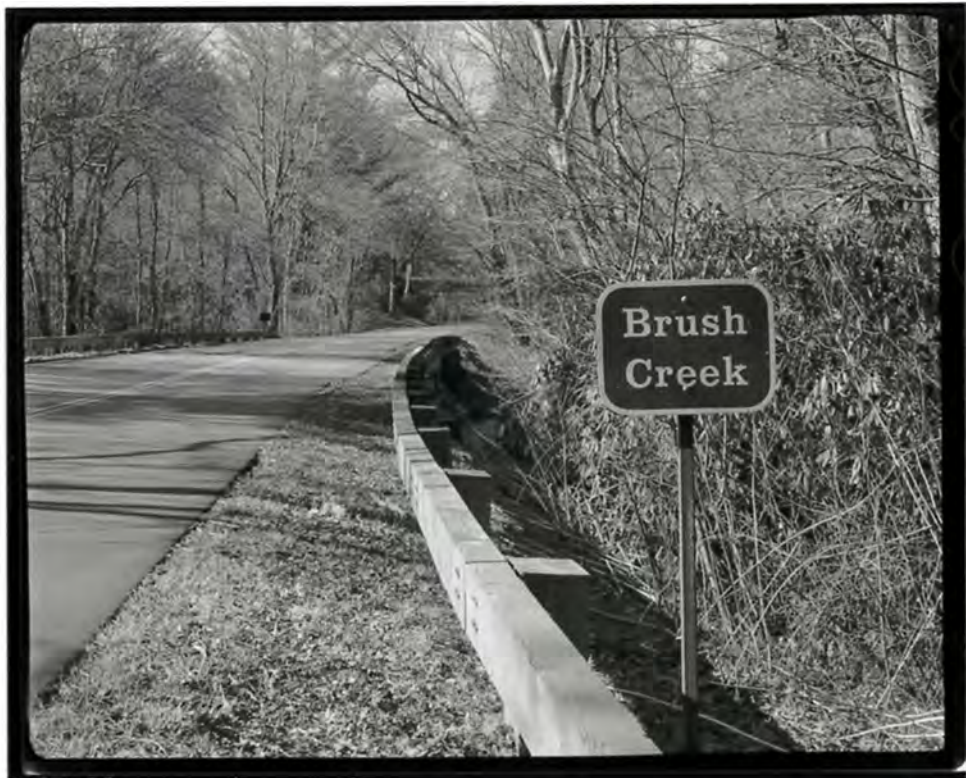
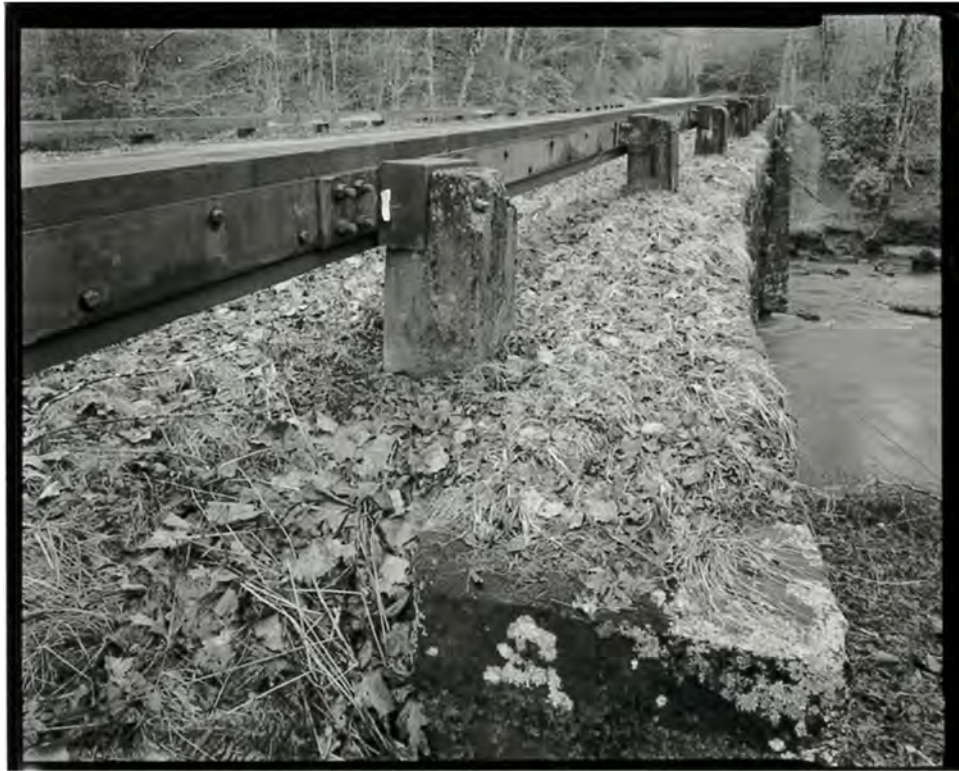
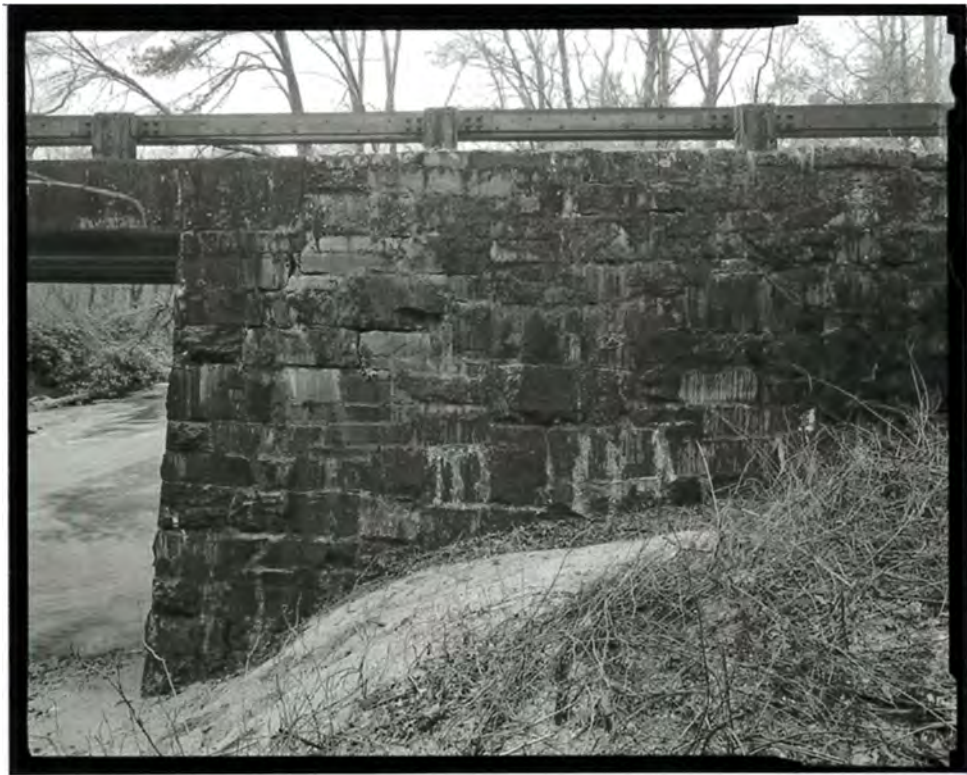
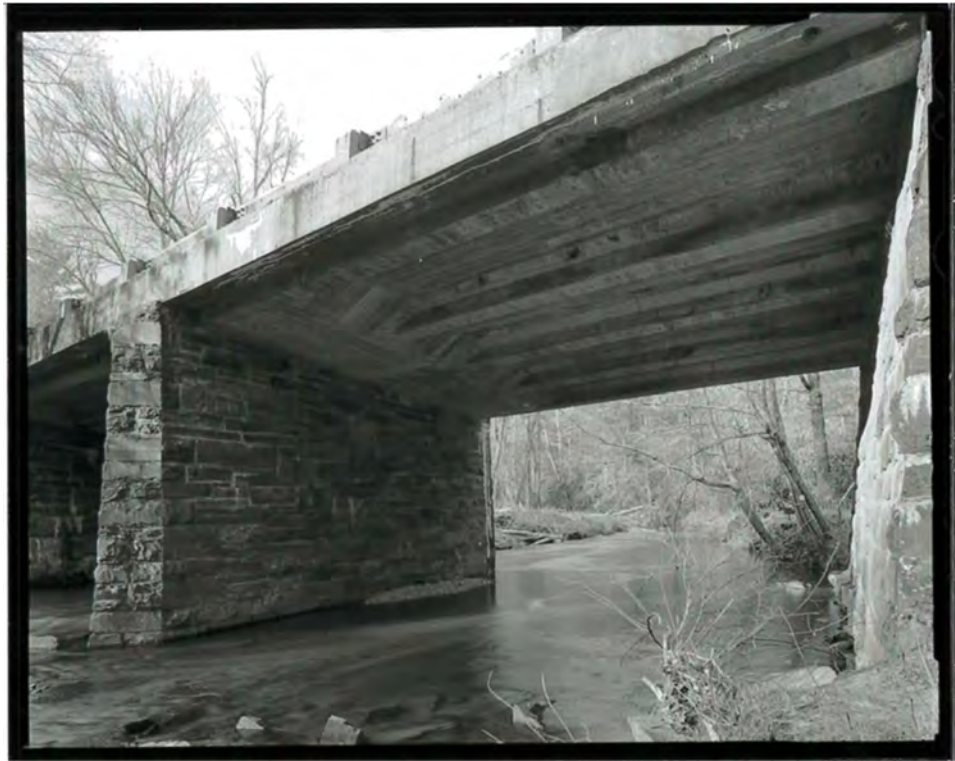
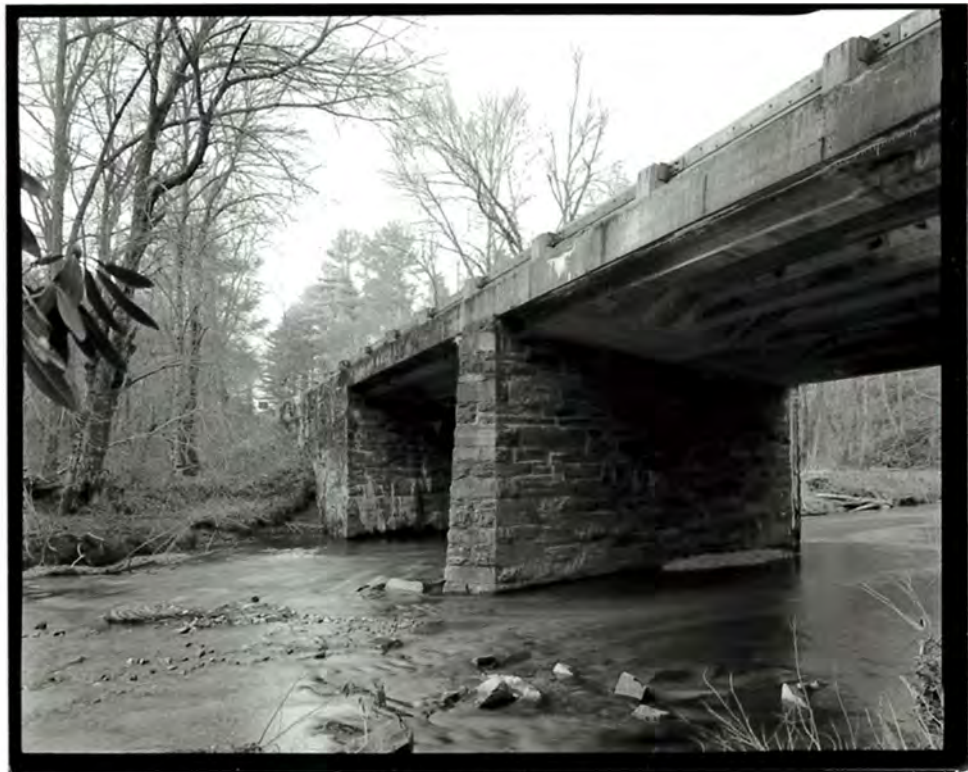
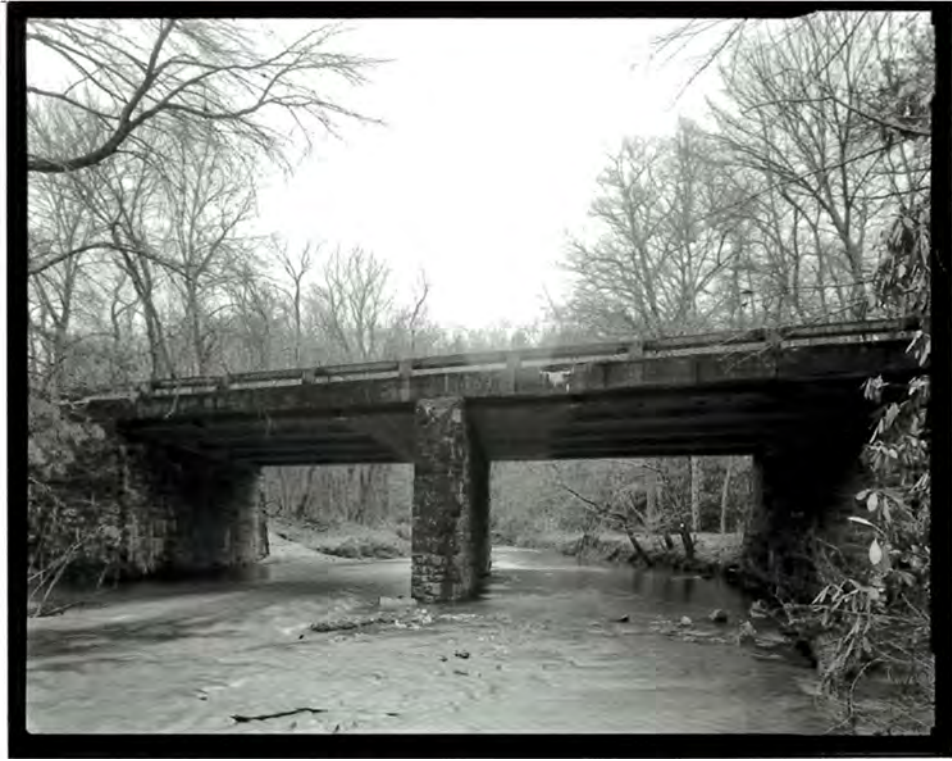
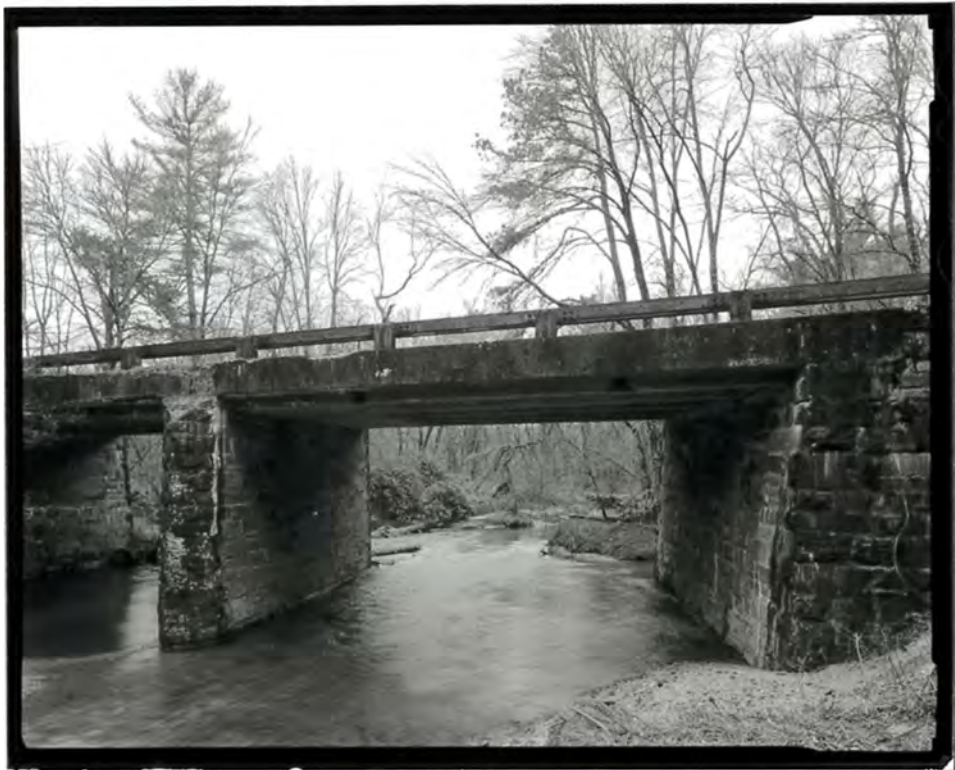
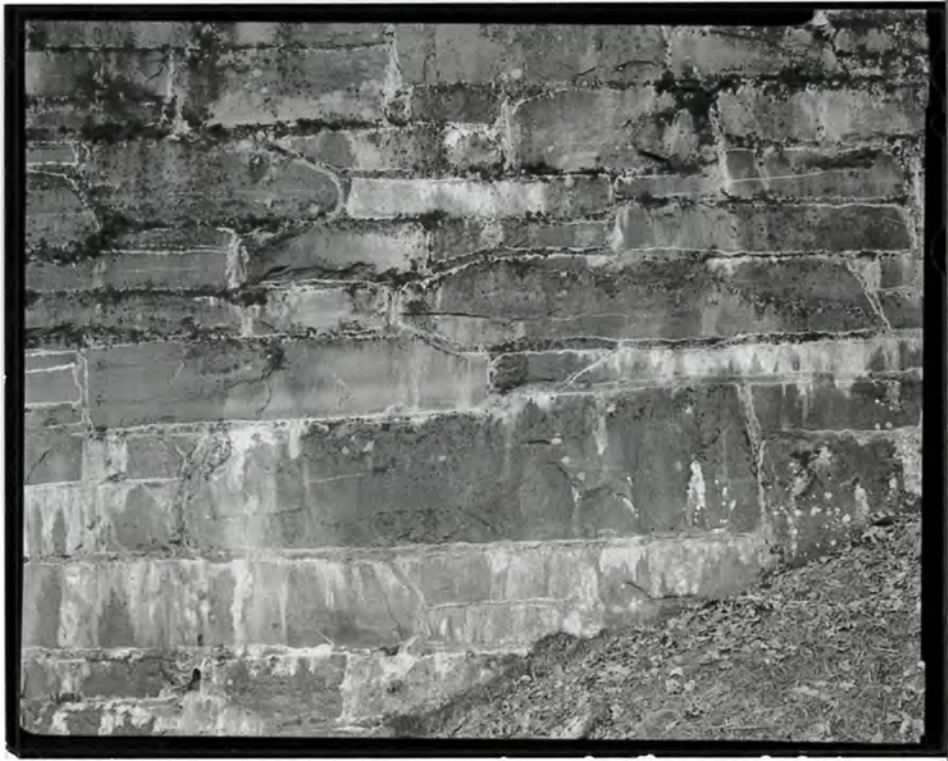
Brush Creek Bridge #1 is a two-span concrete slab structure constructed on a 15° forward right skew. The bridge consists of a concrete slab deck with engaged concrete girders cast into the underside. The slab is supported by battered abutments and a narrow, central, battered pier with a battered cutwater on each end. The abutments and pier are constructed with a core of reinforced concrete clad in quarry-faced stone laid in an uncoursed, broken ashlar pattern in keeping with the rustic style of architecture utilized by the NPS for the buildings and structures of the Blue Ridge Parkway (Photographs 26-34).

Photograph 26. View of Brush Creek Bridge #1, showing the deck, looking northwest (NC-42-E-1).

Photograph 27. View of Brush Creek Bridge #1, southbound on the Blue Ridge Parkway, looking west-northwest (NC-42-E-2).

Photograph 28. Detail view of Brush Creek Bridge #1, showing the guardrail, looking northeast (NC-42-E-3).

Photograph 29. Detail view of Brush Creek Bridge #1, showing the east abutment wall, looking northeast (NC-42-E-4).

Photograph 30. Detail view of Brush Creek Bridge #1, showing the beams at the underside of the deck, looking north-northeast (NC-42-E-5).

Photograph 31. Detail view of Brush Creek Bridge #1, showing the beams at the underside of the deck and the central pier, looking north (NC-42-E-6).

Photograph 32. View of Brush Creek Bridge #1, looking north-northeast (NC-42-E-7).

Photograph 33. View of Brush Creek Bridge showing east abutment and center pier, looking north (NC-42-E-8).

Photograph 34. Detail view of Brush Creek Bridge #1, showing the stonework at the abutment wall, looking northeast (NC-42-E-9).

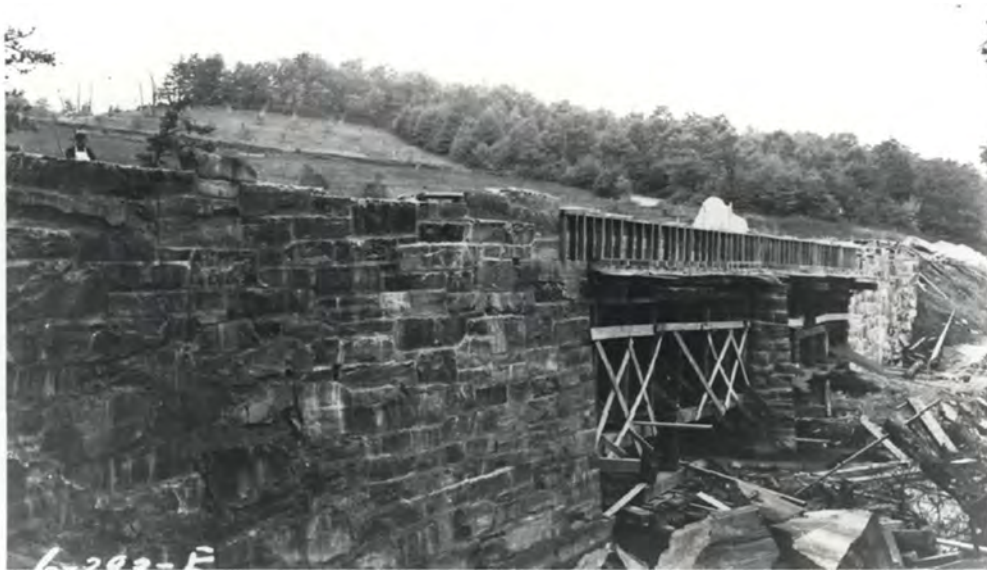
Simons-Mayrant Company, of Charleston, South Carolina, served as contractors for the project. Simons-Mayrant began work on the project in April of 1936 (Figures 14-15). Work stalled for approximately one month, as the contractor “endeavored to find local sand that would pass specifications” and “found that satisfactory sand could not be obtained in the vicinity of this project.” Ultimately, sand was shipped to the project site, and work commenced with the laying of the stone masonry and pouring of concrete. The installation of the timber guard rails was the last of the work to be undertaken (USDA BPR 1937:5). The project was completed, inspected, and deemed satisfactory on April 27, 1937 (14; Figures 14-15).

Figure 14. Photograph, ca. 1937, showing the construction of Brush Creek Bridge #1 (USDA BPR 1937).

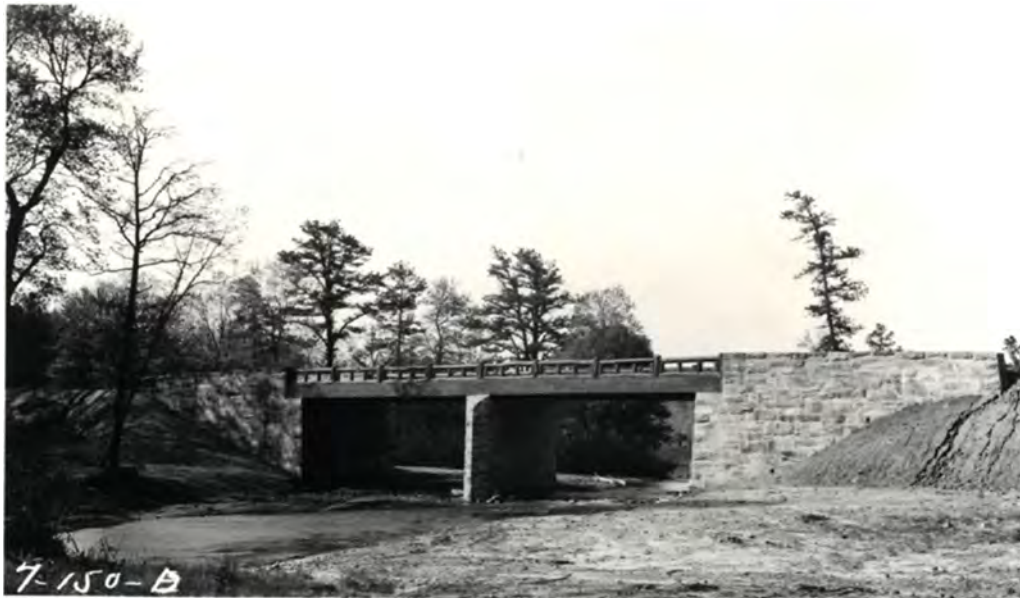
Figure 15. Photograph, ca. 1937, showing the newly completed Brush Creek Bridge #1 (USDA BPR 1937).
