**North Carolina Department of Natural and Cultural Resources**  
**State Historic Preservation Office**

Re: Reepsville Road Interconnection of City of Lincolnton Water System, Lincoln County, ER 18-4236

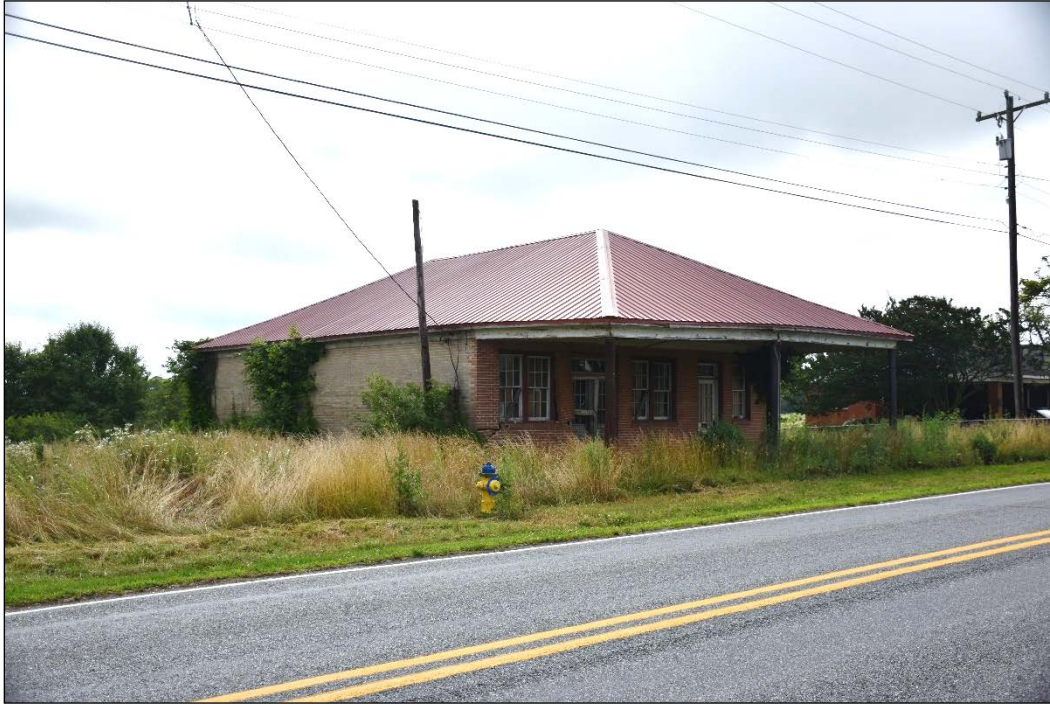
**Figure 4.1. T. C. Falls Store Crossroads (LN0131), store, facing southeast.**

The T. C. Falls Store Crossroads (LN0131) consists of a complex of structures that includes a circa 1930s store, a circa 1920s residence, circa 1940s chicken houses, and a circa 1950s residence, located on the same tax parcel. The circa 1920s Bungalow has undergone significant alteration, resulting in a loss of integrity of materials and workmanship. The circa 1950s Ranch-style house is a common mid-century form and style of house that has integrity of location, design, setting, materials, workmanship, and feeling, but does not represent a significant event or period in history, is not associated with a significant person, and is not a significant example of a particular architectural style. Therefore, these two elements of the T. C. Falls Store Crossroads are recommended

as ineligible for the NRHP. However, the T. C. Falls General Store Building retains its integrity of location, setting, design, materials, workmanship, and feeling. It is an example of one-part vernacular store with transitional elements of an autocentric store; it has a nominally Craftsman form and style, which was common during the 1920s and 1930s. The building is a good surviving example of an early-twentieth-century rural store building and is one of the few remaining stores within Lincoln County with good integrity. Therefore, S&ME recommends the T. C. Falls General Store building (LN0131) as eligible for the NRHP under Criterion C. The T. C. Falls General Store (LN0131) is eligible for the NRHP under Criterion C, for its architecture; however, the waterline, as currently proposed, will not affect the architectural integrity of the store building.

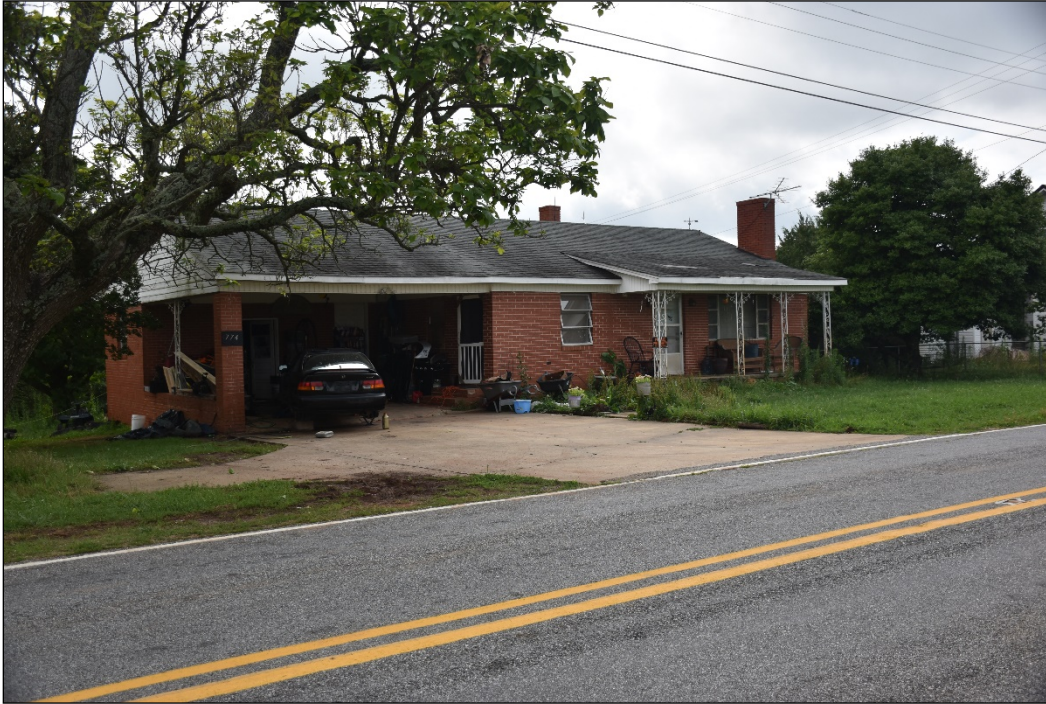
**Figure 4.3. T. C. Falls Store Crossroads (LN0131), ranch house, facing southeast.**

To the south of the store building is a circa 1950s side-gabled, Ranch-style residence with a brick veneer exterior (Figure 4.3). The main section of the house has a central entry door, with a three-pane, metal frame, horizontal tilting window to the north and a tripartite picture window, with a wooden frame, to the south. A two bay, shed-roofed porch is supported by decorative metal posts. Along the north elevation an open carport is located beneath an extension of the main roofline and is supported by brick columns. A secondary entry door is located beneath the carport roof. An exterior brick chimney is located along the south elevation and an interior brick chimney is visible above the roofline at the southeastern corner of the house. The upper portion of the gable ends is covered with vinyl siding and the roof is asphalt shingles. The Ranch residence appears to have undergone little alteration since the 1984 survey.

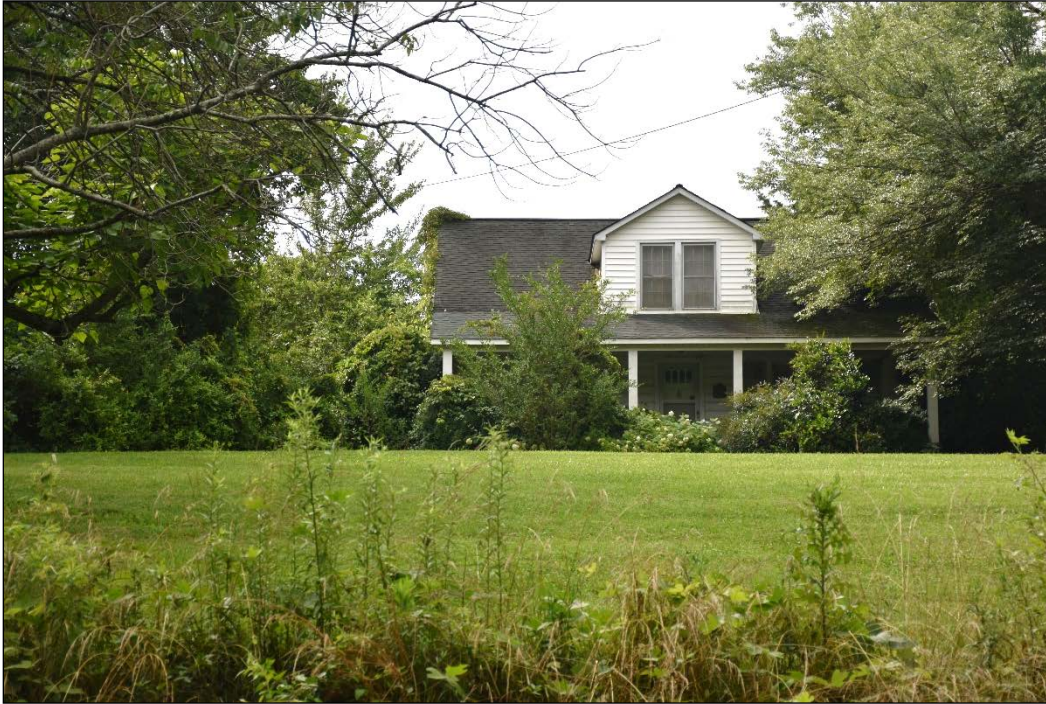
**Figure 4.5. Gilbert House (LN0807), facing southeast.**

The Gilbert House (LN0807) is a circa 1910 one-and-one-half story, frame residence located at 6007 Hoover Elmore Road, along the western portion of the proposed project corridor (Figures 1.1a and 1.2a). The house has a side-gabled roofline, with a shed-roofed porch, supported by square posts, spanning the front elevation (Figure 4.5). The entry door is slightly off-center and is flanked by paired six-over-six, double-hung, wooden sash windows on either side. A large gabled dormer is centered within the front roofline and has paired six-over-six, double-hung, wooden sash windows with exterior storm windows. The gabled dormer is covered with aluminum siding, while the first story, front elevation has German siding; the roof is composition shingles and the roof soffits have been enclosed with vinyl. The house sits back from the road right-of-way and is located within dense vegetation, which hides the side elevations from view. The house is a common example of an early twentieth century residential form that has lost some integrity of materials and workmanship through the addition of modern siding and vinyl soffits. The house does not represent a significant event or period in history, is not associated with a

significant person, and is not a significant example of a particular architectural style; therefore, it is recommended as ineligible for inclusion in the NRHP.

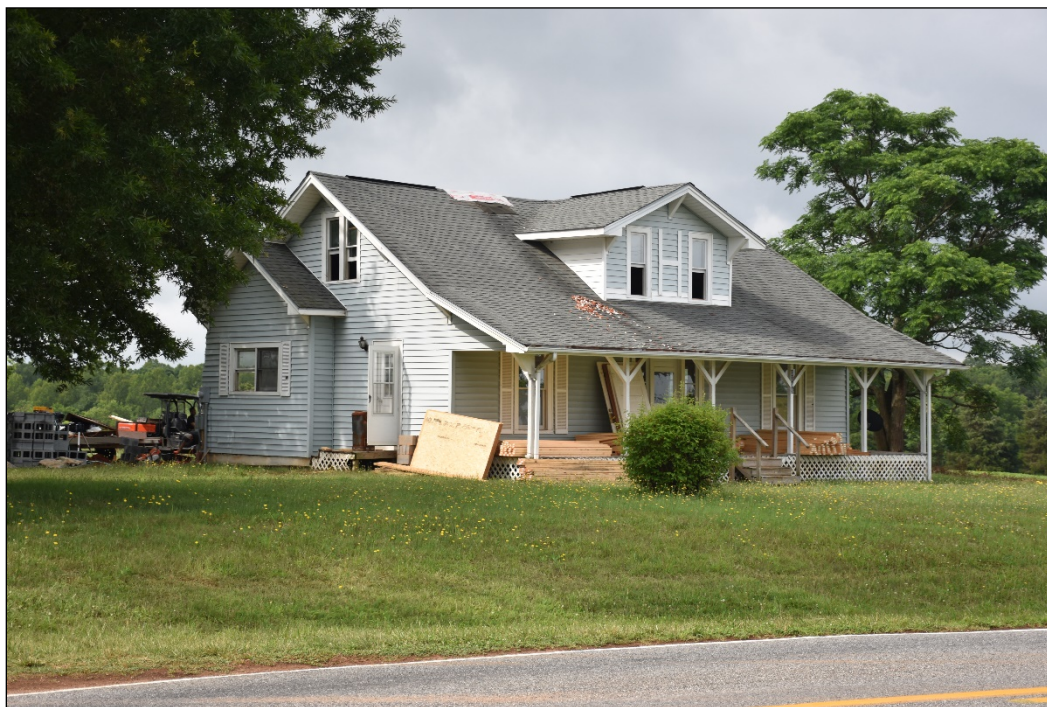
**Figure 4.6. McCord House (LN0808), facing southwest.**

The McCord House (LN0808) is a circa 1925 frame residence that is located at 5793 Hoover Elmore Road, along the western portion of the proposed project corridor (Figures 1.1a and 1.2a). The house is a Bungalow-style structure that has a side-gabled roofline, with a shed-roofed porch, supported by square posts and triangular supports, spanning the front elevation (Figure 4.6). The central entry door has two-pane sidelights and is flanked by a single one-over-one, double-hung, vinyl sash windows on either side. A large gabled dormer is centered within the front roofline and has two single one-over-one, double-hung, vinyl sash windows and a decorative trimwork "H". The west elevation has a one-story, gabled extension with a single one-over-one, double-hung, vinyl sash window; there is another single one-over-one, double-hung, vinyl sash window on the first story and a paired one-over-one, double-hung, vinyl sash window on the upper story. The east elevation has a secondary entry door, a single story gabled extension with paired one-over-one, double-hung, vinyl sash window, and a paired one-over-one, double-hung, vinyl sash window in the upper story. The house originally rested on a brick pier foundation that has been infilled with concrete block and the original piers have been removed. Its exterior is covered with vinyl siding and the roof is composition shingles; the remaining triangular brackets along the wide eave overhangs have been enclosed with vinyl. The house is currently undergoing renovations. It is a common example of an early twentieth century residential form that has lost integrity of materials and workmanship through the addition of modern siding and vinyl windows. The house does not represent a significant event or

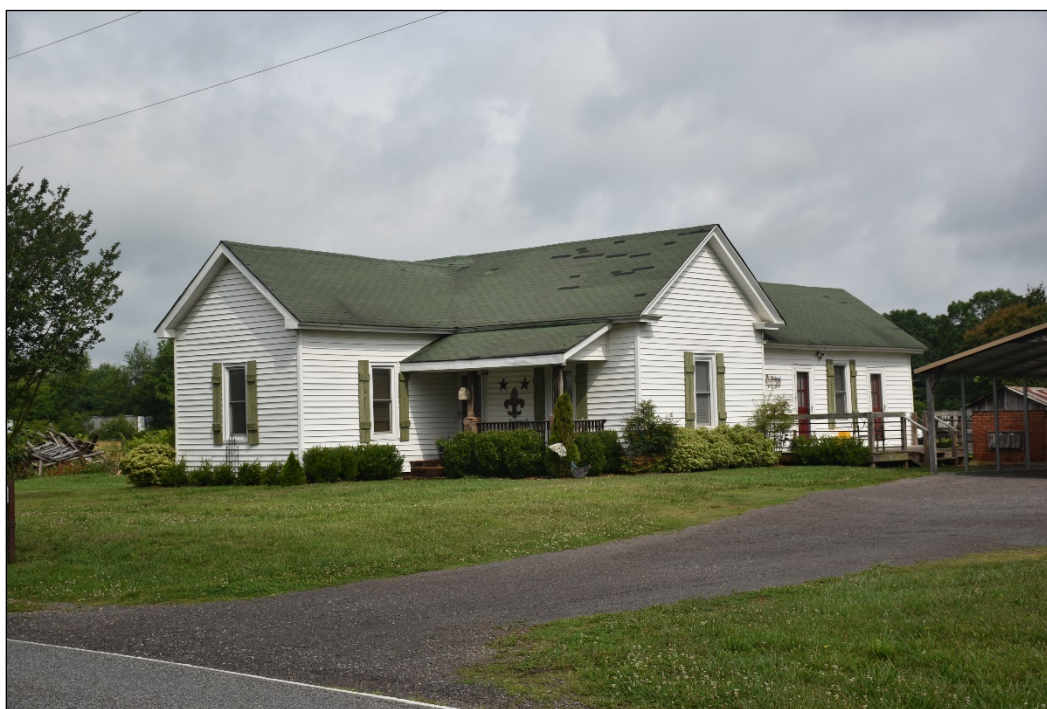
**Figure 4.7. Ida Self Elmore House (LN0086), facing northwest.**

The Ida Self Elmore House (LN0086) is recorded as being on the north side of Hoover Elmore Road, northwest of its intersection with Abernethy Farm Road, at 5712 Hoover Elmore Road, near the western terminus of the project corridor (Figure 1.1a and 1.2a). It was recorded in 1984 but was not evaluated for National Register eligibility; the property consists of a circa 1898 frame residence with a vernacular form, along with some early twentieth century outbuildings (Survey File 1984:LN0086). The house has an irregular plan, with a cross-gabled roofline; the main side-gabled portion of the house is three bays wide, with a front-projecting gabled ell on the western bay (Figure 4.7). A shed-roofed porch spans the eastern two bays, connecting to the front-gabled ell; it is supported by square posts that rest on stone piers; the entry door is centrally located and the remaining two front bays consist of one-over-one, double-hung, vinyl sash windows. The western elevation has a single one-over-one, double-hung, vinyl sash window on the front ell and a single one-over-one, double hung, vinyl sash window on the side-gabled portion; a side-gabled addition, with cornice returns and one-over-one, double-hung, vinyl sash windows is visible along the rear portion of the structure. The eastern elevation has a single one-over-one, double-hung, vinyl sash window in the gable end, which has cornice returns, and a gabled rear ell with secondary entry doors and a single one-over-one, double-hung, vinyl sash window. The house is covered with vinyl siding and the roof is asphalt shingles. Since the 1984 survey, the wooden weatherboard siding has been covered or replaced, the four-over-four windows have been replaced, the original porch supports have been replaced, and the decorative trimwork along the porch has been removed or covered. The wellhouse and barn associated with the house remain extant. The Ida Self Elmore House (LN0086) is a common vernacular form for rural residences during late-nineteenth through early-twentieth centuries; it has lost integrity of materials and workmanship through the addition of modern siding, replacement of windows, and alterations to the porch. Therefore, S&ME recommends the house as ineligible for the NRHP.

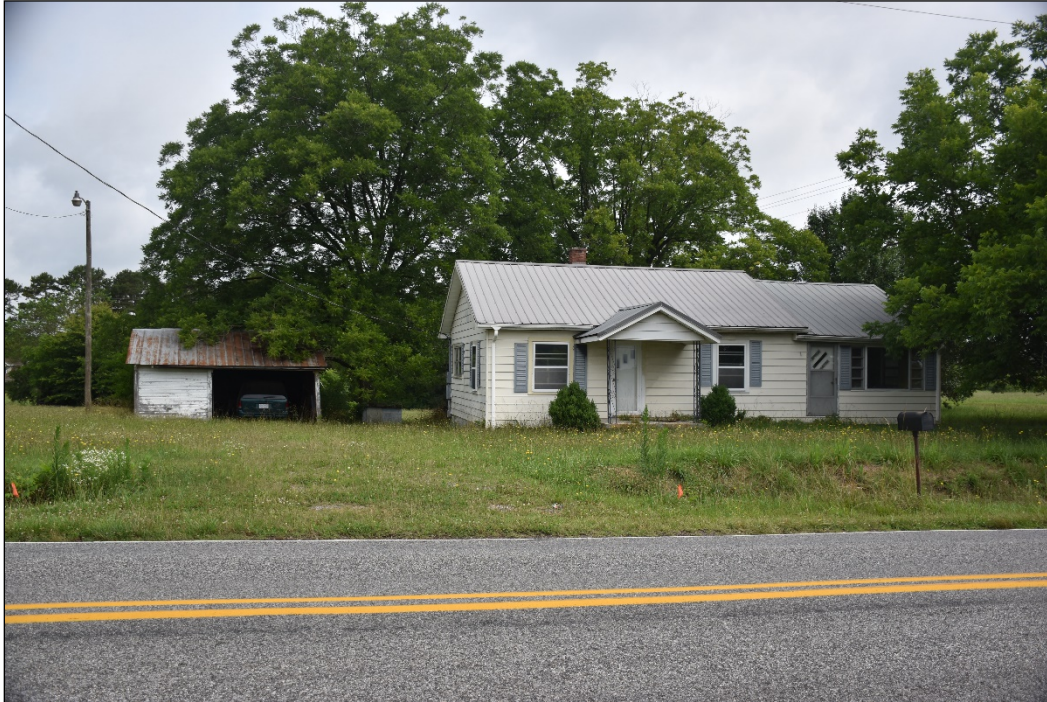
**Figure 4.8. Elmore House (LN0809), facing southwest.**

The Elmore House (LN0809) is a circa 1950 frame residence that is located at 5709 Hoover Elmore Road, along the western portion of the proposed project corridor (Figures 1.1a and 1.2a). The house is a one-story, Minimal Traditional style structure that has a side-gabled roofline; the off-center entry door is located beneath a gabled portico that is supported by decorative metal posts and is flanked by a single two-over-two, double-hung, metal frame window on either side (Figure 4.8). A side-gabled addition has been appended to the western elevation and it included a secondary entry door and tripartite picture window with metal frame; the west elevation of the addition has two single two-over-two, double-hung, metal frame windows. The east elevation has a single two-over-two, double-hung, metal sash window and a paired one-over-one, double-hung, metal sash window. A shed-roofed addition is visible at the rear of the structure and a central brick chimney rises above the roofline. The house, which sits on a concrete block foundation, has a standing seam metal roof and aluminum siding exterior. There is an early twentieth century, side-gabled, frame garage located to the east of the house. The house is a common example of a mid-twentieth century residential form that has lost integrity of design, materials, and workmanship through the construction of an out-of-scale addition and the installation of replacement siding and windows. The house does not represent a significant event or period in history, is not associated with a significant

person, and is not a significant example of a particular architectural style; therefore, it is recommended as ineligible for inclusion in the NRHP.

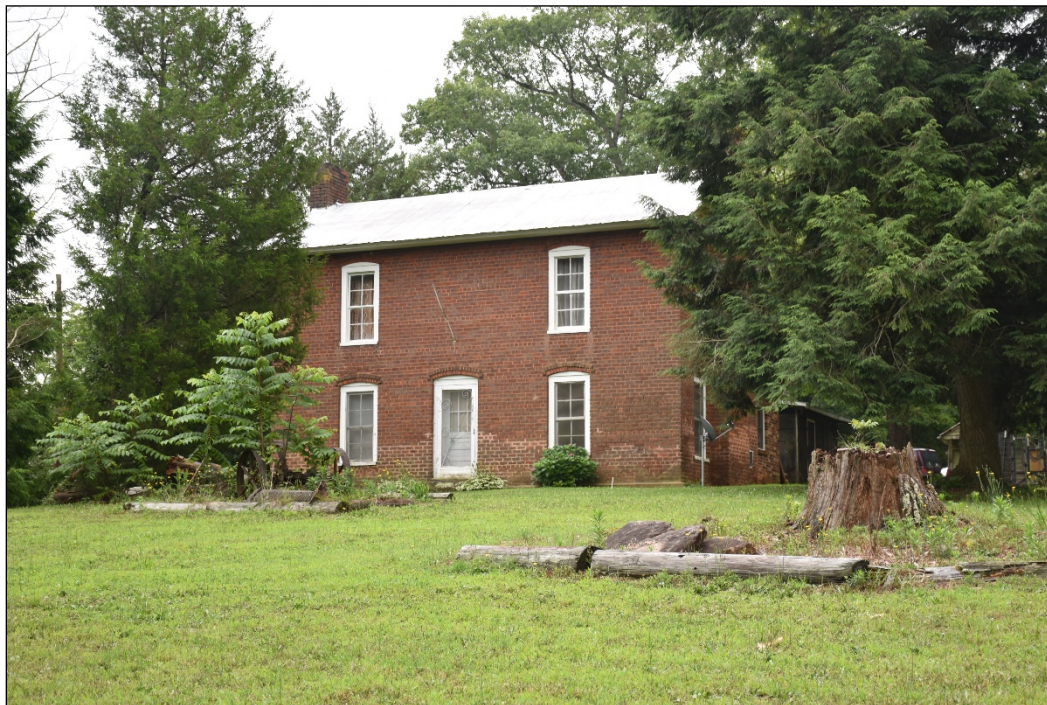
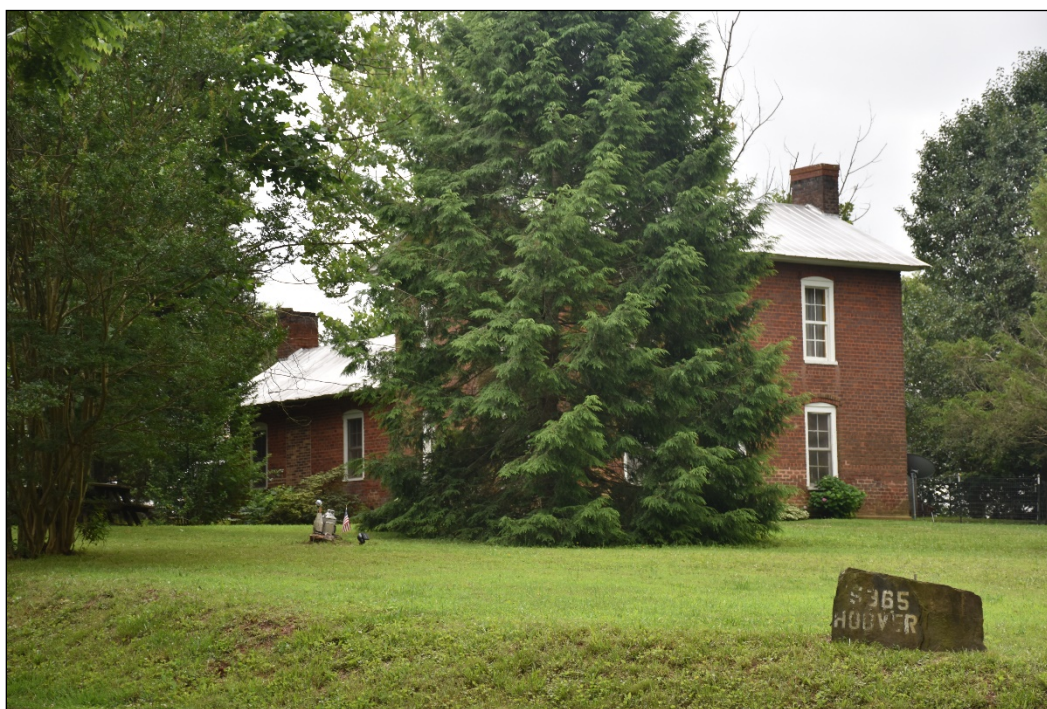
The Eddney Hoover House (LN0087) is recorded as being on the south side of Hoover Elmore Road, at 5365 Hoover Elmore Road, near the western portion of the project corridor (Figure 1.1a and 1.2a). It was recorded in 1984 but was not evaluated for National Register eligibility. The property consists of a circa 1883 brick residence and a number of outbuildings that are not currently visible from the right-of-way; historical information in the file suggests that the bricks were made on site (Survey File 1984:LN0087). The house, which is of American common bond masonry with seven rows of stretchers between rows of headers, is two stories tall, with a side-gabled roofline and three-bay facade (Figure 4.11). The central door is flanked by a single four-over-four, double-hung, wooden sash window on either side and the upper story has two four-over-four, double-hung, wooden sash windows, located above the first story windows; the window and door openings are each arched, with two rows of projecting headers above them. Each side elevation has an exterior brick chimney flanked by a single four-over-four, double-hung, wooden sash window on either side, on both the first and second stories. At the southeast corner, a single story, gabled rear ell, featuring the same American common bond brick construction and four-over-four, double-hung, wooden sash windows with arched openings, has an exterior chimney on its south elevation (Figure 4.12). The roof is covered with standing-seam metal. Since the 1984 survey, the Eddney Hoover House (LN0087) has undergone no visible exterior alterations. Although the Eddney Hoover House is a common rural vernacular form, reminiscent of the frame I-houses that were popular during the period, its brick construction and arched windows make it unique in this portion of Lincoln County. The house retains integrity of location, design, setting, materials, workmanship, and feeling, and it continues to be owned by members of the Hoover family, retaining its historic associations. Therefore, S&ME recommends the house as eligible for the NRHP under Criterion C, for its architecture. The Eddney Hoover House (LN00087) is eligible for the NRHP under Criterion C, for its architecture; however, the waterline, as currently proposed, will not affect the architectural integrity of the house.

**Figure 4.11. Eddney Hoover House (LN0087), facing southwest.**

**Figure 4.12. Eddney Hoover House (LN0087), facing south.**

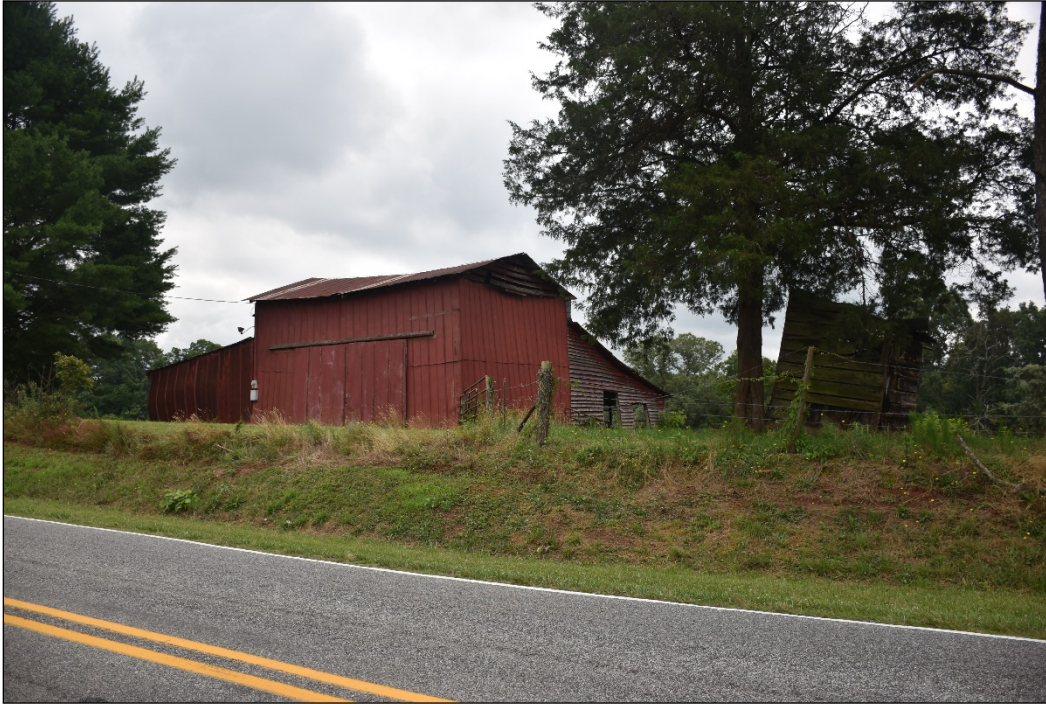
**Figure 4.15. Hoover Barn (LN0812), facing southeast.**

The Hoover Barn (LN0812) is a circa 1930 frame barn that is located on the south side of Hoover Elmore Road, at 5294 Hoover Elmore Road, along the western portion of the proposed project corridor (Figures 1.1a and 1.2a). The barn is a single story, side-gabled structure with a set of sliding doors centered along its north elevation (Figure 4.15). The eastern elevation has a shed-roofed extension that is supported by metal posts; the southern elevation has a shed-roofed addition that has two entry bays along its western side. The main section of the barn has standing-seam metal exterior siding, as does the eastern portion, while the southern addition has horizontal wooden weatherboard, which is also what covers the gable portion of the main barn structure. To the west of the barn is a shed-roofed, wooden corn crib that dates to the early twentieth century. This is an example of a type of an early twentieth century agricultural outbuilding that was common to the rural landscape during the 1900s. Although it retains its integrity of location, setting, and feeling, additions and alterations have compromised its design, materials, and workmanship. Without an associated house and other agricultural outbuildings or grazing lands, the barn has little historical association. Therefore, the barn does not represent a significant event or period in history, is not associated with a significant person, and is not a significant example of a particular architectural style. S&ME recommends it as ineligible for inclusion in the NRHP.

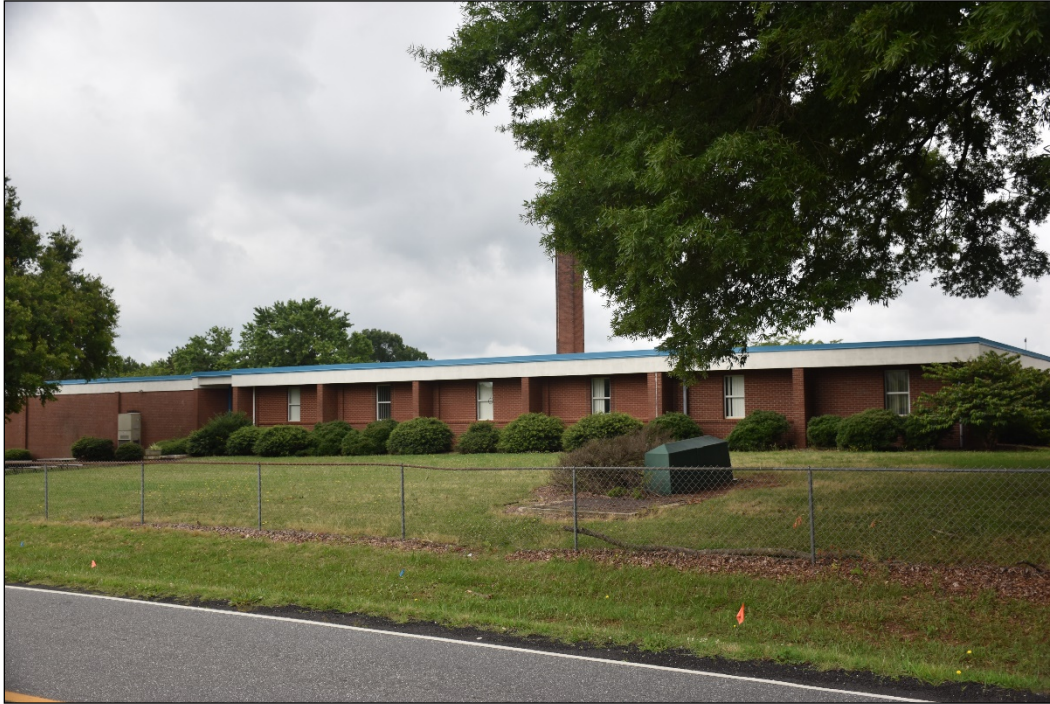
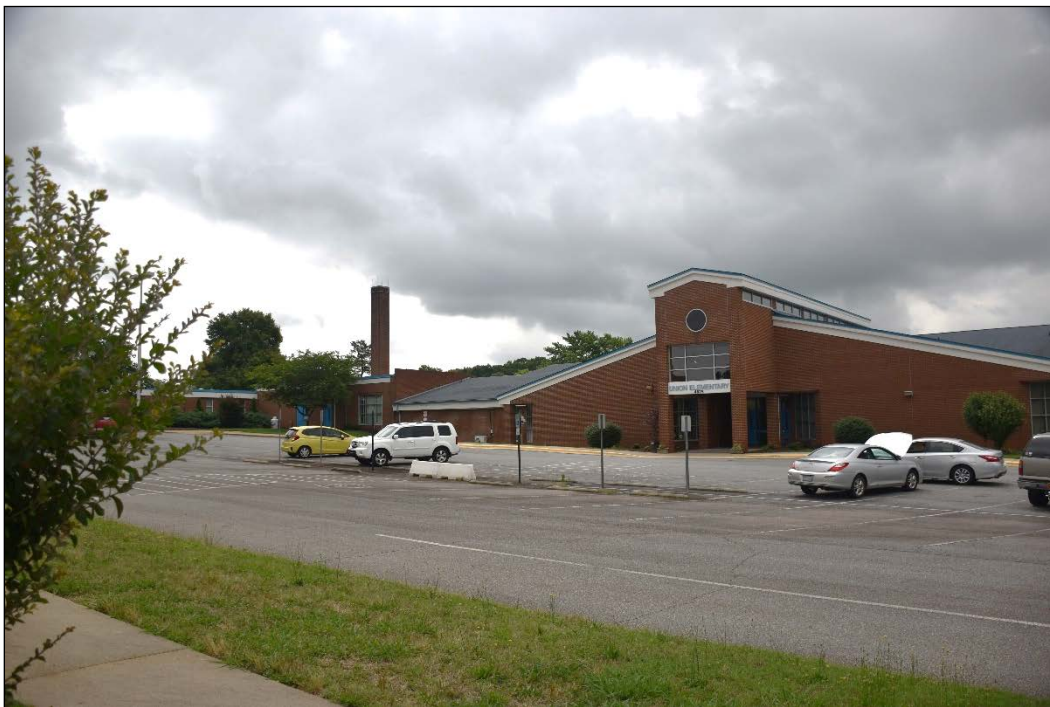
**Figure 4.16. Union Elementary School (LN0813), facing southwest.**

Union Elementary School (LN0813) is a single story school building, built in 1963, that is located on the southwest corner of Hoover Elmore Road and Reepsville Road (Figures 1.1b and 1.2b). The original portion of the school, which has an irregular plan, is a single story, flat-roofed building that fronts onto Reepsville Road (Figure 4.16). The 1960s section of the building has an H-shaped plan, with the entryway located on the small, lateral portion that connects the two longer wings; this original entry section is connected to the current, modern entry that has a two-story central gabled block with a sloped roof section on either side (Figure 4.17). The original portion of the building presents a low, horizontal profile that integrates with the lot topography and landscape. On the eastern elevation, each classroom section has a single two-pane, metal frame window and they are separated by brick buttresses, which bring a vertical element to the design; a set of double, metal, entry doors, with a glass surround, is located to the south of the classroom section, as is a block section, with upper level vents on its southern elevation, that likely was an original cafeteria in the school. The second wing of the original school building has classrooms with exterior doors and two single two-pane, metal frame windows each. There is a wide trim band along the roofline. This portion of the building is mostly brick veneer, although the cafeteria section has a common bond with Flemish header row pattern. To the west of the 1960s school building is a large, modern addition that has a two-story entry structure, a side-gabled classroom section, and a front-gabled extension off of a two-story gymnasium section. The school was built on the former location of Union High School, which had been destroyed by a lightning strike in 1962; it has become Union Elementary School in 1961 when West Lincoln High School was constructed and the students of Union High School began attending the new school. In 1995, the

**Figure 4.17. Union Elementary School (LN0813), facing southeast.**

school was significantly expanded, accounting for the western portion of the current building. Although it retains its integrity of location and setting, the feeling, design, materials, and workmanship have been compromised by the large modern addition and alterations to the 1963 structure. Therefore, S&ME recommends it as ineligible for inclusion in the NRHP.

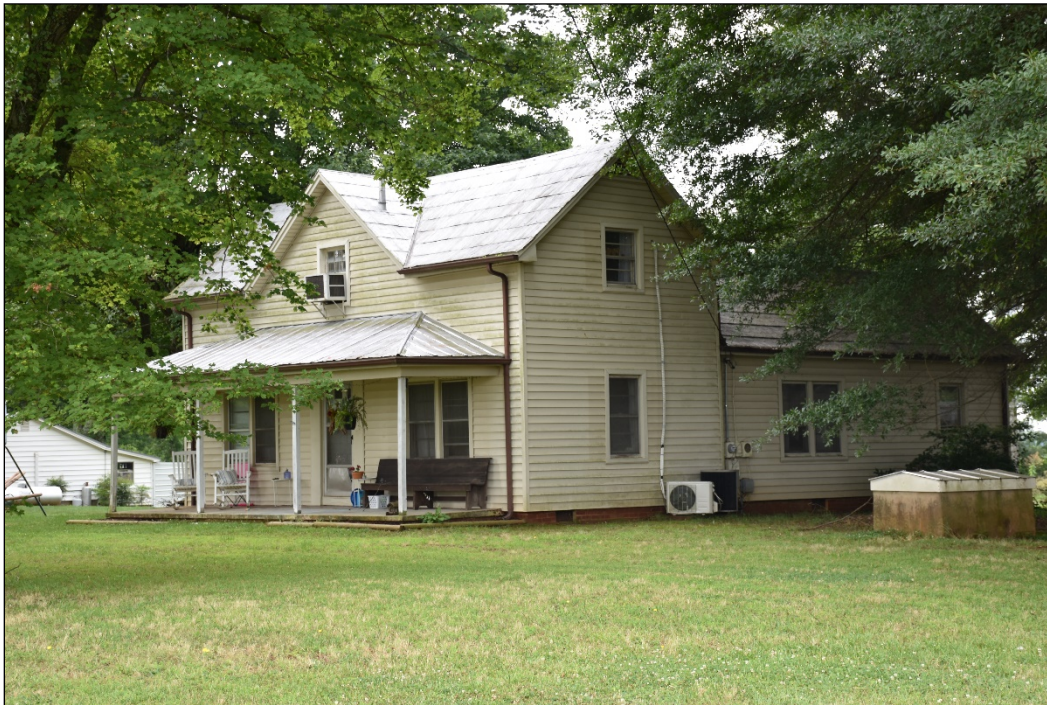
**Figure 4.20. Calaway House (LN0816), facing southwest.**

The Calaway House (LN0816) is a circa 1900 frame residence that is located at 4637 Reepsville Road, along the central portion of the proposed project corridor (Figures 1.1b and 1.2b). The house is a one-and-one-half story structure with a Triple-A form, which was a common rural vernacular residential type in the late-nineteenth and early twentieth centuries (Figure 4.20). The main roof is side-gabled, with a central gable on the front elevation. The three bay front façade is symmetrical, with a central door flanked by paired two-over-two, double-hung, wooden sash windows, with metal storm windows; a full-width, hipped roof porch, supported by square posts, spans the front elevation. The window in the central gable is a six-over-six, double-hung, wooden sash. The east and west elevations are each a single bay, with single two-over-two, double-hung, wooden sash windows on each story. A gabled rear ell projects from the southwestern corner and has single and paired two-over-two, double-hung, wooden sash windows. The house rests on a brick foundation and the exterior is covered with wooden weatherboard siding; the roof of the house and addition are tin shingles, while the porch roof is standing-seam metal. The house is an example of a common rural vernacular form of dwelling from the late-nineteenth through early twentieth centuries; it has lost some integrity of materials and workmanship through the replacement of

most of the windows. The house does not represent a significant event or period in history, is not associated with a significant person, and is not a significant example of a particular architectural style; therefore, it is recommended as ineligible for inclusion in the NRHP.

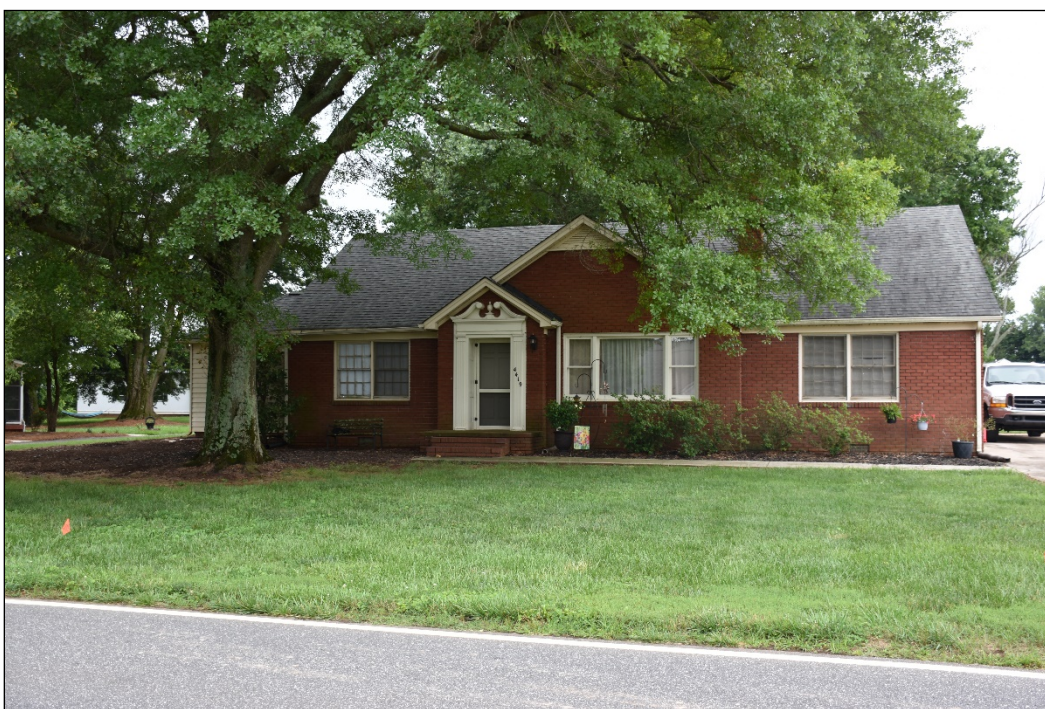
**Figure 4.24. Moore House (LN0819), facing south.**

The Moore House (LN0819) is a circa 1955 frame residence that is located at 4419 Reepsville Road, along the central portion of the proposed project corridor (Figures 1.1b and 1.2b). The house is a one-and-one-half story, cross-gabled structure with a rectangular plan and eclectic style (Figure 4.24). The façade of the house is four bays wide, with a central cross gable projecting slightly from the main side-gabled roof. The off-center entry door is located within a smaller gabled projection, recessed with a decorative Neoclassical style door surround, featuring a broken pediment and fluted pilasters; this multi-level gable arrangement is an element of the early twentieth century Tudor Revival style. The window to the west of the entry door, located on the front-gable section, is a tripartite picture window that was popular in mid-century Ranch residences. The remaining fenestration on the front elevation are paired eight-over-eight, double-hung, wooden sash windows. The west elevation has two single eight-over-eight, double-hung, wooden sash windows on the first story and a single eight-over-eight, double-hung, wooden sash window on the upper story; the east elevation has a one-story, hip-roofed addition, with single eight-over-eight, double-hung, wooden sash windows. The house has a brick veneer exterior and the roof is composition shingles; there is a large interior brick chimney visible to the west of the front-gabled section and there is a trim band at the roof-wall juncture. The house is a unique example of the blending of early and

mid-twentieth century architectural details on a modest residential form; although it retains its integrity of location, design, materials, workmanship, setting, and feeling, it does not represent a significant event or period in history, is not associated with a significant person, and is not a significant example of a particular architectural style. Therefore, it is recommended as ineligible for inclusion in the NRHP.

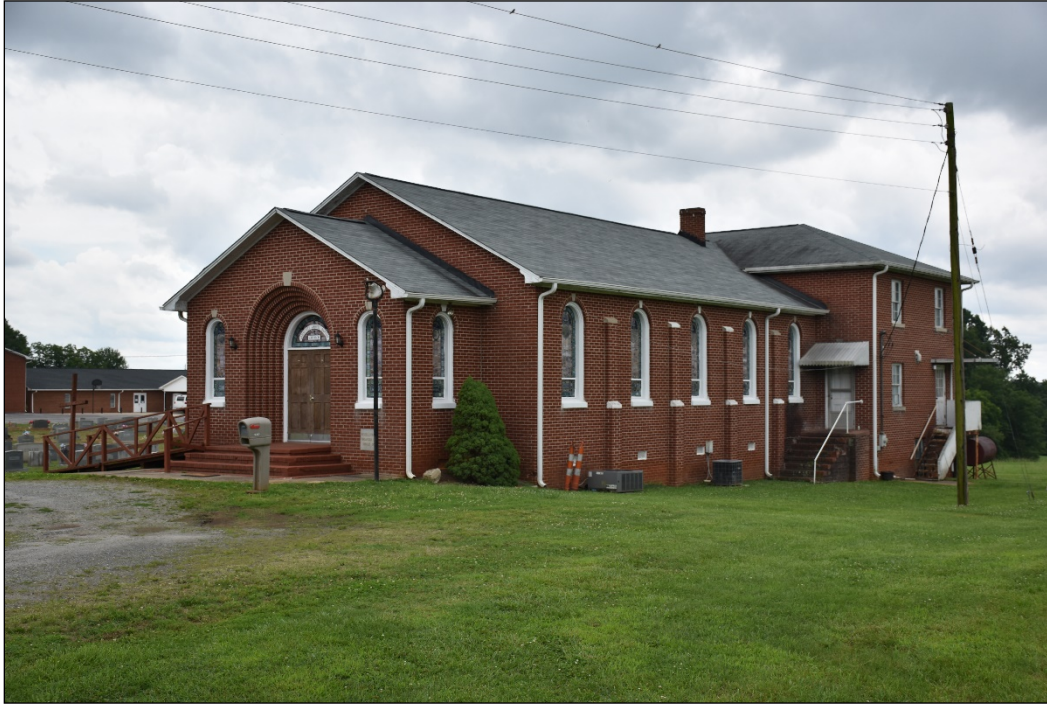
**Figure 4.29. Russell's Chapel (LN0821), facing southeast.**

Russell's Chapel (LN0821), currently the Community Grove Church, is a 1953 church structure that is located at 4321 Reepsville Road, along the central portion of the proposed project corridor (Figures 1.1c and 1.2c). The church is a single story, brick veneer structure with a T-shaped plan (Figure 4.29). The main section of the church is front-gabled, with a projecting front-gabled vestibule; the central double entry door, with stained-glass fanlight, is recessed into a stepped arch opening and is flanked by a single arched, stained-glass window on either side. The structure has five bay side elevations, each separated by a brick buttress and containing a single arched stained-glass window. To the east is a single one-over-one, double-hung, vinyl sash window; each of the arches for the door and windows has a stone keystone. The two-story rear section of the church has a hipped roof. The single bay on the north elevation that projects past either side of the front-gabled second contains an entry door, accessed by brick stairs and covered with a metal awning. The west elevation has an additional entry door on its west side and single six-over-six, double-hung windows on both its first and second stories. The east elevation has

single six-over-six, double-hung, wooden sash windows on its basement, first, and second stories. The roof is composition shingles and there is an interior brick chimney visible near the intersection of the front-gabled and hip-roofed sections. Churches are generally not eligible for the National Register except under Criterion C, for architecture. This church is a common example of a mid-twentieth century ecclesiastical form; although it retains integrity of location, design, material, workmanship, setting, and feeling, it not represent a significant event or period in history, is not associated with a significant person, and is not a significant example of a particular architectural style. Therefore, it is recommended as ineligible for inclusion in the NRHP.

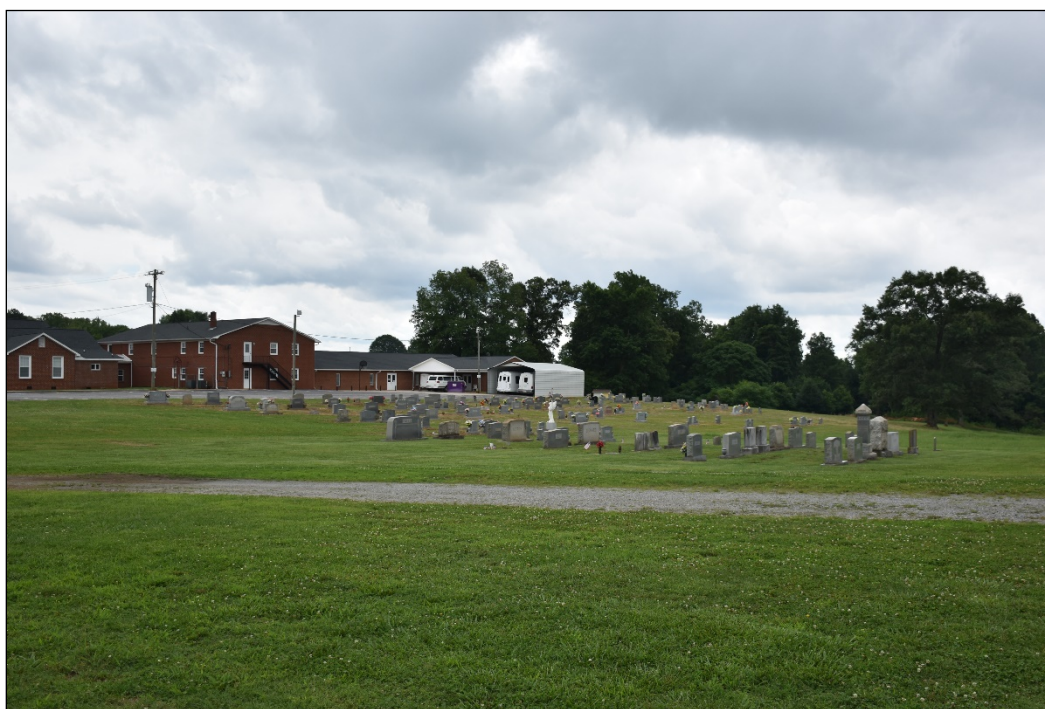
**Figure 4.32. Landmark Church Cemetery, facing southeast.**

Also located on the parcel that includes Reepsville Baptist Church (LN0822) is the southern section of the Landmark Church Cemetery (Figure 4.32). This portion of the cemetery, which is roughly L-shaped with graves oriented east to west, is approximately 1.25 acres in size. Cemeteries are not usually considered eligible for listing in the NRHP, however, they can be eligible under certain Criteria Considerations, usually Criteria Consideration D. Criteria Consideration D states that: "a cemetery is eligible if it derives its primary significance from graves of persons of transcendent importance, from age, from distinctive design features, or from association with historic events." Due to the distance of this cemetery from the proposed project corridor, approximately 100 feet at the closest point, the cemetery was not evaluated for National Register eligibility. However, cemeteries are protected by state law and avoidance of the cemetery is recommended; as the project corridor is currently proposed, the proposed corridor is far enough away that it will not affect the cemetery, although retaining a 10 foot buffer from the edge of the northernmost marked burial is recommended.

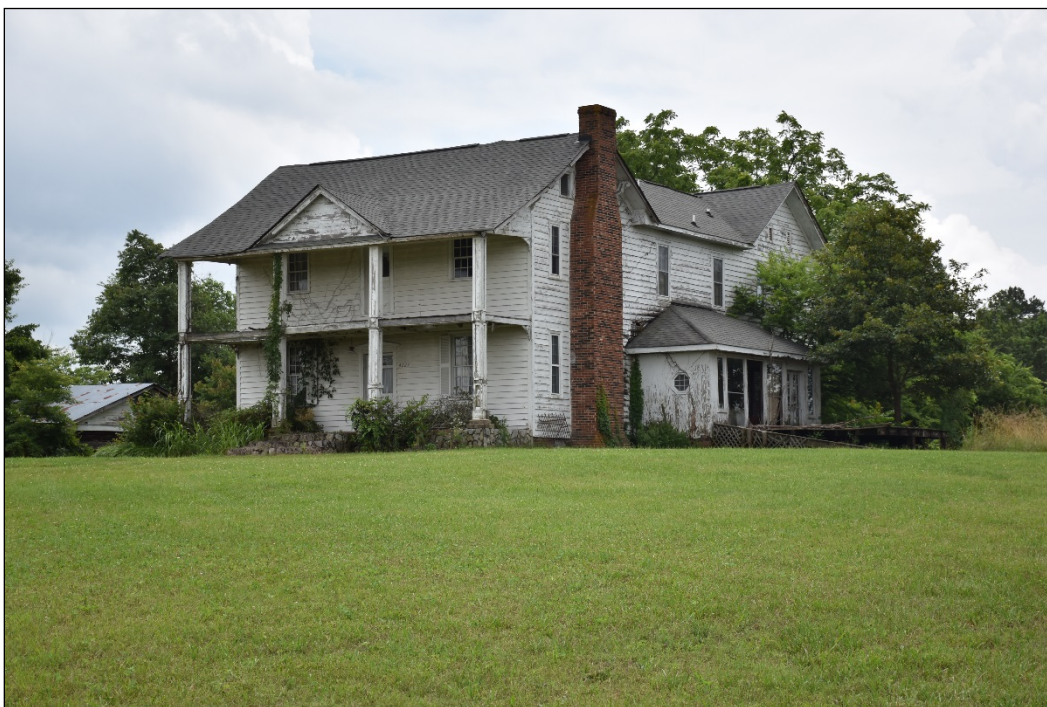
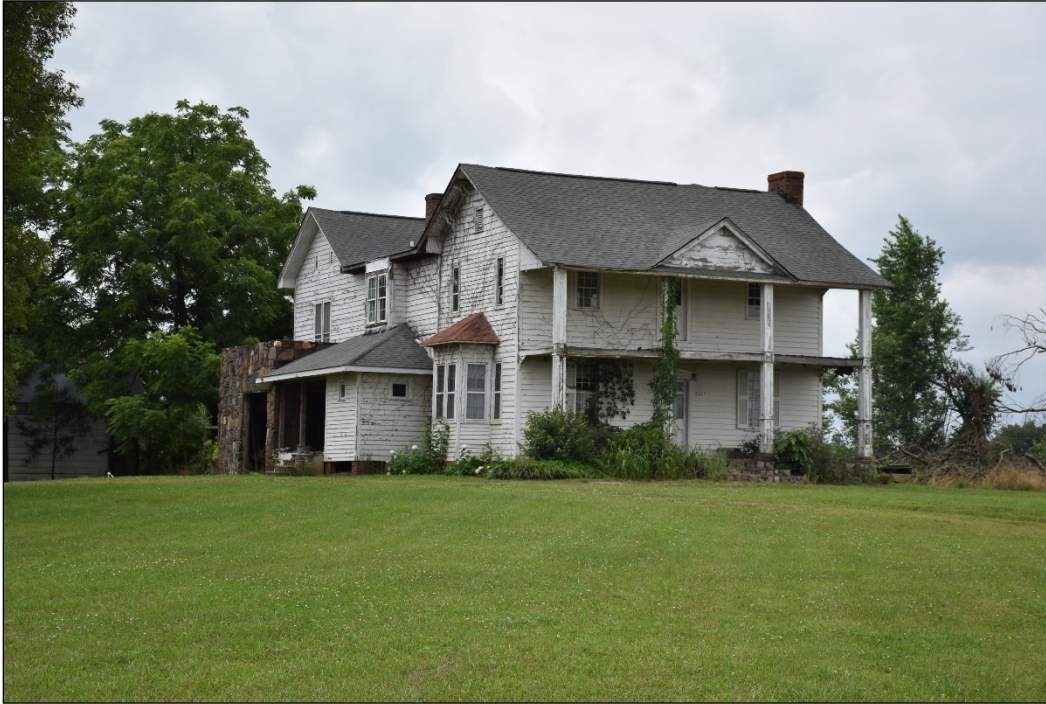
The Maxwell Warlick House (LN0162) is recorded as being on the south side of Reepsville Road, west of its intersection with J. Rhyne Reep Road, at 4227 Reepsville Road, near the central portion of the project corridor (Figure 1.1c and 1.2c). It was recorded in 1984 but was not evaluated for National Register eligibility; the property consists of a circa 1830 frame residence, which was added on to over multiple building periods, that was built for Maxwell Warlick and owned by the Warlick family until the 1970s (Survey File 1984:LN0162). The two-story house has a rectangular plan, with a cross-gabled roofline; the front elevation has a side-gabled section with three bays beneath a two-story front porch (Figure 4.34). The central door, which has a broken pedimented surround, is flanked by a single nine-over-nine, double-hung, wooden sash window on either side; the upper story also has a central door, flanked by a single six-over-six, double-hung, wooden sash window on either side. The porch is created by an overhang of the main roofline and is supported on both levels with square, paneled columns; a central gable is located within the porch roof. A two-story, front-gabled section connects the front portion of the structure to a second side-gabled, rear section. The western elevation of the front portion has an exterior brick chimney flanked by six-over-six and six-over-four, double-hung, wooden sash windows; the remaining windows on the western elevation are four-over-four, double-hung, wooden sashes and there is a single story, hipped roof addition in the center portion of this elevation. The eastern elevation has a three-sided, hip-roofed projecting bay on the first elevation and six-over-four, double-hung, wooden sash windows on the upper story; a single story, hipped roof porch has been partially enclosed on this portion and a stone addition has been built behind it (Figure 4.35). The house is covered with wooden weatherboard siding and the roof is asphalt shingles. Since the 1984 survey, the house has had brackets and gable detailing removed and the porch supports reconstructed; the two-story rear side-gabled portion and stone addition were constructed between 1973 and 1984. The house retains integrity of location, setting, and feeling, as well as association, but the porch alterations and additions have compromised the integrity of design, materials, and workmanship. The structure does not represent a significant event or period in history, is not associated with a significant person, and is not a significant example of a particular architectural style; therefore, it is recommended as ineligible for inclusion in the NRHP.

**Figure 4.34. Maxwell Warlick House (LN0162), facing southeast.**

**Figure 4.35. Maxwell Warlick House (LN0162), facing southwest.**

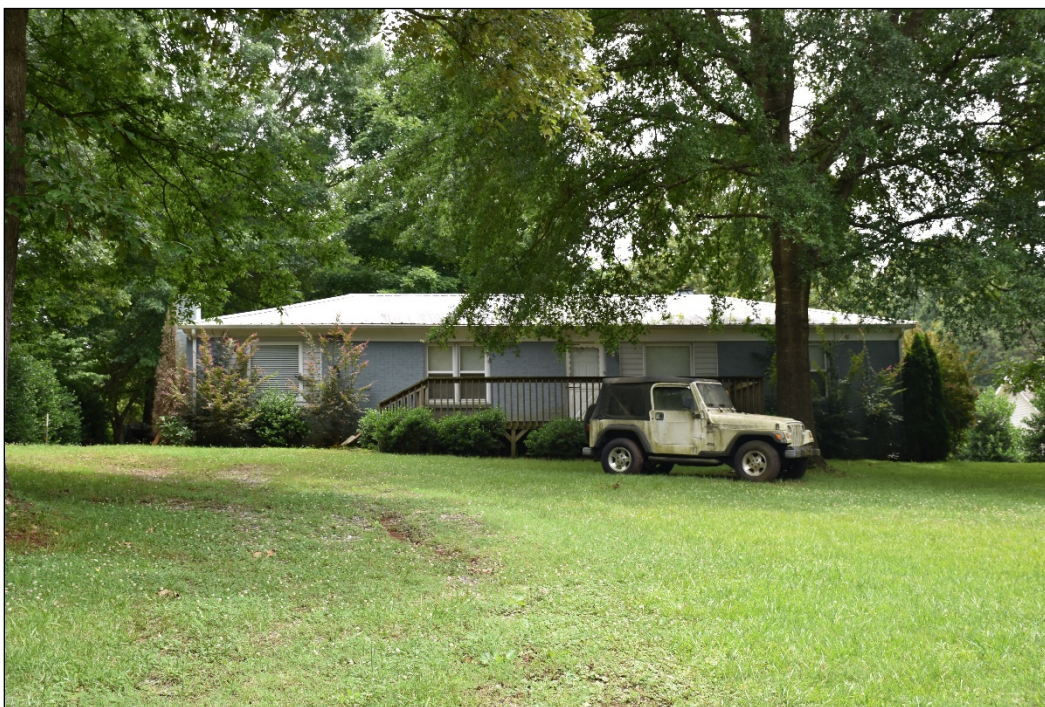
**Figure 4.39. Cook House (LN0826), facing southeast.**

The Cook House (LN0826) is a circa 1960 residence that is located at 3591 Reepsville Road, along the central portion of the proposed project corridor (Figures 1.1d and 1.2d). The house is a one-story, Ranch-style structure with a rectangular plan and hipped roof (Figure 4.39). The front elevation is five bays wide, with a roughly central entry door located beneath the main roofline; the door is flanked by a single one-over-one, double-hung, vinyl sash window and single-pane picture window to the west and a paired one-over-one, double-hung, vinyl sash window and single square pane window to the east. The west elevation has a single one-over-one, double-hung, vinyl sash window, while the eastern elevation has an exterior chimney. The house has a brick veneer exterior,

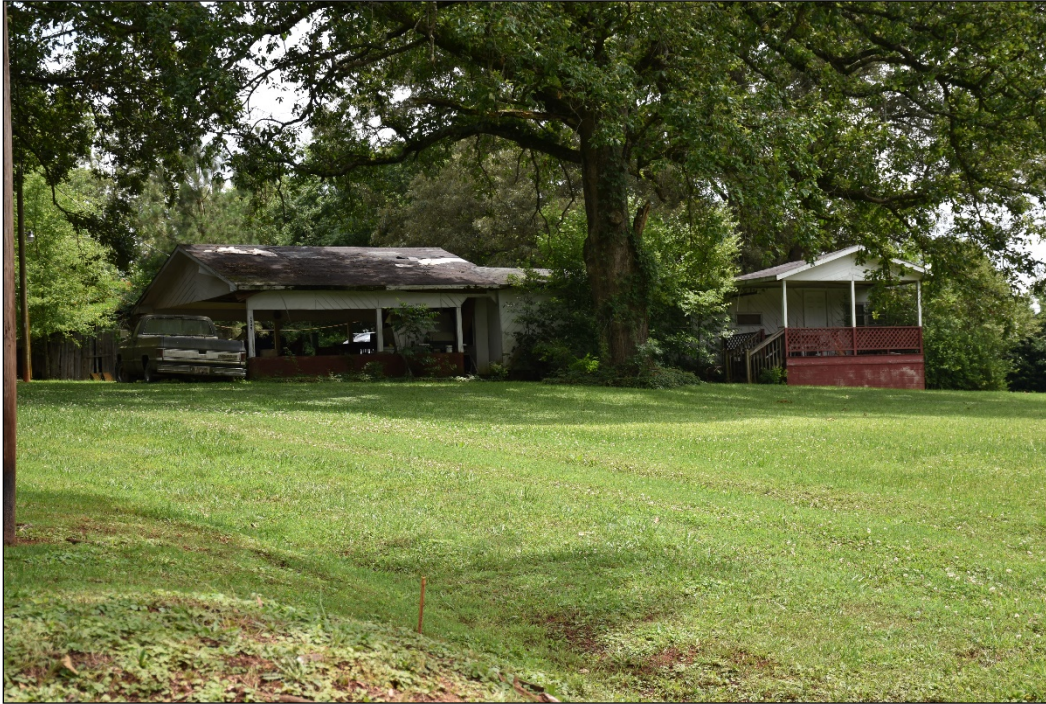
**Figure 4.42. Wood House (LN0829), facing southeast.**

The Wood House (LN0829) is a circa 1965 residence that is located at 3549 Reepsville Road, along the central portion of the proposed project corridor (Figures 1.1d and 1.2d). The house is a one-story, prefabricated structure with a rectangular plan and side-gabled roof (Figure 4.42). The front elevation has a door at the western bay, beneath a gabled portico that is supported by square metal posts. The visible fenestration is one-over-one, metal frame windows. A side-gabled carport extension, supported by square wood posts, has been added to the eastern elevation of the house. The exterior of the house is covered with diagonal wooden panel siding and the roof is asphalt shingles. The house is an example of a mid-twentieth century prefabricated residential form; it has lost

integrity of materials with the replacement of the original siding. The house does not represent a significant event or period in history, is not associated with a significant person, and is not a significant example of a particular architectural style; therefore, it is recommended as ineligible for inclusion in the NRHP.
