**North Carolina Department of Natural and Cultural Resources**  
**State Historic Preservation Office**

Re: Reepsville Road Interconnection of City of Lincolnton Water System, Lincoln County, ER 18-4236

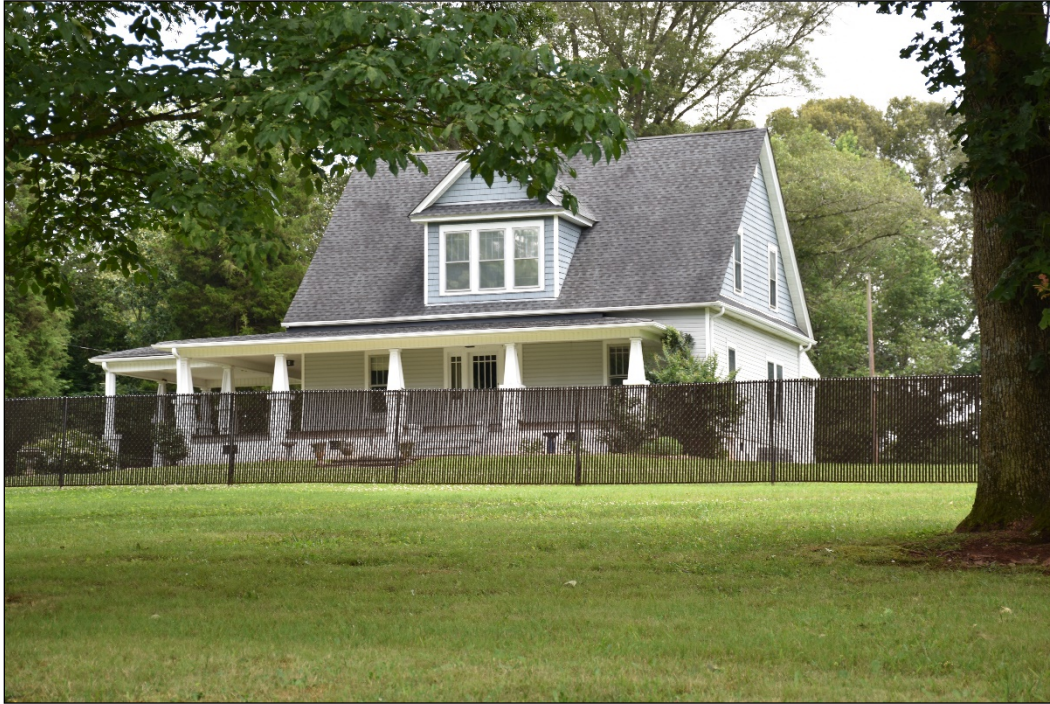
**Figure 4.43. Baxter House (LN0830), facing east.**

The Baxter House (LN0830) is a circa 1930 residence that is located at 3539 Reepsville Road, along the central portion of the proposed project corridor (Figures 1.1d and 1.2d). The house is a one and one-half-story bungalow with a rectangular plan and side-gabled roof (Figure 4.43). The front elevation is three bays wide, with a central entry door, with Prairie-style sidelights, flanked by a single Prairie-style, double-hung, wooden sash windows. A hip-roofed porch, supported by tapered square columns resting on decorative block posts, wraps around the front and east elevations and extends past the east elevation to create a gabled porte-cochere (Figure 4.44). The front elevation has a large gabled dormer, with a ribbon of three Prairie-style, double-hung, wooden sash windows. The side elevations have single and paired Prairie-style, double-hung, wooden sash windows on both the first and second stories. The exterior of the house has horizontal wooden siding on the first story and wooden shingles on the second story and dormer; the roof is composition shingles. The house is good example of an early twentieth century residential form that exhibits elements of both the Craftsman and Prairie styles that were popular contemporary architectural styles; it retains integrity of location, design, materials, workmanship, setting, and feeling. S&ME recommends the Baxter House (LN0830) as eligible for the NRHP under Criterion C, as an example of transitional early twentieth century rural residential architecture. The house is located on a slope, approximately 200 feet from the proposed project corridor and would not be adversely affected by the proposed undertaking.

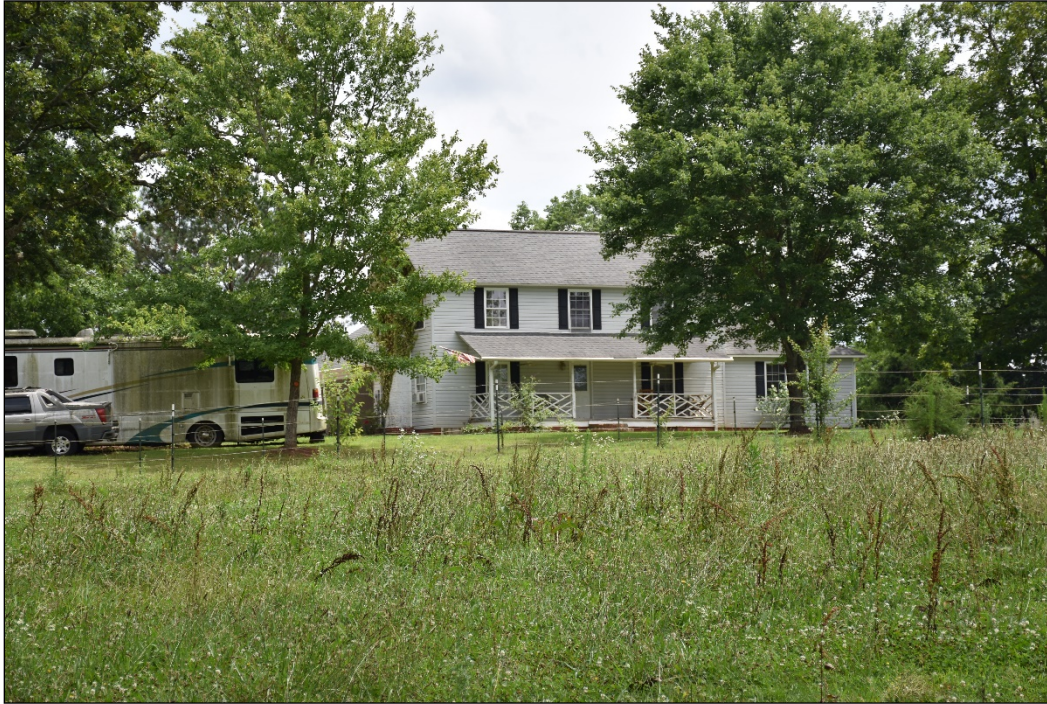
**Figure 4.45. Hardison House (LN0831), facing south.**

The Hardison House (LN0831) is a circa 1875 residence that is located at 3489 Reepsville Road, along the central portion of the proposed project corridor (Figures 1.1d and 1.2d). The structure is an I-house with a side-gabled roofline, which was a common rural vernacular form during the late-nineteenth through early twentieth centuries (Figure 4.45). The front elevation is three bays wide, with a central entry door, flanked by a single six-over-six, double-hung, vinyl sash window on either side; the upper story has three evenly spaced, six-over-six, double-hung, vinyl sash windows. A shed-roofed porch, supported by turned posts with a Chinese Chippendale balustrade, spans most of the front elevation. An exterior chimney is visible along the eastern elevation, flanked by a single six-over-six, double hung window on both the first and second stories. The western elevation has a one-story, hipped roof addition that has paired six-over-six, double-hung, vinyl sash windows. A two-story rear ell is attached to the southwest corner of the house and there is a shed-roofed porch inset between the front section and the rear ell. The house is covered with vinyl siding and the roof is asphalt shingles. The house is a common example of a late nineteenth through early twentieth century rural vernacular residential form; it has lost integrity of design with the large side addition and of materials and workmanship through the replacement siding and windows. The house does not represent a significant event or period in history, is not associated with a significant person, and is not a significant example of a particular architectural style; therefore, it is recommended as ineligible for inclusion in the NRHP.

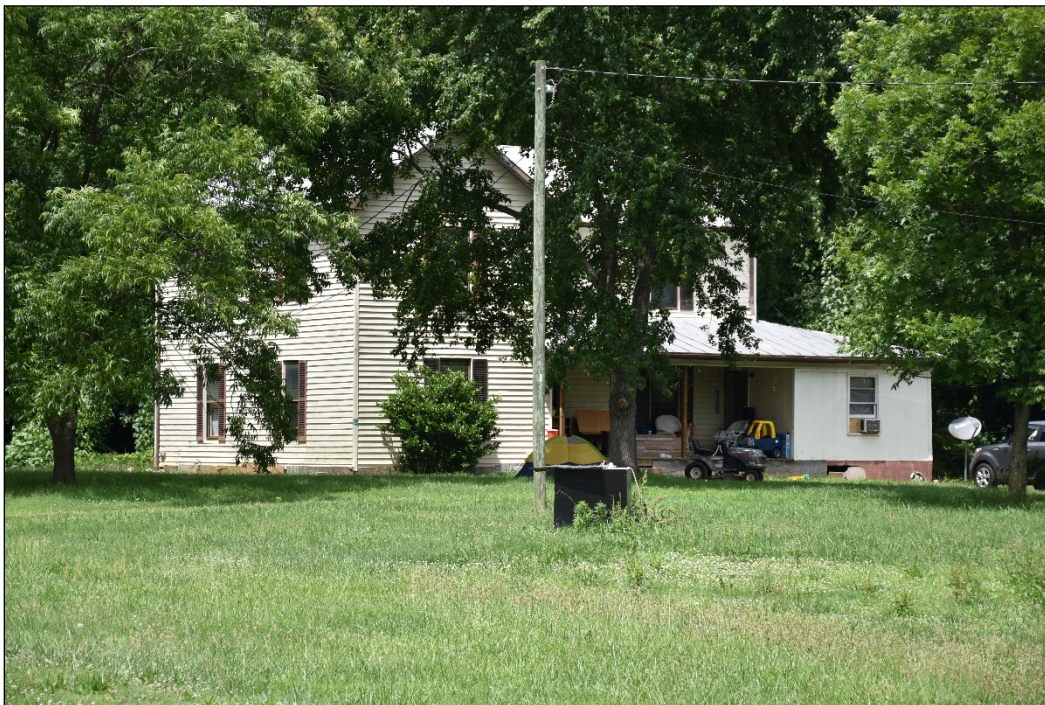
**Figure 4.48. (former) Daniels Lutheran Church Parsonage (LN0163), facing northeast.**

The (former) Daniels Lutheran Church Parsonage (LN0163) is recorded as being on the north side of Reepsville Road, east of its intersection with June Bug Road, at 3260 Reepsville Road, near the central portion of the project corridor (Figure 1.1d and 1.2d). It was recorded in 1984 and, per HPOWEB, was not evaluated for National Register eligibility, although the survey file contains a letter suggesting that it was placed on the North Carolina Study List. The structure was recorded as a two-story, frame residence with a cross-gabled form that was built in 1901–1902 and served as the parsonage for the Daniels Lutheran Church until 1954 (Survey File 1984:LN0163). The house is a two-story, frame structure with T-shaped plan, and cross-gabled roofline, which was a common rural vernacular form during the late-nineteenth through early twentieth centuries (Figure 4.48). The three bay façade has a roughly central entry door, with a single one-over-one, double-hung, vinyl sash window to the east and a single one-over-one, double-hung, vinyl sash window to the west, in the front-gabled section; the upper story also has single one-over-one, double-hung, vinyl sash windows. A hip-roofed porch, which is supported by wooden posts, wraps around the eastern elevation from the inset ell crated from the two gable sections; the eastern portion of the porch has been enclosed and has a single one-over-one, double-hung, vinyl sash window. The east elevation has single one-over-one, double-hung, vinyl sash windows on the first and second stories. The house has a vinyl siding exterior and the roof is covered with tin shingles, although the porch roof is standing-seam metal. Since the 1984 survey, the house has undergone significant exterior alterations, including the replacement of original windows and siding, alterations to the porch supports and enclosure of the porch, and removal of two chimneys. Based on the significant modern changes to the (former) Daniels Lutheran Church Parsonage (LN0163) that have altered its integrity of design, materials, and workmanship, S&ME recommends the structure as ineligible for the NRHP.

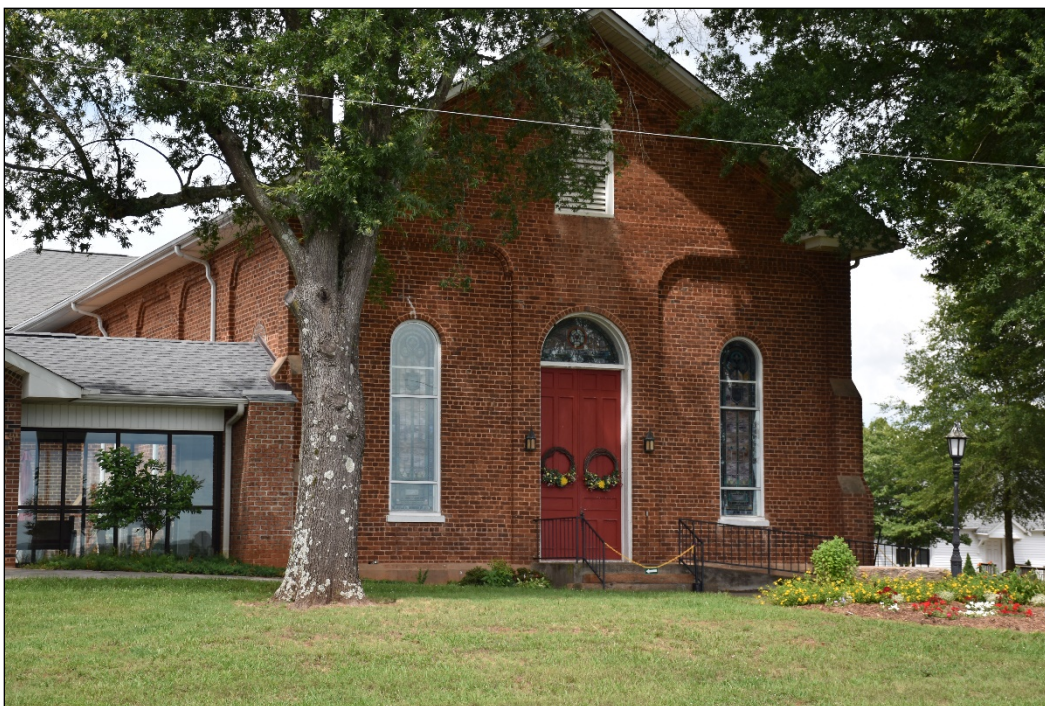
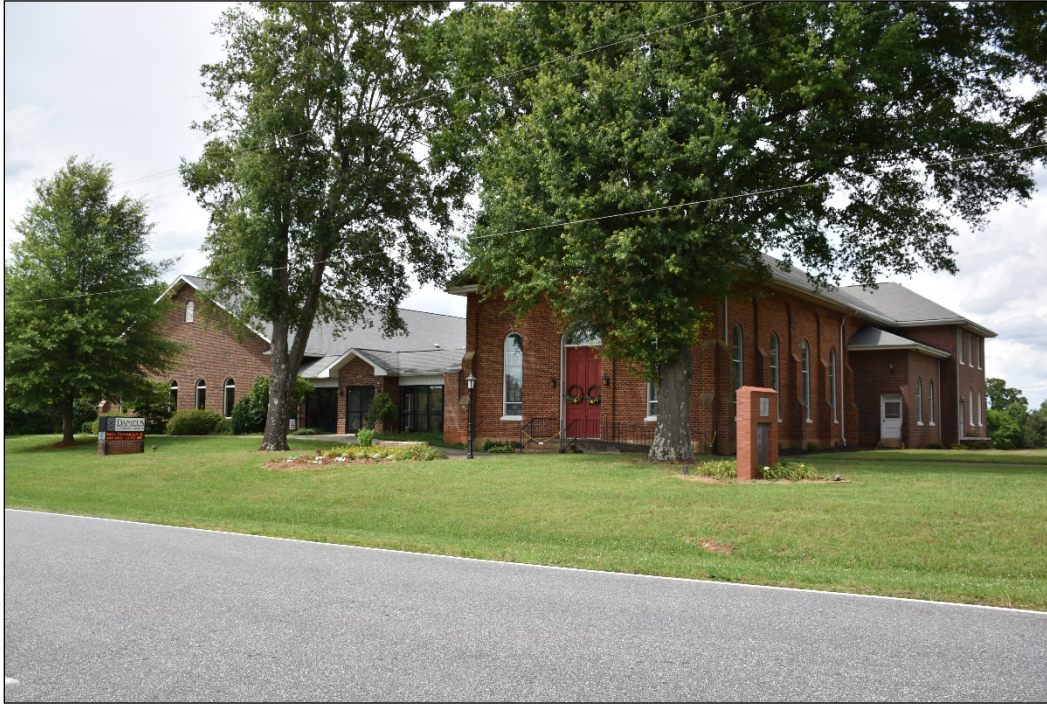
The Daniels Lutheran Church (LN0159) is recorded as being on the north side of Reepsville Road, north of its intersection with Daniel Road, at 3170 Reepsville Road, near the central portion of the project corridor (Figure 1.1d and 1.2d). It was recorded in 1984 and, per HPOWEB, was not evaluated for National Register eligibility, although the survey file contains a letter suggesting that it was placed on the North Carolina Study List. The church was recorded as a front-gabled brick building that was completed in 1889 for the Daniels Lutheran Church congregation with a rear classroom wing that was added in the late 1920s through early 1930s (Survey File 1984:LN0159). The church is a single story masonry structure, laid in American common bond with six rows of stretchers between rows of headers, with a front-gabled, rectangular plan (Figure 4.49). The front elevation is three bays wide, with a central double door with a semi-circular, stained-glass fanlight, flanked by recessed panels each with a semi-circular arched stained-glass window; the gable end has a semi-circular vent and the cornice is corbelled. Along the side elevations, the recessed panels, semi-circular arched stained-glass windows, and corbelled cornices continue, with each panel separated by a buttress. On the north elevation, the 1930s two-story, hip-roofed education annex is visible, along with a vestibule entry (Figure 4.50). A large, modern wing has been added to the church's west elevation, connected by a side-gabled, glass hyphen, built between 2006 and 2008. The only visible exterior alteration to the church since the 1984 survey is the addition, which minimized damage to historic fabric by connecting through a hyphen. Churches are generally not eligible for the National Register except under Criterion C, for architecture. This church is an excellent example of late-nineteenth century rural ecclesiastical architecture that retains integrity of location, design, material, workmanship, setting, and feeling; despite the large addition, the minimal alteration to the original building plan and materials through the use of a hyphen connection did not significantly alter the church's integrity. Therefore, S&ME recommends the Daniels Lutheran Church as eligible for the NRHP under Criterion C; as they are located on the same tax parcel, the Daniels Lutheran Church (LN0159) and the Daniels Evangelical and Reformed Church (LN0160) may be combined into a multi-structure complex that would be NRHP-eligible. The proposed project corridor is located on the south side of the Reepsville Road right-of-way and will not affect the Daniels Lutheran Church.

**Figure 4.49. Daniels Lutheran Church (LN0159), facing north.**

**Figure 4.50. Daniels Lutheran Church (LN0159), facing northwest.**

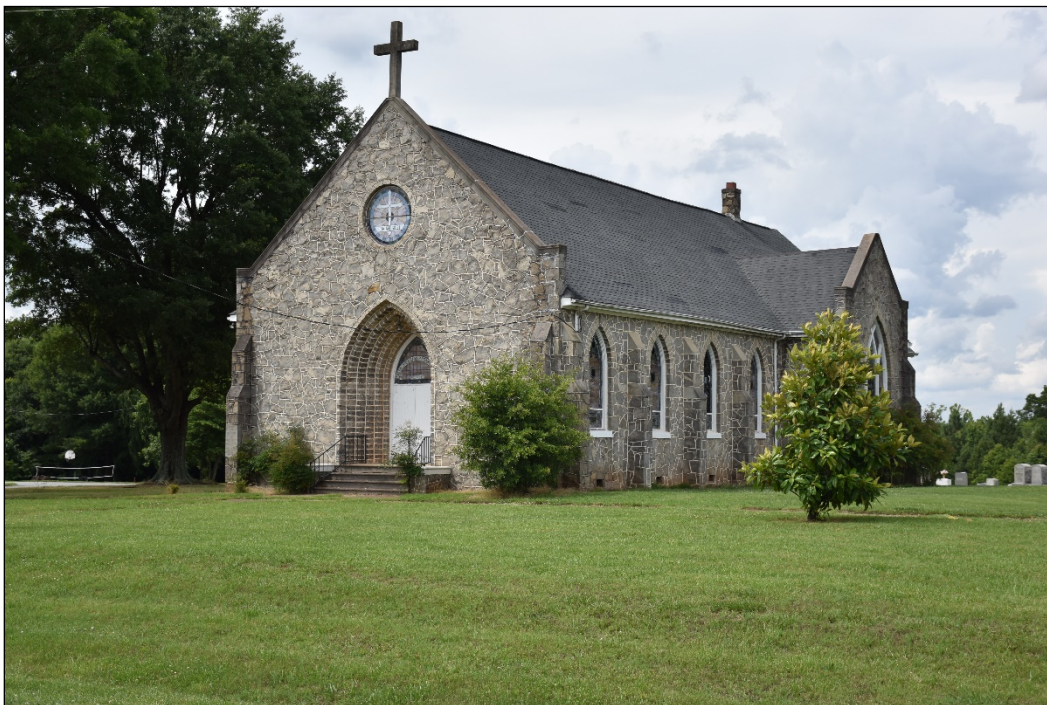
**Figure 4.51. Daniels Evangelical and Reformed Church (LN0160), facing northwest.**

The Daniels Evangelical and Reformed Church (LN0160) is recorded as being on the north side of Reepsville Road, north of its intersection with Daniel Road, at 3170 Reepsville Road, near the central of the project corridor (Figure 1.1d and 1.2d). It was recorded in 1984 but was not evaluated for National Register eligibility; it was identified as a 1936 single story stone church that was built to replace an 1890s brick church that was destroyed by lightning (Survey File 1984:LN0160). The church is a Gothic Revival stone building, with a cruciform plan and gabled roofline (Figure 4.51). The central double entry door, with stained-glass pointed-arch fanlight, is recessed into a stepped arch opening, which has a single, circular stained-glass window above it. The side elevations of the structure each have four pointed-arched stained-glass windows, separated by buttresses, to the south of the side-gabled transepts that create the cruciform plan; the transepts each have a Gothic-style, pointed arch window on its gable end and an entry door on its south elevation; behind the transepts, on the side elevations of the main structure, is a single pointed arch, stained-glass window. Since the 1984 survey, the church appears to have no exterior changes. Churches are generally not eligible for the National Register except under Criterion C, for architecture. This church is an excellent example of a 1930s Gothic Revival ecclesiastical structure that retains integrity of location, design, material, workmanship, setting, and feeling. Therefore, S&ME recommends the Daniels Lutheran Church as eligible for the NRHP under Criterion C; as they are located on the same tax parcel, the Daniels Lutheran

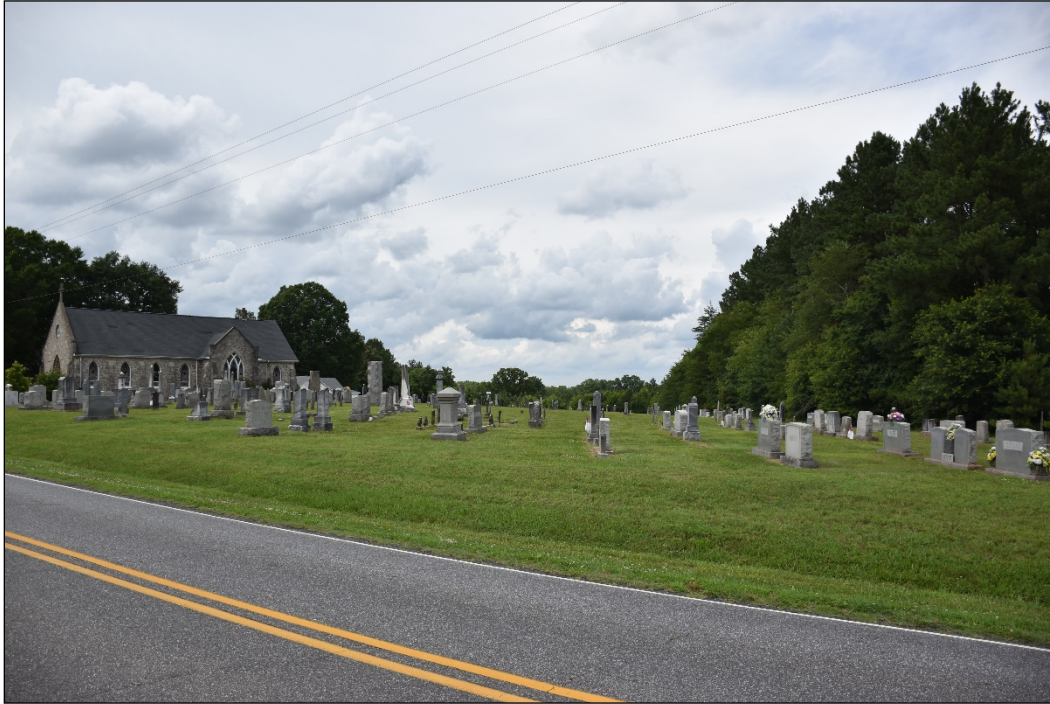
**Figure 4.52. Daniels Church Cemetery, facing northwest.**

Also located on the parcel that includes Daniels Evangelical and Reformed Church (LN0160) is the Daniels Church Cemetery (Figure 4.52). This cemetery has served both the Evangelical Reformed and the Lutheran congregations and is roughly trapezoidal-shaped with graves oriented southwest to northeast; it is roughly 3.5 acres in size. Cemeteries are not usually considered eligible for listing in the NRHP, however, they can be eligible under certain Criteria Considerations, usually Criteria Consideration D. Criteria Consideration D states that: "a cemetery is eligible if it derives its primary significance from graves of persons of transcendent importance, from age, from distinctive design features, or from association with historic events." Due to the distance of this cemetery from the proposed project corridor, approximately 65 feet at the closest point, the cemetery was not evaluated for National Register eligibility. However, cemeteries are protected by state law and avoidance of the cemetery is recommended; as the current project corridor is far enough away that it will not affect the cemetery.

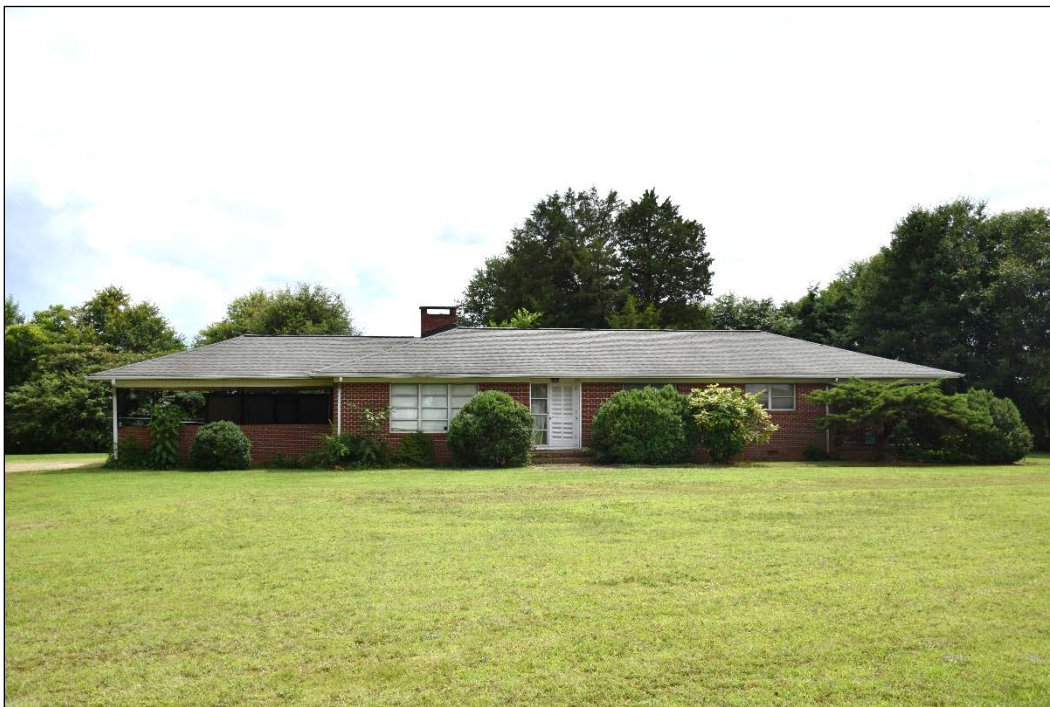
**Figure 4.53. White House (LN0832), facing southeast.**

The house appears to be a well-detailed Ranch and we cannot concur that it is not eligible considering the information provided. Additional information may still result in a recommendation of not-eligible, but the house appears to be unaltered, and a context including comparable examples, as well as an attempt to obtain more history and interior photos are necessary for a complete evaluation. If eligible, the evaluation must include a proposed boundary.

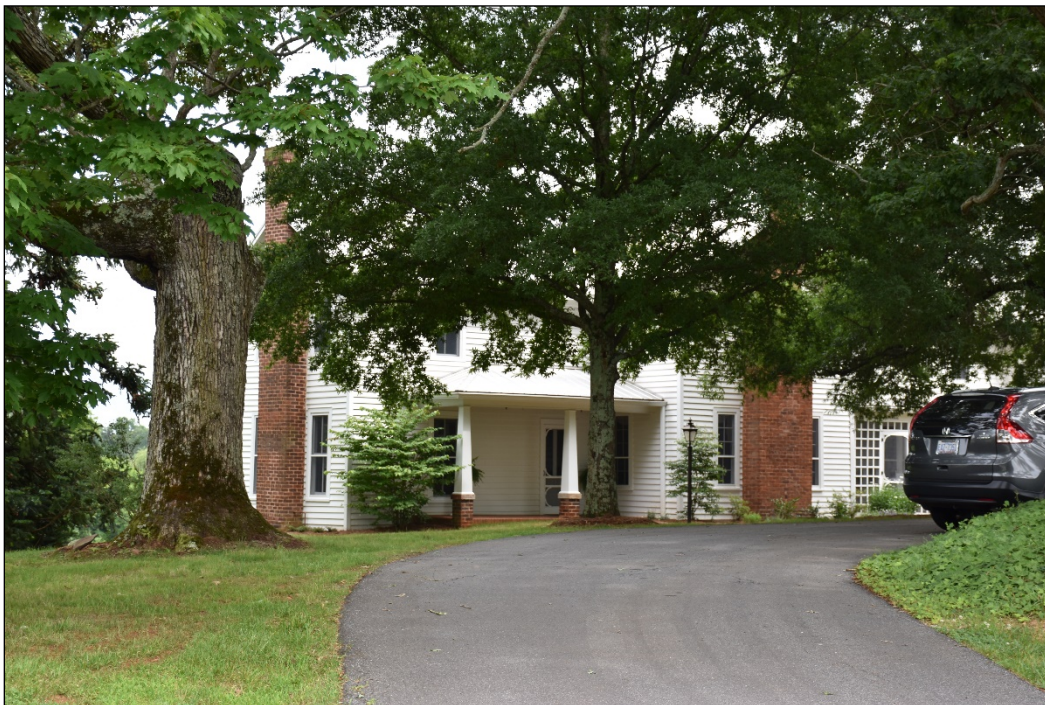
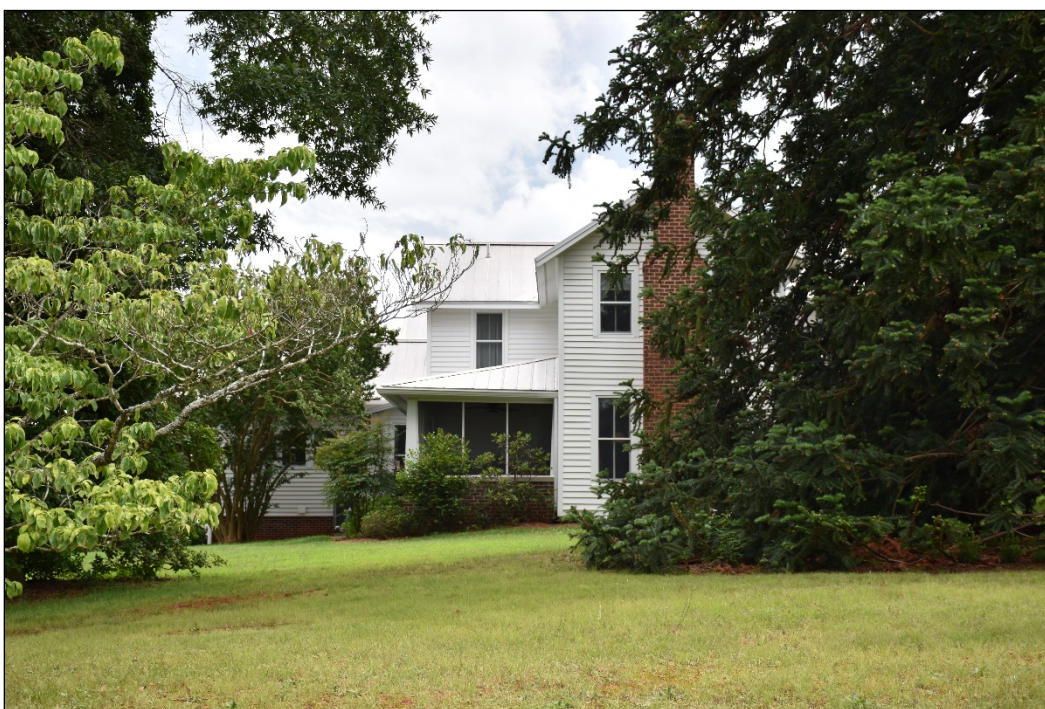
The Yoder Family Farmstead (LN0164) is recorded as being on the southeastern corner of Reepsville Road and Owls Den Road, with an address of 1832 Owls Den Road, near the central portion of the project corridor (Figure 1.1d and 1.2d). It was recorded in 1984 and, per HPOWEB, was not evaluated for National Register eligibility, although the survey file contains a letter suggesting that it was placed on the North Carolina Study List. The main house was recorded as an 1880s frame residence that had been expanded during the early twentieth century, along with agricultural outbuildings, that was constructed for farmer William Yoder (Survey File 1984:LN0164). The tax parcel on which the main house stands encompasses 164.25 acres, and includes the property at all four corners of the intersection. The house is a two-story, T-shaped structure with a cross-gabled roofline that is the result of multiple building periods (Figures 4.54 and 4.55). The front elevation has a side-gabled section, which is two bays wide and contains the entry door, beneath a hip-roofed porch supported by tapered posts on brick piers, intersects the front-gabled section, which has an exterior chimney flanked by a single six-over-four, double-

**Figure 4.54. Yoder Family Farmstead (LN0164), main house, facing southeast.**

**Figure 4.55. Yoder Family Farmstead (LN0164), main house, facing south.**

hung, wooden sash window on either side; the remaining windows on the front elevation are two-over-two, double-hung, wooden sashes. The north elevation of the house has an exterior chimney, flanked by a single two-over-two, double-hung, wooden sash window on either side of both the first and second stories. The rear elevation has a hip-roofed porch inset between the two gabled sections, which has been enclosed. A single story addition is visible along the east elevation and there is also a two-story addition, which connects to a second front-gabled section, along the south elevation. The house is covered with aluminum siding and the roof is composition shingles. In addition to the main house, there are a number of early twentieth century outbuildings located along Owls Den Road, including three barns and a granary, as well as an early twentieth century garage (Figure 4.56). Across Reepsville Road, to the northwest, is a second residence. It is a single story, cross-gabled structure with single and paired Prairie-style, double-hung wooden sash windows, a shed-roofed front porch supported by tapered square columns on brick piers, and a single story rear ell; it has aluminum siding and a standing-seam metal roof (Figure 4.57). The siding is wooden weatherboard and the roof is standing-seam metal. Additional outbuildings, including chicken coops and a storage shed, are located northeast of the single story house (Figure 4.58). Since the 1984 survey, the main house on the Yoder Family Farmstead has undergone a large expansion, with the addition of a second story on the single story south addition and the addition of a second front-gabled section; this likely also resulted in interior design changes. The house is an example of the development of a rural farmhouse, adapted to meet the needs of a growing family, and the agricultural structures represent a rural farmstead from the late-nineteenth through the mid-twentieth centuries. However, the loss of historic design, material, and workmanship on the primary residential structure has compromised the integrity of the farmstead and altered its feeling and associations. Therefore, the Yoder Family Farmstead (LN0164) is recommended as ineligible for the NRHP.

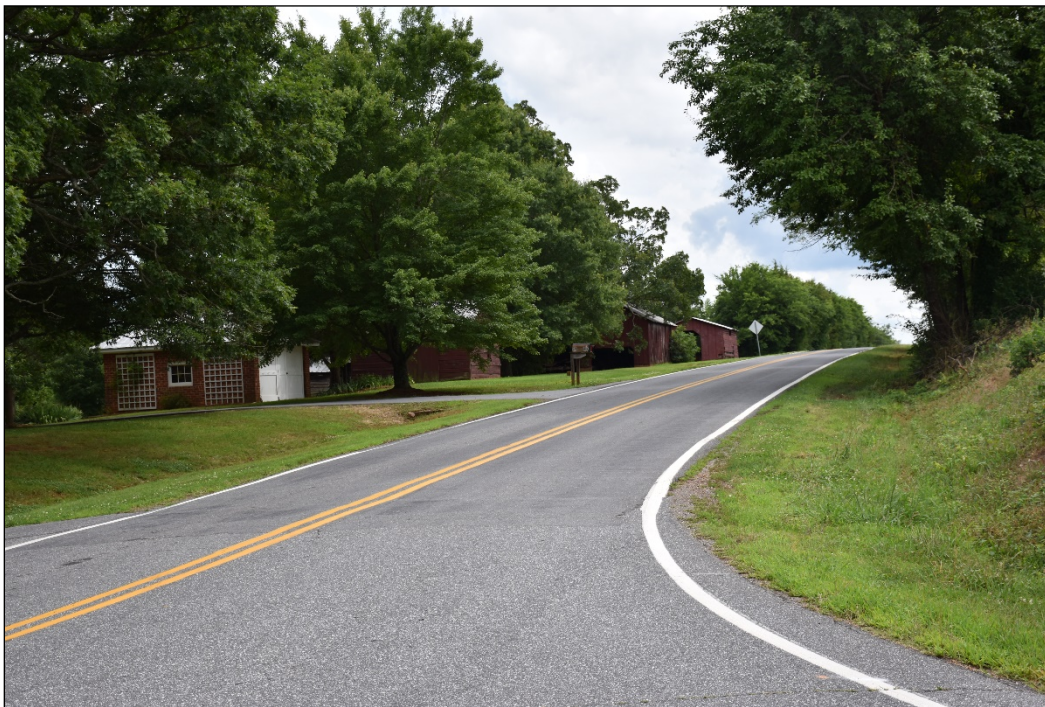
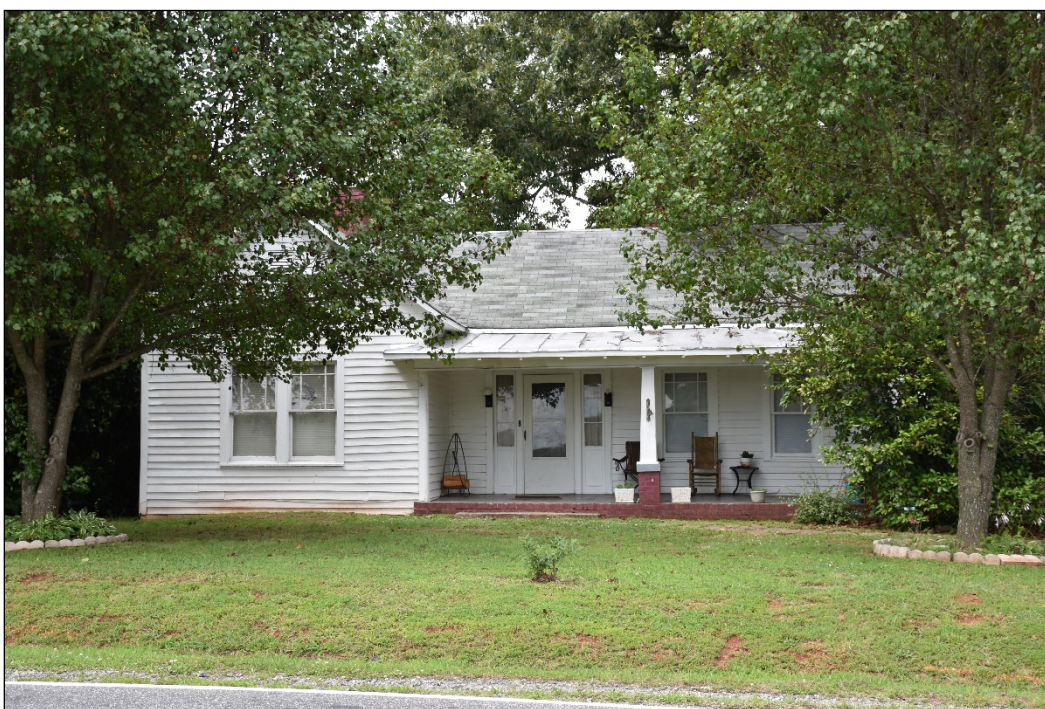
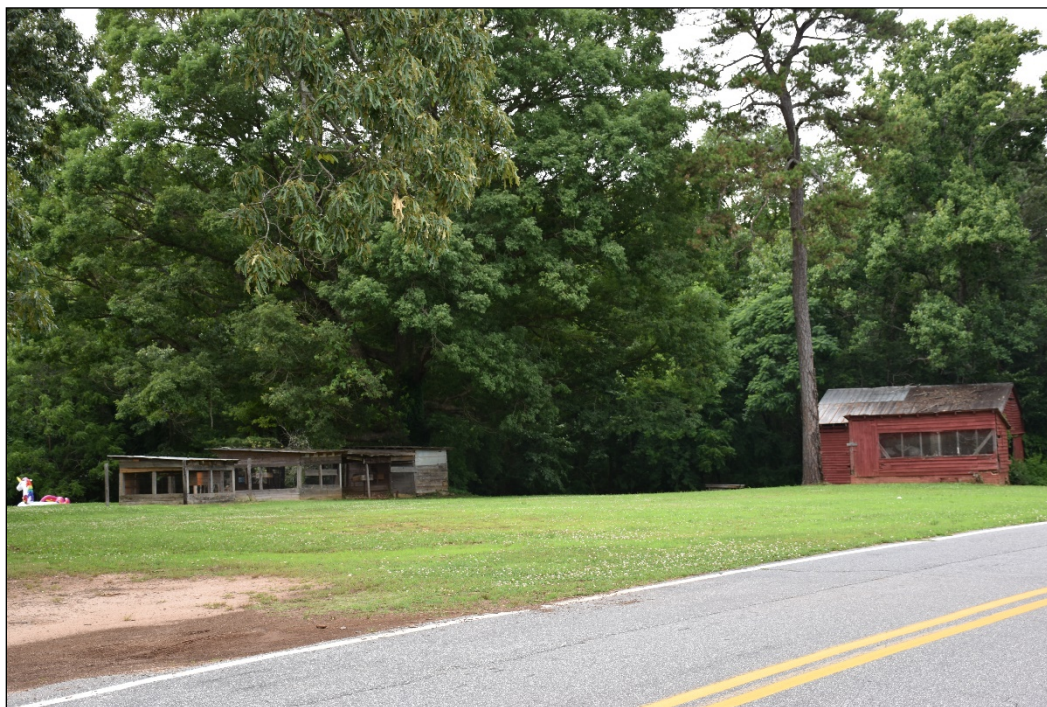
**Figure 4.56. Yoder Family Farmstead (LN0164), outbuildings, facing southeast.**

**Figure 4.57. Yoder Family Farmstead (LN0164), one-story house, facing north.**

**Figure 4.58. Yoder Family Farmstead (LN0164), outbuildings, facing north.**

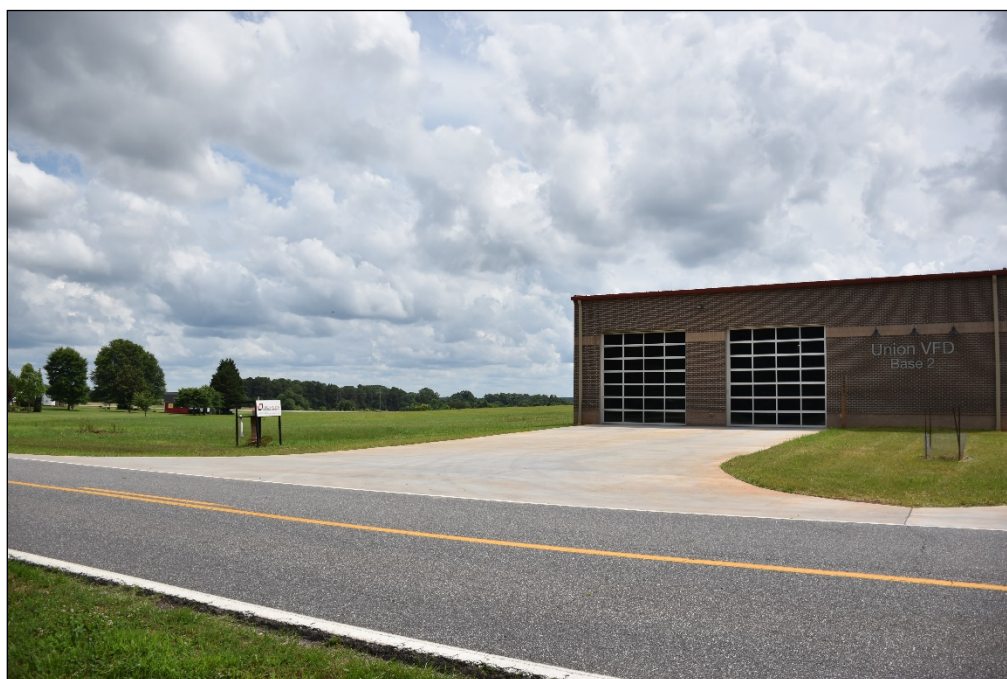
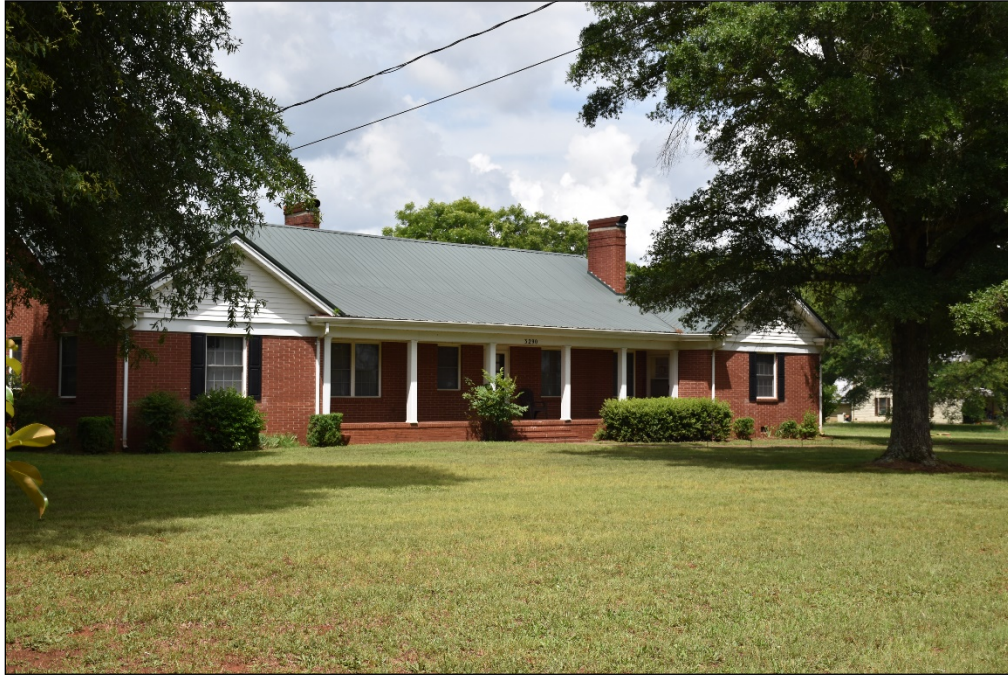
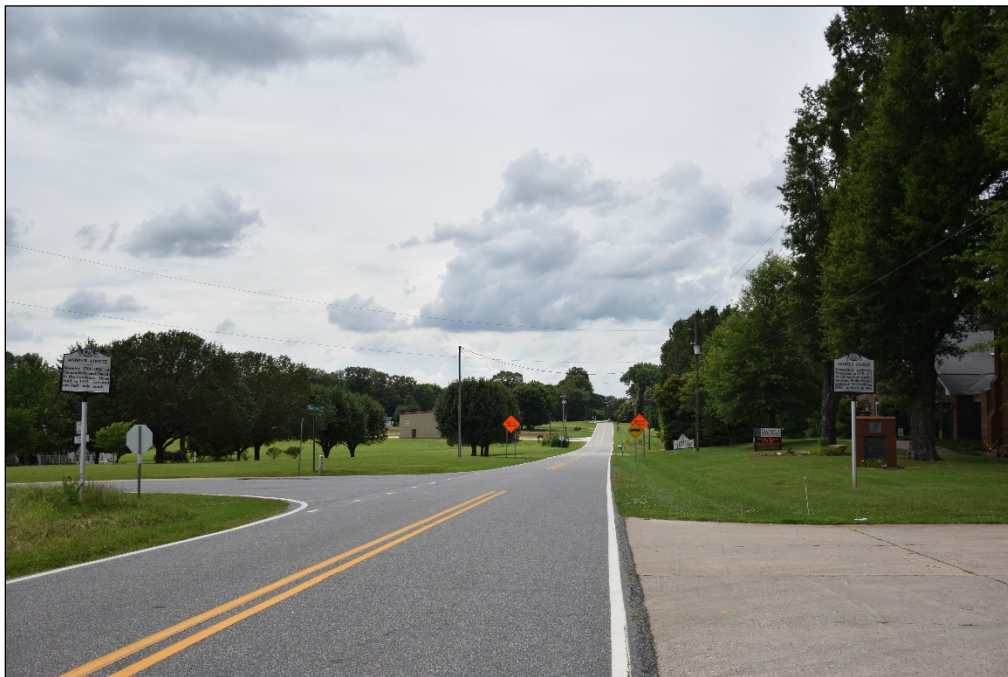
The Daniels Historic District (LN0606) is identified in HPOWEB as being a Study List Historic District, with its center at the intersection of Reepsville Road and Daniels Road; the survey file for the district is limited, consisting of only a copy of the recommendations of the National Register Review Committee listing the Daniels Historic District as being placed on the Study List. There is no listing of included properties and no identification of potential boundaries. Based on a review of previously recorded properties in the area, it seems likely that a potential Daniels Historic District would span from the Heavner-Bangle House (LN0157) to the Yoder Family Farmstead (LN0164) and include the Heavner-Bangle House (LN0158), the Daniels Lutheran Church (LN0159), the Daniels Evangelical and Reformed Church (LN0160), and the (former) Daniels Lutheran Church Parsonage (LN0163). As part of the fieldwork, S&ME revisited each of these properties and also evaluated other parcels within the area between the Heavner-Bangle House (LN0157) and the Yoder Family Farmstead (LN0164). Based on the assessment of the six previously recorded resources within the proposed Daniels Historic District boundary, there has been a loss of two of the structures (LN0157 and LN0158) and significant loss of integrity for two others (LN0163 and LN0164). This, combined with the lack of other resources from the late-nineteenth through early twentieth century period and the modern infill between the six recorded properties (Figures 4.53, and 4.59 through 4.61), has made for a non-coherent district boundary. The portion of the district that retains integrity, the central section, contains the two church structures that are recommended as individually eligible for the NRHP (LN0159 and LN0160), or as a multi-structure complex that encompasses both churches. Based on these factors, S&ME recommends the Daniels Historic District as ineligible for inclusion in the NRHP.

**Figure 4.59. Modern infill and undeveloped land within the Daniels Historic District (LN0606), facing southeast.**

**Figure 4.60. Modern infill within the Daniels Historic District (LN0606), facing northeast.**

**Figure 4.61. Intersection of Reepsville Road and Daniels Road, Daniels Historic District (LN0606), facing west.**

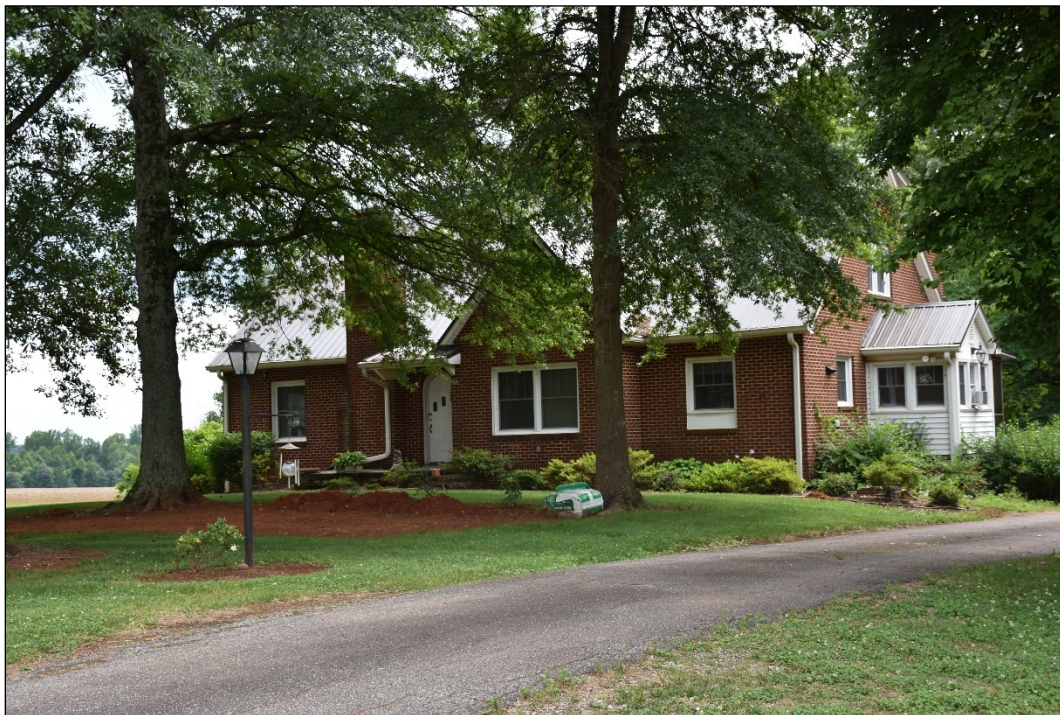
**Figure 4.62. Connor House (LN0833), facing south.**

The Connor House (LN0833) is a circa 1947 residence that is located at 2789 Reepsville Road, along the eastern portion of the proposed project corridor (Figures 1.1e and 1.2e). The house is a one and one-half-story cottage-style structure with nominal Tudor Revival details; it has a rectangular plan and cross-gabled roof (Figure 4.62). The front elevation is four bays wide, with an off-center, arched entry door that is located beneath a shed-roofed portico that is supported by brackets; to the west of the door is a front-gabled section that projects slightly, with a paired eight-over-one, double-hung, wooden sash window, and a single eight-over-one, double-hung, wooden sash window, while to the east of the door is a dominant exterior brick chimney and a single eight-over-one, double-hung, wooden sash window. The west elevation has a single one-over-one, double-hung, vinyl sash window and a one-story, gabled addition, as well as a paired one-over-one, double-hung, vinyl sash window centered within the gable end. The east elevation has two sets of triple eight-over-one, double-hung, wooden sash windows. The house is good example of an early twentieth century residential form with basic Tudor Revival detailing; although it retains its integrity of location, design, materials, workmanship, setting, and feeling, it does not represent a significant event or period in history, is not associated with a significant person, and is not a significant example of a particular architectural style. Therefore, it is recommended as ineligible for inclusion in the NRHP.

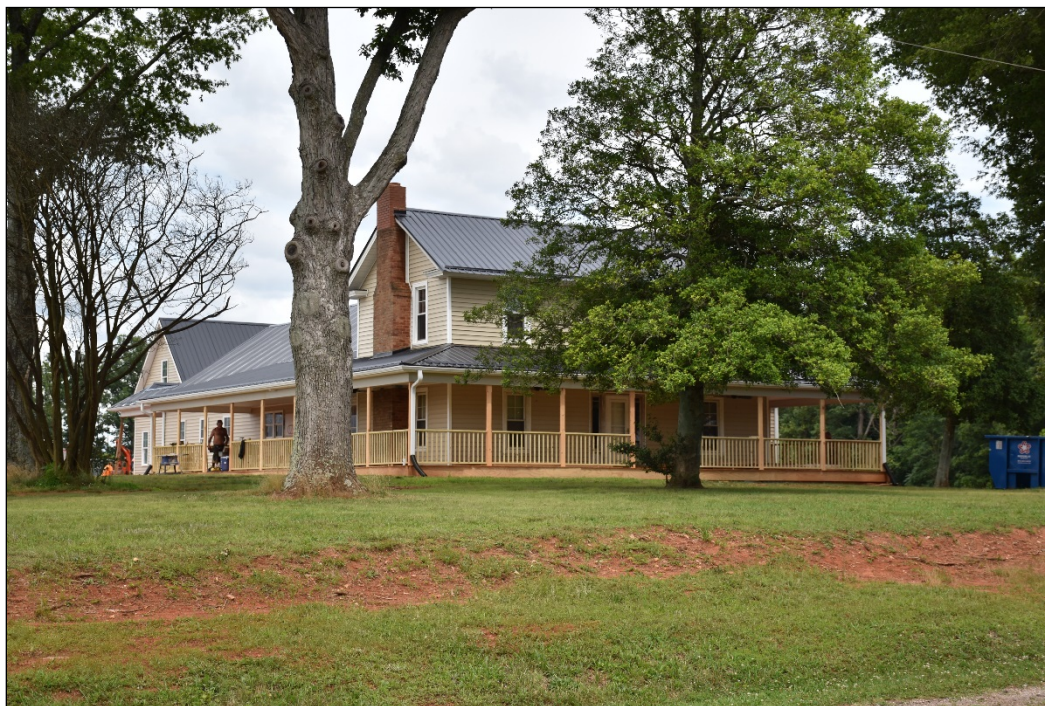
**Figure 4.63. A. A. Killian House (LN0165), facing north.**

The A. A. Killian House (LN0165) is recorded as being on the north side of Reepsville Road, at 2782 Reepsville Road, near the eastern portion of the project corridor (Figure 1.1e and 1.2e). It was recorded in 1984 and, per HPOWEB, was not evaluated for National Register eligibility, although the survey file contains a letter suggesting that it was placed on the North Carolina Study List. The structure was recorded as a two-story, frame residence with side-gabled roofline and rear ell that was built around 1884 (Survey File 1984:LN0165). The house is a two-story, frame I-house form with a symmetrical façade and exterior end chimneys on both gable ends (Figure 4.63). The central entry door, with sidelights, is flanked by a single four-over-one, double-hung, vinyl sash window on either side; the upper story of the front elevation has three single four-over-one, double-hung, vinyl sash windows. A hip-roofed porch spans the front elevation and wraps around the north elevation of the house. The single story rear ell addition, at the northwest corner, connects to a second addition at the rear of the structure. Since the 1984 survey, the house has undergone significant alteration, including the removal of original siding and windows and the extension of the original porch to wrap around the house. The house is a common example of a rural vernacular form that has multiple exterior alterations that have compromised the integrity of design, material, and workmanship. Therefore, S&ME recommends the A. A. Killian House (LN0165) as ineligible for the NRHP.

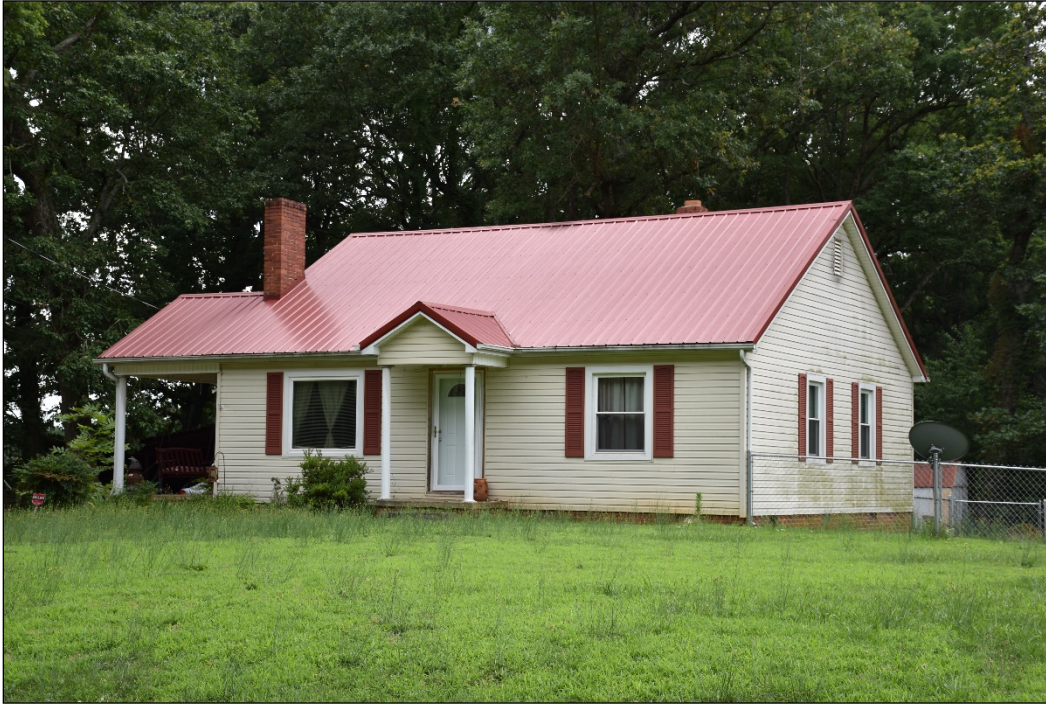
**Figure 4.64. Leonard House (LN0834), facing southwest.**

The Leonard House (LN0834) is a circa 1949 residence that is located at 2695 Reepsville Road, along the eastern portion of the proposed project corridor (Figures 1.1e and 1.2e). The house is a one-story, Minimal Traditional style residence, with a side-gable roof (Figure 4.64). The front elevation is three bays wide, with a central entry door, located beneath a gabled portico that is supported by round columns; to the west of the door is a single one-over-one, double-hung, vinyl sash window and to the east is a single pane picture window. The west elevation has two single one-over-one, double-hung, vinyl sash windows. The eastern elevation has a gabled extension, supported by round columns, shading a secondary entry door and single one-over-one, double-hung,

vinyl sash window, which flank an exterior brick chimney; this elevation also has a paired one-over-one, double-hung, vinyl sash window and there is a shed-roofed addition along the rear addition that is visible along the east elevation. The exterior of the house has vinyl siding and the roof is standing-seam metal. The house an example of a common mid-twentieth century residential form; it has lost integrity of materials and workmanship through the replacement of windows and siding. The house it does not represent a significant event or period in history, is not associated with a significant person, and is not a significant example of a particular architectural style. Therefore, it is recommended as ineligible for inclusion in the NRHP.

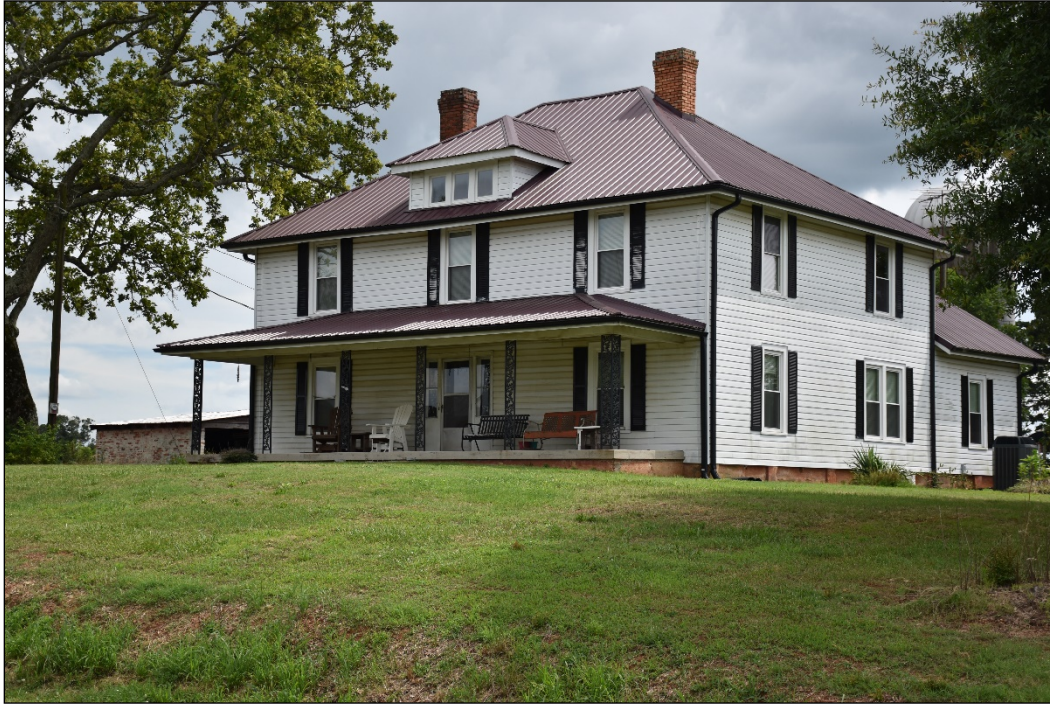
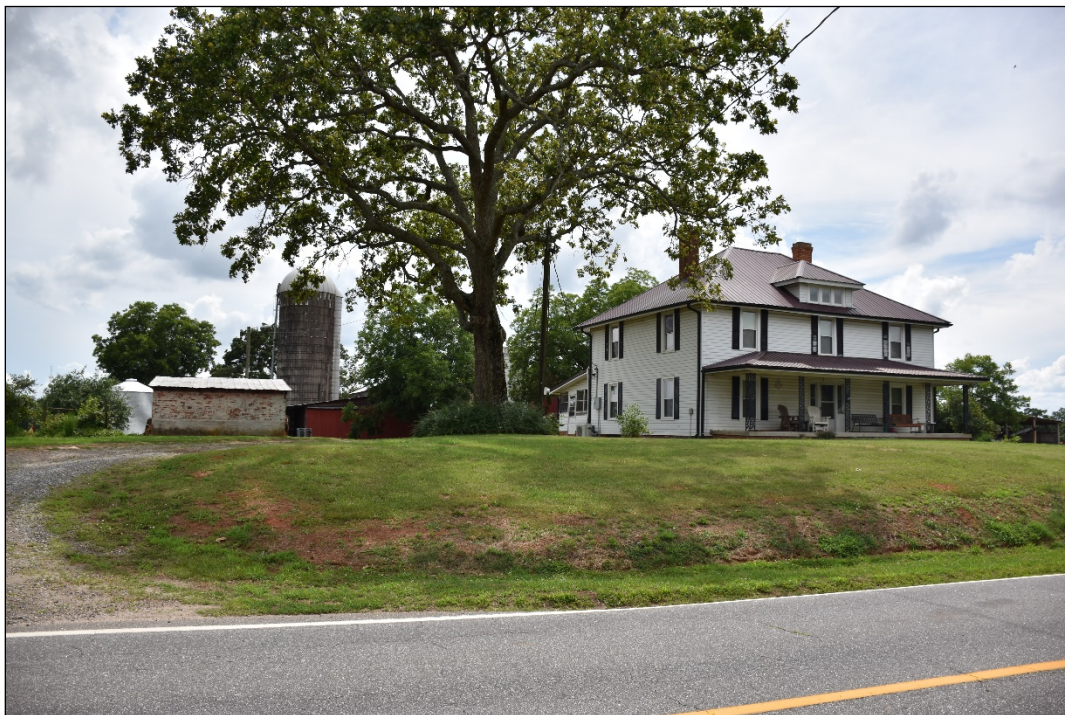
The Leonard House (LN0835) is a circa 1922 residence that is located at 2615 Reepsville Road, along the eastern portion of the proposed project corridor (Figures 1.1e and 1.2e). The house is a two-story, hip-roofed vernacular form with a rectangular plan (Figure 4.65). The front elevation is symmetrical, with three bays; the central entry door, with two-pane sidelights, is flanked by a single one-over-one, double-hung, vinyl sash window on either side. A hip-roofed porch, supported by decorative metal posts, spans the front elevation; above the porch, the second story has three evenly-spaced one-over-one, double-hung, vinyl sash windows. A hip-roofed dormer is centered within the front elevation and features three single-pane, vinyl frame, casement windows. The north elevation has one single and one paired one-over-one, double-hung, vinyl sash window on the first story and two single one-over-one, double-hung, vinyl sash windows on the upper story; a single story, gabled rear addition, with a single one-over-one, double-hung, vinyl sash window. The south elevation of the house has two single one-over-one, double-hung, vinyl sash windows on each story and an enclosed shed-roofed rear porch at the southeast corner (Figure 4.66). There are two symmetrical interior brick chimneys visible above the roofline. The

**Figure 4.65. Leonard House (LN0835), facing south.**

**Figure 4.66. Leonard House (LN0835), facing west.**

house was built on a brick pier foundation, which has been infilled; the exterior of the house has vinyl siding and the roof is standing-seam metal. East of the house are a number of early to mid-twentieth century agricultural outbuildings, including a wooden gabled barn, a concrete stave silo, and a brick milk house. The house is an example of a common rural vernacular form that has little remaining architectural detailing; it has lost integrity of materials and workmanship through the replacement of windows and siding. The house does not represent a significant event or period in history, is not associated with a significant person, and is not a significant example of a particular architectural style. Therefore, it is recommended as ineligible for inclusion in the NRHP.
