**North Carolina Department of Natural and Cultural Resources**  
**State Historic Preservation Office**

Re: Reepsville Road Interconnection of City of Lincolnton Water System, Lincoln County, ER 18-4236

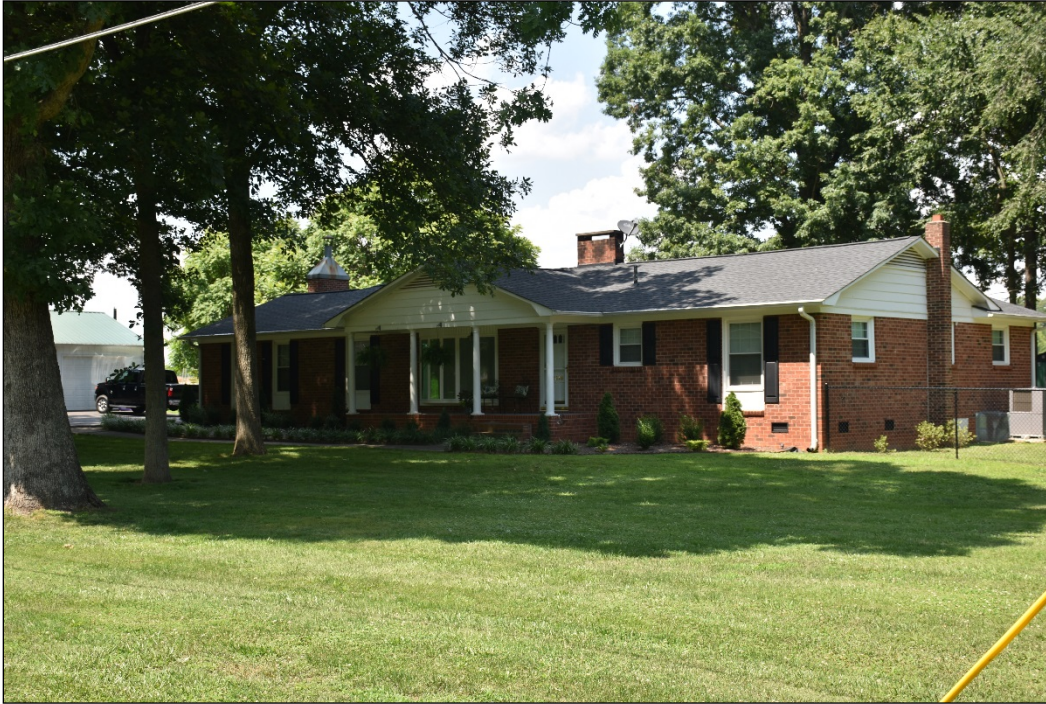
**Figure 4.69. Webb House (LN0837), facing northeast.**

The Webb House (LN0837) is a circa 1965 residence that is located at 2418 Reepsville Road, along the eastern portion of the proposed project corridor (Figures 1.1e and 1.2e). The house is a one-story, stylized Ranch structure with a rectangular plan and side-gabled roof (Figure 4.69). The front elevation is five bays wide, with an off-center entry door located beneath a two-bay, gabled portico that is supported by simple round columns; to the south of the door are two single six-over-six, double-hung, vinyl sash windows, one smaller than the other, and to the north is a bowed bay window with five vertical panes and a six-over-six, double-hung, vinyl sash window. Two additional bays to the north are single six-over-six, double-hung, vinyl sash windows that are part of the attached, side-entry garage. The south elevation has two small single six-over-six, double-hung, vinyl sash windows; on

Ranch-style residences these smaller windows generally denote private interior spaces, such as bedrooms. A hip-roofed addition is visible along the rear elevation. The house has a brick veneer exterior, although the gable ends are covered with vinyl siding, and the roof is composition shingles. The house is a common example of an early to mid-twentieth century residential form; it has lost integrity of materials and workmanship through the replacement of the original windows. The house does not represent a significant event or period in history, is not associated with a significant person, and is not a significant example of a particular architectural style; therefore, it is recommended as ineligible for inclusion in the NRHP.

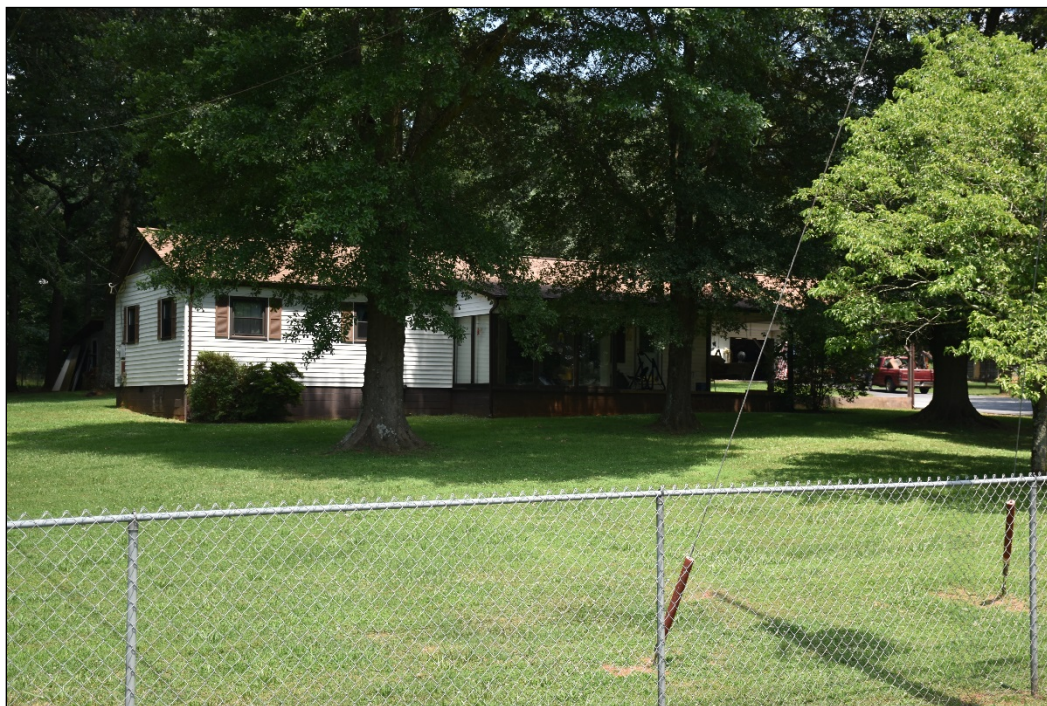
**Figure 4.73. Carpenter House (LN0841), facing southeast.**

The Carpenter House (LN0841) is a circa 1960 residence that is located at 2316 Reepsville Road, along the eastern portion of the proposed project corridor (Figures 1.1e and 1.2e). The house is a one-story, Ranch-style structure with a rectangular plan and side-gabled roof (Figure 4.73). The front elevation is four bays wide; the southern two bays are beneath a shed-roofed porch, which has been partially enclosed with glass panels, while the northern two bays are single one-over-one, double-hung, metal frame windows. The north elevation has two single one-over-one, double-hung, metal frame windows. The southern elevation has a gabled extension supported by metal posts, which creates an open carport. The house rests on a concrete block foundation and has an aluminum siding exterior; the roof, which has an interior brick chimney rising above it, is asphalt shingles. The house is a common example of an early to mid-twentieth century residential form; it has lost integrity of materials and workmanship through the replacement of the original windows and siding. The house does not represent a significant event or period in history, is not associated with a significant person, and is not a significant example of a particular architectural style; therefore, it is recommended as ineligible for inclusion in the NRHP.

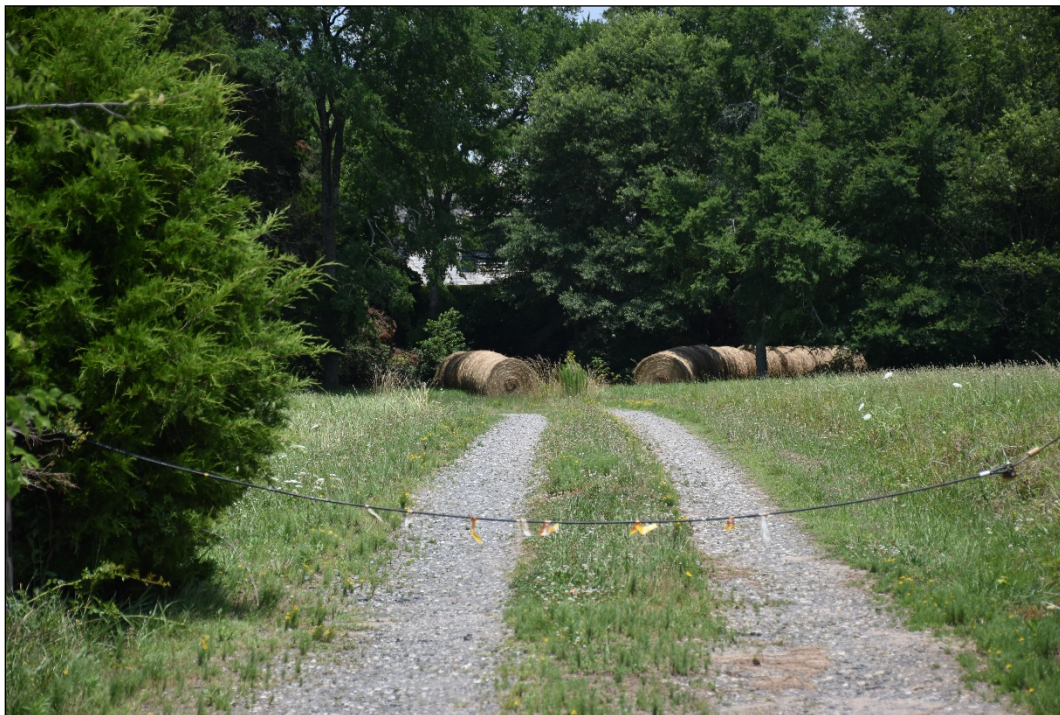
**Figure 4.76. Killian House (LN0843), facing northeast.**

The Killian House (LN0843) is a circa 1900 residence that is located at 1865 Tinsel Trail, along the eastern portion of the proposed project corridor (Figures 1.1f and 1.2f). The house is set back approximately 300 feet from the road, down a private right of way, and is surrounded by vegetation, making it not visible from the public right-of-way (Figure 4.76). Since the Killian House is not visible from Reepsville Road, it was not assessed for NRHP eligibility. However, it is approximately 300 feet from the proposed project corridor and would not be adversely affected by the proposed undertaking.
