SUBJECT: Historic Structures Survey Report, Construct Interchange at I-40 and SR 2500 and Intersection Improvements at NC 9 and SR 2500, I-4409, PA 18-01-0046, Buncombe County, ER 18-4250

**Historic Structures Survey Report  
Interchange Improvements SR  
2500 (Blue Ridge Road) from US 70  
to South of I-40 and South of I-40 to  
SR 2713 (Old Lake Gap Road),  
Buncombe County, North Carolina**

TIP# I-4409  
WBS# 38714.1.2  
PA# 18-01-0046

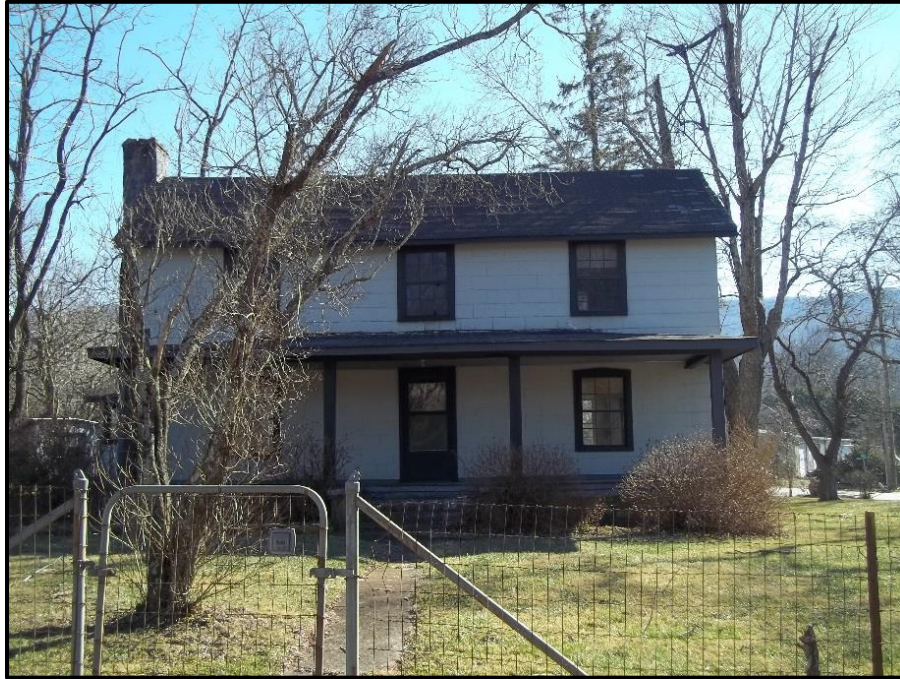
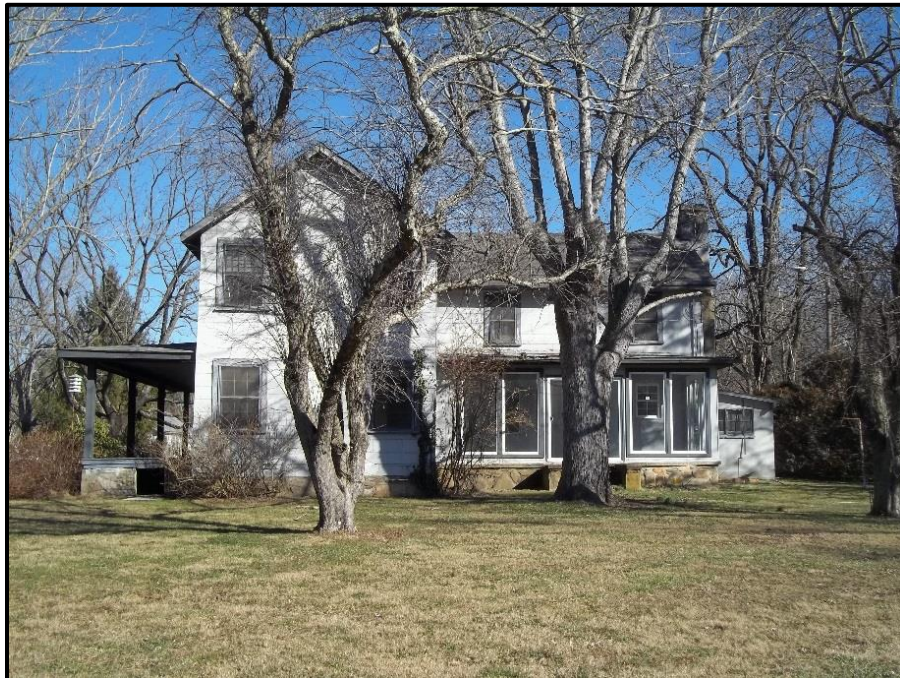
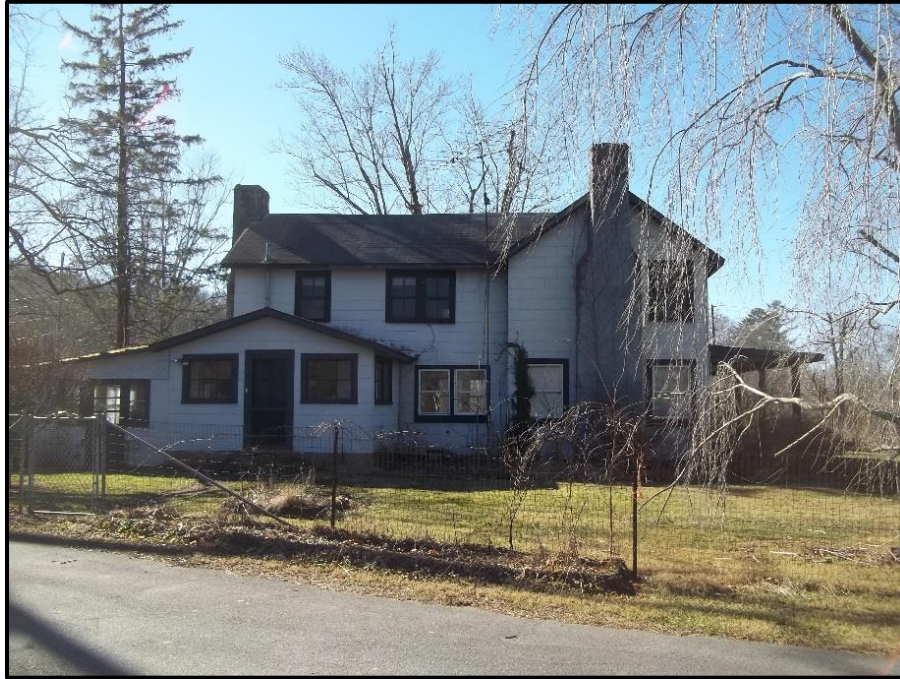
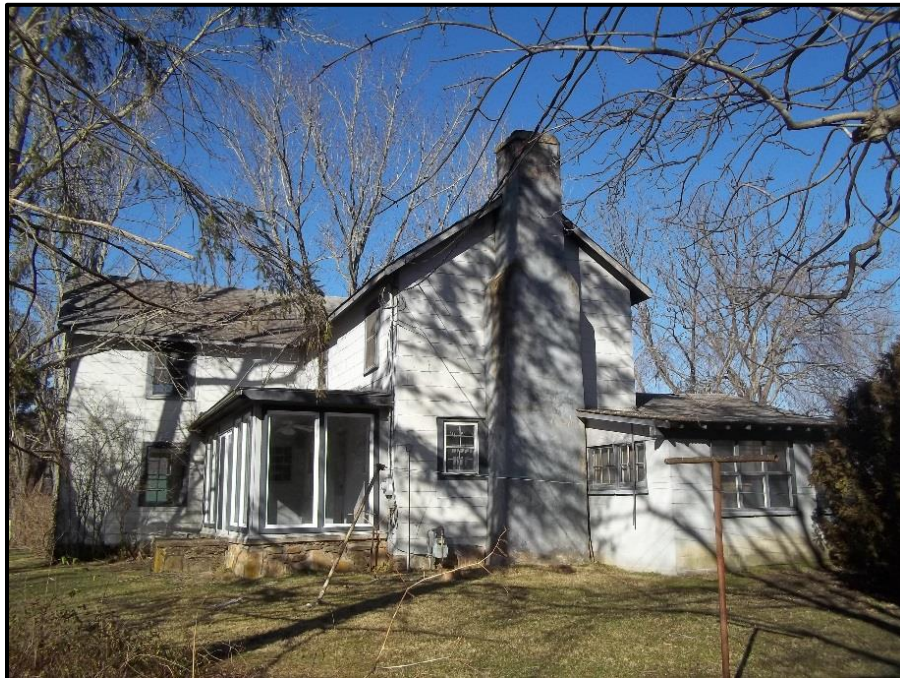
The house is a two-story, three-bay frame dwelling supported by a stone foundation. The exterior walls are clad in asbestos siding and the side gable roof in asphalt shingles. Extending across the façade is a one-story, three-bay, hip-roofed porch supported by square wood posts. A large, parged exterior chimney is located on the northeast gable end; the stone chimney on the southwest gable end was removed during the mid-twentieth century renovations to the house. The dwelling also features a two-story gable-roofed ell with exterior end chimney, also parged. A one-story gable-roofed greenhouse wing was constructed onto the ell's northeastern elevation and a one-story shed-roofed concrete block ell added to the wing in 1950. The one-story, shed-roofed three-season porch off the southwestern elevation of the ell is modern and features floor to ceiling single-light windows. The original porch was removed during the mid-twentieth century renovation (HPO Site Files). Fenestration includes six-over-six wood double-hung sash windows and one-over-one replacement sashes on the first floor of the northeastern gable end of the main block as well as a modern entry door with wood storm door. The rear ell features two-over-two double-hung wood sashes with one-over-one vinyl replacement sashes on the first floor of the northeastern elevation. Fenestration of the one-story wing includes six-light wood framed windows and a wood and glass panel entry door. The attached wing also features a wood and glass panel entry door; however, the door is early twentieth century in date, as well as six-light wood framed windows, a larger fixed six-light wood window on the rear elevation of the one-story ell, with two-light wood casement windows flanking the entry door (Figures 8-17).

**Figure 8. John Runion House, Looking South.**

**Figure 9. John Runion House, Looking East.**

**Figure 10. John Runion House, Looking West.**

**Figure 11. John Runion House, View Looking North.**

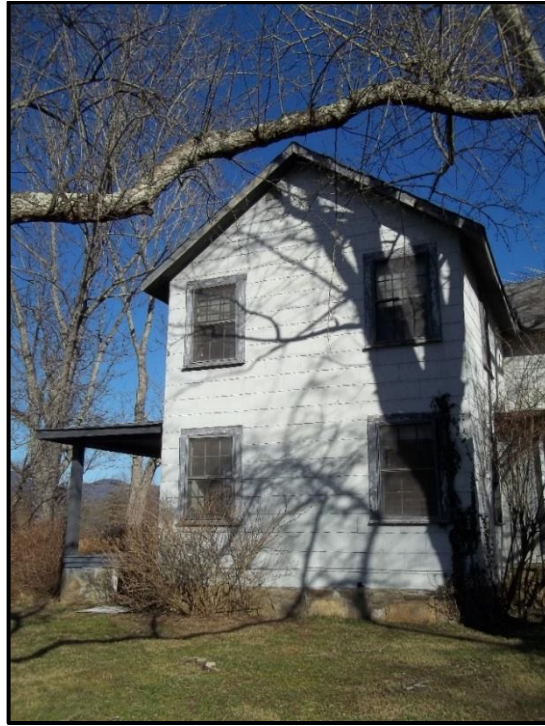
**Figure 12. Southwest Gable End of Main Block, Looking Northeast.**

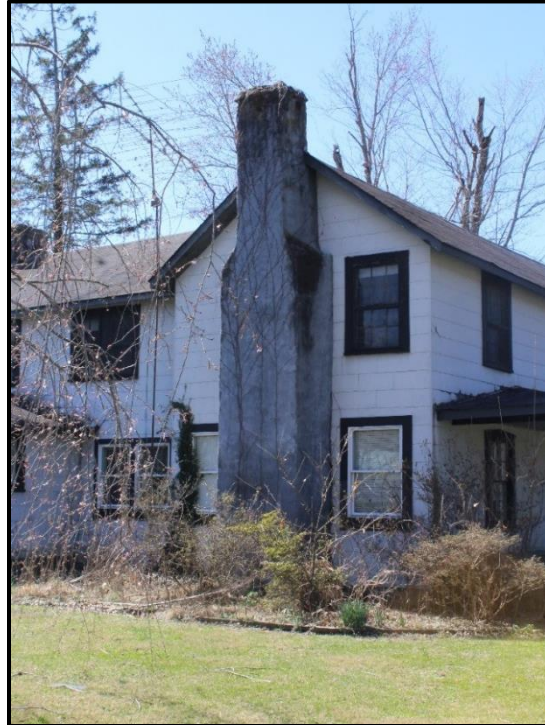
**Figure 13. Northeast Gable End of Main Block, Looking Southwest.**

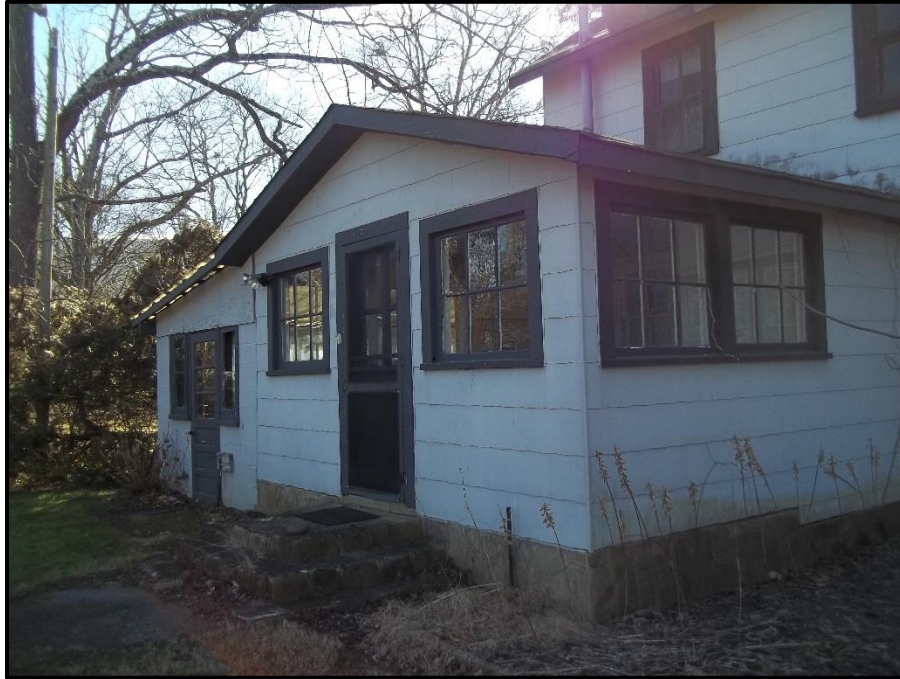
**Figure 14. Detail of One-Story Greenhouse with Shed-Roofed EII, Looking Southwest.**

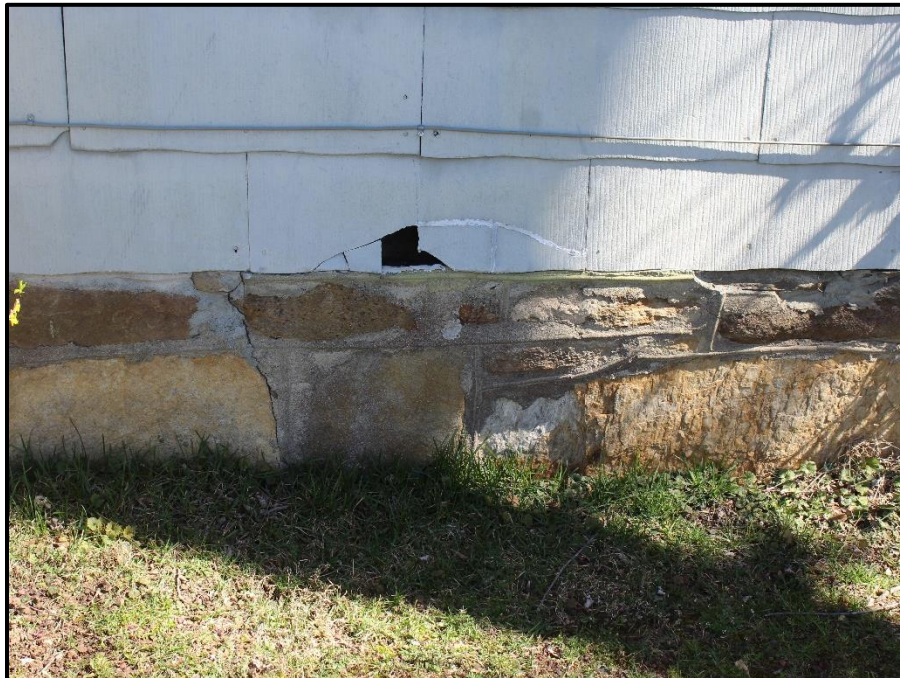
**Figure 15. Detail of Foundation, Looking Northeast.**

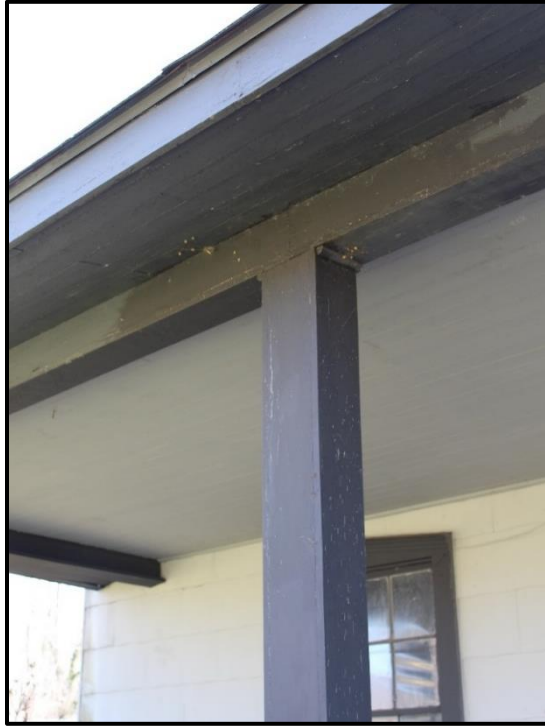
**Figure 16. Detail of Front Porch, Looking East.**

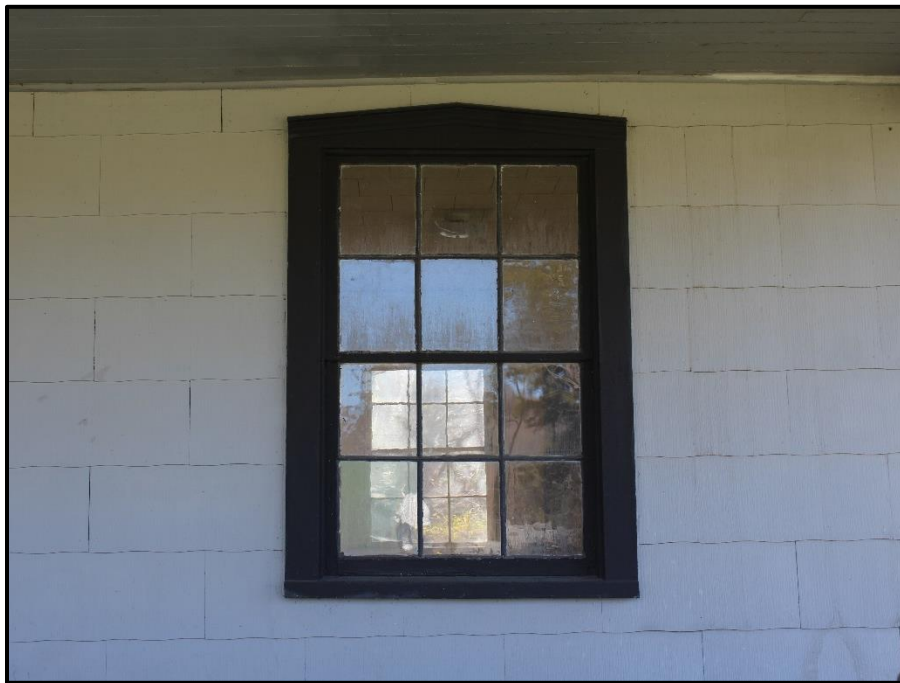
**Figure 17. Detail of Window on Facade, Looking Southeast.**

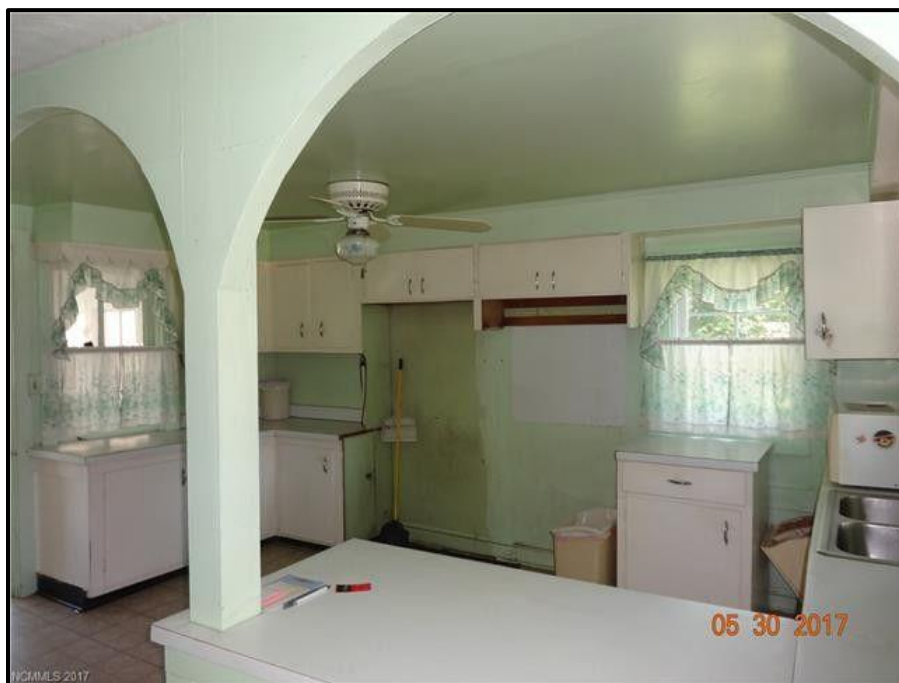
Although the interior of the house was not able to be surveyed during the fieldwork, the house is currently for sale. Representative interior photographs from the on-line listing are exhibited below ([https://www.realtor.com/realestateandhomes-detail/564-Blue-Ridge-Rd\\_Black-Mountain\\_NC\\_28711\\_M57813-31146#](https://www.realtor.com/realestateandhomes-detail/564-Blue-Ridge-Rd_Black-Mountain_NC_28711_M57813-31146#)). The interior reflects the late 1940s as well as some late twentieth century renovations, although one room, which appears to be on the second floor, contains some evidence of the earlier architectural features including a horizontal board wall underneath the current wallpaper. A drop ceiling has been added to the room. The pictures also indicate that the fireplace surround has been removed, the firebox enclosed, and a modern stove added to the eastern first floor room (Figures 18-22).

**Figure 18. Kitchen in Ell (Source: [https://www.realtor.com/realestateandhomes-detail/564-Blue-Ridge-Rd\\_Black-Mountain\\_NC\\_28711\\_M57813-31146#photo6](https://www.realtor.com/realestateandhomes-detail/564-Blue-Ridge-Rd_Black-Mountain_NC_28711_M57813-31146#photo6)).**

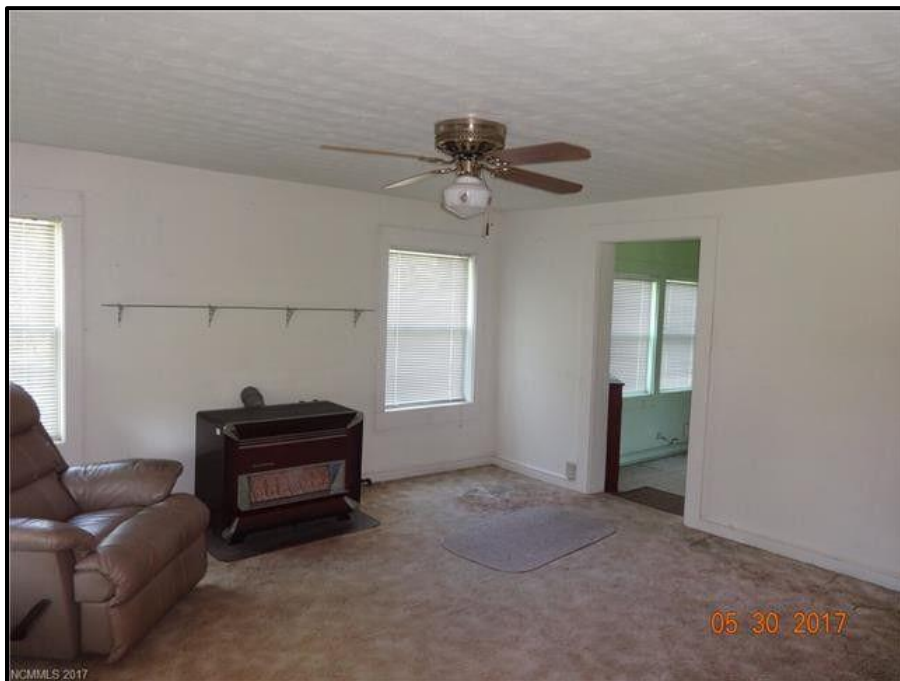
Figure 20. Northeast First Floor Room (Source: [https://www.realtor.com/realestateandhomes-detail/564-Blue-Ridge-Rd\\_Black-Mountain\\_NC\\_28711\\_M57813-31146#photo10](https://www.realtor.com/realestateandhomes-detail/564-Blue-Ridge-Rd_Black-Mountain_NC_28711_M57813-31146#photo10)).

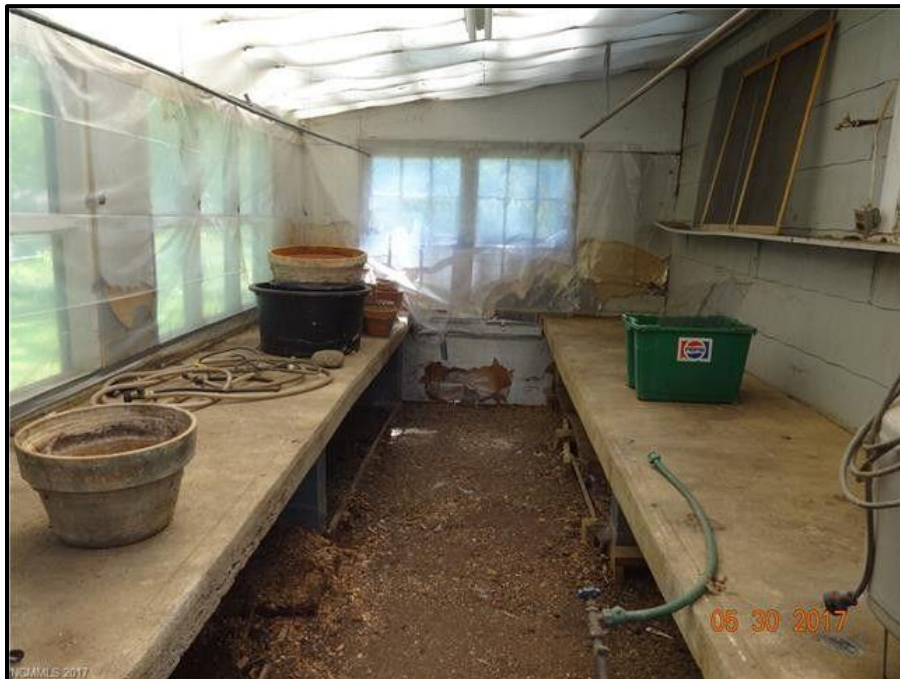
Figure 22. Interior of Greenhouse Wing (Source: [https://www.realtor.com/realestateandhomes-detail/564-Blue-Ridge-Rd\\_Black-Mountain\\_NC\\_28711\\_M57813-31146#photo3](https://www.realtor.com/realestateandhomes-detail/564-Blue-Ridge-Rd_Black-Mountain_NC_28711_M57813-31146#photo3)).

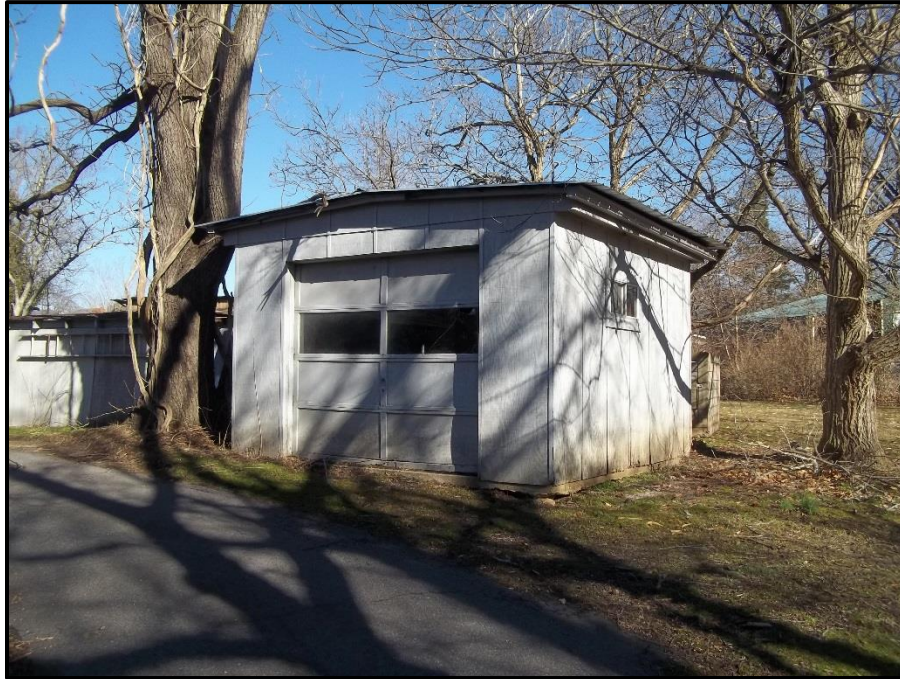
The garage is a one-story, single-bay, frame building supported by a concrete slab. The exterior is sheathed in plywood with the shallow-pitched gable roof covered in v-crimp metal. The plywood on the rear elevation is battened. Fenestration for the garage includes a wood and glass panel retractable garage bay door and a sliding vinyl window (Figure 23).

**Figure 23. Garage, Looking Northeast.**

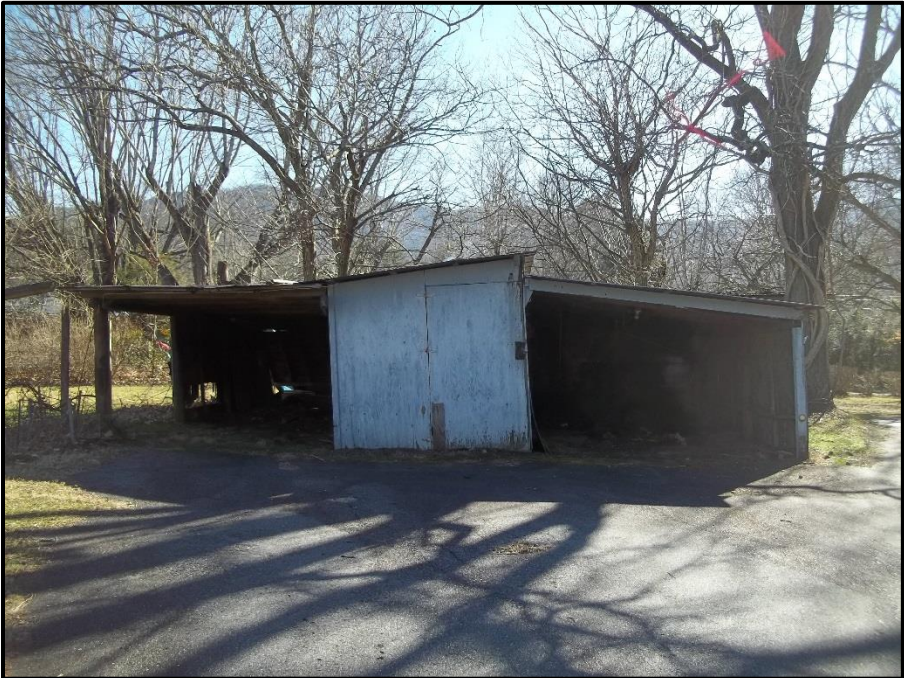
The vehicle shed is a one-story structure built in three sections. The center section is frame with plywood exterior, a shed roof sheathed in v-crimp metal, and a plywood door. Both the eastern and western sections feature a large open bay. The eastern bay is constructed with a flat roof while the western bay features a shed roof (Figure 24).

**Figure 24. Vehicle Shed, Looking South.**

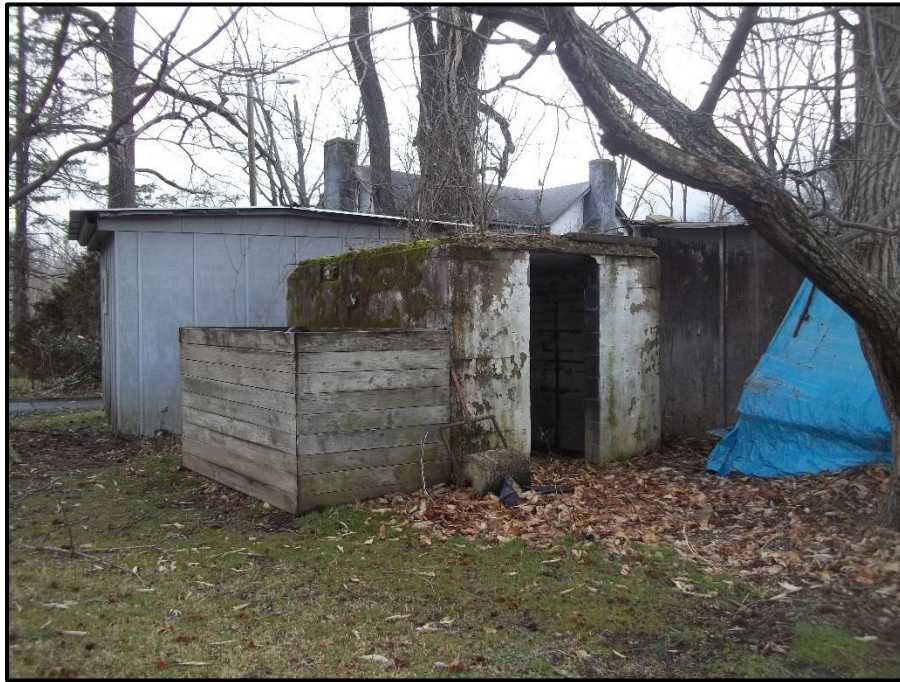
The building, located behind the garage, is a small one-story structure constructed of concrete block with asbestos panels on the exterior and a shallow poured concrete roof. A single entry is present although it appears the door is missing (Figure 25).

**Figure 25. Shed, Looking West.**

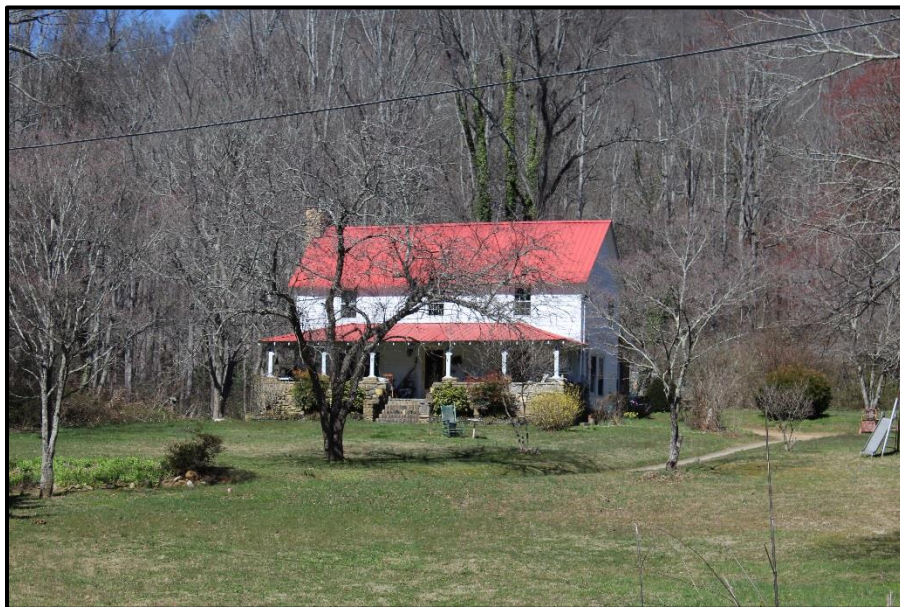
The Millard Jones House, which, as previously surveyed, was dated to the later nineteenth century, has been remodeled since its initial documentation. Photographs of the house in the HPO site files depict the house with a shed-roofed front porch and two-over-two wood sash windows. Since the survey, the porch has been remodeled and now features a hip-roof and six-over-six replacement sashes (Figure 28). The house does retain its stone exterior chimney and although not parged, is similar to the John Runion House. The resource maintains its integrity of setting and location; however, the integrity of materials, workmanship, and design has been compromised by the alterations to the building.

**Figure 28. Millard Jones House (BN0487), Cragmont Road, Black Mountain, NC, View Looking Northwest.**

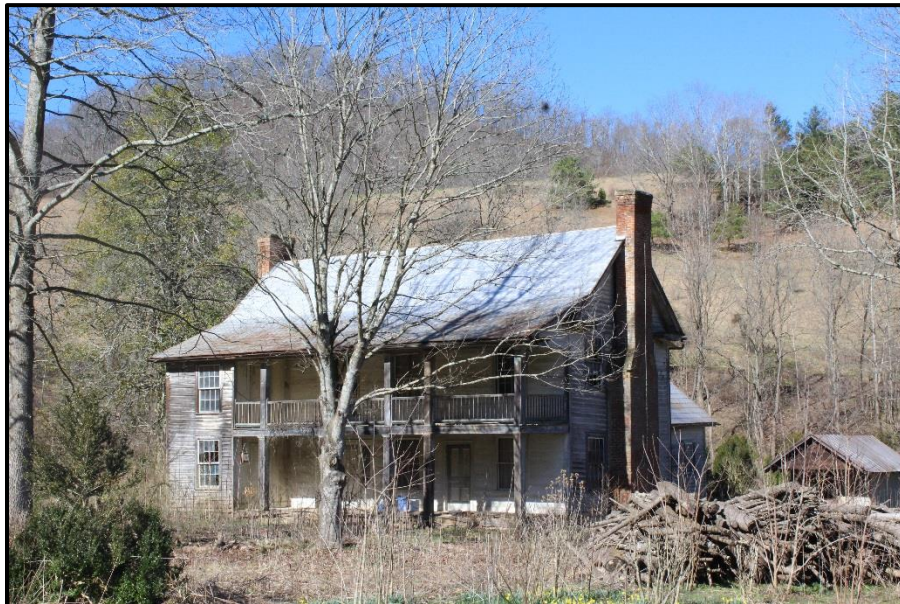
The John N. Wells House (BN0749), constructed c. 1845, is a two-story, frame dwelling with weatherboard siding and a side gable roof sheathed in pressed metal shingles. A two-story, shed-roofed porch extends across the façade and features an enclosed bay on both floors which has separate entrances to accommodate travelers. The porch also features square wood posts and on the second floor, a wood railing. An exterior end brick chimney is located on the southwest and northeast gable ends. The gables also feature end returns. Entry into the dwelling is through single-leaf, wood paneled doors (Figure 29). According to the family history, the northern room, a bedroom, was accessed through the second (north) door on the façade. A small one-story ell is also present (Griffith 2014:9; HPO Site Files; Bishir et. al. 1999:299; Swaim 1981:74). Although the dwelling is currently vacant, the resource retains much of its original features as well as its integrity of materials, design, workmanship, association, feeling, location, and setting. The resource has been determined eligible for listing on the NRHP by the HPO under Criterion C for its architectural merit (Bartos 2014).

**Figure 29. John N. Wells House (BN0749), 235 Willow Creek Road, Leicester, NC, View Looking Southwest.**

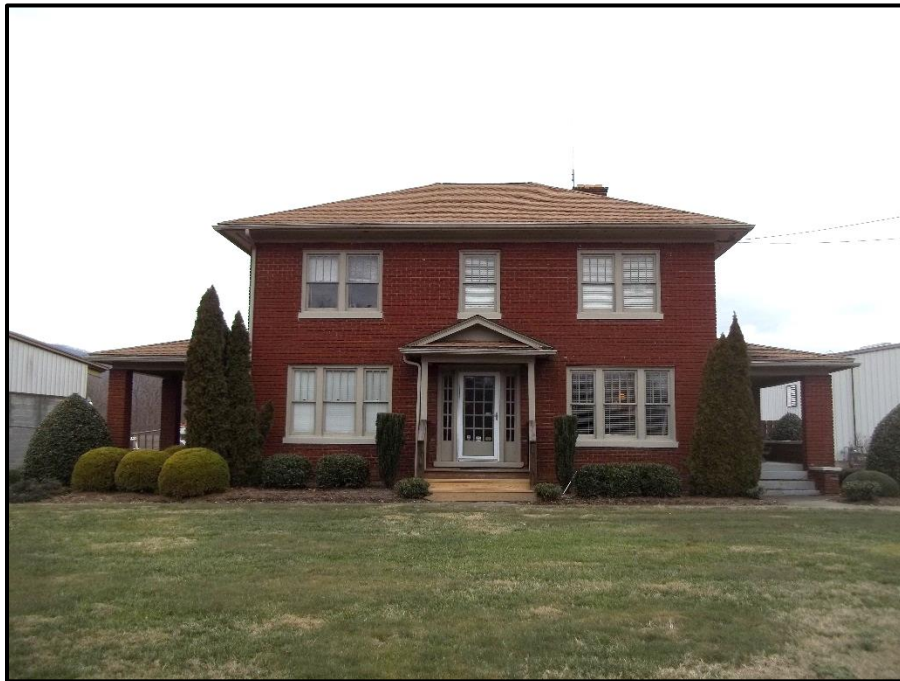
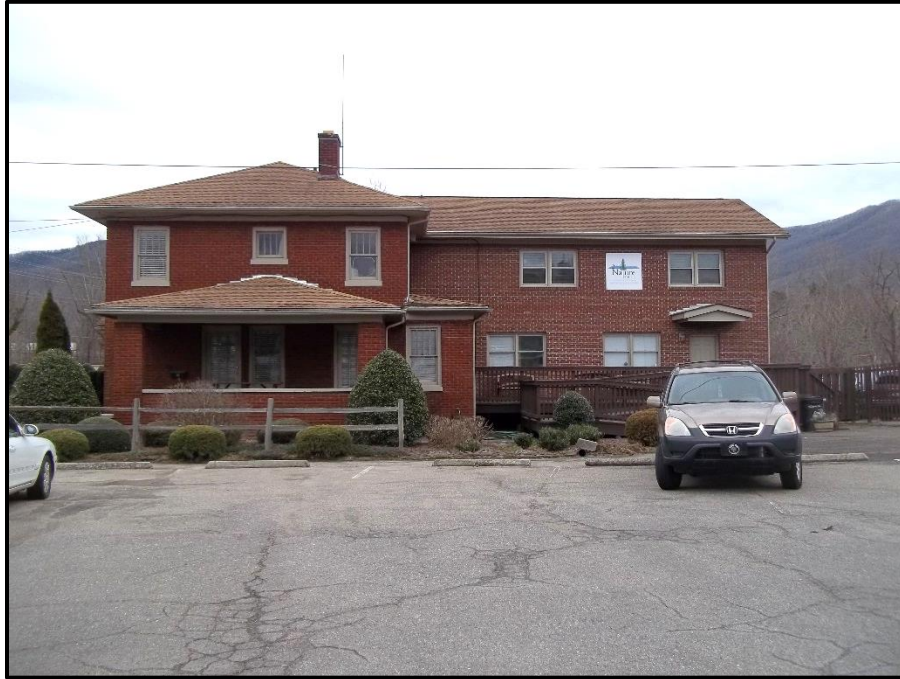
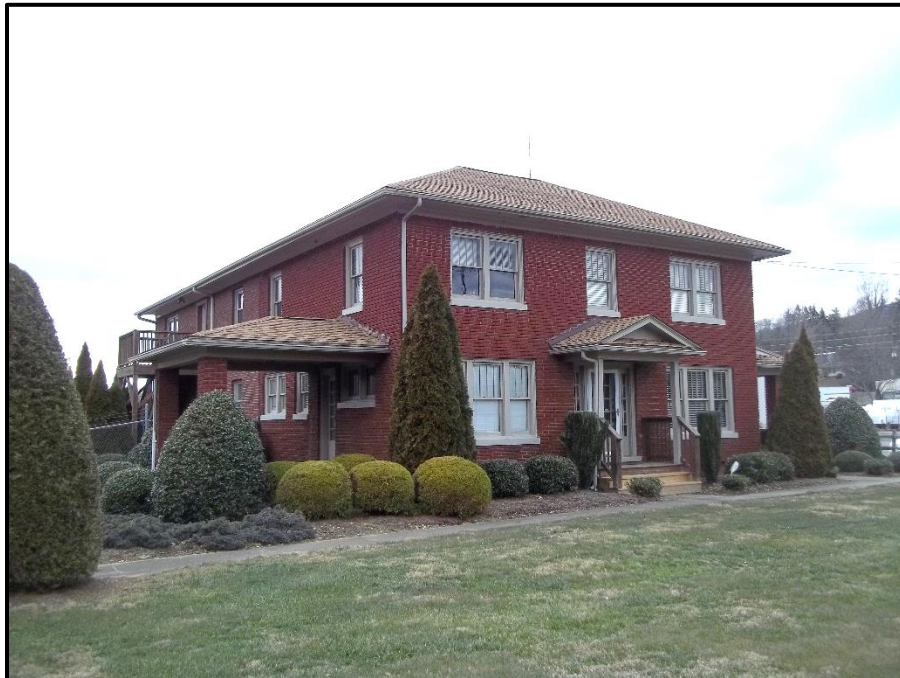
The house, now commercial offices, is a two-story, three-bay dwelling. The exterior walls are brick with the hip-roof sheathed in asphalt shingles. A hipped-roof porch is located off the north and south elevations. The porches each feature large brick support posts and a secondary entrance. A single-bay entry porch with pedimented gable roof and square wood posts is centered on the façade and shelters the main entry. The rails and floor of the porch are modern. The dwelling also features a large brick chimney projecting through the north roof slope. A small one-story ell with hip roof is visible off the northern half of the rear elevation. Fenestration includes single, paired, and triple four-over-one wood double-hung sash windows with stone sills and French-style entry doors. The main entry is flanked by ten-light sidelights. A large two-story ell with brick exterior walls was constructed after 1985. A portion of the rear ell appears to have been demolished to accommodate the addition. Fenestration of the ell includes one-over-one vinyl sashes with brick sills and modern metal entry doors (Figures 34-40).

**Figure 34. Allison House, Looking West.**

**Figure 35. Allison House, Looking South.**

**Figure 36. Allison House, Looking Northwest.**

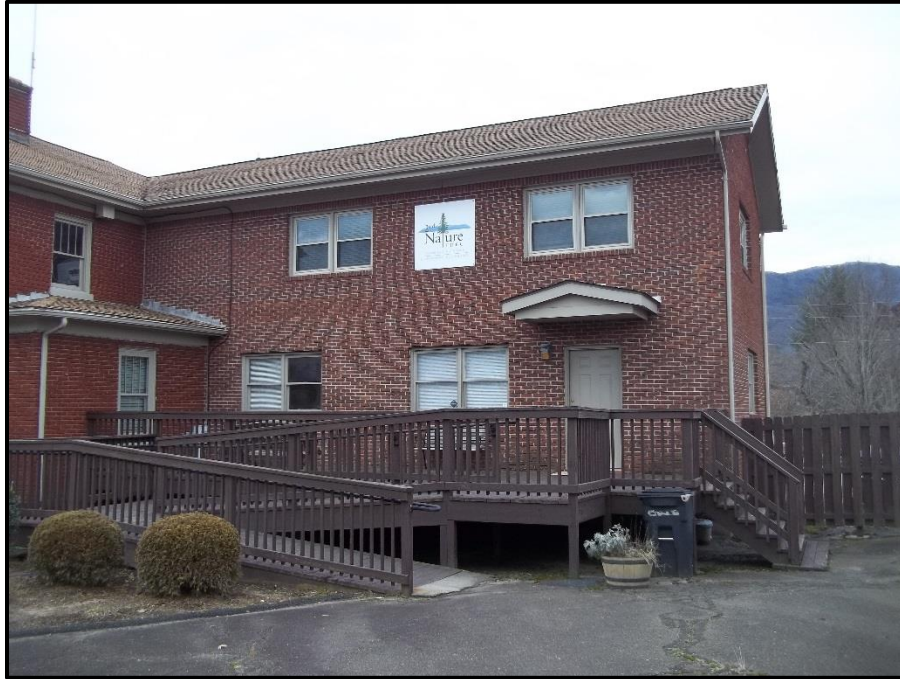
Figure 37. Detail of Post 1985 Two-Story Ell, Looking South.

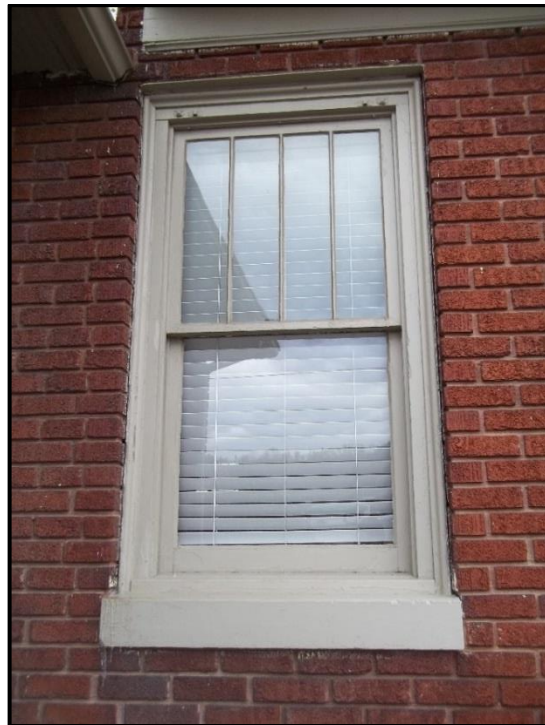
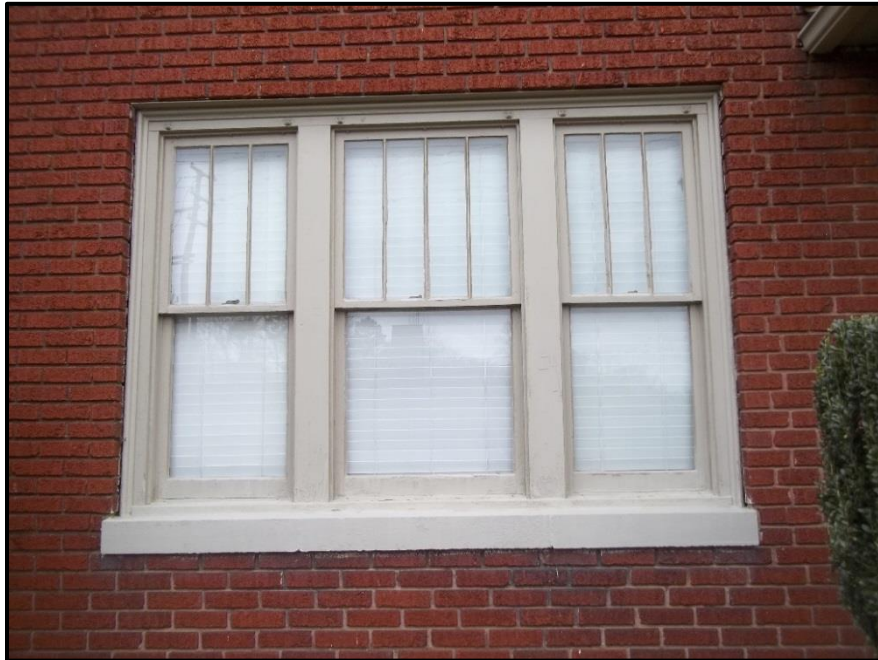
Figure 38. Detail of Window on Facade, Looking West.

**Figure 39. Detail of Triple Window on Facade, Looking West.**

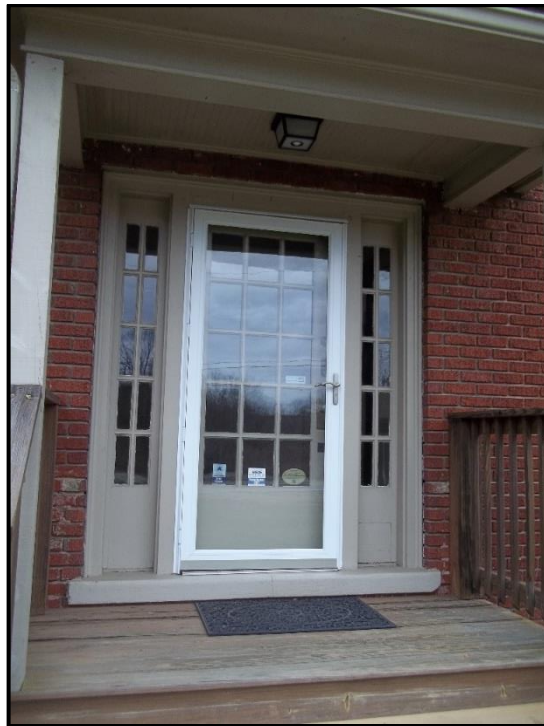
**Figure 40. Detail of Front Entry Door, Looking West.**

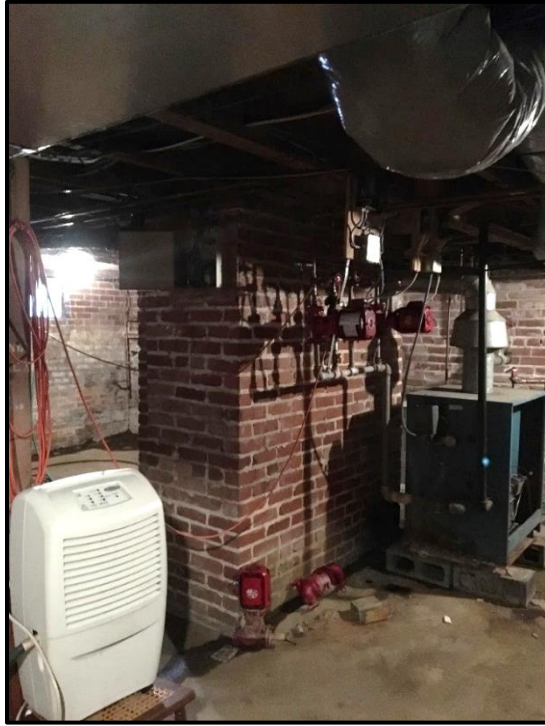
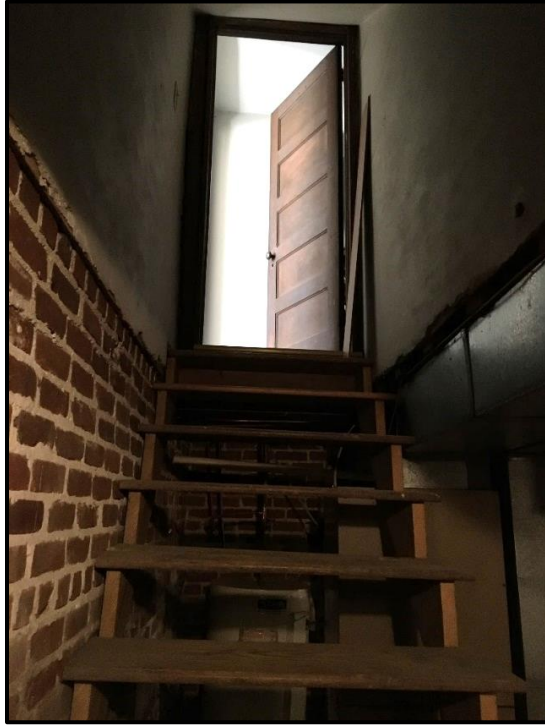
The interior of the house comprises four rooms on the first floor with center hallway and five rooms on the second, including a small bathroom. The house also features a partial basement. The floor of the basement is currently poured concrete. The chimney base and the foundation are brick laid in a six-course American bond pattern. The walls of the basement stair are plaster; however, the stairs appear to have been redone, date unknown (Figures 41 and 42).

Figure 41. Overview of Basement, Looking Northwest.

Figure 42. Basement Stairs, Looking West.

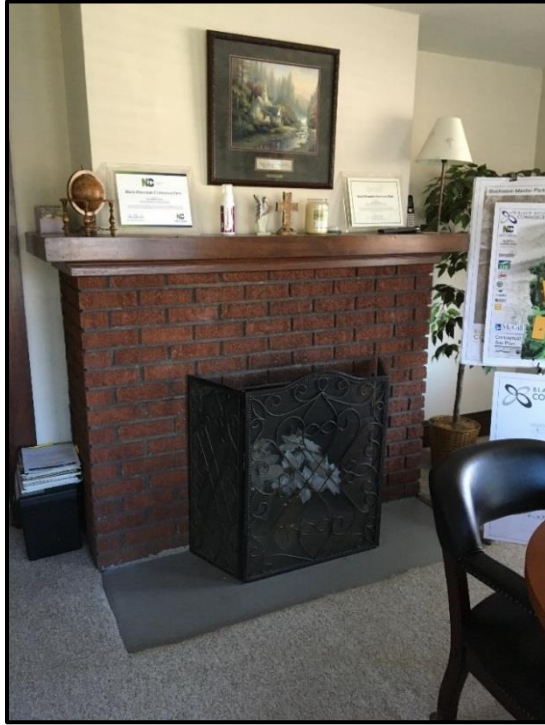
**Figure 44. Detail of Fireplace Wall in Northeast First Floor Room, Looking Northwest.**

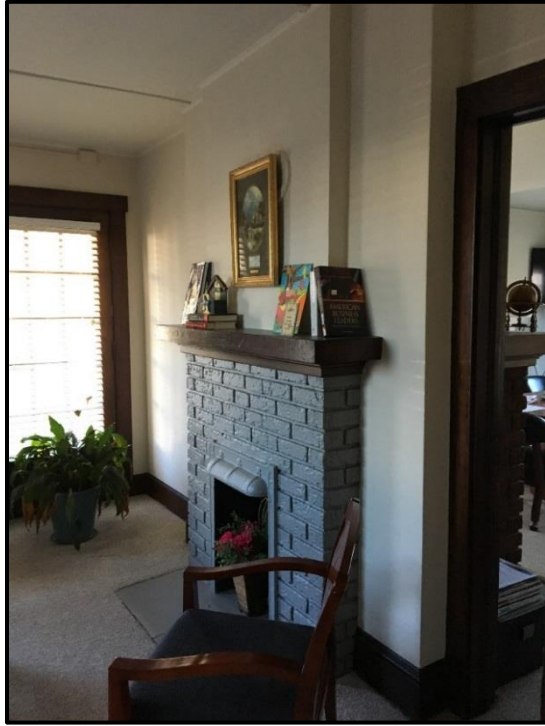
**Figure 45. Detail of Fireplace Wall in Northwest First Floor Room, Looking Northeast.**

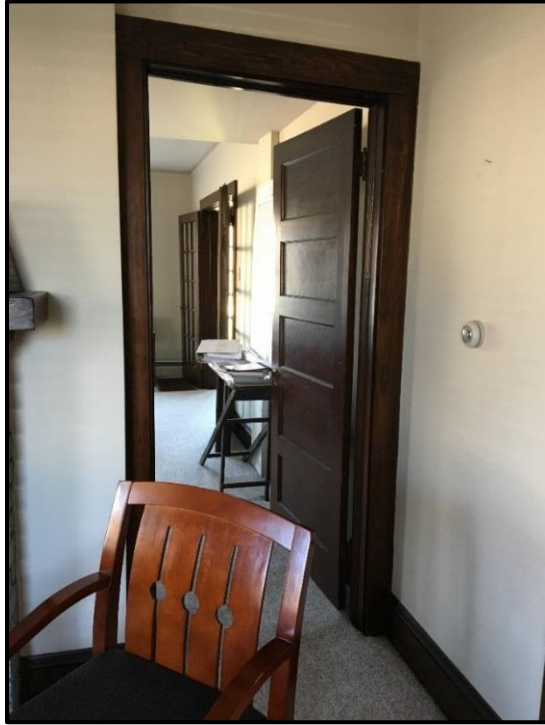
**Figure 46. Door Detail, Looking East from Northwest Room.**

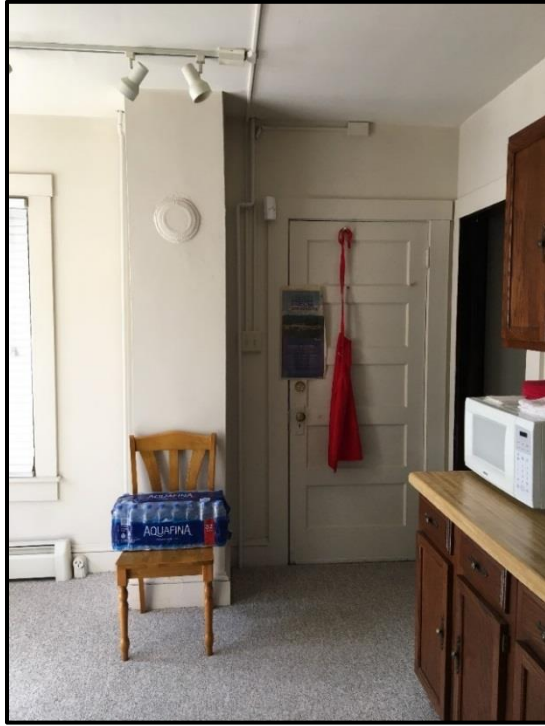
**Figure 47. Kitchen Rear Wall (Southwest Room), Looking West.**

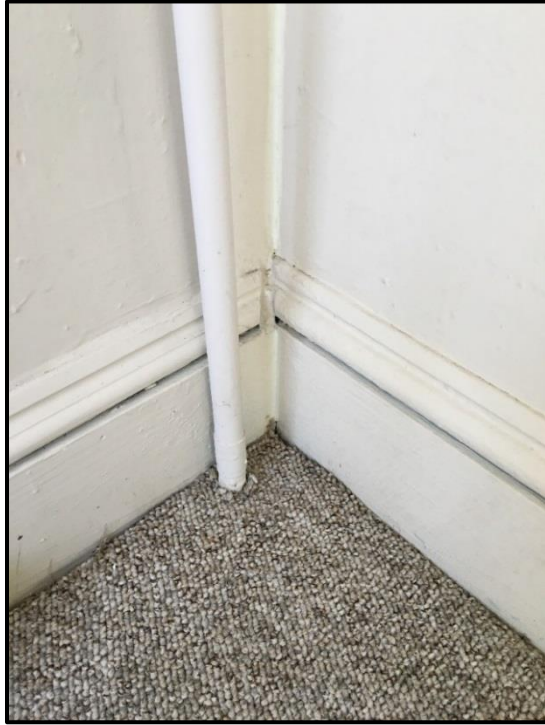
**Figure 48. Kitchen Baseboard Molding Detail, Looking Northwest.**

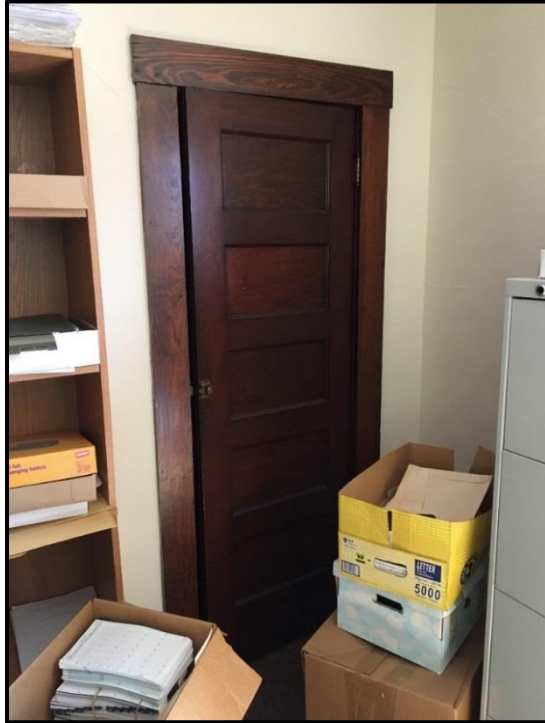
**Figure 52. Closet Example (Southwest Second Floor Room), Looking Southeast.**

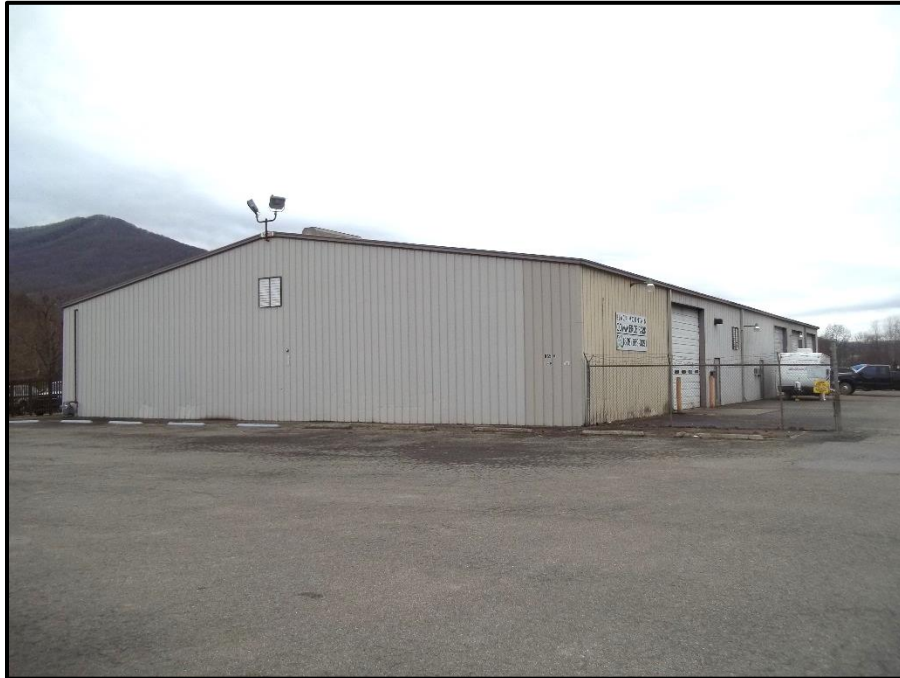
The commercial building is a large one-story, metal-clad structure with side gable roof, also clad in metal. The façade features four large vehicle bays with metal retractable garage bay doors as well as two metal, single-leaf pedestrian entry doors (Figure 53). The building is used for rental space for building contractors.

**Figure 53. Commercial Storage Building, Looking Southwest.**

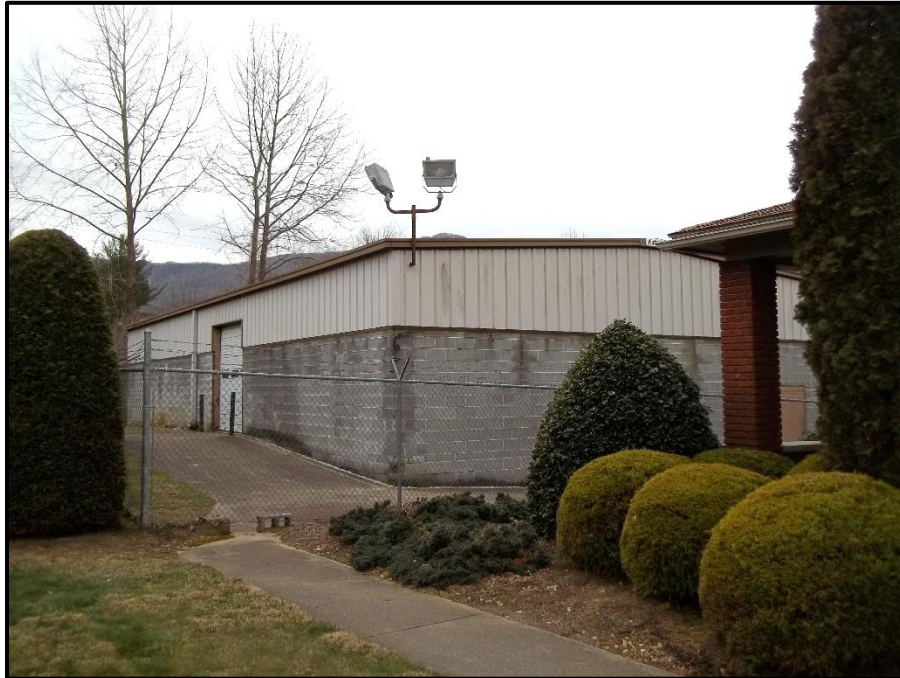
The smaller commercial storage building, located to the south of the former dwelling, is also one-story. The exterior walls are concrete block with seamed metal in the upper third portion of the walls. The gable roof is clad in metal. The building features a central modern retractable garage bay door on the west and east elevation (Figure 54).

**Figure 54. Commercial Storage Building, Looking Southwest.**

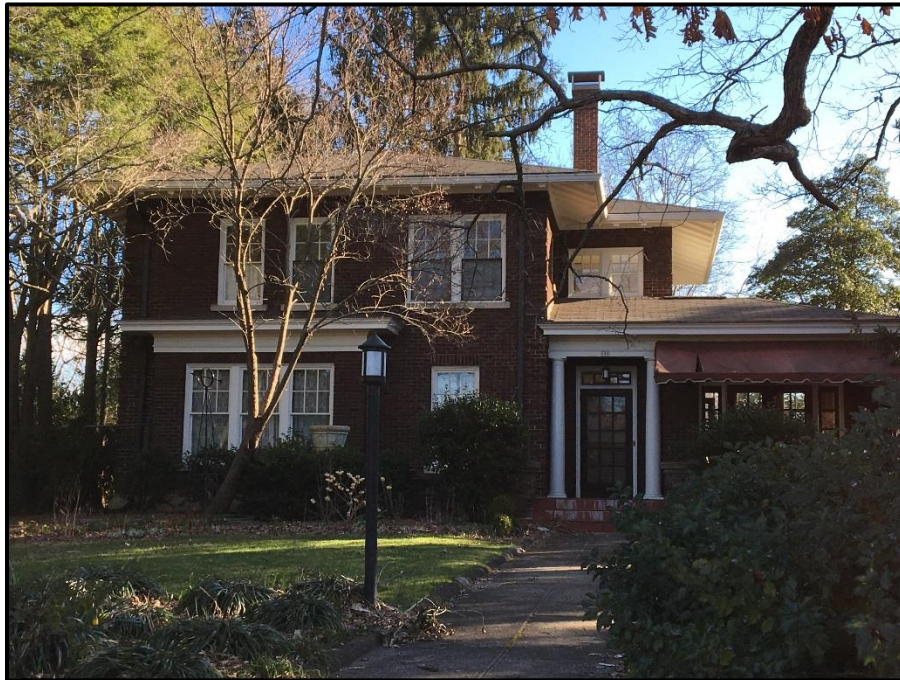
Comparative examples to the Allison House (BN6395) include the Dr. Martin Luther Stevens House (BN0062) located at 155 Montford Avenue, Asheville; a House (BN4308) located at 63 Madison Avenue, Asheville; and the J. T. Bledsoe House (BN2391) located at 44 Sunset Parkway, Asheville. The circa 1929 Dr. Martin Luther Stevens House is a two-story dwelling with brick veneer exterior and a hip-roof (Figure 56). The wide overhang of the roof is reminiscent of the Prairie Style. Colonial Revival elements to the dwelling include quoins and Doric columns flanking the front entrance. The dwelling also features interior brick chimneys, a modillioned cornice, a hip-roofed porch, four-light transom over the front entry, and six-over-one wood sash windows with poured concrete lintels and brick lintels. The house retains its architectural features as well as its integrity of setting, location, feeling, association, workmanship, materials, and design. The dwelling is also a contributing resource to the NRHP-listed Montford Area Historic District (BN0022; HPO Site Files).

**Figure 56. Dr. Martin Luther Stevens House (BN0062), 155 Montford Avenue, Asheville, NC, Looking Northeast.**
