SUBJECT: Historic Structures Survey Report, Construct Interchange at I-40 and SR 2500 and Intersection Improvements at NC 9 and SR 2500, I-4409, PA 18-01-0046, Buncombe County, ER 18-4250

**Historic Structures Survey Report  
Interchange Improvements SR  
2500 (Blue Ridge Road) from US 70  
to South of I-40 and South of I-40 to  
SR 2713 (Old Lake Gap Road),  
Buncombe County, North Carolina**

TIP# I-4409  
WBS# 38714.1.2  
PA# 18-01-0046

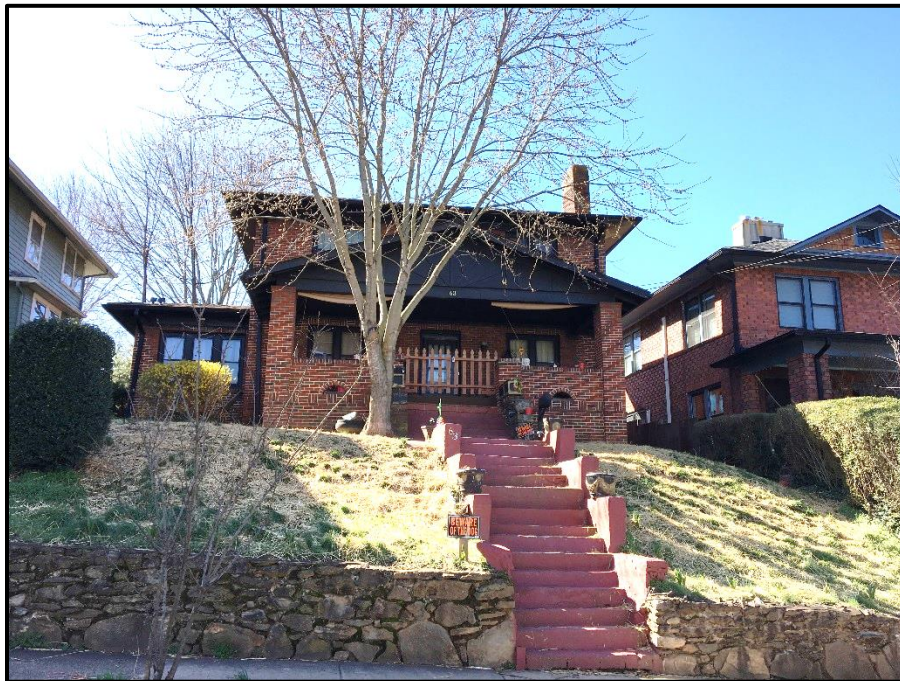
The House (BN4308) located at 63 Madison Avenue is an example of an early twentieth century brick dwelling with Craftsman-style influences as well as a wide overhanging eave influenced by the Prairie style (Figure 57). The exterior walls are brick veneer. The house also features a hip-roof, and a full-width, one-story front porch with gable roof and brick corner supports. Similar to the Allison House, but enclosed, the house also features a hip-roof wing. The windows of the dwelling appear to be three-over-one wood sashes with vinyl sashes in the wing. The dwelling retains its integrity of setting, feeling, association, location, materials, and workmanship. The resource's design has been slightly compromised by the addition of the vinyl sashes on the wing.

**Figure 57. House (BN4308), 63 Madison Avenue, Asheville, NC, Looking West.**

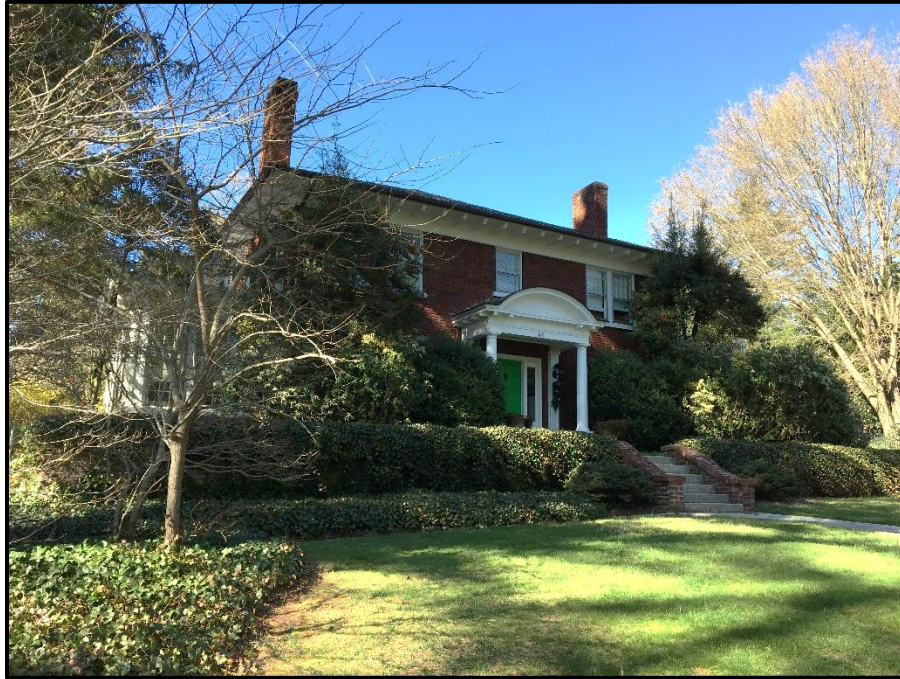
The J. T. Bledsoe House, constructed in 1916, is a two-story, three-bay Colonial Revival dwelling with brick exterior walls and a hip-roof with wide eaves (Figure 58). The house also features a modillioned cornice, interior end brick chimneys, and a central, single-bay entry porch with a round pediment and Tuscan-style wood columns. Fenestration includes twelve-over-one wood sashes with concrete sills and a single-leaf wood panel entry door flanked by sidelights. The dwelling retains its original architectural features and its integrity of setting, feeling, association, materials, workmanship, design, and location. The house is also a contributing resource to the NRHP-listed Grove Park Historic District (BN0194; HPO Site Files).

**Figure 58. J. T. Bledsoe House (BN2391), 44 Sunset Parkway, Asheville, NC, Looking North.**
