Historic Structure Survey Report

NC 68 (Eastchester Drive) Improvements
from SR 1523 (Hickwood Road) to SR 1556
(Gallimore Dairy Road)

TIP No. U-5974, WBS No. 45962.1.1

High Point, Guilford County

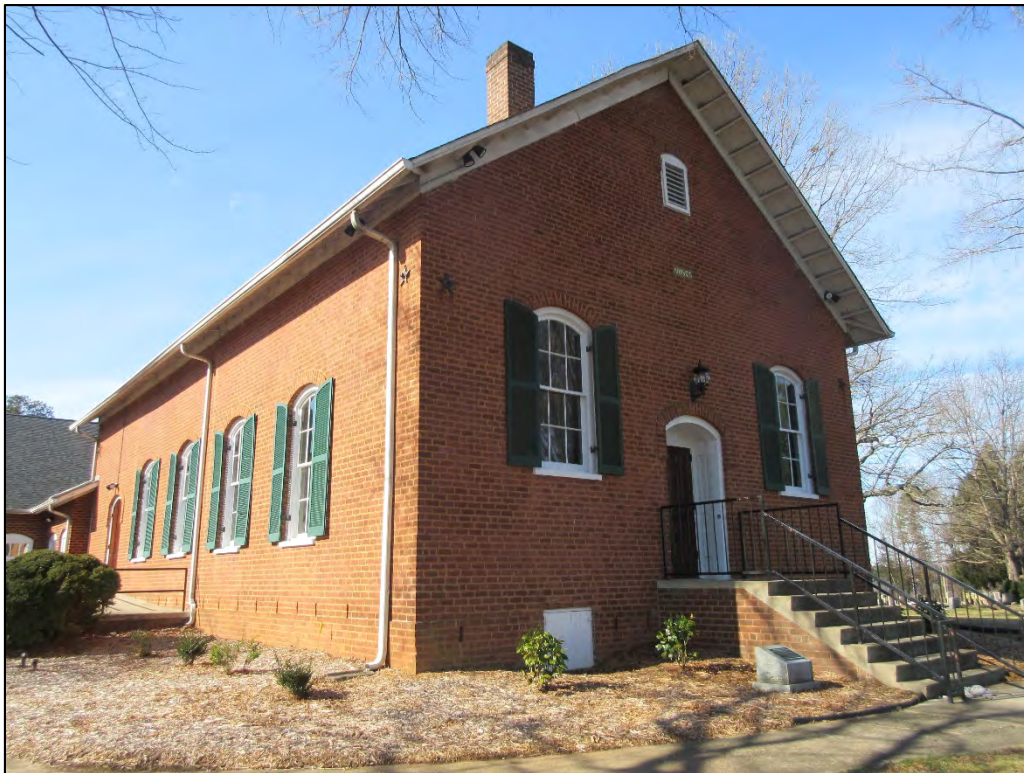
Deep River Friends Meeting House, view to northwest

The brick additions to the rear (west) of the 1875 Meeting House, replacement of the front steps and railing, and the 1990s replacement and recessing of the double-leaf front doors with compatible wood doors, has compromised the overall integrity of the building. Further, a major renovation completed in 1967-68 modernized the interior of the church, that changed the character of the interior so that only the plan and envelope of the 1875 building remains with its windows and sashes and heart of pine floors.¹⁰ As a result, the Meeting House does not retain integrity of design, material, and workmanship.

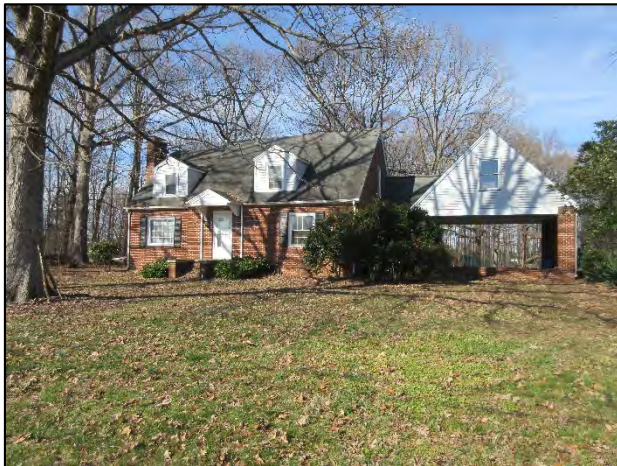
Parsonage façade, view to the north

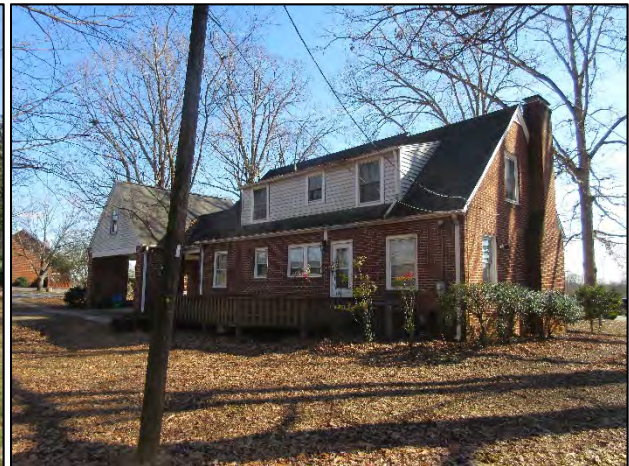
Parsonage oblique view to southeast

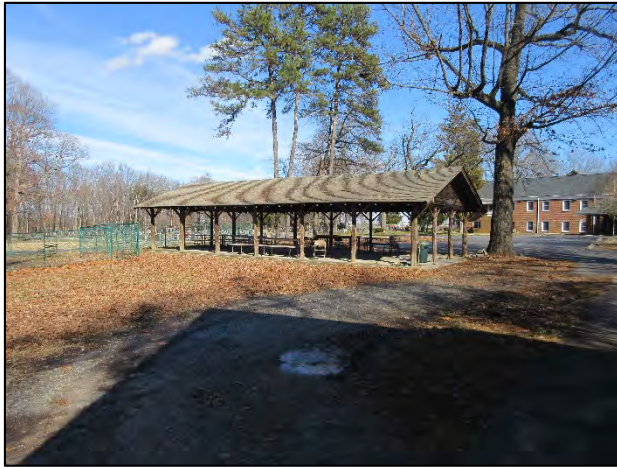
The open log pavilion is located northeast of the parsonage and is visible in historic aerial imagery dated 1965. The gabled ends of the pavilion are clad in German siding and the roof is clad in shingles. The structure is set on a concrete slab. A modern playground set is located directly west of the pavilion and is enclosed with a chainlink fence.

Log pavilion, view to the northeast

This simple log, open structure is recreational in purpose, probably for picnics and other outdoor gatherings at the Friends Meeting, and rustic in style, characterized by the natural wood (log) construction. The exposed rafter beams appear to be the result of convenience as opposed to a stylistic treatment.

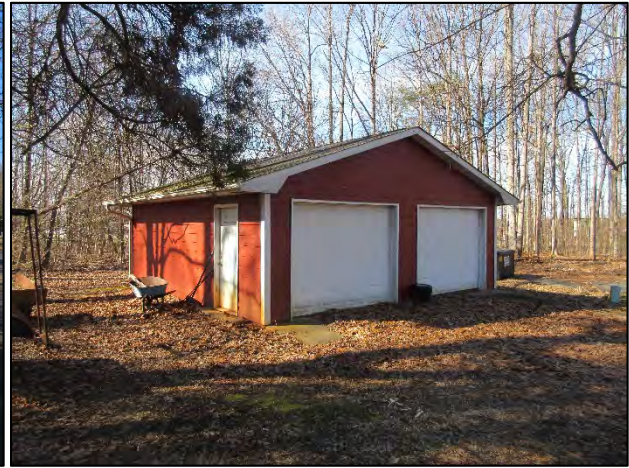
A two-bay, detached garage is located northwest of the parsonage. Two vinyl roll-up doors are present in the gable end (east-facing) with a single entry in the south elevation. The garage is clad in a composite board siding and the roof is clad in asphalt shingles. This structure post-dates the 1995 survey.

Garage, oblique view to northwest

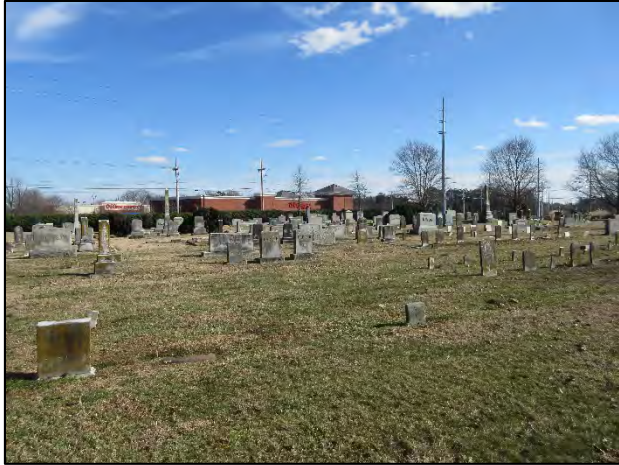
Friends Cemetery, view to the southeast

The cemetery also retains evidence of a 1933 WPA project when many stones were removed, the rolling topography was flattened, and overgrowth was replaced with mowed grass. It is not known whether some of the "rocks" removed were early, unmarked, gravestones, or where they were relocated. More recently in an unfortunate effort to clean gravestones, many stones were sandblasted. The cemetery continues its historic and active use as a burying ground for Quakers and others, with new stones positioned among the old in family plots rather than separated in old and new sections of the graveyard. The cemetery retains its wooded and parkland setting.

The cemetery's current form is largely the result of the 1933 WPA "clean up", at which time the current circulation was established and the grounds were cleared of undergrowth and rocks, leveled, and grassed. As the result of a retrofit, the Friends Cemetery was not made-over in a true "memorial park" form, with strict uniformity and the occasional sculpture. However, the division of the cemetery into four sections through the introduction of paths applied geometric order; and the clearing, leveling, and grassing of the cemetery created the park-like or lawn setting gaining popularity in cemeteries across the country in the decades following the Civil War. These improvements also had the practical effect of making landscaping easier, as the power lawn mower was in common use.

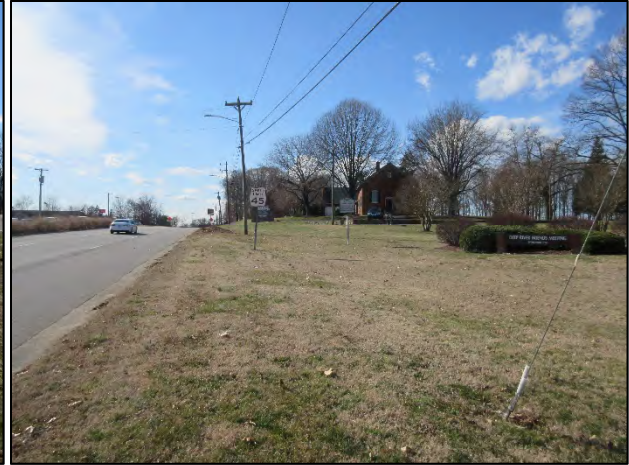
View to the west along W. Wendover Avenue; The Friends Meeting House is visible mid-frame.

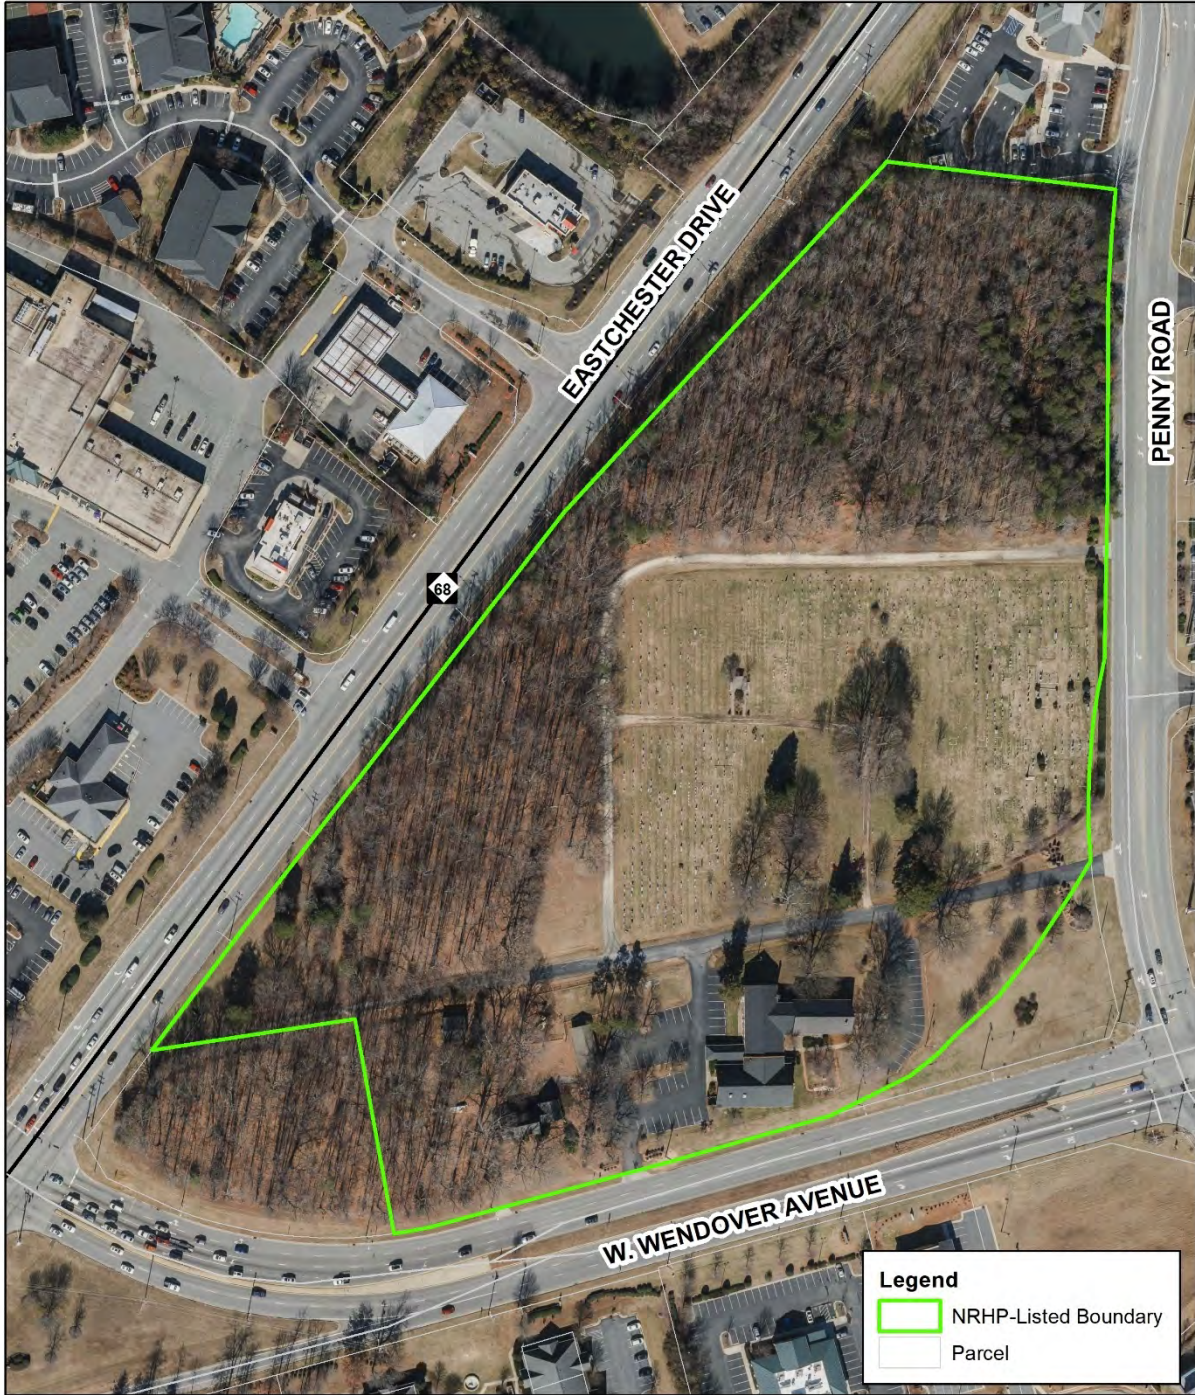
The legal parcel associated with the Deep River Friends Meeting House and Cemetery (Guilford County Parcel Identification No. 7813413764) does not correspond to the NRHP-listed boundary. As the 1995 NRHP boundary remains accurate and appropriate for the resource, the corresponding tax map was overlaid on current parcel data in ArcGIS and a digital file for the NRHP-listed boundary created. The NRHP listed boundary encompasses 17.1 acres within the legal parcel boundary. The NRHP listed boundary does not include property in the southeast or southwest corners of the parcel which are grassed and landscaped (approximately 0.5 acre) and wooded (approximately 1.45 acres), respectively. These areas are not historically associated with the with the Deep River Meeting.

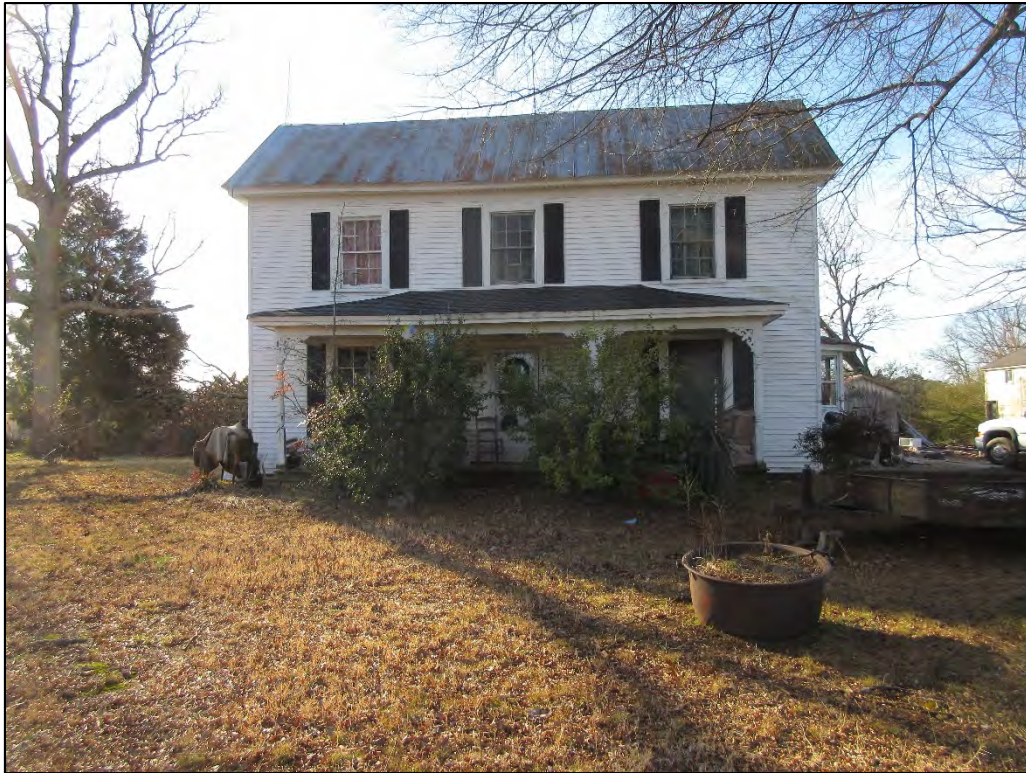
Jordan Dairy Farm, farm house, view to west

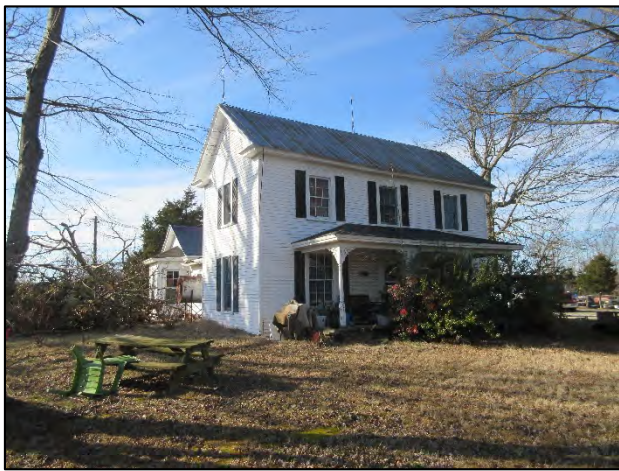
Jordan House (Farm House): This three-bay, single pile, two-story side gabled with cornice return I-house faces east towards NC 68 (Eastchester Drive). The house is clad with vinyl siding applied in the 1980s, which include the narrow eaves and porch ceiling. However, the original weatherboard siding is reportedly intact beneath, according to the current owner. The vinyl siding obscures the foundation, which is reportedly brick piers with concrete block infill. The single story hipped roof front porch is supported by turned wood posts with decorative, pierced jigsaw brackets and likewise sits on brick piers infilled with concrete block. The front door is a wood panel with light and is centered on the façade. Windows on the façade are 6/6 wood sash with 4/4 wood sashes on other elevations; decorative vinyl shutters are present on the main house mass. An exterior brick chimney is present on the rear elevation in the north room and an interior brick chimney was observed breaking the center of the rear roof slope. An interior survey of the house was not permitted, though the current owner indicated it was updated with drywall and drop ceilings. The interview indicated the I-house is a center hall with quarter-turn staircase and two rooms on each floor.

Jordan House façade, view to the northwest

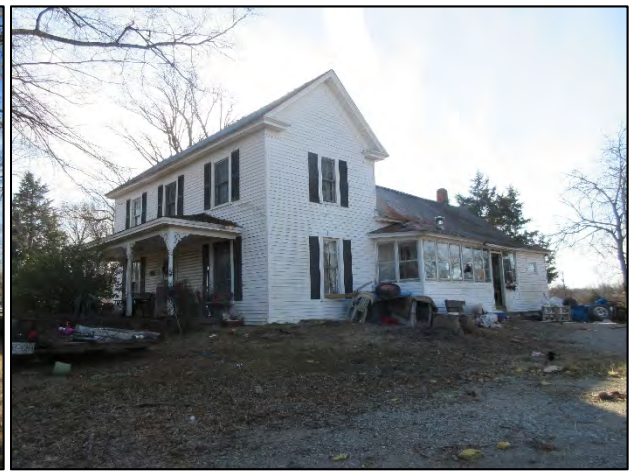
Jordan House oblique view to southeast

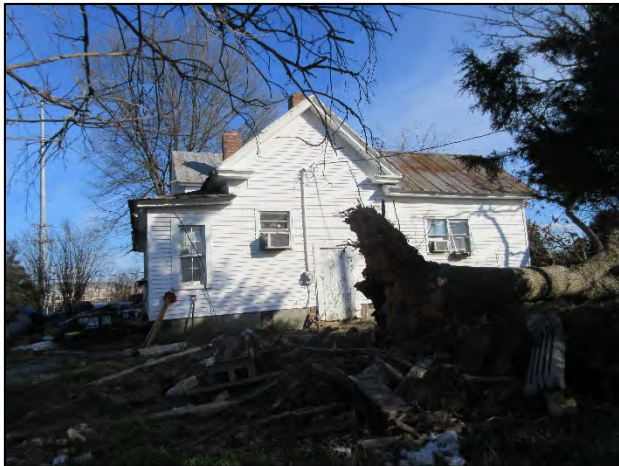
Jordan House rear elevation, view to east

A rear, one-story ell was added to the north end of the house at an unknown time, though before 1965 based on historic aerial imagery. An enclosed, hip-roofed porch extends along the north elevation of the ell addition. A second one-story ell addition extends from the west end of the rear ell paralleling the main mass of the house and terminates at its' southern end in a bay window with three 4/4 wood sash windows under a half-pyramidal roof. Historic aerial imagery indicates this second addition occurred between 1965 and 1968. For a short period of time, this second addition resulted in a small rear

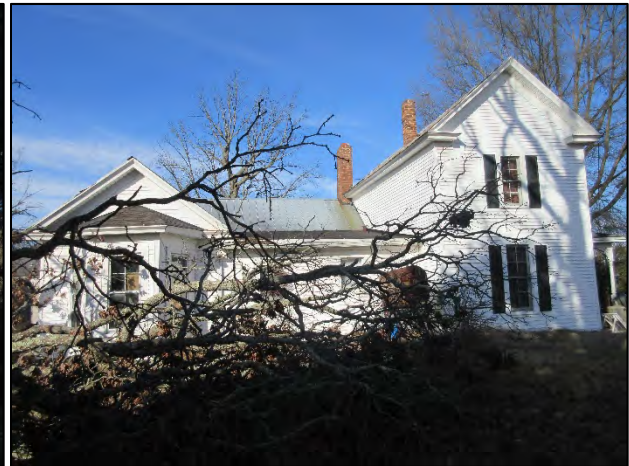
Jordan House south elevation, view to north

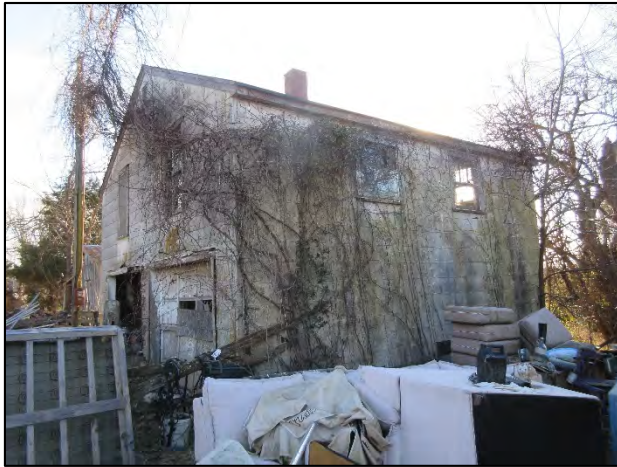
Garage: The two-bay garage with apartment above was reportedly constructed on the property, north of the Jordan house, in the mid-1960s; the garage appears in an aerial image dated 1965. The front gable frame building is set on a concrete foundation and is clad in asbestos shingles. One wood panel rolling garage door remains in the east elevation; the other appears to have been removed. A central brick chimney breaks the roof ridge. The second story is lit by regularly placed 3/1 wood sash windows of varying size and is accessed by a wood and glass door and stairwell in the southwest corner of the structure.

Garage oblique view of façade, view to southwest

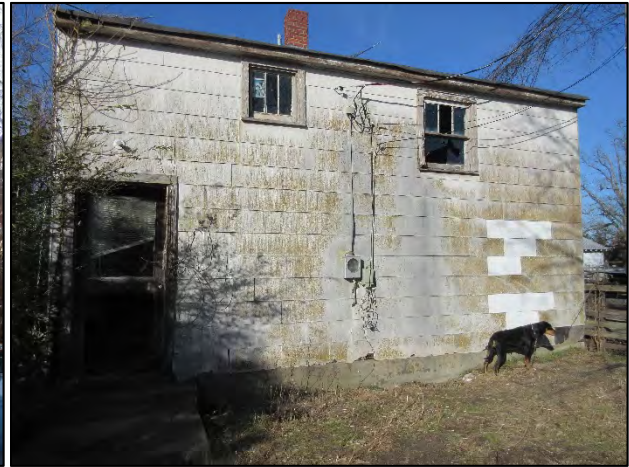
South elevation of Garage, view to northeast

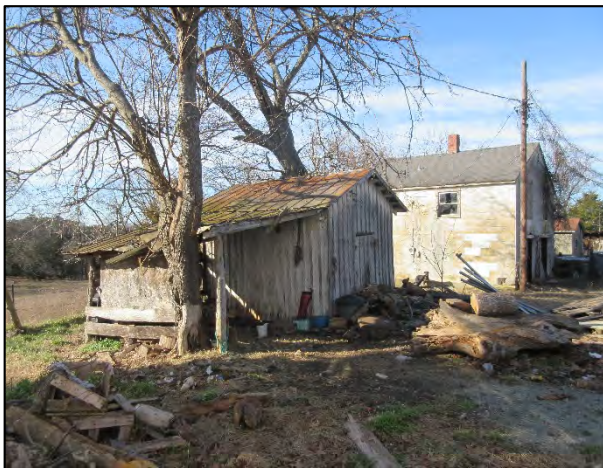
Shed 1: This small, gabled structure northwest of the Jordan House was in place by the mid-1960s based on historic aerial imagery. The simple frame shed is clad with board-and-batten and features a board-and-batten door in the east elevation; the roof is clad in standing seam metal. The structure sits on a stone and mortar foundation and an open, post-framed shed extends from the south elevation.

Shed 1 (foreground), view to northwest. Garage in background.

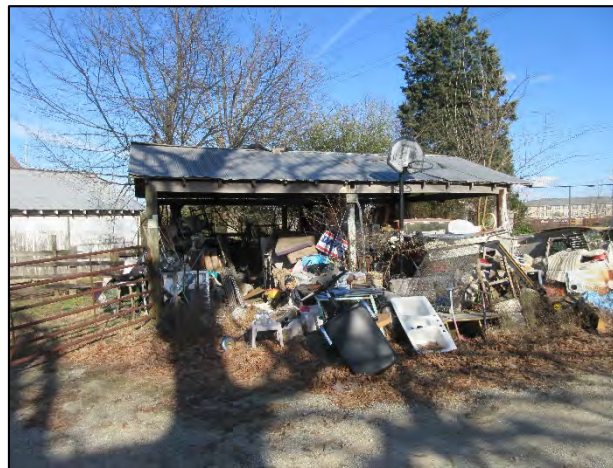
Equipment Shed 1: This two-bay open equipment shed located north of the Jordan House was constructed after 1982 based on historic aerial imagery. Wood posts support the side gable roof with standing seam metal cladding.

Equipment Shed 1, view to northeast

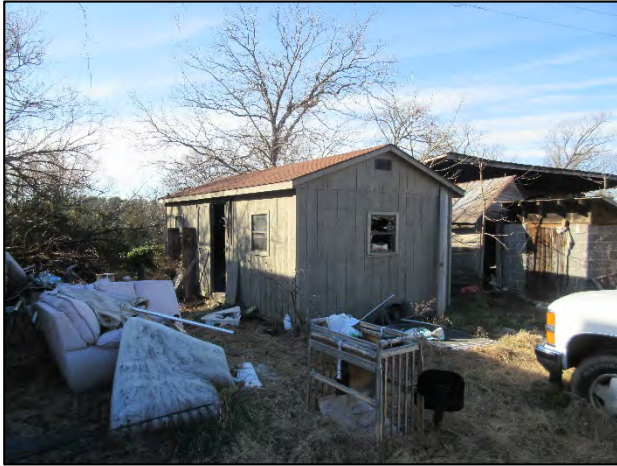
Shed 2: This prefabricated shed appears in historic aerial imagery after 1982.

Shed 2, view to northwest

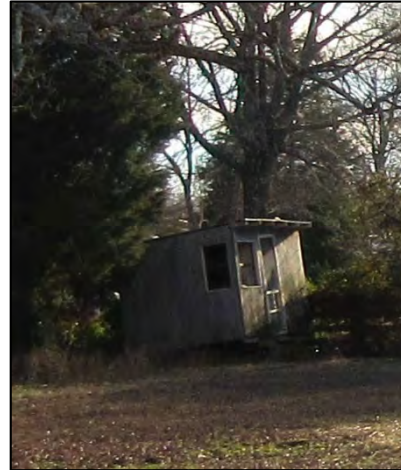
Shed 3: This prefabricated shed appears in historic aerial imagery after 1999.

Shed 3, view to south

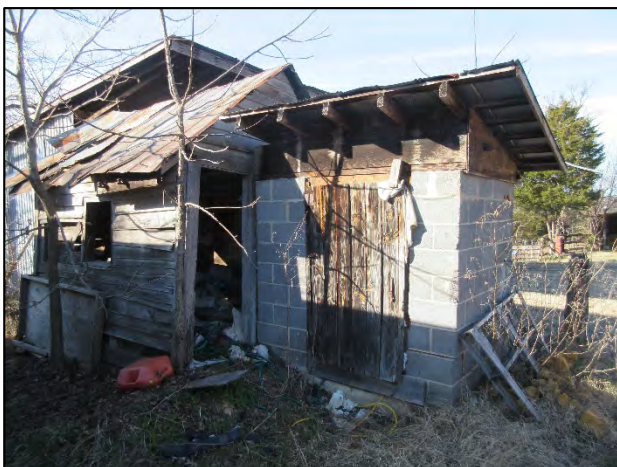
Well House and Tack Room: The well house and tack room are located south of the equipment shed. The concrete block well house sits on a poured concrete foundation and is covered with a wood frame shed roof clad in standing seam metal. A simple wood batten door is affixed to the south elevation. The tack room is attached to the west elevation of the well house and is a simple wood frame structure with an entry in the east elevation, adjacent and perpendicular to the west elevation of the well house. A small window opening is located in the south elevation. The tack room features a front gable roof clad in standing seam metal. These structures appear in aerial imagery dated 1965 and, based on materials and condition, were likely constructed in the late-1940s or early 1950s.

Well house (right) and tack room (left), view to northwest

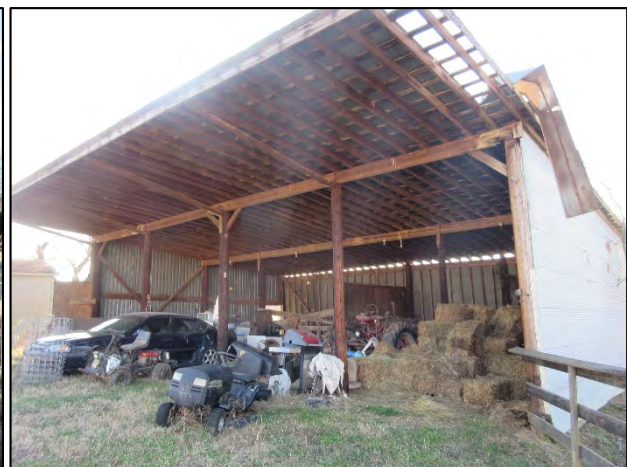
Equipment Shed 2: The equipment shed 2 is a large, four-bay pole-frame shed structure located south of the Milk House. The structure is clad in metal siding and roofing. This structure is absent in aerial imagery dated 1965, but appears in a 1982 aerial image. Based on materials and conditions, equipment shed 2 likely dates to the mid-1970s.

Equipment shed 2, view to southwest

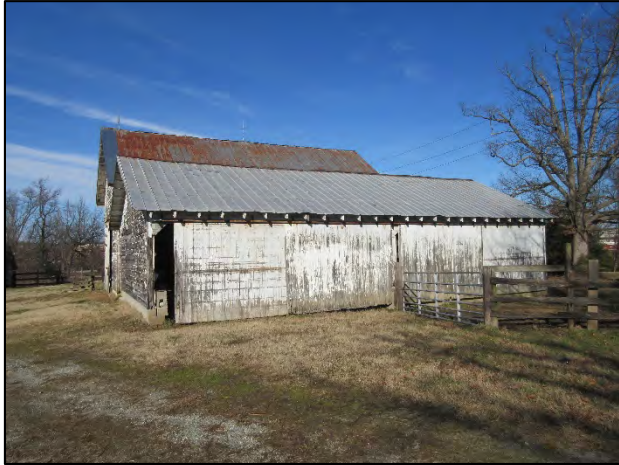
Equipment Shed 3: This side gable structure was relocated to the property after 1982 according to historic aerial imagery. The current owner stated that this structure originated from another Jordan

property to the west. The structure was placed on a concrete block foundation directly south of the double crib barn. A simple wood swinging double-door is located in the east elevation permitting access to a small pasture enclosure, and the south elevation consists of a series of four wood sliding doors. All other elevations are clad with weatherboard. The roof features exposed rafter tails and open sheathing clad in standing seam metal.

Equipment shed 3, view to the northeast

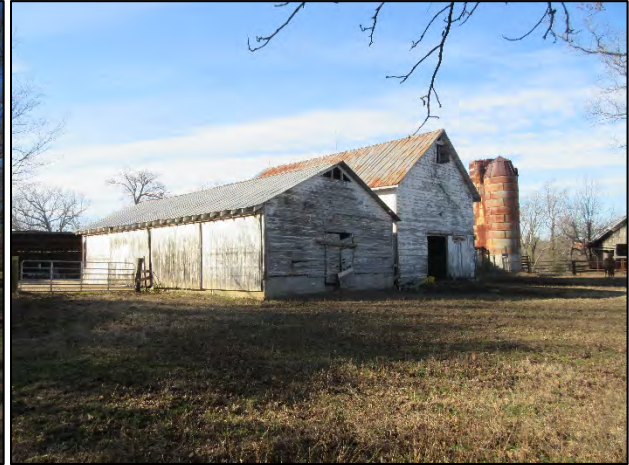
Equipment shed 3 (left), double crib barn and silos (right), view to the northwest

Double Crib Barn: The front gable double crib barn is reportedly as old as the main residence, dating to at least 1903. The current owner indicated a similar style house was present on the site prior to 1903, but burned. It is possible the barn may predate 1903. However, field investigation did not provide additional evidence that could conclusively confirm a date.

The breezeway is accessible by a sliding door in each gable end with eight animal pens (cribs) arranged along either side. The barn is constructed of hand hewn logs fastened by mortise and tenon technique. Later additions and alterations often employ nominal lumber fastened by nail or screw. The walls and roof have open sheathing that is finished with German siding and a metal roof. The concrete block foundation replaced a stone foundation at an unknown date.

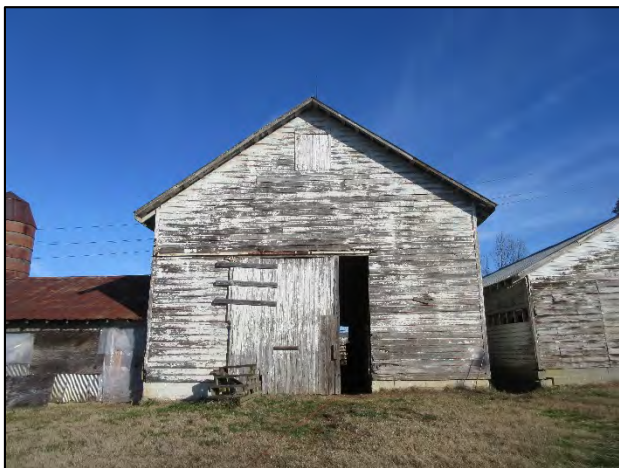
Double crib barn, view to east. Equipment shed 3 at right, milk parlor and silos at left.

Overall, the agricultural outbuildings represent common building types and lack individual distinction. Though the double crib barn retains evidence of its log construction, the weatherboard cladding and later update to the building foundation prevent it from being a good and representative example. Likewise, material alterations and general disrepair prevent the other complementary outbuildings from conveying individual architectural significance. Therefore, these resources are recommended not eligible under Criterion C.

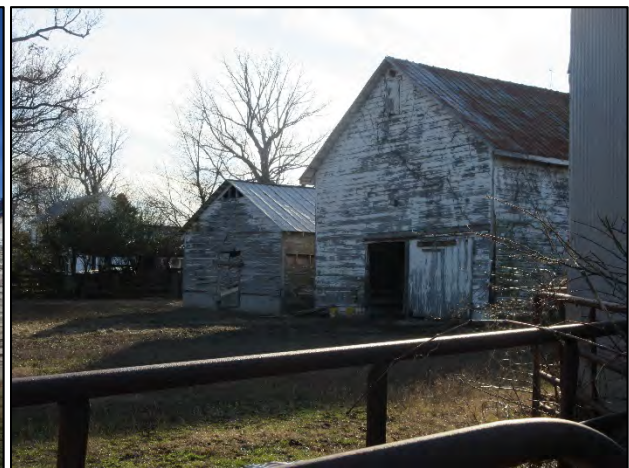
Double crib barn (right), equipment shed 3 (left) view to southwest

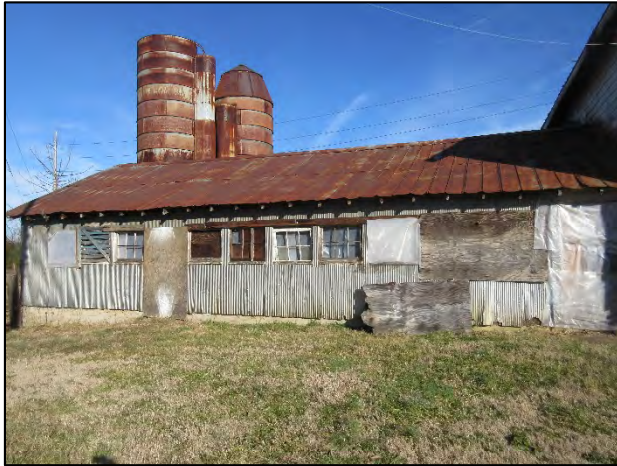
Milk Parlor: The gabled milk parlor was added to the north elevation of the double crib barn and is accessible via a door from one of the animal pens. A raised concrete floor traverses the center of the milk parlor and exits the north elevation via a doorway. The milk house would accommodate 22 cows at a time. The building sits on a poured in slat concrete foundation and is clad with metal. Based on materials and construction technique, specifically the concrete foundation, the milk parlor and complementary milk house (described below) were likely constructed around the same time as each other and correspond to the development of the farm for dairy production. This transition appears to have occurred in the late 1920s, contemporaneous with the adjacent silos.

Milk Parlor, view to east

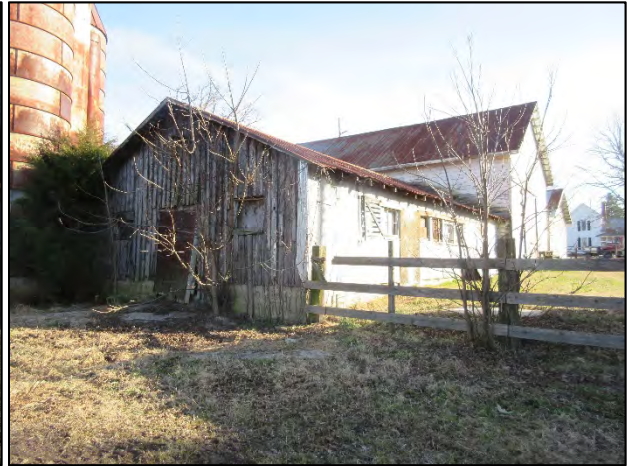
Milk Parlor (center), view to southeast

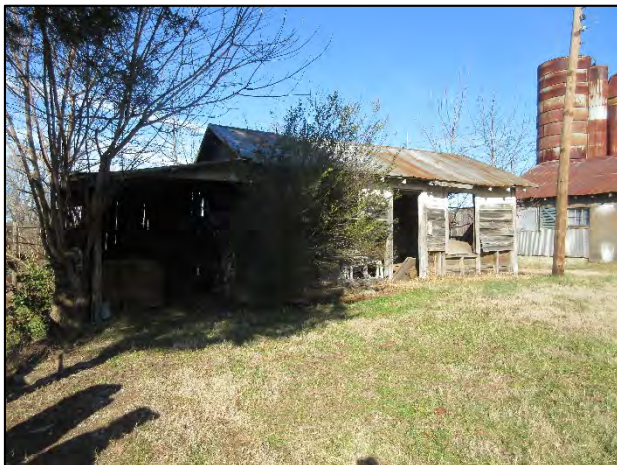
Milk House: Located west of the milk parlor is the milk house, a small side-gabled frame structure. This house stored the milk collected in the parlor for pick-up by a distributor. The milk house is set on a poured in slat concrete foundation and is clad in weatherboard siding. A doorway is centered on the south elevation and flanked by two window openings, however neither door nor windows remain. A shed lean-to extends from the west elevation, enclosed on three sides, to form a tractor shed. Based on materials and construction technique, the milk house appears to date to the late 1920s.

Milk House, view to northeast

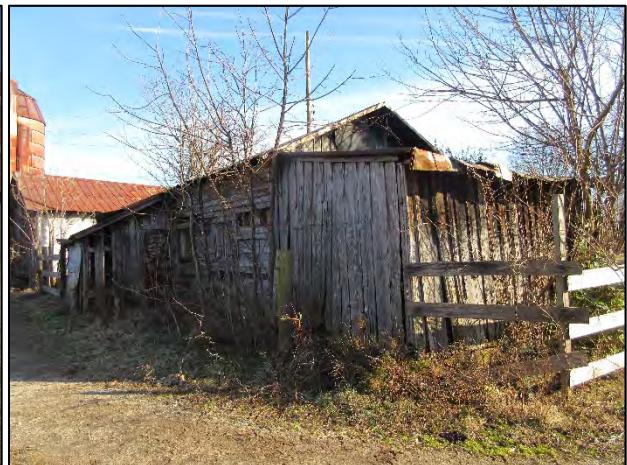
Milk House, view to southeast

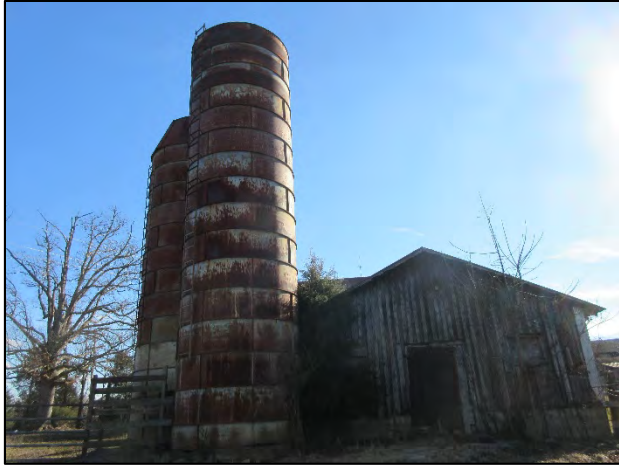
Silos: Two metal panel silos on poured concrete foundations sit adjacent to the northeast corner of the milk parlor. The initials of the three Jordan brothers (H.H., C.E., and R.T) are inscribed in the silo foundations as are the presumed dates of construction, 1928 (the western silo) and 1930 (the eastern silo). The silos housed silage fodder for the dairy cows.

Silos, view to southeast (Milk Parlor at right)

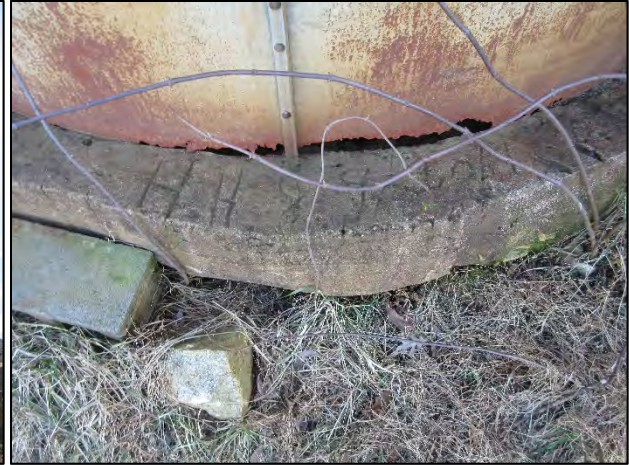
Silo foundation (east) detail, "H.H.J. 9/20/1930"

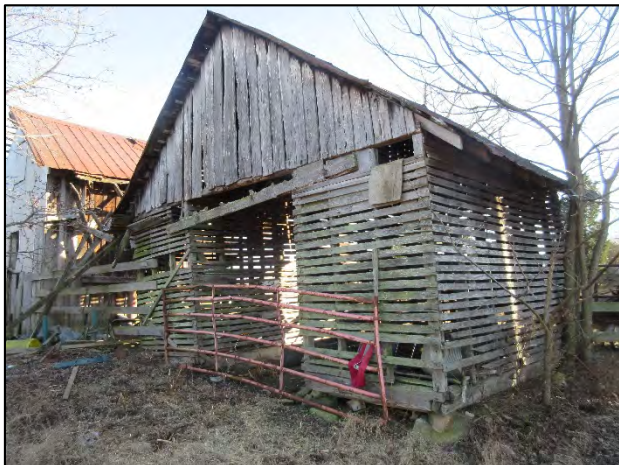
Corn Crib and Granary: These small auxiliary structures are located northeast of the silos and consist of frame construction on stone piers. The dates of construction for these structures are unknown but may pre-date the conversion of the farm to dairying in the late 1920s based on construction technique and materials. The corn crib consists of three bays, or two cribs and a breezeway, under a gable roof clad in standing seam metal. The gable ends are clad in batten boards. The granary is clad in metal siding and the gable roof in standing seam metal. Simple metal-clad doors are located in each gable end.

Corn Crib, view to southeast (granary at left)

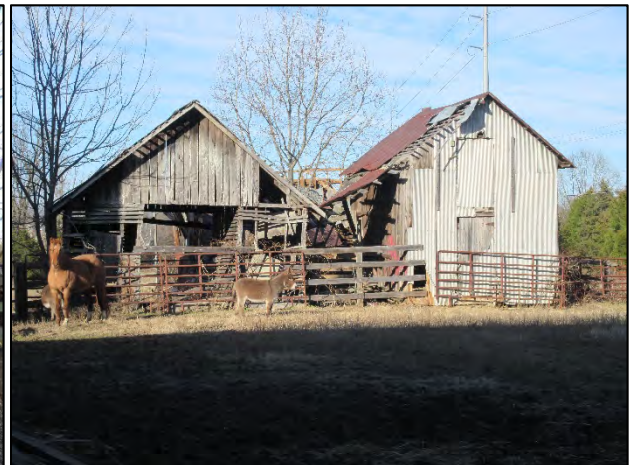
Corn Crib (left) and Granary (right), view to north

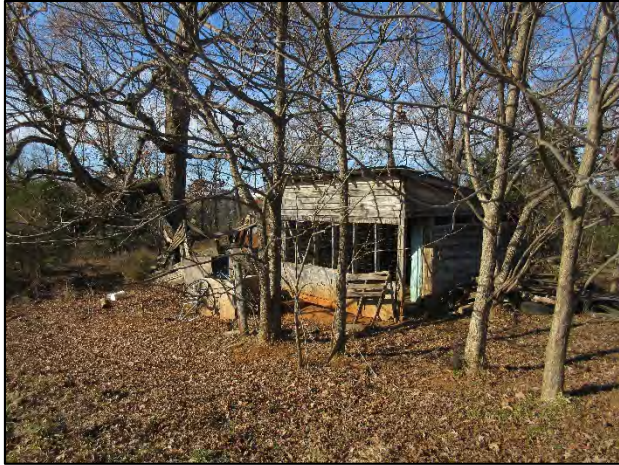
Chicken Coops: Two historic chicken coops – one of which is collapsed – are located northwest of the Milk House and are associated with the remnants of a chicken run north and west of the simple structures. The standing chicken coop is a simple shed structure with weatherboard siding and a door in the east elevation. The south elevation is mostly open, showing exposed structural studs enclosed with hardware cloth.

Chicken coops, view to northwest

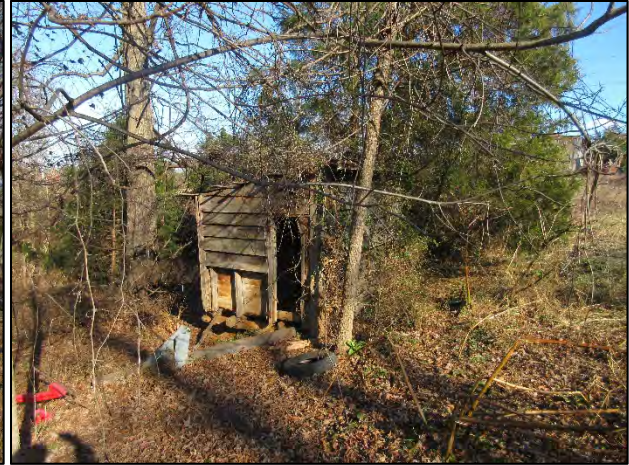
Hog House: A wood frame shed-roofed hog house is located north of the chicken coops. The simple structure is set on a stone and log foundation with weatherboard siding. A narrow entry is located in the west elevation. Similar to the chicken coops, the remnants of a n animal run extend from the west and north side of the hog house.

Hog house, view to northeast

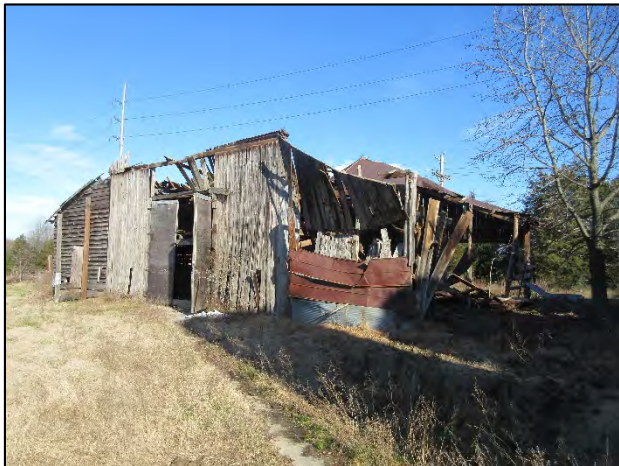
Hay Barn (collapsed): North of the corn crib and granary is a hay barn that has fallen into disrepair and recently collapsed.

Hay barn (collapsed), view to northeast

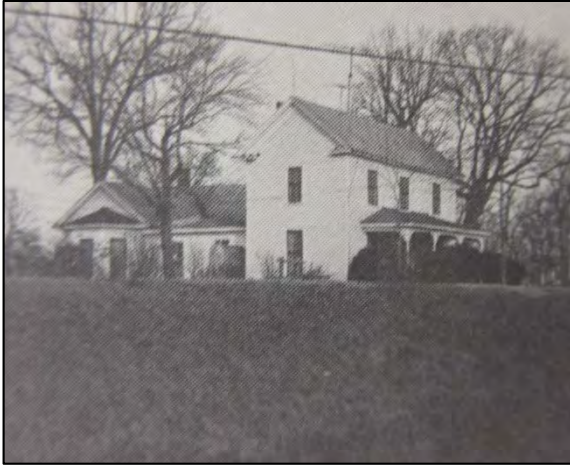
The Jordan Dairy Farm was visited by architectural historians in 1978-79 and in 1995 for regional inventory studies for the NC Department of Cultural Resources. The inventories, though, focused on the residence only. Smith (1979) first identified the house as the “Jordon House”, at which time the vinyl siding had not been applied. The short description notes the presence of molded trim, cornice, and porch with sawn detail. The rear additions were present at this time. Graybeal (1996) recorded the Jordon House and assigned the HPO Survey Site Number GF1421. Though the condition of the house was not addressed, the mid-1990s photograph does appear to show the vinyl siding in place.

"Jordan House" (Smith 1979)

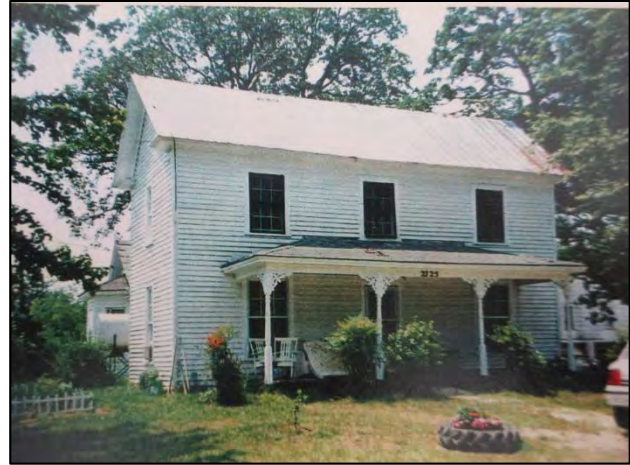
"Jordan House" (Graybeal 1996)

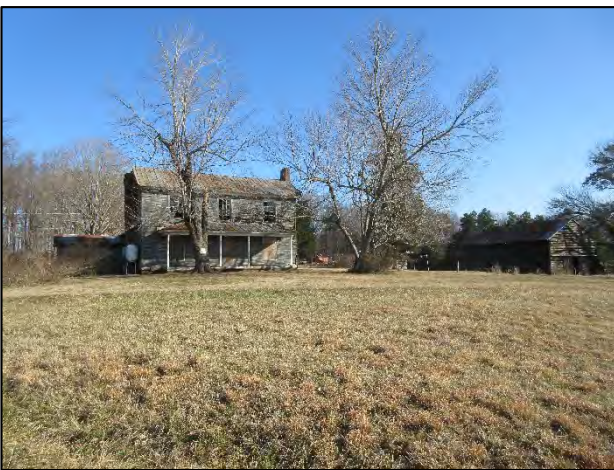
Schoolfield-Hatcher Farm (GF1826) house (at left) and frame barn (at right), view to north

The Schoolfield-Hatcher Farm (GF1826) house located northeast of Greensboro in Guilford County was determined NRHP-eligible under Criteria A and C in 2006. Though the house is in overall poor repair, the two-story, single-pile, triple-bay I-house features exterior end brick chimneys, a feature common to the house form, and a hipped roof front porch supported by simple replacement wood posts. The weatherboard siding was covered with asphalt siding and a rear one-story ell addition with attached shed porch extends from the west side of the house. The house features cornice returns and 6/6 wood sash windows.

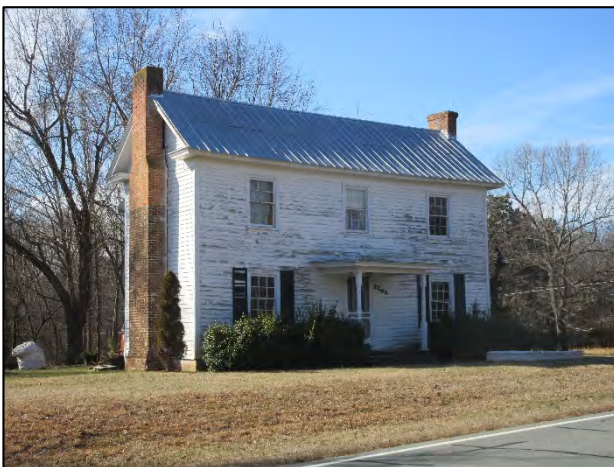
Foust-Carpenter and Dean Dick Farms (GF4959) house, view to northwest

The Foust-Carpenter and Dean Dick Farms (GF4959) located southeast of Greensboro in Guilford County was listed in the NRHP in 2009 under Criterion A in the area of agriculture and ethnic heritage (black). The Foust and Carpenter families constructed a cluster of house and agricultural buildings along Mt. Hope Church and Carpenter House Roads between the mid-nineteenth and mid-twentieth centuries. According to the NRHP Nomination (Fearnbach, 2009), field patterns and road systems within the 325-acre farm district have been consistent since 1937. The circa 1898 weatherboard-clad frame I-house rests on a continuous concrete block foundation with deep boxed cornice and gable

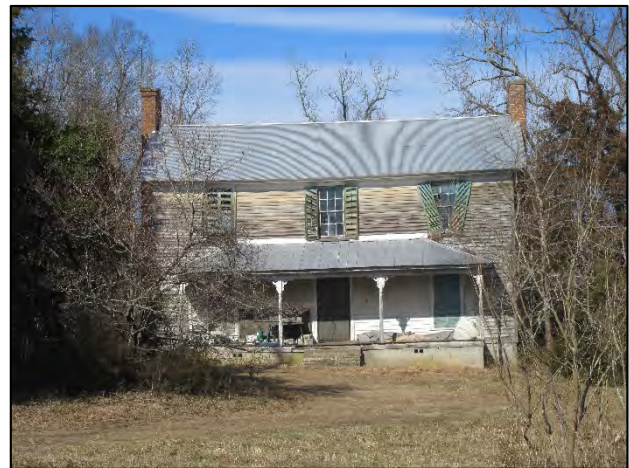
The Thomas R. Greeson House and Farm (GF1923) is located in the southeastern corner of Guilford County. The resource was determined NRHP-eligible in 2015 under Criterion A in the area of agriculture and Criterion C in the area of architecture. The two-story, three-bay, single-pile with rear wing I-house was built in 1881. The house rests on a replacement concrete block foundation and is clad in weatherboard siding with 6/6 wood sashes and operable louvered wood shutters in most windows. The partial-width hipped roof porch is supported by turned posts with decorative millwork brackets which covers a centered, double-leaf wood and glass doors. The side gabled roof has boxed eaves and wide fascia in the gable ends with exterior end brick chimneys.²¹

Thomas R. Greeson House and Farm (GF1923) house, view to northwest
