**HISTORIC STRUCTURES SURVEY REPORT
WIDEN SR 3174/SR1501 (IDLEWILD ROAD) FROM I-485 IN
MECKLENBURG COUNTY TO SR 1524 (STEVENS MILL ROAD) IN
MECKLENBURG AND UNION COUNTIES, NORTH CAROLINA**

**TIP Project U-4913
WBS No. 40543.1.2**

**Prepared by:
Commonwealth Heritage Group, Inc.
P.O. BOX 1198
201 WEST WILSON STREET
TARBORO, NORTH CAROLINA 27886**

APRIL 2018

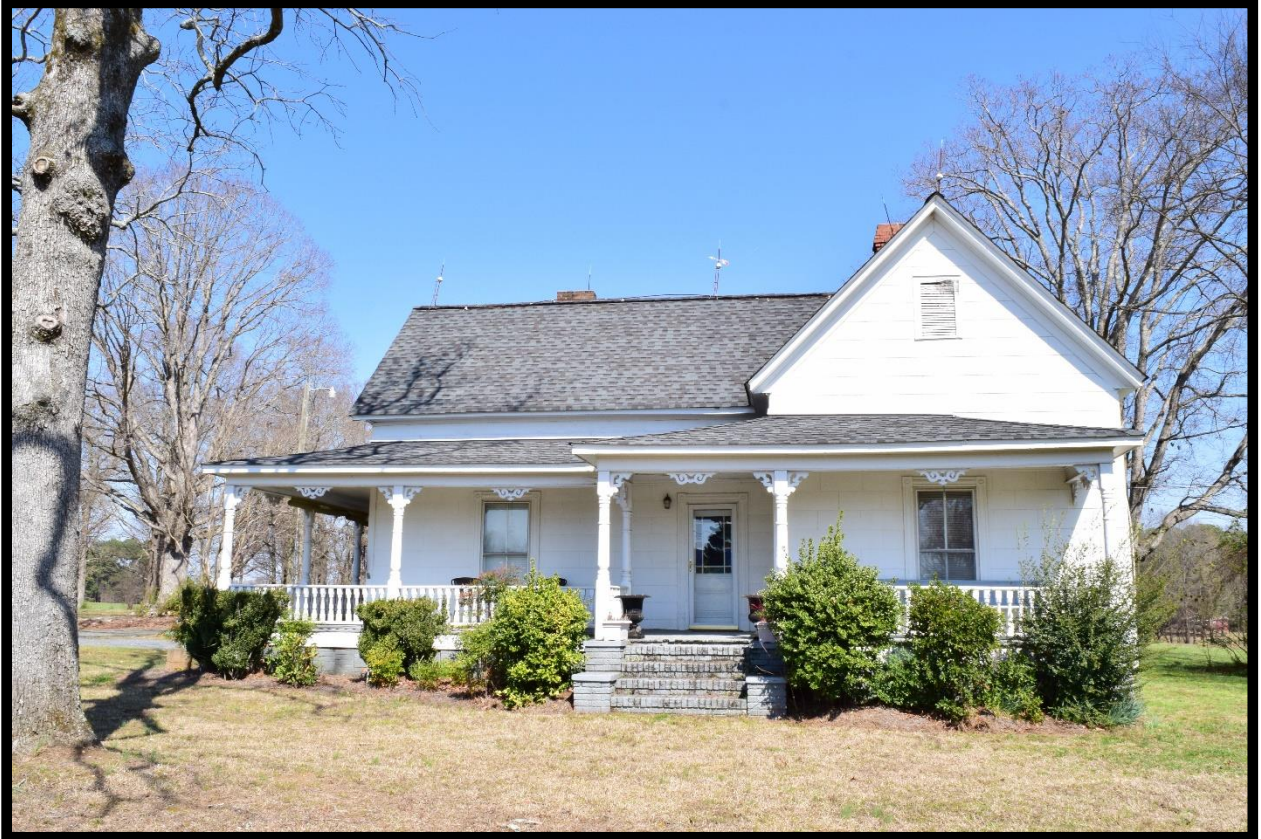
Figure 3: Sustar House, Looking Northeast.

The Sustar House is located on the east side of SR 3174/SR1501 (Idlewild Road) approximately 0.25 miles northwest of the Interstate 485 overpass and less than 0.5 miles from the Mecklenburg and Union County line. The house sits 90 feet from the road and faces southwest toward the corner of SR 3174/SR1501 (Idlewild Road) and Stallings Road, which approaches from the south and terminates at SR 3174/SR1501 (Idlewild Road). The corner lot is sparsely wooded. Immediately surrounding the house is a grassy lawn with some mature trees and two large stumps. A gravel driveway begins at the southwest corner of the parcel and curves toward the northwest elevation of the dwelling where it terminates at the edge of the wraparound porch. Various outbuildings stand northeast and southeast of the dwelling, and a plowed field fills the eastern portion of the irregularly shaped parcel (Figures 3 and 4).

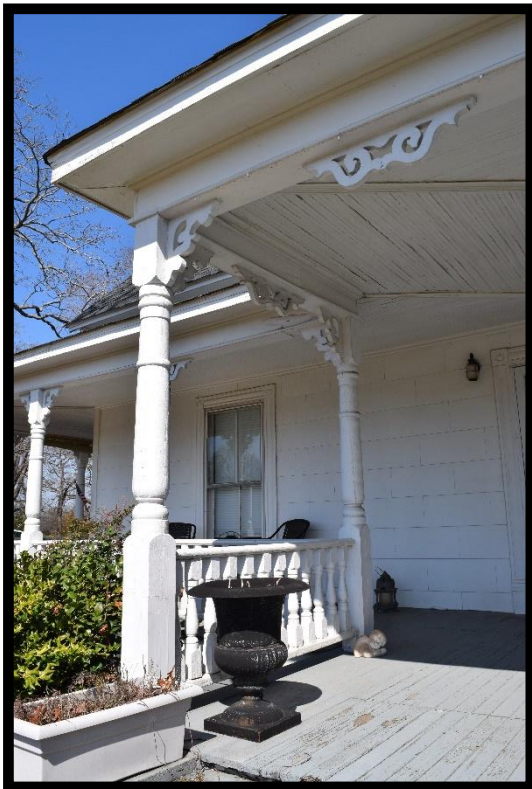
A hip-roofed, wraparound porch with a turned balustrade, turned support posts, and sawnwork brackets spans the southwest (front) elevation and a portion of the northwest (side) elevation (Figure 5). The porch is approached by brick steps. On the southwest (front) elevation, the porch shelters a centered wooden entry door with multiple lights above a panel and two two-over-two wooden sash windows—one north of the entry door and one south of the door on the projecting front gable. The windows and doors have molded surrounds with patera (Figure 6).

Figure 5: Sustar House, Porch Details.

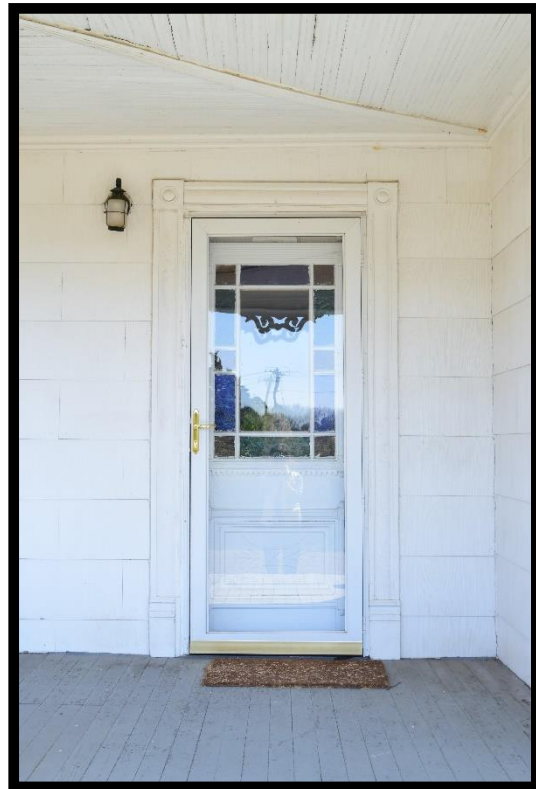
Figure 6: Sustar House, Entry Door.

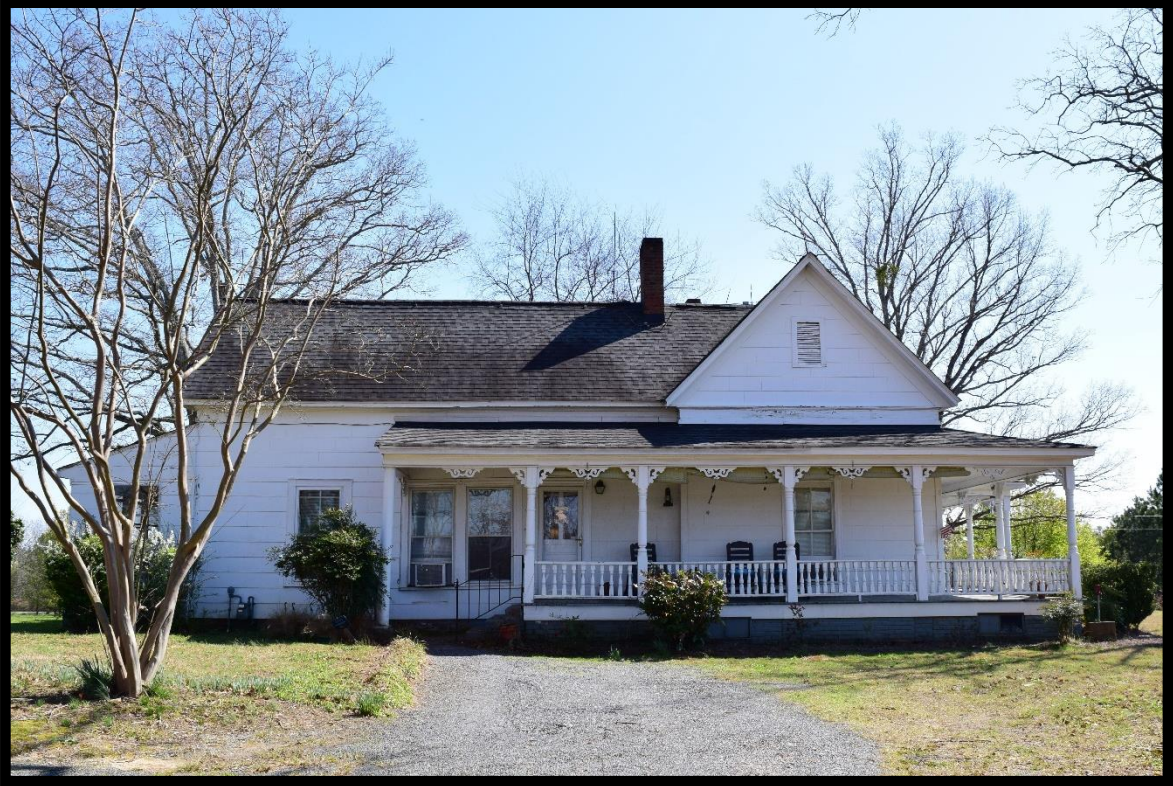
On the northwest (side) elevation the porch shelters a two-over-two wooden sash window, a wooden entry door with two vertical panes above panels, and a pair of two-over-two wooden sash windows. Beyond the porch is a single two-over-two wooden sash window. Though the windows and doors on the northwest (side) elevation have the same molded surrounds as the

southwest (front) elevation, a break in the elevation suggests that the portion beyond the gable belongs to an addition (Figure 7).

Figure 7: Sustar House, Looking Southeast.

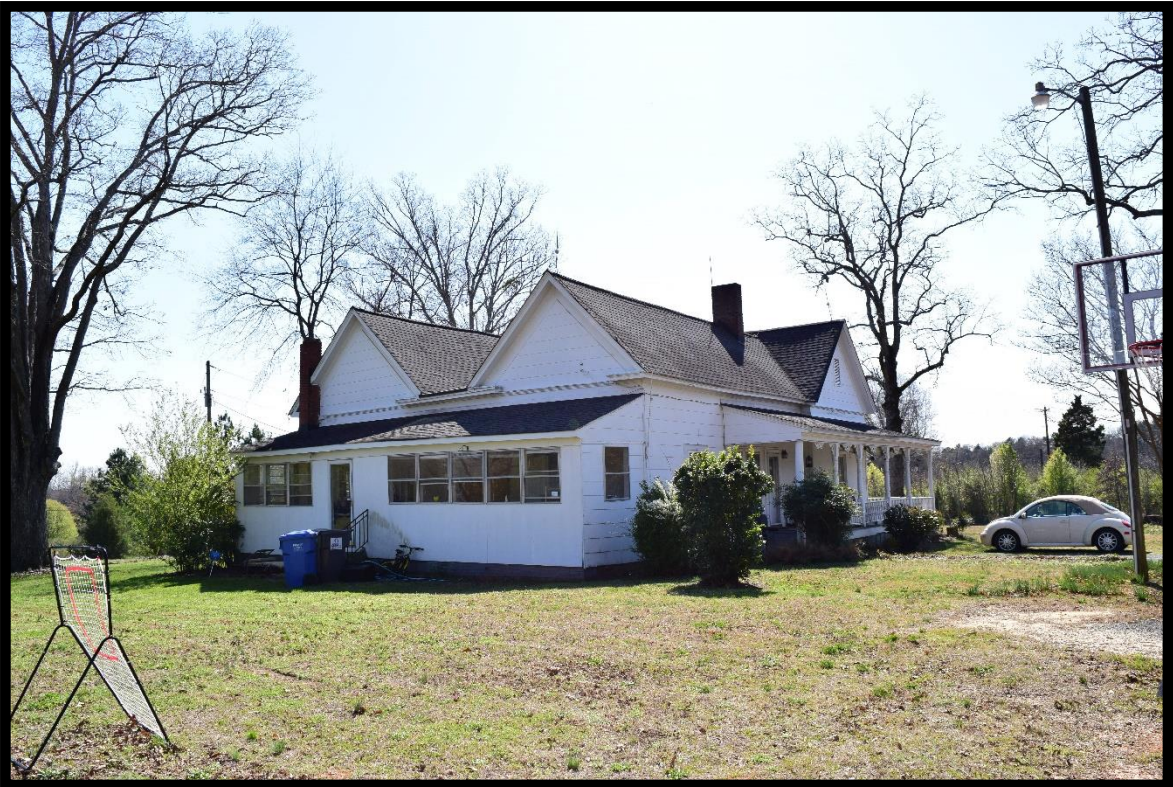
The northeast (rear) elevation of the dwelling is defined by two gables, the southern of which is original and the northern of which belongs to the addition. Below the gables, an enclosed, shed-roofed porch spans the elevation. It has ribbons of one-over-one, metal-sash windows and an off-center, modern, plexiglass door. There is a single one-over-one, metal-sash window on each end (side elevation) of the porch and a narrow, brick chimney rises at the east end of the porch between the porch and main block of the dwelling (Figure 8).

Figure 8: Sustar House, Looking South.

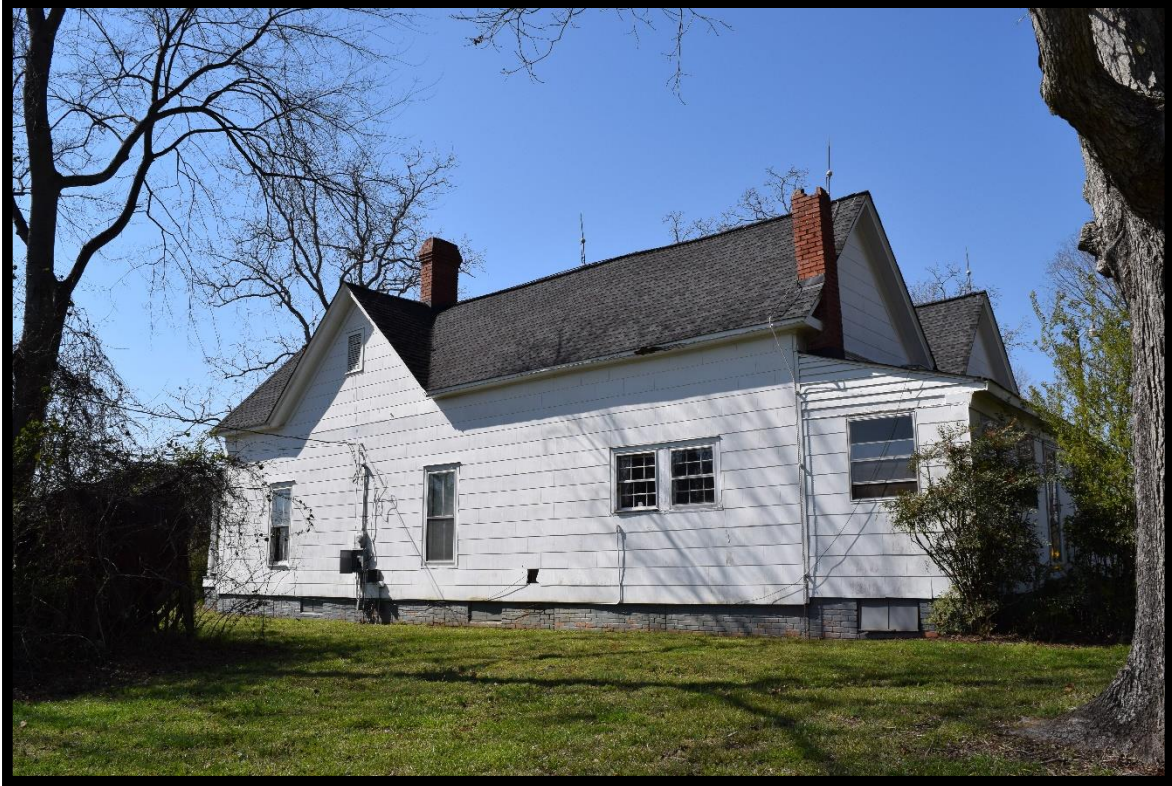
The southeast (side) elevation contains, from east to west, paired six-over-six wooden sash windows and two two-over-two wooden sash windows below an off-center gable. Unlike the windows on the southwest (front) and northwest (side) elevations, the windows do not have molded surrounds or patera, a detail that was likely lost when the dwelling was clad in asbestos siding (Figure 9).

Figure 9: Sustar House, Looking West.

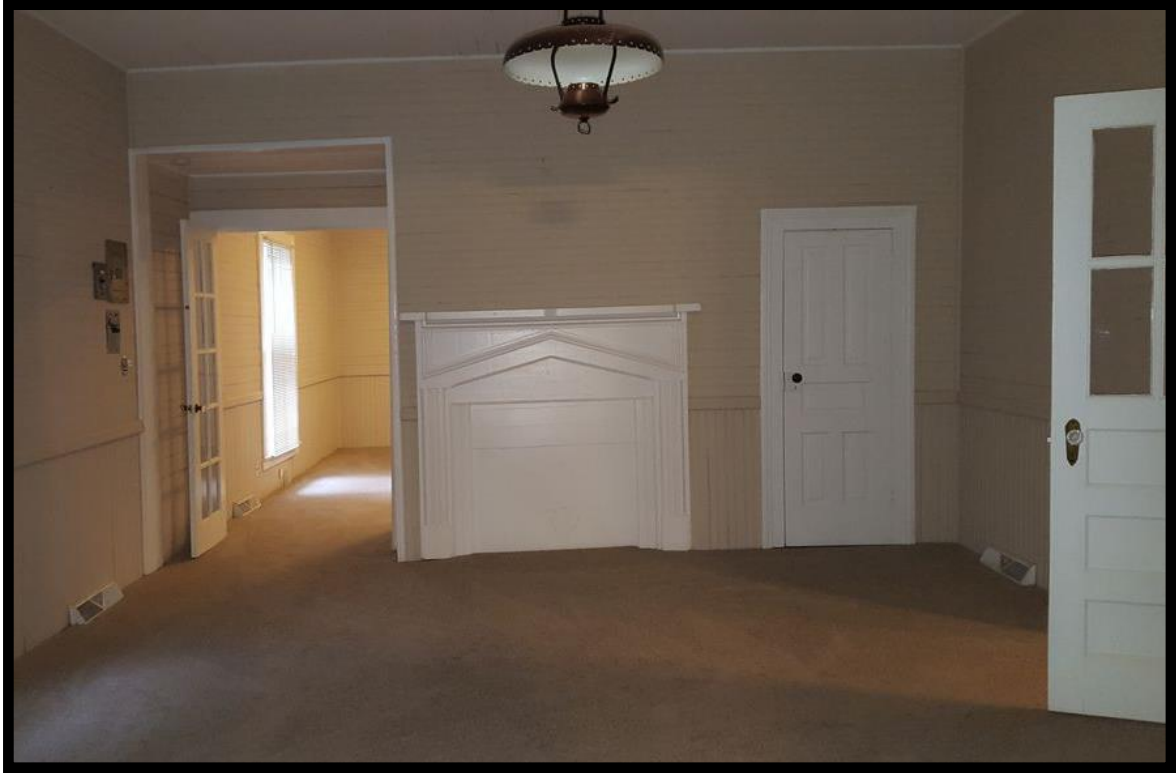
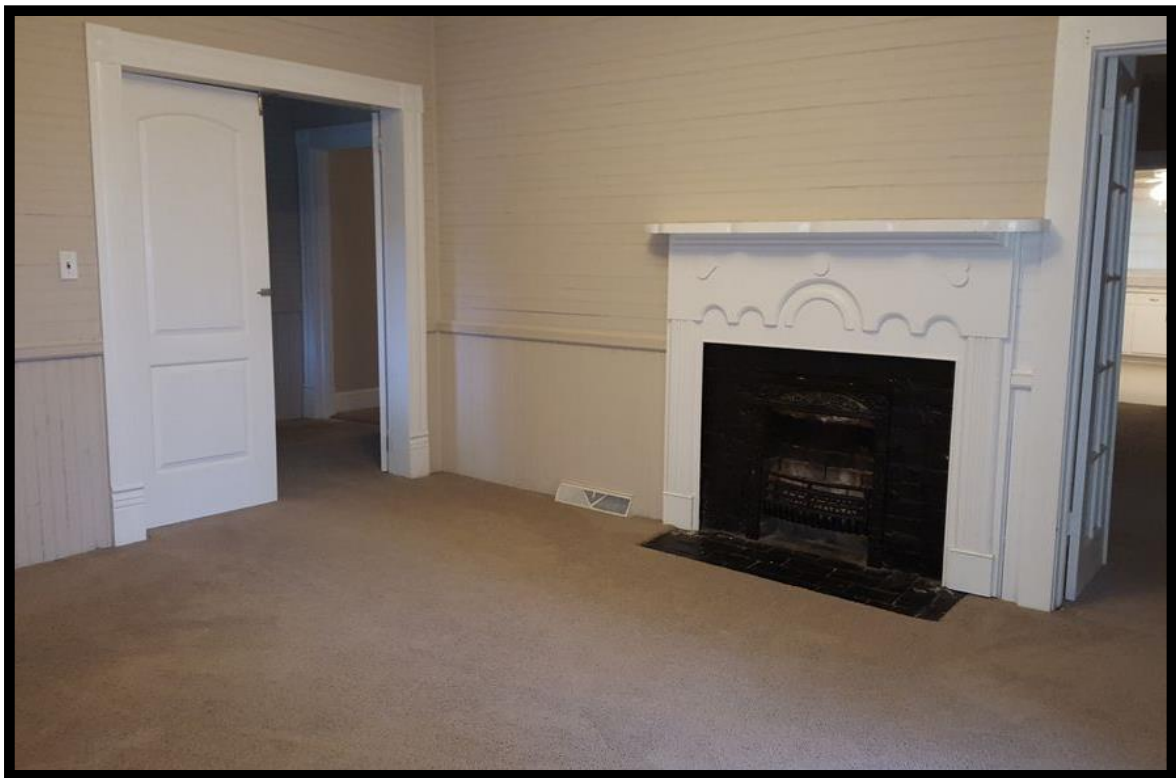
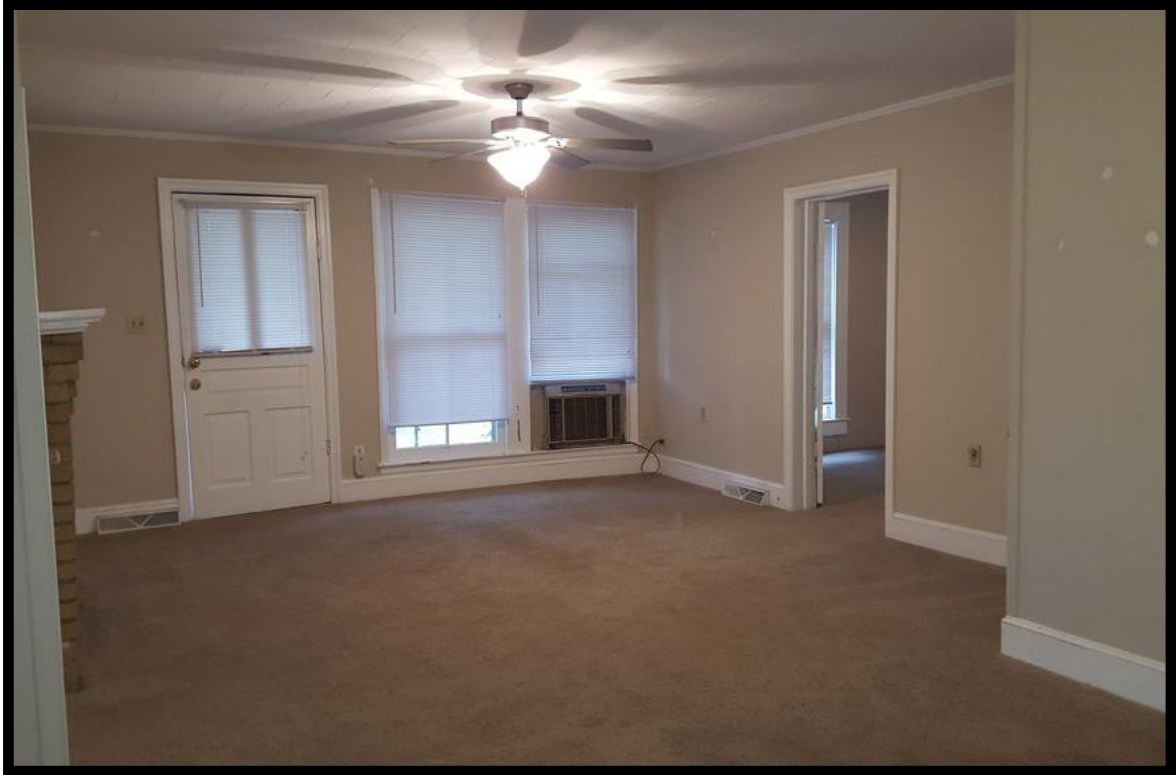
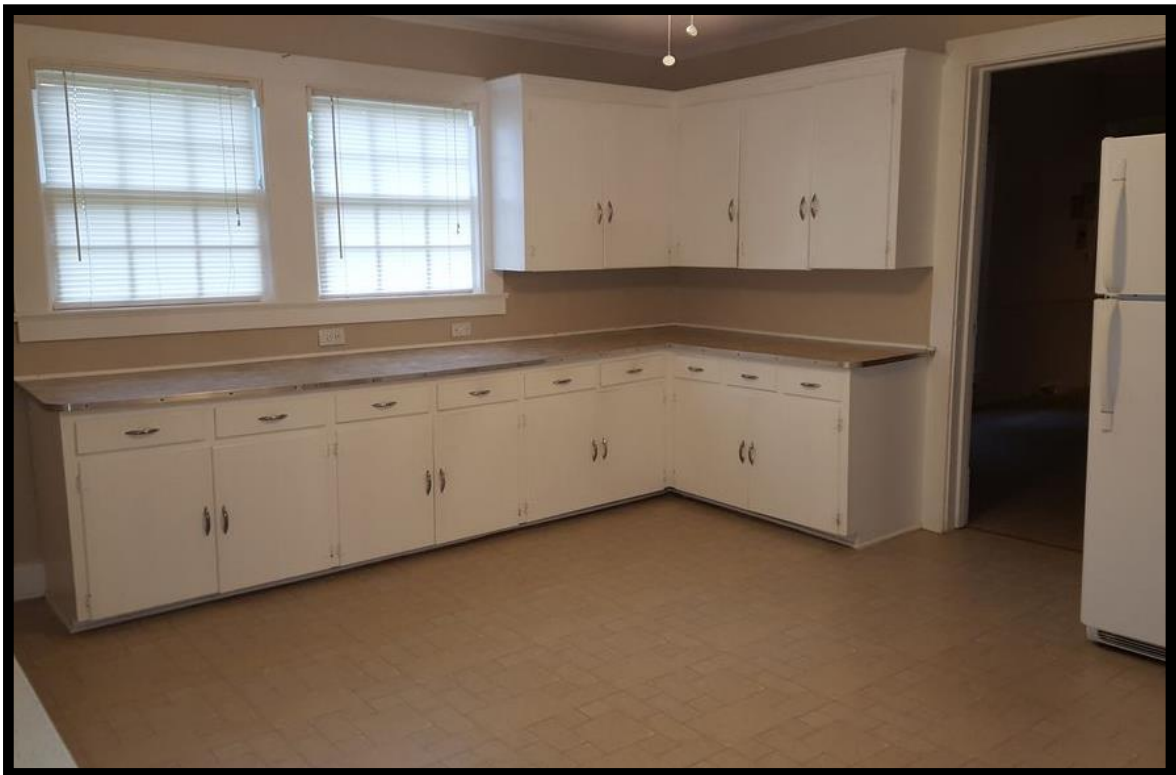
Photos of the house were found on Zillow.com and show that the interior retains original material including doors, door surrounds, mantles, and walls finished with horizontal flush boards above beadboard wainscoting. Kitchens and bathrooms have been altered with new cabinets and flooring, and other spaces have been carpeted. It was possible to enter the dwelling and confirm that the horizontal flush board and beadboard wainscoting are still intact. The resident, who rents the property, expressed that she had had a stroke and had trouble speaking/communicating and it seemed best not to press for interior photos, but rather to visually confirm the interior details viewed online (Figures 10-13).³

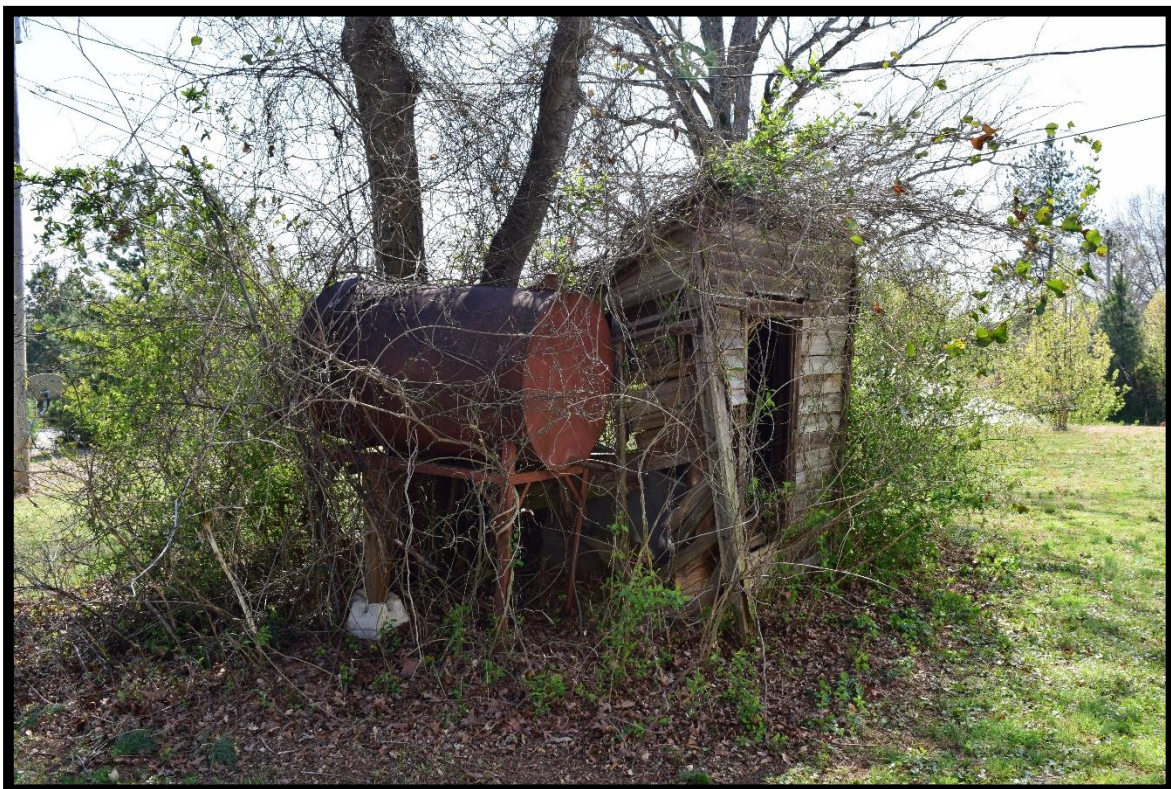
There are four outbuildings that surround the dwelling. The first is a small frame structure with a shed roof and weatherboard siding that stands just southeast of the dwelling and is in ruinous condition. Next to the structure is a raised tank, likely used for water or oil (Figure 14).

Figure 14: Shed and Tank, Looking South.

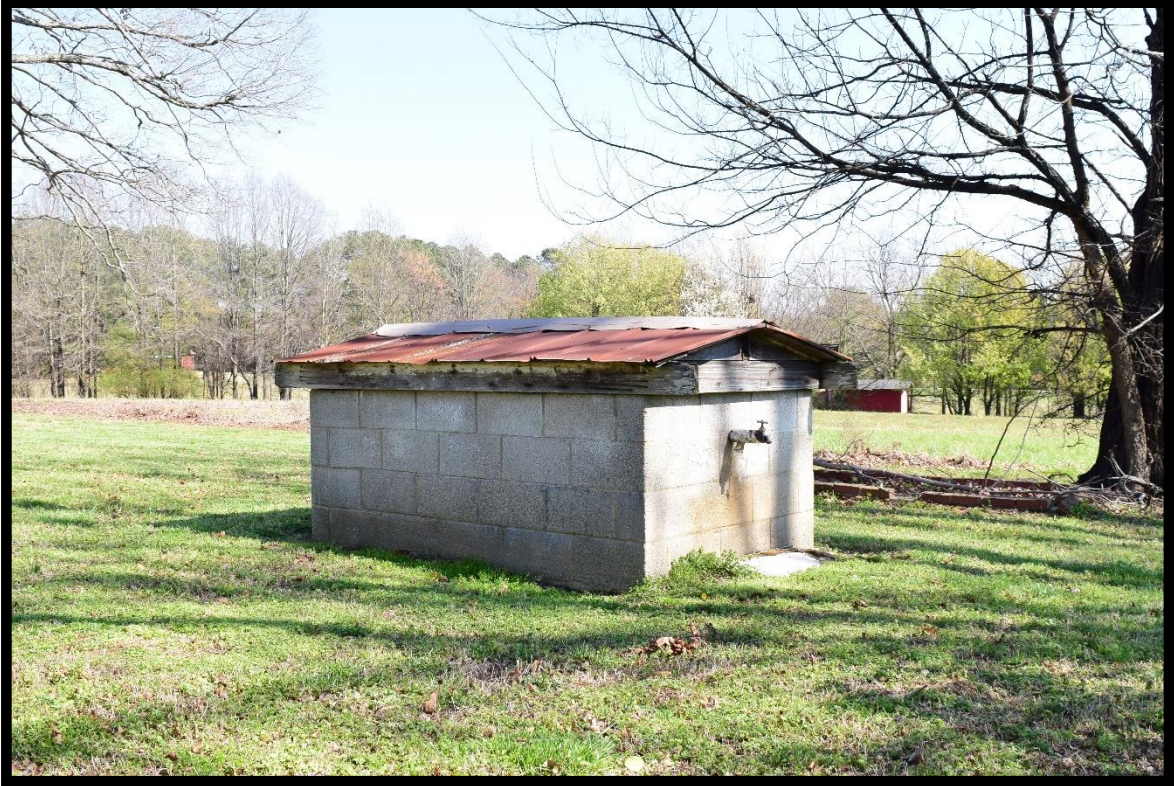
Northeast of the dwelling, in the rear yard, is a concrete block well-shelter with a pump and spigot. It is covered with a slightly gabled, standing-seam metal roof (Figure 15). Just beyond the well-shelter is a shed-roofed storage building with wooden weatherboard siding on three elevations and standing-seam metal on the fourth elevation, a concrete block foundation, a modern entry door, and a small wooden-framed window/opening that does not contain any glass (Figure 16).

Figure 15: Well-shelter, Looking East.

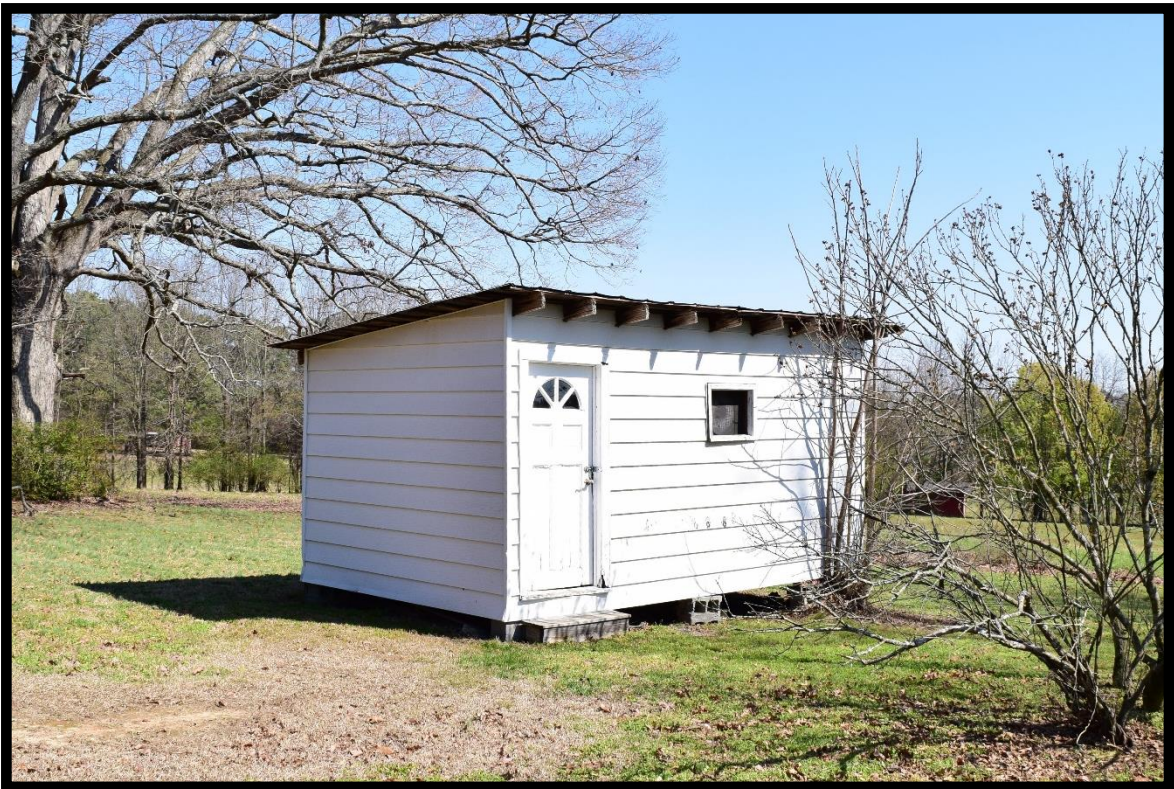
Figure 16: Storage Shelter, Looking East.

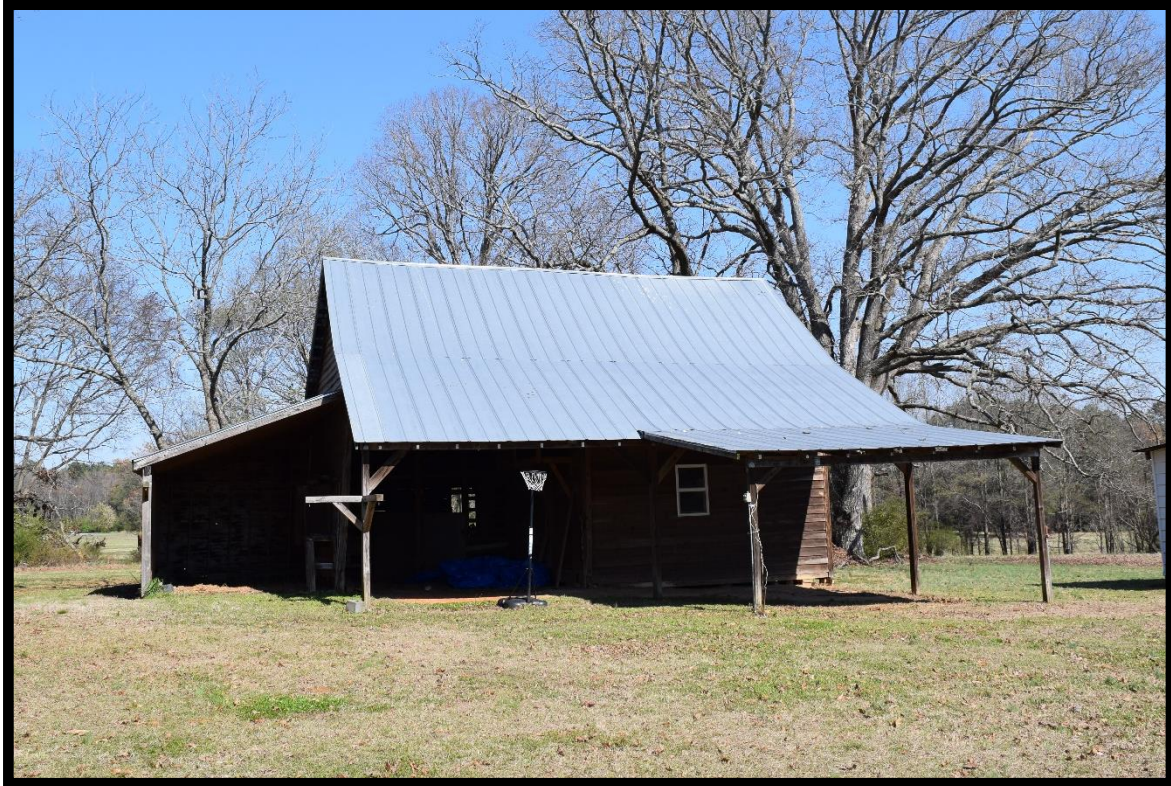
Slightly north of the storage building is a side-gabled barn clad in wooden weatherboard siding and covered with a standing-seam metal roof. An open, shed-roofed section, one section of which is deeper than the other, extends from the southwest (front) elevation and is supported by square posts, and a partially enclosed, shed-roofed wing extends from the northwest (side) elevation (Figure 17). Two shed-roofed wings extend from the northeast (rear) elevation of the barn and an open, shed-roofed storage area extends from the rear of the wings (Figure 18). There are three vinyl sash windows on the barn's southeast (side) elevation.

Figure 17: Barn, Looking Northeast.

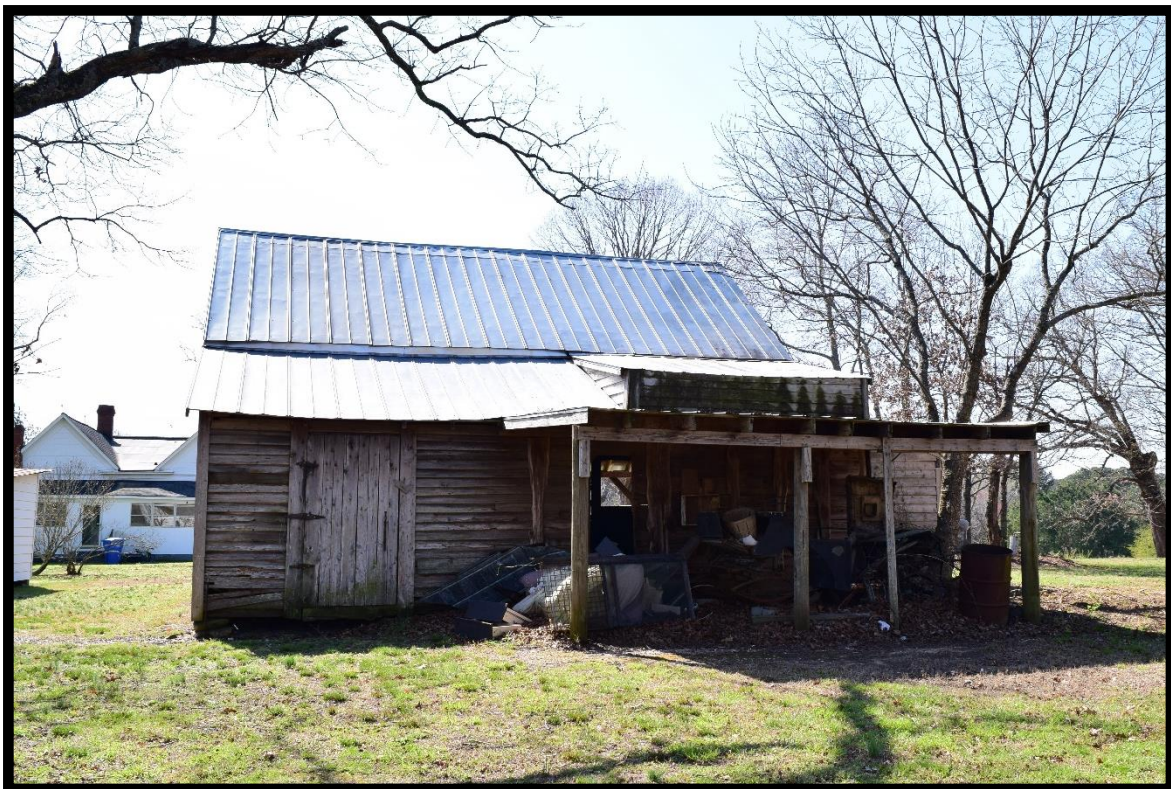
Figure 18: Storage Shelter, Looking Southwest.

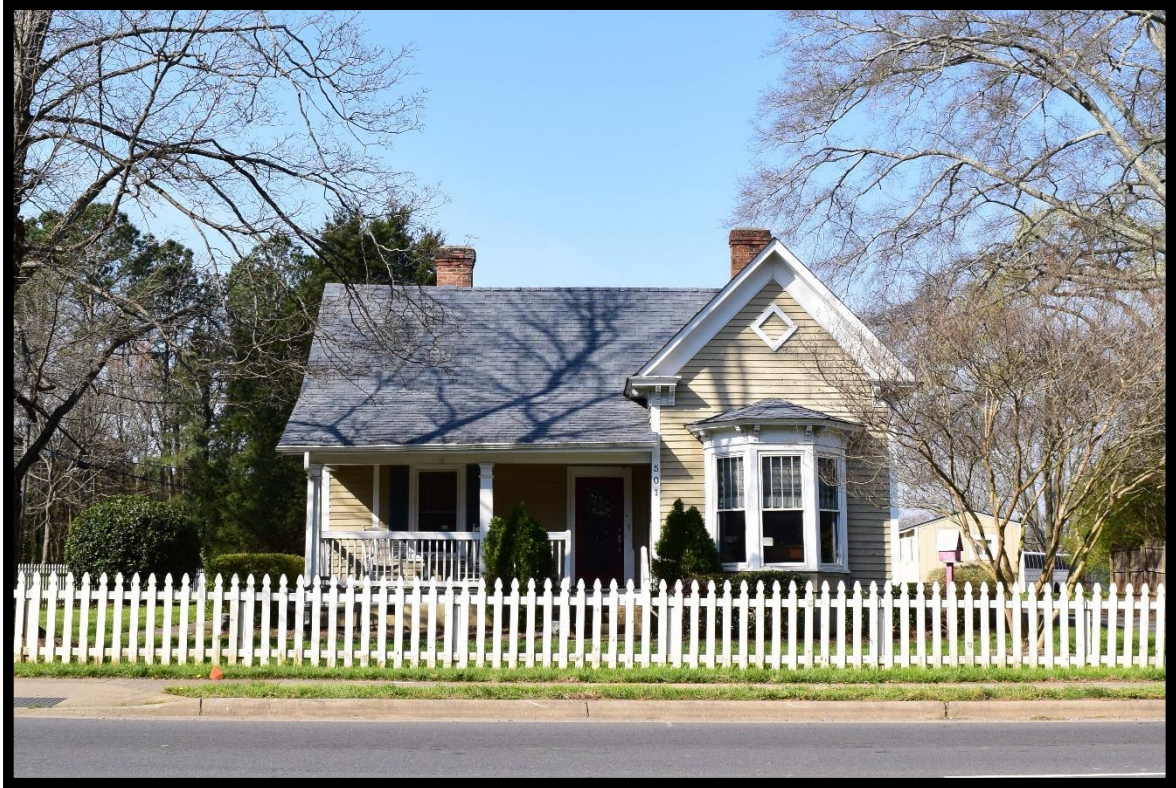
Built in 1921, the dwelling on John Street serves as an urban counterpart to the rural Sustar House.¹⁵ Its architectural details, which include paired brackets, molded door surrounds, and a bay window, exhibit the Italianate style and along with the Sustar House display the adaptability of the gable-and-wing form. Though it is slightly smaller and lacks the Sustar House's wraparound porch, the dwelling is also an example of a more well-preserved property retaining its wooden weatherboard siding and other character-defining details.

Figure 24: 501 West John Street, Matthews, NC (MK1182).

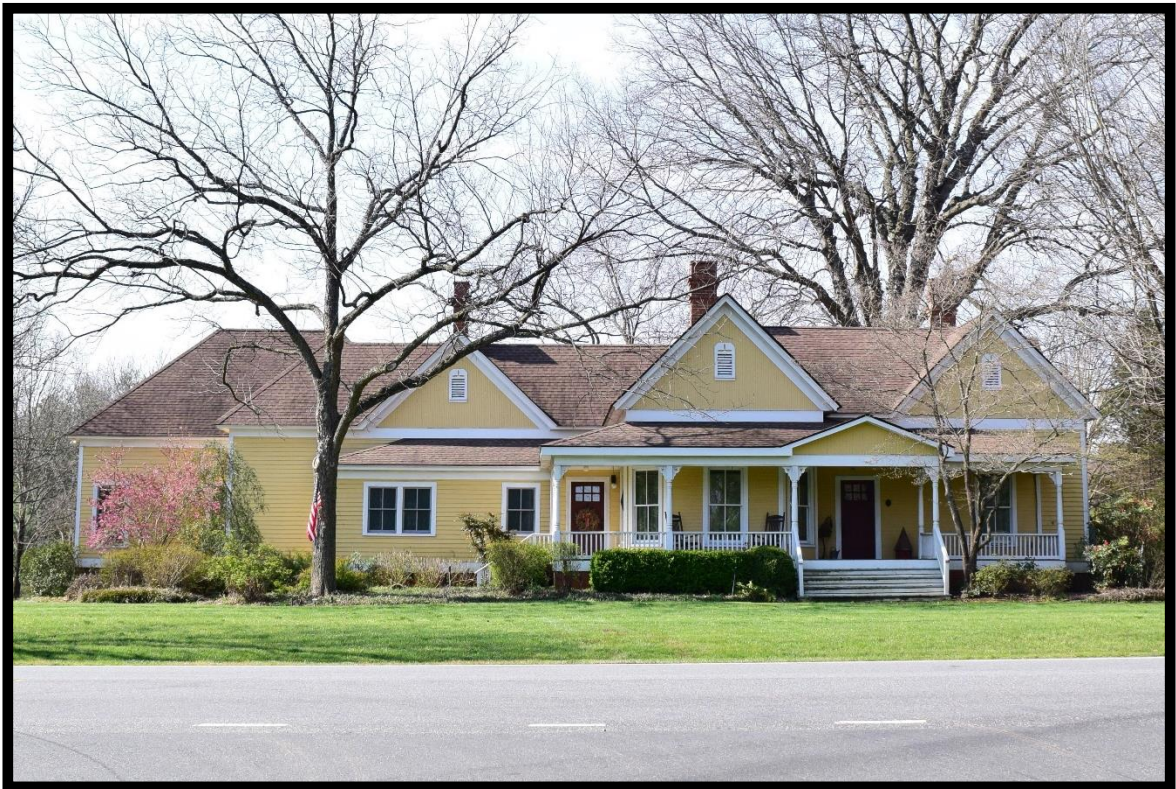
The Barnum & Sarah Sustare House is not only comparable with the Sustar House for its architecture, but also for its relationship to the Sustar(e) family. Constructed by James Sustar's twin brother in 1922, the house has a large wraparound porch, turned porch supports, and sawnwork brackets.¹⁶ It differs from the Sustar House in that it has two front gables as well as a

cut-away-bay window sheltered by the porch. The dwelling is also much larger with a wing that projects from the east elevation of the main block and, according to a survey and research report prepared by Dr. Dan L. Morrill, is original.¹⁷ Like the Sustar House, this house was once a part of a larger farm but has lost much of its associated farmland to the construction of new houses. Nevertheless, the house has been well-maintained on both the exterior and interior as exhibited by Dr. Morrill's report, and represents the success and influence of the Sustar(e) family as early residents in Mecklenburg County.¹⁸ The Barnum & Sarah Sustare House was designated as a local historic landmark by the Charlotte-Mecklenburg Historic Landmarks Commission in April of 2011.¹⁹

Figure 25: Barnum and Sarah Sustare House 13700 Idlewild Rd., Matthews, NC (MK1212).
