SUBJECT: Historic Structures Survey Report for W-5704 F, Intersection Improvements at
NC 581 and SR 1324 and SR 1317, PA 18-06-0021, Wayne County, ER 19-0984

**HISTORIC STRUCTURES SURVEY REPORT
INTERSECTION IMPROVEMENTS AT NC 581 AND
SR 1324 (NOR-AM ROAD) AND SR 1317
(BUCK SWAMP ROAD), WAYNE COUNTY,
NORTH CAROLINA**

**TIP Number: W-5704F
WBS#: 44850.1.6
PA#: 18-06-0021**

WY0590: Deans House

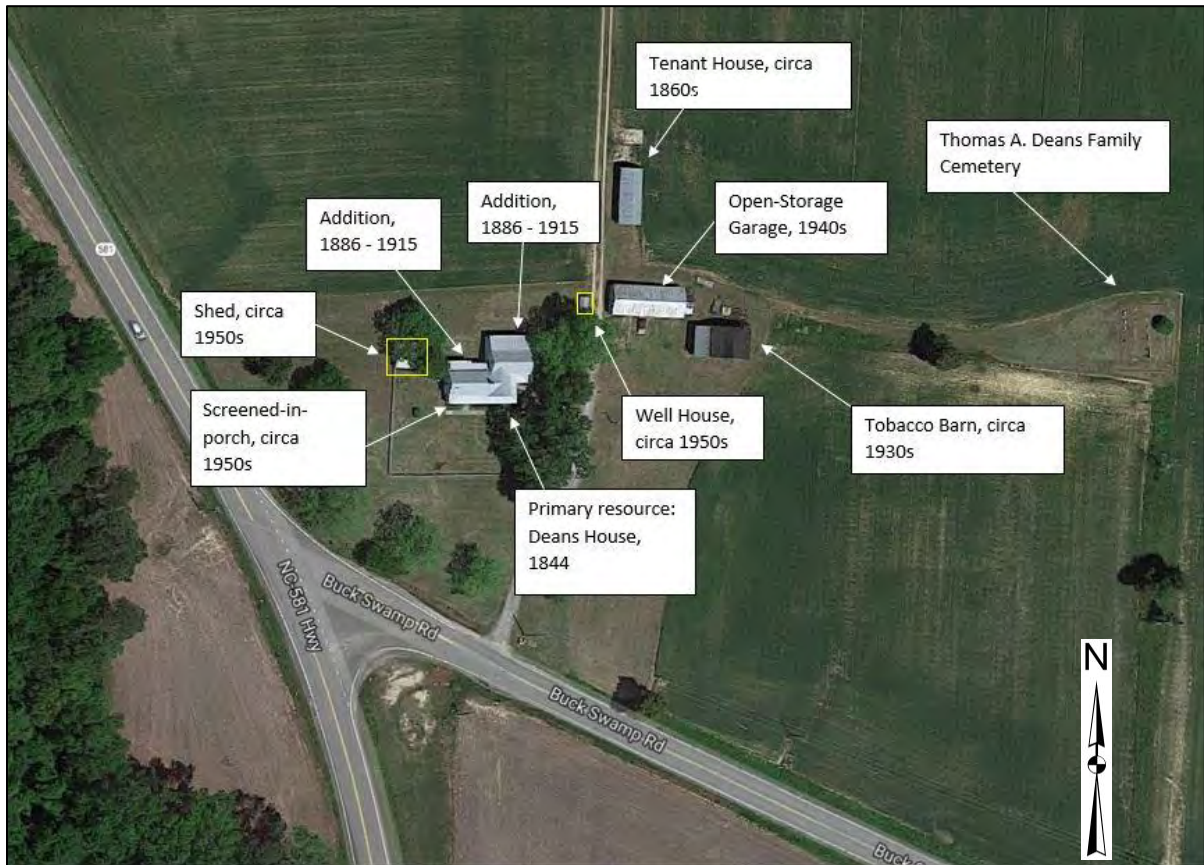
Figure 5: Site Plan of the Deans House (WY0590).⁹

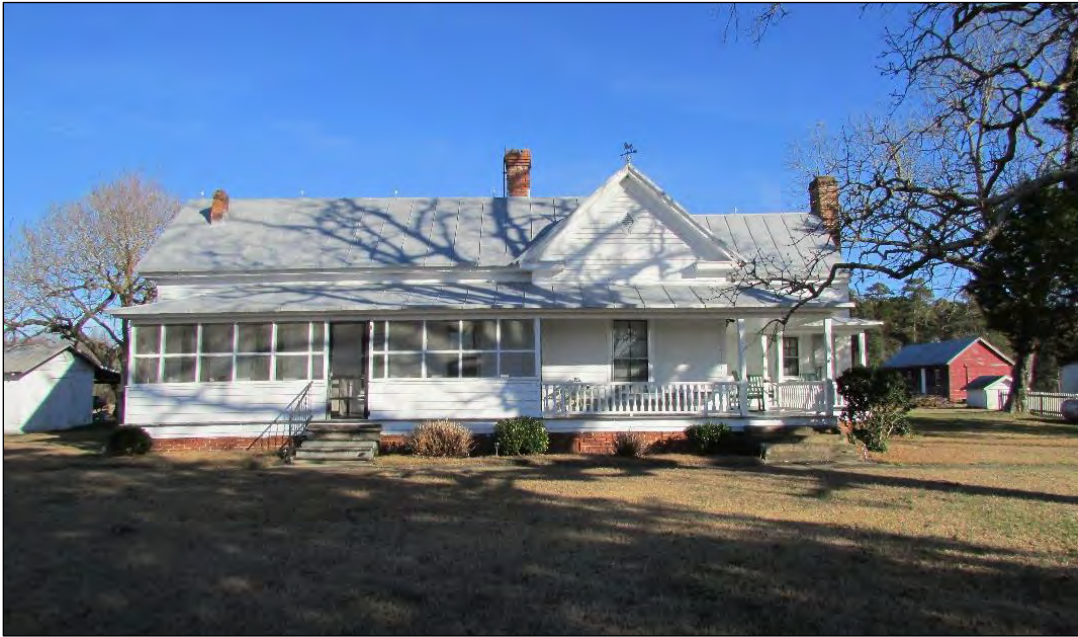
Photo 1: Primary (South) Elevation of Deans House.

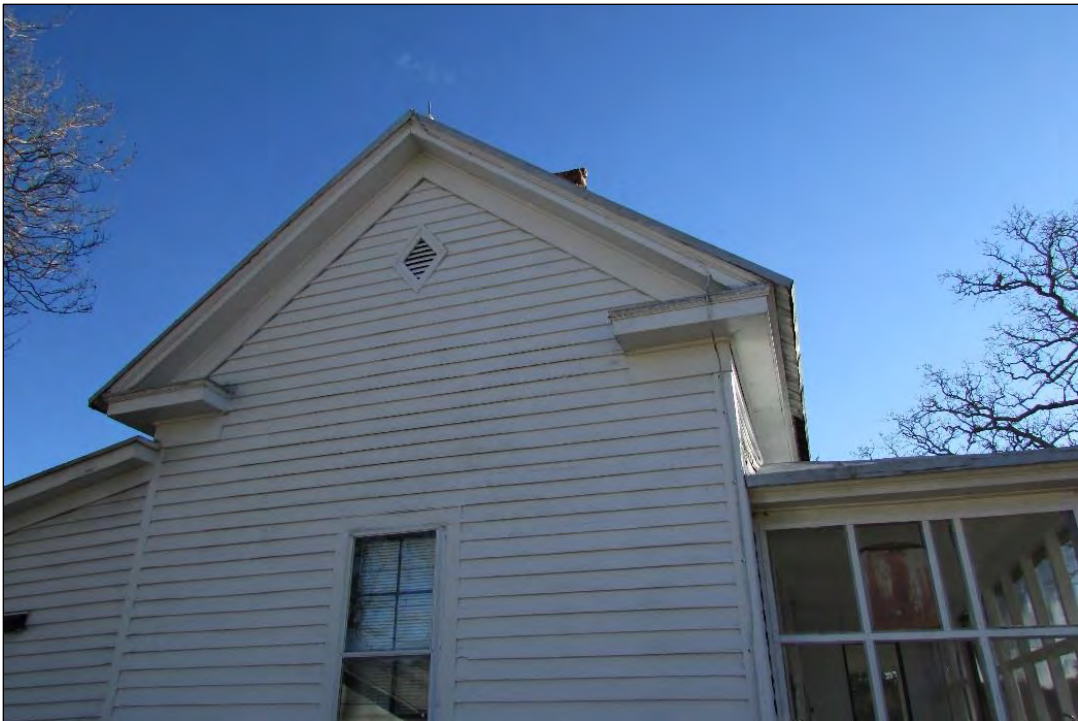
underneath the current roofing (Photo 4, p. 12). Diamond-shaped vents are located in the south and west gable ends (Photo 2, p. 11). A weather vane sits atop the projecting front gable.

Photo 2: Detail of Vent in Gable End, Looking East.

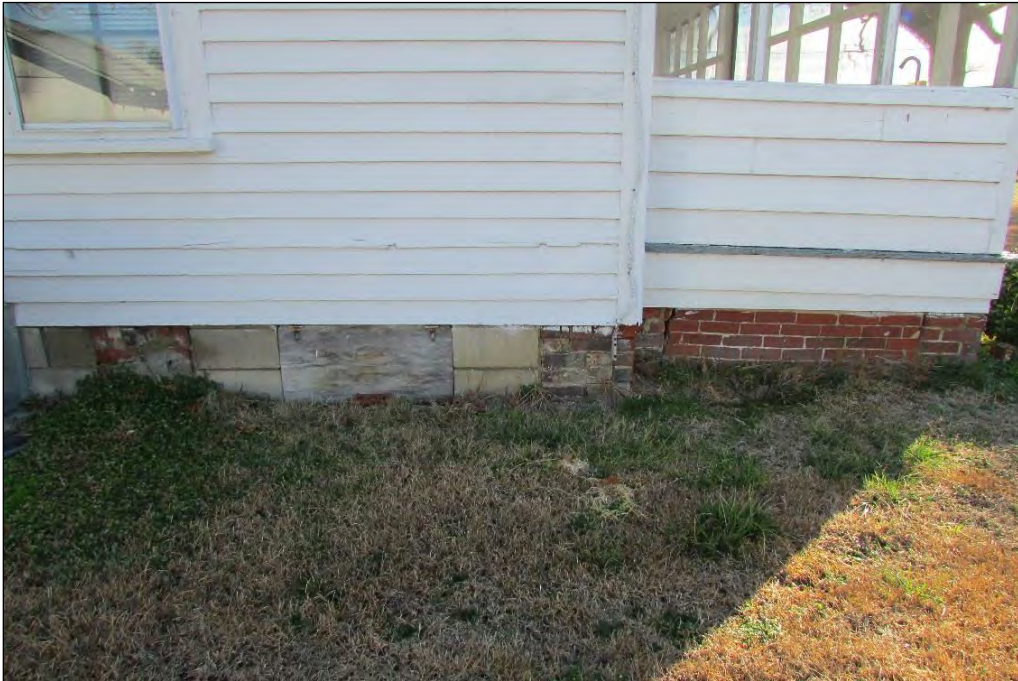
Photo 3: Detail of Concrete, Wood, and Brick Foundation, Looking West.

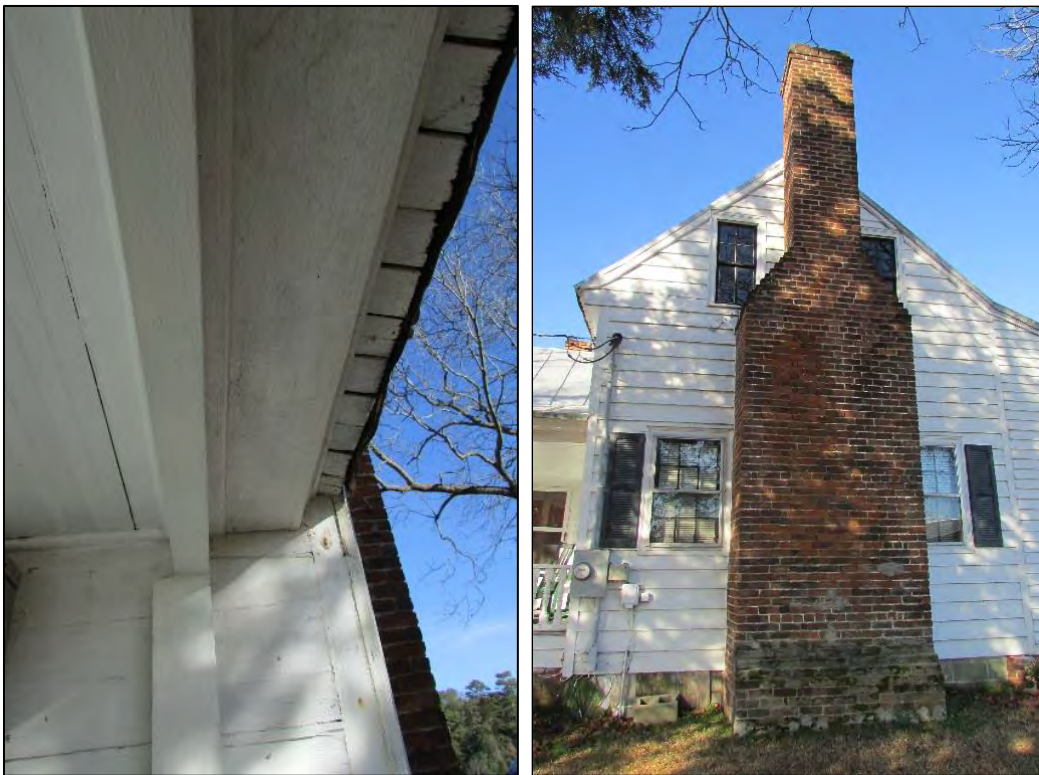
Photo 4: View of Original Shingles Underneath Metal Roof, East Elevation (Left) and View of Original Chimney on East Elevation (Right).

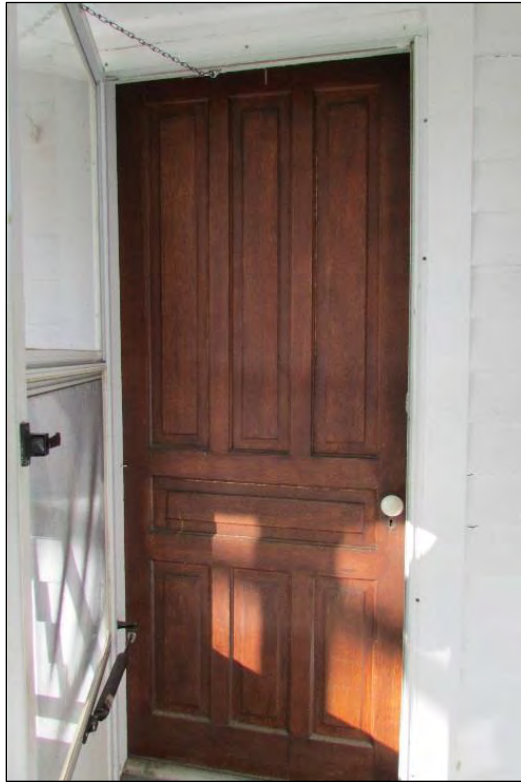
Photo 5: View of Original Door, Looking West.

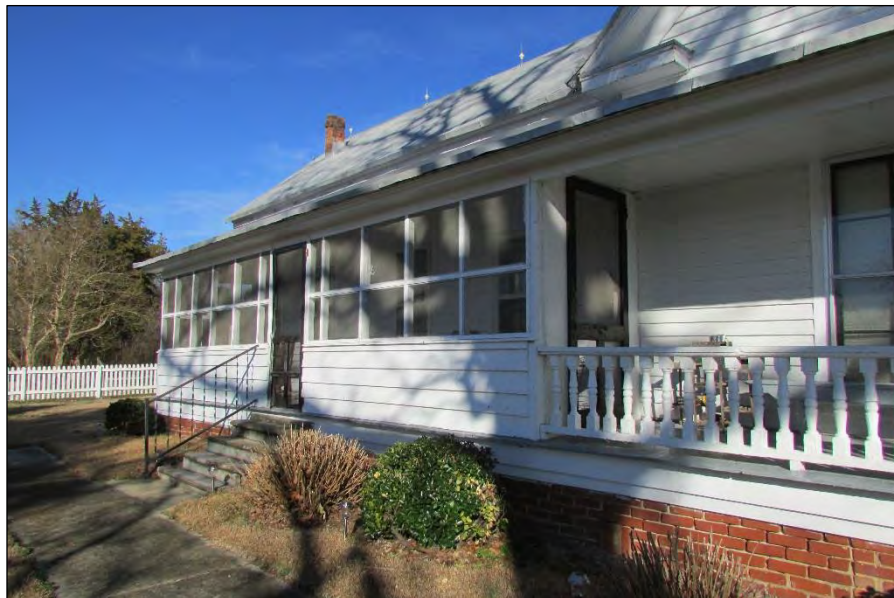
Photo 6: View of Doors on the Screened-in-Porch, Looking Northwest.

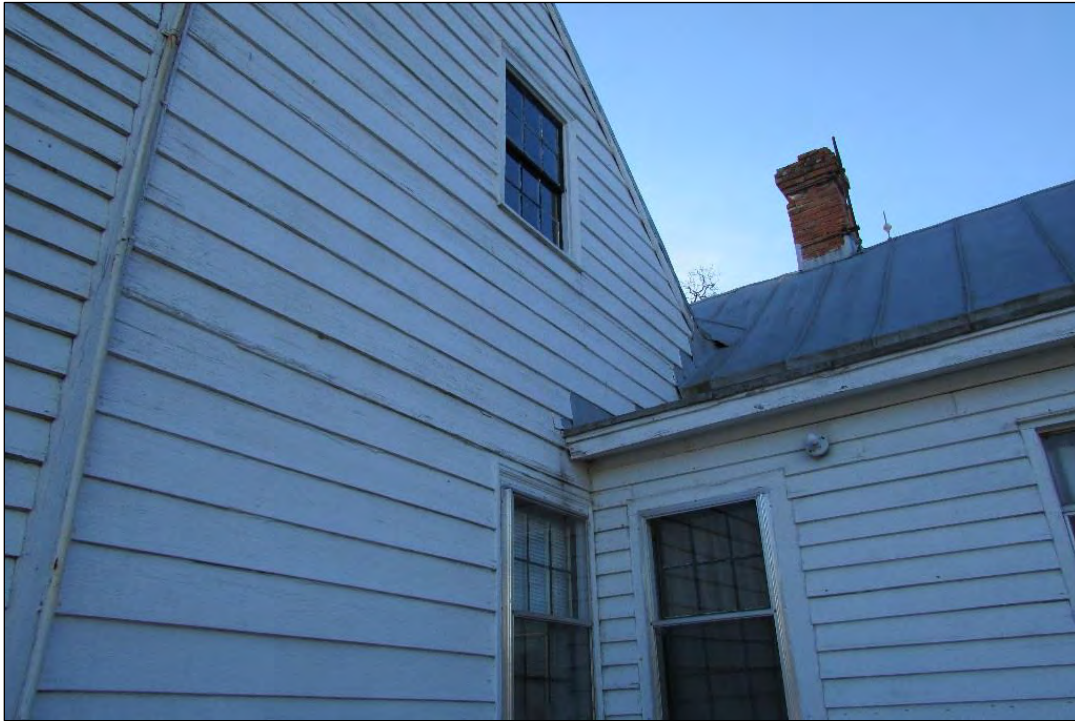
Other large additions were added to the rear (north) elevation of the house between 1886 and 1915 (Photo 7–Photo 8, pp. 14–14).⁷ Similar in materials to the original, the additions are clad in thinner weatherboard and sit on wood, concrete block, and brick foundations. The east elevation addition's roofline continues in slope with the original roof, giving it a shed-like appearance. This addition has a single-leaf, wood paneled door covered by a metal storm door accessed by three concrete steps (Photo 9, p. 15). Mirroring those found on the 1844 section of the house, this addition has two six-over-six, double-hung-sash, wood-frame windows. It is probable that this section contains a kitchen or laundry room. The west addition also has a shed roof, but it is not continuous with the front of the house's roofline. Three windows in the same style as the others on the original core and eastern addition feature in the façade; there is no door in this section.

Photo 7: View of Original Core Attached to Additions, Looking Southeast.

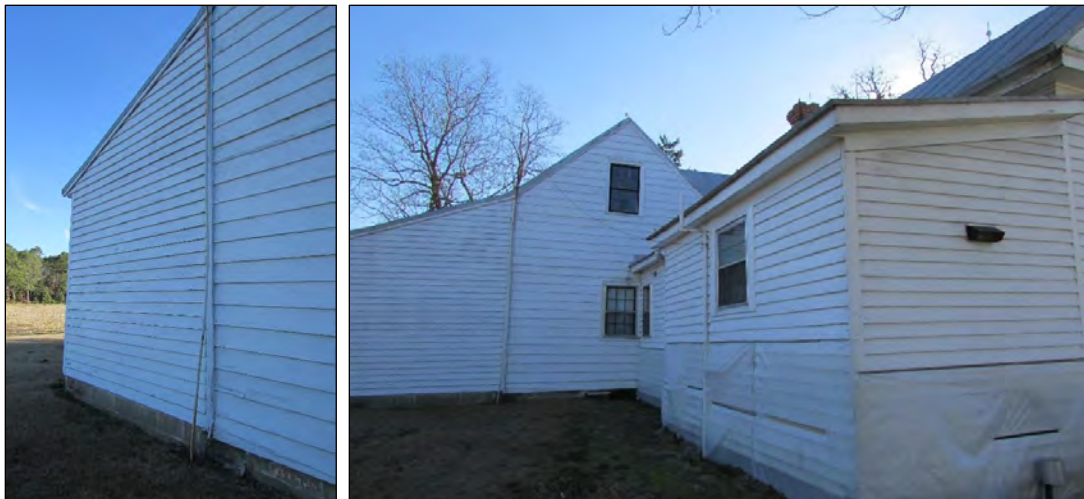
Photo 8: View of Split between Addition and Original Sections, Looking Northeast (Left) and View of Additions, Looking Southeast (Right).

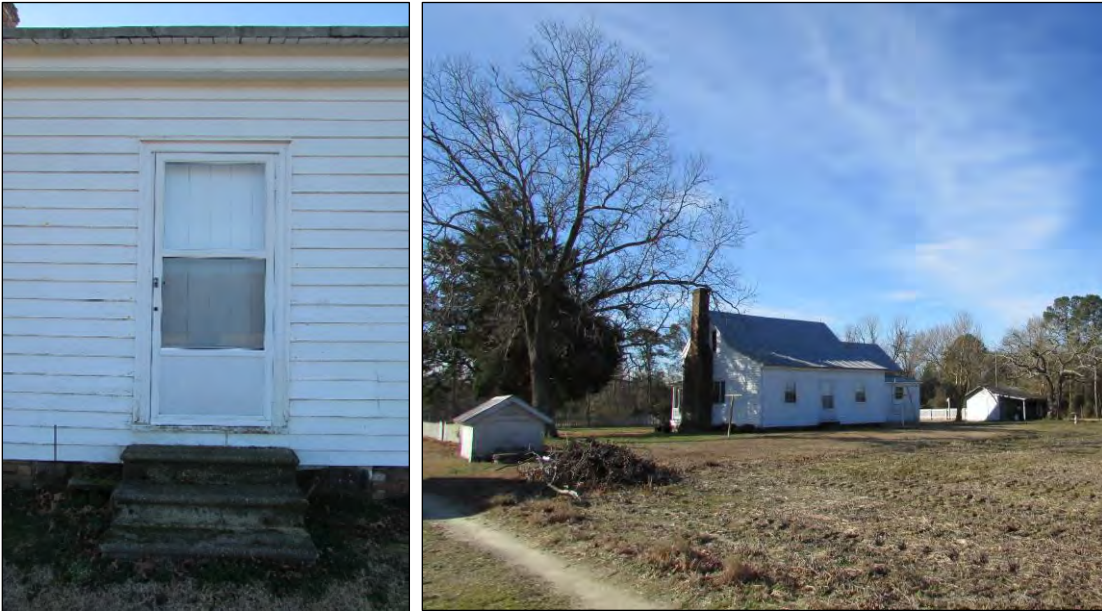
Photo 9: View of Door on North Elevation, Looking South (Left) and View of North Elevation, Looking Southwest (Right).

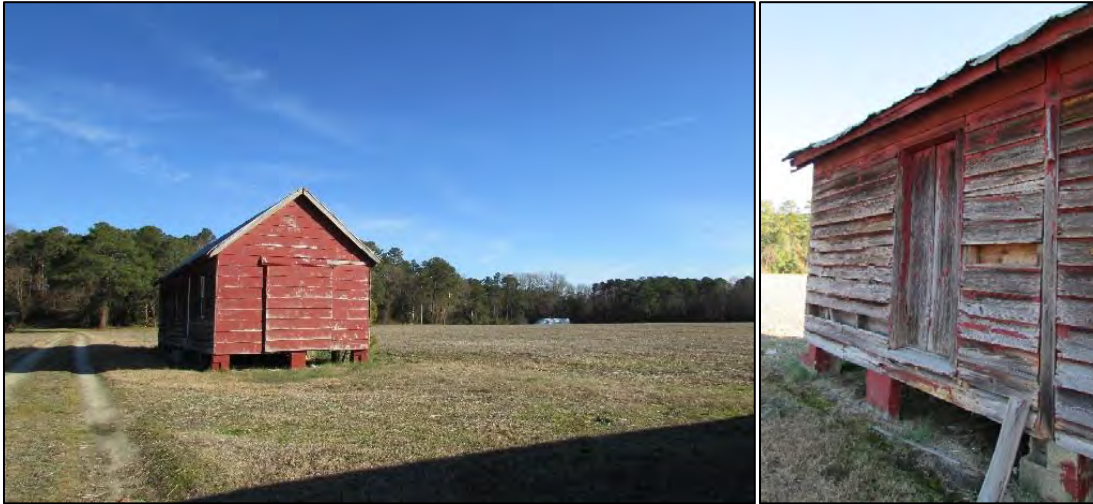
A one-story, three-bay, tenant house built circa 1860 is located northeast of the primary resource (Photo 10, p. 17).¹³ The foundation consists of raised concrete blocks and supports the structural system that is clad in weatherboard topped with a side-gabled v-crimp-metal sheathed roof. Two original, six-over-six, wooden, double-hung-sash windows pierce the

Photo 10: Tenant House, Looking North (Left); Detail of Door on Primary Elevation, Looking Northeast (Right).

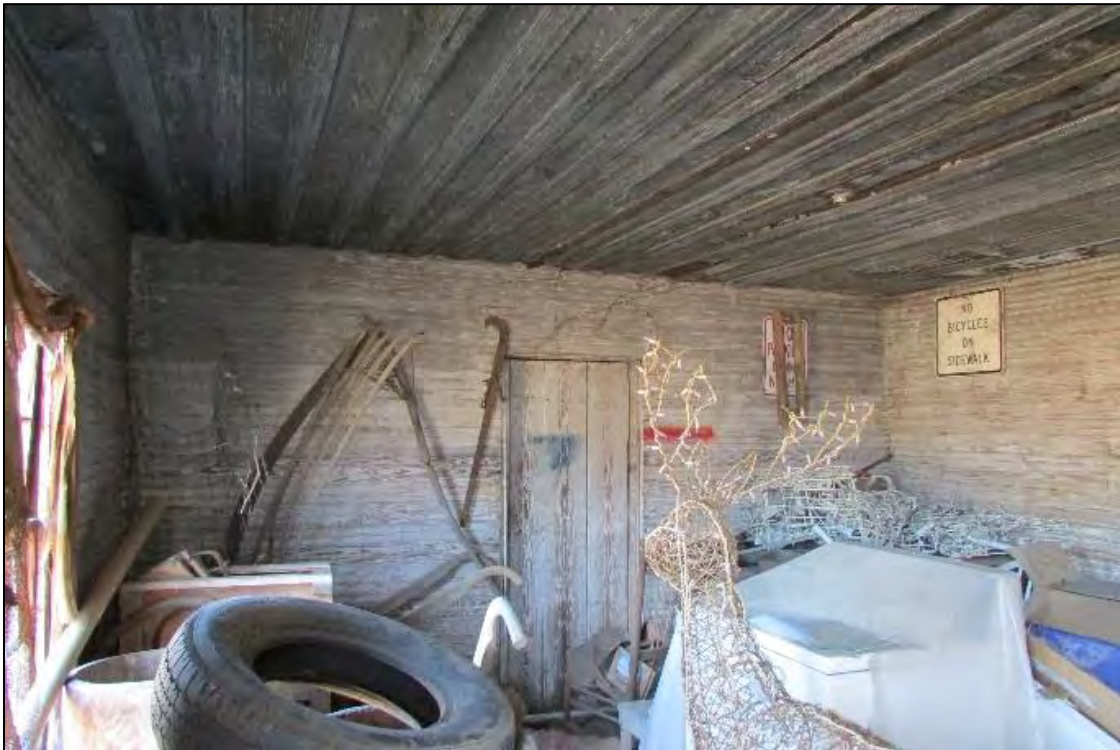
Photo 11: Interior of Tenant House, Looking North.

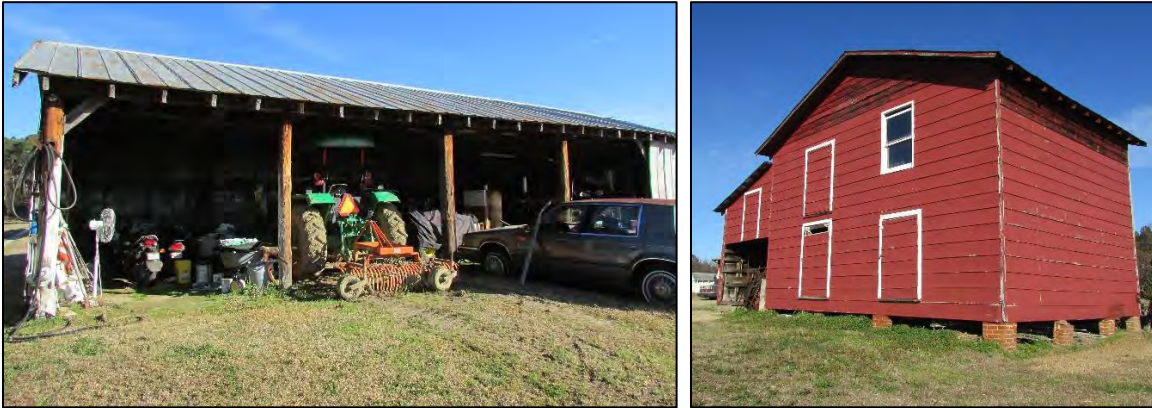
A one-story, four-bay, circa-1940 garage sits south of the tenant house and east of the primary resource (Photo 12, p. 18).¹⁵ Four wooden posts support the side-gabled, standing-seam metal roof. Currently, the Lancaster family uses the garage for additional storage space.¹⁶ To the east of this shed is a two-story, three-bay tobacco barn built around 1930, clad in weatherboard and topped by a front-gabled, metal-sheathed roof (Photo 12, p. 18).¹⁷ It sits on elevated brick piers as its foundation¹⁸. The west portion of the barn features a "garage" with an enclosed doorway overtop. The main section of the barn features three enclosed bays and one, one-over-one, double-hung-sash, vinyl window. The survey from 1996 mentions an additional secondary resource to the south of the barn, but Charles Lancaster mentioned that it was torn down about fifteen years ago¹⁹.

Photo 12: Primary (South) Elevation of Open Garage, Looking North (Left) and Northwest Oblique of Barn, Looking Northwest (Right).

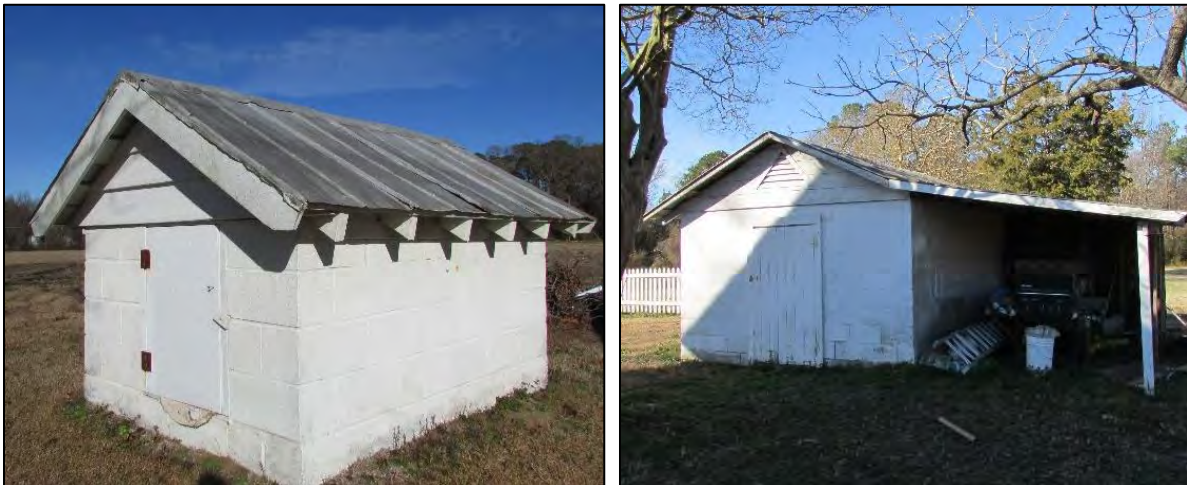
Two smaller outbuildings sit on the property as well. A utilitarian one-story, one-bay, front-gabled roofed well-house sits to the northeast of the house (Photo 13, p. 18). Made of cinderblock, the circa-1950 structure has a small, single-leaf door on the south front elevation. This is the only fenestration present. The roof is covered in pressed metal. On the west side of the primary resource sits a one-story, one-bay front-gabled shed constructed around 1950 (Photo 13, p. 18). It has a single-leaf, wooden door on the east elevation. No other fenestration is present. On the north side of the shed sits an open "garage" for additional storage. It also has a pressed metal roof.

Photo 13: Northwest Oblique of Well-House, Looking Northwest (Left) and Primary (East) Elevation of Shed, Looking West (Right).

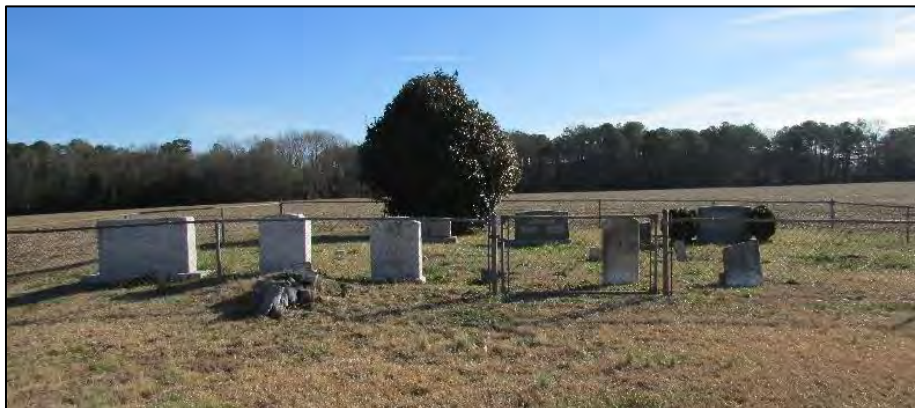
The Thomas A. Deans Family Cemetery is located on the property to the far east of the primary resource (Photo 14, p. 18). Thomas A. Deans (1811–1876), builder and original owner of the house, is buried there alongside several other family members. Two cedar trees used to stand in the cemetery, but have since fallen or been cut down.²⁰ A complete list of family members who are buried in the cemetery with marked graves can be seen in Table 2 (p. 19).

Photo 14: View of Thomas A. Deans Family Cemetery, Looking East.

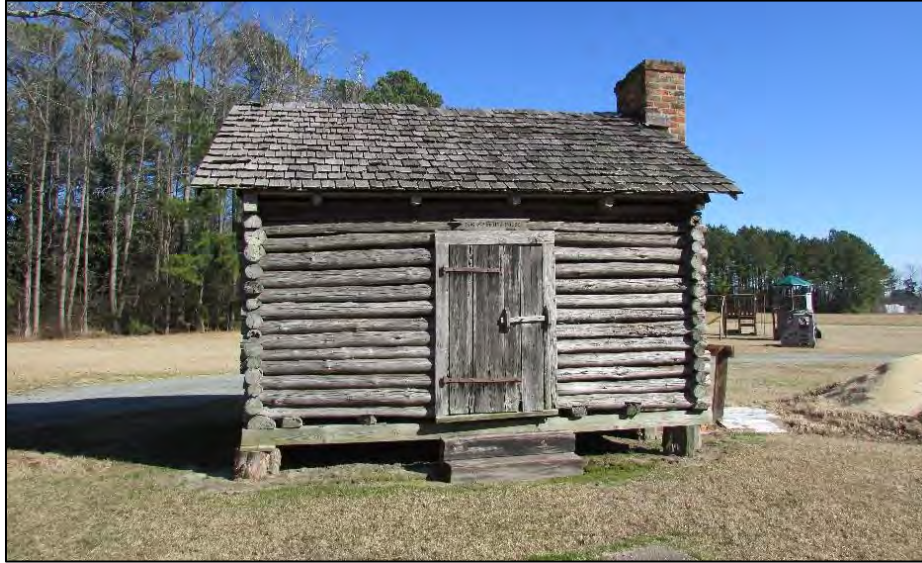
The land on which the Deans House is located has been in possession of the Deans family since 1801. Daniel Deans (d. 1789) was one of the first Deans to settle in North Carolina. Daniel Deans was a prominent figure in Wayne County: he fought in the Revolutionary War for three years and then became a Methodist preacher after introducing the religion to the county in 1786 by inviting Bishop Francis Ashbury to preach. He built the first Methodist meeting house and established the Salem Methodist Church. The meeting house is still extant; however, it was moved from its original location by the church and relocated to the church’s permanent home at 2706 Salem Church Road (Photo 15, p. 20). He had a son, George Deans, who,

Photo 15: View of Deans Meeting House, Looking East.

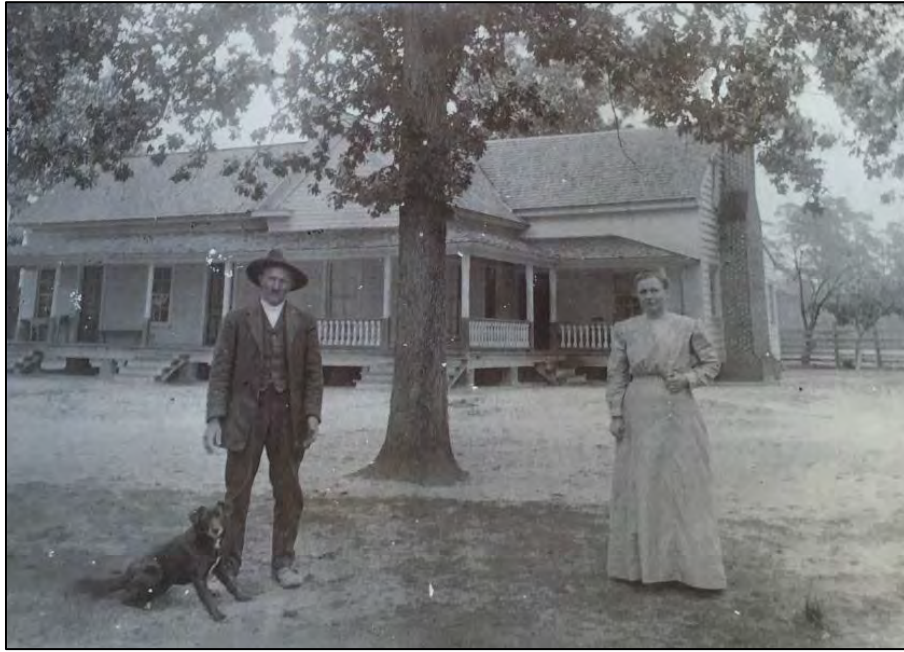
The 1844 core is linear in form; however, two large additions were added to the house. A one-story, wrap-around front porch was built on the primary (south) elevation circa 1890–1950s (Photo 16, p. 22). This is a major feature in Queen-Anne style residences. The western half of the porch was screened in likely during the 1950s. A hipped roof sheathed in standing-seam metal covers the porch and is supported by wooden chamfered posts. The porch is made of wood and is supported by a brick foundation lined with a wooden balustrade. The screened-in porch is accessed by two exterior entrances: a single-leaf, wood-framed doorway and four concrete steps lined with a metal railing located on the south elevation and another single-leaf, wood-framed screen door, located on the east elevation (on the porch itself) (Photo 6, p. 13). The current primary entrance, also a single-leaf, paneled door, is located on this 1890s front-gabled addition to the south and east elevation of the house. A central-interior brick chimney pierces the roof's south slope and a third brick chimney is located on the western end of the house along the slope of the roof. Both of these chimneys are smaller in size than the exterior-end chimney and are not a part of the original core (Photo 1, p. 11).

Photo 16: Photograph of Benjamin and Lula Deans in front of Deans House,
Date Post-1892.³⁵

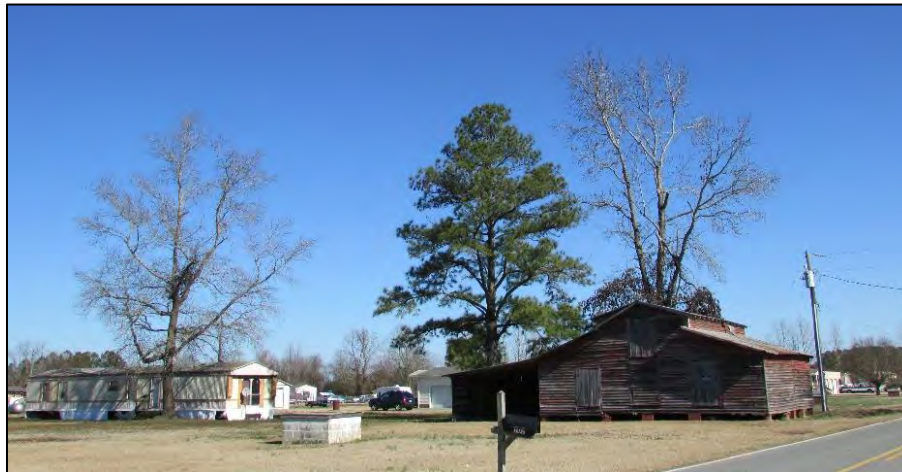
the resources are diverse, much of the landscape within the county is still rural and utilitarian in nature. It is not uncommon to see a modern-era house adjacent to a dilapidated tobacco barn that had been sitting on the property for years (Photo 17, p. 24).

Photo 17: View of Mobile House and old Barn along Weathervane Road (near 414 Weathervane Road).

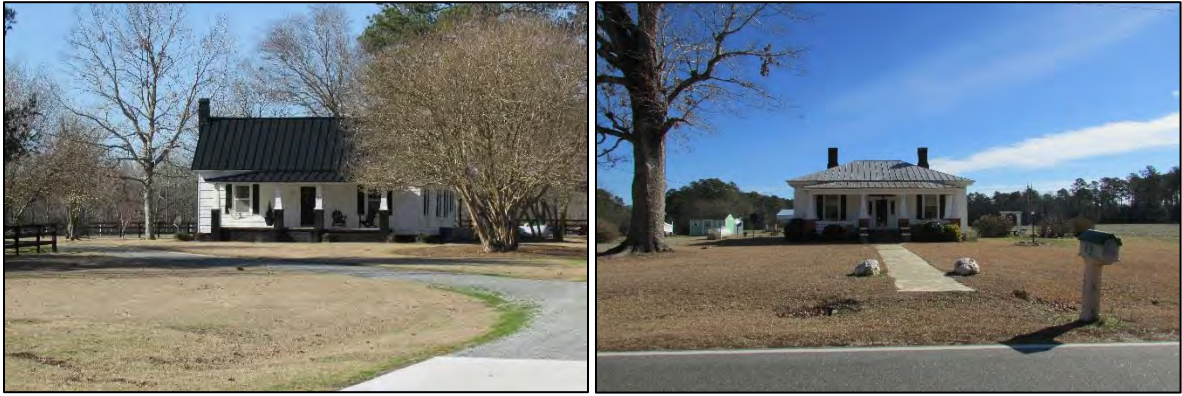
Many houses within Wayne County and close to the Deans House are farmhouses with Craftsman elements (Photo 18, p. 25). These one-story, three-bay houses feature side-gabled or hipped roofs with a front porch supported by the typical Craftsman styled post-on-piers. Many either have one or two exterior-end brick chimneys. Other common forms found within the area were similar Craftsman style houses with cross-gabled roofs featuring a front-gabled projection with a vent (Photo 19, p. 25). Other popular housing style and forms in the area were Ranch-styles, Contemporary-styles, Minimal Traditional-styles, and mobile houses.

Photo 18: View of 849 Nor-Am Road (Left) and 194 Nor-Am Road (Right).

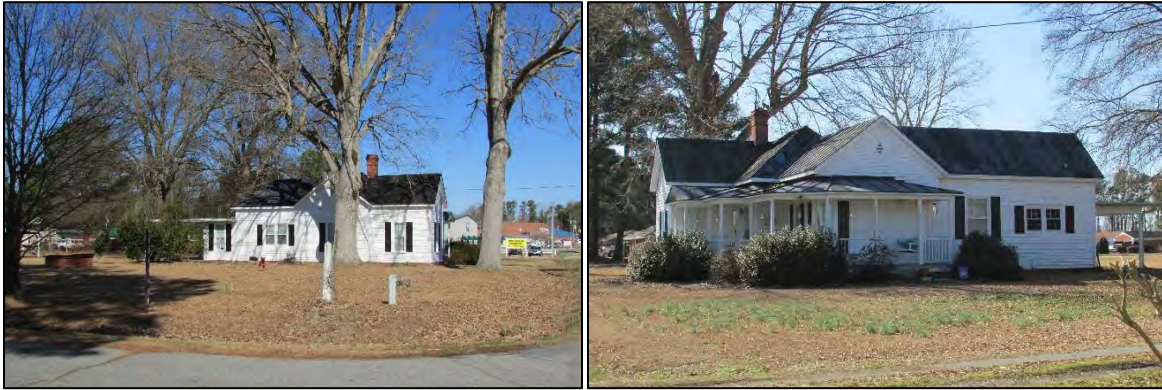
A house located at 617 NC 581 Road appeared the most similar in style and appearance to the Deans House. Located about 3.8 miles away from the Deans House, 617 NC 581 is a one-story, three-bay house with an attached front porch that wraps around the north side of the resource (Photo 20). A small addition with a carport sits on the rear (west side) of the house. Eleven thin piers support the front porch with a hipped roofline and a central brick chimney sits at the center of the house. The house is cross-gabled with three front-gabled projections featuring a diamond shaped vent; this was a popular farmhouse type of the 1900 to 1920 time period.⁴⁵ It was sometimes called “the Triple-A’ so named for the type’s three A-shaped gables: one on each end of the roof and one centered over the front elevation.”⁴⁶ Windows appear to be six-over-six, double-hung-sash, vinyl windows; most feature fixed shutters on either side. Other fenestration could not be seen from the right of way.

Photo 20: View of 617 NC 581 Road from the south side (Left) and the north side (Right).

The obvious similarities between 617 NC-581 and Deans House include the diamond shaped vents in the front-gables and the front porch. Given that the house fits the “Triple-A” form so fittingly, it was more than likely constructed in the 1920s, about 75 years after the Deans House was built. While the Deans House has some paired down elements of the picturesque, 617 NC 581 fits that description more strongly due to the multiple varying levels at the roof line. Although this house appears similar in style, it proves the Deans House unique setting within the Wayne County architectural landscape.

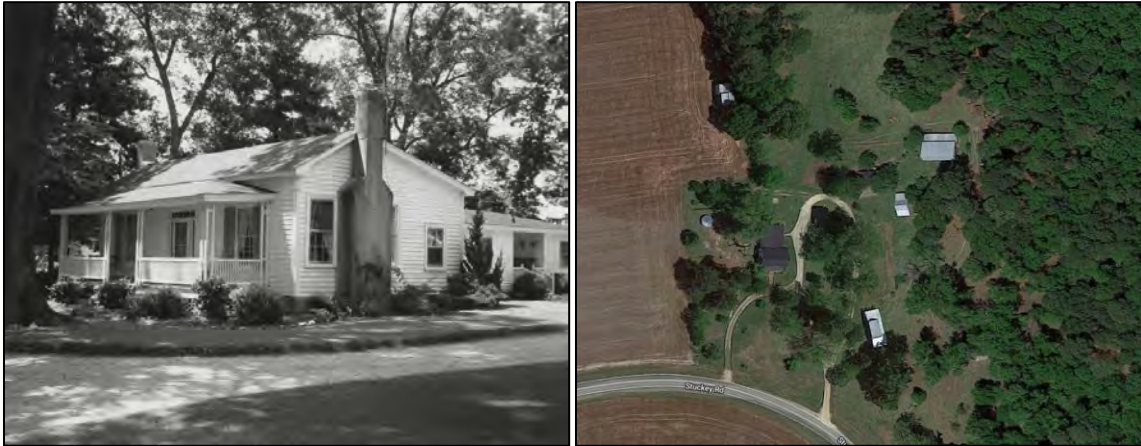
The Barnes-Hooks Farm (WY0139) is a National Register property that is similar to the Deans House (Photo 21, p. 27). Built in 1874, the main house is representative of the Greek Revival and Italianate style.⁴⁷ The property also includes the following: an early-nineteenth century hall and parlor house, a mule stable, framed tenant house (1920), a tobacco barn (1930), a smoke house (1874), and two grain bins (1970s–1980s).⁴⁸ The property has remained with the same family for 250 years and is currently still used for farming.⁴⁹ The farm complex was nominated under Criterion A and C due to its strong architectural and agricultural integrity and history within the community. The property was unable to be viewed at the time of fieldwork for the project, but a current aerial photograph of the property is featured below (Photo 21, p. 27).⁵⁰

Photo 21: Picture of Barnes-Hooks Farm Main House, Taken from NR Report (Right) and Aerial of Barnes-Hooks Farm, Taken from Google Maps (Left).⁵¹

Located within Fremont, the Barnes-Hooks Farm is about 11.3 miles away from the Deans House. Both properties historically functioned as farms, and still function as such to this day and were once a part of large tracts of lands that followed agricultural trends common for the region, such as using tenant labor and primarily producing tobacco and cotton.⁵² Both properties currently retain their original hall and parlor houses as well as agricultural buildings such as tenant houses and tobacco barns.
