Re: Robeson LNG Project, Construct Liquefied Natural Gas Peaking Facility, Robeson County,
ER 19-1012

Phase I Historic Architectural Survey Report

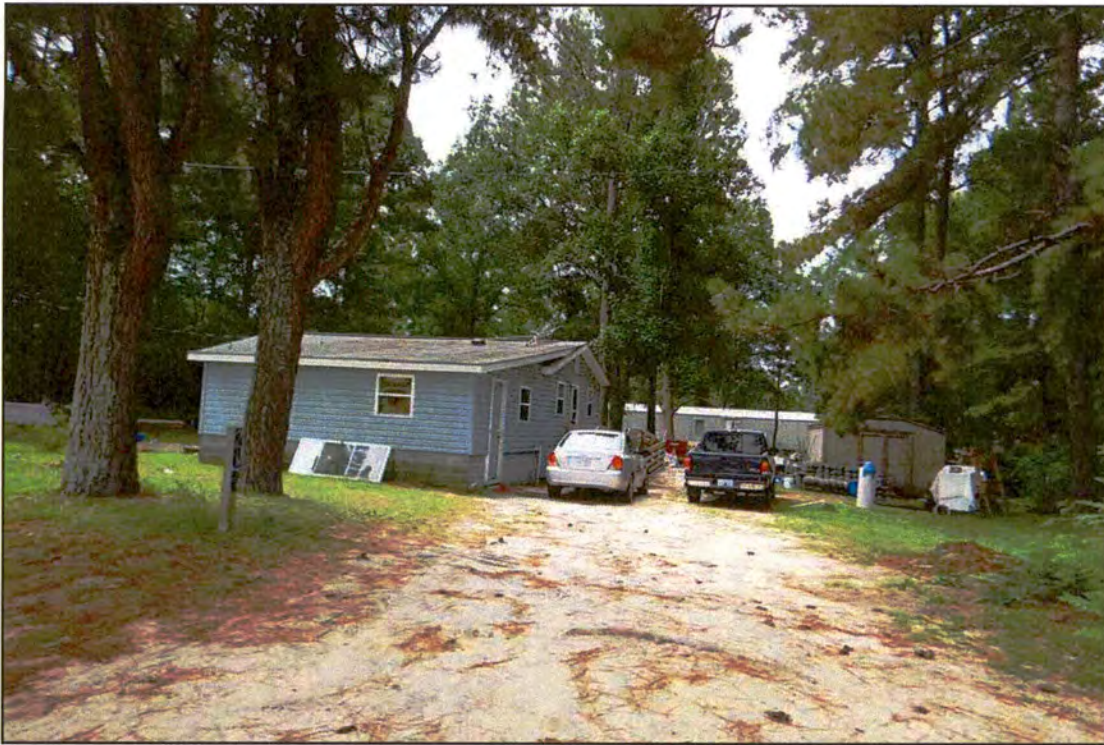
According to the Robeson County Tax Administration website, RB0697 was built in 1968. The one-story dwelling has an asphalt shingle, front-gabled roof, replacement vinyl siding, and a continuous concrete masonry unit foundation (Appendix B, Figure 2). The resource includes one-over-one, double-hung, vinyl windows and vinyl vents in the upper gable ends of the east and west elevations. The primary entrance is located on the west elevation through a vinyl storm door. The actual door was obscured at the time of survey. A circa 1990, partial-width addition is located on the north elevation (Appendix B, Figure 3). Its materials and fenestration are consistent with the main block, except that the concrete masonry unit foundation extends further up, almost acting as a water table. The addition has an asphalt shingle, shed roof. A six-paneled vinyl door is located on the addition's west elevation. To the east of the dwelling is a circa 1970 well house (Appendix B, Figure 4). The well house has a concrete masonry unit foundation and exterior, an asphalt shingle, front-gabled roof, and plywood in the upper gable ends. Both the dwelling and well house are in fair condition.

Figure 2. RB0697, dwelling, west and north elevations, view to the southeast.

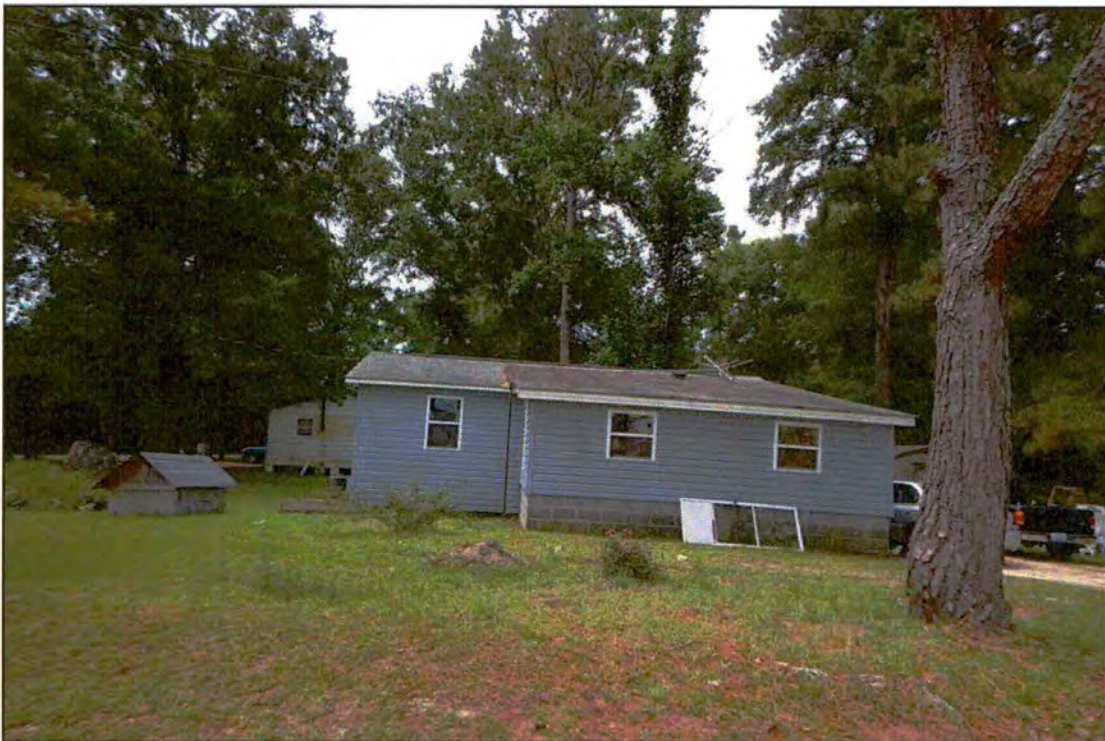
Figure 3. RB0697, dwelling addition, north elevation, view to the south.

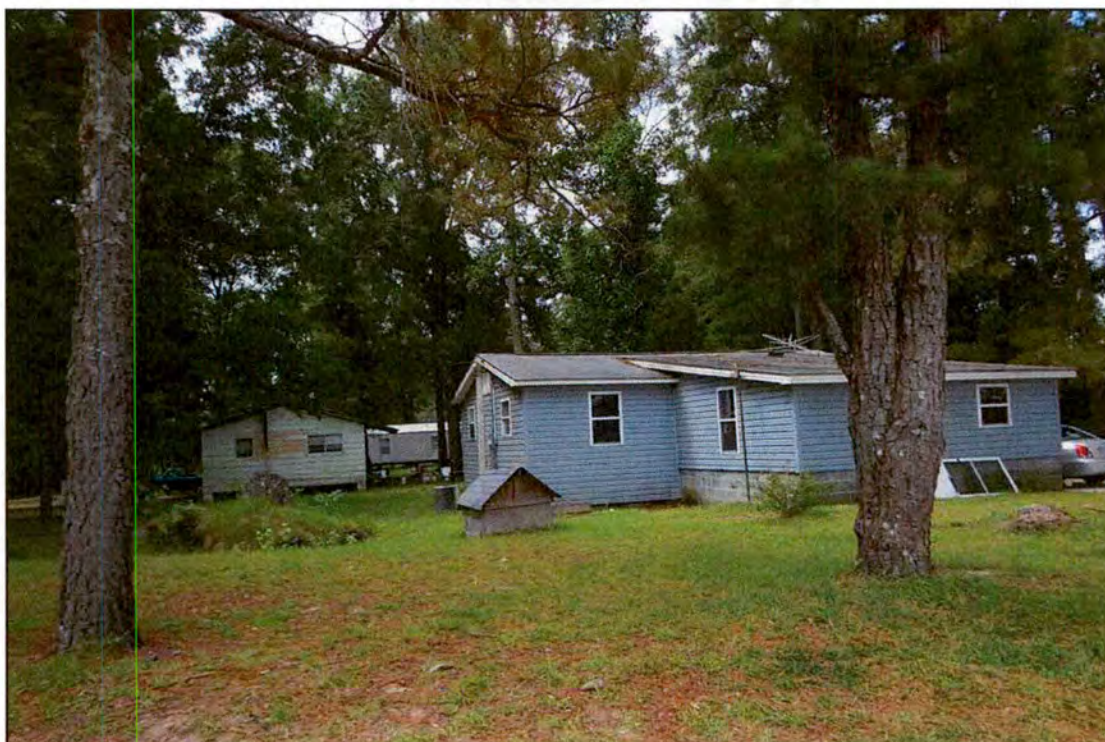
Figure 4. RB0697, dwelling and well house, east and north elevations, view to the southwest.

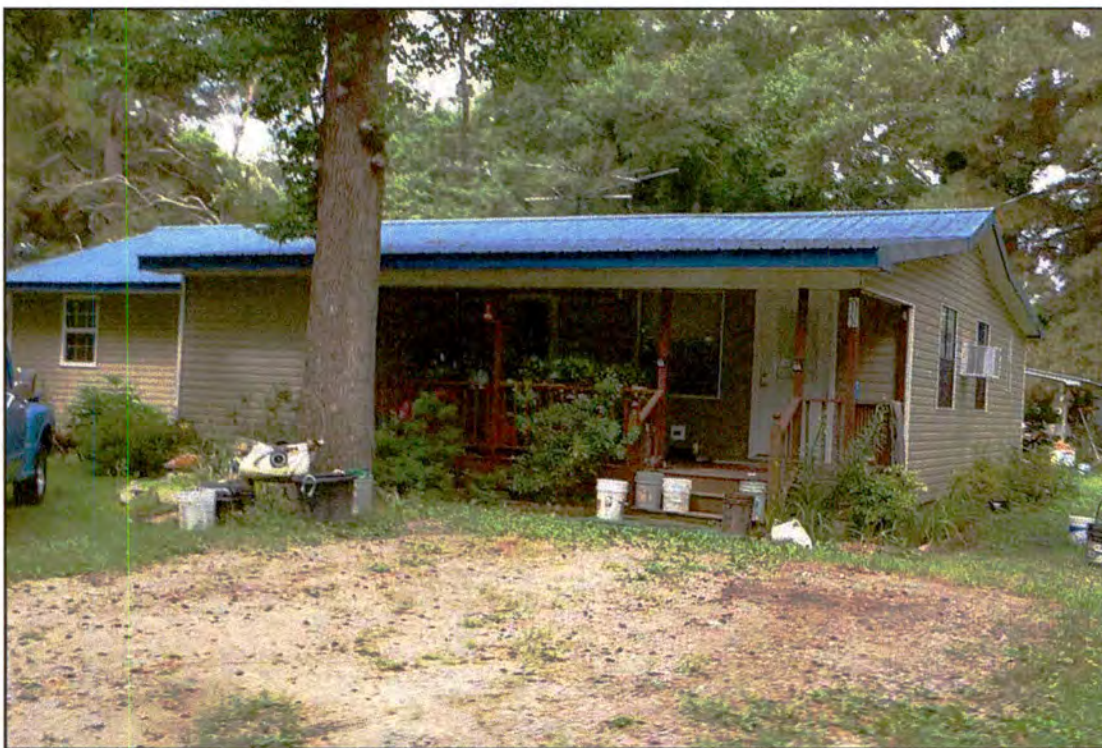
The dwelling is a one-story structure built in 1968 (Robeson County Tax Administration Office 2018). RB0698 is a side-gabled dwelling with a standing-seam metal roof, replacement vinyl siding, and continuous concrete masonry unit foundation, which is painted red to resemble brick (Appendix B, Figure 6). The primary entrance is located on the east elevation through a vinyl door with two lower panels and one large, upper light. Windows consists of one-over-one, double-hung, vinyl units with either four-over-four, six-over-six, or no applied muntins. An octagonal vinyl vent is located on the upper gable of the south elevation. A circa 1990 partial-width addition is located on the original block's east elevation. Its materials appear consistent with the original block, but the foundation is obscured by vegetation. This shed-roof addition consists of a porch on the northern end, and an enclosed addition on the southern end. The porch on the northern end leads to the primary entrance. Three wooden steps lead to the porch, which has a wooden floor, bannister, and is supported by squared wooden posts. A vinyl, dentil-like ribbon is located below the porch's roofline. The enclosed part of the addition on the southern end has no fenestration. A second addition is located on the rear (west) elevation, but could not be seen from the road. The dwelling is in good condition

Figure 6. RB0698, dwelling, north and east elevations, view to the southwest.

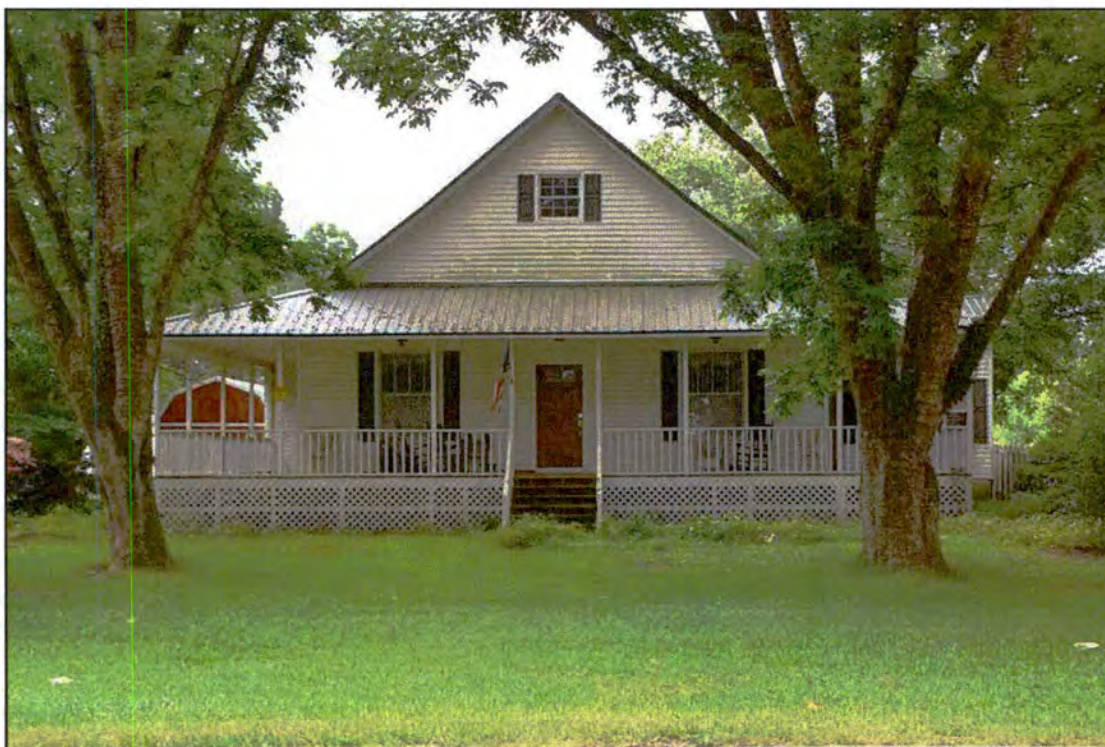
The one-and-a-half story dwelling associated with RB0699 was built in 1924 (Robeson County Tax Administration Office 2018) and has a front-gabled, standing-seam metal roof and replacement vinyl siding (Appendix B, Figure 9). The pier foundation is obscured by lattice skirting. A brick, exterior-end chimney is located on the west elevation (Appendix B, Figure 10). The primary entrance is centered on the north elevation through a replacement wooden door with four panels and two upper lights. The entrance is accessed via a circa 1960 replacement wrap-around porch that spans the entire façade, and portions of the east and west elevations (NETR Online 2018). Six wooden steps on the north elevation lead to the porch, which has a wooden floor and bannister, and a hipped, standing-seam metal roof supported by squared wooden posts. The dwelling's original block has four-over-one, double-hung wooden windows on the first floor, and a single, six-over-six, double-hung wooden window in the upper-half story. All windows have fixed, vinyl shutters. The dwelling also includes two, circa 1970 gabled additions on the east and west elevations (Appendix B, Figures 11 and 12). Both have siding and roofing materials consistent with the main block. Both have continuous concrete masonry unit foundations, one-over-one, double-hung, vinyl windows with six-over-six applied muntins, flanked by fixed vinyl shutters. A rear addition on the south elevation could not be seen from the public road, but according to aerial photographs, has a hipped roof. The dwelling is in fair condition.

Figure 9. RB0699, dwelling, north elevation, view to the south.

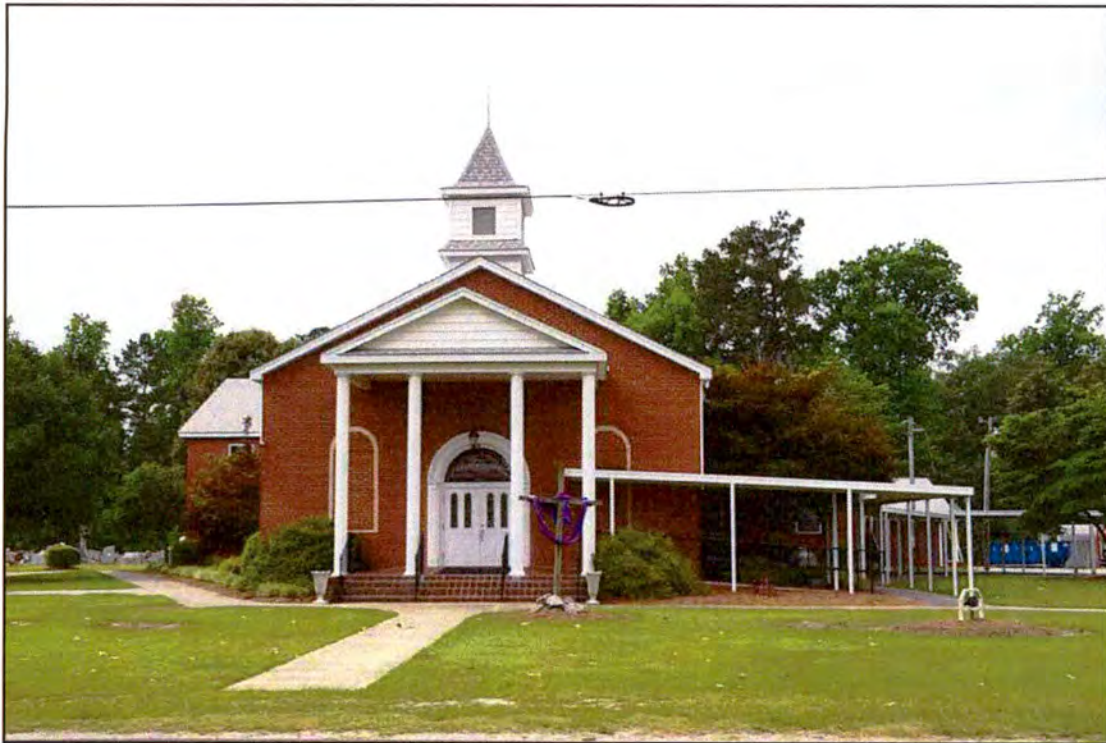
Figure 18. RB0700, Cherokee Chapel Holiness Methodist Church, east elevation, view to the west.

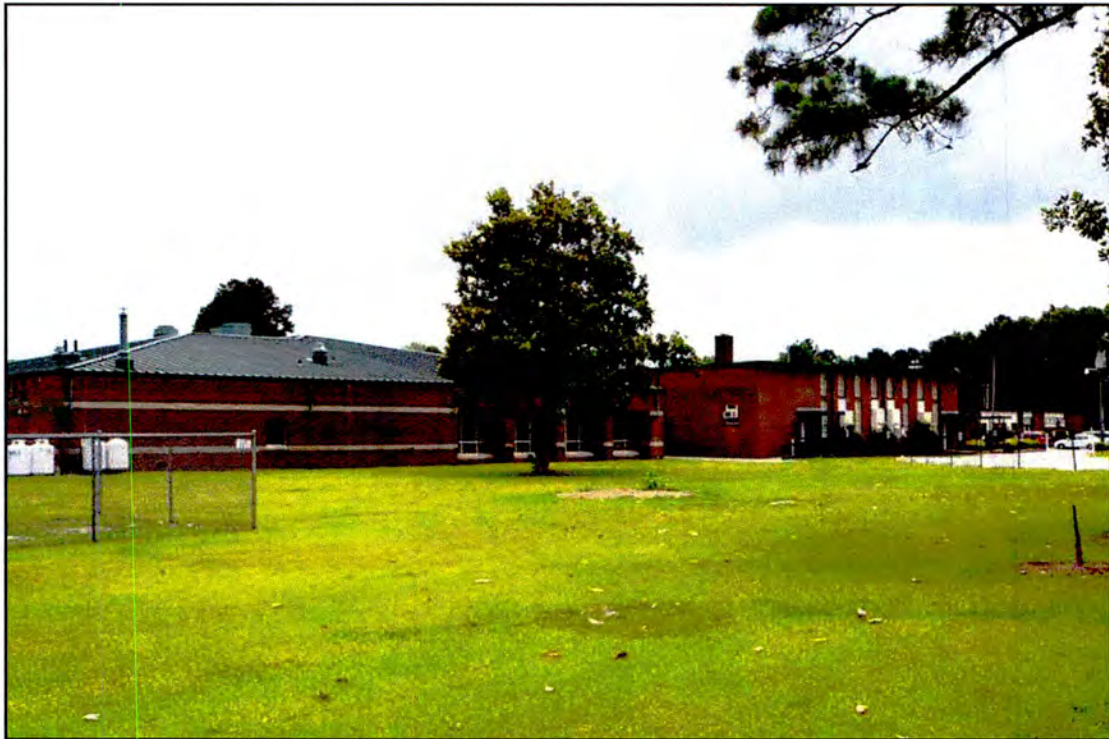
NRHP Assessment: Oxendine Elementary School is a mid-century modern school whose design is common in the region. In addition, the school has had many additions, which almost completely obscure the original block of the building and diminish the historic integrity of the structure. ERM recommends RB0701 not eligible for the NRHP under Criterion C. The Oxendine School (now Oxendine Elementary) was established in the early twentieth century to serve the Native American population in the vicinity of Wakulla. The land was donated by the Oxendine family, a prominent family in the community of Lumbee Indians in Robeson County. The school, and by its close association, the Cherokee Chapel Methodist Church, were important parts of the local community. However, the current Oxendine School is not representative of the 31 subscription schools established by the Lumbee in the late nineteenth century, and no longer conveys its association with events significant to history. The resource is therefore recommended ineligible

Figure 26. RB0701, Oxendine Elementary School, overview, west and north elevations, view to the southeast.

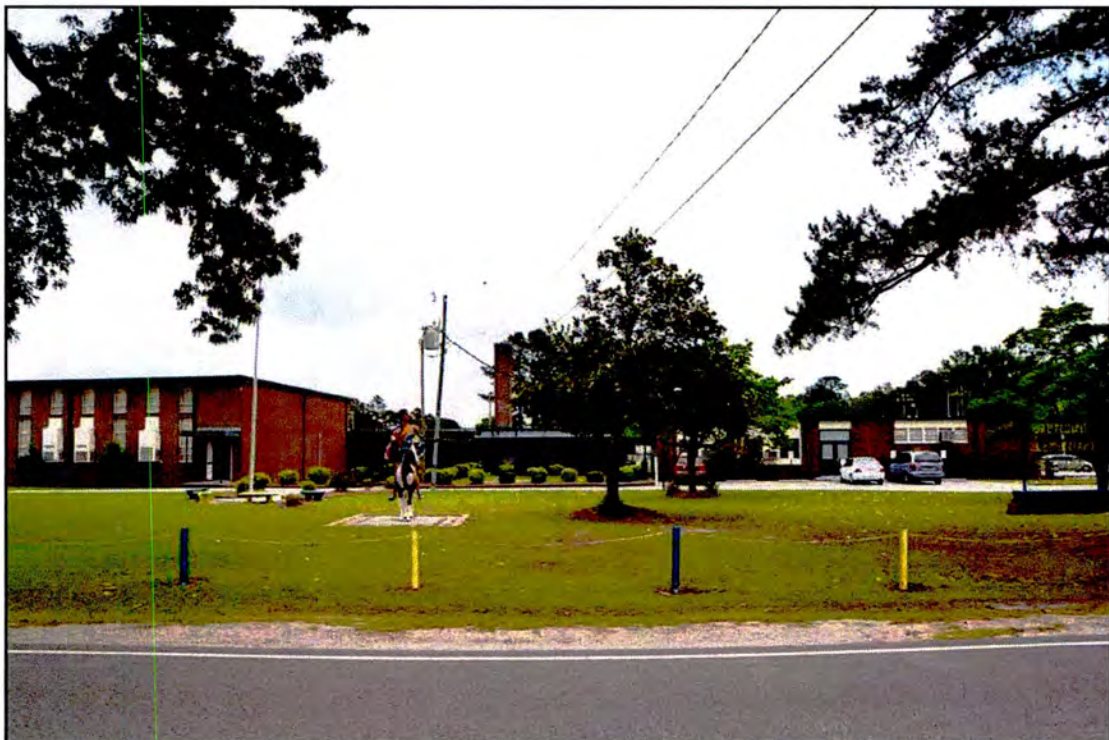
The school has many additions, but the one-story original school is currently the center block of the resource. The original block has a concrete masonry unit foundation and exterior with brick infill, and a flat, metal roof (Appendix B, Figure 27). A brick chimney stack is located on the western end of the structure. Both the exterior and chimney stack is arranged in a 5:1 Flemish bond brick pattern. The entrance is located on the west elevation. The windows on the original block's south elevation are wooden with one-over-one horizontal panes. The lower pane is an awning window while the upper pane is fixed. The windows on the original block's north elevation also have wooden, horizontal panes, but are two-over-two. Above these windows is a row of wooden, awning windows (Appendix B, Figure 28). The school includes two pre-1959 additions. The first addition (Addition 1) is located on the east elevation of the school and has the same materials and window fenestration as the original block (Appendix B, Figure 29). A two-story addition (Addition 2) is located to the north of the original block and connects to the original block through a porch (Appendix B, Figure 30). The porch is located on the original block's west elevation. It has a metal, flat roof and is supported by round metal posts sitting on poured concrete. The porch also has a metal, flat-roofed walkway addition on its western elevation with round metal posts and a poured concrete floor. Addition 2 has materials consistent with those of the main block, and has the same 5:1 Flemish bond brickwork and a brick chimney towards the western end (Appendix B, Figure 31). The first floor has wooden windows that are double-hung and have two-over-two horizontal panes. Above these windows is a fixed, two-paned window. The second floor has a row of hopper or awning windows below fixed, 2-paned windows. Addition 2 has two entrances on the west elevation filled with metal doors and a two-paned sidelight. Both have entry porches with metal, flat roofs, concrete floors, and rounded metal posts. A circa 1970 one-story addition (Addition 3) is located on the original block's south elevation (Appendix B, Figure 32). Addition 3 has the same materials as the original block, except for the additional T1-11 siding around the window fenestration. It has one-over-one, double-hung wooden windows and vinyl sliding windows. The primary entrance is located on the west elevation through a metal double door with an upper light and a transom window. Another entrance is located on the south elevation through a single metal door with an upper light (Appendix B, Figure 33). The final addition (Addition 4) is located to the north of Addition 2. This one-story addition has a hipped roof with gable extensions on its east and south elevations. Addition 4 has a standing-seam metal roof with a brick exterior laid in stretcher bond with two bands of concrete masonry units (Appendix B, Figure 34). The hipped-roof part of the addition has fixed metal windows with single or two panes. Above and below the windows is soldier course bricks. A double metal door with a large center light is located on Addition 4's south elevation. The southern gabled extension connects the porch addition and the north and east elevations of Addition 4. This gabled extension has a concrete masonry unit exterior and a metal door with a large light on the west elevation (Appendix B, Figure 35). The eastern extension on Addition 4 has single-paned metal windows, a stretcher bond brick exterior with two bands of concrete masonry units (Appendix B, Figure 36). Addition 4 also has a metal, flat roofed walkway with a poured concrete floor and rounded metal posts for support. The school is in good condition.

Figure 27. RB0701, Oxendine Elementary School, original block with chimney stack, west elevation, view to the east.

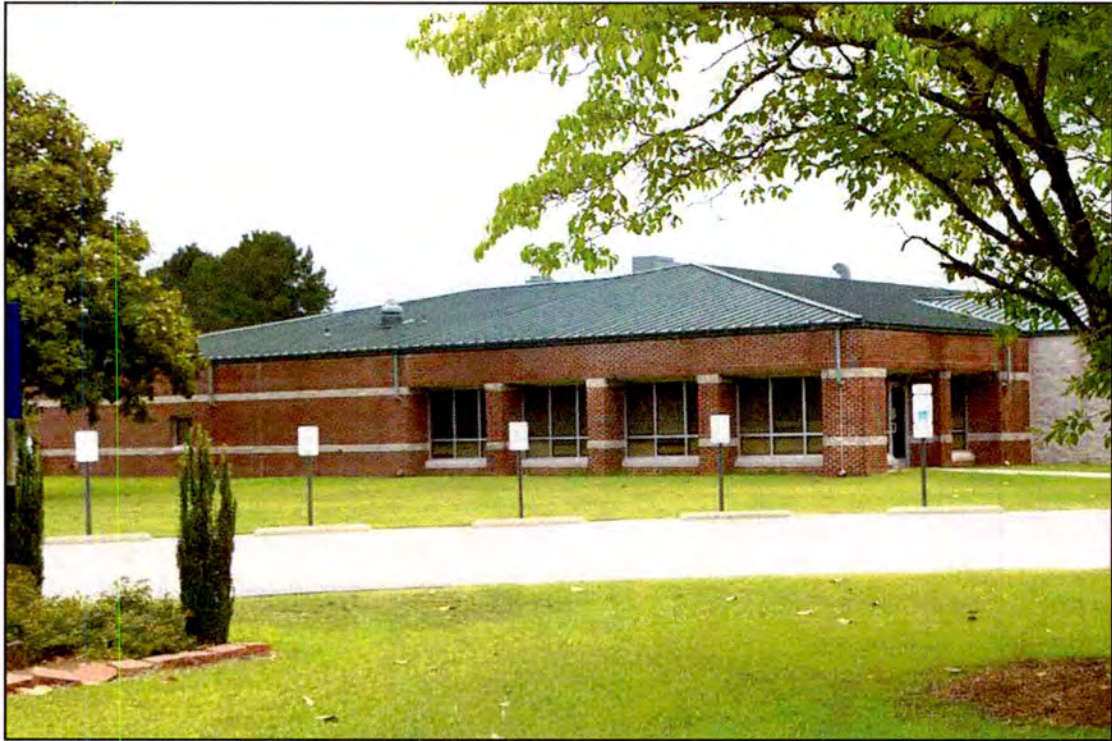
Figure 34. RB0701, Oxendine Elementary School, Addition 4, south and west elevations, view to the northeast.

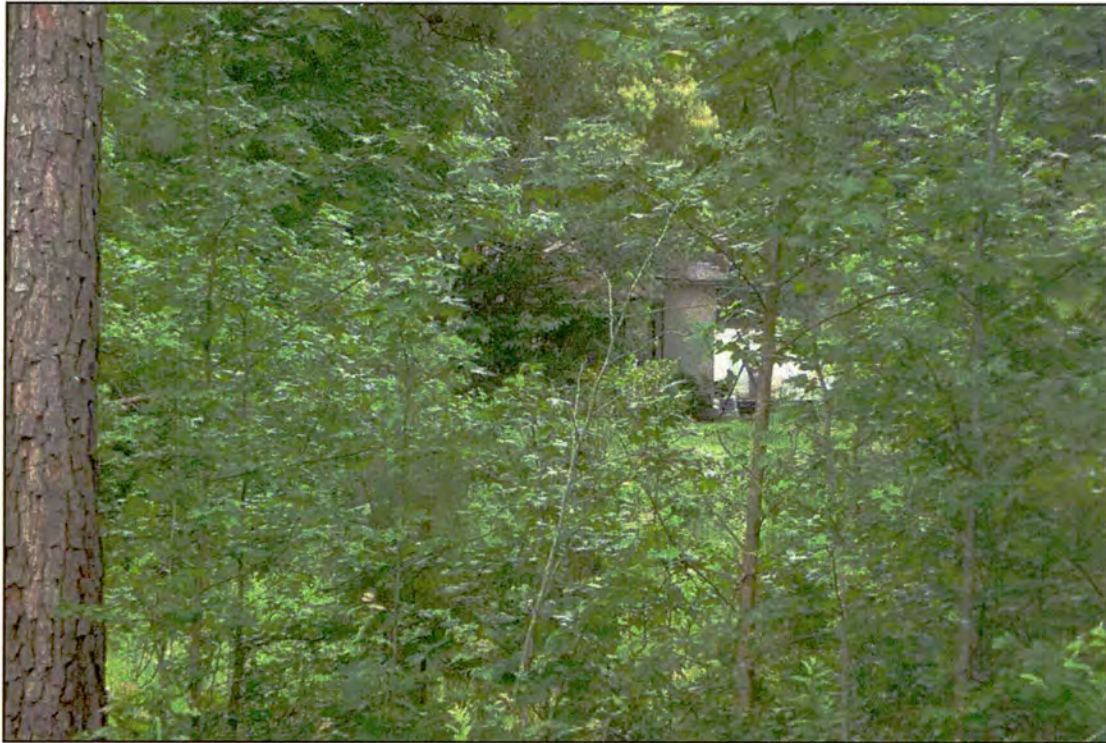
The dwelling at RB0702 is a one story, circa 1950 structure (Robeson County Tax Administration Office 2018) that is obscured from the public right-of-way. Aerial views reveal that it is a side-gabled structure with a gabled, rear-ell. It has a concrete masonry unit foundation and exterior with a standing-seam metal roof (Appendix B, Figure 46). The rear ell's southwest elevation has Masonite hardboard siding and is partly covered in a plastic tarp (Appendix B, Figure 47). The dwelling has a partial-width porch addition on its northwest elevation that leads to the primary entrance. The porch has a shed, standing-seam metal roof. The chimney is located on the slope of the northwest elevation. A circa 1950 outbuilding is located to the southeast of the dwelling (Appendix B, Figure 48). It has a front-gabled, standing-seam metal roof and a concrete masonry unit exterior. It has a shed-roof addition on its southeast elevation. The shed is located to the west of the outbuilding and has a standing-seam metal shed roof and vertical-oriented wood siding. The pool was placed in circa 2015 and is located to the south of the dwelling (Appendix B, Figure 49). All structures are in poor to fair condition. No other details on the dwelling or outbuildings could be discerned from the public right-of-way.

Figure 46. RB0702, dwelling, northwest elevation, view to the southeast.
