SUBJECT: Historic Structure Survey Report, Widen NC 50 (Creedmoor Rd) from Baileywick Road to Old Creedmoor Road, PA 18-06-0018, U-5891, Wake County, ER 19-1253

# **HISTORIC STRUCTURES SURVEY REPORT**

**Widen NC 50 (Creedmoor Rd) from Baileywick Rd to  
Old Creedmoor Rd, Wake County, North Carolina**

**TIP # U-5891  
WBS # 44706.1.1  
PA # 18-06-0018**

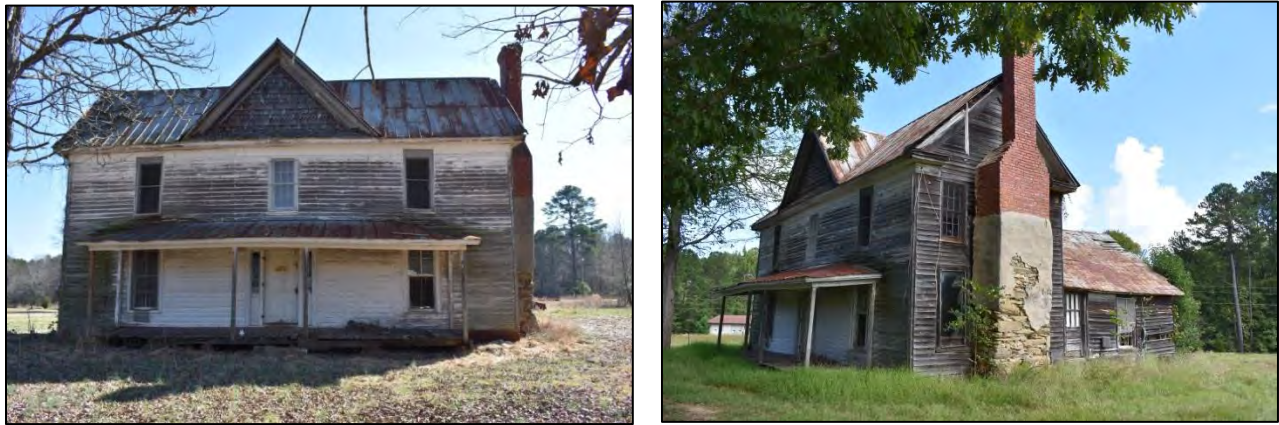
Figure 7: Left, view of front (western) elevation; right, front and south side elevations

A three-bay hip-roof porch topped with standing seam metal and supported by wooden posts embraces the building’s façade. The two central posts are chamfered, which suggests that they are original or early. The others are later additions. Beneath the porch is a centrally placed door, which is a replacement. It is flanked on either side by original three-light-over-two-panel sidelights. Four-over-four sash windows frame either side of the door. Where not removed, six-over-six sash windows are found on the building’s second floor. All windows appear to retain their original casings.

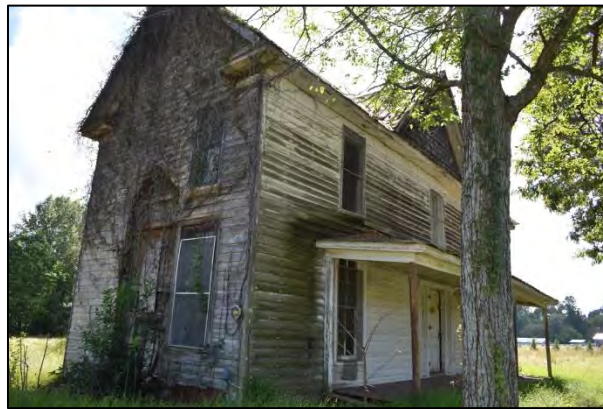
The frame I-house with its triple-A roof and rear ell embodies the architectural features of this common Wake County and North Carolina housing type. The two-story, three-bay house and its rear kitchen ell are clad in original weatherboards and edged by wooden cornerboards. The building’s side-gabled roof is capped with standing seam metal and features cornice returns. Decorative wood shingles adorn the building’s facade gable. A single exterior-end shouldered chimney comprised of a brick stack on a stone rubble base embraces the building’s southern gable end. At the time of Lally’s 1990 survey of the property the building boasted two additional chimneys, one on the southern gable end of the main house and a third on the gable end of the rear ell. These two appendages have since fallen (Figure 7 and Figure 8).

Figure 8: North side and west front elevations; note loss of chimney and boarding over of hearth opening

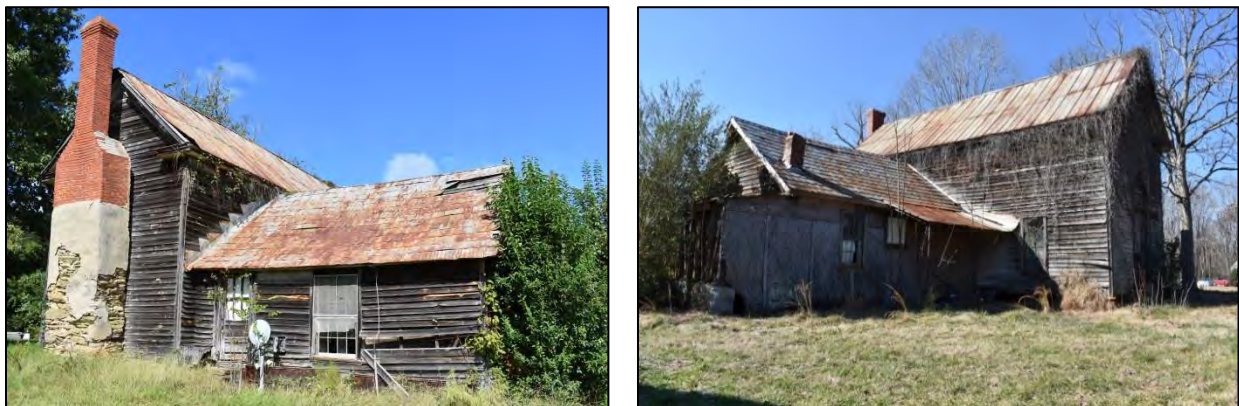
Figure 9: Left, south side and east rear elevation; right, rear and north side elevations

In keeping with common practice, the rear kitchen ell was once attached to the main house by a breezeway that has been filled in. The single-story frame wing, which is topped with metal shingles, holds a six-light-over-two-panel door (Figure 9, left) in addition to an added eight-over-eight sash window on its southern elevation. The weatherboards on the ell's eastern elevation have been covered by plywood and a single-stack brick chimney projects through the eastern roof slope. A single-bay shed roof porch has been erected at the intersection of the ell with the main house on the north, where the passageway was located (Figure 9, right).

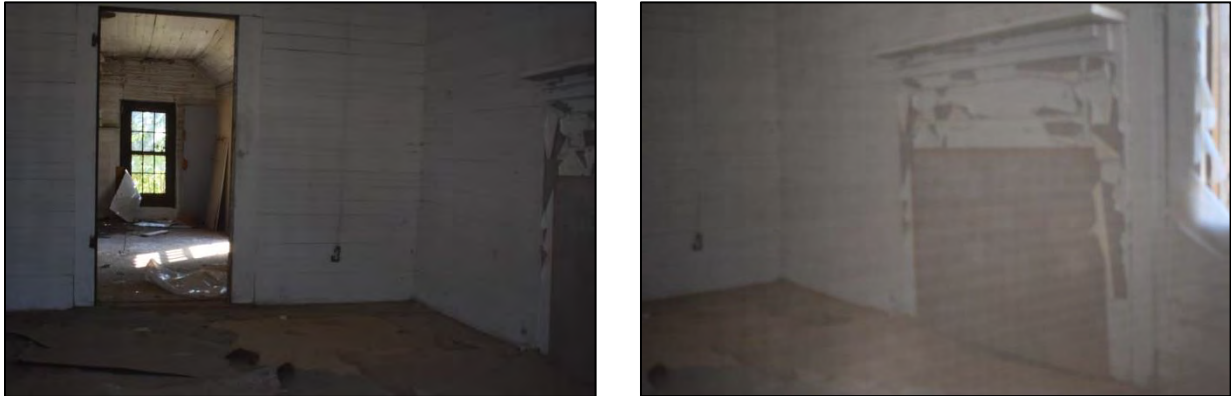
Figure 10: Left, view through front window into south parlor and on into ell; right, south parlor mantel

The first-story interior, as seen through windows, reveals original wood floors and beadboard walls and ceilings. (The house is sealed, in poor structural condition, and was not entered.) The south parlor retains a simple, original, wooden mantel piece (Figure 10). Empty hinges indicate the building's doors have been removed, but original door and window surrounds are still in place. An original, simply finished staircase with stick balusters rises from stair hall's rear (Figure 11). At the ell, a mantel remains where a chimney and hearth once stood (Figure 12). An added bathroom opens at the rear.

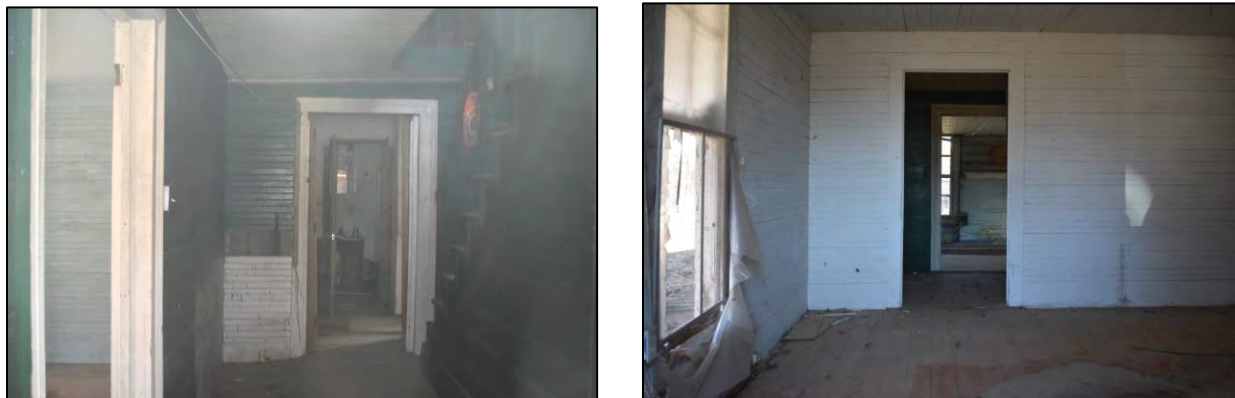
Figure 11: Left, view through front sidelight into stair hall and, beyond, ell and added bathroom—north parlor through opening at left; right, view through side window of south parlor with hall and north parlor beyond—note enclosure of hearth and removal of mantel in north parlor

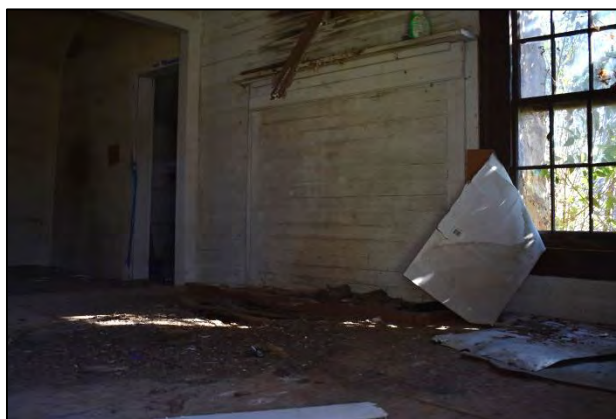
Figure 12: Mantel remaining on rear wall of ell; entry to later-added bathroom at left

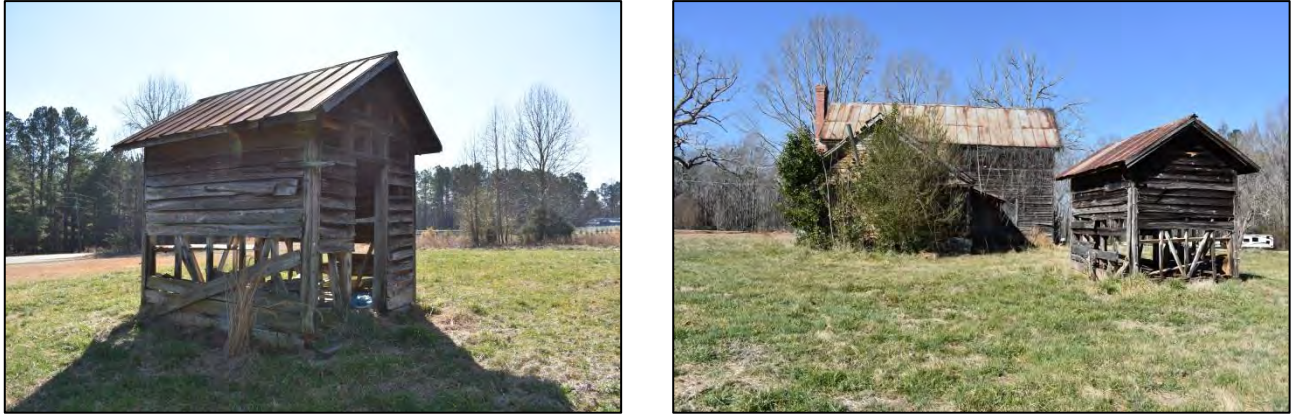
Located east of the George Washington Ray House, this frame building stands in disrepair and is clad in weatherboards and topped with a standing seam metal roof (Figure 13). The building was identified as a smokehouse by both Lally and Slane in their earlier surveys of the property.

Figure 13: Left, view of smokehouse looking to southeast; right, view of smokehouse looking west toward the house’s rear elevation

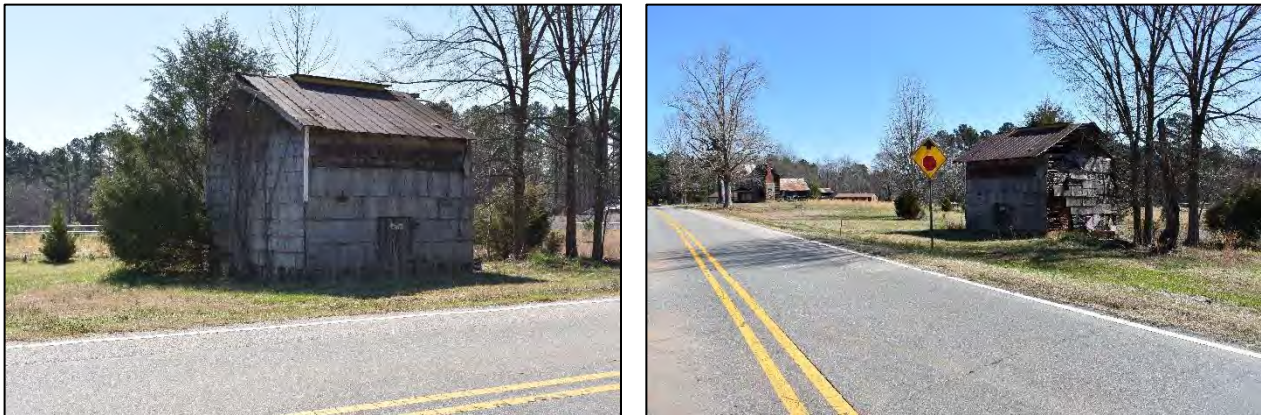
The frame tobacco barn sits on the south side of Old Creedmoor Road, roughly 90 yards to the southwest of the Ray House. The side-gabled building is clad in large wooden shingles and topped with metal sheathing.

Figure 14: Left, view of tobacco barn looking south; right, view of tobacco barn looking northeast toward George Washington Ray House

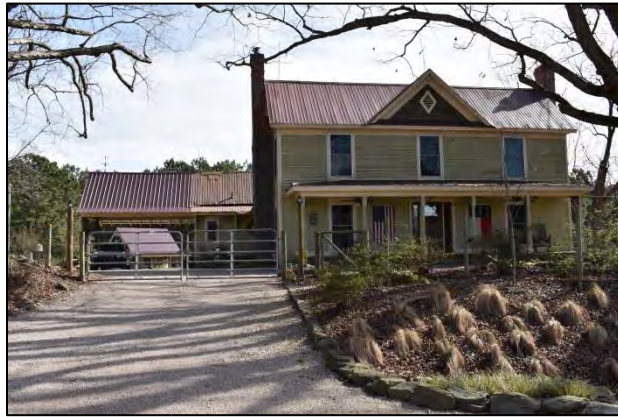
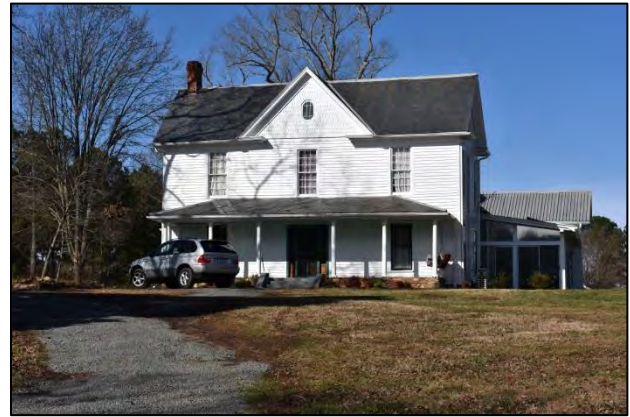
The Branch Ferrell House (WA1863) at 3928 Billy Hopkins Road in Zebulon (Figure 15, left) was constructed during the mid-nineteenth century. Following her 1990 survey of the house, Lally (1994:200) provided the following description:

The Ray Complex (WA1337) (Figure 15, right) at 12401 Boyce Mill Road in Barton's Creek Township is another fine example of Wake County's abundant supply of triple-A I-houses. Constructed ca. 1877, the house appears little changed since it was first surveyed by Lally. She describes it as follows (1994:312):

The property continues to operate as an active farm and boasts a significant number of associated outbuildings, both historic and modern.

Figure 15: At left, the Branch Ferrell House (WA1863) at 3928 Billy Hopkins Road; at right, the Ray Complex (WA1337) at 12401 Boyce Mill Road

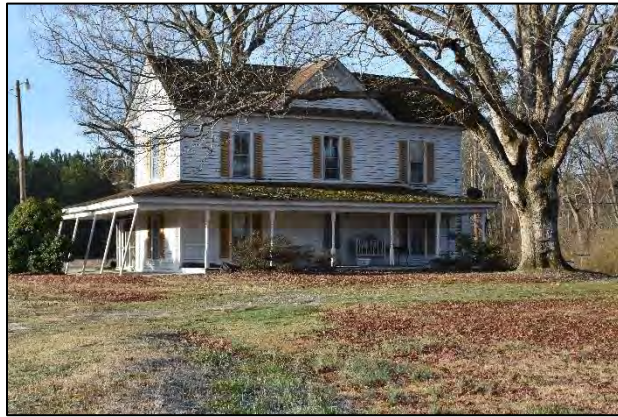
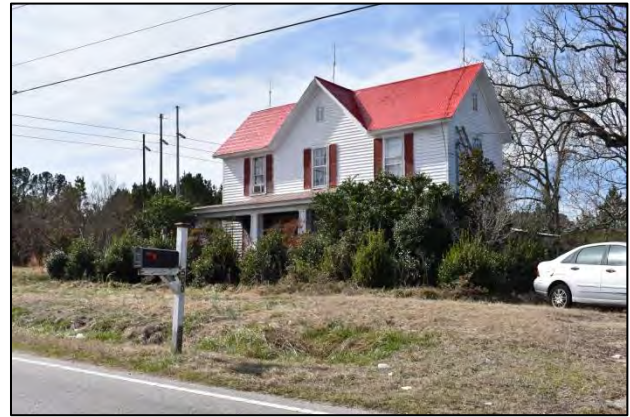
The Charles Y. Williams Farm (WA1985) (Figure 16, left), which stands at 2509 Marks Creek Road in Wendell, is another surviving example of the building type and was described by Lally (1994:282) as follows:

The Robert B. Horton House (WA2009) (Figure 16, right) is located 500 S. Wakefield Street in Zebulon and, like most of its contemporaries, dates to the end of the nineteenth century. Also included in her 1994 survey, Lally described the I-house as follows (1994:206):

The house retains its early-twentieth-century Craftsman-style porch, early six-over-six sash windows and surrounds, original weatherboards and cornerboards, and painted tin roof. With the exception of significant vegetative growth, the house appears little altered since Lally's survey. The property additionally retains some original outbuildings to its rear, although they stand in various states of disrepair.

Figure 16: At left, the Charles Y. Williams House (WA1985) at 2509 Marks Creek Road; at right, the Robert B. Horton House (WA2099) at 500 S. Wakefield St

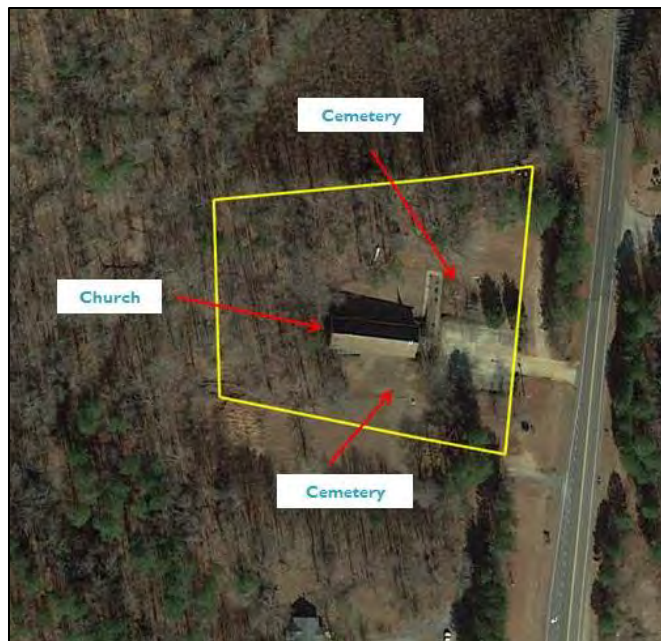
Evans Grove Baptist Church occupies a 2.35-acre parcel that is bounded to the north, south, and west by trees, and to the east by Creedmoor Road. The church stands in the middle of the lot and is oriented to the east. A parking lot sits between the church and the road. To the north and south of the parking lot is the cemetery, the earliest marker of which dates 1943, postdating the construction of the original church building (Figure 17).

Figure 17: Site plan of Evans Grove Baptist Church parcel

The Evans Grove Baptist Church Cemetery is divided into two sections, one situated to the north and the second to the south of the parking lot (Figure 17, above). The southern section postdates the northern one and contains just a small number of graves dating from 1994 to 2017 (Figure 22, at left). Stones found in this section are modern, upright, granite markers. The northern section of the cemetery is older and larger. It holds the cemetery’s oldest grave, that of the church’s first pastor, Reverend Willie D. Evans (1900-1943) (Figure 22, at right) and many traditional, flat marker types.

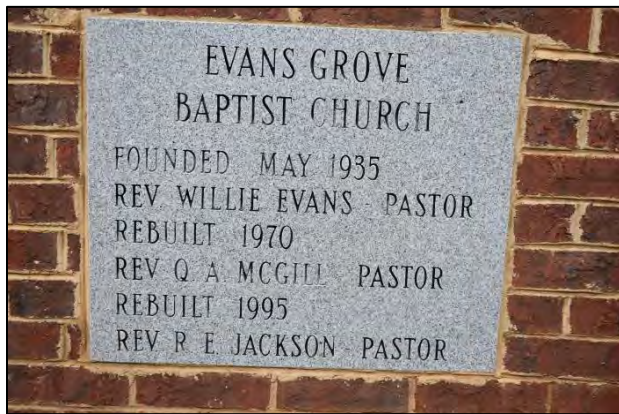
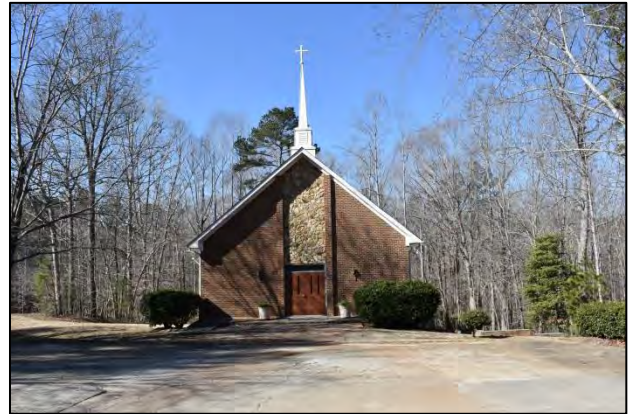
Figure 18: Left, date stone located on front elevation; right, east front elevation

According to a date stone located on the primary (eastern) elevation of Evans Grove Baptist Church (Figure 18, left), the church was founded in May 1935, and the original church building was likely constructed around this time. The stone additionally notes the building was rebuilt in 1970 and again in 1995, suggesting that the structure which currently stands is the third iteration of Evans Grove Baptist Church. The building appears to date from no earlier than 1970 or perhaps even 1995. If any structural components survive from the 1935 church, they are hidden from view.

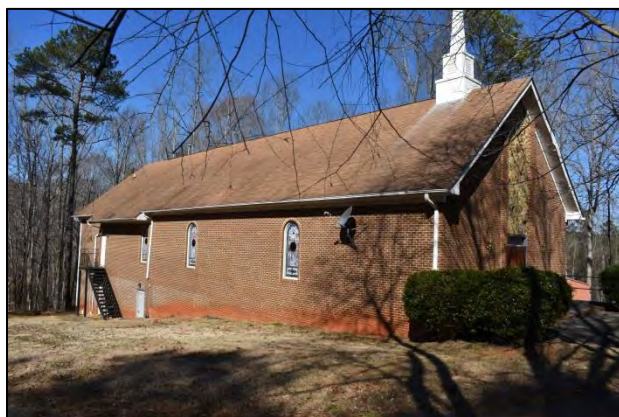
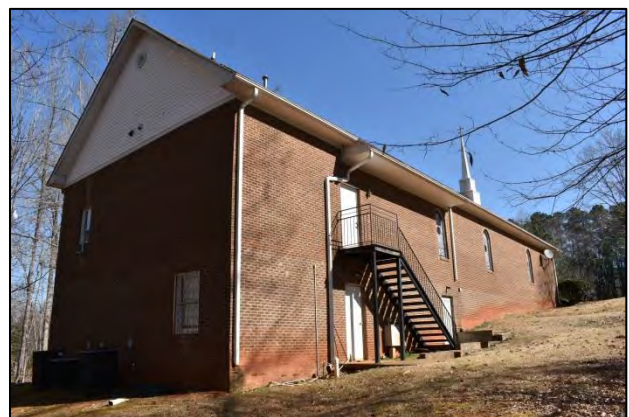
Figure 19: Left, side and front elevations; right, west rear and south side elevations

The front-gabled brick building is linear in plan and built into a hill, revealing a partially exposed basement on its rear (western) elevation (Figure 18 through Figure 20). A boxy metal steeple graces the building's roof, which is clad in asphalt shingles. Keeping with the church's simplicity, the building is accessed through a pair of steel doors which include tall, plain, narrow windows. Framing the door to the left and right are raised brick pilasters that span the entire height of the building's eastern gable end. Resting above the door and between the pilasters is a decorative inlay of large stones which vary in their shape and coloring. Secondary steel doors are found at the building's rear on both its northern and southern elevations and reached by exterior metal stairs.

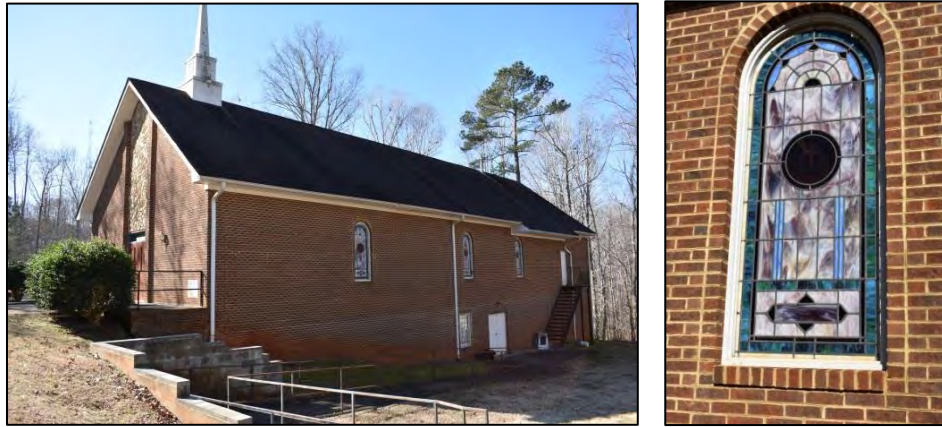
Figure 20: Left, south side and front elevations; right, detail of stained-glass window

Three arched stained-glass windows unevenly punctuate both the northern and southern elevations (Figure 20). They appear to predate 1970 and may have been part of the original church building or acquired from elsewhere.

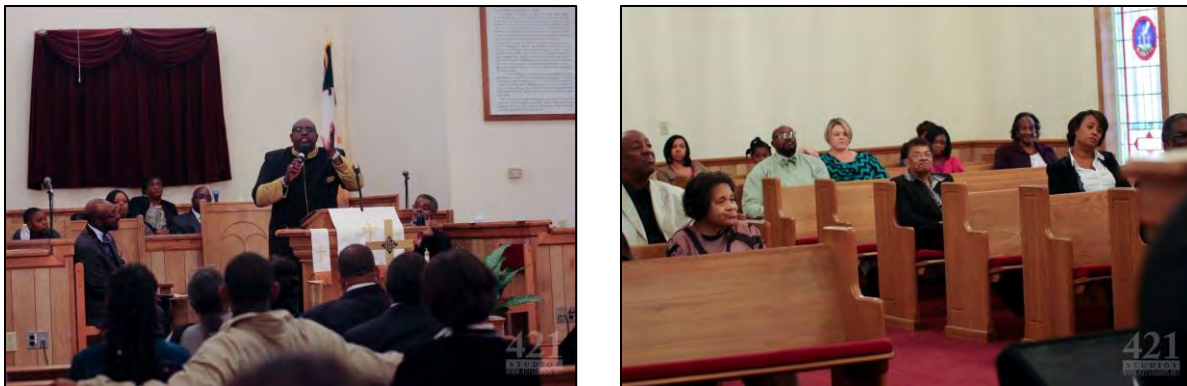
Despite multiple site visits and attempts to contact church staff, interior access to the building was not made available. Images of the church’s interior posted to its social media page reveal a very modern one-room sanctuary space on the first floor. Based upon the location of the windows within the sanctuary in relation to the building’s exterior elevation, it is likely that a front vestibule or gathering space is located on the building’s eastern end (accessed through the front doors). The interior images of the church also reveal late-twentieth-century church pews, carpeted floor coverings, and plastered walls with late-twentieth-century wainscoting (Figure 21). Except for the stained-glass windows, nothing on the church’s interior or exterior appears to be 50 years old or older.

Figure 21: Church sanctuary (source: Evans Grove Missionary Baptist Church Facebook Page)

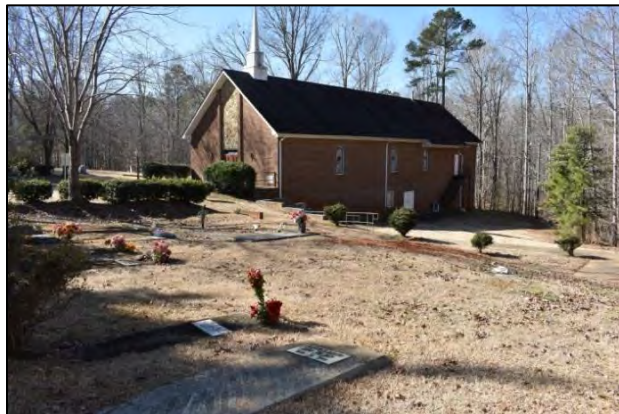
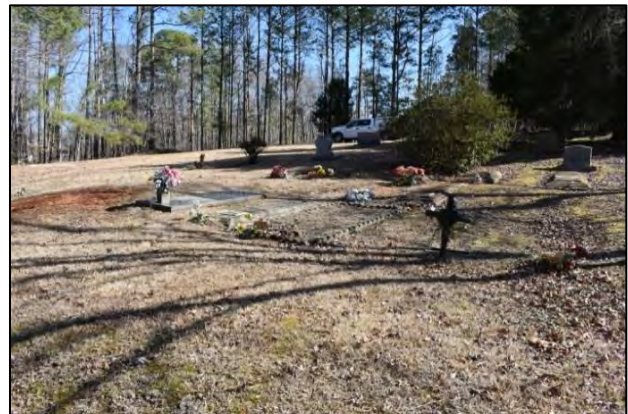
Figure 23: Views of northern section of cemetery looking toward church and, at right, Creedmoor Road

A variety of grave marker types populate the cemetery. These include carved granite headstones with arched tops, flat engraved granite ledgers, and concrete slabs laid even with the ground (Figure 23 and Figure 24). The ledgers and slabs are traditional forms commonly found throughout twentieth-century African American cemeteries in Wake County and North Carolina (Figure 25). In her Wake County architectural history, Lally (1994:118-119) notes that: “Flat concrete vault coverings, some engraved with names or decorated with paint, carvings or etchings, and even marbles, became popular among black congregations in the 1930s or 1940s and provided a more attractive means of marking graves than simply using field stones.” According to Little (1998:250) in her volume on North Carolina’s gravemarkers, “Cast concrete monuments make up the majority of gravemarkers in traditional African American graveyards in North Carolina.” She further notes that:

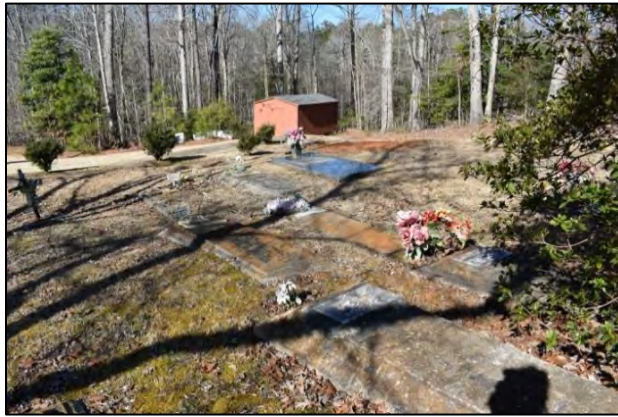
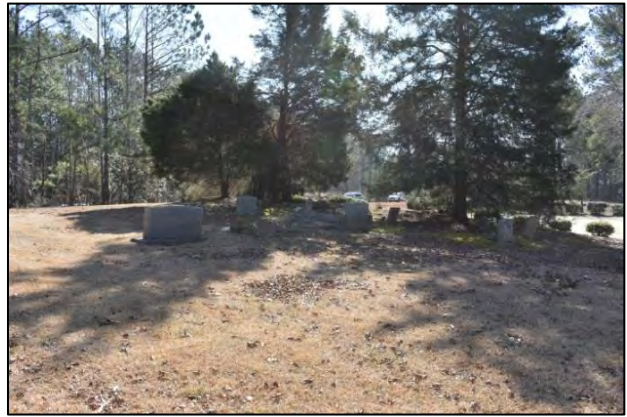
Figure 24: Cemetery's northern section, looking north at common flat grave types, at left, and northeast where upright marker types predominate

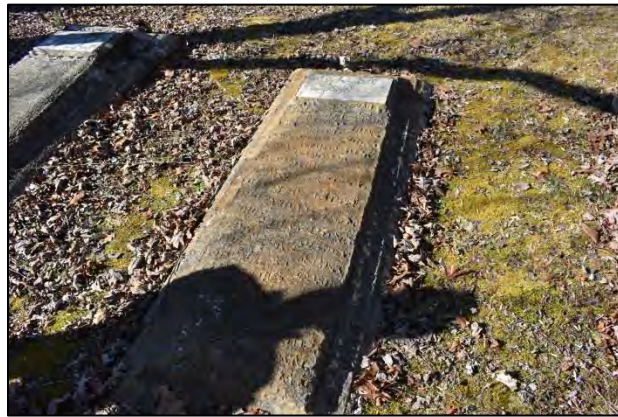
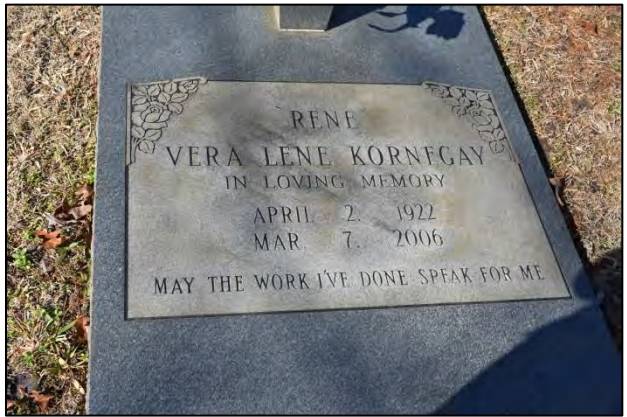
This treatment is found at Evans Grove concrete slabs from the 1970s and later.

Figure 25. Left, concrete slabs atop graves of Britt L. Morgan (1924-1976) and Sylvester Morgan (1943-1976); right, polished granite ledger over recent Kornegay grave

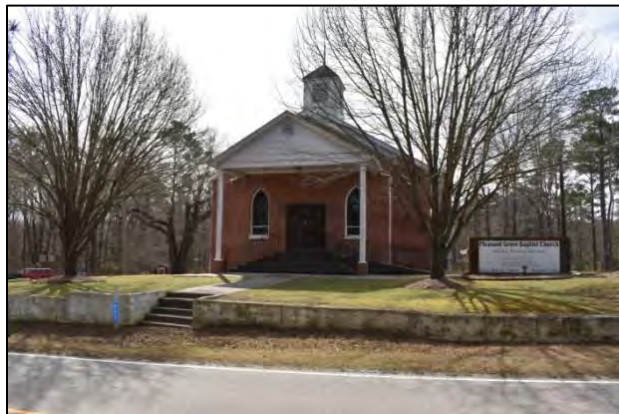
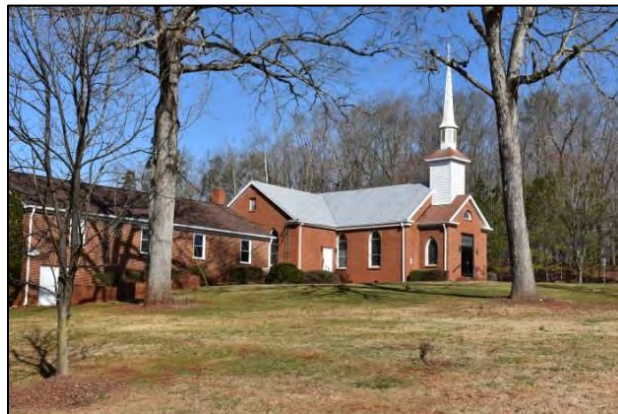
The congregation of Pleasant Grove Baptist Church (WA2126) (Figure 26, left) in Wendell dates to the early 1800s and a group of former slaves. After a handful of early buildings, construction of the current worship space was begun in 1948 and completed in 1950 (Pleasant Grove 2019). The front-gabled building is composed of a single rectangular sanctuary clad in brick and features a pedimented front portico supported by simple Doric columns. A frame weatherboarded steeple rises from the building's roof. Pointed-arched windows pierce the building's eastern and western elevations, and two are symmetrically placed on the façade. Each opening holds a stained-glass window which appears original to the building's construction. Unlike many other county churches, no major alterations have been made to the building's footprint.

Figure 26: At left, Pleasant Grove Baptist Church (WA2126); at right, Stony Hill Baptist Church (WA1441)

During her 1994 survey of Wake County, Lally documented the Stony Hill Baptist Church (WA1441) (Figure 26, right) in Wake Forest, describing it as follows (1994:294-295):

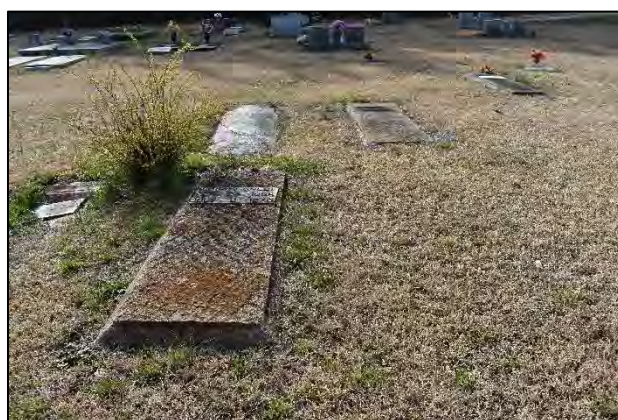
The large Pleasant Grove Baptist Church cemetery (WA2100), located a mile to the sanctuary's east, is an excellent and large example of an African American cemetery that includes a wide variety markers. Many of these are horizontal ledgers, box tombs, and concrete slabs (Figure 27).

Figure 27: View of Pleasant Grove cemetery looking southeast; detail view of concrete ledgers

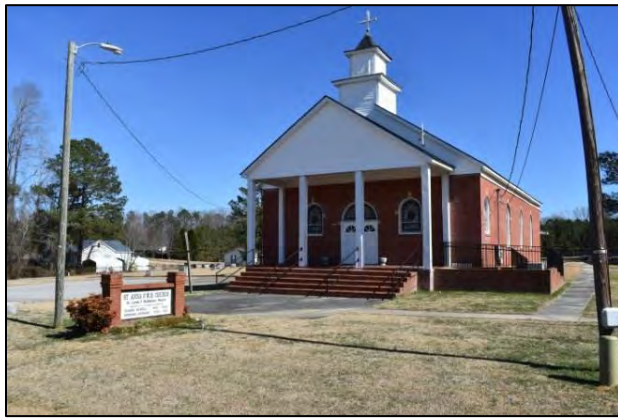
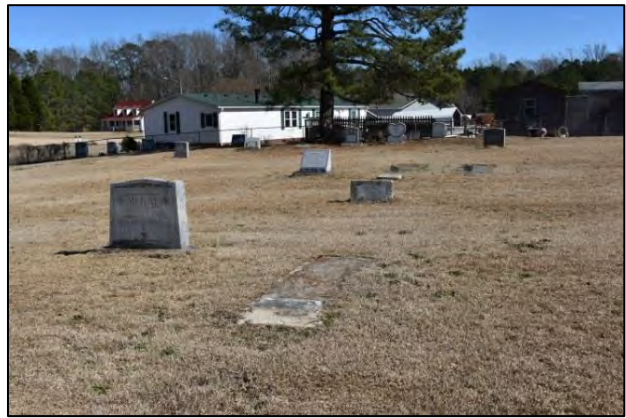
Saint Anna Free Will Baptist Church (WA1168) (Figure 28) in Willow Springs is a rectangular brick-clad building. It appears to consist of a front vestibule, center sanctuary (both of which appear original) and a small hipped-roof addition at the building's eastern end. A four-bay pedimented portico with synthetic siding embraces the building's façade. Original arched window openings topped with keystones hold early stained-glass windows. To the north of the building lies a small cemetery, which

is likely contemporary with the church, and dates to the 1920s. The church has an African American congregation and the marker types in its cemetery are similar to those of Evans Grove.

Figure 28: Saint Anna F.W.B. Church and cemetery (WAI I68)

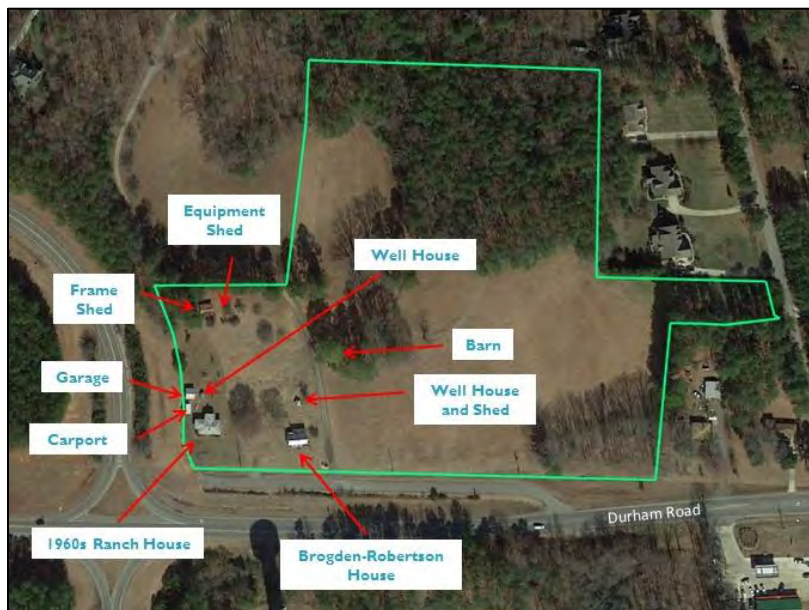
The Brogden-Robertson House sits near the western edge of a 14.47-acre lot on the north side of Durham Road/NC 98, just east of the cloverleaf that connects NC 98 with Creedmoor Road (Figure 30). The house rests in a large clearing and appears to have been vacant for some time. A 1960s ranch house is located approximately 50 yards to the west of the Brogden-Robertson House and sits along the western edge of the parcel boundary. Both houses are accessed by a long paved drive which runs perpendicular with Durham Road and terminates as it reaches the ranch house. To the rear (north) of the Brogden-Robertson House are a wellhouse, frame shed, and a barn. To the rear (north) of the ranch house are a carport, garage, wellhouse, frame shed, and equipment shed.

Figure 30: Site plan of current Brogden-Robertson property

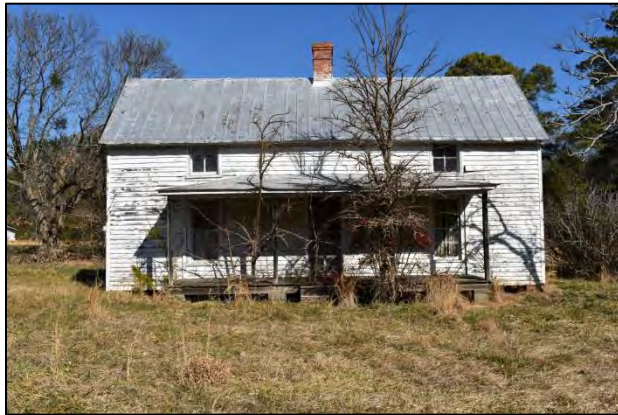
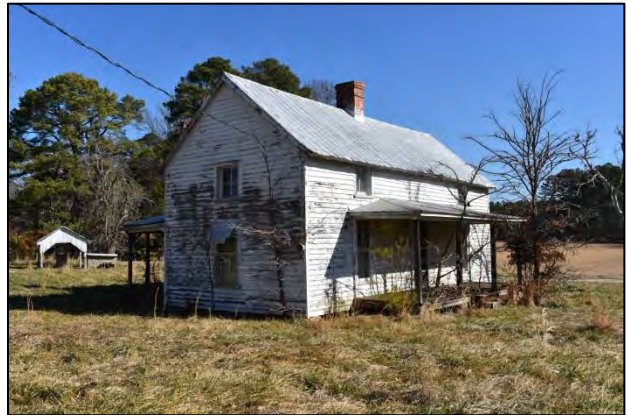
Figure 31: Left, view of front (southern) elevation; right, view of southwestern elevation

The Brogden-Robertson is a one-story-and-a-loft or “story-and-a-jump” residence that stands three bays wide on a brick-piered foundation and is clad in plain weatherboards. The deep relief visible at its upper-story window openings suggest it is of log construction; however, it is in fact frame (as noted by both Lally and Slane in their earlier surveys of the property (NC HPO WA1330 file)). A side-gabled roof covered with standing-seam metal sheathing tops the building. An interior corbelled brick chimney is centrally placed on the roof’s peak. A three-bay hip-roofed porch which appears to be a replacement crosses the central portion of the front (south) elevation (Figure 31). A six-light-over-two-panel door, also likely a replacement, is centered beneath the porch, framed on either side by original four-over-four-light windows and original plain casings. Hinged four-pane windows set in deep handmade window casings are found at the building’s loft level (Figure 32).

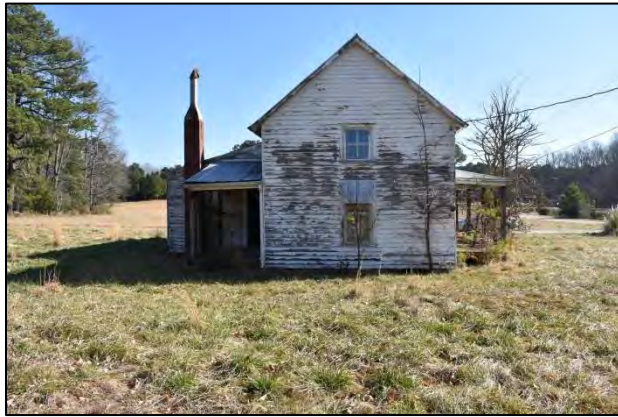
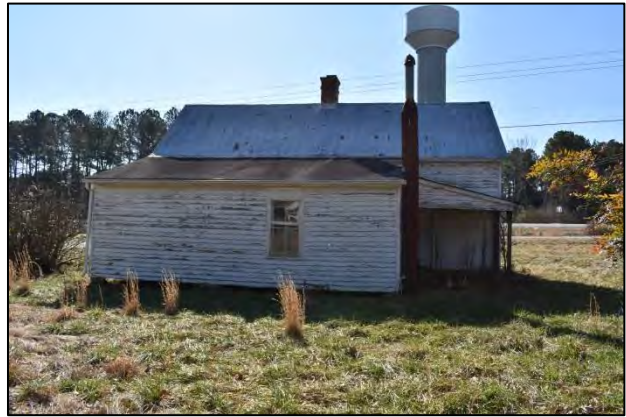
Figure 33: Left, view of eastern elevation; right, view of rear (northern) elevation of house

Extending from the building’s rear (northern) elevation is a frame shed-roof ell which is clad in the same weatherboards as the house and capped with asphalt shingles (Figure 33). This addition appears to be early, although not original, and features the same four-over-four-light sash windows as the first story of the front block. A secondary entrance to the building, covered by a single-bay shed-roofed porch, is found on the addition’s western elevation. An exterior, single-stack, brick flue also marks this side of the addition.

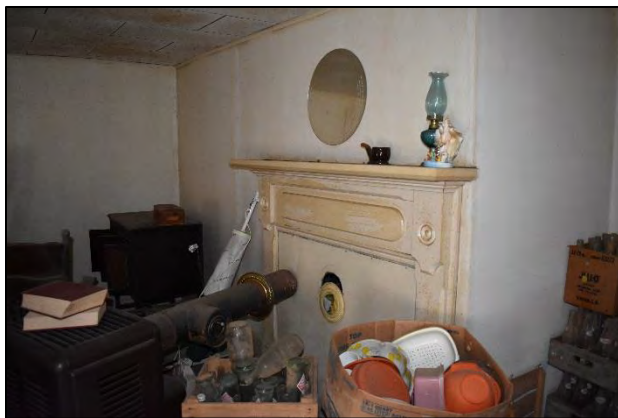
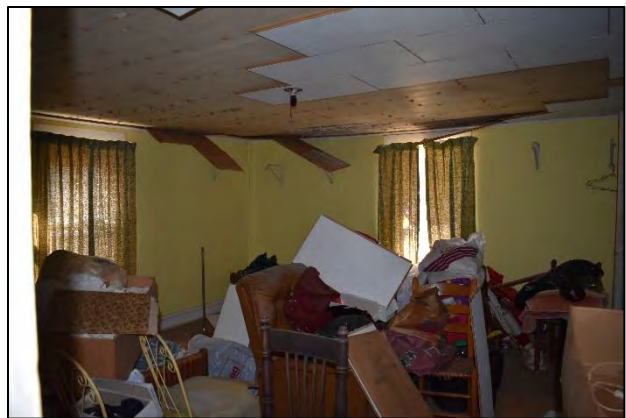
Figure 34: Left, west room of main block with Victorian mantel; right, east room with part of wood ceiling and dollops of glue from fallen acoustic tiles exposed

The main block of the house is divided into two rooms of equal size (Figure 34 and Figure 35, top). Both retain some original material including wood floors and ceilings (partially hidden by modern acoustic panels). The walls appear to be covered with a later-added material. Whether plain flush boards or beadboard lie beneath could not be determined. The building's front door opens into the west room, in which is found an original Victorian-style post-and-lintel mantel centered on its interior wall. The main block additionally retains original or early multi-paneled doors and hardware. An original five-paneled door is located on the north wall of the east room and opens to the exterior (adjacent to the rear shed-roof addition).

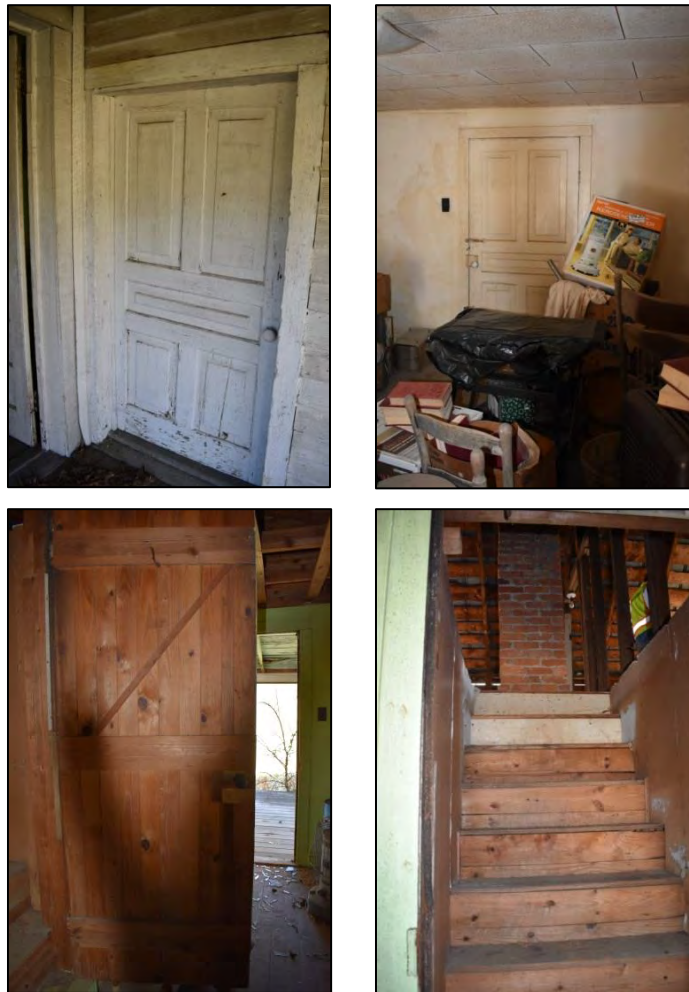
An interior stair leading to the usable loft space is accessed through the rear shed roof addition. The wooden batten door appears to be original to the front block, as do the stair risers (Figure 35, bottom). It is unclear how the attic space would have been accessed prior to the rear shed-roof addition as the wooden batten door is light in its construction and not designed as an exterior door. Likely the house always had a rear ell.

Figure 35: Left, five-panel door connecting ell and west room: right, door to attic and stairs

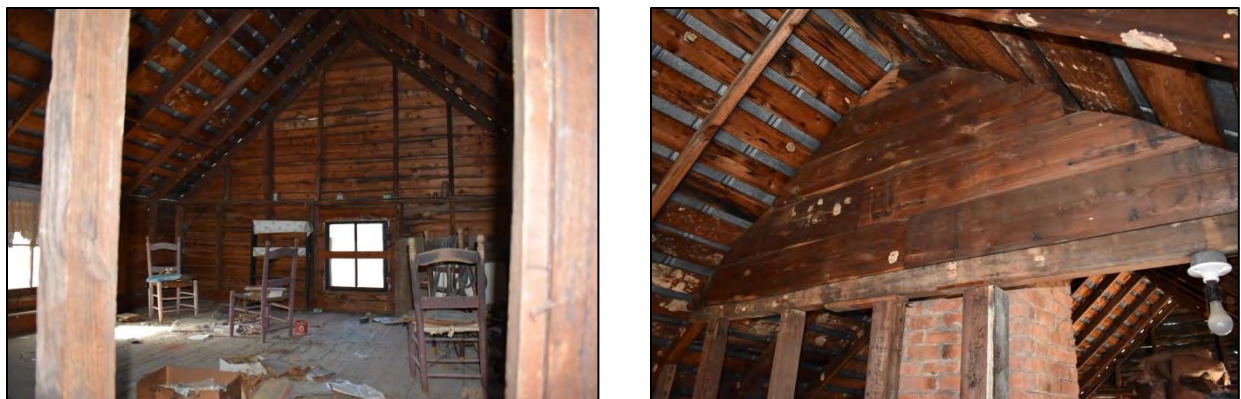
The attic's ceiling is exposed, revealing the building's original common-rafter framing system. The wood floors remain in place, as does part of a partition that divided the loft in two. Nailing marks and open mortices in the partition studs indicate that it was erected from salvaged timbers. The boards atop the partition framing appear to have been salvaged as well (Figure 36). The four-light casement

Figure 36: Common rafter system, wood floor, and partition in loft

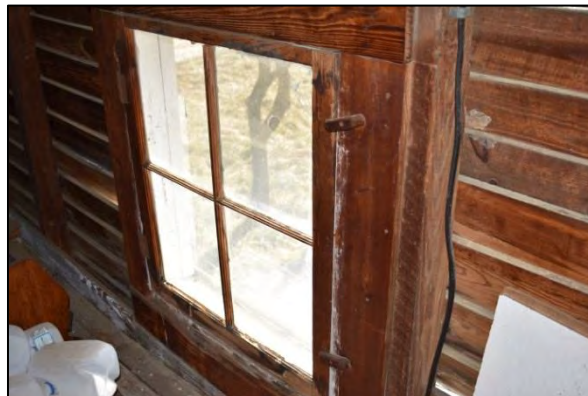
windows retain original hinges and wooden latches. Cut nails and circular saw marks are consistent with a late-nineteenth or early-twentieth-century construction date for the house.

Figure 37. Casement attic window with hinges and wooden latches in place

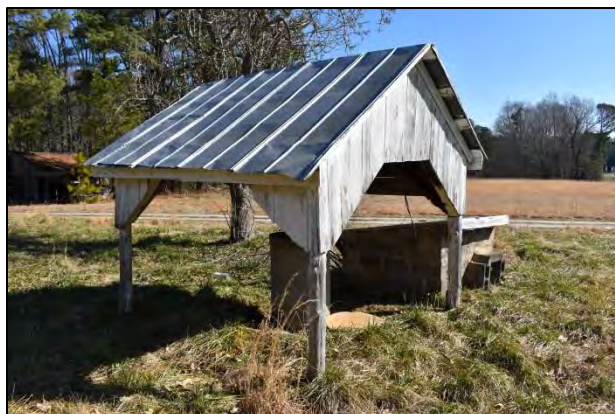
### Shed and Wellhouse (Figure 38)

Located to the rear (northeast) of the Brogden-Robertson House, the open-air frame shed is topped by a front-gabled roof and supported by wooden posts. Standing seam metal tops the structure. A concrete wellhouse is situated directly east and topped with a metal roof. According to Slane’s 2017 survey, the shed and wellhouse date to the 1920s.

Figure 38: View of frame shed and low concrete-block wellhouse looking to northeast

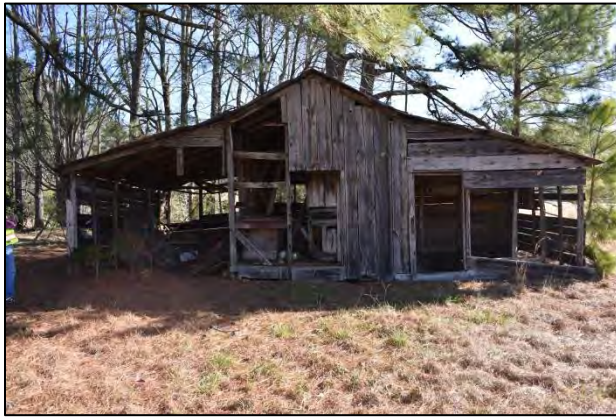
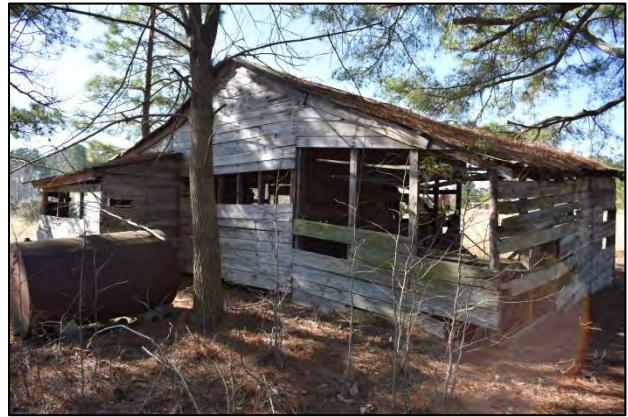
The frame barn, which also dates to the 1920s according to Slane, stands to the rear (northeast) of the Brogden-Robertson House. The front-gabled building is composed of a central gable block clad in vertical and horizontal sheathing. A shed-roofed bay extends from its northern and southern elevations. Interior views into the building (Figure 40) suggest that the barn was used as a feed barn.

Figure 39: Left, view of eastern elevation; right, view of western elevation

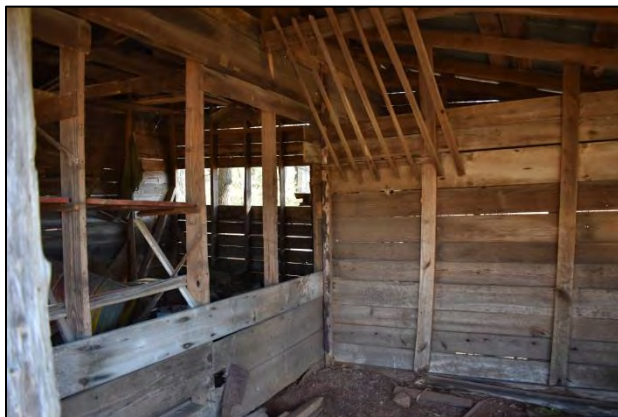
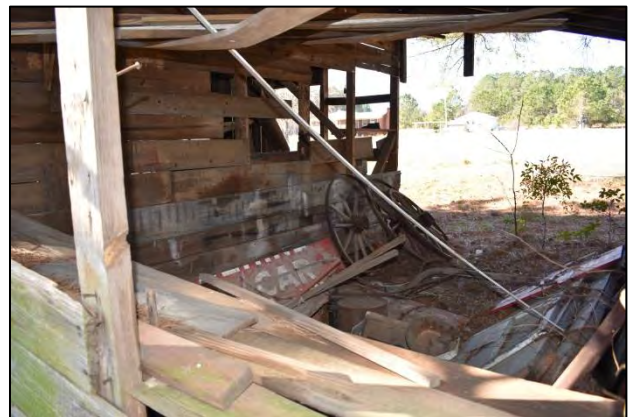
Figure 40: Left, view to interior stall; right, view of machine storage

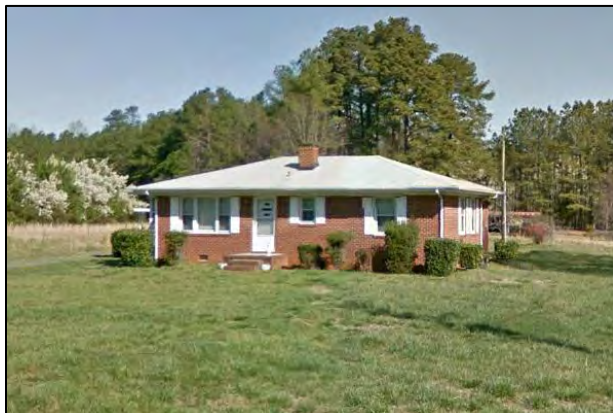
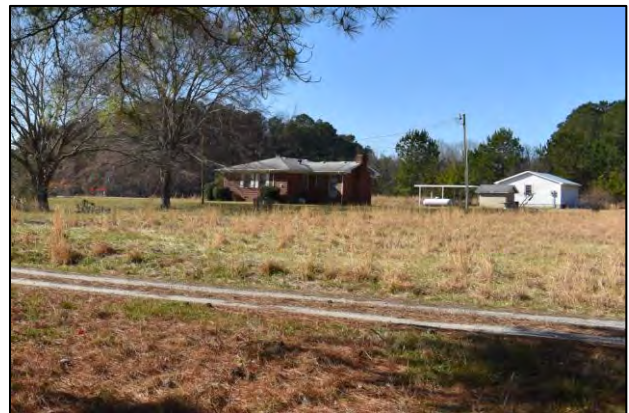
The single-story brick ranch house stands to the west of the Brogden-Robertson House. The house stands four bays wide and features a combination of banded windows and two-over-two sash windows. Its hipped-roof is capped with asphalt shingles and features an interior brick chimney, which projects through the southern slope.

Figure 41: Left, view of front (southern) elevation of ranch house; right, view of ranch house from rear with frame garage at far right

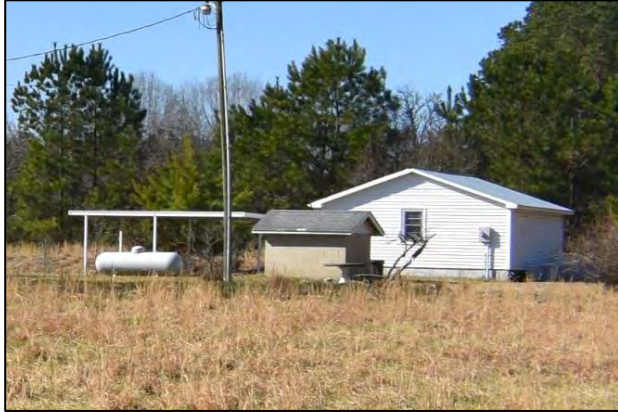
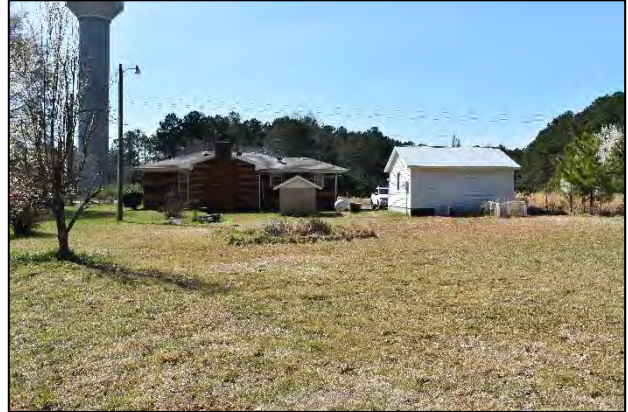
Located to the north of the ranch house, the frame side-gabled garage, side-gabled concrete block wellhouse, and single-bay carport date to the mid/late-twentieth century.

Figure 42: Left, pictured from left to right: carport, wellhouse, and garage; right, view of ranch house, wellhouse, and garage looking south

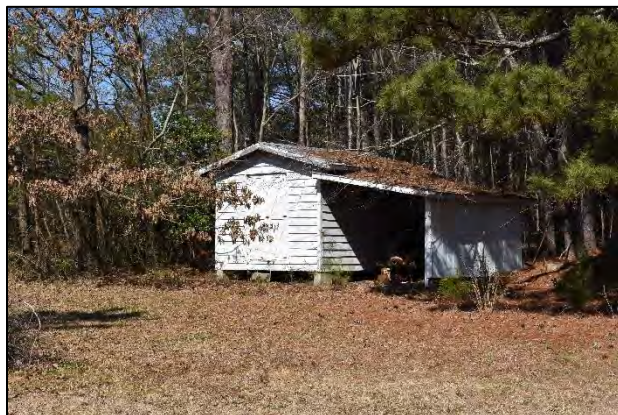
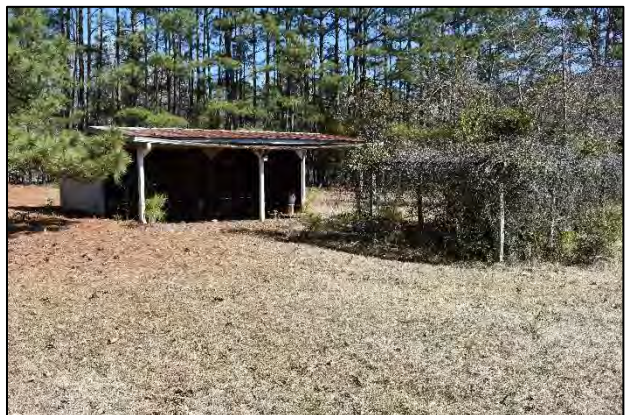
Situated to the direct east of the frame shed, the frame equipment shed stands two-bays wide and is supported by square wooden supports. The entire northern elevation, in addition to parts of the eastern and western elevations, is enclosed with plain weatherboards. The southern elevation is open. The building is topped with metal sheathing and appears contemporary with the frame shed.

Figure 43: Left, frame shed located to north of the ranch house; right, equipment shed located to east of frame shed

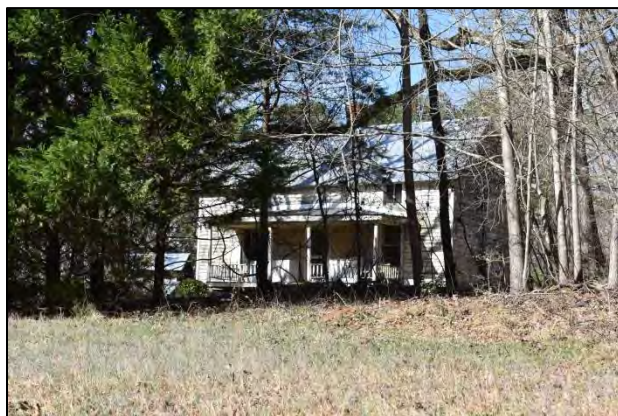
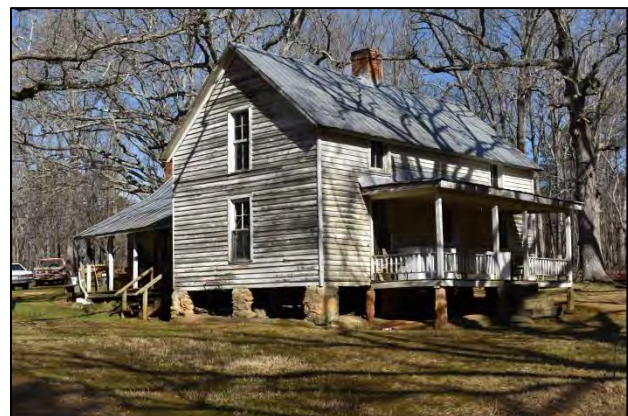
The Farm Complex (WA1395) (Figure 44) located at 7625 Stony Hill Road in Wake Forest (not included in the county publication) is described at in its survey file as follows:

Probably built in the early 20th century, this 1 and 1/2 story, side gable-roofed frame dwelling represents the most common of northern Wake County house types. Elevated on a stone pier foundation, the house is marked by a central brick chimney, single sash windows on the upper story, a hip-roofed porch with simple square supports, and a rear kitchen ell with stuccoed, stone-based exterior end chimney. There is a fairly intact complex of outbuildings associated with the dwelling, including two log tobacco barns and a log corn crib, all with saddle notching; feed barn and packhouse, both frame, and an old well.

Figure 44: Above, Farm Complex (WA1395) at 7625 Stony Hill Rd
