SUBJECT: Historic Structure Survey Report, Widen NC 50 (Creedmoor Rd) from Baileywick Road to Old Creedmoor Road, PA 18-06-0018, U-5891, Wake County, ER 19-1253

# **HISTORIC STRUCTURES SURVEY REPORT**

**Widen NC 50 (Creedmoor Rd) from Baileywick Rd to  
Old Creedmoor Rd, Wake County, North Carolina**

**TIP # U-5891  
WBS # 44706.1.1  
PA # 18-06-0018**

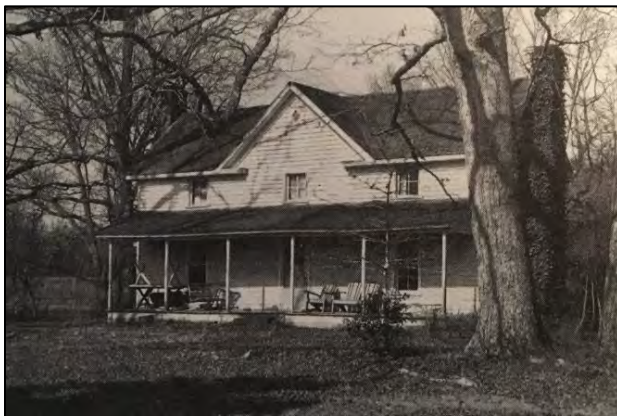
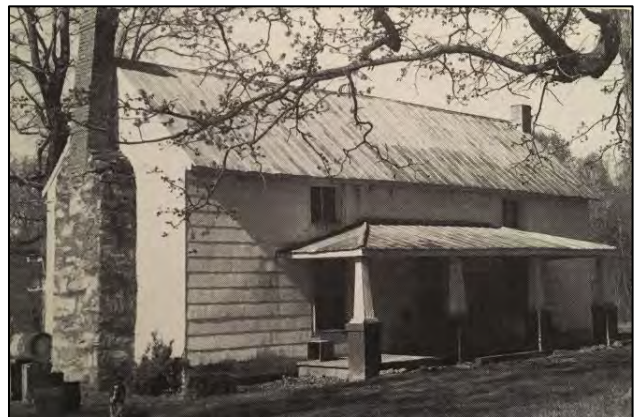
Figure 46: At left, the Melvin Arnold House (WA1334) ca. 1994, now gone; at right, the Keith Farm (WA1442) ca. 1994, now gone (photo credits: Kelly Lally)

Constructed ca. 1890 the Melvin Arnold House (WA1334) (Figure 46, left) stood at 1501 Sweet Meadow Lane in Rogers Store, a little over one mile south of the Brogden-Robertson House, until it was demolished in 2016. The house was surveyed by Lally (1994:310) who described it as follows:

This side-gable-roofed frame house is an example of the late nineteenth- and early twentieth-century house type found with great frequency in northern Wake County, readily identified by the single-sash upper-story windows on the front façade. This particular example has a rear ell, a hip-roofed porch with Craftsman-style supports (probably replacements), and one of its two original stone based exterior stone end chimneys. The original weatherboards have been covered with asbestos siding. The property retains a full complement of outbuildings...

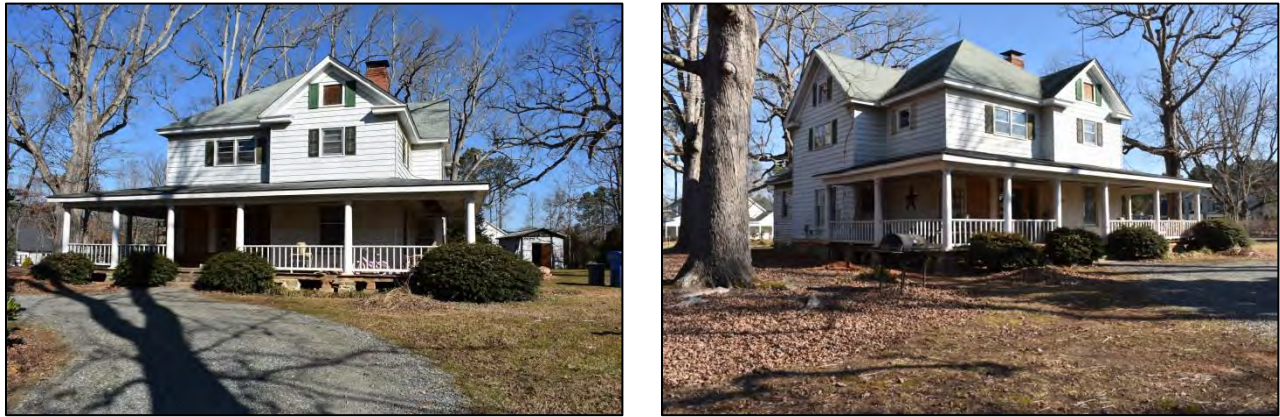
Figure 47: Left, view of (front) southern elevation; right, view of southwestern corner

The transitional Queen Anne/Colonial Revival-style John Arnold House stands two stories tall and is topped with a hipped-roof with projecting two-story gabled bays on its southern, eastern, and western elevations. Cornice returns edge the building’s gables, and a corbelled brick chimney stack rises from the building’s northern and eastern roofs (Figure 47). The house rests on stone piers that were later filled in with stone. At present, the top portion of the house’s southern, eastern, and western elevations are clad in aluminum siding; however, the house’s current owners are undertaking an intensive restoration of the house that involves the removal of this newer exterior cladding. The aluminum has already been removed on the first floor to reveal original weatherboards.

A hipped-roof porch supported by Doric columns embraces the façade and continues around to the eastern and western elevations of the house, partially embracing those elevations (Figure 47). The porch retains its original floorboards and beadboard ceilings. Beneath the porch on the façade (southern elevation) rests a one-light-over-two-panel door with sidelights of the same configuration (Figure 48).

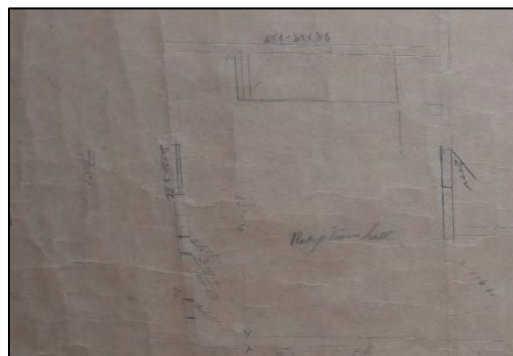
Figure 49: Portion of original floorplan depicting entry and sidelight arrangement between porch and reception hall, at left, and stairway at top

The house's original windows have been largely replaced by vinyl four-over-four sash on the first floor and two-over-two horizontal-pane windows on the second floor (Slane 2017). Additionally, the placement of many openings has been altered on all elevations of the house, as denoted by both the building's original floorplans and discussion with the building's current owner Jason Allen (Allen 2019) (Figure 49). As part of his restoration plan, Allen is undertaking the task of reversing the altered openings and replacing the modern windows with period appropriate materials.

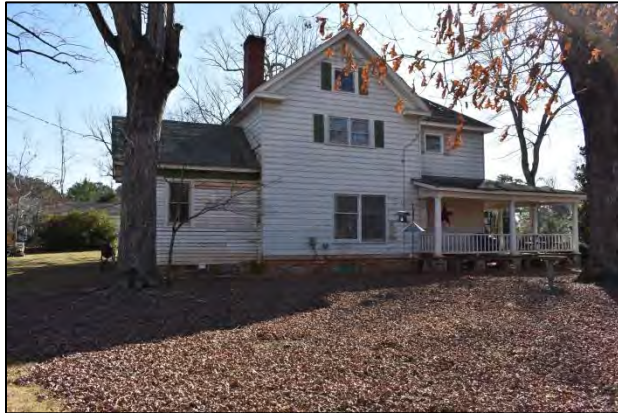
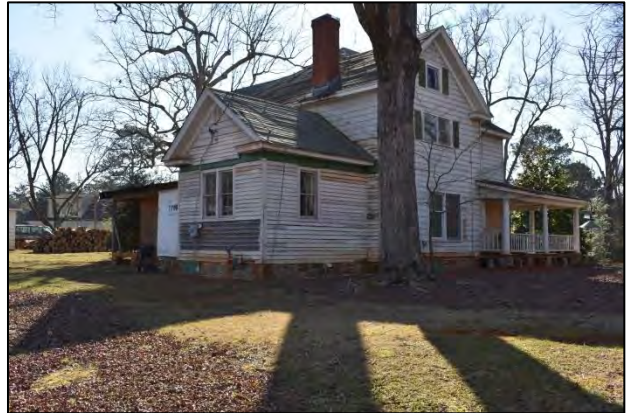
Figure 50: Left, view of western elevation, right, view of northwest corner

A single-story ell extends to the building's rear (northern elevation). The ell is clad in original weatherboards and capped with cornerboards. Like the main body of the house, the gabled appendage features cornice returns and stands on a stone-piered foundation later filled in with stone. Paired two-over-two light sash windows are centered on the ell's northern and western elevations. A later-built hipped-roof porch (currently undergoing repair) extends from the northern elevation and connects to both the main body of the house and the rear ell (Figure 50 and Figure 51).

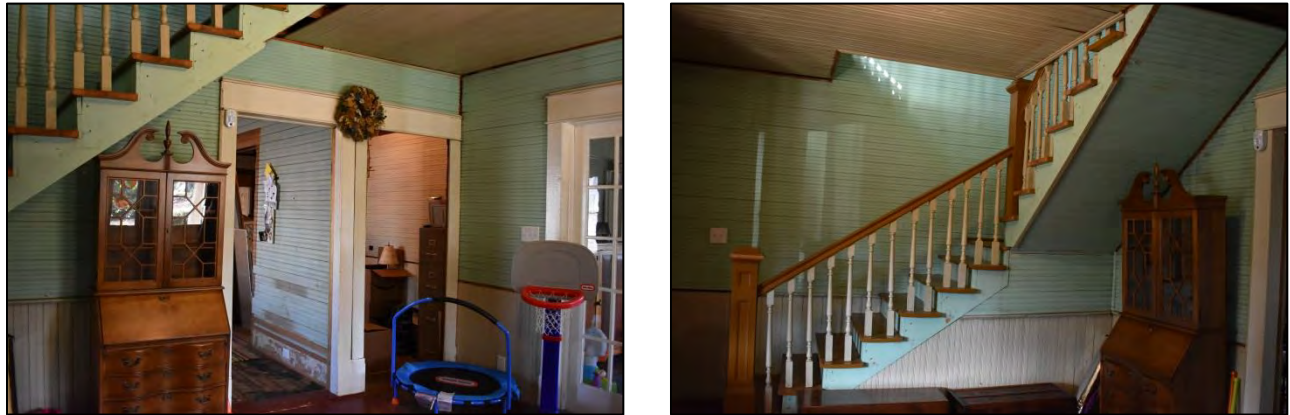
Figure 52: Left, view of front entryway; right, view of staircase (located on west wall of entryway)

Near complete access to the interior of the John Arnold House, provided by the homeowner, revealed an exceptional amount of original material and a high degree of integrity. All of the house's rooms retain their original beadboard walls and ceilings, hardwood floors, doors of six stacked panels with their hardware, and minimal Colonial Revival-style surrounds intact. A staircase with original spindles and boxy newel posts is located in the reception hall. Little of the original interior finish has been lost (Figure 52).

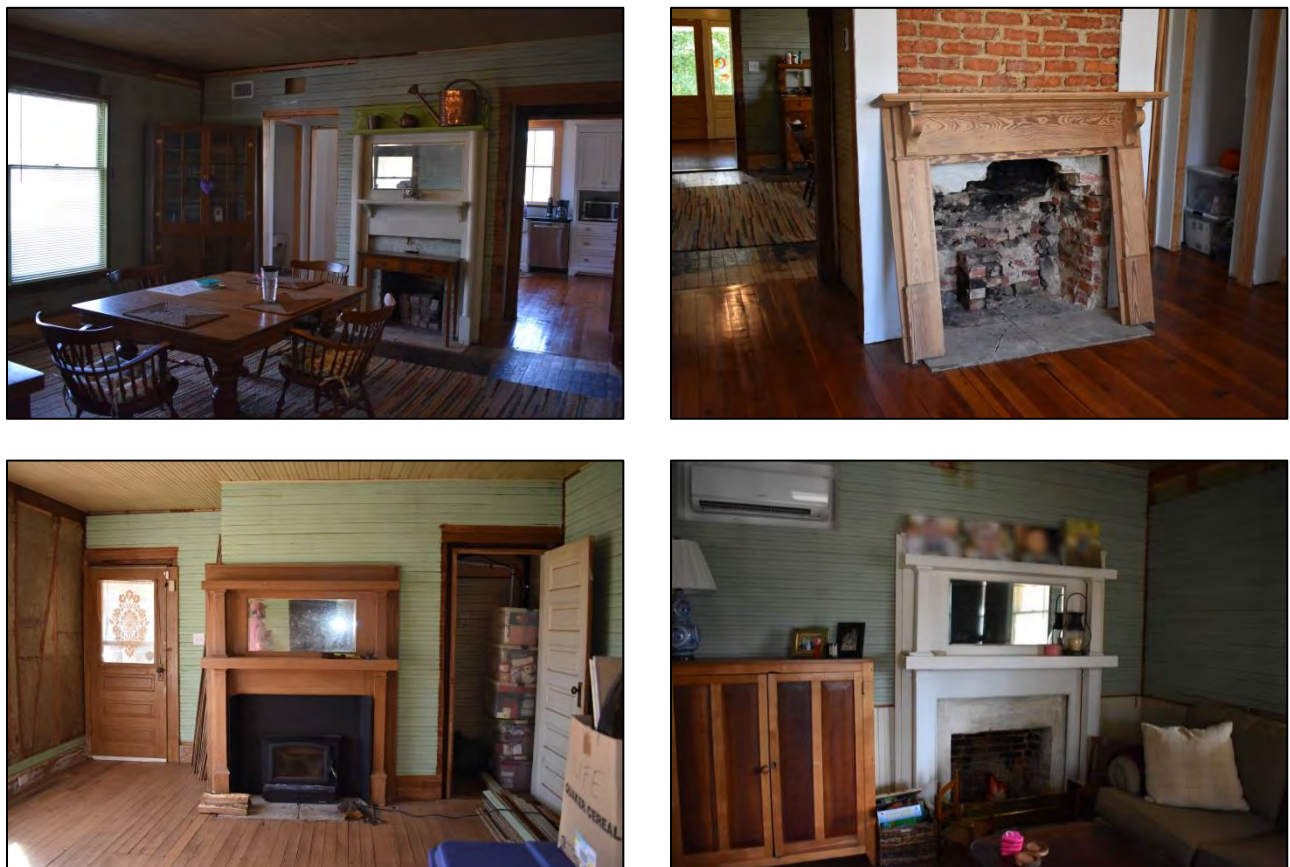
Figure 53. Clockwise from upper left, mantels in dining room, kitchen, front parlor, and rear parlor

In addition to floors, walls, and ceilings, original mantels continue to serve the rooms in the main body of the house. Three of the first-floor mantels have square or rounded columns that extend above the hearth shelf to embrace mirrored overmantels. A more basic post-and-lintel mantel that has been stripped down to its pine surface currently leans against a hearth in the kitchen (Figure 53).

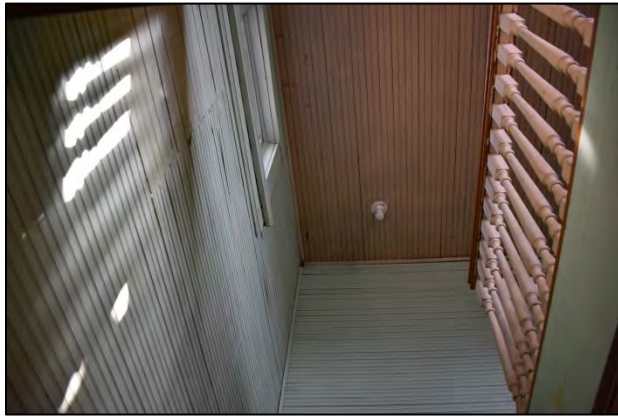
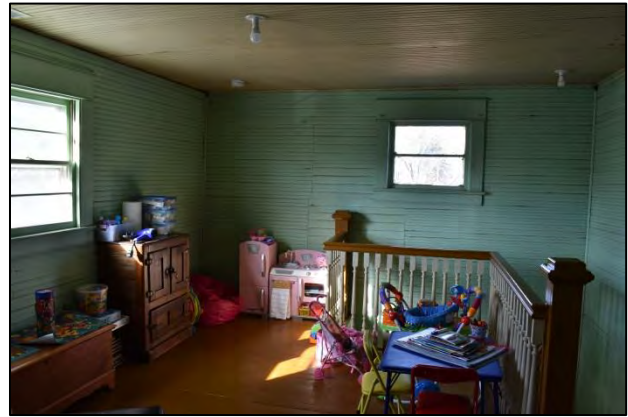
Figure 54: Stairs and beadboard looking up from first floor and from within upstairs hall

The second floor, too, retains original floors, walls, doors with surrounds, and a mantel (Figure 54 and Figure 55). Even the unfinished attic is intact. The roof was apparently always kept watertight, for the common rafters, other framing members, and roof boards remain in excellent condition (Figure 56).

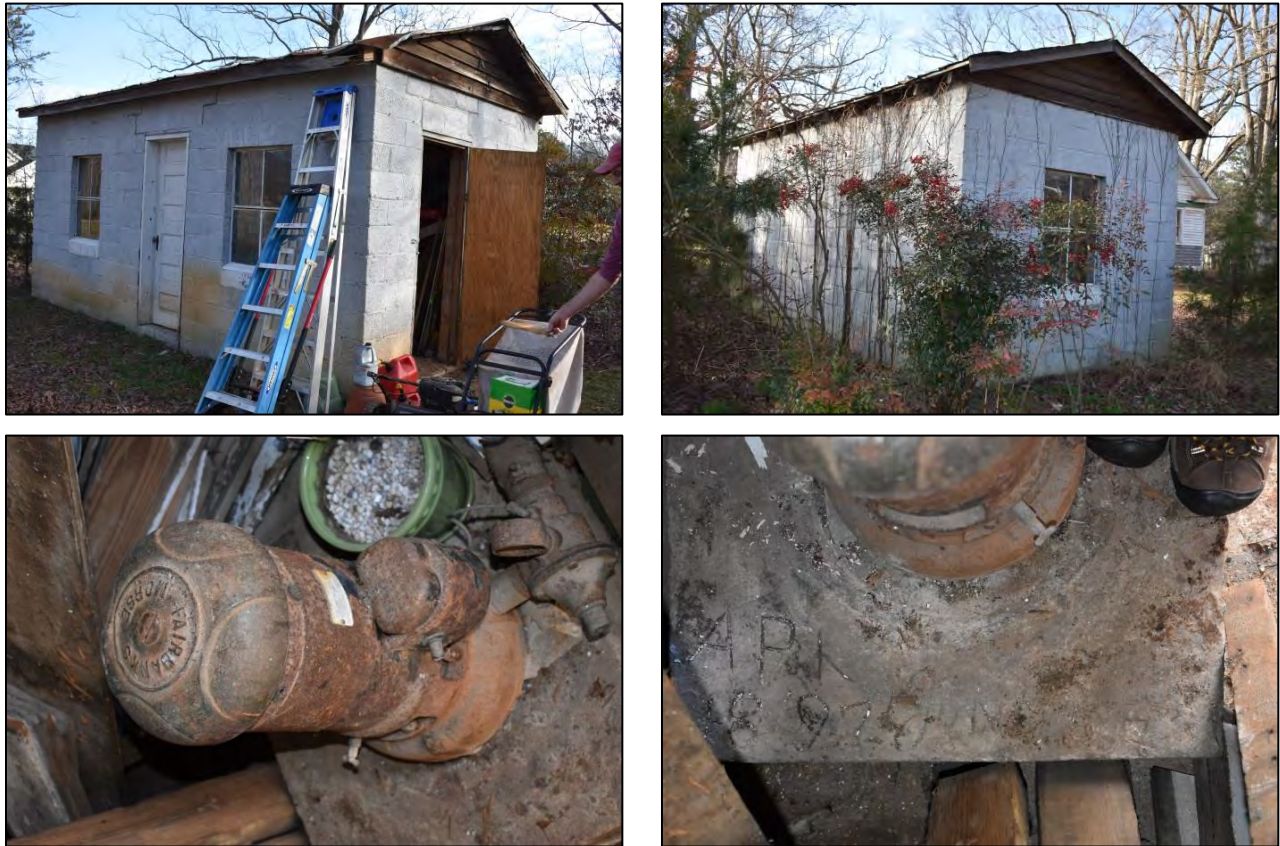
Figure 57: At top, concrete-block body of shed; at bottom, Fairbanks-Morse light plant or well pump fixture standing upon and 1897-dated concrete

The three-bay, side-gabled, concrete-block shed is oriented to the west and capped with a standing seam metal roof (Figure 57). A centrally placed six-panel door is found on the façade and framed on either side by two-over-two hinged windows. The body of the building likely dates from the mid-twentieth century. It may, however, stand on the site of, and have been built to replace, the building

that held the “light plant” and perhaps, additionally, a well. A concrete pad in the building has the date “1897” scratched into it and three initials, the first two of which are “A” and “P”; the last initial is perhaps an incomplete “K.” Atop the pad is equipment manufactured by the Fairbanks Morse company. The company produced, among other mechanical equipment, well pumps and light plants. A plat map depicts a light plant on or near this site in 1933 (see detail at Figure 58, below).

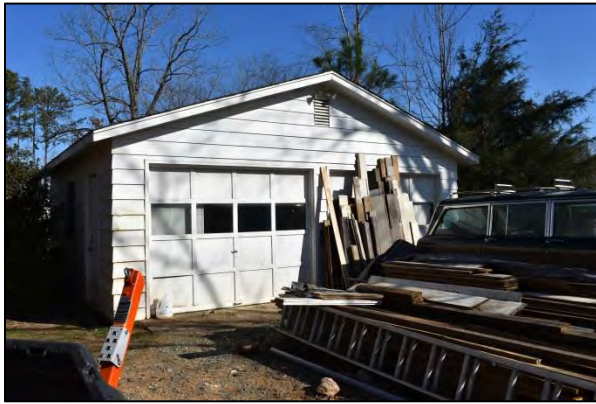
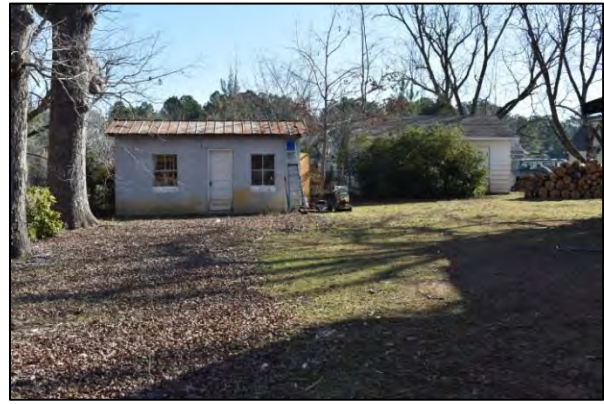
Figure 58: Modern garage between house and shed

A two-bay frame garage to the east of the house likely dates to the late twentieth century. The front-gabled building is clad in vinyl siding and has two four-light wooden garage doors. A six-paneled door is located on its western elevation (Figure 58).

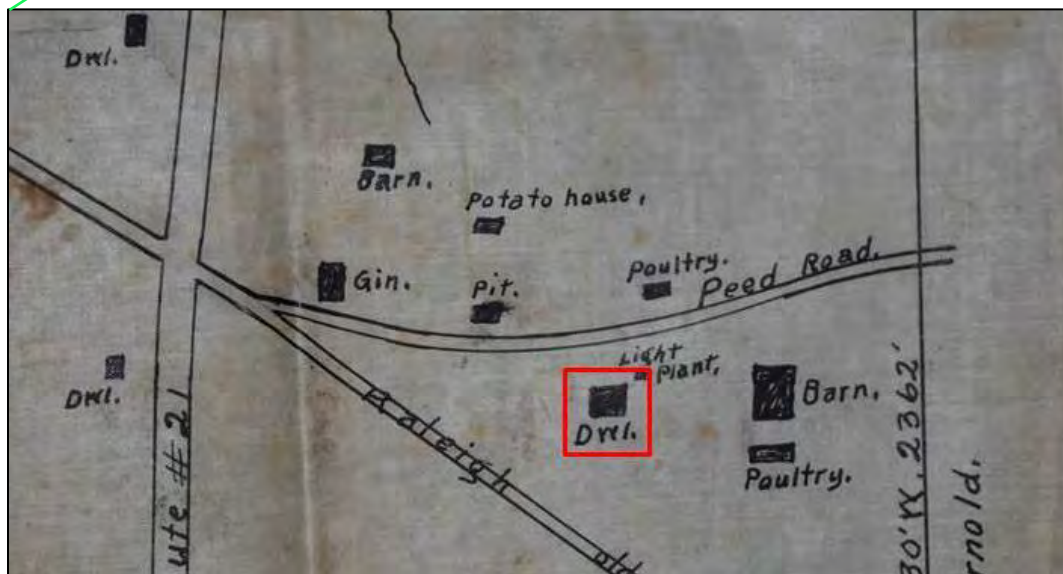
Figure 59: 1933 plat of property (courtesy of homeowner, Jason Allen)

John H. was apparently up to the challenge, for a 1933 plat of the property (likely drawn as result of the construction of the new Creedmoor Road) that survived in the Arnold House depicts a large and well-developed farm complex that had likely largely arisen through his efforts. It included two barns, two poultry houses, a cotton gin, and a potato house (Figure 59). Additionally, two dwellings on his

The 1933 plat also depicts two parcels of land owned by John H. Arnold in 1933. The Arnold House rests on the easternmost parcel and is surrounded by numerous farm structures, none of which remain standing today (although the concrete-block shell of the shed may stand on the site of the light plant). Lally's 1990 survey includes a photograph of three outbuildings, but no other information on them. What remained was torn down between 2010 and 2013 to make way for the construction of new houses (Slane 2017). As seen in the upper image, Arnold's eastern parcel was bisected north to south by the Raleigh Creedmoor Road/Route 21 (or current day NC 50). Mt. Vernon Church Road (labeled on the map as the Raleigh/Creedmoor Old Road) bisects the property east to west. Peed road also cuts through the eastern corner (Figure 59).

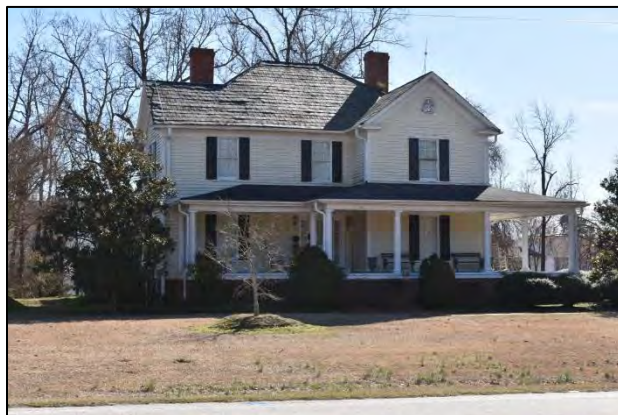
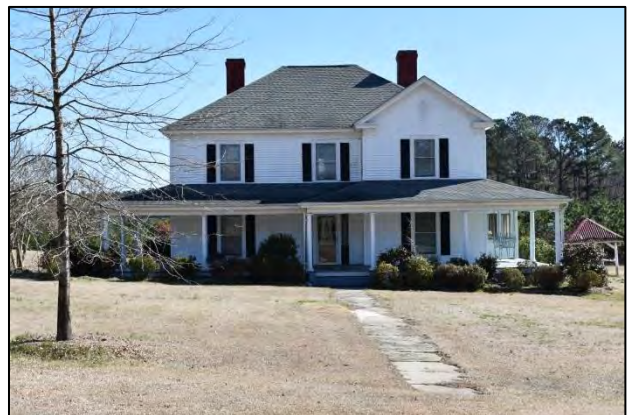
Figure 60: Rufus Merrimon Upchurch House (WA0773/7336) at left; Alious Mills House (WA1004) at right

The ca. 1896 Rufus Merrimon Upchurch House (WA0773 and WA7336) (Figure 60, left) sits at 1600 Jenks Carpenter Road in Cary. Likely once a farm seat with considerable land holdings, today the house is surrounded by encroaching modern subdivisions. Lally included the house within her county survey and described it as follows (Lally 1994:336):

Alious Mills built a store and house around 1916 in the crossroads community of Green Level... The two-story L-plan house on the lot adjacent to the store is situated in a grove of mature hardwood trees. The prominent dwelling is topped by a high hip roof and, like many houses of the same era, features interior brick chimneys, large one-over-one sash windows, and a wraparound porch with Doric supports. Beside and behind the house are several frame outbuildings; some are recent, but most are contemporary with the dwelling and store.

The overall footprint of the house appears to remain intact, however the building has lost its original windows and surrounds, and its weatherboards have been covered by vinyl. The house was determined ineligible for NRHP listing in 2013 (NC HPO web).

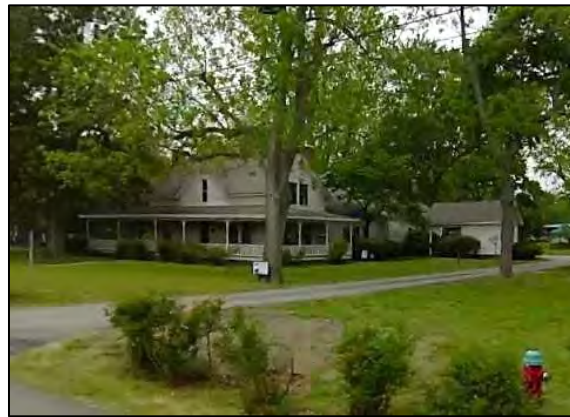
Figure 61: Henry H. and Bettie Knight Farm (WA0220)

The Henry H. and Bettie S. Knight Farm (WA0220) at 7045 Knightdale Boulevard in Knightdale was NR listed in 1987 under Criteria A and B for its association with the Knight Family which was responsible for the organization of the town of Knightdale (Figure 69). Although not singled out for its architecture, the property serves as “a good example of a twentieth-century farm complex with its Victorian triple-A-roofed farmhouse and tobacco farm outbuildings...” (Lally 1994:283). The resource’s nomination form provides the following description:

The Knight House has had a series of additions and alterations since it was constructed ca. 1890, most of which appear to have occurred early in its history. The front portion of the house is one and a half stories, with a cross-gable roof that has a central gable at the front... Behind this three-bay, single-pile section is a deep, full-width, hipped rear wing, at least parts of which may be a ca. 1900 addition. Ca. 1915, a semi-detached kitchen was moved from the northwest corner of the house and either this wing, or a new gable-roofed kitchen wing, attached to the northeast. An original rear porch was enclosed and a hipped-roof sleeping porch built over it.

Despite rapidly encroaching development, the house sits on almost 35 acres of land and retains a large number of the outbuildings depicted in the 1987 NRHP nomination form. Additionally, the house itself does not appear to have changed significantly.

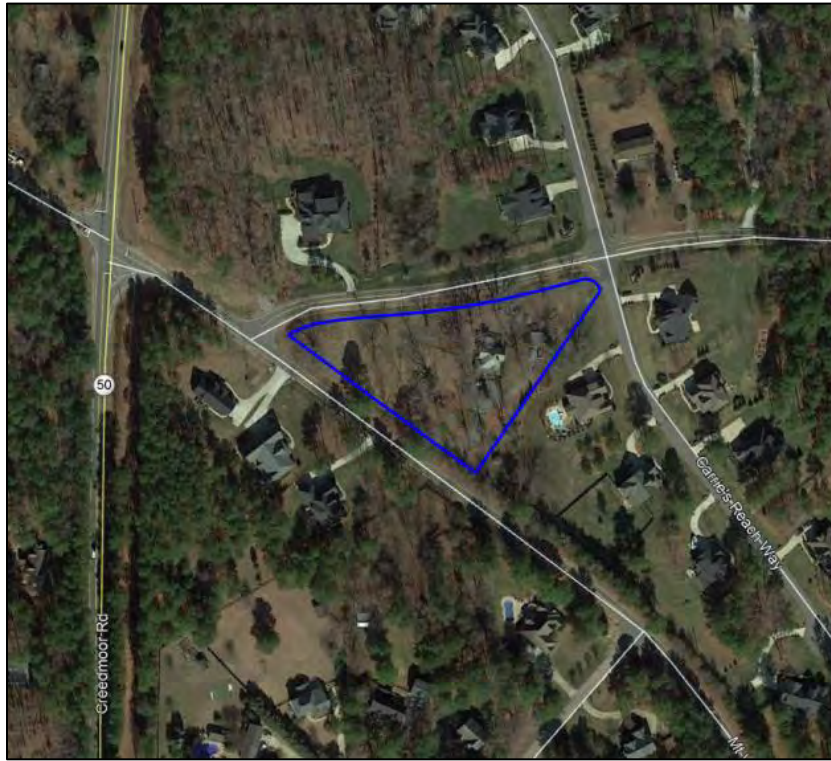
Figure 62: Proposed NRHP boundary for the John Arnold House (outlined in blue)

The recommended boundary of the John Arnold House is its entire 1.75-acre parcel (PIN #0890391364), which is historically associated with the house (Figure 62). This parcel contains the house, its contributing shed, and its noncontributing garage. The proposed boundary is believed to provide the John Arnold House with sufficient historic setting to support its significance. At its north and west, the boundary does not extend into the right-of-way of Peed or Mt. Vernon Church roads, but rather terminates at the interior edge of the NCDOT-maintained ditch dividing the property from the roads.

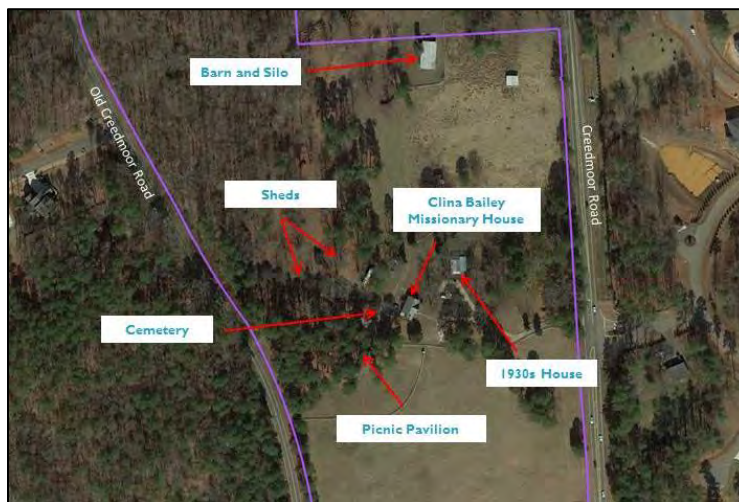
Figure 63: Site plan of Lassiter Farm

The Lassiter Farm is composed of a sprawling 69.69-acre rectangular parcel bounded on its east by NC 50/Creedmoor Road and to its west by Old Creedmoor Road. Open pasture bounds the parcel to the south and new growth woods borders to the north. A 1950s masonry cottage sits near the center of the lot and likely served as the farm seat for the mid-twentieth-century farm complex. To the northeast of the cottage sits a single-story frame house, likely a tenant house or earlier residence. Surrounding the two residential structures is an assortment of mid/late-twentieth-century ancillary buildings which include a farm barn and silo, numerous small sheds, and a modern picnic pavilion. A small family cemetery is located to the rear (west) of the cottage.

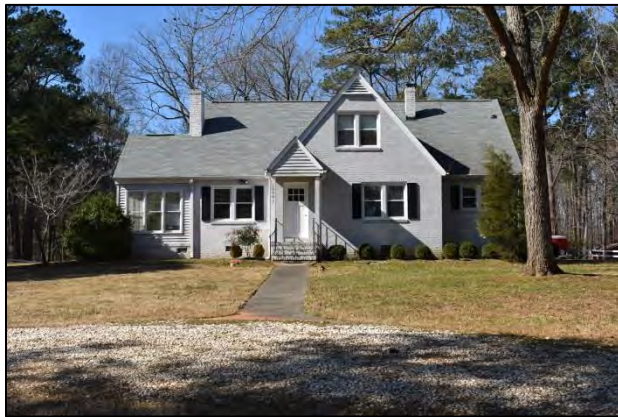
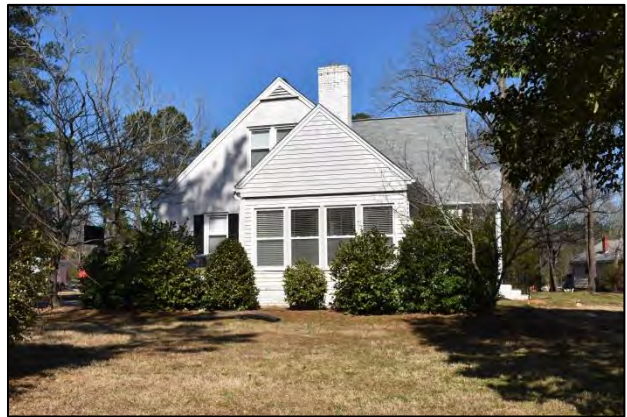
Figure 64: Left, view of front (eastern) elevation; right, view of southern elevation

The one-and-a-half story, side-gabled Clina Bailey Missionary House stands four bays wide and is clad in brick. A projecting two-bay front gable is centered on the building's façade and holds a replacement six-light-over-two-panel door. The door rests underneath a single-bay pedimented porch supported by wooden posts. Two interior brick chimney stacks rise from the building's roof and appear original (Figure 64). A former single-bay porch extends from the building's southern elevation and has been enclosed and clad with vinyl siding. Bands of one-over-one sash are found on the elevations of this enclosed porch. At the house's rear, on the northeast corner, a recessed porch has also been enclosed and clad in vinyl (Slane, 2017) (Figure 65). All of the building's windows are replacements. Although multiple site visits were made, interior access was not available.

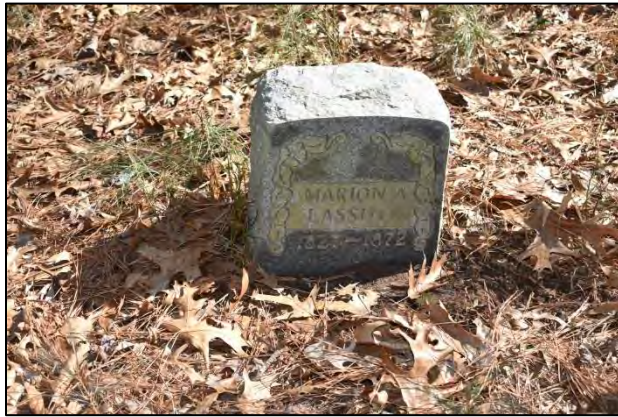
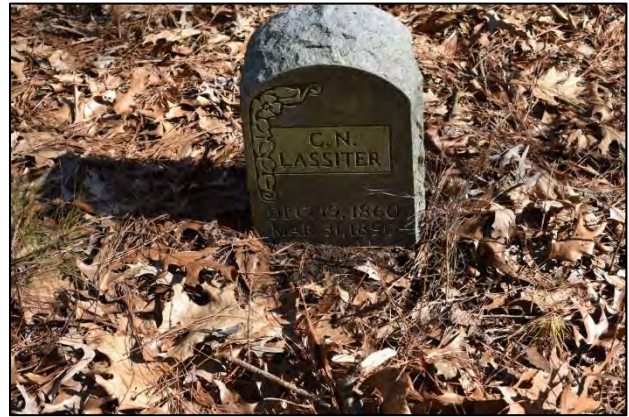
Figure 66: Images of Lassiter Family headstones found in small family cemetery to rear (west) of house

The small family cemetery lies to the rear (west) of the Bailey House, according to Slane, consists of at least nine graves (Slane 2017). At the time of the most recent site visit, many of the gravemarkers were enveloped by vegetation and only three were visible. These small engraved granite markers displayed the following names: C.N. Lassiter 1890, Marion Lassiter, 1872, and L.A.L. Son of Marion and Margaret Lassiter (Slane, 2017).

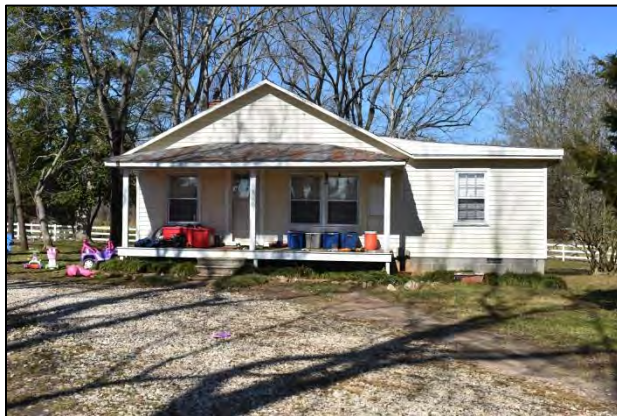
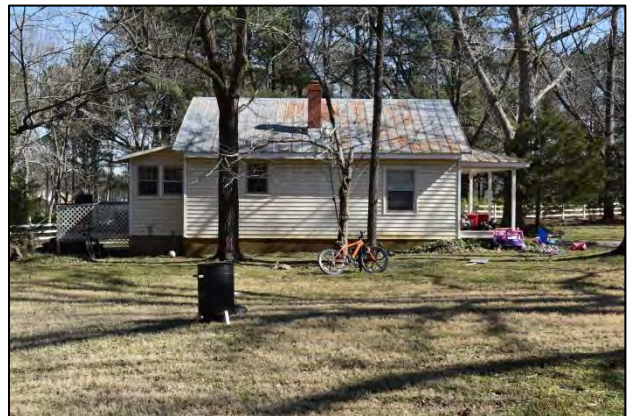
Figure 67: Left, view of front (southern) elevation; right, view of western elevation

Situated to the northeast of the Bailey House, the frame minimally Craftsman-style residence stands one story tall and is clad in vinyl siding. The building is comprised of an original three-bay wing with a single-bay shed roof wing extending off its eastern elevation. A two-bay hipped roof porch embraces the building's façade. Beneath the porch, a six-over-two-panel door is centered between replacement windows. A small interior brick chimney stack rises from the northwest corner of the roof and a three-bay, single-block, shed roof addition extends to the building's rear (Figure 67 and Figure 68).

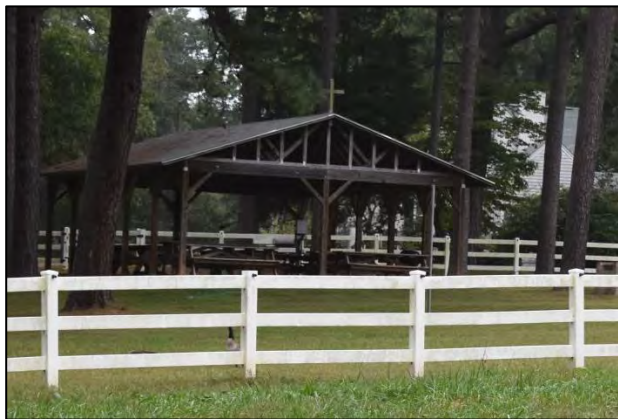
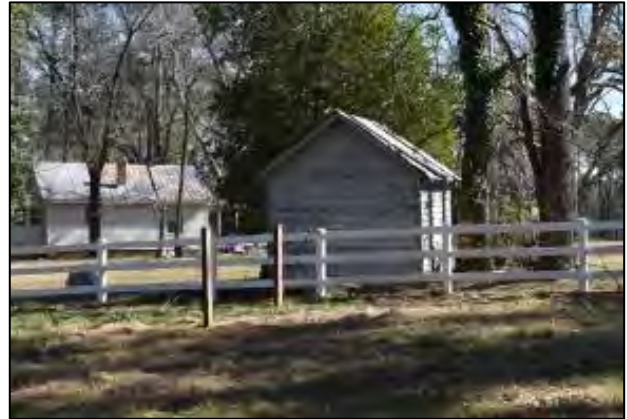
Figure 69: Left, view looking southwest toward picnic pavilion; right, view looking south toward frame shed

The small gable-roofed shed is of frame, clad in weatherboards, and topped with a standing seam metal roof. The building rests on a piered concrete foundation and likely dates to the 1930s (Slane, 2017).

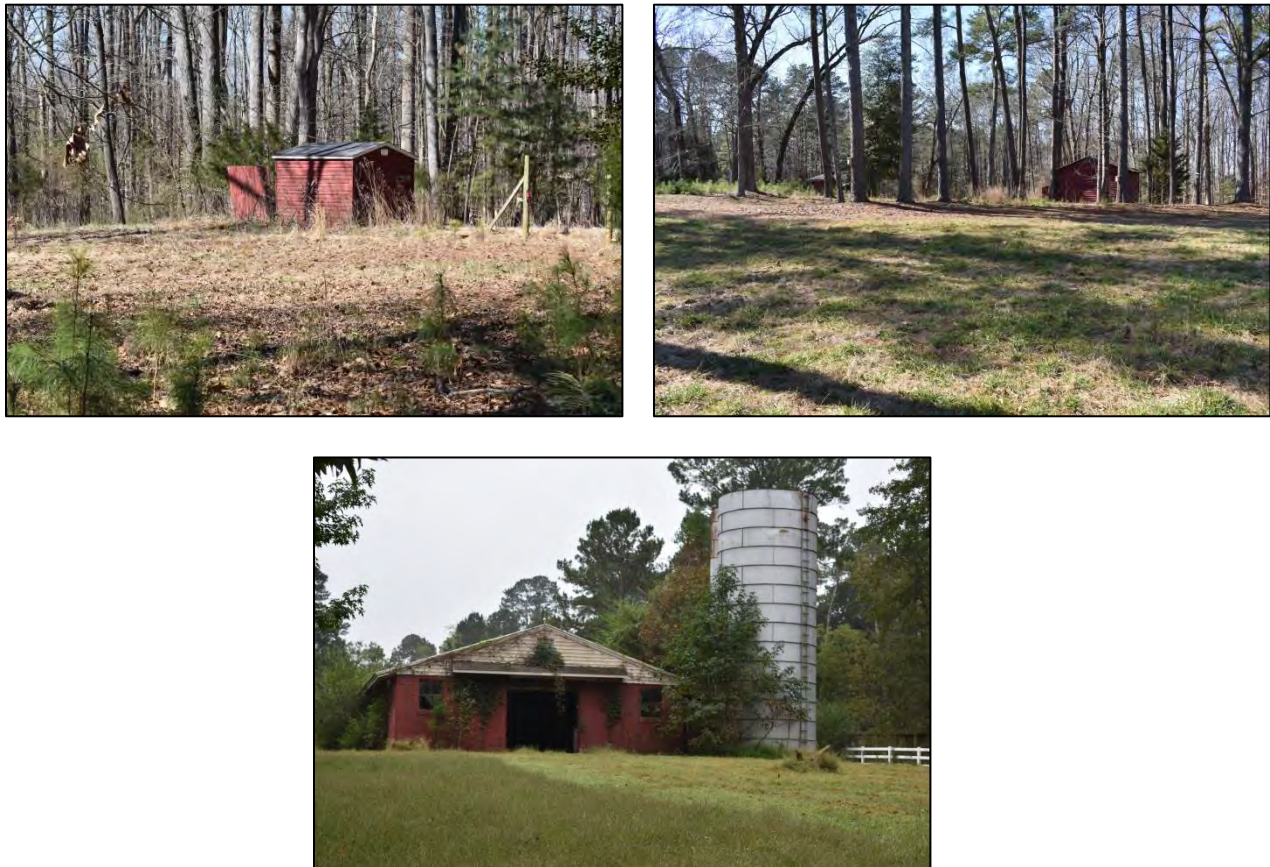
Figure 70: Top left and right, view looking north of sheds in woods; bottom center, view of barn and silo

The mid-twentieth-century barn is located approximately one-tenth of a mile to the north of the Bailey House. The front-gabled building is built of concrete block and vinyl siding fills its gables. A center passage is flanked on either side by two-over-two-light hinged windows. Standing off the barn's northwest corner is a silo which is clad in metal.

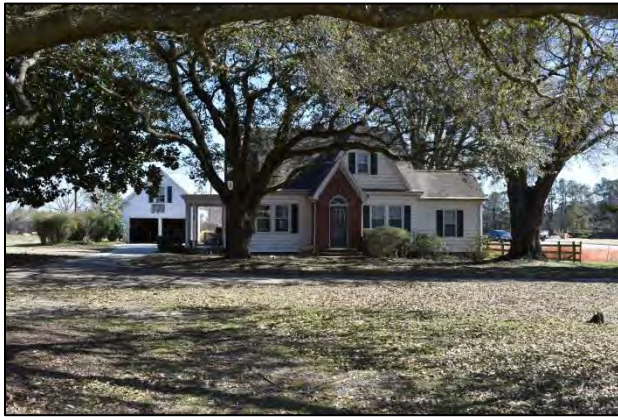
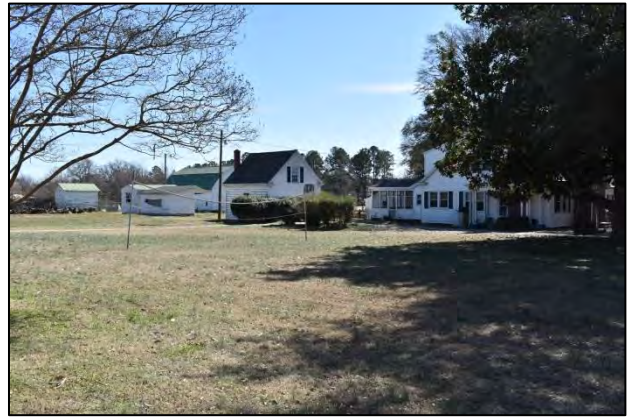
Figure 71: Above, the Booth Farm (WA7509) at 1490 N. Salem Street

The ca. 1946 Booth Farm (WA7509) (Figure 71) is situated at 1490 N. Salem Street on a 1.5- acre lot just outside of Apex. The one-and-a-half story side-gabled Period Cottage is clad in replacement vinyl siding and displays replacement vinyl windows and surrounds. The building retains its original brick front-facing gabled entrance which is centered on the façade. An original paneled door is topped with a fanlight transom. While the house has lost a significant amount of its original land, it retains a number of outbuildings including a gambrel roof barn and numerous early sheds/smaller barns.

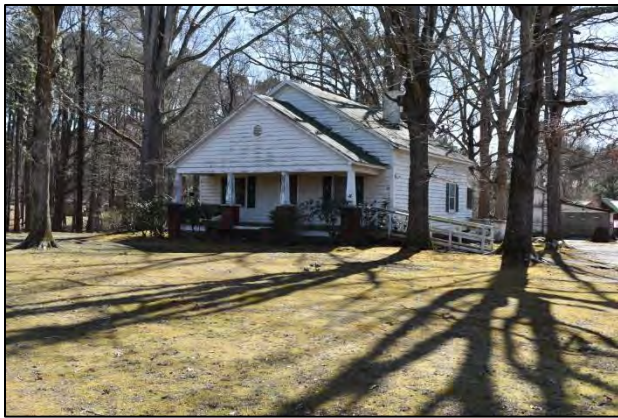
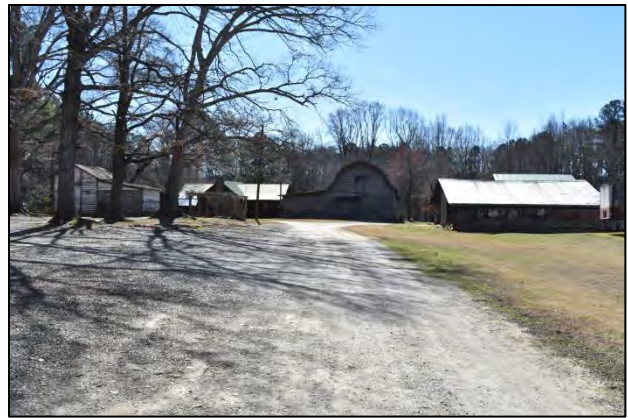
Figure 72: Above, farm at 3724 Ten Ten Road (WA6412)

Located at 3724 Ten Ten Road Road in Apex, the property labeled simply as “Farm” (WA6412) (Figure 72) was built ca. 1945 according to NCHPO records. A single-story, front-gabled, frame residence fronts the property and is clad in original weatherboards and also retains original cornerboards. A three-bay pedimented front porch embraces the façade and is supported by battered wooden columns sitting atop brick piers in the Craftsman style. The house also appears to retain original three-over-one sash windows. Situated to the rear of the house is an assortment of mid-twentieth-century farm buildings including multiple frame sheds and a gambrel-roof barn. A modern log house sits to the rear of this farm complex.

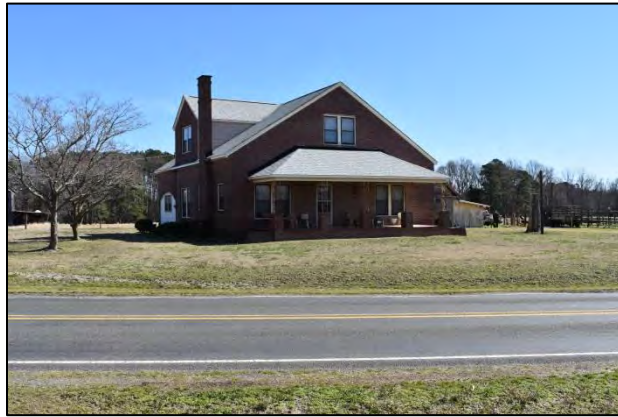
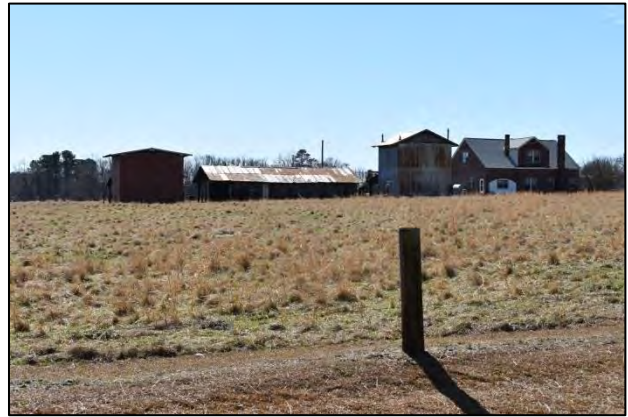
Figure 73: Above, farm complex at 7453 Kennebec Road (WA4829)

The Farm Complex (WA4829) (Figure 73) sits right on Kennebec Road at number 7453 in Willow Spring. According to the NCHPO, the house was constructed ca. 1950 and it still operates as an active farm today. A single-story, side-gabled, brick house serves as the farm’s seat. Gabled dormers are perched on either roof slope and an exterior brick chimney stack is attached to its northern elevation. The house retains six-over-six sash windows with original surrounds, and an enclosed carport extends from its northern elevation. The house is accompanied by mid-twentieth-century farm buildings including a large frame barn and a number of supporting sheds and other frame buildings.
