SUBJECT: Historic Structures Survey Report, R-5809, Improve NC 45 from Washington County Line to South of Colerain, PA 18-01-0055, Bertie County, ER 19-1576

MdM Historical Consultants (MdM) prepared this report in December 2018 and April 2019 in support of the proposed improvements to NC 45 from the Washington County line to south of Colerain in Bertie County, North Carolina (TIP# R-5809). The project lies in eastern rural Bertie County just west of the Chowan River. The Area of Potential Effects (APE), the geographic area or areas within which an undertaking may directly or indirectly cause changes in the character or use of historic properties, extends approximately 250 feet in each direction off the center line of the highway. The APE for the project is delineated on a series of maps on pages 9 to 13 of this report.

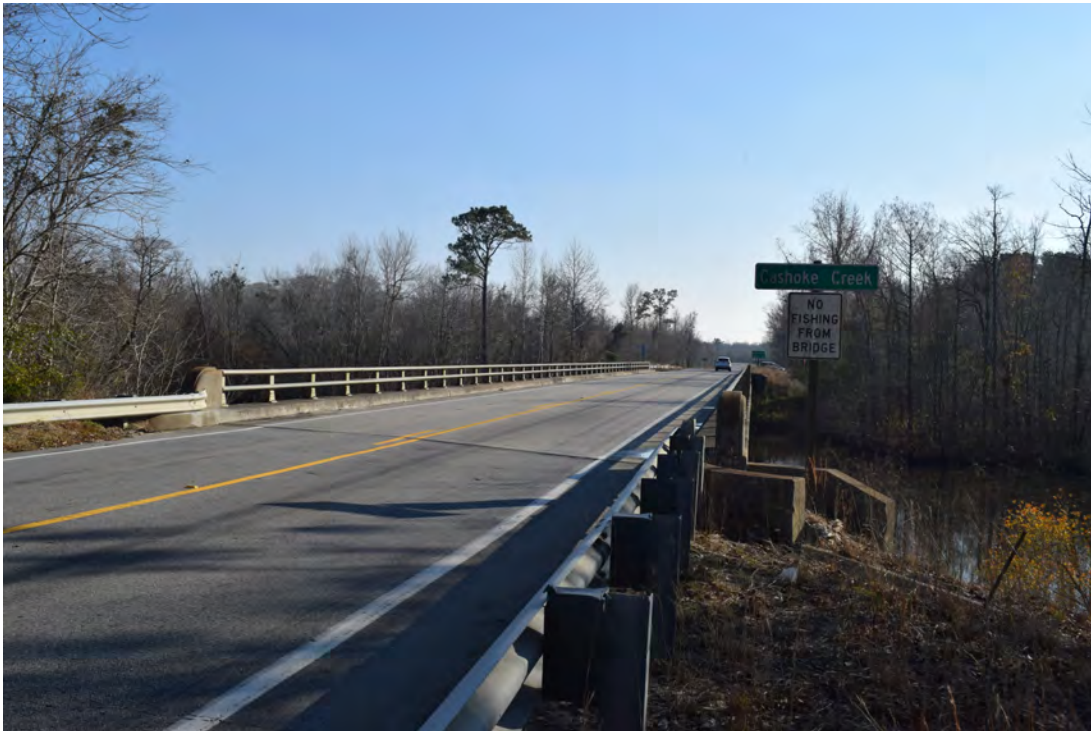
Bridge over Cashoke Creek built in 1967 near the south end of the project area, view to the south

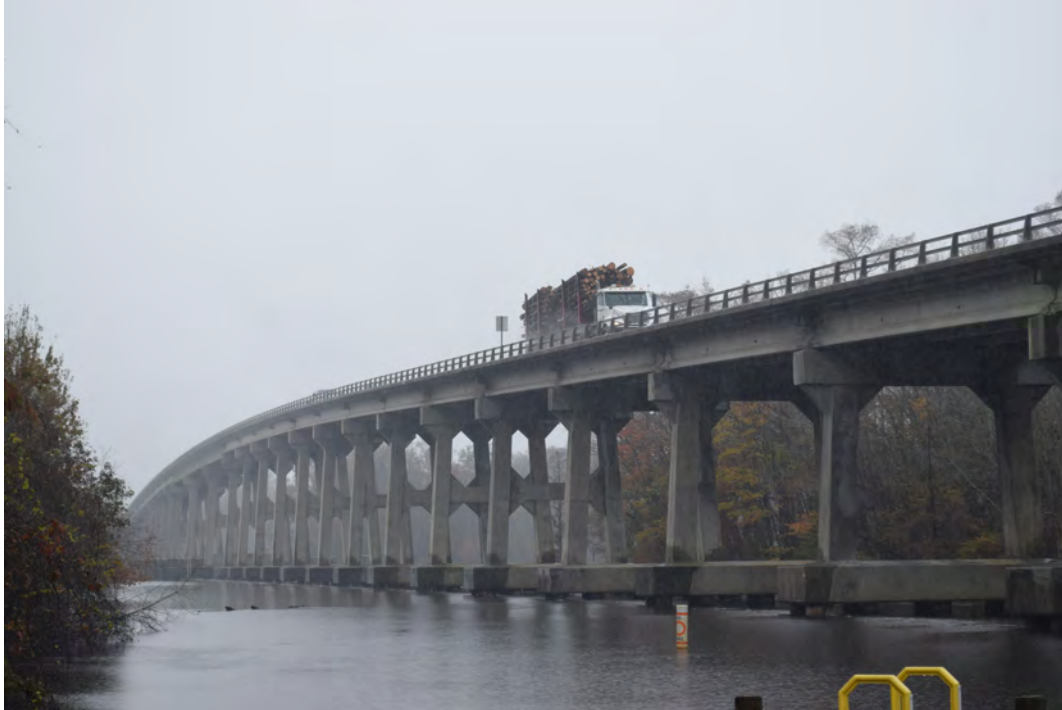
Bridge over the Roanoke River at the south end of the APE, view the northeast

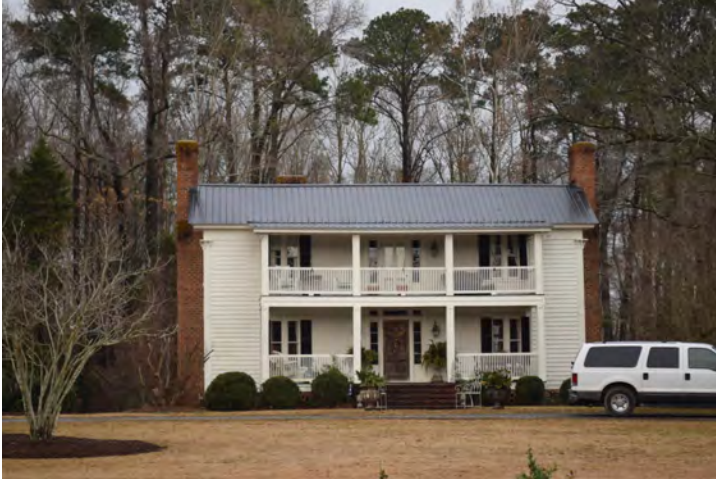
An example of the early shift in styles is the 1871 Abram Burden House (BR0023), an Italianate house with some vestigial Greek Revival elements. The house has notable bracketed pilastered cornerboards ornamented with diamond appliques as well as decorative bargeboards and raking cornices. Greek Revival style is present in the symmetry of the side-gabled two-story dwelling as

The Italianate-style Albert Burden House (BR0023), view to the south

well as at some interior mantels. Similar pilastered cornerboards appeared at other rural Bertie County houses and reflect a local building tradition, perhaps one influenced by pattern books. The Italianate style persisted into the 1890s, appearing in rural areas and in towns.¹

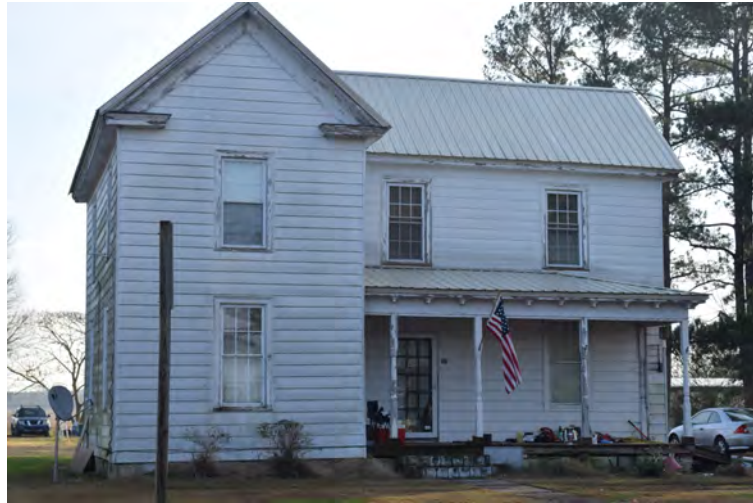
Houses originally built in a gable-front-and-wing form were popular at the turn of the twentieth century, commonly with gable end returns and boxed eaves. A number of examples remain. In Colerain stands a ca. 1890 house (BR0666) that also includes a bracketed eave at a front porch that spans the width of the façade wing. Turned porch posts and an interior chimney remain, but the windows have been replaced and the house sided in aluminum. Another example, the ca. 1890 Scott White House (BR0783) near Askewville, has an exterior end chimney at the gable wall at the southwest side elevation. Sidelights with carved panels flank the front entry, but windows have been replaced and aluminum siding applied. Original porch posts were replaced with Craftsman-style battered wood post

Vernacular Queen Anne-style house (BR0666) in Colerain, view to the east

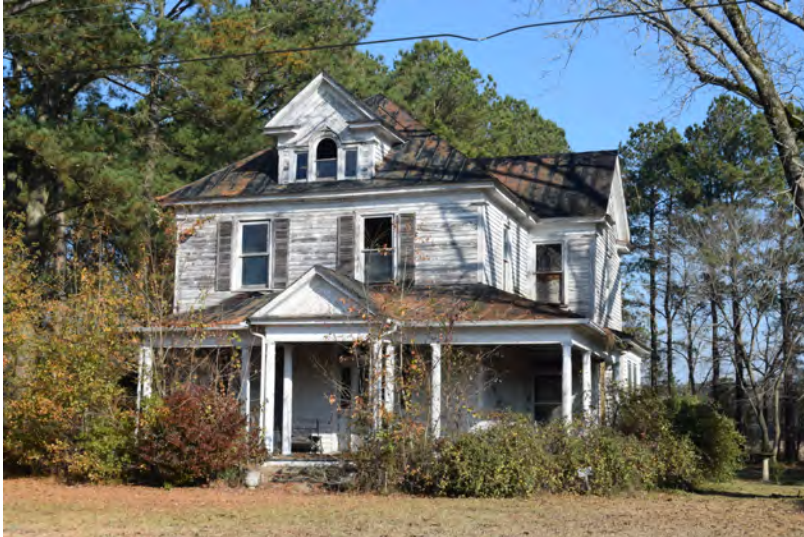
(BR0813) at 206 W. Main Street in Powellsville. The house has a main two-story pyramidal block with a substantial projecting two-story gabled bay at the rear. Both the gable at the bay and the gabled dormer on the front roof slope have boxed cornices and end returns; the main roof also has a

J.E.R. Perry House (BR0813) in Powellsville, view to the northwest

boxed cornice. The single-story wraparound porch has a gabled entry portico. This gable and that in the dormer have diagonal flush-board sheathing; the rest of the house is covered with weatherboards. Windows are one-over-one sash. The ca. 1918 two-story dwelling at 253 Old Merry Hill Road has a pyramidal roof over the first story and a substantial gabled dormer in the front roof slope to shelter a full second story with paired windows under a gable with end returns and a boxed cornice. Original two-over-two windows and

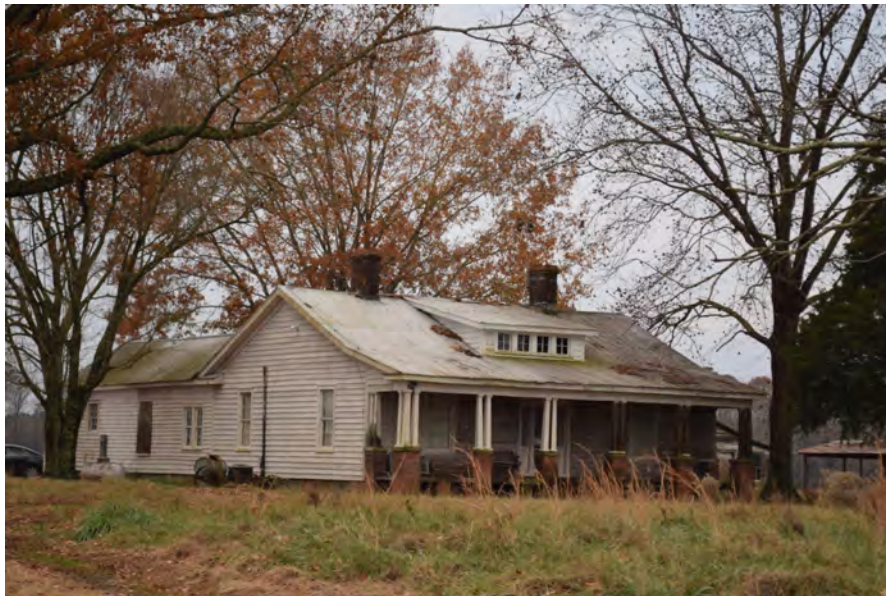
Wadsworth Farm (BR1216) bungalow, view to the southwest

The circa 1920 weatherboard bungalow on the Wadsworth Farm (BR1216) at 143 Indian Woods Road south of Lewiston is a one story side-gabled house with intact shed dormer, six-over-six windows and full-width porch with pairs and trios of slender battered porch posts on brick piers. The one-and-a-half-story, side-gabled Butterton-Phelps House (BR0541) at 326 Sutton Road near Merry Hill retains its original windows but has been sheathed in aluminum siding. A particularly intact

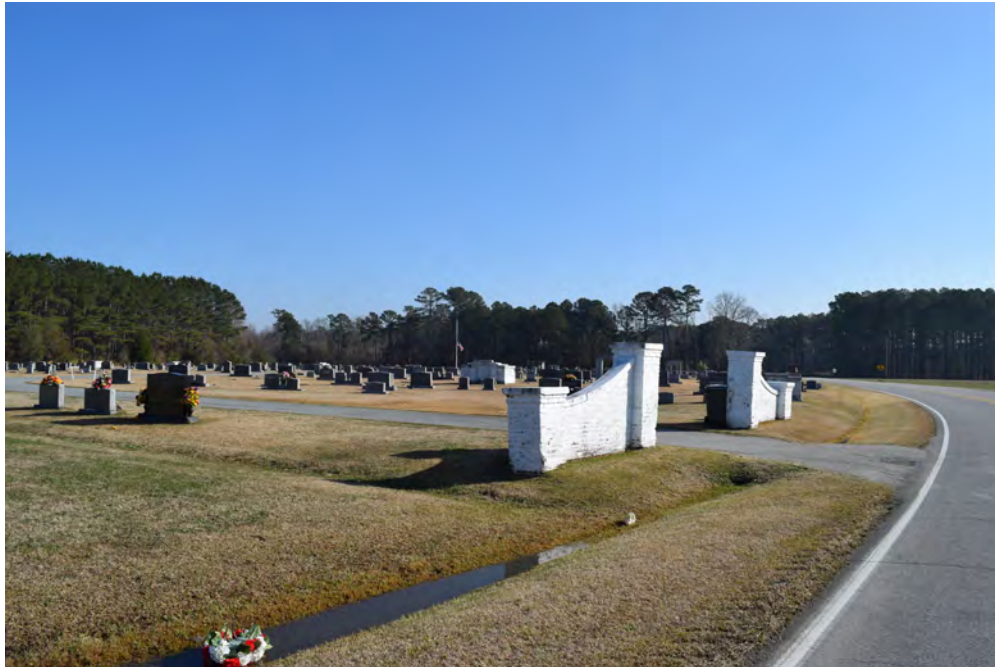
Eastview Cemetery in Aulander is a roughly 8-1/2-acre municipal cemetery on a relatively flat

Eastview Cemetery in Aulander, view to the east

parcel north of Brick Mill Road. Entry gate posts of brick flank an asphalt-paved lane that extends to the back of the cemetery parcel and returns to the roadway in a squared U shape. Another lane enters from the roadway, extends halfway toward the back of the cemetery, then turns east to intersect with the first lane, outlining rounded squares and rectangles for access to grave

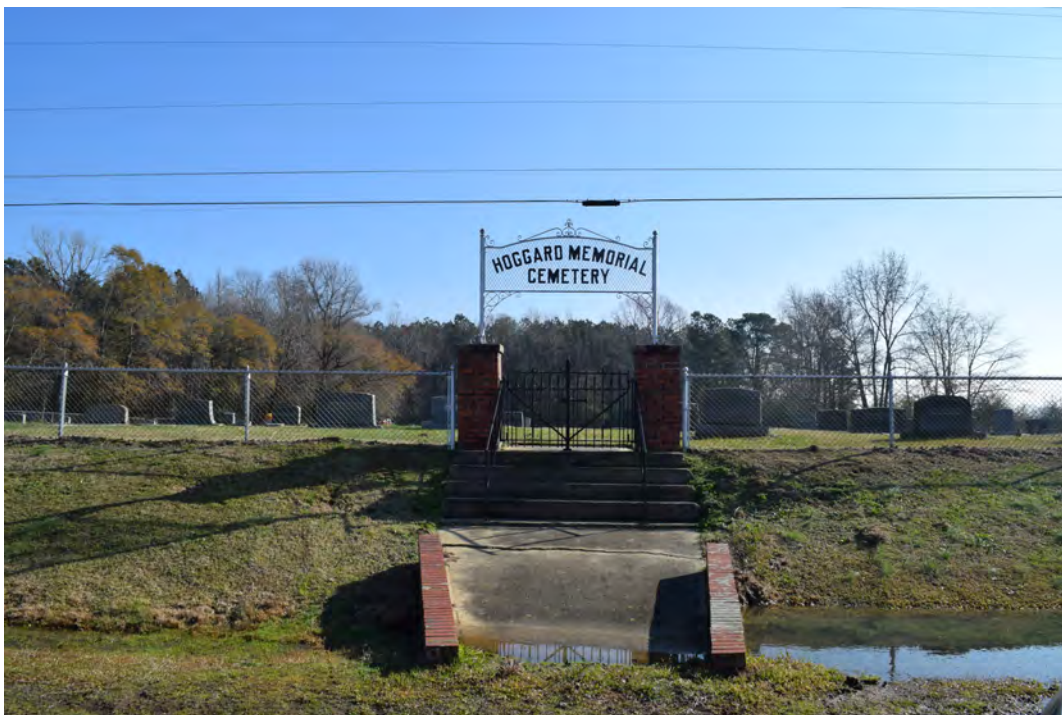
Hoggard Memorial Cemetery occupies about three acres on the east of NC Highway 11 north of Lewiston. The land was deeded to the Town of Lewiston in two parts—first in 1941 with an added section in 1969. The pedestrian entrance has simple squared brick gate posts at a concrete stair with an iron gate and mesh metal sign on tall metal gateposts. The cemetery’s name is spelled out in simple black letters against the diamond-pattern metal mesh. A lane exits the highway and circles around the perimeter of the polygonal parcel back to the roadway. Burials date to the early twentieth century; the cemetery appears to still be active for burials. Stones are typical of their periods: marble in the early twentieth century, and more standardized granite markers from the later twentieth century.¹²

Hoggard Cemetery entrance, view to the east

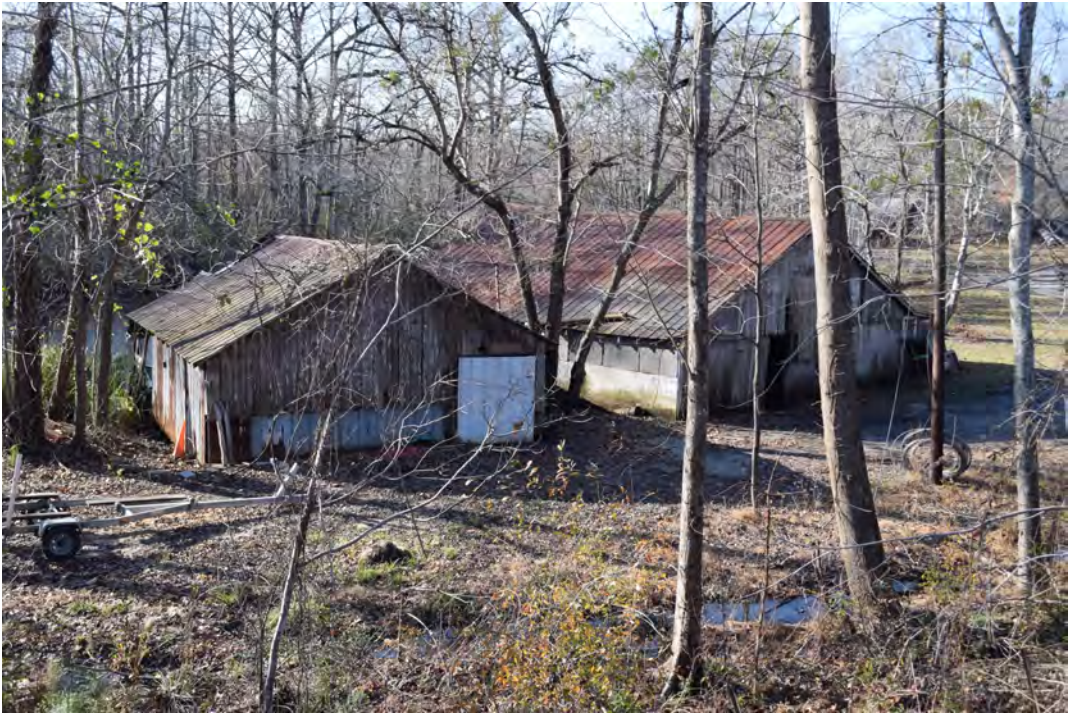
Guy Smith Fish House (left) and J.A. Layton Fish House (right) on Cashoke Creek, view to the west

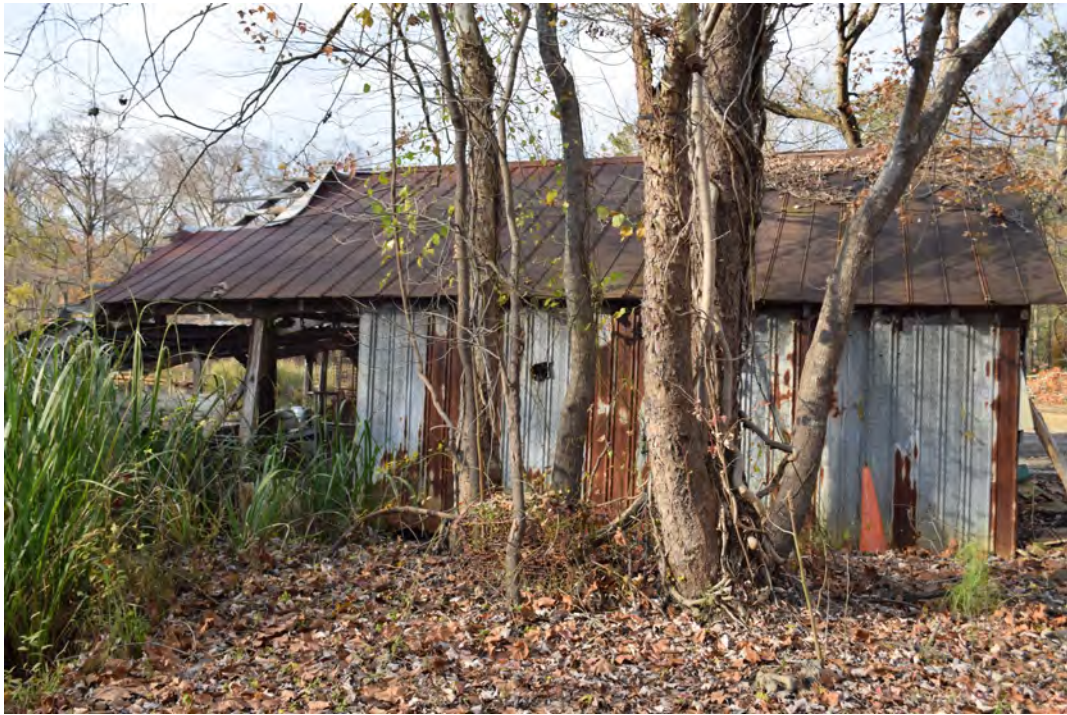
Guy Smith fish house, south elevation, view north-northwest

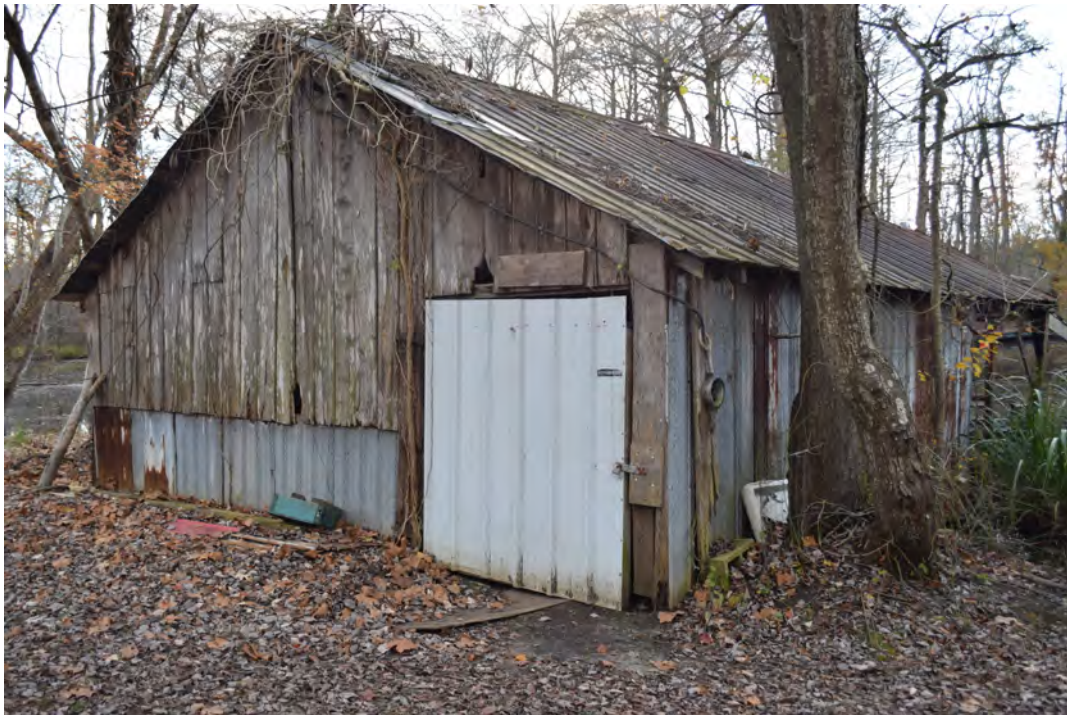
Guy Smith fish house, north corner, view south

The one-story, gable-roofed building is sided in vertical wood and corrugated metal. On the river side, the building is open so that boats can dock underneath the gable roof. The rest of the building is used for processing and selling fish. The interior was not accessible.

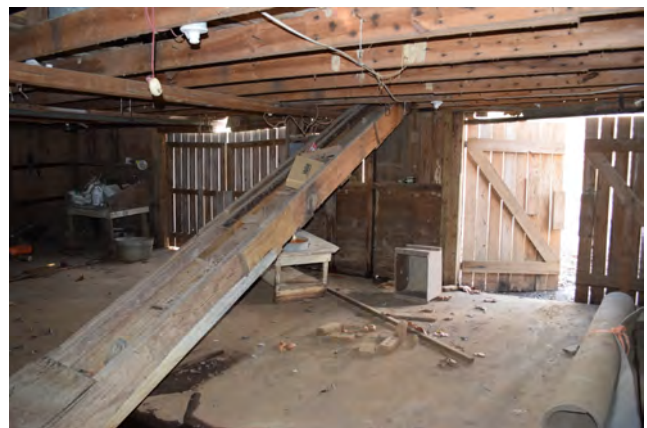
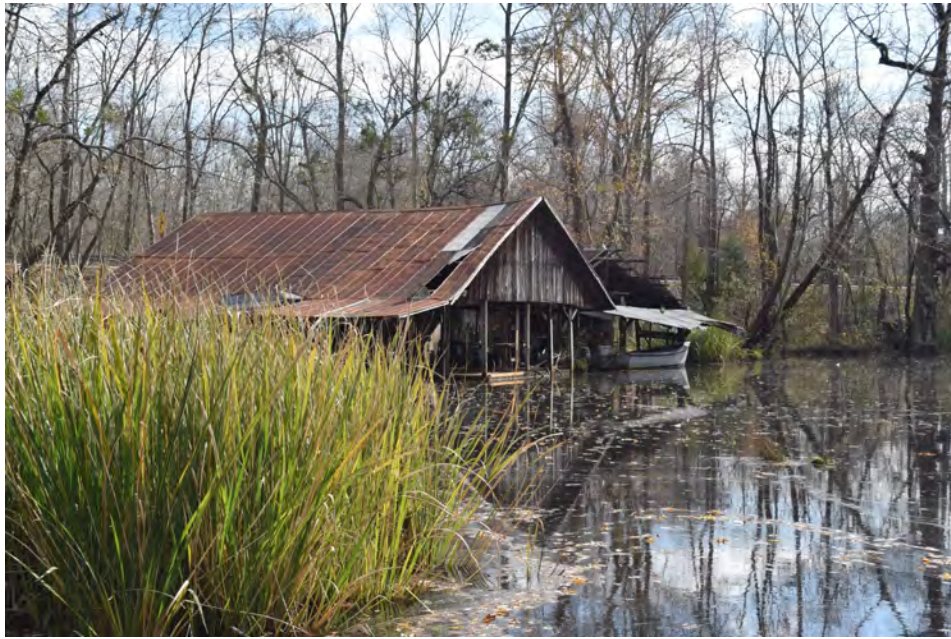
J. G. Layton Fish house
Circa 1940

J.G. Layton fish house, creekside docks beneath gable roof on left (view to the west); interior looking at front door (view to the east-northeast)

J.G. Layton fish house on Cashoke Creek, west side, view to the southeast

The one-story gable-roofed building is sided in vertical wood. On the river side, the building is open so that boats can dock underneath the gable roof. The fishermen used the chain remaining on the creek side of the building to haul fish into the upper loft. The interior still contains a wooden chute from the upper level through the main level floor to the water below where fish parts were discarded. The main level of the interior space was used for selling fish.

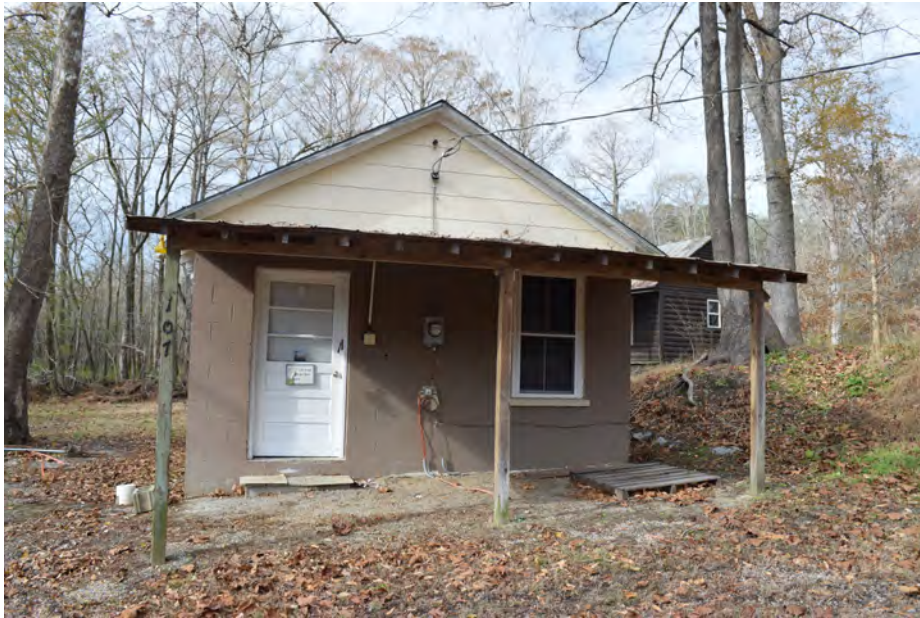
Dick Smithwick Store
Circa 1950

Dick Smithwick Store, view to the west

The circa 1950 concrete block store is a rectangular, front-gabled building with asbestos shingles in the front gable and a shed-roof porch with rafter tails sheltering a two-bay façade. The interior has been altered in order to convert the building to a hunting and fishing lodge. Richard (Dick) Smithwick (1911-1981) built the concrete block store around 1950. According to owner Ricky Hughes, the store served residents in this area of Bertie County before the construction of the bridge across the Roanoke River in 1967, which allowed easy access to Plymouth.

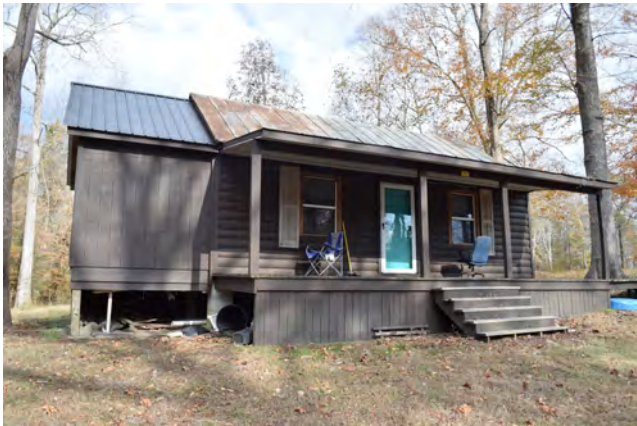
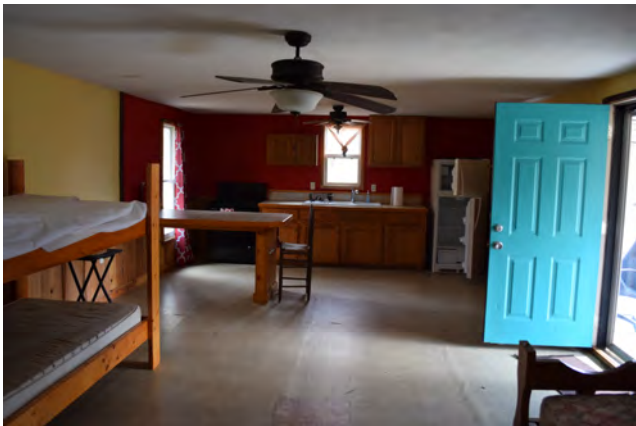
Former Kitchen
Circa 1880, 2015

Former kitchen, façade, on left (view to the north) and interior, on right (view to the east)

A side-gabled cabin just to the northwest of the store is sheathed with half-round log sheathing. The interior contains one large room and a bathroom on the west side. The building originally functioned as the kitchen for Eastbrook, the dwelling just to the north. The current owner moved the kitchen around 2000 and later added the log siding to the exterior.

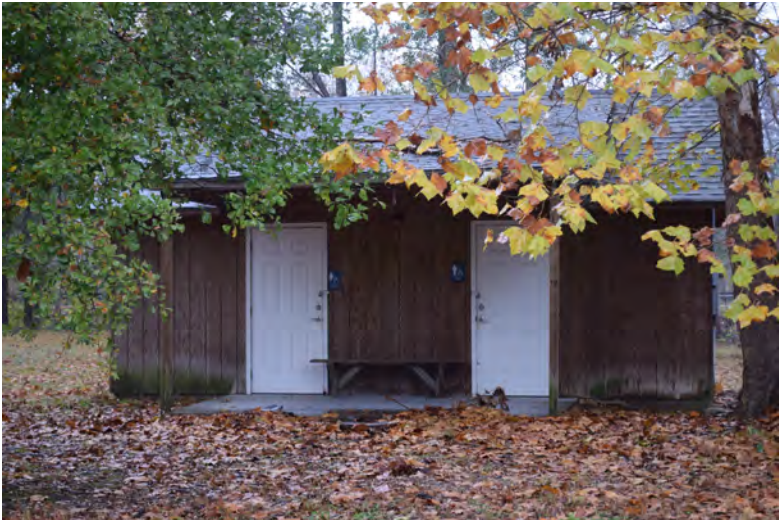
Bath House
Circa 2000

Bath House, view to the east

A modern bath house with vertical composite wood siding and a side gabled roof is on the east side of the complex.

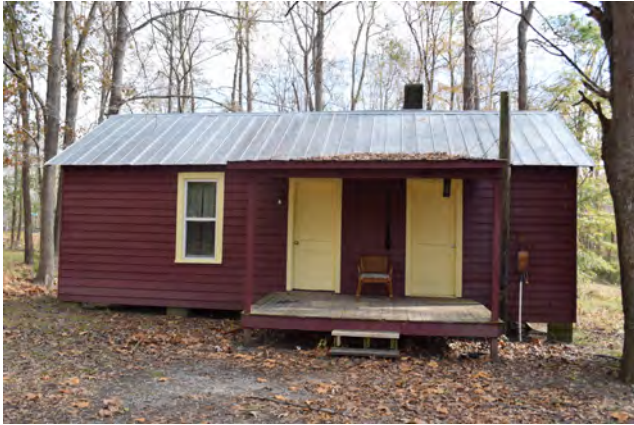
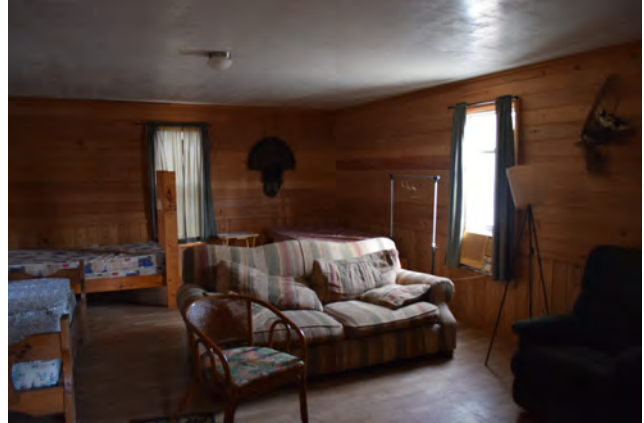
Hunting Cabin
Circa 1940

Hunting cabin facade, on left (view to the east); interior, on right (view to the northeast)

Just to the south of the bathhouse stands the side-gabled, weatherboard cabin with a standing-seam metal roof. A shed-roofed porch shelters its two front doors. Some of the siding has been replaced. The interior has modern sheathing on the walls, floors, and ceiling.

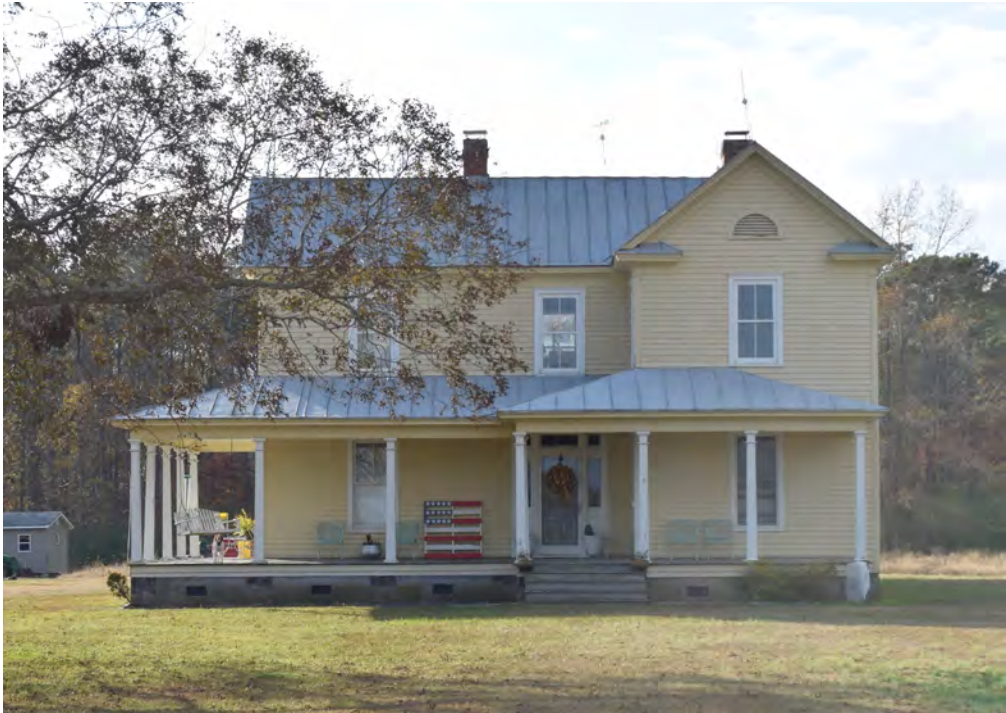
Façade, view to the west

A standing seam metal roof covers the intact dwelling. The interior follows a central-passage plan and contains a grand staircase. The main block remains mostly intact with original woodwork, doors, and mantels. New wallboard has replaced the original plaster. The ell has been substantially renovated and an exterior porch along its south elevation incorporated into the interior.

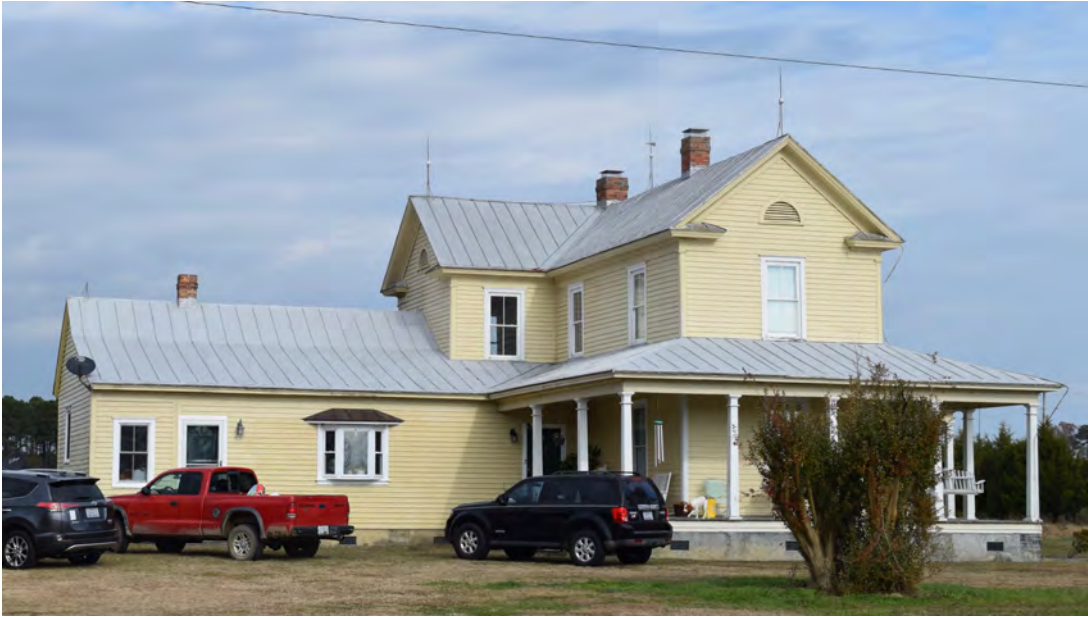
South elevation, view to the north

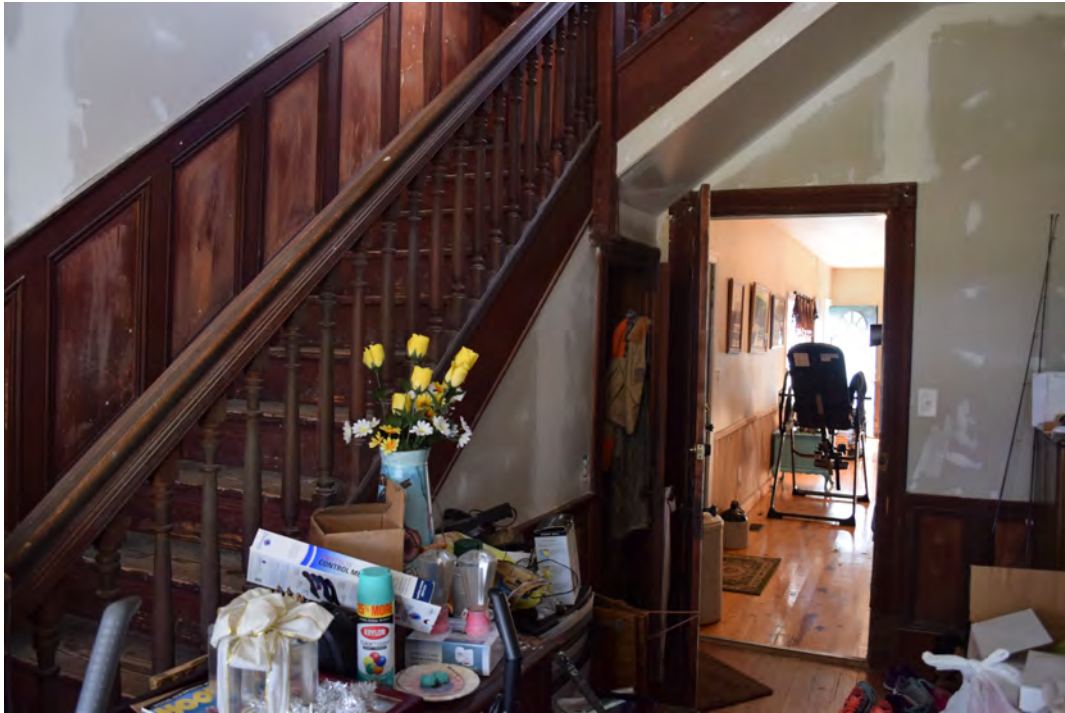
Central passage of main block looking into rear ell, view to the west southwest

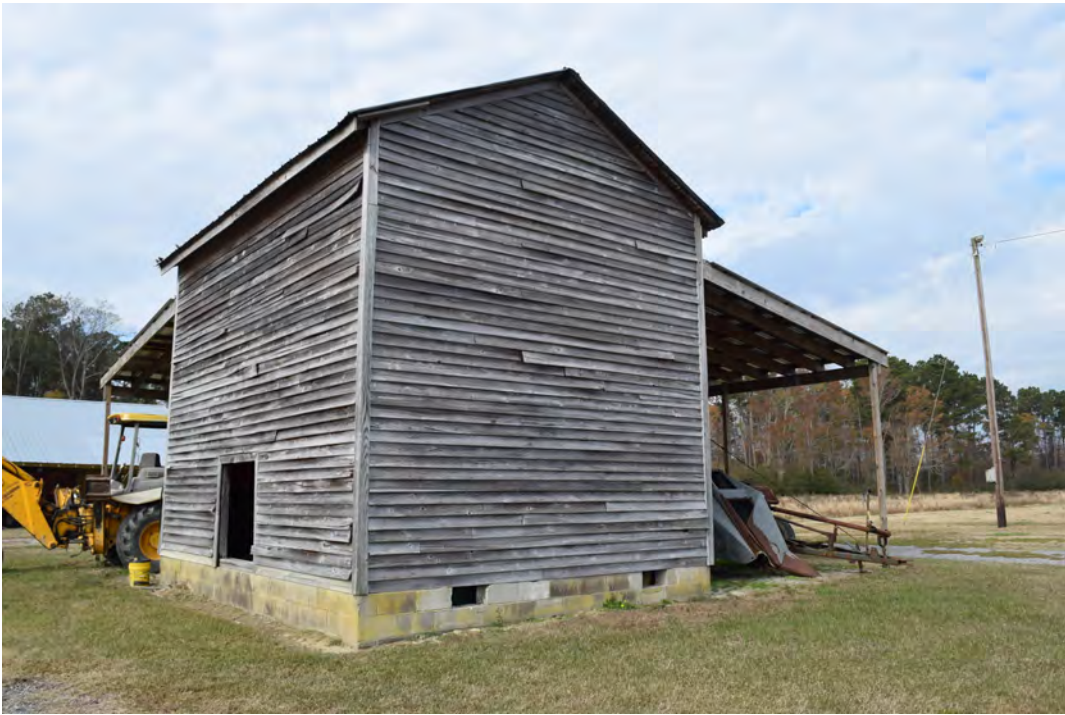
Outbuildings include a weatherboard tobacco barn, a concrete block mule barn, and a small modern storage building. The mule barn has been converted to a bunk house. Two farm ponds are southwest of the agricultural complex.

Tobacco barn, view to the northeast

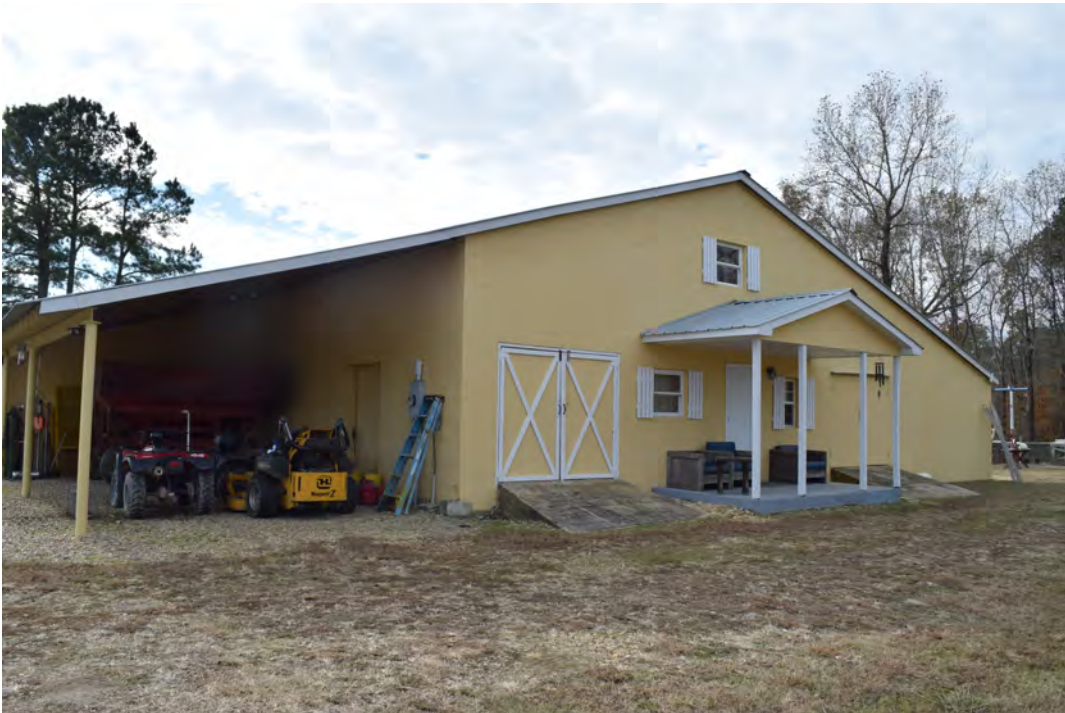
Mule barn, view to the southwest

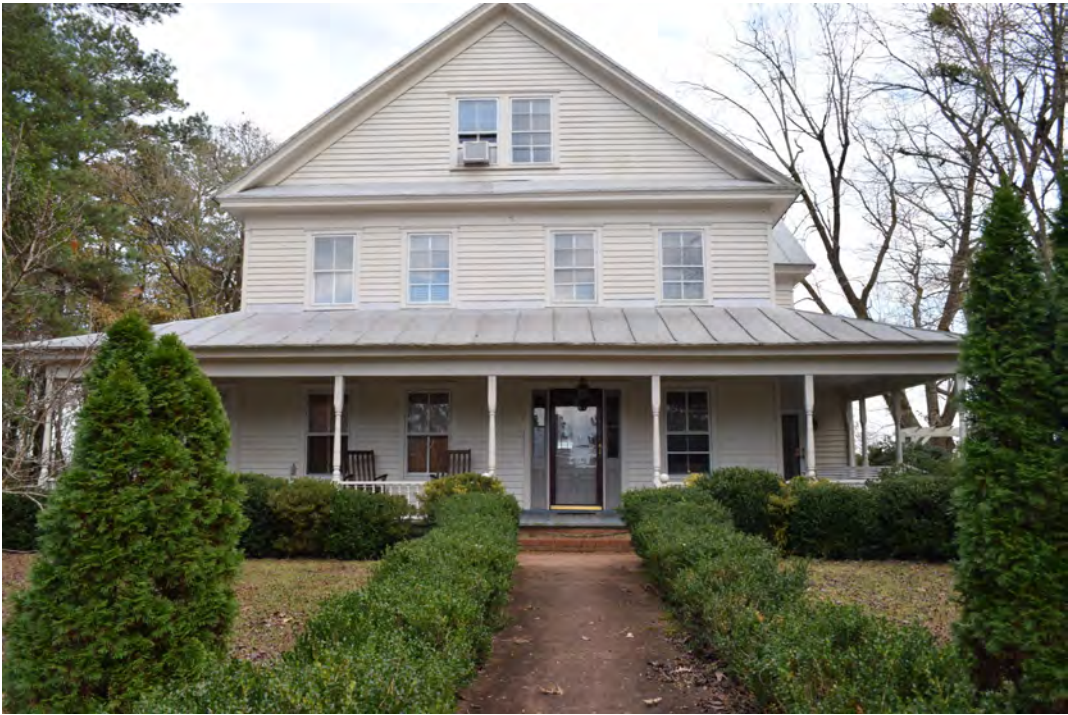
Façade, view to the southeast

The two-story, weatherboard vernacular Queen Anne-style house with asymmetrical massing features a two-story rear wing, two-over-two windows, and turned posts and balusters supporting the one-story wraparound porch. A one-story, gable-roofed wing extends from the rear elevation and features a shed-roofed porch spanning its south (side) elevation. A board-and-batten shed with a nearly flat roof stands east of the house.

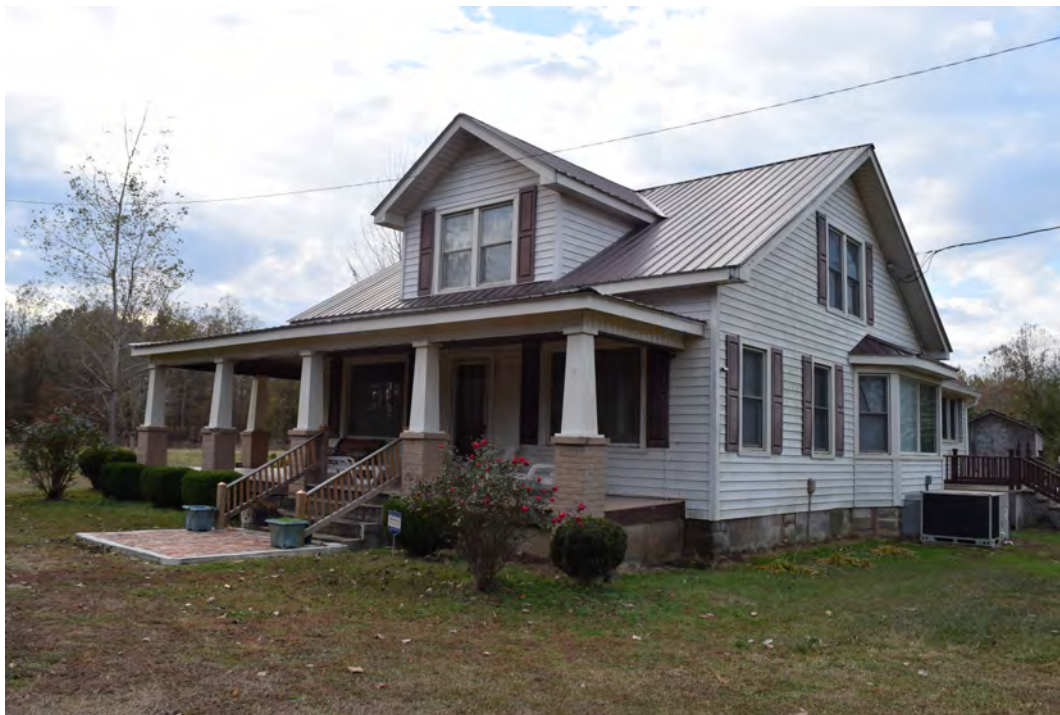
Southeast corner, view to the northwest

The one-and-a-half-story, side-gabled, vinyl-sided bungalow displays battered wood posts atop brick plinths supporting a hip-roofed wraparound porch. A large front-gabled dormer rests on the front roof slope. The foundation consists of rusticated concrete block piers infilled between with modern smooth-face concrete blocks. The interior chimneys have been removed above the roofline. Windows are modern replacements.

The Ella and Eugene Phelps House stands in its original location in rural Bertie County and therefore retains integrity of location and setting. The house, altered with replacement windows, vinyl siding, and the removal of two brick chimney stacks, lacks integrity of workmanship, design, association, and materials.

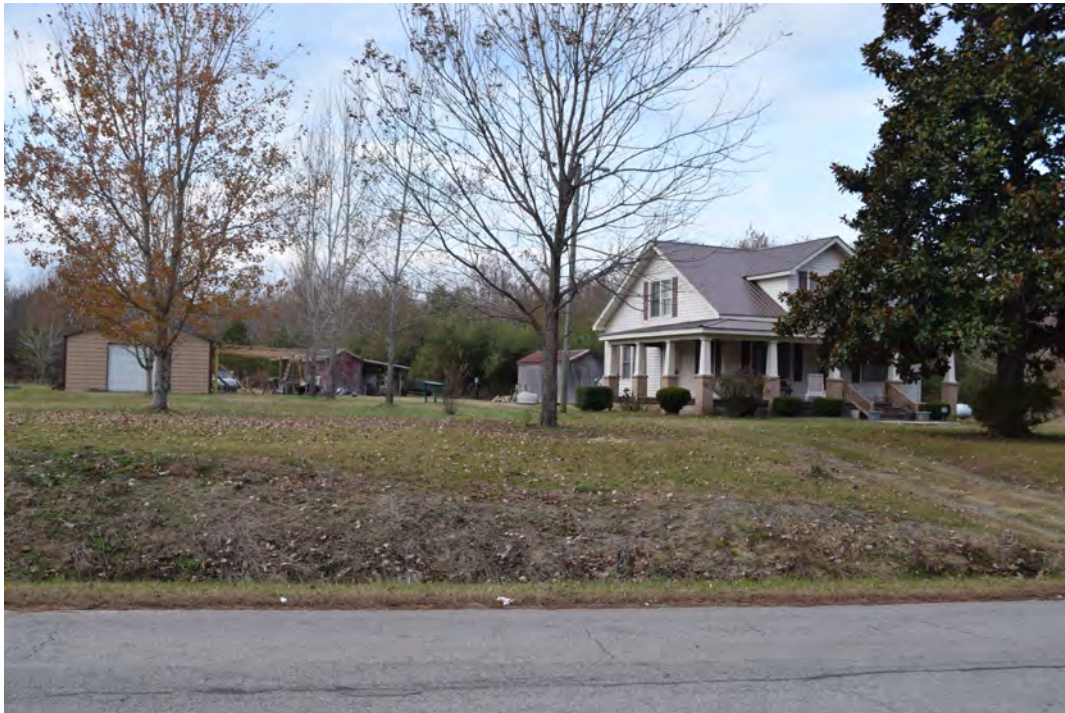
Southwest corner of the dwelling and outbuildings, view to the north-northeast

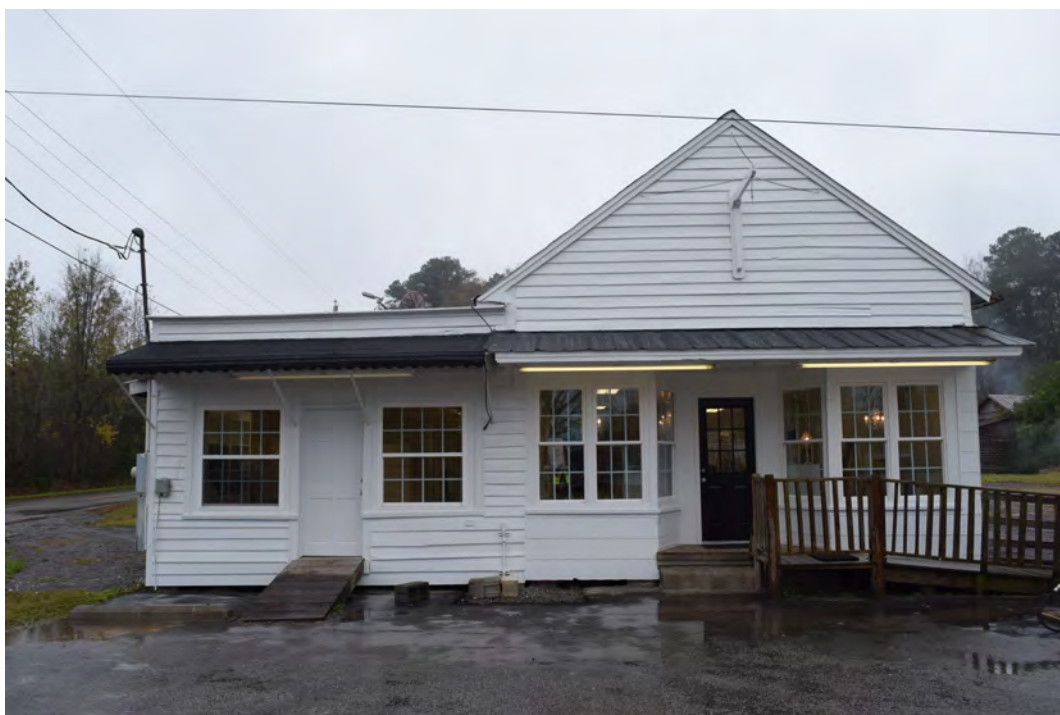
Façade (east elevation), view to the west

The one-story, gable-front, weatherboard building retains its recessed entry flanked by windows. The one-story addition to the south is a flat-roofed building with entry doors flush with its flanking windows. A shallow awning extends across the façade of both sections. A small, nearly flat-roofed, vinyl-sided addition on concrete blocks extends from the rear. All of the windows except for one on the rear elevation have been replaced.

Taylor's Store stands in its original location alongside NC 45 in a rural setting in Bertie County and therefore retains its integrity of location and setting. The building's original recessed storefront and most of its weatherboard siding remain intact. However, the majority of its windows have been replaced recently, an alteration that compromises its integrity of workmanship, design, feeling, association, and materials.

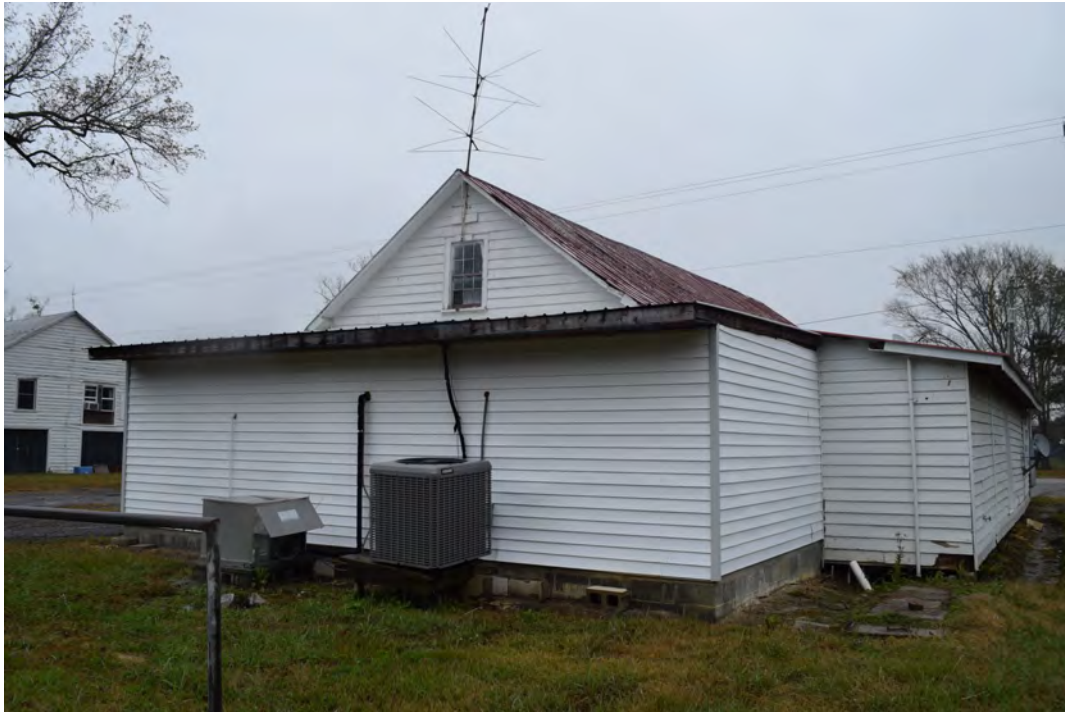
Nearly flat-roofed addition on rear, view to the northeast

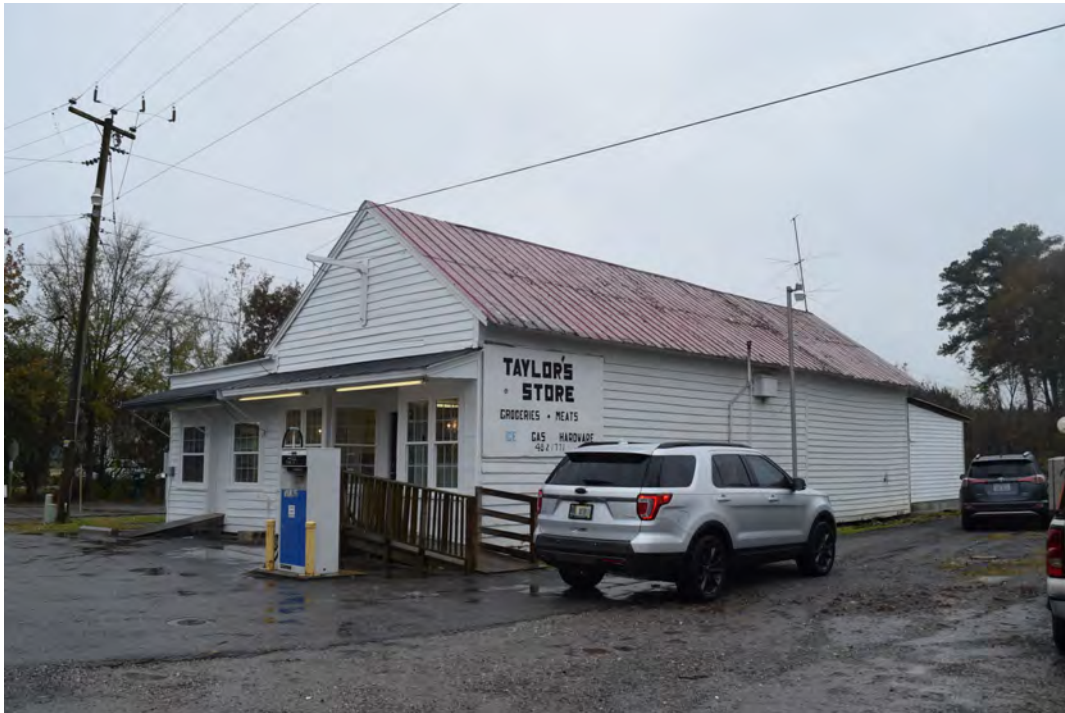
Front (northeast) corner, view to the southwest

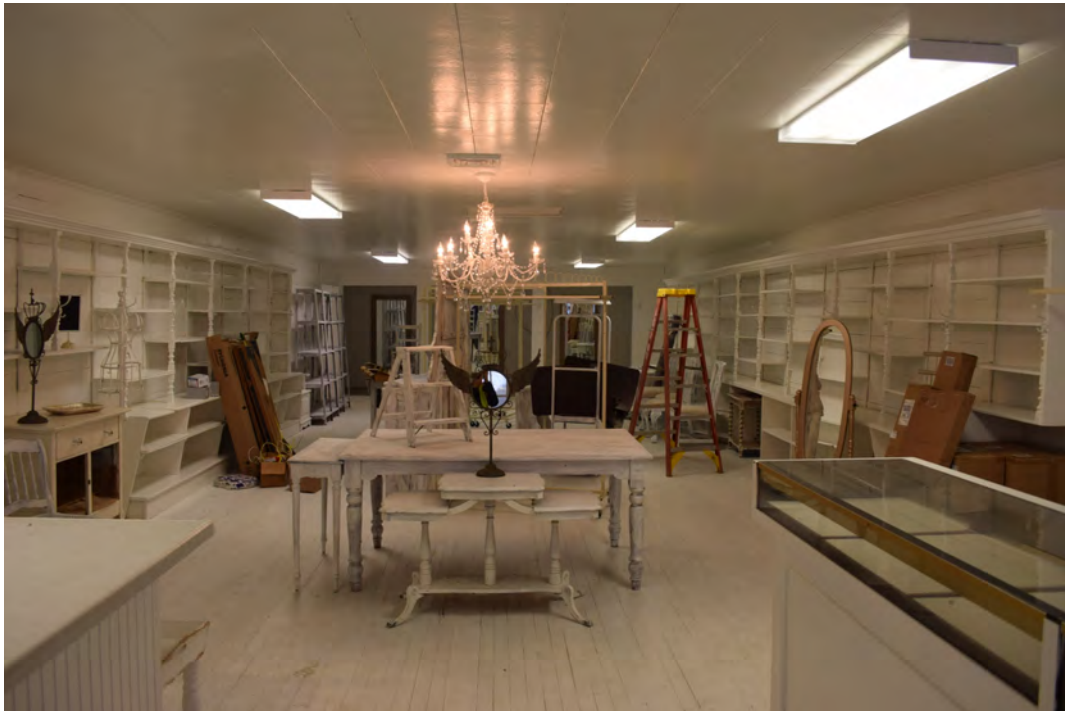
The interior maintains wooden shelves with turned supports and original wood floors. All surfaces have been painted white throughout the building.

Interior of main portion, view to the west
