SUBJECT: Historic Structures Survey Report, R-5809, Improve NC 45 from Washington County Line to South of Colerain, PA 18-01-0055, Bertie County, ER 19-1576

MdM Historical Consultants (MdM) prepared this report in December 2018 and April 2019 in support of the proposed improvements to NC 45 from the Washington County line to south of Colerain in Bertie County, North Carolina (TIP# R-5809). The project lies in eastern rural Bertie County just west of the Chowan River. The Area of Potential Effects (APE), the geographic area or areas within which an undertaking may directly or indirectly cause changes in the character or use of historic properties, extends approximately 250 feet in each direction off the center line of the highway. The APE for the project is delineated on a series of maps on pages 9 to 13 of this report.

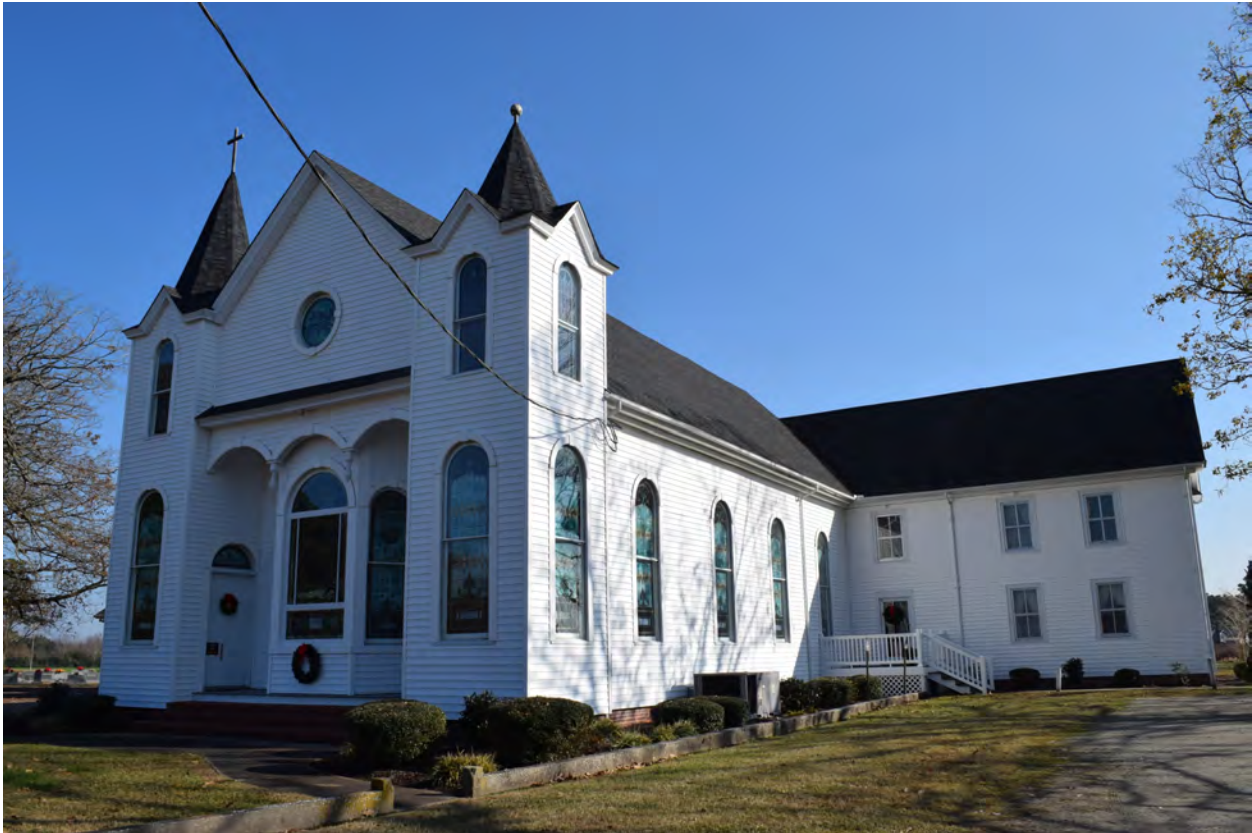
Front (northwest) corner, view to the south-southeast

Built in 1918, the weatherboard church covered in vinyl siding features two towers with spires of differing heights flanking a front-facing gable marked by a small round stained-glass window containing the dates 1824 and 1918, the year the church was founded and the construction date of the current building. Below the gable, three arches with hanging pendants top a recessed porch partially filled by a bay window. Stained glass fills the numerous round-arch windows on the main block. The vinyl siding covers all window trim.

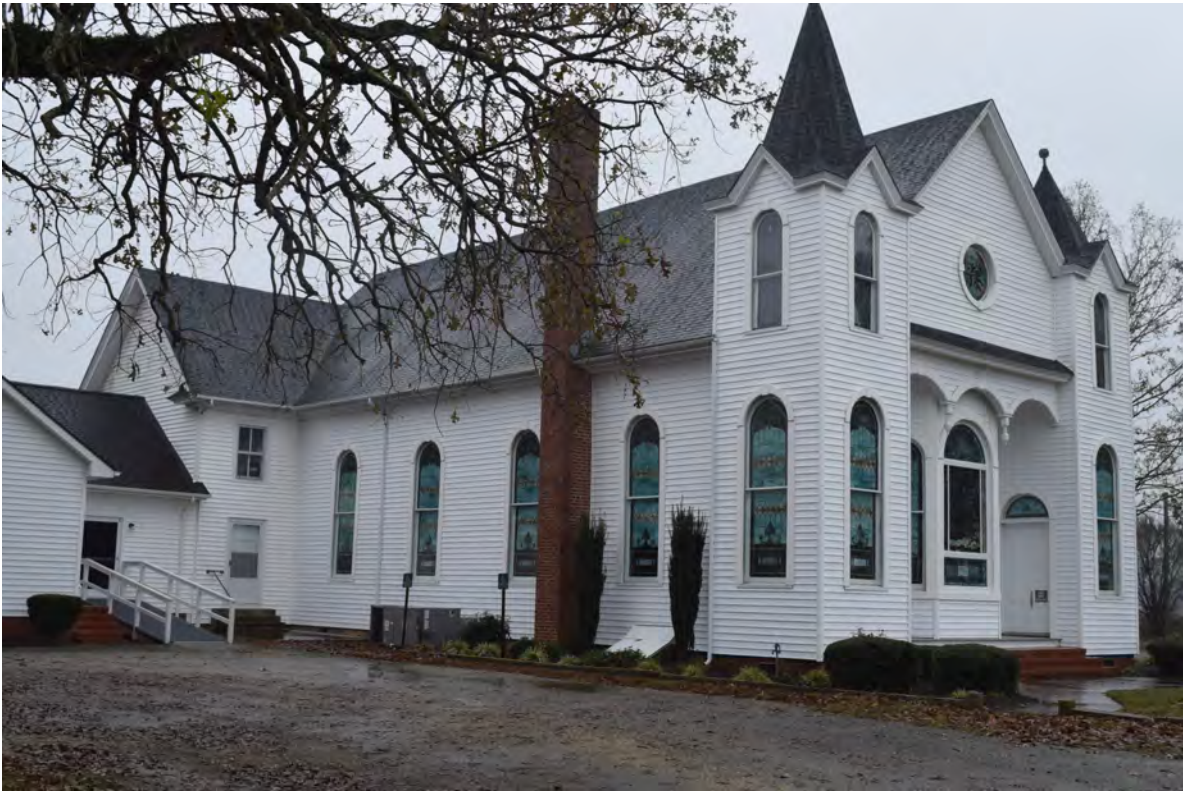
Northeast corner, view to the southwest

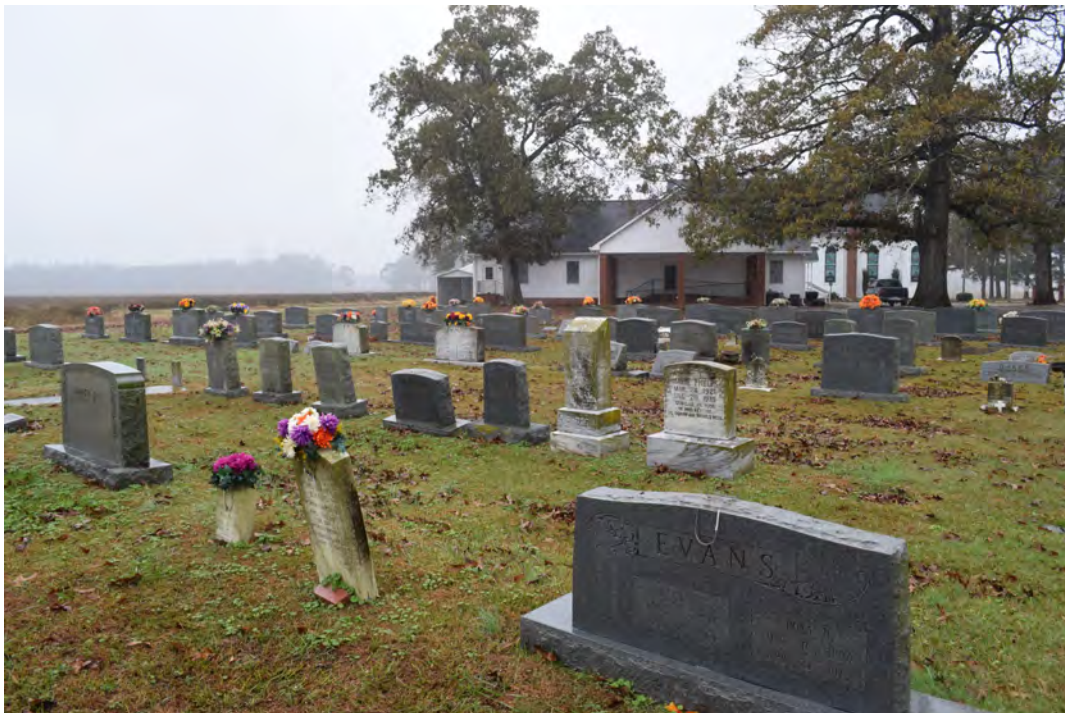
The large cemetery spreads out in a field east of the church and contains mostly modern granite markers. The earliest grave markers date to the 1920s, but the large majority are from 1970 and later.

Cemetery, view to the west-southwest

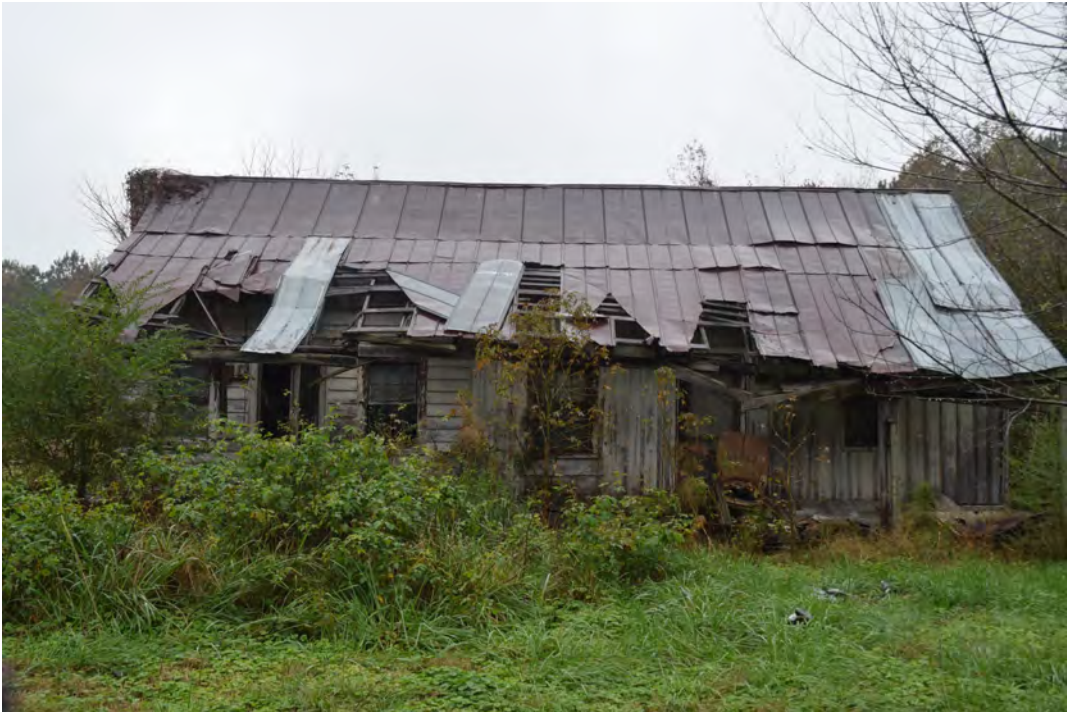
Façade (east elevation), view to the west

The extremely deteriorated, one-story, side-gabled house rests on concrete blocks and sawn wood and is composed of two, three-bay sections with different exterior claddings. It appears the southern section was built first, followed by the northern block. Plain weatherboard covers the southern section. The front wall of the northern section is sheathed in board-and-batten, while the rest of that part of the dwelling is weatherboard. Each side of the facade features a door with a window to one side. An engaged porch shelters the full-width front porch. The dwelling’s poor

condition prevented interior inspection, but it appears the southern section contains one room. The interior of the northern section whose façade is sheathed in board-and-batten was not accessible. A portion of the porch has collapsed, as has most of the rear exterior wall leaving the interior open to the elements. The north gable end has also collapsed.

The Bowen House stands in its original location in rural Bertie County and therefore retains integrity of location and setting. The house retains its original siding and some original windows but has suffered from extreme neglect resulting in the partial collapse of the front porch and full collapse of most of the rear elevation where the back wall is missing. In addition, much of the roofing is gone and a large portion of the upper chimney has collapsed. Because of its current condition, the house lacks integrity of workmanship, design, association, and materials.

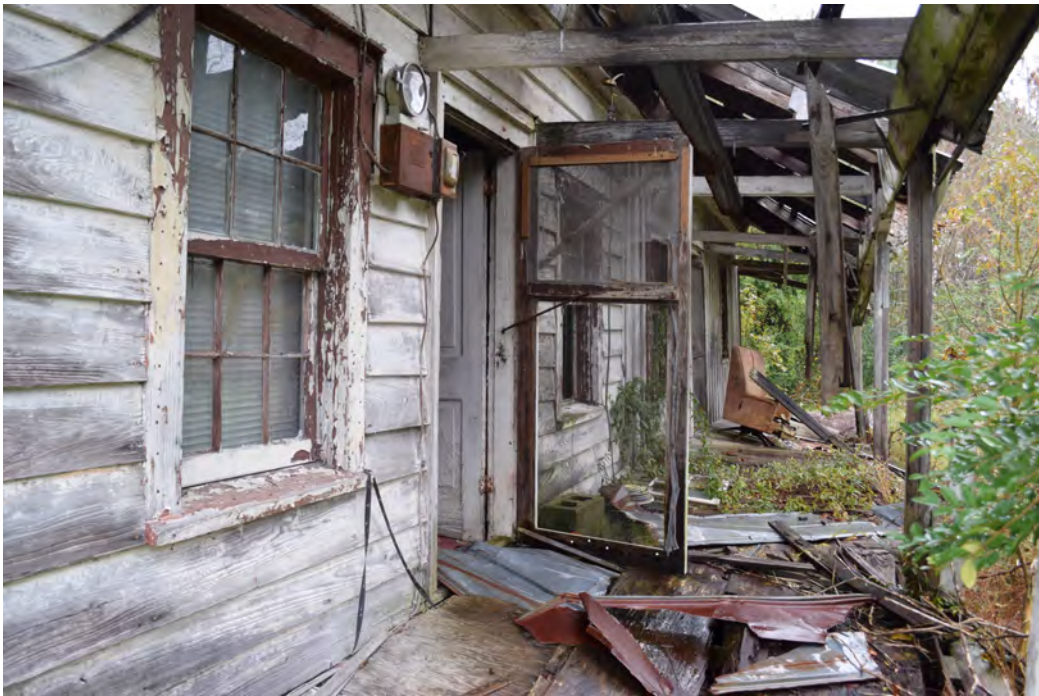
Front porch, view to the north-northwest

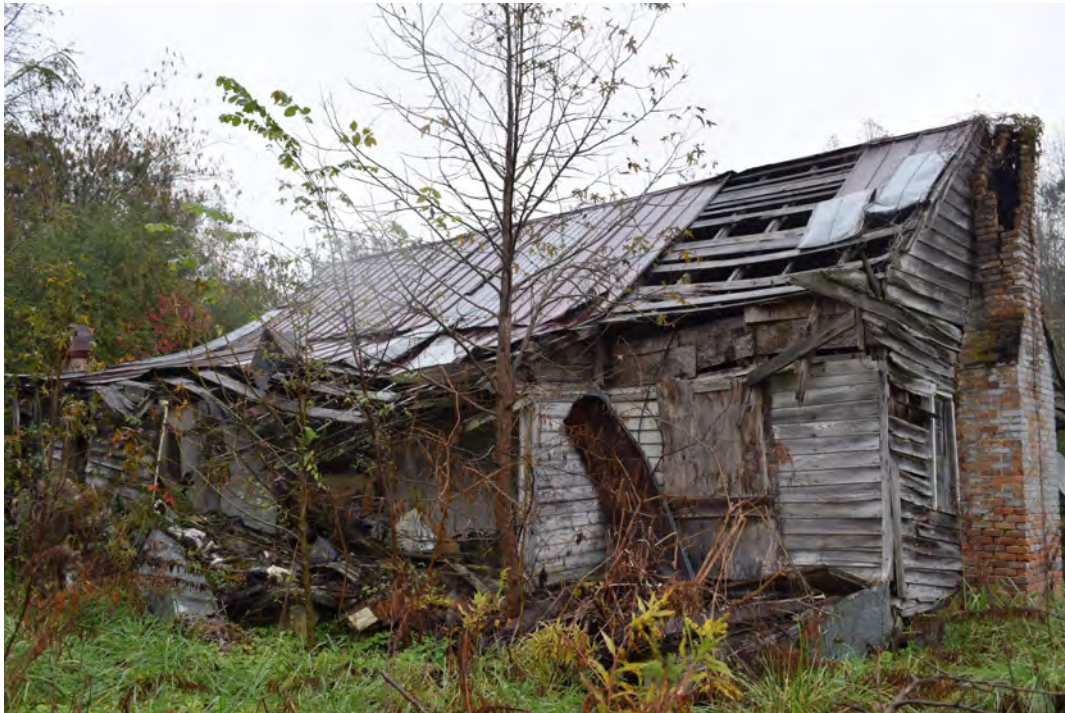
Rear elevation, view to the east-northeast

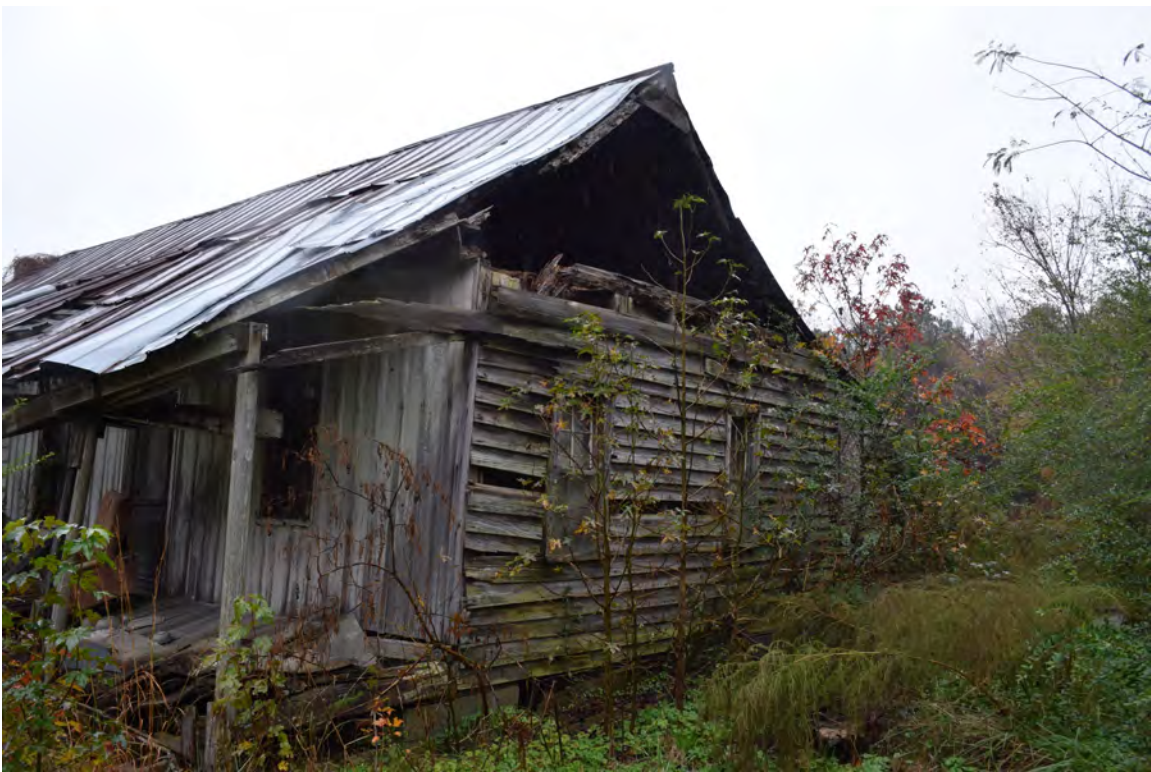
North gable end, view to the southwest

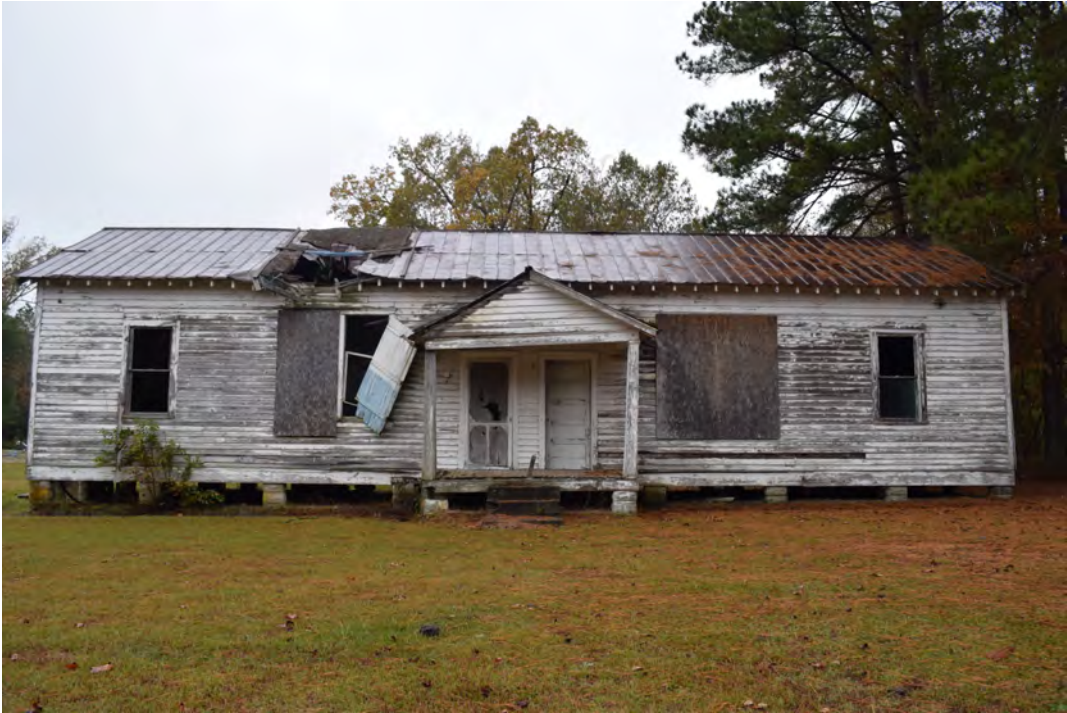
Façade, view to the west-northwest

Ashland School stands in its original location in rural Bertie County and therefore retains integrity of location and setting. The school retains its original siding and portico but has suffered from hurricane damage resulting in the partial collapse of a portion of the roof. Despite the damage, the school, with its intact interior and fenestration patterns, retains integrity of workmanship, design, association, and materials.

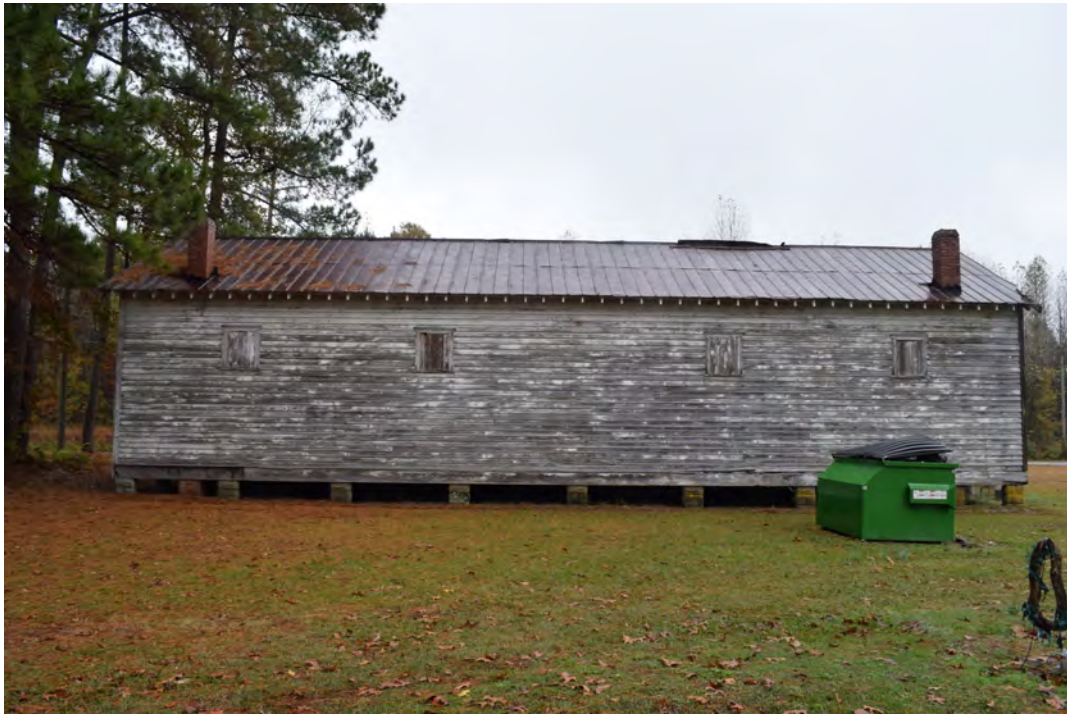
The one-story, rectangular, weatherboard building resting on concrete blocks features a symmetrical façade with a projecting front-gabled portico sheltering two five-panel doors. A single door pierces the south gable end. The rear elevation displays four small high windows to allow in western light. A roof with exposed rafter tails and covered with standing-seam metal crowns the school.

Rear elevation, view to the east-southeast

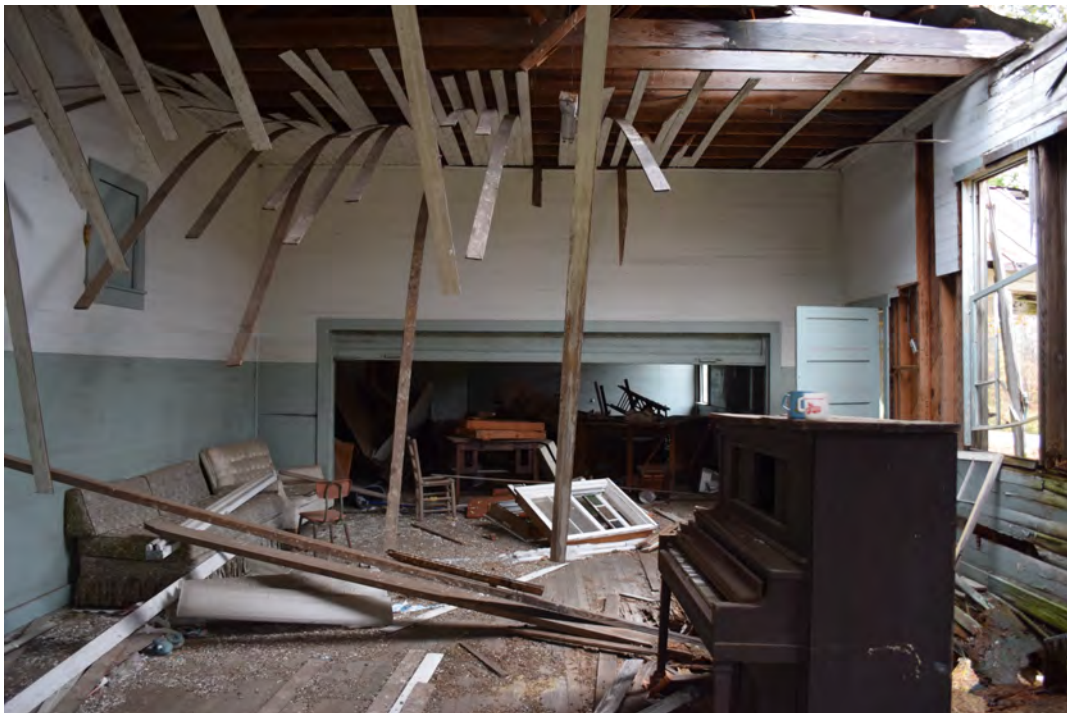
Interior, view to the north-northeast

The interior retains its original finishes and pull-down classroom divider. A hole in the roof has compromised not only a portion of the roof structure, but also the ceiling boards and floor boards under the hole.

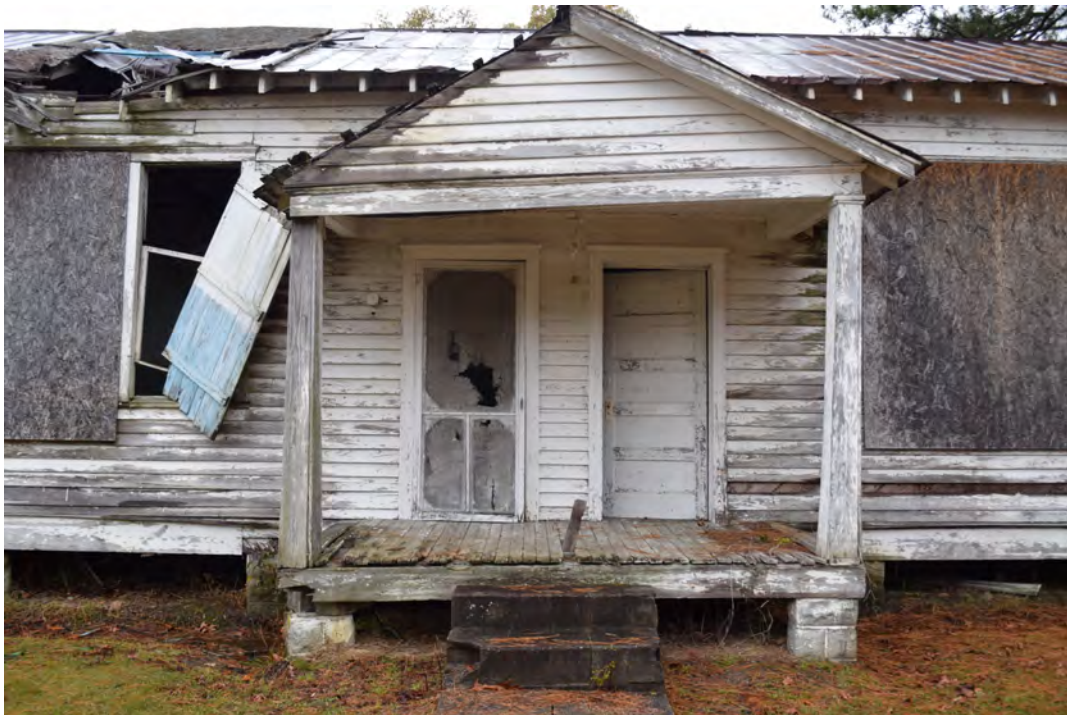
Detail of front portico, view to the west-northwest

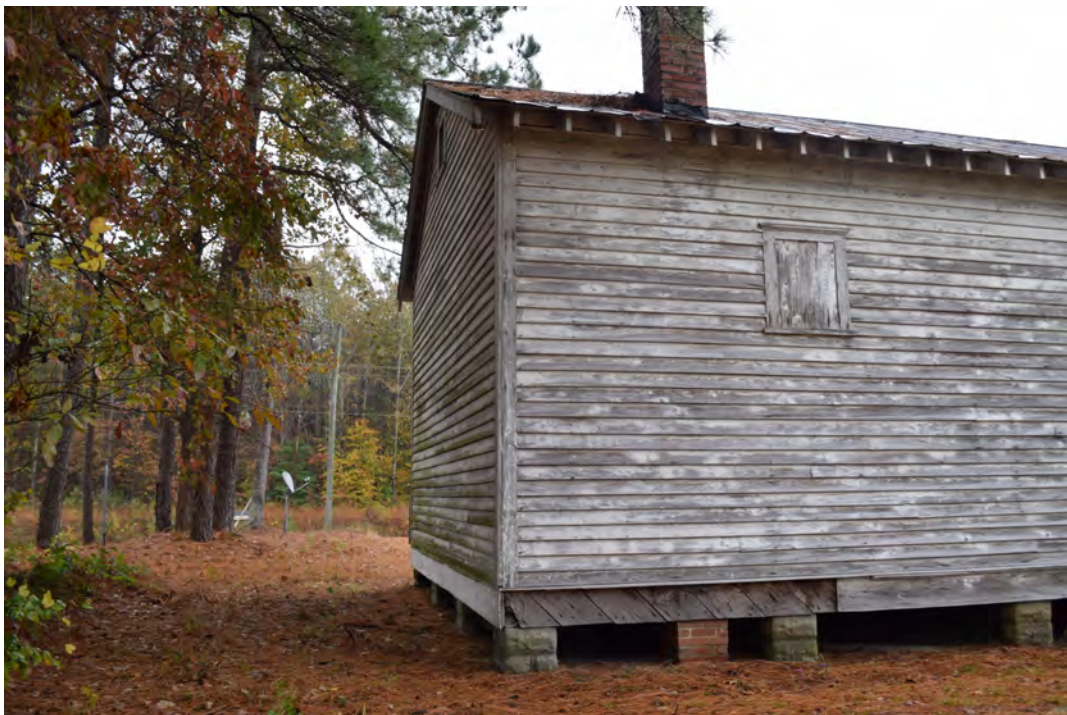
North gable end, view to the east

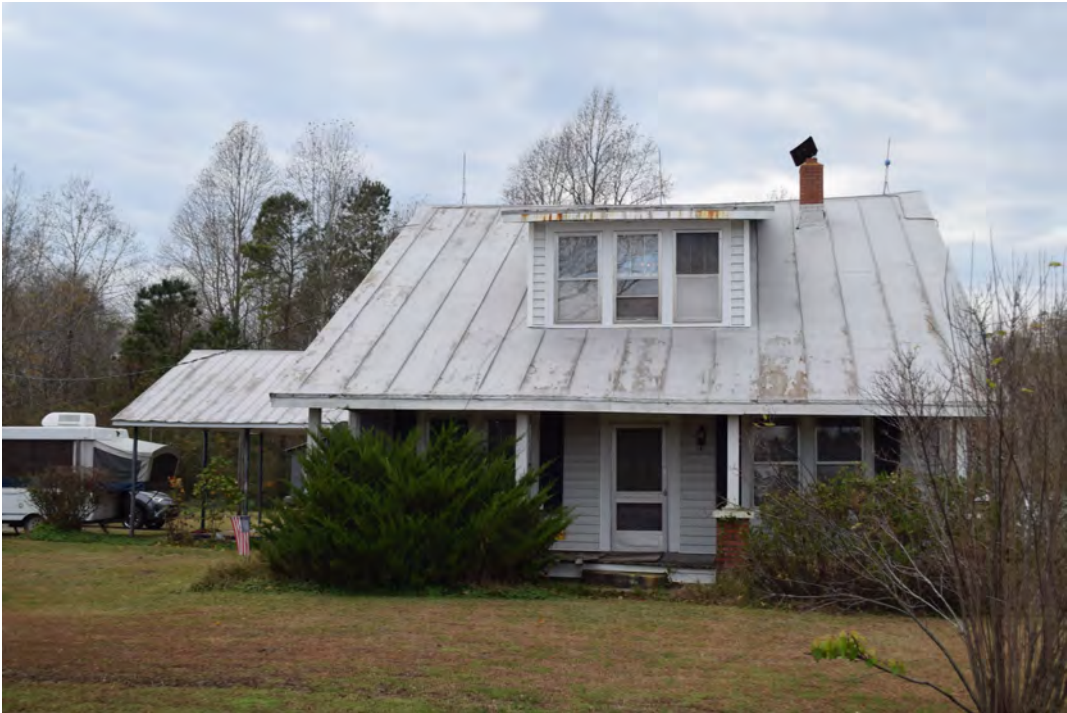
Facade, view to the west

One-and-a-half-story, side-gabled bungalow features original three-over-one windows and a full-façade recessed porch supported by square posts on brick plinths. A shed-roof dormer with three windows rests on the front roof slope. A single brick chimney rises from the interior near the house’s north end. Aluminum siding sheathes the exterior. A side-gabled carport with round metal posts extends from the west side of the south elevation. A two-story, front-gabled wood packhouse and a one-story metal-sided shed stand behind the house.

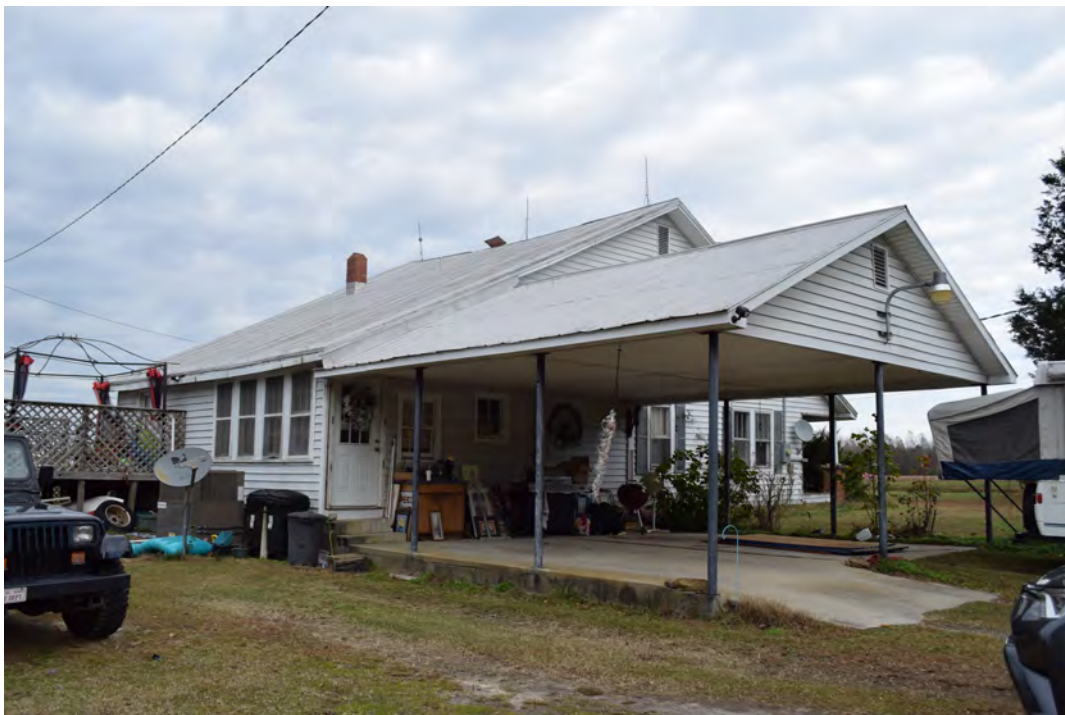
Southwest (rear) corner showing carport addition, view to the northeast

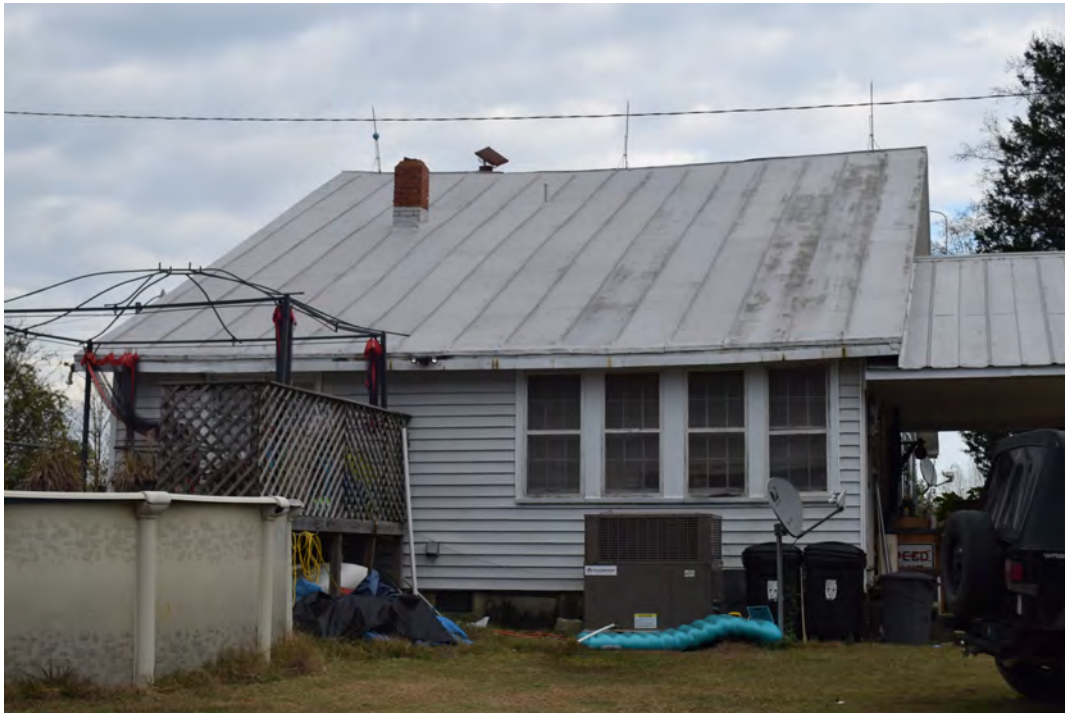
West (rear) elevation, view to the east

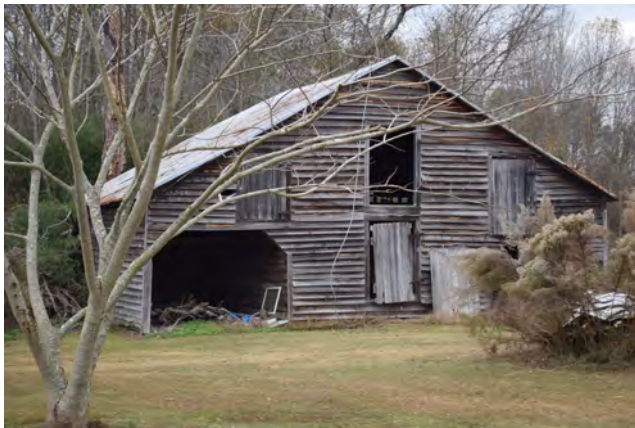
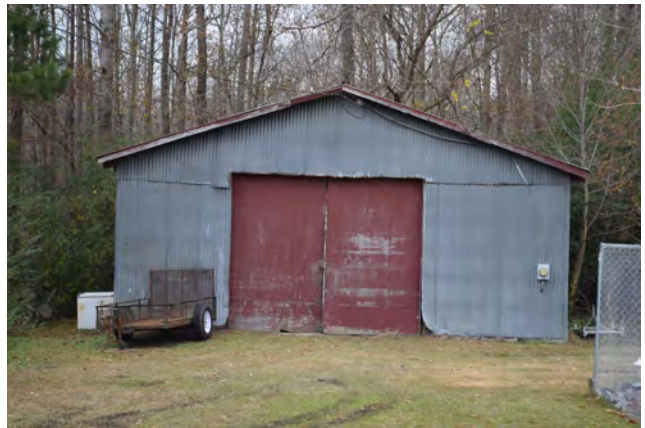
Packhouse and garage behind the house, view to the west

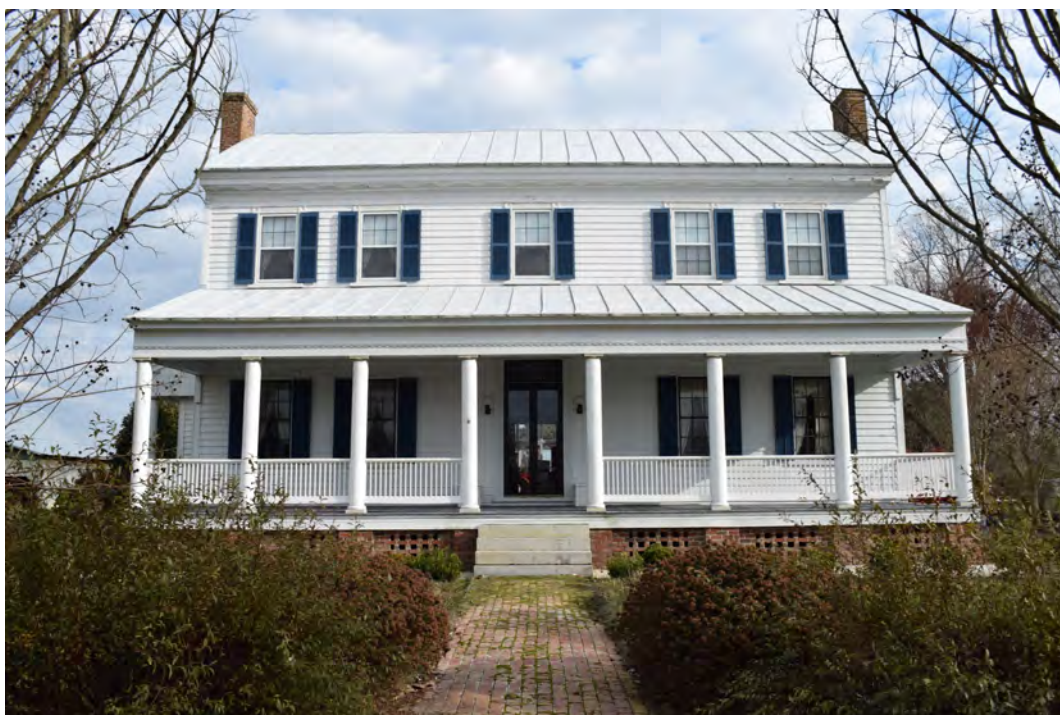
Facade of Ashland, view to the east-southeast

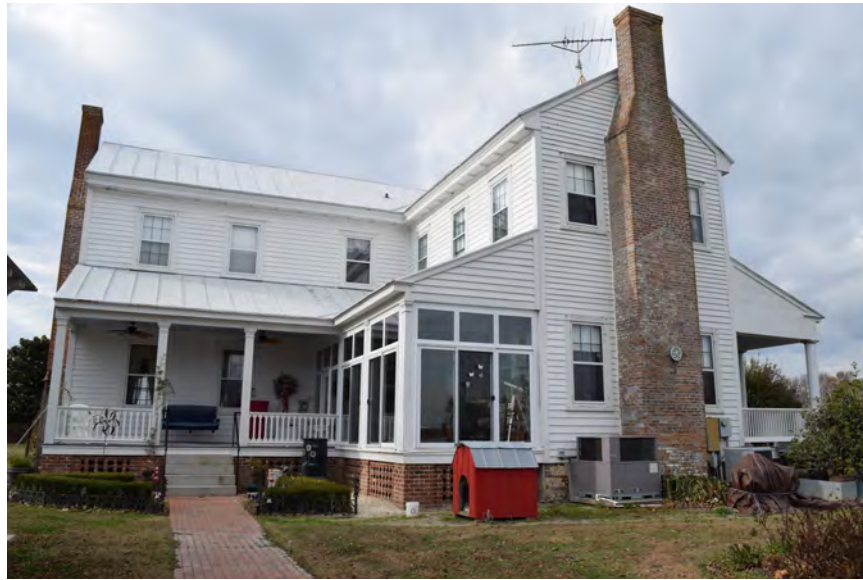
Rear elevation, view to the west

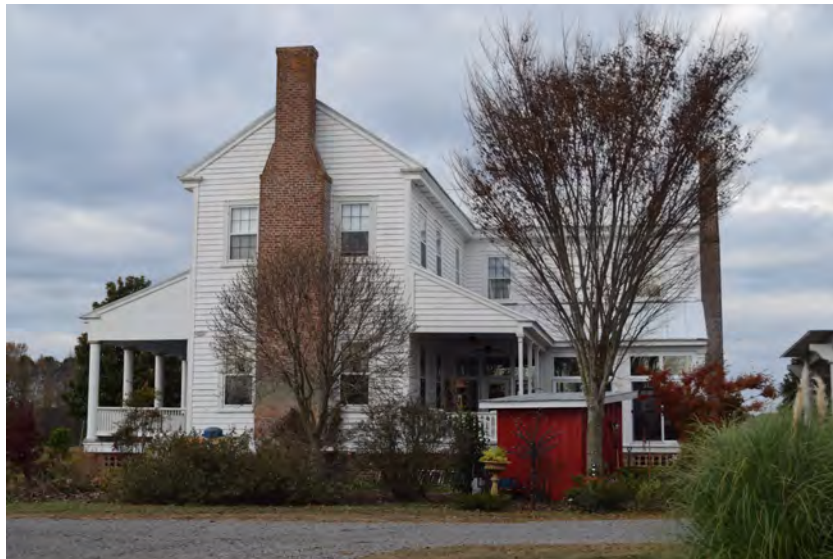
South elevation, view to the north

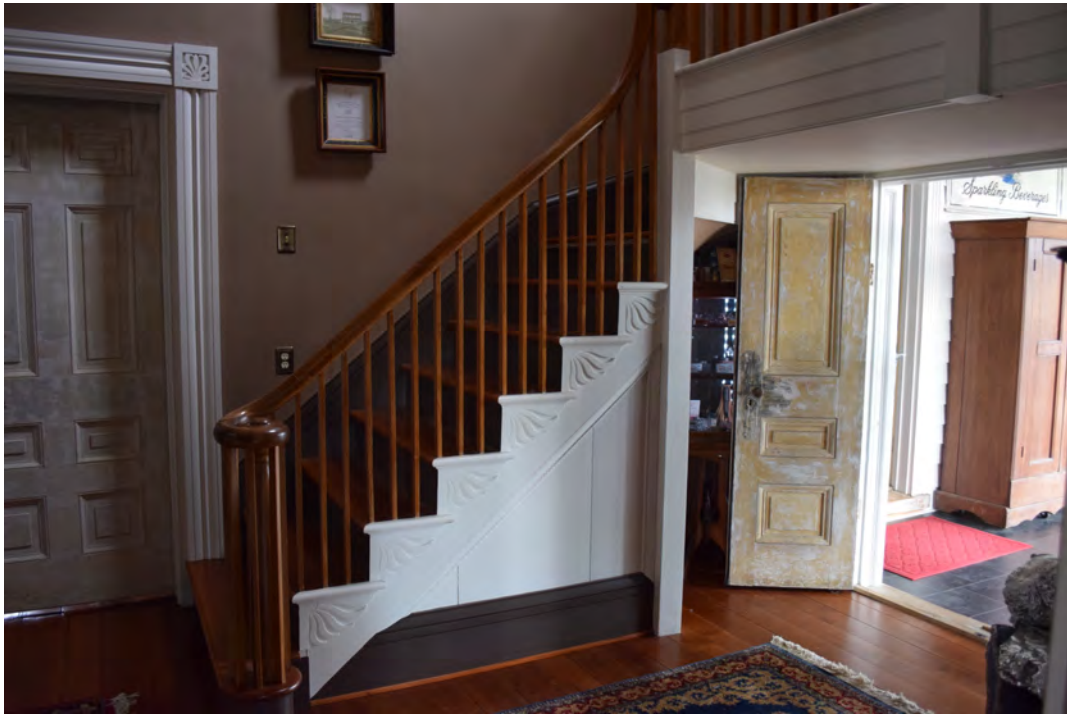
Two parlors on the first floor and two bedrooms on the upper level flank the center hall. In addition to the main stair, a service stair serves the rear ell. Both stairs feature narrow, rectangular balusters, rounded handrails, and tapered newel posts. The interior includes twelve-foot ceilings, heart-pine floors, tall baseboards, Greek Revival mantels, and architraves with a variety of cornerblocks.

Stair in central passage, view to the north-northeast

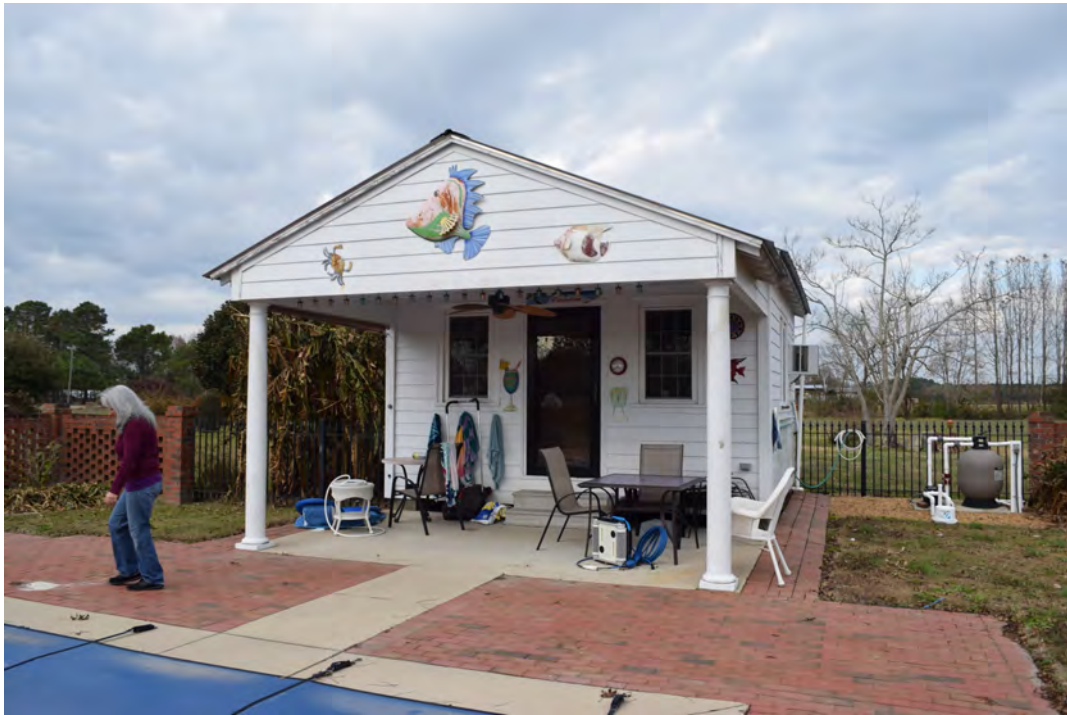
Two outbuildings, a swimming pool, and a pergola-topped carport have been added to the property since it was listed in the NRHP in 2003. Since the listing, a former rural commercial building was moved to the backyard to serve as a pool house and a pool was built just to the south of the former store. A modern metal barn and workshop was constructed in the south yard.

Relocated store now a pool house in rear yard, view to the north-northwest

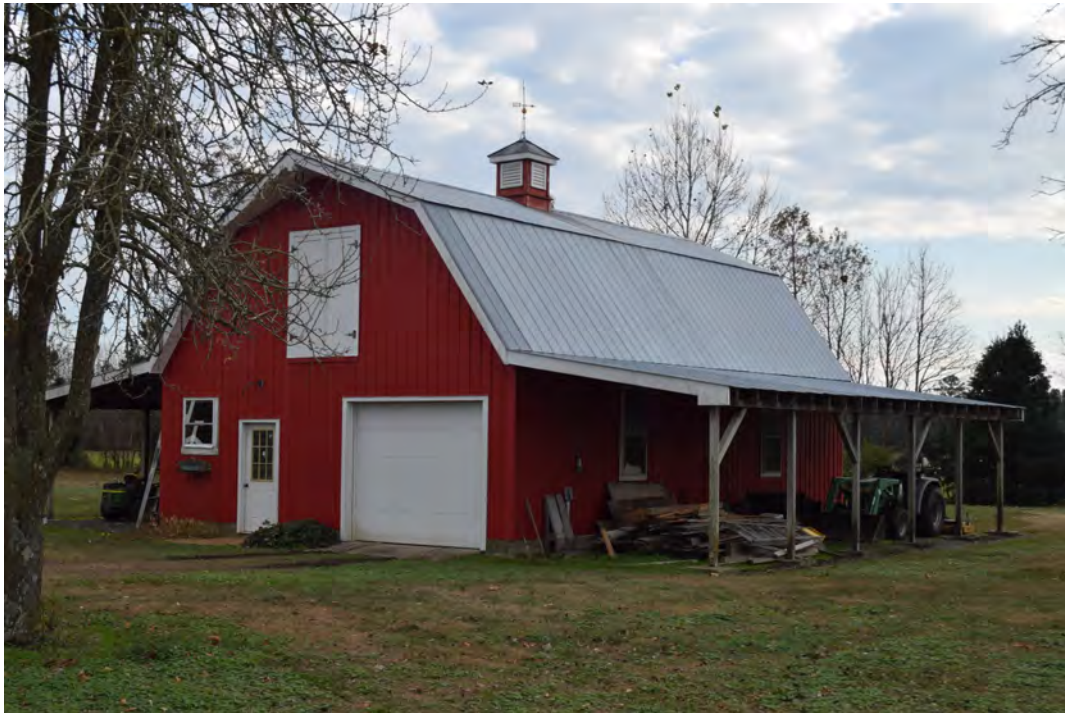
Modern barn and workshop, view to the southeast

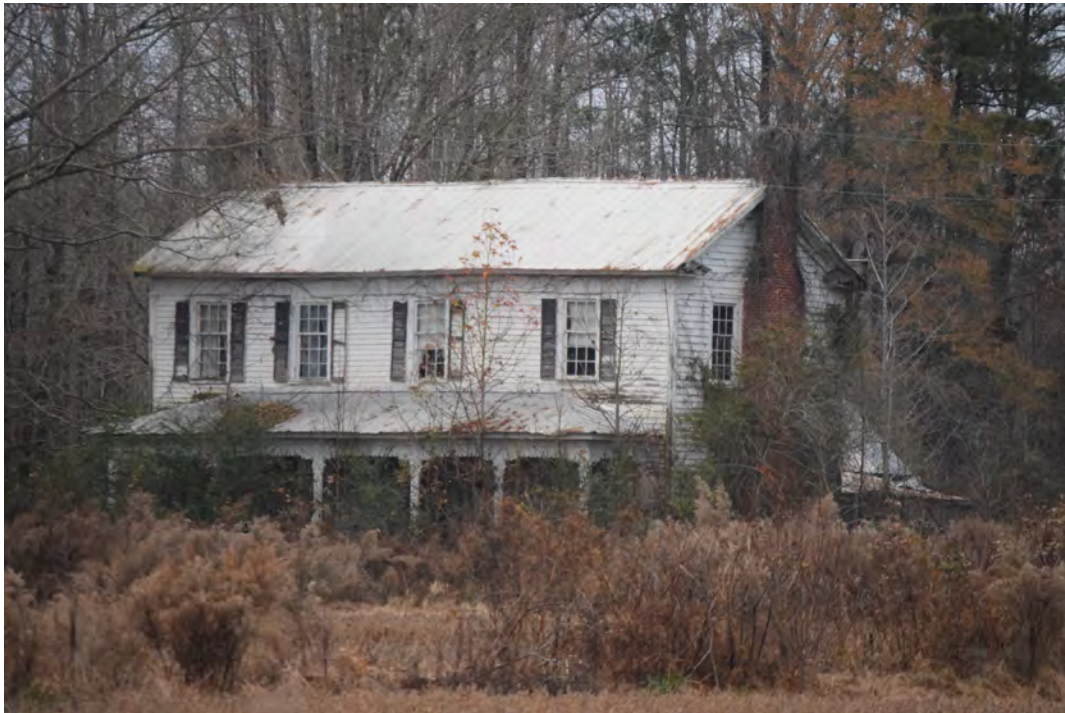
Another Federal-Greek Revival example is the circa 1840 Taylor-Simmons House (BR0156), a two-story, side-gabled, four-bay wide house. The Taylor-Simmons House has weatherboard siding, six-over-nine windows, pilastered cornerboards, and a sawnwork bargeboard at the hip-roofed porch. A vestigial cornerboard between the third and fourth bays indicate an expansion of the original house. The house may have been originally a side-passage plan but the added rooms altered the original configuration. The house has exterior brick chimneys, boxed eaves, and metal roofing.

Taylor-Simmons House, view to the northeast

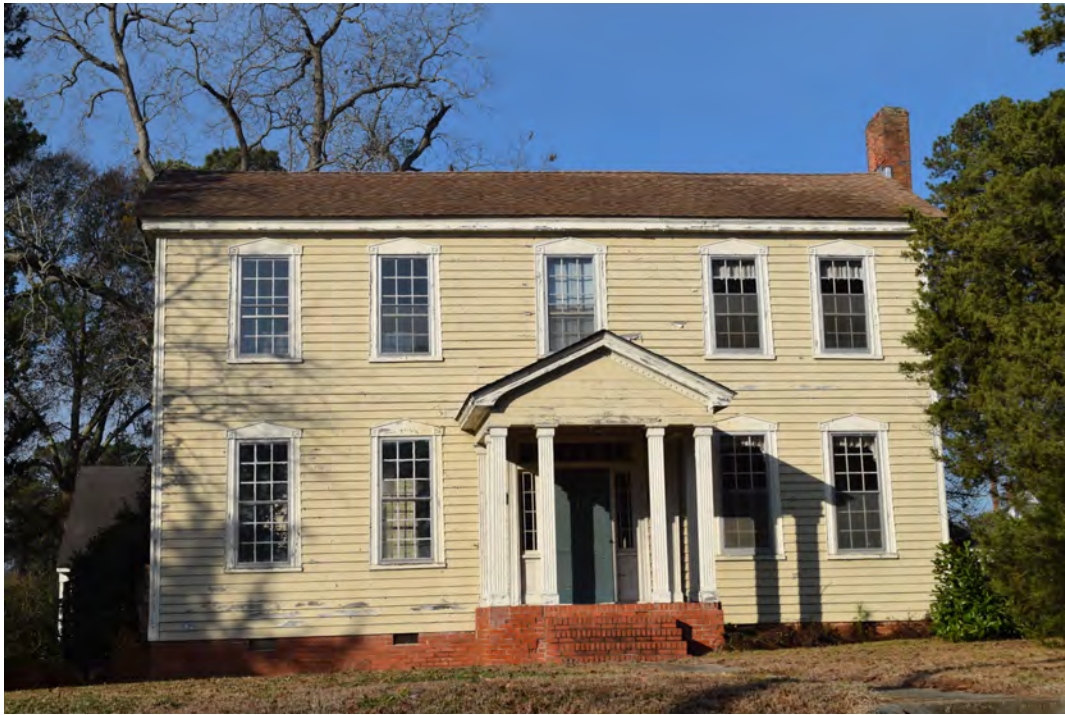
The circa 1840 Henry Beasley House (BR0015) is a two-story, side-gabled Greek Revival dwelling in Colerain. Its façade is five bays wide with a gabled portico with fluted squared columns at the centered front entry. Molded architraves with peaked lintels and Greek key cornerblocks accent the nine-over-nine sash. The front entry has sidelights and a transom, weatherboards sheathe the exterior, and a brick exterior end chimney is at each pedimented gable-end wall. Another side-gabled, five-bay wide Greek Revival example is the circa 1845 Lane House (BR0587), which has a nearly full-width, hip-roofed porch with Tuscan columns, weatherboard exterior, nine-over-nine sash, and double-leaf front entry, and exterior brick chimneys at pedimented gable ends. The Henry Beasley and Lane Forehand houses are both I-houses.²⁹

Henry Beasley House in Colerain, view to the west

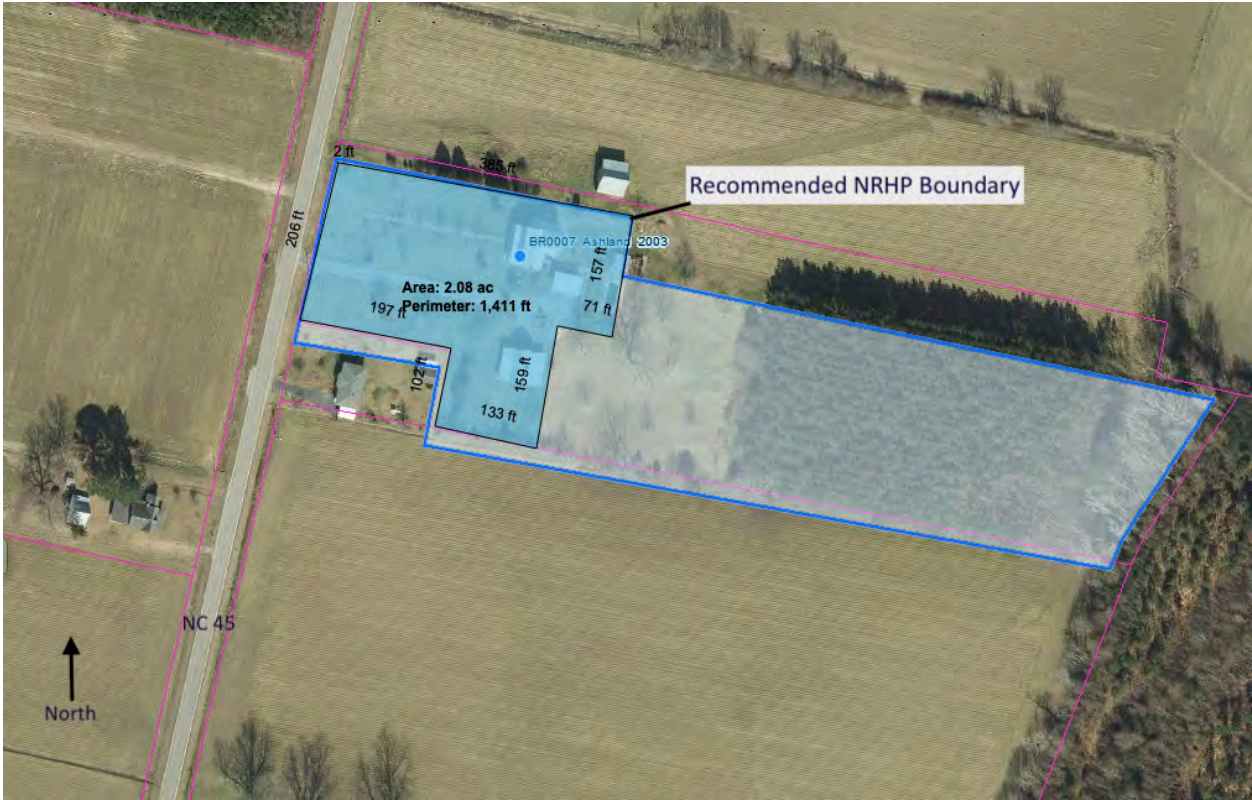
Ashland NRHP Boundary, created from HPOWEB

When Ashland was listed in the NRHP in 2003, two acres was included as part of the nominated parcel. To remain consistent with those boundaries, the recommended NRHP boundary for Ashland is two acres, which includes the dwelling and the original front brick walk and the noncontributing barn, former store, and swimming pool. This setting provides a historically appropriate setting for the house, which is listed in the NRHP for its architectural significance.

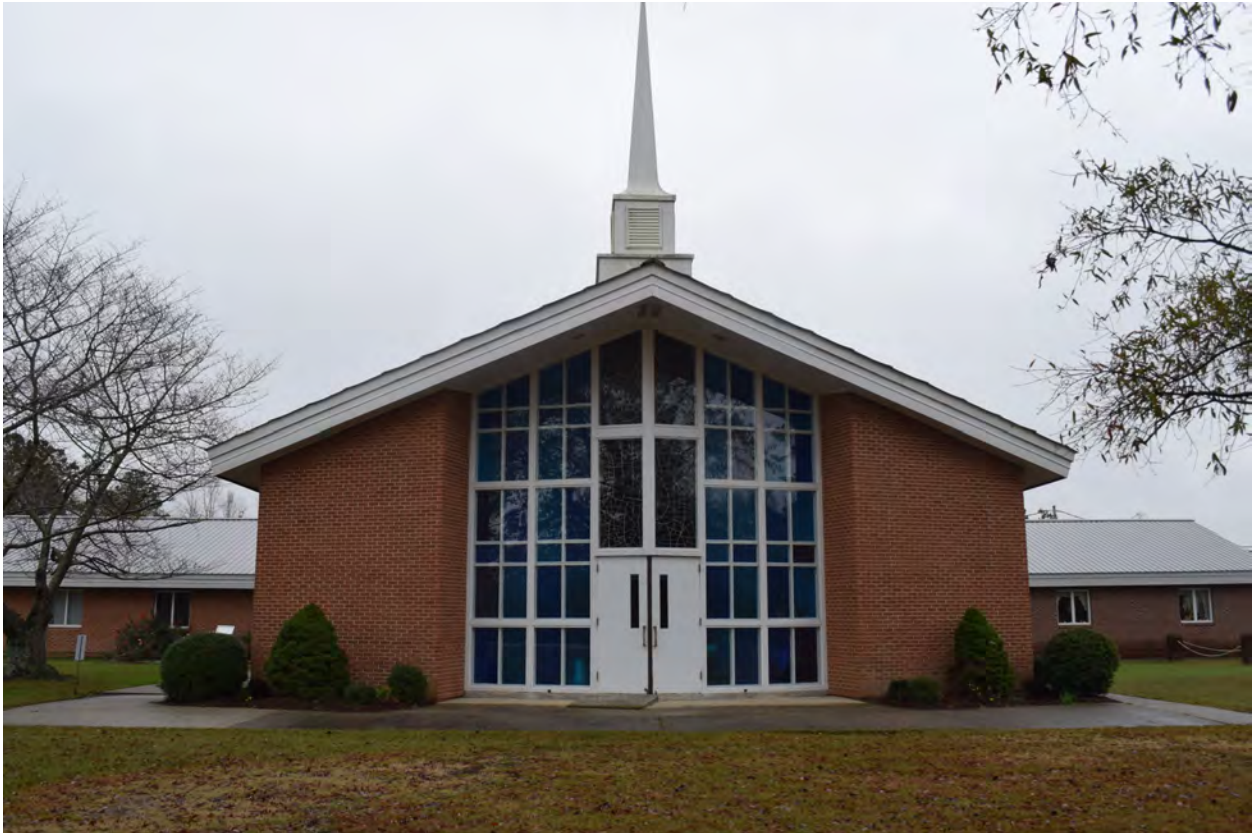
Facade of sanctuary, view to the east-southeast

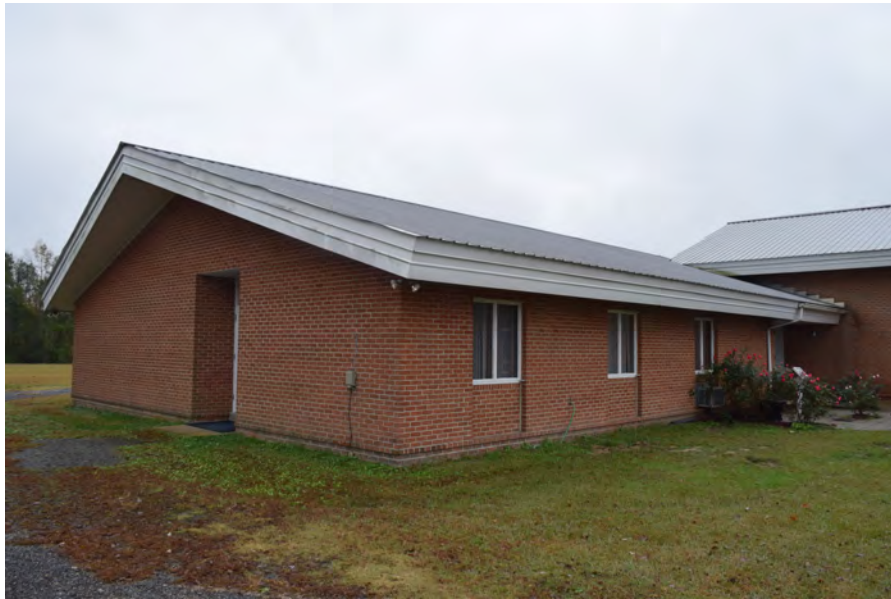
Original north wing built in 1967, view to the southeast
