SUBJECT: Historic Structures Survey Report, R-5809, Improve NC 45 from Washington County Line to South of Colerain, PA 18-01-0055, Bertie County, ER 19-1576

MdM Historical Consultants (MdM) prepared this report in December 2018 and April 2019 in support of the proposed improvements to NC 45 from the Washington County line to south of Colerain in Bertie County, North Carolina (TIP# R-5809). The project lies in eastern rural Bertie County just west of the Chowan River. The Area of Potential Effects (APE), the geographic area or areas within which an undertaking may directly or indirectly cause changes in the character or use of historic properties, extends approximately 250 feet in each direction off the center line of the highway. The APE for the project is delineated on a series of maps on pages 9 to 13 of this report.

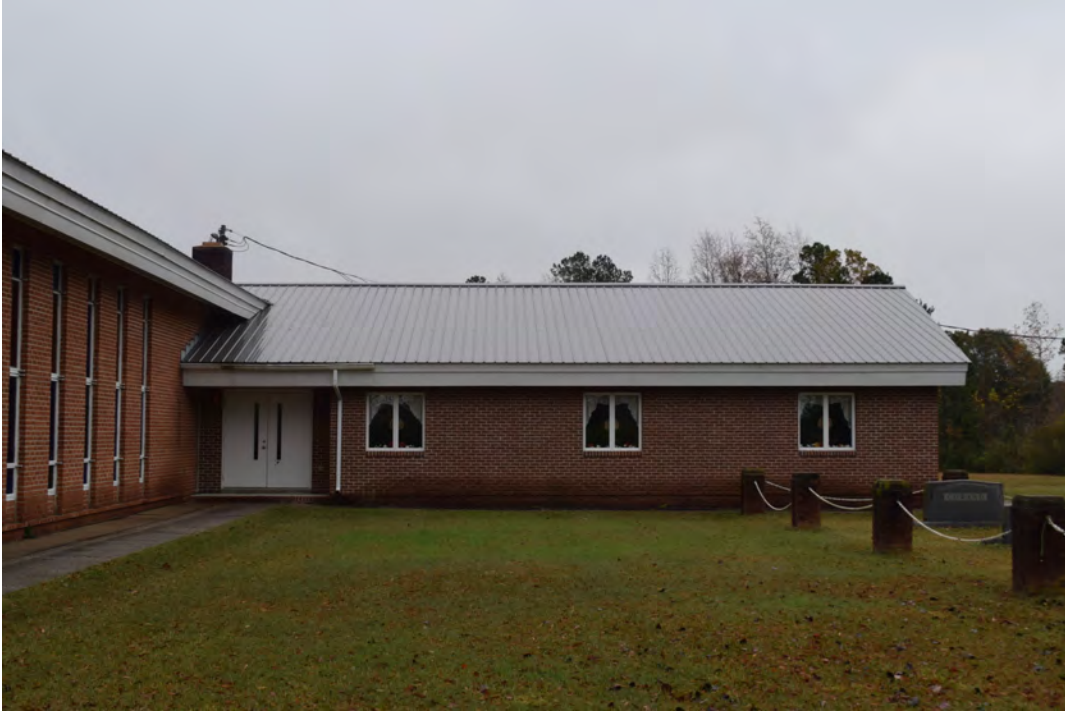
South wing added in 1983, view to the east

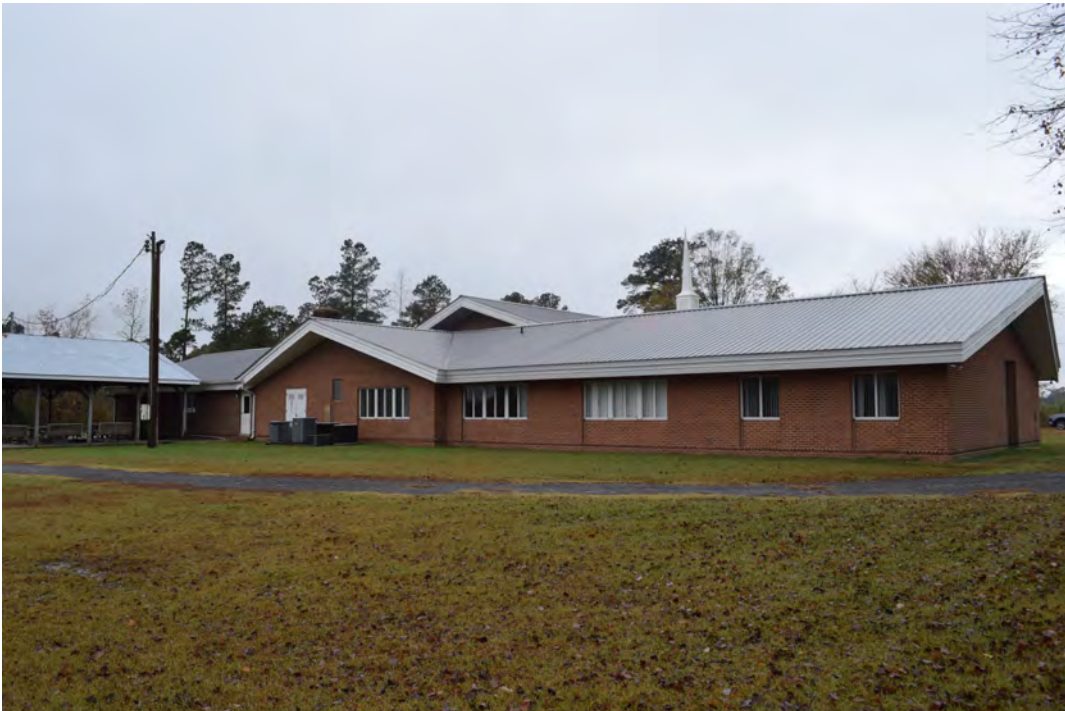
A freestanding gable-roofed shelter (circa 1990) with a gable roof stands behind the church. Just to the south stands a modern shed added to the site in 1989. A tennis/basketball court is east of the parsonage and a baseball field is directly east of the church.

Rear of north wing and portion of 1990 picnic shelter, view to the southwest

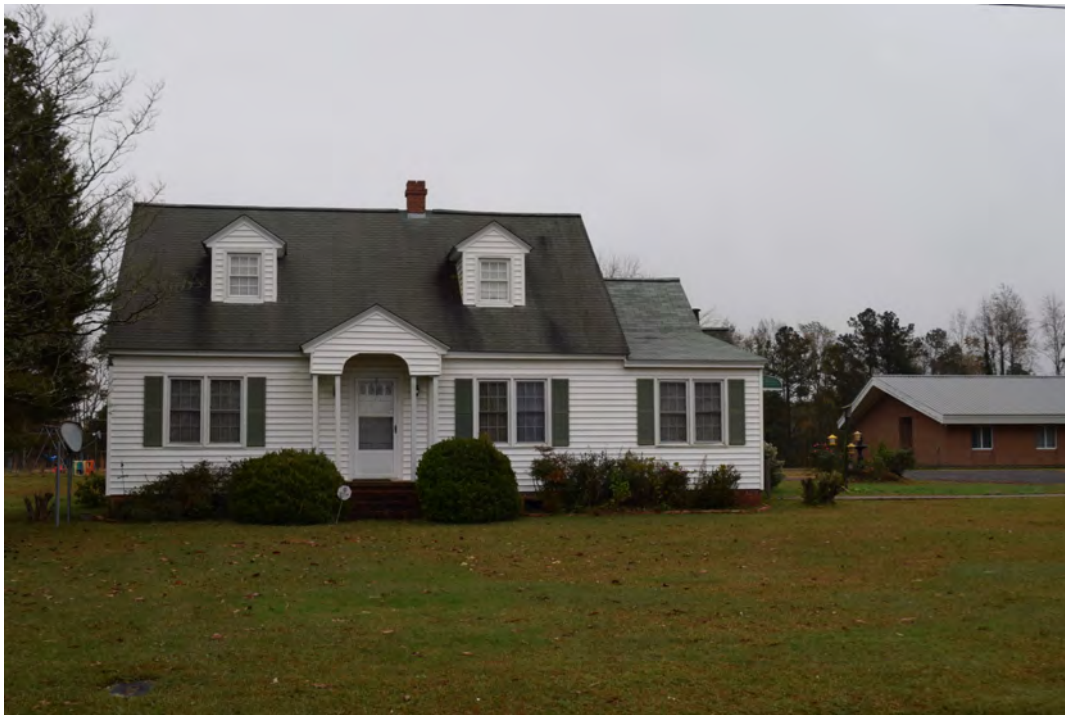
The significantly-altered parsonage dates to the late 1940s and is a one-and-a-half-story, side-gabled dwelling with a front-gabled porch supported by simple posts. An interior brick chimney is located on the roof ridge. The side porch was enclosed in 1985 and vinyl siding was applied in 1998. Windows are modern replacements. In the early 2000s, a carport was added to the rear yard.

Parsonage, view to the east

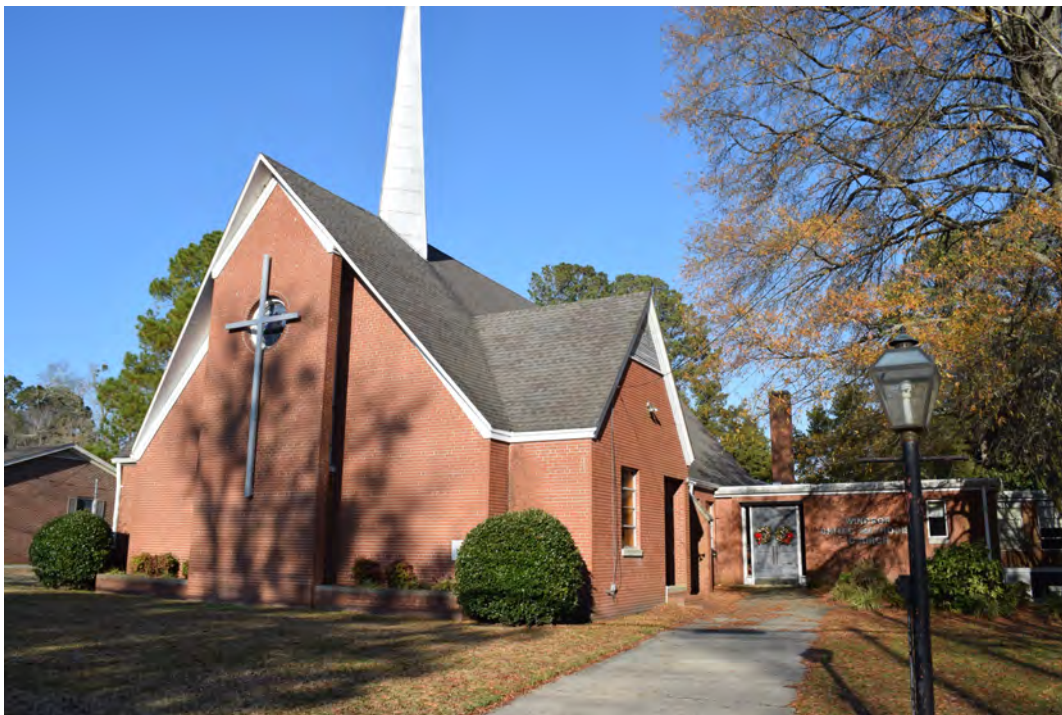
Built in 1962, Windsor United Methodist Church at 408 South Queen Street in Windsor is a red-brick building with a soaring ship's prow gable. A swath of the façade's center wall projects forward and is flanked by windowless expanses on both sides. An original metal-shingle-clad steeple rises from the roof's ridge. An original one-story, flat-roofed classroom wing retains its metal awning-style windows. The sanctuary displays original wood sheathing on the walls and ceiling.

Windsor United Methodist Church, view to the north

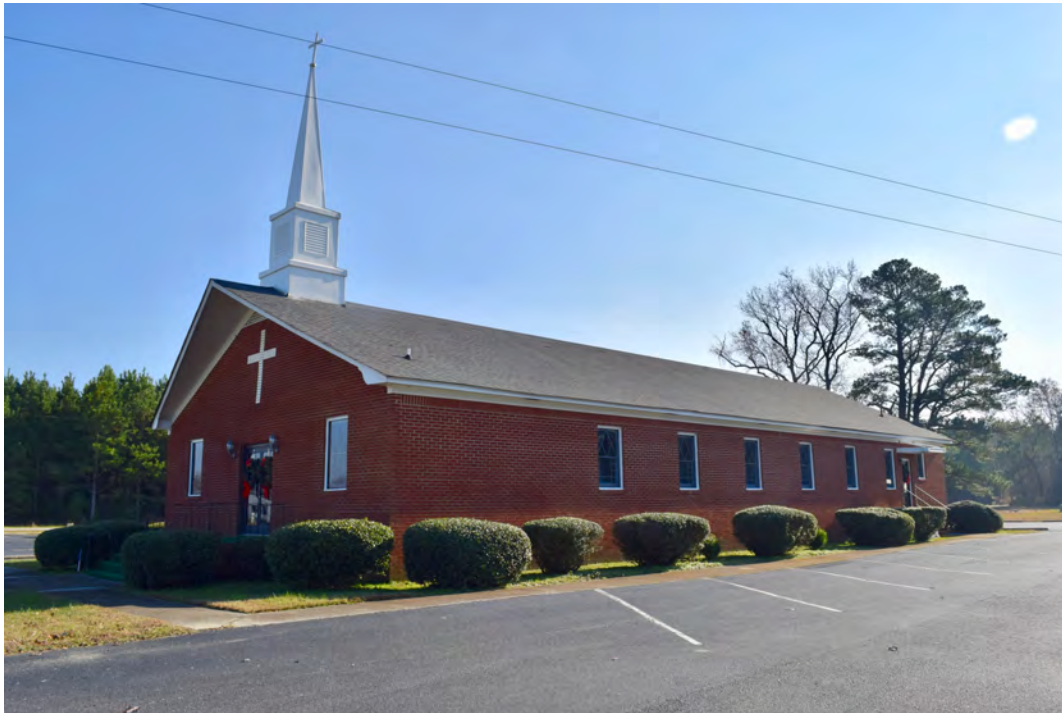
Peterson Chapel Missionary Baptist Church, view to the southeast

Peterson Chapel Missionary Baptist Church at 514 Avoca Farm Road in rural east Bertie County dates to 1974. The restrained modernist red-brick edifice built for an African American congregation displays a ship's prow front gable sheltering a cross crafted from white brick. Other modernist churches in Bertie County include Askewville Assembly of God built in 1960 and Windsor Assembly of God from 1973.

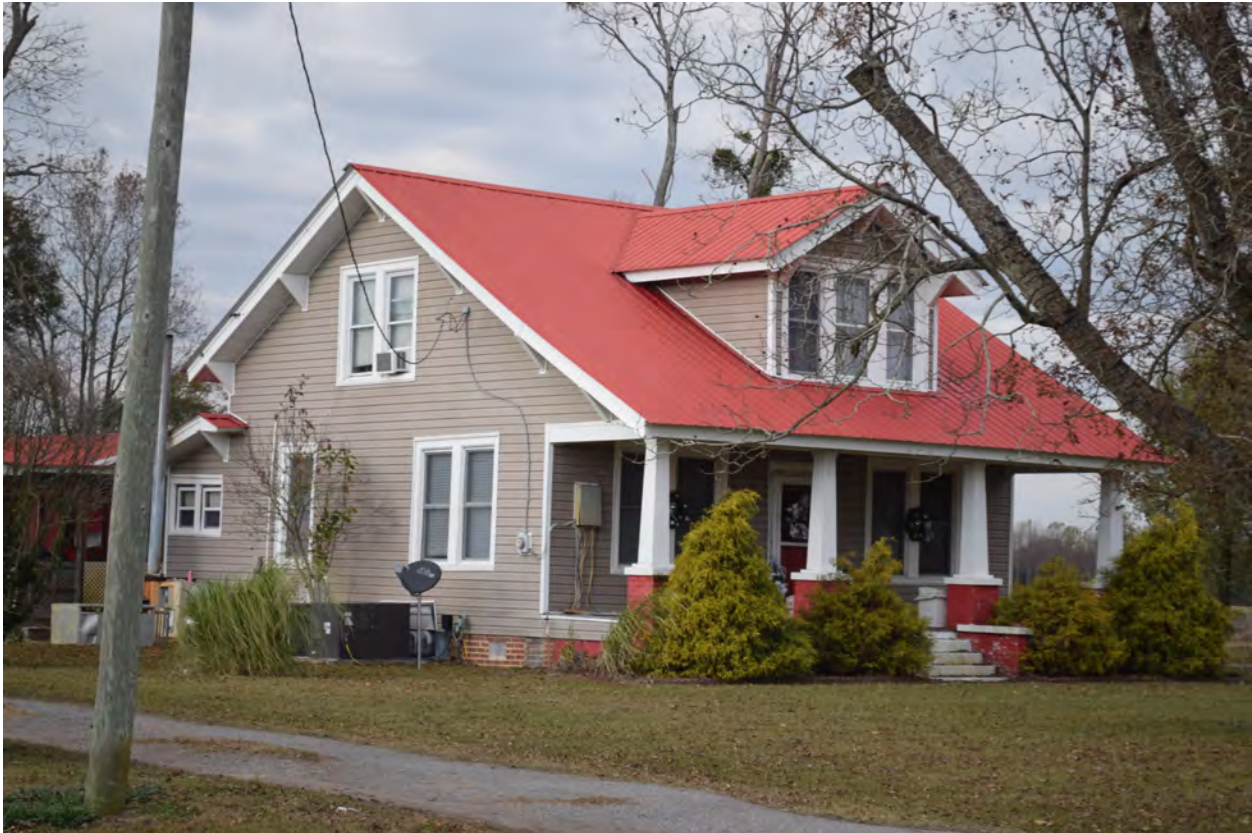
Southeast (front) corner, view to the northwest

One-and-a-half-story, side-gabled bungalow features a full-façade recessed porch supported by battered posts on brick plinths and a one-story gabled rear ell. A front-gable dormer with three replacement windows rests on the front roof slope. Chimneys flues have been removed and all windows have been replaced. Vinyl siding sheathes the exterior. Three modern outbuildings

The Mizelle House stands in its original location in rural Bertie County and therefore retains integrity of location and setting. The house, altered with the application of vinyl siding and replacement of its windows, lacks integrity of workmanship, feeling, design, association, and materials.

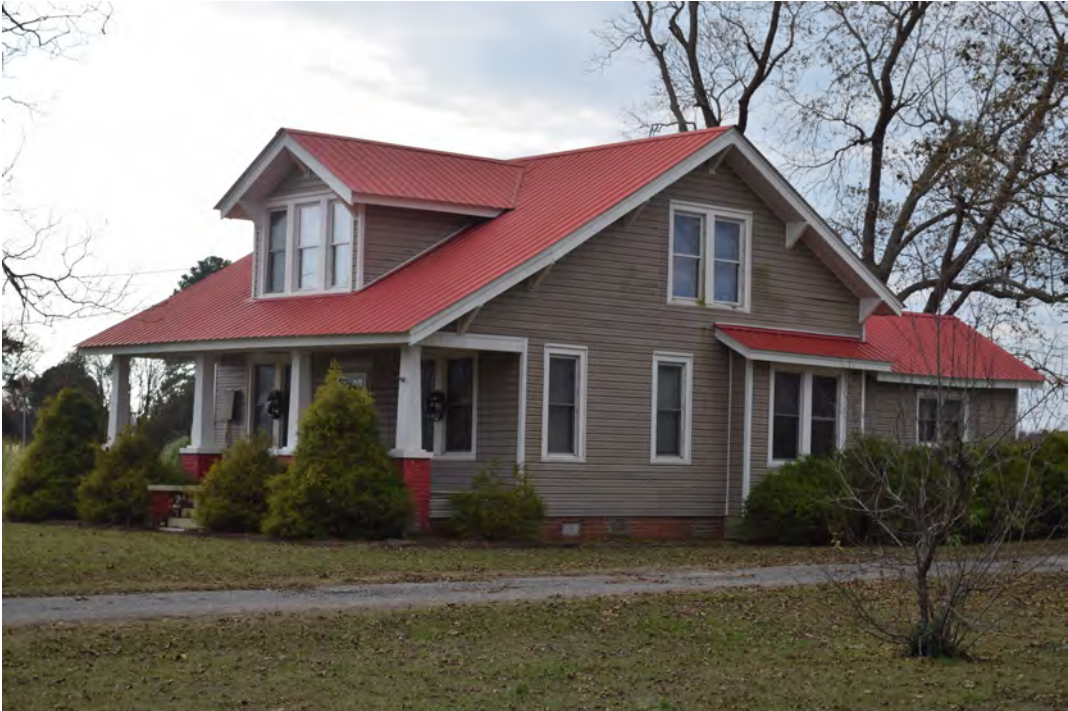
Northeast (front) corner, view to the southwest

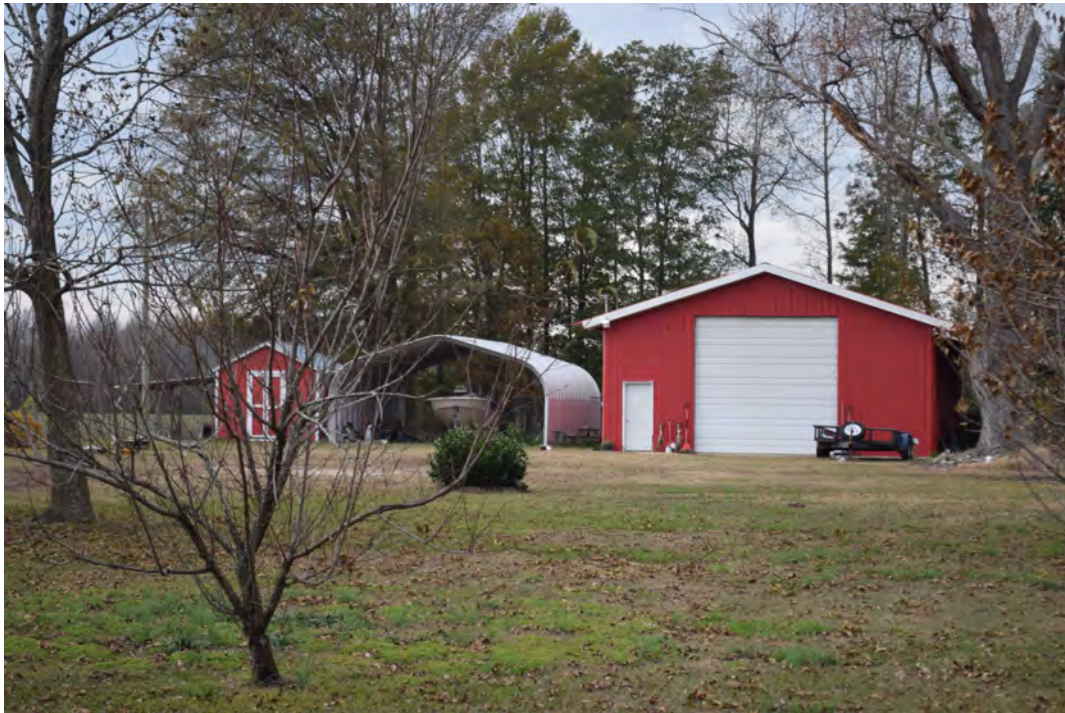
stand behind the house: a large metal-sided barn, a front-gabled storage building with an open shed on the south side and a metal storage building that is open on its façade.

Three outbuildings in rear yard, view to the west

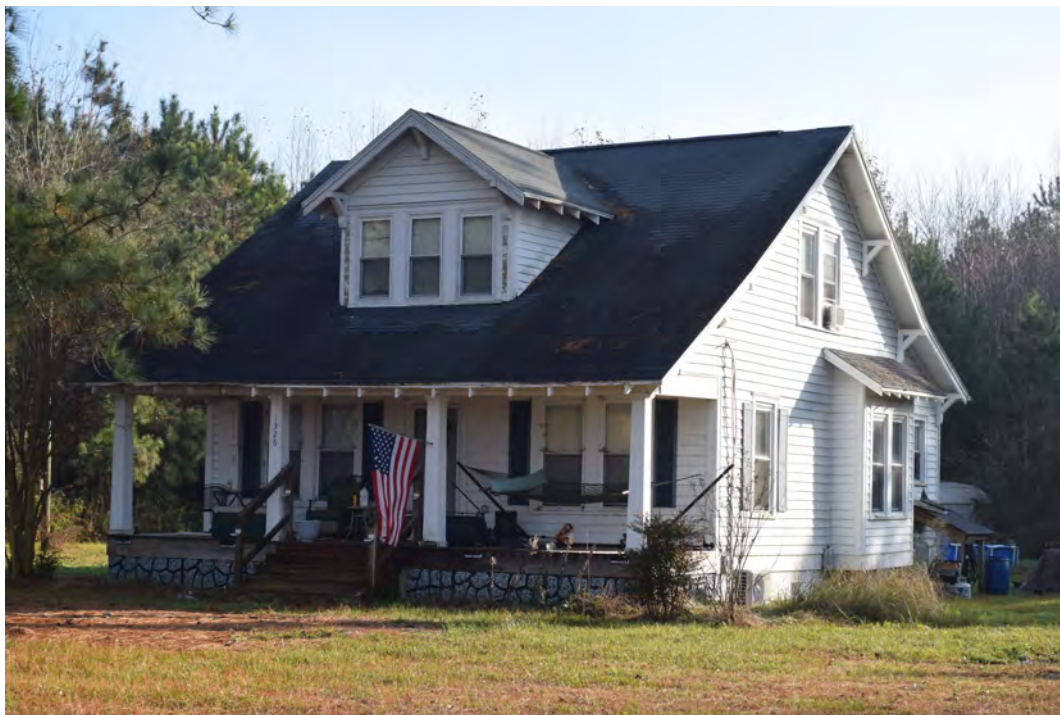
House, view to the northeast

The one-and-a-half-story, side-gabled bungalow features a full-façade recessed porch supported by battered wooden full-height posts. A front-gable dormer with three replacement windows rests on the front roof slope. Chimneys flues have been removed and all windows have been replaced. Aluminum siding sheathes the exterior. The house retains rafter tails and triangular knee braces.

The Harrell House stands in its original location in rural Bertie County and therefore retains integrity of location and setting. The house, altered with the application of vinyl siding and insertion of replacement windows, lacks integrity of workmanship, feeling, design, association, and materials.

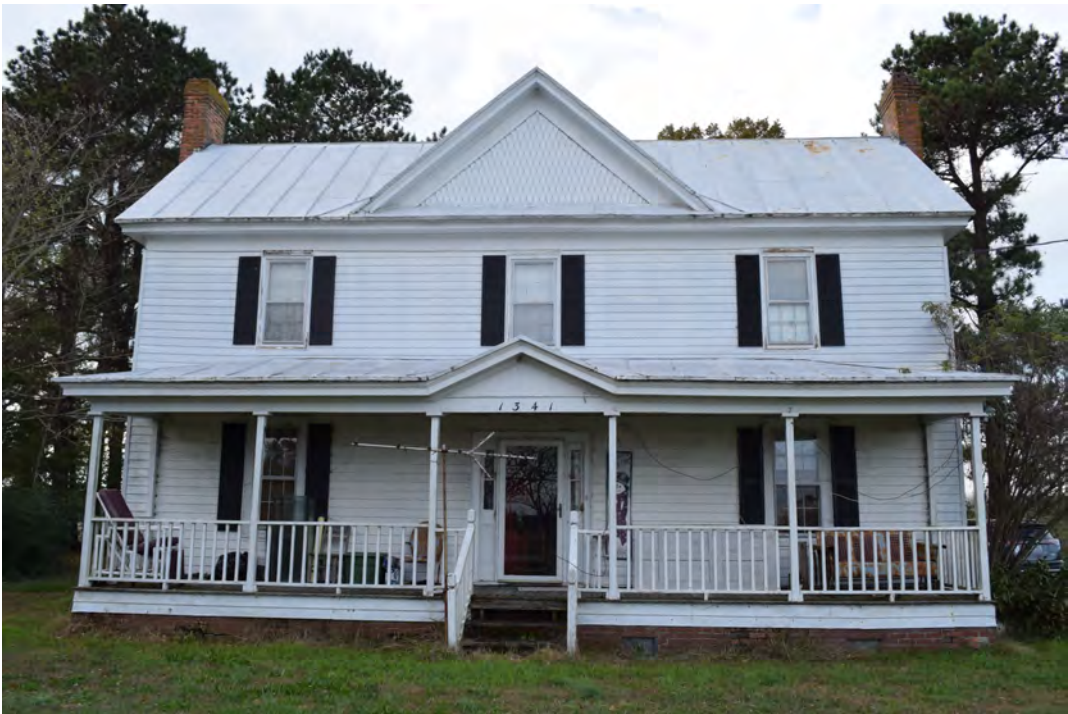
Façade, view to the west

The two-story, triple-A house features a one-story, full-façade, hip-roofed porch supported by slender replacement posts and crowned at the center by a small front gable. Diamond wood shingles sheathe the larger front gable above. Brick chimneys rise from the gable ends of the main block, which also feature returns common on I-houses from the early twentieth century. Original six-over-six windows remain throughout the dwelling. Vinyl siding covers the exterior.

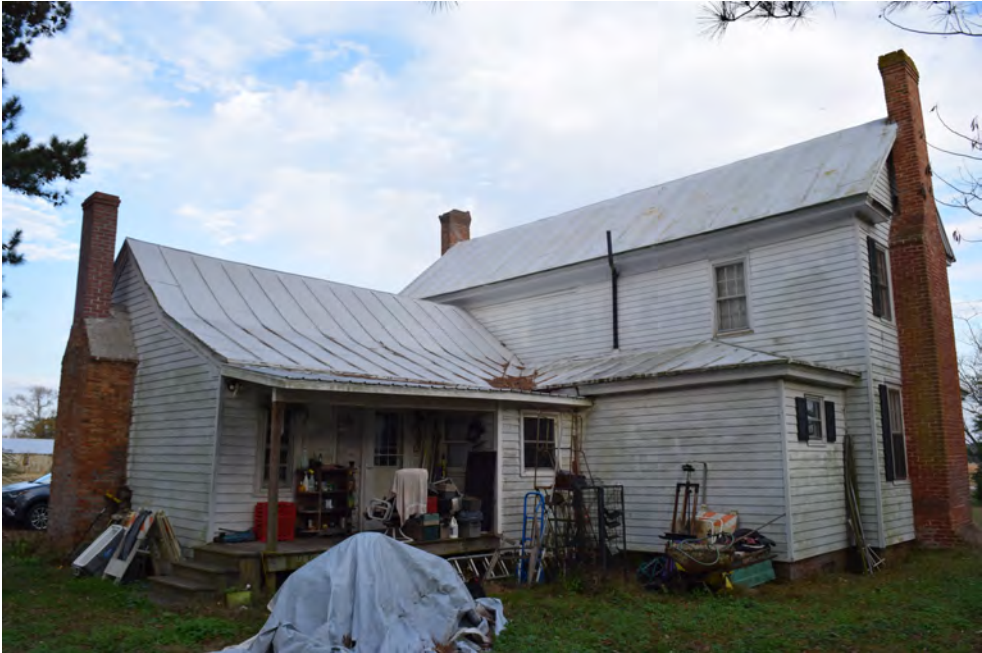
A hip-roofed, one-story room and a one-story ell with flush gable ends extends from the rear elevation. A porch runs along most of the south (side) elevation of the ell. The flue on the chimney at the west end of the ell has been replaced after being knocked down by Hurricane Isabell.

Southwest (rear) corner, view to the northeast

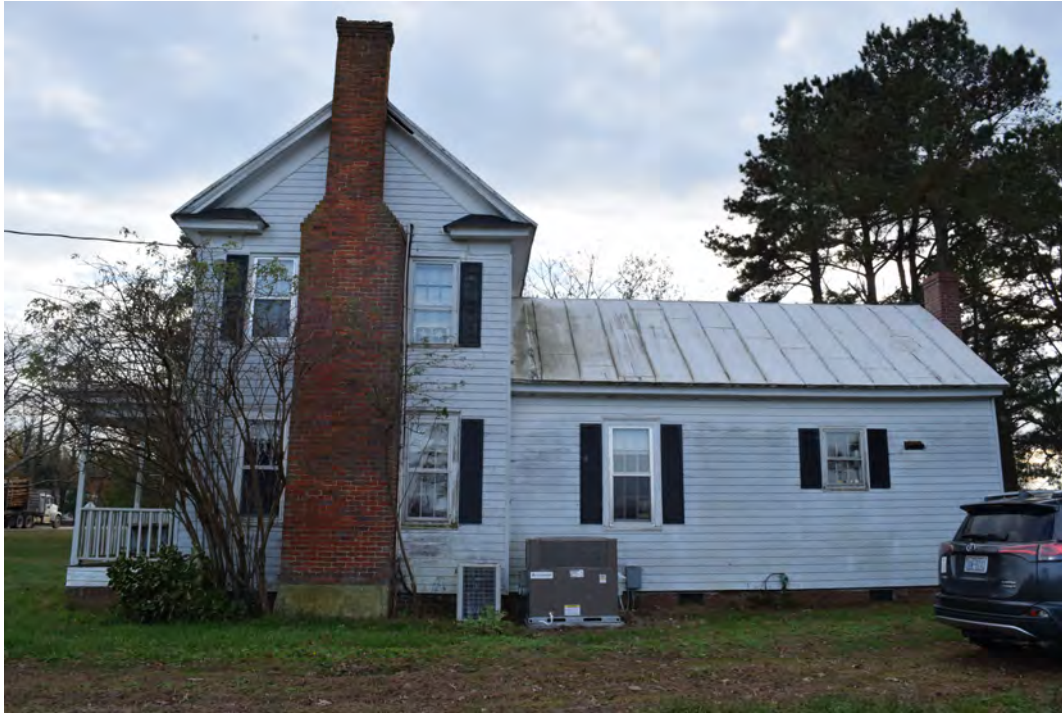
North gable end, view to the south

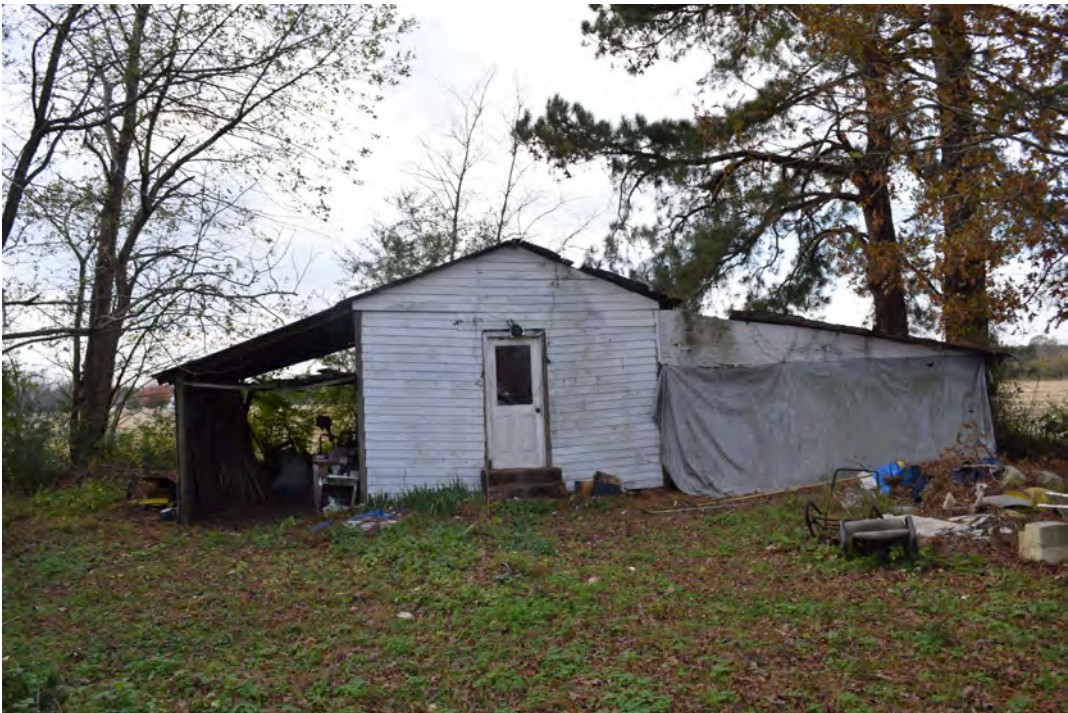
Storage building in rear yard, view to the west

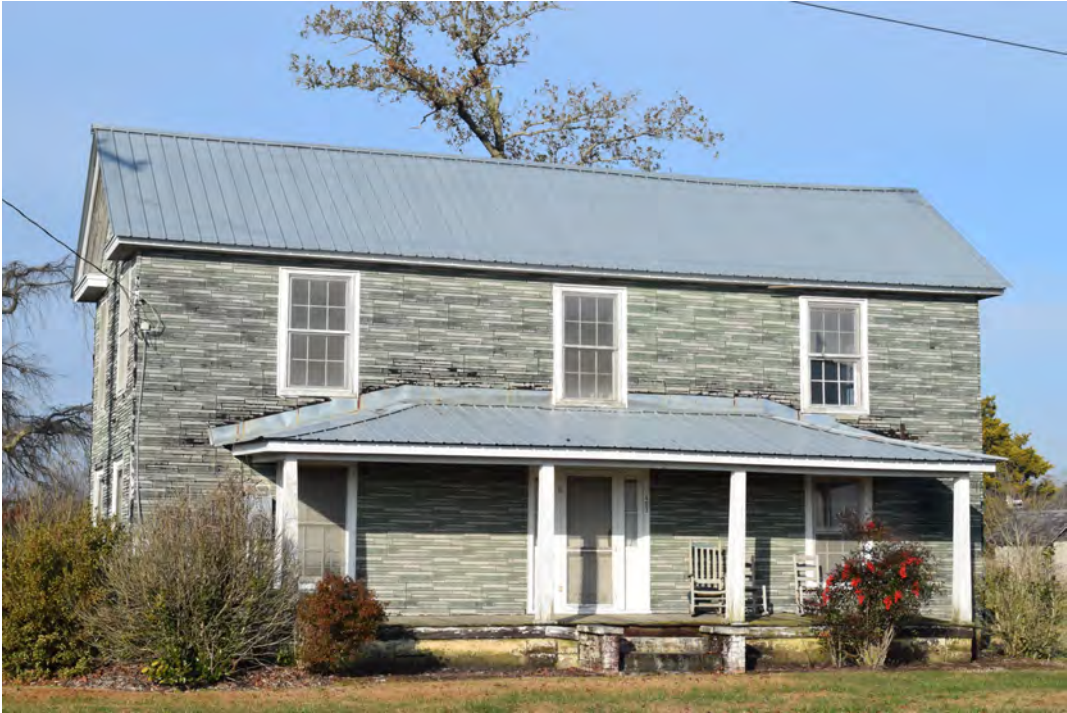
Facade, view to the west-northwest

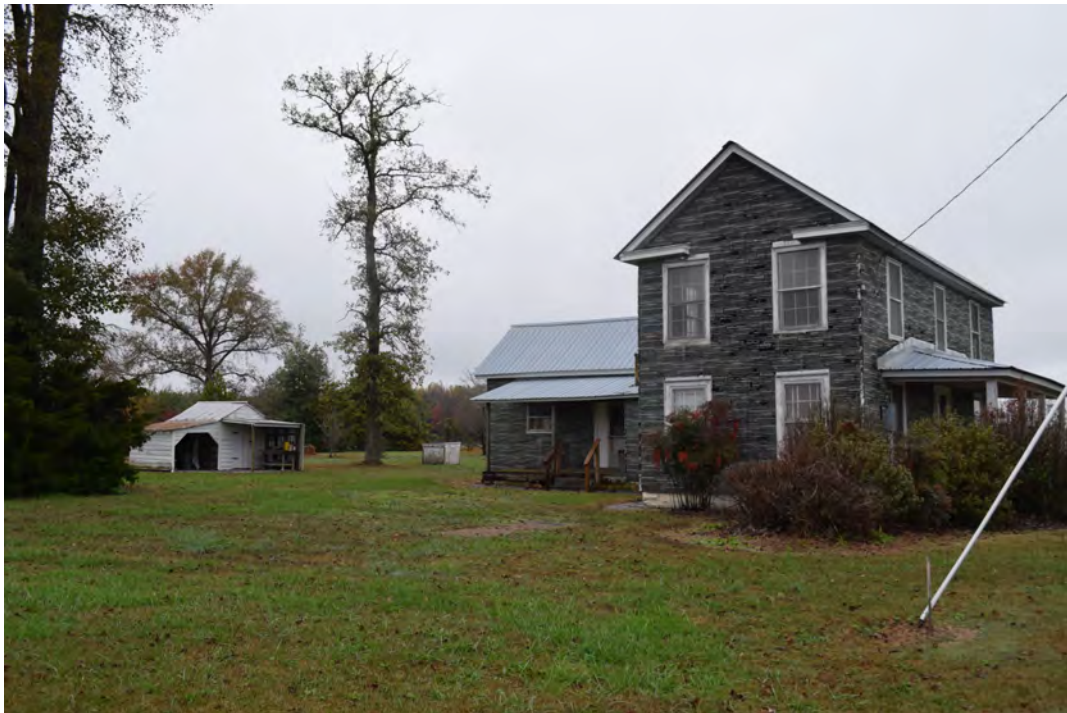
The parcel contains a front-gabled outbuilding with an attached single-bay garage and an open-sided shed.

South elevation and outbuilding, view to the northwest

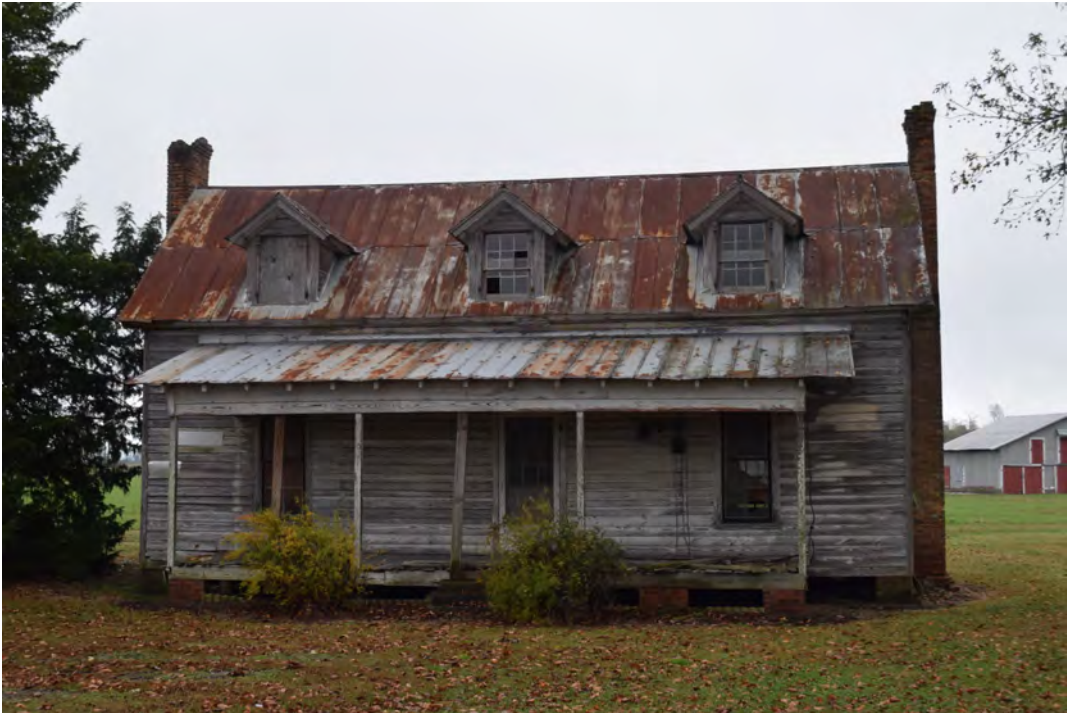
Facade, view to the east

The one-and-a-half-story, side-gabled dwelling with a one-story, gable-roofed ell displays a shed-roofed front porch with slender wood replacement posts and brick chimneys on each gable end of the main block. Original weatherboard and some German siding remain on the exterior. Three front-gabled dormers rest on the front roof slope, while two front-gabled dormers occupy the rear roof slope. A shed roofed porch extends along the rear elevation continuing to the south (side) elevation of the ell. The house rests on brick foundation piers.

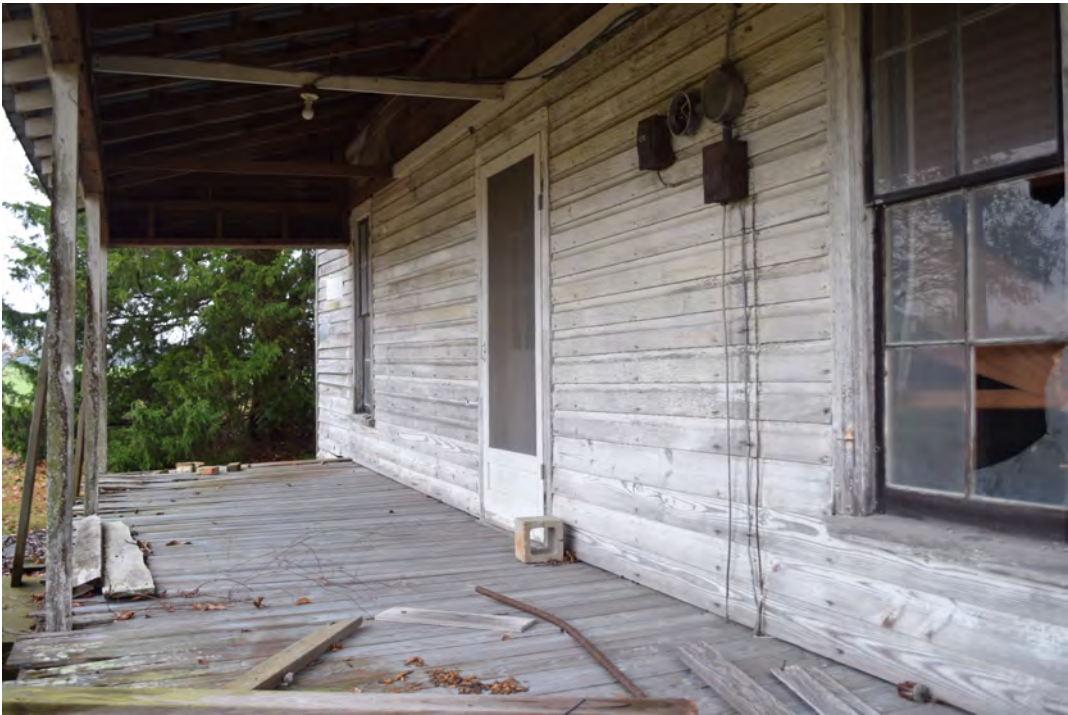
Detail of front porch, view to the north-northeast

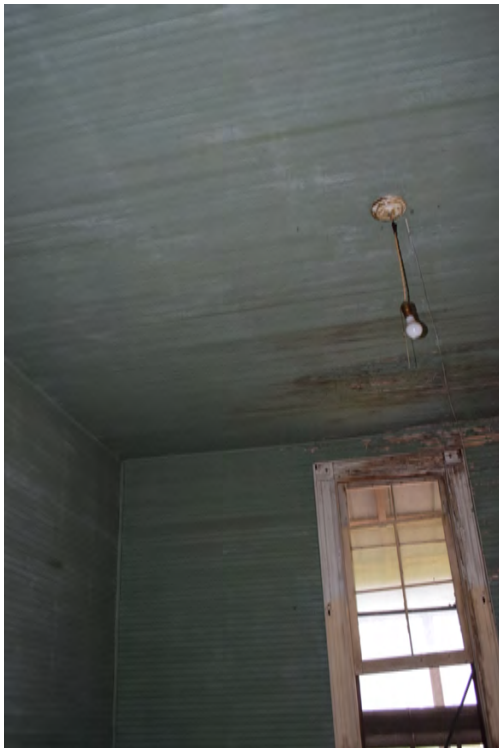
The interior retains original beadboard sheathing on the ceilings and walls, wood floors, and window trim with simple molded corner blocks.

South parlor taken from front window, view to the east

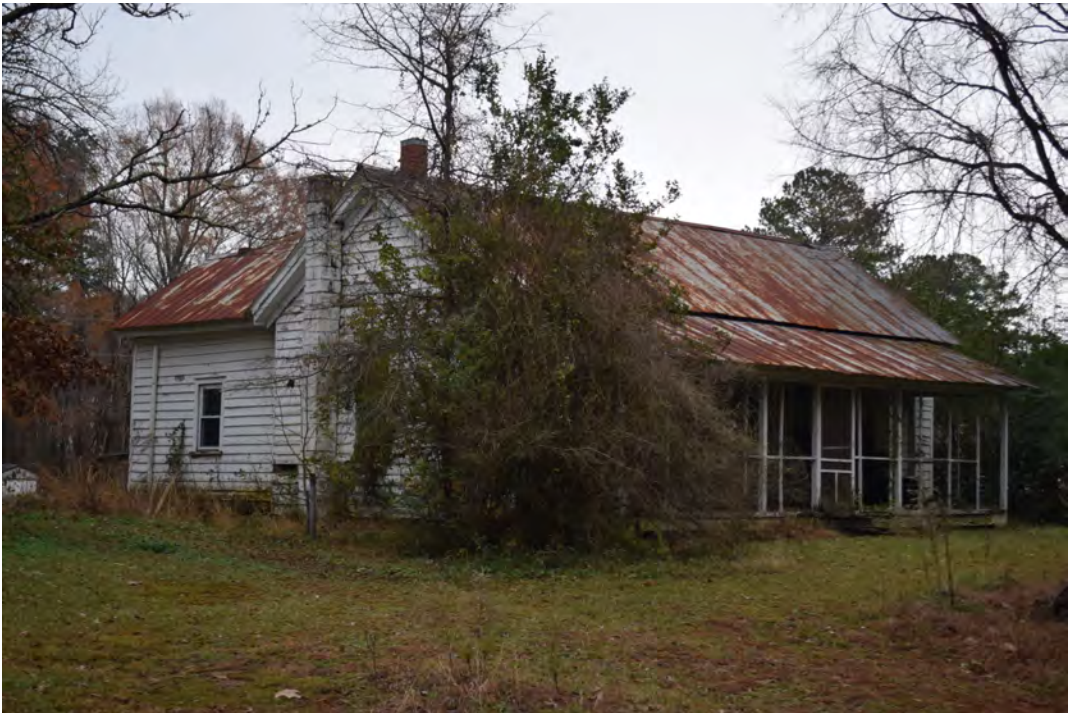
The Bond House at 333 Indian Woods Road southwest of Windsor is a one-story, side-gabled weatherboard house that retains its weatherboard siding. A full-width shed-roofed porch extends along the façade and a single interior brick chimney rises from the roof ridge near the deteriorated dwelling’s north end.

Bond House at 333 Indian Woods Road, view to the southeast

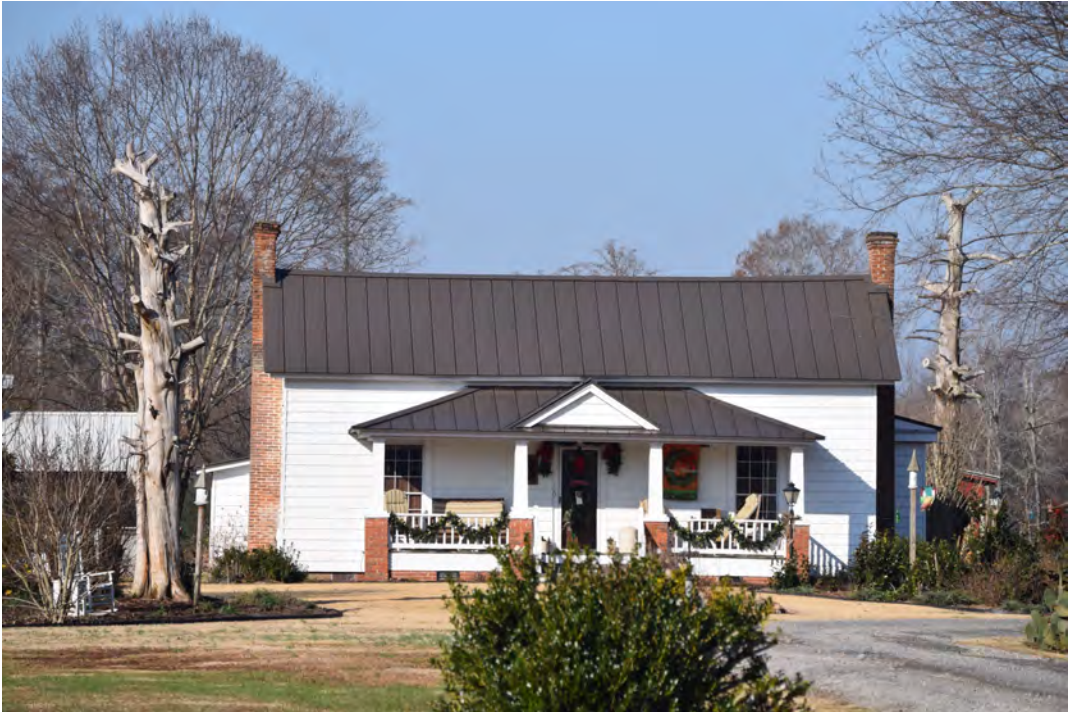
Overflow Farm (BR0764) at 2949 NC 13N contains a one-story, side-gabled dwelling with gable end brick

chimneys. The single-pile house with a later Craftsman porch has been altered with vinyl siding and a modern metal roof.

House on the Overflow Farm (BR0764), view to the west

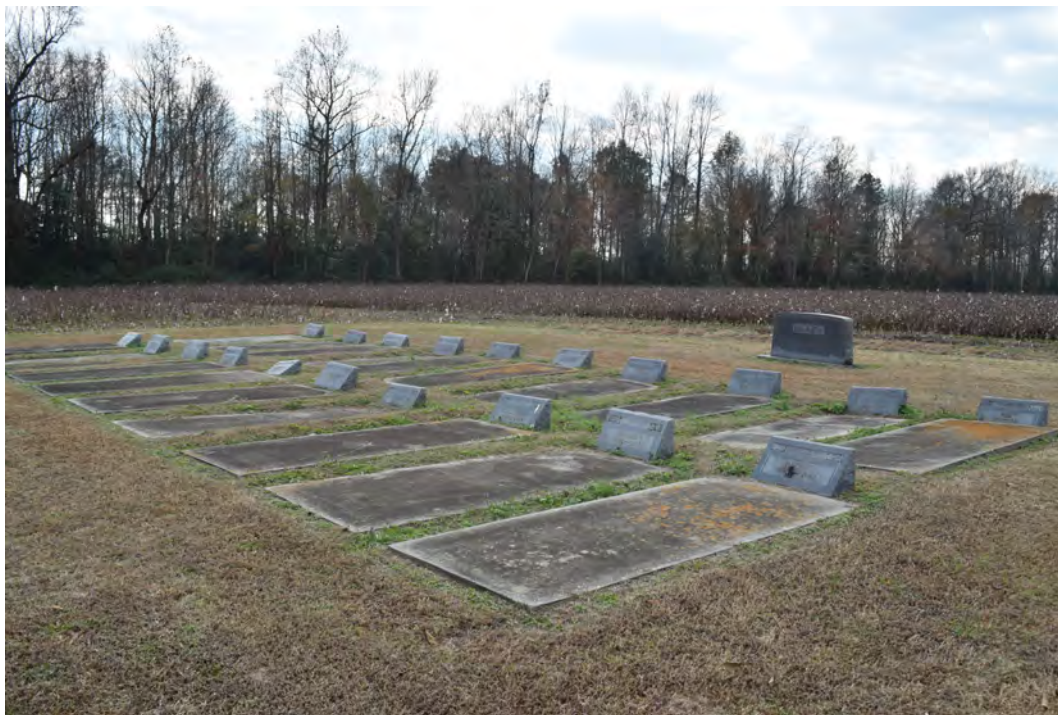
Hassell Cemetery, view to the southwest

The small family cemetery contains twenty identical grave markers installed at the same time or within a short period of one another. Each grave is marked by a gray granite slanted upright headstone behind a flat unmarked rectangular flush ledger tablet. An upright marker at the rear of the cemetery is inscribed “Leary” for the surname of some of the occupants.

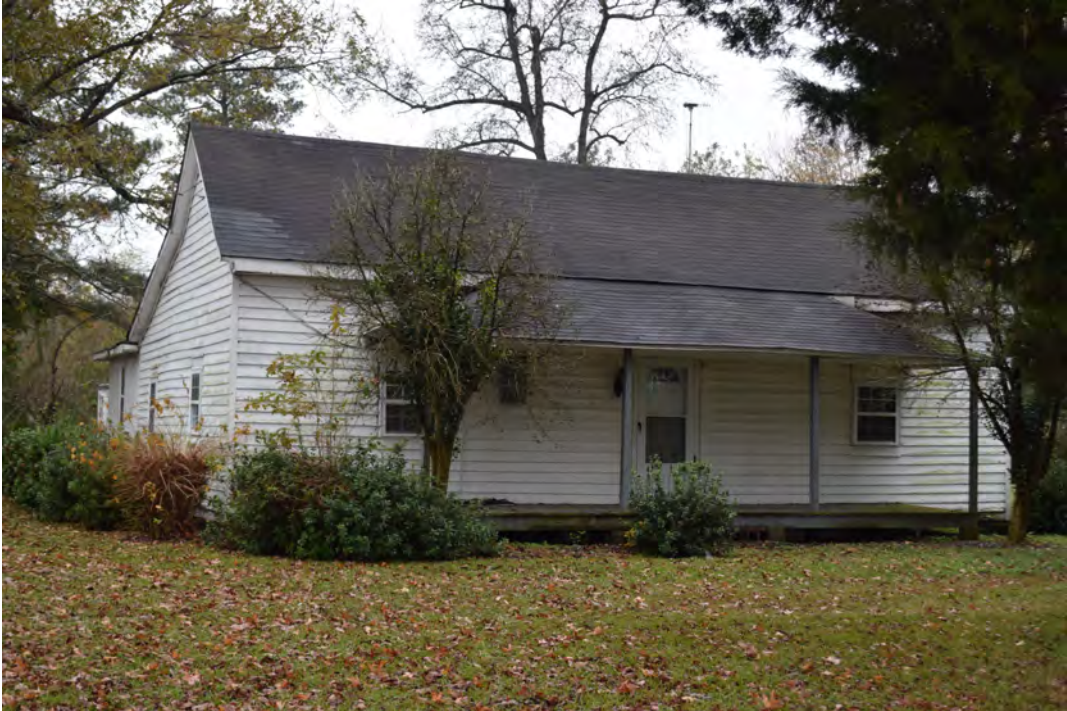
Façade, view to the west

The Wilson House is a one-story weatherboard house standing on a concrete block pier foundation with a side-gabled roof that extends to a shed roof on the rear elevation. A partial-width, shed-roofed porch with plain wood posts and a wood floor shelters the replacement front door. A later ell with a low-pitched gable roof and a plywood exterior extends from the rear elevation. Two brick interior flues extend through the shed-roofed portion of the main block. Window bays on the main block have been minimized and fitted with vinyl replacement windows.

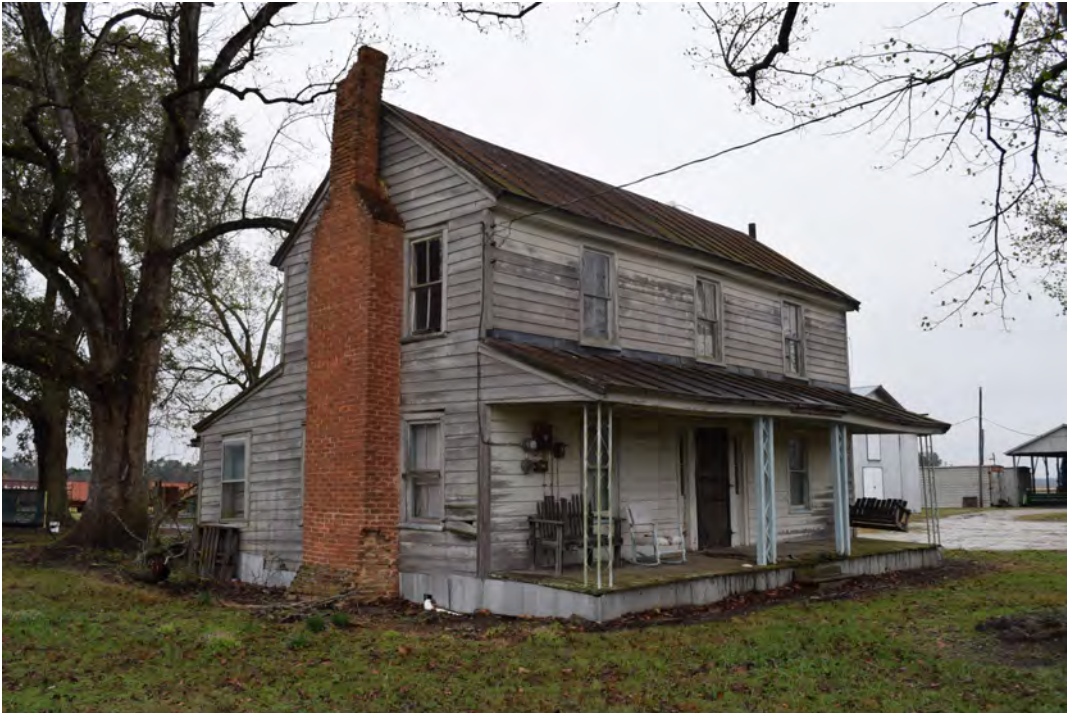
Southeast corner with view of some of the modern farm equipment, view to the northwest

The weatherboard I-house displays a shed-roofed, one-story front porch with decorative iron and wooden posts with lattice. The porch shelters a single-leaf front door with paneled wood and glazed sidelights and a wooden porch floor. Brick chimneys—both damaged at their flues—mark each gable end of the main block. The dwelling features a standing-seam metal roof, a boxed cornice, and intact two-over-two windows. A one-story shed room with a nine-over-six window

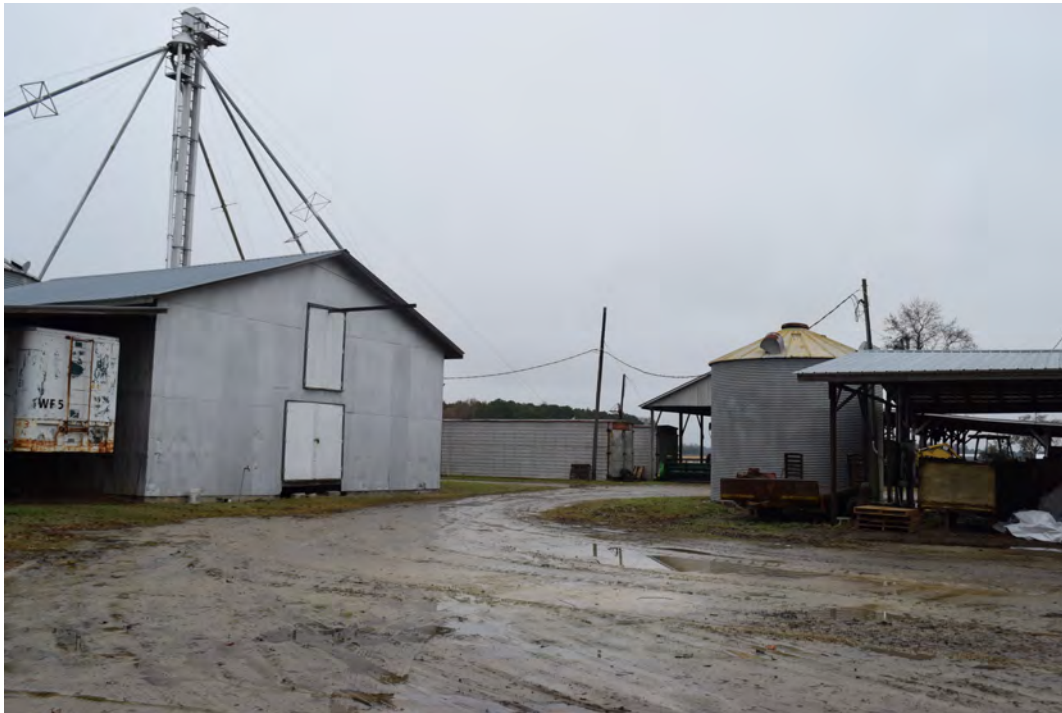
Modern farm buildings and structures located just north of the house, view to the northwest

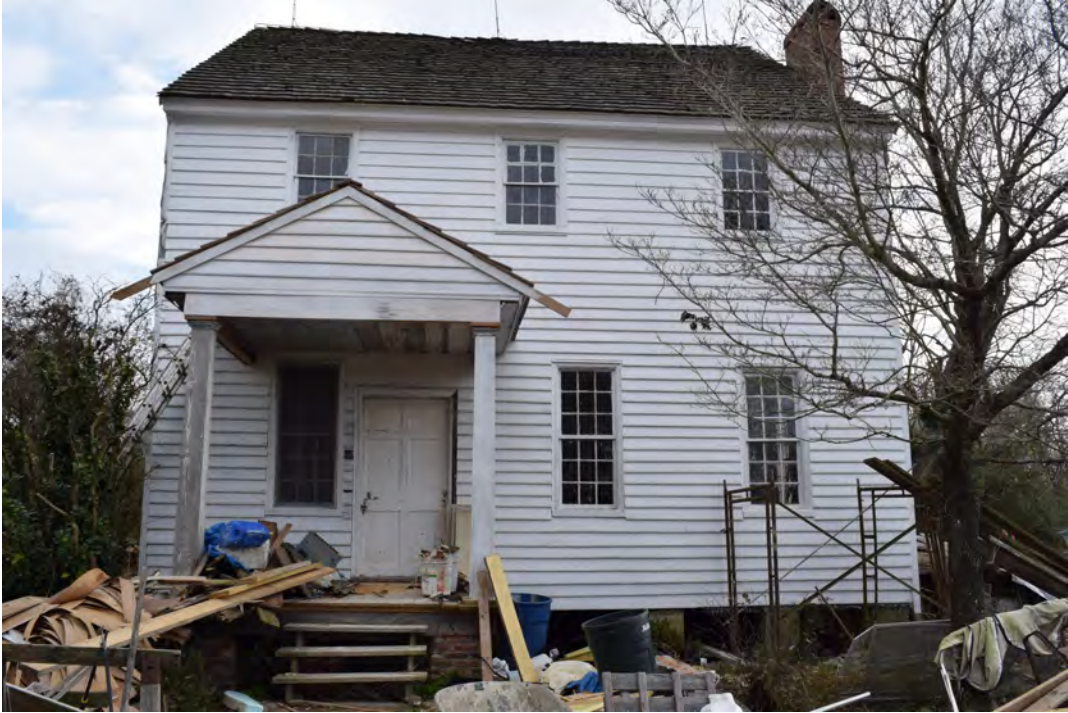
Facade, view to the east

The house faces west-northwest and sits back from NC 45 approximately 420 feet. The two-story, side-gabled house displays a weatherboard exterior—some of which has been replaced in kind with wood from houses of the same period—and a wood shake roof. Portions of the weatherboard are beaded. The front-gabled portico with square posts and simple caps is a modern addition that replaced a circa 1920 Craftsman-style porch. The current portico is based

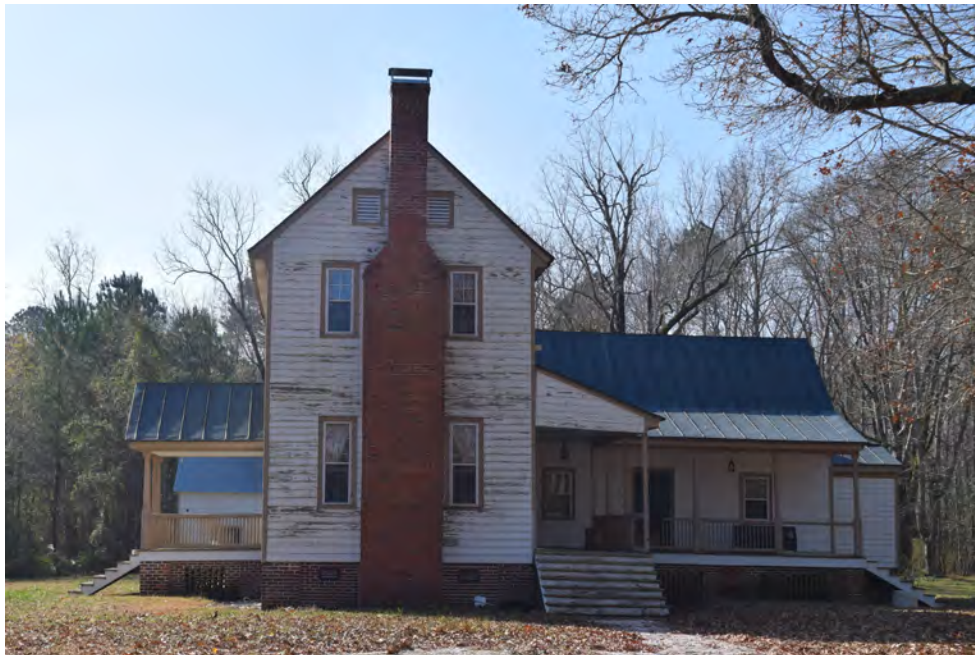
The simple hall-parlor and center-passage floor plans from seventeenth-century building traditions continued in use well into the nineteenth century. A third-floor plan, the side-passage plan, is less often found in surviving dwellings from this period. It is generally associated with double-pile dwellings, also relatively rare, for the access the side hall provides to the full depth of the dwelling. The one-and-a-half-story, double-pile, circa 1830 Eason House (BR0046) has a side-passage, opening to two downstairs rooms. A single room occupies the half-story. An unusual single-pile side-hall example is the circa 1828 Federal-style second phase of the King-Freeman-Speight House (BR0098, NR 1982). The use of the side passage with the shallower depth could relate to its status as an addition to an older house. The passage holds the open stair, and provides access to the parlor on the first floor and three small rooms above. The Eason House and the King-Freeman-Speight house also have decorative painting in common and similar original or early paint colors.³⁸

North elevation of the King-Freeman-Speight House (BR0098, NR), view to the south
