SUBJECT: Historic Structures Survey Report, R-5809, Improve NC 45 from Washington County Line to South of Colerain, PA 18-01-0055, Bertie County, ER 19-1576

MdM Historical Consultants (MdM) prepared this report in December 2018 and April 2019 in support of the proposed improvements to NC 45 from the Washington County line to south of Colerain in Bertie County, North Carolina (TIP# R-5809). The project lies in eastern rural Bertie County just west of the Chowan River. The Area of Potential Effects (APE), the geographic area or areas within which an undertaking may directly or indirectly cause changes in the character or use of historic properties, extends approximately 250 feet in each direction off the center line of the highway. The APE for the project is delineated on a series of maps on pages 9 to 13 of this report.

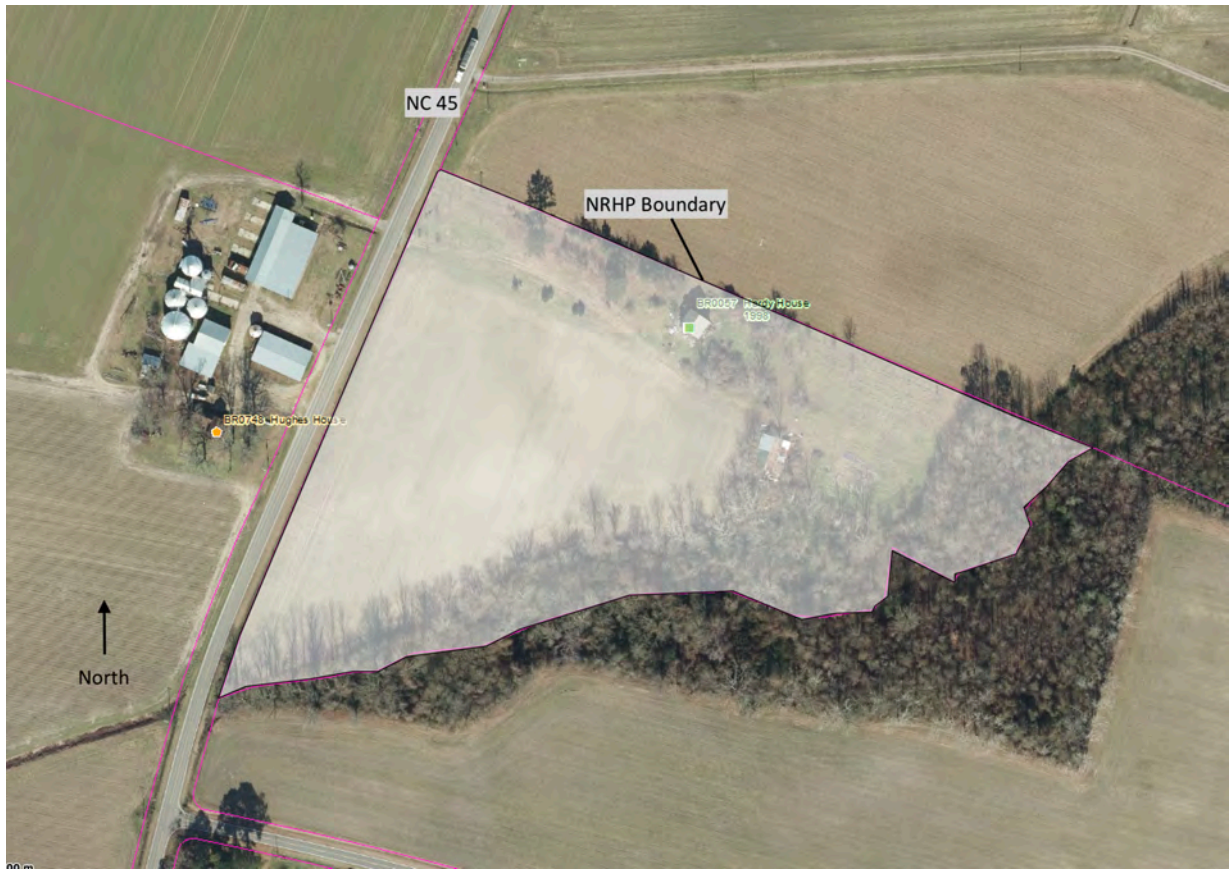
The recommended NRHP boundary for the Hardy House is the twelve acres containing the house, outbuilding, and surrounding acreage. The boundary follows the right-of-way along NC 45, the branch flanked by thick trees along that forms the south and east property line and the south edge along the cultivated field directly to the north. The twelve-acre boundary provides a historically appropriate setting for the house, which is recommended eligible for the NRHP for its architectural significance.

NRHP boundary map, created from HPOWEB

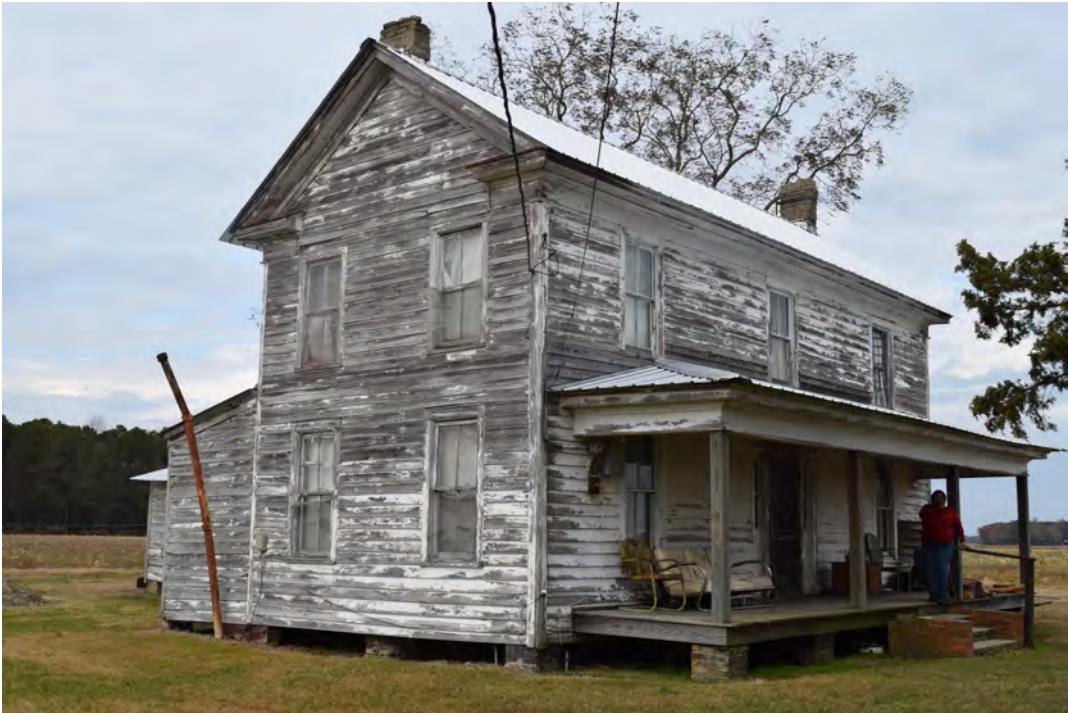
Southeast (front) corner, view to the northwest

The weatherboard I-house stands on brick pier foundation and is topped with a standing seam metal roof. The dwelling displays restrained Greek Revival-style elements most notable in the cornerboards with caps and the paneled and glazed sidelights flanking the front door. The nearly-unpainted house features a one-story, hip-roofed front porch with replacement wood posts, cornice returns, and a pair of interior end brick chimneys on the main block. A small shed room attaches to the south end of the rear of the main block. A one-story, gable-roofed ell with an exterior end chimney extends from the rear elevation. A partial width recessed porch spans the

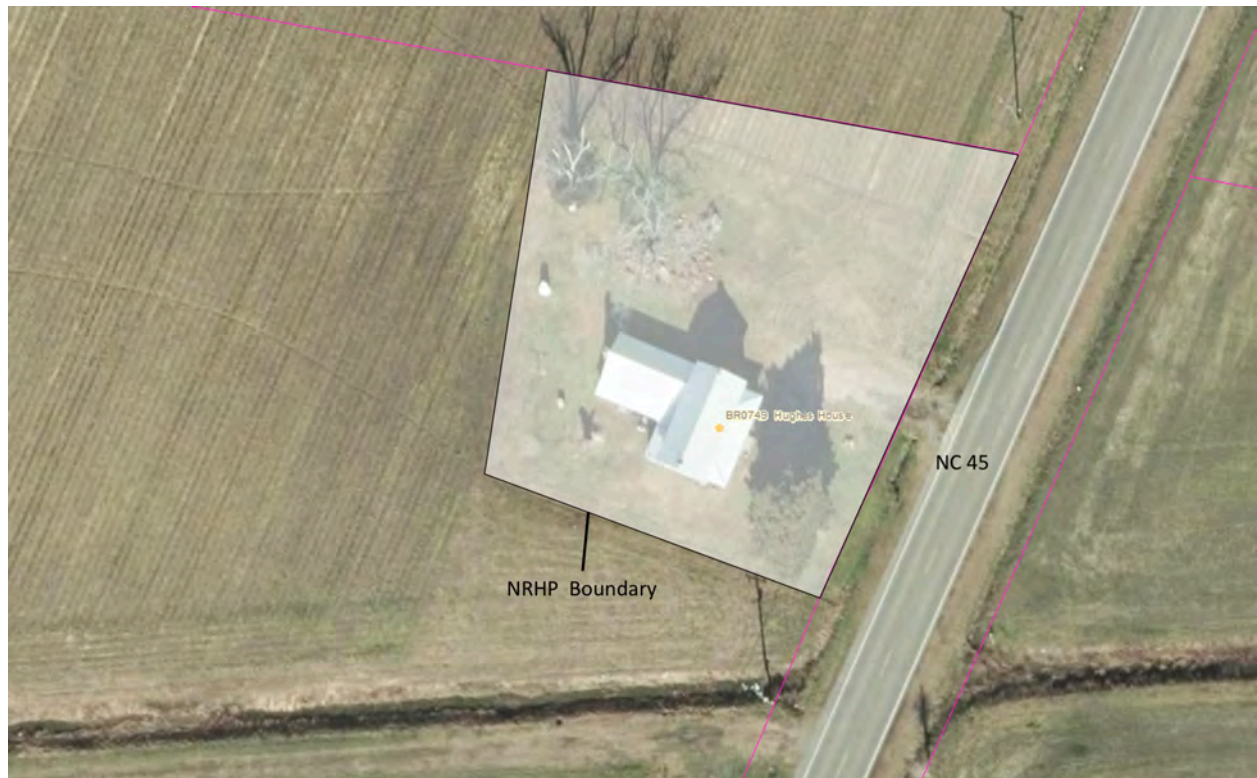
The recommended NRHP boundary for the Hughes House is the one-half acre containing the house and immediate yard. The boundary follows the right-of-way along NC 45 and the border of the immediate yard containing the house. The boundary excludes the remaining forty-nine-and-a-half acres of the tract because that acreage is unrelated to the house's significance in the area of architecture. The .5-acre boundary provides a historically appropriate setting for the house, which is recommended eligible for the NRHP for its architectural significance.

NRHP boundary map, created from HPOWEB

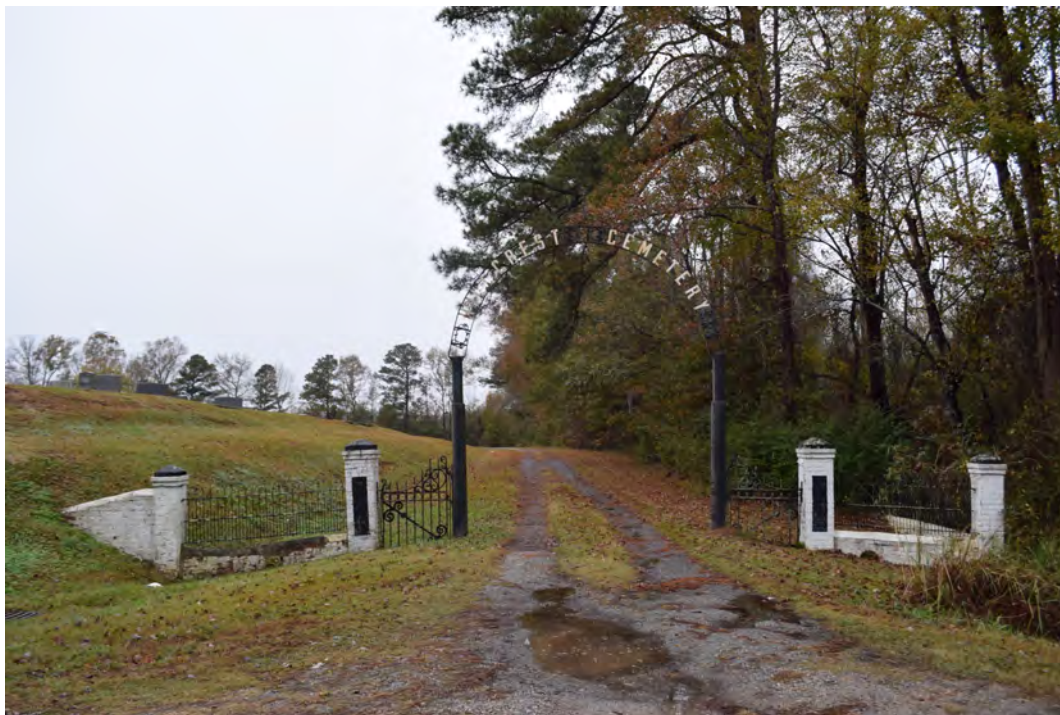
North entrance from NC 45, view to the west

A metal archway on tall metal poles marks the north entrance to the cemetery. White-brick and iron gates flank the arched entrance. The driveway under the arch continues westward and extends on the north side of property. Four dirt driveways extend roughly north south between the main north entrance road to the parallel south secondary entrance. These four drives divide the cemetery into five unequal sized sections.

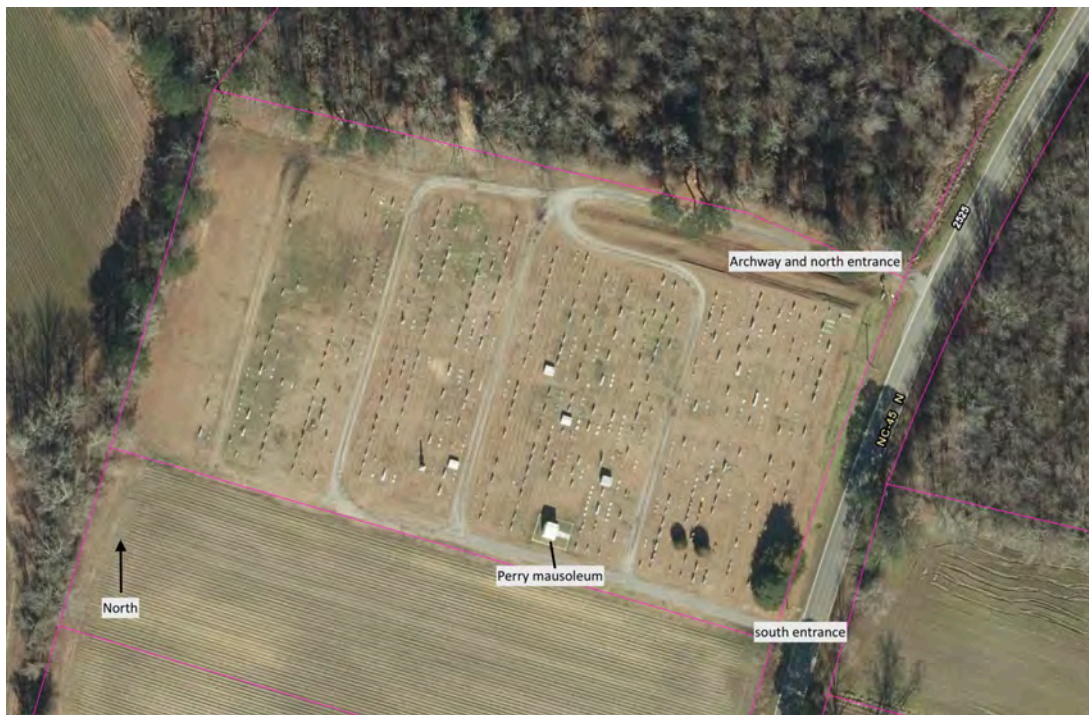
Site plan, created from HPOWEB

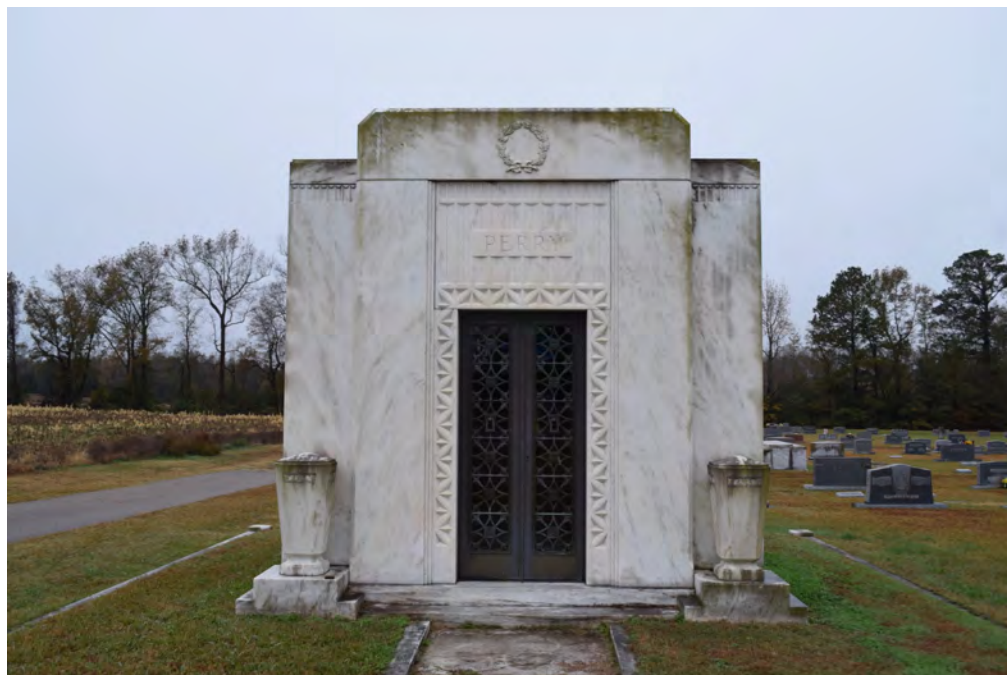
The cemetery contains one large mausoleum for the Perry family and several smaller free-standing burial vaults associated with other families. The Perry mausoleum is a flat-roofed marble edifice inscribed with the family name and festooned with a wreath motif above its traceried metal double-leaf doors. A pair of marble urn-like objects flank the entrance. Elsewhere, the cemetery contains typical markers such as obelisks and flat and upright tablets. Granite is the most common material for markers.

Perry Mausoleum, view to the west
