SUBJECT: Historic Structures Survey Report, Replace Bridge 250 on SR 118 over Clear Creek,
PA 18-101-0004, Cabarrus County, ER 19-1577

Historic Structure Report
Bridge No. 250 Replacement, on SR 1118 (Ben Black Road)
Over Clear Creek, WBS No. 17BP.10.R.104, PA No. 18-10-0004
Cabarrus County, North Carolina
S&ME Project No. 4213-19-049

**Historic Structure Report
Bridge No. 250 Replacement
SR 1118 (Ben Black Road) over Clear Creek
Cabarrus County, North Carolina**

2.1 Small-Black House (CA1593)

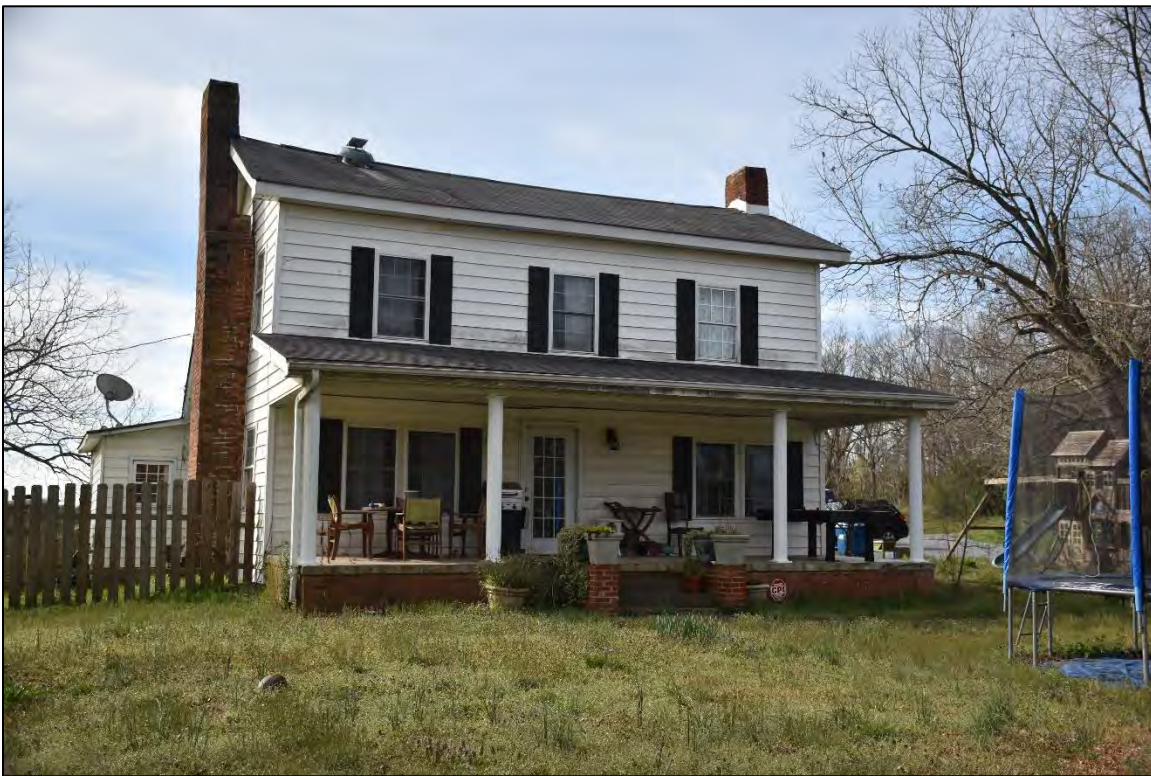
Figure 2.1. Small-Black House (CA1593), house, facing south.

The Small-Black House (CA1593) is located at 1480 Ben Black Road, on a hill above Clear Creek, approximately 0.45-mile southeast of the intersection of Ben Black Road and Bethel Avenue Extension; the house is located in the southwestern portion of Cabarrus County, approximately 0.6-mile east of its boundary with Mecklenburg County (Figures 1.1 and 1.2). The main portion of the house was originally constructed around 1886, but shows evidence later additions, dating from the early-twentieth century. It is located on an 18.36-acre parcel of land, set back from the road and shielded by large trees planted along the right-of-way. The property also includes ten standing outbuildings, the remains of one outbuilding that is no longer extant, and fields that are used for livestock pastures.

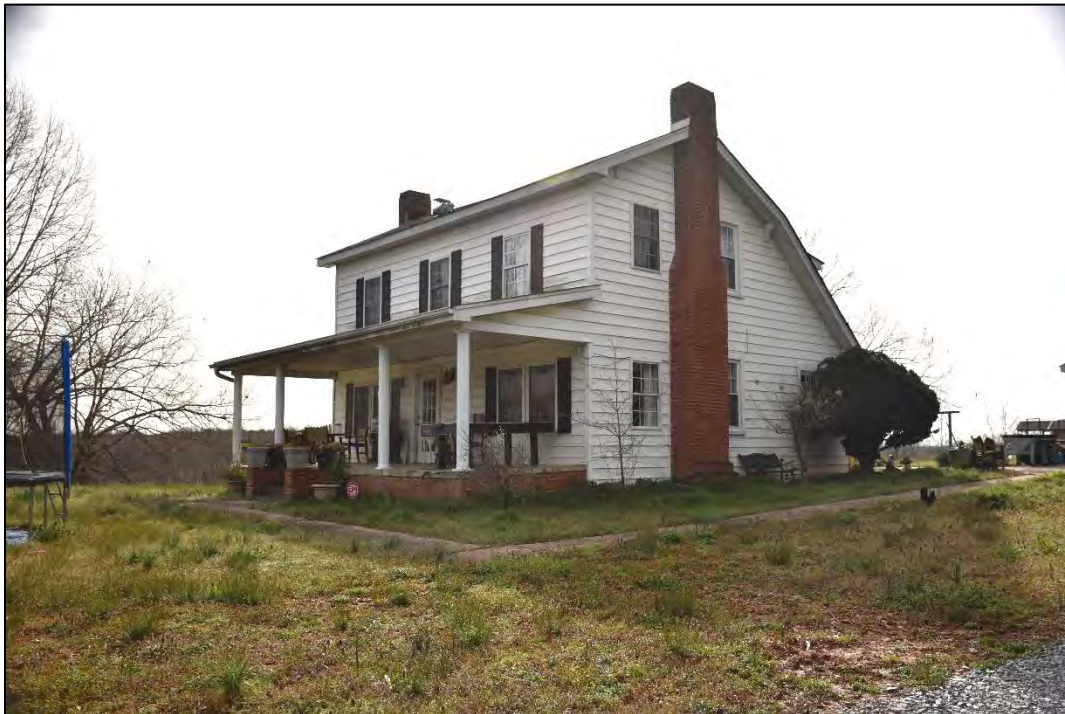
The house is oriented with its front elevation facing north, toward Ben Black Road. The original section of the structure is an I-house with a three bay façade and side-gabled roofline; the foundation on this portion of the house is hidden under modern siding. The front elevation has an off-center doorway, which consists of a modern fiberglass door with 15-pane glass; it is flanked by paired six-over-six, double-hung, vinyl sash windows (Figures 2.1 and 2.3). The upper story has three evenly spaced six-over-six, double-hung, vinyl sash windows. A one-story, shed-roofed porch spans the front elevation and is supported by metal fluted Doric columns; the porch floor is concrete on top of a modern brick foundation and the access stairs are concrete flanked by a short brick wall. Centered within each gable end is a brick chimney that rests on a stepped stone foundation (Figure 2.3). The original portion of the house is two bays deep, with single six-over-six, double-hung, vinyl sash windows flanking the chimney, on both the first and second story, on each side elevation (Figures 2.4–2.7). The windows in front of the chimney are a shorter, wider window than those behind the chimney, which appear to retain at least some of the original window casing. Along the eave overhang, two triangular brackets are visible on the east elevation.

Figure 2.3. Small-Black House (CA1593), house, facing southeast.

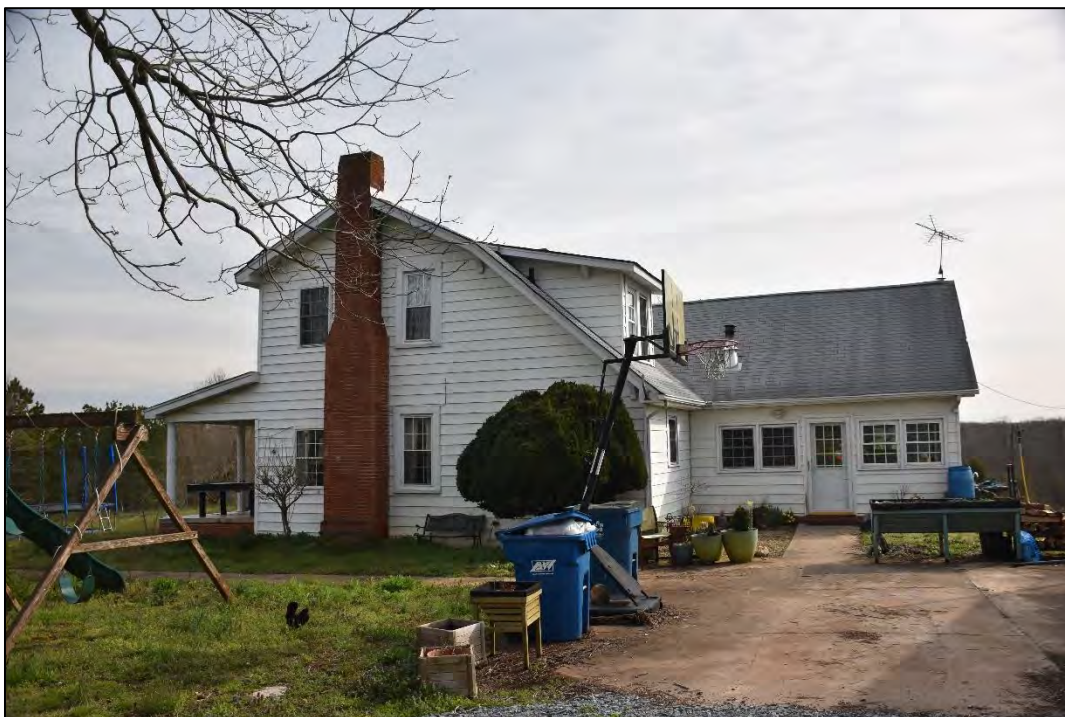
Figure 2.4. Small-Black House (CA1593), house, facing east.

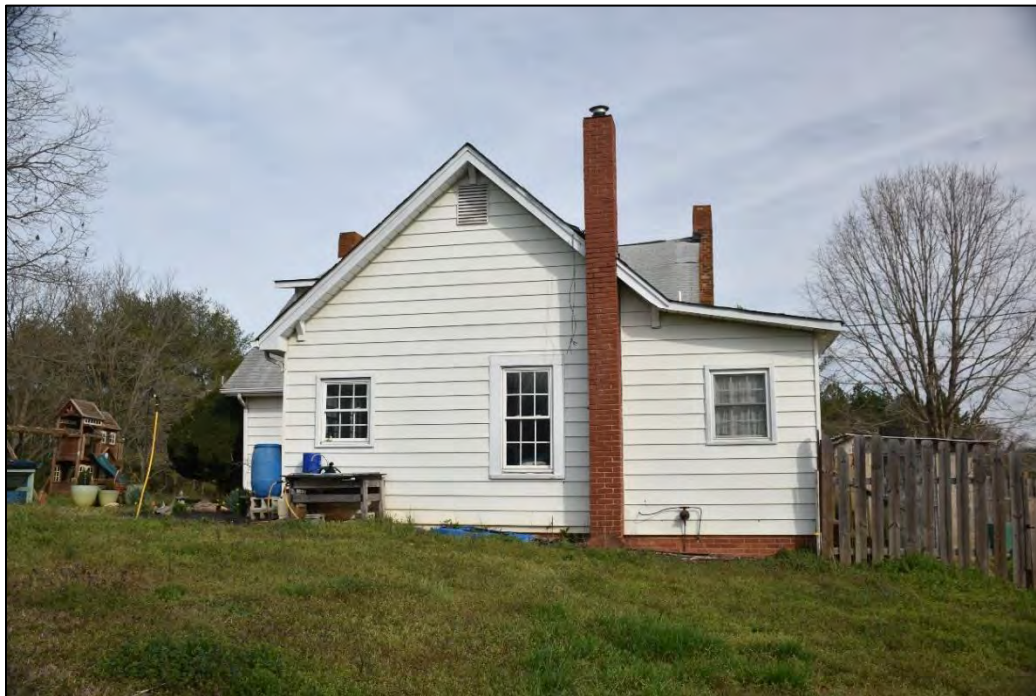
added to the western half of the addition to create a one and one-half-story space and the dormer has a paired six-over-six, double-hung, vinyl sash window (Figure 2.5).

Figure 2.5. Small-Black House (CA1593), house, facing north.

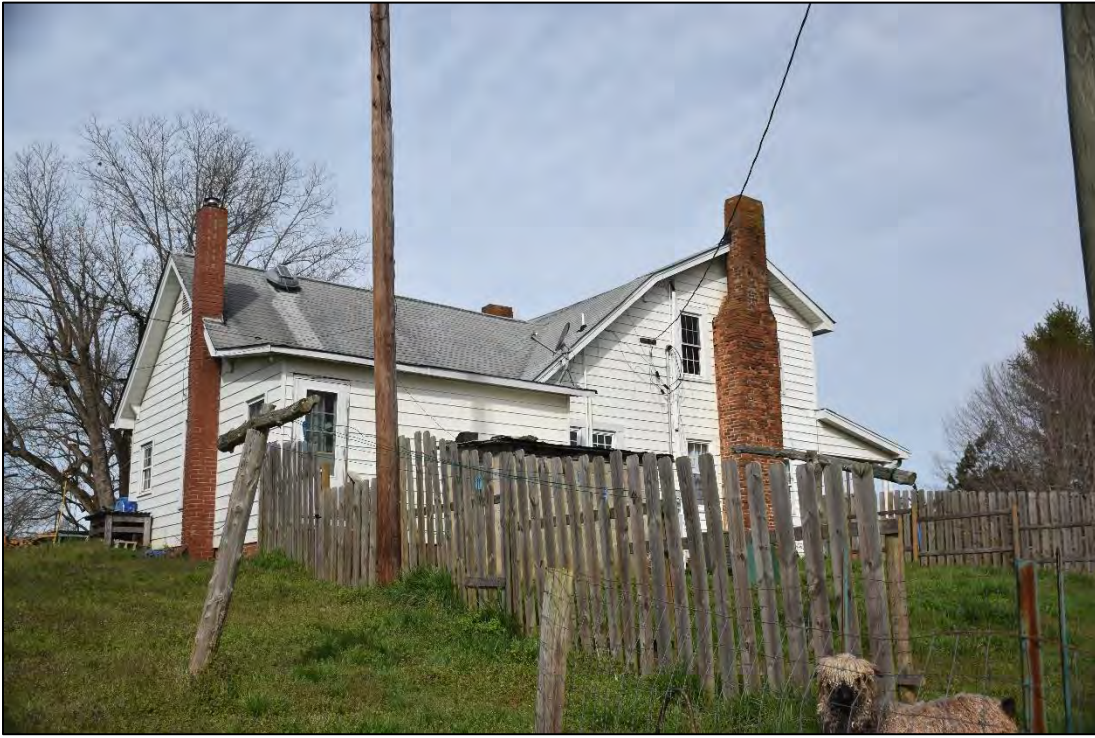
Attached to the shed-roofed addition is a single story, gabled rear ell. The ell was likely built in the early twentieth century, as it has vestige brackets in its gable end and appears to rest on a brick pier foundation that has been partially covered with modern siding (Figure 2.5). The window configuration suggests that the ell may have originally had an open porch on its western elevation, as it has a central doorway flanked by two small six-over-six, double-hung, vinyl sash windows on either side (Figure 2.4). The south elevation of the ell shows the difference in windows between the western side and the eastern side, with a single small six-over-six, double-hung, vinyl sash window to the west and a taller six-over-six, double-hung, vinyl sash window to the east, cased in a simple surround (Figure 2.5). There is a rectangular attic vent in the gable end of the rear ell and an exterior brick chimney is visible along the south elevation. A small, shed-roofed, single story addition has been appended to the eastern wall of the rear ell (Figures 2.5 and 2.6). This addition sits on a modern brick foundation that matches the current foundation on the front porch; it has single, six-over-six, double-hung, vinyl sash window on its south wall. On the eastern elevation of this section, there is an entry door, leading to a fenced section of the yard, while there is a single six-over-six, double-hung, vinyl sash window on the small northern wall of the addition (Figure 2.7).

Figure 2.6. Small-Black House (CA1593), house, facing northwest.

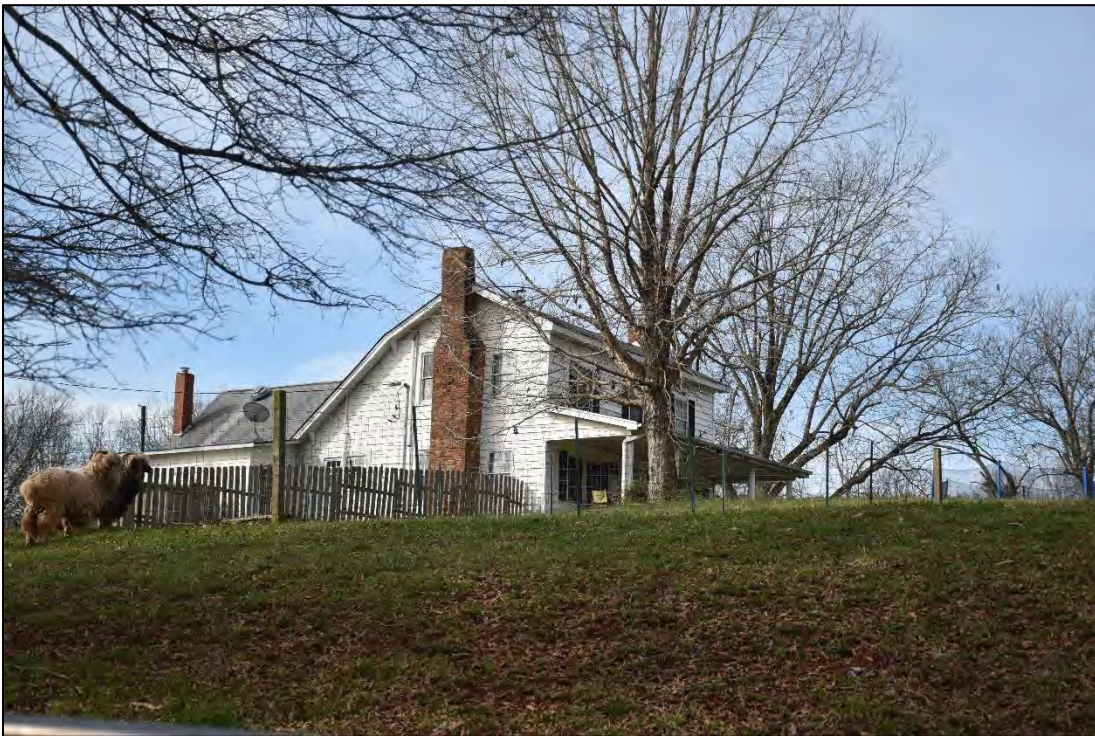
Figure 2.7. Small-Black House (CA1593), house, facing southwest.

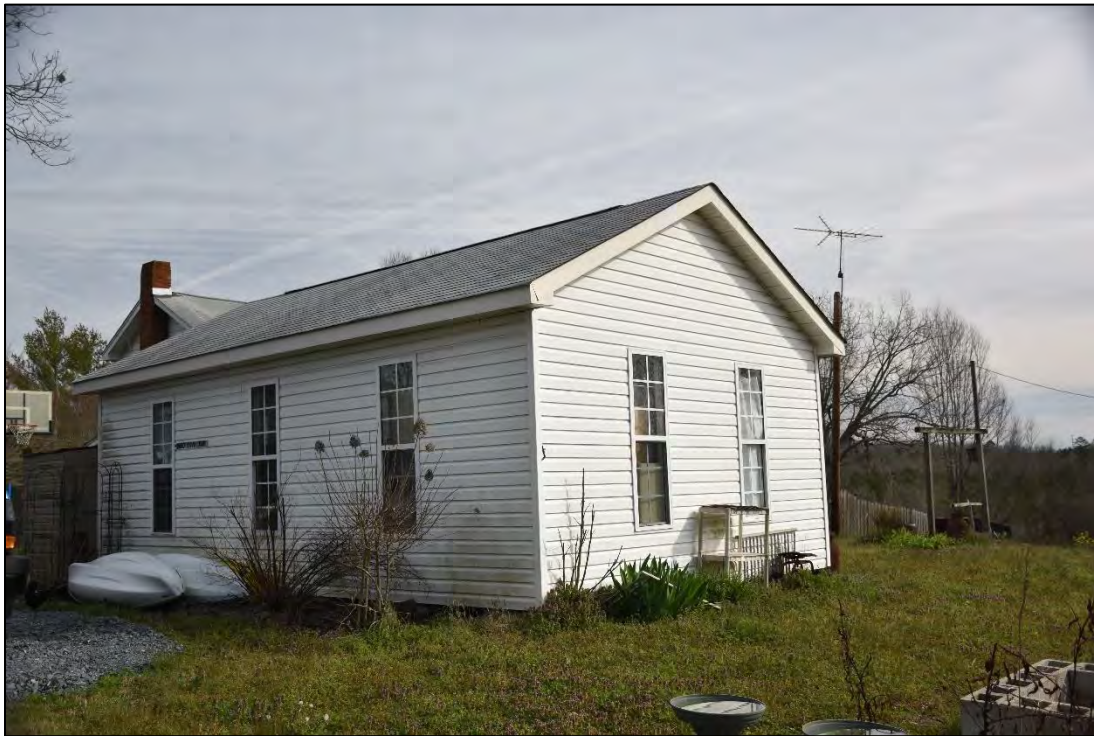
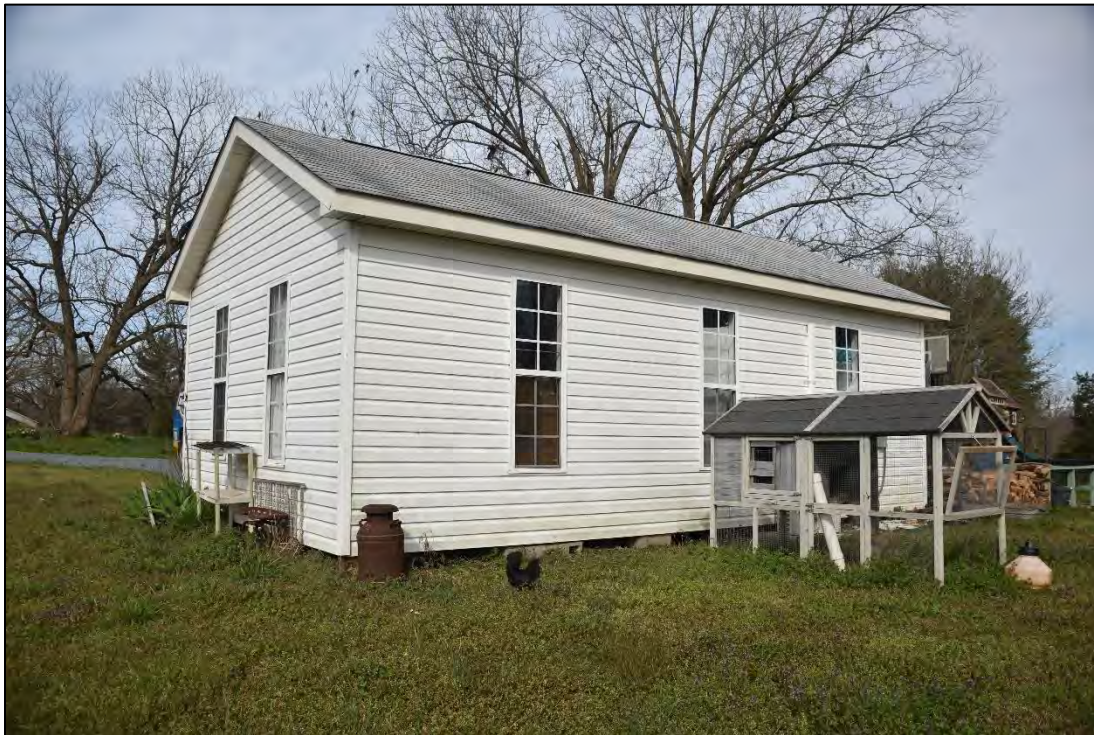
Associated with the Small-Black House are ten extant outbuildings, dating from the mid-twentieth century through the twenty-first century, and the visible remnants of another outbuilding, along with surrounding pasture lands (Figure 2.2). Located southwest of the house is a single story, gabled structure that may have originally been used as a garage but is currently used as a workshop (Figures 2.8 and 2.9). The north elevation of the building has a fiberglass French door with multi-pane glass on the upper portion. Each side elevation has three tall six-over-six, double-hung, vinyl sash windows, while the rear of the building has two tall six-over-six, double-hung, vinyl sash windows. The building rests on a concrete block pier foundation and is covered with vinyl siding and asphalt shingles. Two late-twentieth-century sheds are also located to the southwest of the house. The closer of the two sheds is a frame structure with a gabled roofline, double doorway on the front elevation, and single six-over-six, double-hung, vinyl sash window next to it (Figure 2.10). This structure is covered with vertical wooden paneling and the roof is asphalt shingle. Approximately 100 feet to the southwest of the first shed is a second gabled shed (Figure 2.11). This rectangular, frame structure has a side-gabled roof. There are two one-over-one, double-hung, metal frame windows in the north elevation; the east elevation also has a one-over-one, double-hung, metal frame window and the entry door is on the south elevation. The exterior is covered with vertical wooden paneling and the roof is asphalt shingles. Between the two twentieth-century sheds is the remains of a wooden outbuilding that appears to date to the early-to-mid-twentieth century (Figure 2.12)

Figure 2.8. Small-Black House (CA1593), garage/workshop, facing northeast.

Figure 2.9. Small-Black House (CA1593), garage/workshop, facing northwest.

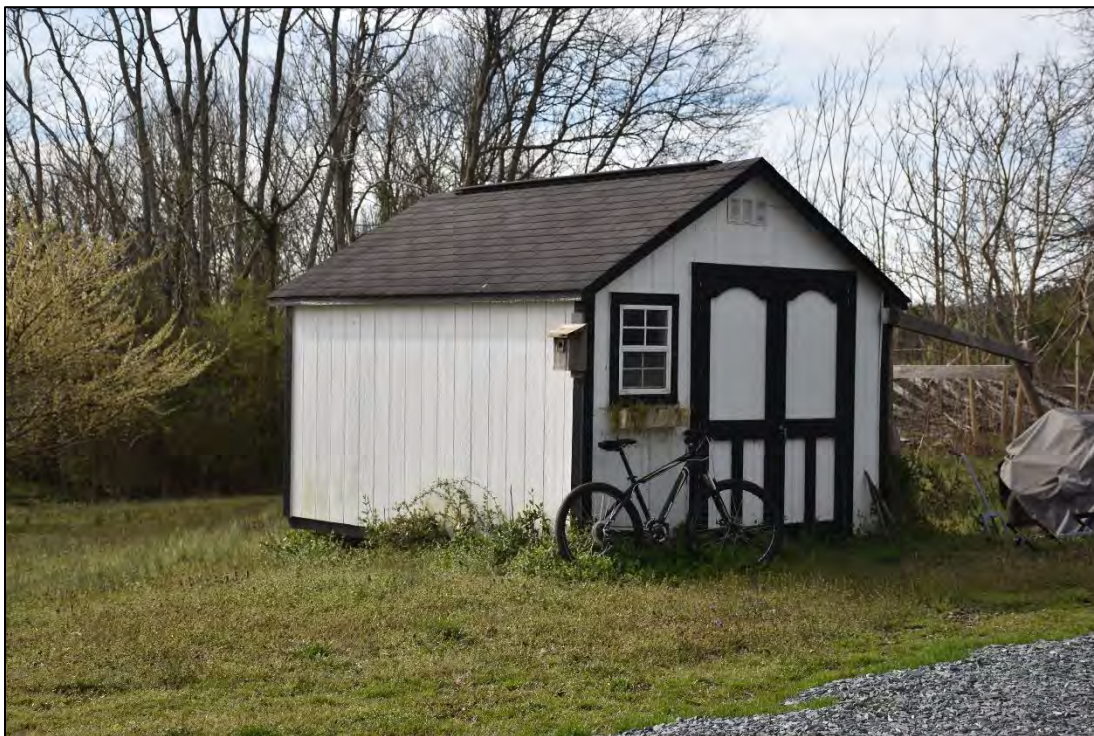
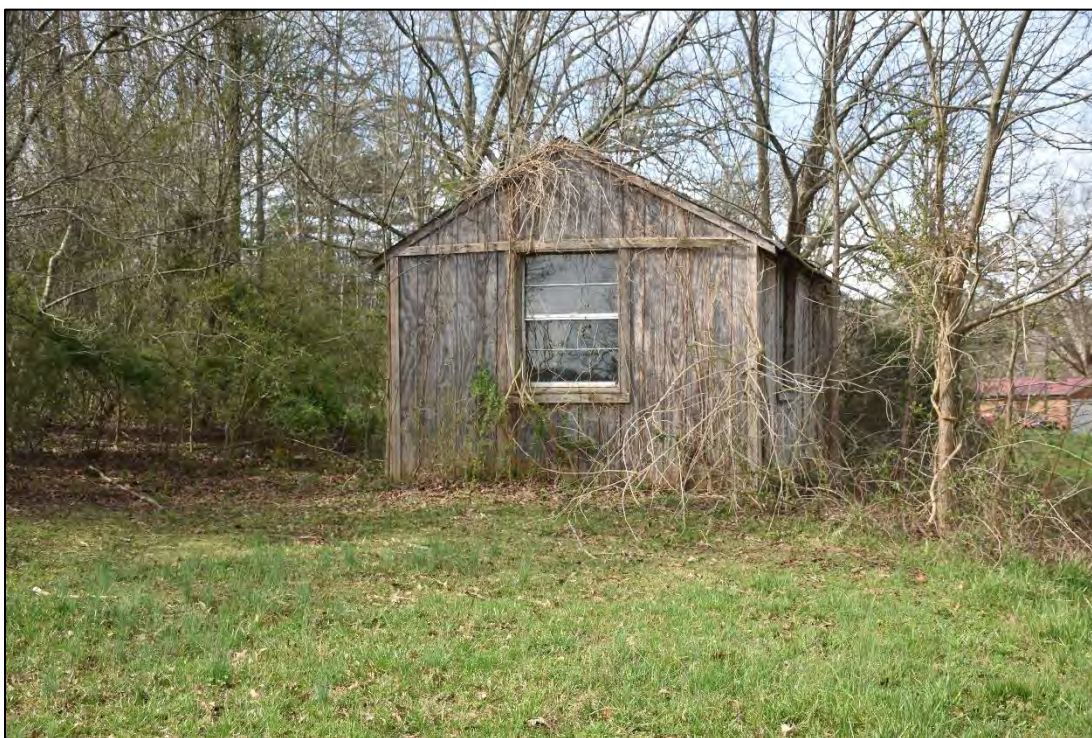
Figure 2.10. Small-Black House (CA1593), late-twentieth-century shed, facing south.

Figure 2.11. Small-Black House (CA1593), late-twentieth century shed, facing west.

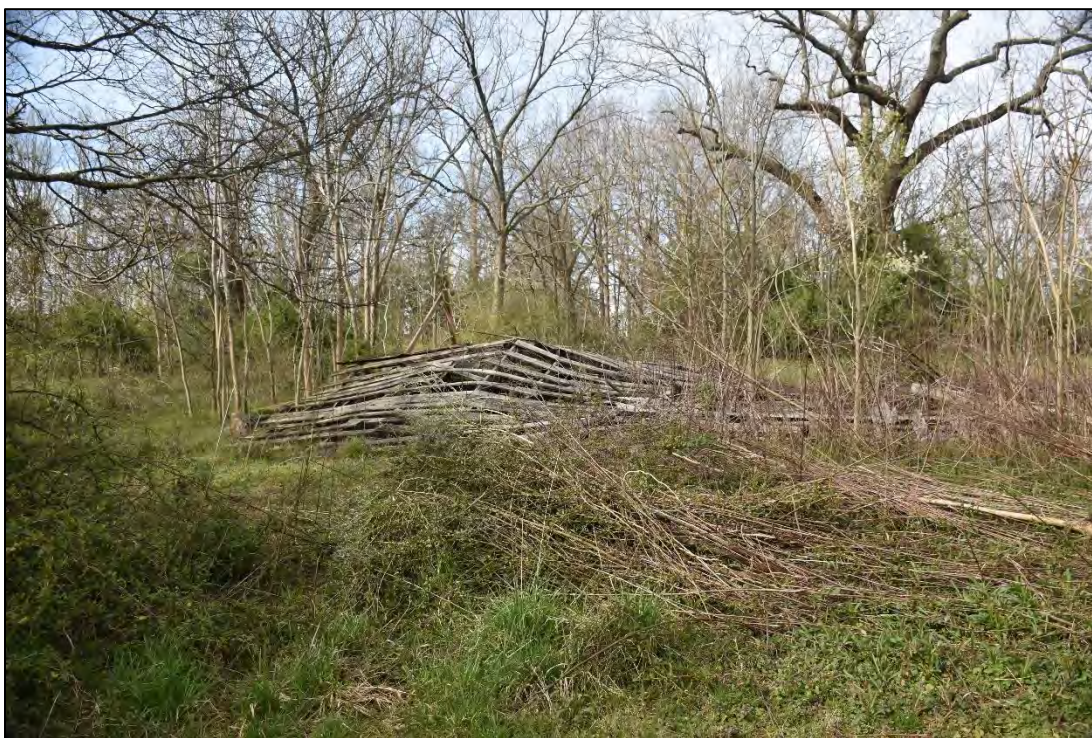
Figure 2.12. Small-Black House (CA1593), remains of a wooden outbuilding, facing west.

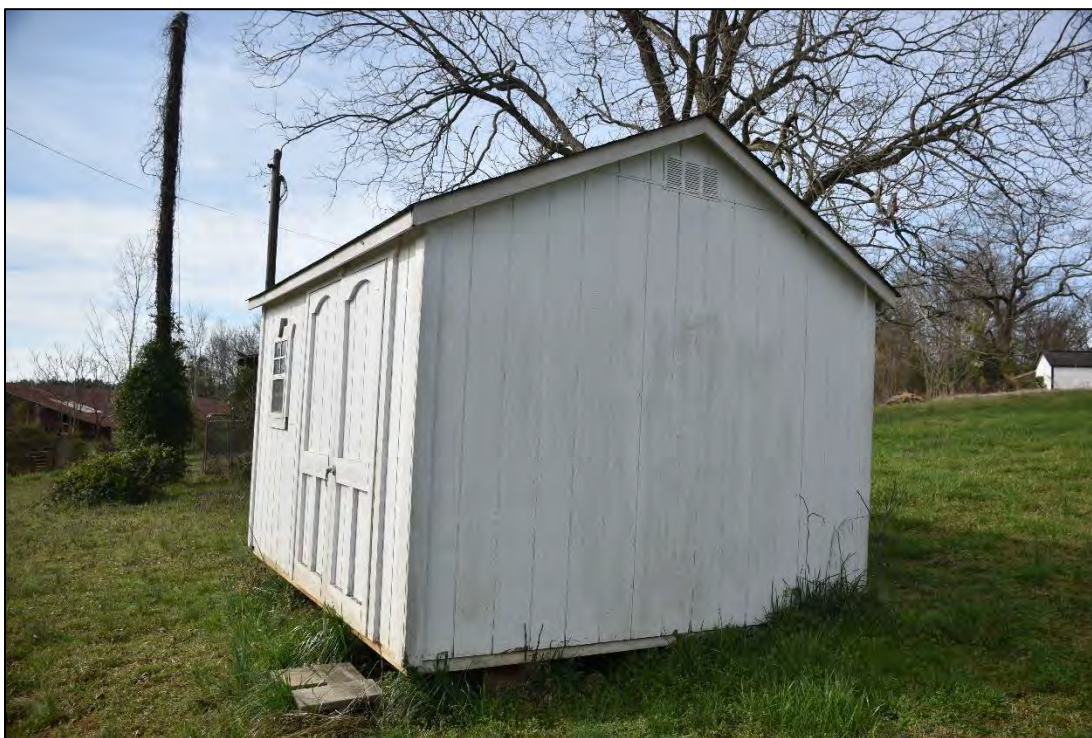
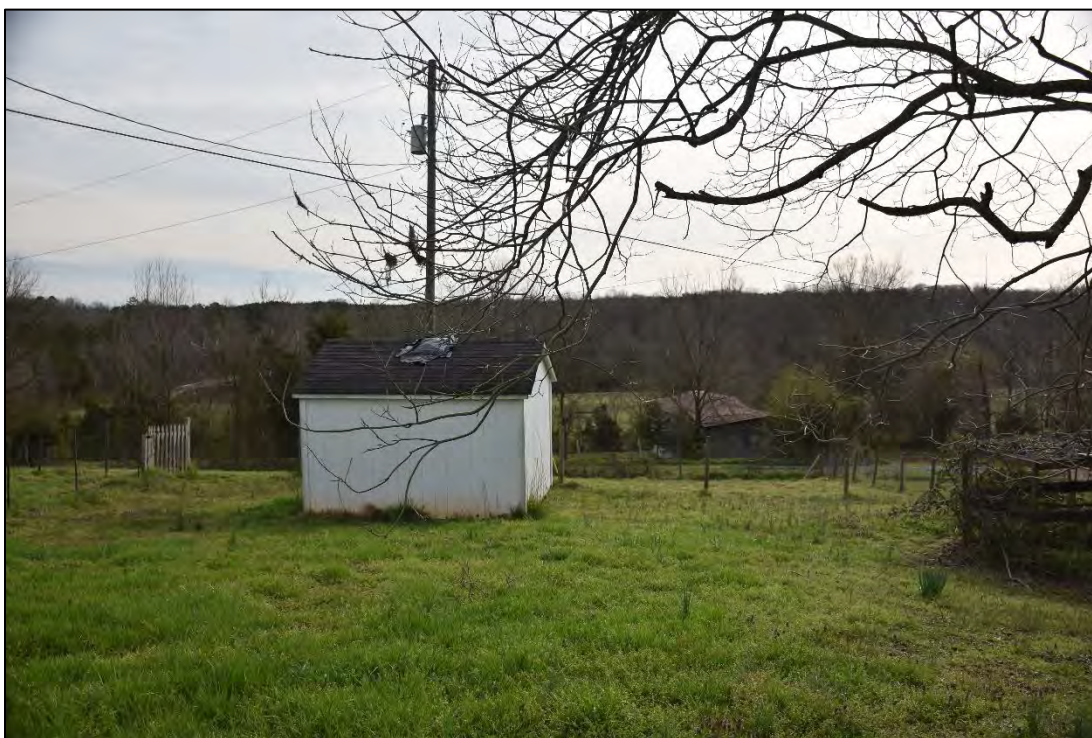
Located east and southeast of the house are seven outbuildings, six of which have specific agricultural uses (Figure 2.2). Directly east of the house is a modern, flat-roofed lean to structure, located within a fenced section of the yard, which is used as a shelter for livestock. The structure has plywood walls and the roof is currently covered with a tarp (Figure 2.13). Southeast of the lean to, is a modern frame shed with a gabled roof (Figures 2.14 and 2.15). The rectangular building has a side-gabled roofline, with a double entry door on its eastern elevation and a single, six-over-six, double-hung, vinyl sash window next to the door. The exterior of the structure is covered with vertical wooden paneling and the roof is asphalt shingles. South of the modern shed is a mid-twentieth century chicken coop (Figures 2.16 and 2.17). The coop was constructed in two sections, with the northern section being a shed-roofed, rectangular box with a raised floor, open front covered with chicken wire, visible rafter tails, and a standing-seam metal roof. The southern section is an enclosed box, also with a pent roof and visible rafter tails; this section has a four-pane vinyl casement window and a corrugated metal roof.

Figure 2.14. Small-Black House (CA1593), twenty-first-century shed, facing south.

Figure 2.15. Small-Black House (CA1593), twenty-first-century shed, facing east.

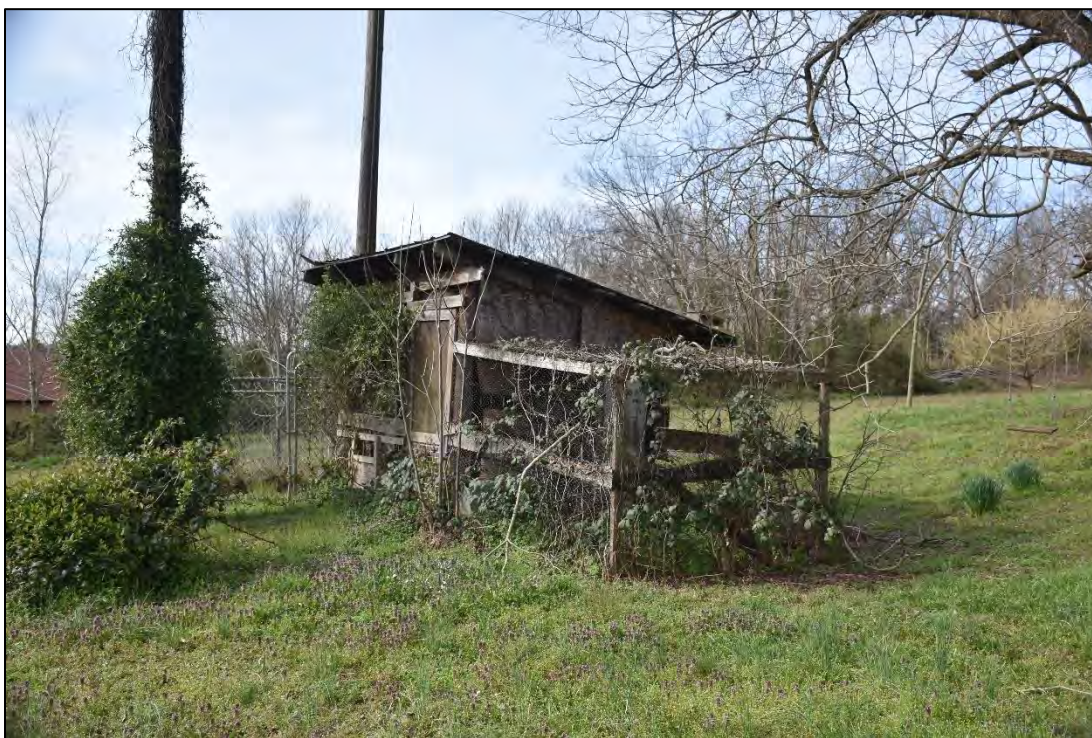
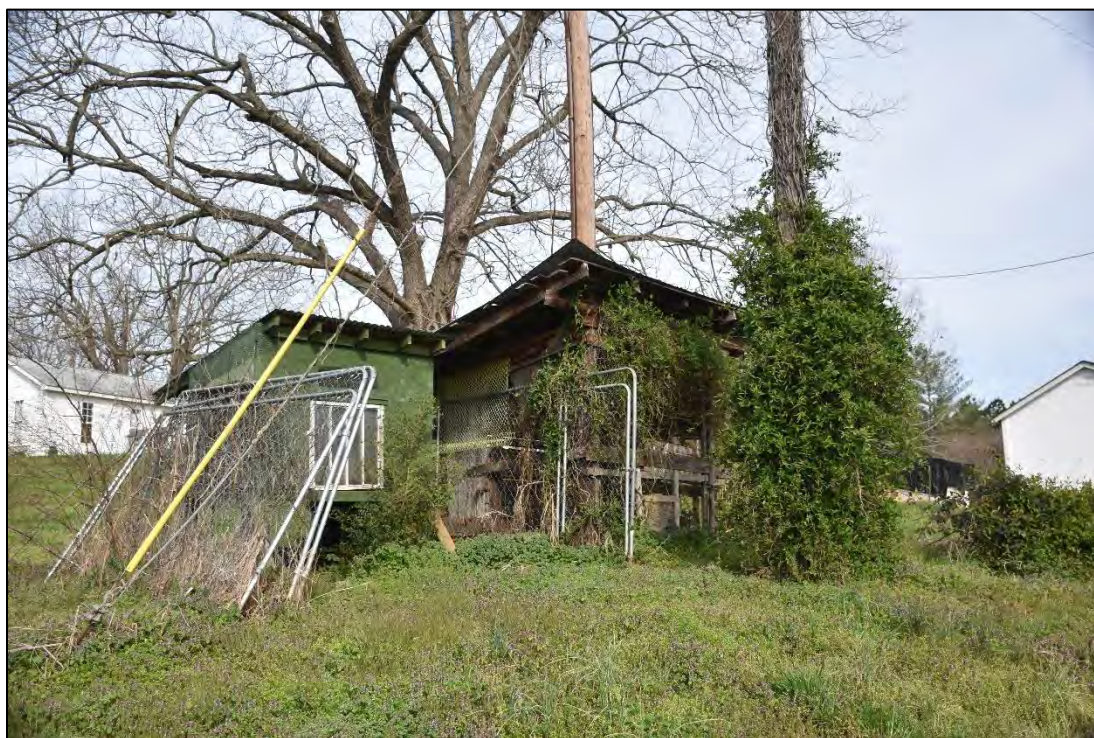
Figure 2.16. Small-Black House (CA1593), chicken coop, facing southwest.

Figure 2.17. Small-Black House (CA1593), chicken coop, facing northwest.

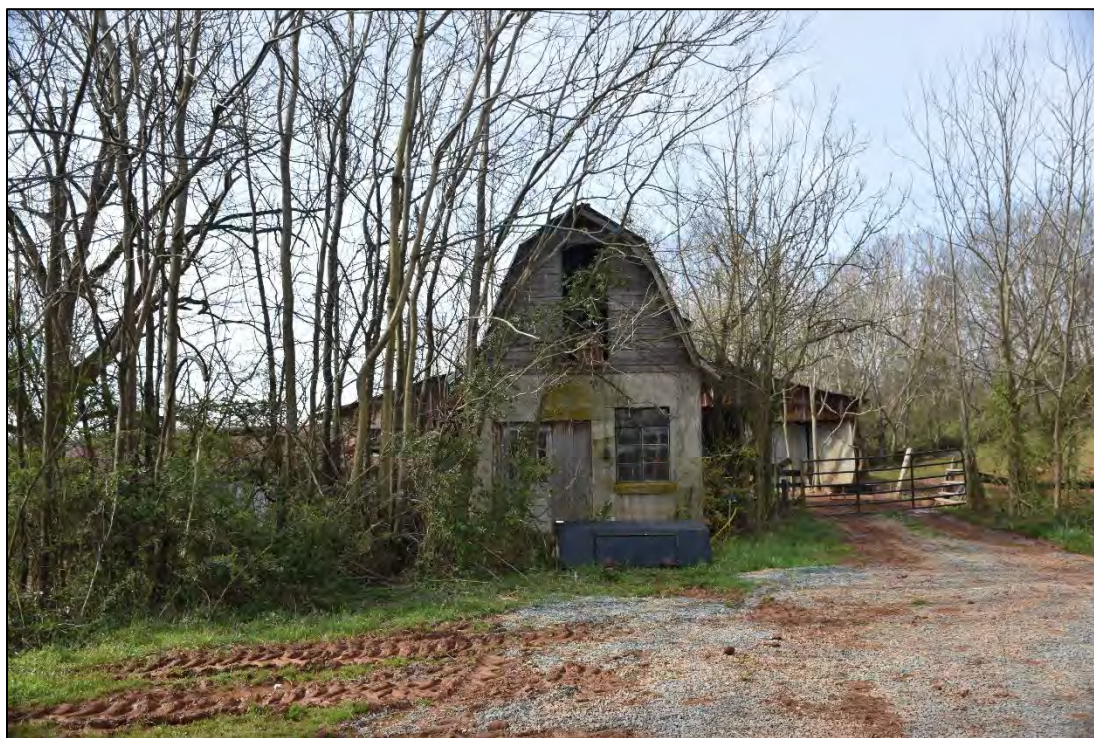
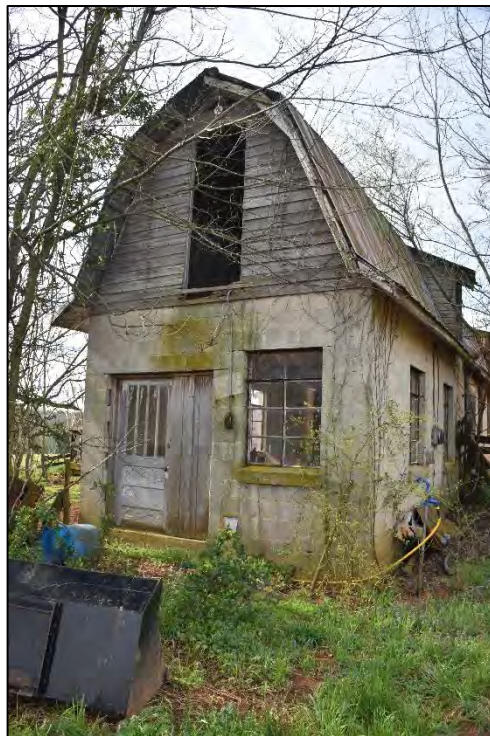
A grouping of four agricultural outbuildings is located in the southeastern portion of the property (Figure 2.2). The earliest of these structures is a mid-twentieth century dairy barn (Figures 2.18 and 2.19). It is a two-story, concrete block structure, that is long and narrow, with a steep gambrel roof, peak extension, and flared eaves. The front elevation has a large, off-center door opening that has been partially enclosed; it has a wooden door with three lower panels and four vertical glass panes in the upper section. To the north of the door is an eight-pane casement window with metal framing. Each side elevation has five eight-pane casement windows with metal frames, evenly spaced along the wall surface. The loft story, beneath the gambrel roof, has an unenclosed opening on its front elevation and is sheathed in horizontal wooden siding; the roof is covered with standing-seam metal. Behind the dairy barn is a large, gabled livestock barn that is of frame construction, supported by rough timbers (Figure 2.20). The central section of this three-bay barn is open, although it has swinging metal gates blocking the entrance; the northern portion is covered with corrugated metal. The loft story of the barn is sheathed in standing-seam metal, as is the roof. A single story, side-gabled addition, framed with wooden posts, has been extended from the south elevation of the barn (Figure 2.21). It is also enclosed with standing-seam metal both on the exterior walls and on the roof. East of the two barns is a pent-roofed, open agricultural storage building (Figure 2.22). It is wooden framed and partially supported by rough timbers; the exterior is covered with corrugated metal, as is the roof. In a separate, fenced off field, northeast of the barns is a second agricultural storage building, this one having a gabled roofline that is covered with standing-seam metal and corrugated metal covering its frame construction (Figure 2.23).

Figure 2.18. Small-Black House (CA1593), dairy barn, facing southwest.

Figure 2.19. Small-Black House (CA1593), dairy barn, facing south.

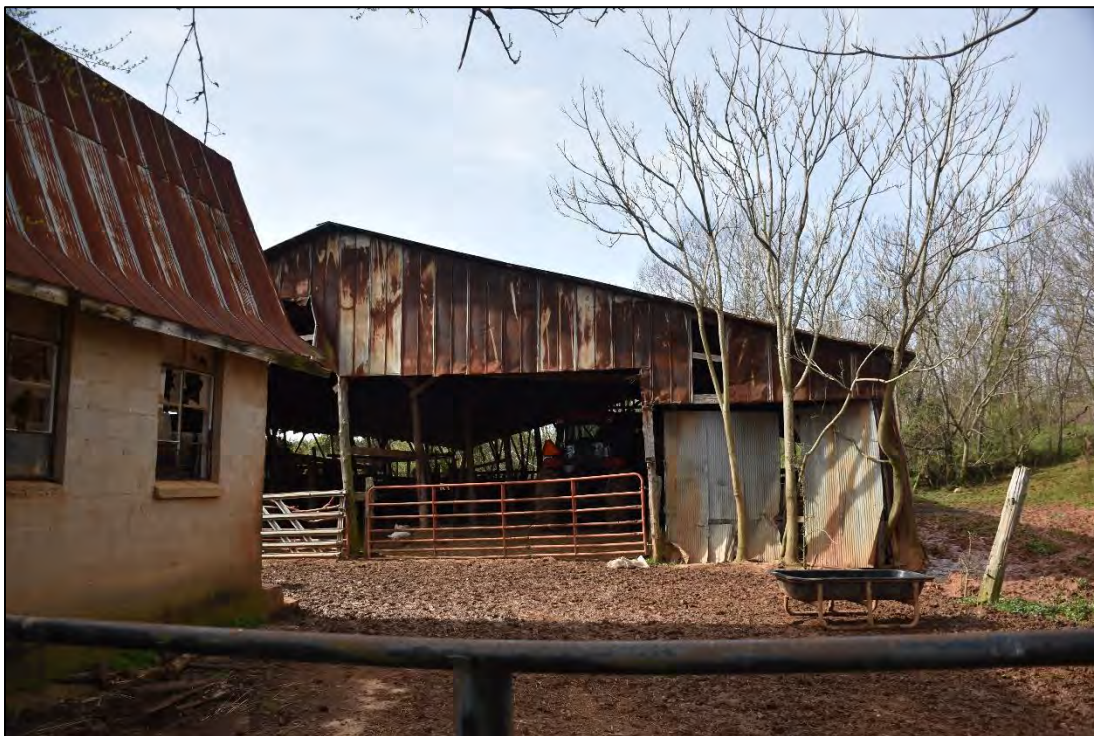
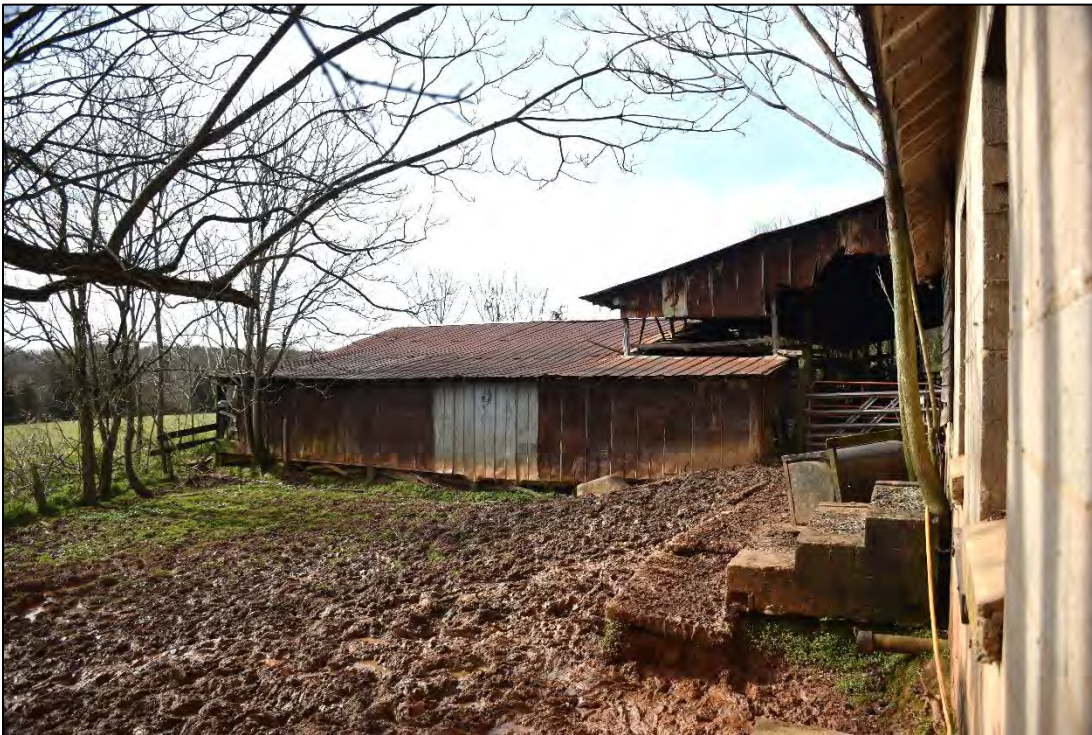
Figure 2.20. Small-Black House (CA1593), livestock barn, facing southwest.

Figure 2.21. Small-Black House (CA1593), livestock barn, facing south.

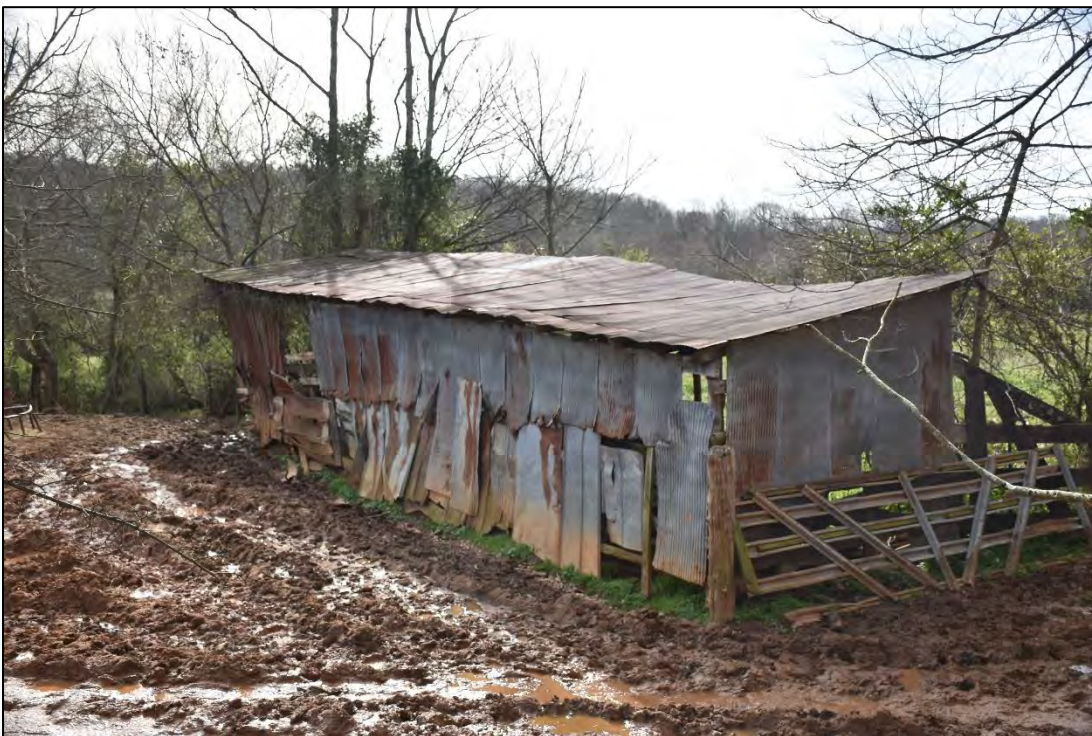
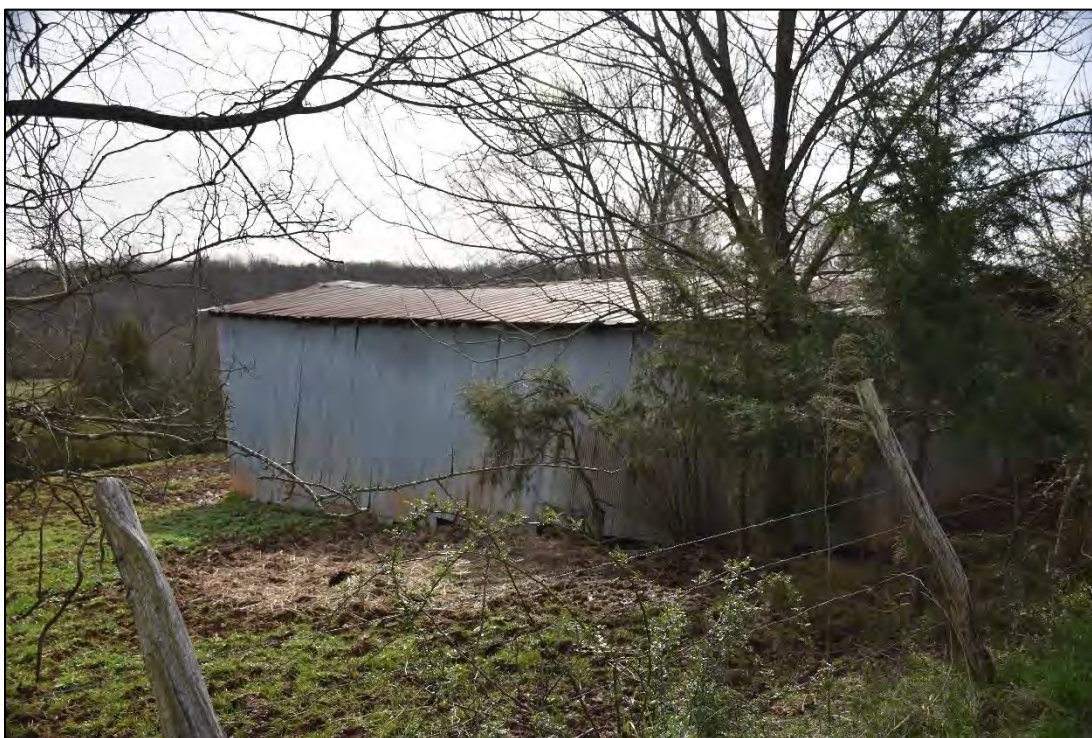
Figure 2.22. Small-Black House (CA1593), agricultural storage building, facing south.

Figure 2.23. Small-Black House (CA1593), agricultural storage building, facing southeast.

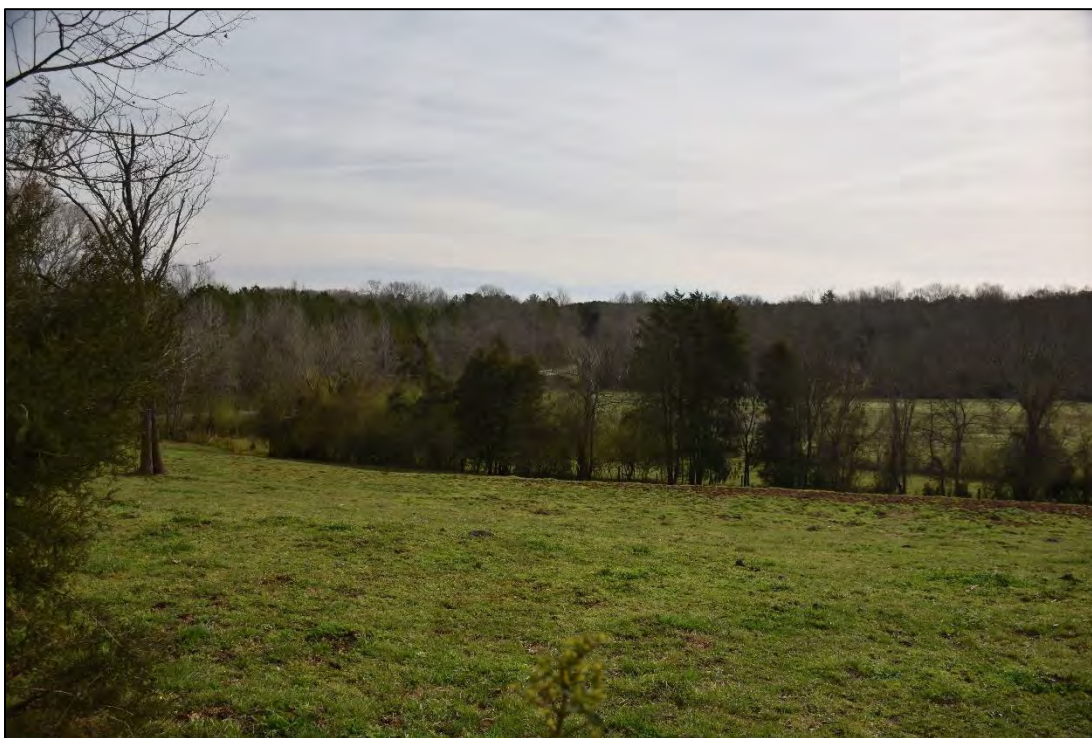
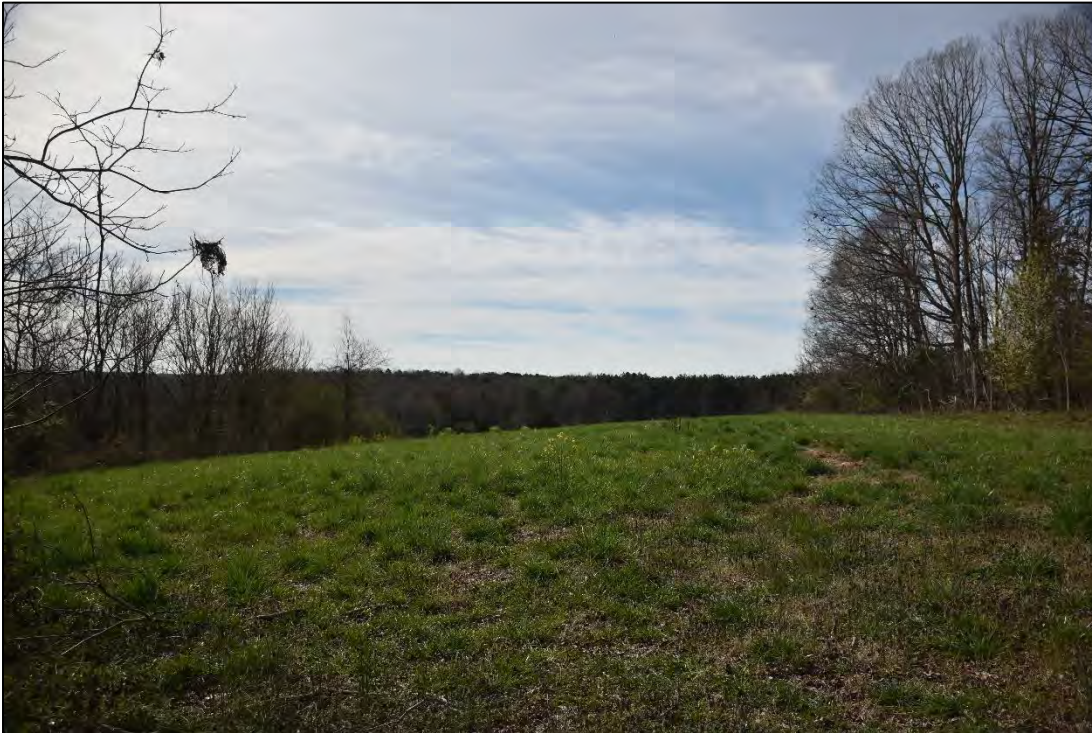
Surrounding the house and outbuildings are former agricultural fields, which are primarily used as pasture lands. Livestock are still kept on the land and are pastured on fields to the south and east of the house (Figures 2.24 and 2.25).

Figure 2.24. Small-Black House (CA1593), livestock pasture, facing east.

Figure 2.25. Small-Black House (CA1593), open land/pasture, facing south.

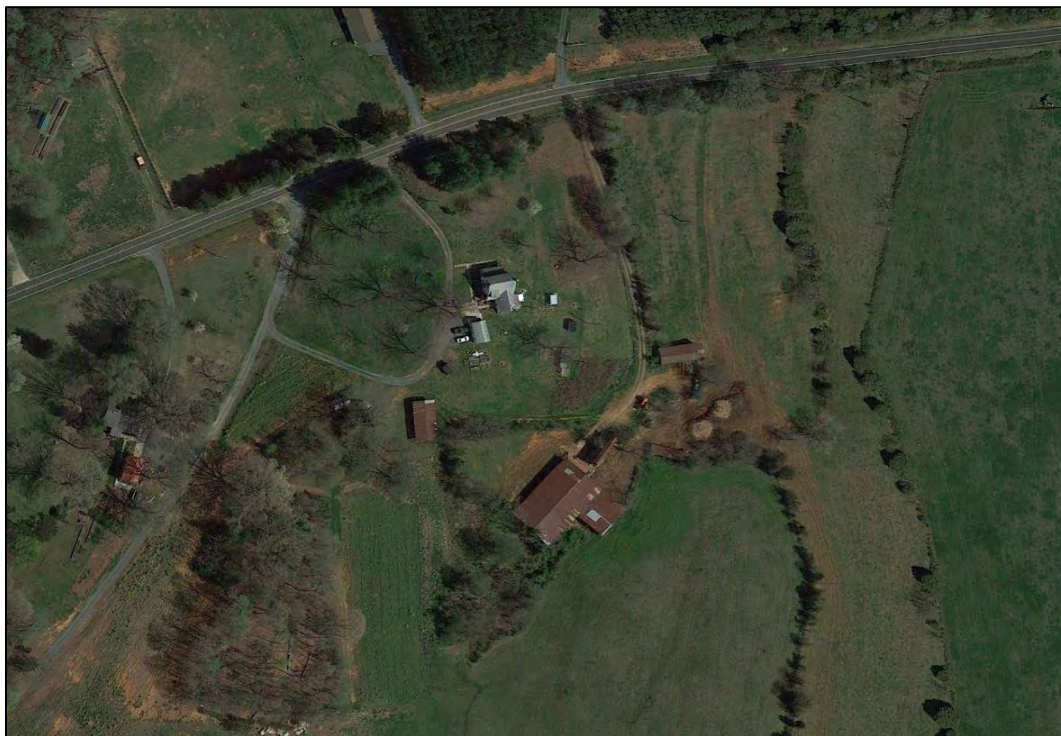
A series of aerial photographs from 1948 thorough 2018 show the changes to the buildings and land associated with the Small-Black house during the second half of the twentieth century and the early part of the twenty-first century. The earliest aerial photograph is from 1948 (Figure 2.28). It shows the Small-Black House and a number of outbuildings located close to it; near the location of the dairy barn and livestock barn, there is a small open space, but those agricultural structures had not yet been built. By 1950, some additional small outbuildings had been constructed to the south and southwest of the house (Figure 2.29). In 1960, the dairy barn and livestock barn had been built, as had one of the two agricultural storage buildings and a portion of the chicken coop; additional land had been cleared since 1950, likely for pasture for the dairy cows (Figure 2.30). By 1964, the second agricultural storage building had been constructed and there is evidence of a large livestock trough behind the livestock barn (Figure 2.31). Five years later, the one-story addition had been built onto the livestock barn and the trough had been expanded; outside of the five agricultural outbuildings, only two other small structures are visible near the house (Figure 2.32). In 1993, some of the boundaries between fields had a new tree line and there was an outbuilding near the location of the present day collapsed structure; the house, dairy barn, livestock barn, two agricultural storage buildings, and chicken coop also were visible (Figure 2.33). By 1998, a garage with a side-gabled roof had been added near the house (Figure 2.34) and by 2005, one of the modern sheds had been built (Figure 2.35). Sometime between 2005 and 2009, the side-gabled garage was demolished and the current front-gabled structure had been built (Figure 2.36). By 2013, the lean to and two additional sheds had been added and between 2013 and 2018, the wooden outbuilding to the southwest of the house had collapsed (Figure 2.37).

Figure 2.37. USGS aerial photograph (2013) showing the Small-Black House and property.
