HISTORIC STRUCTURES SURVEY REPORT

Replace Bridge No. 08 over North Fork New River on NC 194, Ashe County

TIP# BR-0002

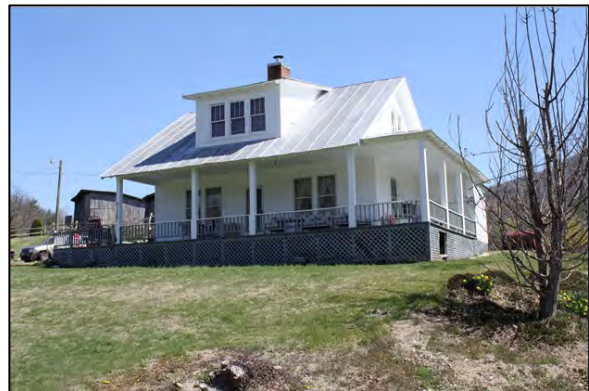
Resource Name	Thompson-Barr House
HPO Survey Site Number	AH0372
Street Address	6256 NC HWY 194, N. Warrensville
PIN	02219033
Construction Dates	ca. 1930
NRHP Recommendation	Not Eligible

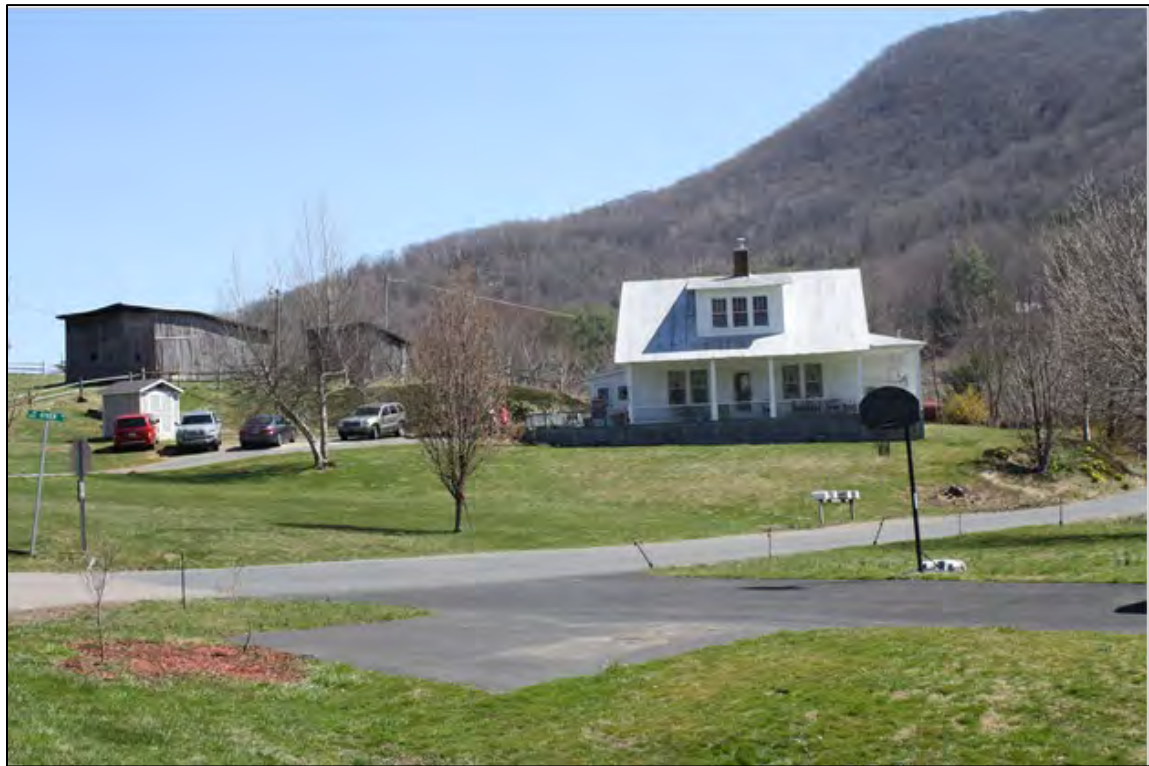
Figure 2: Looking northeast. Two original barns historically associated with the property to the northwest behind the house are extant, though now located on a subdivided adjacent parcel.

One modern shed is located within the parcel boundary and west of the house. However, two ca. 1930-1940 wooden tobacco barns historically associated with the property are extant just northwest of the existing parcel boundary.

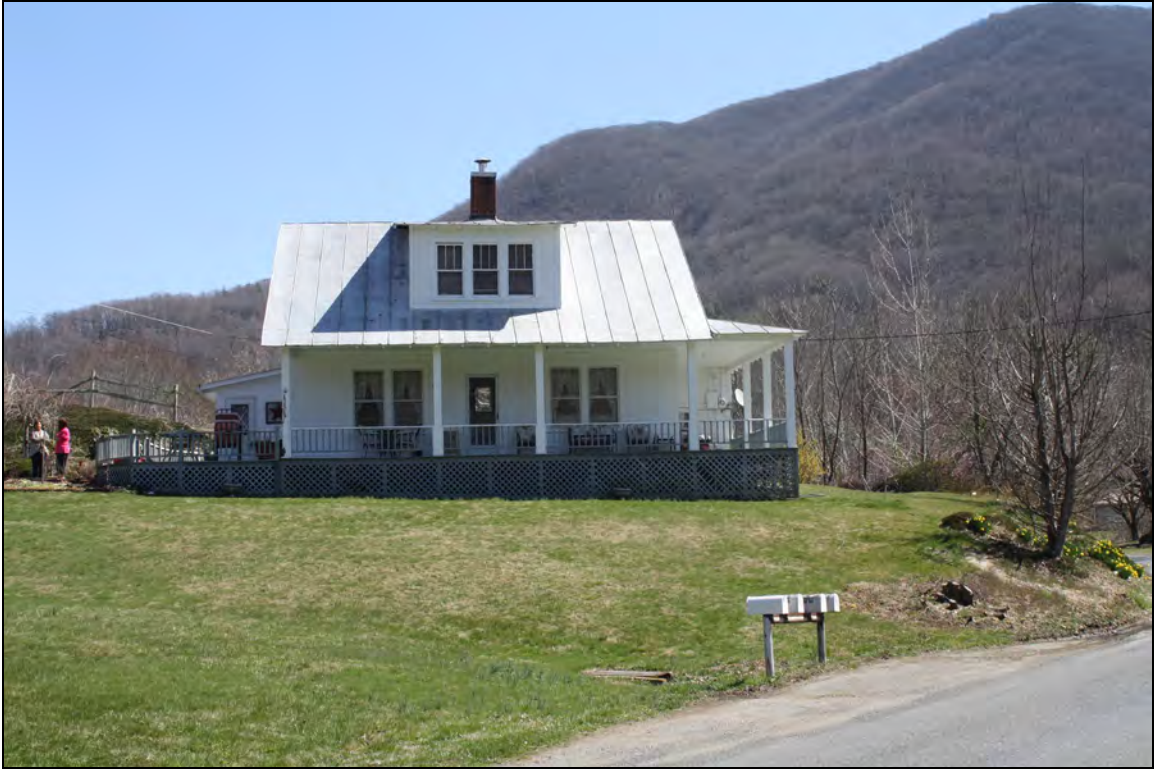
Figure 3: South (front) elevation

The south façade is accessed by a replacement, central single leaf door. Two pairs of bungalow style double-hung sash windows, with a three-over-one design, flank the door. Three smaller bungalow windows, of the same design, are present in the shed dormer. The porch ceiling and floor are wooden plank. The narrow wooden posts are constructed of vertical plank and are capped by a quarter-round molding at the base and top. The porch balustrade is constructed of simple vertical posts held in place by top and bottom railings, and the house's foundation is covered by wooden lattice.

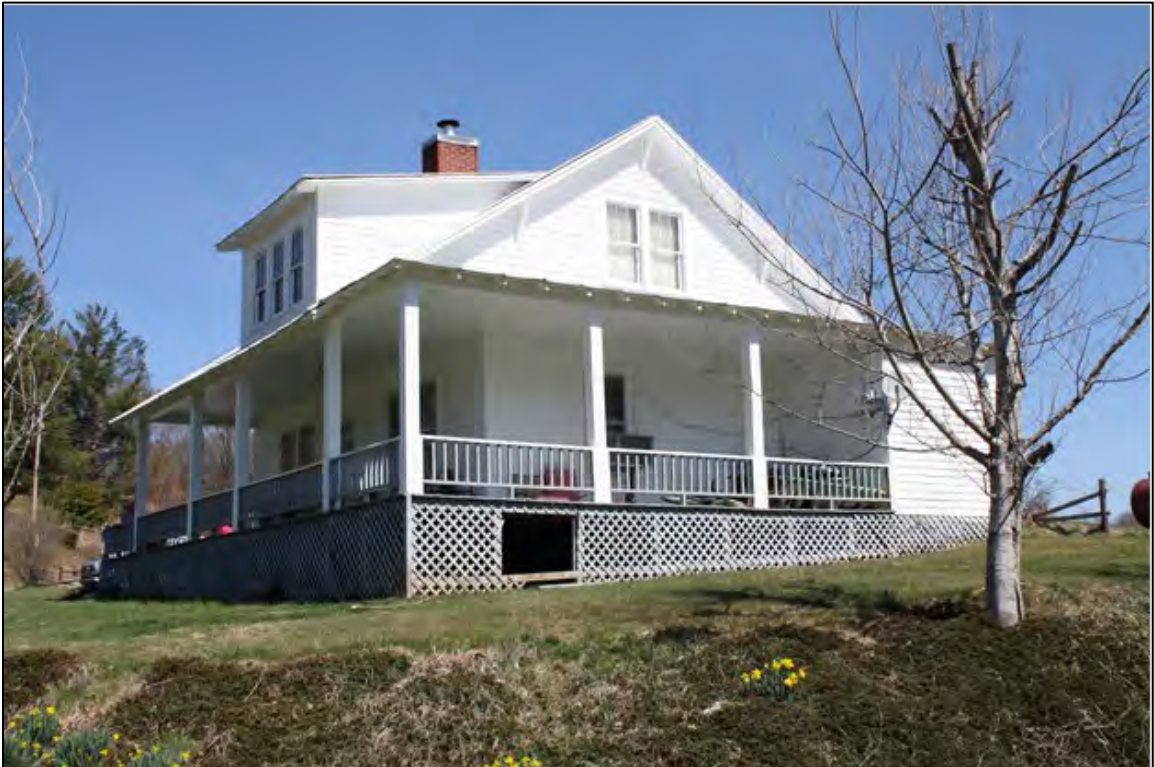
Figure 4: East elevation

On the east elevation, one bungalow style window is present on the first floor's south end, and a pair of similar, smaller windows are located on the second floor under the gable. The hipped roof porch on this elevation terminates at a one-room addition on the north end. At some point, a door was cut into the one-room addition to access the porch and was subsequently later removed and the opening sealed with siding.

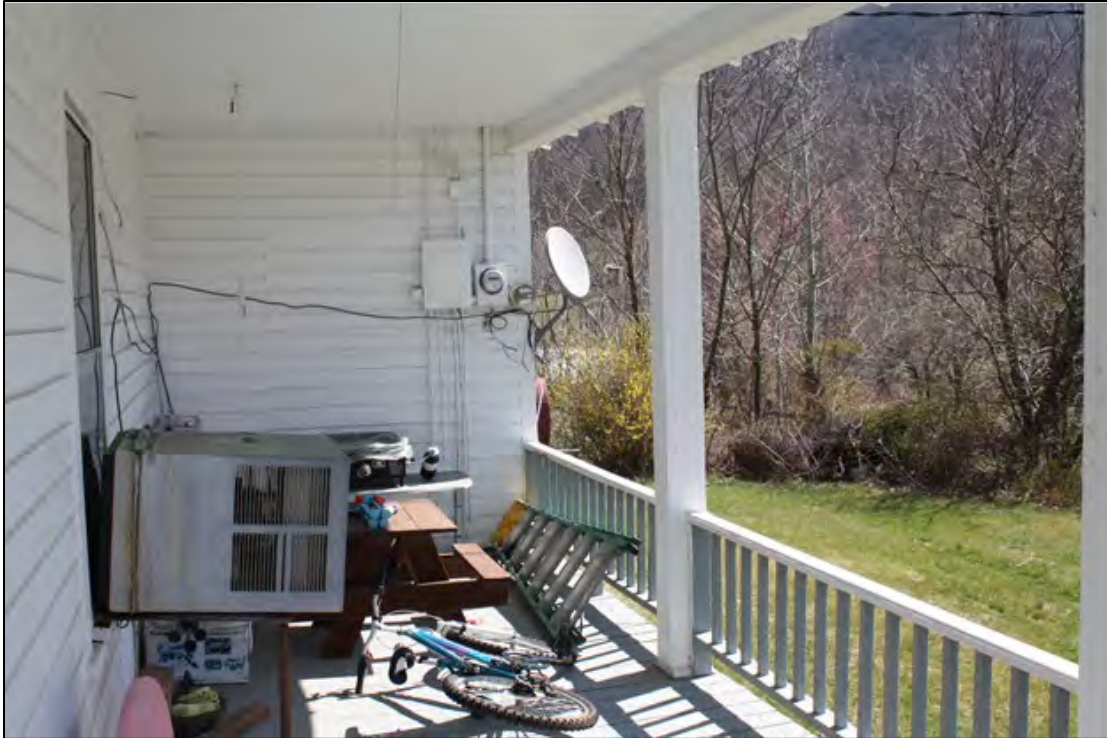
Figure 5: Looking north on the front porch. An area of patched siding can be seen on the far wall where a door was once present.

In 1948 the property was purchased by Virgil (1878–1964) and Bessie Thompson. In the 1940 Census, Virgil Thompson's occupation was recorded as farming. According to area residents, the Thompsons had a child with special needs, and the exterior door to the small room at the eastern side porch's

northern end was enclosed to create a first-floor bathroom. The adjoining room, now used as a dining room, was apparently a first-floor bedroom for the child.³

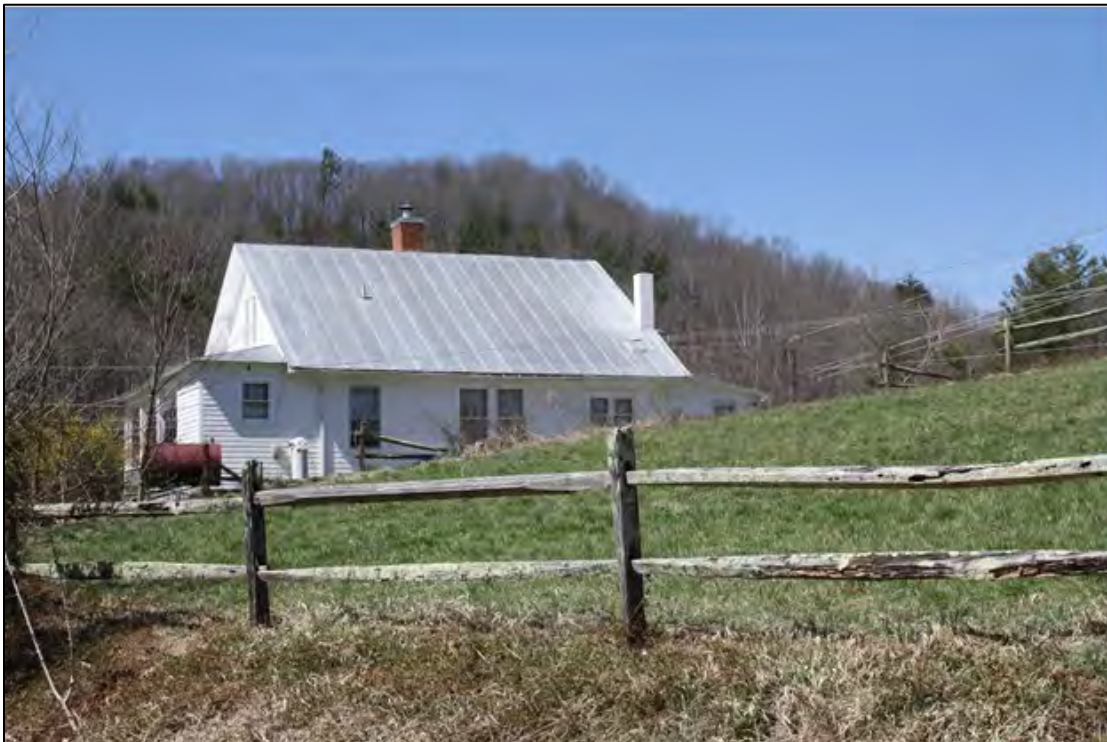
Figure 6: North (rear) elevation

The north, or rear, elevation has asymmetrical fenestration. A total of seven bungalow style windows are present and of various sizes and placement. The land rises sharply at the rear of the house.

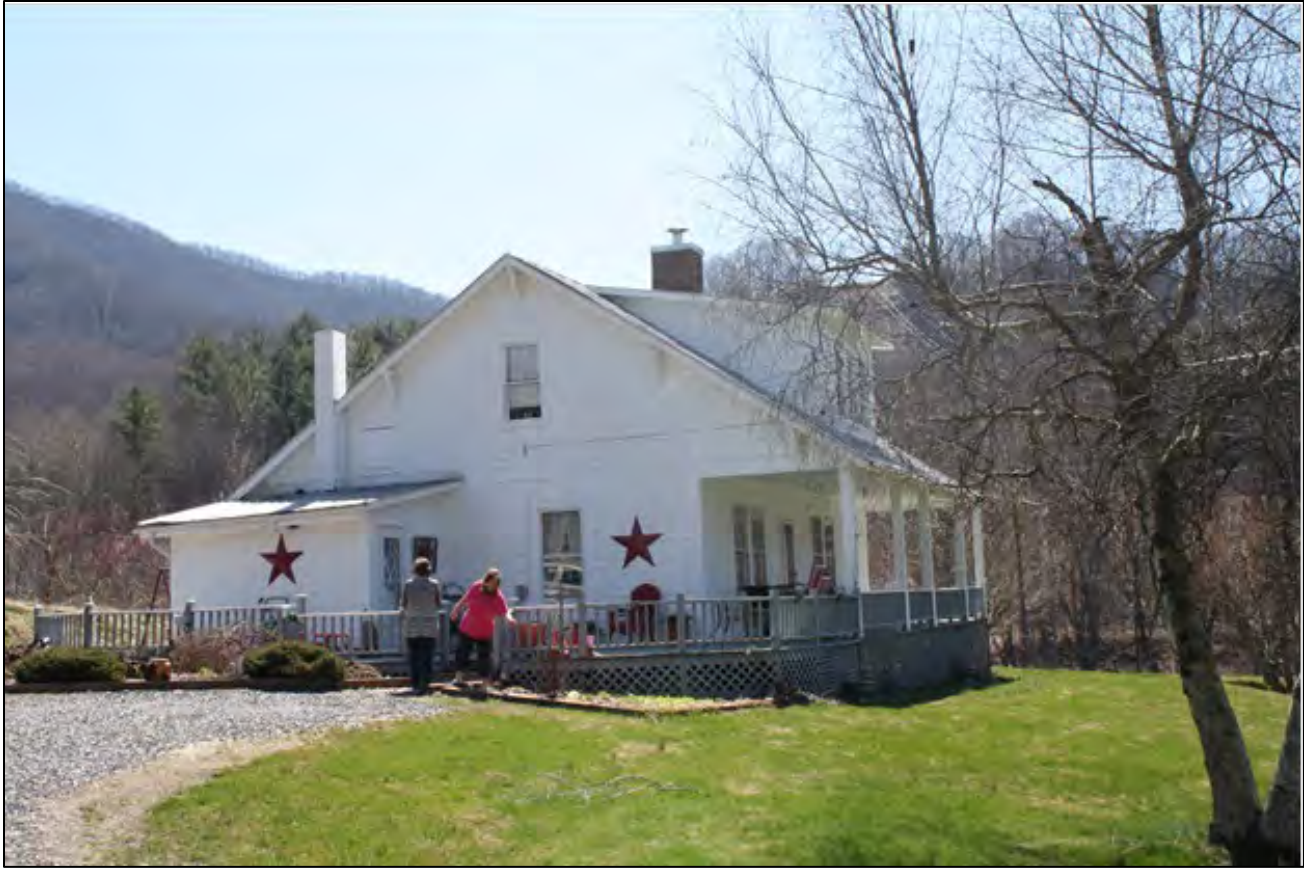
Figure 7: West elevation

The west elevation's gable end features a single bungalow style window on the first floor's south side, and another similar single window centered in the gable on the second floor. A small addition, sheathed in weatherboard rather than German siding, extends from the northern end of this elevation. The addition is accessed via a single-leaf door with a diamond pane pattern on the upper half. A white-painted cinderblock exhaust stack rises from between this addition and the main house.

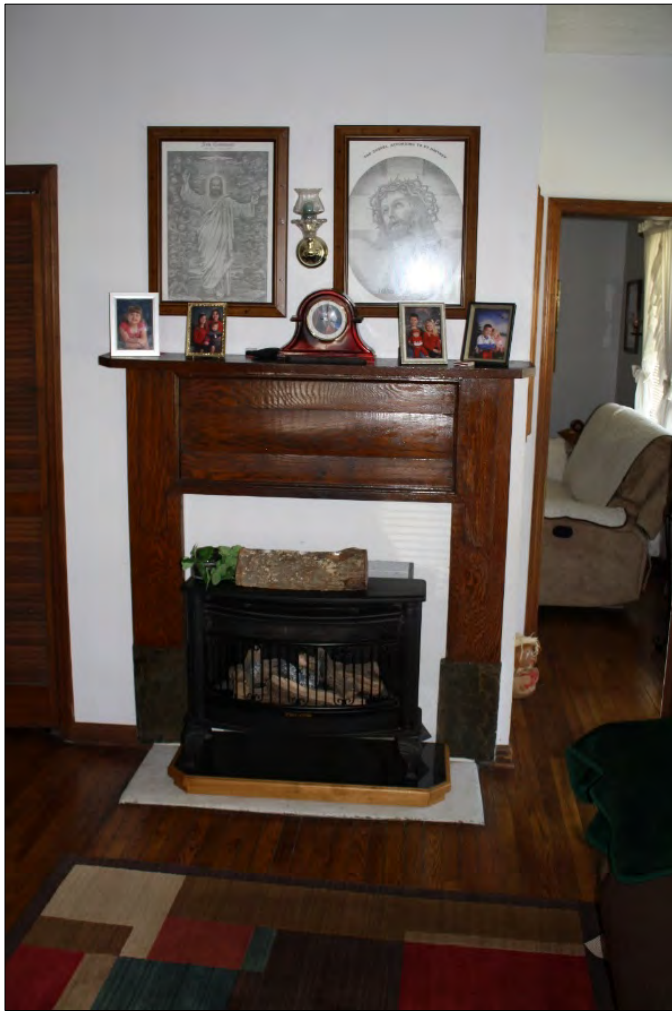
Figure 8: Interior fireplace surround, first-floor west room (identical surround in east room)

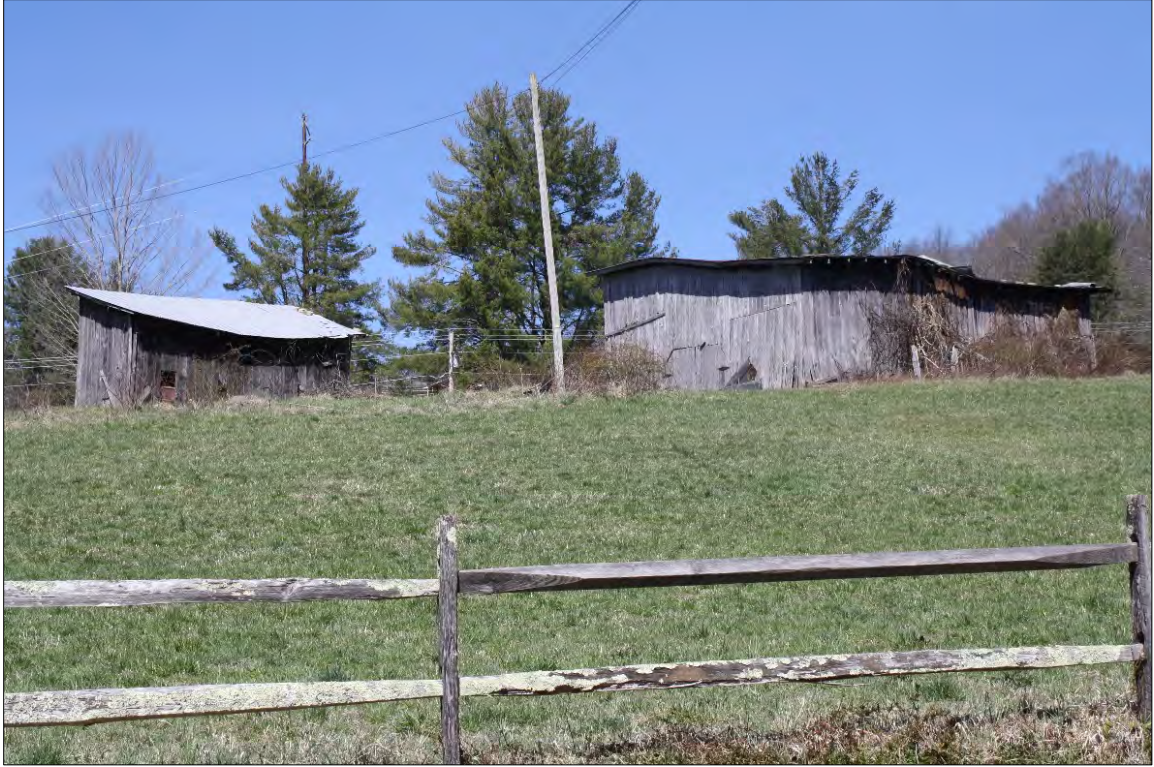
Figure 10: Two original outbuildings, now on adjacent subdivided parcel, looking southwest

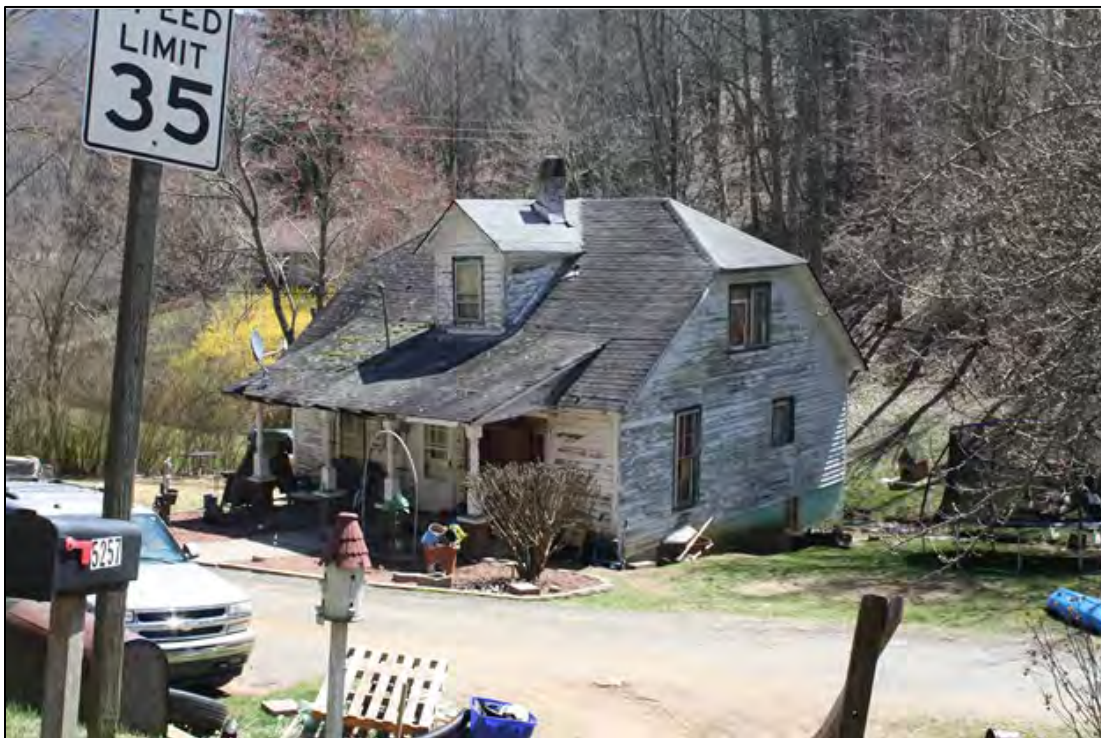
Figure 15: Bungalow, ca. 1915, 5257 NC HWY 88, Warrentonville

The earliest example (Figure 18), is a ca. 1915 rural interpretation of a side-gable bungalow, with an unusual clipped gable roof and truncated semi-engaged shed porch roof.

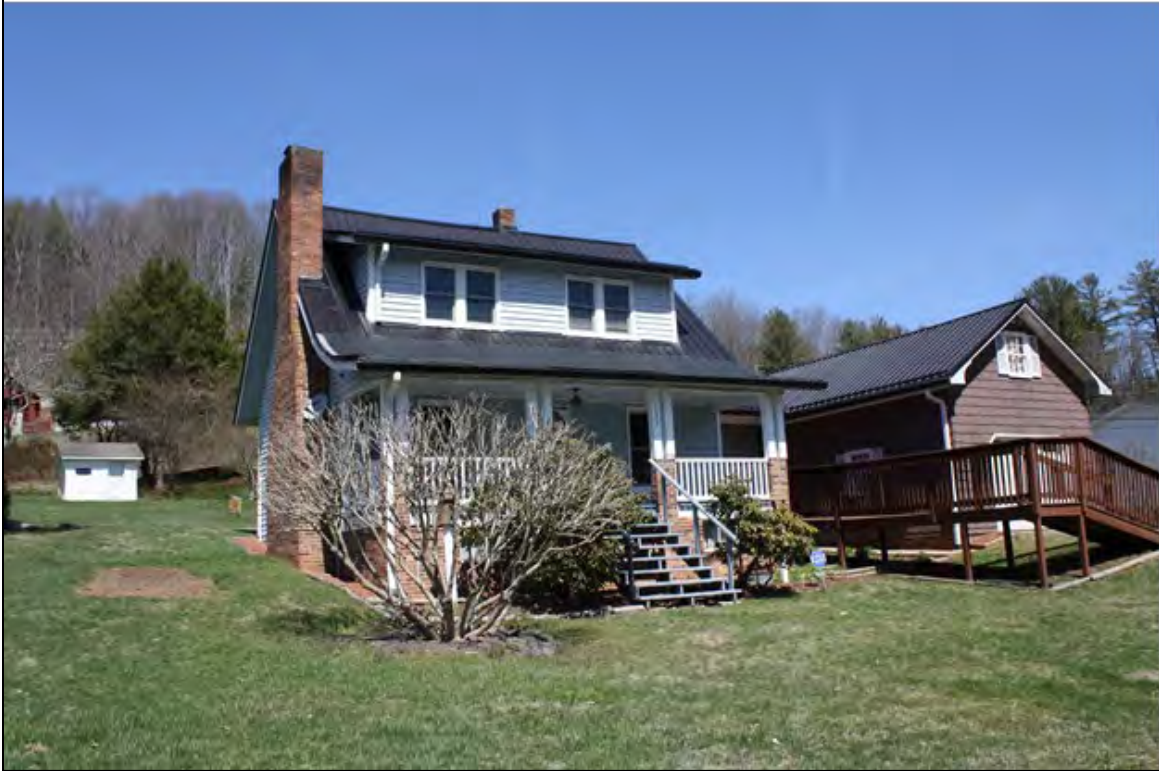
Figure 16: Bungalow, ca. 1925, 139 Northwest School Road (SR 1505), N. Warrensville

Very near the Thompson-Barr House is a more sophisticated side-gable bungalow (Figure 19), ca. 1925, with a sloping engaged porch roofline, wide shed dormer with four double-hung sash windows set in two pairs, and brick end and interior chimney stacks. The porch balustrade is of the same design as the study property. At some point, this house was clad in vinyl siding.

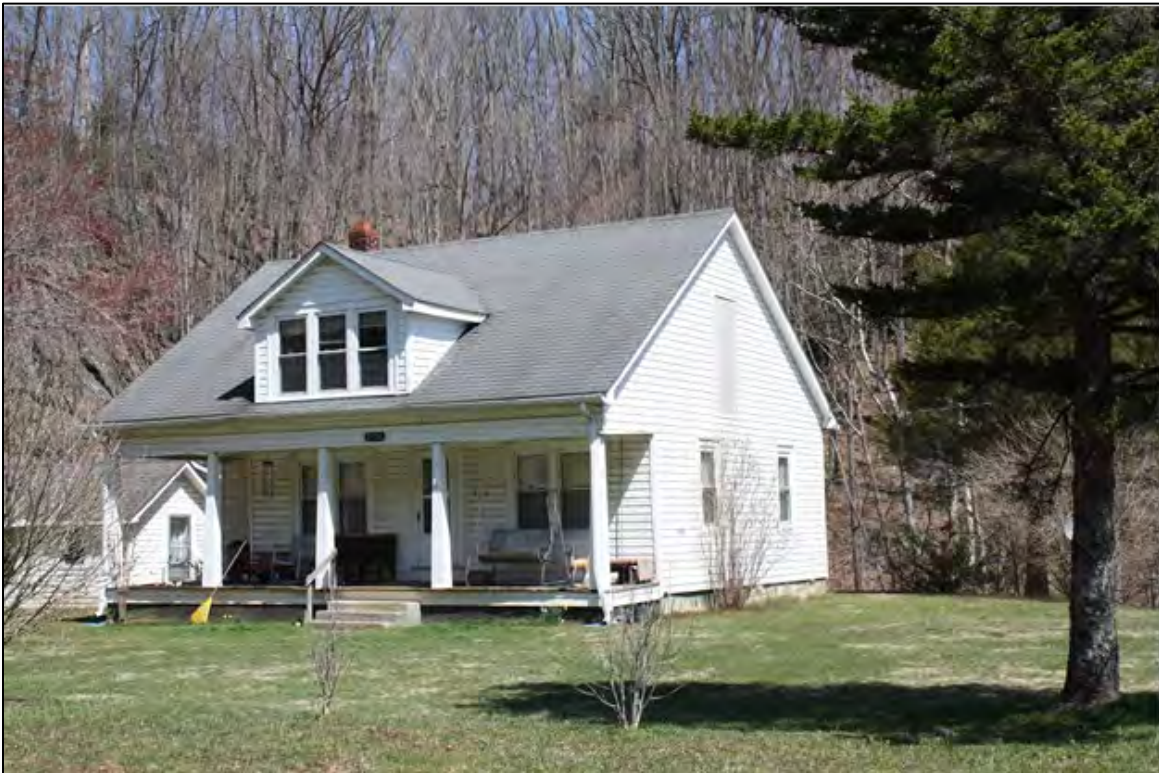
Figure 17: Bungalow, ca. 1930, 2556 NC HWY 88, W. Jefferson

Two other examples on Highway 88 (Figures 20 and 21) are likely the latest chronologically, ca. 1930, and present a simplified, sturdy, aesthetically simple appearance similar to the Thompson-Barr House. Both of these examples feature triple windows in the shed dormer, though one is under a shed roof, and the other under a gable.

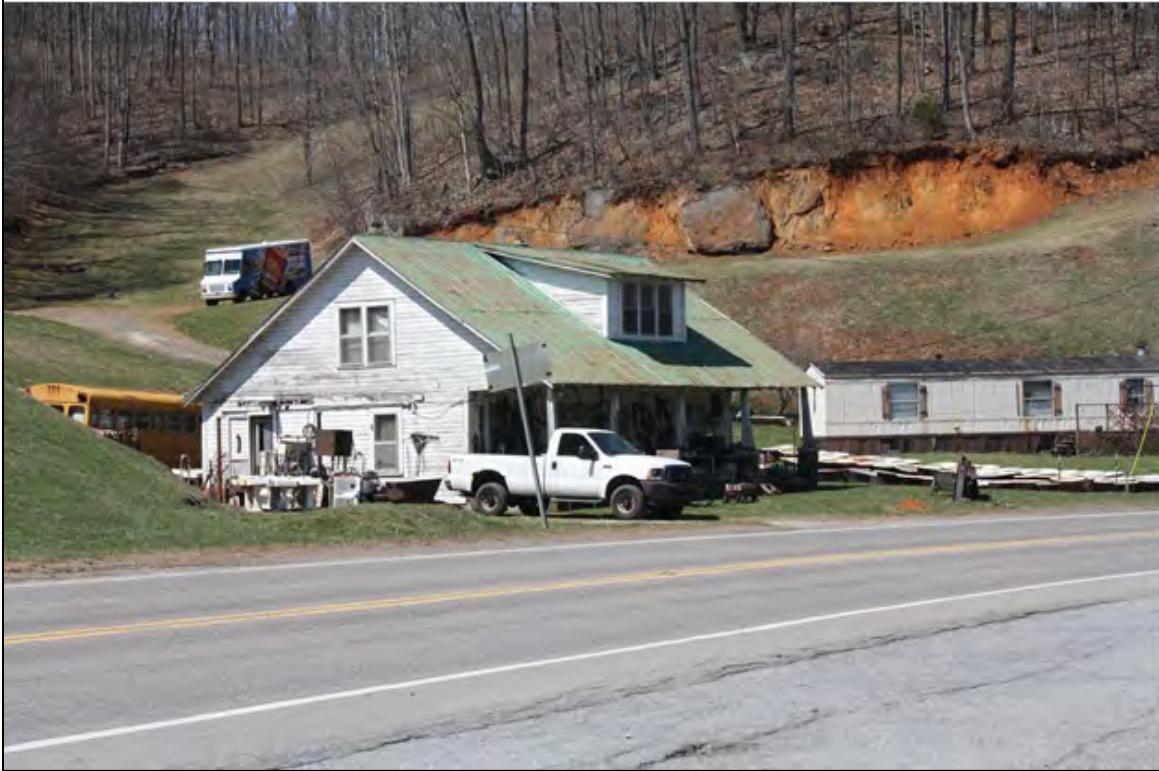
Figure 18: Bungalow, ca. 1930, 1799 NC HWY 88, W. Jefferson
