North Carolina Department of Natural and Cultural Resources
State Historic Preservation Office

SUBJECT: Historic Structures Survey Report, U-5798, Widening SR 1102 from US 401 to south of
Stewarts Creek, Cumberland County, ER 19-1847

Resource Name:	William John Gillis Farmstead
NCDOT Survey Site Numbers:	001
HPO Survey Site Numbers:	CD0211, CD1491 and CD1492 (former CD0793)
Location:	2761 Gillis Hill Road, Fayetteville, NC 28115
Parcel ID:	9486-40-2513, 9486-40-0356 and 9486-30-9165
Dates(s) of Construction:	Ca. 1900 (Dwelling), ca. 1910 (Saw Mill and Cotton Gin)
Recommendation:	Eligible

Resource Name:	McInnis House
NCDOT Survey Site Number:	002
HPO Survey Site Number:	CD0213
Location:	3039 Gillis Hill Road, Fayetteville, NC 28115
Parcel ID:	9485-27-1543
Dates(s) of Construction:	Ca.1850
Recommendation:	Eligible

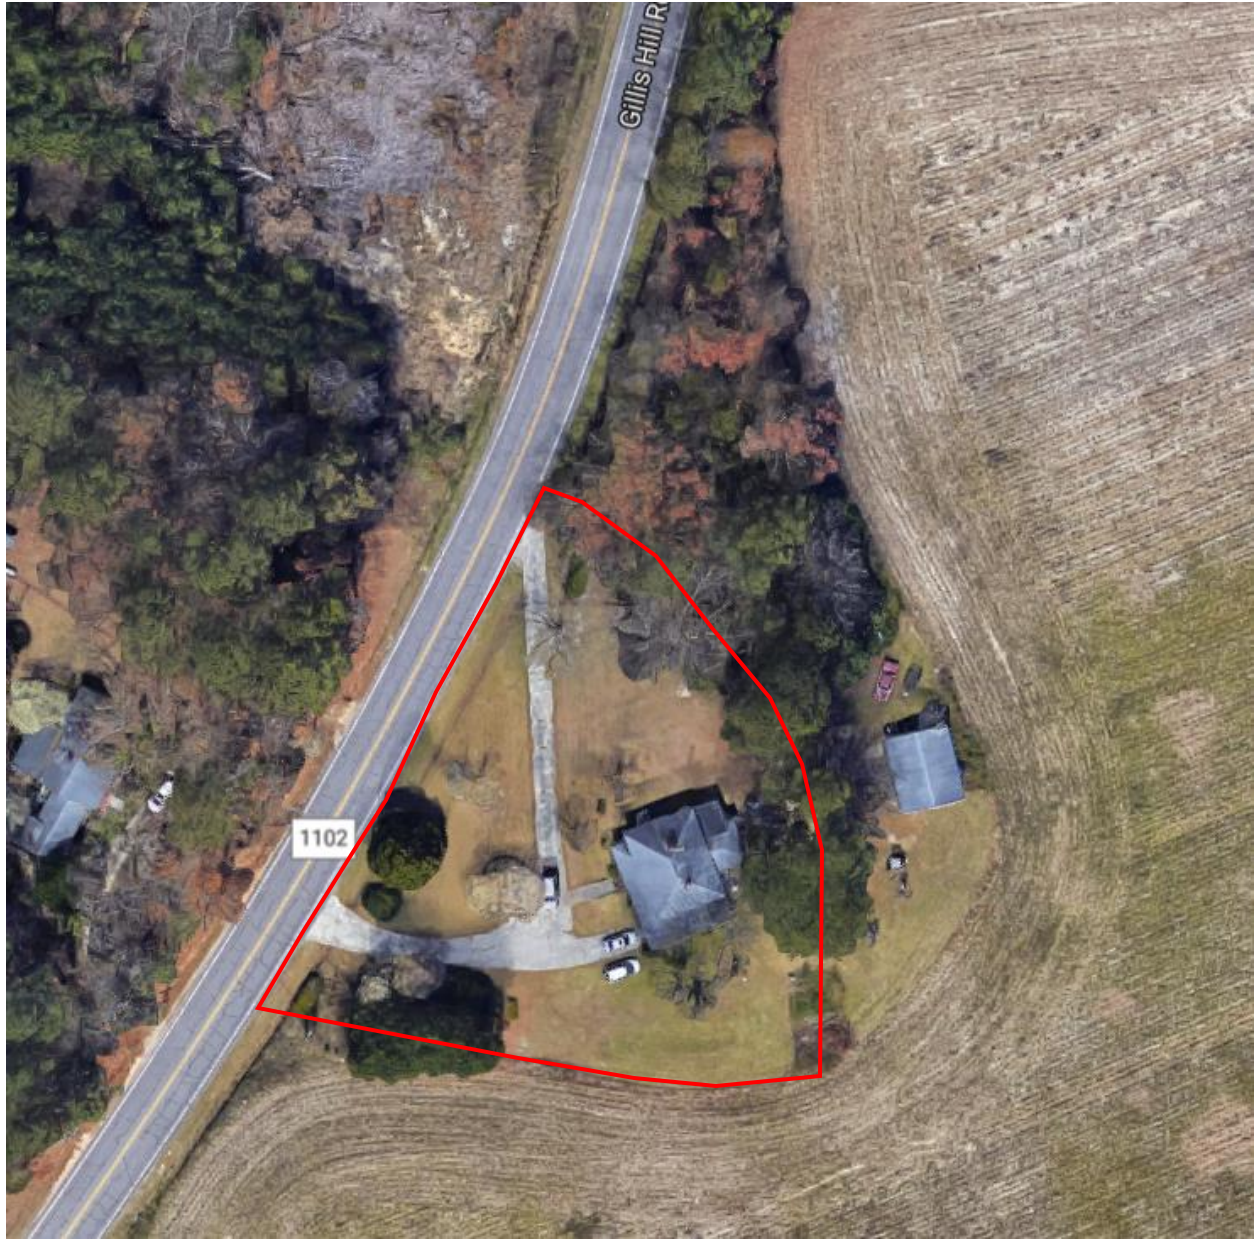
Attachment: Map

McInnis House Boundary: following the cultivated field along the south edge, then following a tree line to the north and northwest, then following the edge of pavement back to the beginning.

However, we do not concur with the proposed boundary for the McInnis House. In 1998, the McInnis House was determined eligible with a boundary that included about one acre. Attached is a proposed boundary that sufficiently conveys the house's architectural significance and includes approximately one acre of land. The house no longer retains its agricultural associations, and the current report failed to justify including the larger tract. The attached proposed boundary follows the edge of pavement along SR 1102, an agricultural field along the southern edge, and then follows a tree line north and northwest back to the road.

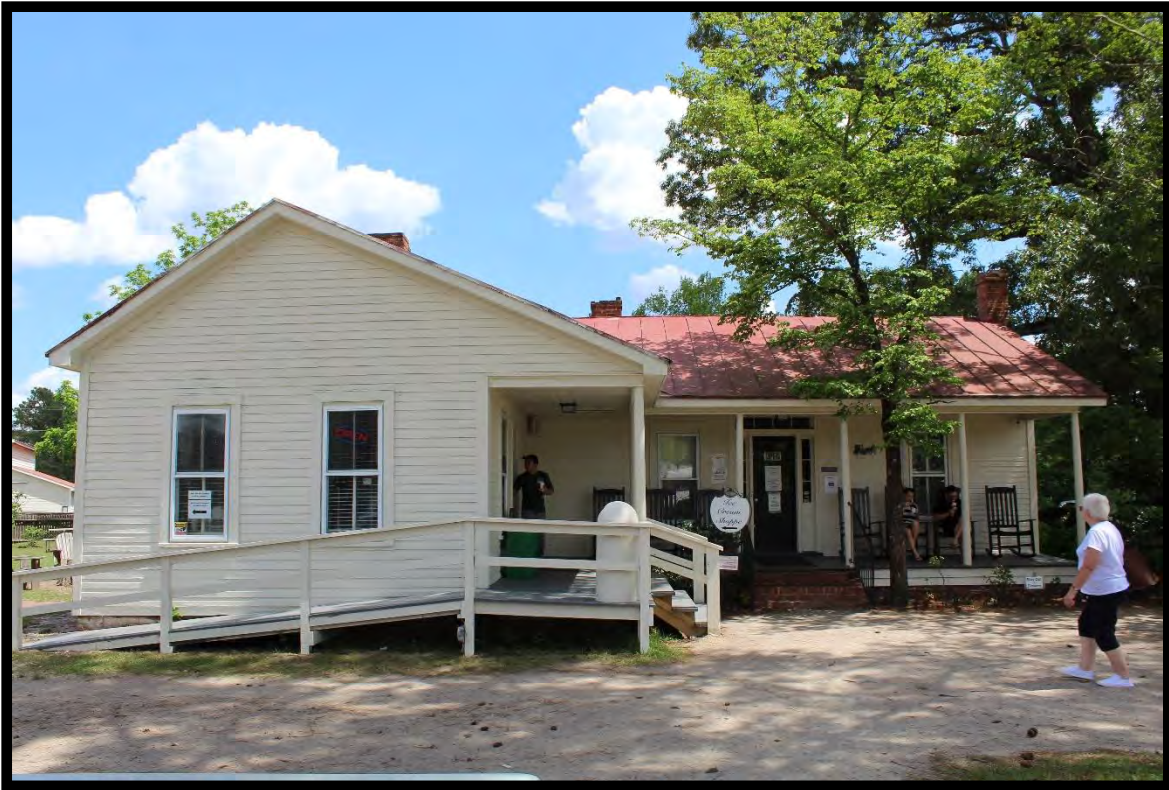
Figure 3: William John Gillis Farmstead, Dwelling, Looking Southeast.

The dwelling is a one-story vernacular house with Greek Revival features such as a divided light transom and sidelights and slender columns that support an integral porch. The house is of frame construction, rests on a brick foundation, and is clad in German (or drop) siding and metal roofing. The dwelling is largely asymmetrical in massing and has an irregular footprint due to having had several wings added since it was originally constructed. The façade has an L-plan appearance with a front gabled projecting wing meeting a side-gabled wing. It differs from a typical gable-and-wing form in that it is larger and has an integral L-shaped porch that shelters the side elevation of the projecting gable and the front elevation of the wing. A set of brick steps on the side-gabled wing lead to the original entrance with a wooden entry door flanked by sidelights that are divided into three equally sized panes over a recessed wooden panel and capped by a transom with four equally sized panes (see Figure 3). Though the exact timeline of additions is not entirely clear, based on interviews with the current owner and changes in the interior treatment, the original portion of the house appears to be the central side-gabled section. The kitchen addition and porches to the southeast and the L-shape portion to the northwest were likely added in the early-twentieth century, though the exact dates are not clear (Figure 6). Tax assessor data also states 1915 as the construction date for the house. This date, however, seems late for the original portion and may be in reference to the additions. Based on historic aerials, the house has had its current form since at least 1956.

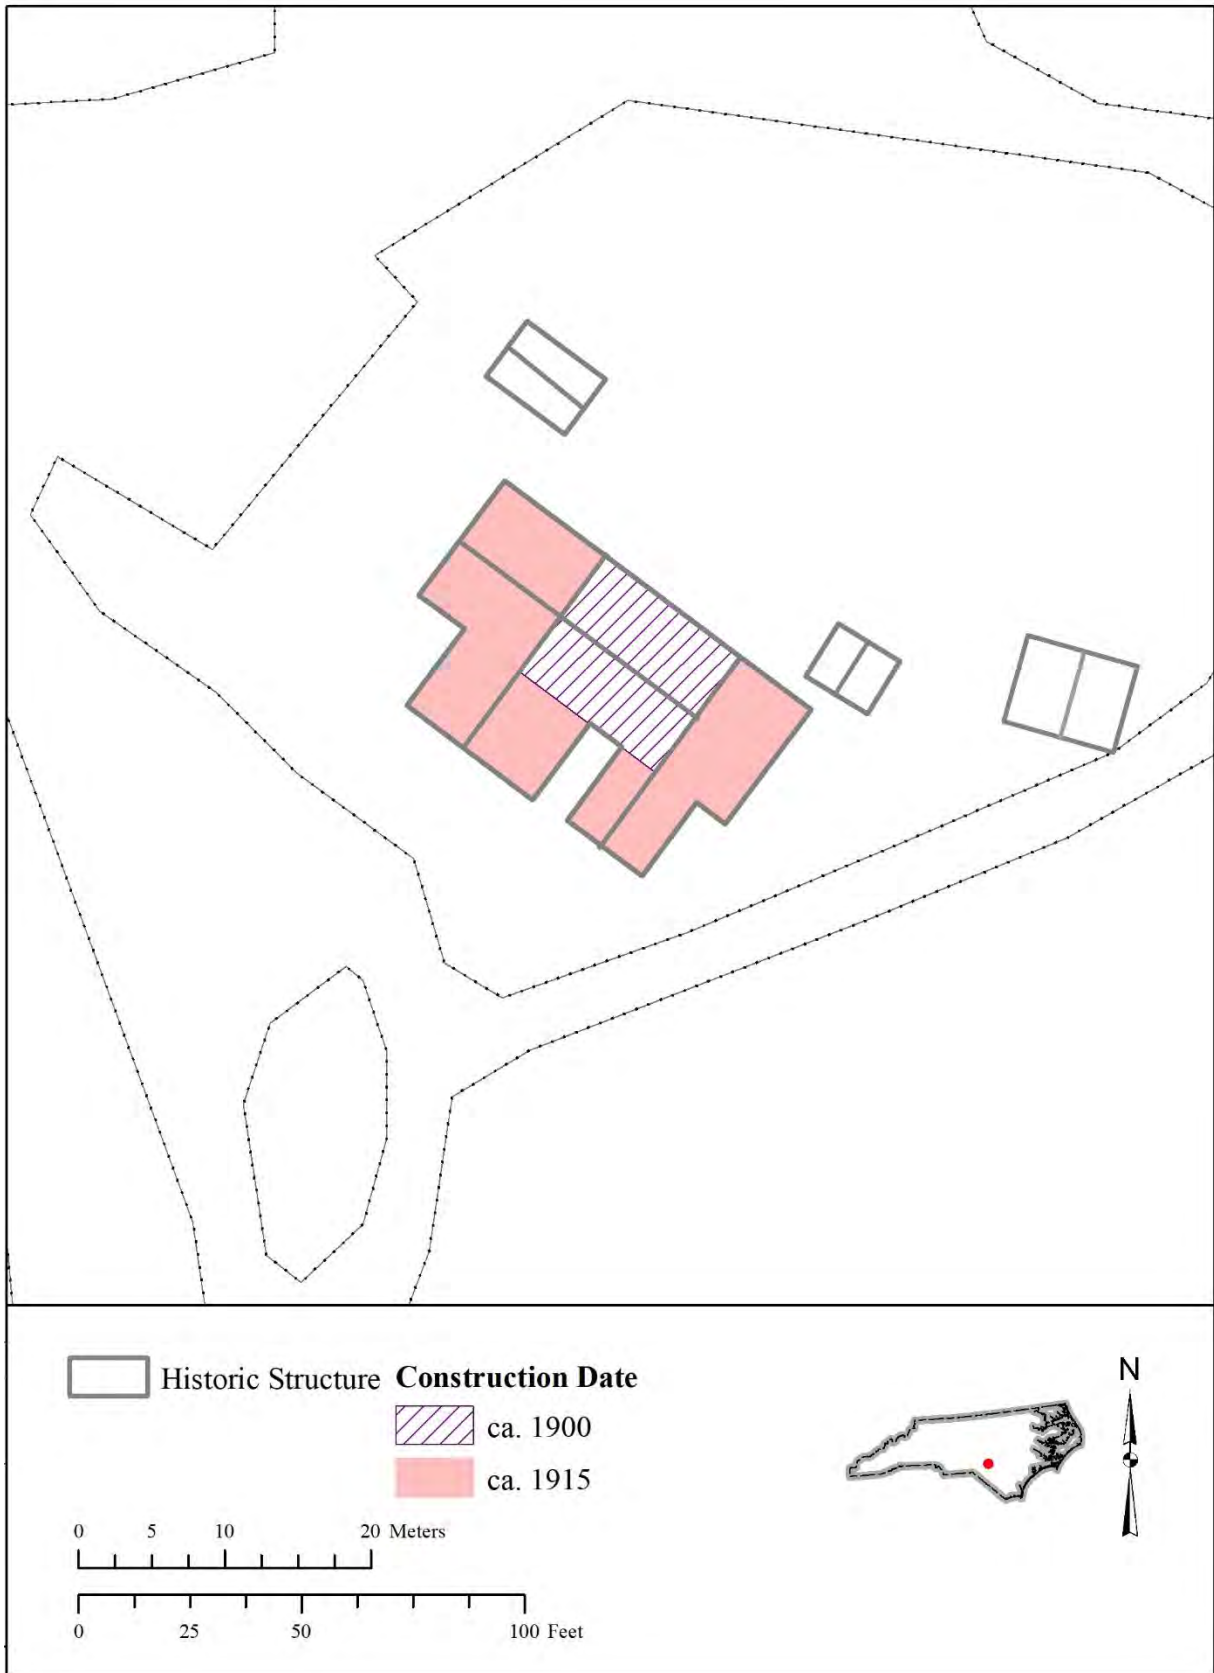
Figure 6: William John Gillis House, Dates of Construction.

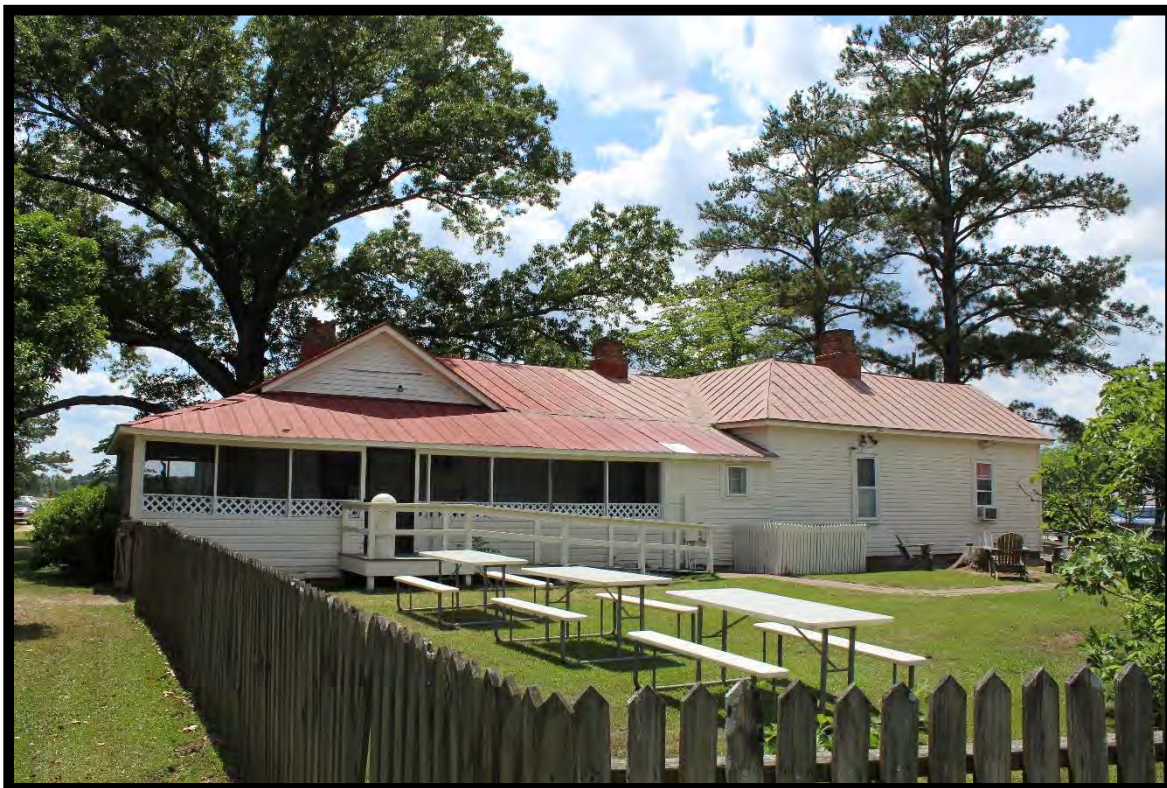
Figure 7: William John Gillis Farmstead, Dwelling, Looking Southwest.

The northeast (side) elevation reveals the complex rooflines of the William John Gillis House. The northwesternmost section has a partially hipped roof with a brick chimney extending from the center of the roofline. Fenestration on this section includes two two-over-two, wooden, double-hung-sash windows. A side-gabled central section contains another brick chimney and connects the previously described section of the house to the other end, which is defined by a Dutch gable roof and has a third chimney. The Dutch gable appears to be the result of additions, rather than an intentional design feature. A shed-roofed screened porch runs the length of the southeastern two-thirds of the elevation and has a screen door accessed by a wooden entry ramp. Decorative latticework separates the screened windows from German siding below on the porch (Figure 7).

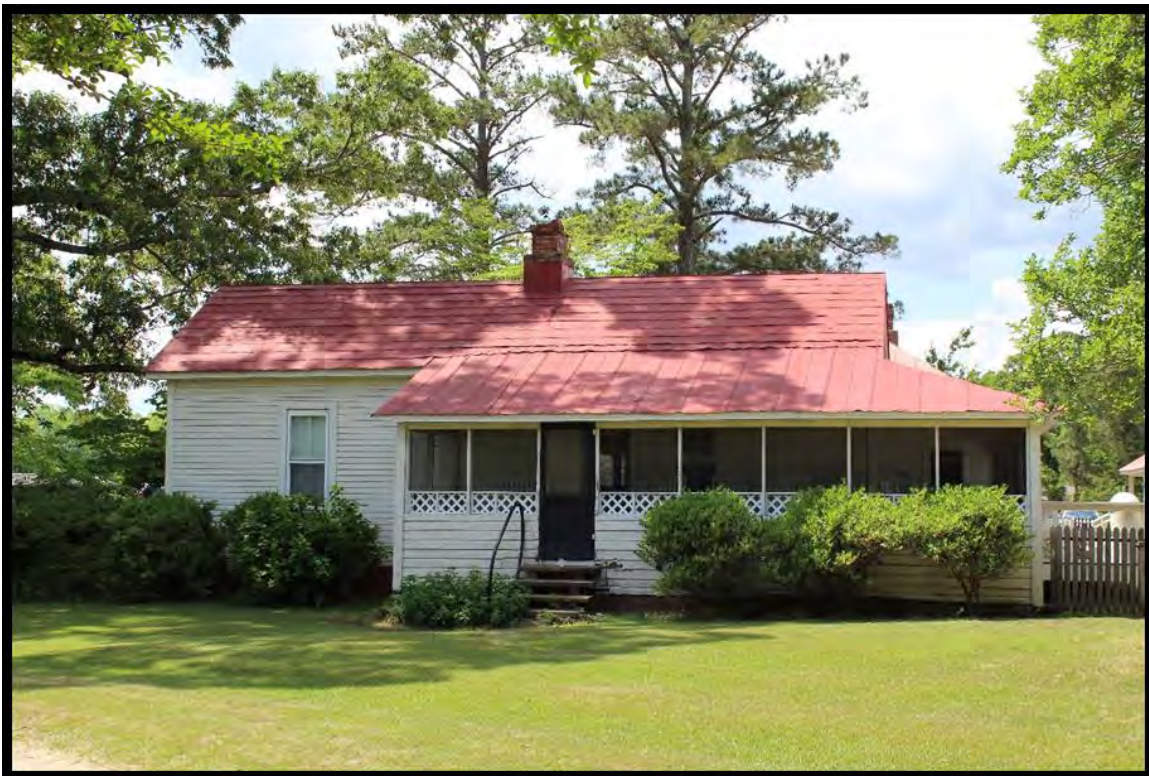
The southeast (rear) elevation is comprised of a simple side-gabled roof with a continuation of the shed-roofed porch seen on the northeastern elevation of the house (Figure 8). Porch fenestration remains consistent with screened windows over latticework and siding. Another pedestrian entrance is accessed by a set of wooden steps which lead to the screened porch. Within the screened porch there is a secondary entrance to the rear of the house. The porch covers about two-thirds of this elevation, leaving the southwestern third exposed. A single two-over-two, wooden, double-hung-sash window with simple wooden enframing is centered on this exposed section. Additionally, this section of the house has decorative pressed tin roofing. Other sections of the house are clad in standing-seam metal, like the porch seen on this elevation.

Figure 8: William John Gillis Farmstead, Dwelling, Looking Northwest.

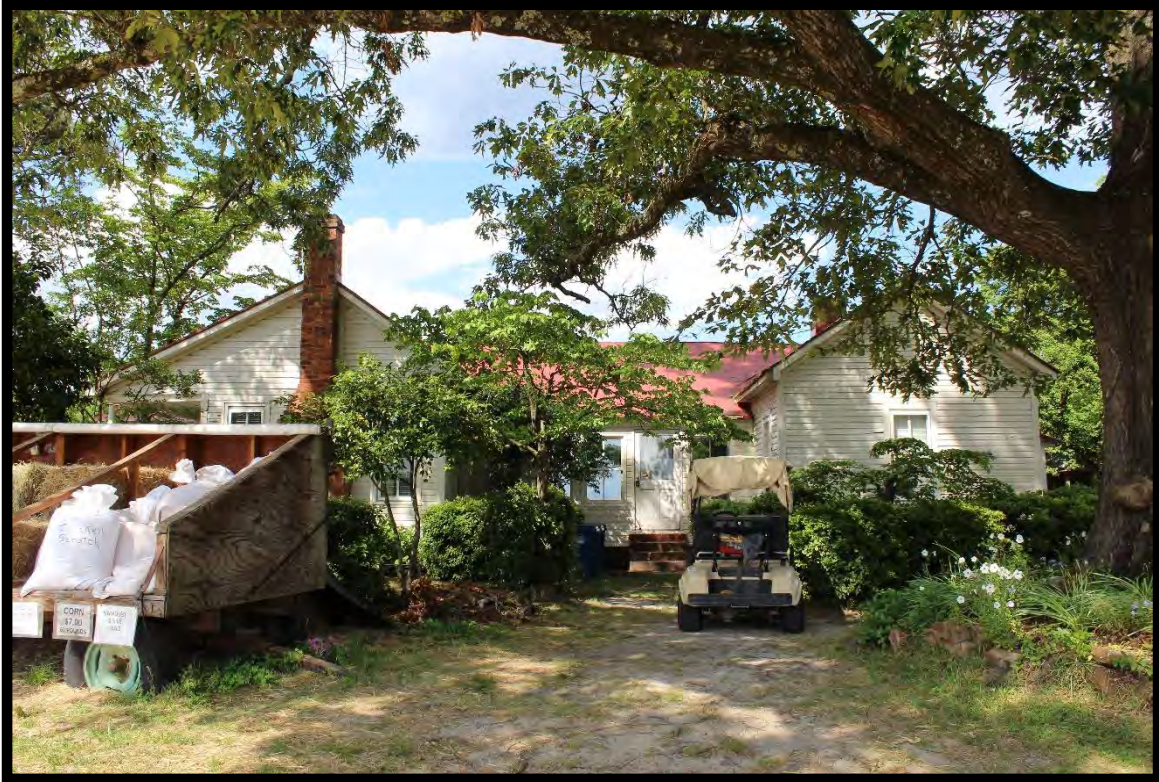
Figure 9: William John Gillis Farmstead, Dwelling, Looking Northeast.

and a centrally placed brick end chimney flanked by two-over-two, wooden, double-hung-sash windows. The central hyphen has an enclosed porch accessed by a set of brick steps. The porch has a wooden frame enclosure finished with wooden siding and a centrally placed wooden door flanked by two-over-two, wooden, double-hung-sash windows. The second gabled wing contains a centrally placed two-over-two, wooden, double-hung-sash window on the gabled end and another window with a similar treatment on the interior side elevation (Figure 9).

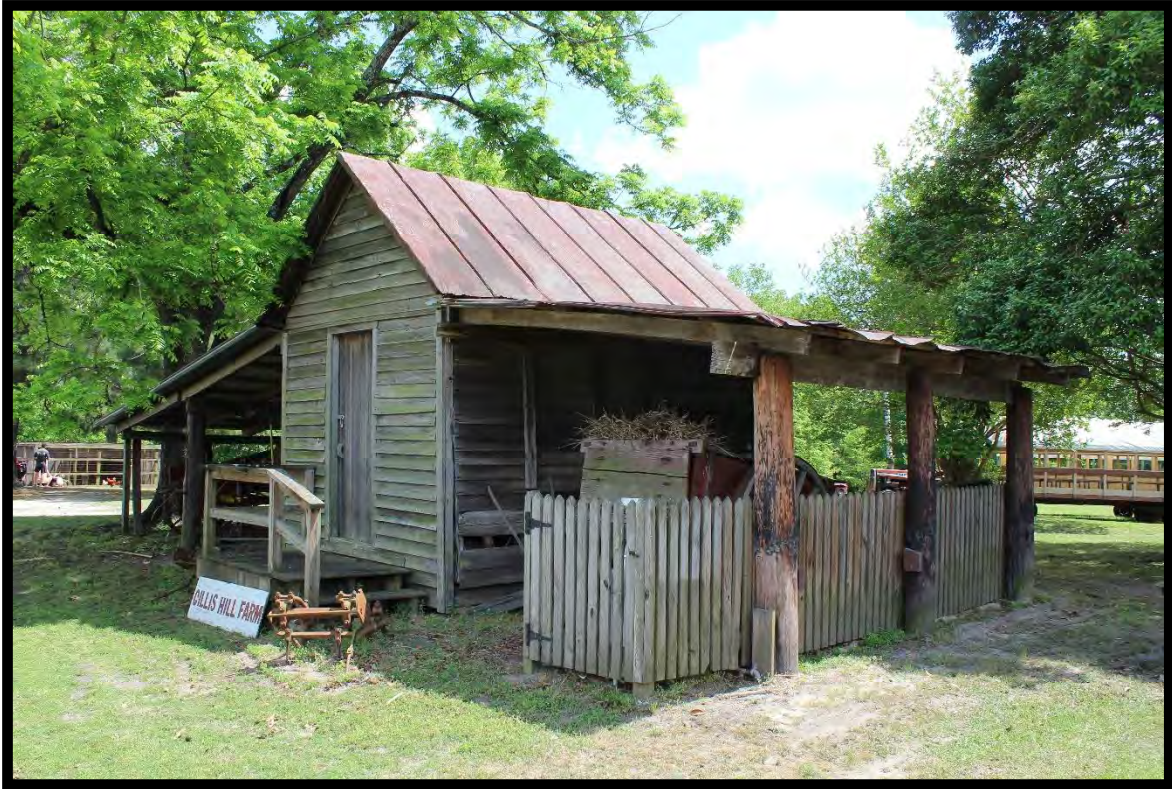
Figure 19: William John Gillis Farmstead, Smokehouse, Looking Northwest.

The smokehouse (Figure 19), is original to the site and located approximately 40 feet east of the dwelling. Its construction likely dates to around the same time as the dwelling, ca. 1900. The structure has a simple front-gabled form, weatherboard siding, and a standing seam metal roof. A pedestrian door is located on the north elevation, and open-air wings with exposed rafters flank either side of the central gabled form. The smokehouse was used for meat curing and storage in order to maintain a supply of consumable meat products prior to refrigeration. The meat was salted and then hung from interior rafters to cure. A small fire was stoked in the enclosed shelter and the smoke subsequently cured the meat over several weeks. Behind the smokehouse is a modern chicken coop (Figure 20), and farther north and east is a modern

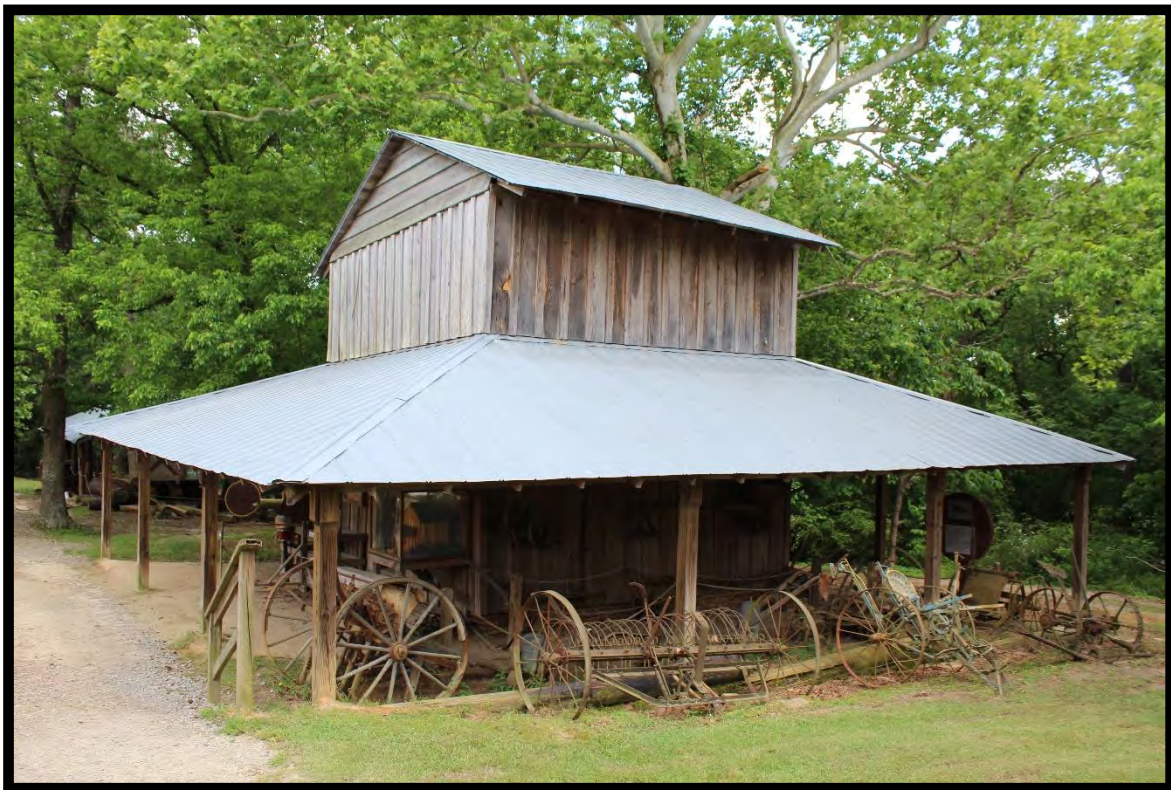
Figure 24: William John Gillis Farmstead, Tobacco Barn, Looking Northwest.

originally utilized a wood stove but was later updated to gas. He reconstructed the wood stove when the barn was placed here in order to illustrate the original function of the tobacco barn (Figures 26 and 27).⁴⁰ This is an example of a two-story gabled tobacco barn with a one-story hip-roofed porch. The exterior is finished with board and batten wooden siding and both roofs are clad in metal.

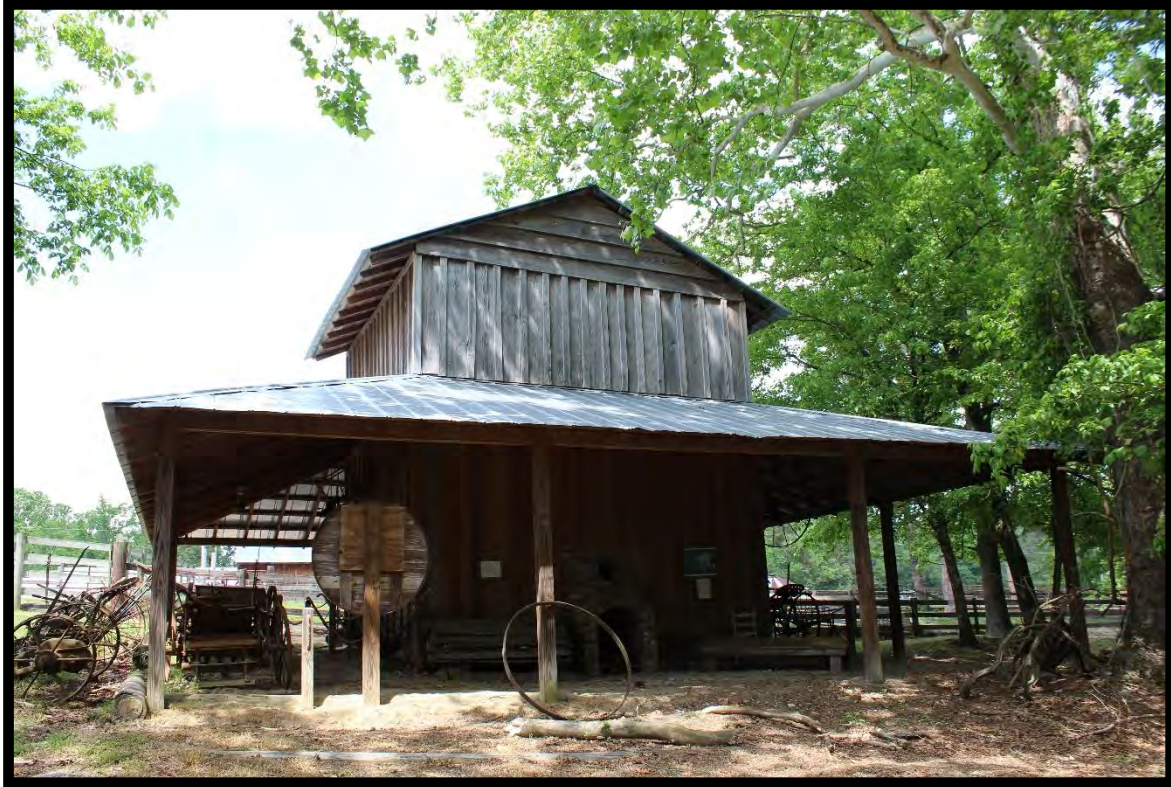
Figure 25: William John Gillis Farmstead, Tobacco Barn, Looking Northwest.

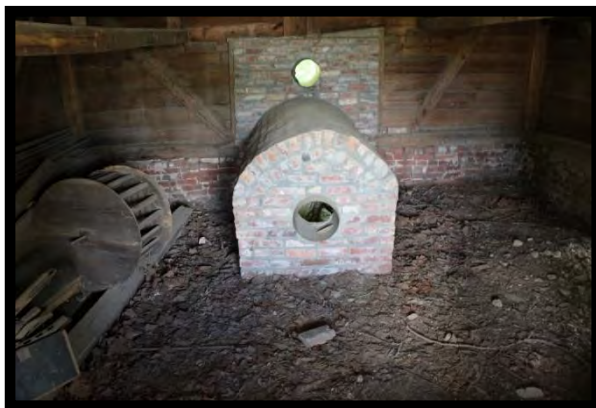
Figure 26: William John Gillis Farmstead, Tobacco Barn Stove, Looking South.

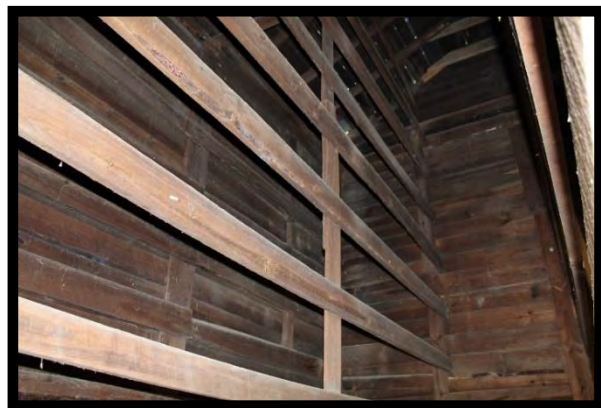
Figure 27: William John Gillis Farmstead, Interior of Tobacco Barn.

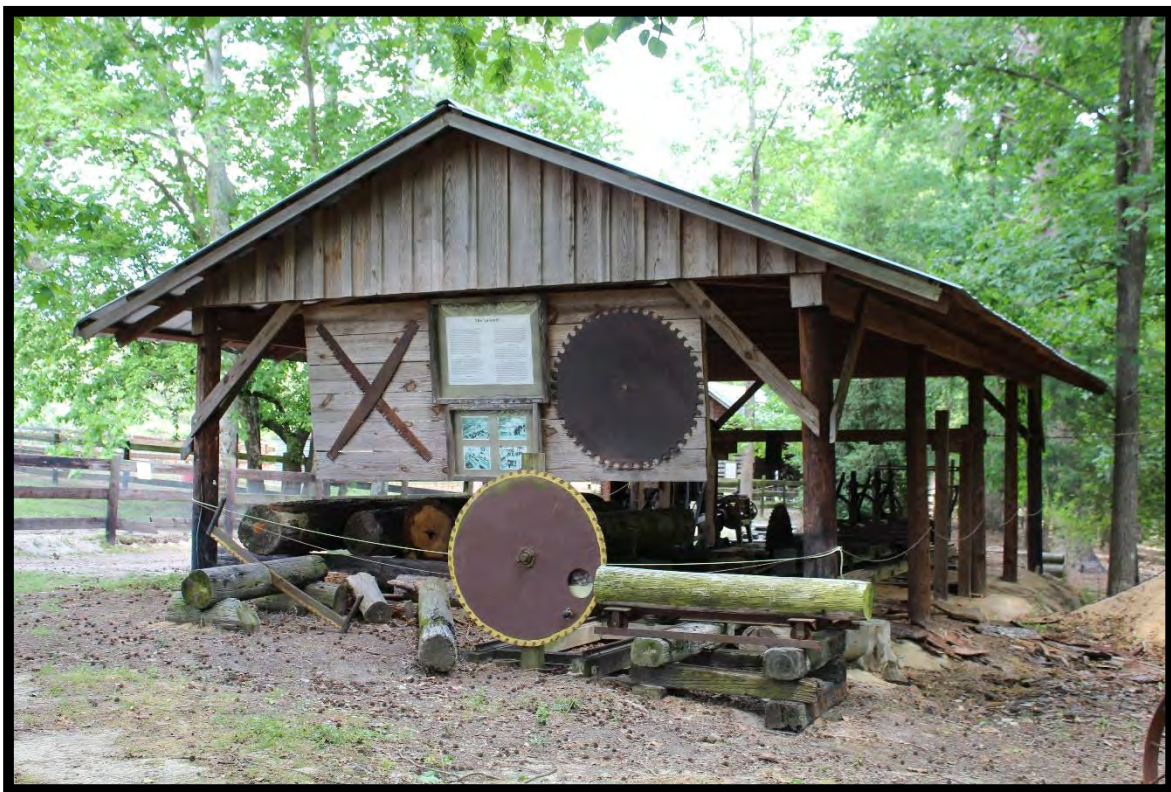
Figure 28: William John Gillis Farmstead, Saw Mill, Looking Northeast.

The form of the original shelter of the sawmill is unknown, but based on family photos, it was nonextant as early as the 1980s. The present shelter was constructed sometime in the mid-2000s and is a simple front-gabled open-air structure (Figures 28 through 30). The wooden frame structure has a rectangular footprint and consists of unfinished wooden posts supporting a frame roof clad with corrugated metal. Each gable contains vertical board and batten siding. Little other detail is found on the structure outside of interpretive signage.

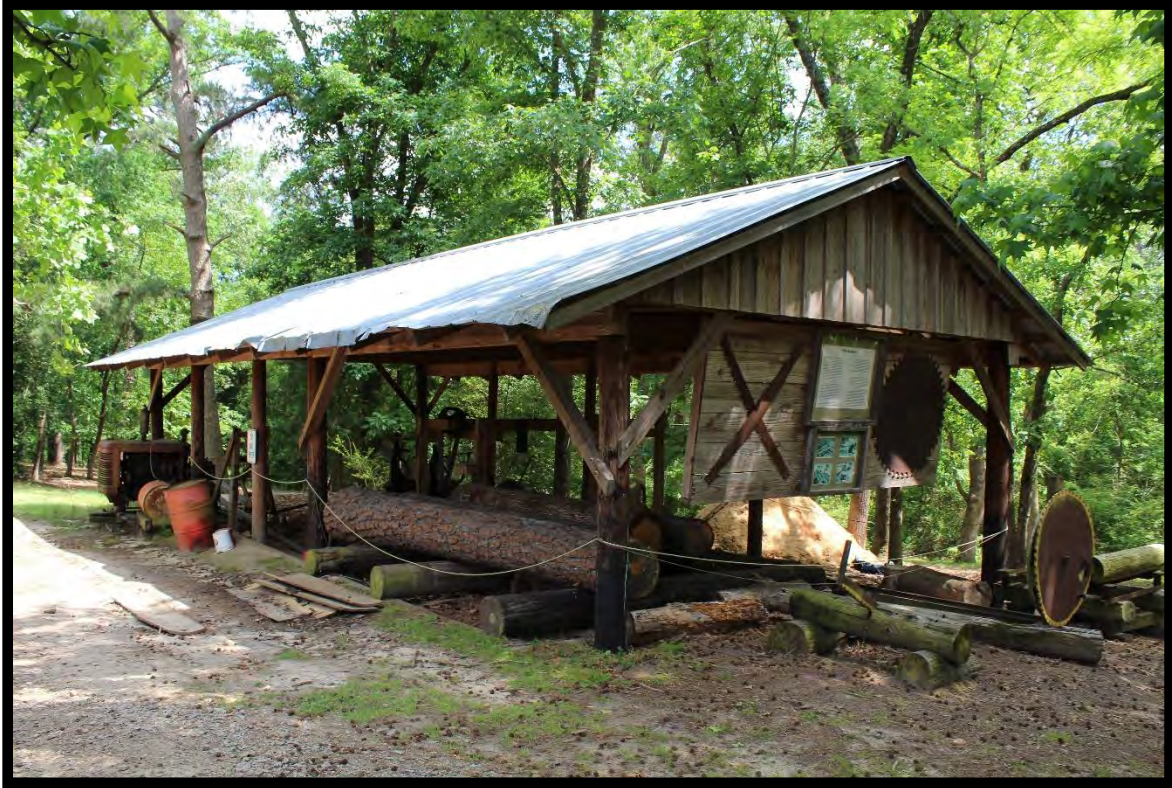
Figure 29: William John Gillis Farmstead, Saw Mill, Looking Southeast.

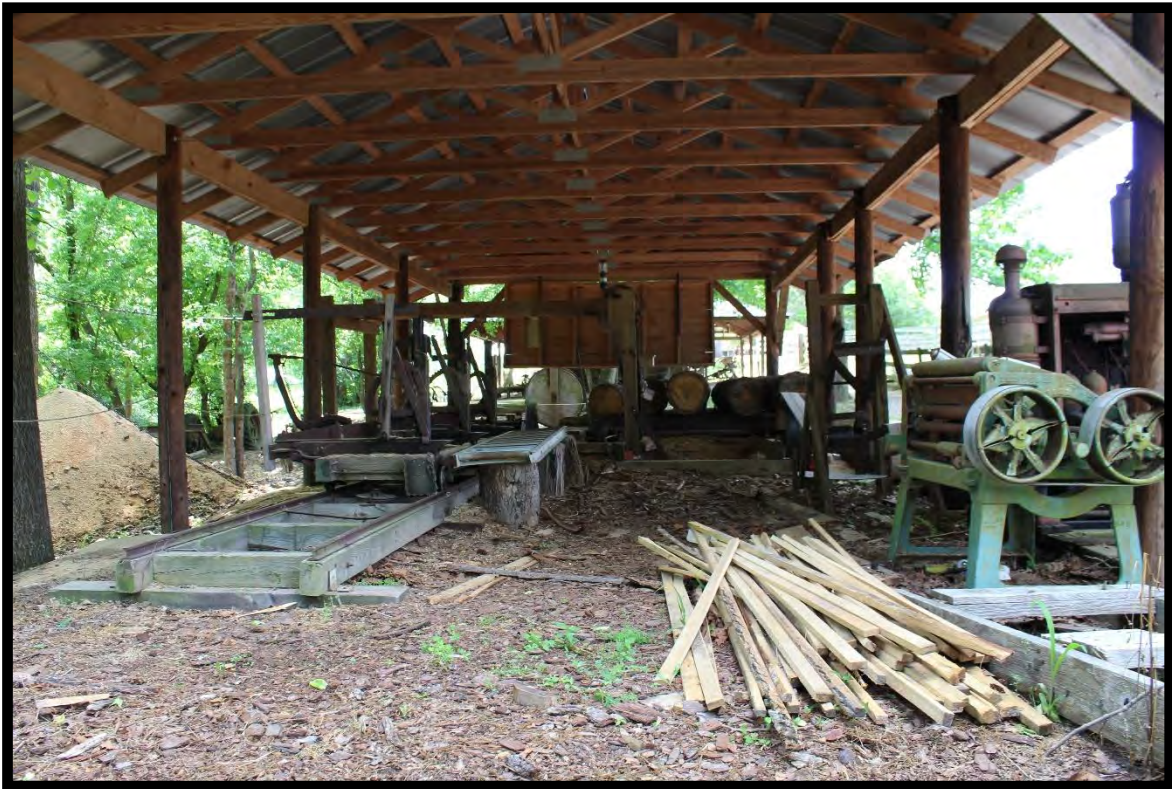
Figure 30: William John Gillis Farmstead, Saw Mill, Interior Setup, Looking West.

This is an example of an early twentieth-century diesel powered saw mill. This particular power unit is similar to one identified as an International Harvester Inc. power unit, possibly a UD-9 power unit produced in the 1940s (Figures 32 and 33).⁴¹ It functions by starting with gas and then switches to diesel to power the saw mill. The diesel power unit and a circular saw are both located at the northeastern corner of the shelter with the saw centrally located under the shelter itself. The saw mill mechanism is an example of a Moffitt Sawmill indicating a brand that was popular during the early twentieth century (Figure 34).⁴² These sawmills were produced by Moffitt Ironworks located in Sanford, North Carolina, just north of Fayetteville. Moffitt Ironworks operated from 1888 into the first half of the twentieth century.⁴³

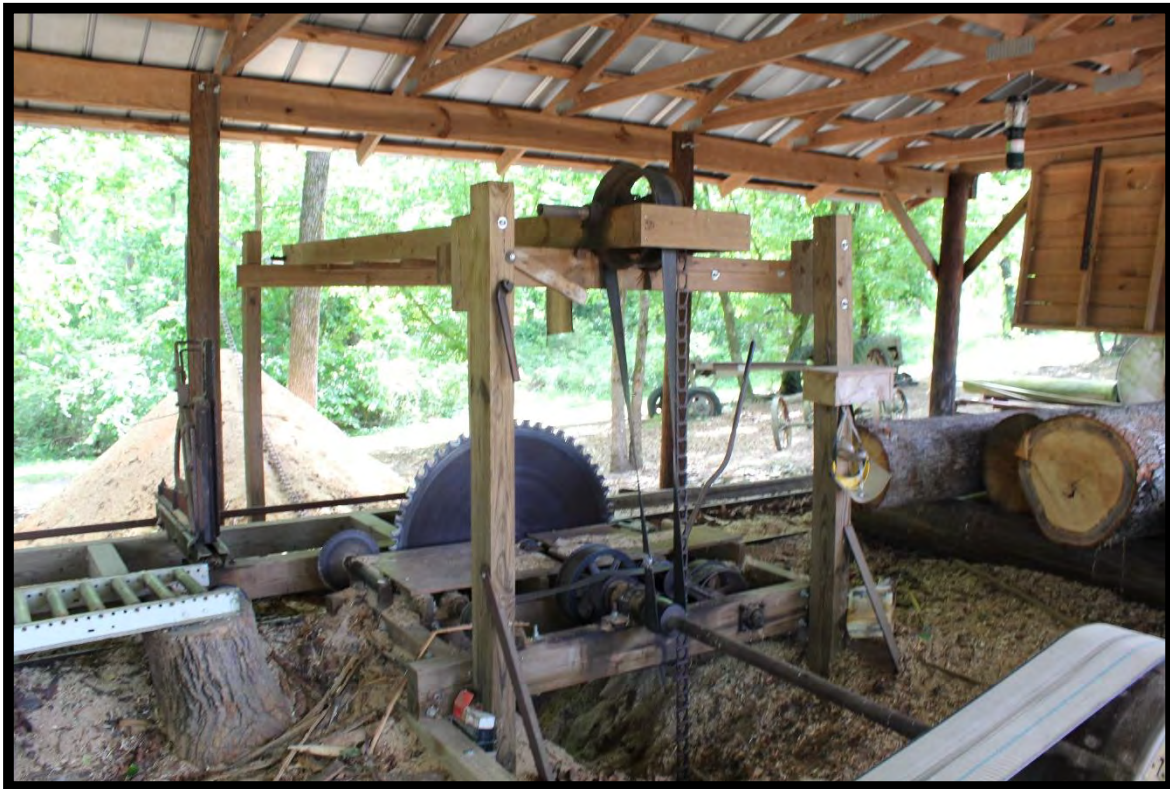
Figure 31: William John Gillis Farmstead, Saw Mill, Circular Saw, Looking Southwest.

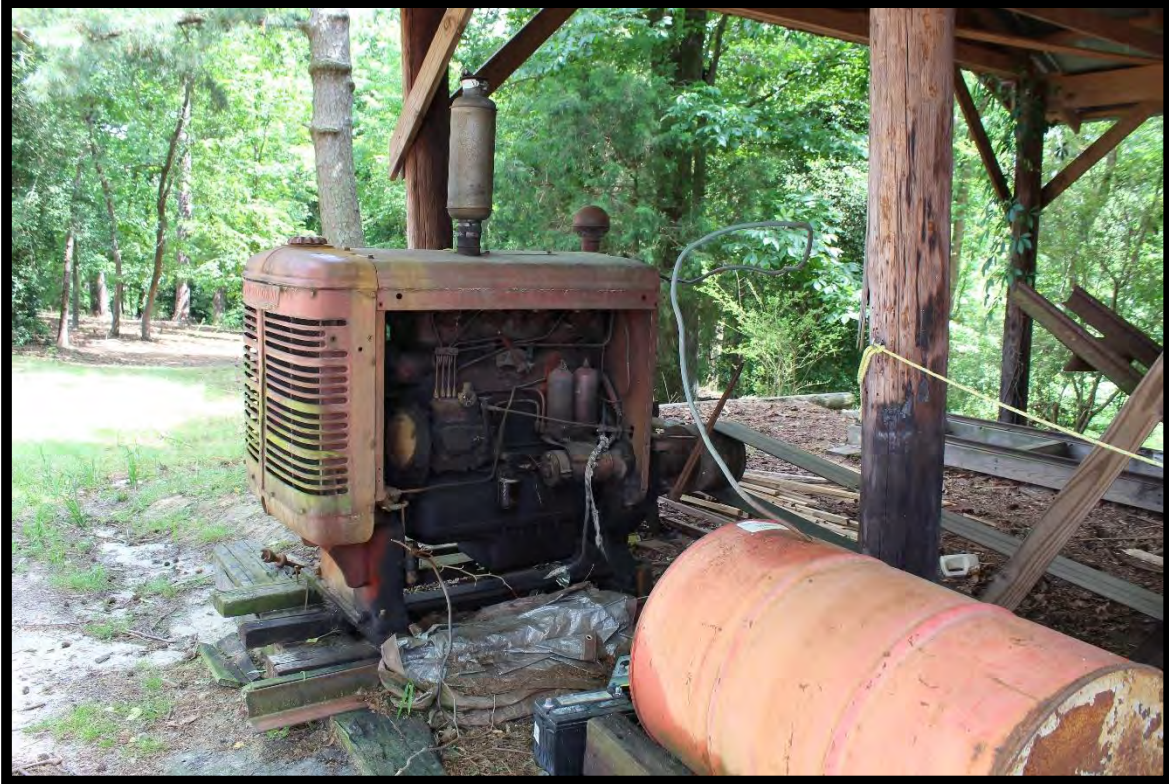
Figure 32: William John Gillis Farmstead, Saw Mill, Diesel Engine, Looking Southeast.

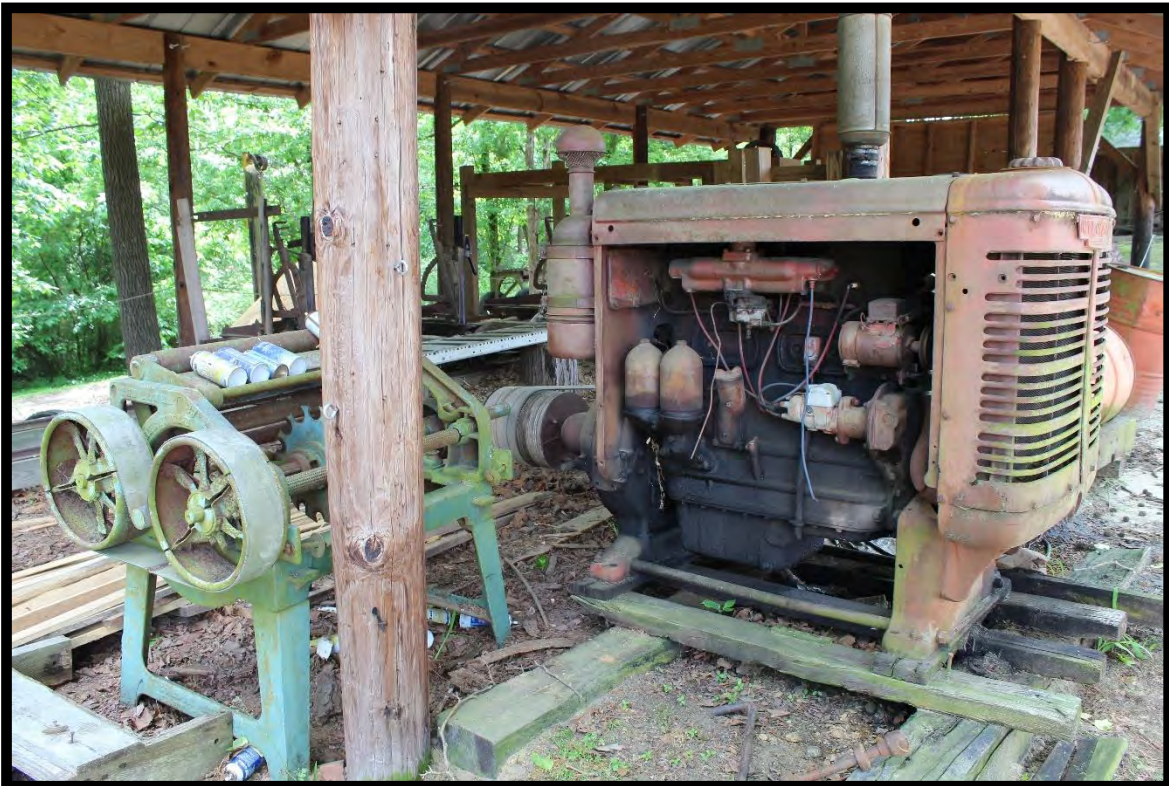
Figure 33: William John Gillis Farmstead, Saw Mill, Diesel Engine, Looking Southeast.

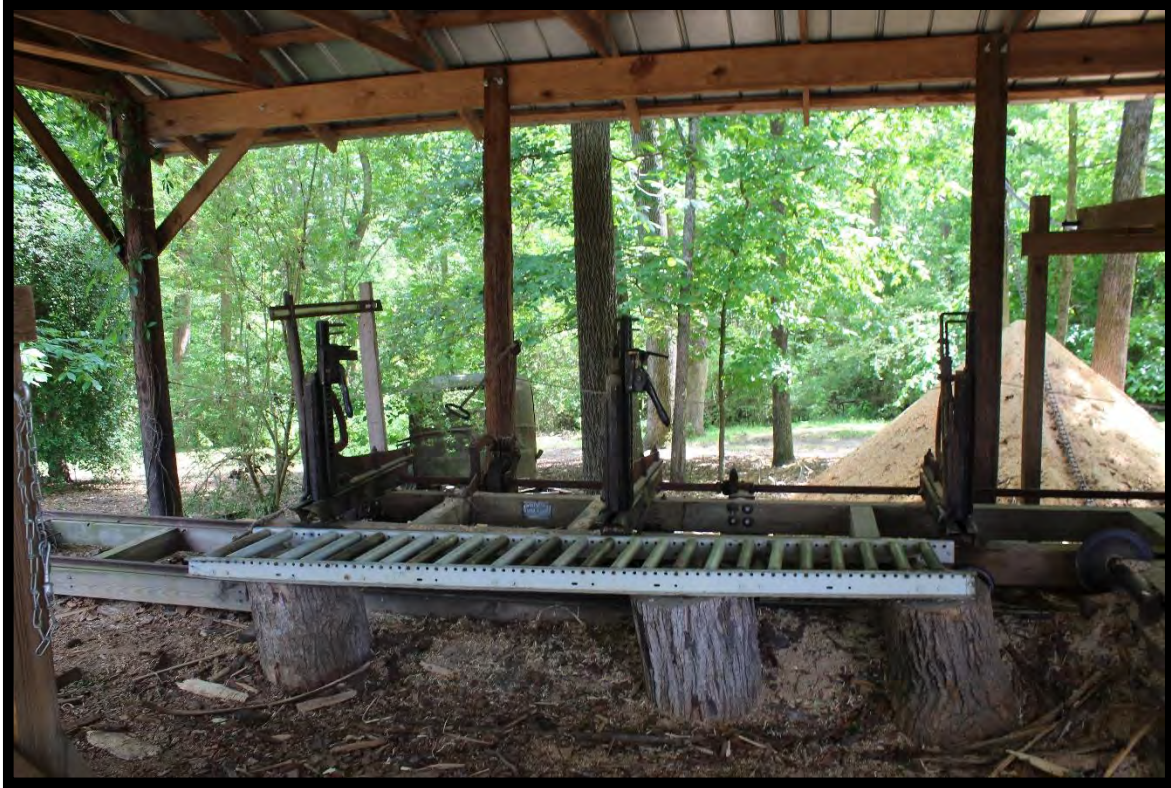
Figure 34: William John Gillis Farmstead, Saw Mill, ca. 1900 Moffit Saw Mill, Looking Southeast.

that was moved from Pitt County to the state fairgrounds around 2009. The buildings/shelters that originally stood over the mill equipment were documented, but were too deteriorated to continue to use, along with the boiler. The mechanism was reassembled as it once stood on the original site. Similar to this example, the Gillis saw mill (which was originally steam powered but is currently powered by an early twentieth century diesel power unit) was moved and reassembled at its present site in order to illustrate the function of the twentieth century machinery (Figures 50 and 51). Additionally, the saw mill mechanism appears to be similar to the Moffit Saw Mill found at the Gillis site.

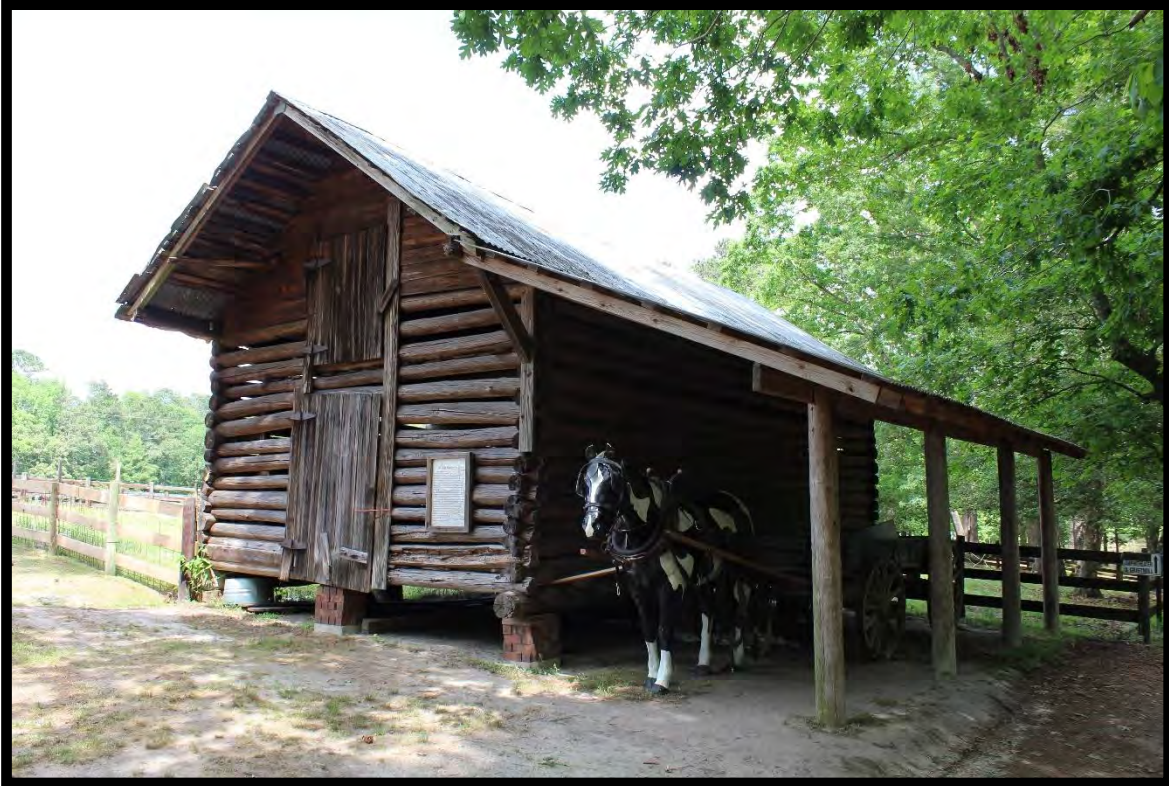
Figure 35: William John Gillis Farmstead, Corn Crib, Looking Northeast.

Located behind the sawmill moving east, a corn crib is located approximately 450 feet east of the dwelling with its primary elevation facing west toward the dwelling and Gillis Hill Road (Figure 35). It is a front-gabled log structure with a projecting eave and an open southern wing. The structure sits on loose brick piers and its roof is clad with ribbed metal sheets. The architecture is typical of a corn crib with saddle notching and ventilation space between the logs. It also features a primary pedestrian door and a second-story door providing access to loft space in the gable. This particular barn is not original to the Gillis farmstead, but belonged to the Willis family whose property was sold for development. The corn crib was moved from that property and saved from development in the mid-2000s and moved to its current location in February of 2010. It dates from ca. 1923.⁴⁴

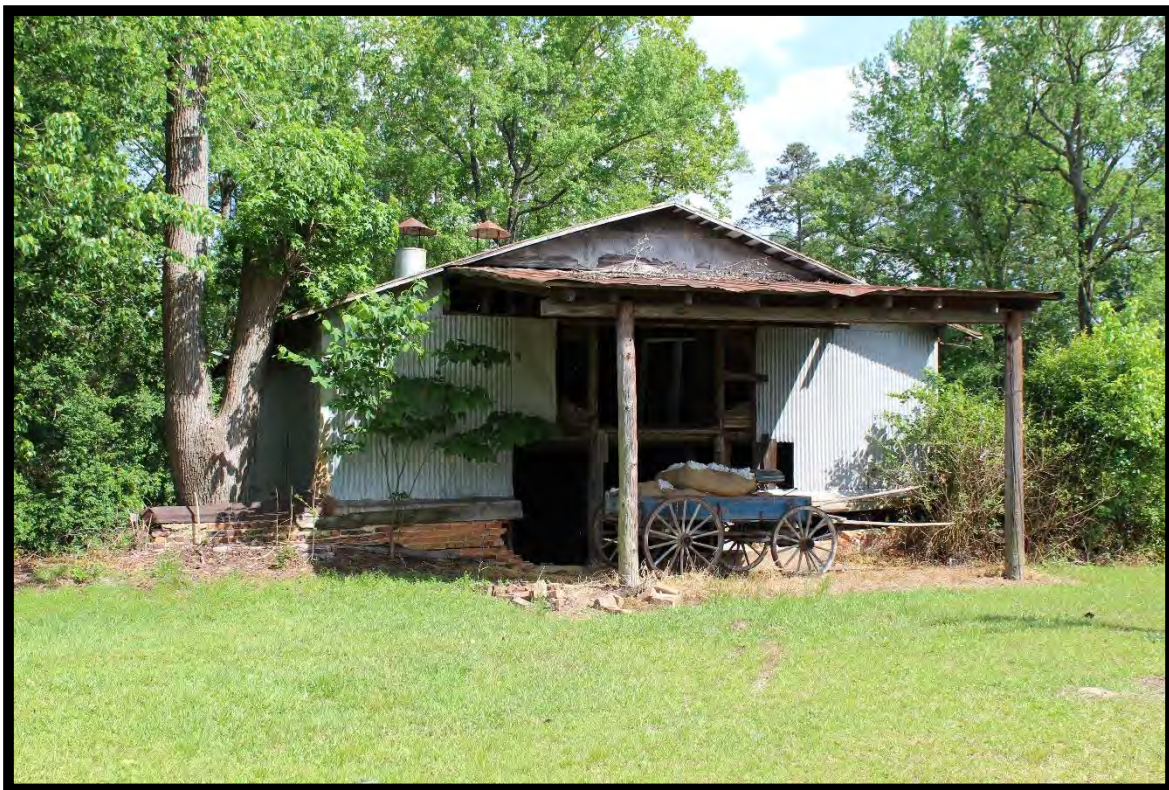
The Gillis Cotton Gin No. 2 is an example of a two-story front-gabled cotton gin complex with an upper divided loft above and an open plan ground floor with intact drive shafts (Figures 37 and 38). A seed house is attached to the rear and forms a one-story shed-roofed projection on the rear elevation (Figure 39). The structure has a wooden frame and is clad in corrugated metal sheets. A retaining wall cuts across the westernmost third of the structure and is largely overgrown with vegetation, making access to the other elevations and rear of the structure impossible. An adjacent fence separates the structure from the neighboring parcel. The rear elevation was not directly accessible due to the brick retaining wall and overgrowth surrounding the area.

Figure 37: Gillis Cotton Gin No. 2, Looking Northeast.
