North Carolina Department of Natural and Cultural Resources
State Historic Preservation Office

SUBJECT: Historic Structures Survey Report, U-5798, Widening SR 1102 from US 401 to south of
Stewarts Creek, Cumberland County, ER 19-1847

Resource Name:	William John Gillis Farmstead
NCDOT Survey Site Numbers:	001
HPO Survey Site Numbers:	CD0211, CD1491 and CD1492 (former CD0793)
Location:	2761 Gillis Hill Road, Fayetteville, NC 28115
Parcel ID:	9486-40-2513, 9486-40-0356 and 9486-30-9165
Dates(s) of Construction:	Ca. 1900 (Dwelling), ca. 1910 (Saw Mill and Cotton Gin)
Recommendation:	Eligible

Resource Name:	McInnis House
NCDOT Survey Site Number:	002
HPO Survey Site Number:	CD0213
Location:	3039 Gillis Hill Road, Fayetteville, NC 28115
Parcel ID:	9485-27-1543
Dates(s) of Construction:	Ca.1850
Recommendation:	Eligible

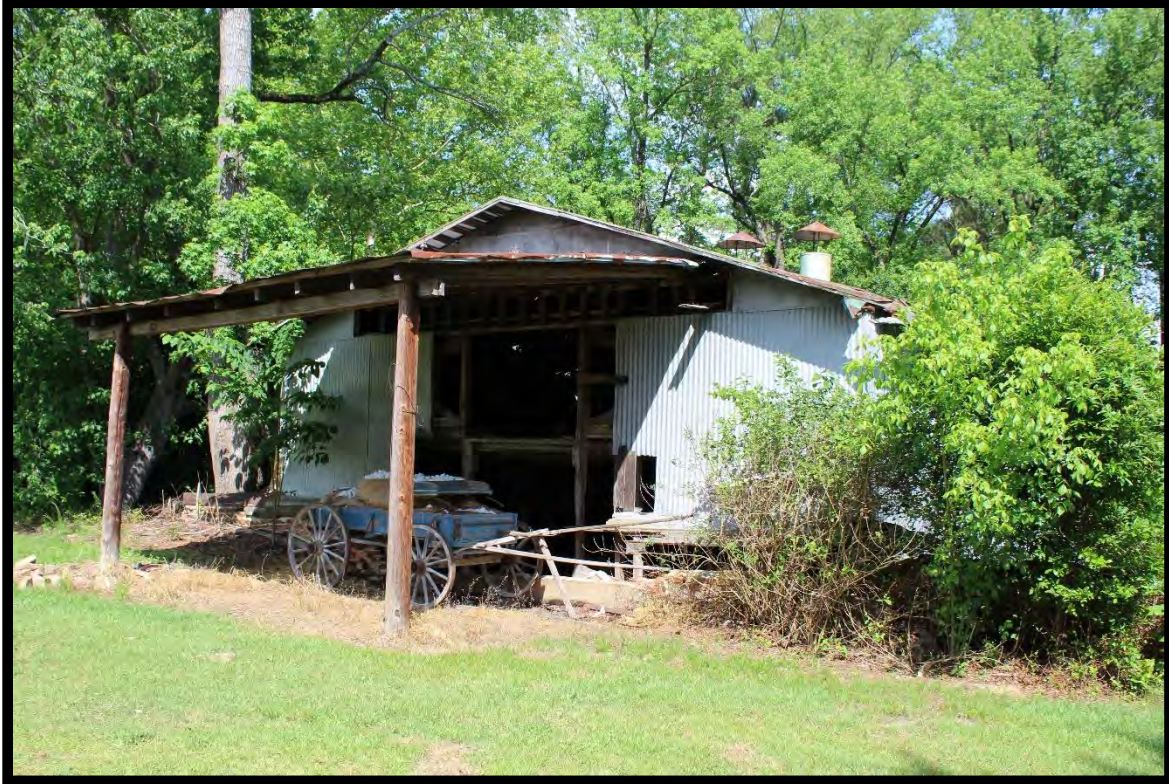
The Gillis Cotton Gin No. 2 is an example of a two-story front-gabled cotton gin complex with an upper divided loft above and an open plan ground floor with intact drive shafts (Figures 37 and 38). A seed house is attached to the rear and forms a one-story shed-roofed projection on the rear elevation (Figure 39). The structure has a wooden frame and is clad in corrugated metal sheets. A retaining wall cuts across the westernmost third of the structure and is largely overgrown with vegetation, making access to the other elevations and rear of the structure impossible. An adjacent fence separates the structure from the neighboring parcel. The rear elevation was not directly accessible due to the brick retaining wall and overgrowth surrounding the area.

Figure 38: Gillis Cotton Gin, Looking Northeast.

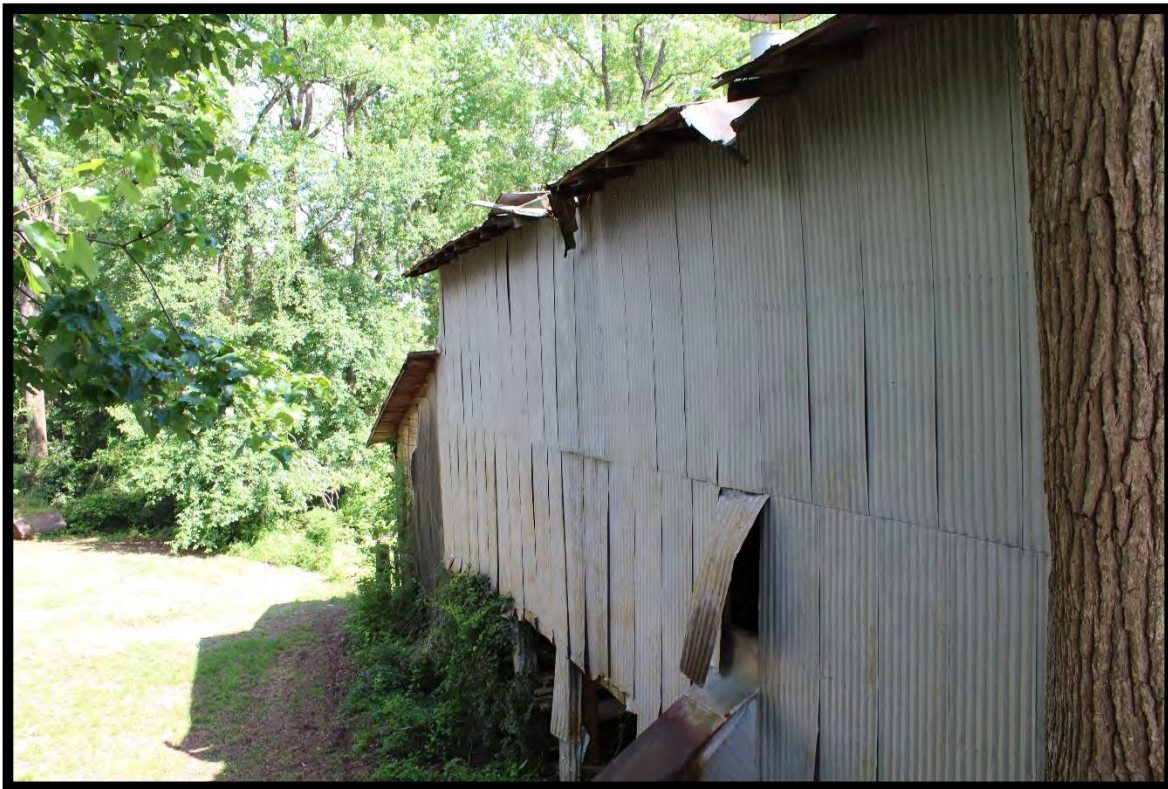
Figure 39: Gillis Cotton Gin 2, View of Side Elevation and Seed House, Looking Southeast.

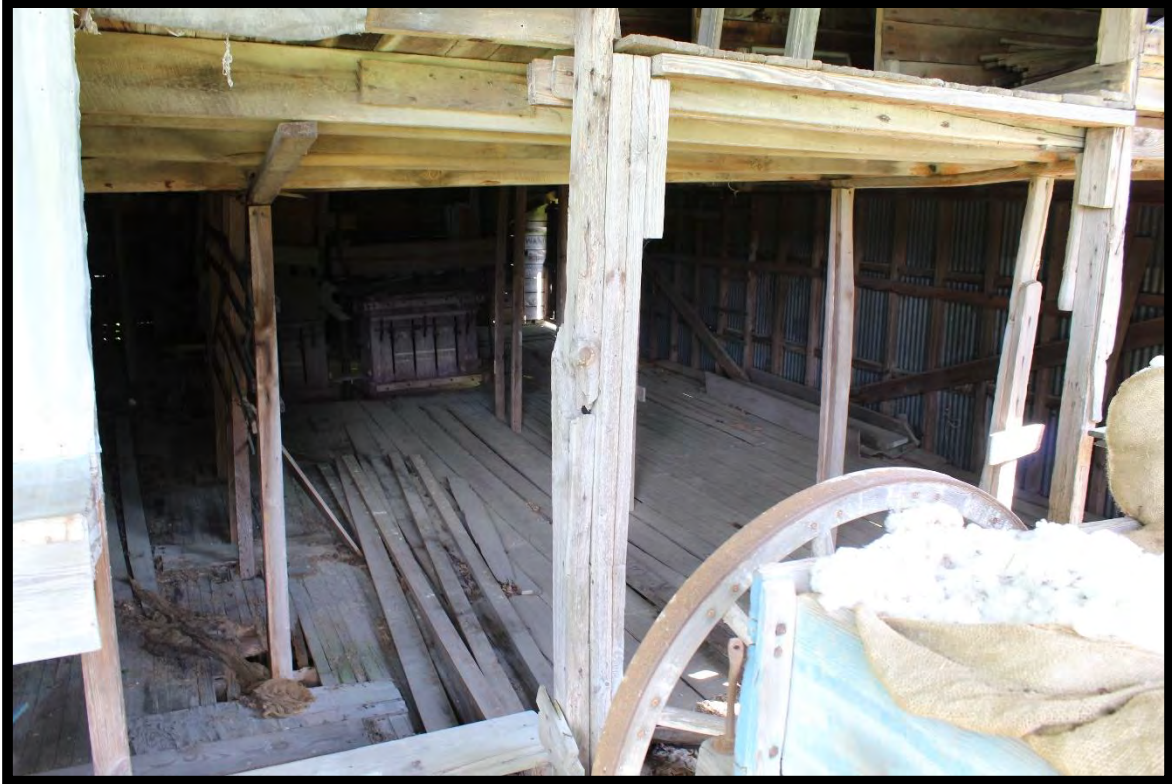
Figure 40: Gillis Cotton Gin 2, View of Ground Floor and Drive Shafts, Looking Southeast.

The ground floor of the cotton gin has an open floor plan and contains the original driveshafts (Figure 40). The upper story contains divided loft space three to four bays deep (Figure 41).

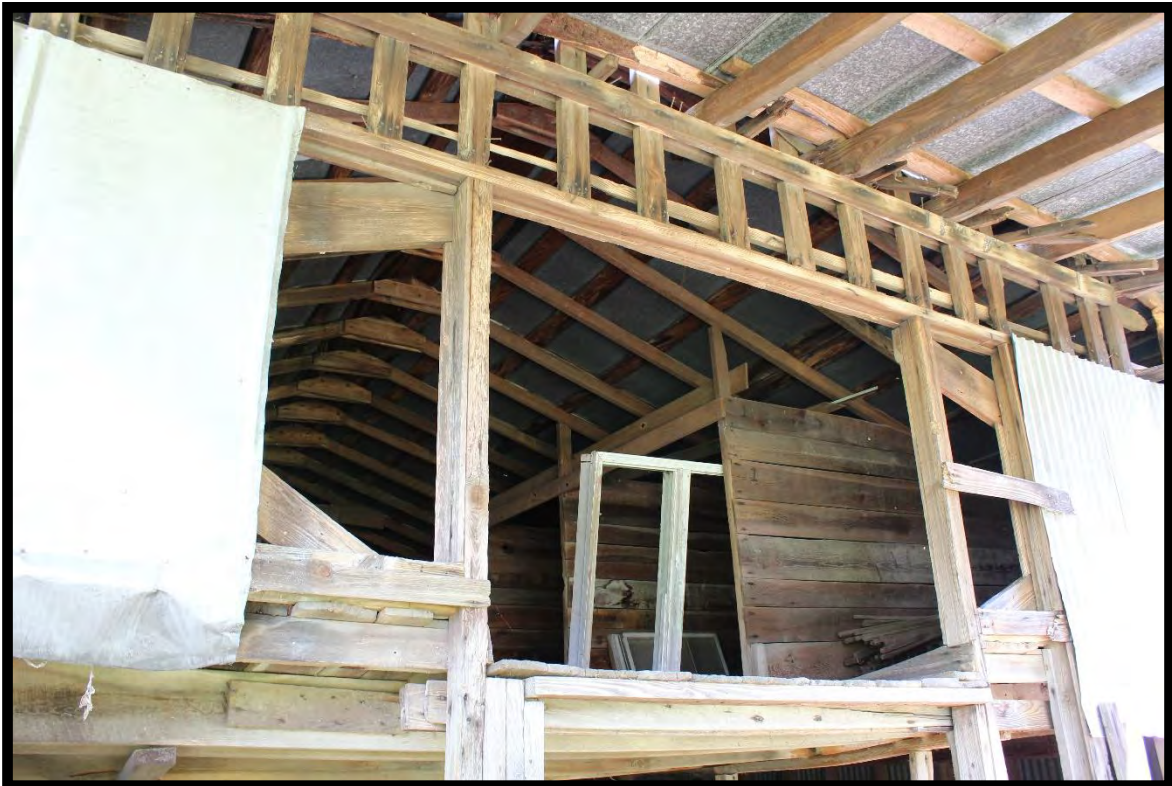
Figure 41: Gillis Cotton Gin 2, View of Divided loft in upper story, Looking Southeast.

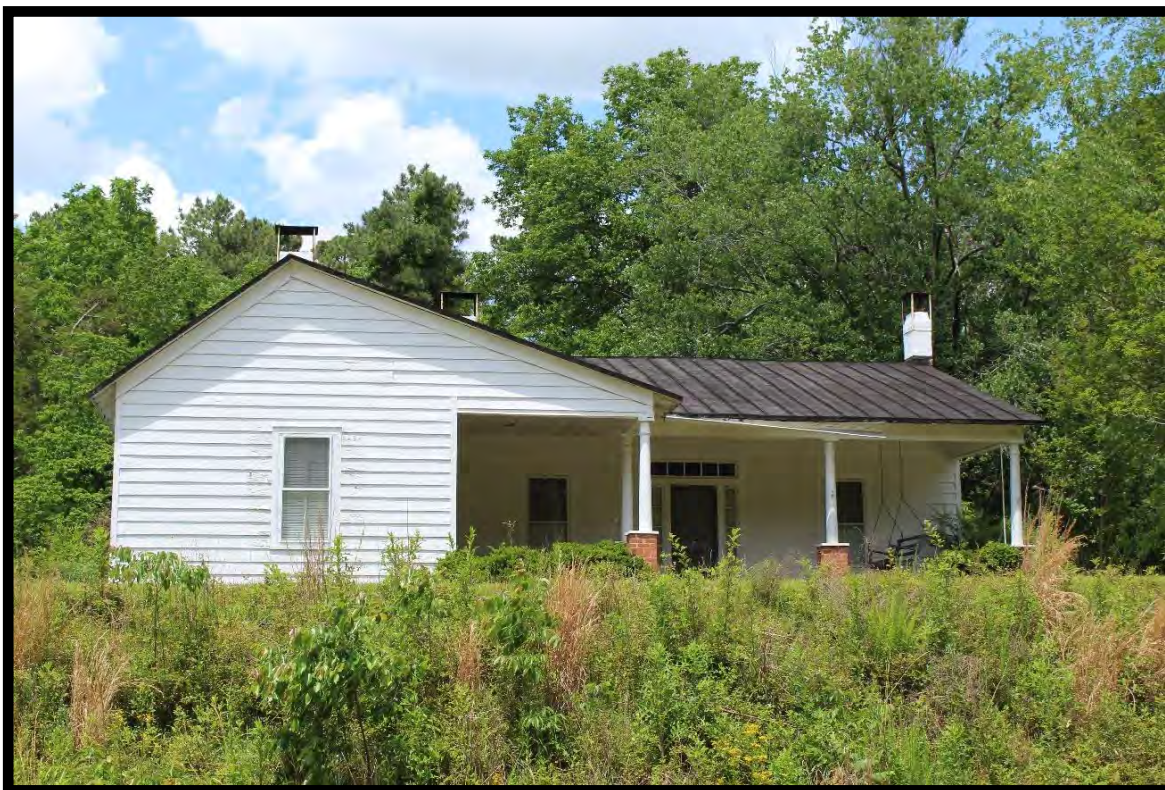
One resource identified by the current owner of the Gillis farmstead is the William John Gillis House No. 2, which is part of the Shaw-Gillis Historic District (CD0210). It is located approximately three miles northeast of the William John Gillis House. Constructed in ca. 1920, this residence is very similar in plan, consisting of an L-form and simple asymmetrical massing. Transom and sidelights surround the primary entryway which faces south toward Old Raeford Road. The similarities between the two homes were attributed to the wife of William John Gillis, Maude Gillis. The story of the William John Gillis House No. 2 was discussed earlier in this report and is known to be identical to the William John Gillis House No. 1 in its floor plan, shape, and style. The William John Gillis House No. 2 (Figure 48) shares many qualities with the William John Gillis House No. 1. The Shaw-Gillis House, a two-story Greek Revival house constructed in 1857, is also located in the district, along with several outbuildings. The outbuildings appeared to be in poor condition at the time of survey, but both houses were intact. This district is evaluated as eligible under Criterion C for architecture. While both William John Gillis Houses have intact exteriors in regard to wooden siding, wooden sash windows, massing, and simple details like window enframingent and sidelights and transom, the current state of the interior of the William John Gillis House No. 2 is not known. The interior of the William John Gillis House No. 1 however, is known to be intact. Based on the evaluation of the William John

Figure 48: William John Gillis House No. 2 (CD0210), Looking North.

Gillis House No 2 as contributing to a district, it is recommended that the William John Gillis House No. 1, which retains similar if not higher integrity, should be evaluated as eligible. Furthermore, the William John Gillis House No. 1 contains more intact associated outbuildings and retains a higher degree of integrity in terms of its association with its twentieth-century agricultural history.

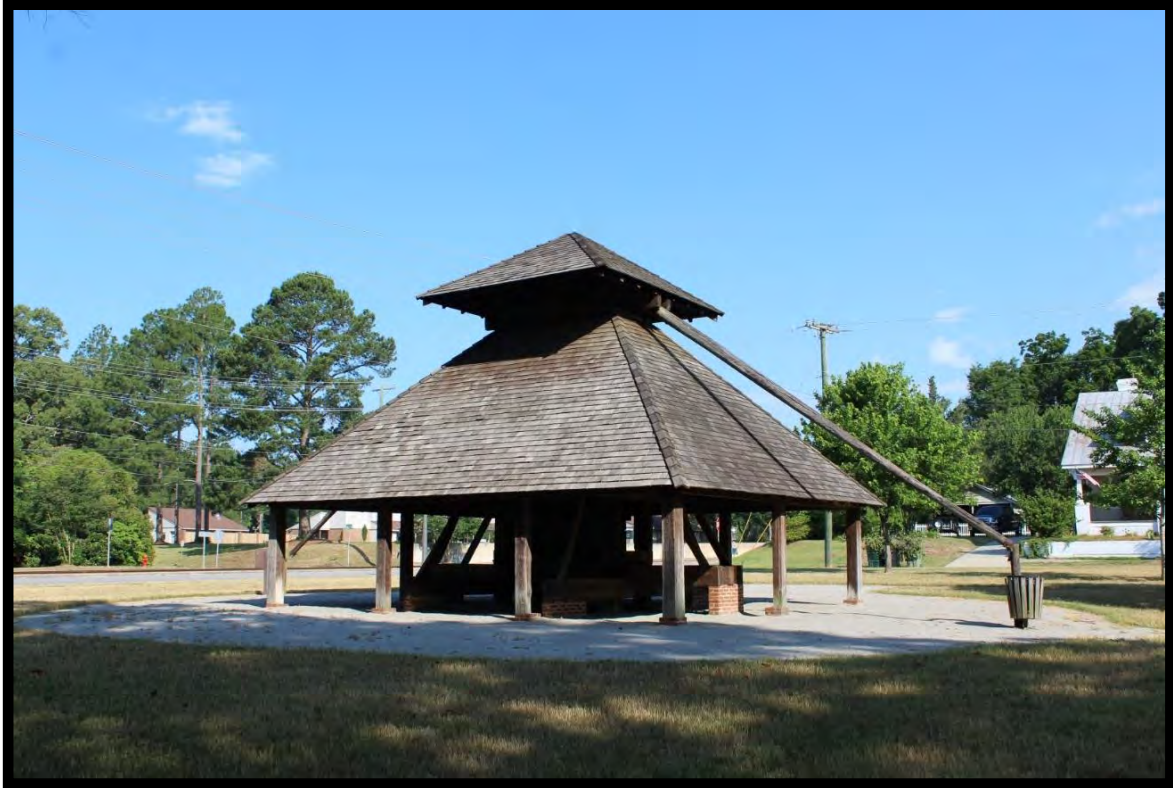
One example of relocated agricultural equipment with a reconstructed shelter is the Cotton Press (ED0007) located in Edgecombe County (Figure 49). The Cotton Press was originally constructed ca. 1840 and moved to its current location from a nearby plantation around 1938.⁶⁹ It was listed on the NRHP under Criteria A and C in 1971 and evaluated as a structure. It is described as “one of the few remaining examples of the type of machinery used by Southern cotton growers in the nineteenth century.”⁷⁰ The cotton press is a very well preserved example of an early and rare piece of agricultural equipment. While the Gillis Saw Mill is similar in that it is also an intact example of an agricultural complex, it does not rise to the level of individual eligibility like the that of the Cotton Press. Diesel power units were a twentieth century development for powering saw mills and are not as rare of a resource as a mid-nineteenth century cotton press. However, the saw mill still has the ability to contribute to the site it occupies on the William John Gillis Farmstead and is a part of the farm’s evolution from an early eighteenth century farmstead to a burgeoning twentieth century farm that periodically updated equipment in order to stay relevant in the agricultural industry.

Figure 49: Cotton Press (ED0007), Looking West.

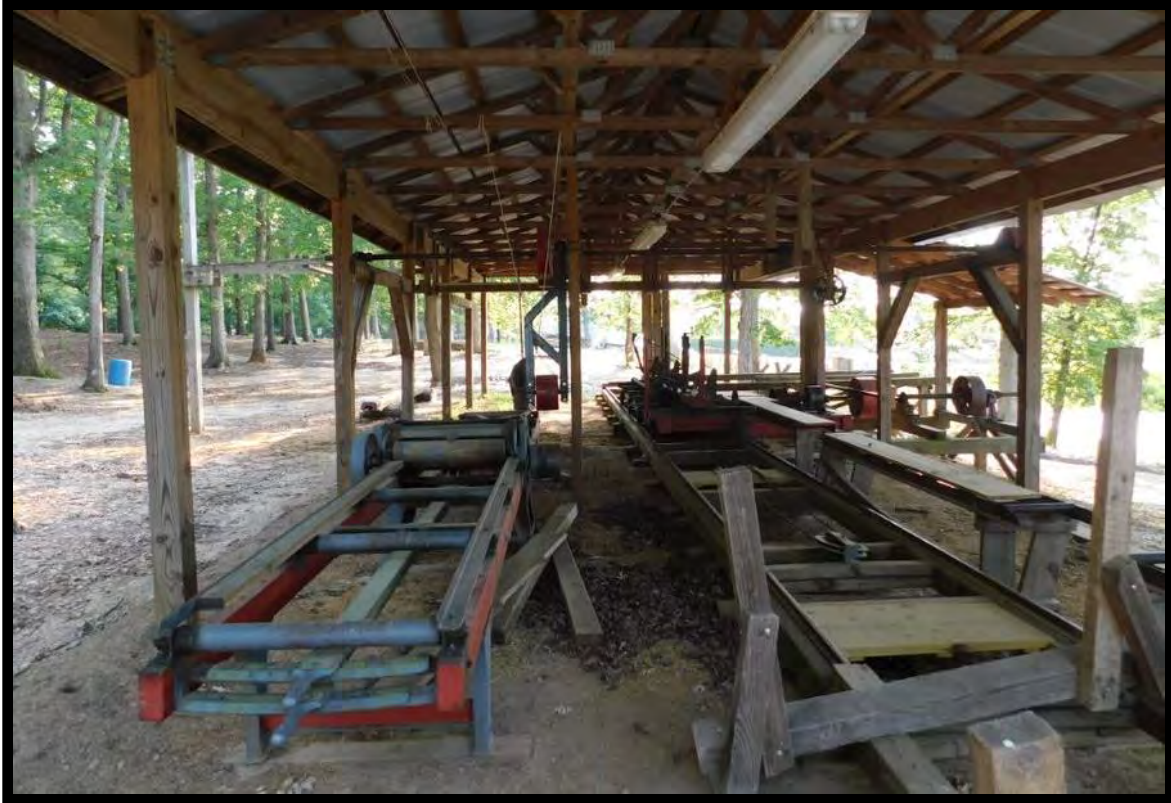
Figure 50: Saw Mill at State Fair Grounds, Saw Mill Mechanism.

that was moved from Pitt County to the state fairgrounds around 2009. The buildings/shelters that originally stood over the mill equipment were documented, but were too deteriorated to continue to use, along with the boiler. The mechanism was reassembled as it once stood on the original site. Similar to this example, the Gillis saw mill (which was originally steam powered but is currently powered by an early twentieth century diesel power unit) was moved and reassembled at its present site in order to illustrate the function of the twentieth century machinery (Figures 50 and 51). Additionally, the saw mill mechanism appears to be similar to the Moffit Saw Mill found at the Gillis site.

The Gillis Saw Mill and the saw mill at the state fairgrounds have many similarities. Both were moved from their original site, and both have new, similarly constructed, open air shelters built around them. Therefore, both are very similar in terms of their level of integrity. They also function in similar capacities as working examples of farm equipment that now serve a more educational purpose in the realm of agritourism. The Gillis Saw Mill, however, though in a different physical location, was only moved a short distance, still being located on the farmstead it was originally associated with. The Gillis Saw Mill is also powered by a diesel power unit, a later technology than the steam powered equipment at the state fair grounds. Though the exact date of the switch from steam power to diesel is unknown, similar International

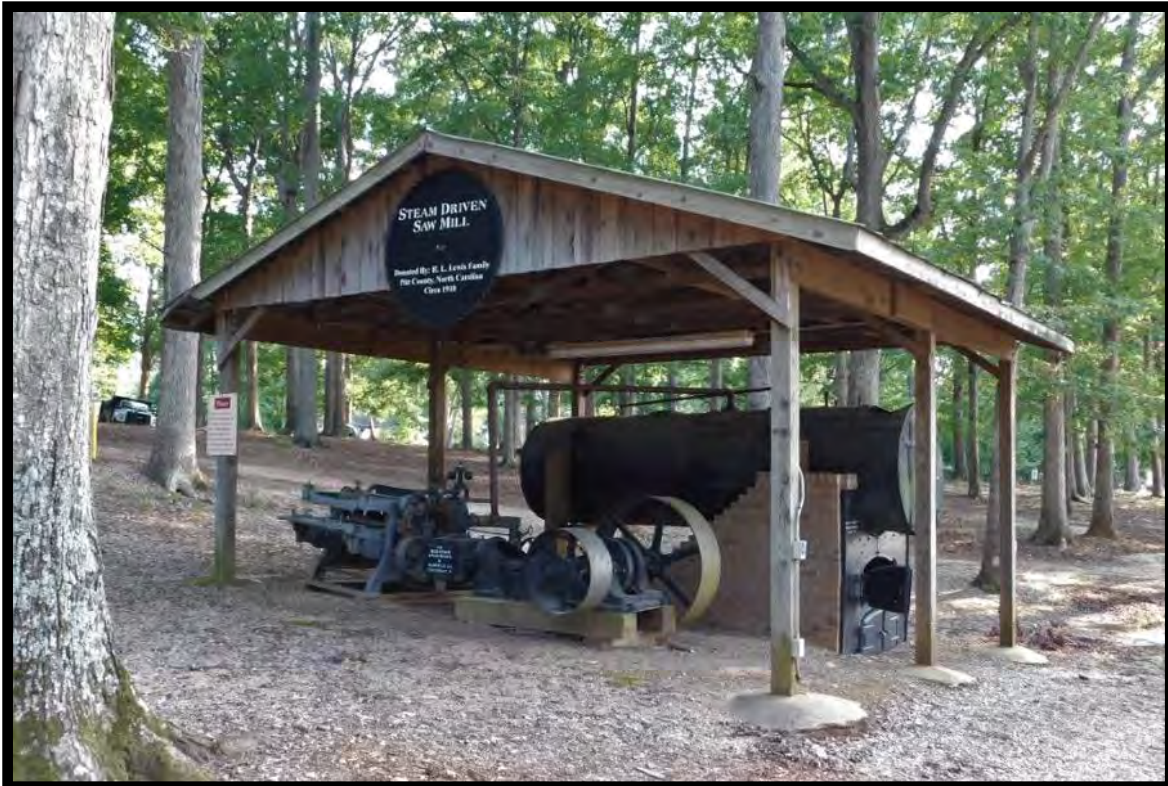
Figure 51: Saw Mill at State Fair Grounds, Steam Engine and Boiler.

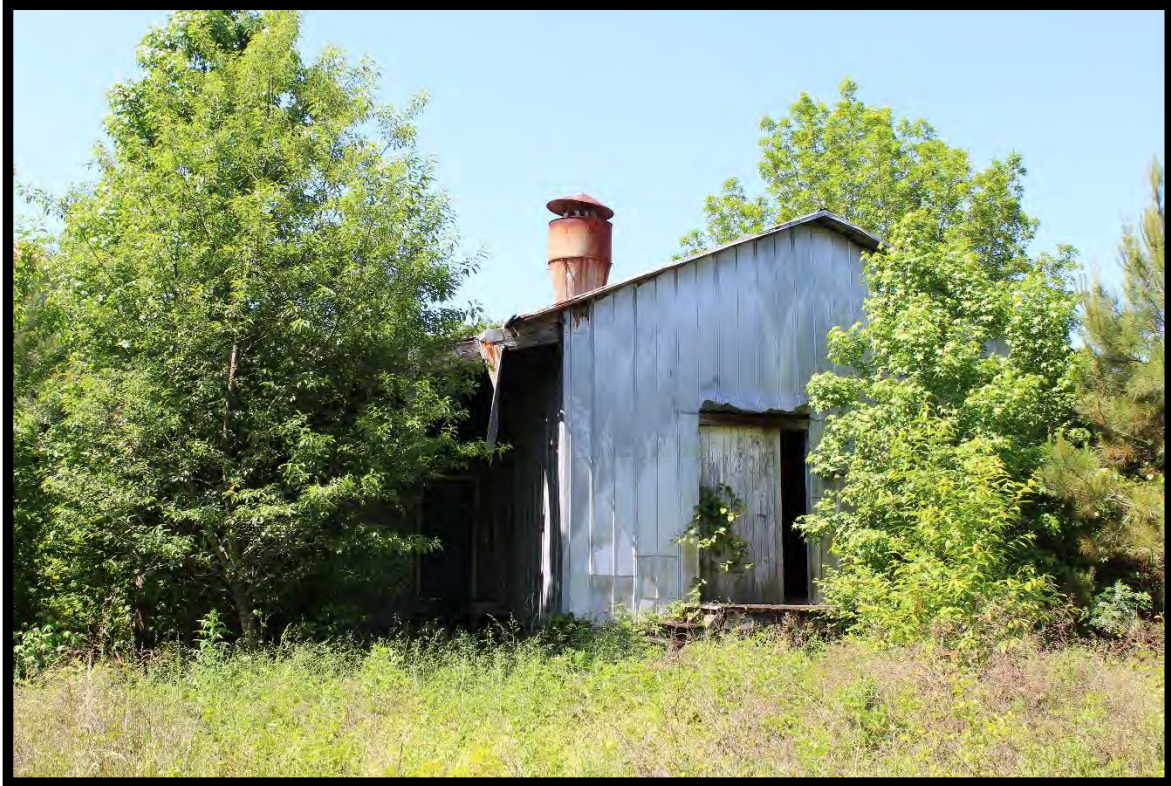
Figure 52: Gillis Cotton Gin, CD0792, Looking Southwest.

HPOWeb lists the only other cotton gin in Cumberland County as the Gillis Cotton Gin (CD0792) just southeast of the resource being evaluated here. The Gillis Cotton Gin (Figure 52), was also evaluated in this report and was recommended not eligible due to lack of integrity in 1998 and again in 2019. In an effort to find more examples with which to compare the Gillis Cotton Gin 2, surrounding counties were searched similarly scaled cotton gins from the time period, though certain gins from other parts of the state did serve as better examples.

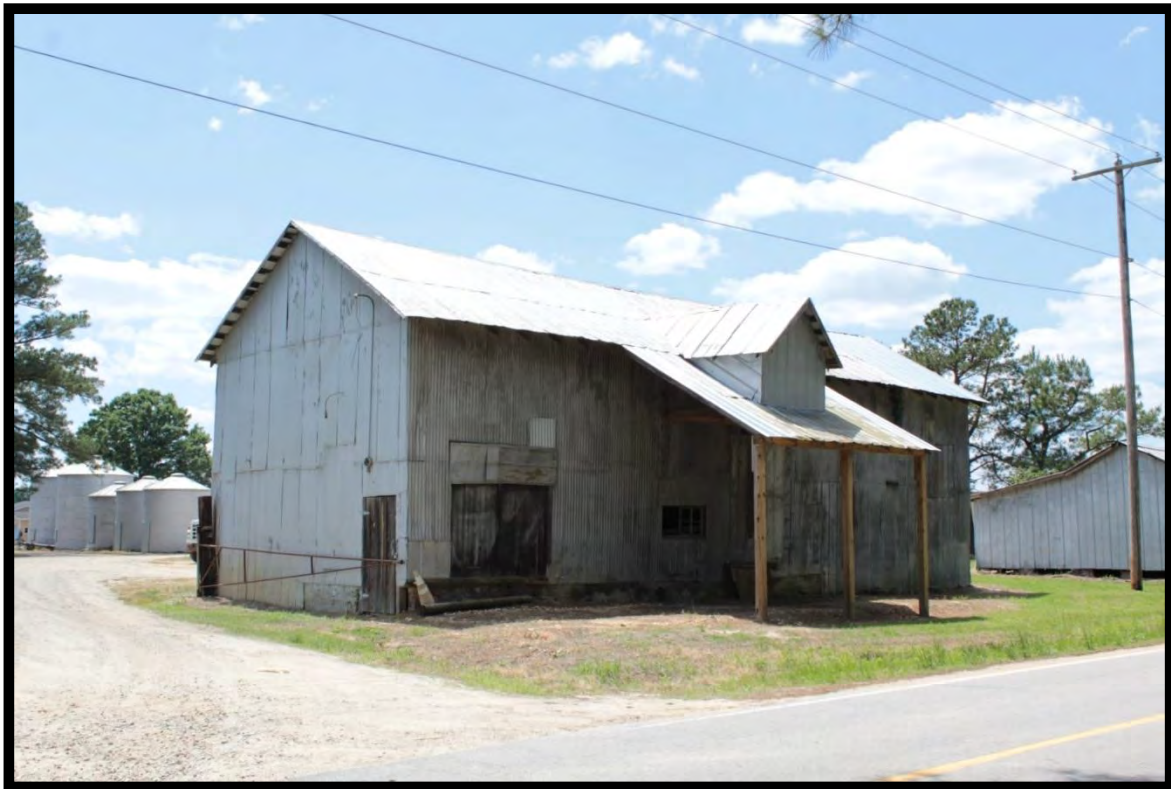
Figure 53: O. J. Smith Cotton Gin, NS0513, Looking North.

One such example is the O. J. Smith Cotton Gin in Nash County (Figure 53). It is characterized as a “c. 1935 1-story side gabled building clad in corrugated metal” and includes a cotton gin building, a seed house, and a well. Similar to the Gillis Cotton Gin complex from the early to almost-mid twentieth century, this complex was recommended eligible under Criterion A and C. The complex itself remains intact with a large number of integral outbuildings all with sufficient integrity to collectively illustrate the historic practices that took place at the complex. Much like the O. J. Smith Cotton Gin, the Gillis Cotton Gin 2, though somewhat deteriorated, is associated with a larger farm complex. Furthermore, the Gillis Cotton Gin No. 2 still retains original driveshafts while the O. J. Smith Cotton Gin does not contain any original machinery.

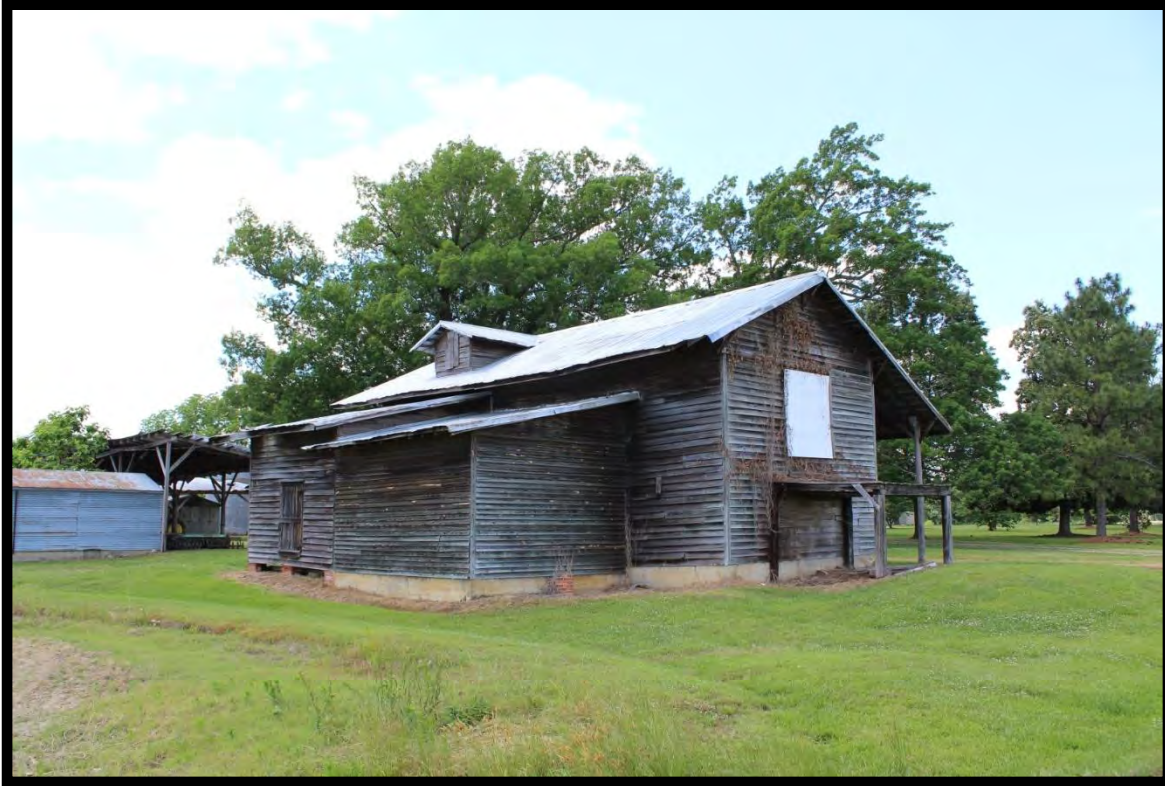
The Davenport Cotton Gin (Figure 54) was constructed in the 1930s and is similar in scale and size to the Gillis Cotton Gin, though it is clad with wooden siding versus the Gillis Cotton Gin’s metal sheathing. This structure, though not formally evaluated, appears to retain more physical integrity than the Gillis complex.

Figure 54: Davenport Cotton Gin, ED0646, Looking Northwest.

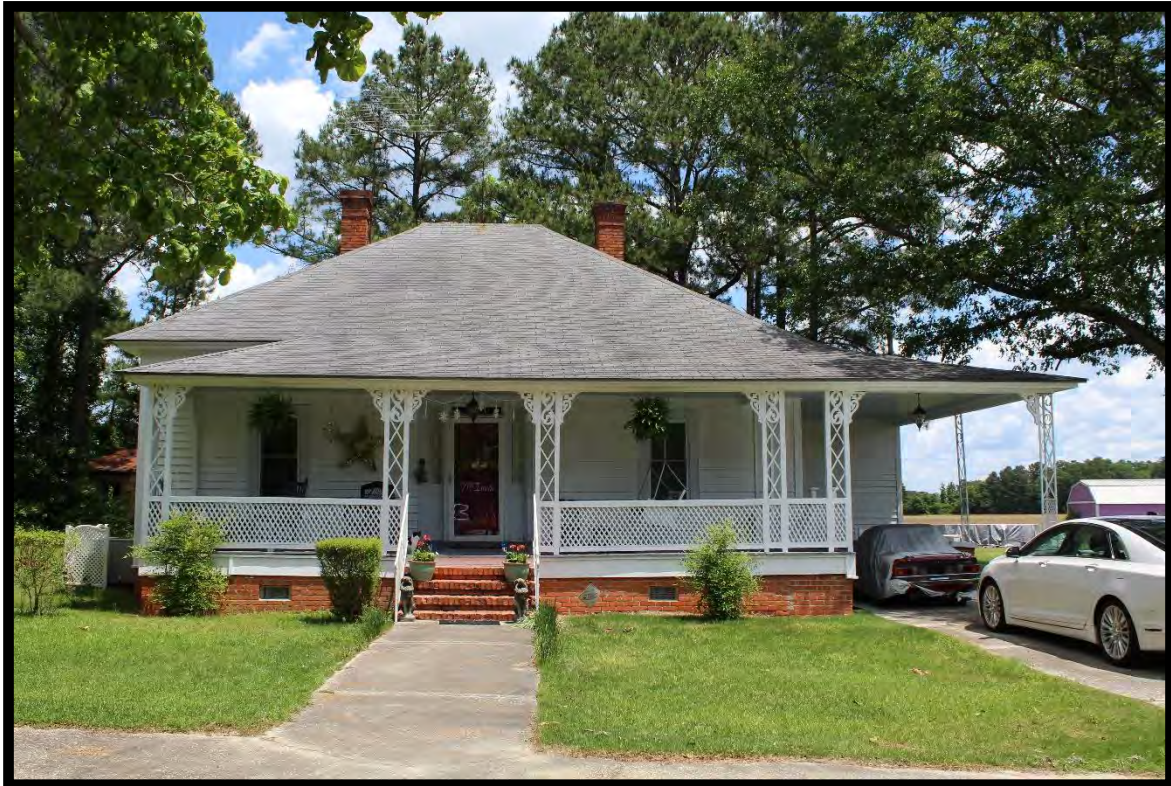
Figure 56: McInnis House, Looking Northeast.

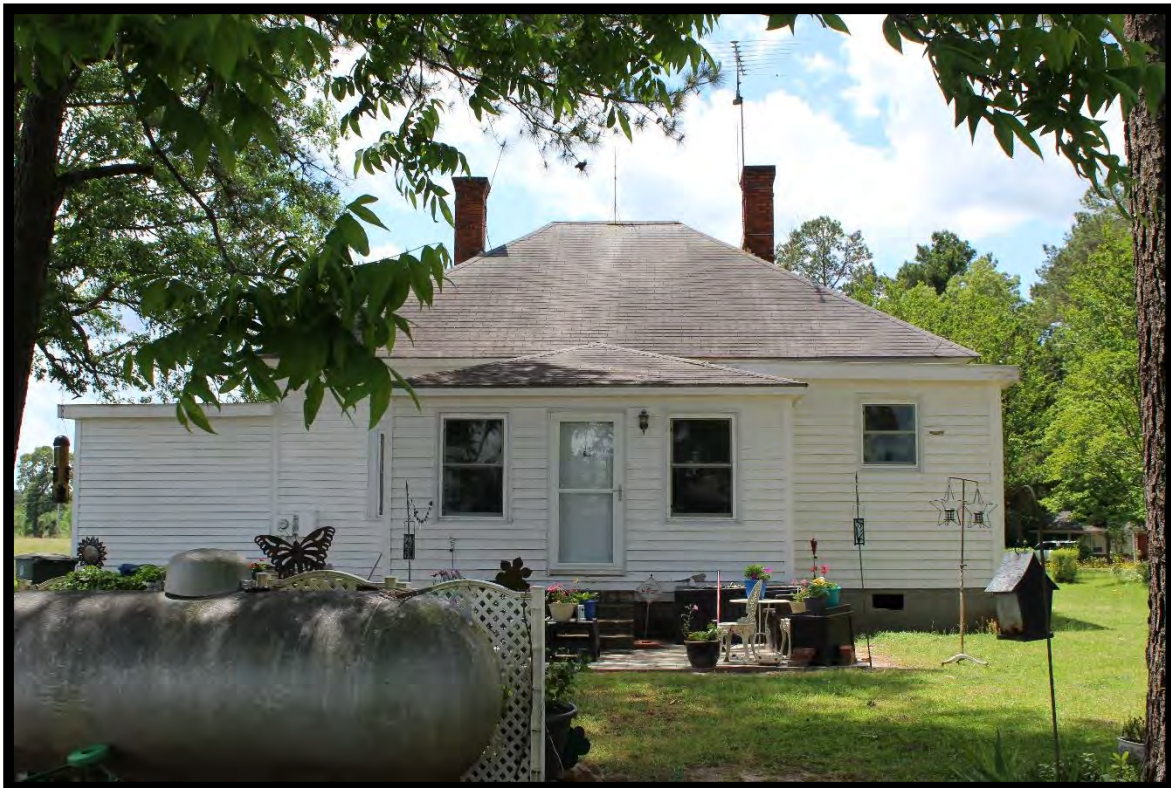
The house is a one-story, hip-roofed dwelling of framed construction with Greek Revival elements, resting on a brick foundation, and clad in weatherboards and asphalt shingles. The façade faces southwest towards Gillis Hill Road. The house is a rare and relatively intact example of a double pile Greek Revival cottage in the county. It features two interior chimneys with somewhat decorative brick corbelling consisting of a single projecting brick course below several normal courses and finished with three courses of stepped bricks and a metal cap. The chimneys are located on the side-slopes of the roof reinforcing the symmetrical massing of the house. The house has a continuous hip-roofed porch that runs almost the entire length of the façade and retains original decorative lattice woodwork that is the dominant decorative feature of the façade. The porch shelters a symmetrical façade with a wooden entry door flanked by five-pane sidelights over recessed wooden panels and capped by a three-pane transom. On either side of the entryway are one-over-one replacement windows. Based on the existing site file and survey photos for this house from the late-1990s, original windows were wooden, nine-over-six, double-hung-sash windows. The porch is approached by a small set of brick steps (see Figure 56). A wing extends from the southeast (side) elevation of the dwelling creating a car port-like addition on the corner of the residence. The carport is comprised of decorative latticed support beams sitting on brick piers. The house does contain several small-scale additions, two on the rear elevation, and one on the southeast elevation that was just described.

Figure 59: McInnis House, Looking Southwest.

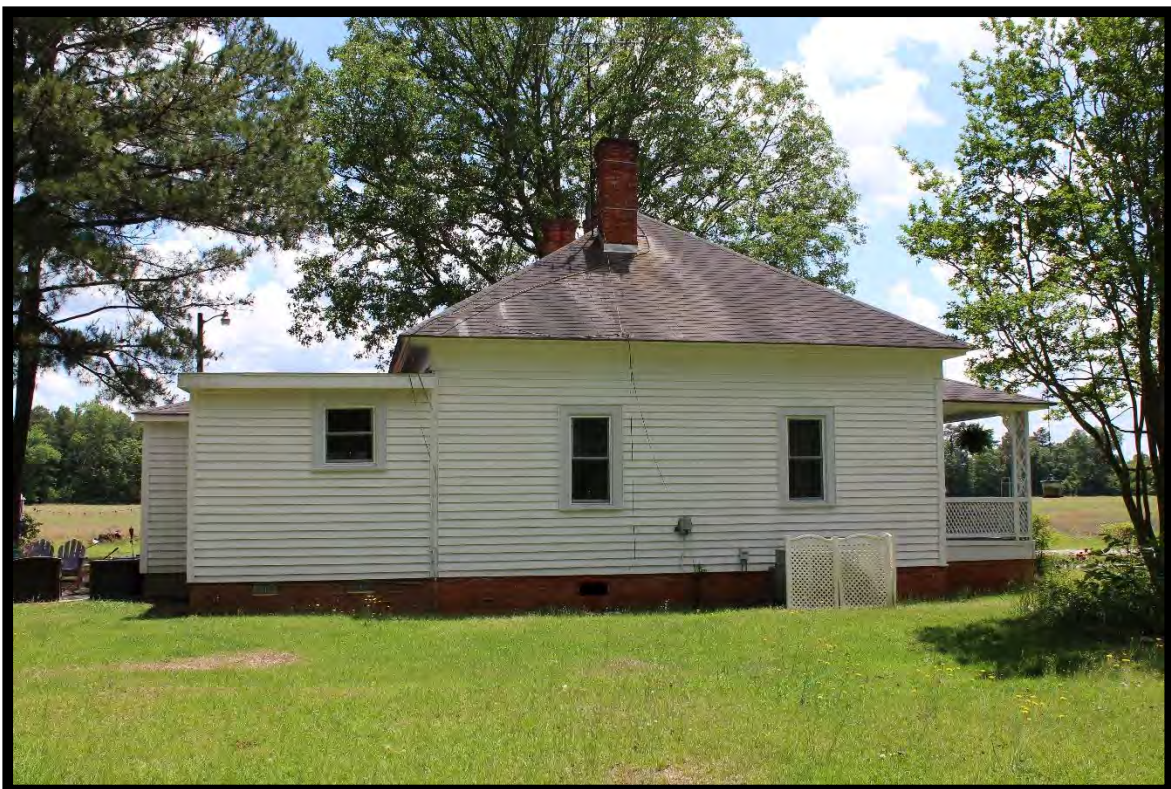
Figure 60: McNinnis House, Looking South.

The side elevation to the northwest is fairly plain in fenestration containing two one-over-one modern replacement windows and a shorter one-over-one modern window on the flat-roofed addition (Figure 60). The remaining side elevation to the southeast contains a flat-roofed projection slightly shorter than the original section of the home that connects to the roof of the carport (Figure 61). One small horizontally oriented window is located in the upper west section of the flat-roofed projection (Figure 62).

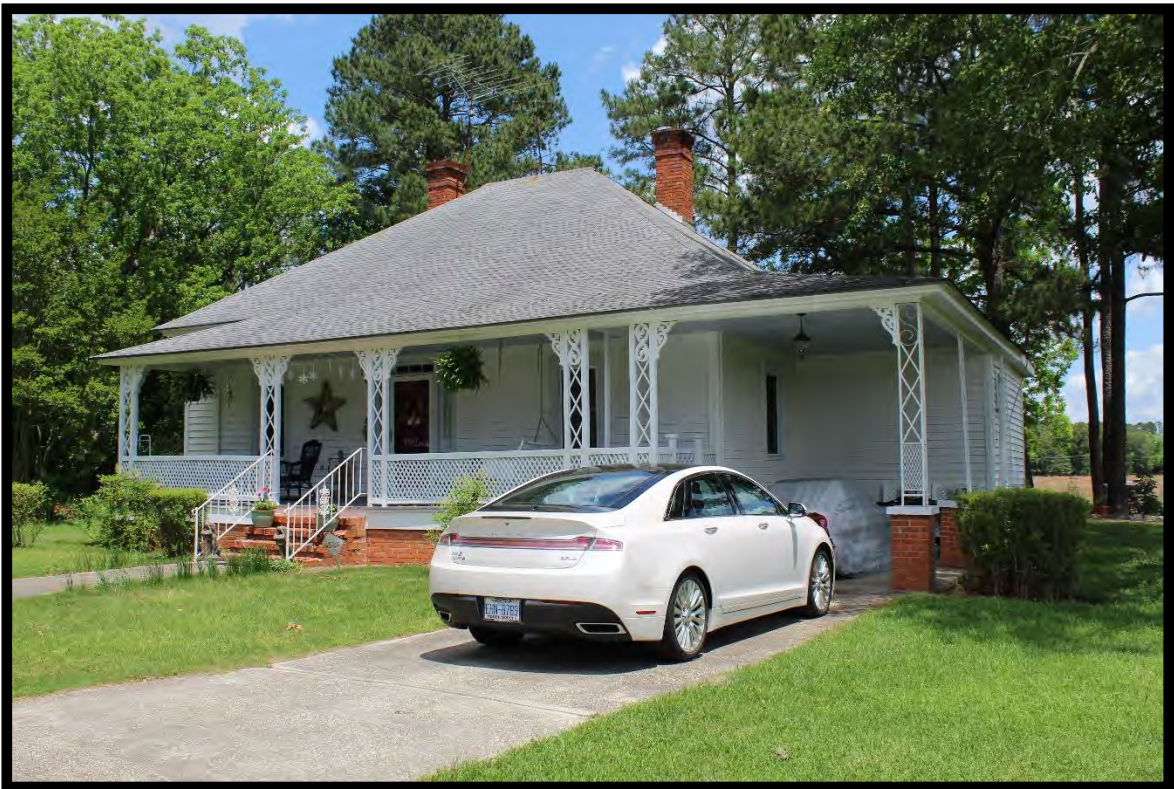
Figure 62: McInnis House, Looking Northeast.

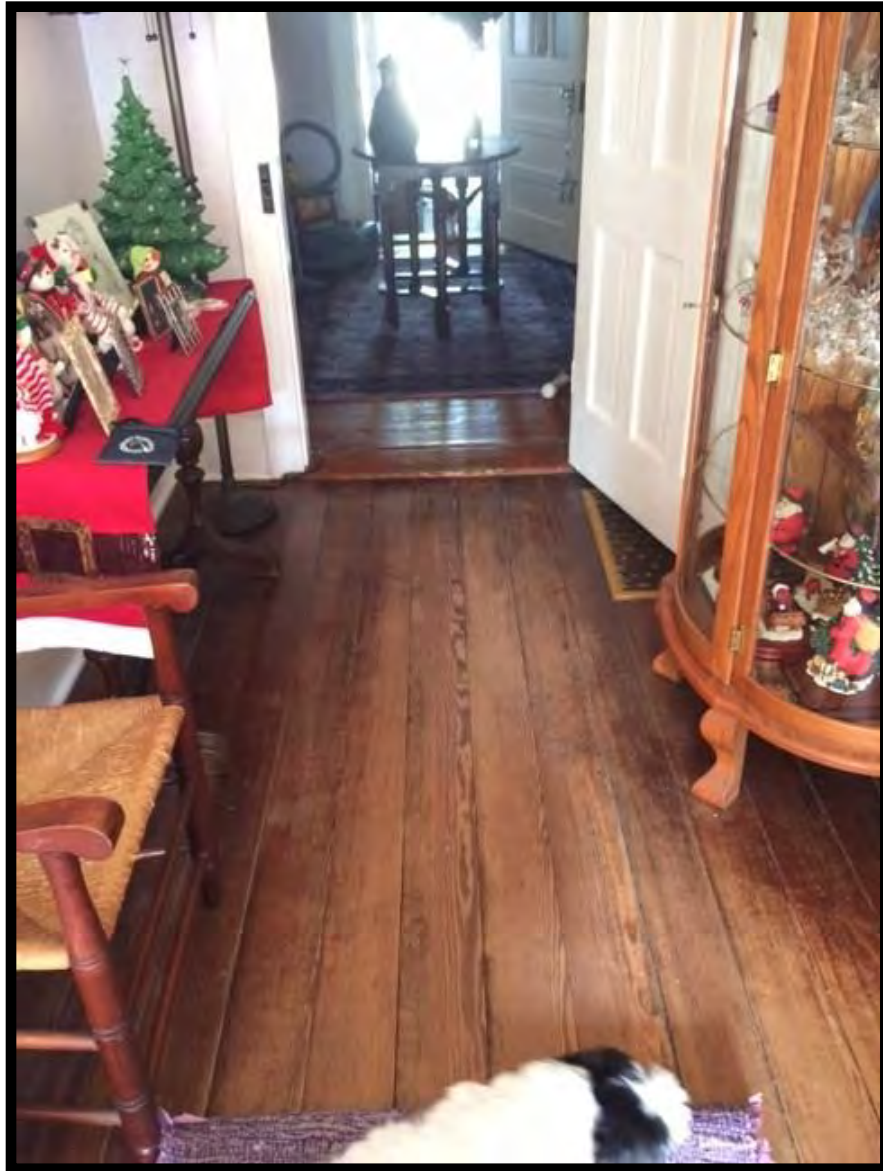
Figure 63: McInnis House, Central Hall, Floorboard Detail, Looking Northeast (Neill McInnis, 2019).

Based on several interior photos provided by the homeowners (Neill and Jackie McInnis), the dwelling appears to retain a high level of integrity. Wide heart pine wood floors can be found throughout the house (Figure 63), and its central hall plan remains intact (Figure 64). Fireplace mantels also retain their integrity and exhibit detailing in keeping with the Greek Revival Style (Figure 65). The feathering found on two mantels was a common alternative to purchasing

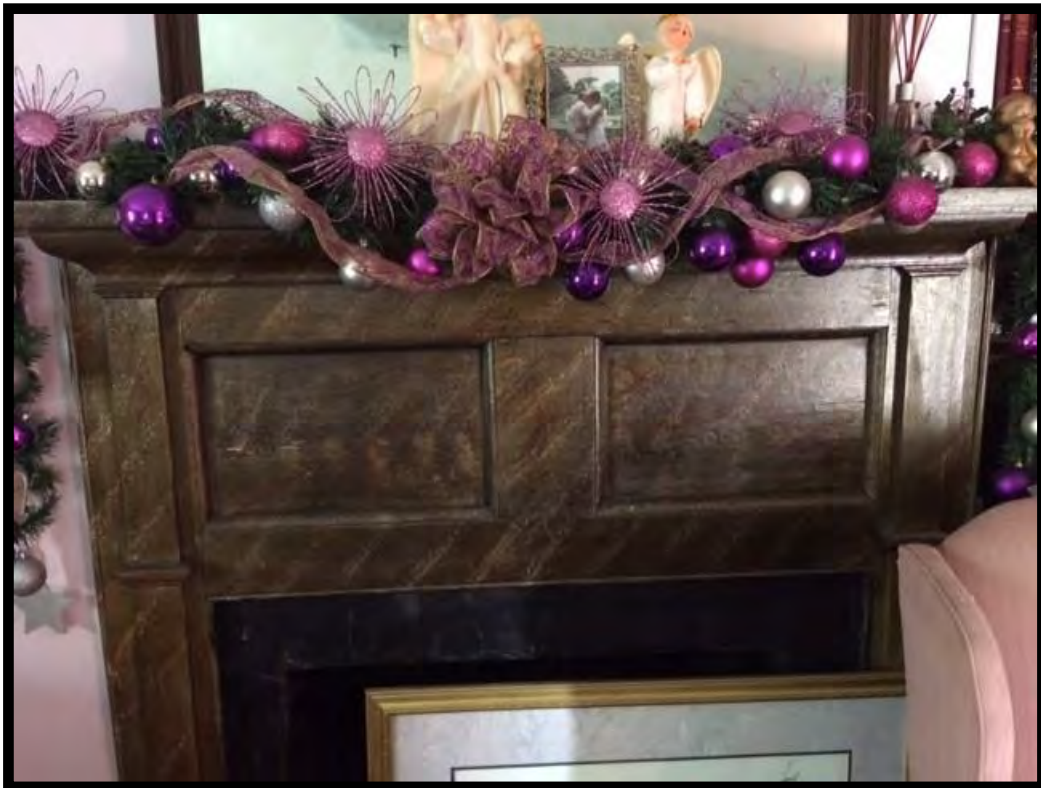
Figure 66: McInnis House, Living Room Mantel. (Neill McInnis, 2019)

expensive marble that may have been difficult to acquire (Figure 66). This practice of finishing wood mantels with a faux marble finish was typical of the Greek Revival Style.⁷⁴

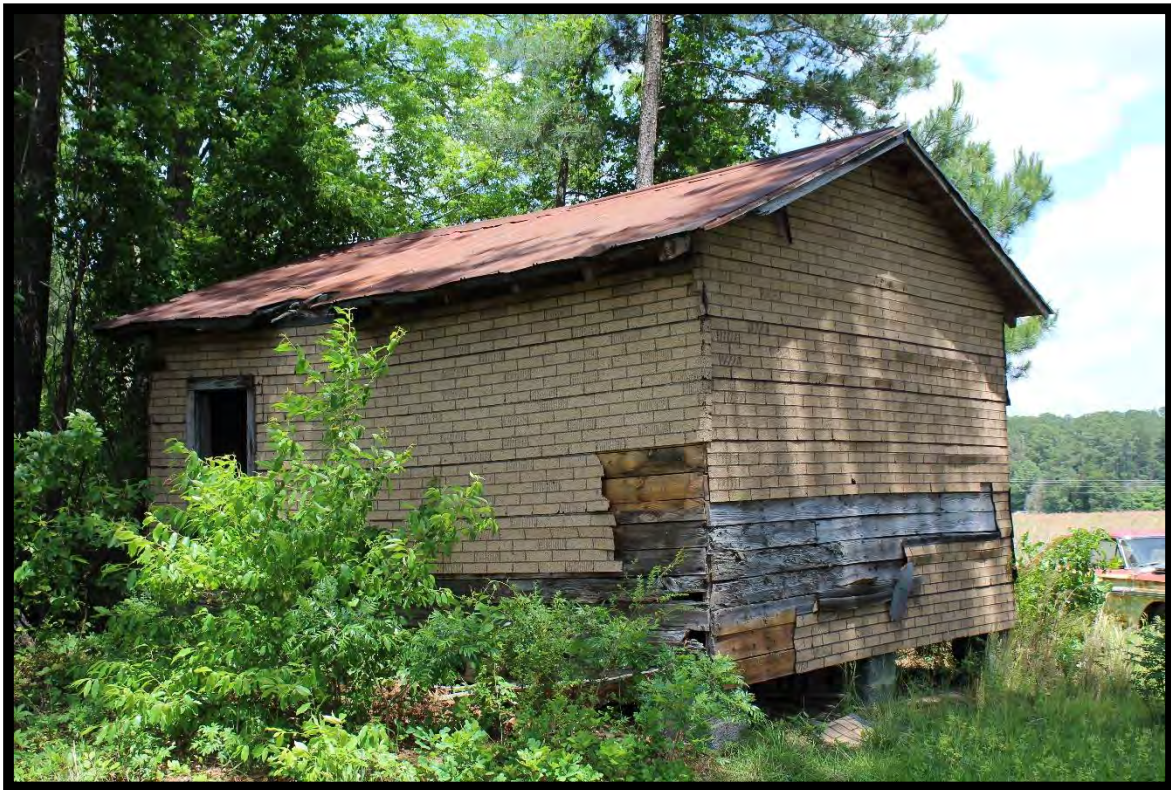
Figure 67: McInnis House, Shed, Looking Northeast.

Ancillary structures associated with the dwelling include a ca. 1940 side-gabled structure, a three-car garage, two modern storage structures and an above ground swimming pool. The side-gabled structure appears to be the only historic structure of the ancillary buildings and is located just north of the dwelling. The structure is partially obstructed by overgrowth and displays some deterioration (Figure 67). The wood-frame structure is clad in a faux brick asphalt siding and has a metal clad roof with exposed rafters. Portions of the exterior replacement siding are missing, revealing flush wood board underneath. The structure sits on a raised concrete block foundation. What appears to be a door opening is located on the northernmost side of the western elevation, but no door is present. A window opening with a six-over-six wood sash window is located on the eastern elevation but obstructed by overgrown vegetation.

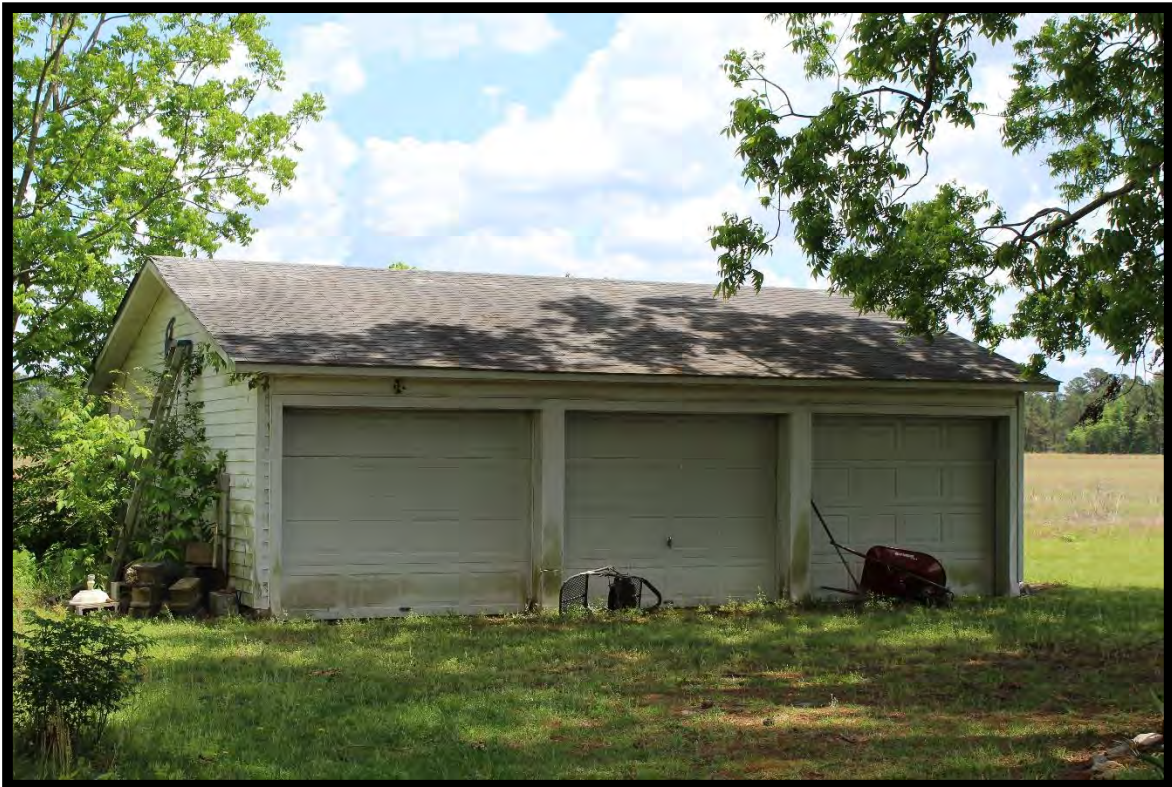
Figure 68: McInnis House, Modern Garage, Looking Southeast.

A modern side-gabled three-car garage located northeast of (behind) the dwelling (Figure 68). The façade (southwest) is comprised of three paneled overhead metal doors. The exterior is clad in vinyl siding and the roof is finished with asphalt shingles. No other fenestration appears on other elevations.

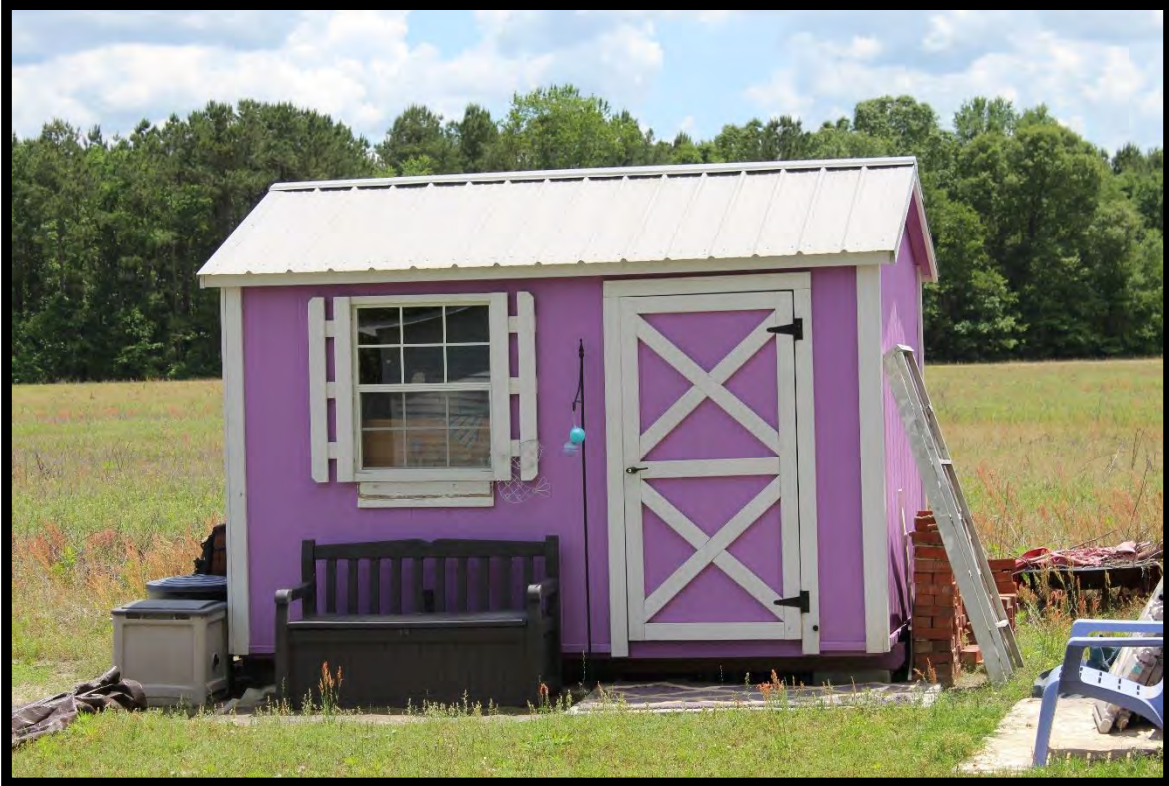
Figure 69: McInnis House, Side-Gabled Modern Storage Shed, Looking South.

The final two outbuildings on the property are modern storage structures located southeast of the dwelling. One is a side-gabled metal structure with its primary elevation facing north toward Gillis Hill Road (Figure 69), and the other is placed at a right angle to its counterpart and has a gambrel roof. Its primary entrances on its eastern elevation facing the agricultural fields to the north and east (Figure 70). Both structures have modern standing seam metal clad roofs and vertical wood board exteriors. They rest on raised concrete piers on a poured concrete slab. What appears to be a covered above ground pool is located just east of these two structures.
