North Carolina Department of Natural and Cultural Resources
State Historic Preservation Office

SUBJECT: Historic Structures Survey Report, U-5798, Widening SR 1102 from US 401 to south of
Stewarts Creek, Cumberland County, ER 19-1847

Resource Name:	William John Gillis Farmstead
NCDOT Survey Site Numbers:	001
HPO Survey Site Numbers:	CD0211, CD1491 and CD1492 (former CD0793)
Location:	2761 Gillis Hill Road, Fayetteville, NC 28115
Parcel ID:	9486-40-2513, 9486-40-0356 and 9486-30-9165
Dates(s) of Construction:	Ca. 1900 (Dwelling), ca. 1910 (Saw Mill and Cotton Gin)
Recommendation:	Eligible

Resource Name:	McInnis House
NCDOT Survey Site Number:	002
HPO Survey Site Number:	CD0213
Location:	3039 Gillis Hill Road, Fayetteville, NC 28115
Parcel ID:	9485-27-1543
Dates(s) of Construction:	Ca.1850
Recommendation:	Eligible

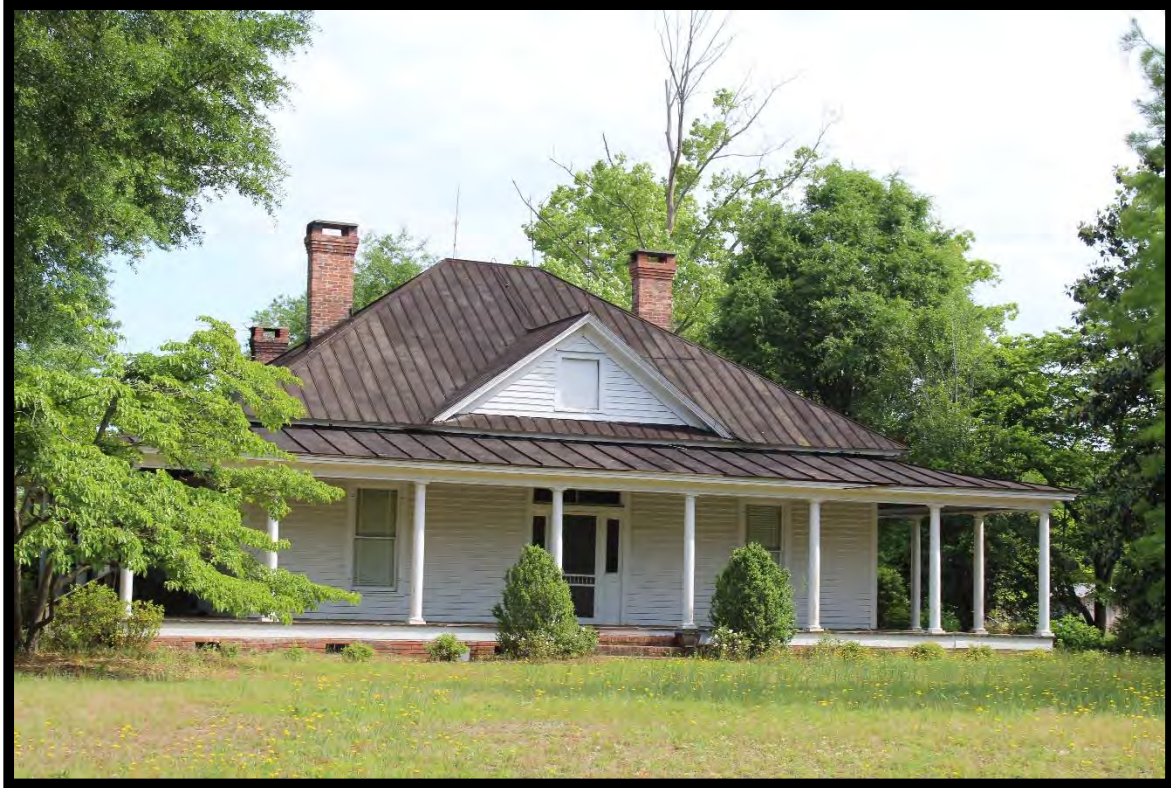
Figure 81: James L. Cooley House (SC0039), Looking Northeast.

Another similar example was found in Scotland County. Recorded in HPOWeb as the James L. Cooley House (SC0039), this residence is a similar example in that it is a one-story frame Greek Revival dwelling with a hipped roof. The Cooley House shares several architectural characteristics of the McInnis House including a hipped roof, transom and sidelights, and a shed-roofed porch (Figure 81). The house is located within the Spring Hill Historic District. It differs from the McInnis House in that it is slightly larger and retains many of its associated outbuildings and appears to still function in an agricultural capacity. The home appears to retain its original weatherboard siding, porch details, and chimneys, much like the McInnis House. This house also appears to have one-over-one replacement windows.

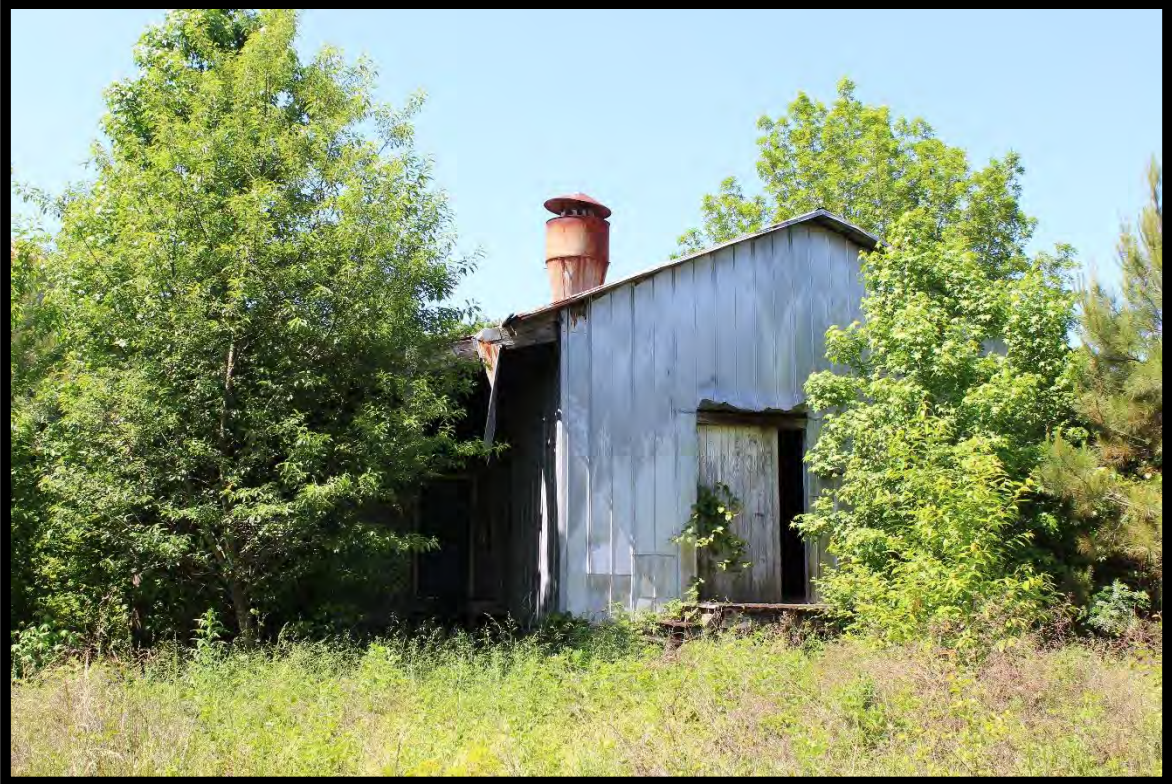
Figure 83: Gillis Cotton Gin, Structure, Looking Southwest.

This abandoned cotton gin complex is located on the southwest side of Stoney Point Road just north of an intersection with Strickland Bridge Road and the Aberdeen and Rockfish Railroad line (Figure 83). The complex consists of a collection of outbuildings that begin approximately 200 feet from Stoney Point Road. A partially cleared path extends about 150 feet from the road toward the complex. The path terminates in a clearing before the area surrounding the buildings becomes overgrown and largely inaccessible. Opposite of the cluster of buildings on Stoney Point Road are large tracts of agricultural fields. To the southeast, across the railroad line, is a concentration of modern buildings, including a furniture repair store. A ca. 1990 residential development is located to the southwest of (behind) the cotton gin complex and is visually separated from the agricultural buildings by a heavily forested section of the parcel (Figures 84 and 85).

The largest structure on the property is a one-story cotton gin stand shelter with a vertical metal clad exterior and a metal clad roof. The structure is front gabled with its primary access point facing northeast toward Stoney Point Road (See Figure 83). A slightly recessed sliding door provides access to the interior of the main room of the structure, and a roof projection extends from the eastern roof slope. On the eastern elevation, a smaller enclosed projection and a dropped shed roof open-air wing span much of the elevation (Figure 86). The northwest elevation contains a continuous shed roof projection with a secondary opening, not accessible from the exterior (Figure 87). The rear (south) elevation is obstructed by metal storage bins and vegetation (Figure 88) and is not visible from any angle.

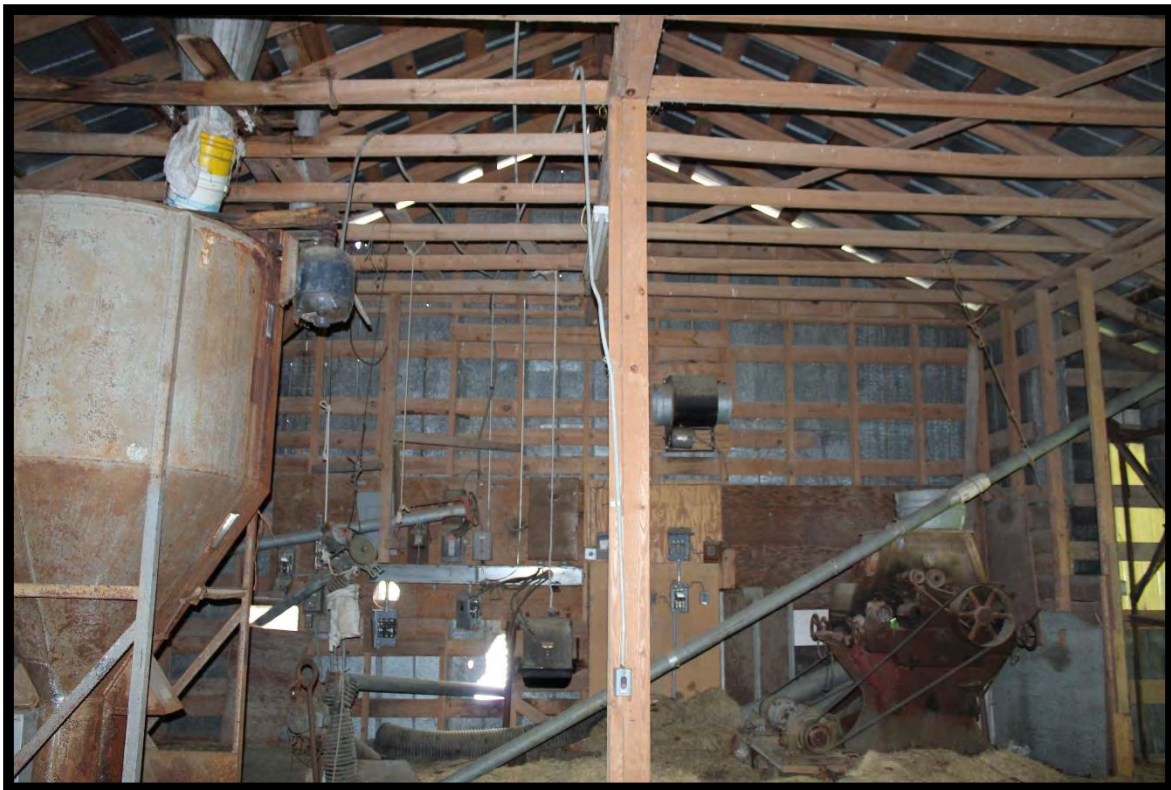
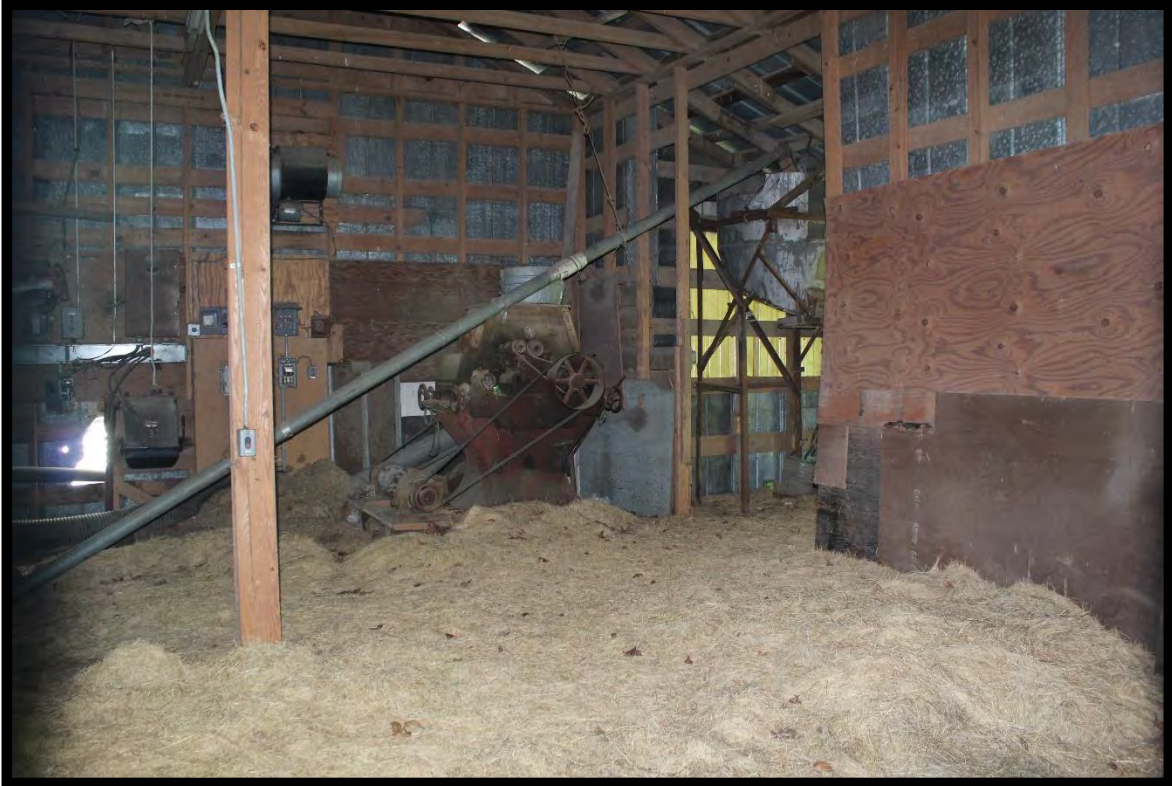
The interior of the cotton gin shelter was accessible through the primary entrance by a set of wooden steps. This entrance opens into the main room of the structure containing various pieces of machinery associated with the gin (Figures 89 and 90). Wooden and metal cladding appear newer, but the structure does appear abandoned. Electrical sockets also appear throughout the structure suggesting it was updated sometime in the mid-to-late twentieth century. This room is connected through an opening in the eastern wall to a smaller secondary room containing a funnel-like structure (Figure 91). Some wood on the interior does appear to be modern, suggesting it was stabilized in the recent past.

While certain structures are extant on the property, only the cotton gin is partially accessible while others have limited visibility and no pedestrian access due to vegetation overgrowth. The interior of the cotton gin does contain some machinery that may be associated with the early or mid-twentieth century complex but appears to be in a state of disarray inside its shelter. The entire complex is characterized by severe deterioration and loss of physical integrity.

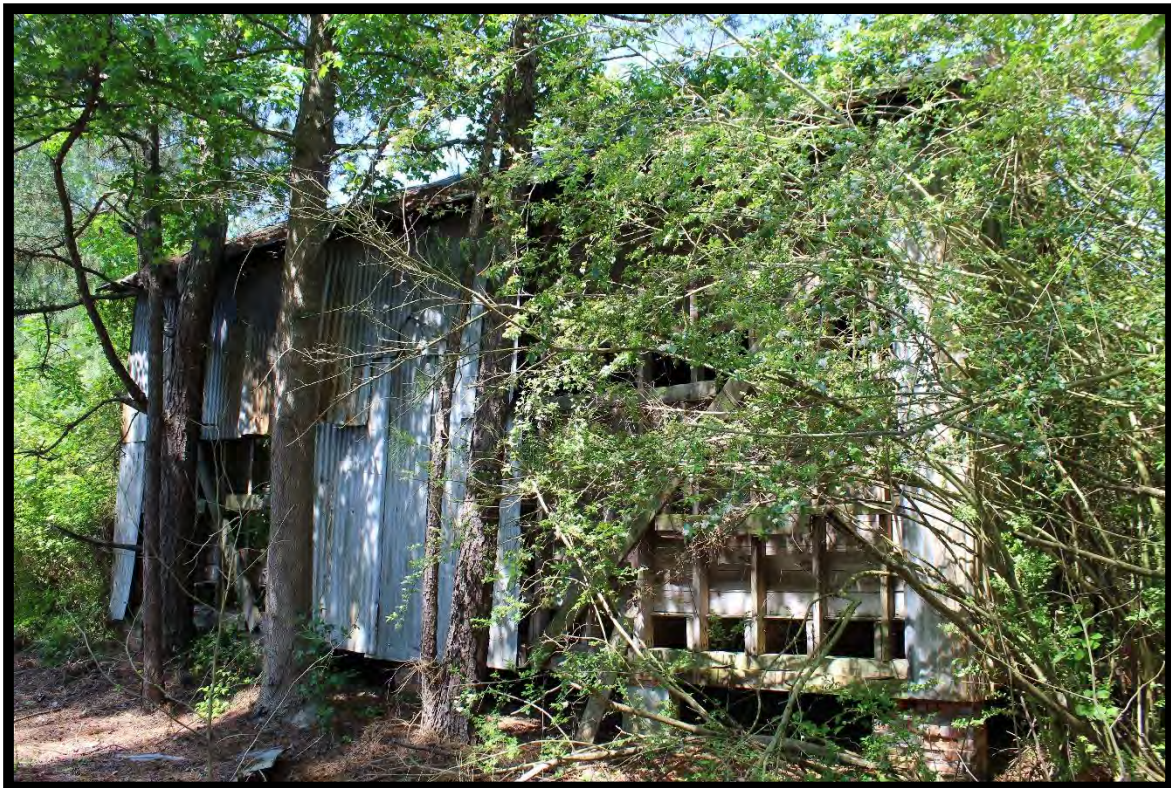
Figure 92: Gillis Cotton Gin, Possible Seed House, Looking West.

Ancillary structures associated with the cotton gin include a front-gabled shelter, a total of eight visible metal storage bins of various sizes, and two extant structures that were inaccessible and essentially not visible due to severe overgrowth of vegetation. The structure that was not completely visually obstructed was only visible from its southeastern elevation adjacent to the railroad. Based on previous survey documentation, it appears that this structure is possibly the old seed house.⁹⁴ The gabled structure is clad in ribbed metal siding, but multiple panels are missing revealing the wooden frame structure beneath. It sits on a raised brick pier foundation. The roof is also clad in metal. The northwest façade is completely obstructed by vegetation and its current state is not known, however, the building overall exhibits severe deterioration (Figure 92). Based on recent aerials of the parcel, two additional extant structures and two metal storage bins are located to the southwest and northwest of the primary building on the complex. However, neither of these structures were accessible, and at best, were only partially visible from areas on the site (Figures 93 and 94). Other structures documented in the 1998 survey, including a feed shed, general purpose shed, and tobacco barn, appear to no longer be extant.

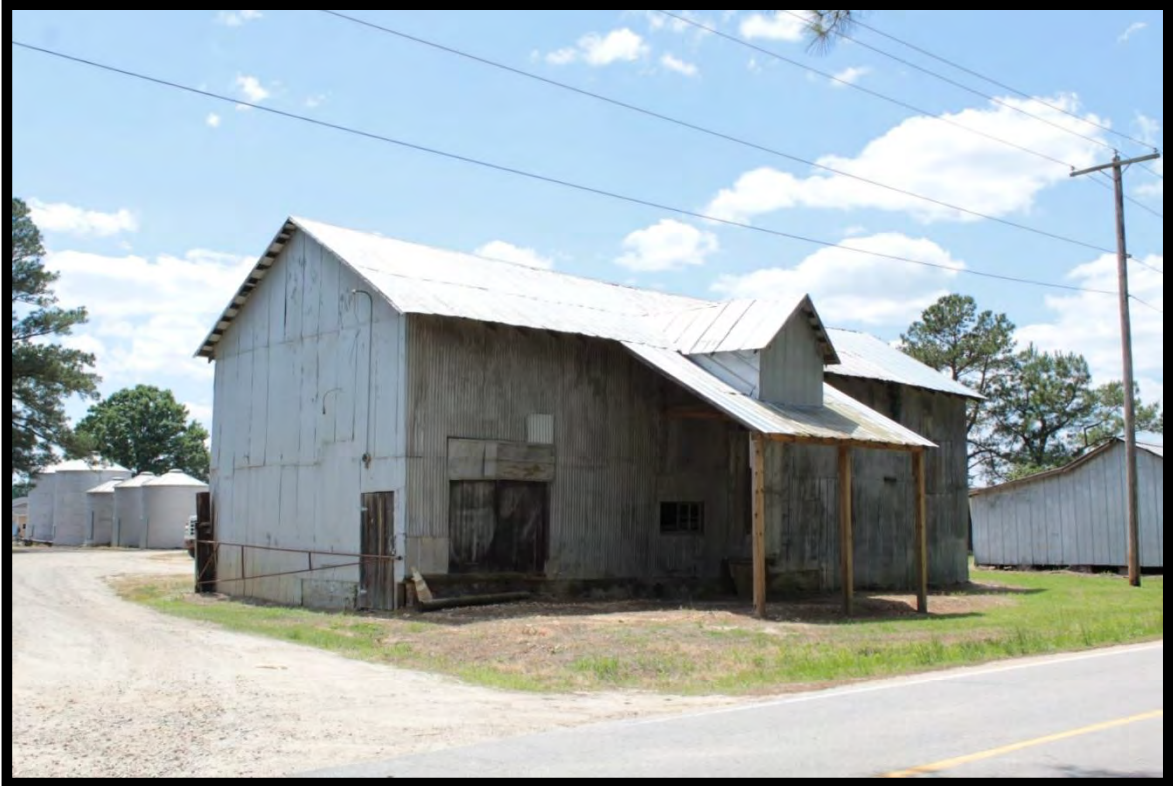
Figure 101: O. J. Smith Cotton Gin, NS0513, Looking North.

In an effort to find more examples with which to compare the Gillis Cotton Gin, surrounding counties were searched for similar criteria including size and construction date. This search revealed a number of examples. One such example is the O. J. Smith Cotton Gin in Nash County (Figure 101). It is characterized as “c. 1935 1-story side gabled building clad in corrugated metal” and includes a cotton gin building, a seed house, and a well. Similar to the Gillis Cotton Gin complex from the early to almost-mid twentieth century, this complex was recommended eligible under Criterion A and C. The complex itself remains intact with a large number of integral outbuildings all with sufficient integrity to collectively illustrate historic practices which took place at the complex.

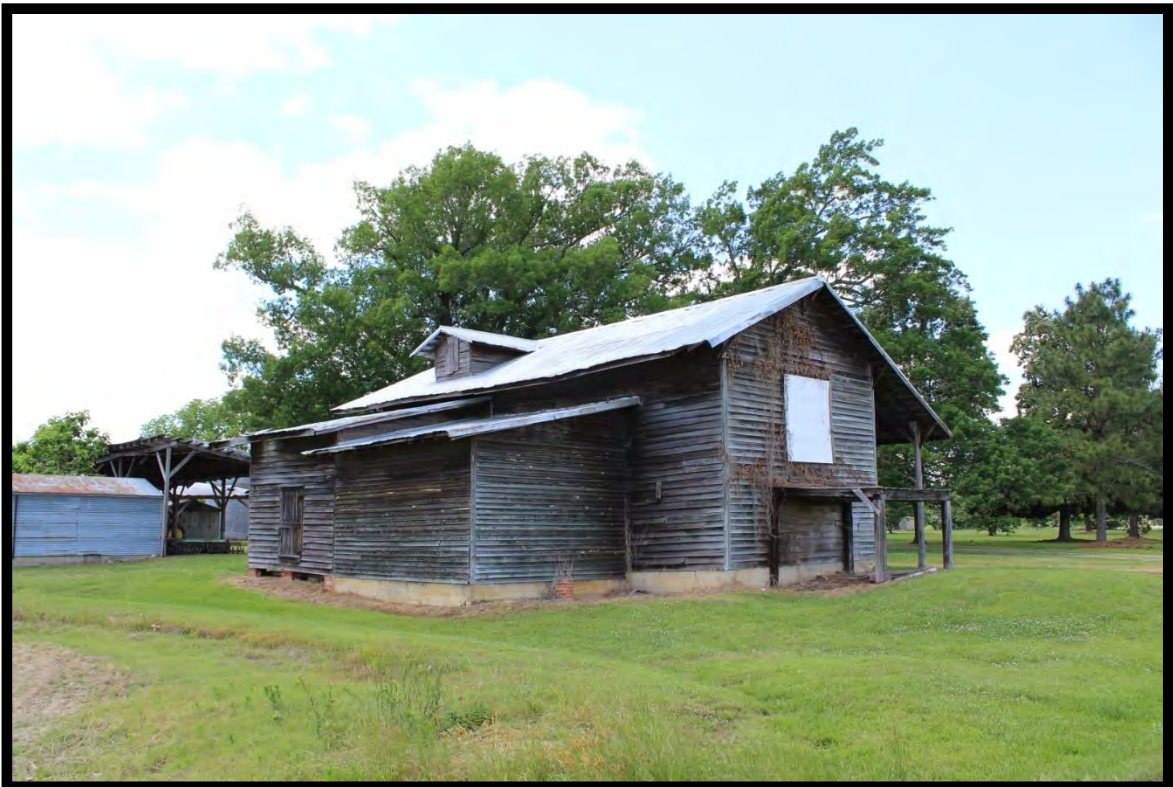
Figure 102: Davenport Cotton Gin, ED0646, Looking Northwest.

The Davenport Cotton Gin (Figure 102) is located in Edgecombe County and was constructed in the 1930s. It is similar in scale and size to the Gillis Cotton Gin, though it differs in exterior cladding. This structure, though not formally evaluated, appears to retain far more physical integrity than the Gillis complex.
