SUBJECT: Historic Structures Survey Report, Upgrade Intersection to Interchange on US 74 at NC
72/NC130, R-5751, PA 18-04-0014, Robeson County, ER 19-2181

**HISTORIC STRUCTURES SURVEY REPORT
UPGRADE INTERSECTION TO INTERCHANGE
ON US 74 AT NC 72/NC 130
ROBESON COUNTY, NORTH CAROLINA**

**TIP PROJECT R-5751
WBS NO. 53087.1.1
PA TRACKING NO. 18-04-0014**

**Prepared by:
Commonwealth Heritage Group, Inc.
P.O. BOX 1198
201 WEST WILSON STREET
TARBORO, NORTH CAROLINA 27886**

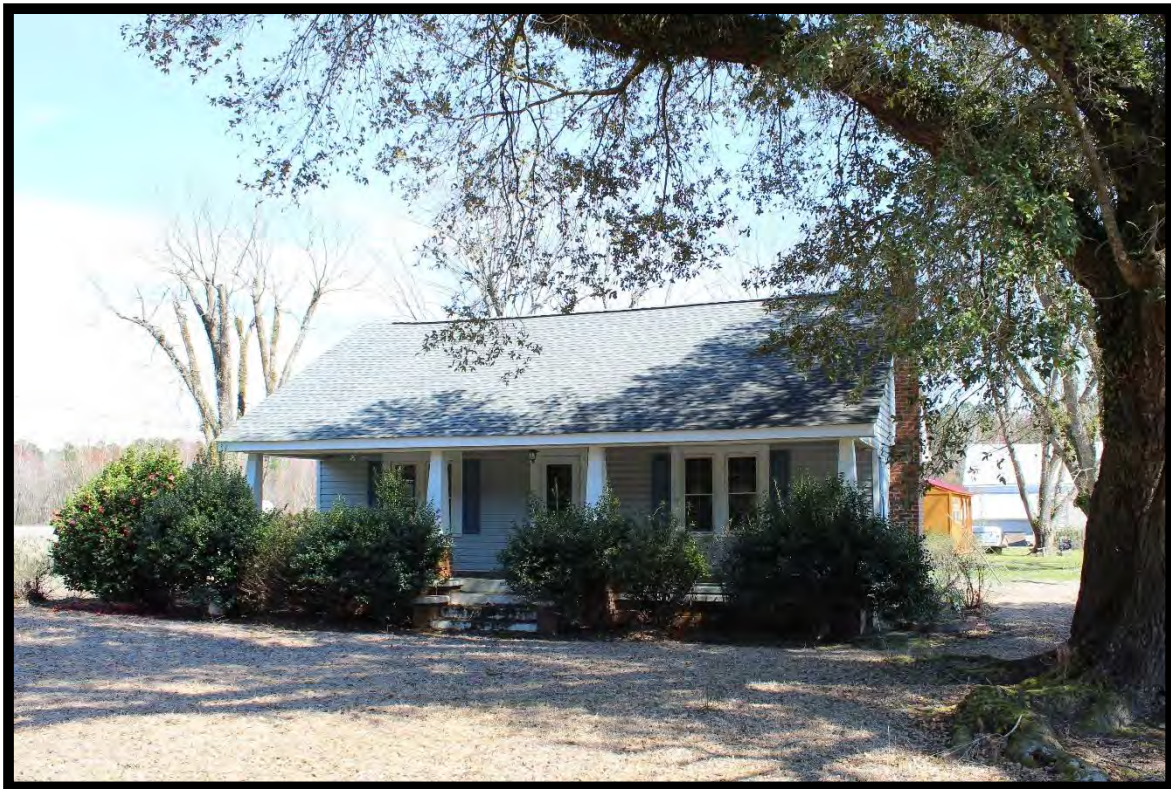
Figure 3: Maulsby and Susan Stephens House, Looking Northeast.

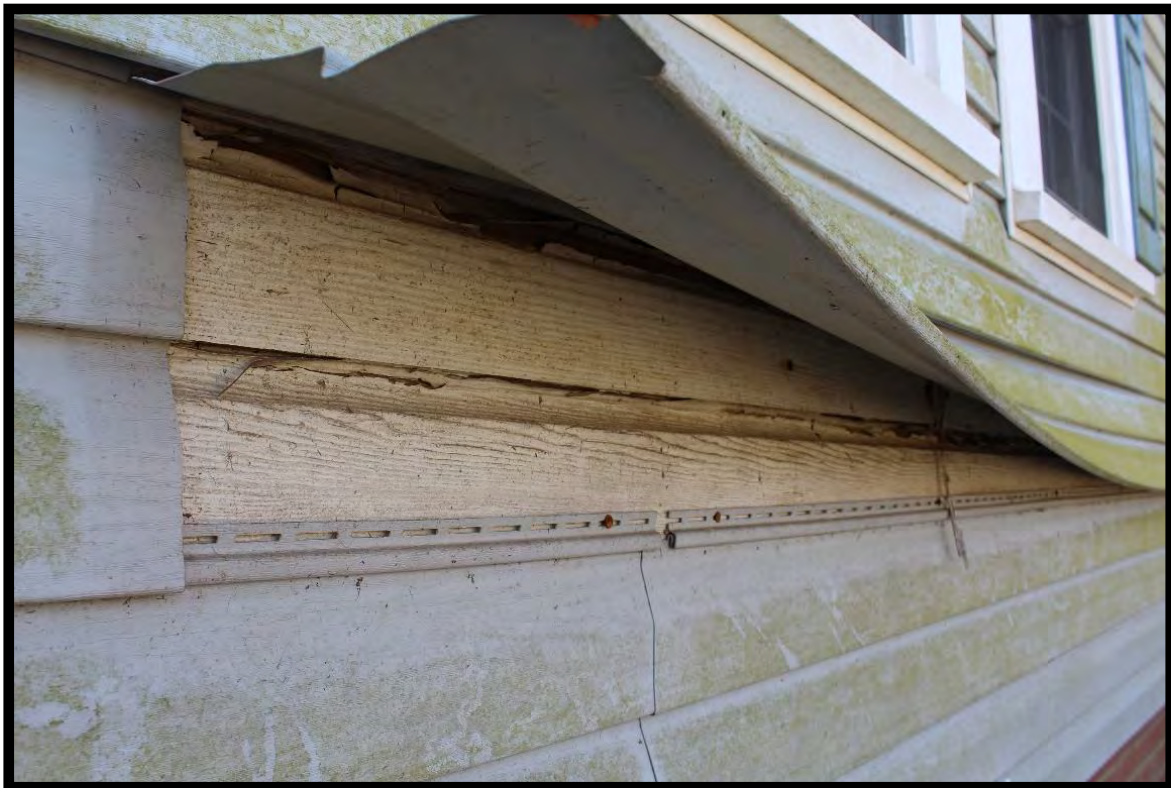
The small one-story dwelling began as a three-bay, side-gabled structure with a gabled rear wing. It was originally clad with German lap siding, which is still present below a layer of vinyl siding (Figure 5). The dwelling likely rested on brick piers, though it appears they have been sheathed and the spaces between them filled with modern brick (Figure 6). Original windows have also been replaced with vinyl sash windows and the roof has been replaced with asphalt shingles. Over time, a hallway, which may have begun as a side porch, was added to the south elevation of the wing, and a side-gabled addition was added on the east elevation of the wing.

Figure 5: Mulsby and Susan Stephens House, Original German Lap Siding Below Vinyl Siding.

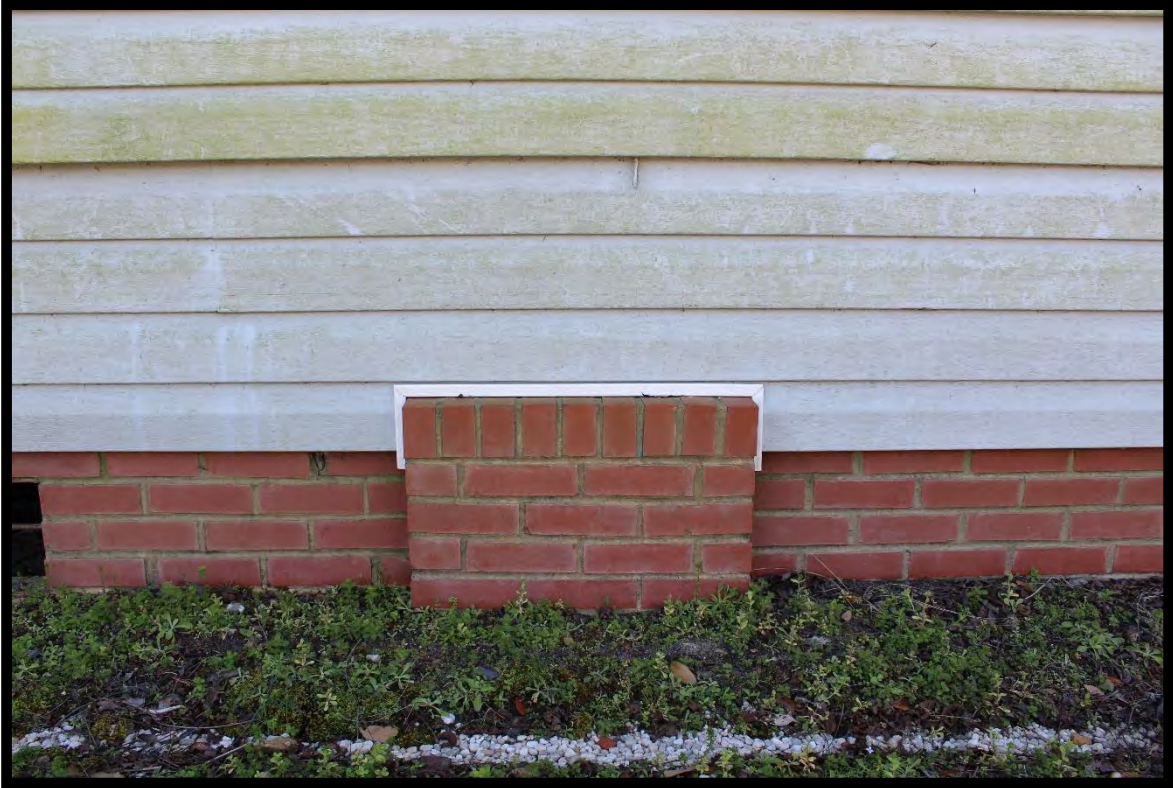
Figure 6: Maulsby and Susan Stephens House, Foundation and Piers.

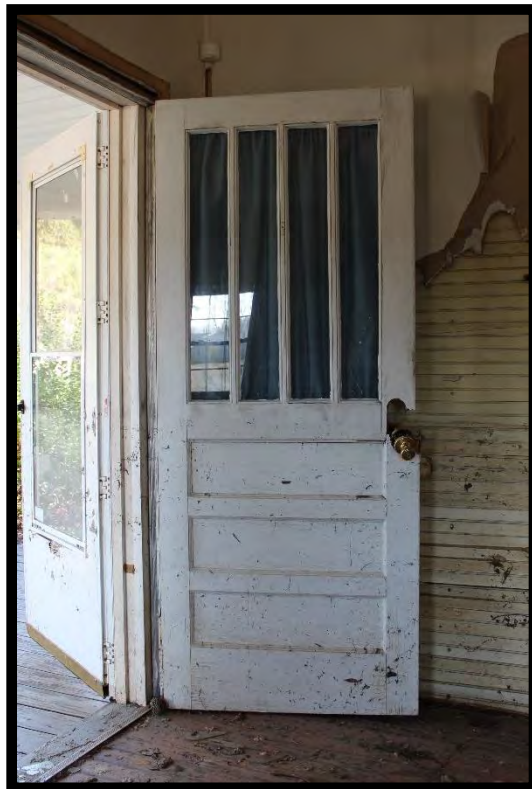
The dwelling's façade is symmetrical and still retains an early wooden entry door with four vertical lights over horizontal panels (Figure 7). It is flanked by paired four-over-four, vinyl sash windows with vinyl shutters (Figure 8). The façade is sheltered by an integral porch supported by battered box columns on brick piers. The upper portion of the columns are clad with metal but may contain the original columns below (Figure 9). The porch is approached by concrete steps flanked by low brick pedestals with concrete caps (Figure 10).

Figure 7: Maulsby and Susan Stephens House, Entry Door.

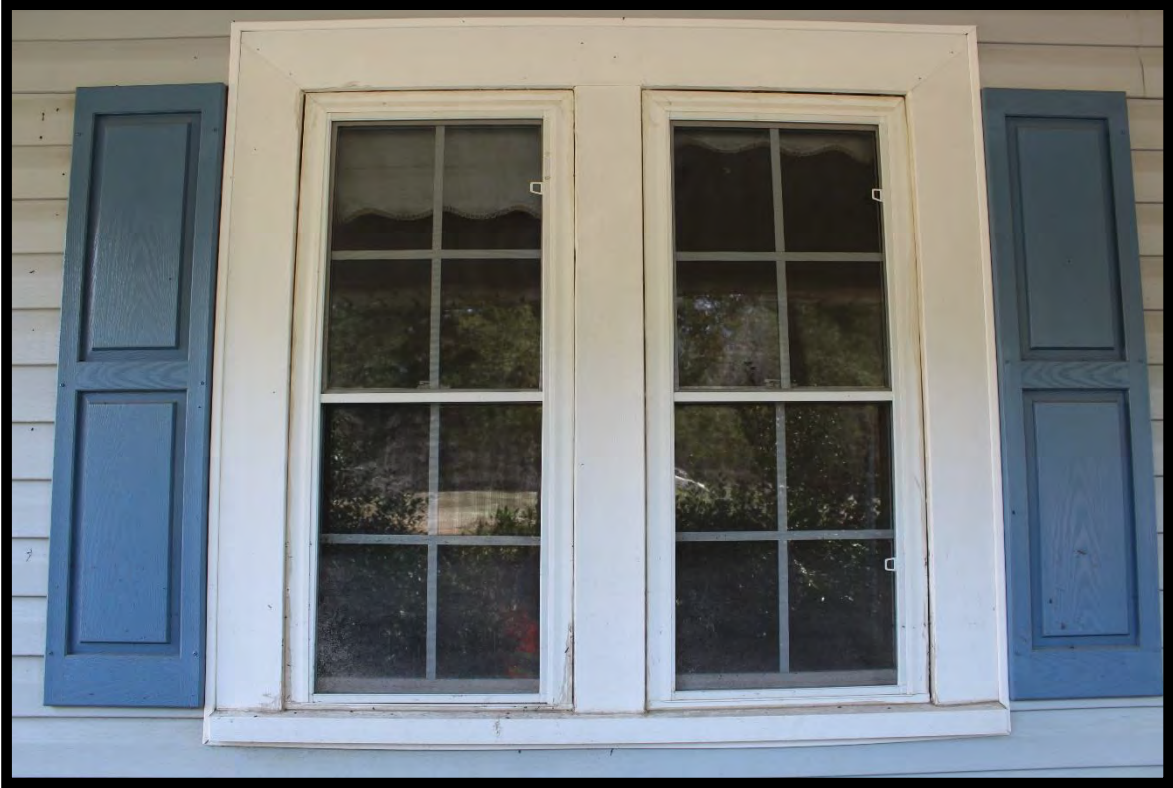
Figure 8: Maulsby and Susan Stephens House, Façade Windows.

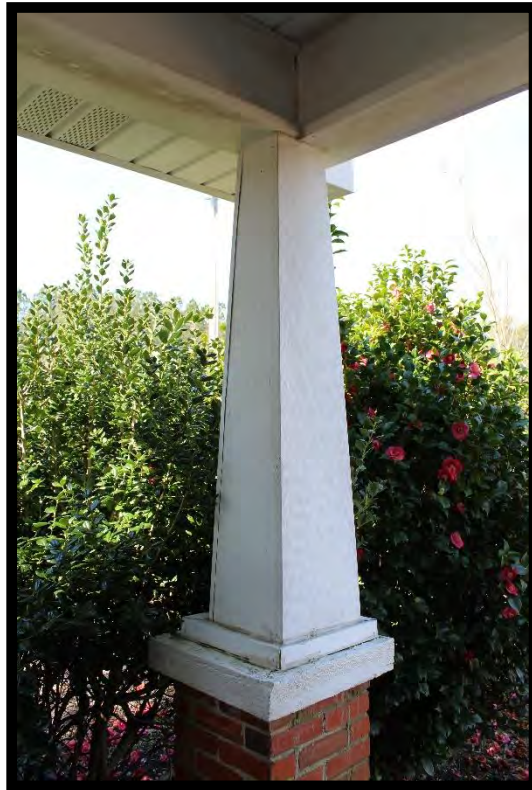
Figure 9: Maulsby and Susan Stephens House, Porch Column.

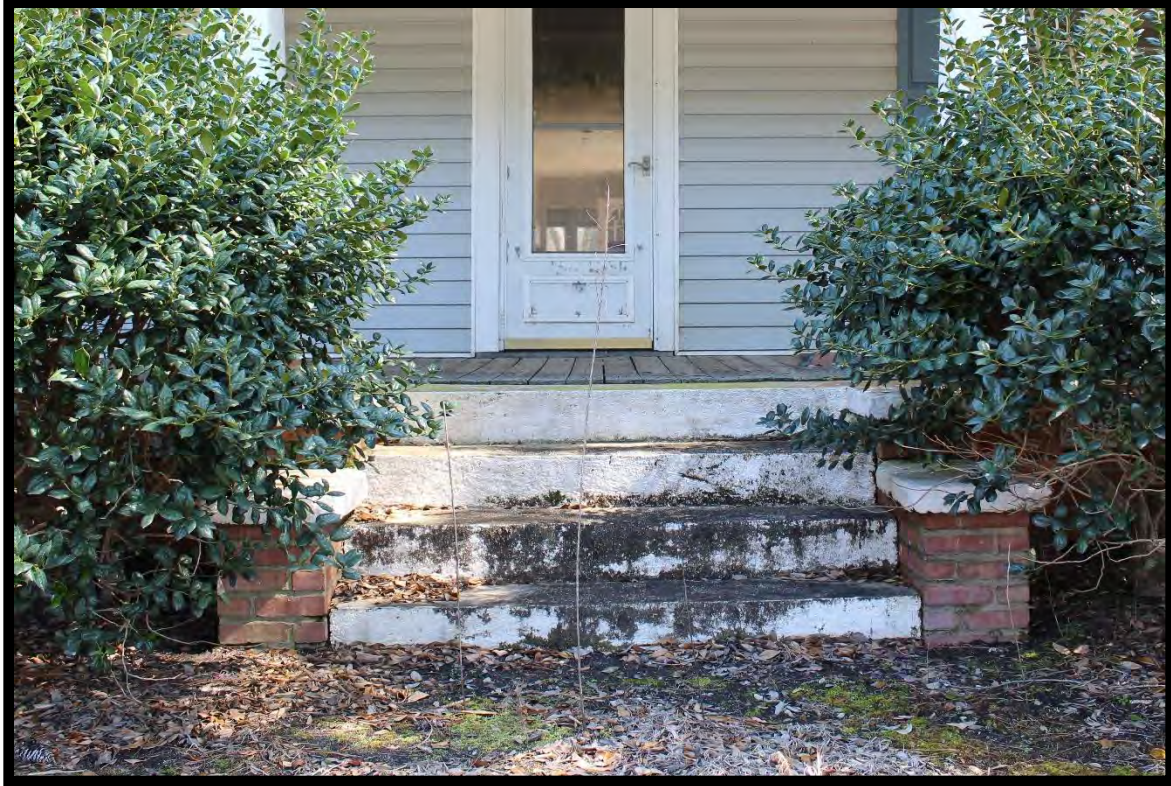
Figure 10: Maulsby and Susan Stephens House, Porch Steps.

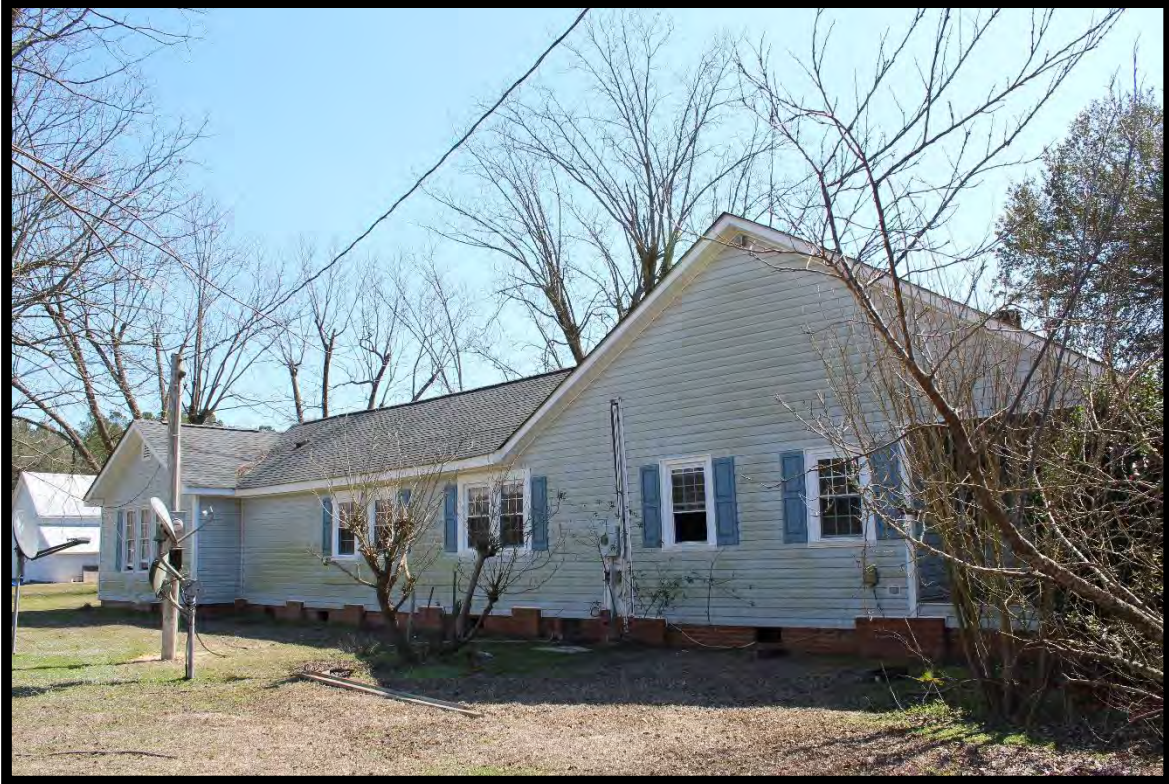
Figure 11: Maulsby and Susan Stephens House, Looking Southeast.

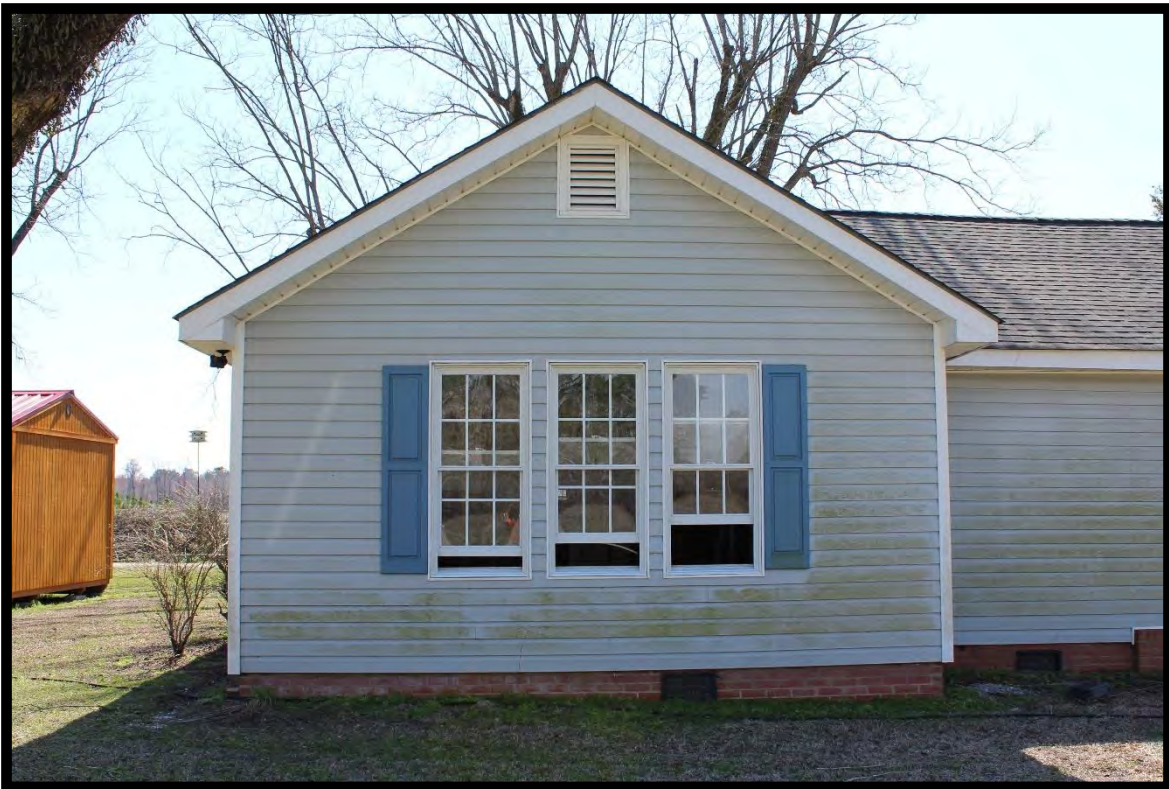
The north (side) elevation of the dwelling has three sections, described west to east. The first section is the gable end of the main block of the dwelling, which contains two six-over-six, vinyl sash windows that are centered below the gable. The second section is the side elevation of the wing with a paired six-over-six, vinyl sash window and two individual six-over-six, vinyl sash windows that are set very close to one another. Though separate, they share one set of vinyl shutters (Figure 11). Evidence on the interior suggests that the original windows on this elevation were enclosed when these were added (see interior photos). The third section is the gable end of the rear addition. It contains three six-over-six, vinyl sash windows, which also share one set of vinyl shutters (Figure 12).

Figure 12: Maulsby and Susan Stephens House, Looking South.

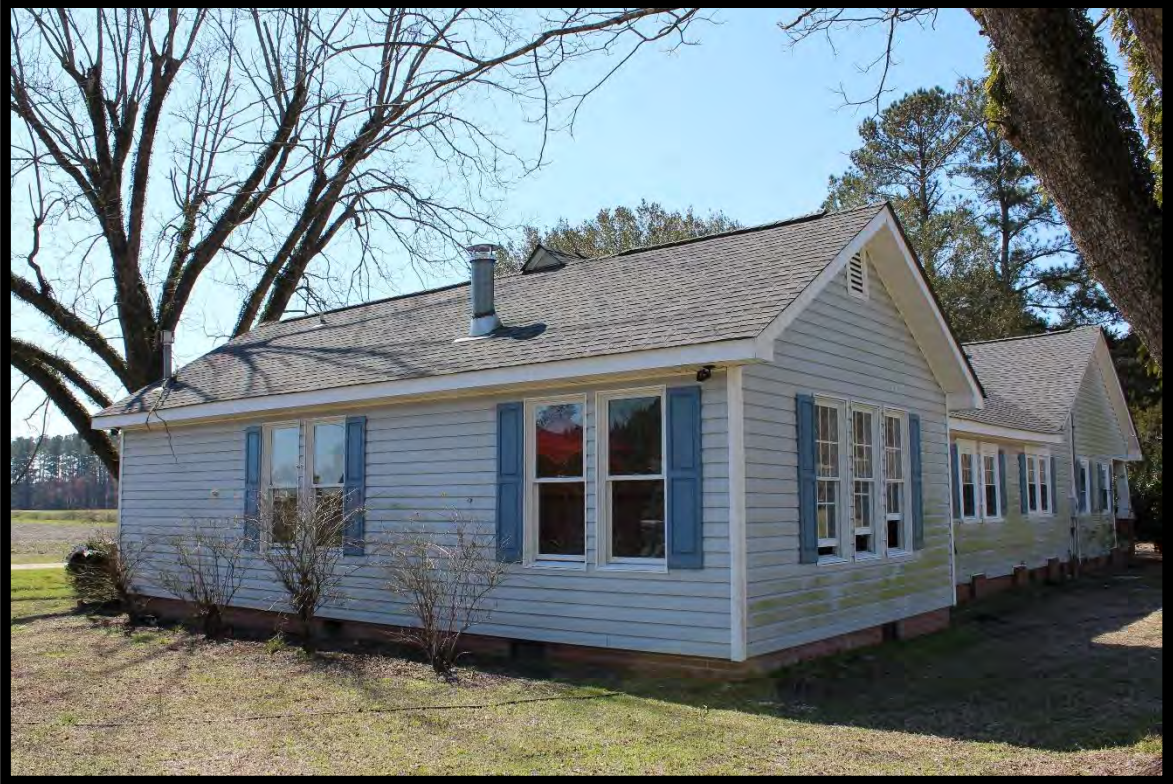
The east (rear) elevation of the dwelling, which belongs to a modern rear addition, contains two sets of individual one-over-one, vinyl sash windows that are set closely together and share one set of vinyl shutters. The windows are placed to the north of the elevation. The rear slope of the addition contains two vents (Figure 13).

Figure 13: Mulsby and Susan Stephens House, Looking Southwest. Note Peak of Rear Wing.

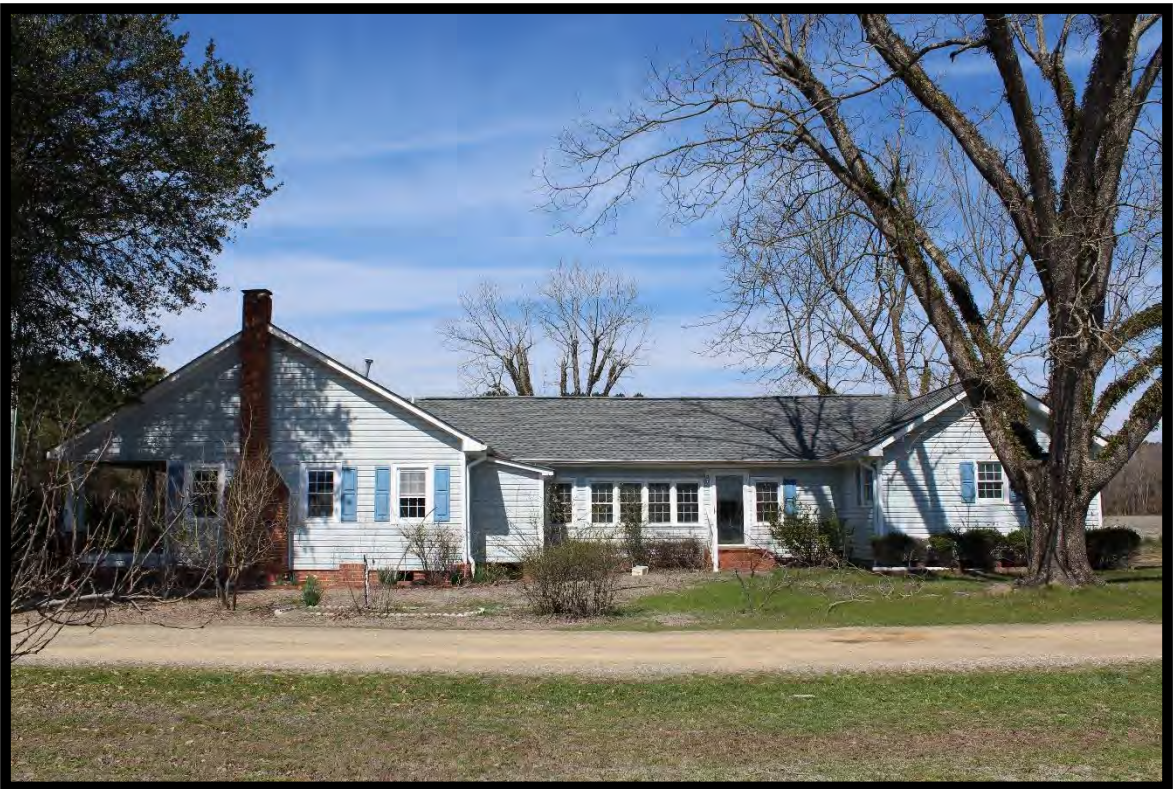
Figure 14: Mulsby and Susan Stephens House, Looking North.

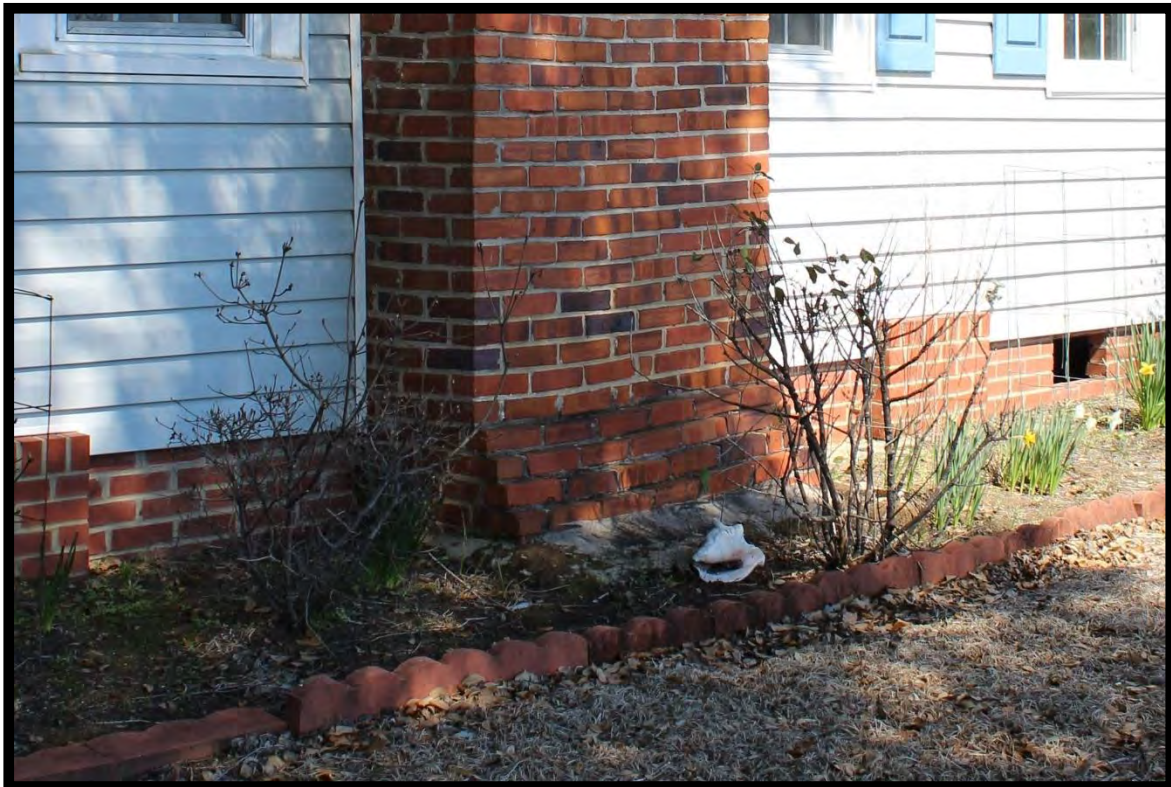
sashes and the window on the east has a single shutter on its east side. A small shed-roofed section fills the ell between the middle and main block of the dwelling. It does not contain any apertures. The gable end of the main block of the dwelling contains three six-over-six, vinyl sash windows and likely reflects the original arrangement of the north gable (Figure 14). The only difference is that an exterior brick chimney rises from the center of the south elevation. The chimney is interesting in that it has a stepped base, likely designed to better support the weight of the chimney and prevent it from falling away from the dwelling. This feature could also relate to a renovation or restabilization of the chimney (Figure 15).

Figure 15: Maulsby and Susan Stephens House, Chimney Base.

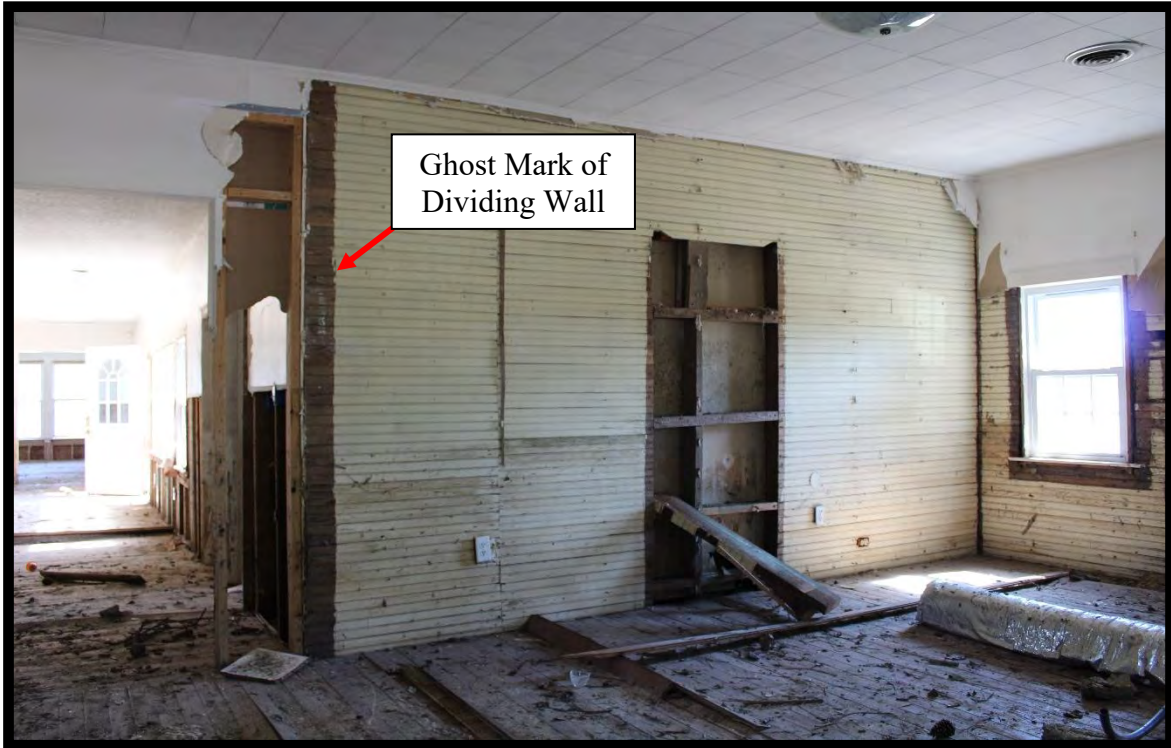
Figure 17: Mulsby and Susan Stephens House, Southwest Room Showing Beadboard, Ghost Mark of Dividing Wall (Mirrored on Opposite Wall), and an Original Doorway.

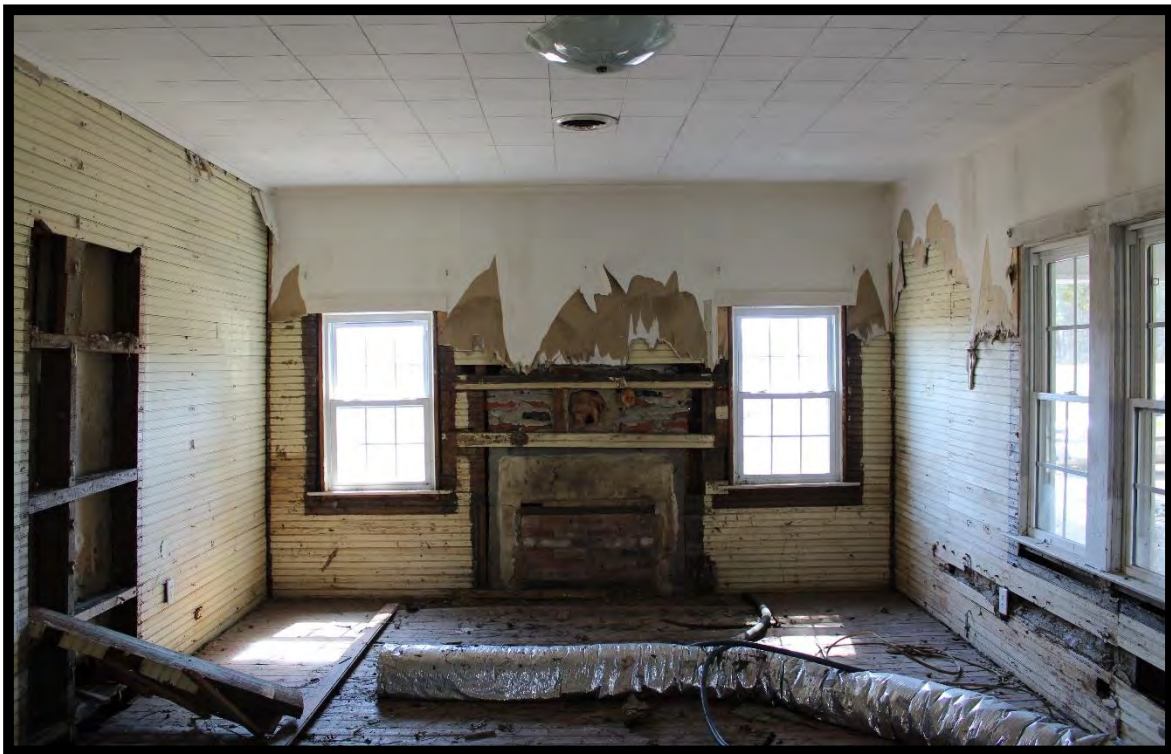
Figure 18: Mulsby and Susan Stephens House, Southwest Room Showing Original Fireplace.

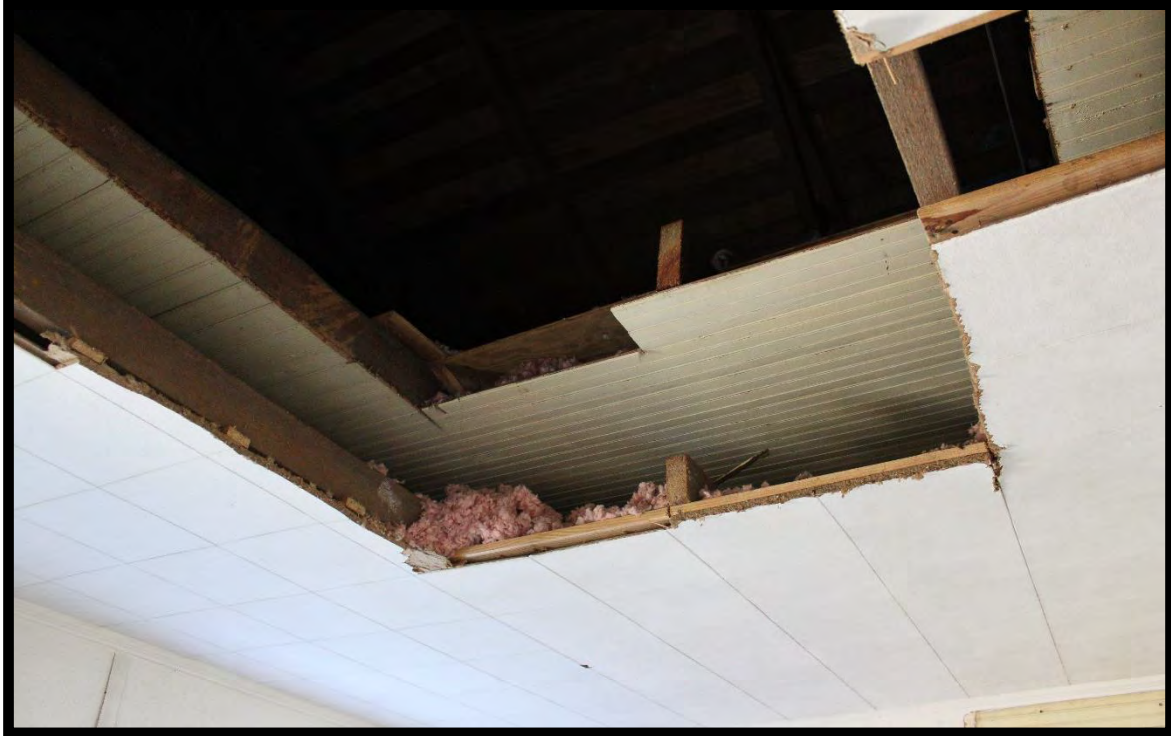
Figure 19: Maulsby and Susan Stephens House, Northwest Room Showing Beadboard Ceiling.

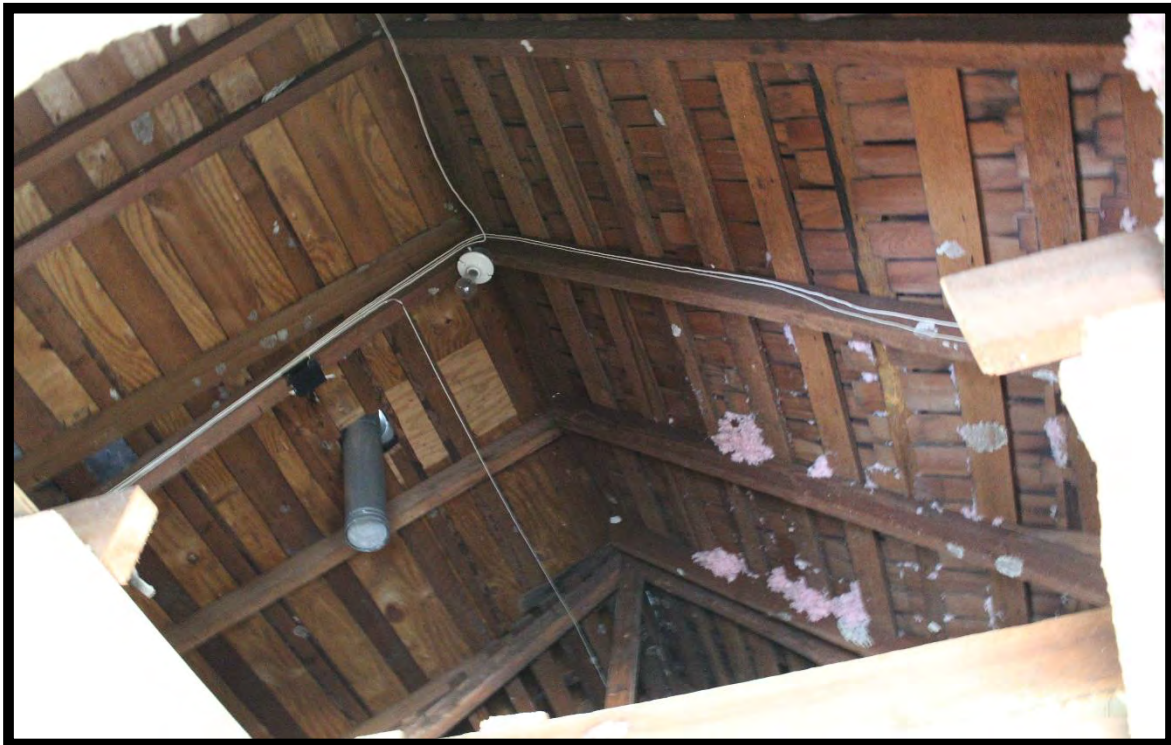
Figure 20: Maulsby and Susan Stephens House, Northwest Room Showing Shake Shingles on Right.

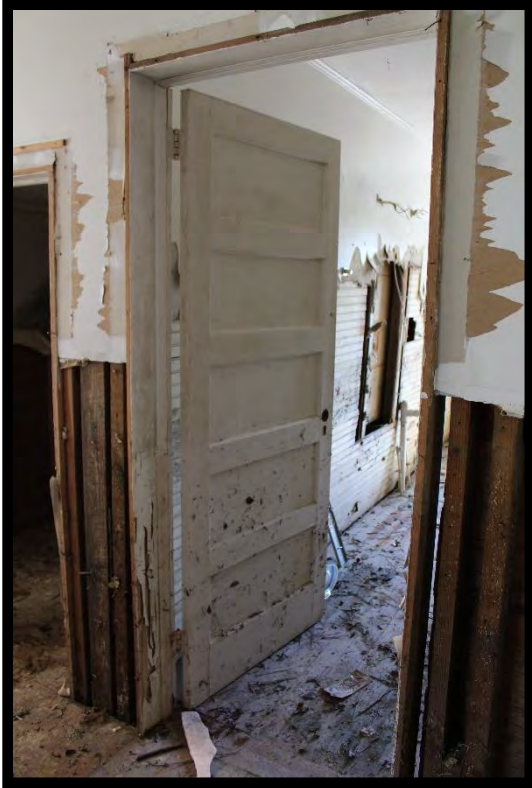
The rear south room retains an original door with five horizontal panels as well as a once-covered window (Figure 21). The rear north room feeds into the rear wing making it larger than the south room. The room has been clad with a wider more decorative paneling that was added over the original flush boards and an original window opening (Figure 22). There is also an original two-over-two, horizontal pane, wooden window sash in the wall between this room and

Figure 21: Maulsby and Susan Stephens House, Original Door and Window Opening.

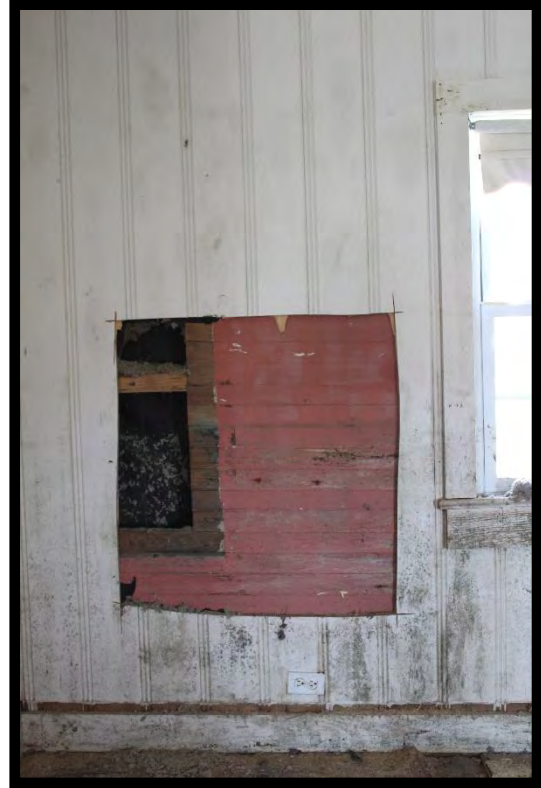
Figure 22: Maulsby and Susan Stephens House, Original Flush Boards and Window Opening.

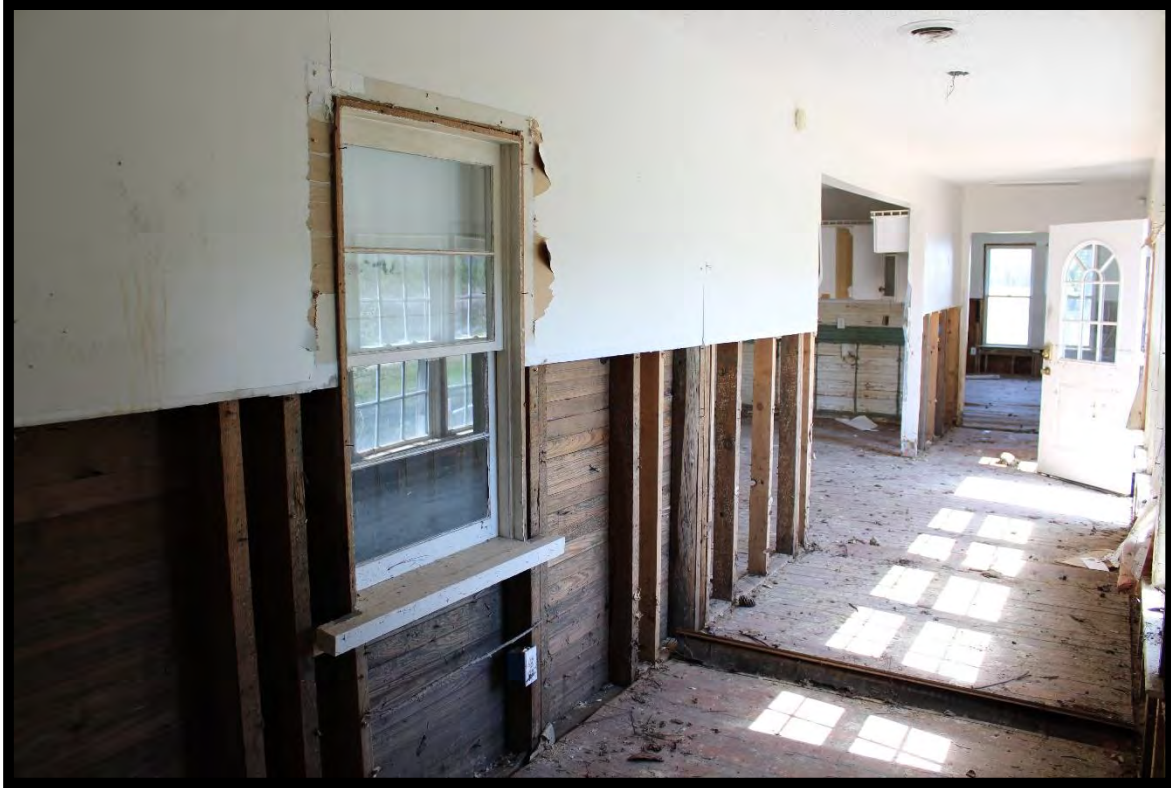
the hall (Figure 23). The rear of the wing was adapted as a kitchen, but the removal of the lower cabinets reveals additional beadboard and another window opening (Figure 24).

Figure 23: Malsby and Susan Stephens House, Original Window and Hall to Rear Addition.

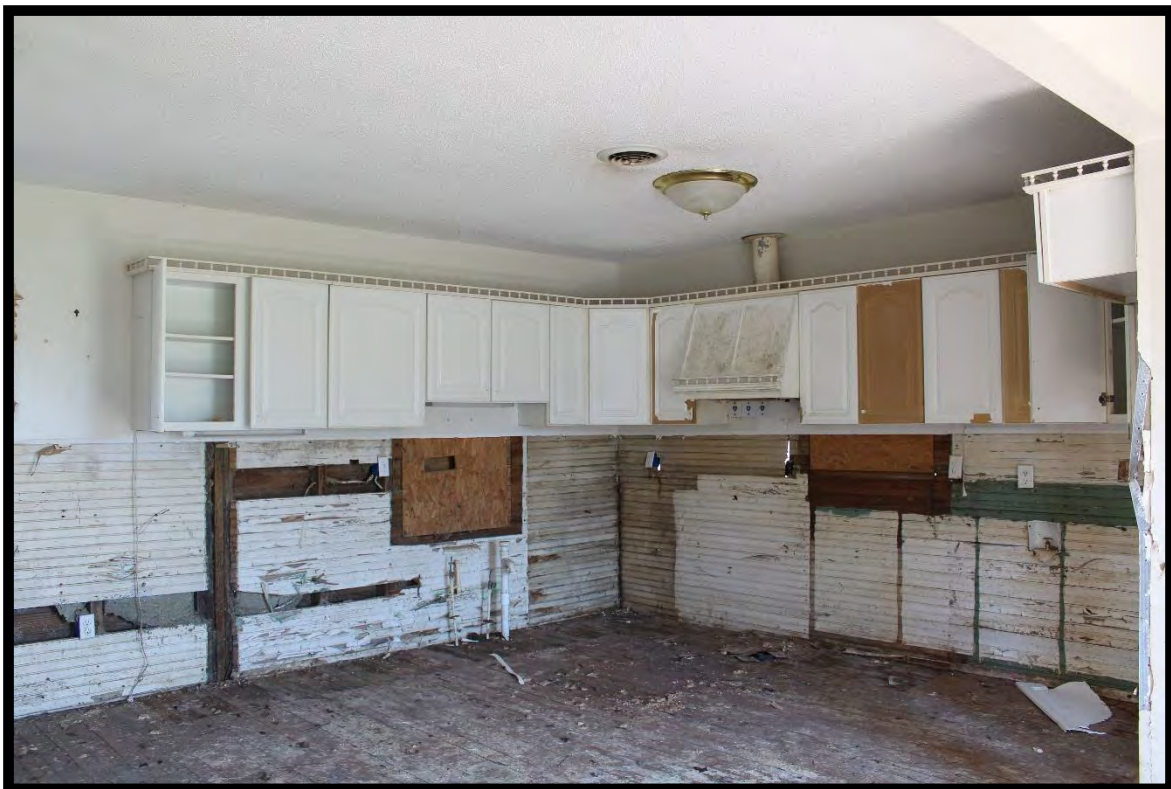
Figure 24: Malsby and Susan Stephens House, Rear Wing Adapted as a Kitchen. Note Original Window Openings Below Cabinets.

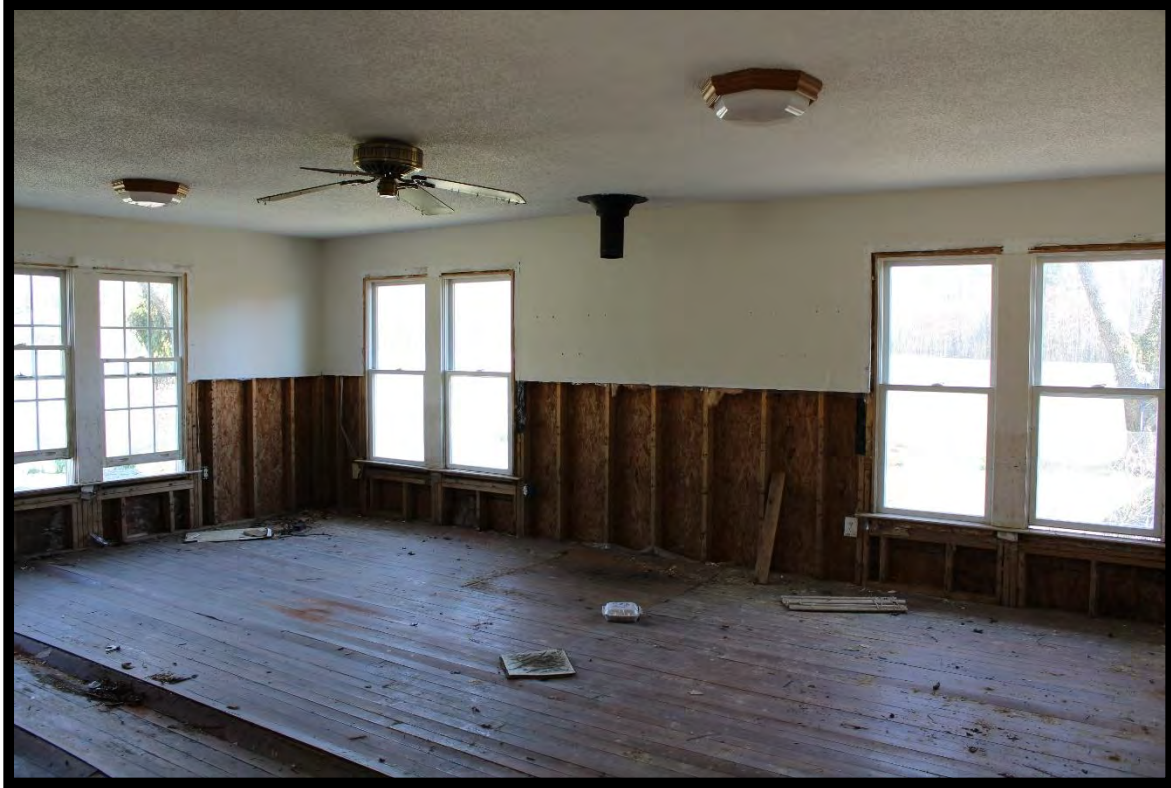
Along the side of the rear wing is a hallway that may have begun as a side porch. It leads to a modern side-gabled addition that was constructed against the east (rear) elevation of the wing and is oriented perpendicular to it giving the dwelling a U-shaped footprint. The addition consists of a den/family room space and a smaller space that may have been used as a bedroom (Figure 25).

Figure 25: Malsby and Susan Stephens House, Rear Addition.

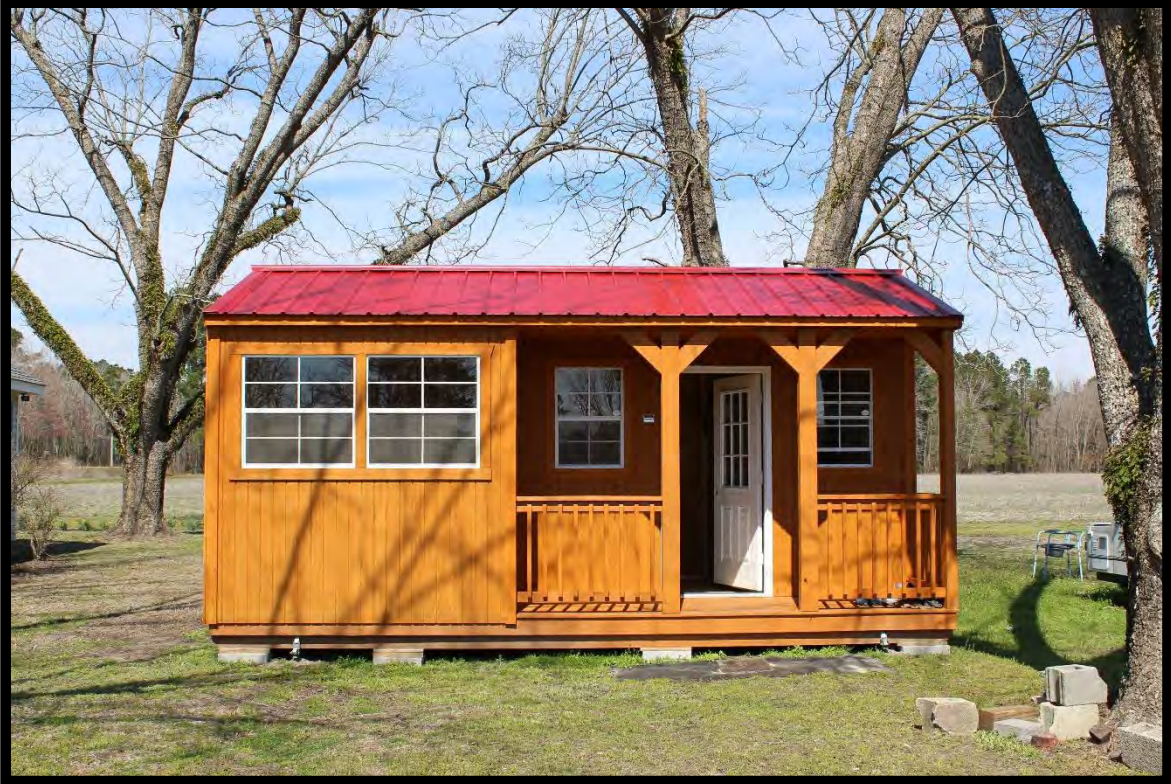
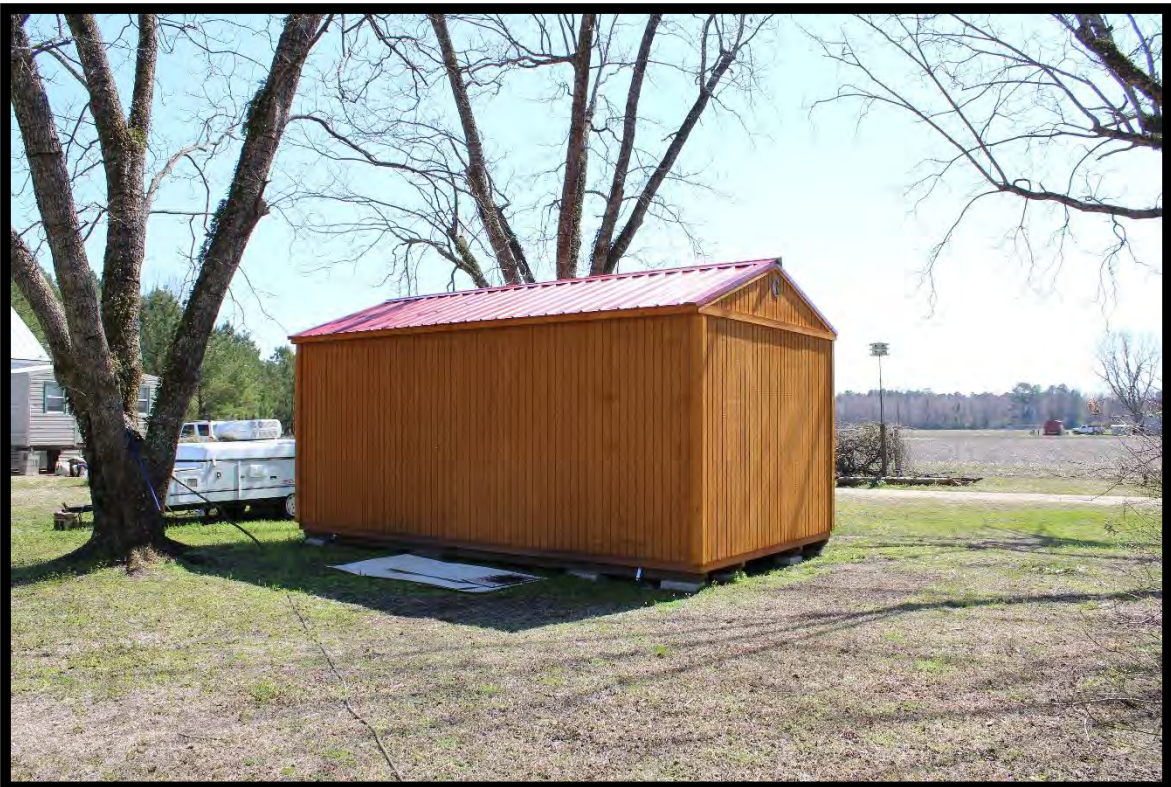
There are two agricultural buildings and two non-traditional dwellings east of the primary dwelling. The structure closest to the primary dwelling was identified as a dwelling by a friend of the owner who was on site. He also shared that it will be removed from the property soon. The structure is considerably smaller than the main house and has a side-gabled standing seam metal roof and vertical wooden sheathing. It faces south and there is a small recessed porch on the façade. The porch shelters the entry door and two four-over-four, vinyl sash windows. It is supported by wooden posts with gallows brackets and has a simple wooden railing. West of the recessed porch there is a pair of four-over-four, vinyl sash windows. The remaining elevations are blind (Figures 26 and 27).

Figure 26: Maulsby and Susan Stephens House, Secondary Dwelling, Looking North.

Figure 27: Maulsby and Susan Stephens House, Secondary Dwelling, Looking Southeast.

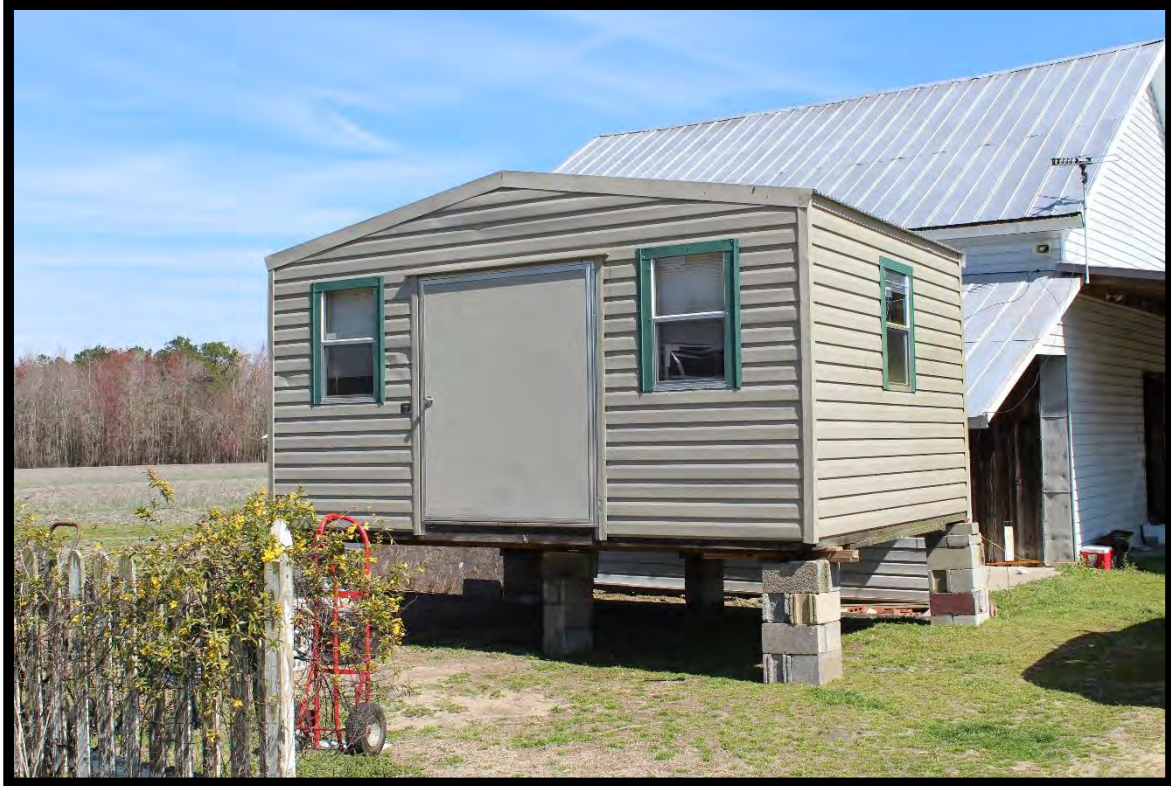
The second structure was also described as a dwelling. It is raised on concrete blocks, roughly 2.5 feet above the ground, likely to protect from flooding. The structure faces west and has a wide entry door flanked by one-over-one, vinyl sash windows. It is sheathed with vinyl siding and has a low-sloped, front-gabled roof covered with corrugated metal. The north and south (side) elevations are lit by one-over-one, vinyl sash windows (Figure 28).

Figure 28: Maulsby and Susan Stephens House, Secondary Dwelling, Looking Northeast.
