SUBJECT: Historic Structures Survey Report, Upgrade Intersection to Interchange on US 74 at NC
72/NC130, R-5751, PA 18-04-0014, Robeson County, ER 19-2181

**HISTORIC STRUCTURES SURVEY REPORT
UPGRADE INTERSECTION TO INTERCHANGE
ON US 74 AT NC 72/NC 130
ROBESON COUNTY, NORTH CAROLINA**

**TIP PROJECT R-5751
WBS NO. 53087.1.1
PA TRACKING NO. 18-04-0014**

**Prepared by:
Commonwealth Heritage Group, Inc.
P.O. BOX 1198
201 WEST WILSON STREET
TARBORO, NORTH CAROLINA 27886**

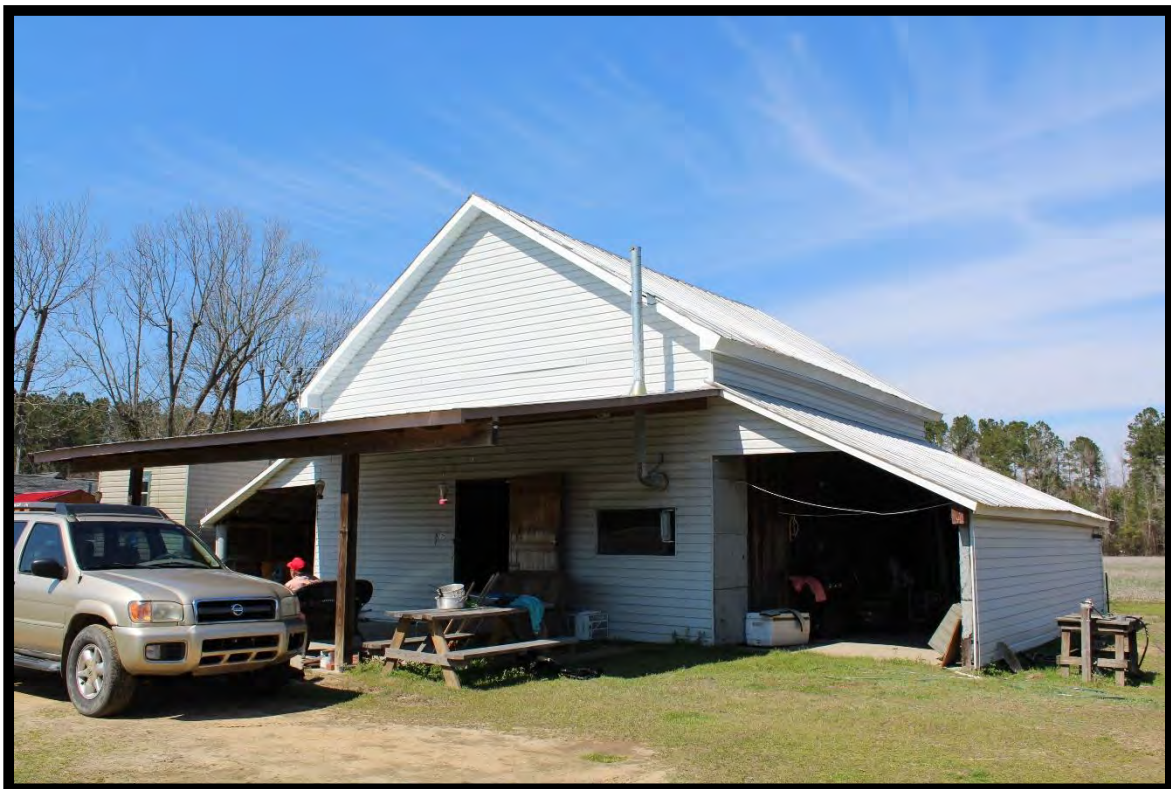
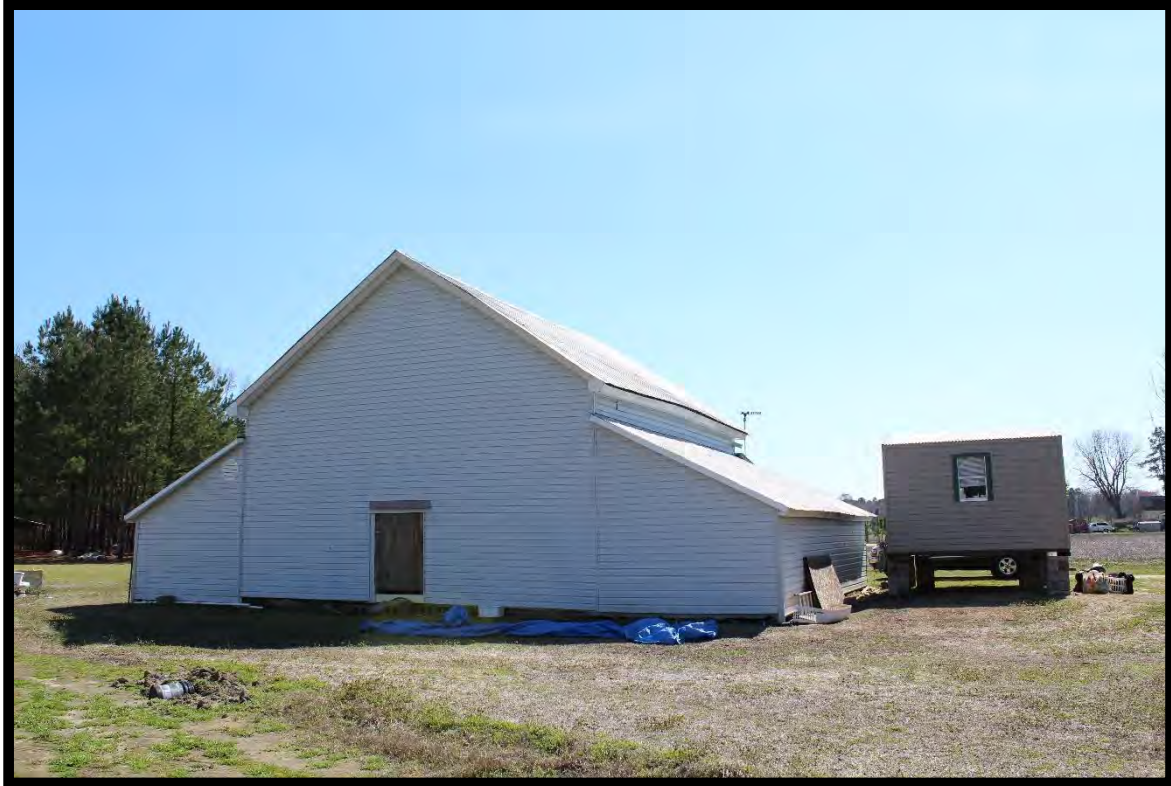
Next to the raised dwelling is a front-gabled packhouse with shed-roofed wings. It is clad with vinyl siding, but the original vertical wooden siding is present on the east and west (side) elevations of the original center bay. The south (front) elevation contains a centered board-and-batten door flanked on the east by a single-pane window. The wings are open on the front though their side and rear elevations are blind. There is also a small board-and-batten door on the rear elevation of the center section (Figures 29 and 30).

Figure 29: Maulsby and Susan Stephens House, Packhouse, Looking Northwest.

Figure 30: Maulsby and Susan Stephens House, Packhouse, Looking Southeast.

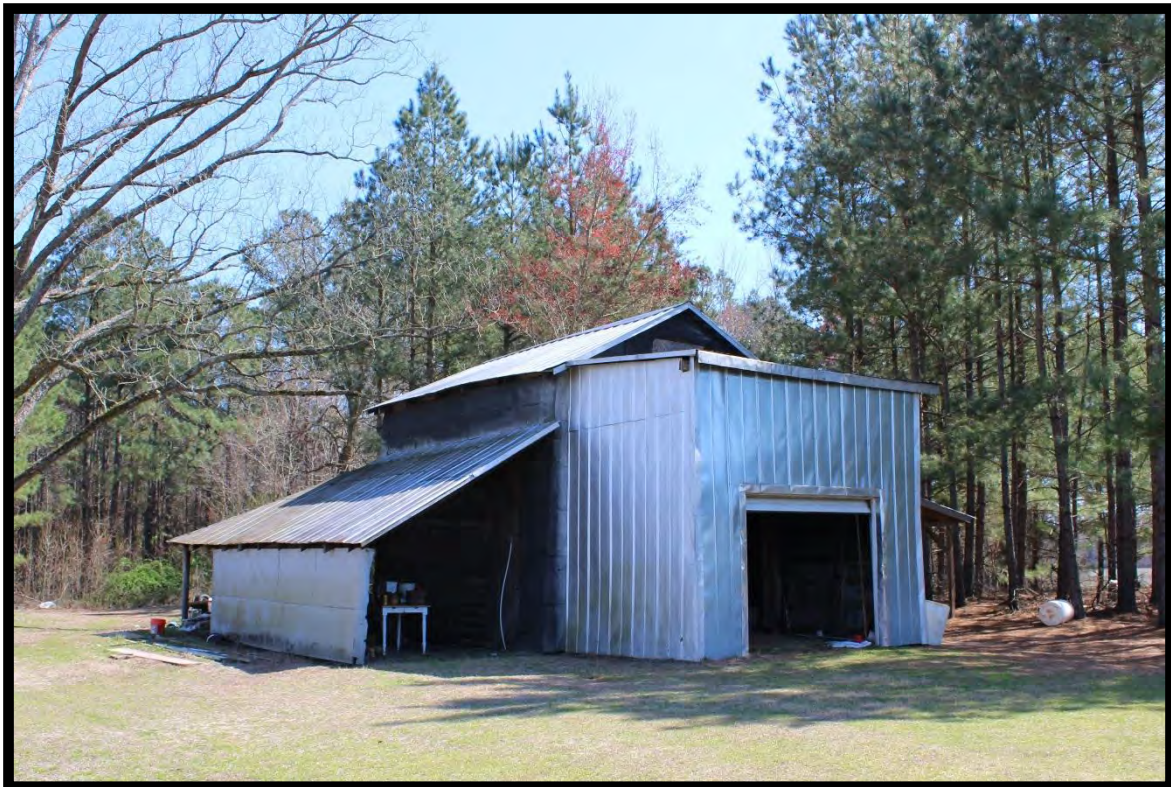
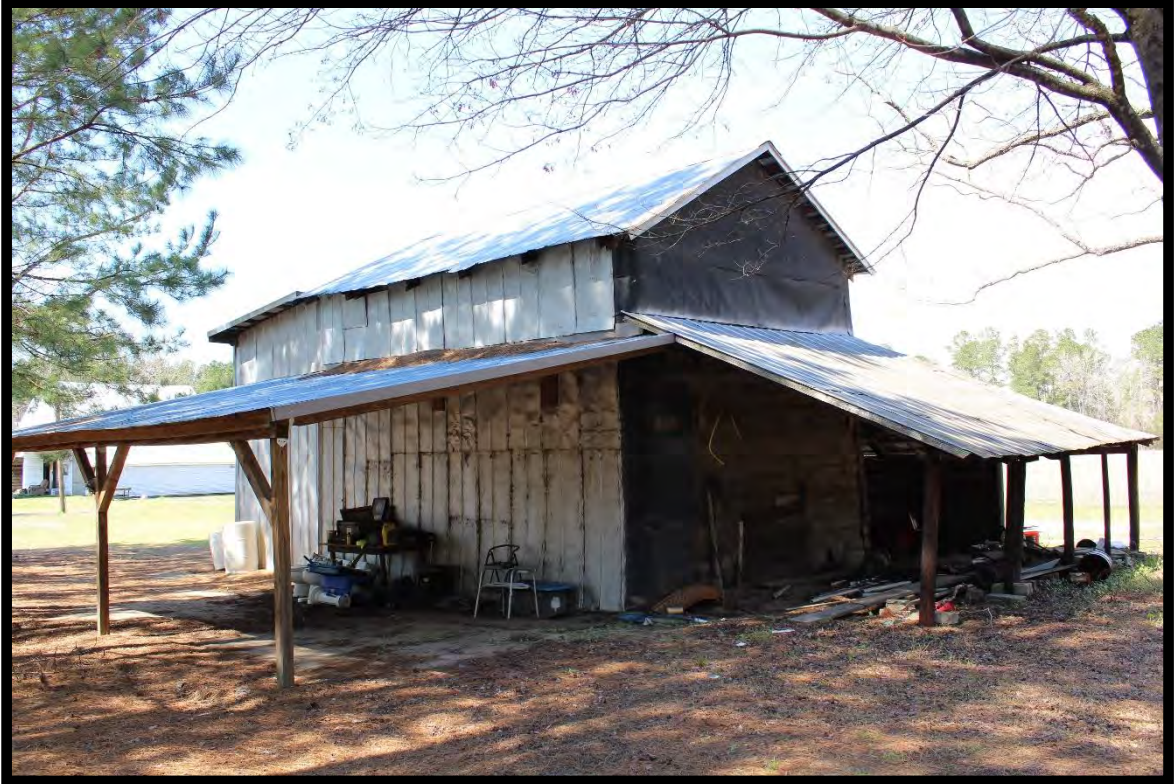
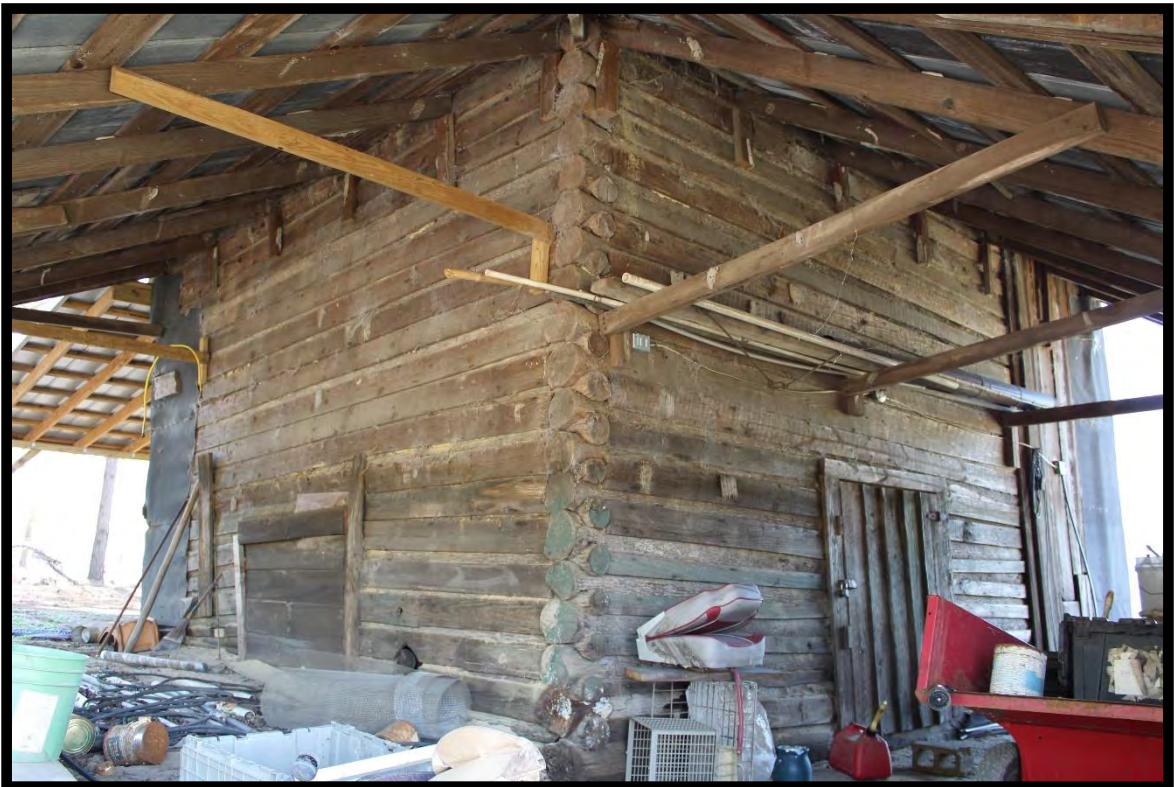
East of the packhouse is a structure with a log tobacco barn as its core. The structure faces west, and while its core is front gabled, there is a tall shed-roofed addition that almost completely conceals the façade. The addition is clad with vertical metal sheathing and has a garage-like entrance. Lower, shed-roofed sections extend from the remaining elevations. These sections, like the log portion and front addition are covered with standing seam metal roofs. On the east side of the log core is a small door that was used to add firewood and heat the barn, and on the north side is a small board-and-batten entry door. A large portion of the exterior of the log barn has been clad with metal sheets, but the interior has been left exposed (Figures 31 through 34).

Figure 31: Maulsby and Susan Stephens House, Tobacco Barn and Additions, Looking Southeast.

Figure 32: Maulsby and Susan Stephens House, Tobacco Barn, Looking Northwest.

Figure 33: Maulsby and Susan Stephens House, Tobacco Barn, Looking Southwest.

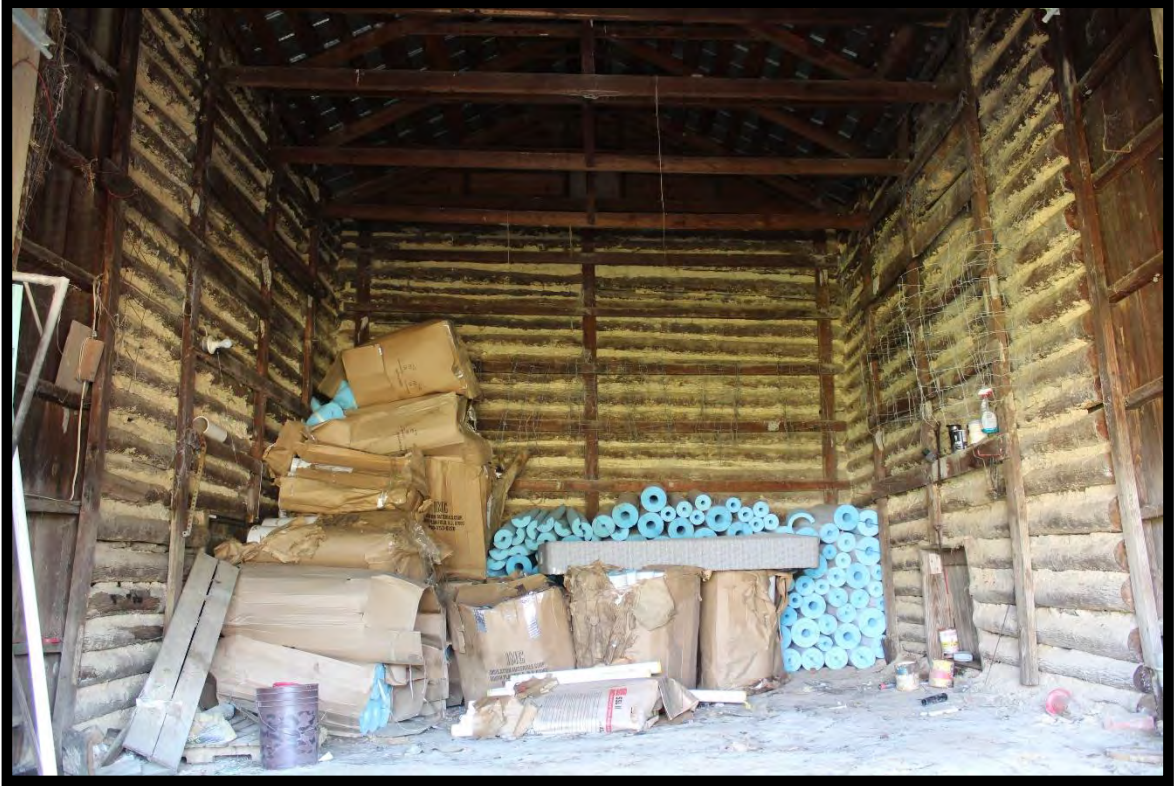
Figure 34: Maulsby and Susan Stephens House, Tobacco Barn, Interior, Looking East.

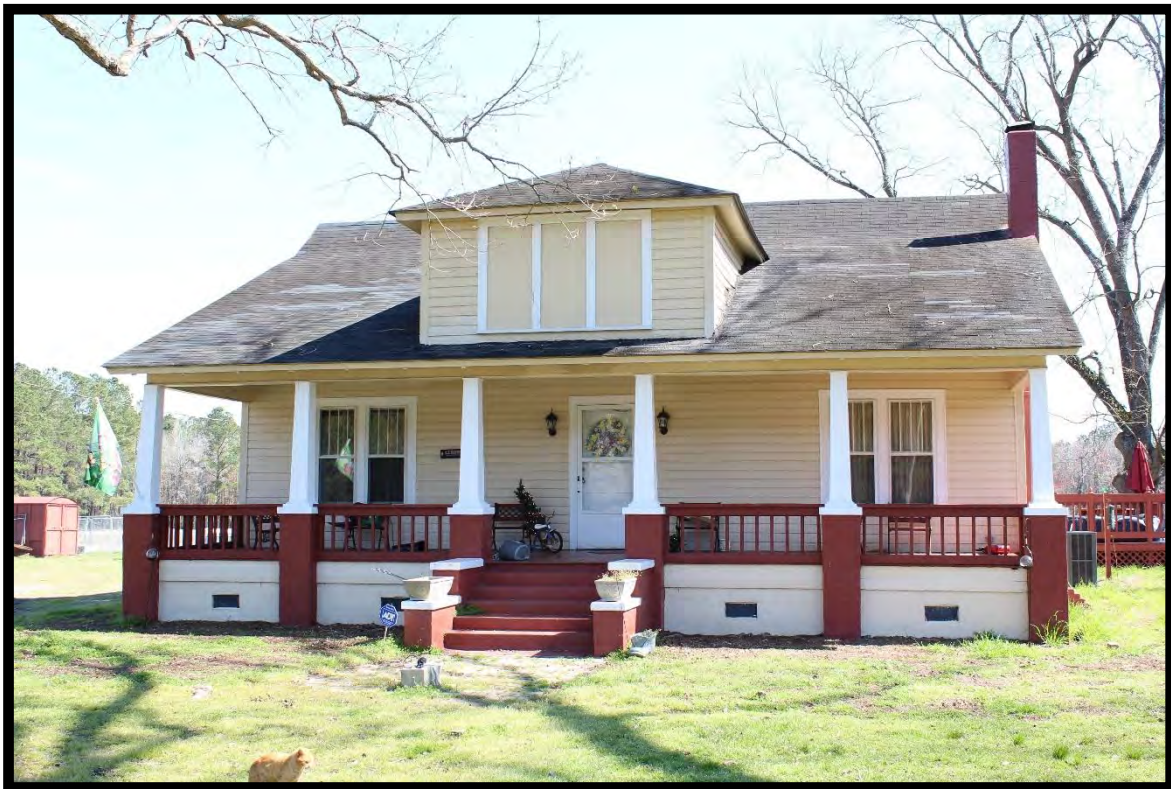
Figure 42: Giles Stephens Homeplace, Looking North-Northeast.

The dwelling retains its original German lap siding and has an asphalt shingle roof. It rests on a parged foundation. Its defining feature is a Craftsman-style porch, which exhibits six battered box columns on parged, likely brick, pedestals that also serve as foundational elements. Below the deck, the space between the piers is filled with parged masonry, and above the deck, it is filled with a simple balustrade. The porch is approached by parged steps flanked by low, parged pedestals and shelters a wooden, six-panel, entry door flanked by paired windows. The windows exhibit wooden sashes with four vertical lights over a single light and are protected by storm windows (Figure 45). A large hip-roofed dormer rests on the forward slope of the roof. It appears to have once contained a set of three windows that are now boarded over (Figure 42).

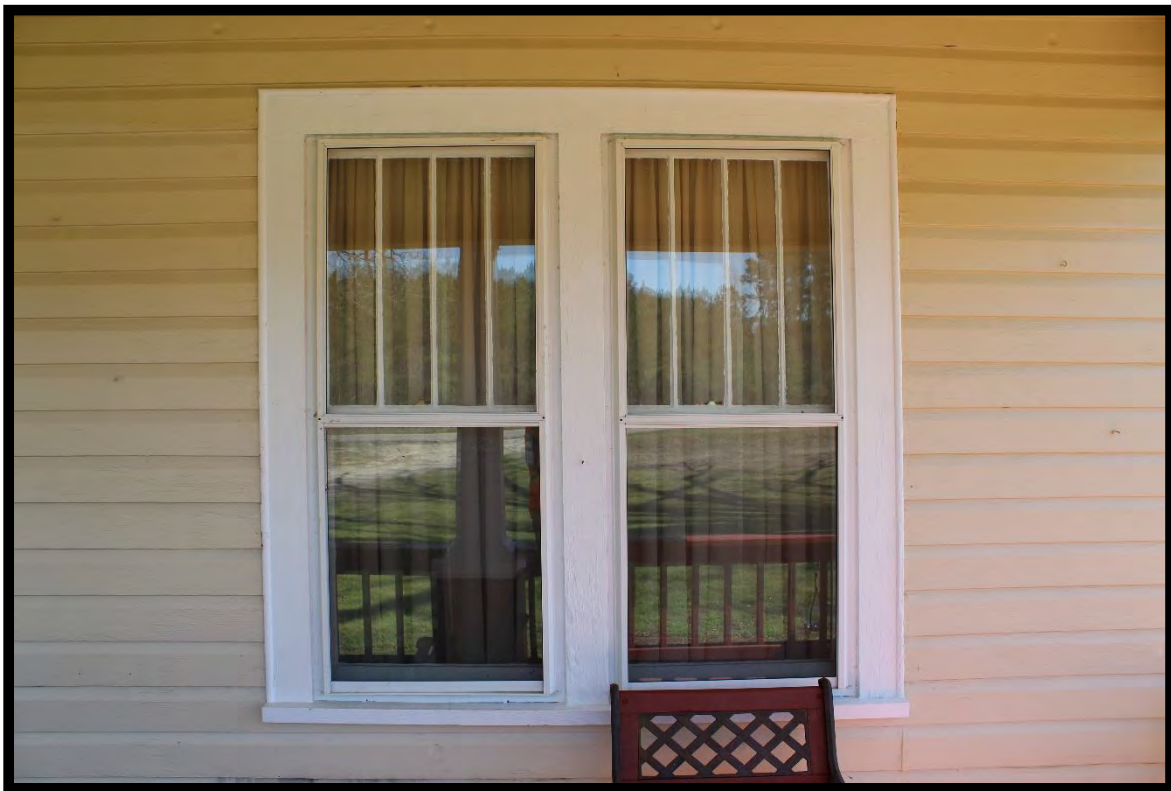
Figure 45: Giles Stephens Homeplace, Original Windows.

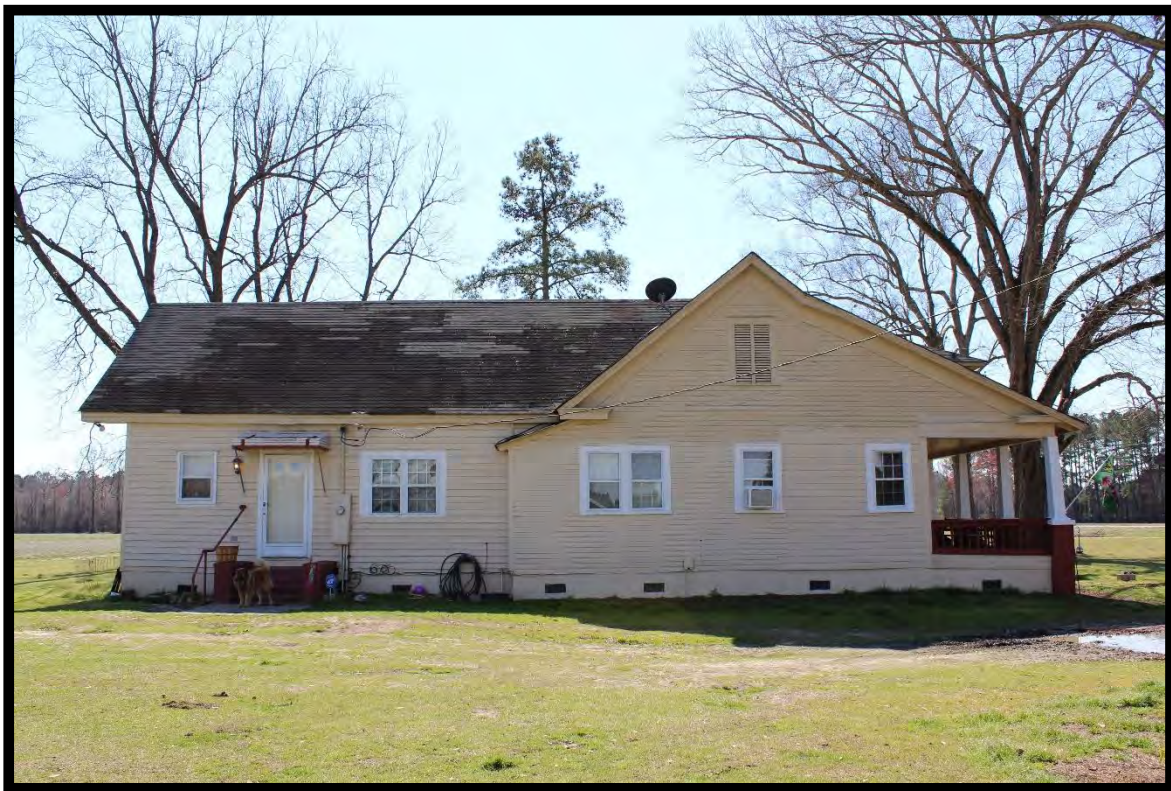
of the gable, which includes a cornice return, likely mirrors the original appearance of the front slope as well. It should be noted that there is a similar cornice return below the eave of the roof but it is not an exact match of the rear return. Also, though the Craftsman style is known for deep eaves, this section of the house has relatively shallow eaves with a frieze composed of flush boards. The remnant of a rear shed-roofed porch or addition is also present at the eastern edge of the gable end. The second half of the elevation, the side of the wing, contains a modern entry door flanked on the west by paired six-over-six, vinyl sash windows and on the east by a small six-over-six, vinyl sash window. The door is approached by parged steps flanked by a low parged walls and sheltered by a metal awning (Figure 46).

Figure 46: Giles Stephens Homeplace, Looking South.

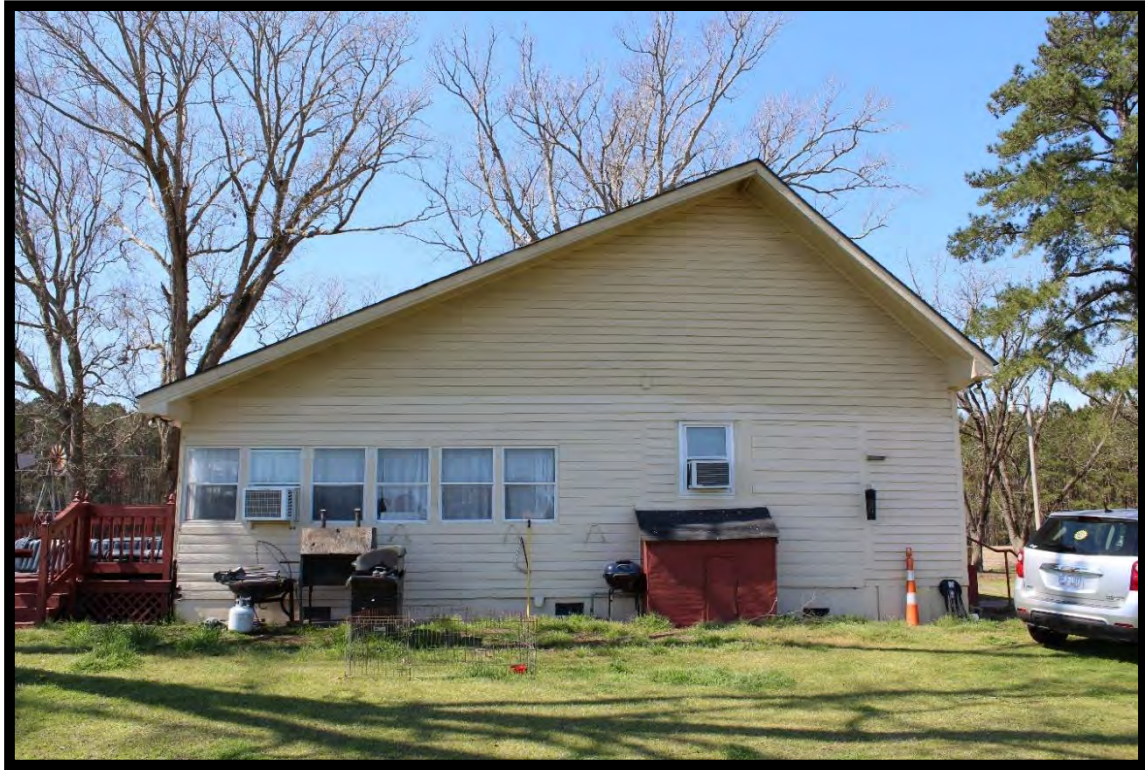
The east (rear) elevation displays an asymmetrical gable with a significantly longer and shallower south slope. This gable also has a much deeper eave than the front or side gables. Furthermore, on the north side of the gable is the ghost mark of a lower gable with a slope that mirrors the north slope. Centered below the peak of the ghost mark is covered doorway. These details indicate that the original rear wing was smaller and served as an additional entry point to the dwelling. South of the covered doorway is a six-over-six, wooden sash window. The siding around the window suggests that it has been altered as well. Below the window there is a small shed-roofed structure that projects from the elevation, and to its north is a small panel that accesses the crawl space below the dwelling. South of the window, and extending to the corner of the elevation, is a ribbon of six one-over-one, vinyl sash windows (Figures 47 and 48).

Figure 47: Giles Stephens Homeplace, Looking West.

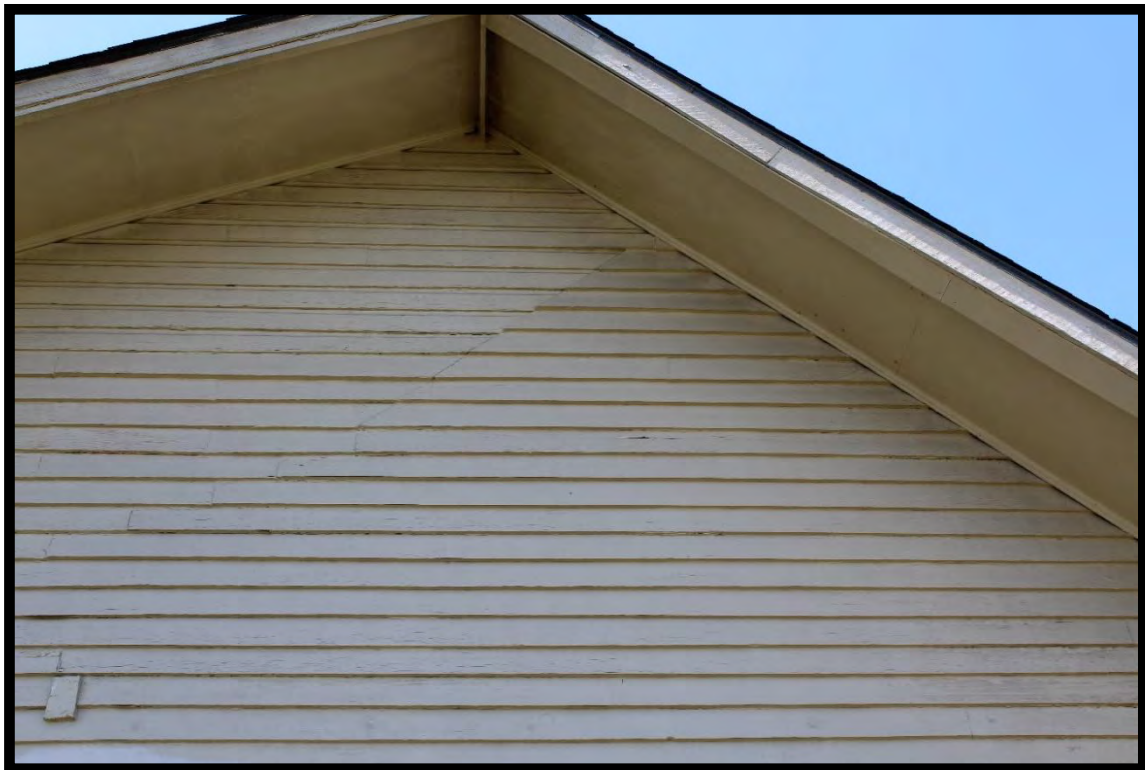
Figure 48: Giles Stephens Homeplace, Detail of East Elevation Showing Ghost Mark of Lower Gable. Note change in siding from plain weatherboard to German lap siding.

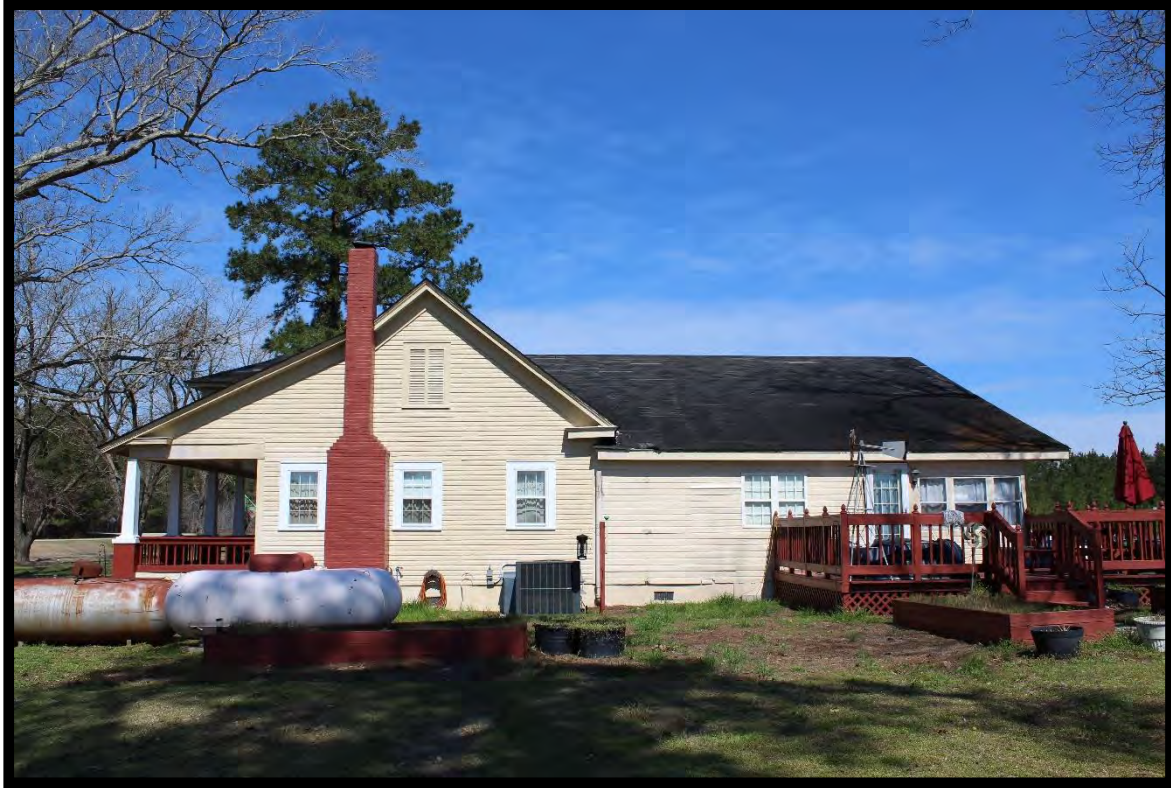
Figure 49: Giles Stephens Homeplace, Looking North.

The south (side) elevation includes the side of the rear wing and a gable end. The side of the rear wing contains a modern, multi-light entry door flanked on the east by a ribbon of three one-over-one, vinyl sash windows and on the west by a pair of six-over-six, vinyl sash windows. A modern deck approaches the entry door. It is roughly square and encompassed by a simple wooden balustrade. Siding east of the windows shows some inconsistency suggesting that an alteration was made in this area. The south gable end is similar to the north gable end except that it contains an exterior brick chimney between the first and second windows and the third window is not paired. The chimney exhibits stepped bricks at its base, likely to prevent it from leaning away from the dwelling. The elevation also has a shuttered window or vent centered below the gable peak and displays a similar configuration of cornice returns. One interesting difference between the two gables is that forward of the chimney the cornice is thinner, though it still exhibits the same flush board frieze (Figure 49).

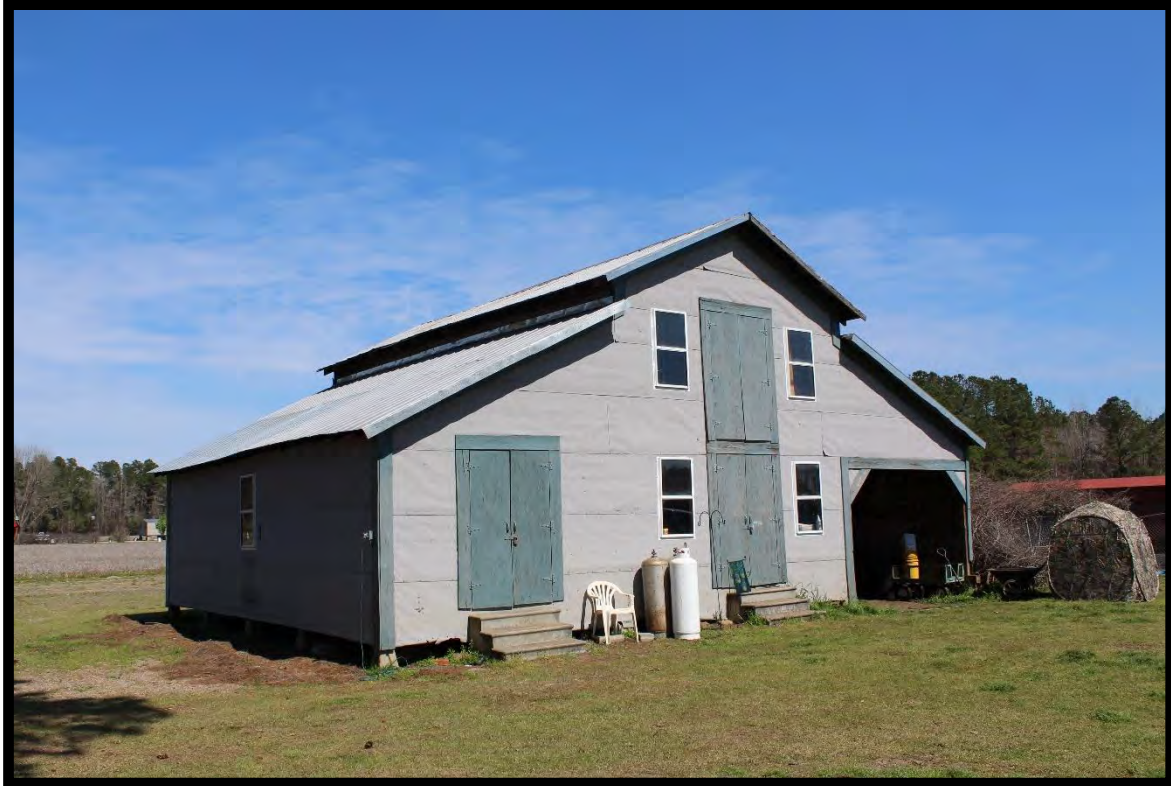
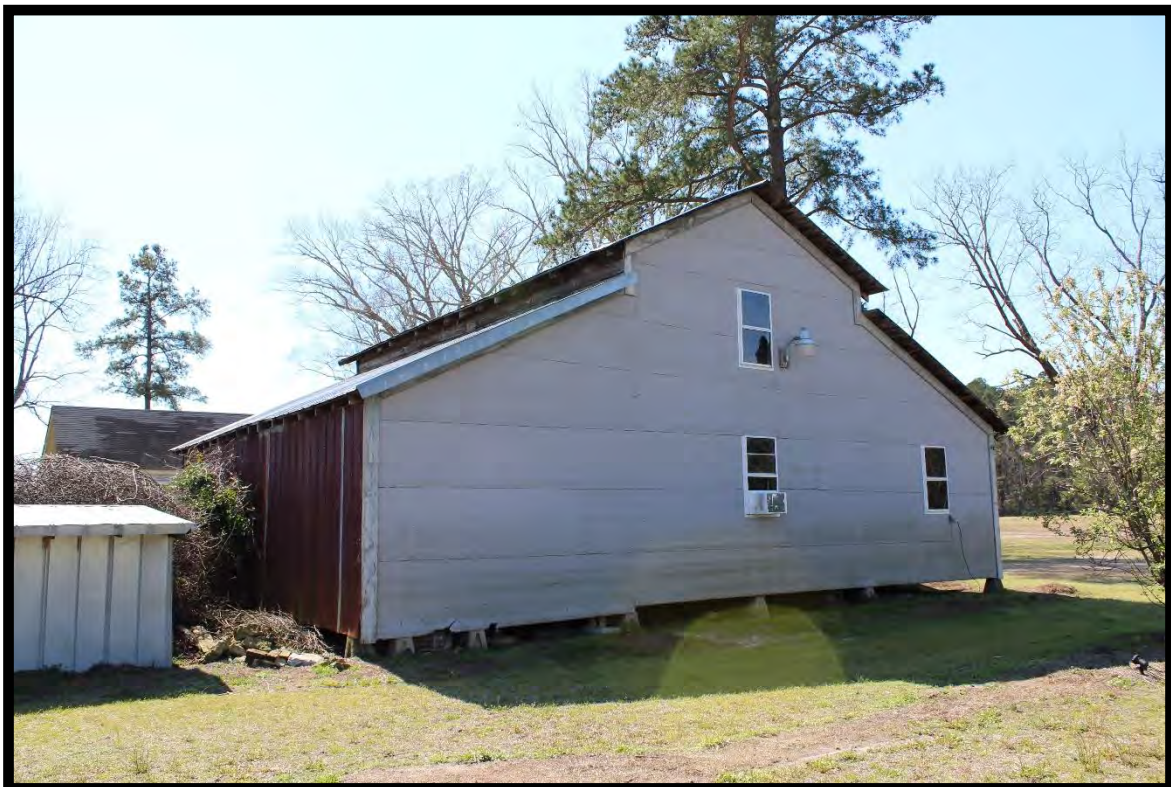
The domestic yard includes a number of small structures including a play house, a well, a possible bird feeder, and three raised garden beds (Figures 50 through 53). North of the yard is a large barn and dog pens. The barn faces south and has a tall center section with double-leaf, plywood entry and loft doors, both of which are flanked by one-over-one, vinyl sash windows. The center section is flanked by lower, shed-roofed wings. The west wing contains doors like the center section and has a one-over-one, vinyl sash window on its west (side) elevation while the east wing has a large opening with clipped corners and is blind on the east (side) elevation. Though the rest of the barn is sheathed with sheets of asphalt, the east elevation is clad with vertical metal sheets. The north (rear) elevation is lit by two centered one-over-one, vinyl sash windows (one above the other) on the center section and one one-over-one, vinyl sash window on the west wing. The barn rests on tapered concrete blocks (Figures 54 and 55).

Figure 54: Giles Stephens Homeplace, Barn, Looking Northeast.

Figure 55: Giles Stephens Homeplace, Barn, Looking Southwest.

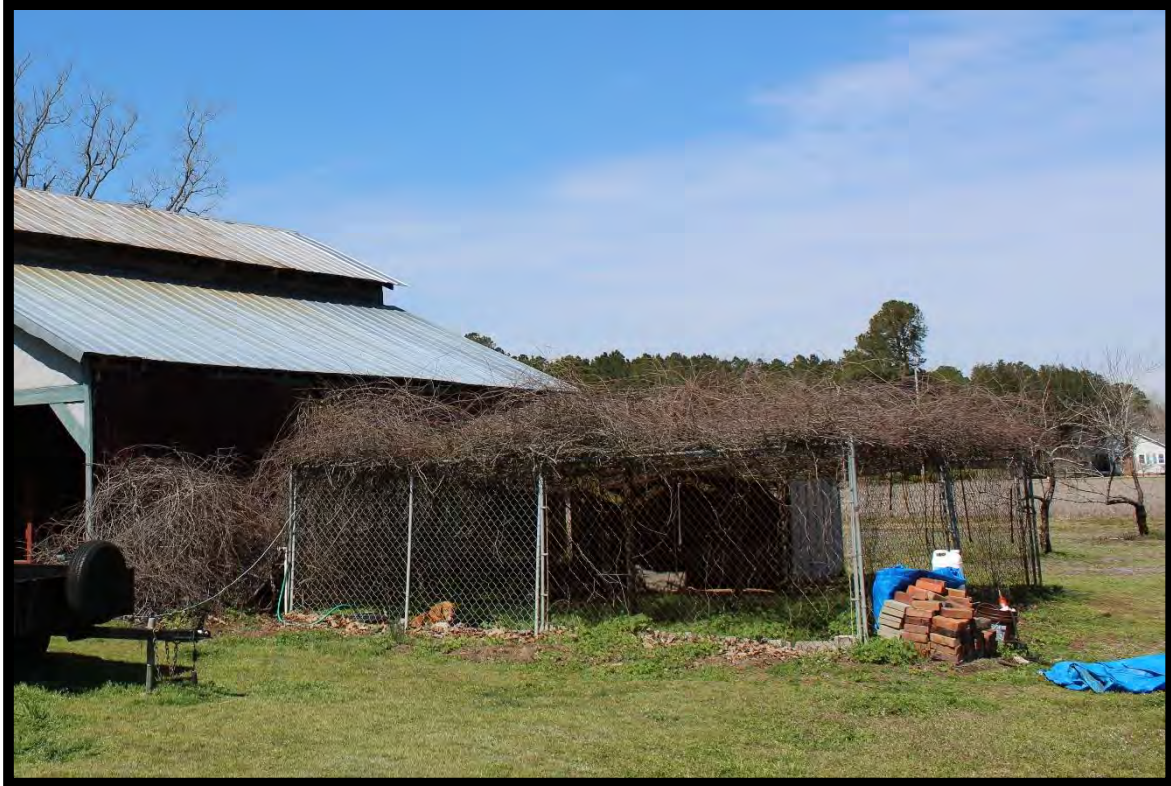
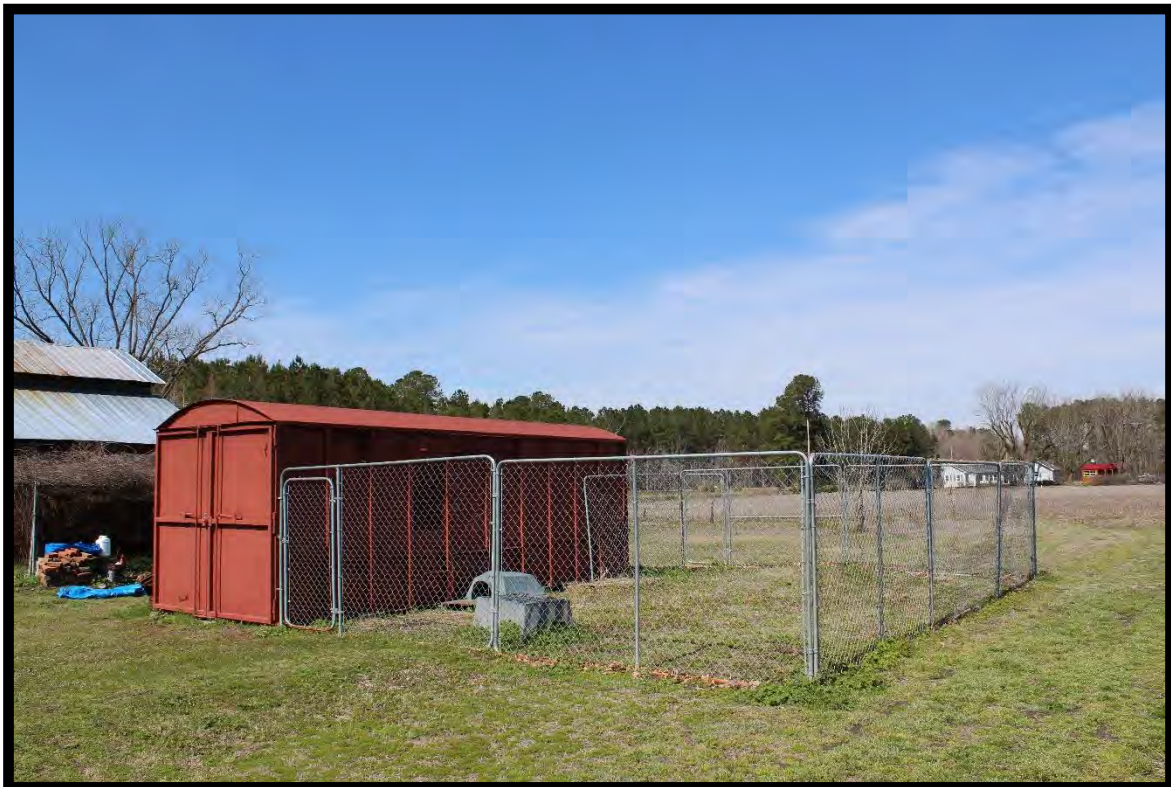
East of the barn are two dog pens. Both are surrounded by a chain link fence and the first is covered with a thatch like roof and has a three-sided, metal-clad structure on the north side. The second is adjacent to a long metal storage container (Figures 56 and 57).

Figure 56: Giles Stephens Homeplace, Dog Pen, Looking Northwest.

Figure 57: Giles Stephens Homeplace, Dog Pen, Looking Northwest.

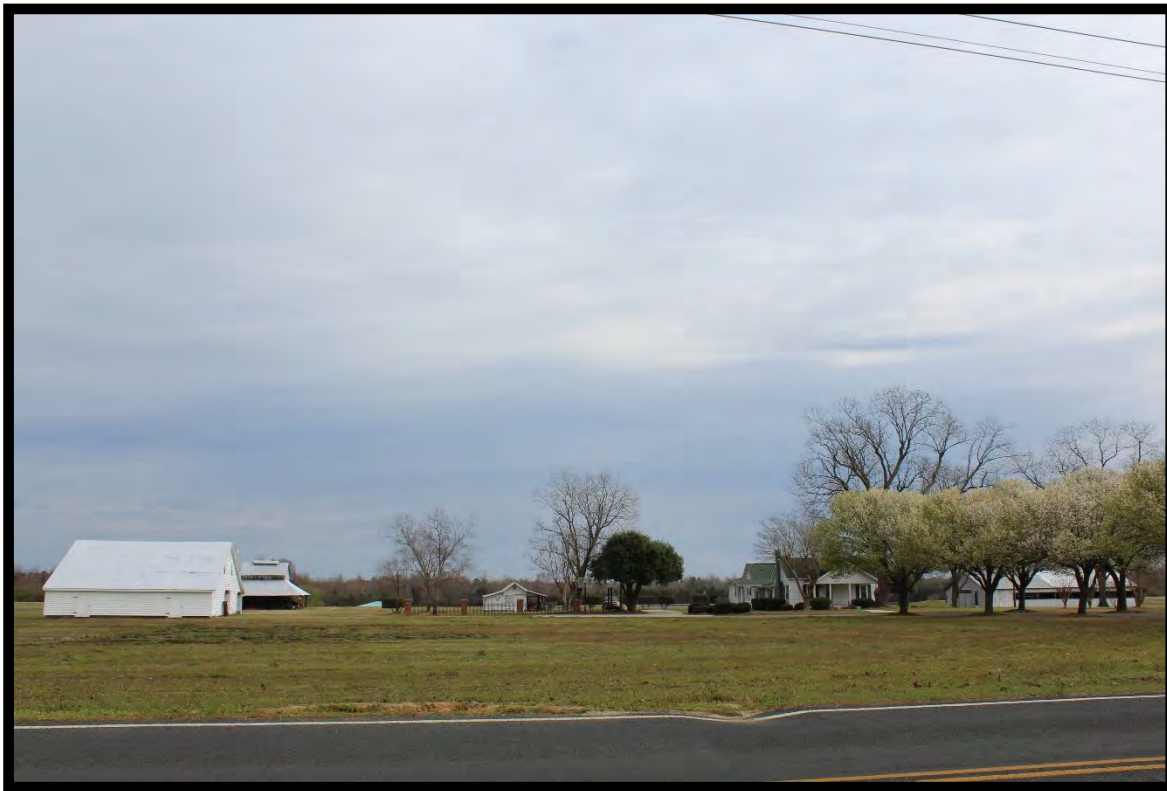
Figure 65: 1693 Popes Crossing Road, Lumberton, North Carolina, Looking Northeast.

Road (Figure 65). The farm consists of a ca. 1910 dwelling surrounded by three large agricultural buildings, a small barn or secondary dwelling, and over 100 acres of plowed fields.³⁶ Unlike the Giles Stephens Homeplace, the agricultural buildings are clad with wooden materials with one clad with metal sheets and all appearing to be well kept. The dwelling, though simply executed, also appears to be well preserved and to have been enlarged over time representing the evolution of the farmstead from humble beginnings to more prosperous times.
