SUBJECT: Historic Structures Survey Report, U-4709, Widen Rockfish Road from Golfview Road to  
Main Street, PA 18-02-0008, Cumberland County, ER 19-2233

# HISTORIC STRUCTURE SURVEY REPORT

## **WIDENING OF ROCKFISH ROAD** (SR 1112) from Golfview Road (SR 1115) to Main Street (NC 59), Cumberland County, North Carolina

**TIP No. U-4709**

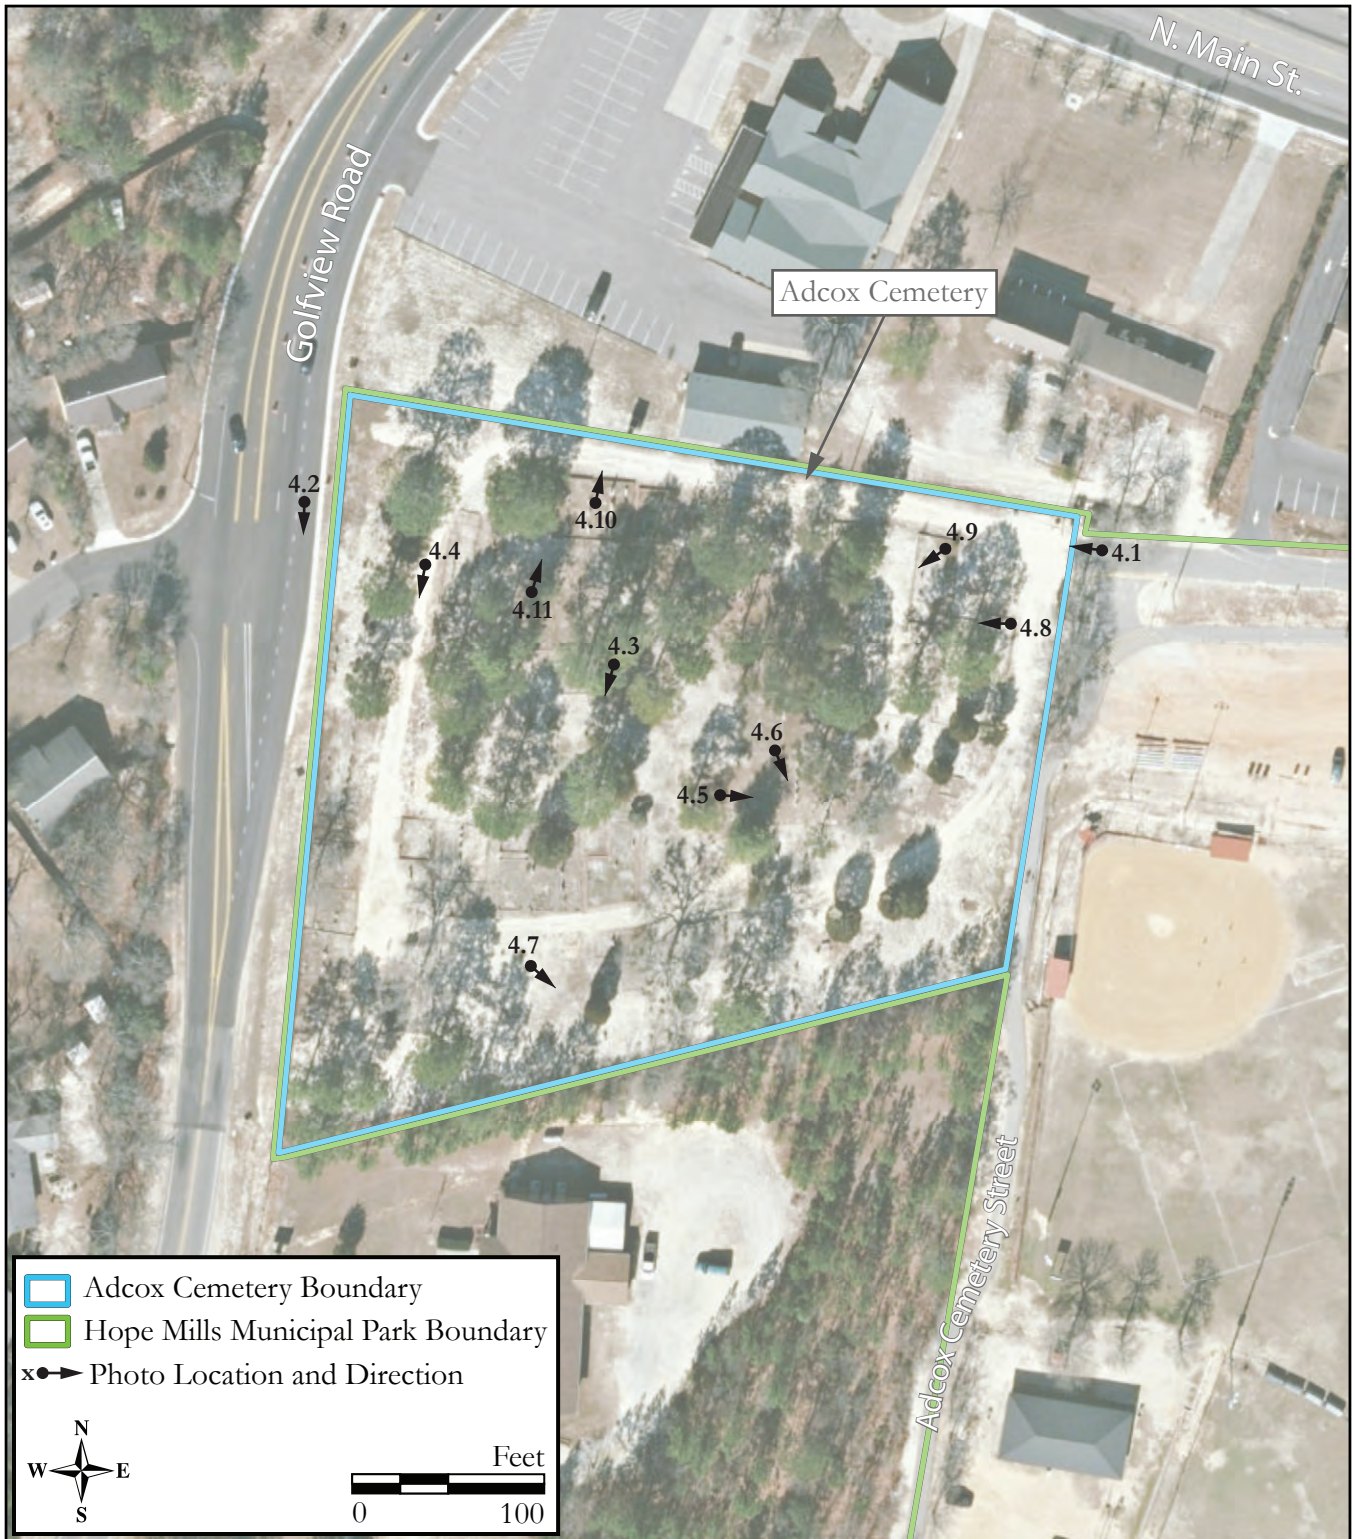
Figure 4.1: Aerial photograph showing the boundary of the Adcox Cemetery (CD 1487) and photograph locations and directions (World Imagery, ESRI 2018).

The Adcox Cemetery<sup>1</sup> is on the east side of Golfview Road (SR 1115) south of its intersection with North Main Street (NC 59) in Hope Mills, Rockfish Township, Cumberland County, North Carolina (Figure 4.1) (Plates 4.1-4.2) (Table 4.1). The cemetery is approximately 0.75 miles northwest of Hope Mills’ historic crossroads intersection, that of Main Street and Trade Street. The cemetery is approximately 2.5 acres in size and is in the northwest part of the 28.87-acre town-owned Hope Mills Municipal Park. The cemetery is accessed through a set of brick piers on Adcox Cemetery Street off the west side of Bullard Street. The town maintains a black chain link fence around the cemetery’s perimeter.

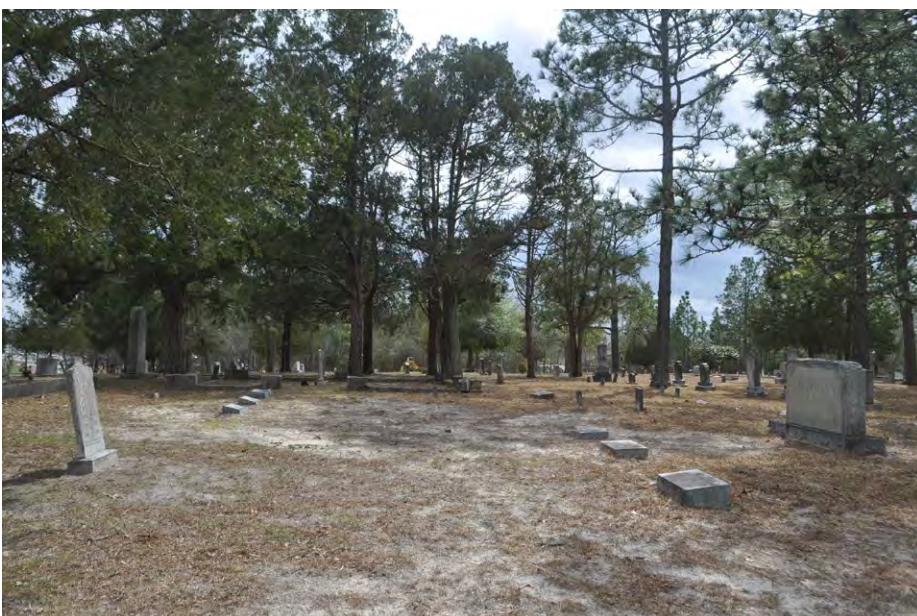
Plate 4.3: General view of Adcox Cemetery.

The Adcox Cemetery is characterized by its cleared landscape and sandy soil, that when left in its natural state, grows little groundcover other than mosses (see Plates 4.3 and 4.4). Mature trees are

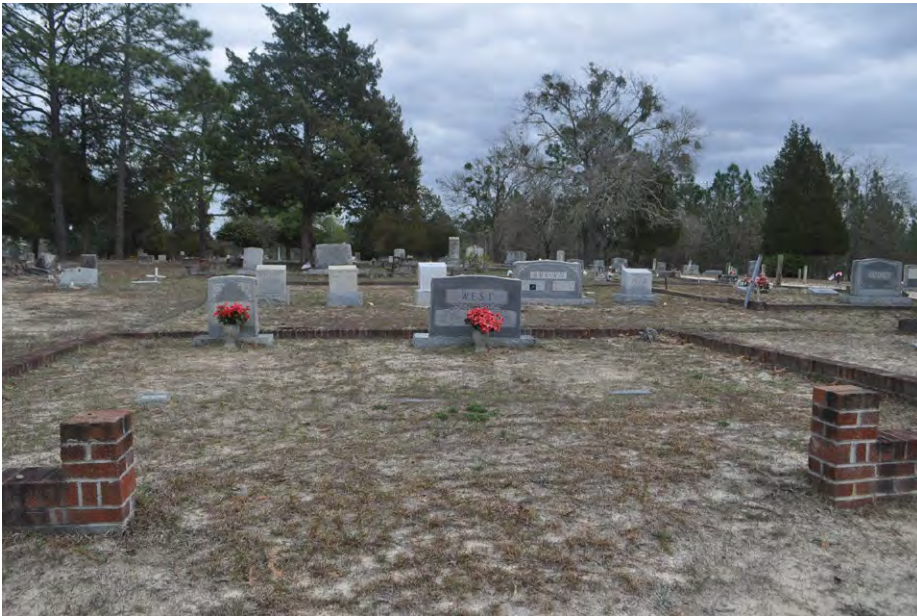
Plate 4.5: View of a brick plot enclosure.

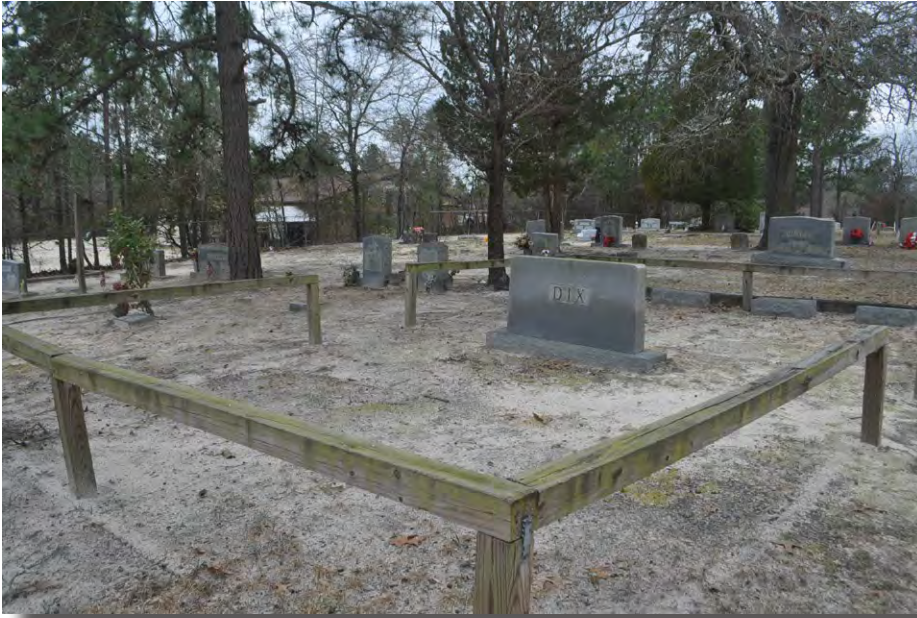
Plate 4.7: View of a modern wood plot enclosure.

present but not in sufficient numbers to create a shady canopy. Tree varieties include loblolly pines, hollies and cedars. Plots are demarcated by enclosures of brick, poured concrete, and concrete block walls; or various types of fencing such as wood, chain-link, post-and-chain, or rolled wire (see plates 4.5-4.8). The individual grave markers come in many sizes and shapes. Most common are flat and arched tablets; however, larger monument-type markers are present as well (See Plate 4.9). Commercially made grave markers of granite and marble were observed during the pedestrian survey. There are a few examples of metal funeral home markers (see Plate 4.10). Handcrafted grave markers are also present such as the brick and concrete ones of the Lamb family plot and other scattered ones fashioned from concrete (see Plate 4.11).

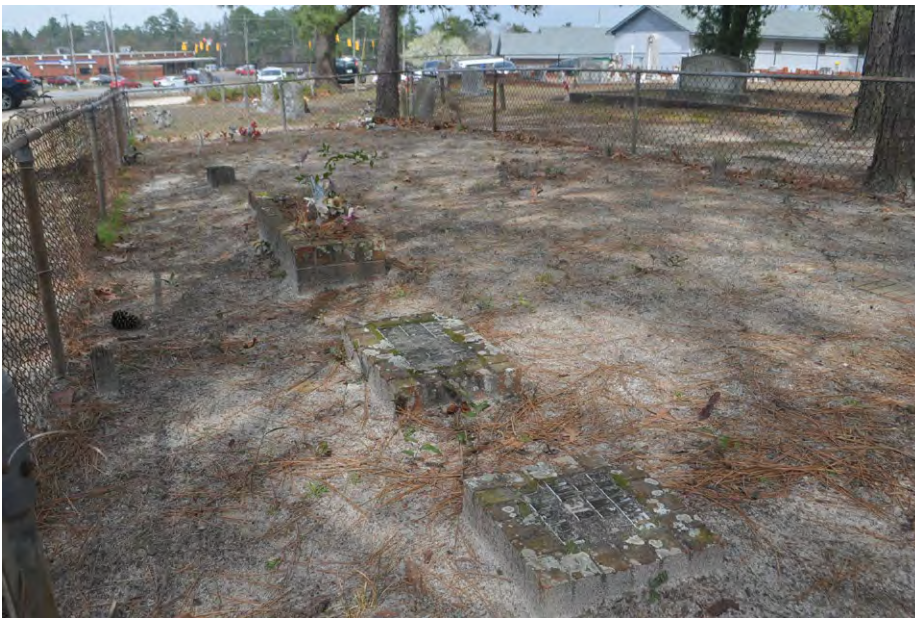
Plate 4.11: View of the Lamb Family Plot.

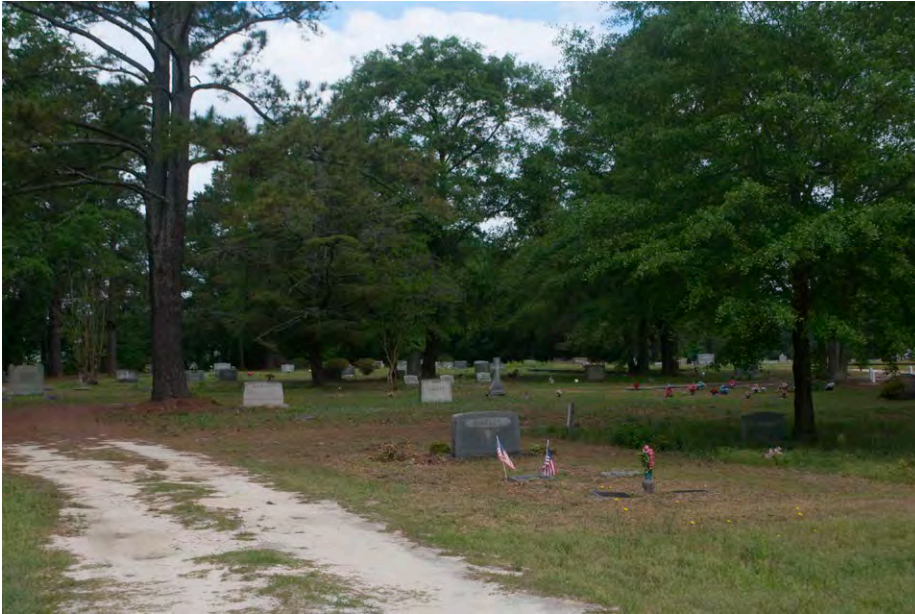
Plate 4.12: View of an unnamed cemetery on North Main Street in Hope Mills.

The Adcox Cemetery is one of three large cemeteries of similar size and appearance in Hope Mills that were inspected as part of this report (Plates 4.12 and 4.13; see Figure 3.6). The unnamed cemetery on the west side of South Main Street at the Church Street intersection is privately owned. It is somewhat overgrown with vegetation, but the sandy driveway that accesses each of its four quadrants is evident. Rectangular family plots are arranged within each quadrant. The Hope Mills Cemetery on Legion Road is owned and maintained by the town. Circulation is provided by a loop road, and graves are arranged in north-south rows. A monument on site states that the Hope Mills Cemetery was established prior to 1800.

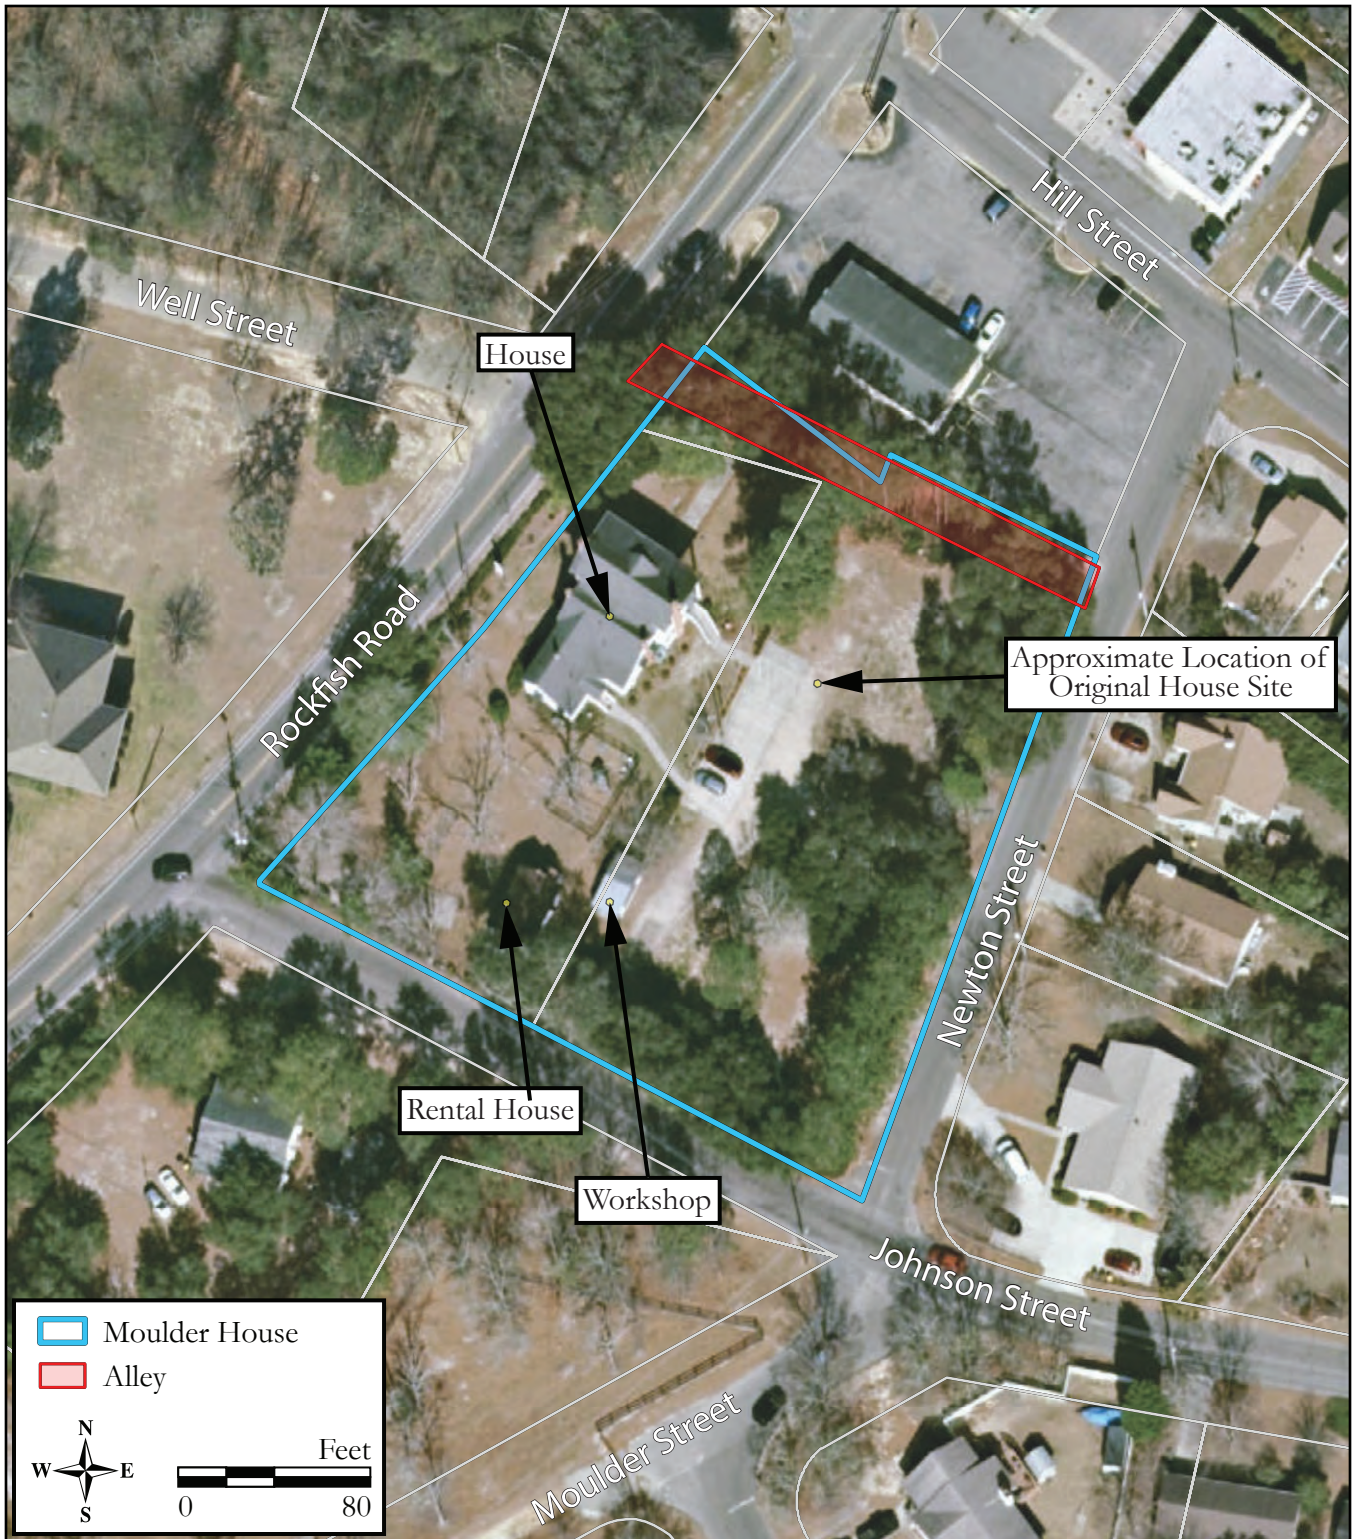
Figure 5.1: Aerial photograph showing the site plan of the Moulder House (CD 1488) and photograph locations and directions (World Imagery, ESRI 2018).

The Moulder House is on the east side of Rockfish Road (SR 1112) in Hope Mills, Rockfish Township, Cumberland County, North Carolina (Figure 5.1; Plates 5.1-5.2) (Table 5.1). The house is 0.34 miles northwest of Hope Mills' historical crossroads intersection, that of Main Street (NC 59) and Trade Street. The Moulder House faces northeast and is positioned in the north half of a 0.56-acre parcel (0414-45-3441) which also contains a secondary dwelling. This parcel is adjacent to a 0.93-acre parcel (0414-45-4358) that contains a workshop, an abandoned road bed, and the original house site. Both parcels are under the ownership of one individual and since the parcels are historically associated, they are considered together for the purposes of this NRHP evaluation. The alley that runs between Rockfish Road and Newton Street serves as the north boundary of the Moulder House tract. Johnson Street, Newton Street and Rockfish Road form the south, east, and west tract boundaries, respectively. The house is on a relatively level lot, at the plateau of a downward slope towards the impounded Hope Mills Lake.

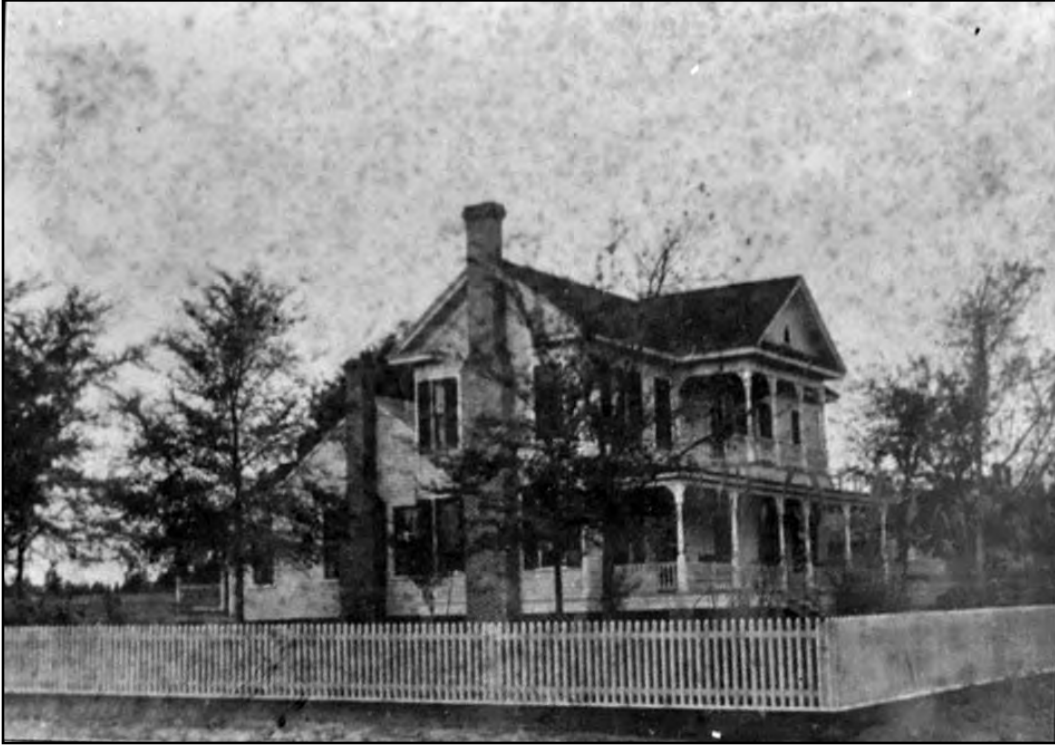
Figure 5.2: Circa 1908 photograph of the Moulder House on its original site (personal collection of Jackie Warner).

The house's current form and appearance has evolved over time with significant changes taking place around 1935 and 1955 (Plates 5.3-5.16). The main block was built as a two-story, one-room-deep, side-gable house with a decorative front gable and a Queen Anne-style porch that featured a double-height central pavilion (see Figures 5.3-5.5). A side-gable wing with a rear shed room was positioned across the rear (south) elevation. Documentary photographs (see Figures 5.3 and 5.4) show the wing with flush eaves, suggesting it could be an earlier dwelling although conclusive physical evidence to support this theory was not found. Around 1935, a gabled, one-story apartment addition was built perpendicular to the earlier one-story wing. All three sections of the house were relocated approximately 100 feet to the northwest of its initial site around 1955 (see Figures 3.5 and 5.1). The northeast-facing orientation of the house was retained. The original porch was removed and replaced with the monumental Mount-Vernon-style porch with square posts that spans the façade today.

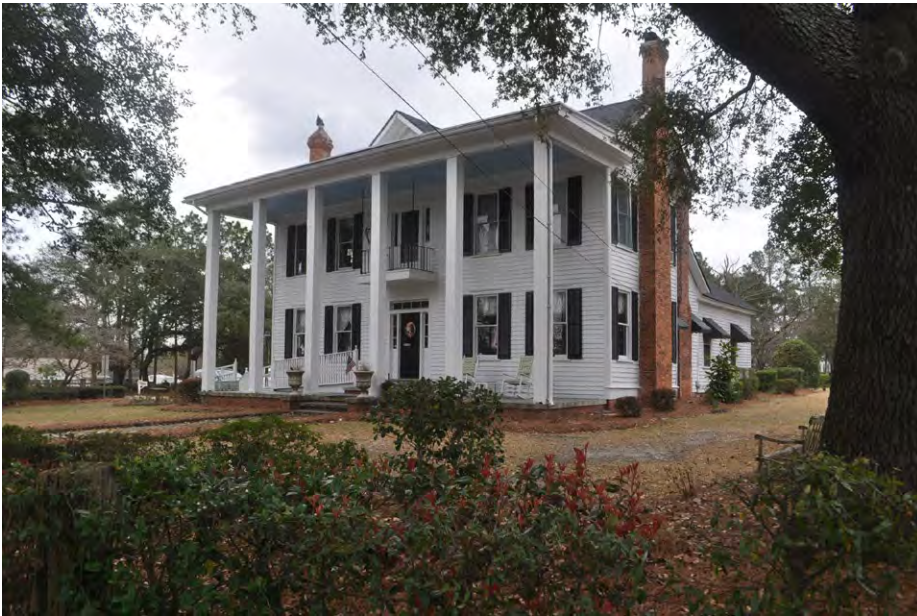
Today, the house presents as a two story I-house with two one-story rear wings. The façade is dominated by a Mount Vernon-style front porch (see Plates 5.3 -5.10). A porch on the southeast side of the apartment wing was enclosed when the house was moved (see Plate 5.6-5.8). The exterior walls of the house are sheathed with original plain weatherboards, except for the apartment wing porch enclosure and the southwest wall of the middle wing, which are covered with German siding. A new continuous brick foundation was built for the house when it was moved. Pre-1955 documentary photographs show all three sections of the house resting on brick piers, which would have been a common foundation treatment when the house was first built. The original roof material could not be discerned from the documentary photographs. Today, all the roof surfaces are covered with composite shingles. The house has four original, exterior common bond brick chimneys with stepped shoulders and corbelled caps, one at each end of the main block and the middle wing. The bricks of the chimney bases match those used in the circa 1955 foundation (see Plate 5.10).

Plate 5.3: View of the façade (northeast side) and northwest side of the Moulder House.

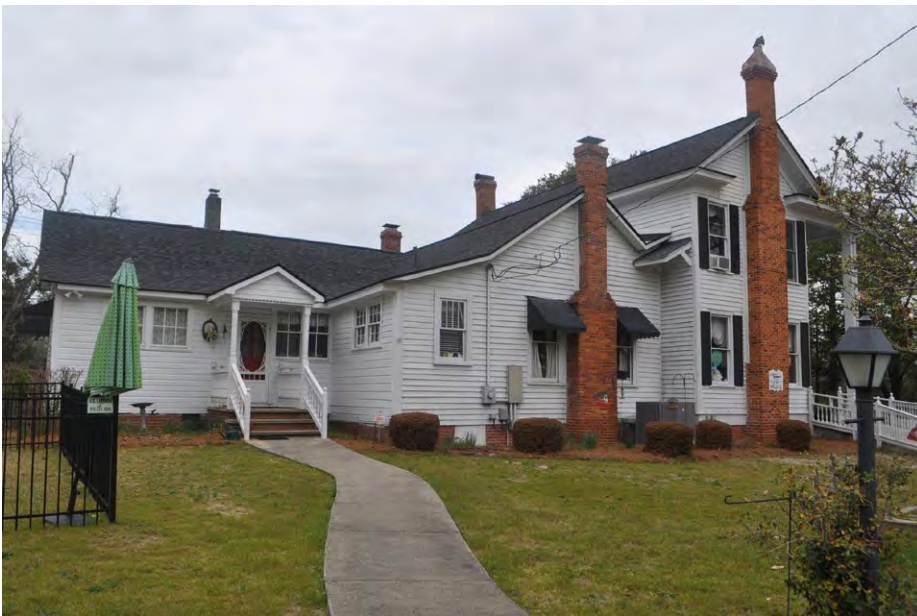
Plate 5.7: View of the southeast side of the Moulder House.

The southeast elevation of the middle section has two 1/1 windows (see Plate 5.7 and 5.9). Above them are black corrugated metal awnings. The chimney runs from its base to the gable between the widows. The projecting eaves are unfinished. Documentary photographs suggest they were flush. The

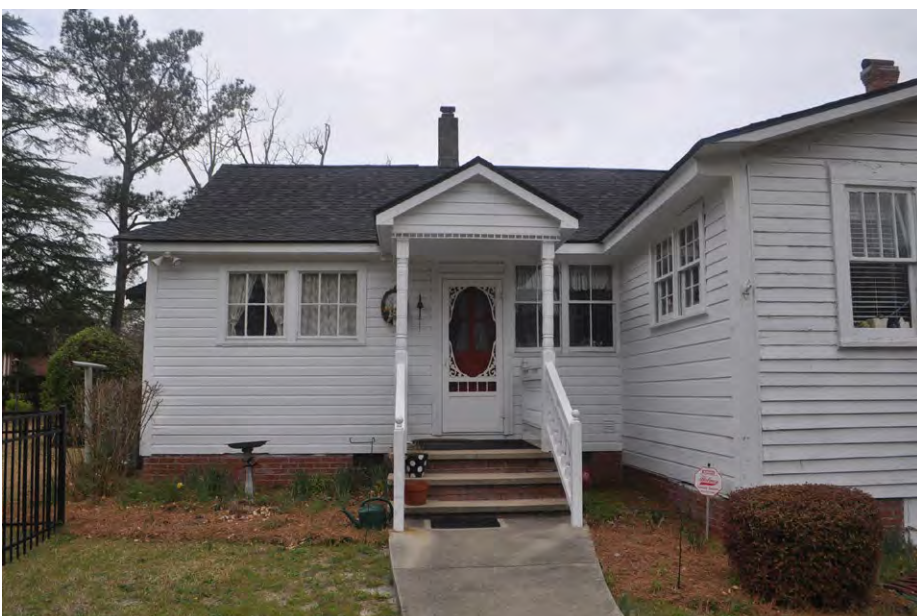
Plate 5.8: View of the southeast side of the apartment addition on the Moulder House.

rear shed section has a Craftsman 4/1 window on the southeast side and a pair of small 6/6 windows on the southwest side. The apartment wing has a one-bay, gabled stoop porch flanked by a set of 2/2 windows and a pair of fixed 6-light sashes (see Plate 5.8). Turned posts support the porch roof. The turned balusters that make up the balustrade are recycled from the original Queen Anne-style front porch (see Plate 5.16) (Jackie Warner Personal Communication March 25, 2019 and April 29, 2019). The rear elevation has one centered 6/6 window in the gable end and one fixed, 6-light sash in the enclosed porch (see Plate 5.6). The northwest elevation mirrors that of the previously described southeast side, with the exception of the apartment section, which has two 6/6 windows with black corrugated metal awnings (see Plate 5.5). There are simple corner boards at the corner of both rear sections and the apartment section has a plain frieze board under the eave.

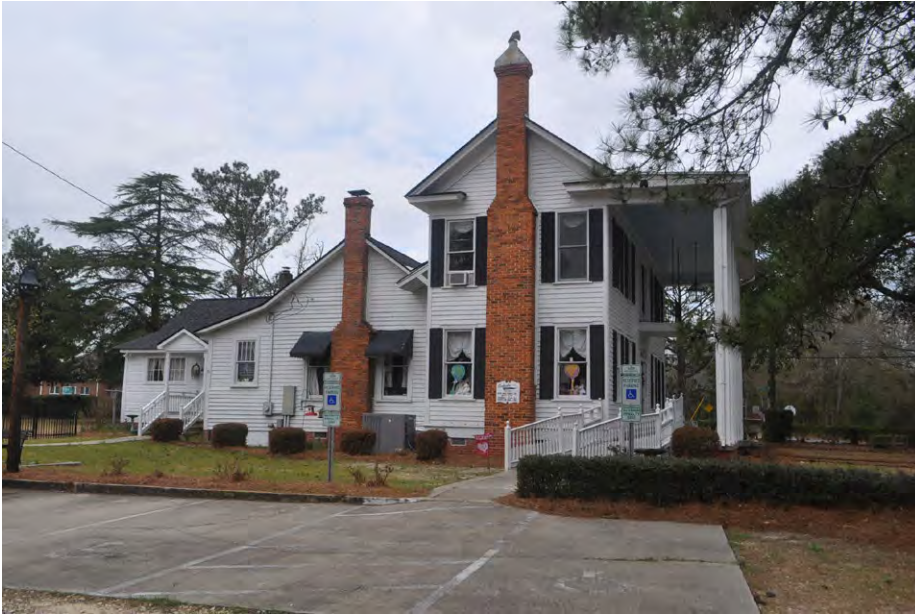
Plate 5.9: View of the southeast side of the Moulder House.

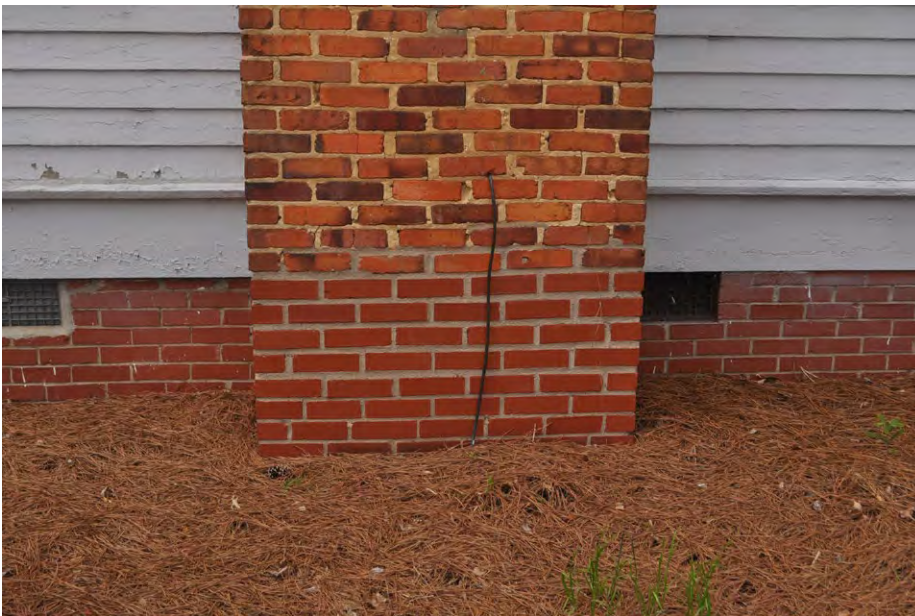
Plate 5.10: View of the base of the chimney on the main block, southeast side of the Moulder House.

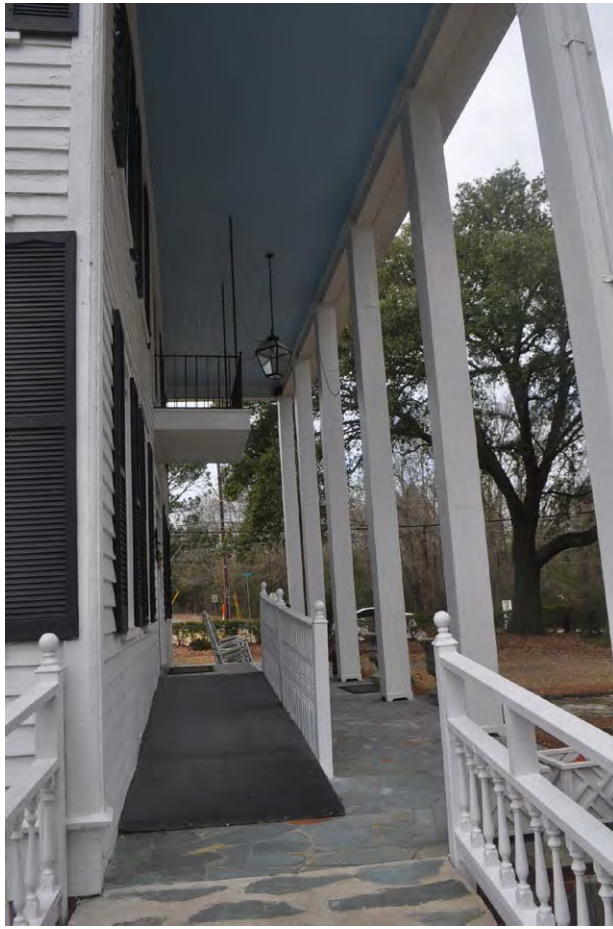
The façade faces northeast and is dominated by a double-height Mount Vernon-style front porch supported by six monumental square columns (see Plate 5.11). The porch is accessed by a ramp on the southeast side. The current owner incorporated the original porch balusters into a section of the ramp (Jackie Warner Personal Communication March 25, 2019 and April 29, 2019). The porch's shed roof partially obscures the second-story front gable of the original porch. The porch floor is slate and the ceiling is sheathed with beadboard. The symmetrical five-bay façade consists of two bays of windows flanking a central entry bay (see Plate 5.12). The circa 1900 entry door is configured with a window above five recessed panels. On each side of the door three sidelights sit atop a raised panel. Above

Plate 5.11: View under the front porch of the Moulder House.

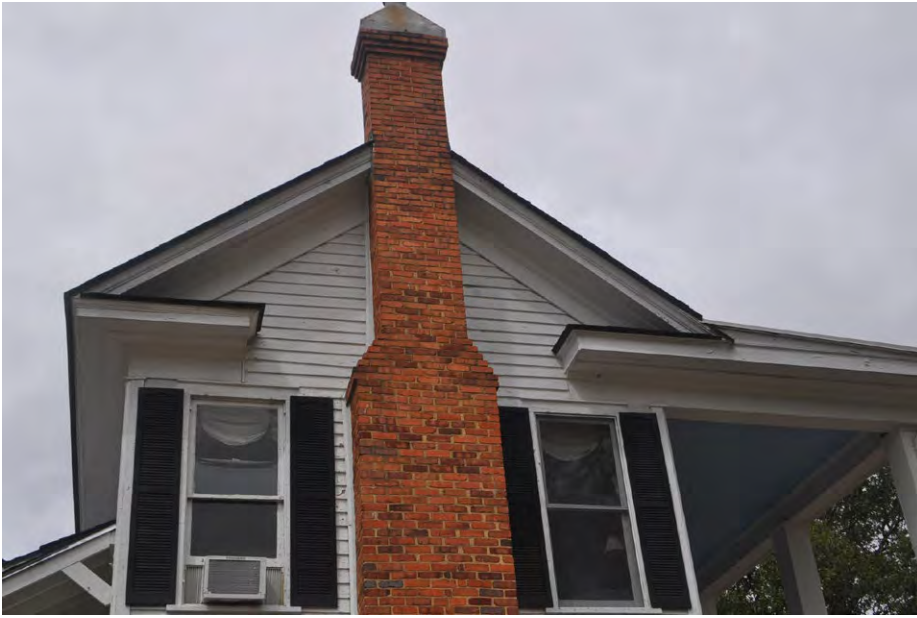
Plate 5.13: View of the gable end return of the southeast main block of the Moulder House.

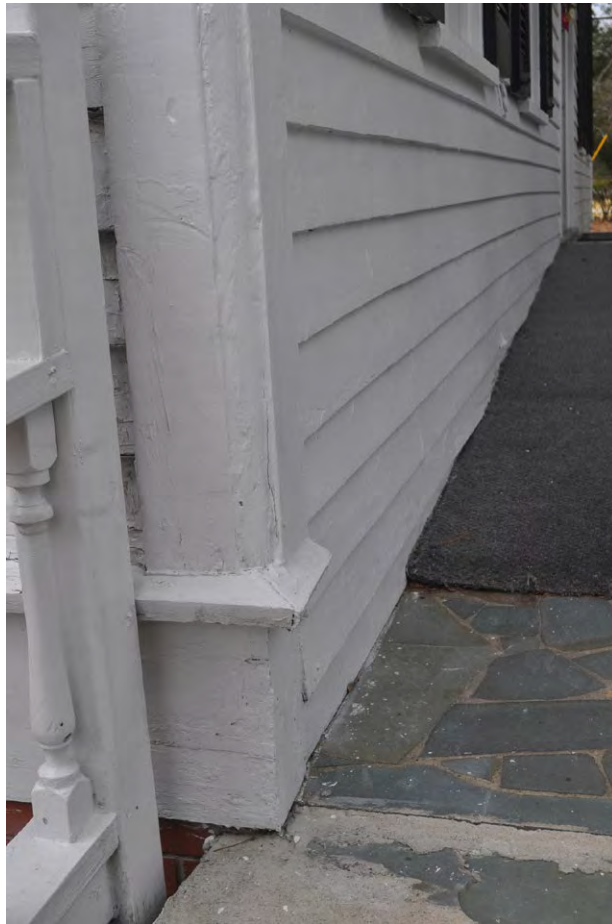
Plate 5.14: View of the corner board and skirt board of the southeast corner of the main block of the Moulder House.

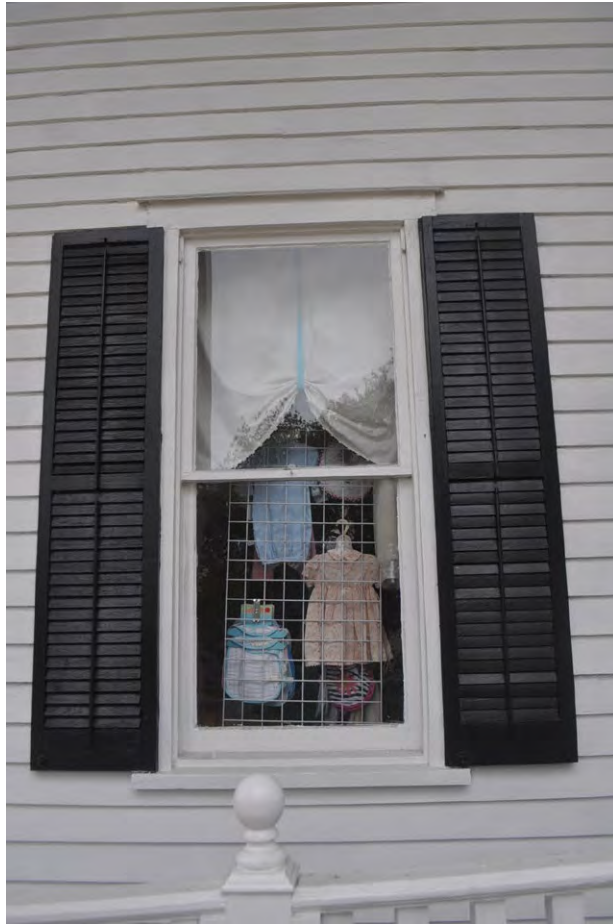
Plate 5.15: View of the first floor window, on the northeast side of the main block of the Moulder House.

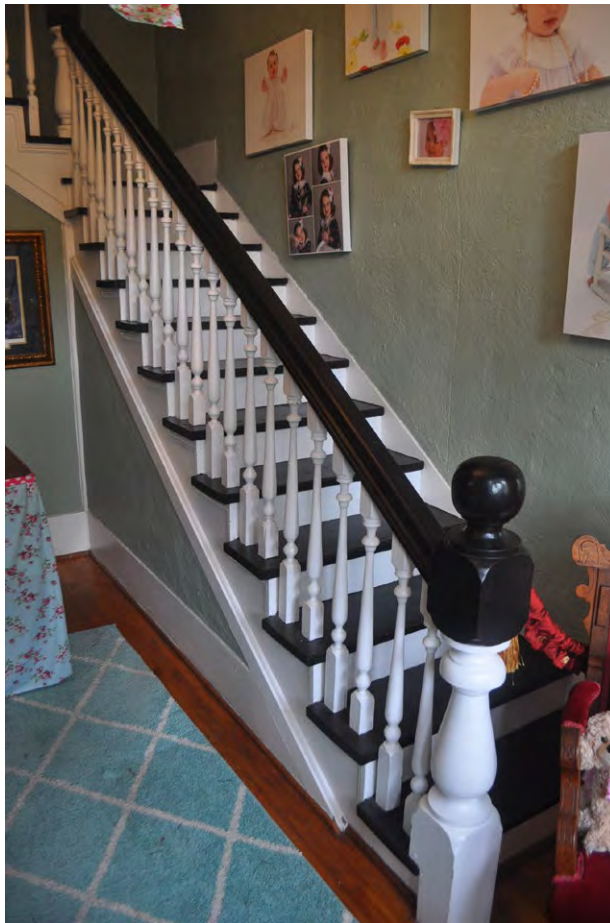
Plate 5.17: View of the center hall stair.

In general, the interior retains a notable degree of circa 1900 materials and vernacular Queen Anne finishes (Plates 5.17-5.24). The rear rooms of the first floor are less materially intact than the front rooms and those of the second story. Circa 1900 finishes include rough plaster walls, beadboard ceilings and pine floors. The main decorative focal point of the interior is the intact stair which has a turned newel and balusters (see Plates 5.17-5.19). Each of the six main rooms has a mantel. The first-

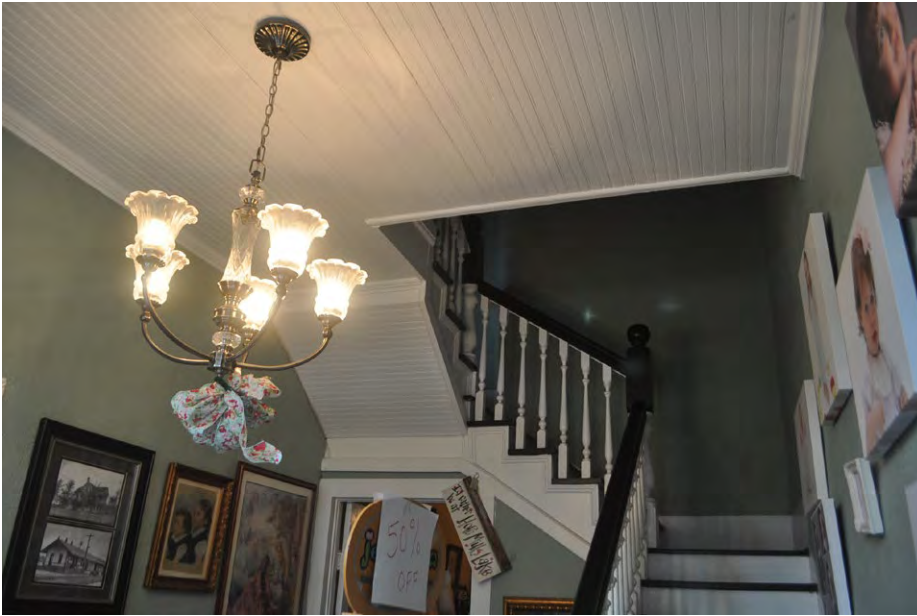
Plate 5.18: View of the center hall with stair and beadboard ceiling.

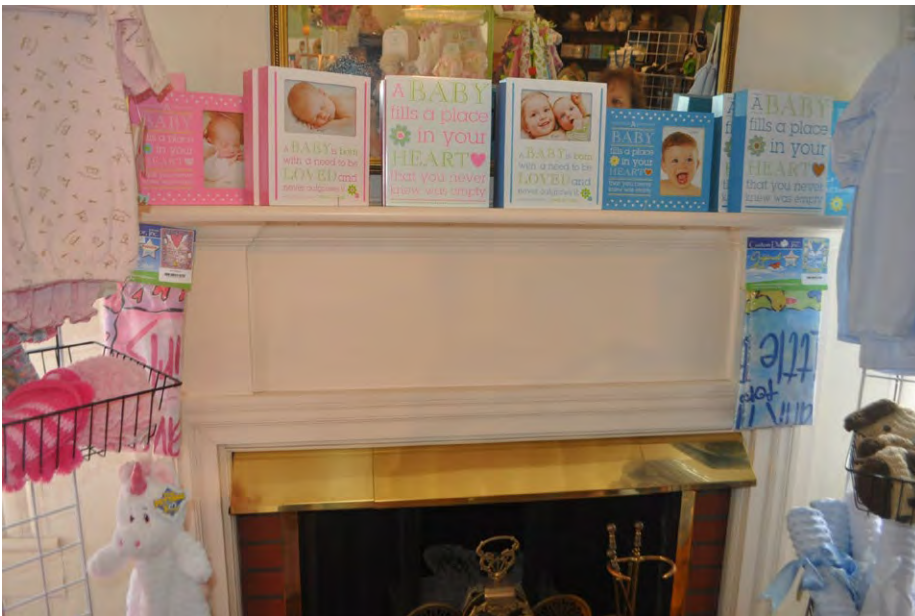
floor mantels display Craftsman and Colonial Revival influences and are likely not original (see Plate 5.21). The upstairs post-and-lintel mantels have bullseye corner blocks and are more in keeping with vernacular Queen Anne style of the original house (see Plate 5.22). Doors are a combination for four-panel nineteenth-century doors and twentieth-century doors with five horizontal panels. The door and window trim features diagonally incised corner blocks, except for the southeast middle room on the first floor which was remodeled with pine sheathing around 1955 (see Plate 5.23-5.24).

Plate 5.21: View of the southeast front room, first floor, and the Colonial Revival mantel.

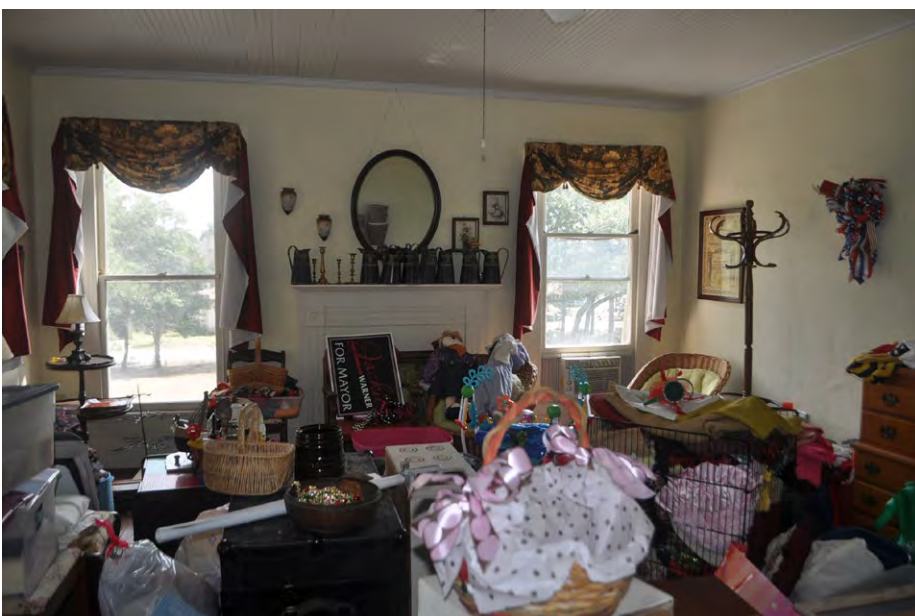
Plate 5.22: View of the southeast room, second floor, and the vernacular mantel.

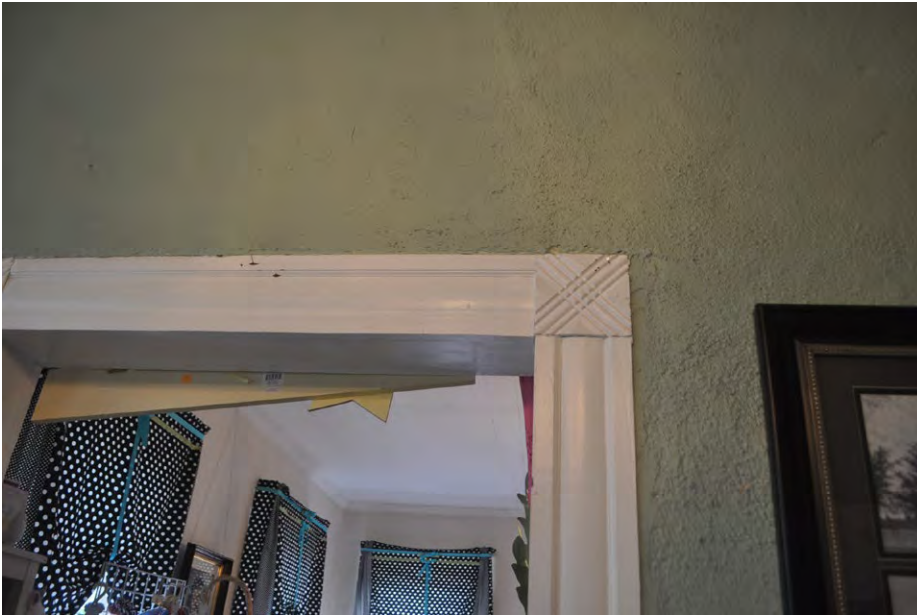
Plate 5.23: View of the southeast front room, first floor, and the door trim.

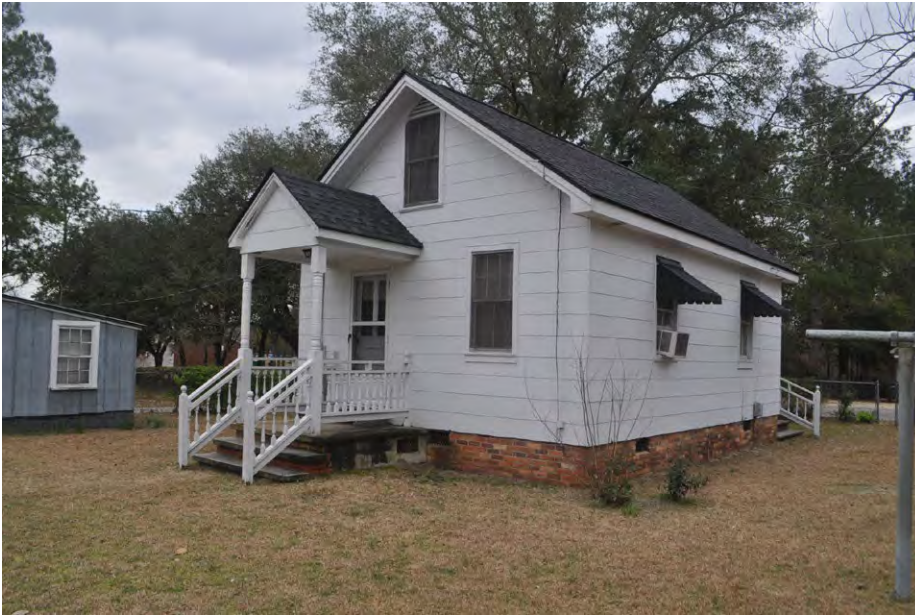
This dwelling was built by Carlton Moulder around 1955 as a rental unit (Plates 5.25-5.26). It is located approximately 70 feet from the back of the Moulder House. The small, gable-front dwelling is one-and-half-stories in height. There are one-bay, gabled entry porches on both the northeast and southwest elevations. The turned posts and balusters of the porches are recycled from the original Queen Anne-style porch of the main house. The windows are 6/2, with one next to the porch on each gabled end and another in each gable. There are two windows surmounted with black corrugated metal awnings on each side of the house. Asbestos shingles cover the exterior walls. The roof is composite shingle. The house rests on a continuous brick foundation.

Plate 5.25: View of the secondary dwelling on the subject parcel.

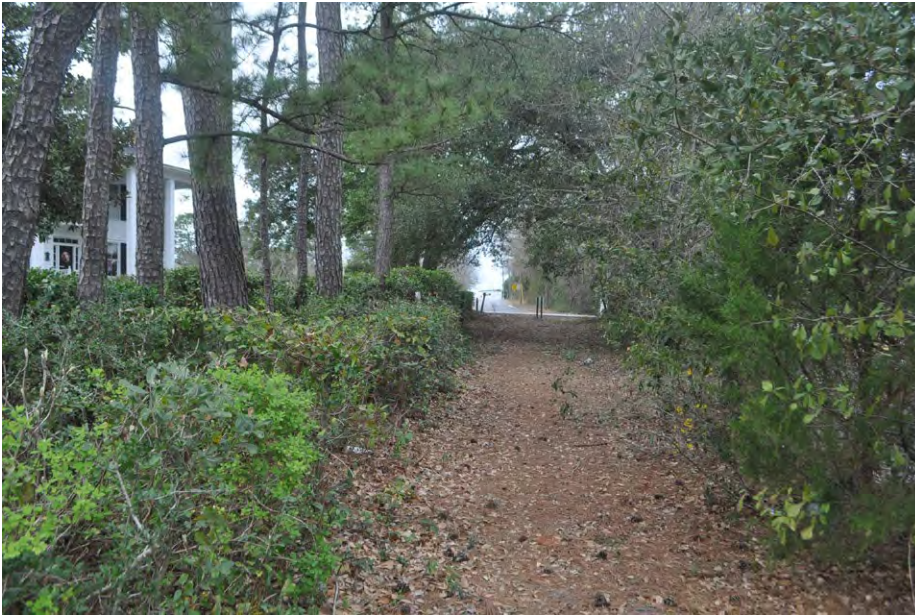
An intact sandy, unpaved roadbed is north of the main house (Plate 5.28). The roadbed, or “alley” as it was described in a 1954 deed (CCDB 658, p. 182), runs northwest to southeast between Rockfish Road and Newton Street. Mature pine trees, oaks, azaleas and other types of landscape plantings line either side of the alley.

Plate 5.28: View of the alley on the subject parcel.

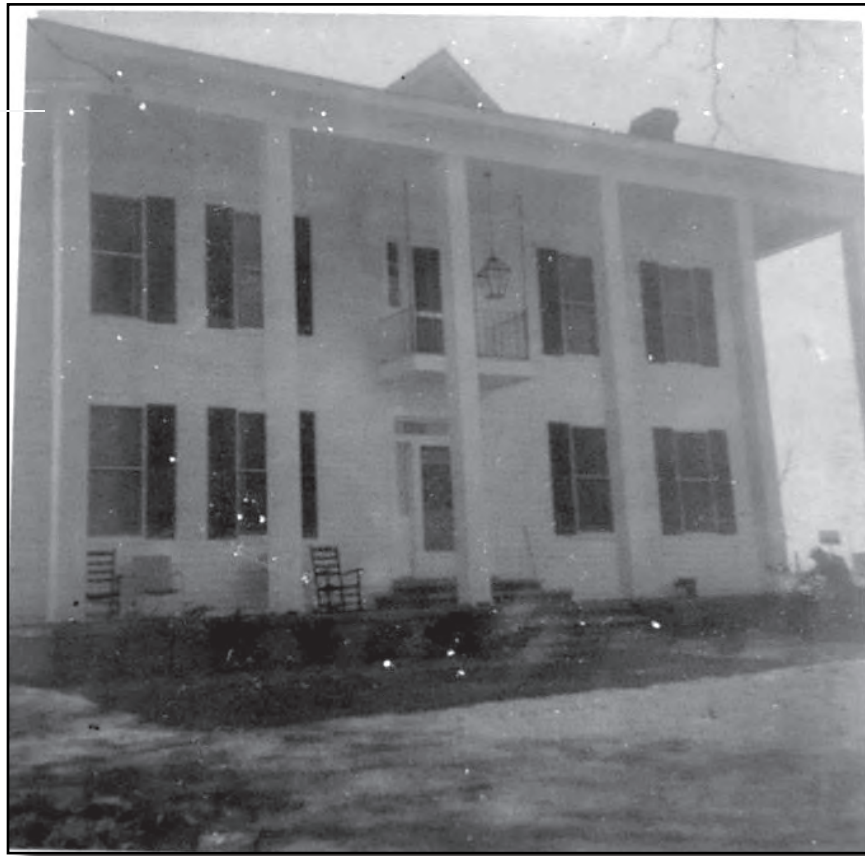
Figure 5.6: 1957 photograph of the Moulder House on its new site (personal collection of Jackie Warner).

In the 1950s, the ACL planned a major track realignment to eliminate the extreme curve present in the rail line south of Hope Mills (Figure 5.6). A more efficient double track was proposed on a new alignment. This proposal had the potential for significant impacts to the Moulder's home, as the new path was planned to traverse the southeast side yard of the property. The ACL and the State Highway Department worked in tandem to acquire the needed right-of-way, and in 1954 Carlton was forced to sell several parcels of land around the Moulder House to the ACL to accommodate the project. He retained the parcel on which the house presently sits (Parcel ID 0401-45-4331). The ACL acquired the adjacent parcel to the southeast (Parcel ID 0401-45-4358). Shortly thereafter Moulder relocated the house approximately 100 feet northwest in order to preserve it (see Figure 3.5 for original location). Moulder removed the original Queen Anne-style porch and replaced it with the current Mount Vernon-style porch. Perhaps he took the opportunity to rebuild in a more "modern" style as Mount Vernon porches were an established phenomenon in Cumberland County since the 1930s and the look persisted through the early 1970s. It is also possible that the shed-roofed and plain square columns of the Mount Vernon porch was a simpler and more cost-effective way to replace the more elaborate bi-level Queen Anne-style porch with its ornate woodwork. What is known is that all three sections of the house and the chimney were moved and a new porch was built around 1955 (Figure 5.7).

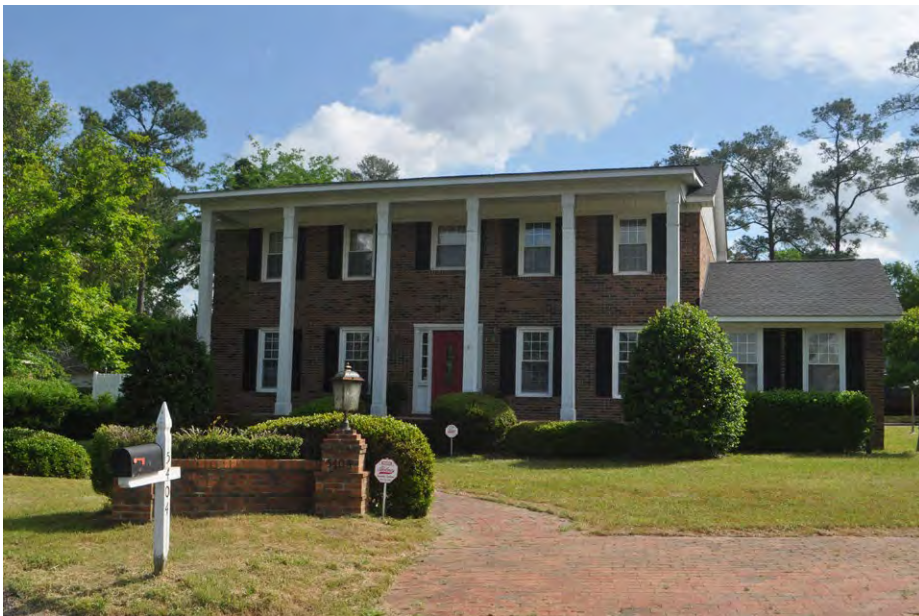
Plate 5.32: View of number 5904 Lakeview Road, Clifton Forge Subdivision in Hope Mills.

The Colonial Revival style of the early twentieth century was a re-imagination and modernization of the Georgian, Dutch and English architecture of the American colonial period. George Washington's Virginia home, Mount Vernon, became a cultural touchstone as the country celebrated the man and his role in the nation's history. Full-scale replicas of Mount Vernon were built at the World's Columbian Exposition in Chicago in 1893, the Panama-Pacific International Exposition in San Francisco in 1915, and the Sesquicentennial Exposition in Philadelphia in 1926. As a result, Mount Vernon's dramatic full-façade double-height portico was popularized and reinterpreted for the twentieth century. The bicentennial celebration of Washington's birth in 1932 cemented the porch's popularity for both commercial and residential architecture. In the early 1930s, Sears Roebuck and Company marketed kit houses based on the Mount Vernon style (Brandt 2019). In the South in particular, the style came to symbolize the social order of an idealized antebellum era. In Fayetteville, older houses were retrofitted with distinctive double-height "Mount Vernon-style" porches, and new houses such as the circa 1936 example at 218 Bradford Avenue were built with full porticoes (Jasperse 1983:7.3-7.5; Michael 2007:7.2) (Plate 5.31). In the 1950s and 1960s, Fayetteville's Vanstory Hills subdivision was developed and the Mount Vernon-style porch remained a popular design choice for new homes there. In Hope Mills, examples of Mount Vernon-influenced porches appear on homes built in the 1970s Clifton Forge subdivision and on individual homes around town (Plate 5.32).
