SUBJECT: Historic Structures Survey Report, R-5772, Upgrade SR 1001 from US 421 to NC 268,
PA 19-02-0016, Wilkes County, ER 19-2317

Historic Structures Survey Report
TIP No. R-5772, WBS No. 44692.1.1, PA No. 19-02-0016
Upgrade SR 1001 (Oakwoods Road)
from US 421 to NC 268 (East Main Street)
Wilkes County, North Carolina
S&ME Project No. 4213-19-107

**Historic Structures Survey Report
TIP No. R-5772
Upgrade SR 1001 (Oakwoods Road)
from US 421 to NC 268 (East Main Street)
Wilkes County, North Carolina**

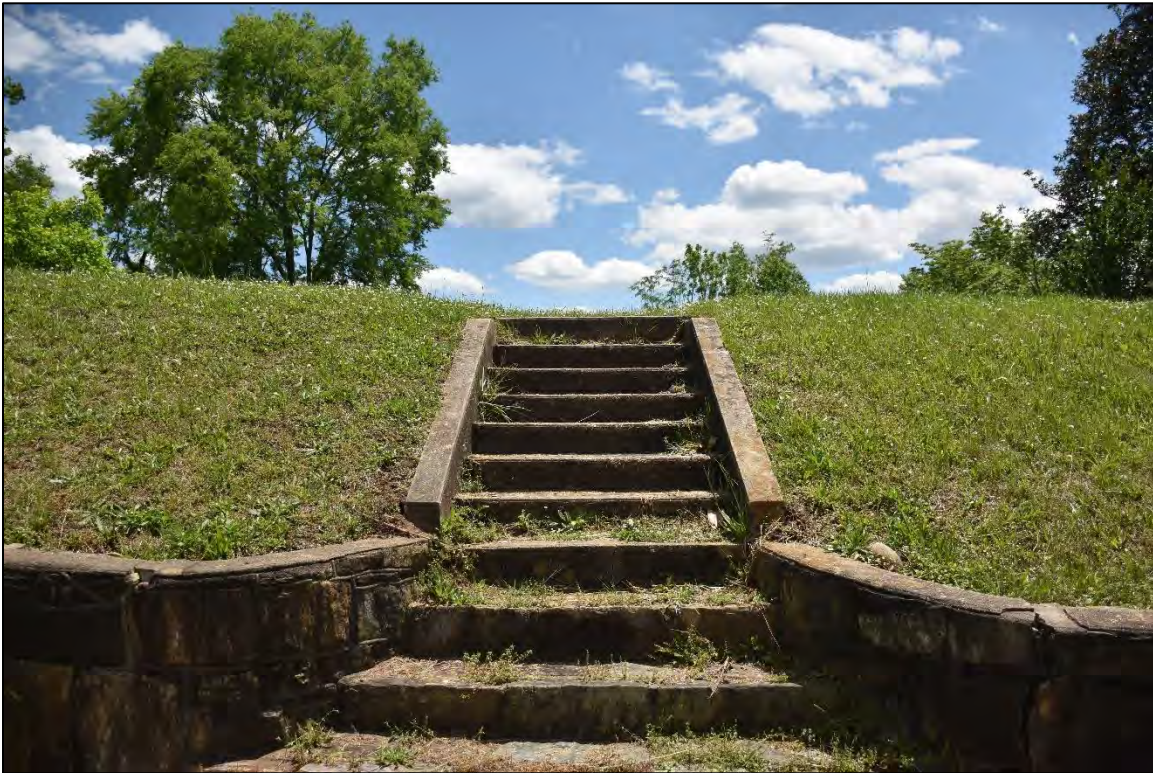
Figure 2.1.1. Location of the Carrigan House (WK0012), facing south.

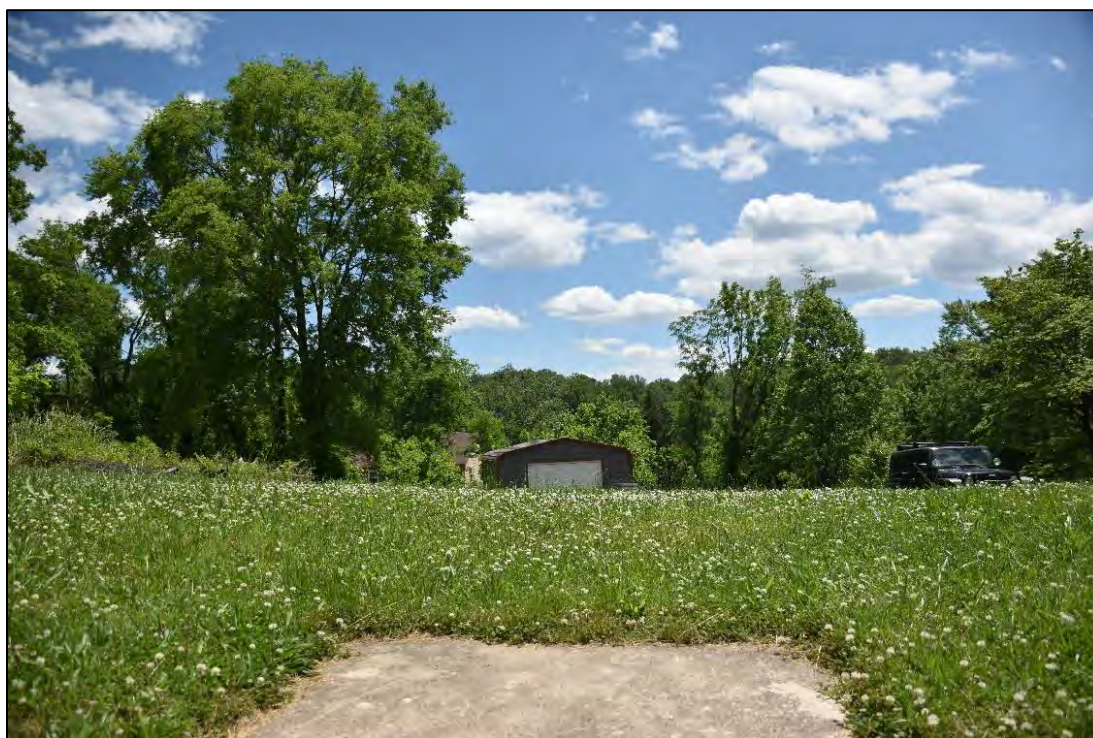
Figure 2.1.3. Metal garage located on Carrigan House (WK0012) parcel, facing south.

Parcel 2 (Carrigan House – WK0012): The Carrigan House (WK0012), a circa 1900 frame residence that was recorded in 1979 as part of the Wilkesboro survey, was formerly located at 405 East Main Street (Figure 2.2.5). The house was damaged by fire in 2015 and was subsequently demolished. The parcel on which it stood is currently empty, except for a modern metal garage that is associated with the Culler House to the west (Figure 2.1.3)

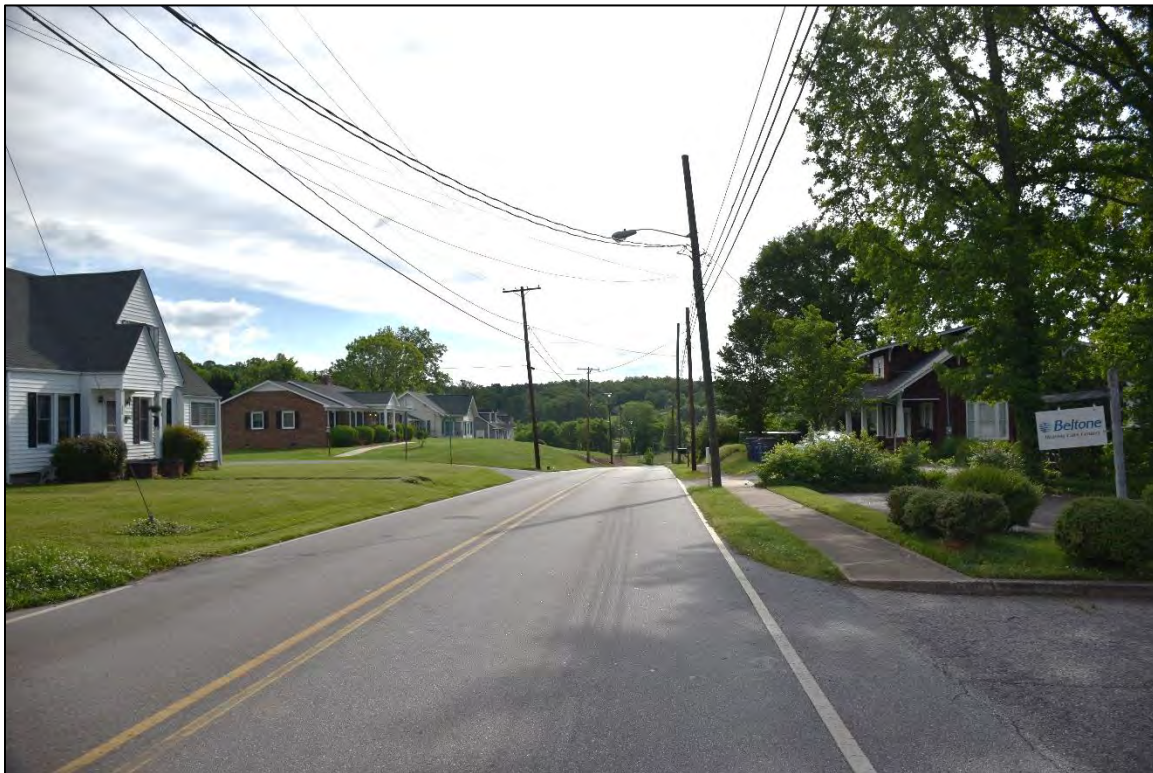
Figure 2.2.1. East Wilkesboro Historic District (WK0450), facing east.

The East Wilkesboro Historic District (WK0450) is located along East Main Street (NC 268), east of its intersection with Oakwoods Road (SR 1001), east of the town center of Wilkesboro (Figures 1.1, 1.2, and 2.2.1). The proposed district is comprised of 23 tax parcels that each have frontage along East Main Street (Figure 2.2.2). It is primarily residential in nature, although there are two commercial structures, and most of the houses within the proposed district date from the late-nineteenth through early-twentieth centuries. The residential lots are integrated into the sloping terrain of the area, with some of the houses being located on raised lots, above the roadbed. Of the 23 parcels within the district boundaries, ten include resources that have been previously surveyed during the architectural survey of Wilkesboro in 1979 (Figure 2.2.2).

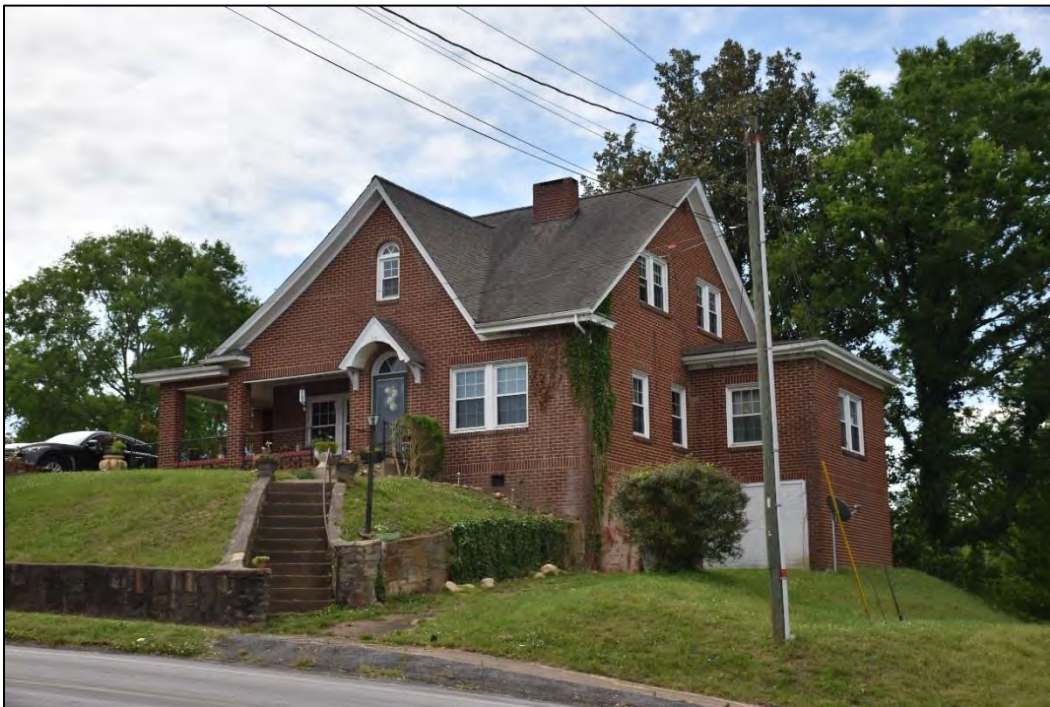
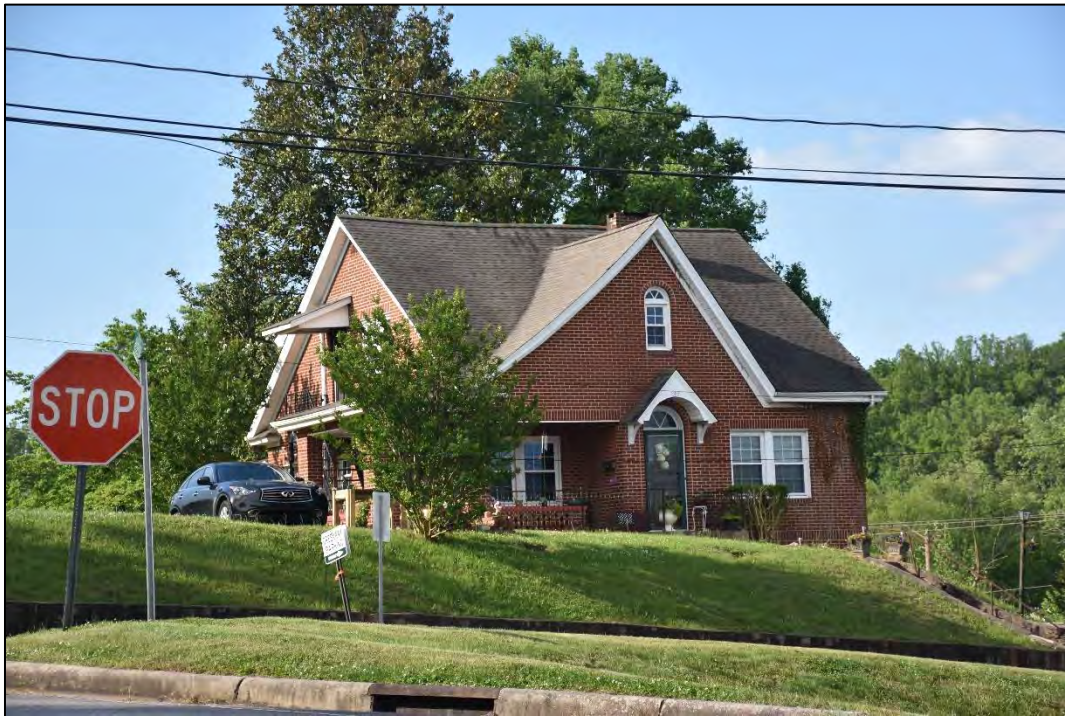
Parcel 1 (Culler House): The Culler House is a circa 1910 one and one-half story residence that is located at 403 East Main Street (Figures 2.2.3 and 2.2.4). The house has a cross-gabled roofline, with a three bay front elevation, the eastern portion of which is recessed beneath a porch that is beneath the main roofline of the front-gabled section, which is supported by a brick pier at the corner; an extension to the porch is located beneath a hipped-roof, supported by a brick pier, and wraps around to the east of the house. Both sections of the porch have a decorative masonry balustrade. The entry door is centered in the front elevation and has an arched opening, with a fanlight transom. Above the door is a pedimented hood, supported by triangular brackets, with an open arched underside. Centered above the doorway, in the front-gabled end, is a single four-over-four, double-hung, vinyl sash window with a fanlight. The remaining fenestration on the front elevation is paired six-over-six, double-hung, vinyl sash windows. The western elevation of the house, which has a visible basement level because of the slope of the lot, has a hipped roof addition to its basement and first stories; the lower level of the addition has a garage door and the upper level has single and paired six-over-six, double-hung, vinyl sash windows. The main portion of the house has single six-over-six, double-hung, vinyl sash windows on the first story and paired six-over-six, double-hung, vinyl sash windows on the second story. The eastern elevation of the house has a secondary entry door under the porch extension, as well as small single and paired six-over-six, double-hung, vinyl sash windows on the first story. The upper story has a paired six-over-six, double-hung, vinyl sash window and an upper exit door, accessed by a metal fire escape. The rear elevation of the house has a large shed-roofed dormer. The house is frame construction with brick veneer; the roof is covered with composition shingles and there is a large, interior brick chimney visible along the roof ridge. The gable ends have cornice returns and the front-facing gable has a slight flare at its eave. The Culler House exhibits elements of several contemporary architectural styles from the early-twentieth-century, including Tudor Revival in the arched doorway opening, doorway hood, and flared eave; Craftsman in the brackets supporting the doorway hood; and Colonial Revival with its fanlights and cornice returns.

Figure 2.2.3. East Wilkesboro Historic District (WK0450), parcel 1, Culler House, facing southeast.

Figure 2.2.4. East Wilkesboro Historic District (WK0450), parcel 1, Culler House, facing southwest.

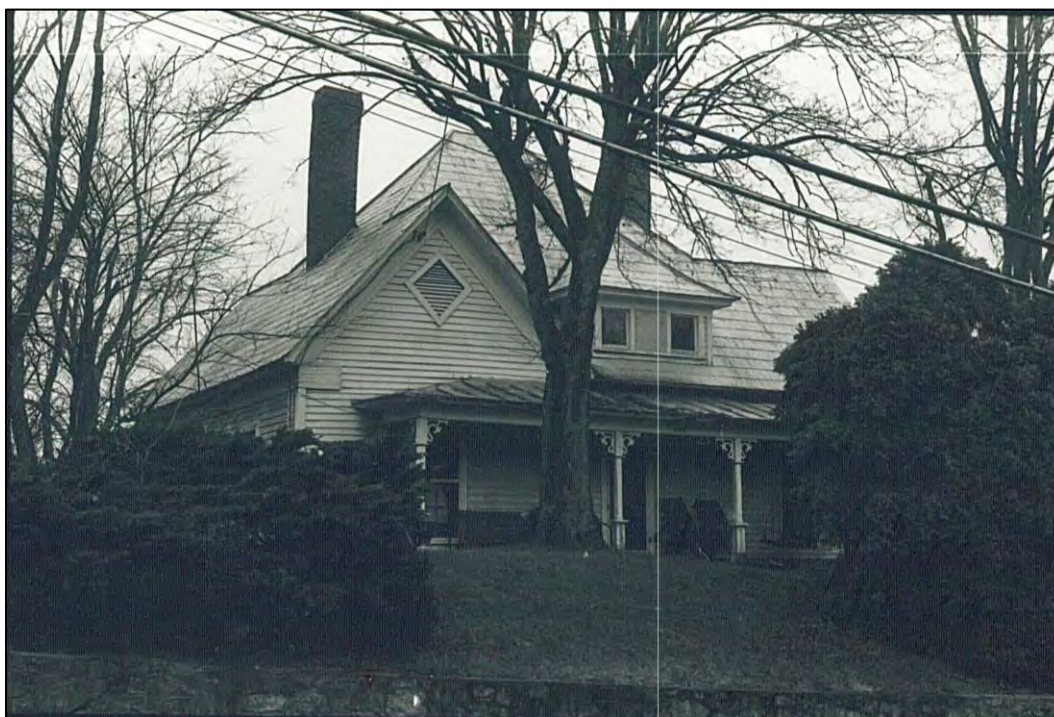
Figure 2.2.5. East Wilkesboro Historic District (WK0450), Carrigan House (WK0012), 1979.

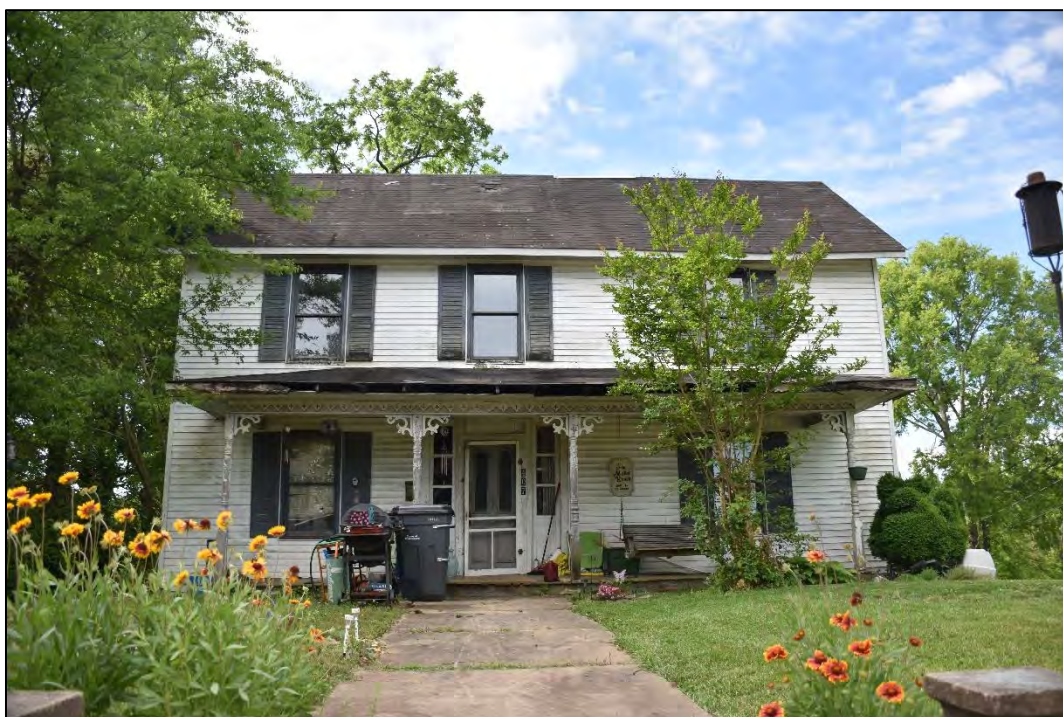
Parcel 3 (C. Y. Miller House – WK0045): The C. Y. Miller House is a circa 1870 two-story residence that is located at 407 East Main Street (Figures 2.2.6 and 2.2.7); it was recorded in 1979 as part of the Wilkesboro survey. The house is a vernacular I-house style, with Victorian detailing that exhibits influences from other late-nineteenth-century architectural styles. The main portion of the structure is a two-story, side-gabled, structure of frame construction on a brick pier foundation that has been infilled. The three-bay front façade is asymmetrical, with the eastern two bays being closer together. The entry door is paneled, with two tall arched panes in the upper section, giving the impression of a double door, which was popular in the Italianate and Gothic Revival styles of the mid-to-late-nineteenth century; the door surround has three-pane sidelights and an upper transom that has been covered with wooden paneling. The windows on both the first and second stories of the front elevation are single one-over-one, double-hung, vinyl sashes. There is a hipped-roof porch that spans most of the front elevation; it is supported by turned posts with intricate scrollwork brackets; the porch frieze has decorative sawn trim, also indicative of a Gothic Revival influence. The western elevation of the house is one-bay deep, with a paired one-over-one, double-hung, vinyl sash window on the first story and a single one-over-one, double-hung, vinyl sash window on the second story; a diamond-shaped attic vent is centered in the gable. The rear of the house has a single story, rear ell addition, which sits on a concrete block foundation. The visible fenestration on this portion of the house is single and paired one-over-one, double-hung, vinyl sash windows. The eastern elevation of the house has an exterior brick chimney, flanked by single one-over-one, double-hung, vinyl sash windows on the first story.

Figure 2.2.6. East Wilkesboro Historic District (WK0450), parcel 3, C. Y. Miller House (WK0045), facing south.

The house is covered with vinyl siding; the roof of the main portion is asphalt shingle, while the roof of the rear ell is standing-seam metal. Comparison with survey photographs from 1979 indicates that the C. Y. Miller House has undergone multiple alterations in the past 40 years. In addition to the replacement windows and siding, the support posts on the front porch have been replaced and an interior chimney has been removed.

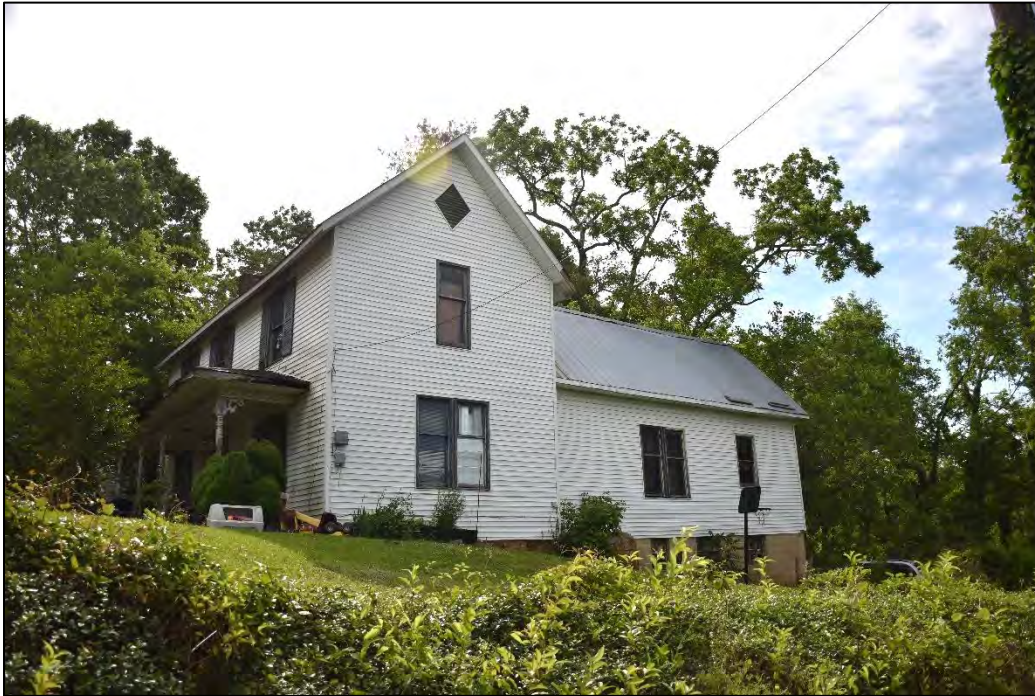
Figure 2.2.7. East Wilkesboro Historic District (WK0450), parcel 3, C. Y. Miller House (WK0045), facing southeast.

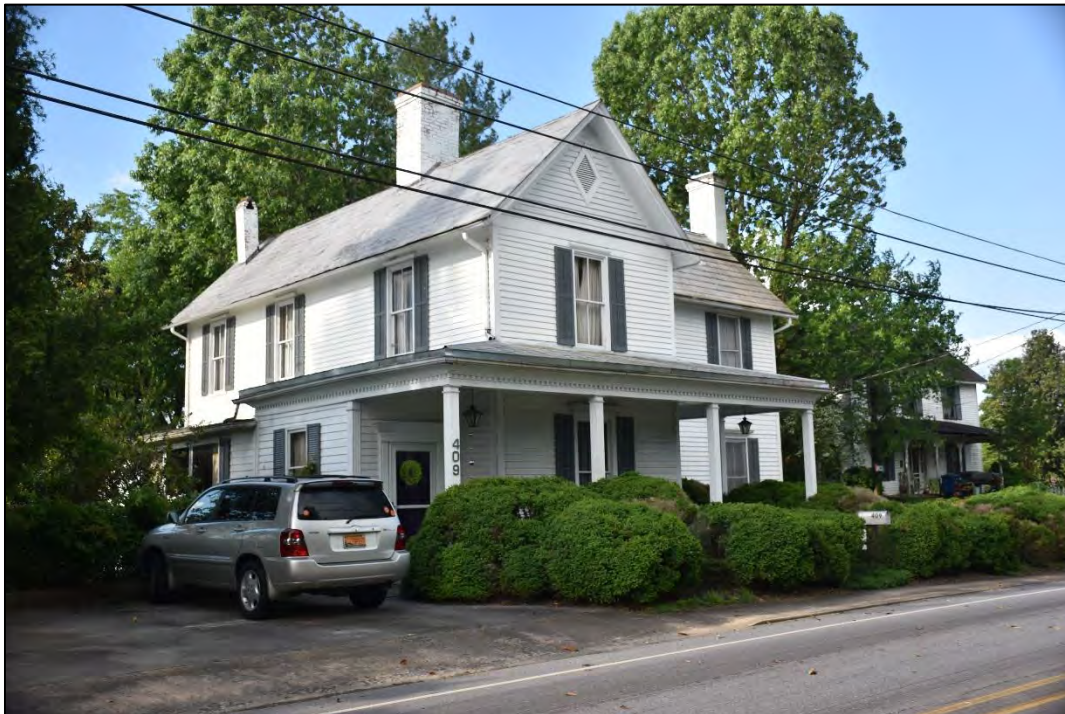
Parcel 4 (Greenwood-Hayes House – WK0025): The Greenwood-Hayes House is a circa 1895 two-story residence that is located at 409 East Main Street (Figures 2.2.8 and 2.2.9); it was recorded in 1979 as part of the Wilkesboro survey and dated to circa 1910. The house is a two-story, gable-front-and-wing form with a three bay façade. The eastern portion of the front elevation is a projecting front-gabled bay, with a single two-over-two, double-hung, wooden sash window on both the first and second stories; a diamond shaped attic vent is centered within the gable end. The side-gabled section is two bays wide; on the first story, the entry door is located next to the front-gabled projection and the remaining windows on the first and second stories are single two-over-two, double-hung, wooden sash windows. The door surround is a classic Colonial Revival style, with fluted pilasters and a decorative crown; the windows each have a crown molding hood. A hipped roof porch, supported by fluted square columns and having denticulated molding along the cornice, wraps around the front-projecting gable. A single story addition to the east holds a secondary entry door, beneath the porch roof. The eastern elevation is three bays deep, with a single one-over-one, double-hung, vinyl sash window in the addition portion and a glassed sunroom behind it; there are three single one-over-one, double-hung, wooden sash windows on the upper story. The western elevation has an exterior brick chimney centered within the gable end, flanked by a single two-over-two, double-hung, wooden sash window on either side, on both the first and second stories. A two-story, shed-roofed rear addition is visible along this elevation. The house is covered with horizontal wooden weatherboard siding and has a tin shingle roof; in addition to the exterior chimney, there are two interior brick chimneys visible along the roof ridge of the front-gabled section. Comparison with survey photographs from 1979

Figure 2.2.8. East Wilkesboro Historic District (WK0450), parcel 4, Greenwood-Hayes House (WK0025), facing southwest.

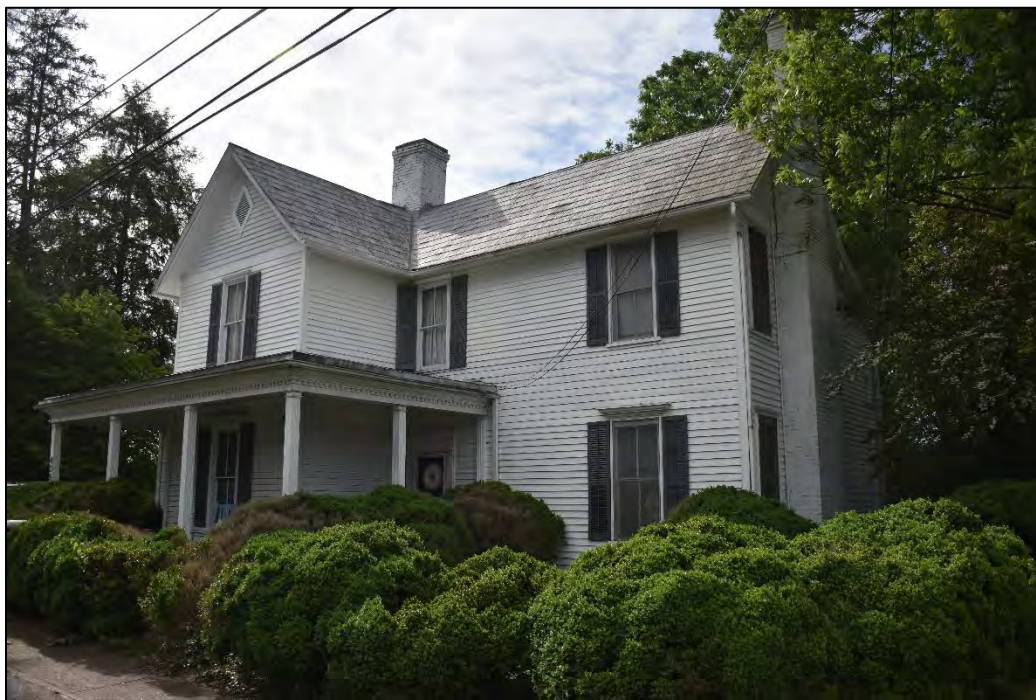
Figure 2.2.9. East Wilkesboro Historic District (WK0450), parcel 4, Greenwood-Hayes House (WK0025), facing southeast.

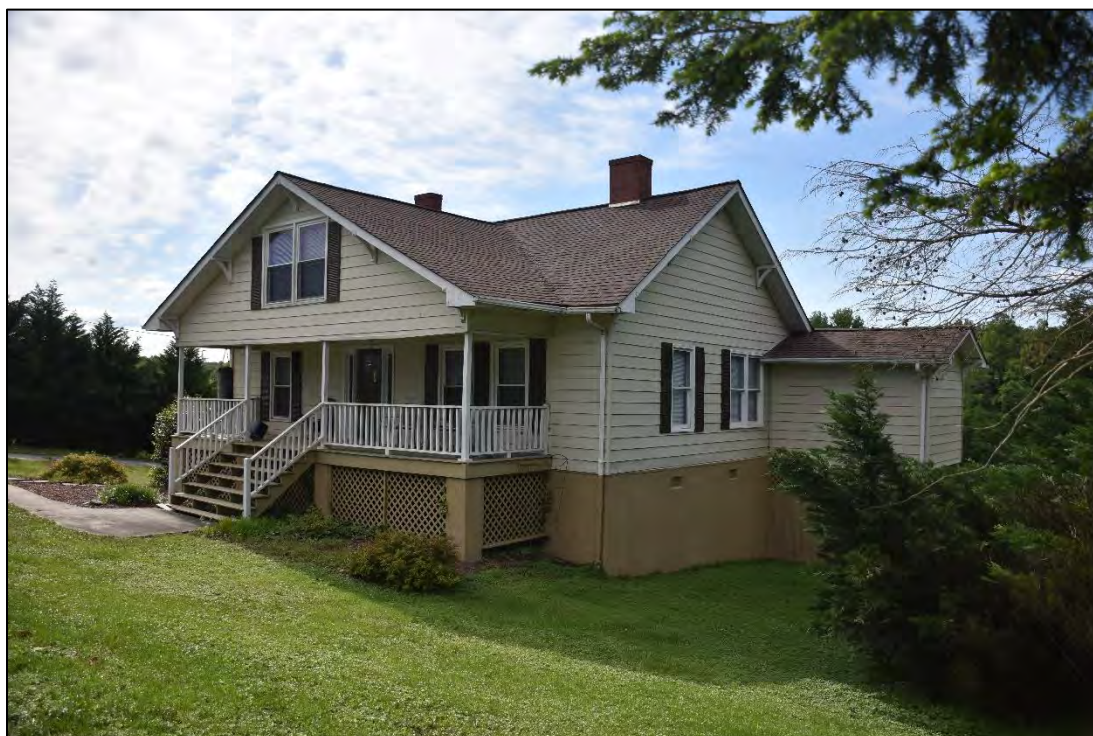
Parcel 5 (Barber House): The Barber House is a circa 1920 one-and-one-half story residence that is located at 411 East Main Street (Figures 2.2.10 and 2.2.11). The house has a Craftsman-style form; it is of frame construction and rests on a raised foundation that has been covered in stucco. The main section of the house is side-gabled, with a dominant front-gable that is recessed below to create a full-width porch, supported by simple square posts. The façade is three bays wide, with a central door, flanked by tall, slender sidelights, that has a single one-over-one, double-hung, vinyl sash window to the east and a paired one-over-one, double-hung, vinyl sash window to the west. The upper story of the front-gable has a paired one-over-one, double-hung, vinyl sash window. The western elevation is two bays deep, with a single and a paired one-over-one, double-hung, vinyl sash window. A side-gabled addition has been attached to the rear portion of this elevation. The eastern elevation has a three-bay, projecting picture window and a small one-over-one, double-hung, vinyl sash window on the first story and a paired one-over-one, double-hung, vinyl sash window on the upper story. A one-story, gabled, rear ell projects from the southeast corner of the house and is accessed by a wooden deck; it has an entry door beneath a gabled projection and a single one-over-one, double-hung, vinyl sash window. The house is sheathed in vinyl siding and the roof is composition shingles. Two interior brick chimneys are visible above the roof ridge. The only remaining original detail left on the exterior of the house are the triangular brackets that are visible in the front-projecting gable and the side-gable ends.

Figure 2.2.10. East Wilkesboro Historic District, parcel 5, Barber House, facing southeast.

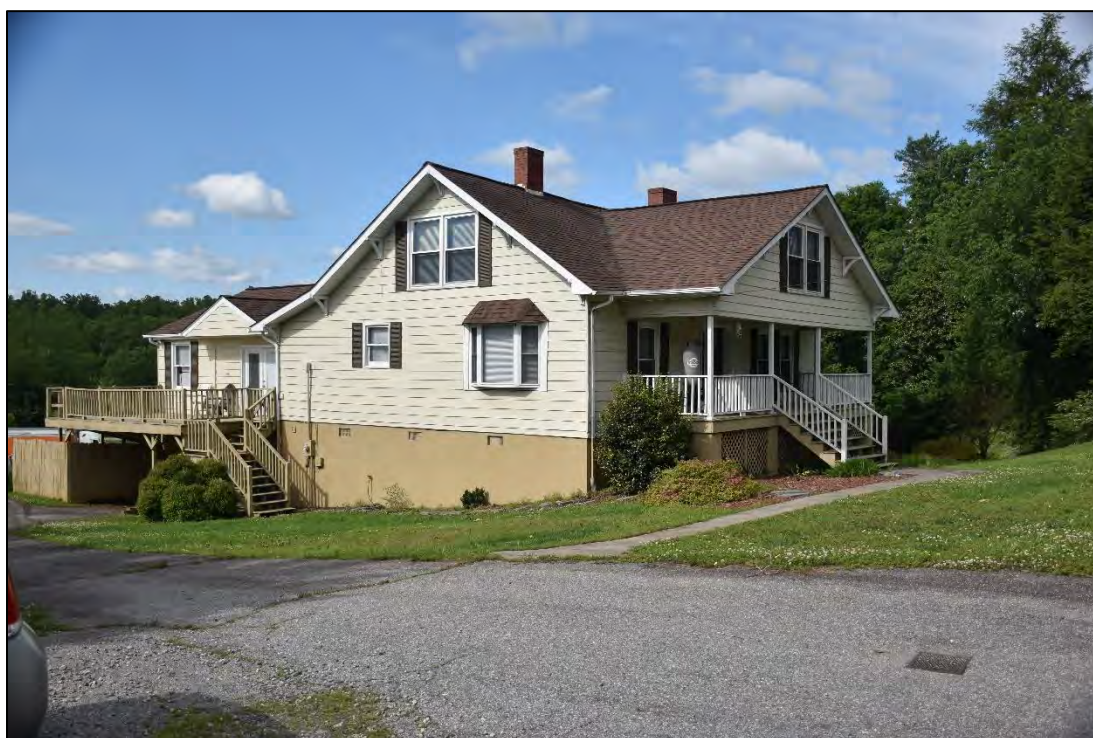
Figure 2.2.11. East Wilkesboro Historic District, parcel 5, Barber House, facing southwest.

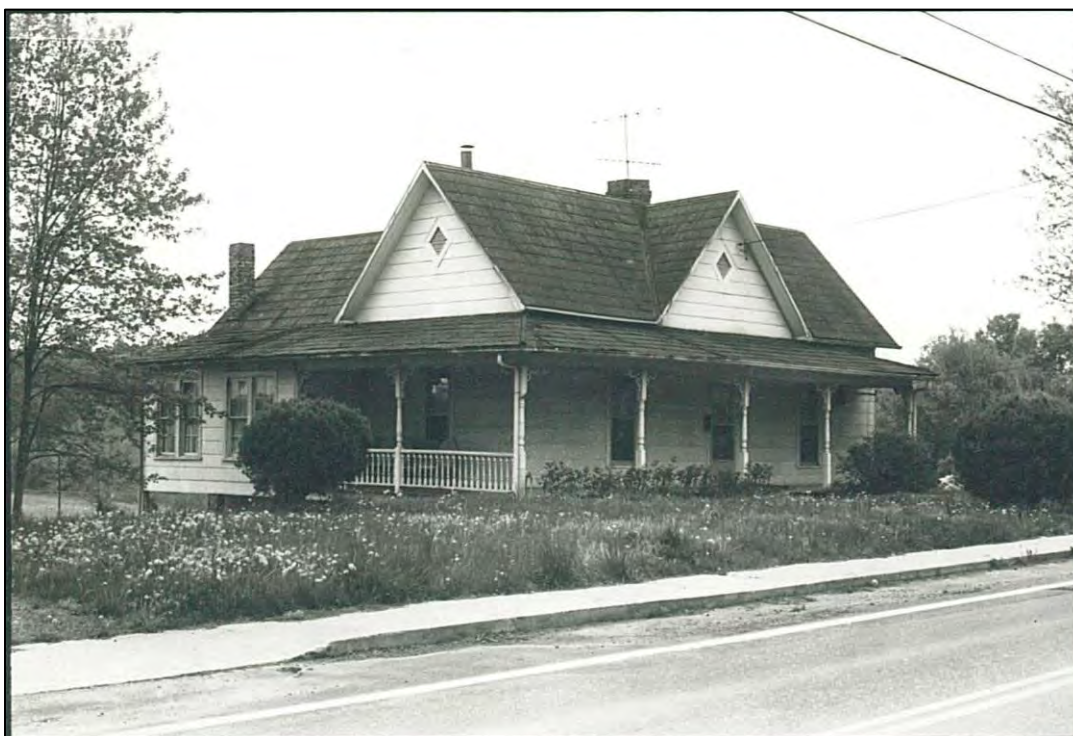
Figure 2.2.12. East Wilkesboro Historic District (WK0450), unnamed House (WK0034), 1979.

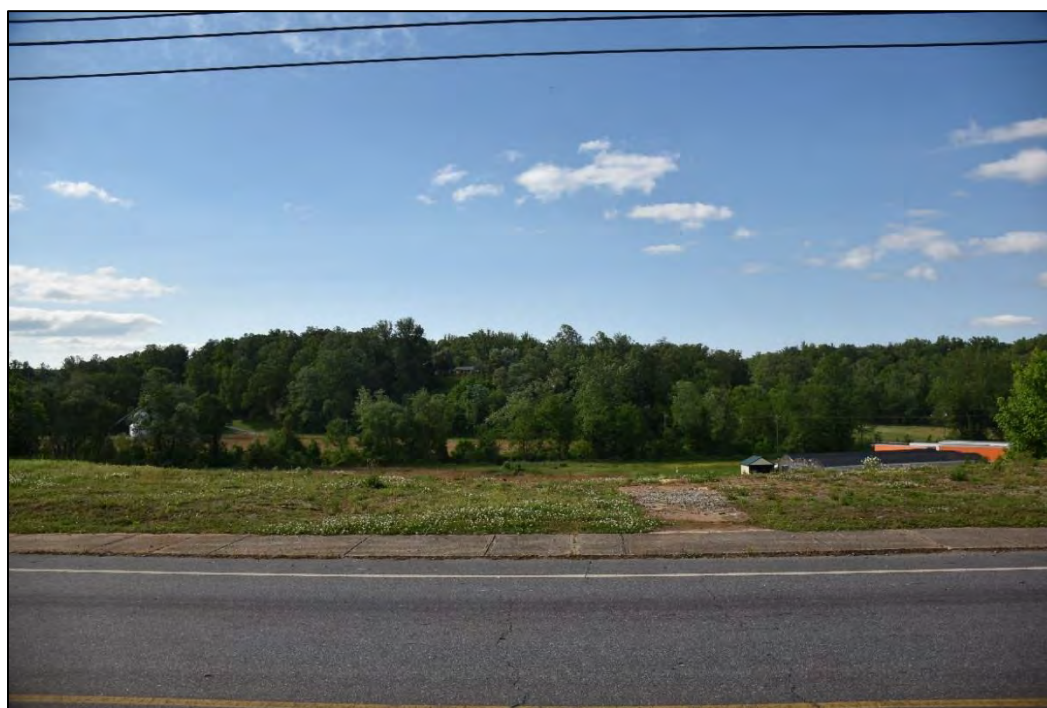
Figure 2.2.13. East Wilkesboro Historic District (WK0450), parcel 6, location of unnamed House (WK0034), facing south.

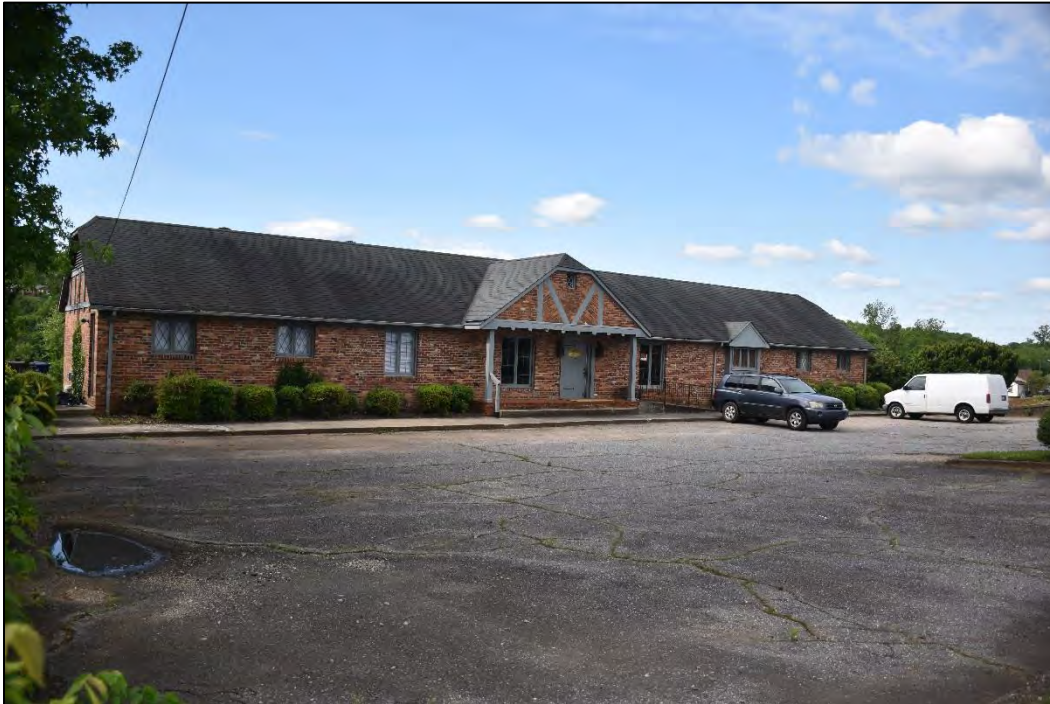
Parcel 7 (Hicks Building): The Hicks Building is a one-story commercial structure, located at 503 East Main Street, that was built around 1965 (Figure 2.2.14). It is a one-story, frame construction building that has elements of the styled Tudor tradition that was popular during the mid-twentieth century. The building is laterally oriented to the road, with a jerkinhead roof that has half timbering in each of the ends. The central entry is located beneath a projecting porch with a jerkinhead roof and half timbering and decorative masonry, which is supported by square columns; a rectangular window with diamond faux leaded glass is centered in this projection. There are four bays on either side of the entry door, one of which is located beneath the porch. To the east are two two-part casement windows with diamond faux leaded glass, a two-part casement vertical casement window with eight panes on each section, and a two-part casement window with ten panes on each section; to the west is a two-part casement window with ten panes on each section, a projecting wooden gabled bay window with three rectangular windows with diamond faux leaded glass, and two two-part casement windows with diamond faux leaded glass. The building is one of only two commercial structures within the boundaries of the district and is significantly newer than most of the residential structures in the district.

Figure 2.2.14. East Wilkesboro Historic District (WK0450), parcel 7, Hicks Building, facing southwest.

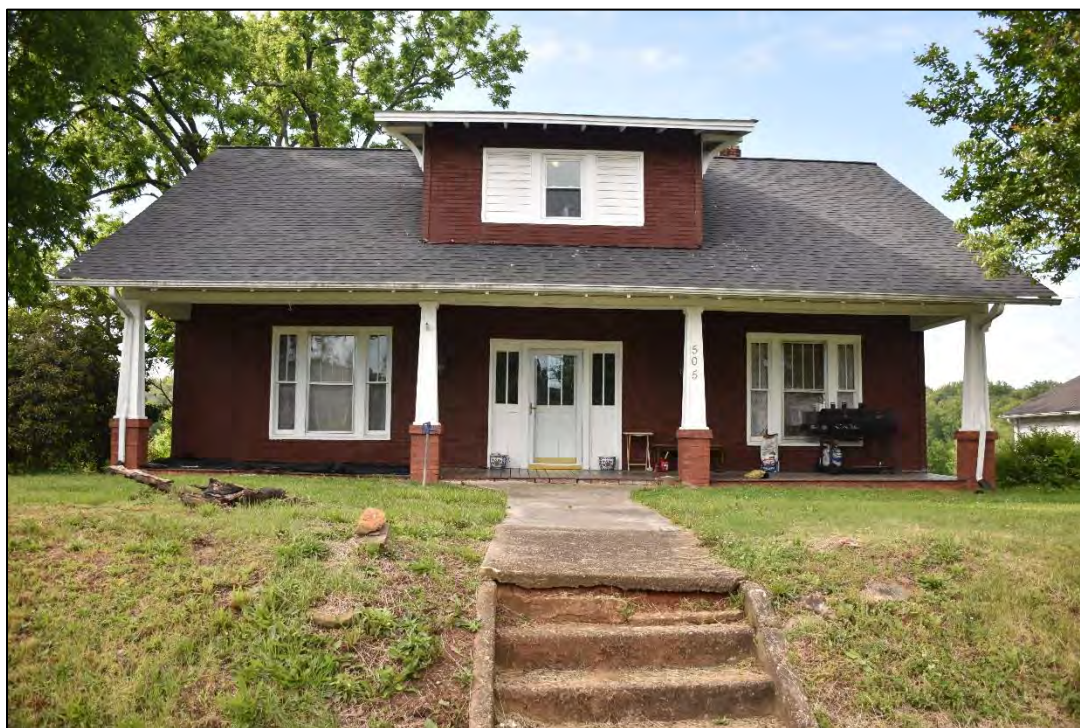
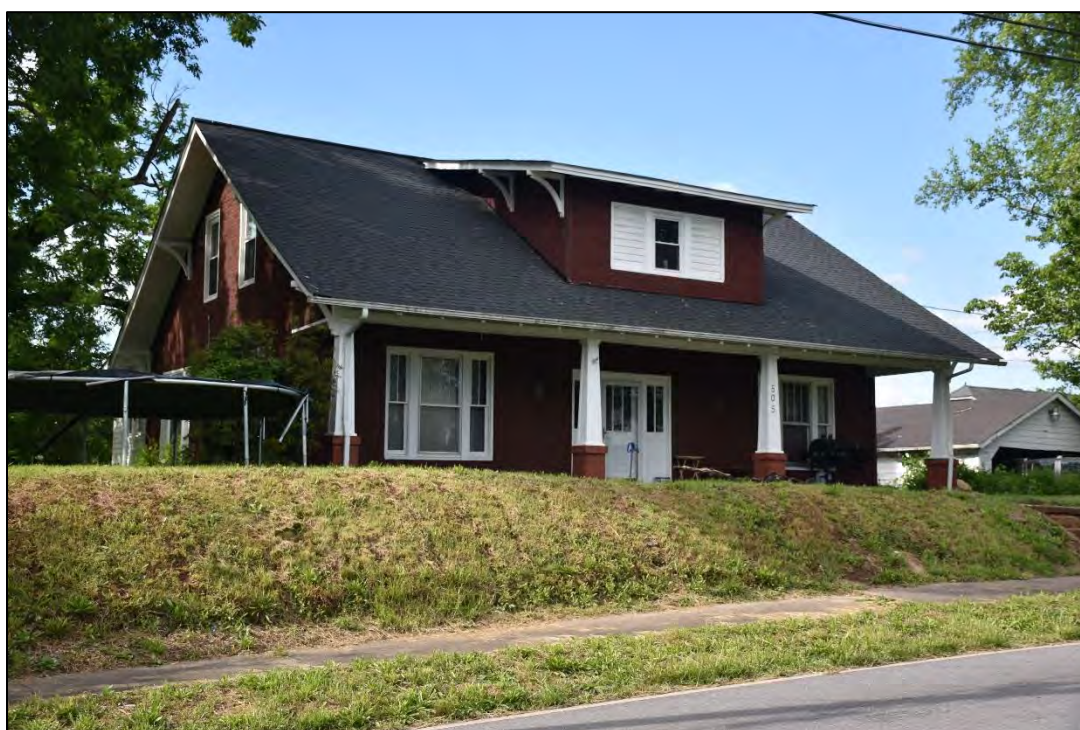
Parcel 8 (Henderson House): The Henderson House is a circa 1920 one and one-half story residence that is located at 505 East Main Street (Figures 2.2.15 and 2.2.16). The house is a Craftsman-style residence of frame construction with a side-gabled roofline and three bay front façade; the central door, which has a two paneled bottom and three-pane top section, has sidelights with two vertical panes and is flanked by a tripartite window, with a central four-over-one, double-hung, wooden sash window and two two-over-one, double-hung, wooden sash windows, on either side. The front elevation is spanned by a full width porch that is integrated beneath the main roofline

and is supported by tapered square columns that rest on brick piers. A shed-roofed dormer, with a central one-over-one, double-hung, vinyl sash window that has vinyl siding on either side, presumably where other windows completed the window ribbon, is centered within the front roofline. The east elevation of the house has two bays on the lower story, with the same tripartite windows as the front elevation, and two single, one-over-one, double-hung, vinyl sash windows on the upper story. A shed-roofed, one-story addition that is covered with vinyl siding is visible at the southeast corner. The western elevation has the same window configuration as the eastern elevation. The house is sheathed in faux brick paneling and the roof is covered with composition shingles. There are triangular brackets along the gable ends of the house, as well as along the shed roofline of the dormer; formerly visible raftertails along the front porch roof and dormer has been partially hidden by gutters and trim.

Figure 2.2.15. East Wilkesboro Historic District (WK0450), parcel 8, Henderson House, facing south.

Figure 2.2.16. East Wilkesboro Historic District (WK0450), parcel 8, Henderson House, facing southwest.

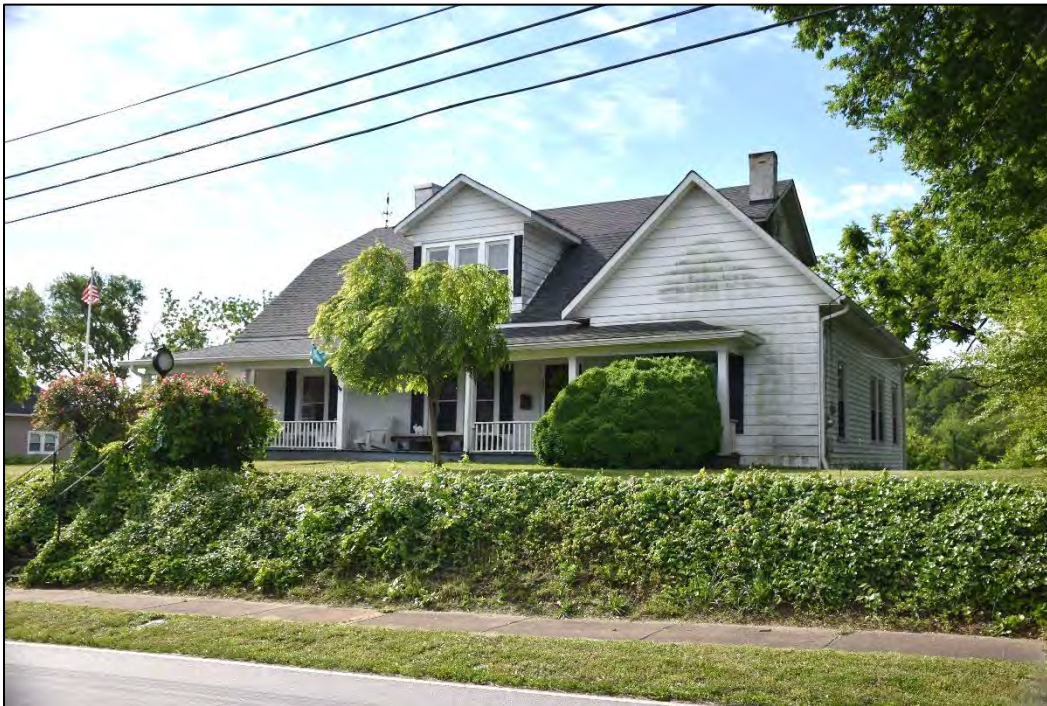
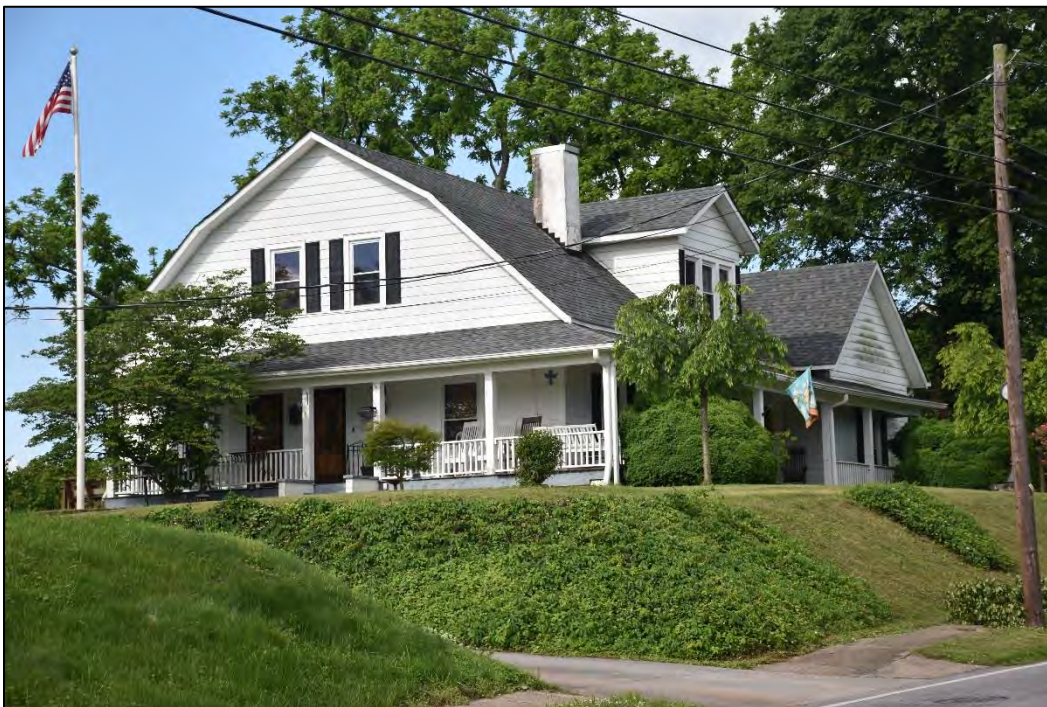
Parcel 9 (J. F. Jordan House – WK0042): The J. F. Jordan House is a circa 1900 one-and-one-half story residence that is located at 601 East Main Street (Figures 2.2.17 and 2.2.18); it was recorded in 1979 as part of the Wilkesboro survey and dated to around 1910. The house is an example of the Colonial Revival style, with a gambrel roofline on the main section of the house, which is oriented laterally to the road. The front elevation has a front-projecting cross-gable at the western corner, with a paired one-over-one, double-hung, vinyl sash window; to the east of the cross-gabled section is the entry door and two paired one-over-one, double-hung, vinyl sash windows. There is a large gabled dormer, with a ribbon of three one-over-one, double-hung, vinyl sash windows roughly centered within the roofline. A hip-roofed porch, supported by square posts, wraps around the front and eastern elevations. The western elevation of the house has three bays, with both single and paired one-over-one, double-hung, vinyl sash windows. An exterior brick chimney is partially visible behind the front-facing gable on this elevation. The eastern elevation has two additional entry doors and two single one-over-one, double-hung, vinyl sash windows on the lower level and two single one-over-one, double-hung, vinyl sash windows on the upper level. The house is covered with aluminum siding and the roof is composition shingles. In addition to the

Figure 2.2.17. East Wilkesboro Historic District (WK0450), parcel 9, J. F. Jordan House (WK0042), facing southeast.

Figure 2.2.18. East Wilkesboro Historic District (WK0450), parcel 9, J. F. Jordan House (WK0042), facing southwest.

exterior chimney on the western elevation, there is an interior brick chimney visible along the roofline to the east of the dormer. Comparison with photos from the 1979 survey indicates that the two-over-two wooden sash windows have been replaced with modern vinyl windows.

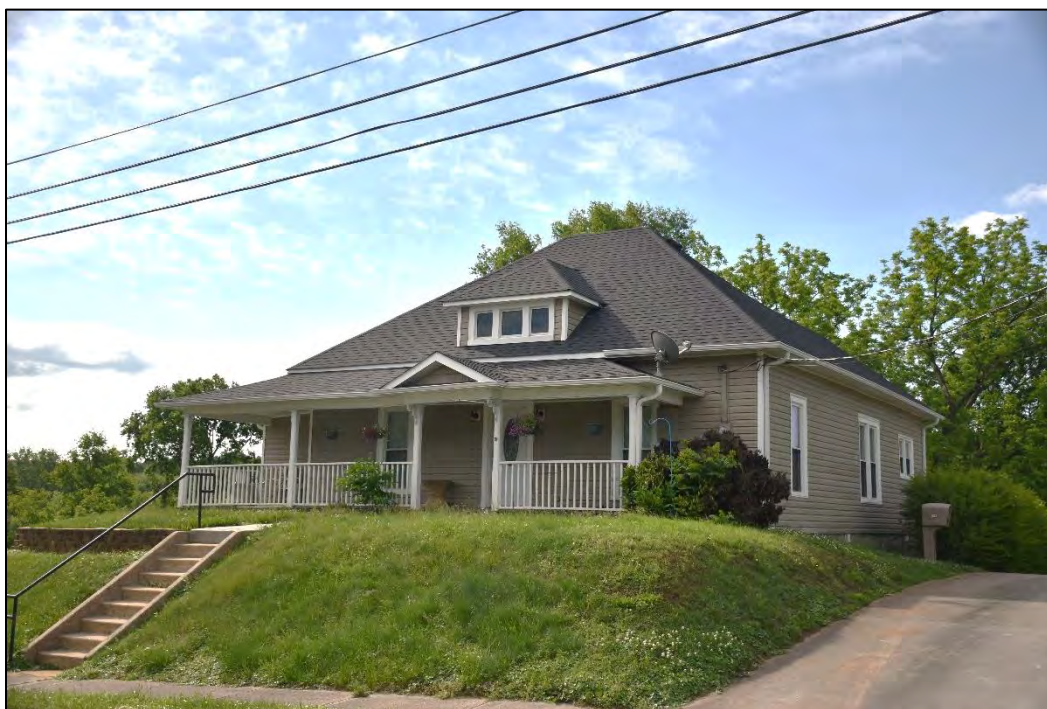
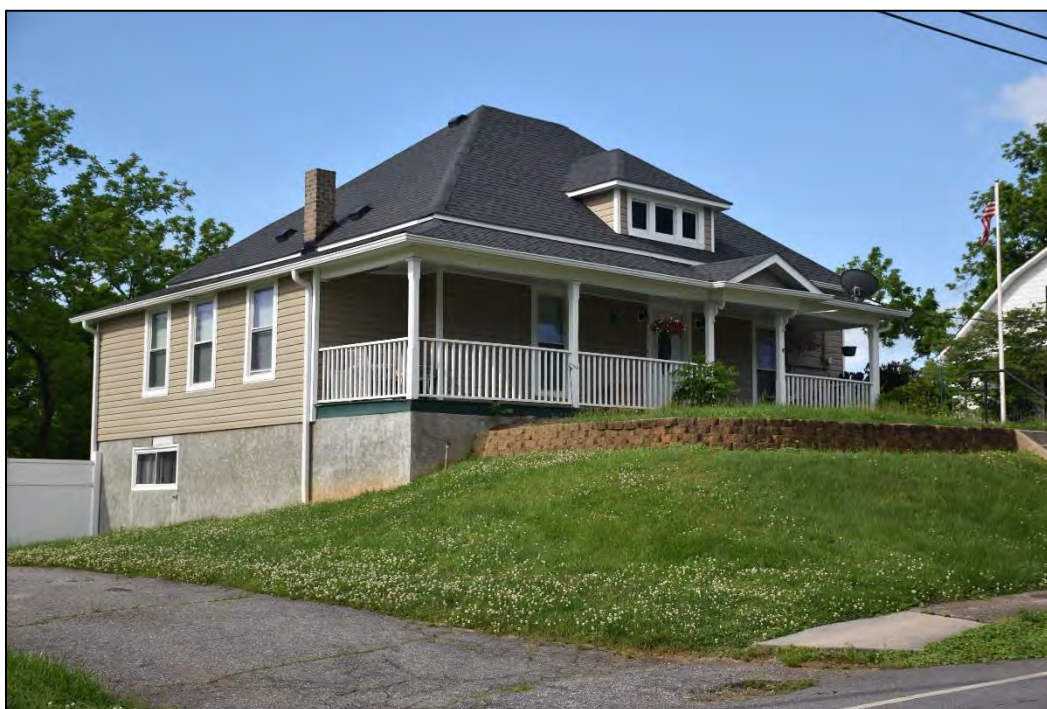
Parcel 10 (House – WK0030): An unnamed House, located at 603 East Main Street, is a circa 1920 one-and-one-half story residence (Figures 2.2.19 and 2.2.20); it was recorded in 1979 as part of the Wilkesboro survey and dated to around 1910. The house is a one and one-half story residence of frame construction with a pyramidal roof; it rests on a raised foundation that has been covered with stucco. The front elevation is three bays wide, with a modern central door that is flanked by a single one-over-one, double-hung, vinyl sash window on either side. A hip-roofed dormer, with a three-pane vinyl-framed casement window, is centered within the front roofline. A full-width, hipped-roof porch spans the front elevation of the house; it is supported by chamfered square posts. A pedimented projection, supported by scrollwork brackets, provides access to the porch and corresponds to the location of the door. Along the eastern elevation, the front façade steps backward, suggesting that the porch may have originally wrapped around to the eastern elevation but was enclosed before 1979. The east elevation has three bays, each with a single one-over-one, double-hung, vinyl sash window. The basement level has a two-pane horizontal sliding window. An interior brick chimney is visible along the juncture of the main structure and enclosed porch portion. The western elevation of the house is also three bays deep, with a single one-over-one, double-hung, vinyl sash window, a paired one-over-one, double-hung vinyl sash window, and a smaller paired one-over-one, double-hung, vinyl sash window. The house is covered with vinyl siding and the roof is composition shingles. The lot on which the house sits is sloped, with a brick retaining wall and concrete stairs in front of the house. Comparison with photographs from the 1979 survey indicates that the wooden weatherboard siding has been replaced with vinyl siding, the four-over-four, double-hung, wooden sash windows have been replaced, a second interior chimney at the southwest corner of the house has been removed, a door in the enclosed section of the porch has been removed, additional windows have been added to the enclosed section of the porch, and a secondary porch entrance to the east of the main entrance point has been enclosed when a modern balustrade was added to the porch. A shed-roofed frame garage that was attached to the southeastern corner of the house has also been removed.

Figure 2.2.19. East Wilkesboro Historic District (WK0450), parcel 10, unnamed House (WK0030), facing southeast.

Figure 2.2.20. East Wilkesboro Historic District (WK0450), parcel 10, unnamed House (WK0030), facing southwest.

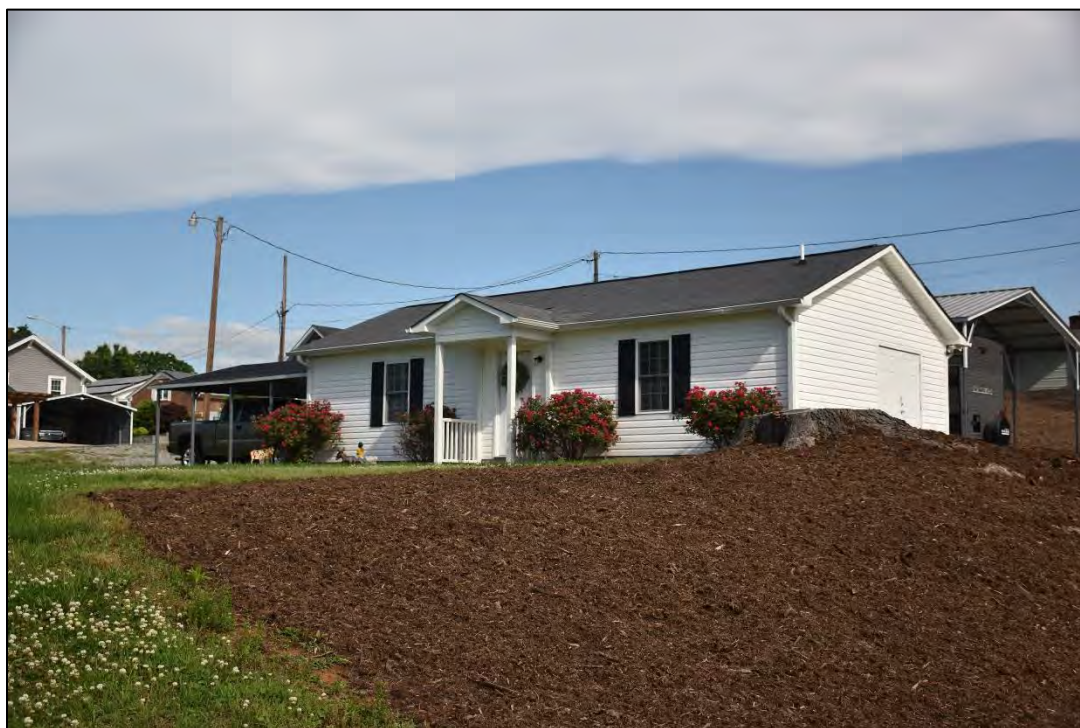
Parcel 11 (Parker House): The Parker House is a modern, one-story residence that was built around 2008; it is located along the north side of and fronts onto East Main Street, however its address is 611 Winston Street (Figure 2.2.21). The house is a simple, side-gabled, frame residence with a three-bay front elevation. The entry door is central, located beneath a gabled portico that is supported by square vinyl posts; the door is flanked by a single six-over-six, double-hung, vinyl sash window on either side. The eastern elevation has a modern, fiberglass double door. The house is covered with vinyl siding and the roof is asphalt shingles. Aerial photographs indicate that the house was constructed between March and November 2008.

Figure 2.2.21. East Wilkesboro Historic District (WK0450), parcel 11, Parker House, facing northeast.
