SUBJECT: Historic Structures Survey Report, R-5772, Upgrade SR 1001 from US 421 to NC 268,
PA 19-02-0016, Wilkes County, ER 19-2317

Historic Structures Survey Report
TIP No. R-5772, WBS No. 44692.1.1, PA No. 19-02-0016
Upgrade SR 1001 (Oakwoods Road)
from US 421 to NC 268 (East Main Street)
Wilkes County, North Carolina
S&ME Project No. 4213-19-107

**Historic Structures Survey Report
TIP No. R-5772
Upgrade SR 1001 (Oakwoods Road)
from US 421 to NC 268 (East Main Street)
Wilkes County, North Carolina**

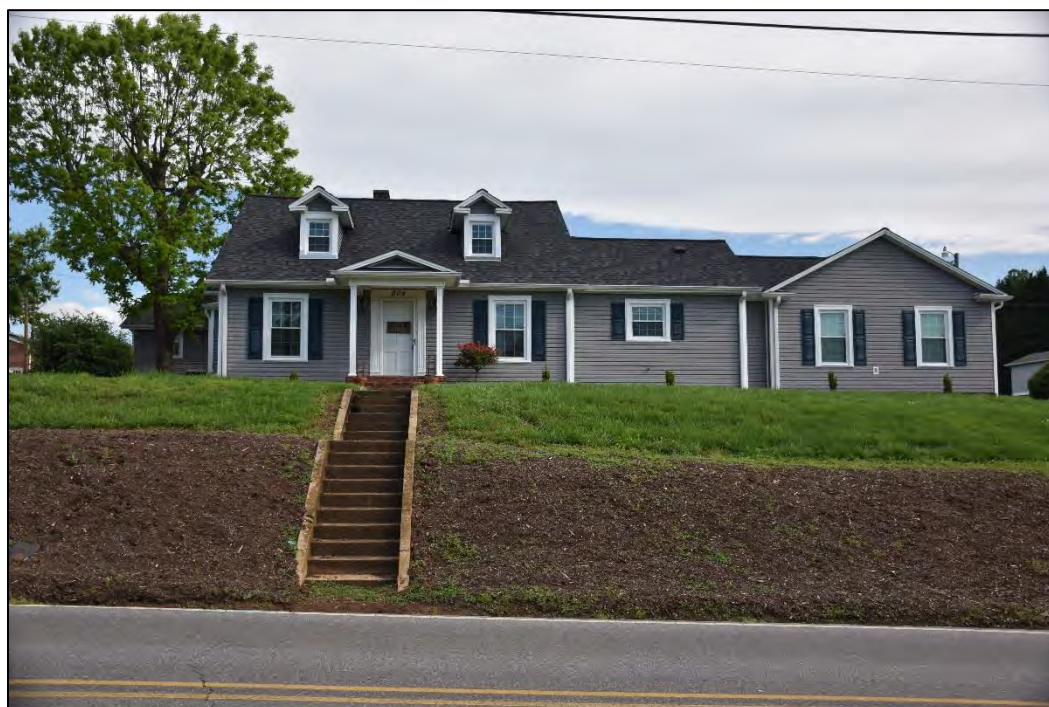
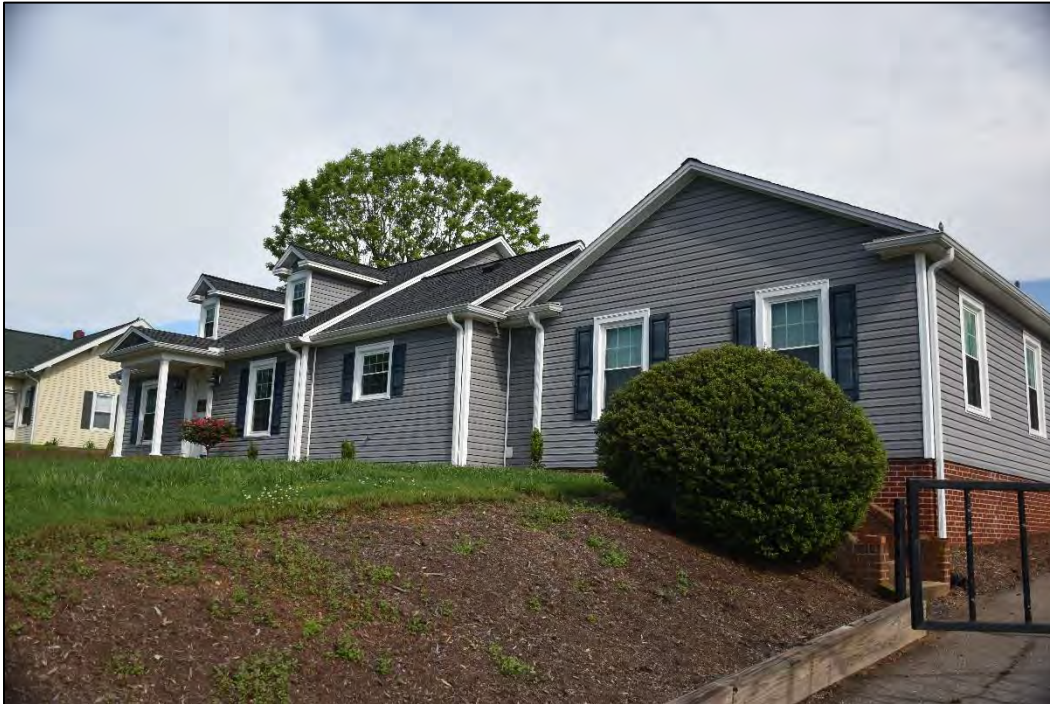
Parcel 12 (Garza House): The Garza House is a circa 1935 one-and-one-half-story residence that is located at 604 East Main Street (Figures 2.2.22 and 2.2.23). The original portion of the house is three bay Colonial Revival-style house, which has been added onto multiple times. The main section of the house has a central door, with a surround that has fluted pilasters, located beneath a gabled portico that is supported by square posts; the door is flanked by single six-over-six, double-hung, vinyl sash windows on either side. There are two symmetrical gabled dormers along the front roofline, each having a single six-over-six, double-hung, vinyl sash window and cornice return on the gable end. To the east of the main section of the house is a one-story, side-gabled hyphen and a one-story, front-gabled wing, which has two single six-over-six, double-hung, vinyl sash windows and cornice returns to mirror the gabled dormers. The east side of the wing has two single six-over-six, double-hung, vinyl

Figure 2.2.22. East Wilkesboro Historic District (WK0450), parcel 12, Garza House, facing north.

Figure 2.2.23. East Wilkesboro Historic District (WK0450), parcel 12, Garza House, facing northwest.

sash windows. There is a single story rear ell addition that is attached to the northwestern corner of the house. The house is sheathed in vinyl siding and the roof is composition shingles.

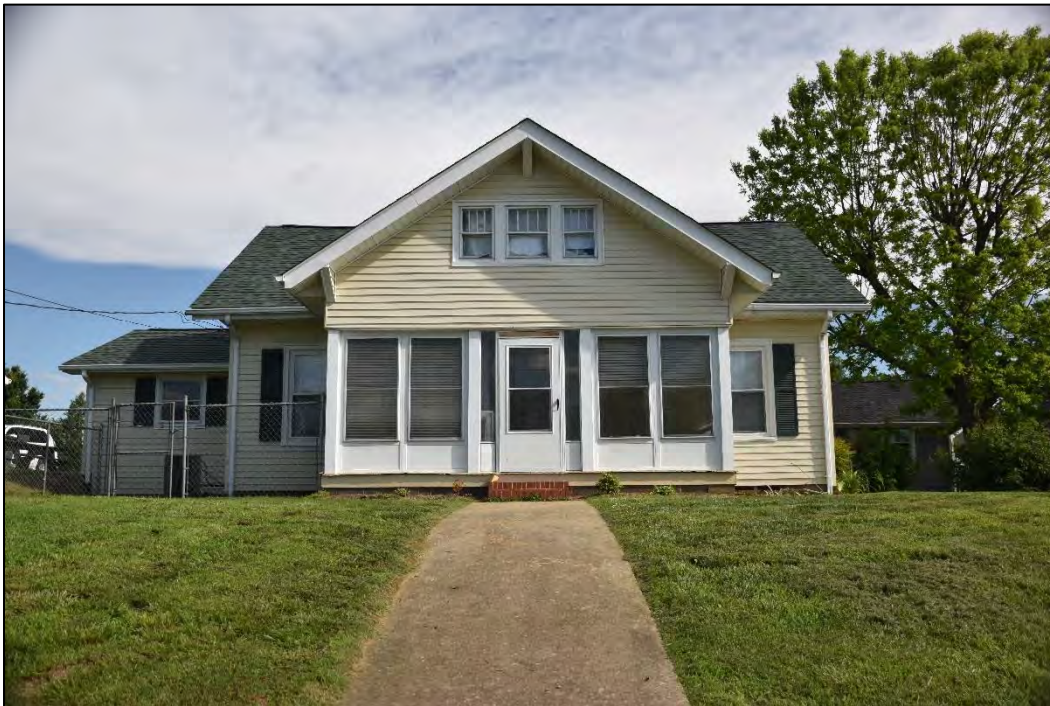
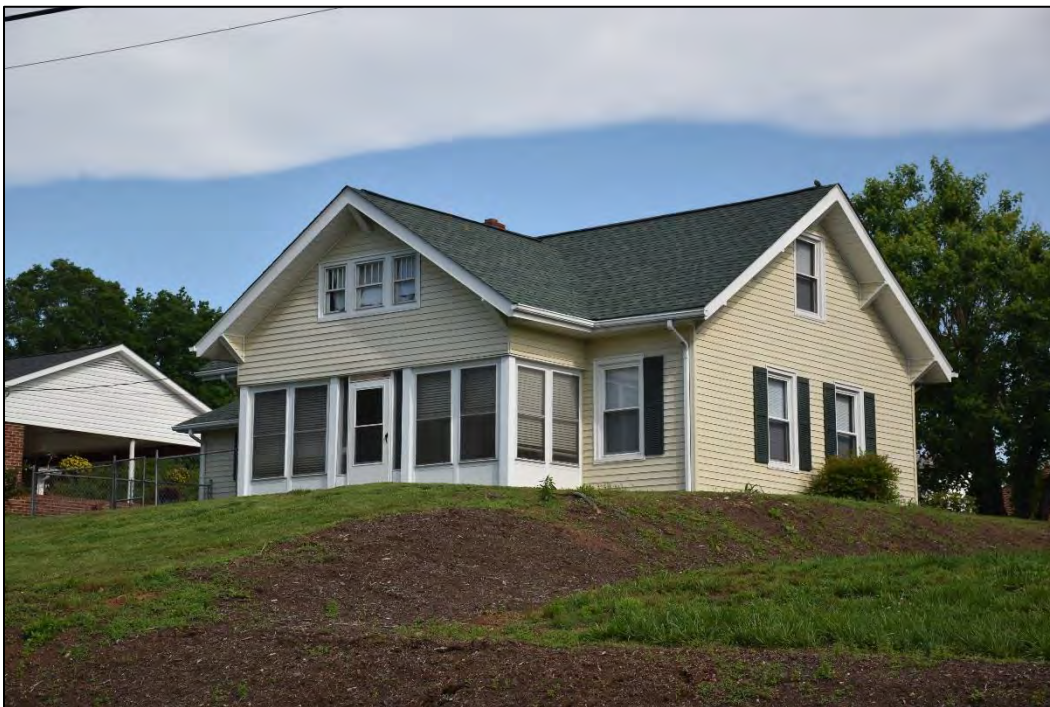
Parcel 13 (Hayes-Parker House): The Hayes-Parker House is a circa 1925 one-and-one-half-story residence that is located at 602 East Main Street (Figures 2.2.24 and 2.2.25). The house is a side-gabled, Craftsman-style residence of frame construction. The front elevation has a large, projecting, front-gabled section that originally created a partial-width front porch, which has been enclosed with wooden paneling and large windows; the central door in the enclosed porch indicates that the original door position is likely central as well. The upper story of the front gable has a ribbon of three four-over-one, double-hung, wooden sash windows. On either side of the enclosed porch on the front elevation is a single one-over-one, double-hung, vinyl sash window. The eastern elevation of the house has two single one-over-one, double-hung, vinyl sash windows on the first story and a single one-over-one, double-hung, vinyl sash window on the upper story. The western elevation has a single one-over-one, double-hung, vinyl sash window and a one-story, side-gabled addition. The house is covered with vinyl siding and the roof is composition shingles; there is an interior brick chimney visible behind the roof ridge to the west of center. The gable ends and the front-facing gable retain the triangular brackets along the eaves, although they have been enclosed with vinyl siding.

Figure 2.2.24. East Wilkesboro Historic District (WK0450), parcel 13, Hayes-Parker House, facing north.

Figure 2.2.25. East Wilkesboro Historic District (WK0450), parcel 13, Hayes-Parker House, facing northwest.

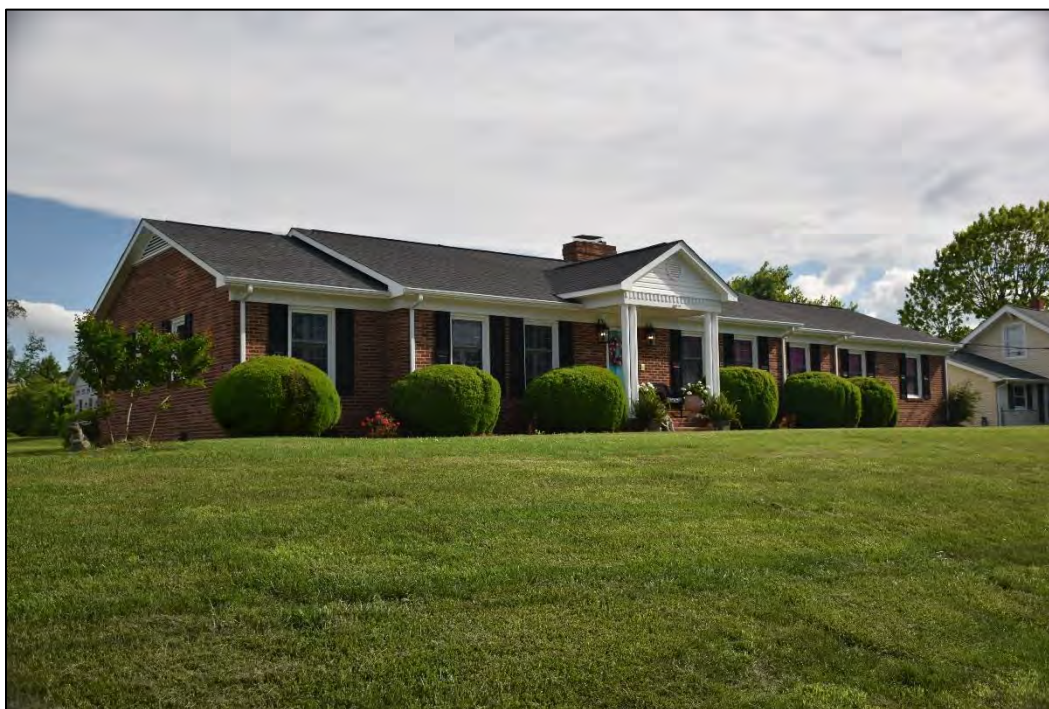
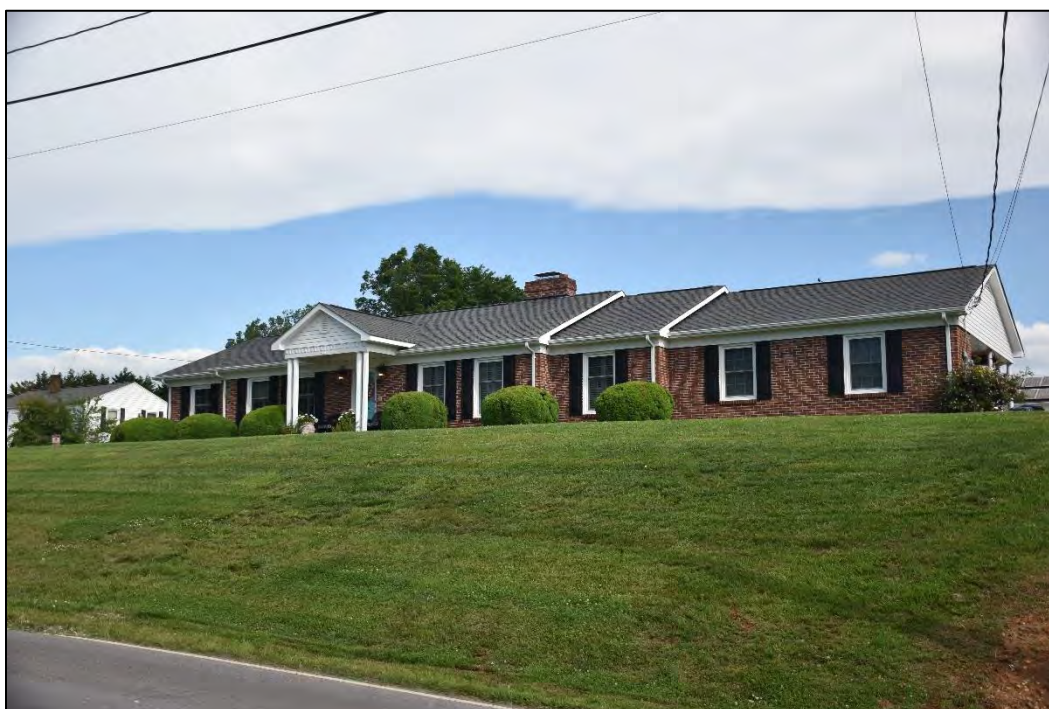
Parcel 14 (Jones-Parker House): The Jones-Parker House is a circa 1965 one-story residence that is located at 600 East Main Street (Figures 2.2.26 and 2.2.27). The house is a Colonial Revival Ranch residence with a side-gabled roof and brick veneer exterior. The house has four parts: a primary section, two stepped back hyphens, and a carport. The main section is five bays, with a central door located beneath a gabled portico, which is supported by paired columns; flanking the door are two single six-over-nine, double-hung, vinyl sash windows. Each of the hyphens, which are located on either side of the main section, are a single bay with a single six-over-nine, double-hung, vinyl sash window. The easternmost section, which is stepped back along the façade from the eastern

Figure 2.2.26. East Wilkesboro Historic District (WK0450), parcel 14, Jones-Parker House, facing northeast.

Figure 2.2.27. East Wilkesboro Historic District (WK0450), parcel 14, Jones-Parker House, facing northwest.

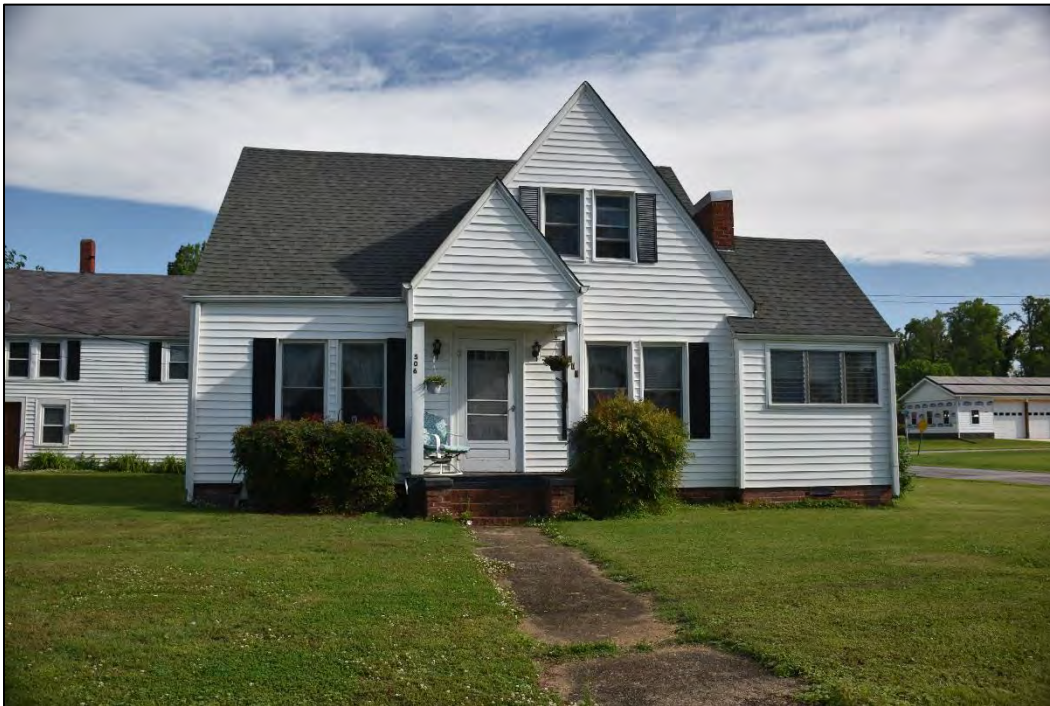
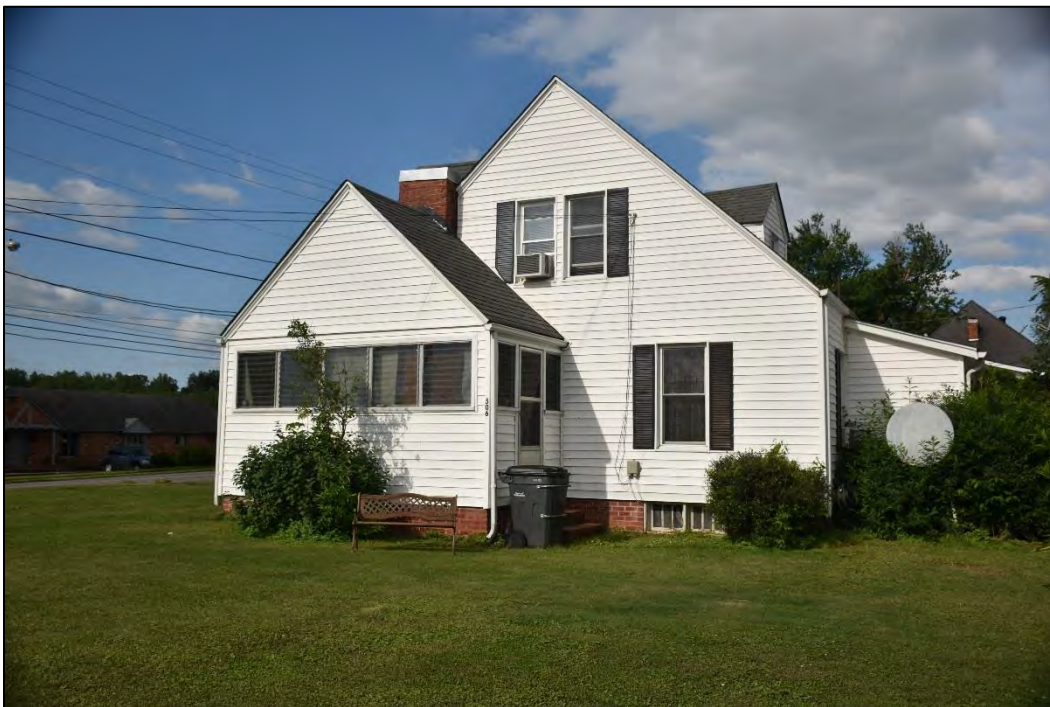
Parcel 15 (Forrester-Hayes House): The Forrester-Hayes House is a circa 1930 one-and-one-half story residence that is located at 506 East Main Street; in addition to the main house, there is also a 1930s garage that has been converted to living space and a secondary early-twentieth-century residential building on the property (Figures 2.2.28–2.2.32). The main house is a frame residence that rests on a brick pier foundation; its form aligns it with the Tudor Revival style, although much of the original detail has been altered. The house has a front-facing gable with a side-gabled wing; the façade is three bays wide. The central doorway is located within the front-facing gable, beneath a gabled portico that creates a nested gable that is common in Tudor Revival architecture; the gabled portico is supported by square vinyl posts. The doorway is flanked by paired one-over-one, double-hung vinyl sash windows on either side. The upper story of the front-facing gable has a paired one-over-one, double-hung, vinyl sash window centered within it. The western elevation of the house has a single one-over-one, double-hung, vinyl sash window on the lower level, along with three smaller one-over-one, double-hung, vinyl sash windows, and a paired one-over-one, double-hung, vinyl sash window on the upper story. The eastern elevation has a side-gabled addition, which has ribbons of jalousie windows on each of its three sides and an entry door on its rear elevation. The east side of the main structure has a single one-over-one, double-hung, vinyl sash window on the lower story and a paired one-over-one, double-hung, vinyl sash window on the upper story. A brick chimney is visible between the main house and the addition. The rear elevation has a shed-roofed addition and a gabled dormer. The house is covered with vinyl siding and the roof is composition shingles.

Figure 2.2.28. East Wilkesboro Historic District (WK0450), parcel 15, Forrester-Hayes House, facing north.

Figure 2.2.29. East Wilkesboro Historic District (WK0450), parcel 15, Forrester-Hayes House, facing west.

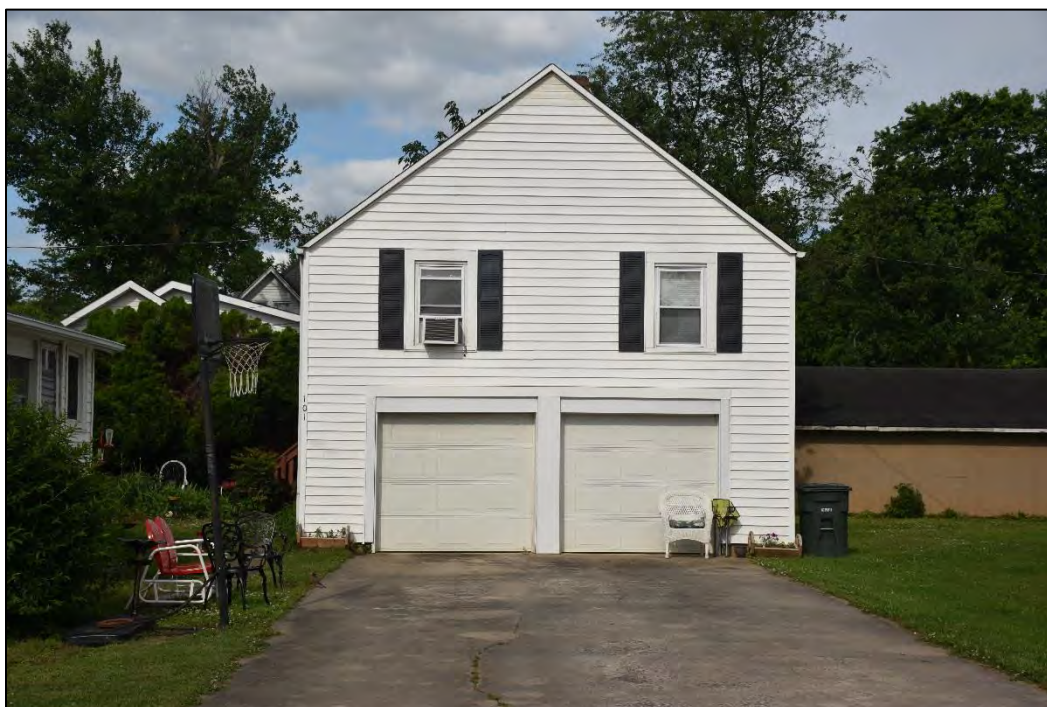
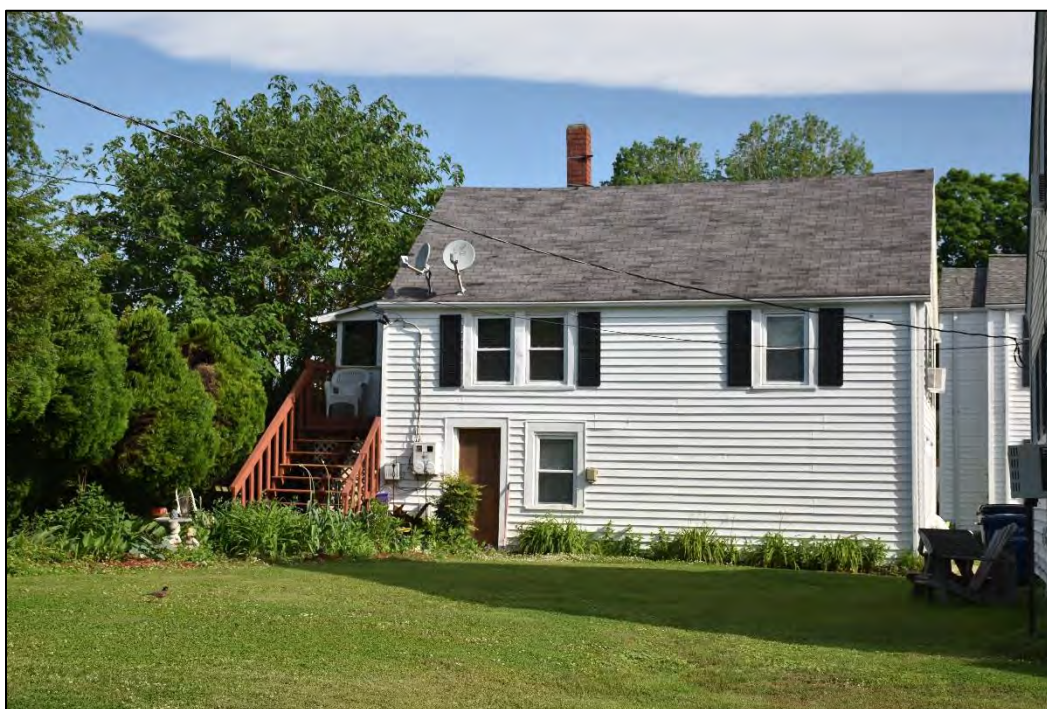
To the northwest of the house is a two-story garage structure that tax records date to the 1930s; the second story of the garage has been converted into an apartment. The building is front-gabled, with the two garage bays facing Salem Street to the east; on the upper story of this elevation are two single one-over-one, double-hung, vinyl sash windows. The south elevation of the garage has a lower level entry door and a single one-over-one, double-hung, vinyl sash window; the upper story has a single and a paired one-over-one, double-hung, vinyl sash windows. A wooden stairway is located along the southwestern corner of the garage and allows access to a shed-roofed rear addition that serves as the entry to the apartment. The garage is covered with vinyl siding and the roof is composition shingles.

Figure 2.2.30. East Wilkesboro Historic District (WK0450), parcel 15, Forrester-Hayes House, garage apartment, facing west.

Figure 2.2.31. East Wilkesboro Historic District (WK0450), parcel 15, Forrester-Hayes House, garage apartment, facing north.

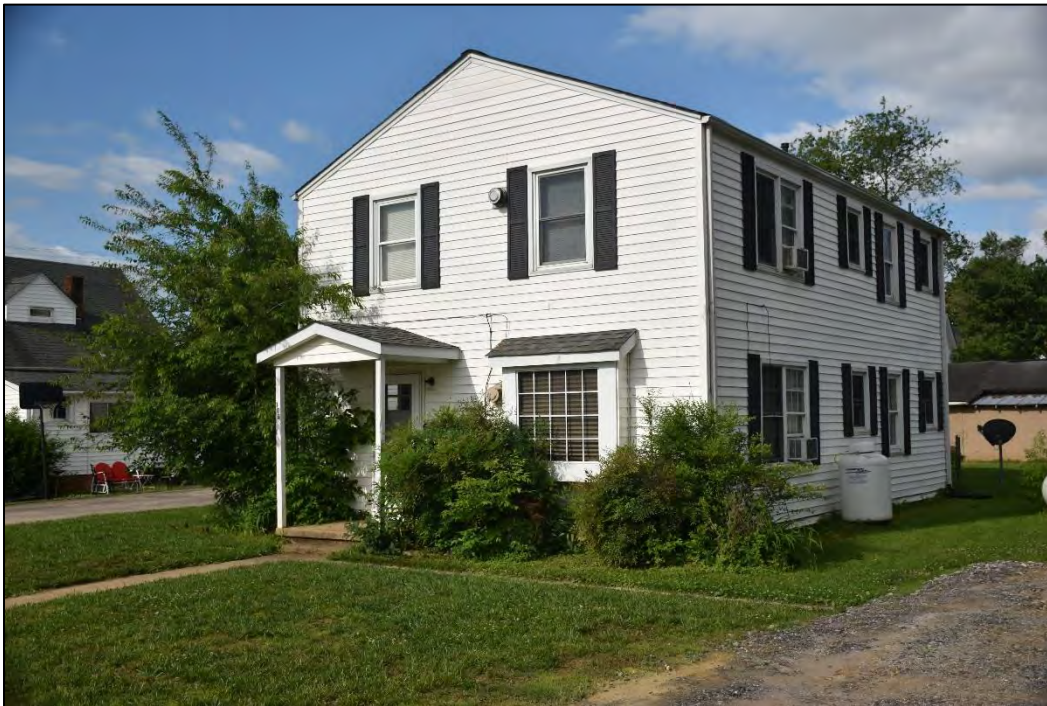
To the northeast of the house is two-story residential structure that is dated to 1940 by tax records. The house has a front-gabled roofline and rests on a concrete block foundation. The front elevation, which faces Salem Street, is two bays wide; the southern bay is the entry door, which is located beneath a gabled portico supported by slender square posts, while the northern bay is a 20-pane picture window located in a shed-roofed projecting bay. The upper story has two single one-over-one, double-hung, vinyl sash windows. The northern elevation has one set of paired six-over-six, double-hung, wooden sash windows on the first and second story, along with three single one-over-one, double-hung, vinyl sash windows on each level. The south elevation has two sets of paired one-over-one, double-hung, vinyl sash windows on each story and a single one-over-one, double-hung, vinyl sash

Figure 2.2.32. East Wilkesboro Historic District (WK0450), parcel 15, Forrester-Hayes House, additional residential building, facing southwest.

window between the stories, presumably in a stairwell. An interior brick chimney is visible above the roofline. The secondary residential structure is covered with vinyl siding and the roof is composition shingles.

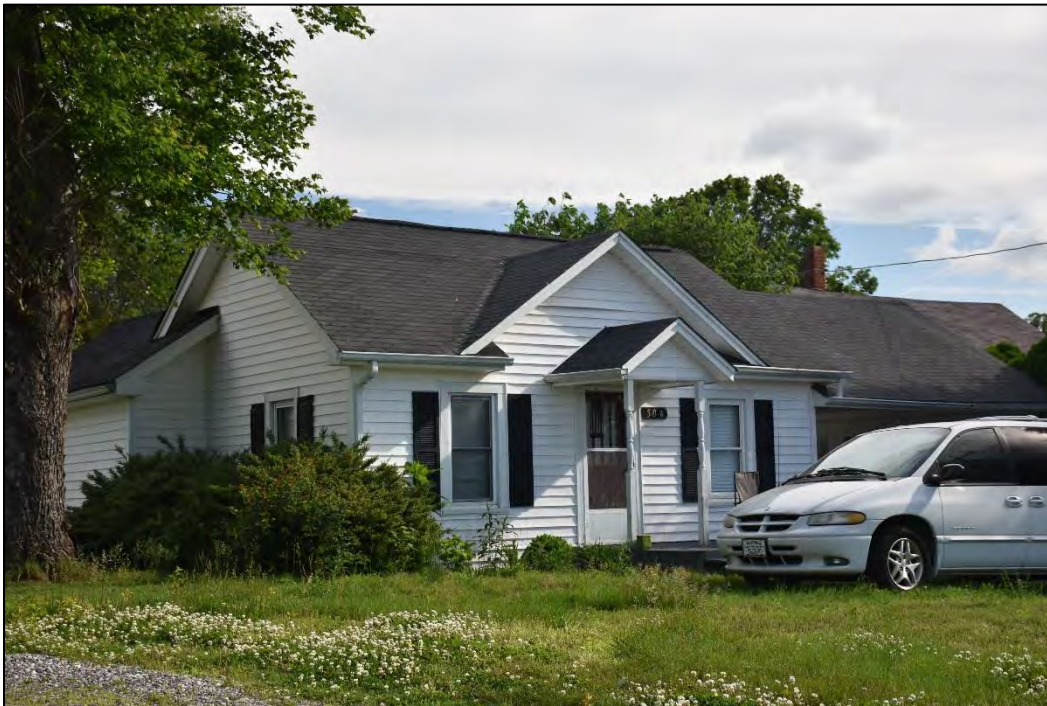
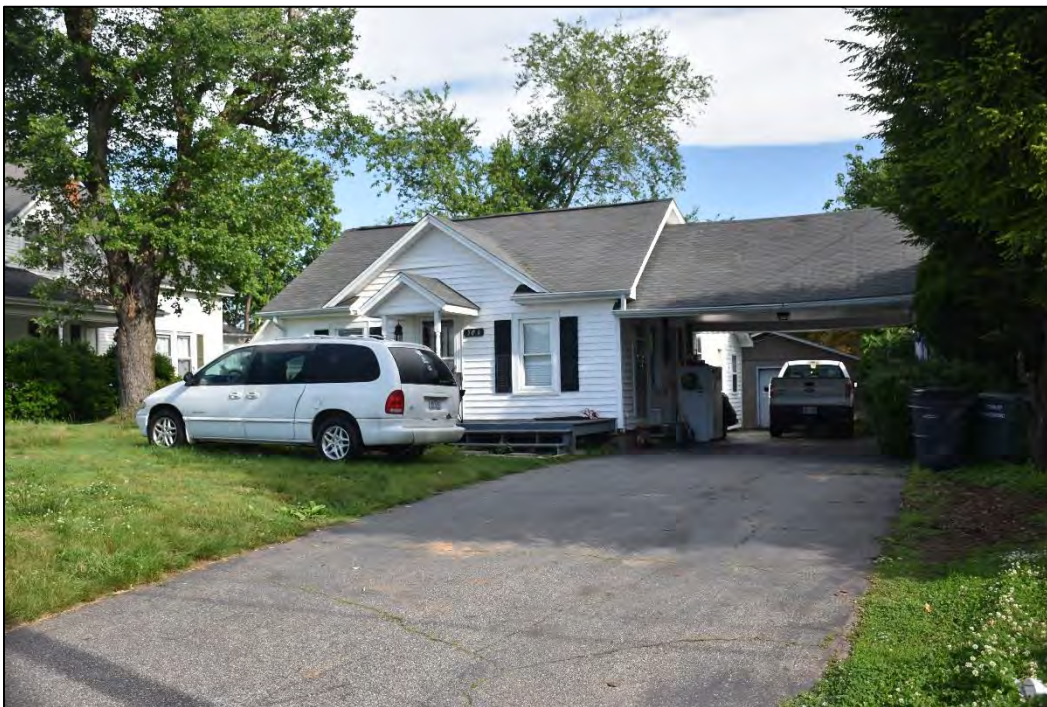
Parcel 16 (Fracassi House): The Fracassi House is a circa 1928 one-story residence that is located at 504 East Main Street (Figures 2.2.33 and 2.2.34). The house is a frame residence, with a basic Triple-A form with a low-pitched central gable. The main side-gabled section is three bays wide, with a central door located beneath a gabled portico that is supported by turned posts; the door is flanked by a single one-over-one, double-hung, vinyl sash window on either side. The western elevation has a single one-over-one, double-hung, vinyl sash window and a shed-roofed addition off a rear ell that is visible along the northwestern corner. The east elevation of the house has a secondary entry door, a single one-over-one, double-hung, vinyl sash window and a small paired one-over-one, double-hung, vinyl sash window. The rear ell, which includes a modern entry door, one-over-one, double-hung, vinyl sash window, and six-over-six, double-hung, vinyl sash window, is visible at the northeastern corner. An open carport, supported by metal posts, is attached to this elevation. The house is covered with vinyl siding and the roof is asphalt shingles.

Figure 2.2.33. East Wilkesboro Historic District (WK0450), parcel 16, Fracassi House, facing northeast.

Figure 2.2.34. East Wilkesboro Historic District (WK0450), parcel 16, Fracassi House, facing northwest.

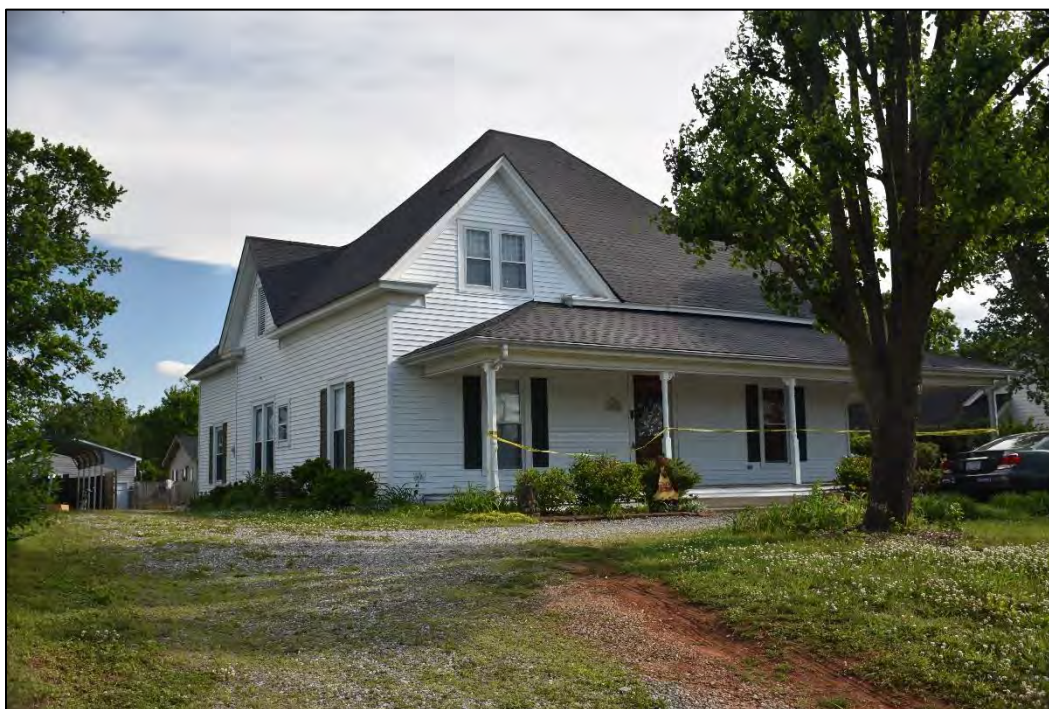
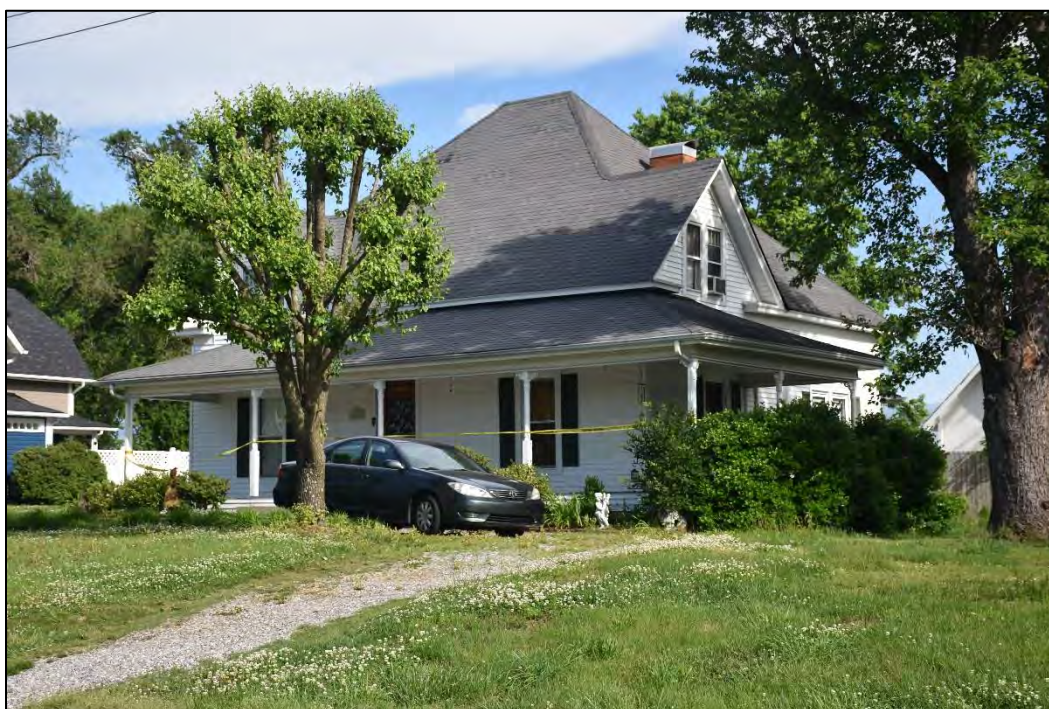
Parcel 17 (Pharr House – WK0035): A previously unnamed House (now the Pharr House), located at 502 East Main Street, is a circa 1915 one-and-one-half story residence (Figures 2.2.35 and 2.2.36); it was recorded in 1979 as part of the Wilkesboro survey and dated to around 1910. The house, which has a steep pyramidal roof with cross gables, has a Victorian form; it is of frame construction and rests on a brick pier foundation. The front elevation is three bays wide, with a central doorway flanked by a single one-over-one, double-hung, metal frame window on either side. The front-facing cross gable has a paired sixteen-over-one, double-hung, wooden sash window centered within it. The house has a hip-roofed porch that wraps around from the front elevation to the eastern elevation, supported by turned posts and carved brackets. The east elevation has a single one-over-one, double-

Figure 2.2.35. East Wilkesboro Historic District (WK0450), parcel 17, Pharr House (WK0035), facing northeast.

Figure 2.2.36. East Wilkesboro Historic District (WK0450), parcel 17, Pharr House (WK0035), facing northwest.

hung, metal sash window beneath the porch roof and a paired one-over-one, double-hung, metal sash window behind it. The eastern cross gable has a paired four-over-one, double-hung, wooden sash window centered within it. The western elevation has a central cross gable, with a louvered rectangular vent centered within it. On the lower story are two single and one paired one-over-one, double-hung, metal frame windows and a smaller one-over-one, double-hung, vinyl sash window. The house is covered with vinyl siding, as are the undersides of the roof eaves; the roof is composition shingles. An interior brick chimney is visible behind the eastern cross gable. Each of the gable ends has cornice returns, reflecting a Colonial Revival influence from the early twentieth century. Comparison with photographs from the 1979 survey shows that the house has undergone alterations to the porch supports, which were previously Doric columns, also an element of the Colonial Revival style; the removal of a second chimney along the interior near the western cross gable; and the installation of vinyl siding and a new roof.

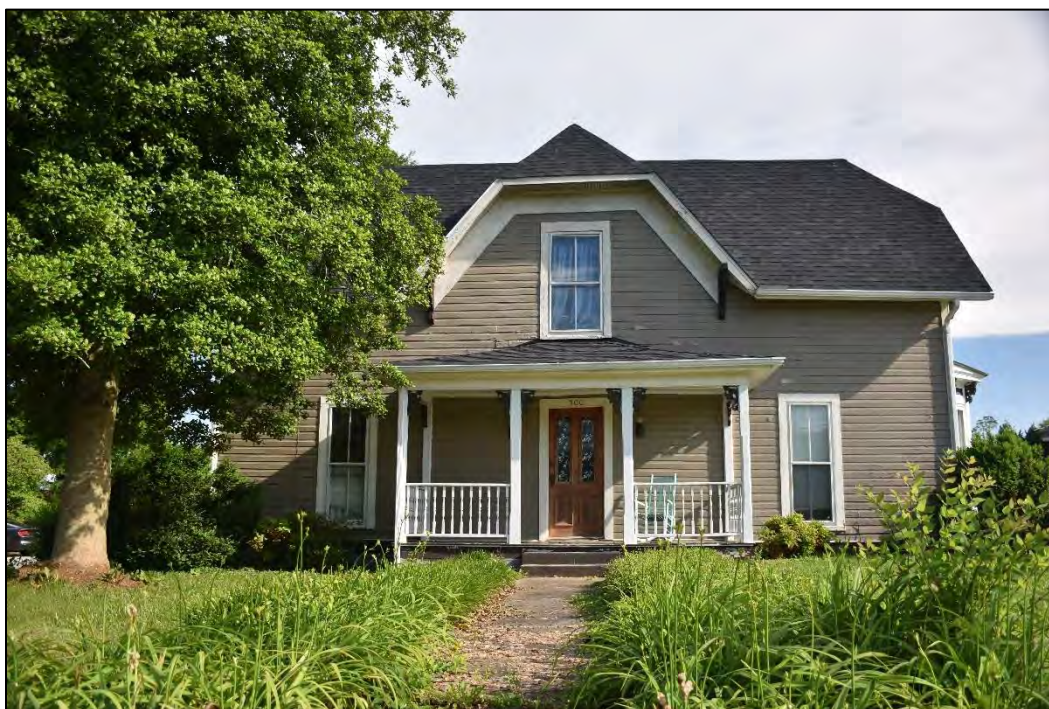
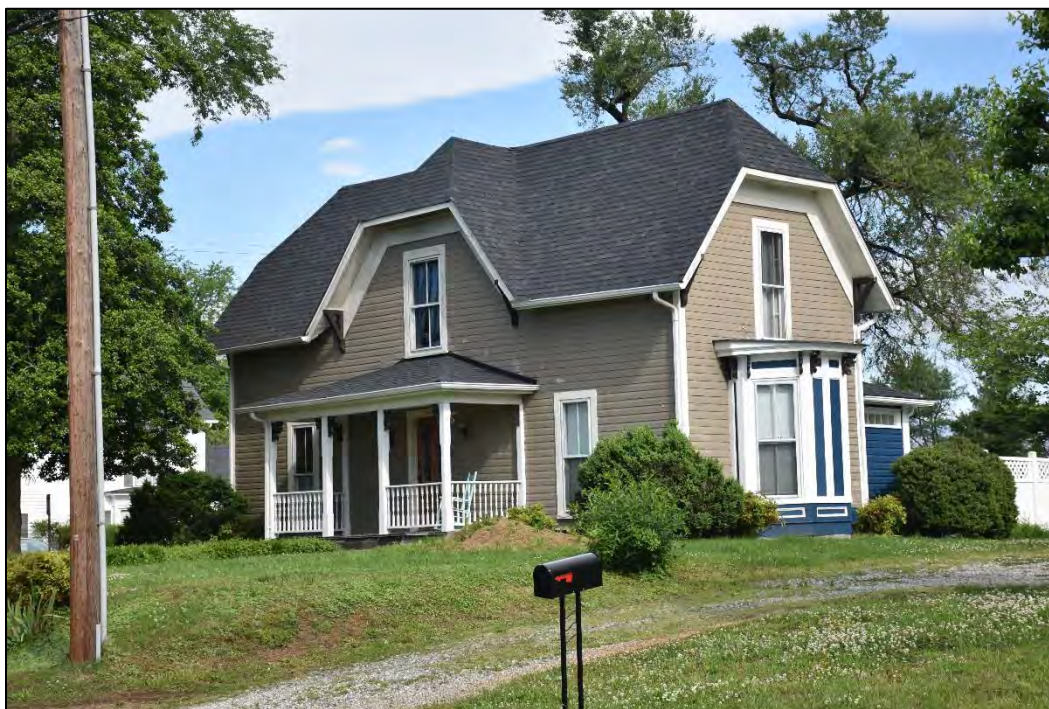
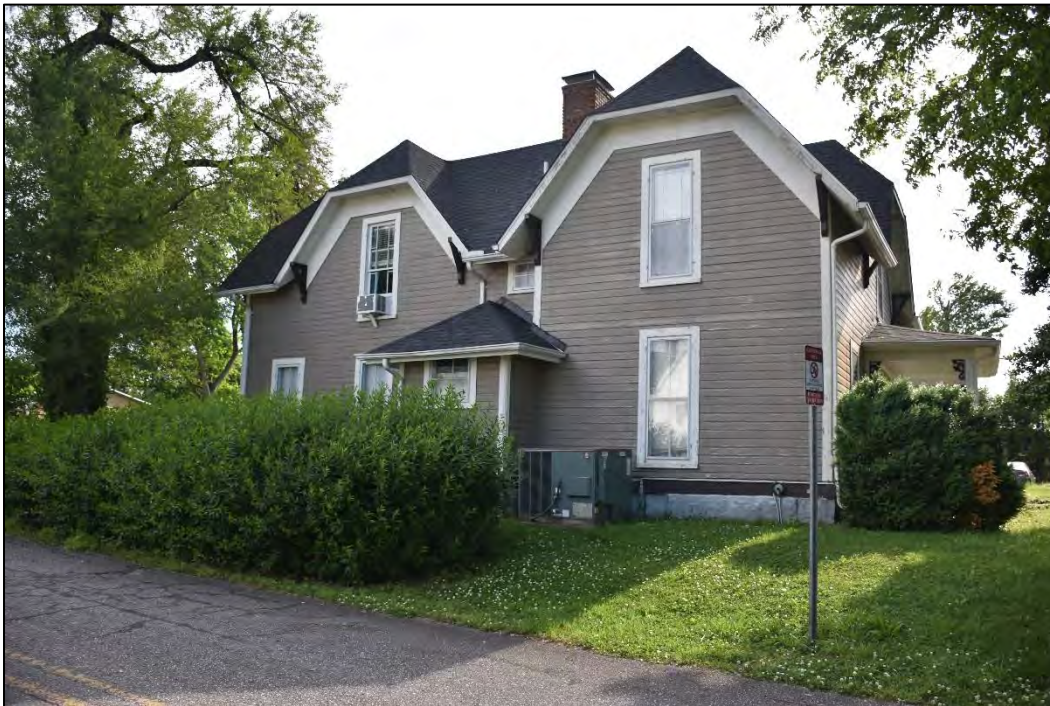
Parcel 18 (Dr. Erwin House – WK0019): The Dr. Erwin House is a circa 1890 one-and-one-half story residence that is located at 500 East Main Street (Figures 2.2.37–2.2.39); it was recorded in 1979 as part of the Wilkesboro survey and dated to around 1880. The house is an eclectic mixture of architectural styles, reflecting multiple contemporary styles from around its construction period as well as having details that may have been added during the early twentieth century. The frame residence has a Folk Victorian form, reminiscent of the popular Triple A house, but the central front gable and both end gables are clipped, creating a jerkinhead roofline. The central door has two lower panels and two tall glazed upper panes, which reflects a Gothic Revival or Italianate influence. It is flanked on either side by a single, tall, two-over-two, double-hung, wooden sash window; a single two-over-two, double-hung, wooden sash window is centered within the upper story. A one-bay, hip-roofed portico that is supported by chamfered posts covers the central portion of the first story, below the central clipped gable. A wide frieze trim band is located along the raking cornice of the central clipped gable and triangular brackets are located at the corners of this central section; the wide trim band may reflect the Colonial Revival style or may be a substitute for the bargeboard used in Victorian architecture, while the triangular brackets align with the later, twentieth century, Craftsman tradition. The house has an L-shaped plan, with a two-story rear ell extending back from the main side-gabled section. The western elevation has two clipped-gable sections, there are three single two-over-two, double-hung, wooden sash windows on the first story, while the second story of each clipped-gable section has a decorative window with a central pane surrounded by smaller panes on both the upper and lower sash. A small, one-story, hipped roof addition projects out slightly from between the two gabled sections; this addition has a small, four-pane window located in it and another four-pane window is located between the two gable sections, potentially in a stairwell. An interior brick chimney is visible between the two gables. Each clipped-gable section has the same wide frieze and brackets as the front gable. On the east elevation, there is a single clipped-gable section that is one bay deep. The upper story has a single two-over-two, double-hung, wooden sash window. The lower story has a three-sided projecting bay with two-over-two, double-hung, wooden sash windows on two sides and a decorative herringbone wooden pattern on the central section; above the windows are small diagonal pattern wooden panels and carved brackets. This detailed projecting bay fits into the Victorian tradition of the late nineteenth century. The gable end on the eastern elevation also has the wide trim and brackets as the other elevations. The north (rear) elevation of the house is a single bay, with clipped-gable roof that has the wide trim and brackets; a single two-over-two, double-hung, wooden sash window is located on both the first and second stories. A hipped roof porch is inset between the front side-gabled section and the rear ell, at the northeast corner of the house. The house is sheathed in horizontal wooden weatherboard siding and the roof is composition shingles. Comparison with photos from the 1979 survey show that two additional porch supports, near the center of the porch, and a balustrade have been added to the house but little else has changed on the exterior.

Figure 2.2.37. East Wilkesboro Historic District (WK0450), parcel 18, Dr. Erwin House (WK0019), facing north.

Figure 2.2.38. East Wilkesboro Historic District (WK0450), parcel 18, Dr. Erwin House (WK0019), facing northwest.

Figure 2.2.39. East Wilkesboro Historic District (WK0450), parcel 18, Dr. Erwin House (WK0019), facing northeast.

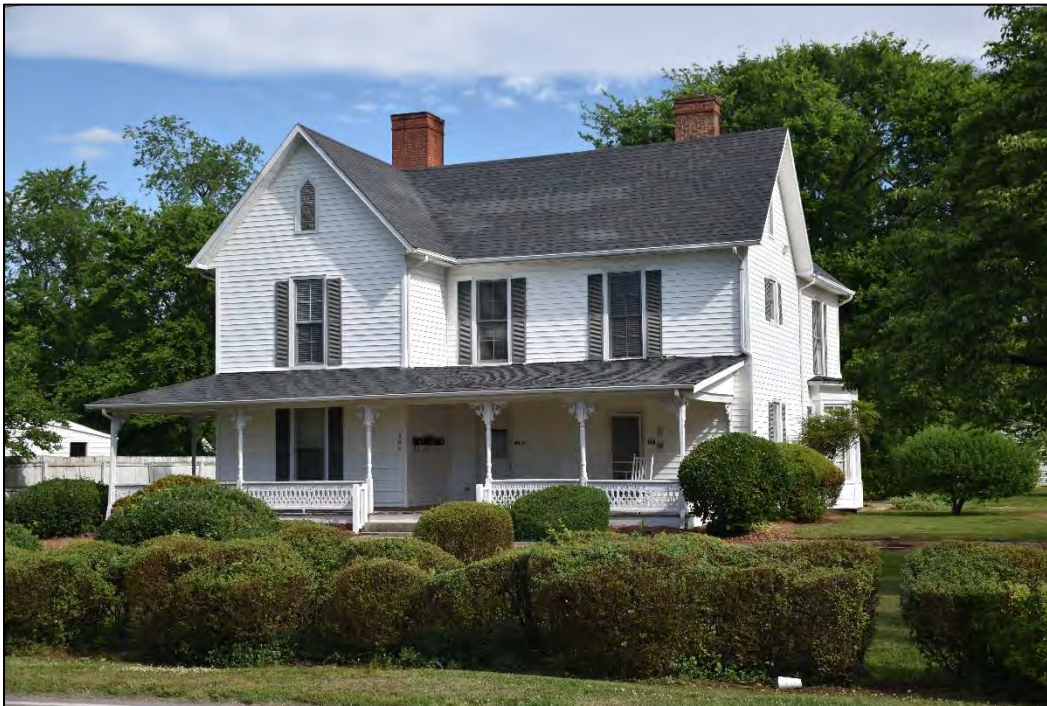
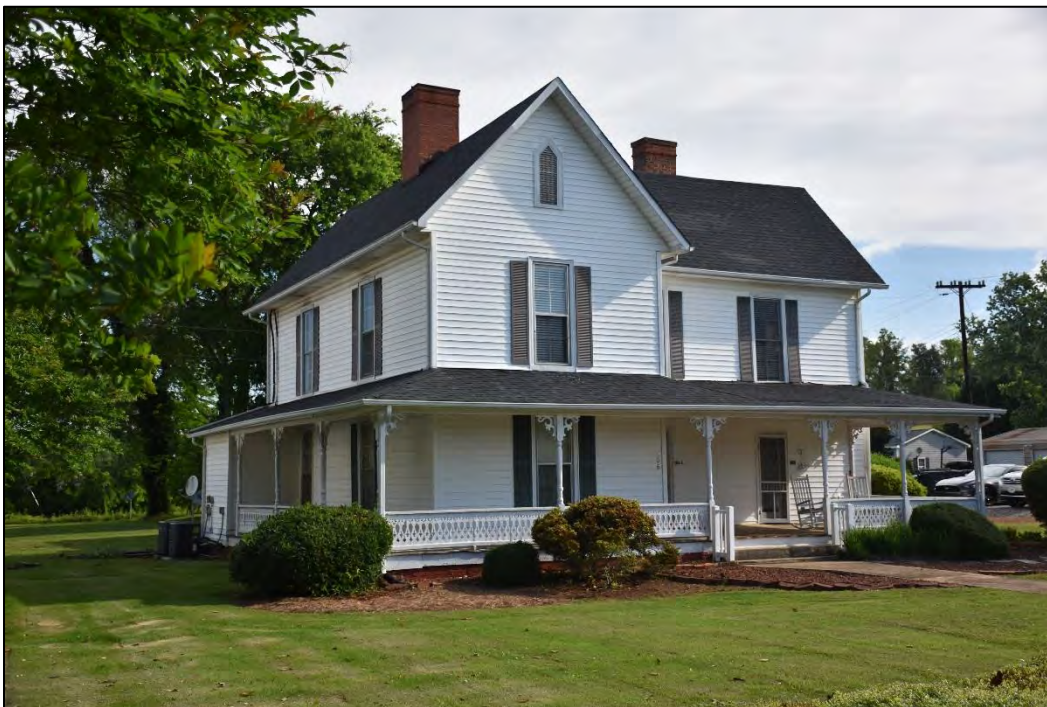
Parcel 19 (Barber House – WK0007): The Barber House is a circa 1900 two-story residence that is located at 406 East Main Street (Figures 2.2.40 and 2.2.41); it was recorded in 1979 as part of the Wilkesboro survey and dated to around 1880. The house is a two-story, gable-front-and-wing form with a three-bay façade and Victorian detailing. The western portion of the front elevation is a projecting front-gabled bay, with a single four-over-four, double-hung, wooden sash window on both the first and second stories; a pedimented attic vent is centered within the gable end. The side-gabled section is two bays wide; on the first story, there are two entry doors on the first elevation, as the house has been divided into two apartments, while the windows on the second story are single four-over-four, double-hung, wooden sash. A hipped roof porch, supported by turned posts with scrollwork brackets and with an intricately carved balustrade, spans the front elevation and wraps around the front-gabled section to the western elevation; a rear section of the porch on the west elevation has been enclosed. The western elevation is two bays deep, with a single four-over-four, double-hung, wooden sash window on both the first and second stories. The eastern elevation of the main portion of the house is one bay deep, with a single four-over-four, double-hung, wooden sash window on the lower story and a smaller window on the upper story; a pedimented attic vent is centered within the gable. A two-story, gabled rear addition, with a single four-over-four, double-hung, wooden sash window on the upper story and a three-sided projecting bay window on the lower story, is visible along this elevation. A single story, gabled rear addition extends from the two-story rear ell. The house is covered with vinyl siding and has a composition shingle roof; two interior brick chimneys are visible along the roof ridge of the side-gabled section. Comparison with survey photographs from 1979 indicates that the Barber House has had vinyl siding installed, which has removed a trim band along the raking cornice of the gable ends, and has had one of its lower story windows on the front elevation converted to a door when the house was split into two apartments; the roof has also been replaced.

Figure 2.2.40. East Wilkesboro Historic District (WK0450), parcel 19, Barber House (WK0007), facing northwest.

Figure 2.2.41. East Wilkesboro Historic District (WK0450), parcel 19, Barber House (WK0007), facing northeast.

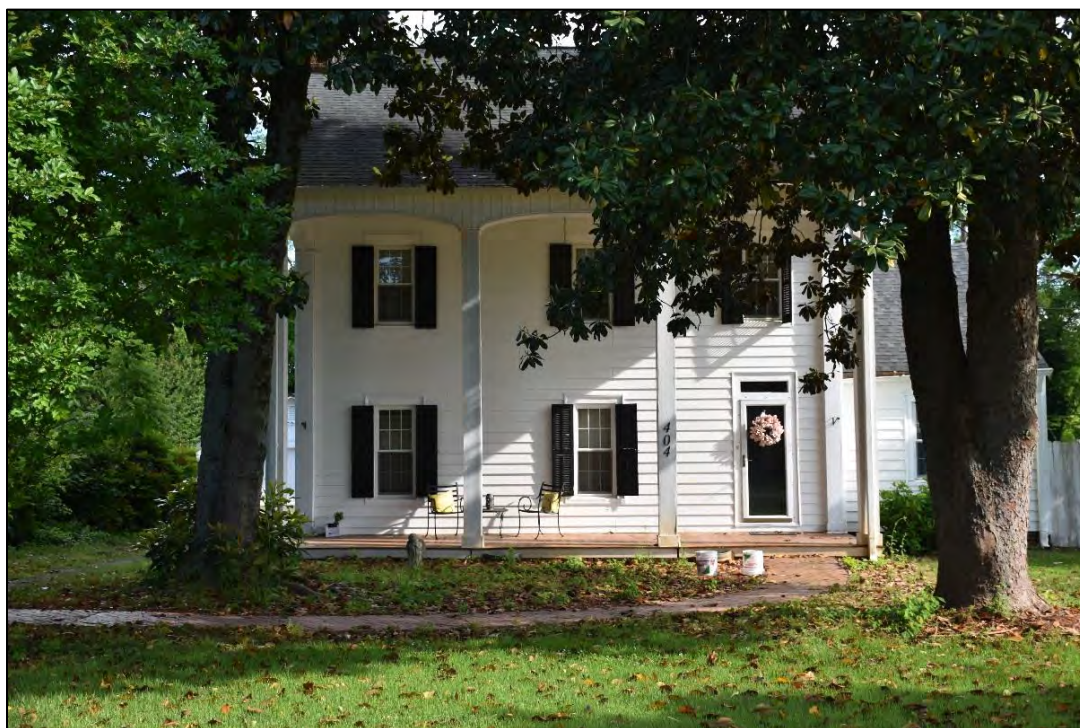
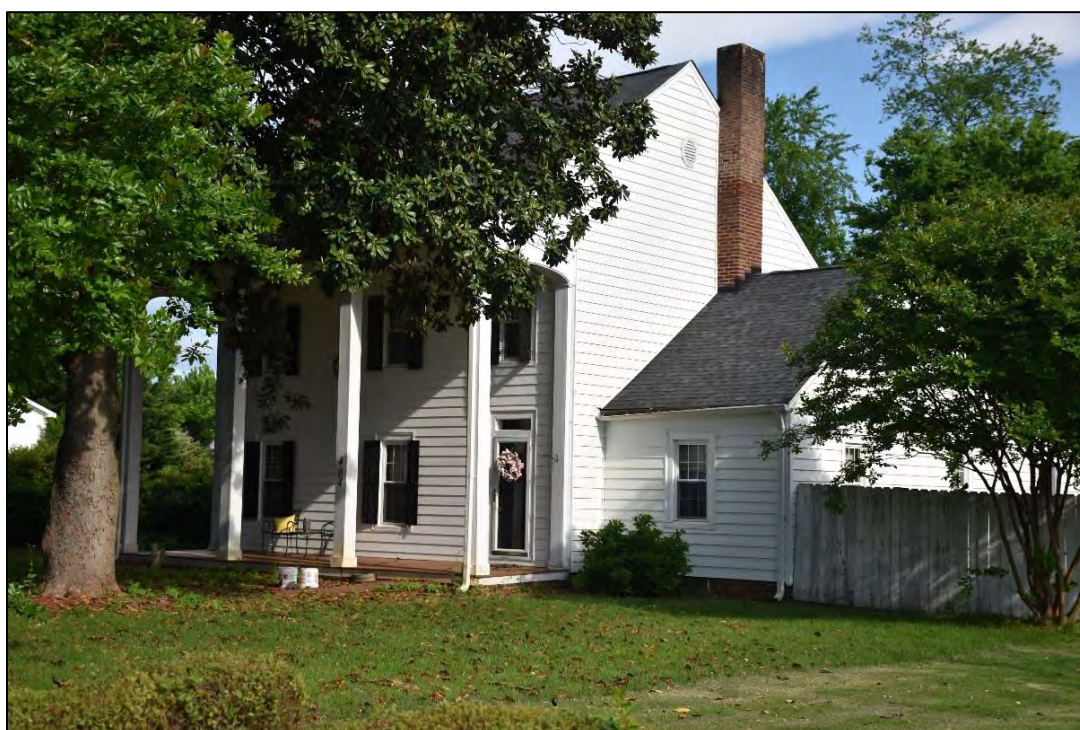
Parcel 20 (Ballinger House): The Ballinger House is a circa 1935 two-story residence that is located at 404 East Main Street (Figures 2.2.42 and 2.2.43). The house is of frame construction and has elements of the Neoclassical style that was popular during the early twentieth century. The front elevation is three bays wide, with the entry door, with a single pane transom, at the eastern bay and two single six-over-six, double-hung, wooden sash windows to the west; the upper story has three single six-over-six, double-hung, wooden sash windows. The house has a monumental two-story porch that is located beneath an extension of the main side-gabled roofline that is supported by square columns; the columns of the porch have an arched band beneath the roof eave, which has been covered with vertical vinyl paneling. The west elevation has an engaged exterior brick chimney, with two single six-over-six, double-hung, wooden sash windows on each story behind it; an octagonal attic vent is centered in the gable end. The eastern elevation has an exterior brick chimney and an octagonal attic vent, but no visible window openings. A single story, side-gabled wing has been attached to this elevation and has a single six-over-six, double-hung, wooden sash window on its south elevation and two single six-over-six, double-hung, wooden sash windows on its east elevation. The house is covered with vinyl siding and the roof is composition shingles.

Figure 2.2.42. East Wilkesboro Historic District (WK0450), parcel 20, Ballinger House, facing north.

Figure 2.2.43. East Wilkesboro Historic District (WK0450), parcel 20, Ballinger House, facing northwest.
