SUBJECT: Historic Structures Survey Report, R-5772, Upgrade SR 1001 from US 421 to NC 268,
PA 19-02-0016, Wilkes County, ER 19-2317

Historic Structures Survey Report
TIP No. R-5772, WBS No. 44692.1.1, PA No. 19-02-0016
Upgrade SR 1001 (Oakwoods Road)
from US 421 to NC 268 (East Main Street)
Wilkes County, North Carolina
S&ME Project No. 4213-19-107

**Historic Structures Survey Report
TIP No. R-5772
Upgrade SR 1001 (Oakwoods Road)
from US 421 to NC 268 (East Main Street)
Wilkes County, North Carolina**

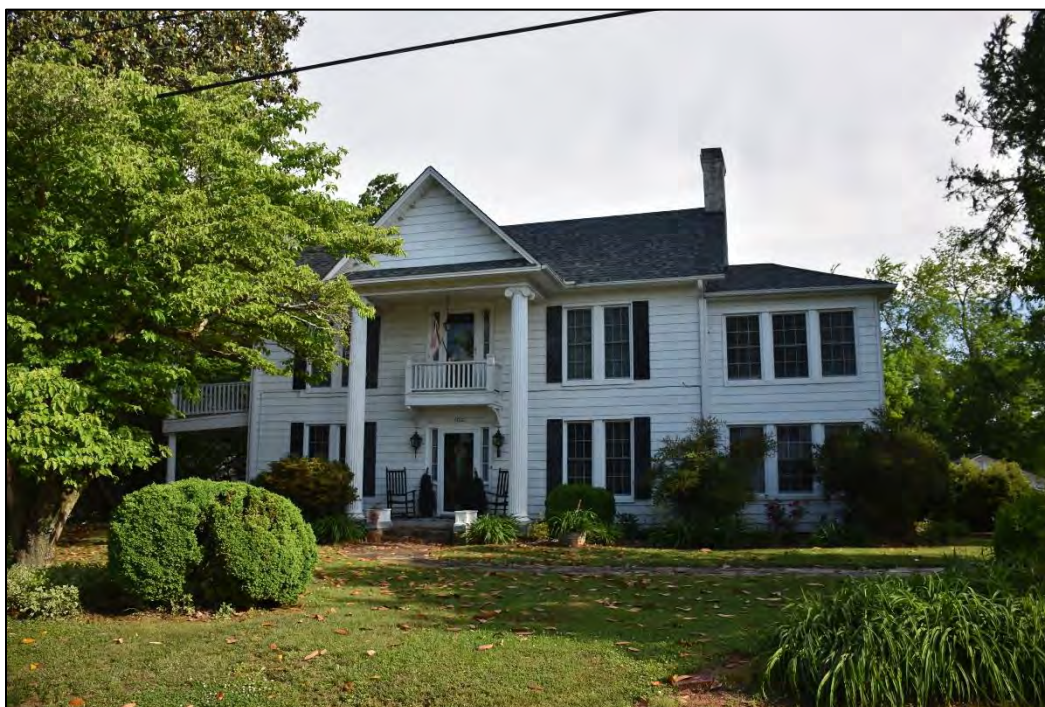
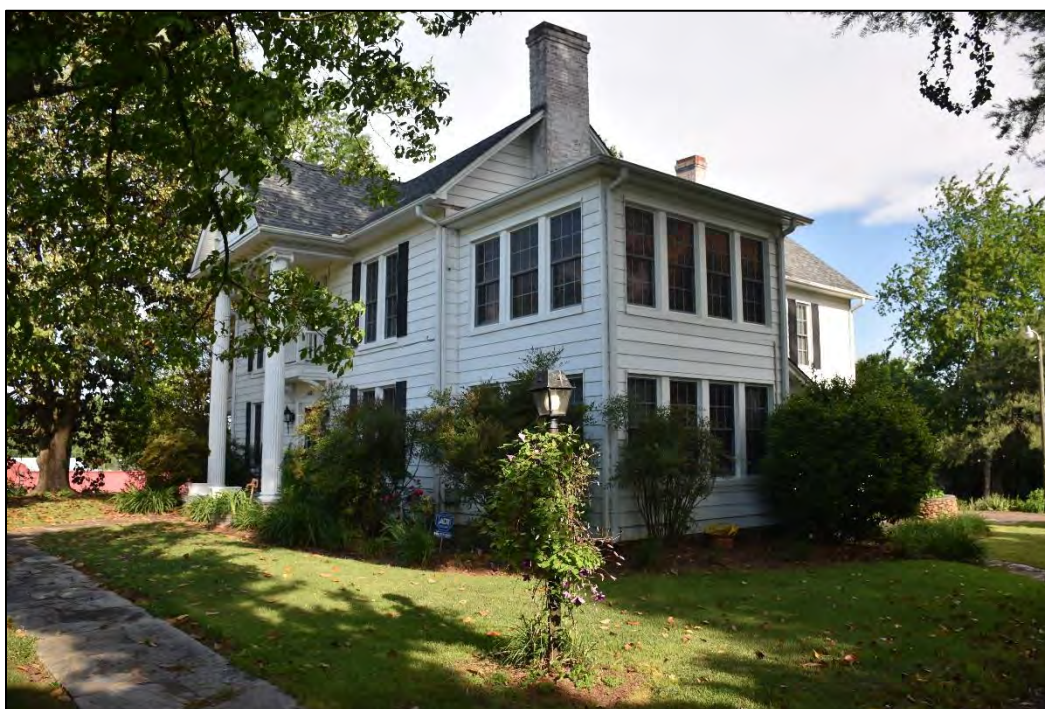
Parcel 21 (McNeill-Hayes House – WK0044): The McNeill-Hayes House is a circa 1895 two-story residence that is located at 402 East Main Street (Figures 2.2.44 and 2.2.45); it was recorded in 1979 as part of the Wilkesboro survey and was dated to the 1890s. The frame residence has a side-gabled roofline and three bay front façade. The central door, which has three-pane sidelights, is flanked by paired nine-over-nine, double-hung, vinyl sash windows on either side. The upper story has the same configuration as the lower story, with the upper doorway leading to a balcony that is supported by triangular brackets. The central bay of the house has a monumental gabled two-story porch, supported by Ionic columns and has denticulate trim along the frieze and the raking cornice. These Neoclassical elements postdate the original construction of the house and were part of a circa 1930s remodel. The original section of the house has symmetrical exterior end chimneys that remain visible above the additions on either side. The eastern elevation has a two-story, hipped roof addition that has a ribbon of three six-over-six, double-hung, vinyl sash windows on both the first and second stories of the south elevation and a ribbon for four six-over-six, double-hung, vinyl sash windows on both stories of the east elevation. The western elevation has a two-story porch that is supported by Ionic columns. A large, two-story gabled rear addition connects to another side-gabled section of the house along the northwest corner. The house is covered with aluminum siding and the roof is composition shingles. Comparison to photographs from the 1979 survey show that the house has undergone little exterior change in the past four decades.

Figure 2.2.44. East Wilkesboro Historic District (WK0450), parcel 21, McNeill-Hayes House (WK0044), facing north.

Figure 2.2.45. East Wilkesboro Historic District (WK0450), parcel 21, McNeill-Hayes House (WK0044), facing northwest.

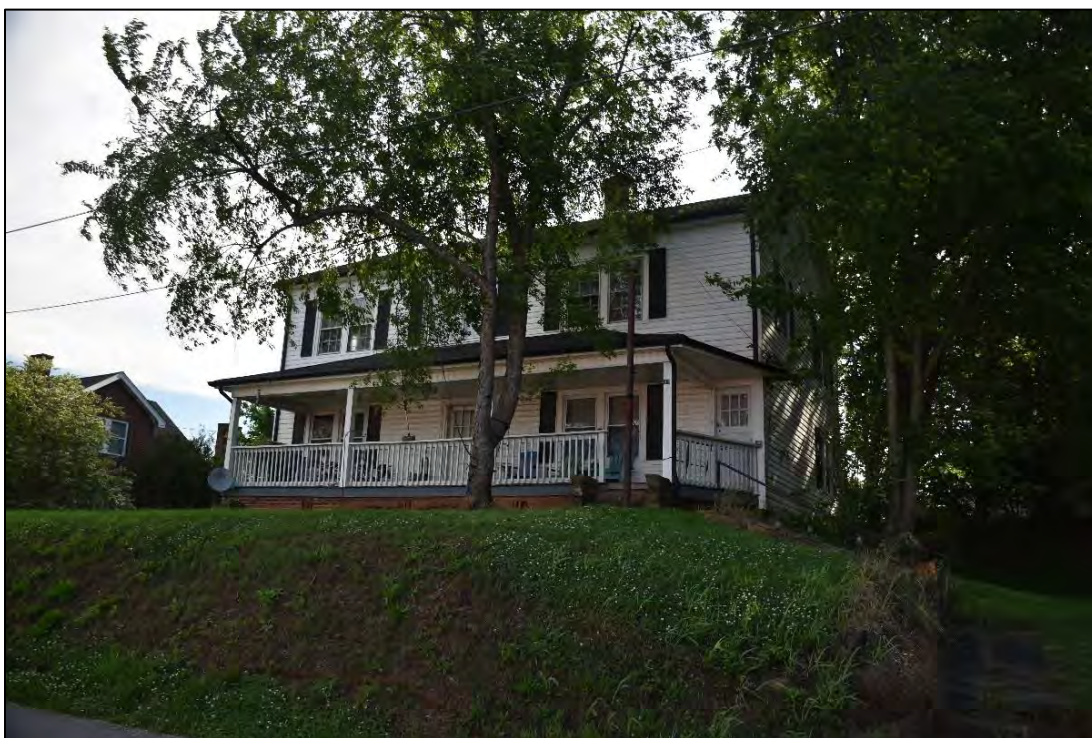
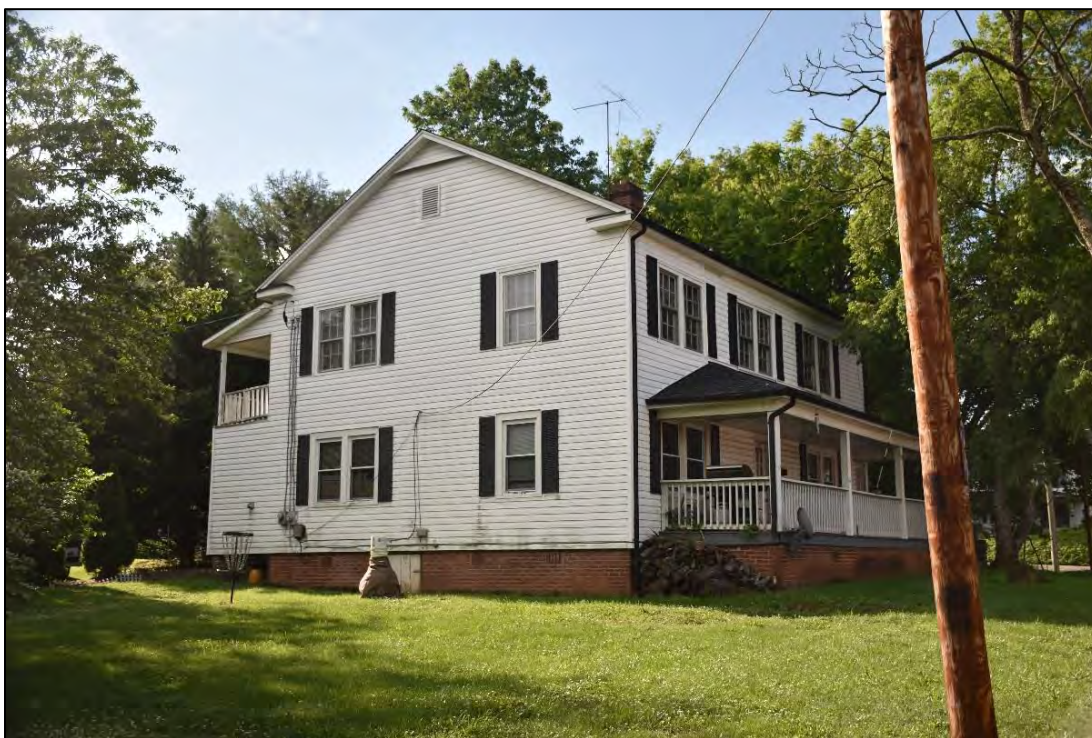
Parcel 22 (Greene House): The Greene House is a circa 1940 two-story residence that is located at 100 Jefferson Street (Figures 2.2.46 and 2.2.47). The house, which has road frontage along East Main Street but is oriented toward Jefferson Street, has a side-gabled roofline and rests on a brick foundation. The front elevation has three bays, although there is an added entry door at the southwest corner of the house; the central entry door is flanked by paired one-over-one, double-hung, vinyl sash windows on either side. A one-story, hipped roof porch, supported by square posts, spans the façade. The upper story has three evenly spaced, paired, six-over-six, double-hung, wooden sashed windows. The northern elevation has a single and paired one-over-one, double-hung, vinyl sash windows on the lower story and a single and paired six-over-six, double-hung, wooden sash windows on the upper story. A shed-roofed rear porch, which has been enclosed along the first story, is visible at the northeast corner of the house. The south elevation has a paired one-over-one, double-hung, vinyl sash window on the lower story and a paired six-over-six, double-hung, wooden sash window on the upper story. The house is covered with vinyl siding and the roof is composition shingles; the gable ends have cornice returns, which are the lone architectural detailing, and an interior brick chimney is visible along the roof ridge.

Figure 2.2.46. East Wilkesboro Historic District (WK0450), parcel 22, Greene House, facing northeast.

Figure 2.2.47. East Wilkesboro Historic District (WK0450), parcel 22, Greene House, facing southeast.

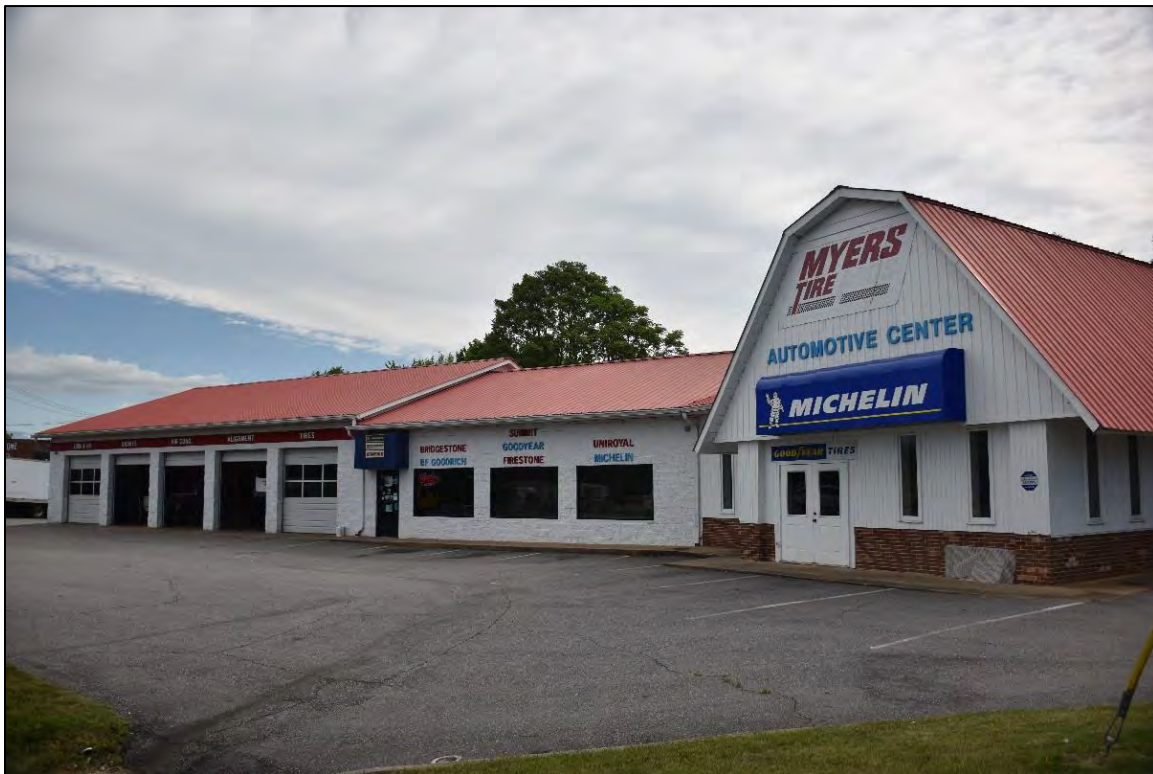
Parcel 23 (Myers Tire): Myers Tire is a circa 1970s one-story commercial building, with a mid-1990s addition, that is located at 400 East Main Street (Figures 2.2.48 and 2.2.49). The 1970s section of the building is the two-story portion with the gambrel roofline that is oriented to the front of the building, diagonally away from the corner of East Main Street and Jefferson Street. The three-bay front elevation has a modern double entry door, with two tall vertical fixed window panes. The lower portion of the front elevation has a brick veneer, while the portion beneath the roof-wall juncture has vertical wooden siding; the gambrel portion of the house overhangs the first story slightly and is covered with vertical metal panel siding. The vertical fixed pane windows, brick veneer, and wooden paneling continue along the southwest elevation of the building. A side-gabled hyphen, with two tall vertical fixed window panes, links the main structure to the later additions. The additions consist of two concrete block masonry, side-gabled sections with rooflines of slightly different heights. The southern addition has a single entry door and three large plate glass display windows. The northern addition has five garage door bays. The entire structure has a standing-seam metal roof.

Figure 2.2.48. East Wilkesboro Historic District (WK0450), parcel 23, Myers Tire, facing north.

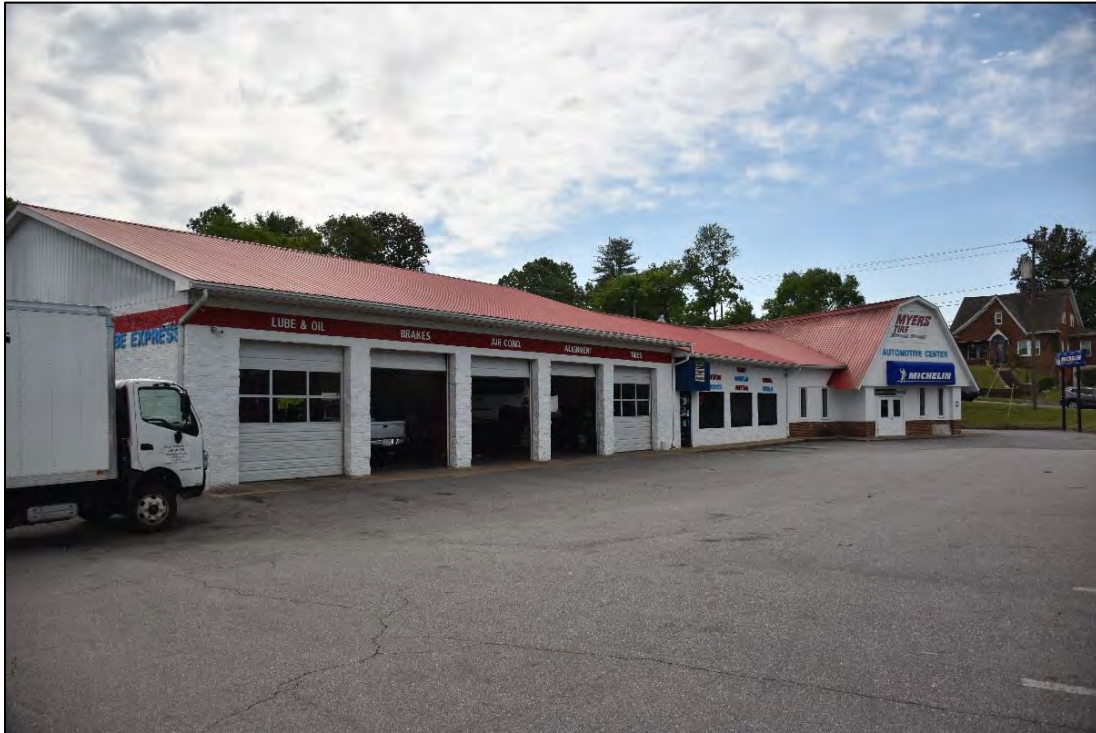
Figure 2.2.49. East Wilkesboro Historic District (WK0450), parcel 23, Myers Tire, facing south.

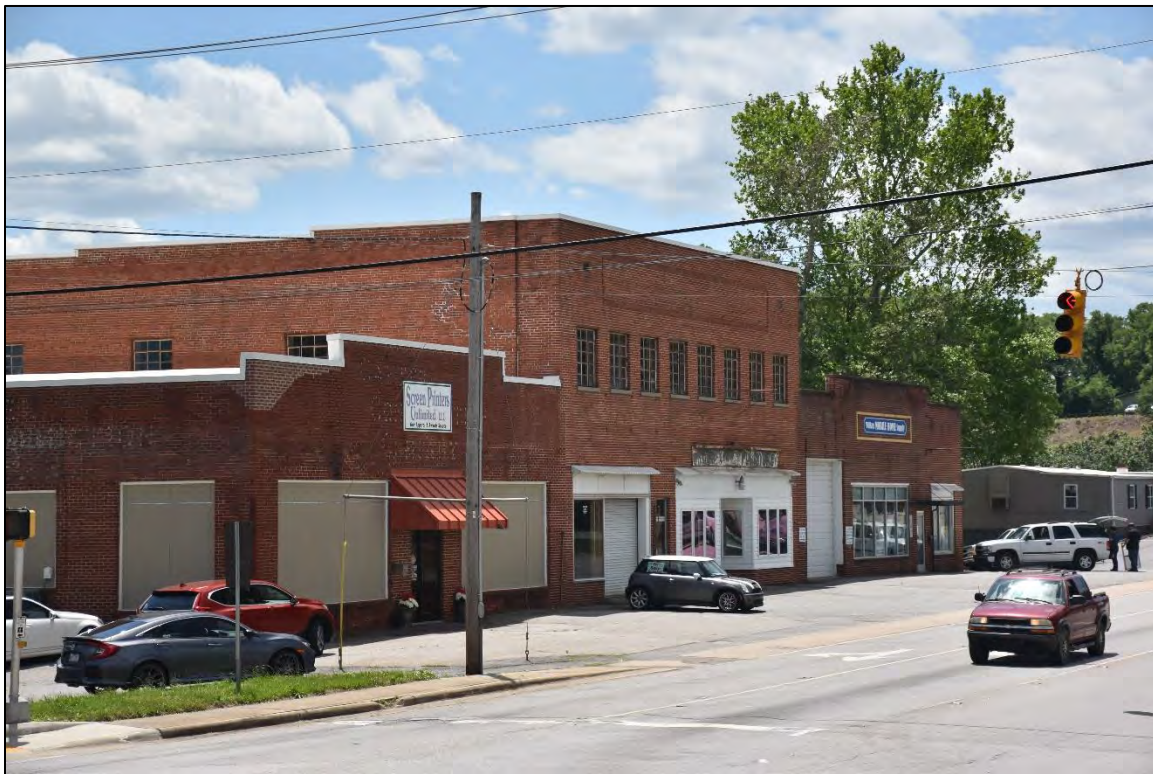
Figure 2.3.1. 300 East Main Commercial Block (WK0451, WK0452, and WK0453), facing southwest.

The 300 East Main Commercial Block consists of three adjacent structures (WK0451, WK0452, WK0453) and tax parcels, which create a commercial block along the south side of East Main Street, west of its intersection with Oakwoods Road. The three structures are currently addressed as 309, 327, and 331 East Main Street (Figures 1.1 and 1.2). The three buildings were originally constructed beginning in 1945, with the easternmost building (331 East Main Street) being erected first, followed by the adjoining structures. The commercial block presents a symmetrical appearance, with a two-story central block flanked by a single story structure with a parapet roof on either side (Figure 2.3.1). The lot on which the commercial block sits slopes away from the frontage on East Main Street, leaving each structure with a lower level that is accessible from the rear of the lot (Figure 2.3.2). Currently, the central structure is unoccupied, with the eastern and western buildings holding commercial businesses.

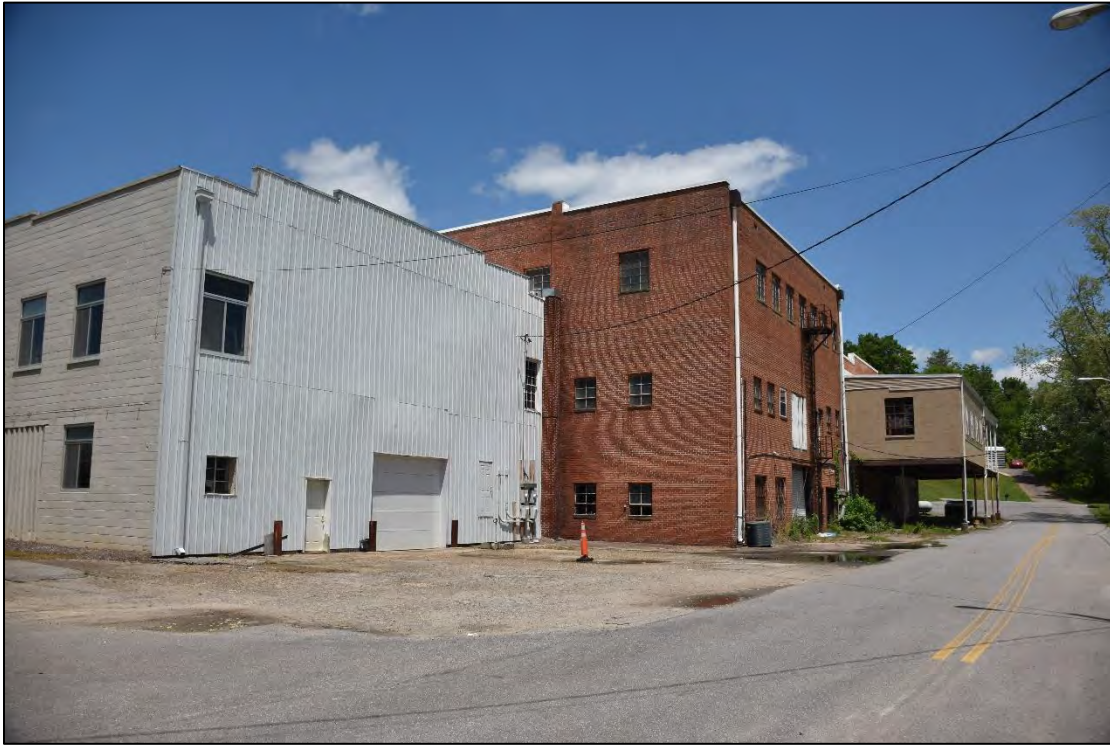
Figure 2.3.2. 300 East Main Commercial Block (WK0451, WK0452, and WK0453), facing northeast.

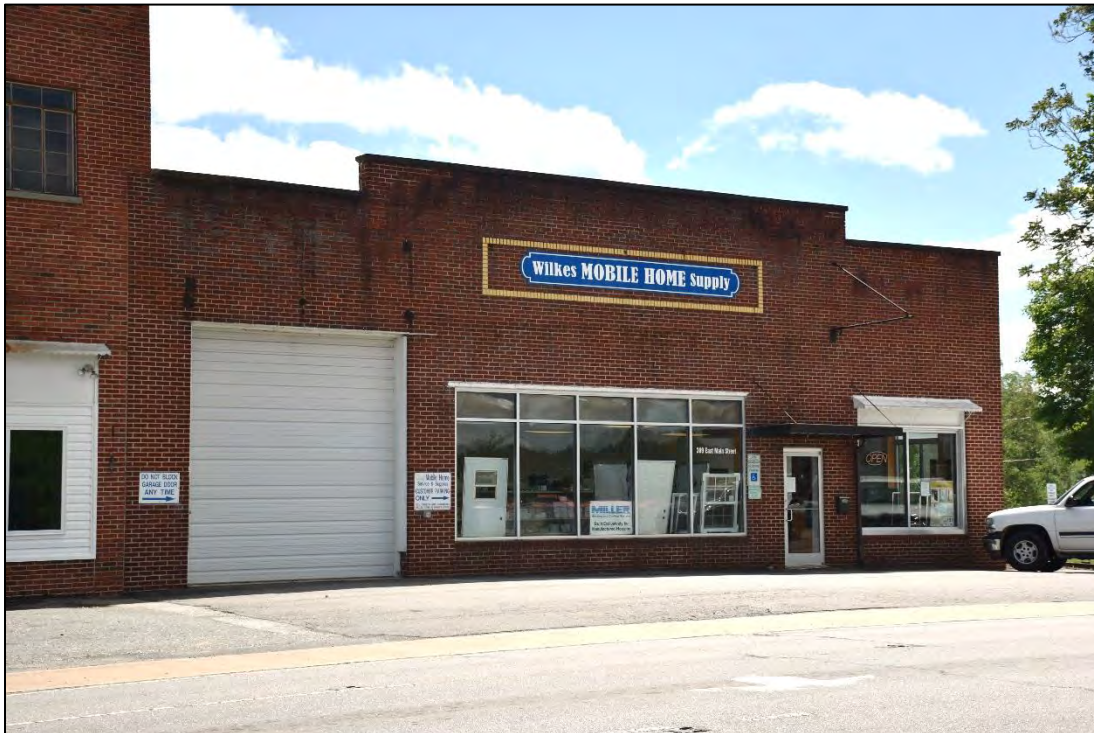
The westernmost structure in the commercial block is 309 East Main Street (WK0451). This structure is a one-story, concrete block masonry building, with a brick veneer façade (Figure 2.3.3). Like the other two buildings in the block, the topography of the parcel and parking lot reveal a second, basement-level story on the west side and rear (north) elevations (Figure 2.3.4). The front elevation has a central stepped parapet with a centered sign marquee below it, which is comprised of buff-colored brick and outlined with rowlock courses above and below and headers along the sides. The lower portion of the facade is asymmetrical. The eastern bay is a roll-up garage door and a main, modern metal and glass entry door is located beneath the western side of the central parapet. Between the two entry bays is a large display window that has been divided into five panels with metal-framed windows; each panel has a tall lower window and a smaller rectangular transom. The westernmost bay is a large window with two metal-framed panes, with a wooden panel covering the area where transoms may have originally been. The main entry door has a flat metal canopy, supported by metal brackets, above it; a similar bracket for a larger canopy remains on the west side of the sign marquee and the attachment points for other brackets are visible to the east of the sign marquee. The smaller display window has a modern cloth awning supported by metal brackets.

Figure 2.3.3. WK0451, 309 East Main Street, facing south.

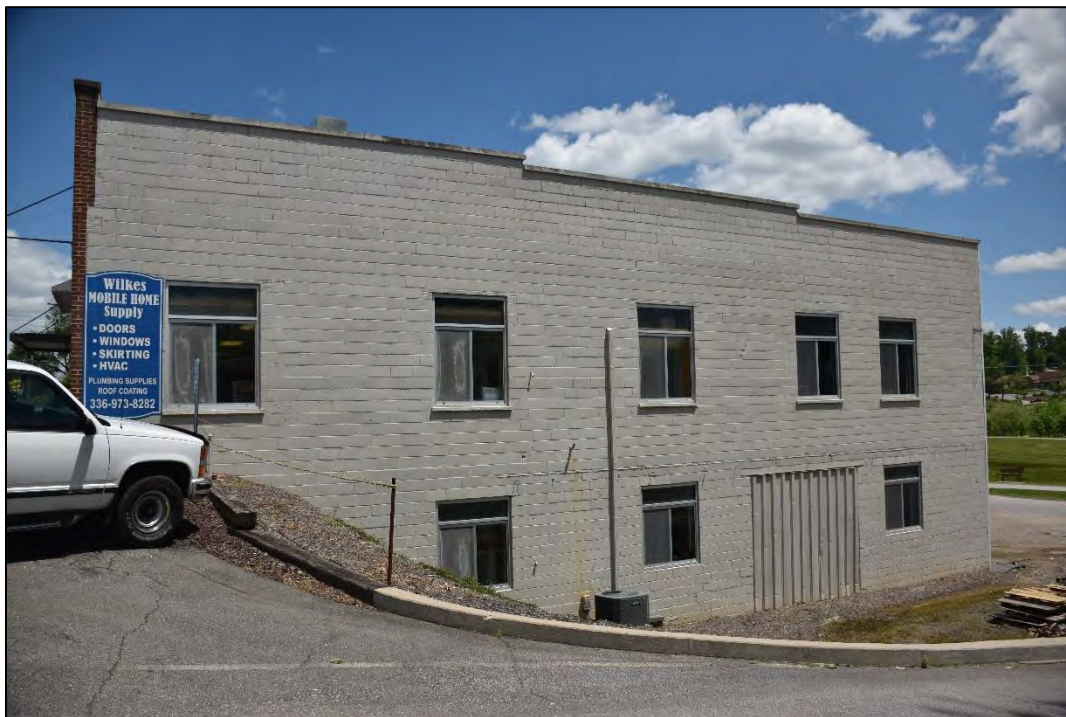
The western elevation of the building shows the concrete block masonry construction of the building (Figure 2.3.4). The upper level has five evenly spaced window openings, each with metal framed windows consisting of two lower panes and an upper transom. The lower, basement level, has three of these windows and a larger, garage door-sized opening that has been covered with corrugated metal. Along this elevation, the flat roofline steps down away from the front façade. The rear elevation of the building is covered with standing-seam metal sheeting with vertical orientation (Figures 2.3.5 and 2.3.6). The roof on this elevation has a parapet with two steps. The central bay is a modern garage door, with a modern metal entry door to the west and a raised modern entry door to the east. The lower story also has a single, six-pane, metal casement window. The upper story has two

Figure 2.3.4. WK0451, 309 East Main Street, facing southeast.

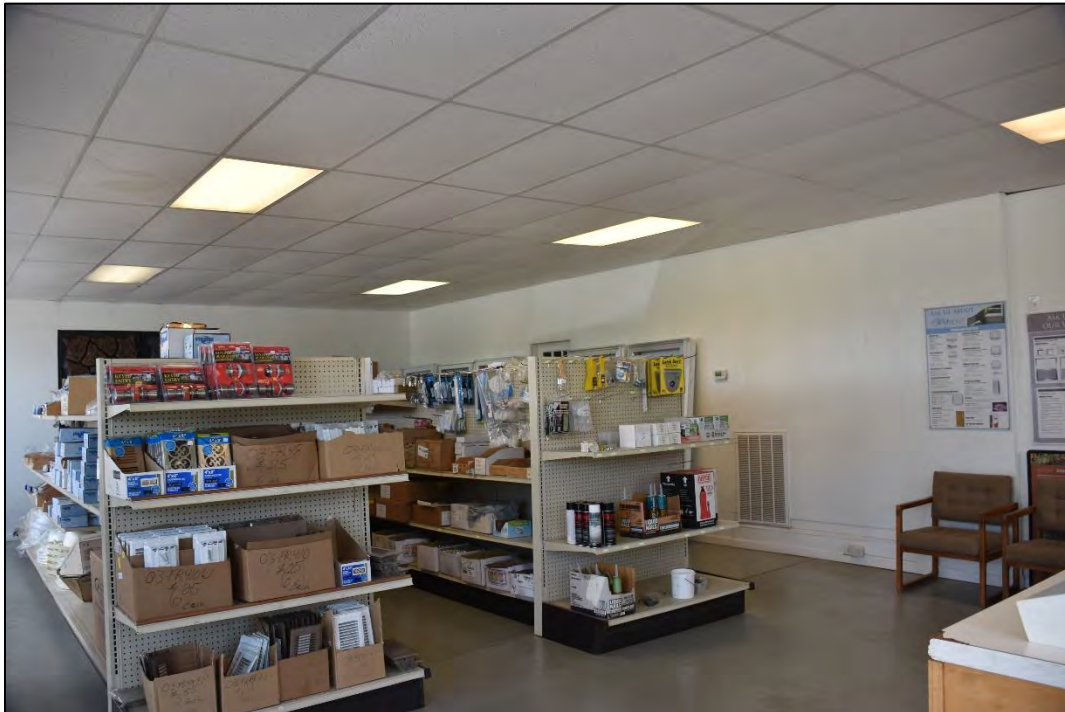
The interior of 309 East Main Street is laid out as a modern commercial business (Figure 2.3.7). There is a late-twentieth century counter structure along the west wall and display shelves oriented parallel to the large display window. The interior walls are modern gypsum board, the floor is vinyl commercial tile, and there is a drop-ceiling with a metal frame. Behind the main display area, the remainder of the building is used as warehouse space and was inaccessible at the time of the survey.

Figure 2.3.7. WK0451, 309 East Main Street, interior, facing southeast.

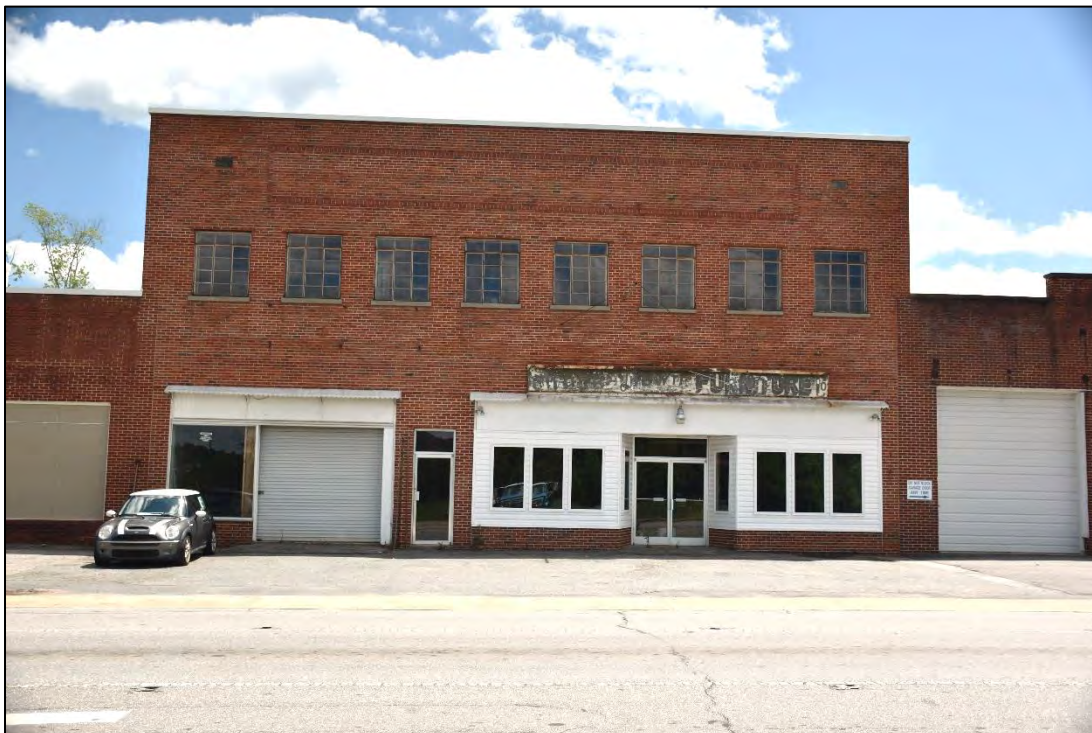
The central structure in the commercial block is 327 East Main Street (WK0452). This structure is a two-story, concrete block masonry building, with a brick veneer exterior (Figure 2.3.8). Like the other two buildings in the block, the topography of the parcel and parking lot reveal a third, basement-level story on the west side and rear (north) elevations (Figures 2.3.9 and 2.3.10). The building has a flat roof, with a centered sign marquee on the front elevation, which is outlined with rowlock courses above and below and headers along the sides. The second story has eight evenly spaced windows, each with a 15-pane, metal-frame casement window. The lower portion of the facade is asymmetrical. The eastern portion consists of a small storefront, with a single-pane, metal framed display window and a roll-up, garage door bay; above the entire storefront is a rectangular transom, divided into three sections, that has been covered with wooden panels. A modern fabric awning spans this storefront. A modern metal and glass entry door, with single pane transom, separates the eastern storefront from the western storefront. The westernmost storefront retains the original chamfered shape of the display window, although the window openings

Figure 2.3.8. WK0452, 327 East Main Street, facing south.

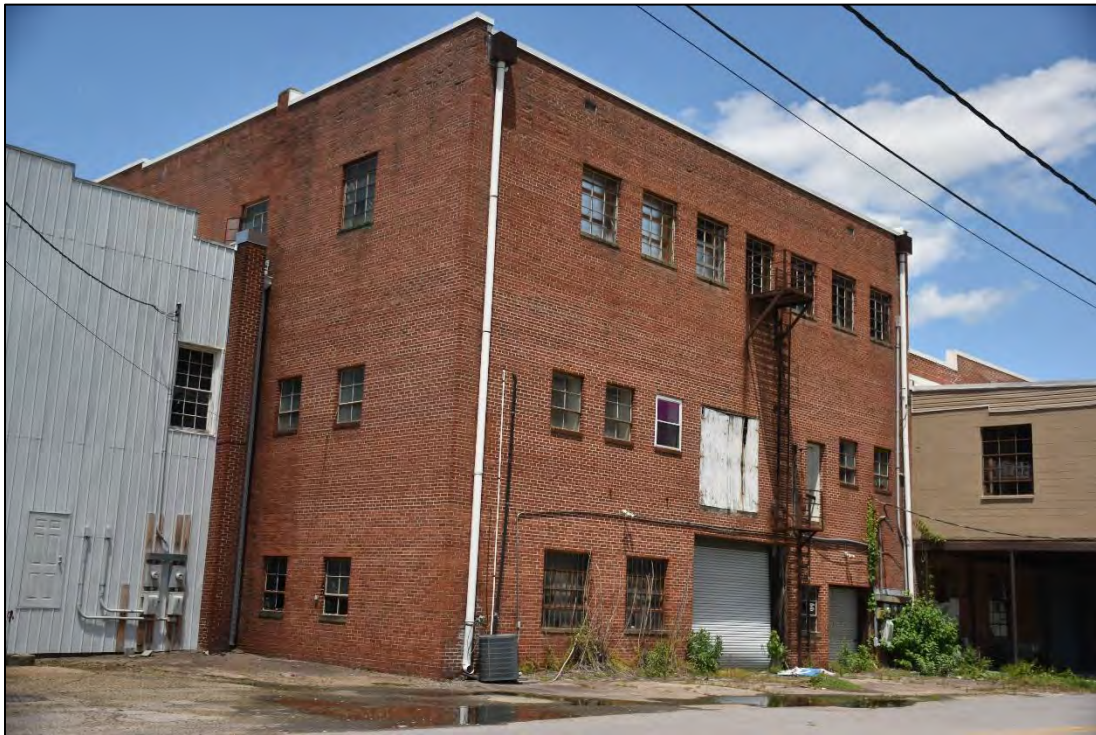
Structure WK0452 spans further back on the lot than WK0451 to the west, revealing two bays of its western wall from the rear of the lot (Figure 2.3.9). The upper story has the same 15-pane, metal frame, casement windows as the front elevation, while the lower two stories each have two, evenly spaced, six-pane, metal frame, casement windows. The south (rear) elevation has seven 15-pane, metal frame, casement windows along the uppermost story, with the central window having a metal fire escape attached. The basement story has a central roll-up, garage door bay; to the west are two 36-pane, metal frame, casement windows and to the east is a single six-pane, metal frame, casement window and a smaller, roll-up, garage door bay. The second level has a central opening, potentially originally a door, that has been covered with vertical wooden panels. To the west of center are three window bays, two with six-pane, metal frame, casement windows and the third with a modern one-over-one, double-hung, vinyl sash window; to the west of center is a five-panel wooden door and two six-pane, metal frame, casement windows.

Figure 2.3.9. WK0452, 327 East Main Street, facing northeast.

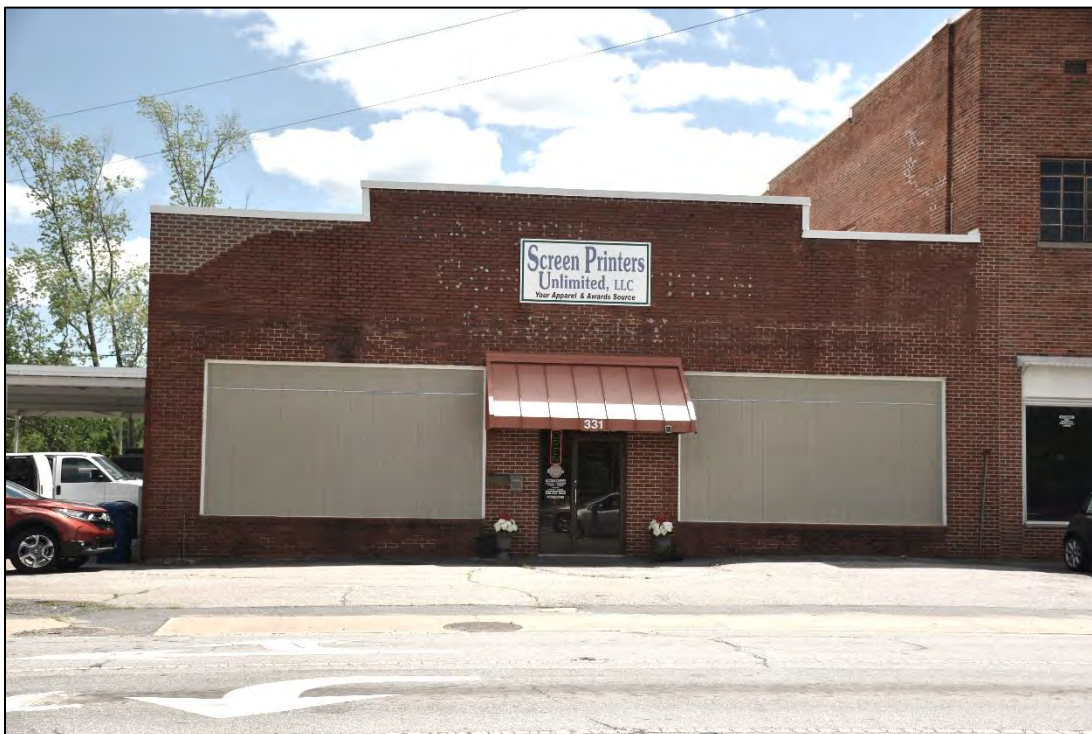
The easternmost structure in the commercial block is 331 East Main Street (WK0453). This structure is a one-story, concrete block masonry building, with brick veneer (Figure 2.3.13). Like the other two buildings in the block, the topography of the parcel and parking lot reveal a second, basement-level story on the east side and rear (north) elevations (Figure 2.3.2). The façade shape of WK0453 is the same as WK0451, suggesting that they were designed around the same time, potentially for a similar original purpose. The front elevation has a central stepped parapet metal coping along the edge; unlike WK0451, there is no sign marquee below the parapet, but there is ghost signage that provides evidence of former painted commercial signs. The lower portion of the facade is symmetrical. The central doorway is modern glass with a metal frame and it includes a transom light; a steeply pitched metal awning shades the entryway. The large rectangular display windows on either side of the doorway, which still bear evidence of a rectangular transom, have been covered with vertical wooden paneling.

Figure 2.3.13. WK0453, 331 East Main Street, facing south.

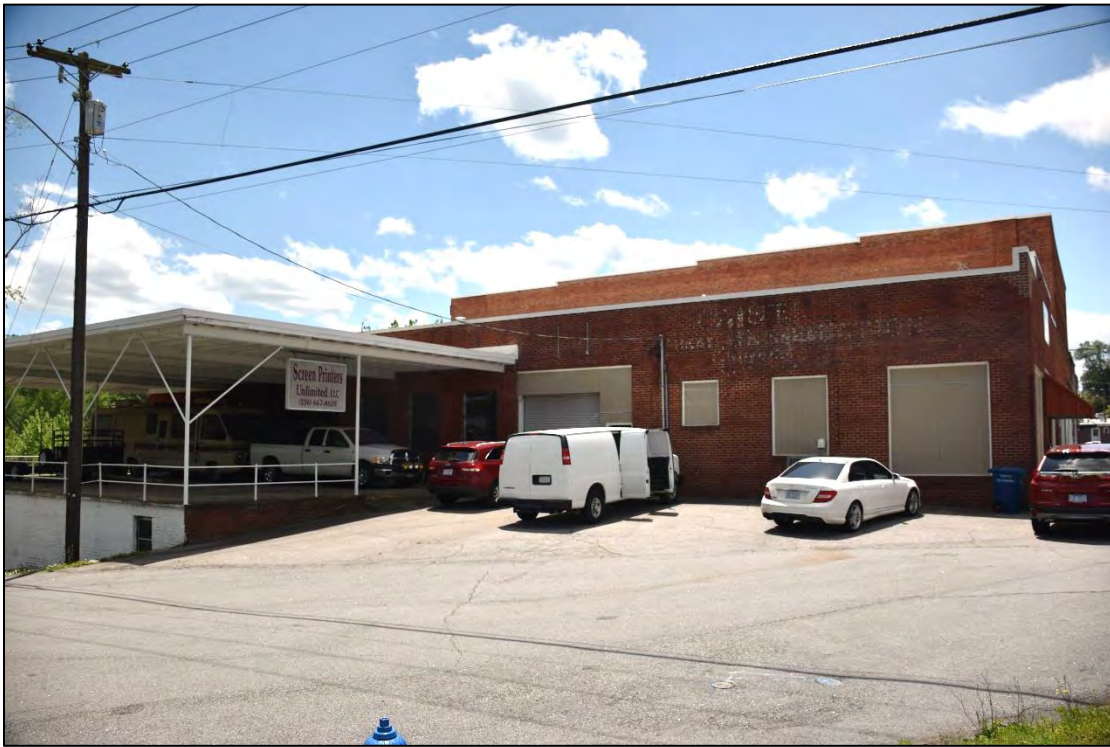
On the east elevation, there are three window openings of various sizes, each covered with vertical wooden paneling (Figure 2.3.14). A roll-up, garage door bay has also been partially enclosed by wooden paneling to make it smaller than its original size. A flat-roofed metal carport, supported by metal posts, has been attached to the rear portion of the eastern elevation; this canopy provides a parking area that is on top of a lower, basement level (Figure 2.3.15). Beneath the canopy, three 15-pane, metal frame, casement windows are visible. The parking canopy also extends south, past the rear wall of the main structure, and is supported by a steel-frame floor that originally served as a canopy over then rear lower level (Figures 2.3.15 and 2.3.16). A part concrete block masonry and part frame upper story addition has been added to the rear of the main building, abutting the carport area, also supported by the steel-frame canopy; this section has four modern six-over-six, double-hung, vinyl sash windows evenly spaced along its south elevation.

Figure 2.3.14. WK0453, 327 East Main Street, facing southwest.

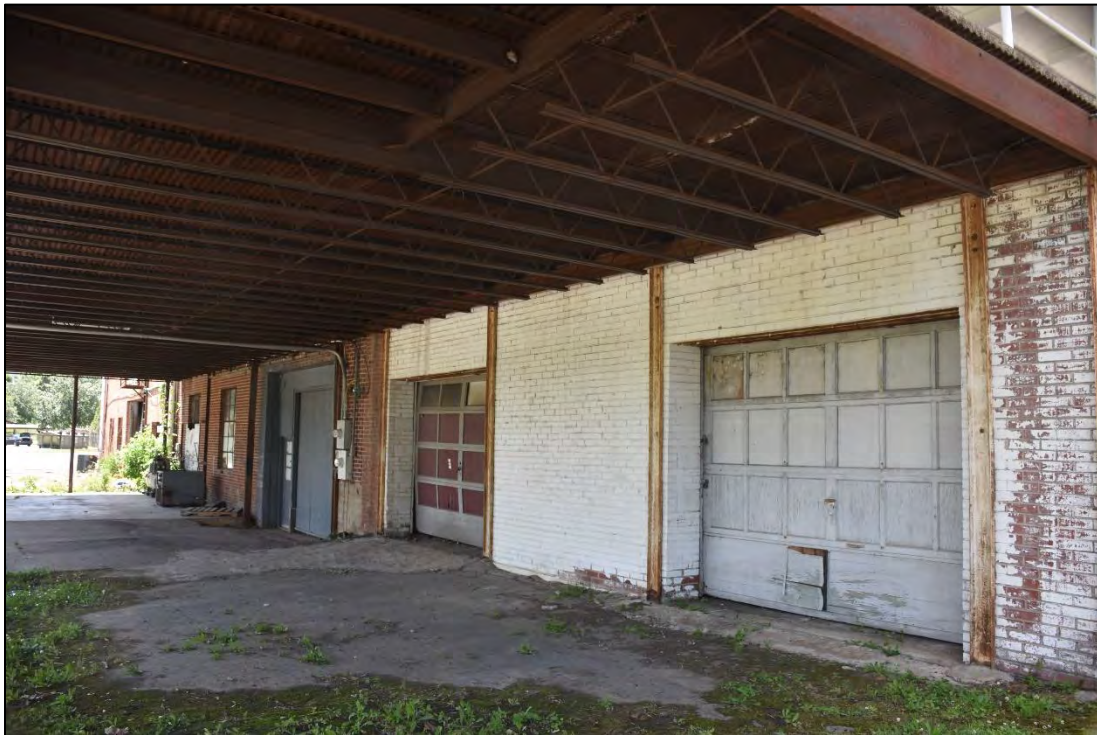
The basement level of the building located beneath the steel canopy, which is supported by metal posts in concrete bases, contains a number of access points. The eastern two bays are wooden, multi-panel, garage door bays, located beneath the front portion of the carport (Figure 2.3.17). The walls of the garage door openings show the concrete block masonry units that comprise the structural portion of the building; metal supports for the metal canopy are located on either side of each garage bay. The central bay was originally another garage door opening, but it has been enclosed with vertical wooden paneling; adjacent to this garage door is a man-sized entry door, which is comprised of wood, with three lower panels and three horizontal window openings in the upper portion (Figure 2.3.18). West of the central garage door bay is a single 5-pane, metal frame, casement window and a former door opening that has been covered over with plywood.

Figure 2.3.17. WK0453, 327 East Main Street, facing northwest.

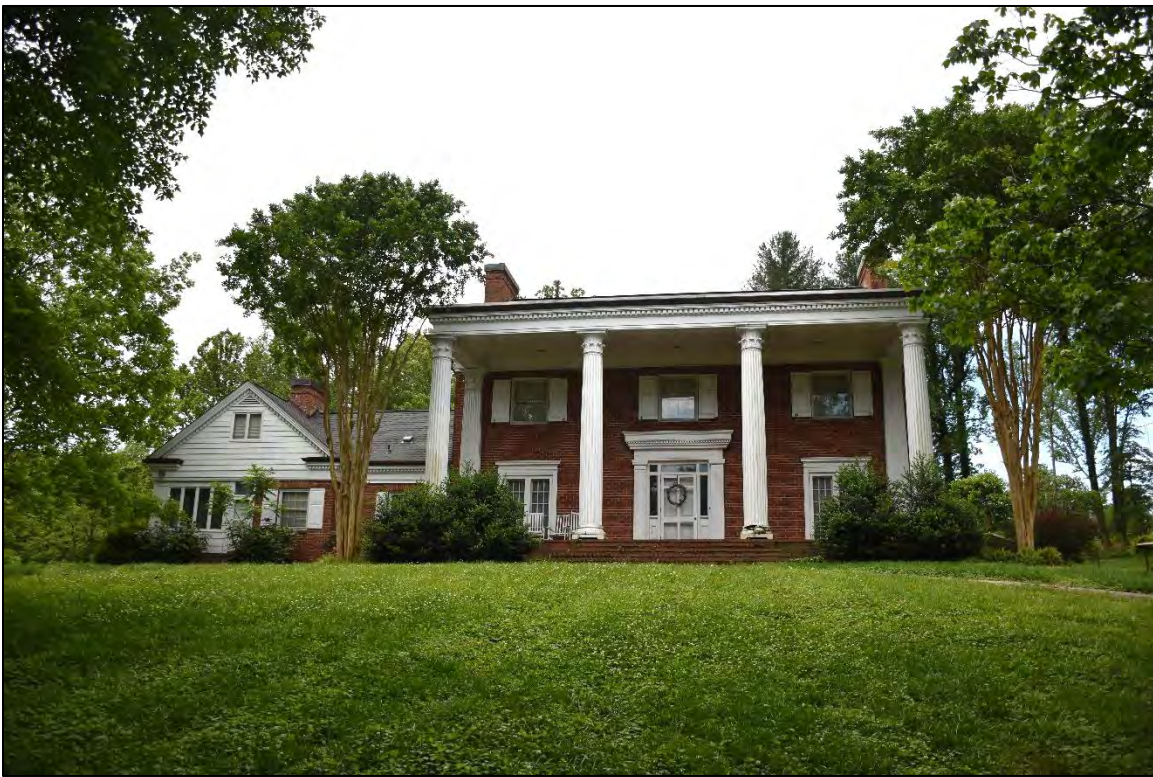
Figure 2.4.1. Julius A. Rousseau House (WK0454), facing south.

The Julius A. Rousseau House (WK0454) is located west of Oakwoods Road (SR 1001), approximately 0.3-mile south of its intersection with East Main Street (NC 268), east of the town center of Wilkesboro (Figures 1.1 and 1.2). The house sits approximately 0.15-mile from the road and is accessed by a long driveway that also provides access to two additional houses to the south. It overlooks Cub Creek, which is located approximately 0.15-mile to the north of the house, and is set upon a hilltop, with the lot sloping down towards the creek. The house was built around 1957 and is an example of the Neoclassical style that was popular during the early-to-mid-twentieth-century (Figure 2.4.1). The two-story, frame structure has a brick veneer exterior. The main portion of the house is three bays wide by two bays deep, with a single story wing attached to the eastern elevation and a one-story, rear ell, both of which date to the original period of construction. The front elevation of the house is dominated by a monumental, full façade, two-story, flat-roofed porch, which is supported by four fluted Corinthian columns and has a band of denticulated molding at the cornice line; two engaged Corinthian pilasters are located where the

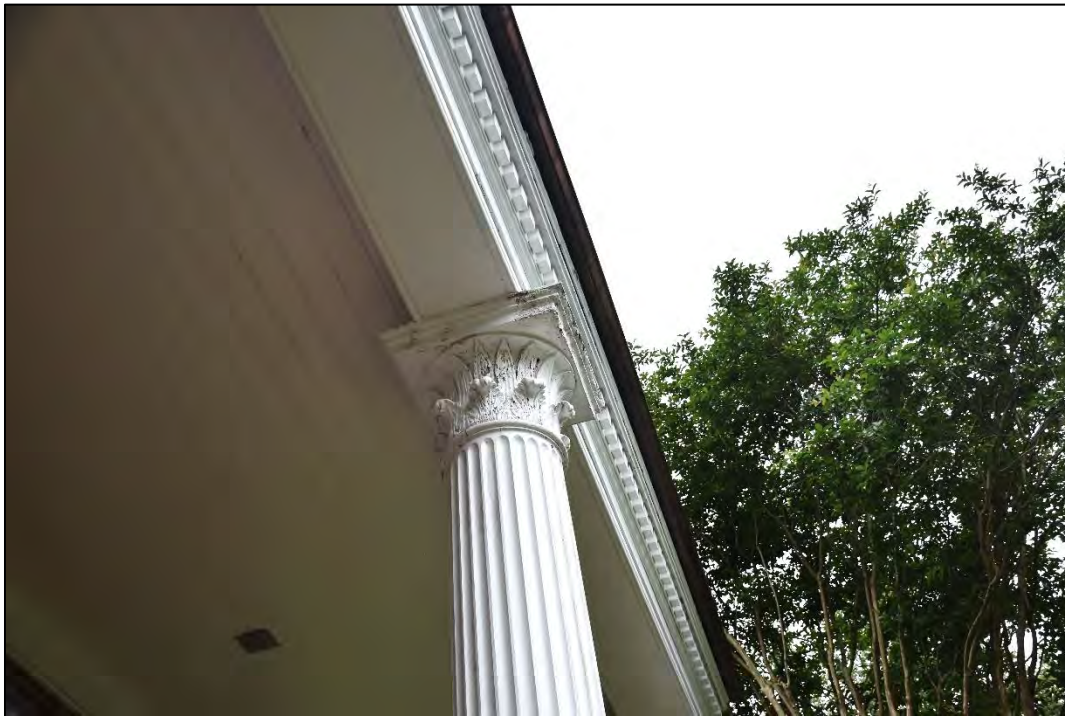
Figure 2.4.2. Julius A. Rousseau House (WK0454), porch detail, facing southwest.

porch meets the house (Figure 2.4.2). The central doorway has an elaborate fluted surround, with a heavy cornice and denticulated molding, sidelights, and a transom (Figure 2.4.3). Flanking the door on either side are paired 15-pane French doors, with decorative surrounds featuring denticulated molding. The upper story has three evenly spaced eight-over-eight, double-hung, wooden sash windows, with exterior storm windows and non-functional shutters. The front of the house is accessed by a set of brick stairs that spans the width of the porch.

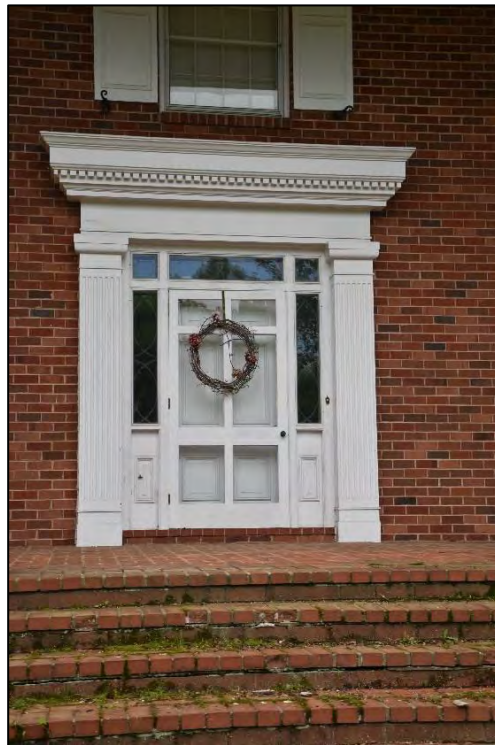
Figure 2.4.3. Julius A. Rousseau House (WK0454), door detail, facing south.

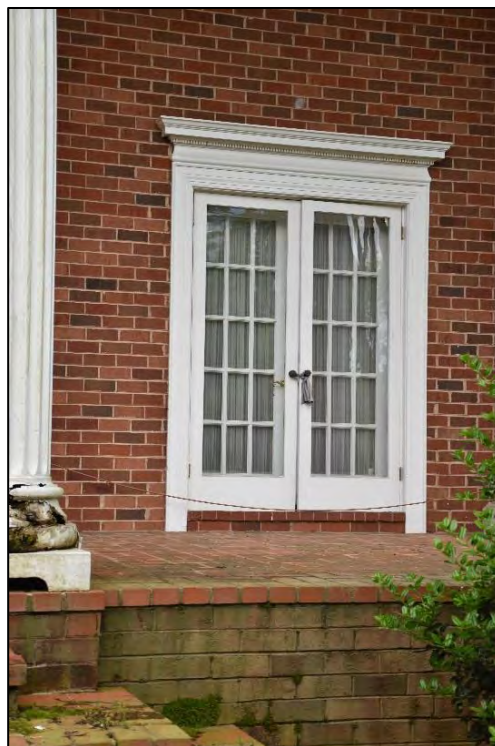
Figure 2.4.4. Julius A. Rousseau House (WK0454), door/window detail, facing south.

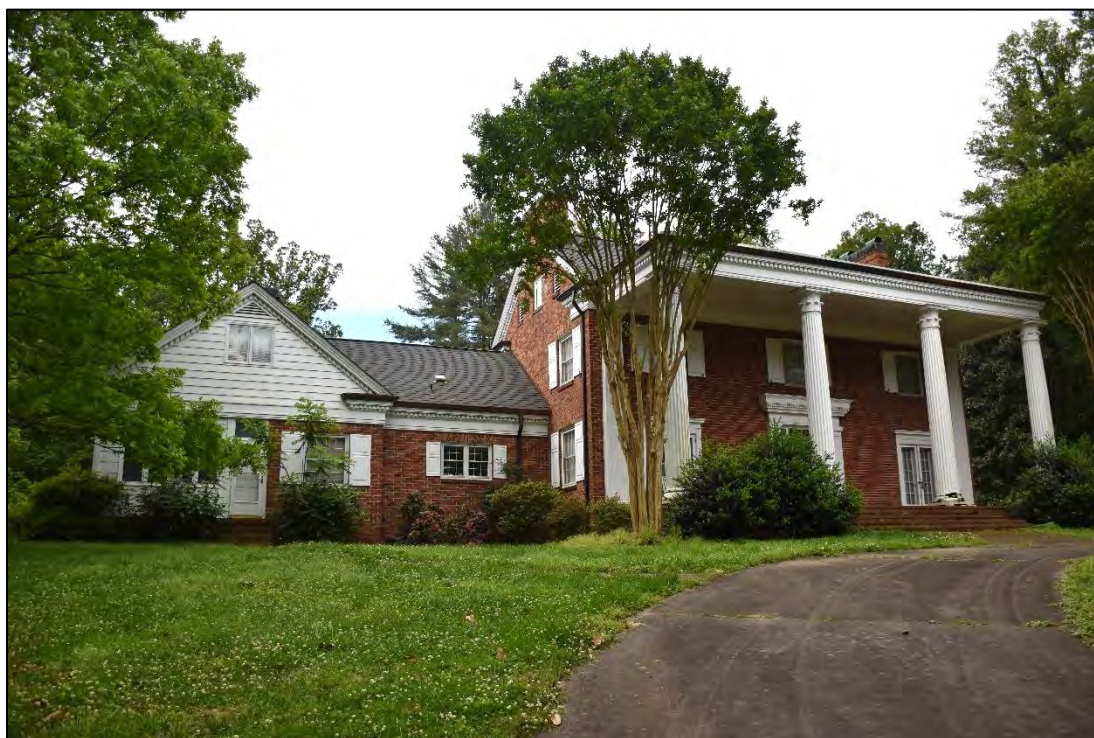
The eastern elevation of the house has a one-story, front-gabled wing that is attached via hyphen, obscuring the rear portion of this side of the house (Figures 2.4.5 and 2.4.6). The northern bay, which is visible, has an eight-over-eight, double-hung, wooden sash window on both the first and second stories. A faux chimney stack breaks the gabled roofline, which has deep cornice returns and denticulated molding. Centered within the attic story is a single-pane casement window, flanked by a single rectangular attic vent on either side (Figure 2.4.5). The single story wing is attached to the main house via a side-gabled hyphen, which has a paired six-over-six, double-hung, wooden sash window. The front-gabled portion of the wing has a central entry door, accessed by a stoop and brick stairs. To the west is a single, eight-over-eight, double-hung, wooden sash window; to the east is an enclosed porch that is covered with horizontal wooden siding and has a casement window with four vertical panes. The gable portion of the wing, which has a two-pane, wooden-frame casement window centered within it, is covered with horizontal wooden siding and has the same deep cornice returns and denticulated molding as the main portion of the house (Figure 2.4.6). The enclosed porch portion of the wing wraps around to the eastern elevation, continuing with horizontal wooden siding and casement windows with three vertical panes (Figure 2.4.7). An interior chimney is visible along the roof ridge. The rear portion of the front-gabled wing has a modern entry door and eight-over-eight, double-hung, wooden sash window on the lower floor and a single six-over-six, double-hung, wooden sash window in the upper story (Figure 2.4.8).

Figure 2.4.5. Julius A. Rousseau House (WK0454), facing southwest.
