SUBJECT: Historic Structures Survey Report, R-5772, Upgrade SR 1001 from US 421 to NC 268,
PA 19-02-0016, Wilkes County, ER 19-2317

Historic Structures Survey Report
TIP No. R-5772, WBS No. 44692.1.1, PA No. 19-02-0016
Upgrade SR 1001 (Oakwoods Road)
from US 421 to NC 268 (East Main Street)
Wilkes County, North Carolina
S&ME Project No. 4213-19-107

**Historic Structures Survey Report
TIP No. R-5772
Upgrade SR 1001 (Oakwoods Road)
from US 421 to NC 268 (East Main Street)
Wilkes County, North Carolina**

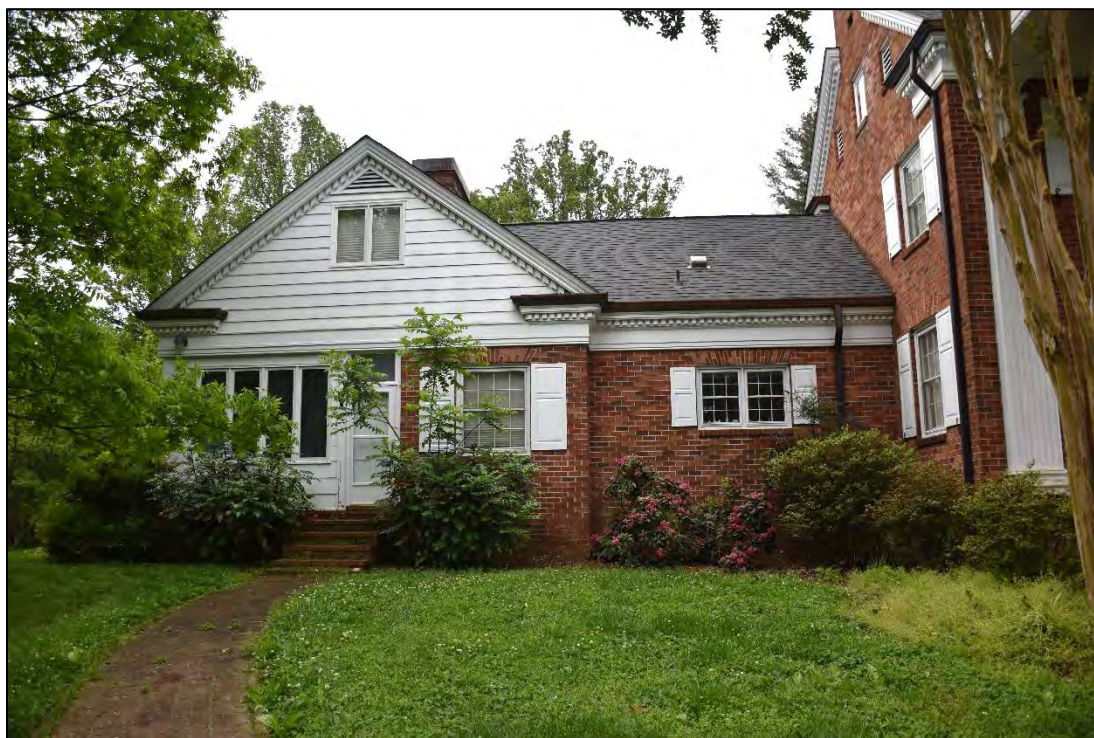
The eastern elevation of the house has a one-story, front-gabled wing that is attached via hyphen, obscuring the rear portion of this side of the house (Figures 2.4.5 and 2.4.6). The northern bay, which is visible, has an eight-over-eight, double-hung, wooden sash window on both the first and second stories. A faux chimney stack breaks the gabled roofline, which has deep cornice returns and denticulated molding. Centered within the attic story is a single-pane casement window, flanked by a single rectangular attic vent on either side (Figure 2.4.5). The single story wing is attached to the main house via a side-gabled hyphen, which has a paired six-over-six, double-hung, wooden sash window. The front-gabled portion of the wing has a central entry door, accessed by a stoop and brick stairs. To the west is a single, eight-over-eight, double-hung, wooden sash window; to the east is an enclosed porch that is covered with horizontal wooden siding and has a casement window with four vertical panes. The gable portion of the wing, which has a two-pane, wooden-frame casement window centered within it, is covered with horizontal wooden siding and has the same deep cornice returns and denticulated molding as the main portion of the house (Figure 2.4.6). The enclosed porch portion of the wing wraps around to the eastern elevation, continuing with horizontal wooden siding and casement windows with three vertical panes (Figure 2.4.7). An interior chimney is visible along the roof ridge. The rear portion of the front-gabled wing has a modern entry door and eight-over-eight, double-hung, wooden sash window on the lower floor and a single six-over-six, double-hung, wooden sash window in the upper story (Figure 2.4.8).

Figure 2.4.6. Julius A. Rousseau House (WK0454), wing, facing south.

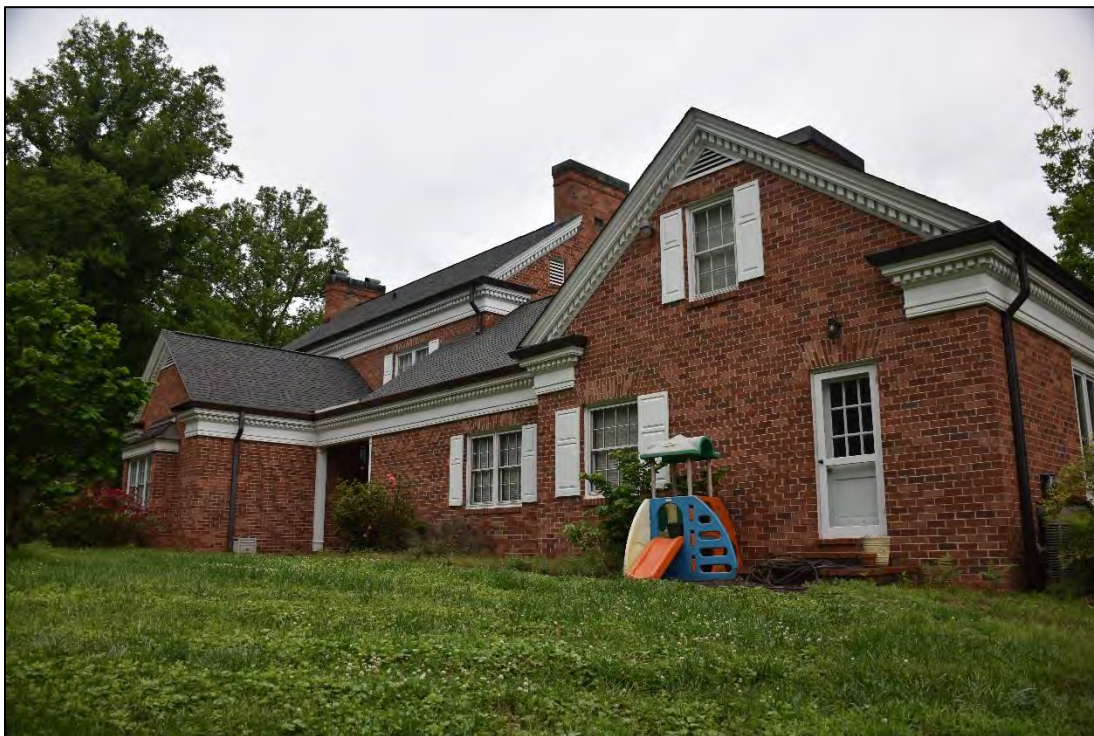
Figure 2.4.8. Julius A. Rousseau House (WK0454), house, facing northwest.

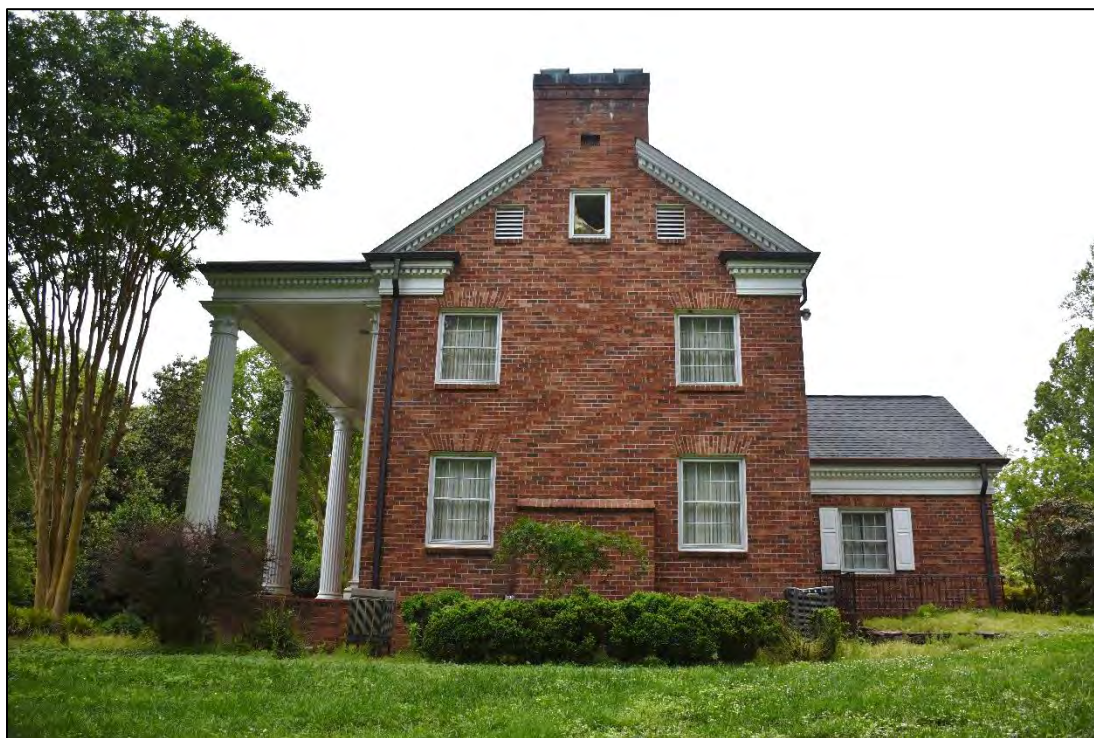
The western elevation of the house is symmetrical, with two eight-over-eight, double-hung, wooden sash windows on each story (Figure 2.4.10). These windows flank a faux chimney, that has a projecting exterior section on the first story and breaks the peak of the house's gable. A single-pane casement window is centered within this faux chimney, in the attic level, flanked by a single rectangular vent on either side. The roof of the house is covered with composition shingles. S&ME attempted to gain interior access to the structure but the request was denied.

Figure 2.4.10. Julius A. Rousseau House (WK0454), facing east.

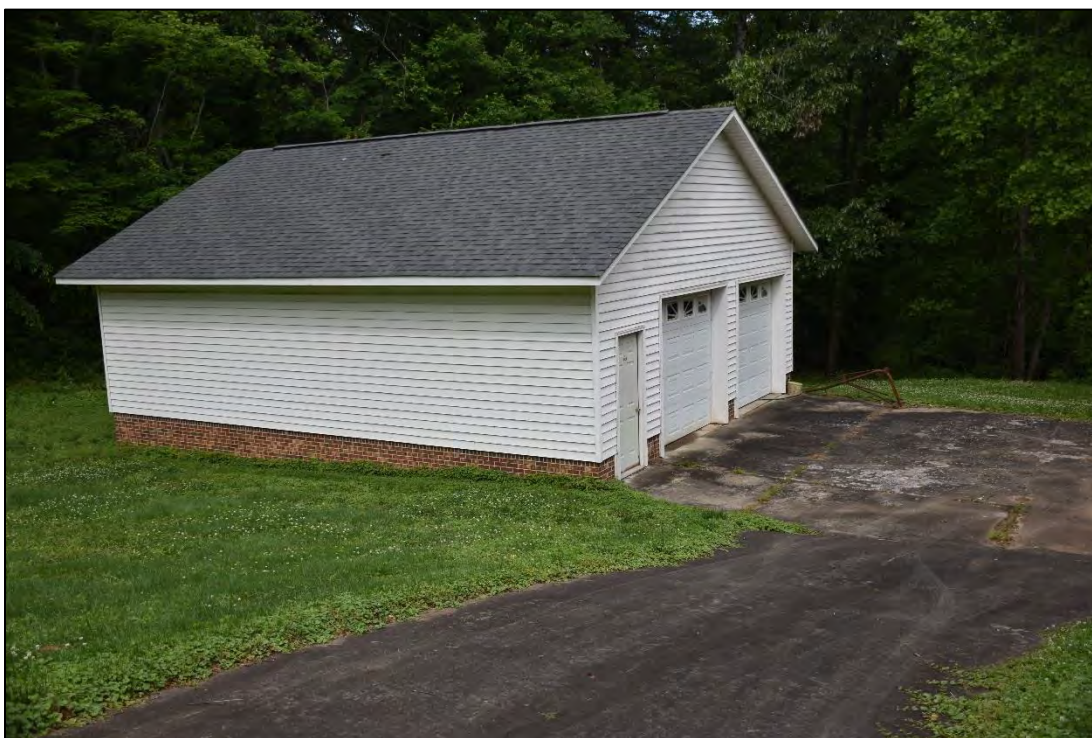
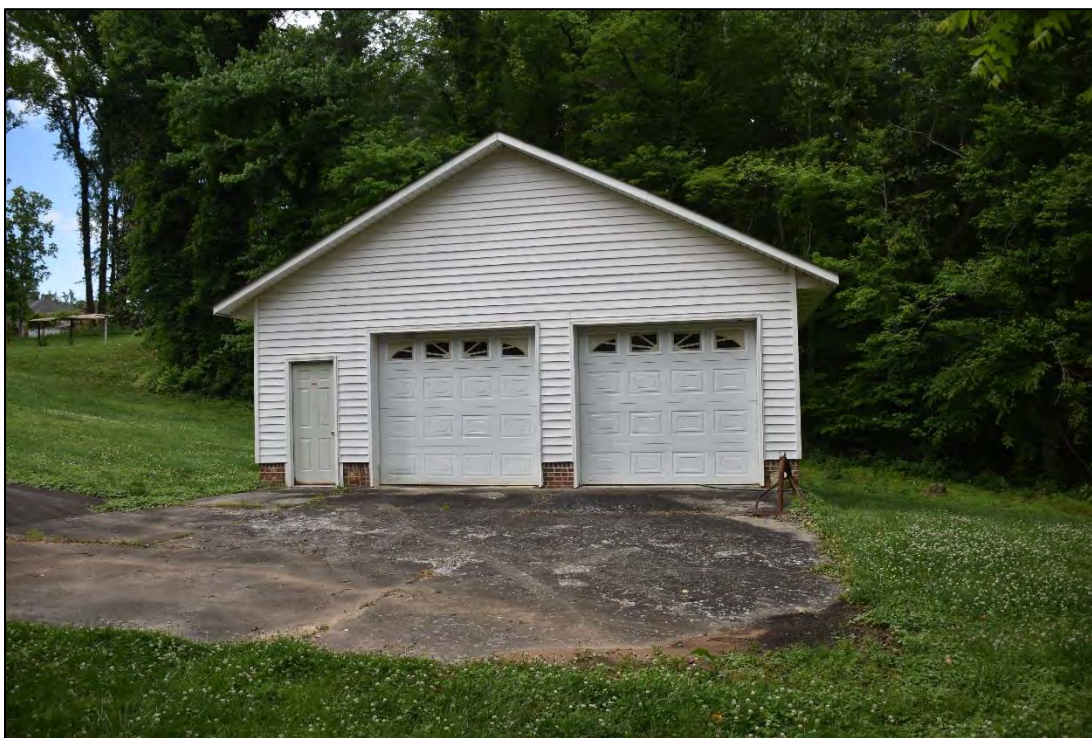
To the northeast of the house is a modern, frame, gabled garage structure (Figures 2.4.11 and 2.4.12). The garage has a brick foundation and is covered with vinyl siding; the roof is composition shingles. The eastern bay on the garage has two garage doors and a single, man-sized entry door. West of the house is a late-twentieth century, metal carport (Figure 2.4.13). The house is accessed by a long driveway, which ends in a circular turn around (Figure 2.4.14). The center of the circle drive has a landscaped vegetative area, with a single tree surrounded by a low brick wall. The lot on which the house stands is terraced, sloping downward to the north of the house (Figure 2.4.15). To the south and west of the house, the lot slopes upward, with the area to the west of the circular driveway containing a grape arbor (Figure 2.4.16).

Figure 2.4.11. Julius A. Rousseau House (WK0454), modern garage, facing northwest.

Figure 2.4.12. Julius A. Rousseau House (WK0454), modern garage, facing west.

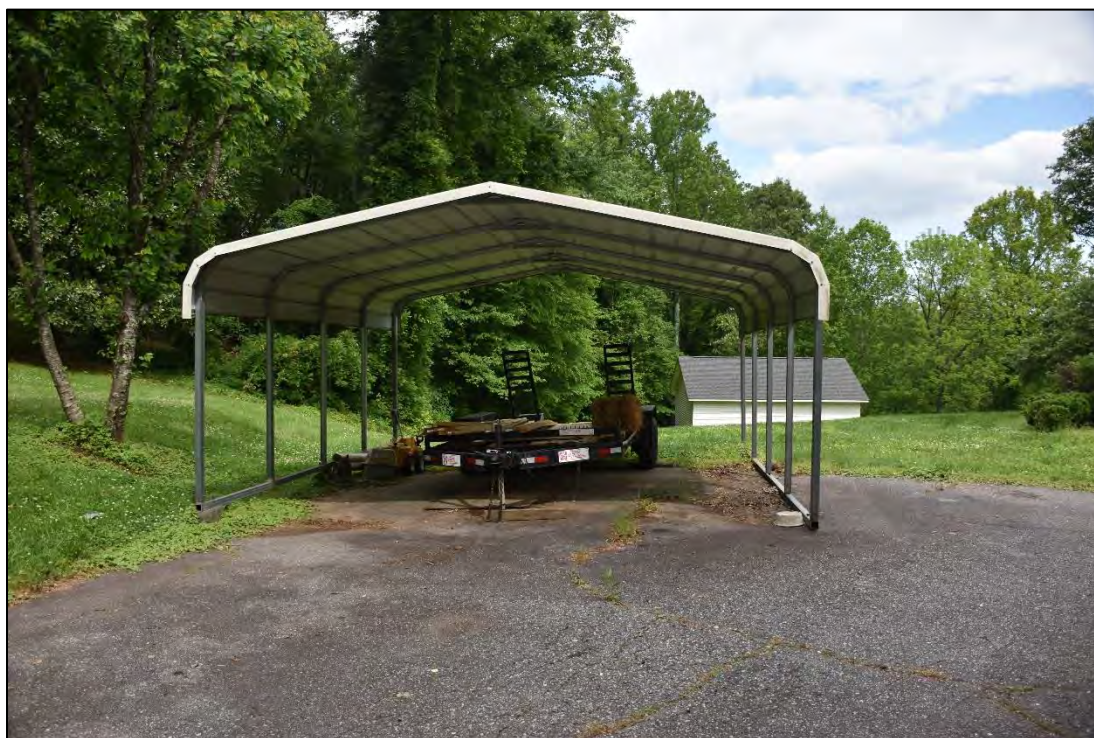
Figure 2.4.13. Julius A. Rousseau House (WK0454), modern carport, facing north.

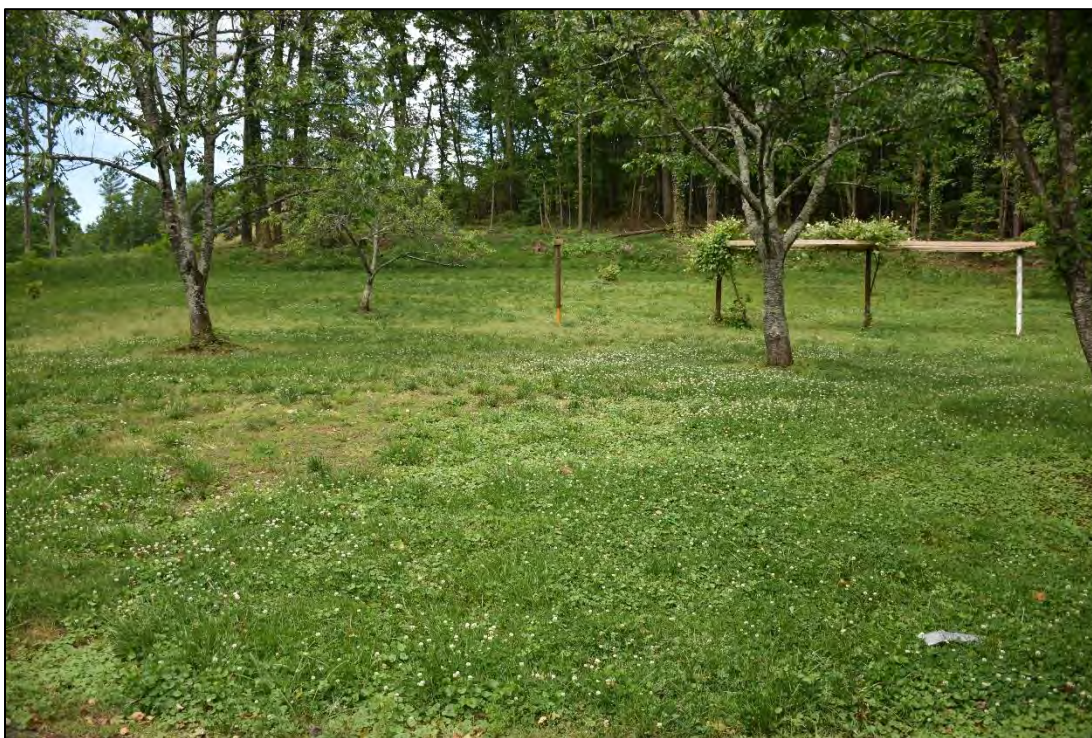
Figure 2.4.16. Julius A. Rousseau House (WK0454), house, facing west.

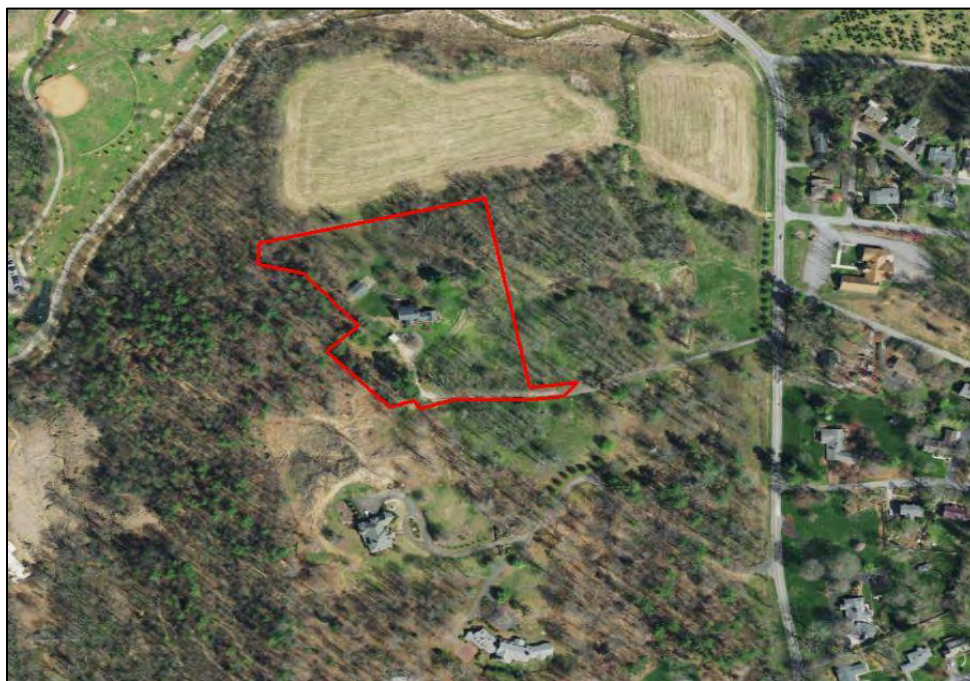
The National Register boundary for the Julius A. Rousseau House includes the house and 5.22-acre property (Figure 2.4.27). Although the significance of the resource is for the architecture of the house, the situation of the house on the lot, located on a hill overlooking Cub Creek, is an important representation of the mindset behind the Neoclassical style choice and the prominent place that it should occupy in the built environment. Therefore, the terraced lot and natural view of Cub Creek reflects the revival of the early American country home that the Neoclassical style was adopted to represent. The landscape, including the circle drive and terraced lot, are contributing elements; however, none of the other structures within the boundary (the modern garage and carport) contribute to the eligibility of the property.

Figure 2.4.27. NRHP boundary for the Julius A. Rousseau House (WK0454).

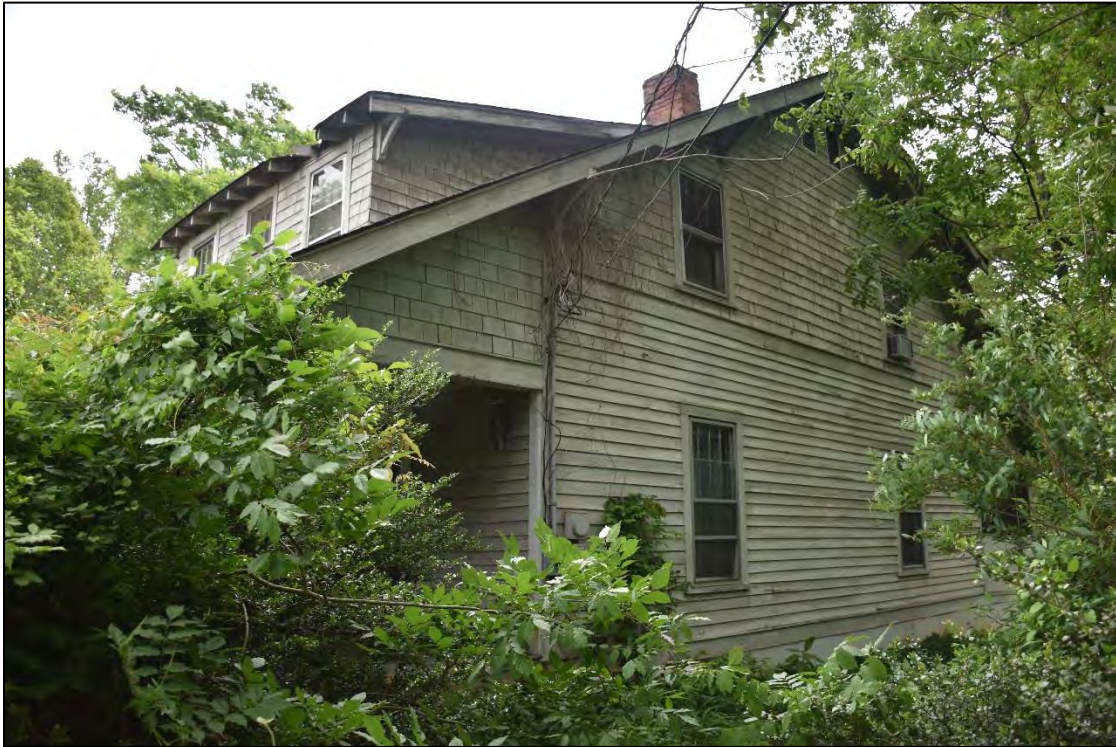
Figure 2.5.2. James Calloway Harris House (WK0455), facing northeast.

The south elevation of the house has two single, four-over-one, double-hung, wooden sash windows on both the upper and lower story (Figure 2.5.2). The lower portion of the house is covered with horizontal wooden weatherboard siding, while the upper portion, including the extension of the main roofline to create the porch roof, is covered with wooden shingles. A pair of rectangular attic vents are located in the gable end (Figure 2.5.3). A shed-roofed extension of the main roofline, which was originally a porch at the southeastern corner of the house, has been enclosed with vertical wooden paneling and screening. The foundation along this portion of the house has been covered with plywood.

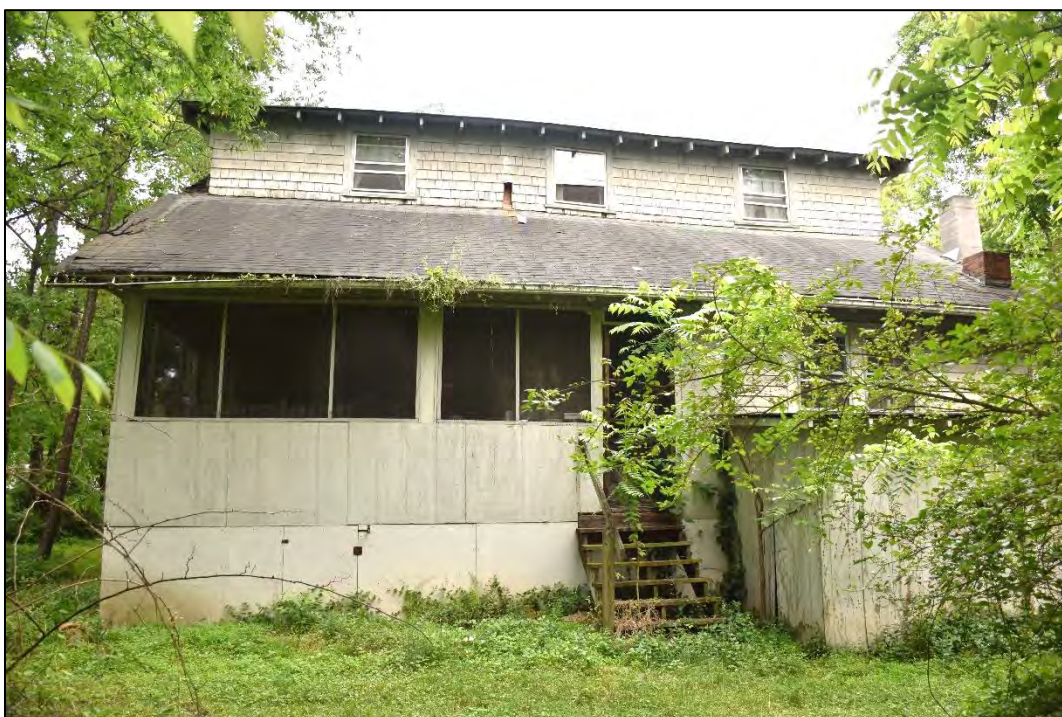
The eastern elevation of the house has a large shed-roofed dormer that encompasses much of the rear roofline (Figure 2.5.4). It has three evenly spaced four-over-four, double-hung, wooden sash windows and is covered with wooden shingles. There are visible raftertails along the eave line of the dormer. A set of wooden stairs accesses a central entry door, which is part of the enclosed porch area. To the north of the door, another enclosed section of the porch, likely done earlier than the southern portion, has horizontal wooden weatherboard and a paired six-over-six, double-hung, wooden sash window (Figure 2.5.5). A shed-roofed, plywood sided storage addition, with two doors, has been added to the northeastern corner of the house.

Figure 2.5.4. James Calloway Harris House (WK0455), facing west.

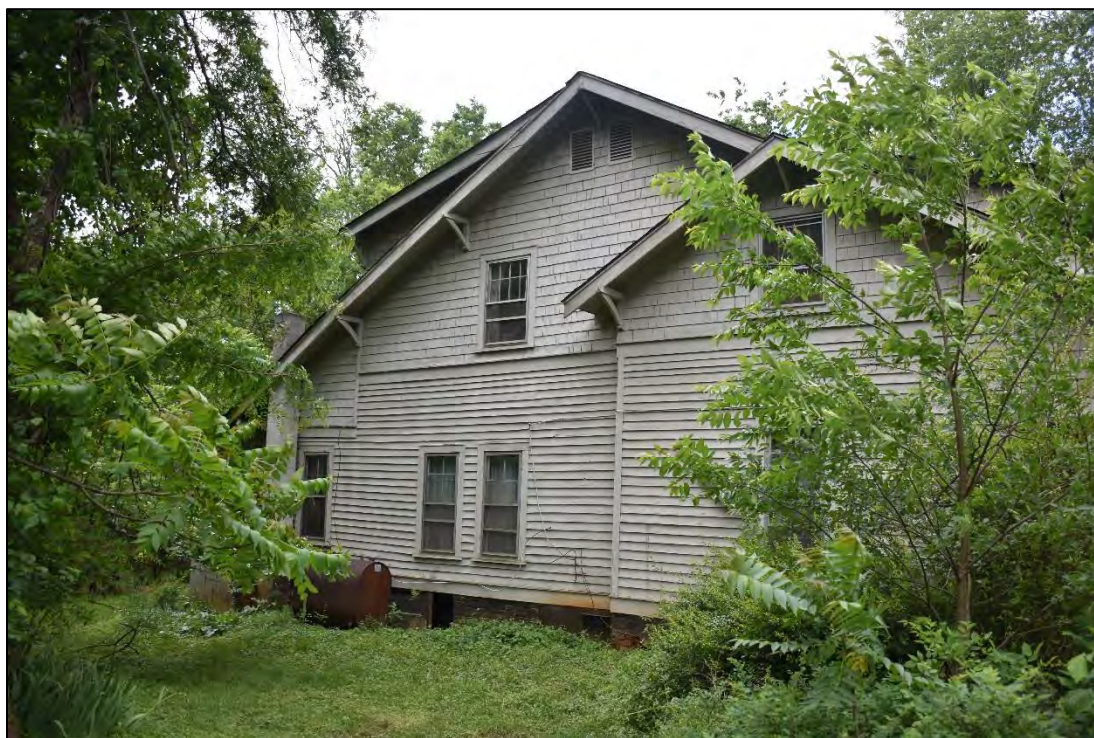
Figure 2.5.6. James Calloway Harris House (WK0455), facing southeast.

hung, wooden sash window in both the upper and lower story. On the main house section, the lower story has two, single, four-over-four, double-hung, wooden sash windows located close to each other, while the upper section has a single four-over-one, double-hung, wooden sash window. The northern elevation and projecting bay continue the pattern from the other elevations of the house, with horizontal wooden weatherboard on the lower section and wooden shingles on the upper portion (Figure 2.5.7). The wide eave overhang with decorative brackets also continues along this elevation. The original foundation of the house, which is brick piers infilled with newer brick, is visible along a portion of the northern elevation.

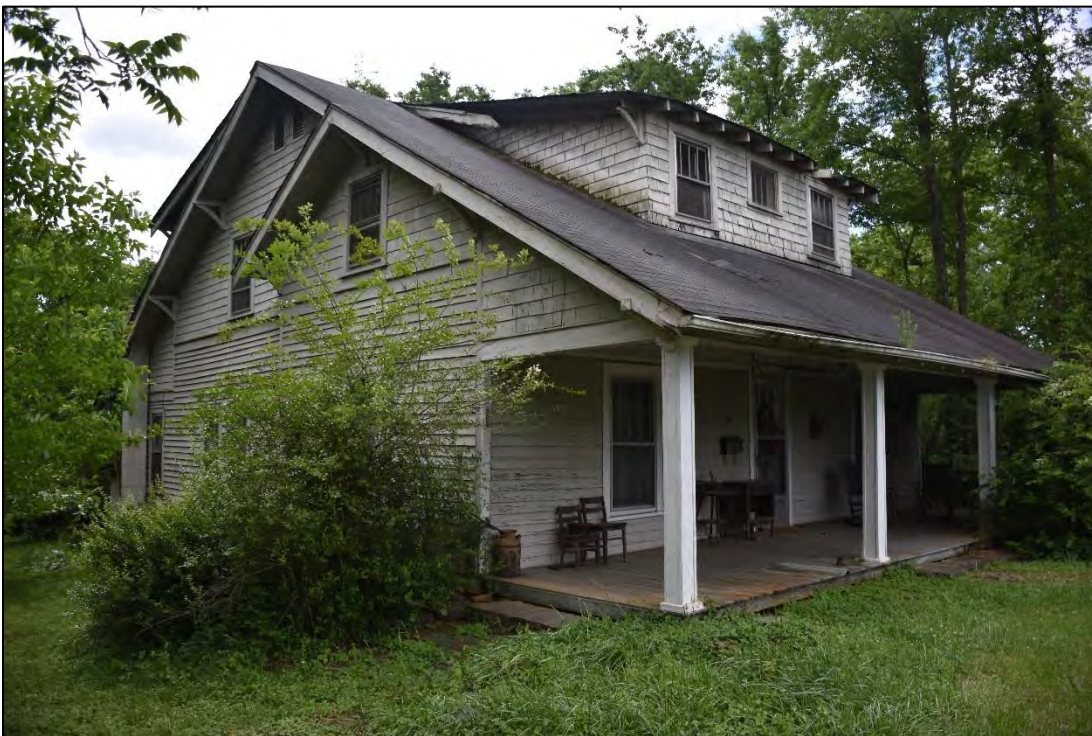
Figure 2.5.7. James Calloway Harris House (WK0455), facing southeast.

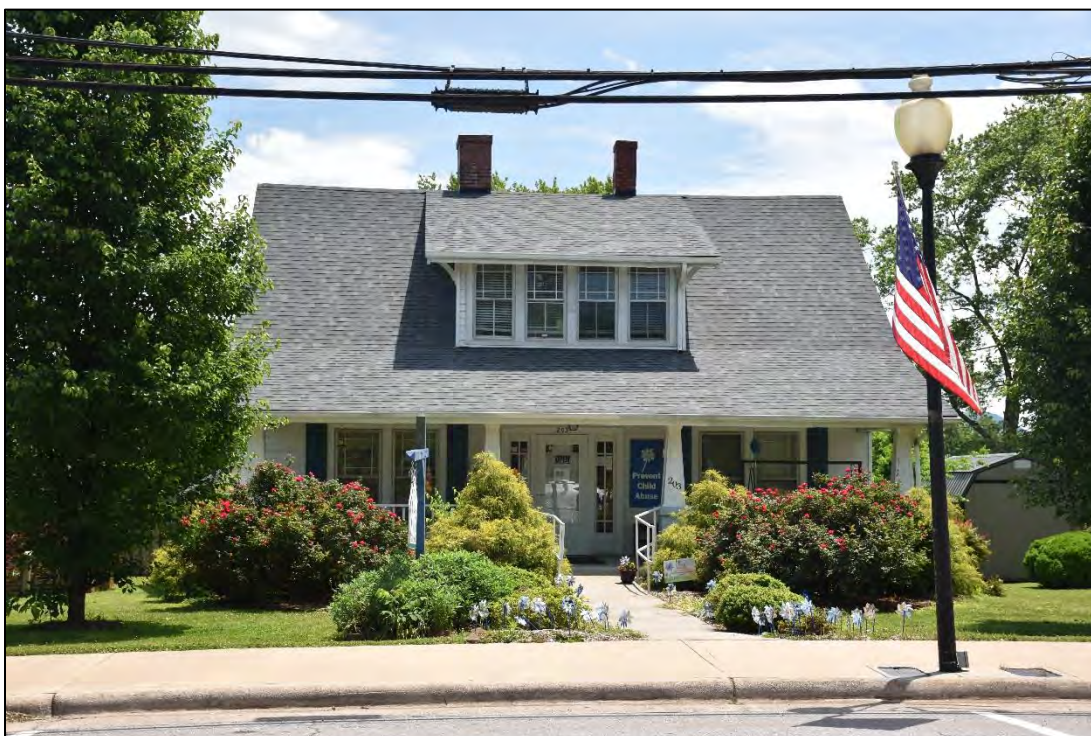
In Wilkesboro, the Bumgarner-Bullis House (WK0243), which contributes to the Downtown Wilkesboro Historic District, at 203 East Main Street, was built in 1927 and exhibits the same side-gabled roof, full-width porch, shed-roofed dormer, and eave brackets (Figure 2.5.13). In contrast to the James Calloway Harris House, the windows are a decorative Victorian style and the porch supports are tapered columns. At 300 Woodland Avenue in Wilkesboro is a circa 1920 Craftsman residence that is one and one-half stories tall with a side-gabled roofline (Figure 2.5.14). Despite the tapered square columns on stone piers as porch supports and the different window configuration in the dormer, the house does have four-over-one windows, decorative brackets, visible raftertails, and shingles in the upper story gable above the wooden weatherboard on the lower story. Three houses in North Wilkesboro also conform to the one and one-half story, side-gabled form with a full-width front porch: 229 D Street, 309 D Street, and 507 C Street. The circa 1925 house at 229 D Street, despite a similar form, has a much larger dormer on the front elevation, its porch supports are tapered square columns on brick posts, and it is missing eave brackets; however it does have three-over-one, Craftsman-style windows and visible raftertails (Figure 2.5.15). At 309 D Street, a circa 1930 house displays the same gabled extension along the side elevation and smaller shed-roofed dormer as the James Calloway Harris House, although the porch supports are tapered square posts on brick piers; although the house has been converted to a duplex, its windows have been replaced, and its original siding and eave brackets have been covered with modern materials, the house is recognizable as being built using a similar pattern as the Harris House (Figure 2.5.16). At 507 C Street, an earlier, circa 1900 example of the Craftsman style is visible; the roof, where it joins the porch, flares slightly and the porch supports are tapered square columns on brick piers, but the general feeling of the architecture is the same; the C Street house has lost its original windows, but retains the shingle siding in the upper level above wooden weatherboard on the lower level and the eave brackets (Figure 2.5.17). Outside of the limits of both Wilkesboro and North Wilkesboro, in a similar setting as the James Calloway Harris House, the circa 1925 duplex at 500 Moravian Falls Road is a scaled down version of the style and form, with less decorative detail, but a similar configuration of porch and dormer; the first story windows remain four-over-one sashes, despite the application of mid-century fiberboard siding (Figure 2.5.28).

Figure 2.5.13. Bumgarner-Bullis House (WK0243), facing south.

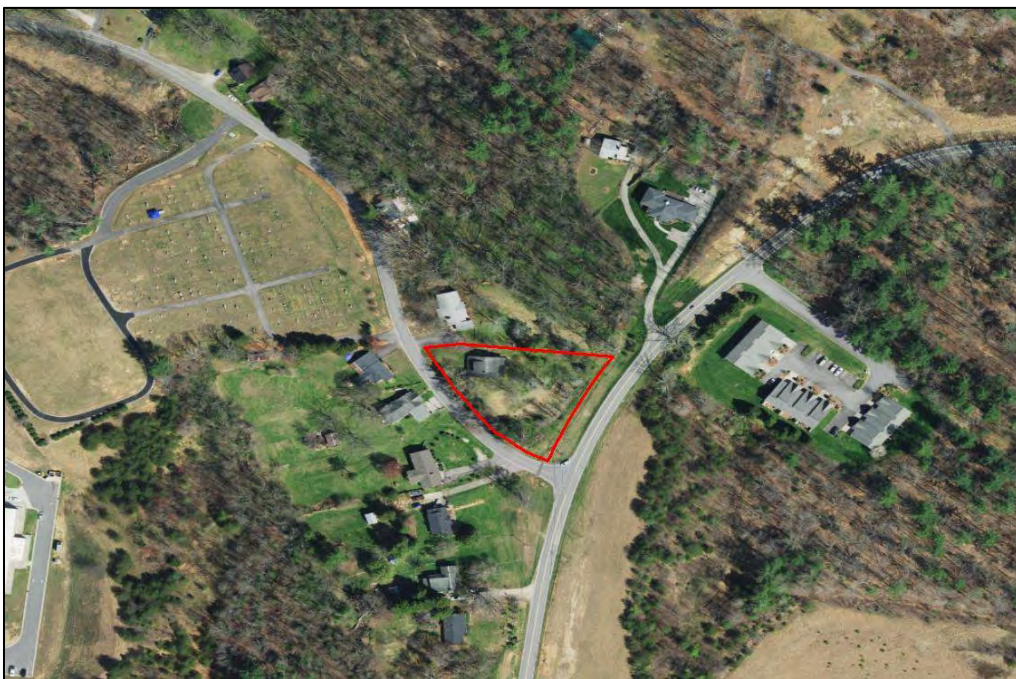
The National Register boundary for the James Calloway Harris House includes the house and 0.8-acre parcel on which it stands (2.5.19). The significance of the James Calloway Harris property is multifaceted, including both its architecture and association with James Calloway Harris, a local African-American painter and decorator who successfully worked his trade in the Wilkesboro area during the first half of the twentieth-century. The entire parcel is associated with Harris and his ownership of the property and, therefore, creates the NRHP boundary.

Figure 2.5.19. NRHP boundary for the James Calloway Harris House (WK0455).
