SUBJECT: Historic Structures Survey Report, Replace Bridge 267 on SR 3336 over Climax Creek,
PA 19-01-0022, Guilford County, ER 19-2356

National Register of Historic Places Eligibility Evaluation Report for the Replacement of Bridge No. 267 on SR 3336 (Coble Church Road) over Climax Creek

The North Carolina Department of Transportation (NCDOT) proposes to replace the two-lane Bridge No. 267 on SR 3336 (Coble Church Road) over Climax Creek in the unincorporated Julian community in southeast Guilford County (WSB# 17BP.7.R.136). The project area is located approximately 12.6 miles southeast of Greensboro, the Guilford County seat. This project is subject to review under the Section 106 Programmatic Agreement for Minor Transportation Projects (NCDOT/NCHPO/FHWA/USFS 2015). A NCDOT architectural historian defined the Area of Potential Effects (APE) as the project site, adjacent parcels, and all properties within the viewshed that may be impacted by the project. The NCDOT subsequently determined that two agricultural properties located within the APE warranted an intensive National Register of Historic Places (NRHP) eligibility evaluation.

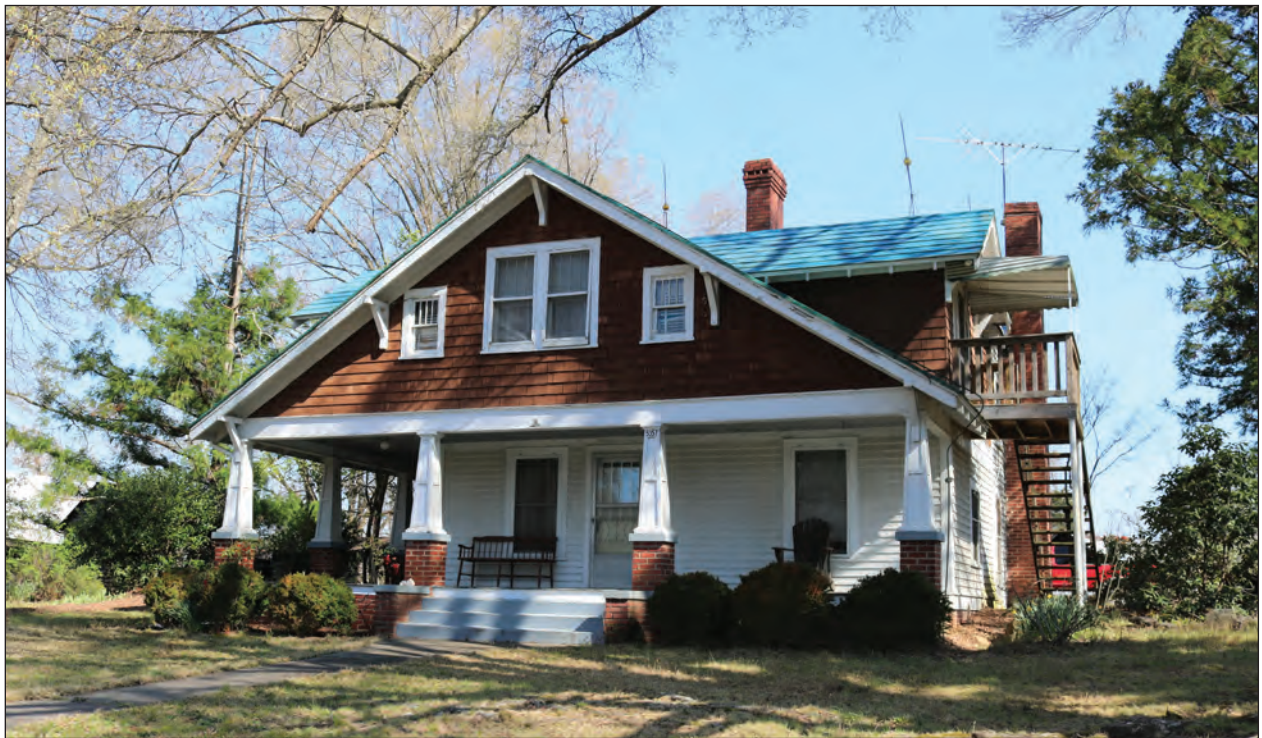
Figure 3.6. David Daniel Coble Farm, Façade and West Elevation, Looking Northwest.

The primary dwelling is a two-story, 2,316 square-foot building with a circa 1875 log core, which was enlarged and renovated circa 1910 and again in the Craftsman-style circa 1930. The original log section of the dwelling was constructed by David Daniel Coble and was a two-story or lofted, center passage dwelling of log or rough-hewn plank construction with a foundation of stone piers. The dwelling was altered in various stages as the Coble farm gained success in the late nineteenth and early twentieth centuries. Around 1910, a rear ell with and shed roof porch was added to the original log core of the house. At that time, the exterior was clad with weatherboard siding and exterior end chimneys were constructed on the east, west, and north elevations (the chimneys have since been replaced). The rear ell retains the original double-hung, six-over-six wood sash windows. The windows on the east and west elevations of the original core are double-hung, two-over-two wood sash dating to the late nineteenth century. The most extensive alteration took place around 1930 when the Cobles added a two-story, Craftsman-style wing to the south façade. This section has a gable-front roof with exposed rafter ends, wood shakes in the gable field, and knee-brace brackets below the eaves. Contained within the roof is a one-story porch that is supported

The main entrance is located centrally on the south façade and has an original to the renovation four-light, three panel glass and wood door flanked by original double-hung, four-over-one wood windows. A second entrance is recessed on the south façade and has a circa 1930 four-light, three panel glass and wood door that provides access to the original core of the house. The circa 1930 addition has a continuous brick foundation and a central brick chimney with a corbeled brick cap. Large, gable-roof dormers are situated on the east and west elevations of the circa 1930 addition. The west dormer contains a pair of original four-over-one wood windows, wood shakes, exposed rafter ends, and knee-brace brackets. The dormer on the east façade contains a pedestrian entrance with a circa 1950 metal awning, flanked by three-light sidelights. The second story is accessed by a wood stairway with a picketed balustrade at the landing. Installed around 1950, the second-floor entrance landing is supported by round metal poles and the stairway has a wrought iron railing. When the Craftsman-style façade was added the entire dwelling was reroofed with pressed tin shingles. In the 1950s, a carport was added to the north elevation that is supported by square wood posts and has an asphalt shingle roof (Figures 3.6 - 3.11).

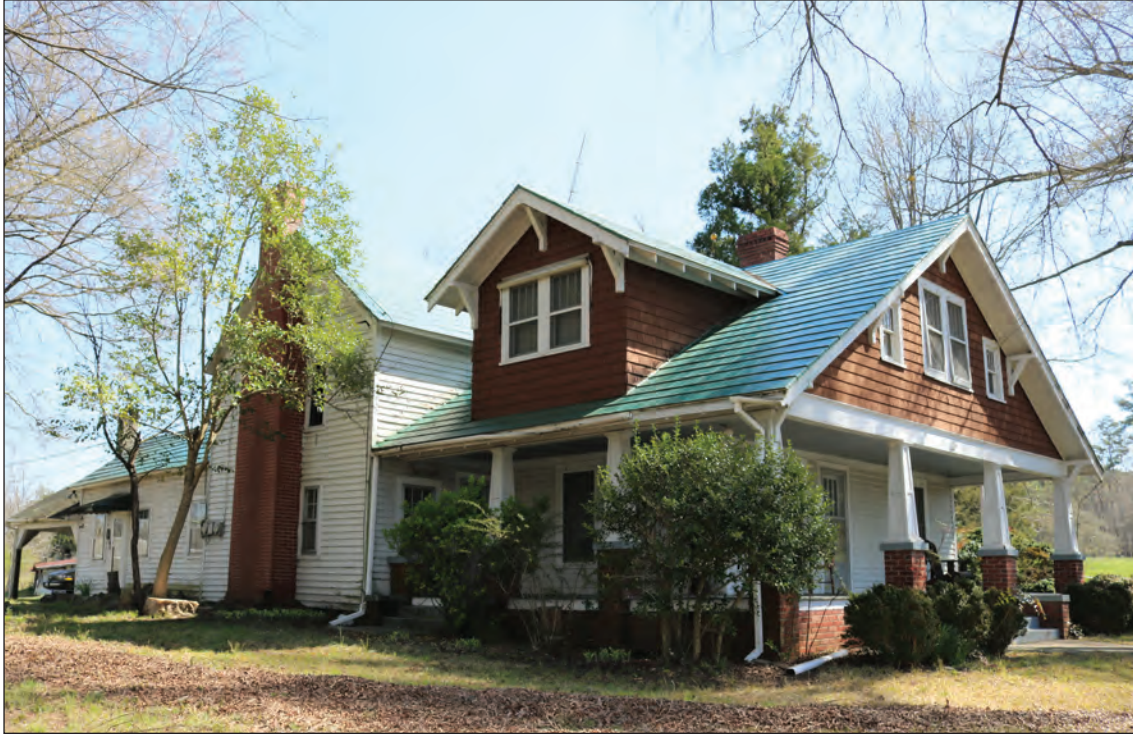
Figure 3.8 David Daniel Coble Farm House, Façade and West Elevation, Looking Northeast.

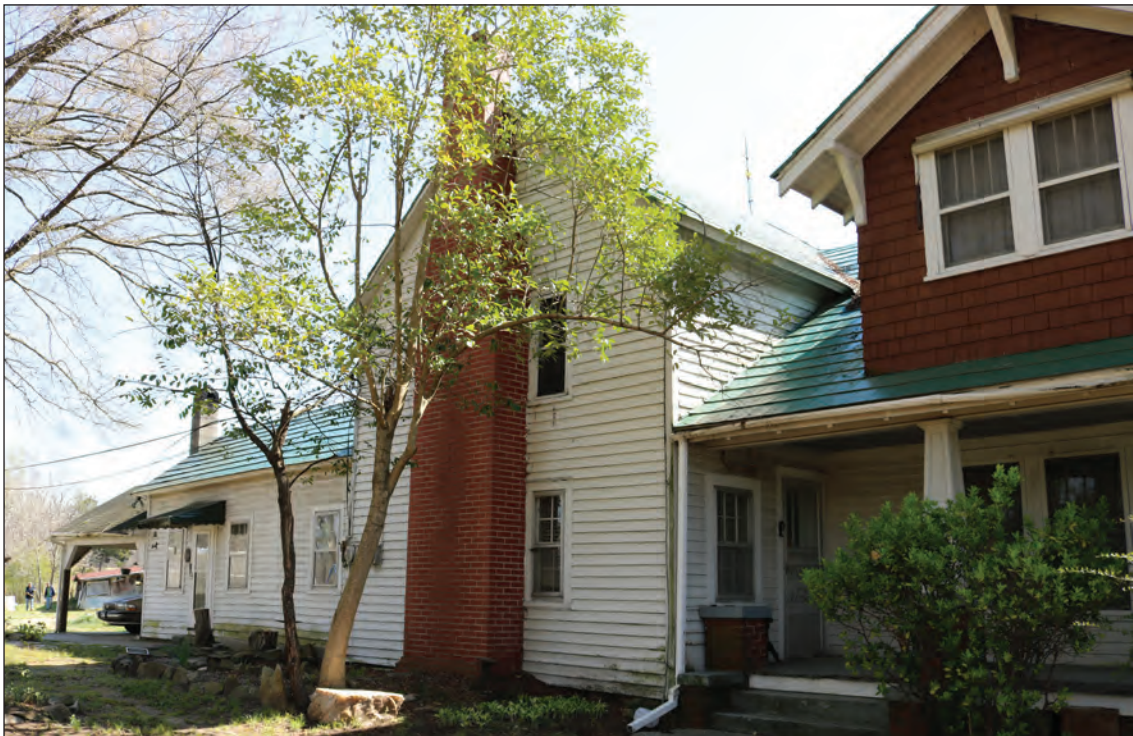
Figure 3.9. David Daniel Coble Farm House, Circa 1900 Additions and Rear Ell, Looking Northeast.

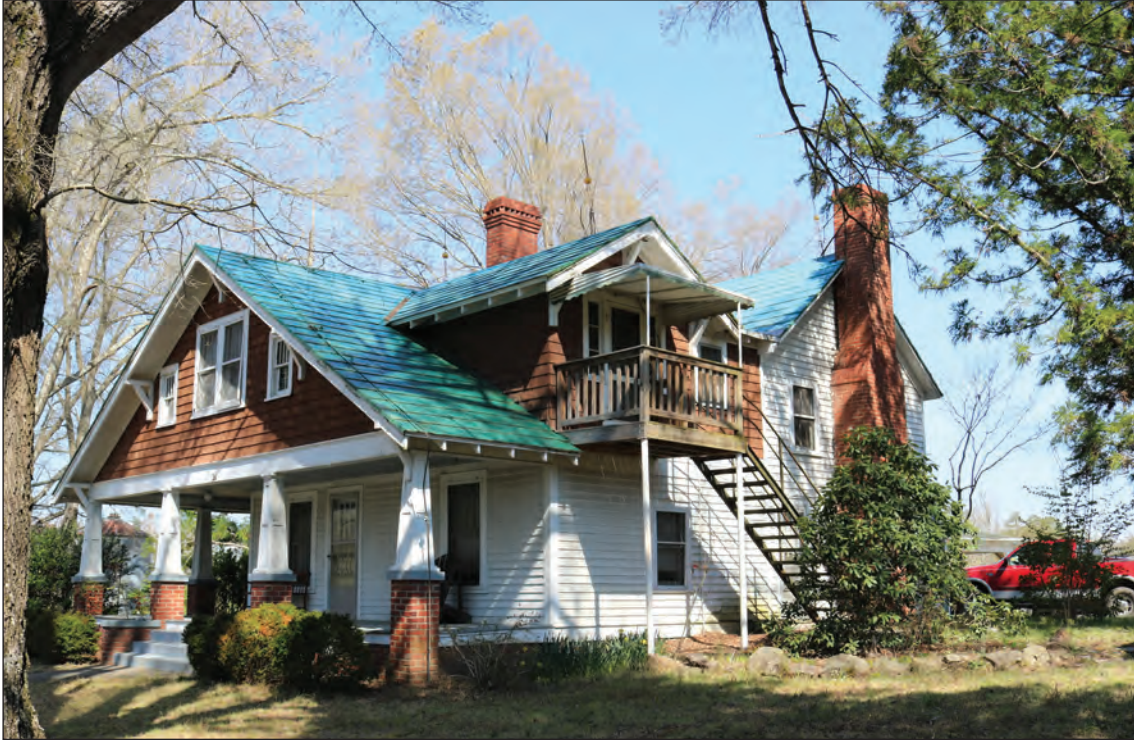
Figure 3.10. David Daniel Coble Farm House, Façade and East Elevation, Looking Northwest.

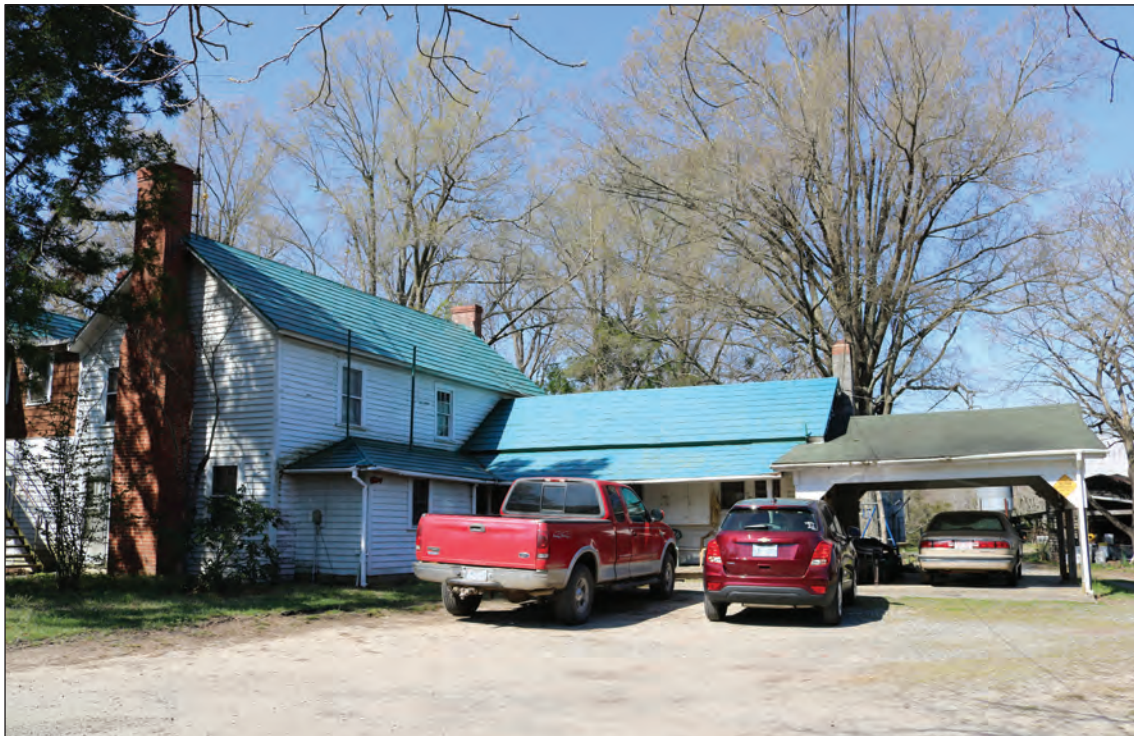
Figure 3.11. David Daniel Coble Farm House, Rear Ell and Carport, Looking Southwest.

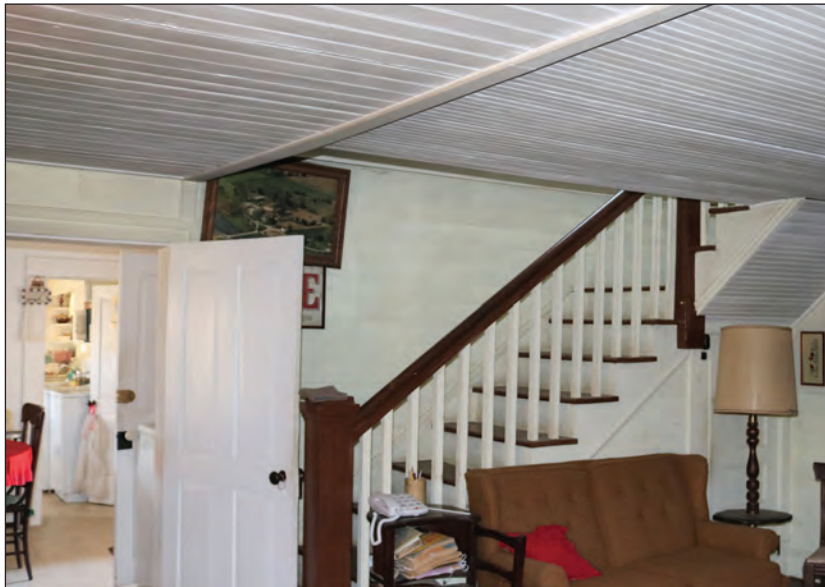
Figure 3.12. David Daniel Coble Farm House, Interior of the Historic Core, Looking Northeast.

The interior of the historic log core of the dwelling retains its circa 1900 clapboard wall coverings and low beadboard ceiling. A quarter-landing staircase with solid square balusters and streamlined, plain shaft wood newel post is also located in the historic core of the house and lends access to the second floor. The dwelling retains most of the circa 1900 three, four, and six panel wood doors. The kitchen, located in the rear ell, retains a circa 1920 wood stove as well as wooden cabinetry updated in the 1960s. The circa 1930 addition retains some of the original features including the plaster walls and wood plank ceiling (Figure 3.12 -3.16).

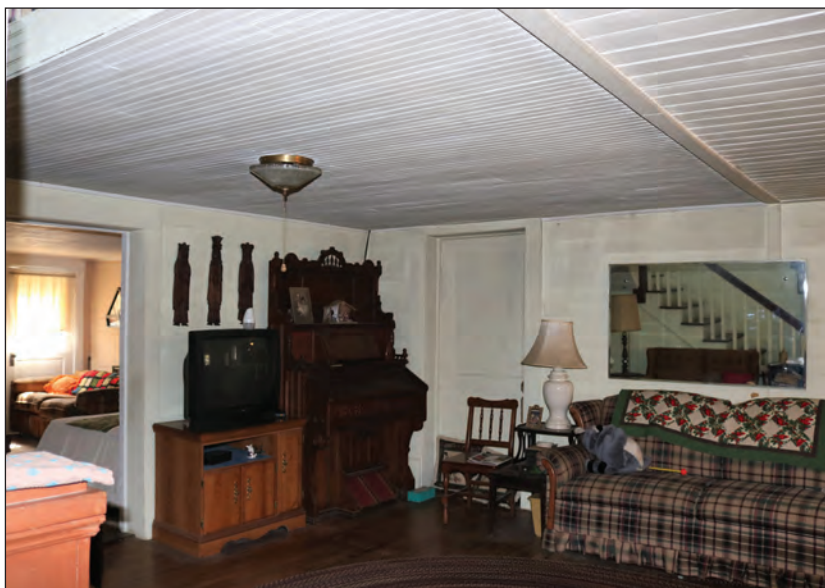
Figure 3.13. David Daniel Coble Farm House, Interior of the Historic Core, Looking Southeast.

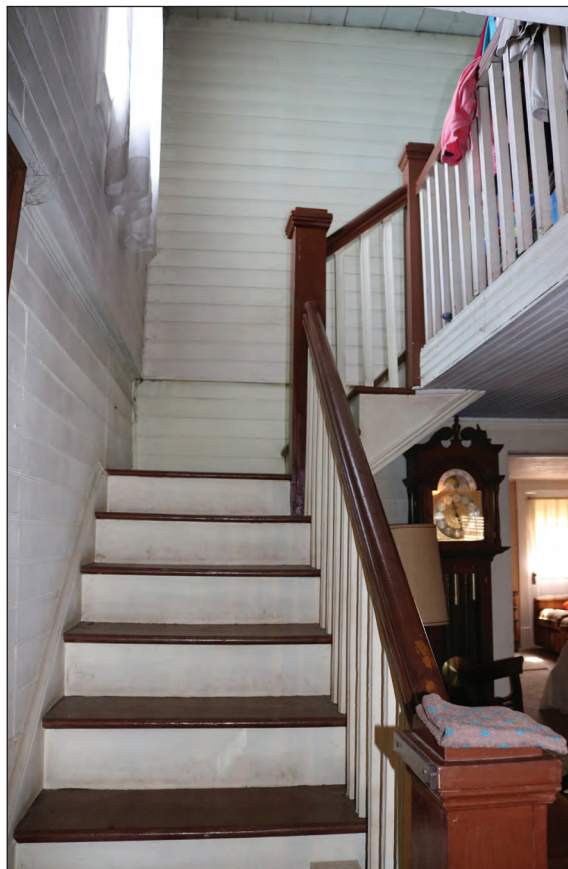
Figure 3.15. David Daniel Coble Farm House, Staircase, Looking East.

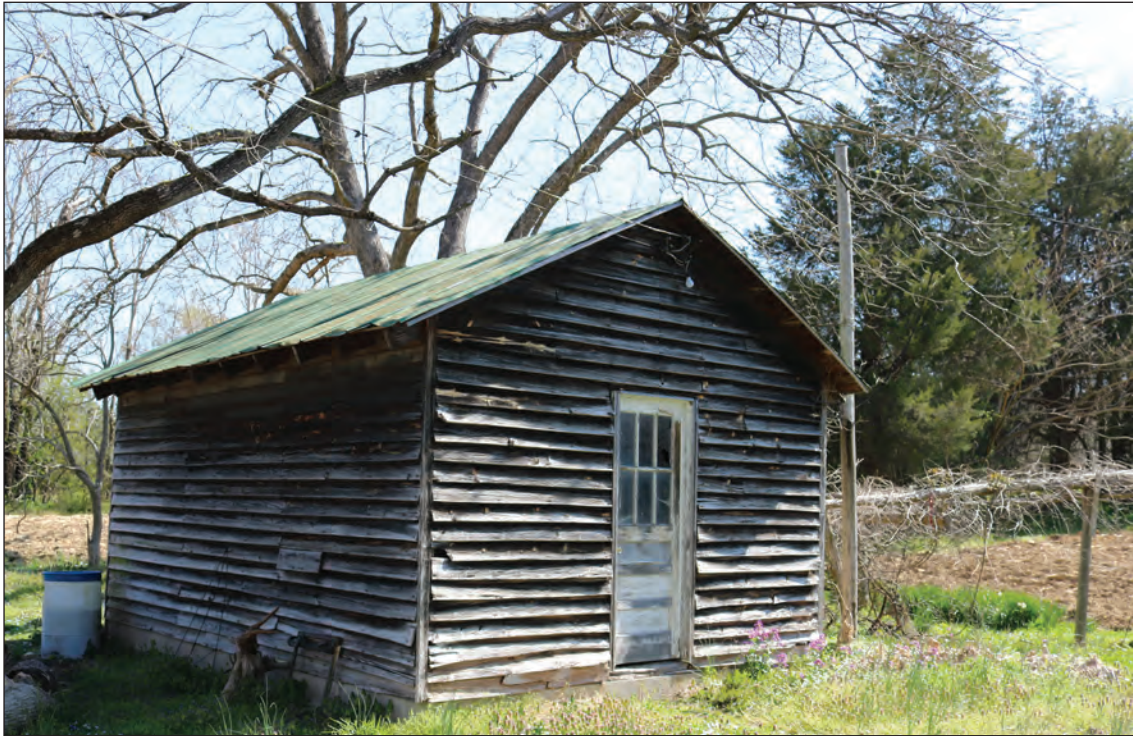
Figure 3.17. Potting Shed and Trellis, Looking Northeast.

A front-gable, frame potting shed is situated to the northeast of the dwelling. Constructed around 1930, the potting shed has a concrete block foundation, a weatherboard siding exterior, and an original standing seam metal roof. A pedestrian entrance is located on the south façade and has an original six-light, multi-panel glass and wood door; an original six-over-six wood sash window is located on the east elevation. A trellis of rough sawn wood posts is located directly east of the potting shed (Figure 3.17 and 3.18).

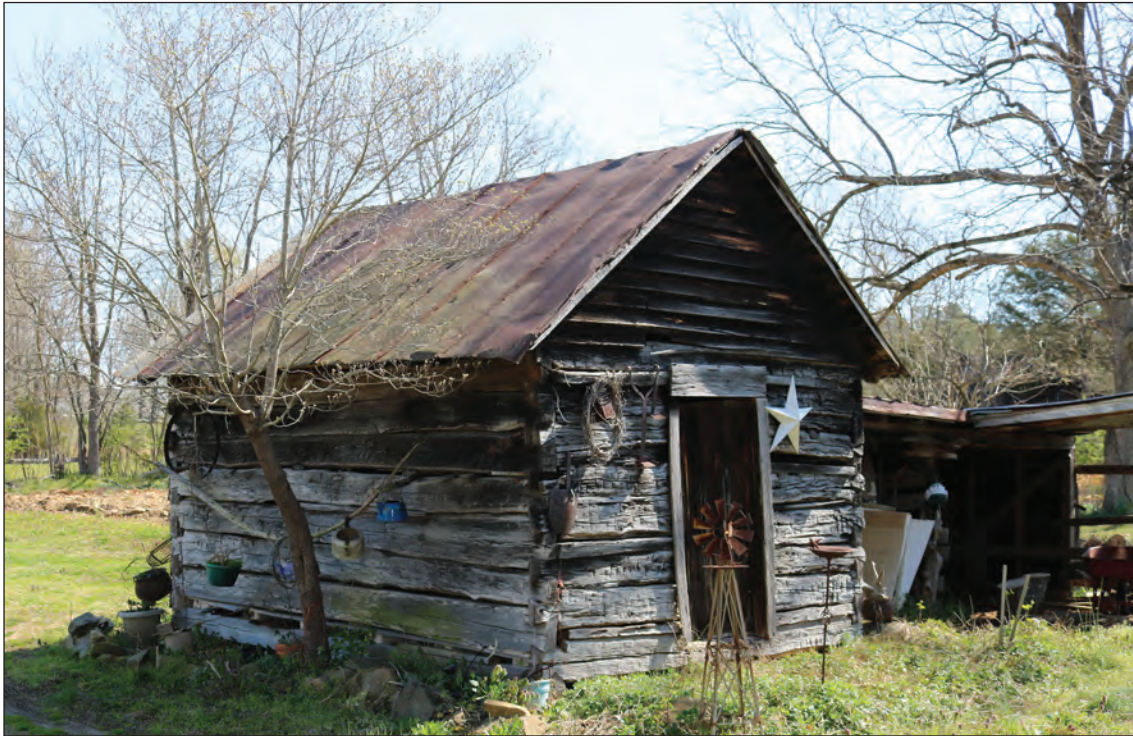
Figure 3.19. Smokehouse, Looking Northeast.

Directly west of the potting shed and north of the main dwelling, is a smokehouse that dates to 1875. Constructed of hand-hewn logs, the smokehouse features half dovetail joints and the original adze marks. A single entrance with vertical board door is located on the south façade and, as is traditional for smokehouses, there is no other fenestration. Around 1930, the gable-front roof was updated with standing seam metal and corrugated metal sheets. Around that time, the smokehouse was connected to a frame equipment shed with a flat roof hyphen. This equipment shed contains two primary bays and has a flat roof with exposed rafter ends that is supported by rough-sawn wood posts. The exterior has rough-cut weatherboard siding (Figure 3.19 and 3.20).

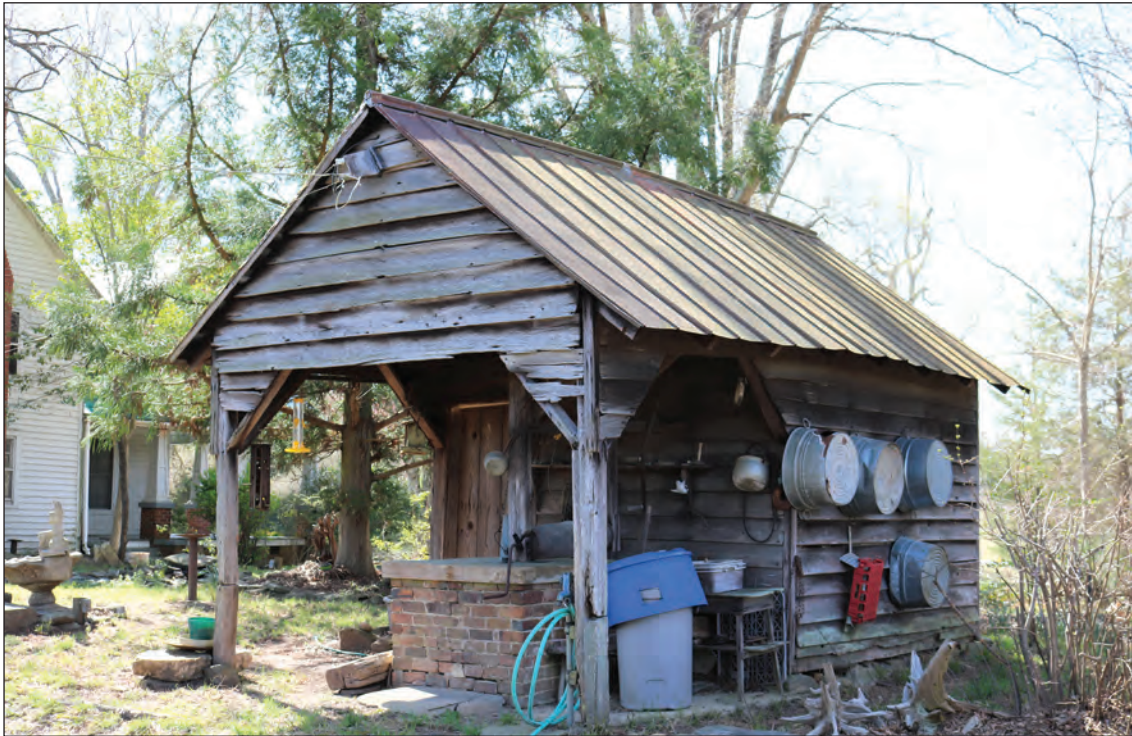
Figure 3.21. Wellhouse, Looking Southeast.

Situated to the west of the main dwelling, facing north is a circa 1930 well house. The well house is constructed on a foundation of brick piers and stacked stones and is clad with rough saw weatherboard. The gable-front roof is clad with standing seam metal. A canopy shed supported by square wood posts provides shelter for a brick well with a cast concrete cap. The main entrance is offset on the north façade and has an original door of vertical boards, the building has no other fenestration (Figure 3.21).

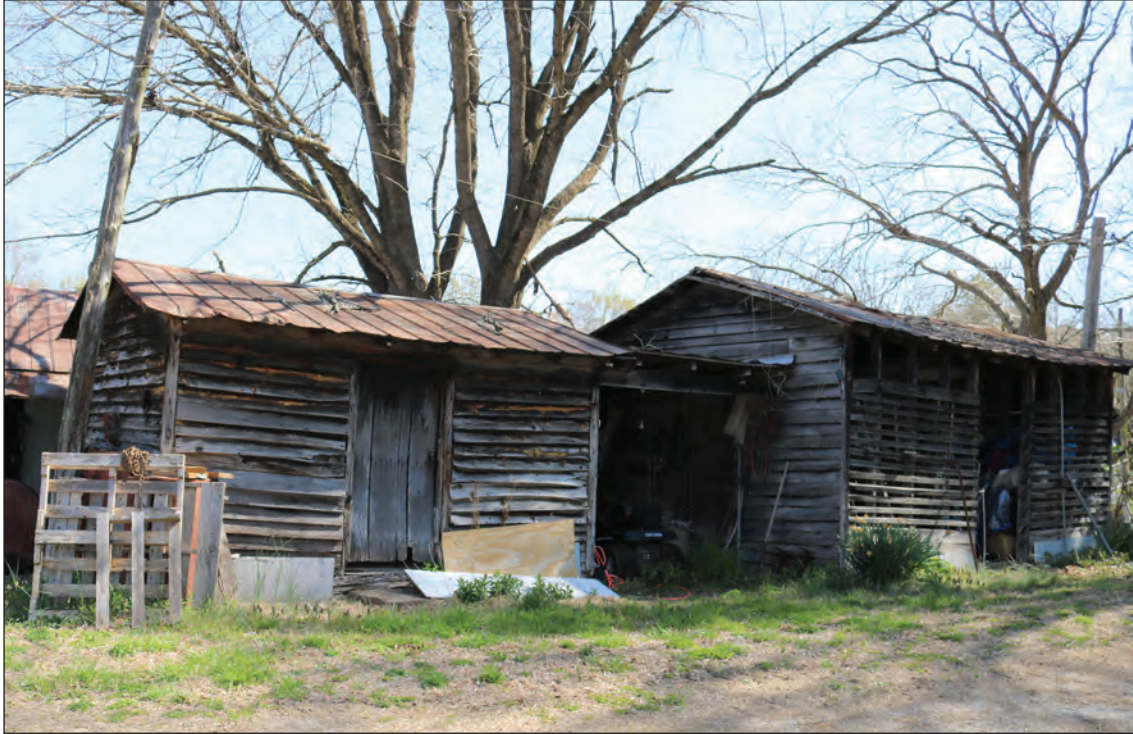
Figure 3.22. Corn Crib and Storage Building, Looking Northeast.

Directly across the gravel drive from the well house and west of the smokehouse is a combined corn crib and storage building. Likely constructed circa 1930, this frame corn crib has a side-gable roof of standing seam metal and weatherboard siding on the east, west, and north elevations. The south wall is comprised of open slats to ventilate the building and allow ears of corn to dry. An open storage bay has been added to the east elevation with a corrugated metal roof supported by round wood posts. A one room storage building constructed circa 1875 is located directly west of the corn crib and is connected to the corn crib with a flat roof hyphen. This storage building has a rough-sawn weatherboard exterior, a side-gable roof of standing seam metal with exposed rafter ends, and a single entrance on the south façade with a vertical board door. A flagstone step has been placed in front of the entrance (Figure 3.22 and 3.23).

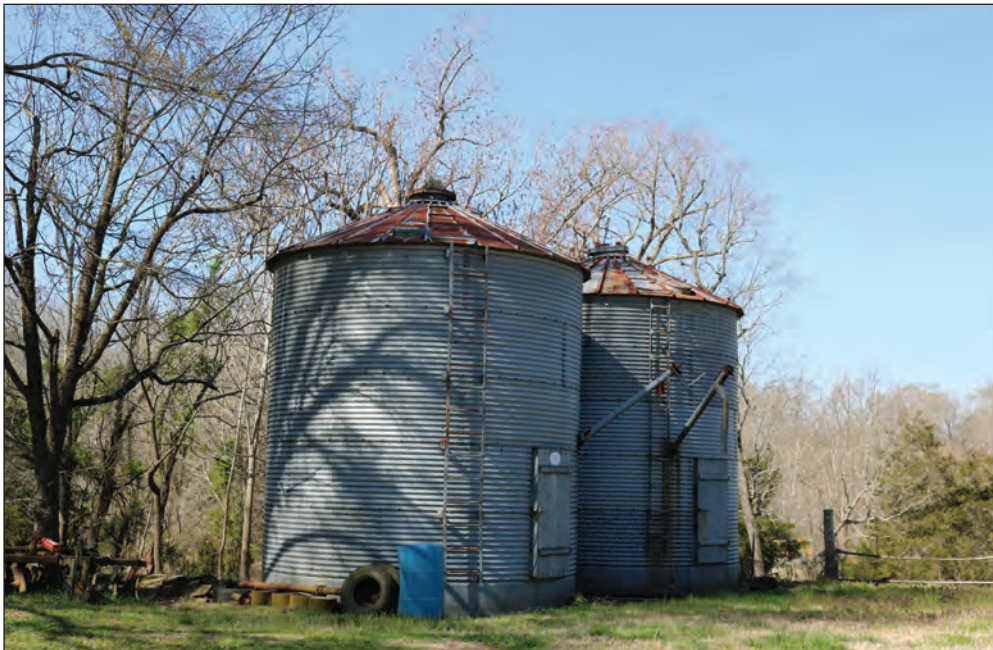
Figure 3.24. Corrugated Metal Silos, Looking West.

Three silos of corrugated metal construction are situated at the southwest corner of the farm complex, one is adjacent to the bank barn. The silos are comprised of sheets of corrugated metal riveted horizontally indicating that they likely date to the 1940s or 1950s. Each silo has a standing seam metal roof and metal ladder; the silo closest to the bank barn has a tapered funnel at the base (Figure 3.24).

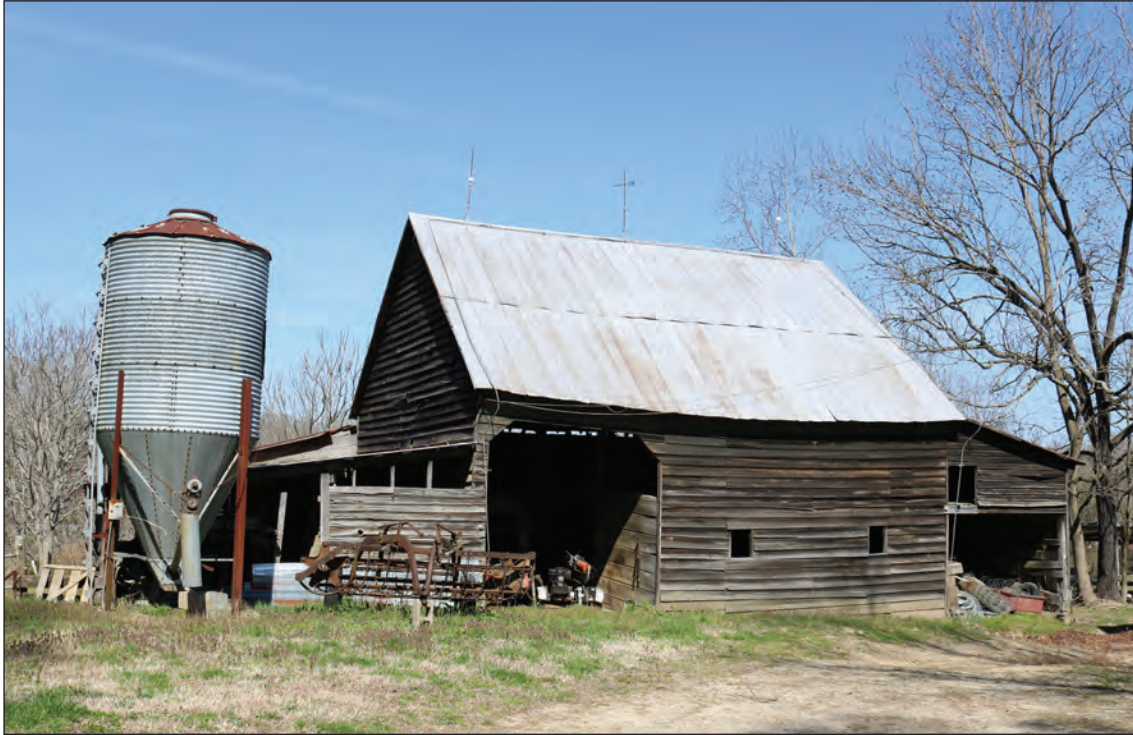
Figure 3.25. Barn and Corrugated Metal Silo, Looking Northwest.

A circa 1930 gable-roof barn with a side passage is located directly north of the paired silos and creates the western boundary of the farm complex. The barn is bounded by the pasture on the west side and has a weatherboard siding exterior, a side-gable roof of standing seam metal, and shed roof runs on the north and south elevations. The primary bay is located on the west façade (Figure 3.25).

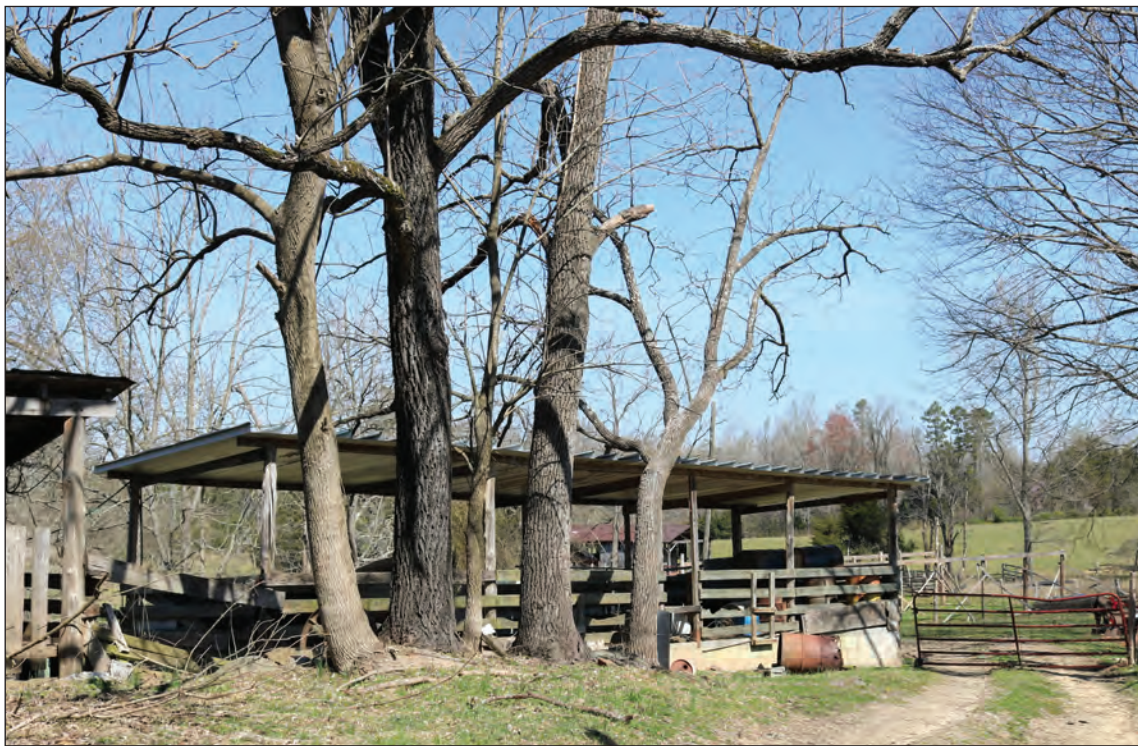
Figure 3.26. Equipment Shed, Looking Northwest.

Directly north of the barn is a frame equipment shed. A review of historic aerials reveals that this equipment shed was constructed sometime between 1969 and 1982. The shed has a concrete slab foundation supported by concrete blocks, wood post framing, and a flat roof of corrugated metal. Adjacent to the shed is a non-historic metal gate that accesses the pasture (Figure 3.26).

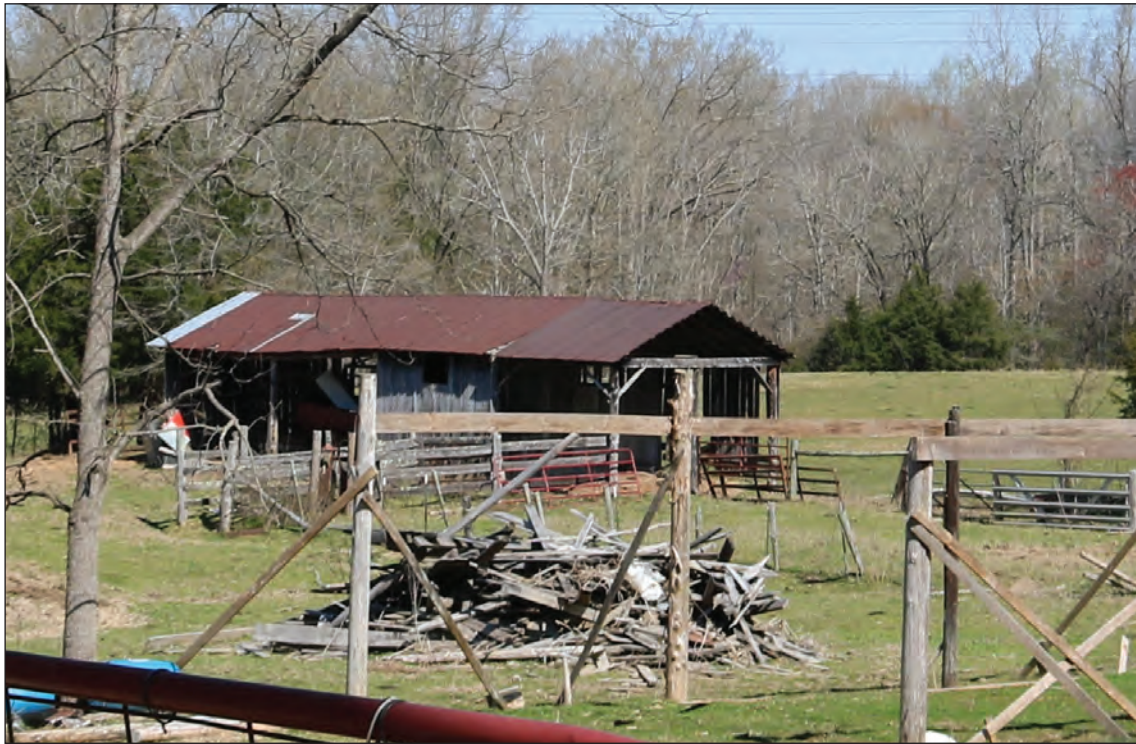
Figure 3.27. Pole Barn, Looking Northwest.

A pole barn constructed between 1955 and 1969 is located in the pasture at the northeastern corner of the farm complex. This barn is of frame construction, has a corrugated metal side gable roof, and a vertical board exterior (Figure 3.27).

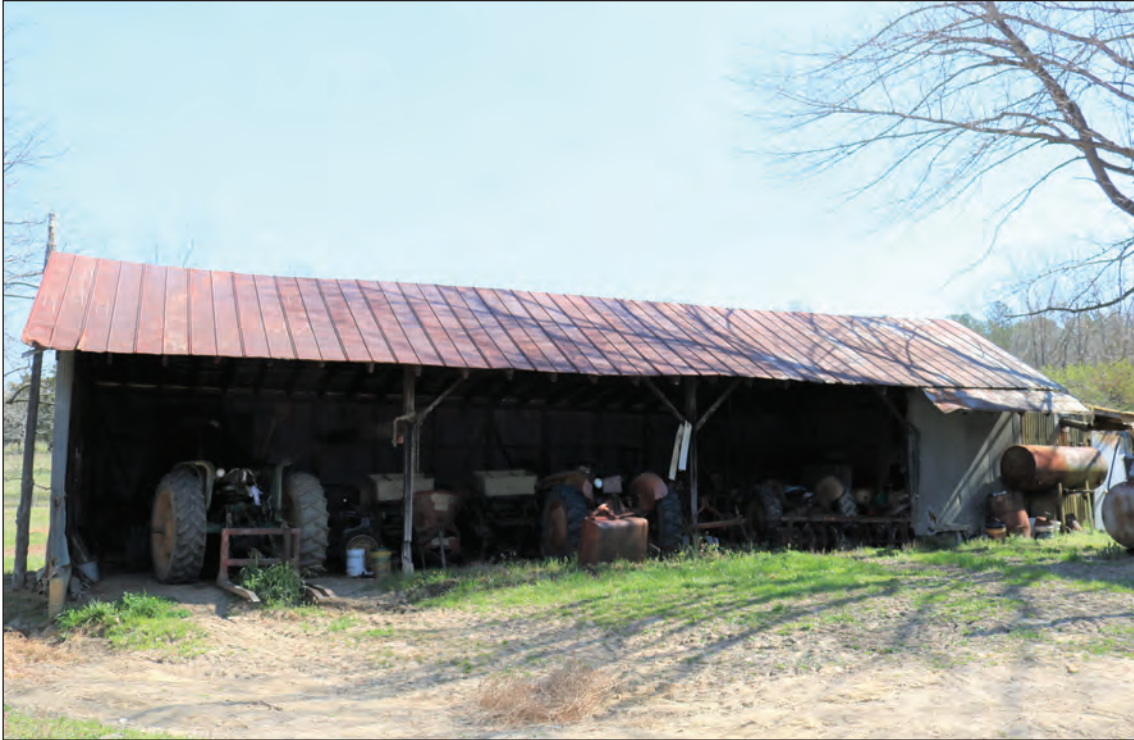
Figure 3.28. Tractor Shed, Looking North.

A circa 1950 tractor shed is located directly east of the equipment shed. The three-bay tractor shed is set into a bank and has a cast concrete slab foundation with visible form board impressions. Supported by vertical poles, the frame tractor shed has a corrugated metal exterior and a side gable roof of standing seam metal with exposed rafter ends. A greenhouse is attached to the east end (Figure 3.28).

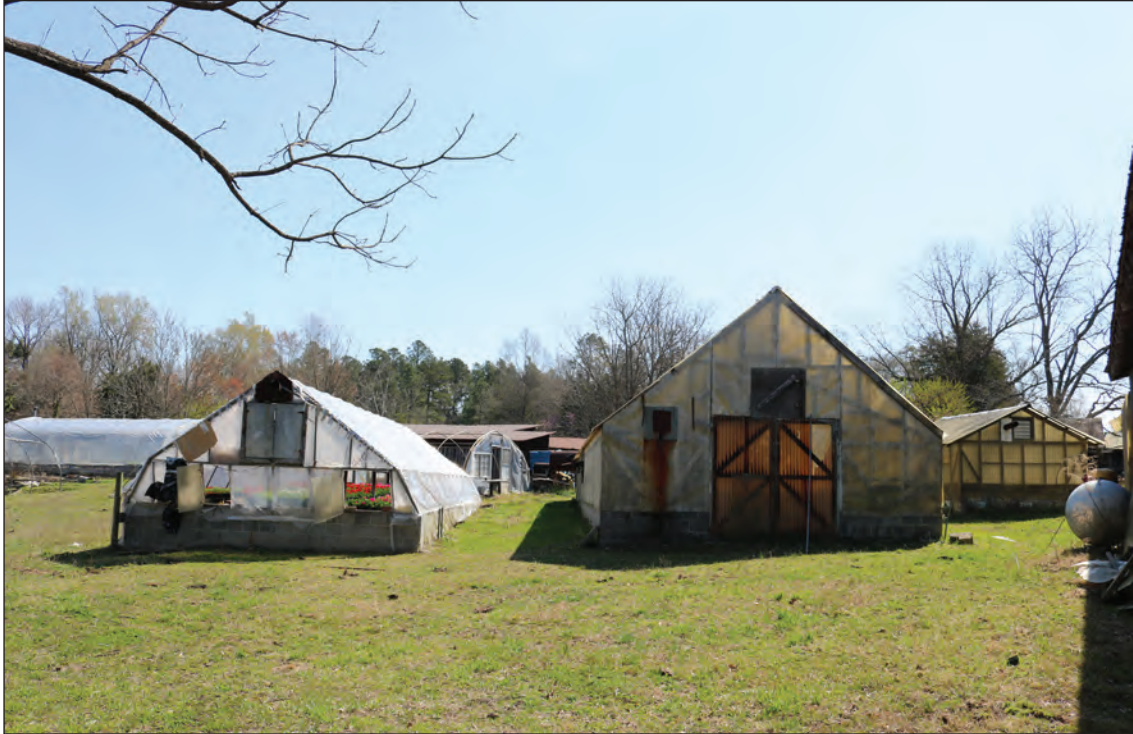
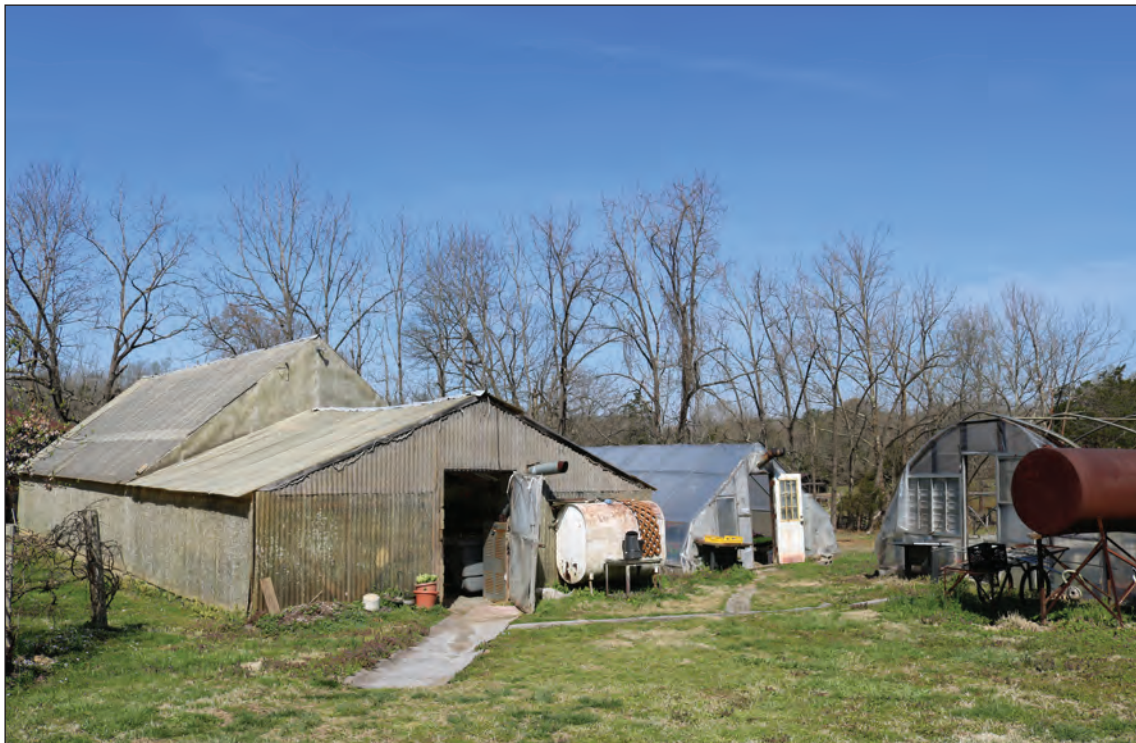
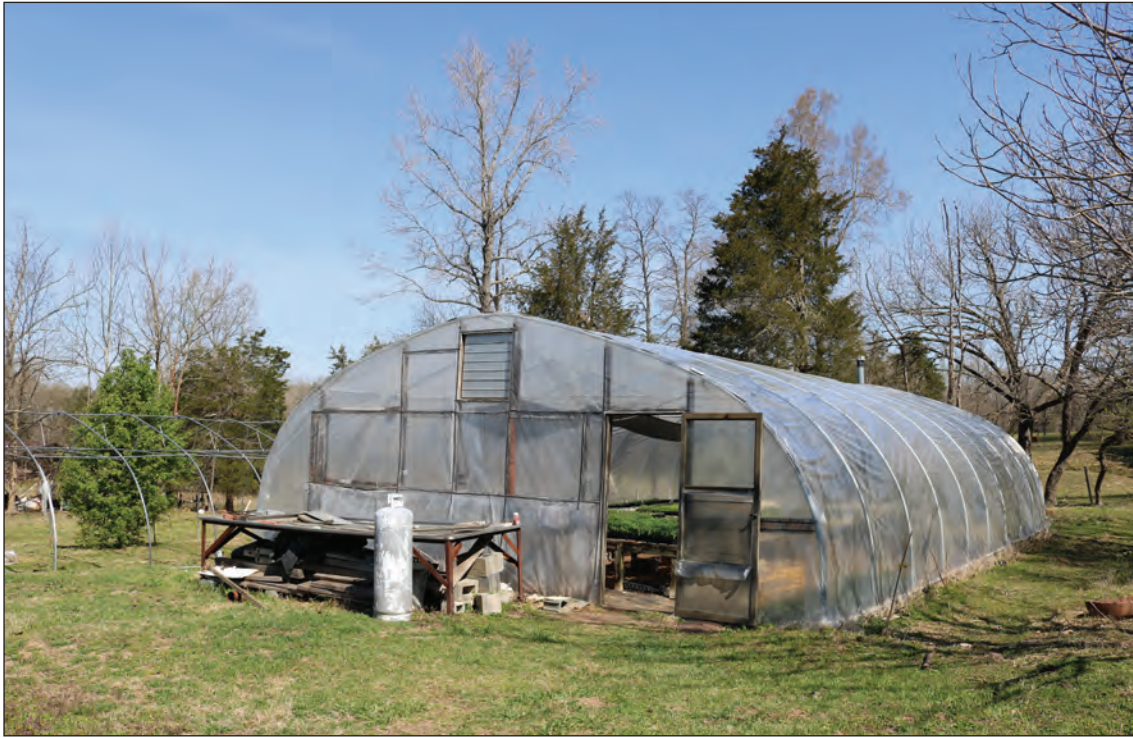
Situated to the north and east of the original farm complex are five greenhouses currently utilized by Sam's Greenhouse, a produce and plant business owned and operated by Ray Coble. Each of the greenhouses exhibits basic frame construction with concrete block foundations and vents in the gable ends for air circulation. The southernmost greenhouses date to the late 1970s and are of wood frame construction with gable roof forms and corrugated, translucent polycarbonate exteriors. The northernmost greenhouses were constructed in the 1990s with metal frames and hooped roofs that support heavy plastic coverings. One metal hooped greenhouse is uncovered and currently under construction. Each greenhouse features an entrance door at the gable end. The greenhouse interiors feature tables for supporting plants (Figure 3.29 - 3.31).

Figure 3.29. Greenhouse Complex, Looking East.

Figure 3.30. Greenhouse Complex, Looking Northwest.

Figure 3.31. Greenhouse Complex, Looking North.

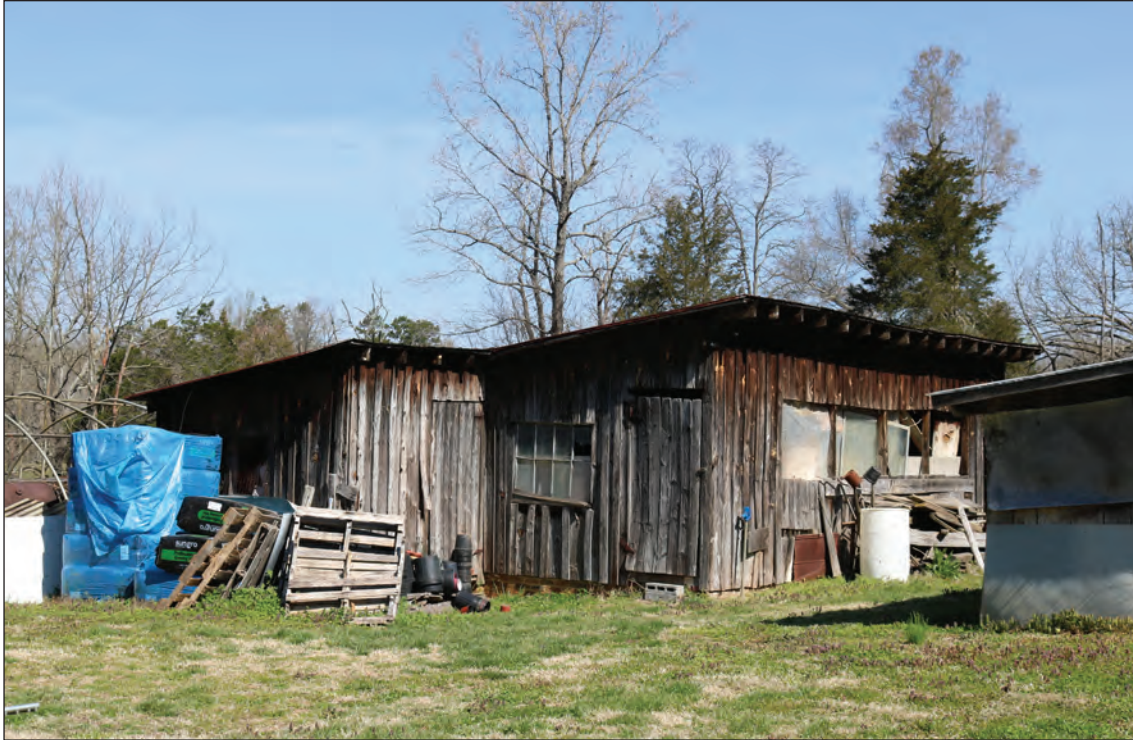
Figure 3.32. Canted Roof Workshop, Looking Northwest.

To the east of the greenhouse complex is a canted roof workshop constructed between 1955 and 1969. This workshop has a continuous brick foundation, a vertical board and batten exterior, and a canted roof with metal panels and exposed rafter ends. Located on the south façade, the vertical board entrance door is flanked by a stationary eight-pane, wood window. A band of window openings has been cut along the west elevation. The building is currently used for storage (Figure 3.32).

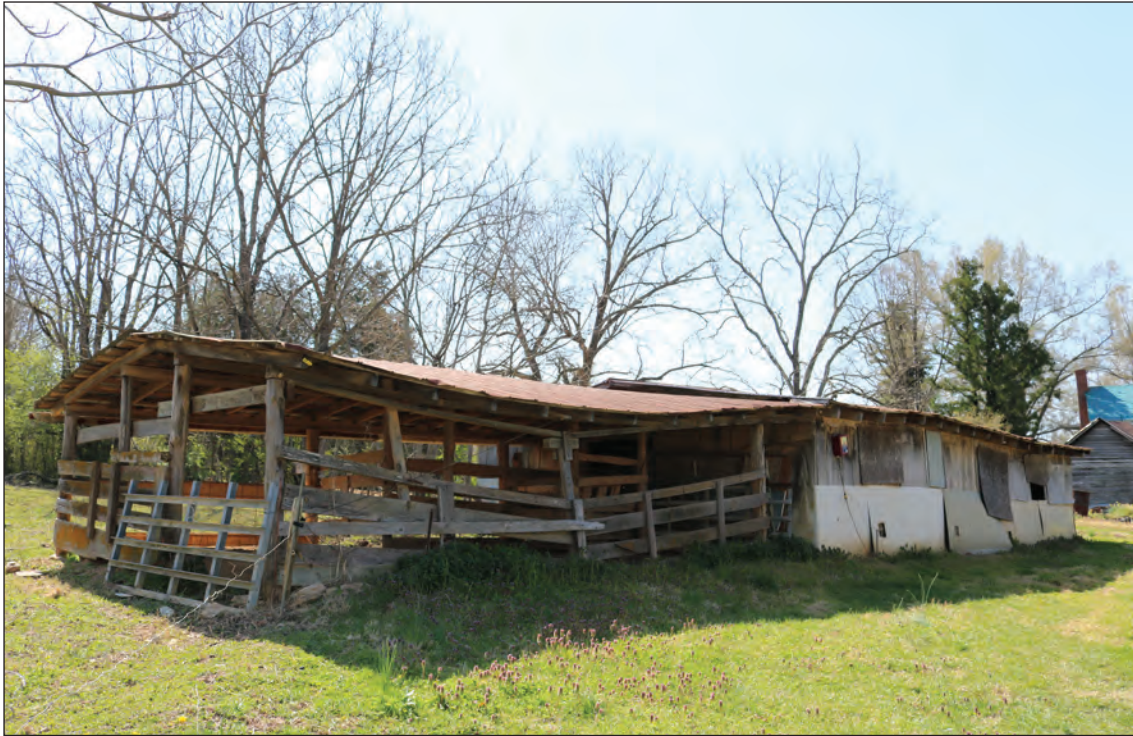
Figure 3.33. Gable-Roof Livestock Barn, Looking Southeast.

A circa 1950 partially enclosed livestock barn is situated at the northeastern corner of the farm complex, adjacent to the greenhouses and workshop and directly behind the smokehouse. This building has a low-pitched gable roof of standing seam metal with exposed rafter ends. The southern portion is enclosed with mixed materials and the north section is of rough-cut frame construction with slatted fencing to corral livestock (Figure 3.33).

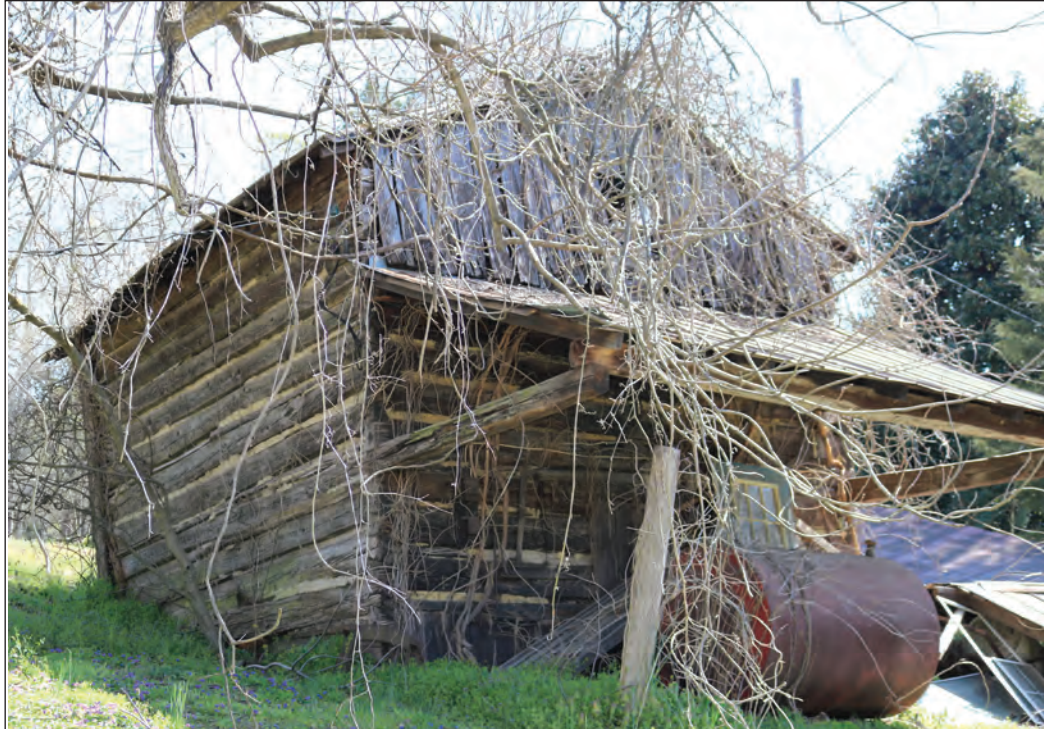
Figure 3.36. Barn, Looking Northeast.

Just west of the tobacco packhouse is a gable-front barn of hand-hewn logs joined with half dovetails and chinking between each log. A shed roof shelter extends from the south façade and is supported by log knee braces. Dating from the late nineteenth century, this log barn has been at this location since at least 1955. Its location and construction suggest that it may have been used as a tobacco packhouse, the area beneath the shed roof would have been used for separating tobacco leaves during the season. This building fronts a gravel path and the westernmost pond (Figure 3.36).

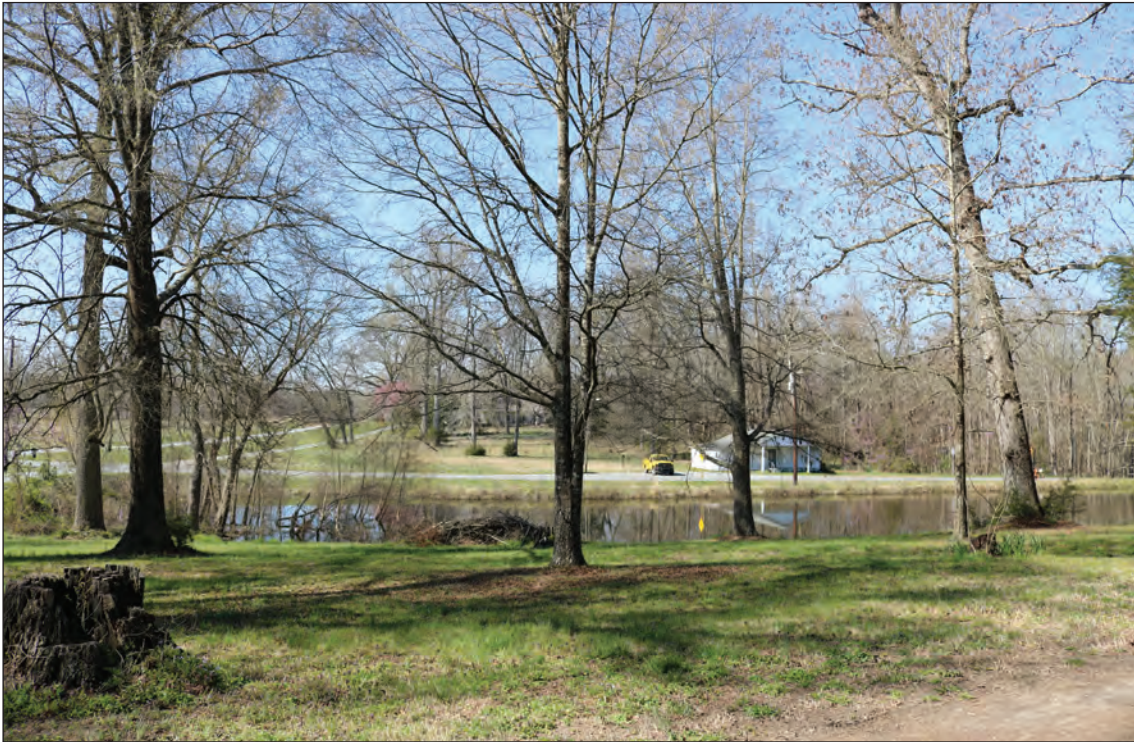
Figure 3.37. Ponds, Looking South.

At the southern edge of the parcel are two man-made ponds created from a tributary of Climax Creek that runs eastward. These ponds are likely used for watering livestock and a review of historic aerials and USGS quad maps reveals that these ponds were constructed between 1920 and 1955 (Figure 3.37).
