SUBJECT: Historic Structures Survey Report, Replace Bridge 267 on SR 3336 over Climax Creek,
PA 19-01-0022, Guilford County, ER 19-2356

National Register of Historic Places Eligibility Evaluation Report for the Replacement of Bridge No. 267 on SR 3336 (Coble Church Road) over Climax Creek

The North Carolina Department of Transportation (NCDOT) proposes to replace the two-lane Bridge No. 267 on SR 3336 (Coble Church Road) over Climax Creek in the unincorporated Julian community in southeast Guilford County (WSB# 17BP.7.R.136). The project area is located approximately 12.6 miles southeast of Greensboro, the Guilford County seat. This project is subject to review under the Section 106 Programmatic Agreement for Minor Transportation Projects (NCDOT/NCHPO/FHWA/USFS 2015). A NCDOT architectural historian defined the Area of Potential Effects (APE) as the project site, adjacent parcels, and all properties within the viewshed that may be impacted by the project. The NCDOT subsequently determined that two agricultural properties located within the APE warranted an intensive National Register of Historic Places (NRHP) eligibility evaluation.

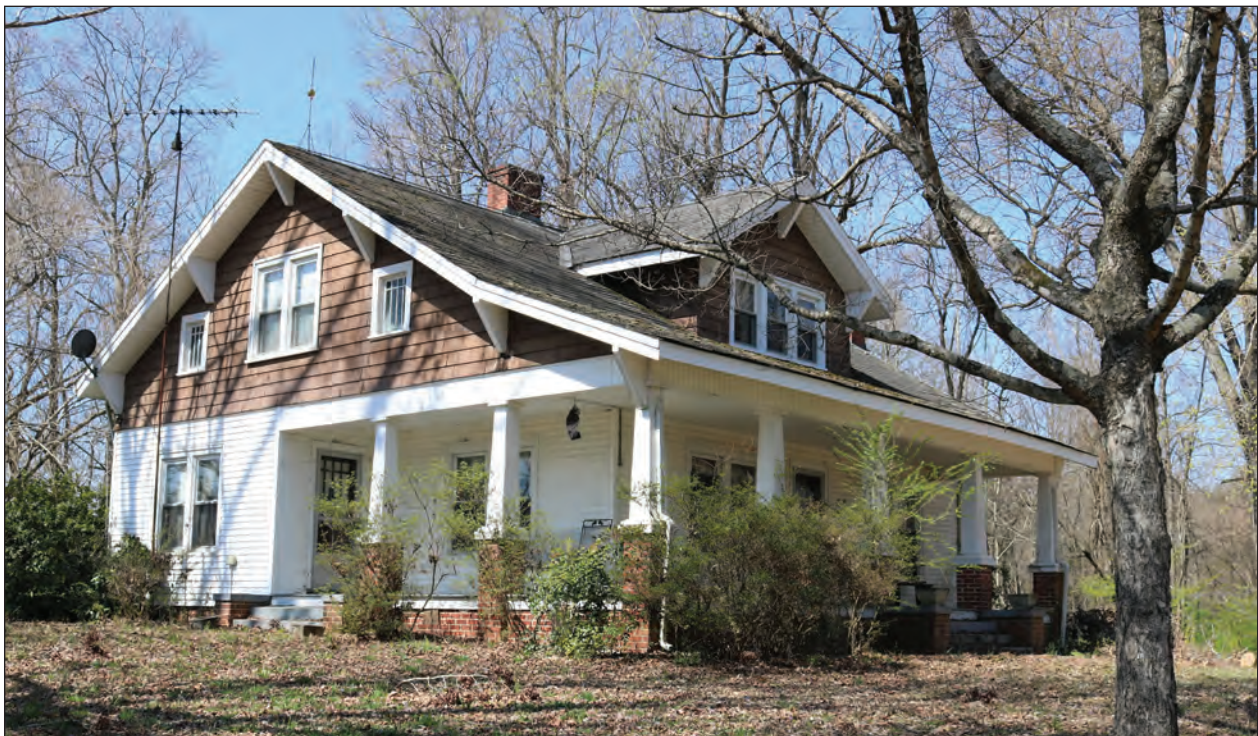
Figure 3.38. Shafter Coble Farm House, Façade and East Elevation, Looking Southwest

The primary dwelling is a two-story, 2,130 square-foot Craftsman Bungalow constructed by C.A. and Shafter Coble in 1928. This dwelling has a side-gable roof of replacement asphalt shingles with a break in the façade slope. Contained with the roof is a full-width porch supported by tapered columns resting on brick piers that extend across the entire width of the north façade and partially across the east elevation. A set of cast concrete stairs lends access to the wood plank porch. The dwelling is clad with synthetic vinyl siding, installed around 2000, and has original wood shake in the gable fields, the fascia and soffit have also been wrapped with vinyl siding. The main entrance is slightly offset on the north façade and has an original glass and wood door with twelve vertical panes. A secondary entrance with an identical door is recessed on the east side of the façade. A gable-roof dormer also clad with wood shake is located centrally on the north façade and contains a bank of three replacement, one-over-one vinyl windows and solid knee-brace brackets. Windows throughout the dwelling have been replaced with one-over-one vinyl sash and are usually set in

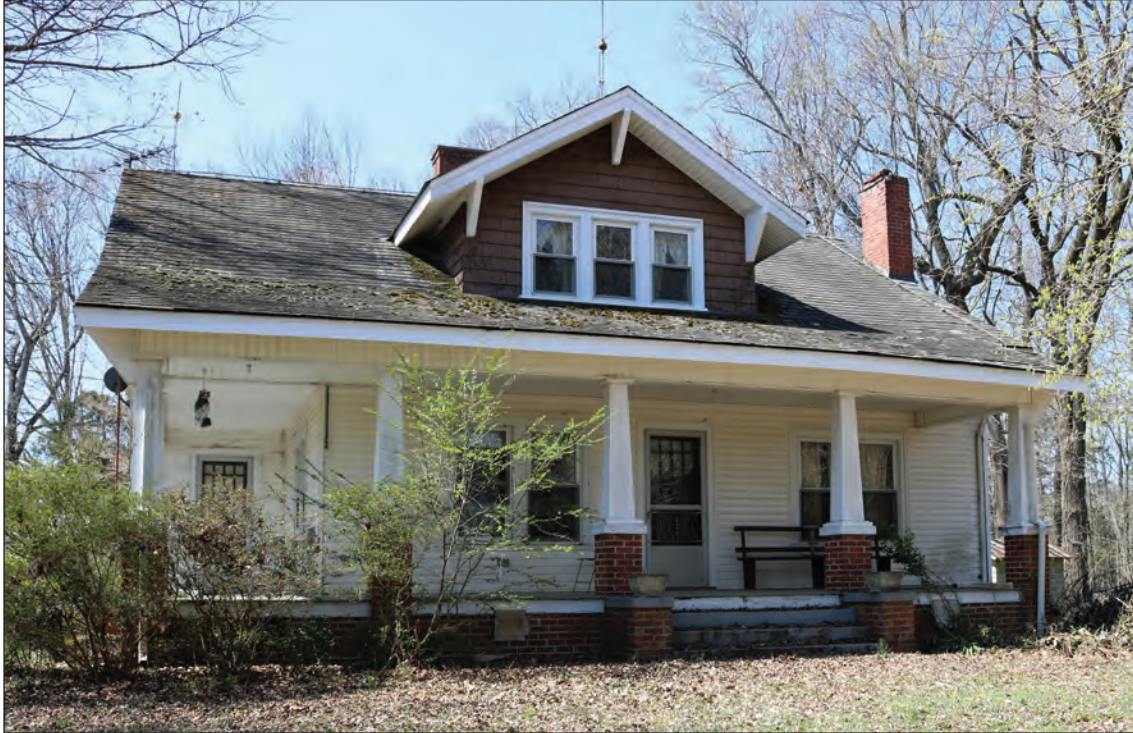
Figure 3.40. Shafter Coble Farm House, Facade, Looking Southwest.

banks of two and three. Each of the gable ends retains two original, twelve-light stationary wood windows that flank a pair of vinyl replacement sash. An exterior end brick chimney is located on the west elevation and is flanked by a circa 1990 shed roof awning that is supported by square wood posts. The dwelling has two interior brick chimneys. A one-story gabled, entrance porch is located on the rear (south) elevation that is supported by square wood posts. The porch retains an original cast concrete circular well that drew groundwater with a hand-operated mechanical chain and bucket. On the south side of the porch is a set of ground-level metal doors providing access to a brick-lined root cellar. The rear porch was partially enclosed in the 1990s (Figures 3.39 - 3.44). The property owner denied access to the dwelling's interior.

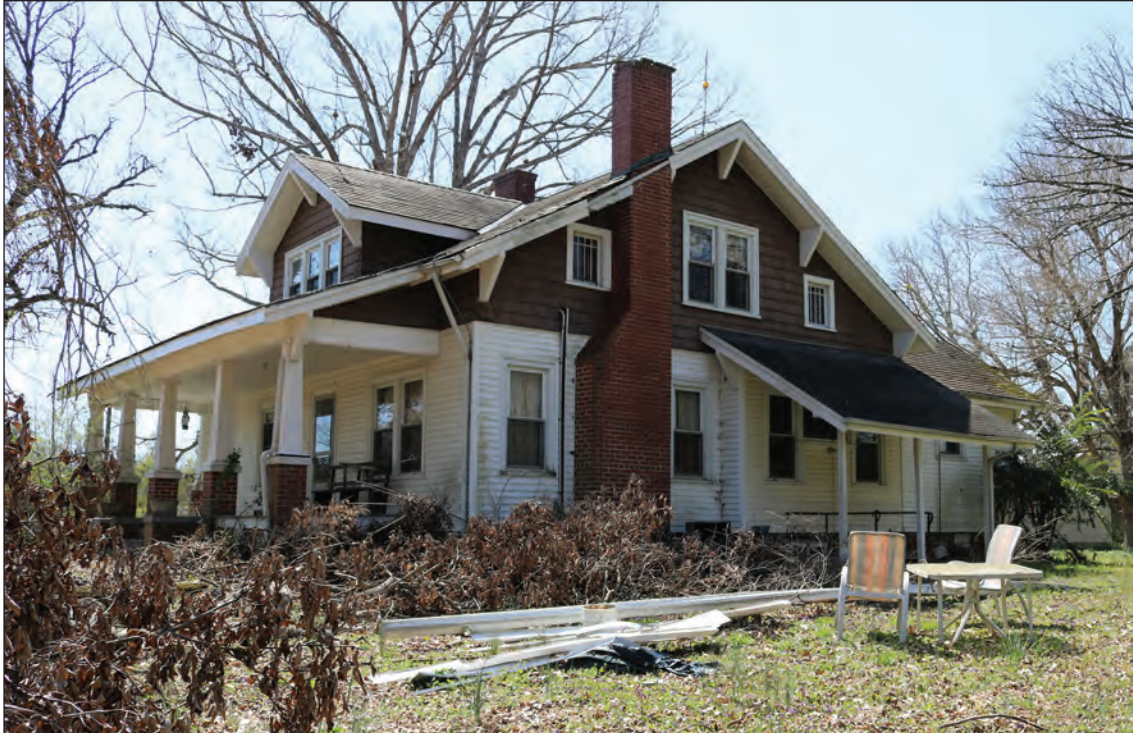
Figure 3.41. Shafter Coble Farm House, Façade and West Elevation, Looking Southeast.

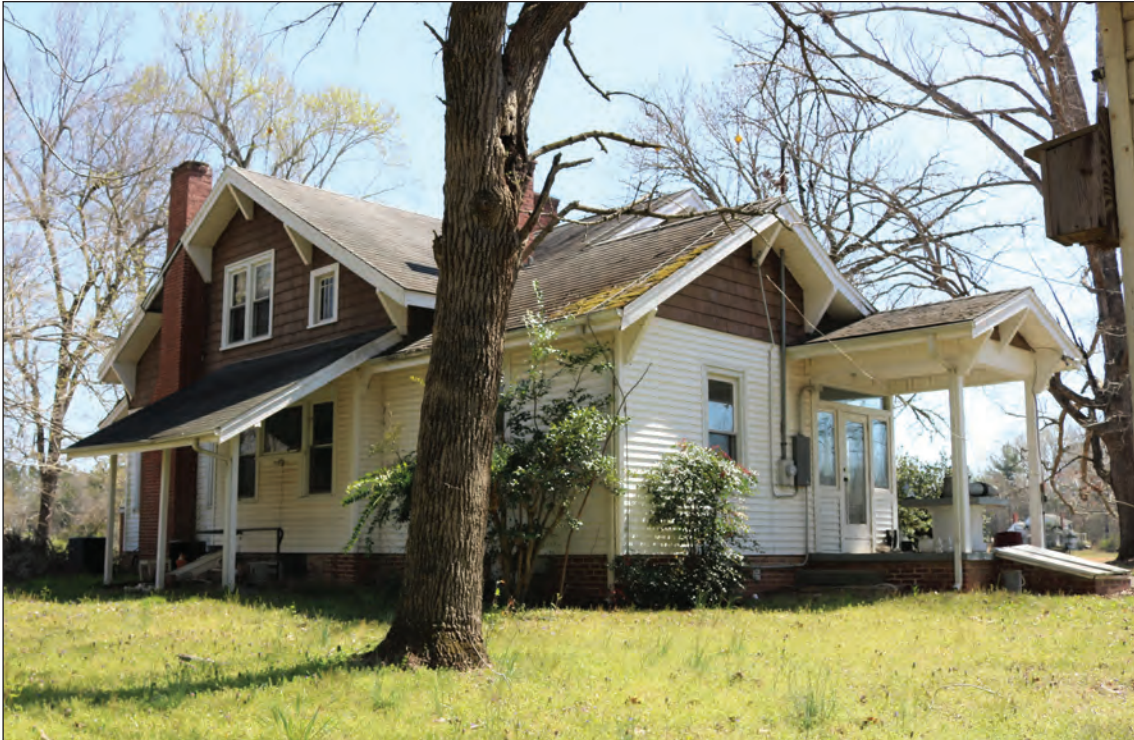
Figure 3.42. Shafter Coble Farm House, West and South Elevations, Looking Northeast.

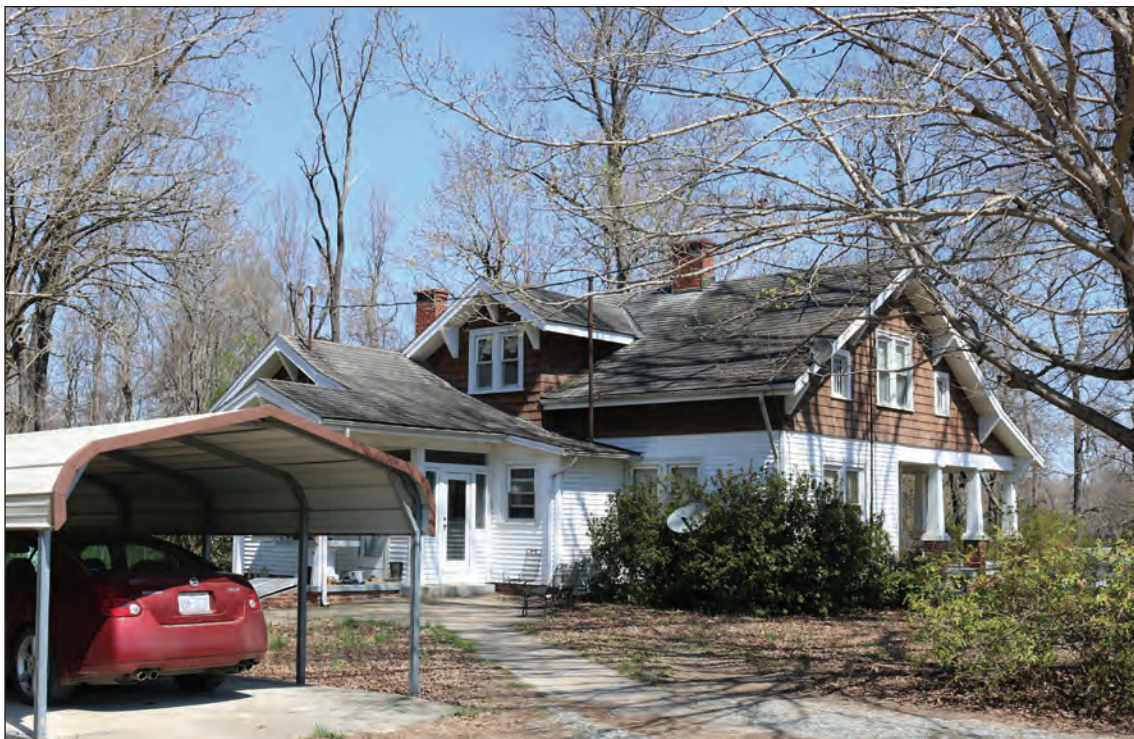
Figure 3.43. Shafter Coble Farm House, South and East Elevations, Looking Northwest

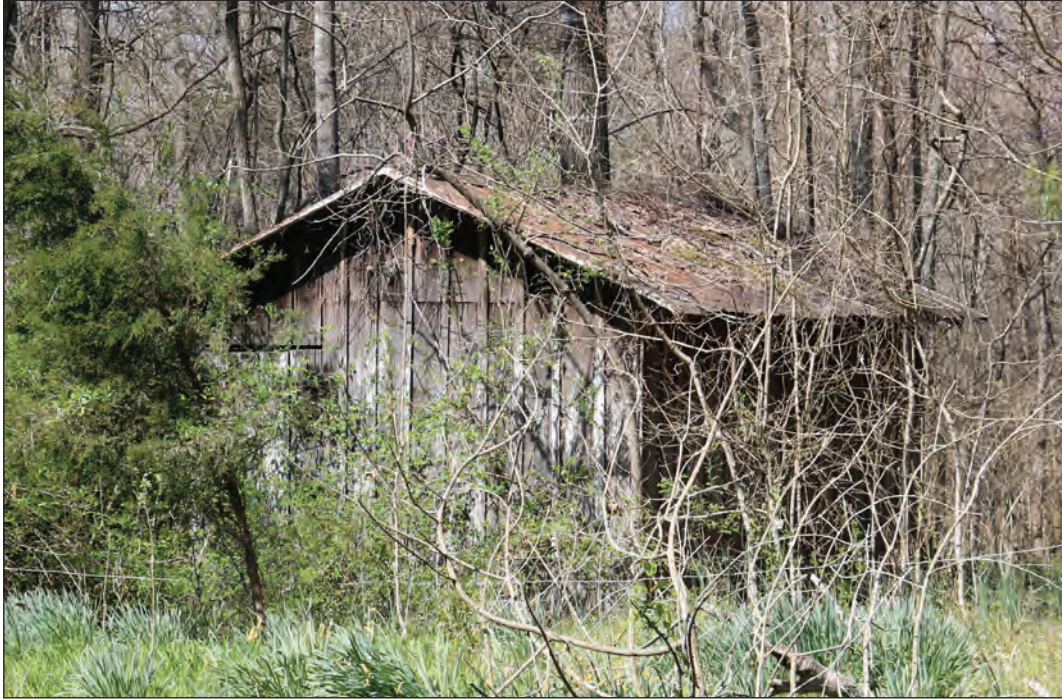
Figure 3.45. Board and Batten Storage Shed, Looking Northwest.

Situated at the northwest corner of the parcel is a one-story frame storage shed with a board and batten exterior and a side gable roof of standing seam metal. This shed dates from the early to mid-twentieth century (Figure 3.45).

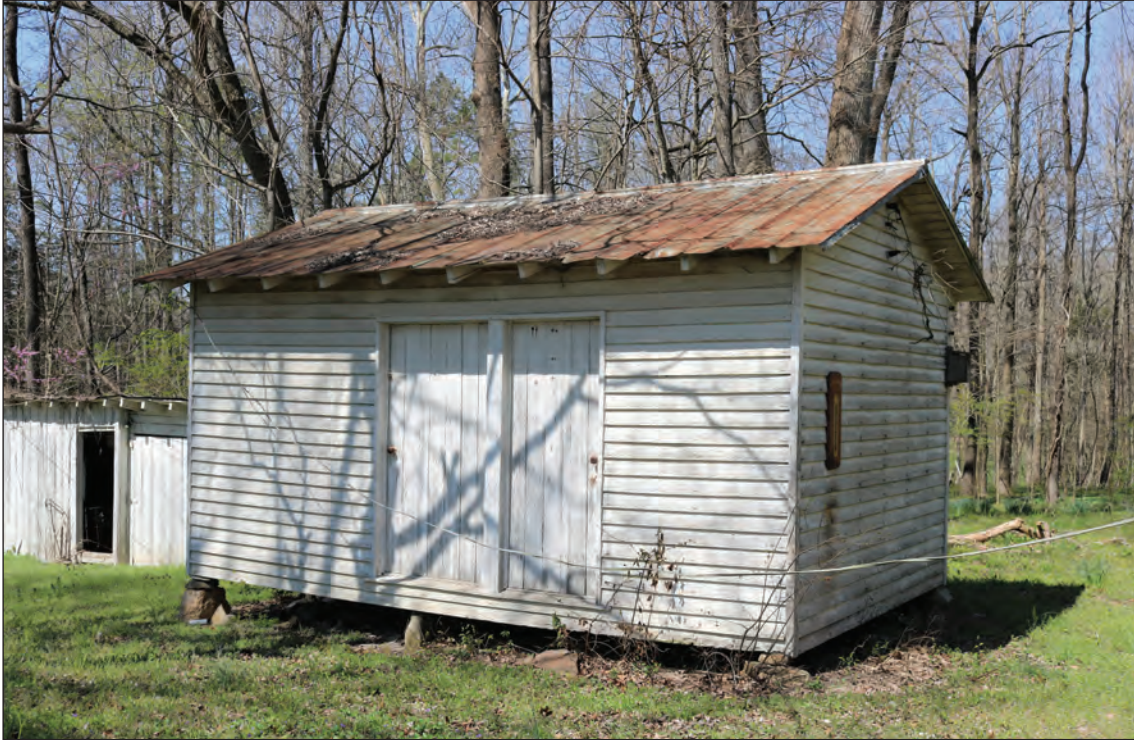
Figure 3.47. Corn Crib, Looking Southwest.

Constructed in the early twentieth century, a double pen corn crib is situated to the southeast of the pumphouse near the northwest corner of the dwelling. This side-gable building was likely used to store dry goods and agricultural products such as corn, and has a foundation of stacked stone piers, an original weatherboard siding exterior, and a roof of original standing seam metal with exposed rafter ends. The building is divided by a central wall and each pen is accessed by its own vertical board door located on the east façade. The building has no additional fenestration (Figure 3.47).

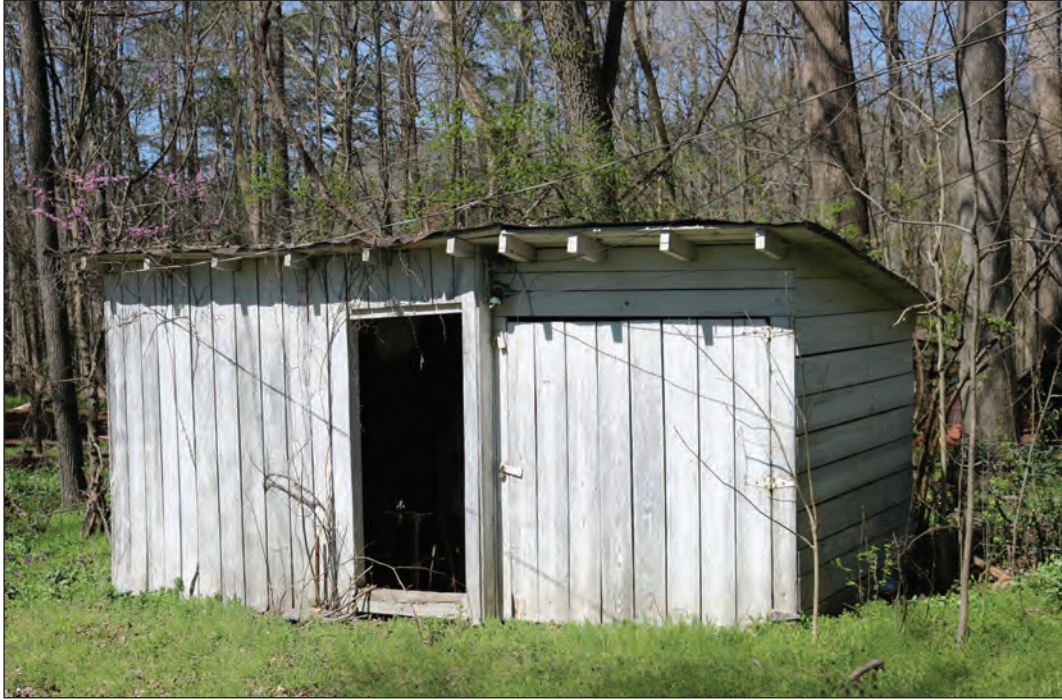
Figure 3.48. Small Chicken Coop, Looking Southwest.

Directly southwest of the corn crib is a canted roof chicken coop with a foundation of stone piers, vertical board siding exterior, and a standing seam metal roof with exposed rafter ends. The coop is accessed by an open-door frame on the west elevation. A secondary entrance, also on the west elevation, has a vertical board siding door. This coop most likely dates from the mid-twentieth century (Figure 3.48).

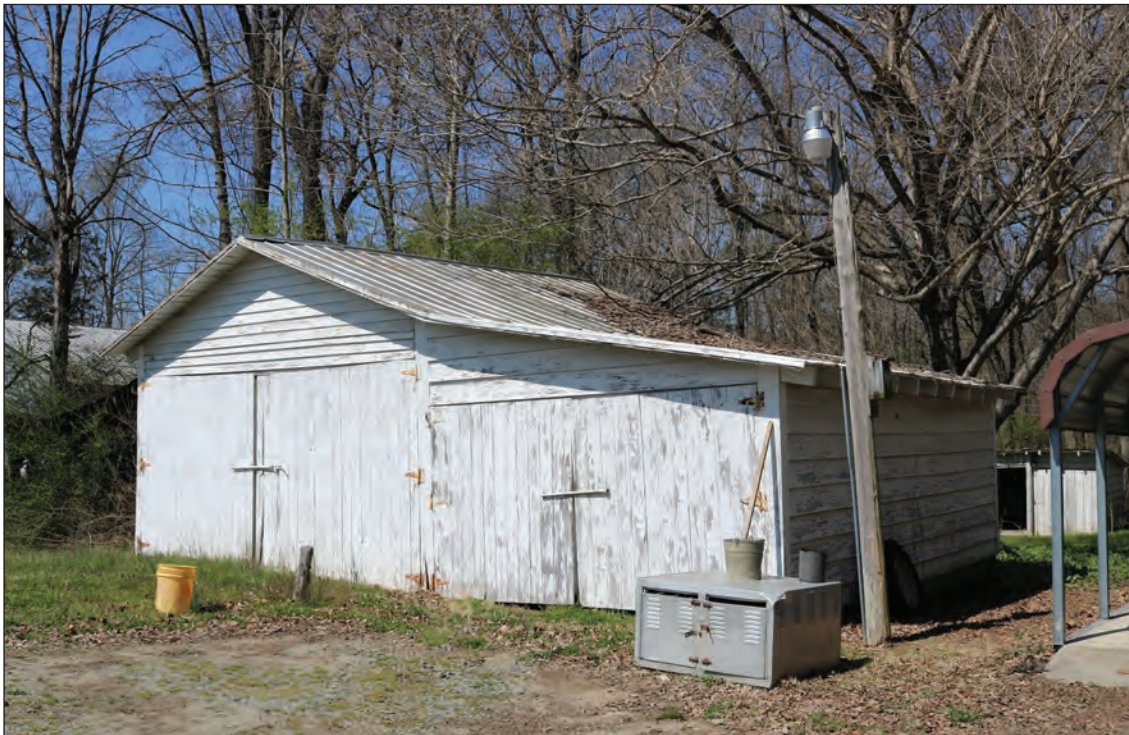
Figure 3.49. Garage, Looking Southwest.

Dating from the early to mid-twentieth century, a detached frame garage with an attached shed roof run is located near the southeast corner of the dwelling. This garage is clad with original weatherboard siding and has a front-gable roof of standing seam metal with exposed rafter ends. A shed roof wing is located on the north side of the building and is likely original to the structure. There are two garage bays on the east façade, each has a pair of vertical board doors (Figure 3.49).

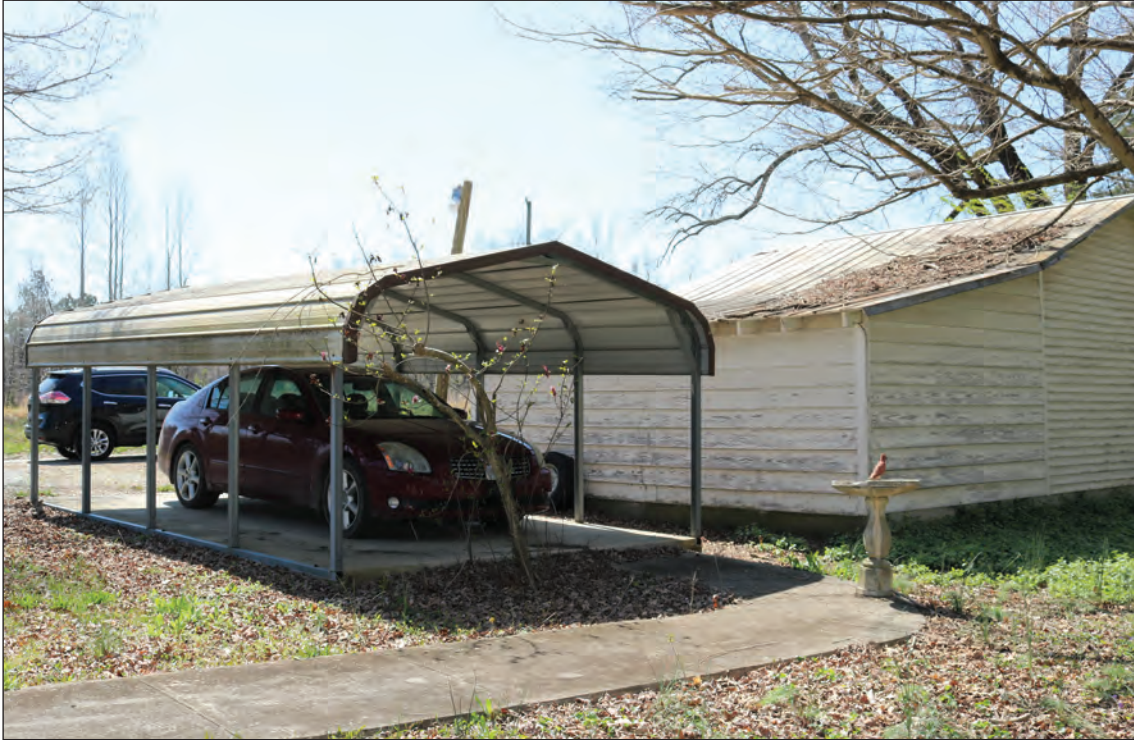
Figure 3.50 Carport, Looking Southeast.

A detached carport is located directly to the north of the frame garage. Built on a cast concrete slab, this prefabricated carport is comprised of ten metal posts that support an arched corrugated metal roof. The carport was constructed between 2003 and 2008. A poured concrete sidewalk connects the carport to the main dwelling (Figure 3.50).

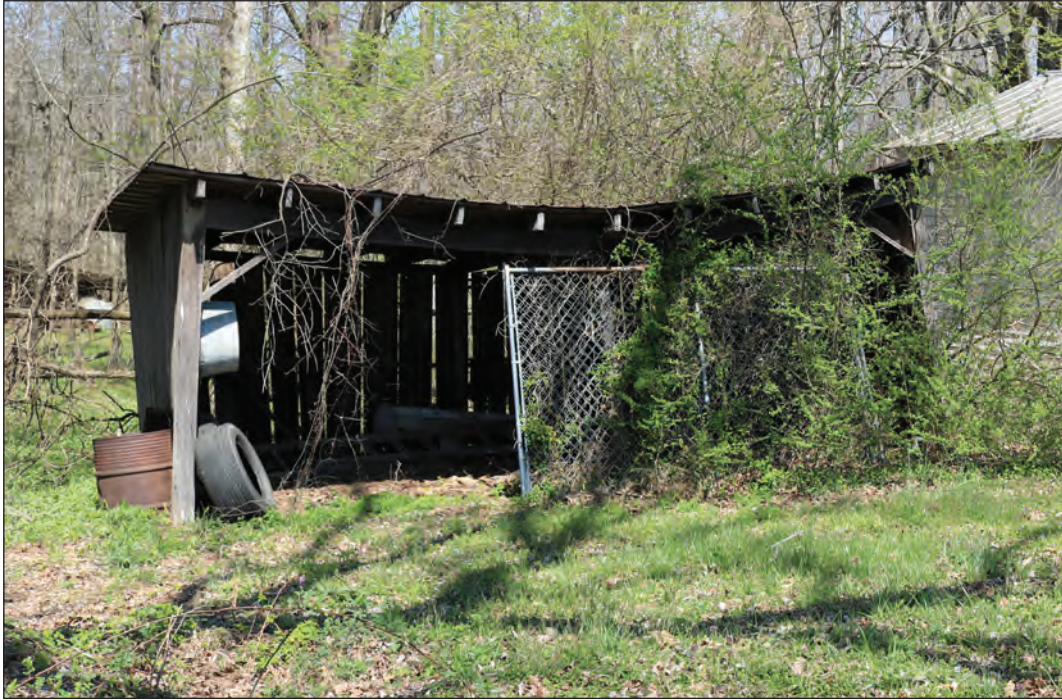
Figure 3.51. Equipment Shed, Looking Northwest.

A frame equipment shed is located to the south of the garage. Clad with vertical boards, this equipment shed has a canted roof of original standing seam metal with exposed rafter ends. The shed likely dates from the mid-twentieth century (Figure 3.51).

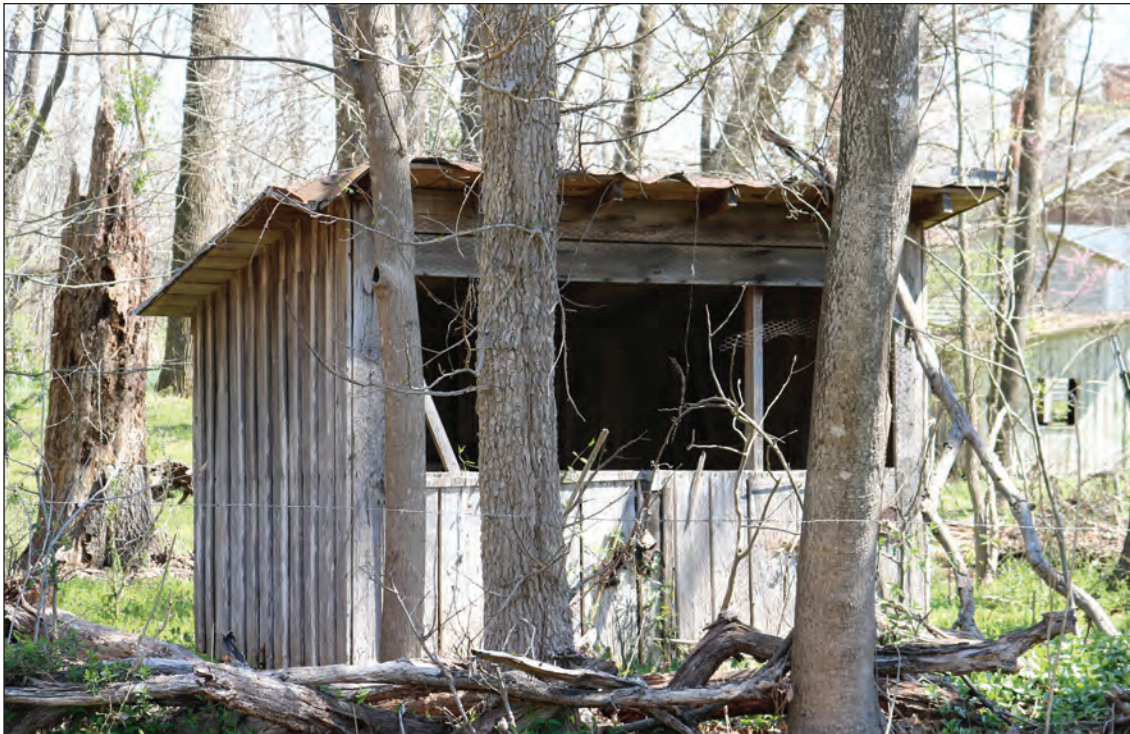
Figure 3.52. Circa 1940 Canted Roof Storage Coop, Looking North.

Situated centrally in the parcel, within a dense grove of trees behind the main dwelling, is a frame storage shed with a board and batten exterior and a canted roof of original standing seam metal. A large open window is located on the south elevation. This building dates from the mid-twentieth century (Figure 3.52).

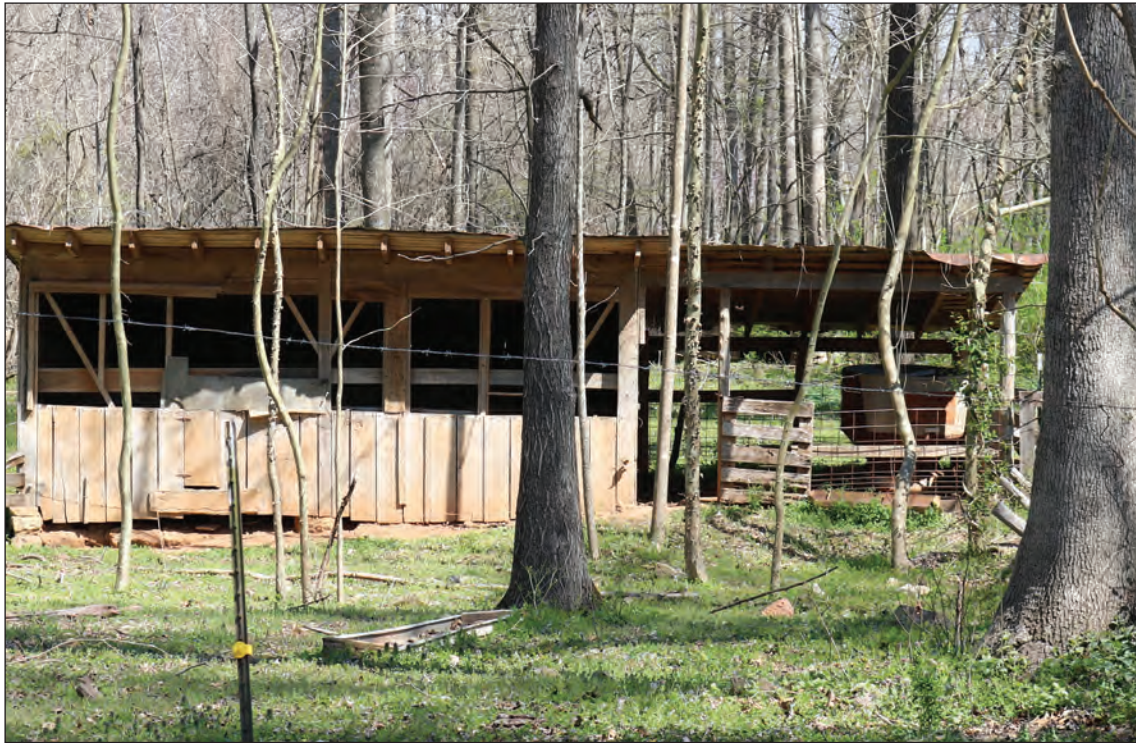
Figure 3.53. Large Chicken Coop, Looking North.

Also, within this grove of trees is a second, larger chicken coop constructed around 1980. This coop is of frame constructed with a foundation of stacked stone piers and a canted roof of standing seam metal with exposed rafter ends. The top half of the south elevation is open, and the bottom half is enclosed with vertical boards. An open storage area is located on the east side of the coop that is supported with rough-sawn wood posts (Figure 3.53).

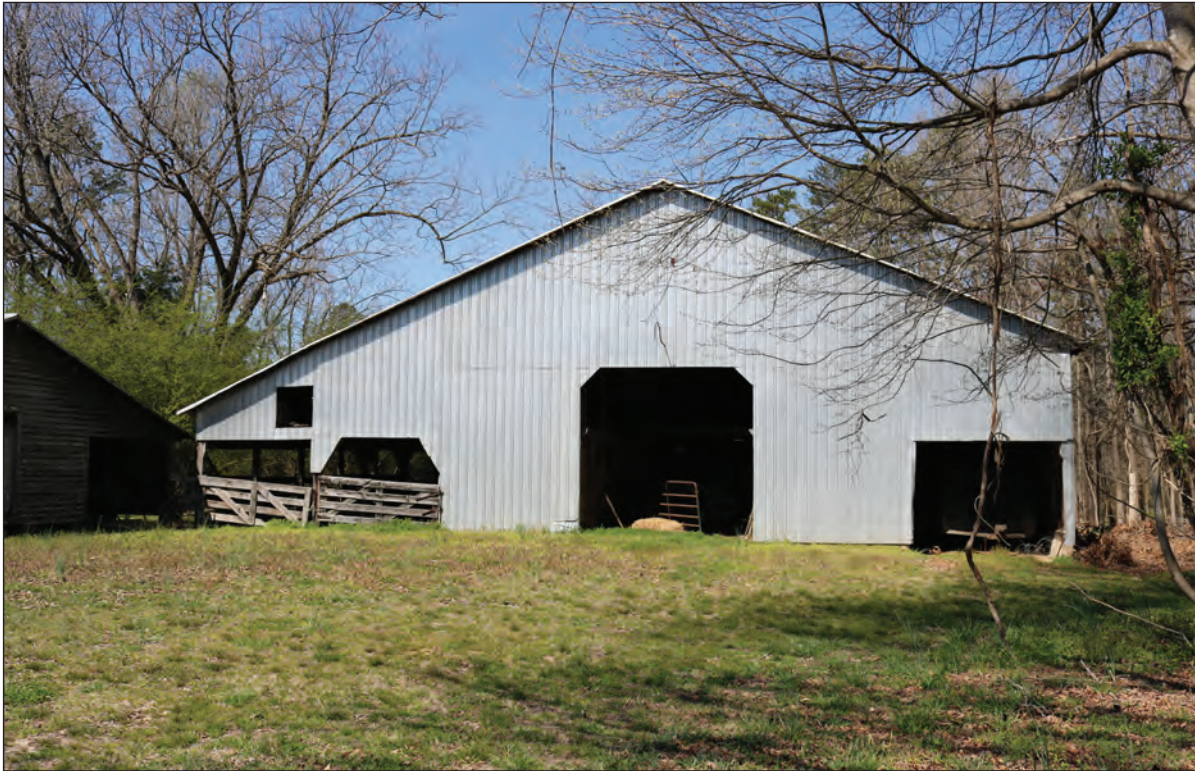
Figure 3.54. Barn, Looking West.

On the south side of the grove, toward the rear of the parcel is a gable roof, two-story barn with four bays set entirely within the roofline. Likely constructed around 1930, this barn has an asymmetrical roofline and retains its frame interior with heavy braced frame construction and a hay loft. The barn was clad with corrugated metal sheets in the 1950s. The central bay is accessed by a large opening on the east façade and two livestock bays are situated under the south side of the roof and are enclosed with paneled wood gates. A single storage bay is located on the north side of the barn and is accessed by a square opening. This multi-purpose barn was used to house hay, farm equipment, and livestock (Figures 3.54 - 3.55).

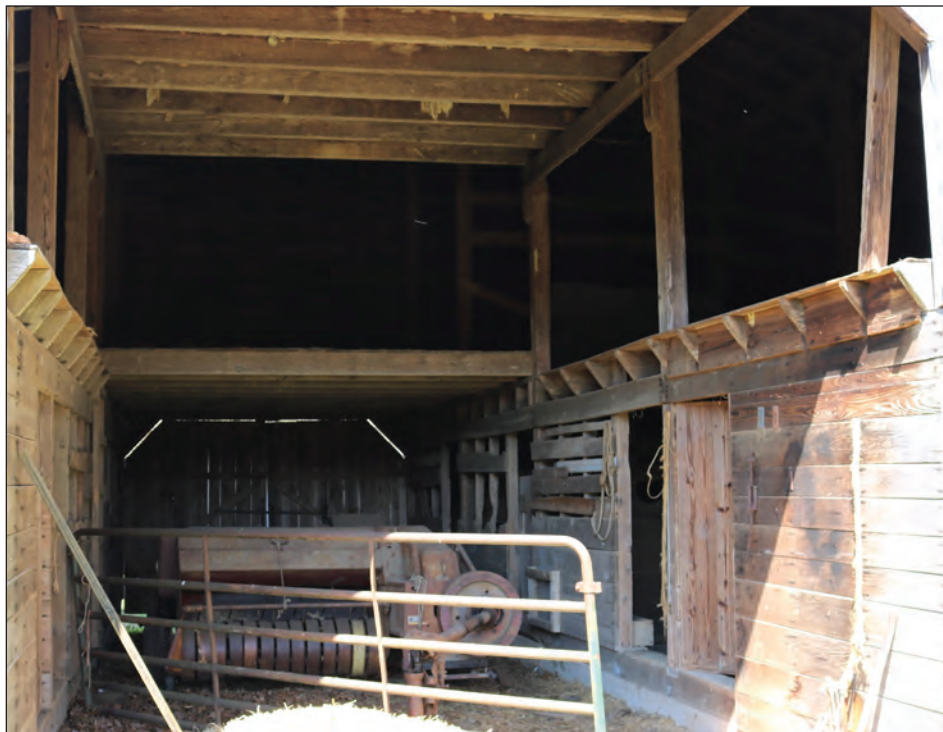
Figure 3.55. Barn Interior, Looking West.

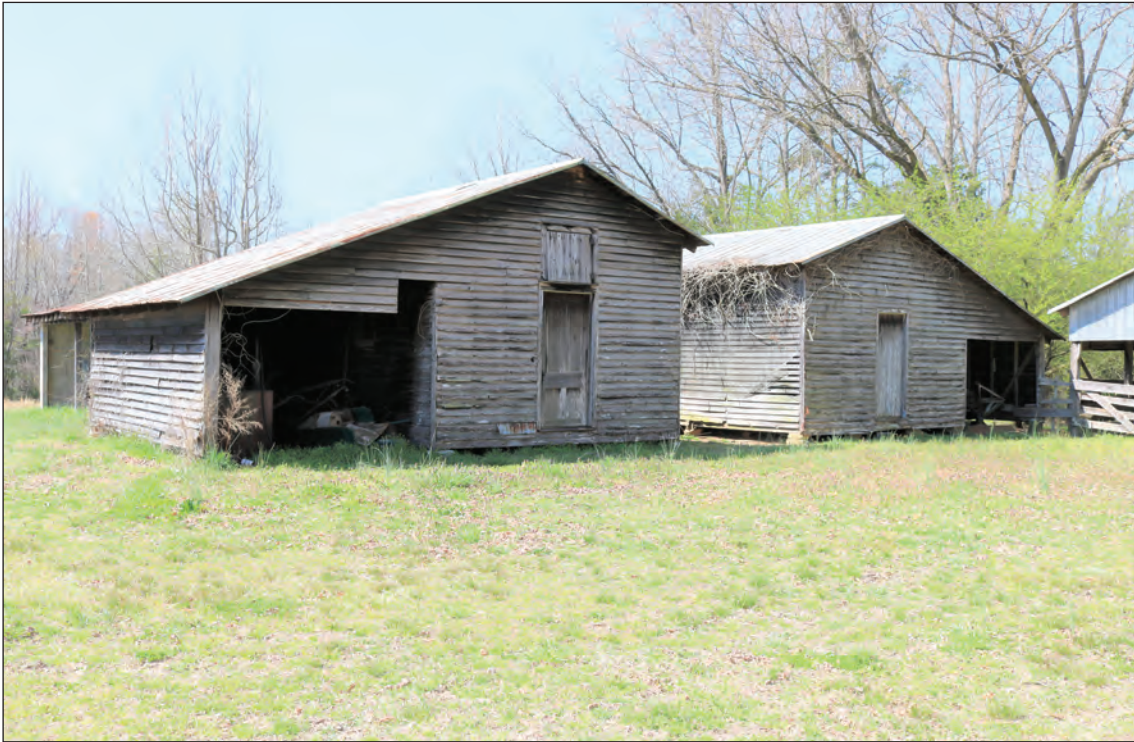
Figure 3.56. Tobacco Packhouses, Looking Southwest.

Located directly east of the barn are two gable-front tobacco packhouses. Based on an analysis of the cladding and construction methods, the eastern most packhouse was likely constructed circa 1920 and rests on a foundation of rough-cut stone piers. The packhouse is rectangular in shape with an asymmetrical gable roof clad in standing seam metal with exposed rafter ends. Most of the building is clad in circa 1920 weatherboard but the rear (south) elevation is enclosed with corrugated metal sheets. A storage run, enclosed on three sides, is located on the east side of the packhouse and is accessed through a large open bay on the north façade. The main entrance to the enclosed portion of the packhouse is centralize on the north façade and has an original four-panel wood door. A transom or loft access is situated directly over the door and retains its original wood casements and vertical board door (Figures 3.56- 3.58).

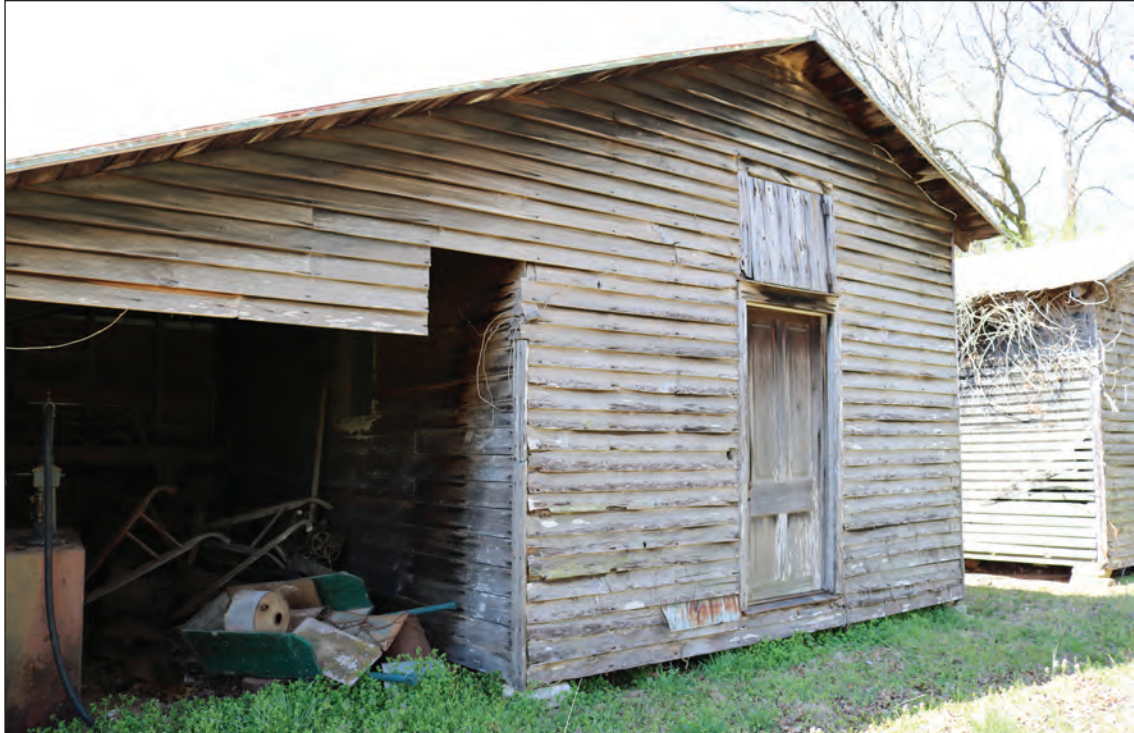
Figure 3.57. East Tobacco Packhouse, Façade, Looking Southwest.

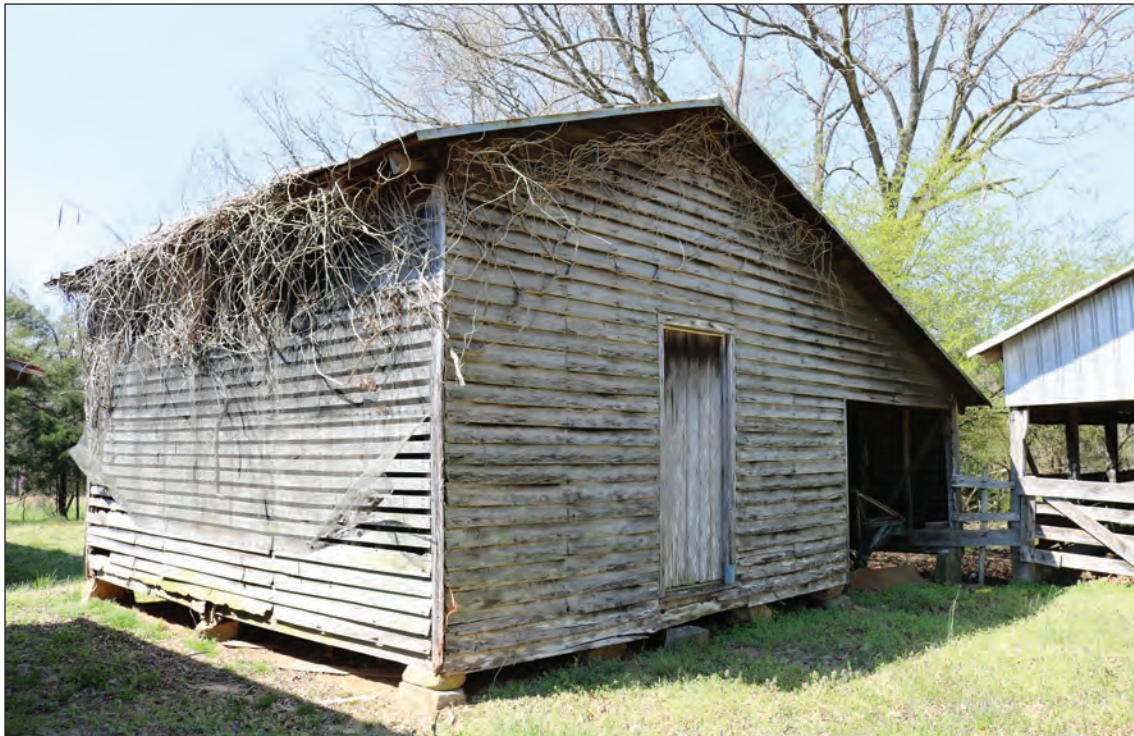
Figure 3.59. West Tobacco Packhouse, Façade and East Elevation, Looking Southwest.

To the west of the first packhouse is a second frame gable-front tobacco packhouse. Likely constructed later, this packhouse rests on a foundation of rough-cut stone piers and has an asymmetrical gable roof of circa 1940 standing seam metal. Most of the building is clad with weatherboard siding but the east elevation is clad with open wood slats to allow for air circulation. The rear elevation is clad with corrugated metal sheets. A storage run, enclosed on three sides, is located on the west side of the packhouse and is accessed by a large open bay. The main entrance to the enclosed portion of the pack house is located centrally on the north façade and has vertical board door (Figure 3.59).

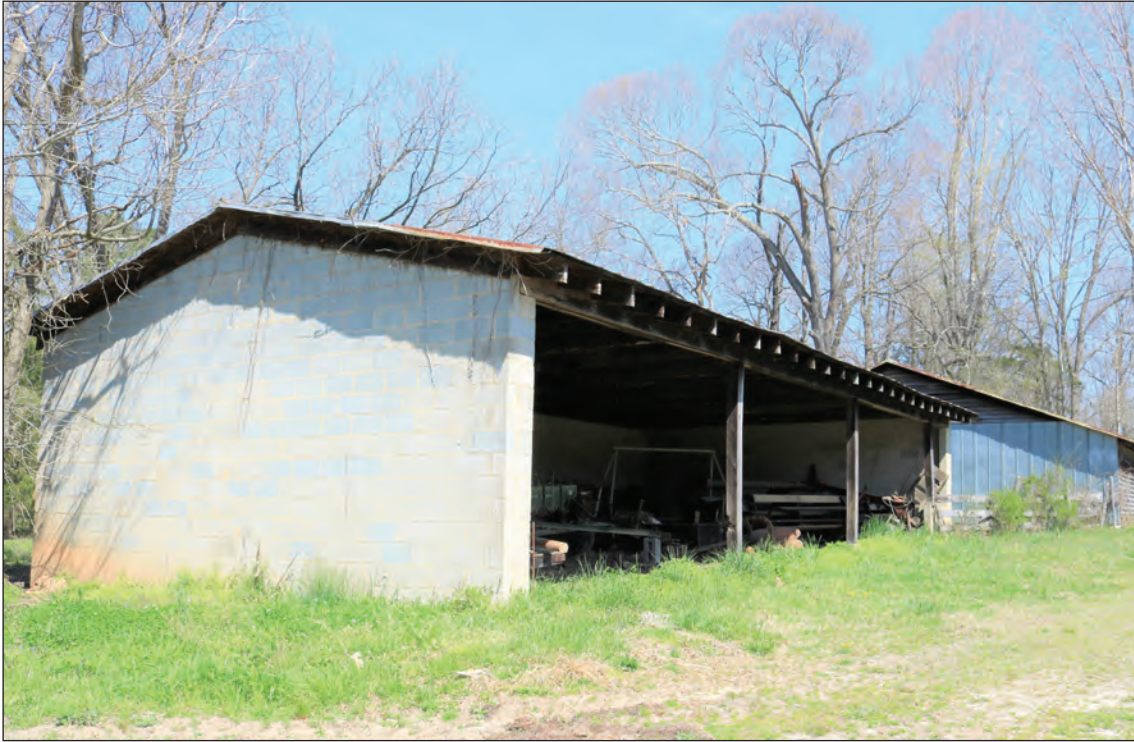
Figure 3.60. Farm Equipment Shed, Façade and South Elevation, Looking Northwest.

Directly to the south of the packhouses is a concrete block farm equipment shed with a gable roof of standing seam metal and exposed rafter ends. The equipment shed has three bays that open to the east. The roof is supported by square wood posts. A review of historic aerials reveals that this shed likely dates to the early 1950s (Figure 3.60).

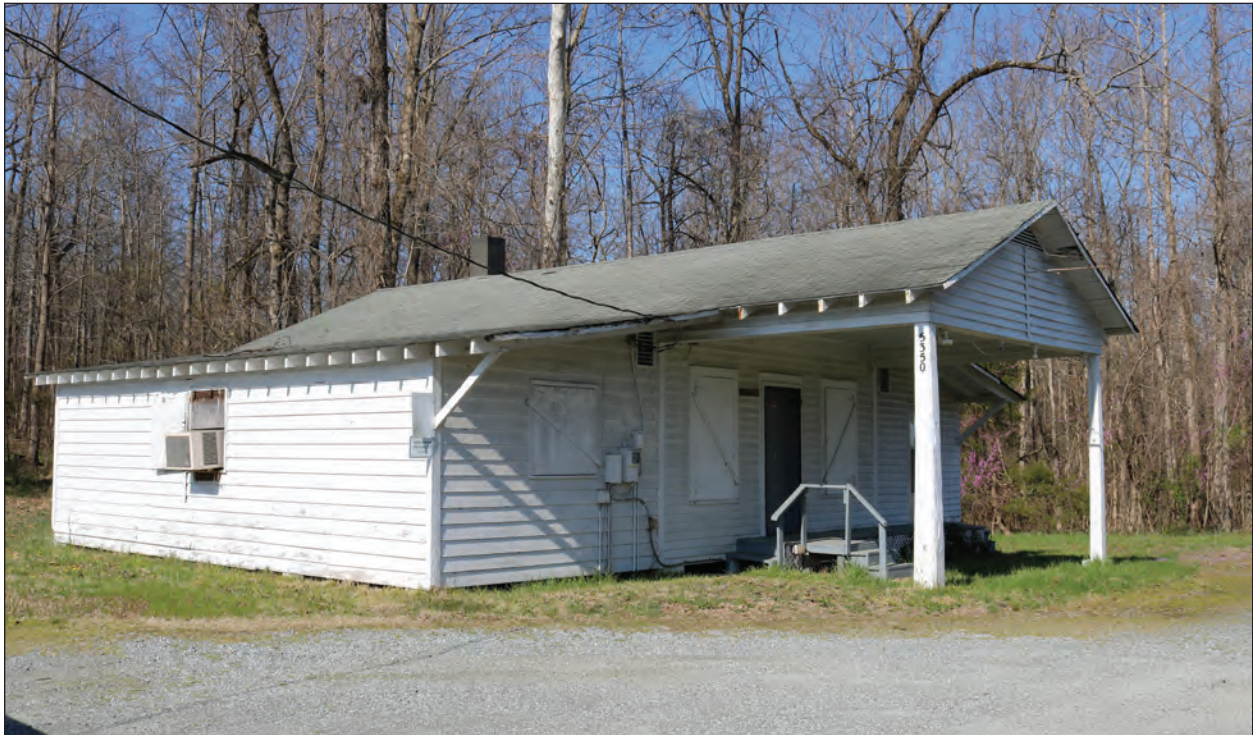
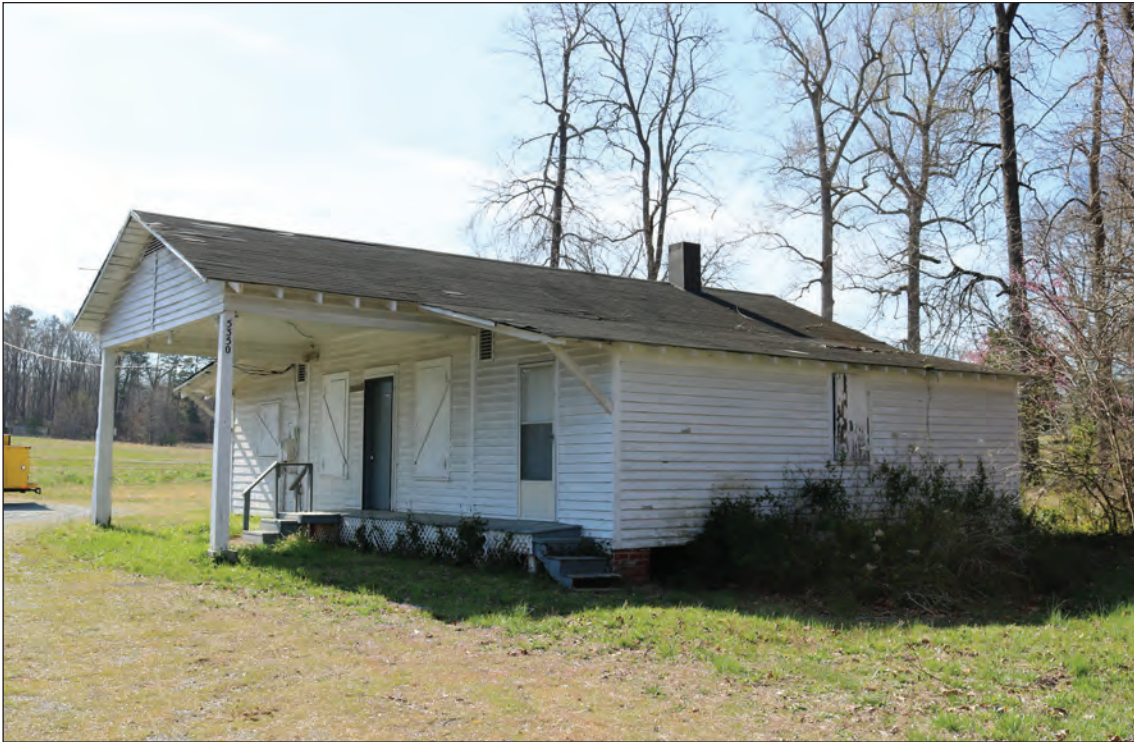
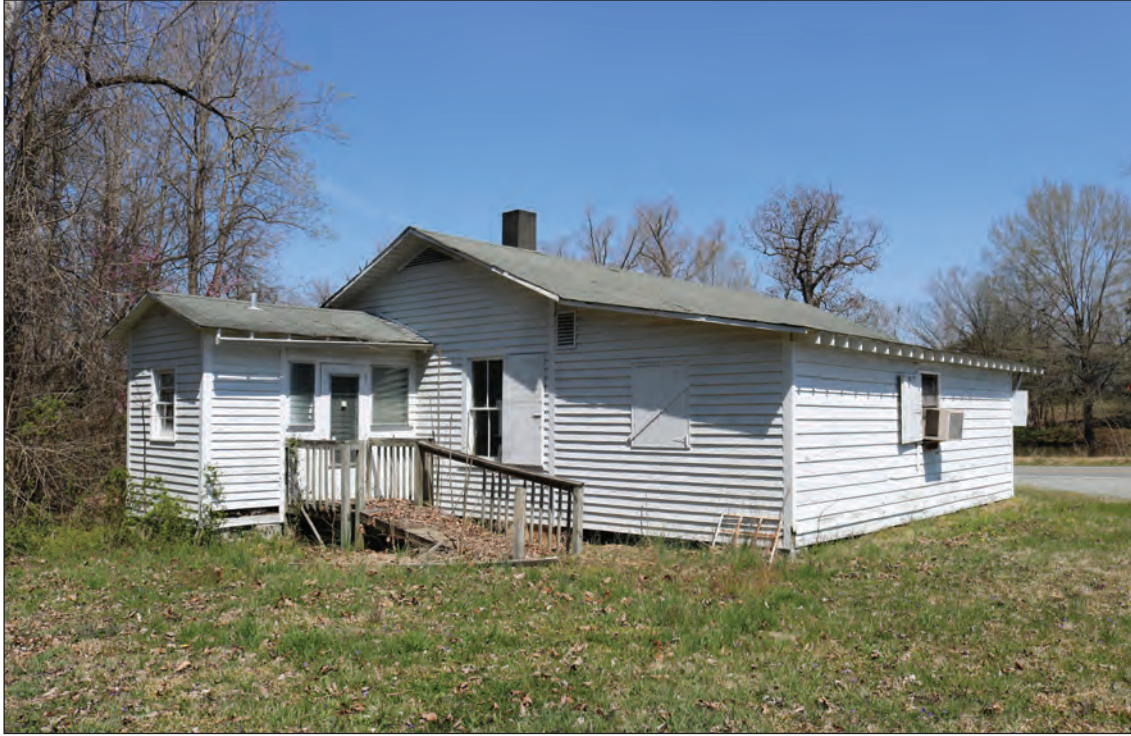
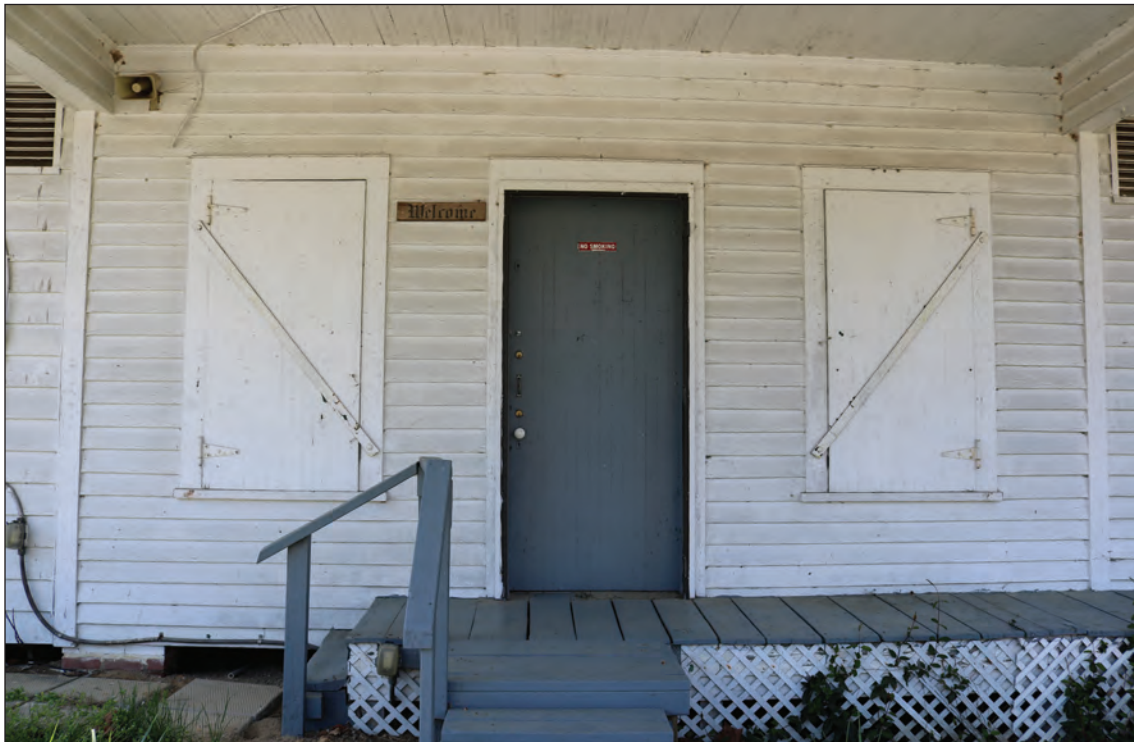
Figure 3.61. Coble General Store and Filling Station, Façade, and East Elevation, Looking Southwest.

The Coble General Store and Filling Station features a central bay located under a gable-front roof with two side wings under shed roof extensions supported by knee-brace brackets. The building has a foundation of brick piers, original weatherboard siding exterior, a central flue, and a gable roof of asphalt shingles and exposed rafter ends. A drive-through canopy shed extends north from the main façade and is supported by rough sawn, tapered wood posts. The canopy shed sheltered parked cars, an attendant, and likely two fuel pumps. The fuel pumps have been removed and no physical evidence remains.

The main entrance is situated under the drive-through canopy shed and has an original vertical board door flanked by two, original two-over-two vertical-light wood sash windows. Each of the windows has a full-width vertical board shutter with strap hinges. A secondary entrance provides access to the west wing which likely served as a store office. This entrance also has an original vertical board and an aluminum screen door. A wooden raised entry porch lends access to the doors that is shielded with lattice and accessed by wood stairs with a wood railing on the east side. The east wing and rear room that houses a kitchenette was added in in the 1950s. A rear entrance is located on the east elevation of the rear wing that is accessed via a wood accessibility ramp with a wood railing and picketed balustrade. The rear entrance has a circa 1950 single-light door with jalousie windows and is flanked by two jalousie windows. The remaining windows in the 1950s addition are two-over-two horizontal-light wood sash (Figure 3.61 – 3.64).

Figure 3.62. Coble Farm Store and Filling Station, Façade, and West Elevation, Looking Southeast.

Figure 3.63. Coble Farm Store and Filling Station, South and West Elevations, Looking Northwest.

Figure 3.64. Coble Farm Store and Filling Station, Main Entrance, Looking South.
