SUBJECT: Historic Structures Survey Report, Replace Bridge 267 on SR 3336 over Climax Creek,
PA 19-01-0022, Guilford County, ER 19-2356

National Register of Historic Places Eligibility Evaluation Report for the Replacement of Bridge No. 267 on SR 3336 (Coble Church Road) over Climax Creek

The North Carolina Department of Transportation (NCDOT) proposes to replace the two-lane Bridge No. 267 on SR 3336 (Coble Church Road) over Climax Creek in the unincorporated Julian community in southeast Guilford County (WSB# 17BP.7.R.136). The project area is located approximately 12.6 miles southeast of Greensboro, the Guilford County seat. This project is subject to review under the Section 106 Programmatic Agreement for Minor Transportation Projects (NCDOT/NCHPO/FHWA/USFS 2015). A NCDOT architectural historian defined the Area of Potential Effects (APE) as the project site, adjacent parcels, and all properties within the viewshed that may be impacted by the project. The NCDOT subsequently determined that two agricultural properties located within the APE warranted an intensive National Register of Historic Places (NRHP) eligibility evaluation.

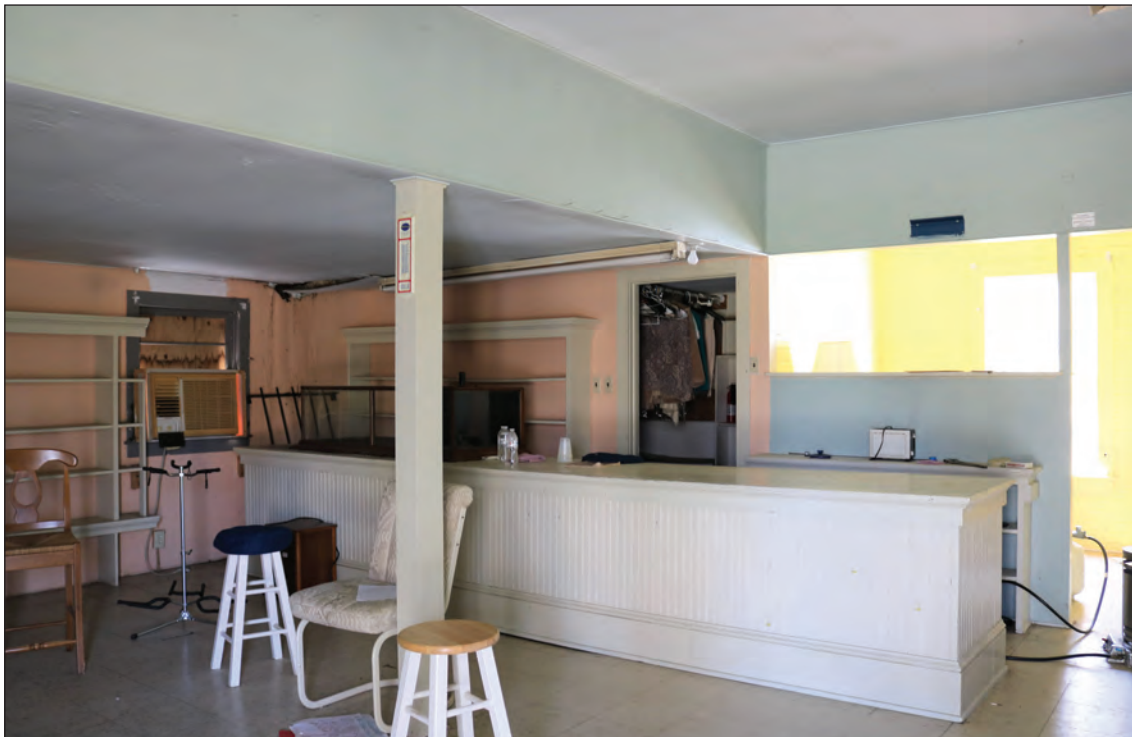
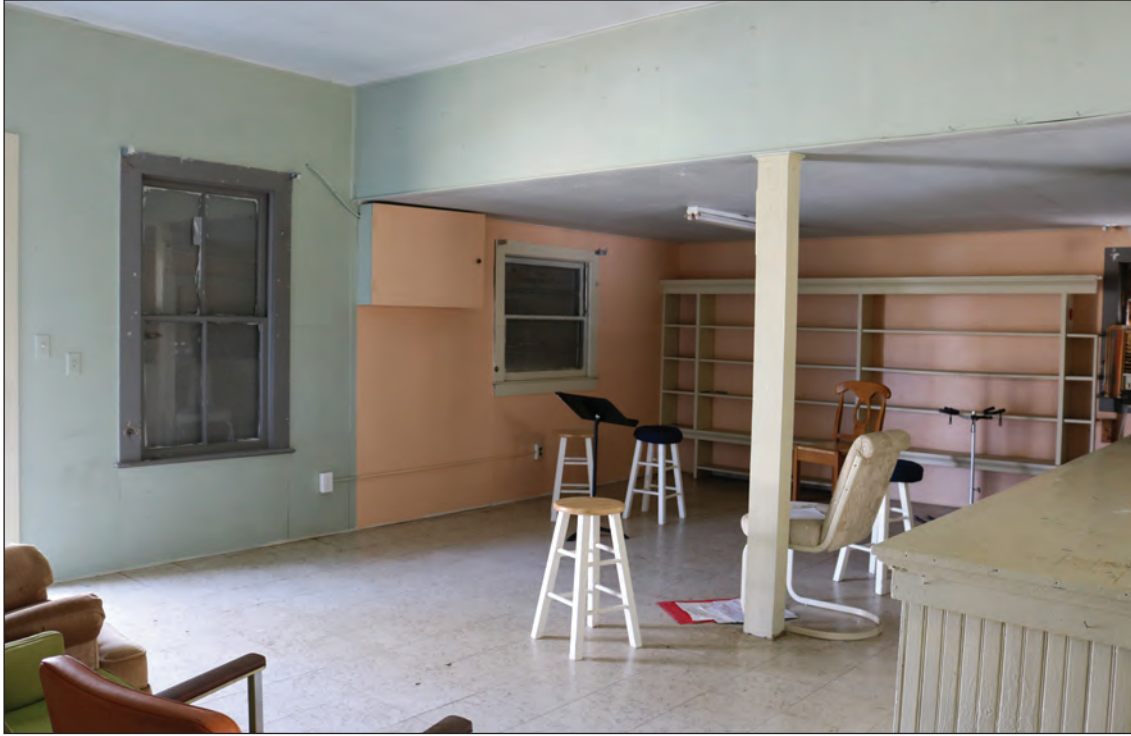
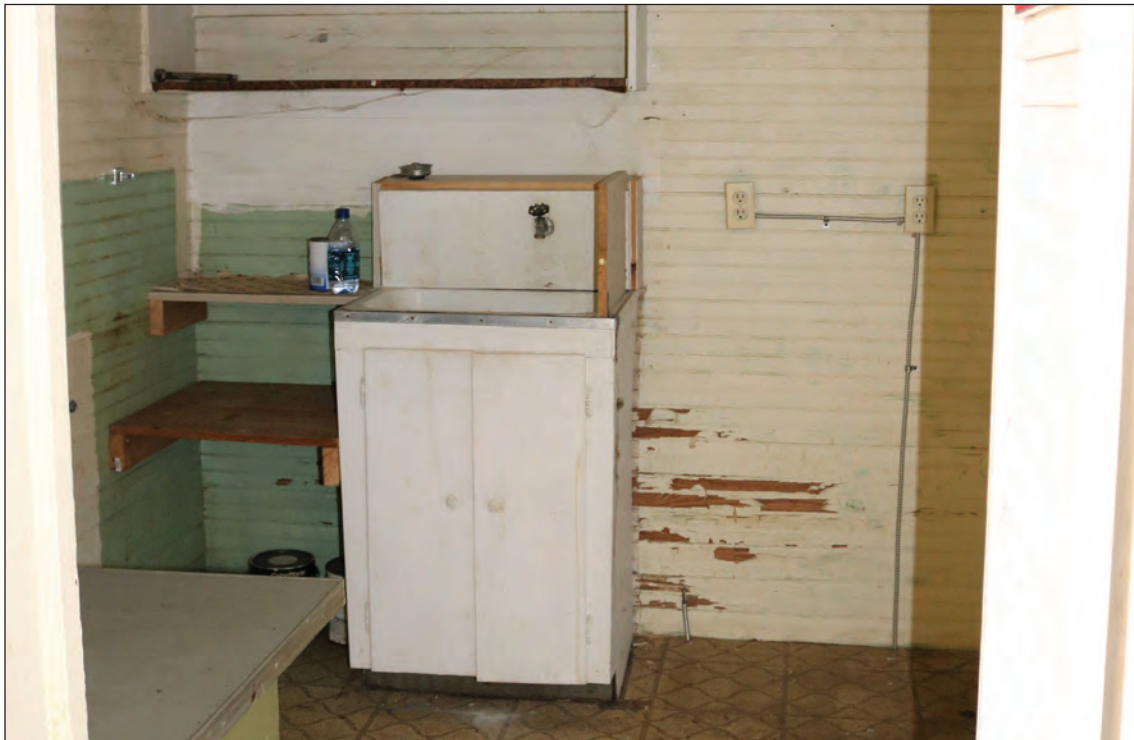
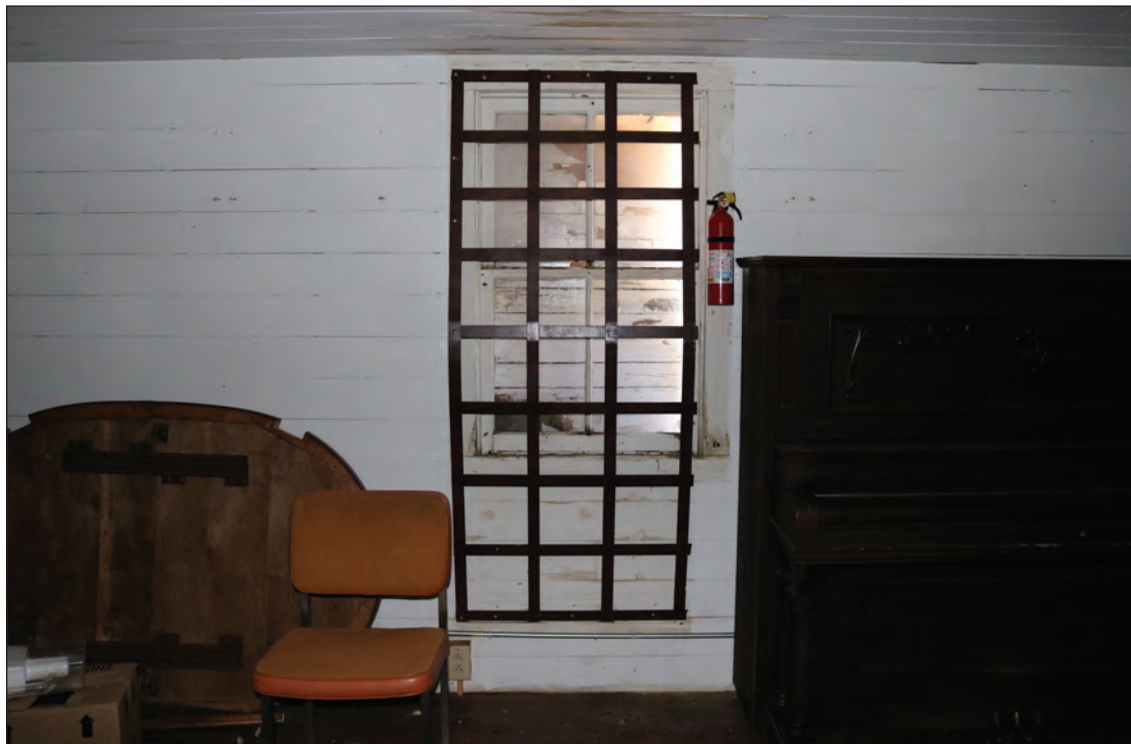
The interior retains much of its original features including the original wood sales counter, display shelves, slant-front glass display cabinet, and beadboard interior paneling. During the 1950s renovation, a portion of the ceiling was dropped, and drywall was added to the main room. At this time, a half-wall was built separating the store from a small storage room adjacent to the kitchenette. The floors in the center bay and 1950s addition are linoleum. The kitchenette retains some of the original 1950s features including wooden cabinetry and linoleum floors. The west wing that likely housed the store office and retains most of the building's original interior finishes including horizontal board walls, wood ceiling, wood floors, and an interior cast iron safety grate over the window (Figure 3.65 – 3.69).

Figure 3.65. Coble Farm Store and Filling Station, Central Bay and Original Store Counter, Looking Southeast.

Figure 3.66. Coble Farm Store and Filling Station, Central Bay, Looking Northeast.

Figure 3.67. Coble Farm Store and Filling Station, Kitchenette, Looking Southwest

Figure 3.69. Coble Farm Store and Filling Station, Cast Iron Safety Grate, Looking West

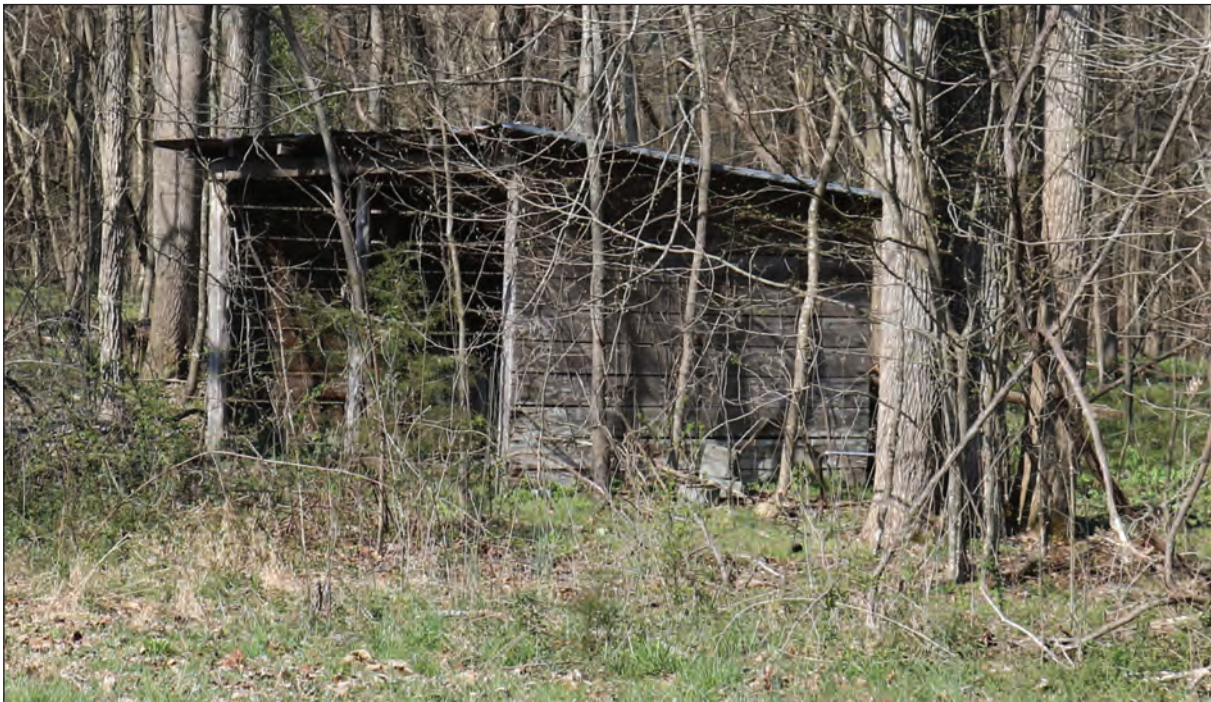
Figure 3.70. Shed, Looking Southwest.

A circa 1930 frame, equipment shed is located behind the general store and filling station to the south. This shed is clad with horizontal boards on three sides and has an open bay on the west elevation. The canted roof is clad with standing seam metal and has exposed rafter ends (Figure 3.70).

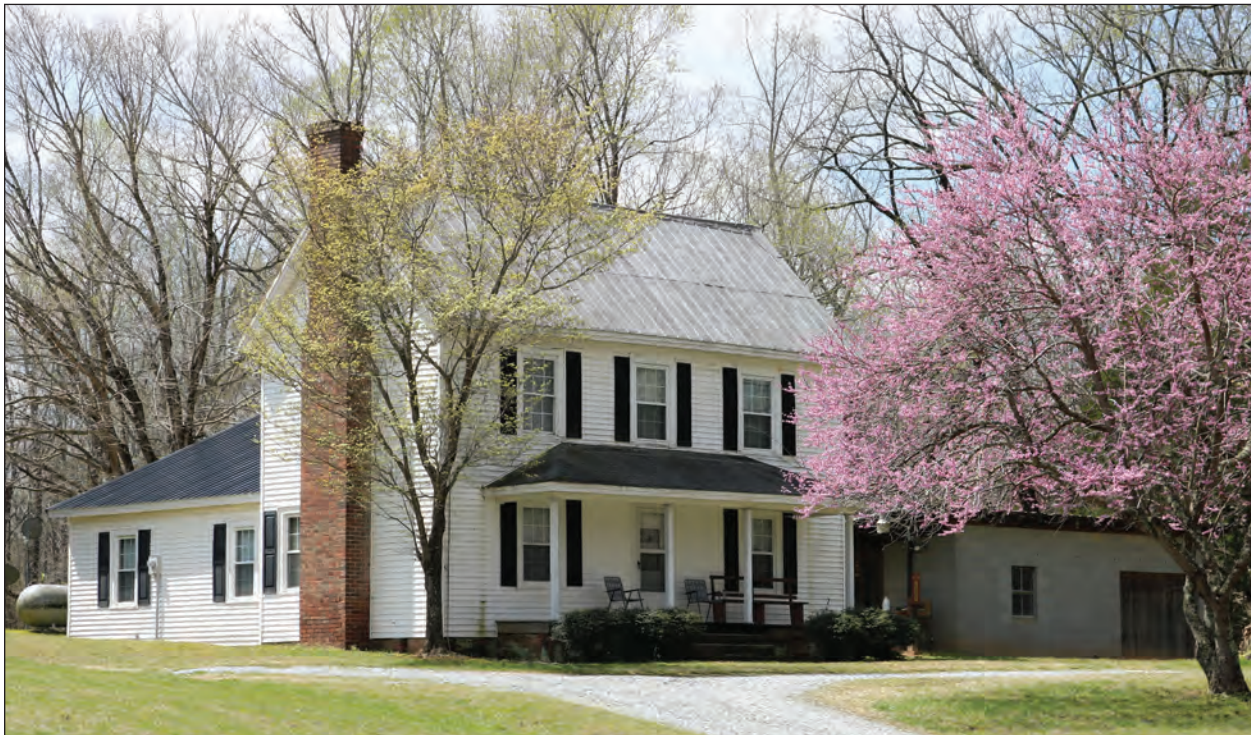
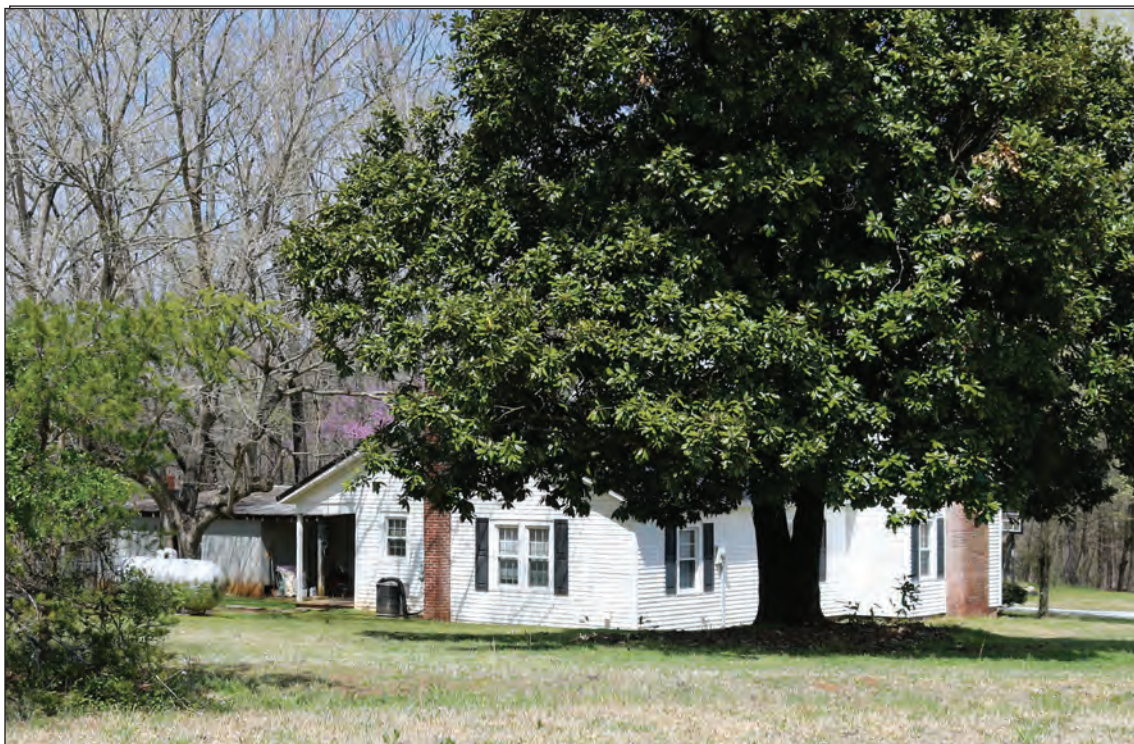
Figure 3.72. C.A. Coble Farm, Façade and East Elevation, Looking Southwest.

The primary dwelling is a two-story 1,848 square-foot, I-House with a rectangular rear wing. Constructed in 1902, this three-bay I-House features a continuous brick foundation, two exterior end brick chimneys, and a side-gable roof of circa 1920 standing seam metal. The house underwent a renovation around 2000 that resulted in new windows, doors, siding, and other features. The windows throughout the dwelling are double-hung, simulated divided light vinyl sash flanked by vinyl paneled shutters. The dwelling was clad with vinyl siding and the roof of the rear wing was replaced with non-historic standing seam metal. A one-story, hipped roof porch with non-historic asphalt shingles is located centrally on the north façade and is supported by square fluted columns. The columns rest on a raised brick foundation and the porch has a paneled wood floor. The main entrance is located centrally under the hipped roof porch and has an original single-pane, multi-panel glass and wood door and a synthetic screen door (Figure 3.72 – 3.74).

Figure 3.74. C.A. Coble Farm, South Elevation, Looking Northwest.

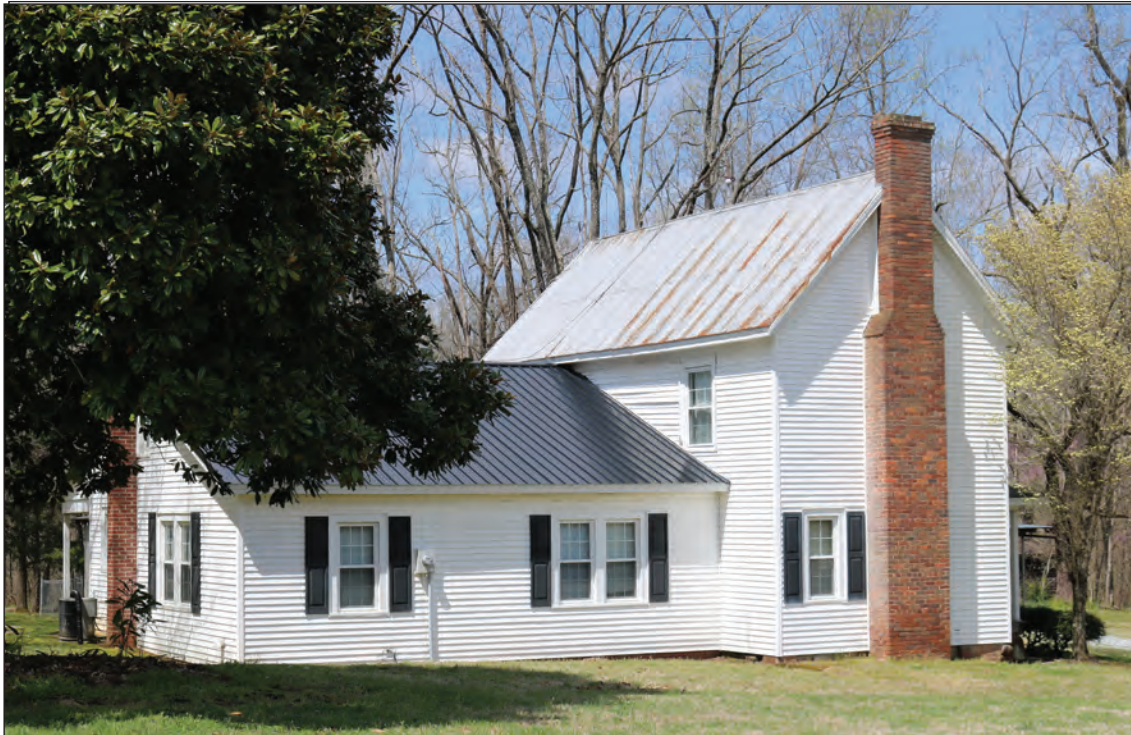
Figure 3.73. C.A. Coble Farm, East and South Elevations, Looking Northwest.

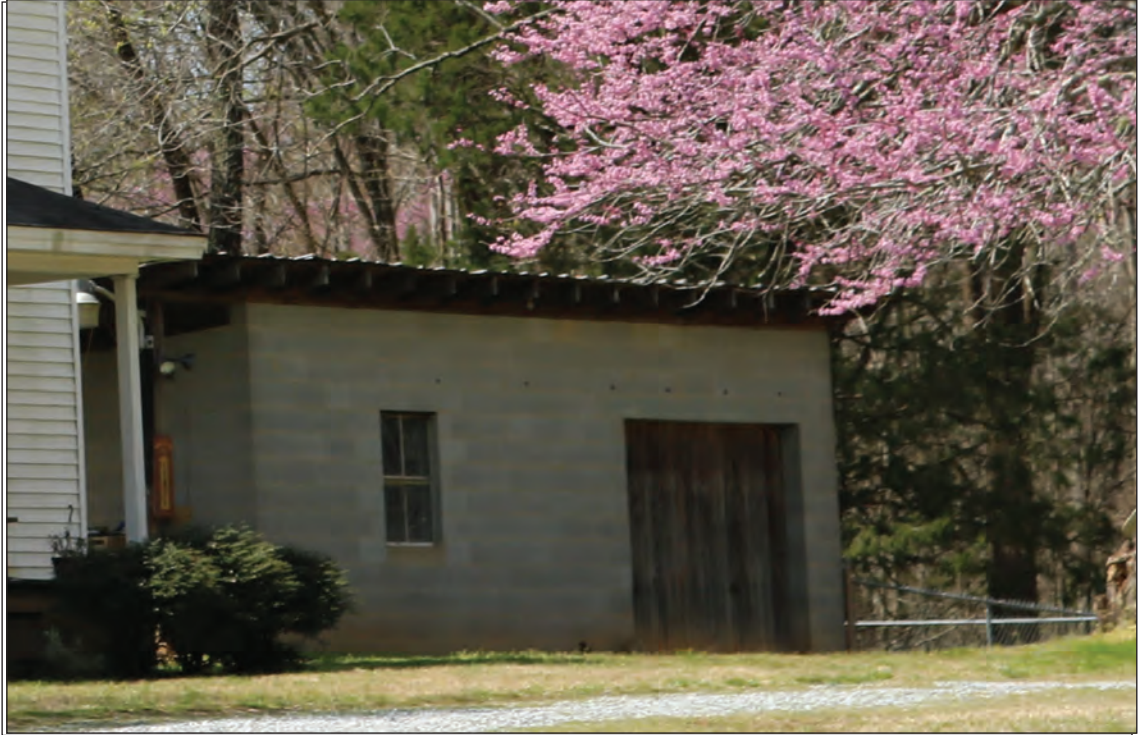
Figure 3.75. C.A. Coble Farm, Garage, Looking Southwest.

Situated directly west of the dwelling is a circa 1930 garage of concrete block construction. The garage features a flat roof of standing seam metal with exposed rafter ends and has one original two-over-two, vertical-light steel sash window on its north façade. A rectangular garage bay is located on the north façade and has a wood door of vertical boards. A pedestrian entrance is located on the east elevation and is sheltered by an integral porch that is supported by rough-sawn wood posts. A flue is located on the rear (south) elevation indicating that the building likely served as a workshop or service area that would have been utilized by the residents on a regular basis in all seasons (Figure 3.75).

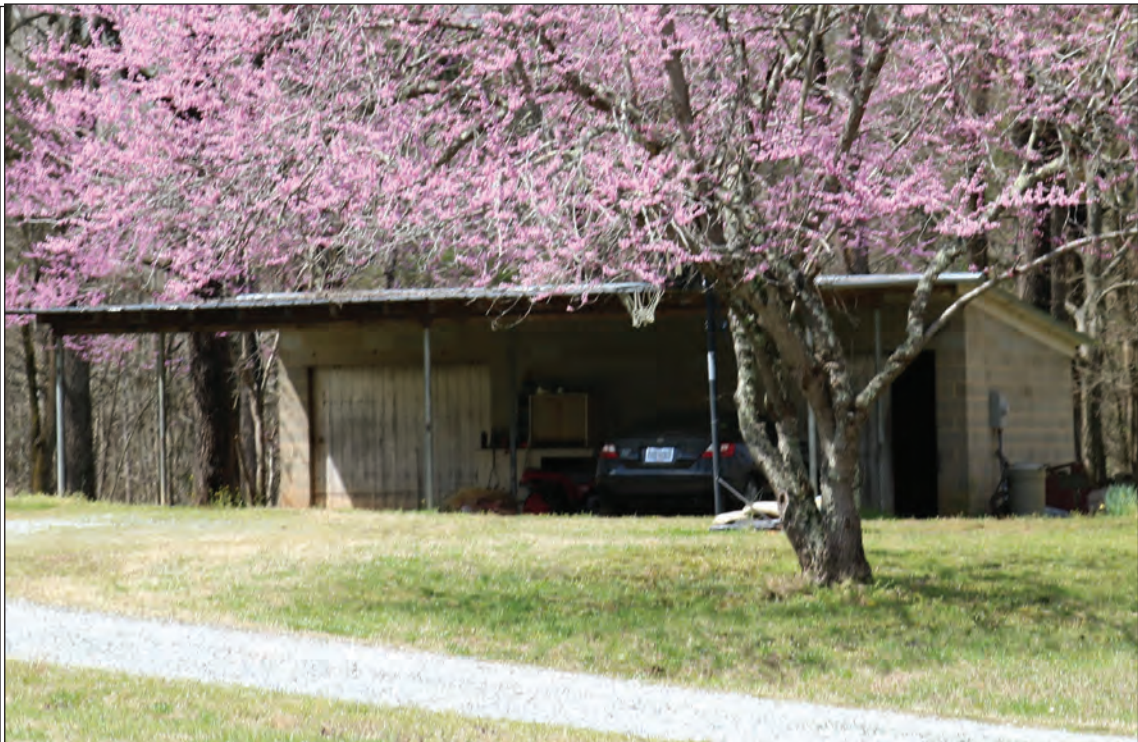
Figure 3.76. C.A. Coble Farm, Garage/Carport, Looking Southwest.

To the northwest of the dwelling and garage is a second concrete block garage with a canted roof of standing seam metal. On the east elevation is a large shed roof awning, serving as a carport, which is supported by four round metal posts. A garage bay is located on the south side of east elevation and has an original vertical board door. A pedestrian entrance is located on the north side of the east elevation, and also has an original vertical board door. This building likely dates from the mid-twentieth century (Figure 3.76).

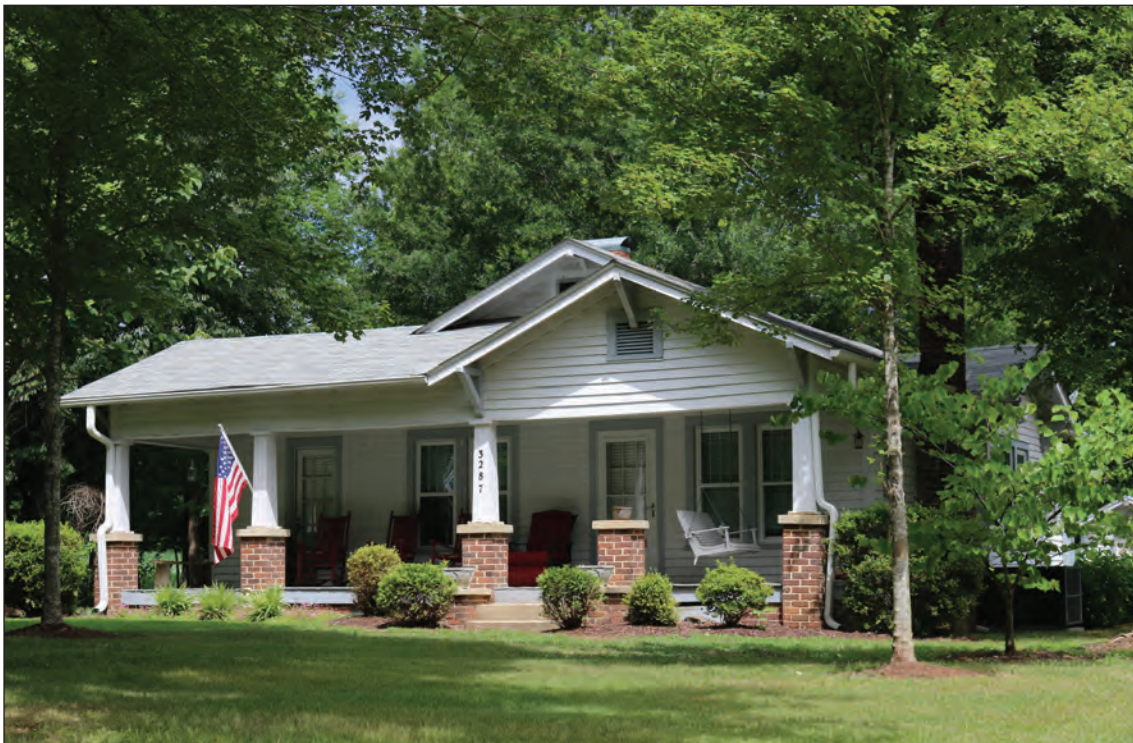
Figure 5.4. Moser Farm (GF8985), Looking West.

As tastes transitioned, different styles were adopted for anchor dwellings on Guilford County farmsteads. Simplified variations of the Craftsman style are found throughout the Julian vicinity, however, only one has been determined eligible for listing in the NRHP, the Moser Farm (GF8985). Determined eligible in a letter dated June 11, 2018, the Moser Farm is situated near the crossroads of NC 62 and Ferguson Road, approximately seven miles northwest of the project area. Similar to farms in the recommended Coble Farms Rural Historic District, the Moser Farm is representative of an early to mid-nineteenth-century farm complex and includes an intact collection of agricultural outbuildings including two barns, a chicken house, and a garage. Architecturally, the house is a modest example of the Craftsman style, much like the circa 1930 addition at the David Daniel Coble Farm and the dwelling at the Shafter Coble Farm, the dwelling features Craftsman-style elements such as knee-brace brackets at the eaves and an incised porch supported by tapered wood columns resting on brick piers (Figure 5.4 and 5.5).

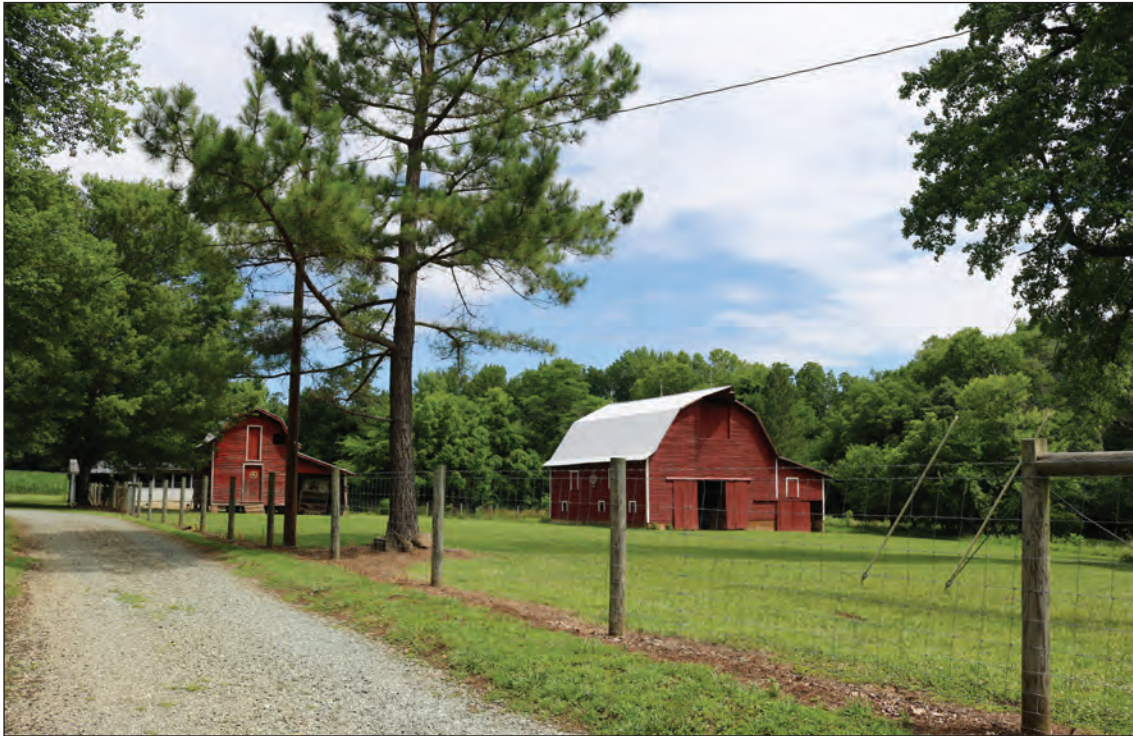
Figure 5.5. Outbuildings at the Moser Farm, Looking Northwest.

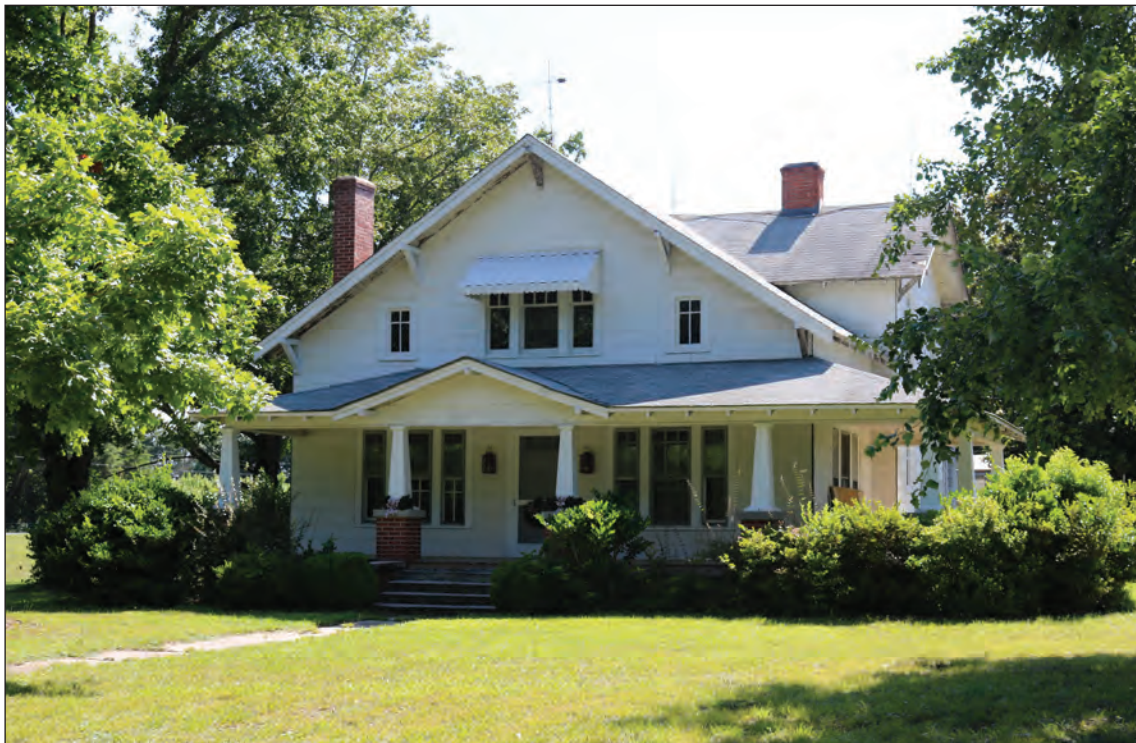
Figure 5.6. 4307 Old Julian Road, Looking Northeast.

Another example of the Craftsman style in the Julian vicinity can be found at the farm at 4307 Old Julian Road. Approximately two miles south and east of the recommended Coble Farms Rural Historic District, this previously unidentified dwelling is similar to the David Daniel Coble House in massing and detail. Unlike the dwelling at the David Daniel Coble Farm, it appears that this dwelling was all constructed all at one time. A prominent gable-front wing characterizes the dwelling and a one-story porch supported by tapered wood columns extends along the façade and south elevation. Knee-brace brackets are situated at the eaves. Like the dwelling at the David Daniel Coble Farm, this house has original six-over-one and two-over-one wood sash windows. The dwelling is clad in replacement, asbestos shingle siding (Figure 5.6).

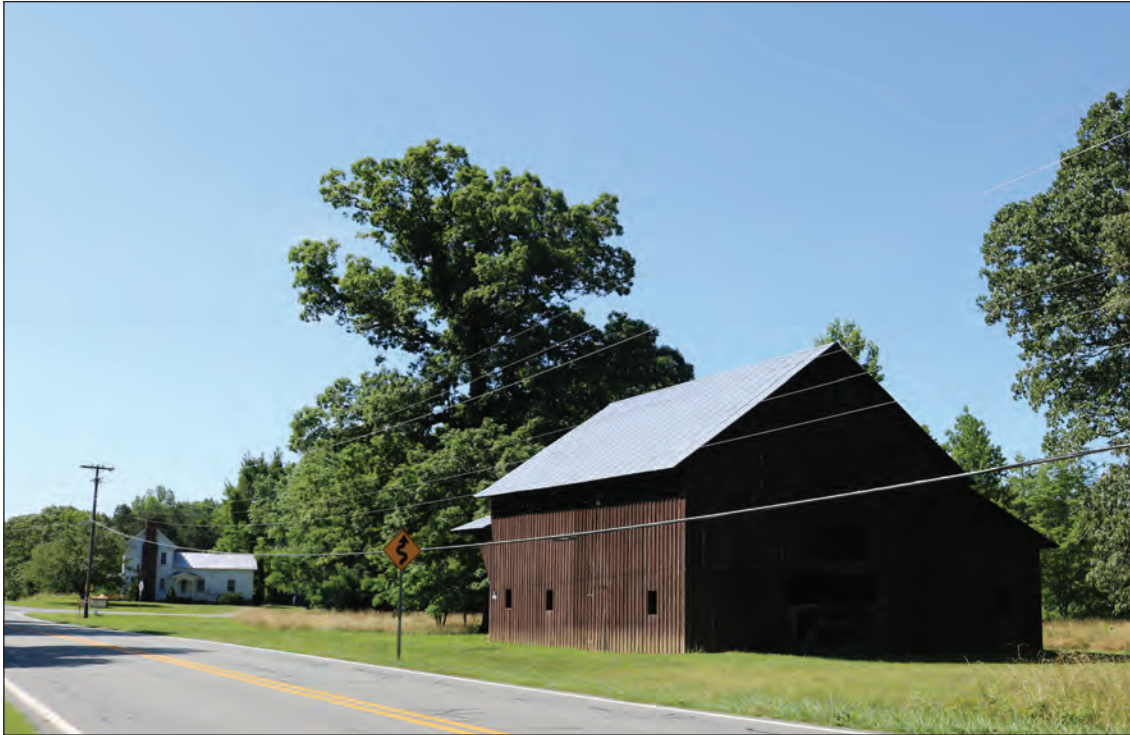
Figure 5.7. Foust-Carpenter and Dean Dick Farms Historic District, Looking South.

The most intact residence in the Foust-Carpenter and Dean Farms District is the John C. and Barbara Foust House at the corner of Mt. Hope Church and Cook-Stewart Roads. Constructed circa 1894, this two-story I-House has a circa 1910 one-story, two-room ell that extends from the rear elevation. The dwelling retains its original weatherboard cladding, deep boxed cornice, and metal roof. Other notable features include two tenant houses constructed circa 1875, a circa 1863 log house, the circa 1940 Carpenter family's lake house, and a sampling of contemporary agricultural outbuilding including barns, corn cribs, a granary, packhouses, equipment sheds, and the ruins of a log tobacco barn (Fearnbach 2009). Much like the recommended Coble Farms Rural Historic District, the contributing resources at the Foust-Carpenter and Dean Dick Farms are situated on contiguous, historically associated parcels that are actively cultivated and retain a sampling of domestic and agricultural buildings representative of the farm's tenure. Both properties illustrate the evolution of farming practices and the changing taste of the residents in Guilford County (Figure 5.7 and 5.8).

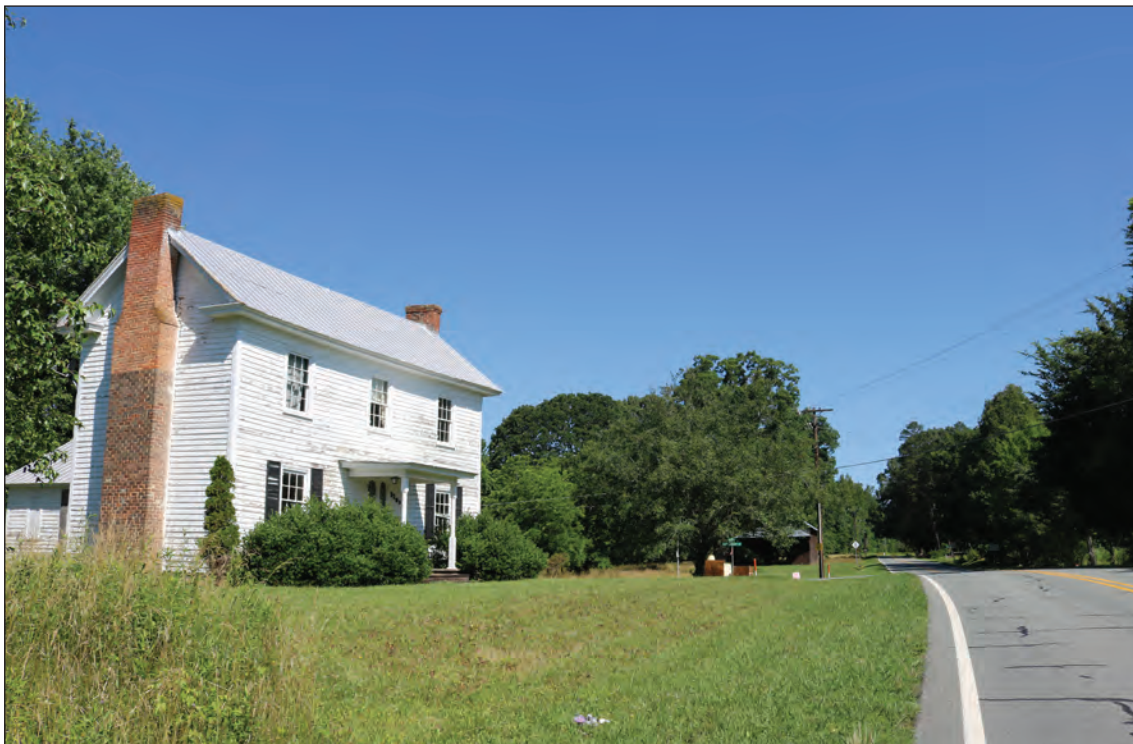
Figure 5.8. Foust-Carpenter and Dean Dick Farms Historic District, Looking Northeast.

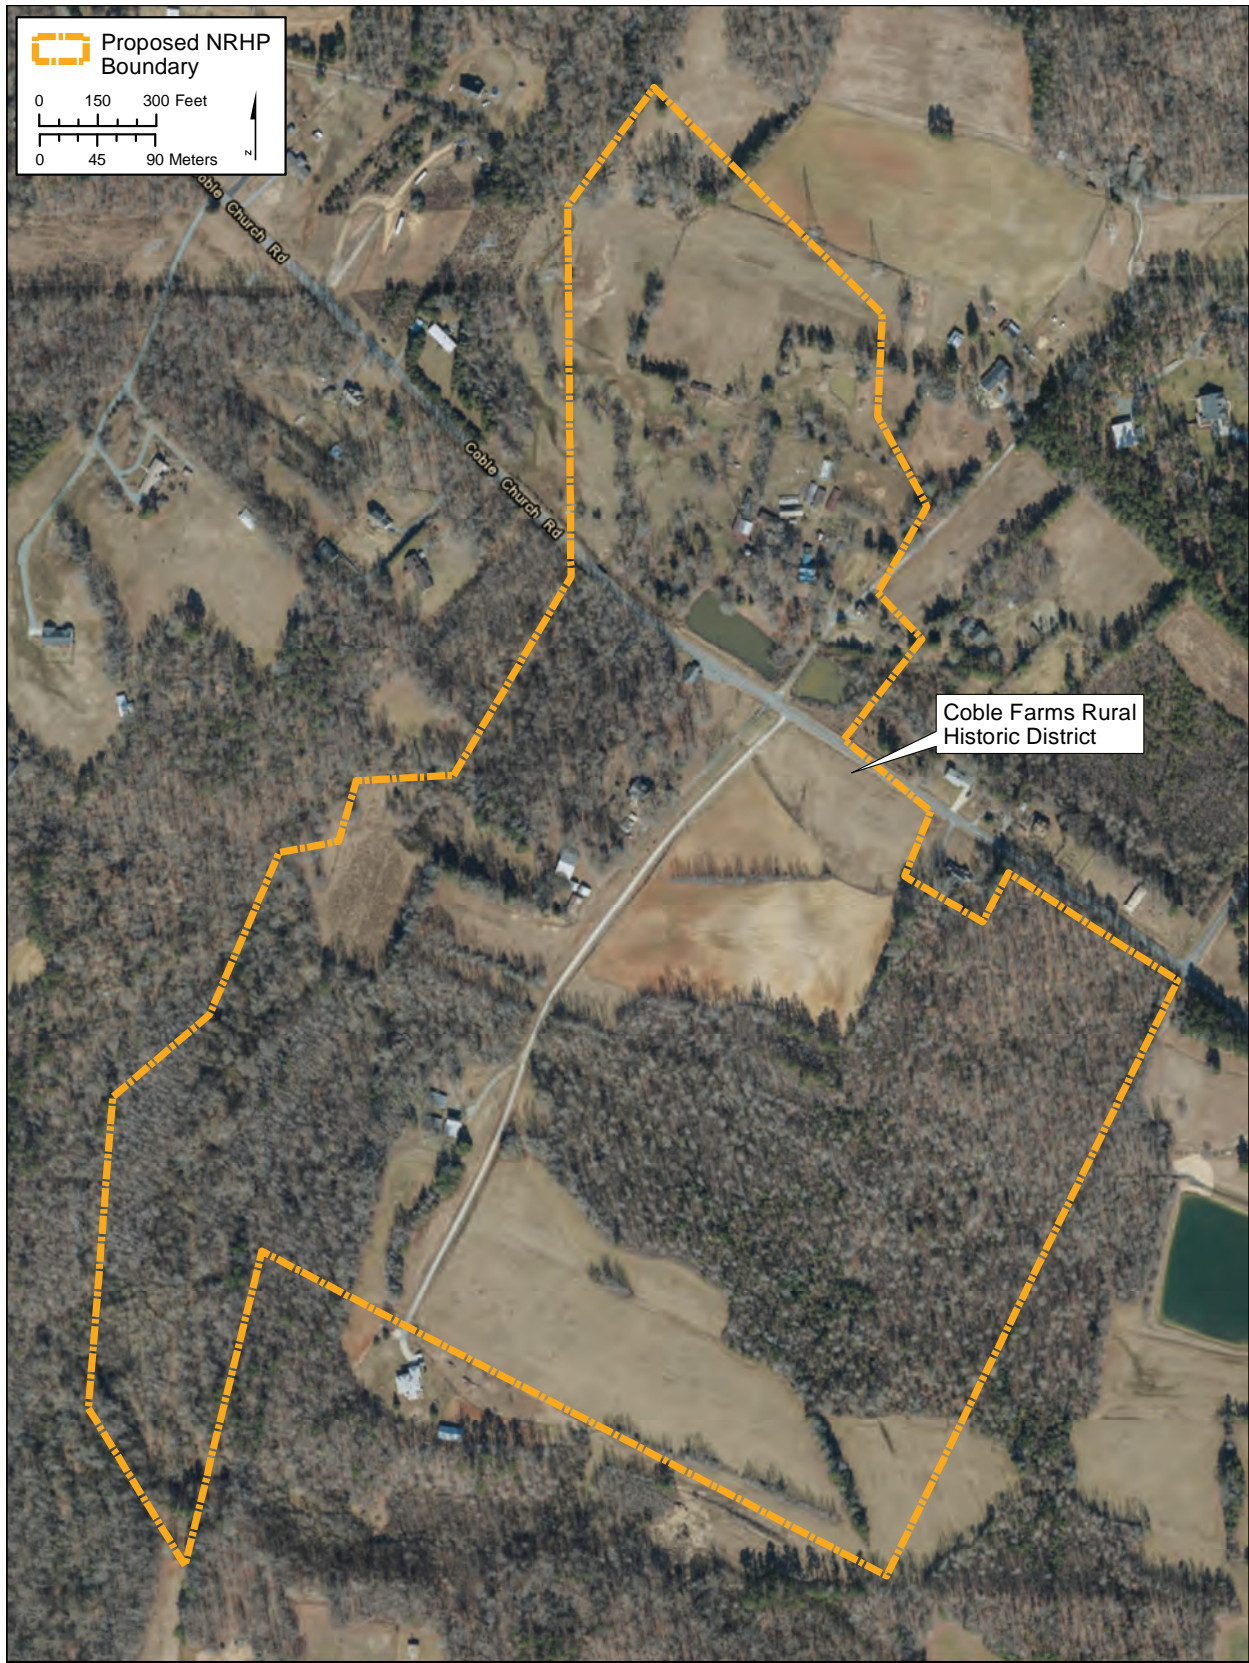
Figure 7.1. Recommended NRHP Boundary for the Coble Farms Rural Historic District.

The recommended boundary shown in Figure 7.1 on page 88 appear appropriate.

North of Coble Church Road the western boundary follows the western property line of 5357 Coble Church Road and crosses Coble Church Road, just east of Bridge No. 267, to join with the western parcel line of 5356 Coble Church Road. Bridge No. 267 and Coble Church Road, though within the proposed district boundaries, are not recommended contributing resources. These are non-historic resources that do not contribute to the district's overall architectural and agricultural significance and, as stated in the earlier sections of this report, Bridge No. 267 was evaluated in 2005 and was determined not eligible for the NRHP (Figure 7.1).
