SUBJECT: Historic Structures Survey Report, U-5858, Widen SR 1418 from US 401 to

SR 1102, Raeford, U-5858, PA 18-08-0003, Hoke County, ER 19-2692

HISTORIC STRUCTURES SURVEY REPORT WIDEN STATE ROAD 1418 (LINDSAY ROAD) FROM U.S. HIGHWAY 401 (FAYETTEVILLE ROAD) TO STATE ROAD 1102 (GILLIS HILL ROAD) RAEFORD, HOKE COUNTY, NORTH CAROLINA

TIP PROJECT U-5858 WBS NO. 46385.1.1 PA TRACKING NO. 18-08-0003

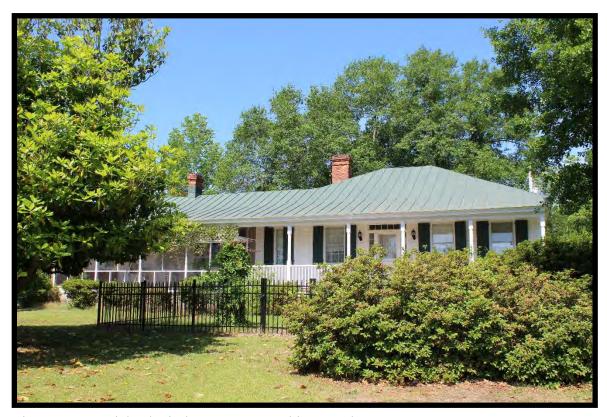
Figure 3: Carmichael-Lindsay House, Looking Northwest.

The house is a one-story framed dwelling with a concrete block and brick foundation, wooden siding, and an irregular shaped roof consisting of a hipped portion and a side-gabled section. The roof is clad in green standing seam metal. In form it appears to be a center-hall house of five bays to which a lateral four-bay extension has been added. The house exhibits several elements of Greek Revival ornamentation, such as the rectangular, glazed transom and sidelights, and deep cornice returns (Figures 6 and 7). It has an integral front porch supported by turned wooden posts, which spans the full length of the façade. Access to the porch is provided by a side staircase that leads to a large screened section on the porch's southwest end and a central wooden staircase that provides access to a small open section of the porch on the northeastern half of the house as well as the primary entrance. Both staircases appear to be new in construction. Wooden lattice work decorates the upper portion of the screened section. The open section of the porch shelters a symmetrical façade with a wooden entry door flanked by sidelights divided into six panes and capped with a six-pane transom. The sidelight windows sit over a rectilinear recessed wooden panel. Six-over-six wooden sash windows framed by shutters flank the entryway. The portion of the primary elevation sheltered by the screened section appears to consist of a secondary entrance and two windows with similar fenestration.

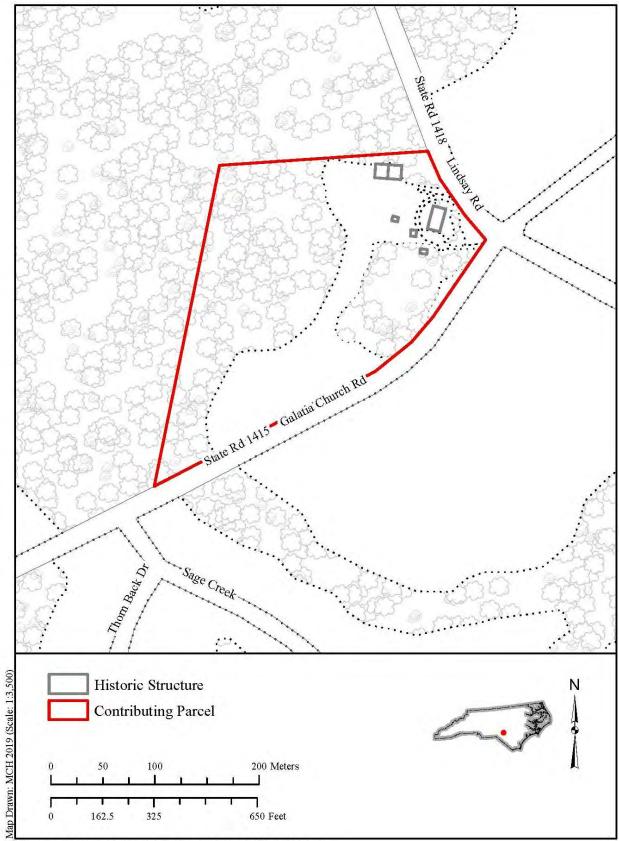
Figure 4. Carmichael-Lindsay House Sketch Map

intersection consist of cleared agricultural land. The remainder of the parcel, which has an irregular shape and consists of 14.22 acres, includes forested land on the western and central portions, and cleared land consisting of lawn and several additional outbuildings (Figures 4 and 5).

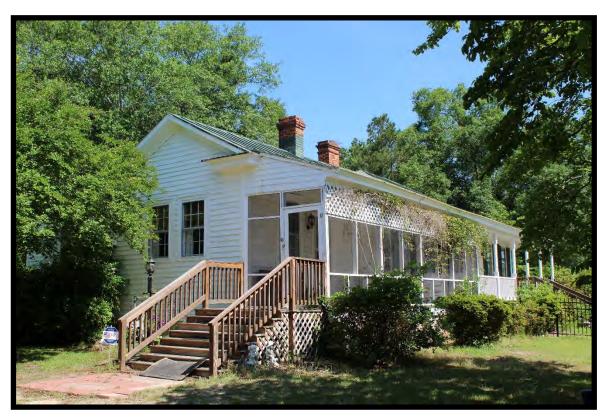
The house has two interior brick chimneys with one located on the gabled extension and one located on the southwestern end of the hipped-roof portion of the dwelling. The chimneys differ slightly but are both decorated minimally. The chimney stack on the hip-roofed section is slightly larger with a single projecting brick course below several flush courses, finished with

Figure 6: Carmichael-Lindsay House, Looking North.

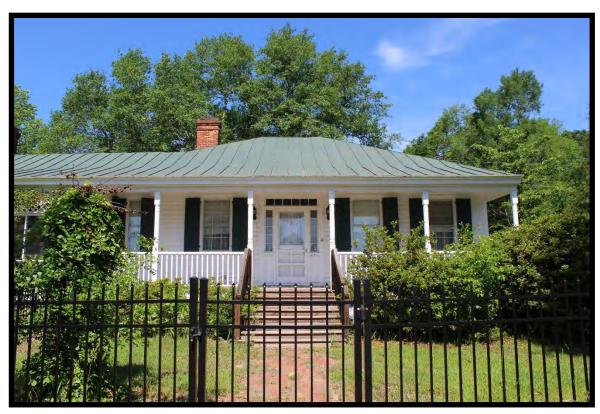
Figure 7: Carmichael-Lindsay House, Looking Northwest.

three courses of corbelled bricks. The second chimney stack contains only three corbeled brick courses and is partially painted at the base. The dwelling's fenestration, including windows, transom and sidelights, and chimneys appear to be original, while many elements of the porch, including the staircases, unfinished flooring, and screened section, are likely newer. It is unclear if the porch railings and posts are also replacement features or if they were retained when the flooring was replaced.

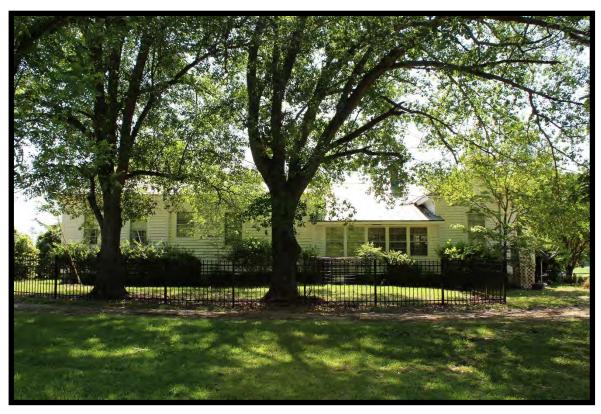
The southwest (side) elevation is characterized by deep cornice returns, two six-over-six wooden sash windows, and a modern wooden staircase that provides access to the screened portion (see Figure 6). The northwest (rear) elevation contains a mixture of rooflines and fenestration. Starting on the northernmost section of the house, the elevation is comprised of a hip-roofed section and contains four evenly spaced six-over-six wooden sash windows with simple wooden enframement centering around a slightly smaller wooden sash window separating the larger windows with two on either side. A central side-gabled portion with a continuously sloped roof

Figure 8: Carmichael-Lindsay House, Looking Southeast.

contains a bank of five six-over-six wooden sash windows. The third section of the elevation is a gabled section with a centered six-over-six wooden sash window (Figure 8).

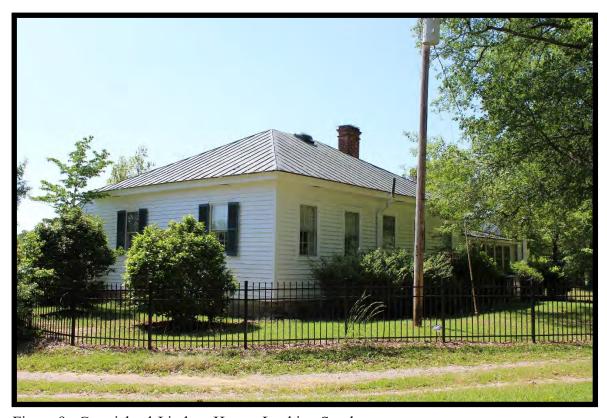
Figure 9: Carmichael-Lindsay House, Looking South.

The northeast (side) elevation contains two six-over-six wooden sash windows with simple wooden enframement and shutters. No other fenestration appears on this elevation, but brick piers along the foundation are visible along with modern concrete infill (Figure 9).

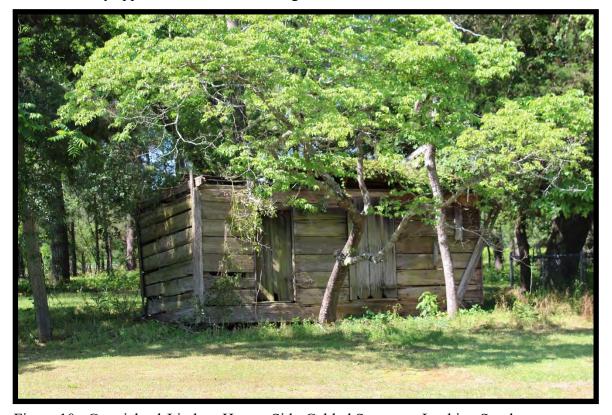
The first outbuilding appears to be a flat-roofed structure located just south of the main house with its primary elevation oriented northeast toward the dwelling. Two pedestrian door openings are placed on this northeast elevation (Figure 10). The structure appears to be in poor condition, and it is not clear if the original roof structure was side gabled or flat. The exterior is finished with wide flush boards applied horizontally.

Figure 10: Carmichael-Lindsay House, Side-Gabled Structure, Looking Southwest.

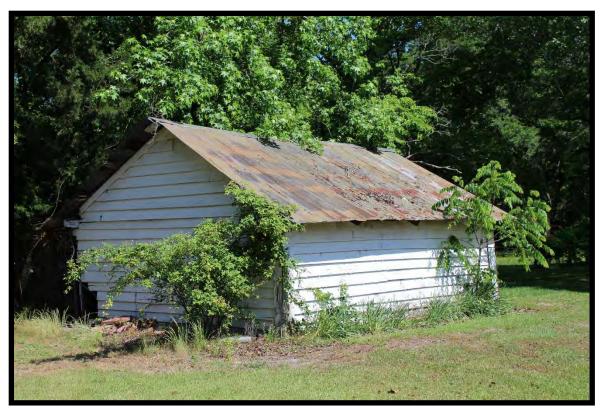
The next outbuilding is a front-gabled structure with a ribbed metal roof and wide weatherboard siding. Certain elevations are obstructed by overgrowth and vegetation. It is oriented parallel with the main house, facing northeast toward Lindsay Road (Figure 11).

Figure 11: Carmichael-Lindsay House, Front-Gabled Structure, Looking North.

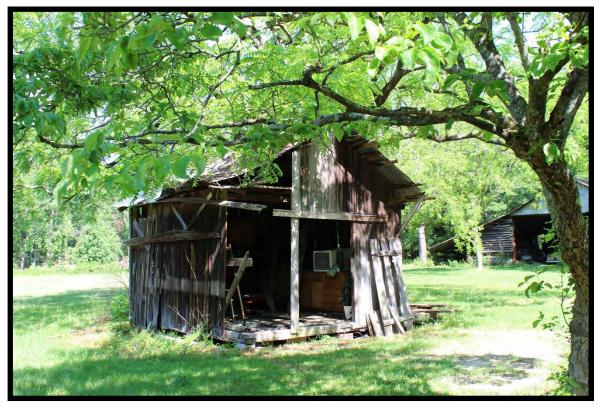
The third outbuilding, also in poor condition, is located northwest of the dwelling (Figure 12). It is a front-gabled storage structure and faces southeast toward the house. The roof is clad with ribbed metal sheets, and the structure sits on a slightly raised brick foundation. The exterior is finished with vertical, flush wooden boarding.

Figure 12: Carmichael-Lindsay House, Front-Gabled Structure, Looking Northwest.

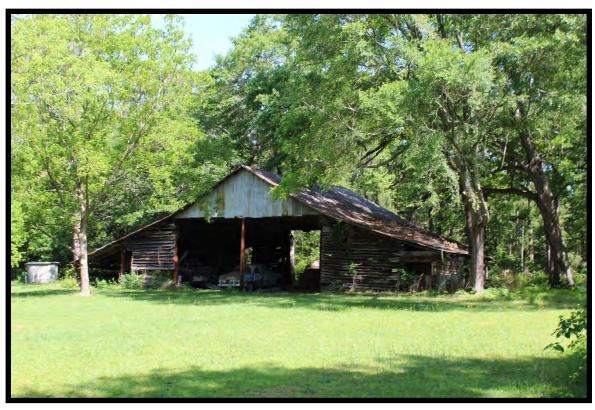
The final outbuilding is located northeast of the dwelling and is a large front-gabled barn with a central open bay and an enclosed, shed-roofed bay to either side (Figure 13). The exterior is finished with wooden siding, the roof is clad in ribbed metal sheets, and the gable is finished with vertical metal panels. A short metal storage bin is located just north of this building. The structure currently appears to be used for storage.

Figure 13: Carmichael-Lindsay House, Barn, Looking Northwest.

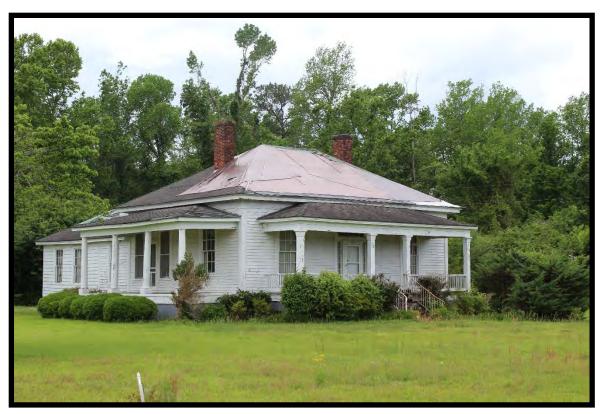
A hip-roofed example that bears some similarity to the Carmichael-Lindsay House was identified in Bladen County and is the Robeson-Stevens House (BL0233, Figure 21). Constructed ca. 1839, the core of the dwelling is a one-story, hip-roofed block with modest Greek Revival detailing that serves as an example of a similar, though somewhat larger, earlier, and more typical, example of a nineteenth century dwelling in the region. The house, however, is less well preserved than the Carmichael-Lindsay House, with chipping paint and a tarp on its replacement asphalt shingle roof, and looked to be vacant at the time of survey. It has hip-roofed front and side porches, which differ from the Carmichael-Lindsay House's integral full-width porch. The Robeson-Stevens House also differs in that it has a three-bay façade. Its porches are supported

Figure 21: Robeson-Stevens House (BL0233), Looking Northwest.

by square pilasters on the façade and Doric columns on the side elevation, and the façade porch shelters a central entry door flanked by sidelights and topped with a five-pane transom. Like the Carmichael-Lindsay House, the house retains its original siding and windows. Additionally, the Robeson-Stevens House has a substantial addition placed on its rear elevation, comparable to the side addition on the Carmichael-Lindsay House. This dwelling was determined eligible under Criterion C in 2010 due to the retention of many of its Greek Revival-style features such as its square Doric columns, transom, and sidelights. The Carmichael-Lindsay House displays a similar level of retention of materials and design elements, in addition to being a more well-preserved example of nineteenth century architecture.

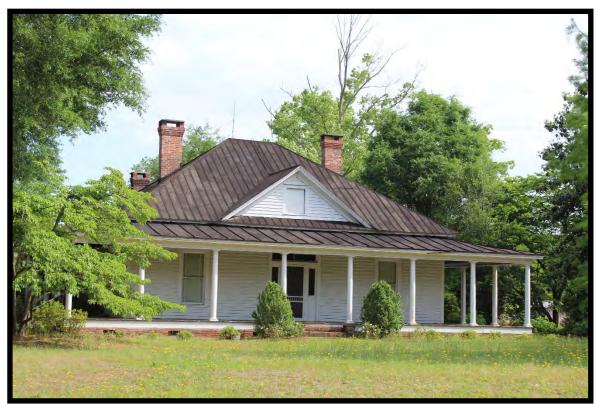
A second comparable dwelling is the James L. Cooley House (SC0039, Figure 22). The James L. Cooley House is located in Scotland County, within the Spring Hill Historic District (SC0360), which was determined eligible in 2005. The house is similar to the Carmichael-Lindsay House in that it is a one-story frame traditional dwelling with a hipped roof and modest Greek Revival-style ornamentation. Aside from their hipped roofs, the houses share several architectural characteristics such as rectilinear transom and sidelights and corbelled chimneys (Figure 22). They differ in that the hip-roofed section of the James L. Cooley House appears to be wider than the hip-roofed section of the Carmichael-Lindsay House though it is only three bays wide. The hip-roofed section of the James L. Cooley House is also taller with a more steeply pitched roof and exhibits a center gable, which is typical of many late-nineteenth century dwellings constructed in North Carolina. The James L. Cooley House also retains many of its associated outbuildings and seems to still function in an agricultural capacity. The house appears to retain its

Figure 22: James L. Cooley House (SC0039), Looking Northeast. original weatherboard siding, porch details, and chimneys, much like the Carmichael-Lindsay House.

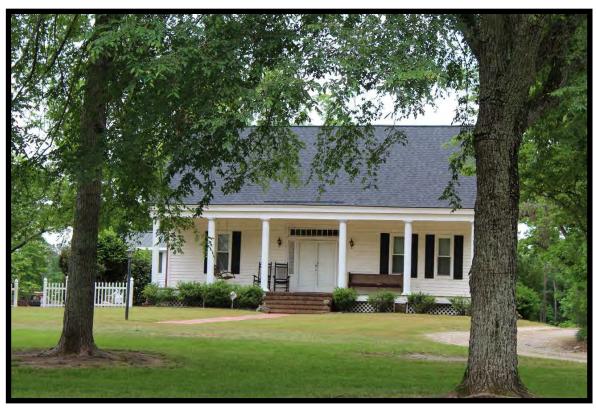
Figure 23: Robert Williams House, CD0144.

A comparable side-gabled example, the Robert Williams House (CD0144) was found in Cumberland County (Figure 23). Listed on the NRHP in 1983, the house is characterized in HPOWeb as an "1850 Greek Revival frame coastal cottage." While slightly earlier in its construction and much taller (one-and-one-half stories), it is an intact example similar in detail to the Carmichael-Lindsay House. Both houses retain wooden siding, wooden sash windows, transom and sidelights, and an integral front porch, though the Robert Williams House's porch is at least its third iteration. Its original design, according to its NRHP nomination form, consisted of rectangular columns with a balustrade of closely spaced slat balusters. The original roof material has also been replaced with asphalt shingles. The Robert Williams House differs from the Carmichael-Lindsay House in that it is side-gabled, has an asymmetrical façade with a double-leaf entrance, and does not have any substantial additions from its period of significance or later. Though the houses differ in composition, they display a comparable level of historic integrity with the Carmichael-Lindsay House retaining more historic material (windows, siding, and roofing) than the NRHP-listed Robert Williams House and both being altered in form through additions and replacement porches.

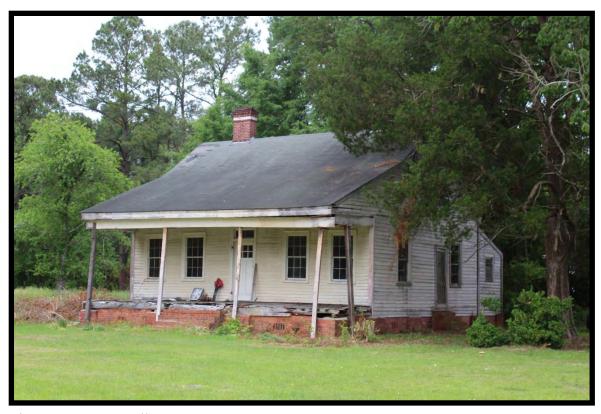
Figure 24: Porter-Allen House, BL0229.

Lastly, an example of a more typical five-bay dwelling for the region was found in Bladen County, the ca.1850 Porter-Allen House (BL0229, Figure 24). Though constructed earlier than the Carmichael-Lindsay House it shares the dwelling's five-bay façade and integral front porch. It also displays the simplicity of the majority of dwellings constructed in the mid-nineteenth century through its simplified version of the Carmichael-Lindsay House's entryway with transom. The dwelling, however, is in poor condition with its porch showing signs of severe deterioration and its supports being replaced with unfinished wooden two-by-fours. Although this comparison property has not been formally evaluated, based on the integrity of its exterior features alone, the Carmichael-Lindsay House serves as a far better example of the type dating from this period.

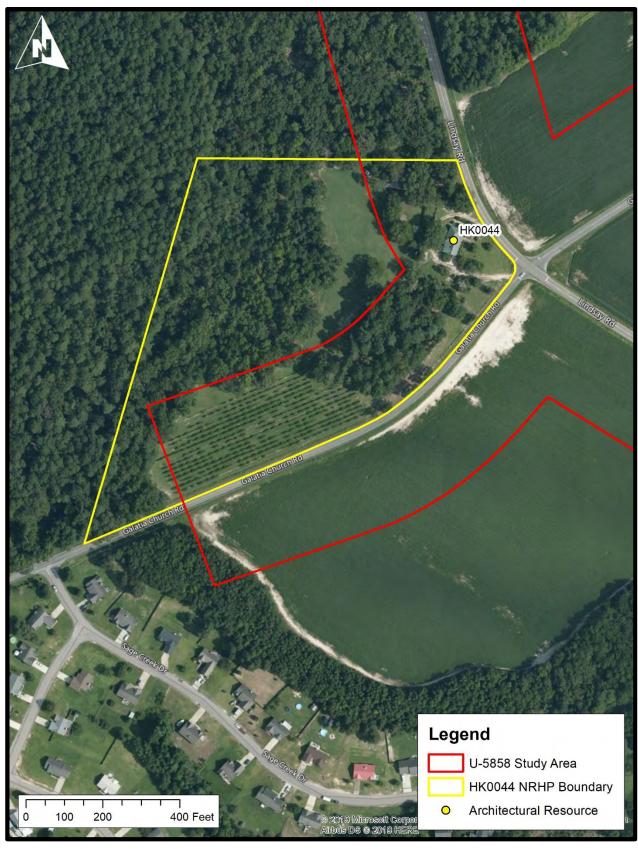
Figure 24: NRHP Boundary of the Carmichael-Lindsay House (HK0044).

The NRHP boundary for the Carmichael-Lindsay House (Figure 24), has been drawn according to the guidelines of National Register Bulletin 21, Defining Boundaries for National Register Properties. The boundary is drawn to include the dwelling, landscape, and associated outbuildings that contribute to the property's setting, and is drawn to the edge of the pavement along Galatia Church and Lindsay Roads in order to encompass all landscaping and fencing. The NRHP boundary is identified as the current parcel 494750201148 (Hoke County PIN's). The boundary contains approximately 14.22 acres.
