**HISTORIC STRUCTURES SURVEY REPORT  
EXTEND SR 1102 (GILLIS HILL ROAD)  
FROM NORTH OF STEEPLE RUN DRIVE TO WESTFIELD DRIVE  
RAEFORD, HOKE COUNTY, NORTH CAROLINA**

**TIP PROJECT U-5707  
WBS NO. 50158.1.1  
PA TRACKING NO. 18-03-0041**

Resource Name:	Wood's Store
NCDOT Survey Site Number:	001
HPO Survey Site Number:	HK0043
Location:	7569 Rockfish Road
Parcel ID:	494850301037
Dates(s) of Construction:	Ca. 1920
Recommendation:	Not Eligible

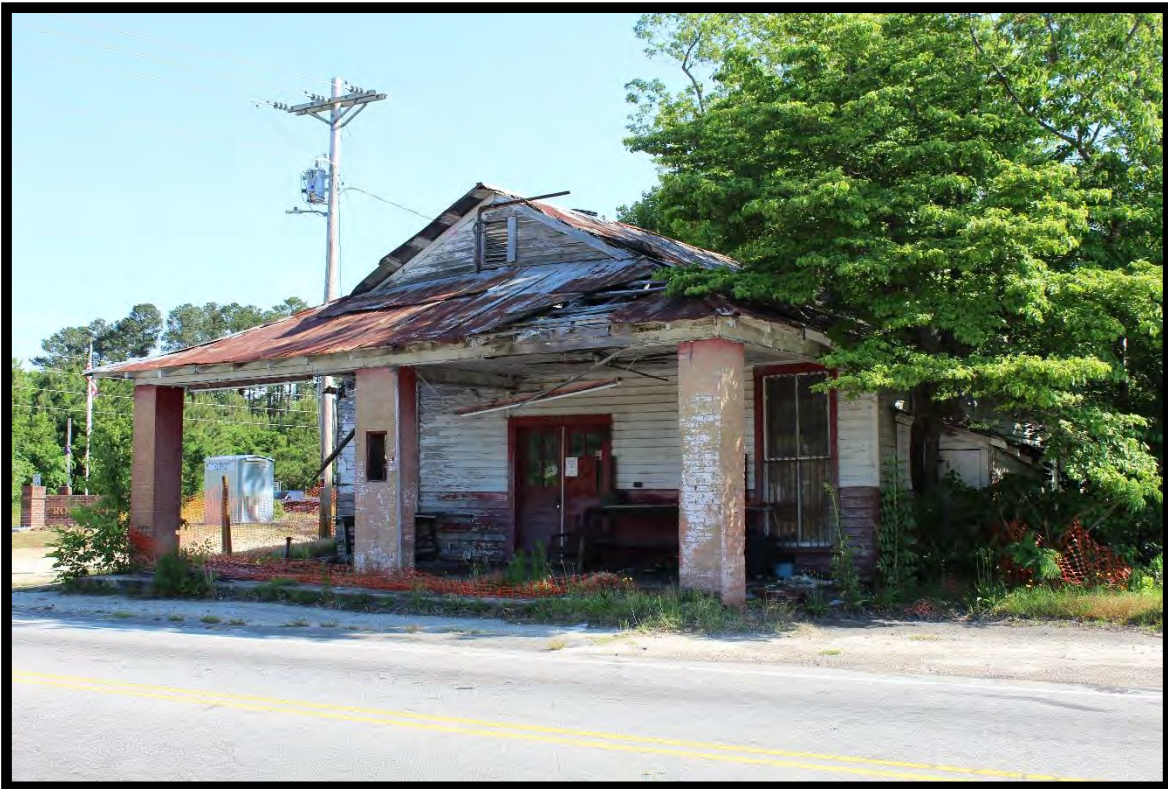
Figure 3: Wood's Store, Looking North.

door is located on the southern elevation, near the façade. It is largely obstructed by overgrown vegetation (See Figures 3 and 9).

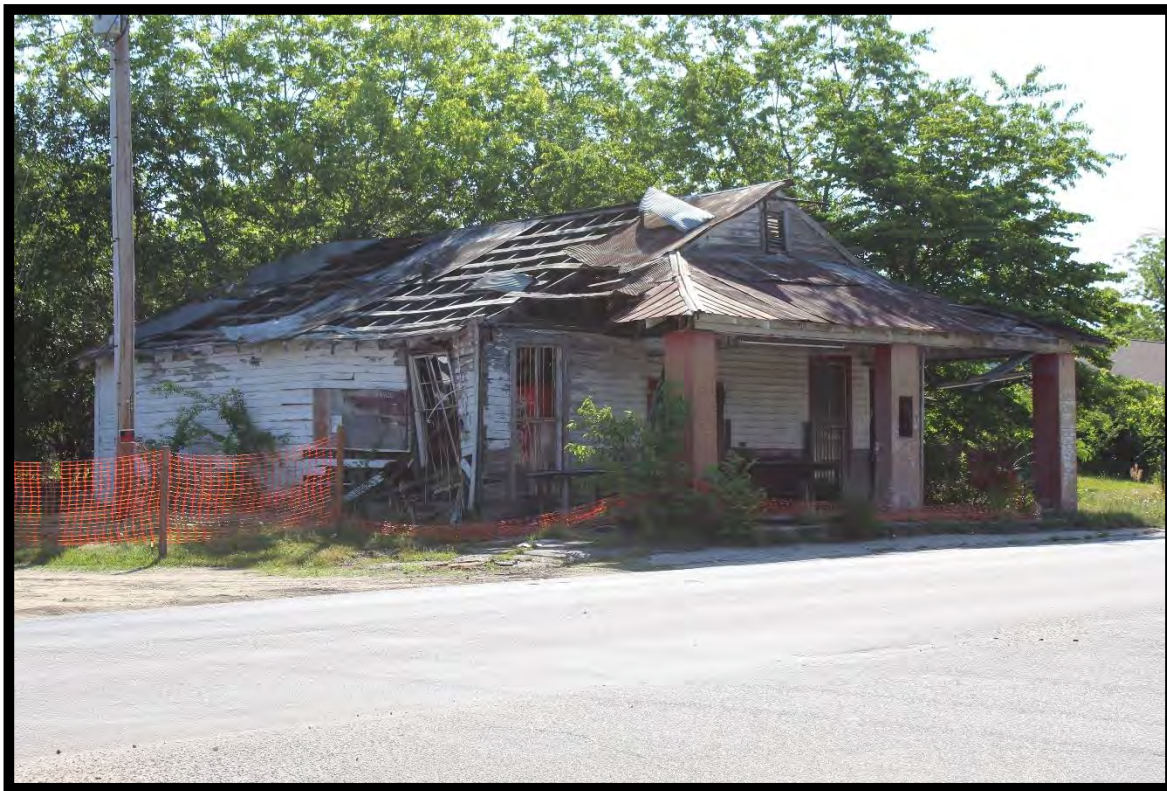
Figure 5: Wood's Store, Looking Southeast.

The store is a one-story commercial building of frame construction resting on a concrete-slab foundation. It is sheathed in weatherboards, and its front-gabled roof is clad in standing-seam metal (Figure 5). The building appears to have originally featured detailing such as exposed rafters, but, typical of a rural commercial building, little other stylistic detailing is visible. The building has a full-width hip-roofed porch that is also clad with standing-seam metal. The porch is supported by three evenly spaced brick piers, and the peak of the gable, which contains a small slatted attic vent, is visible above the porch. The central brick pier has a rectangular opening with an interior wood surround. The function the opening was not entirely clear, and no comparison properties had similar features making it difficult to determine its use. However, there is a long metal pipe that extends from the ground to the top of the pier and is only present on this central pier. Given the building's history as a service station and lack of evidence of pumps elsewhere it is possible that the opening and pipe relate to the location of the gas pump. Alternatively, the opening is similar in size to some mailboxes and could have functioned as a drop off location for outgoing mail (Figure 6).

The porch shelters a symmetrical façade with an entryway flanked by paired two-over-two horizontal pane wooden sash windows. The entryway has double-leaf wooden doors, each with three inset panels on the lower half, and four glazed panes on the upper half (Figures 7). The windows are tall, rising to the ceiling of the porch, and have a simple wooden surround (Figure 8). Vertical metal bars are attached to the exterior. A small shed-roofed wing with a pedestrian

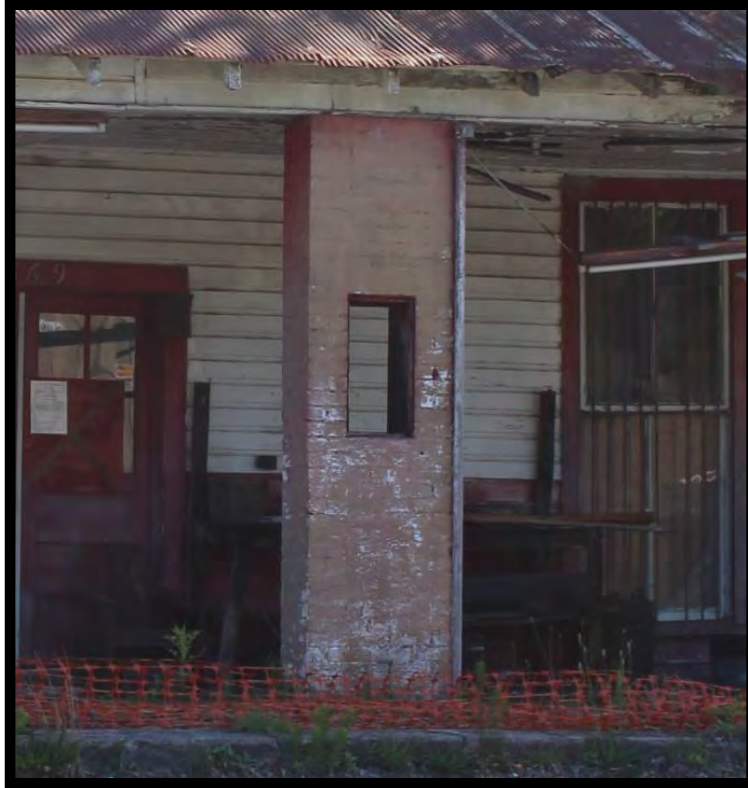
Figure 6: Wood's Store Brick Pier Opening and Pipe, Looking North.

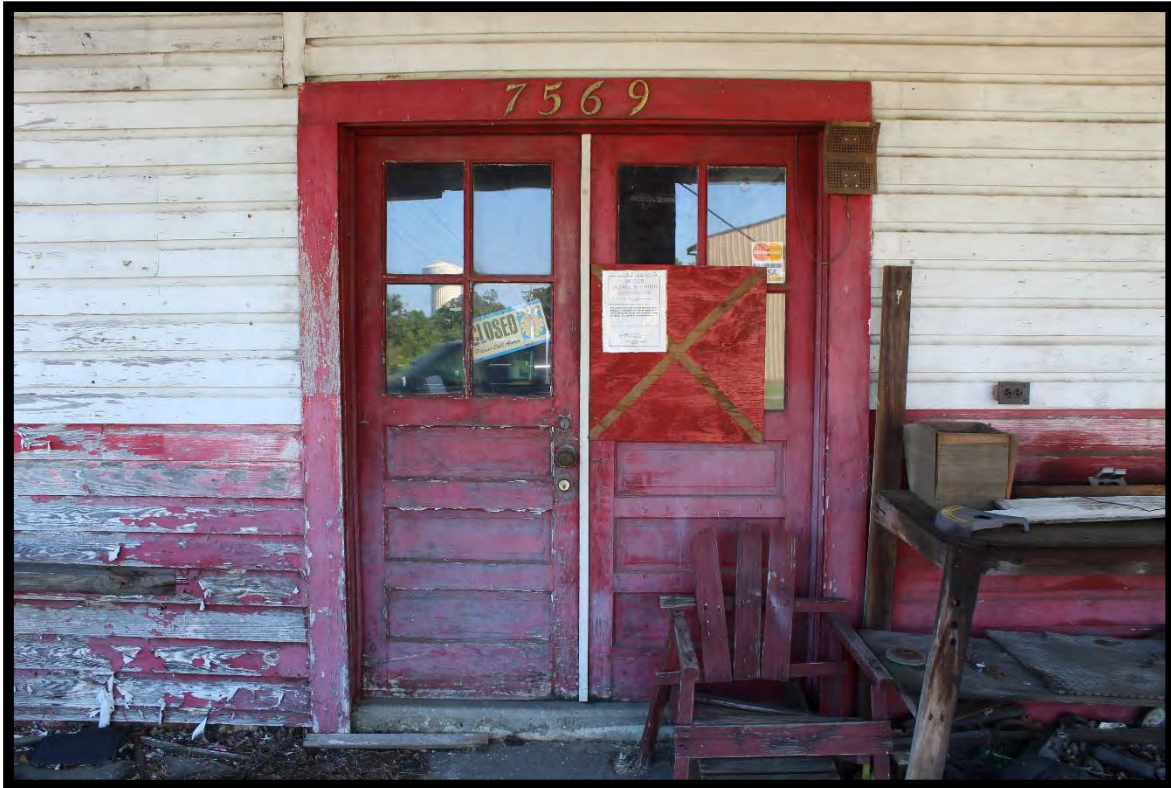
Figure 7: Wood's Store, Detail of Double-Leaf Door, Looking North.

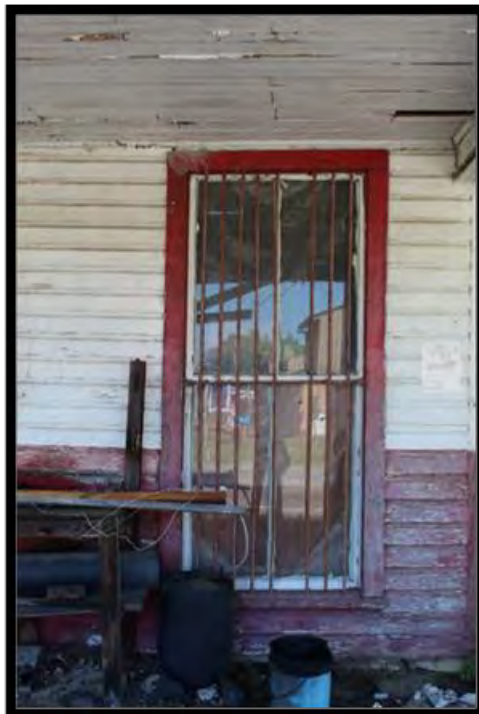
Figure 8: Wood's Store, Detail of Window, Looking North.

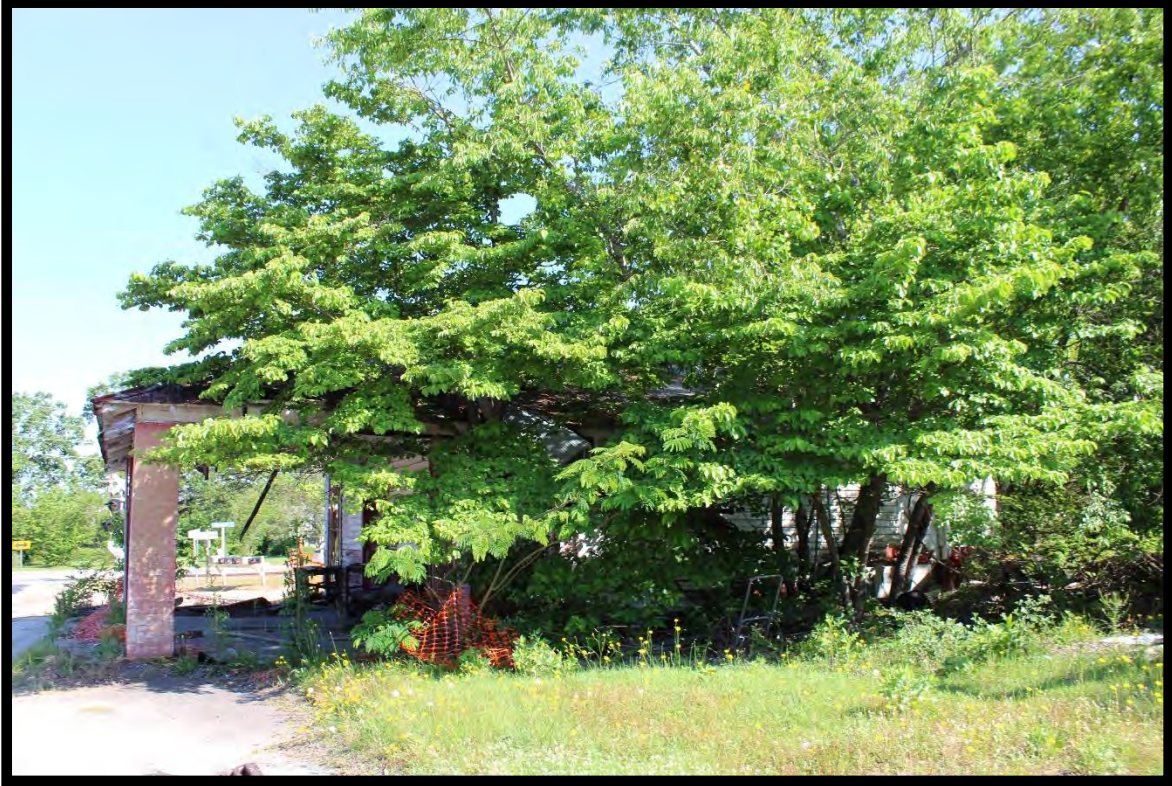
Figure 9: Wood's Store, Looking Northwest.

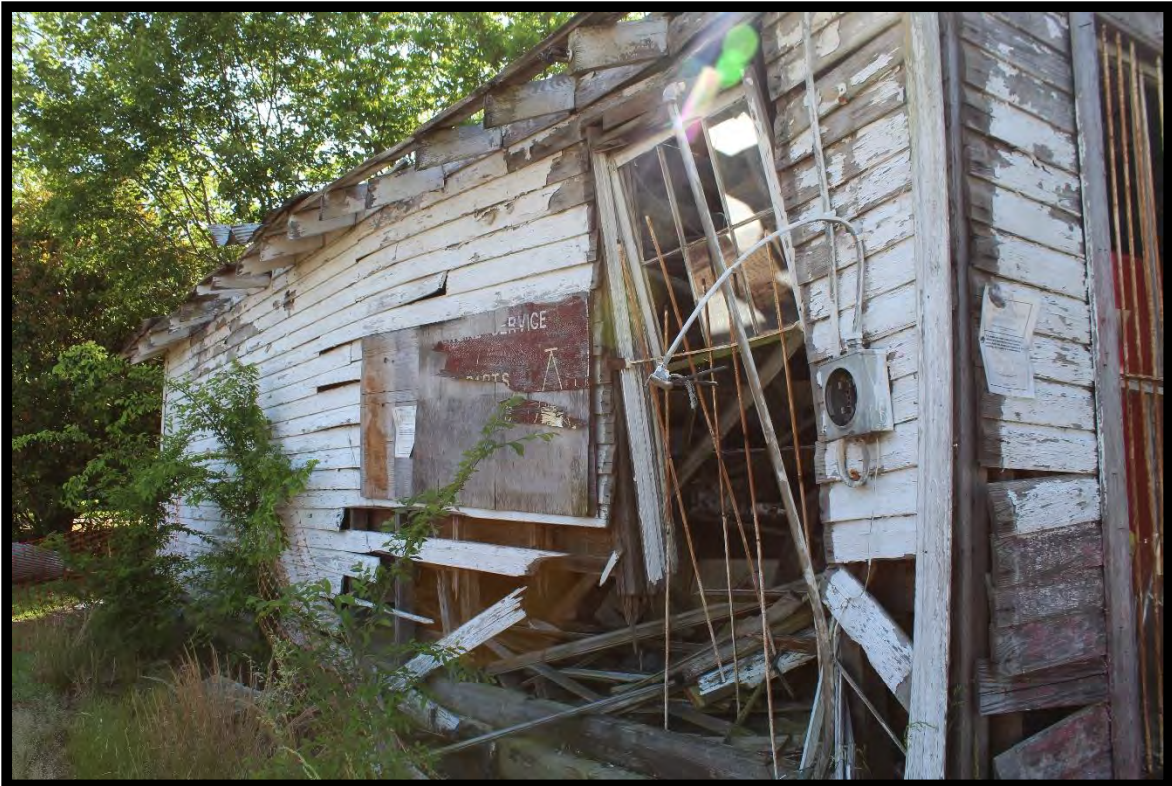
The north (side) elevation contains one window opening on its westernmost end. The window appears to be a six-over-six wooden sash window but is currently in a state of disrepair (Figure 10). It has the same surround as the windows on the façade. Adjacent to the window is a wooden sign board that is heavily deteriorated and not completely legible. However, the words “service” and “parts” are partially visible, illustrating at least one phase of the structure’s history as an auto service station and store. The remainder of this elevation is blind.

Figure 10: Wood's Store, Looking East.

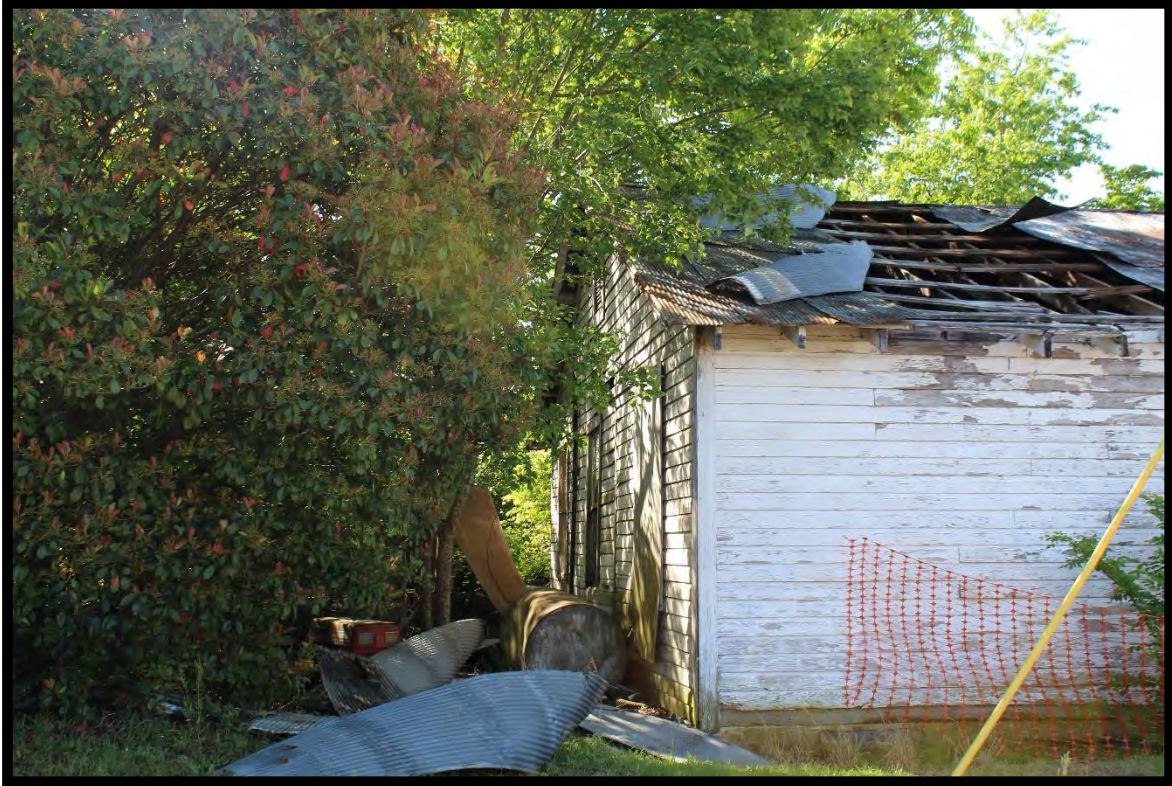
The rear portion of the store is largely obstructed by overgrown vegetation but appears to have a central pedestrian entrance and two window openings. One window opening is boarded over, and the other has metal bars attached on the exterior. They appear to be similar in size of those found on the façade (Figures 11 and 12).

Figure 11: Wood's Store, Looking Southeast.

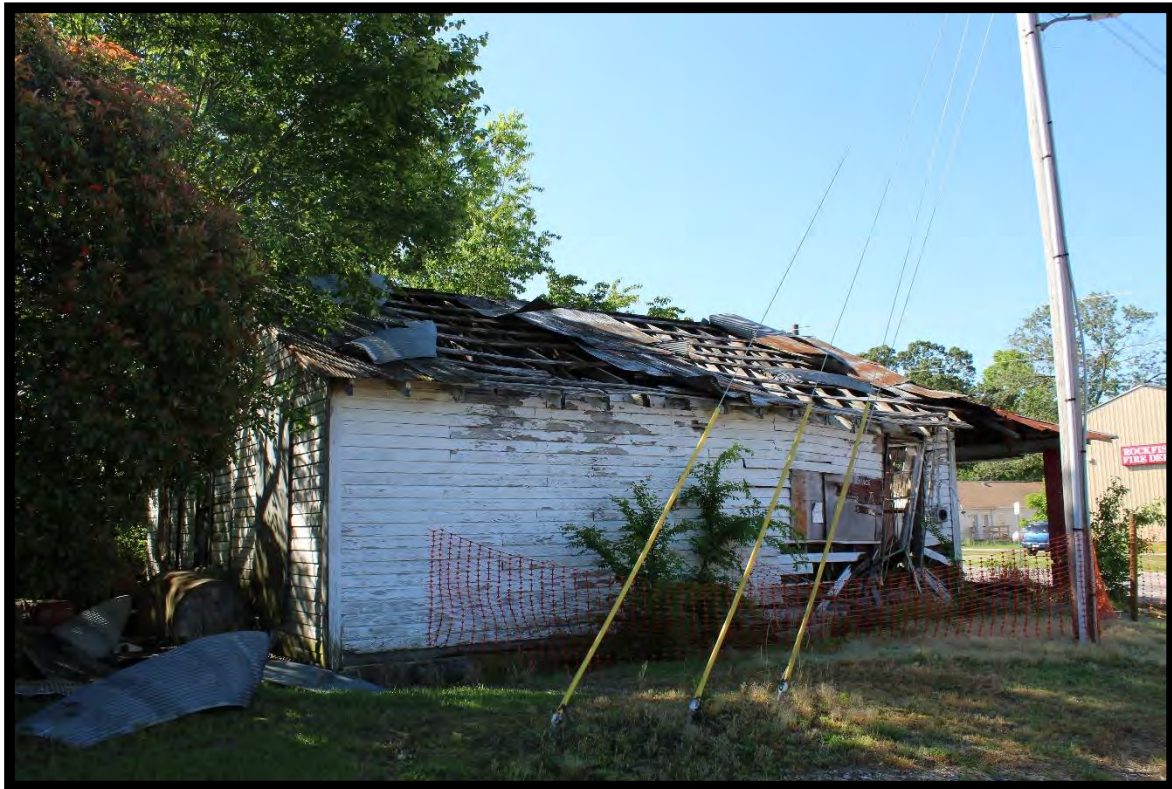
Figure 12: Wood's Store, Looking Southeast.

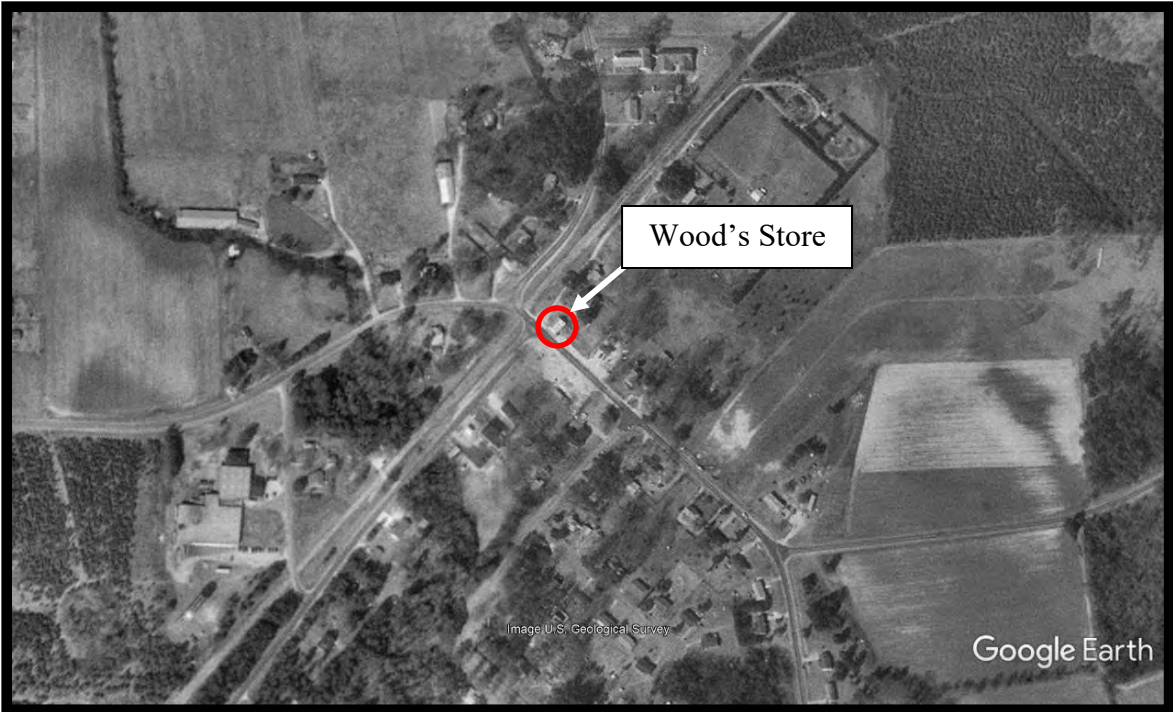
Figure 16: 1993 Aerial Image, Showing Wood's Store and Agricultural Land (Google Earth Pro).

During this time, the landscape of eastern Hoke County changed significantly due to the development of residential neighborhoods to the southwest and southeast on former agricultural land. The majority of this development occurred between 1993 and 1999, vastly changing the landscape of the small community. Though the Wood's Store property has for the most part evaded development, much of the land once owned by the Wood family in Hoke County has succumbed to development. Between 1993 and 1999, the pace of commercial and residential development increased on almost every side of the parcel (Figures 16 and 17). Today, the parcel measures just under one acre and contains only the store. Though some equipment related to its use as a small engine repair shop remains inside the building (suggesting it was abandoned), not much in the way of its function as a service station or store is apparent from the current state of the building. Commercial properties that immediately surround the store are modern.

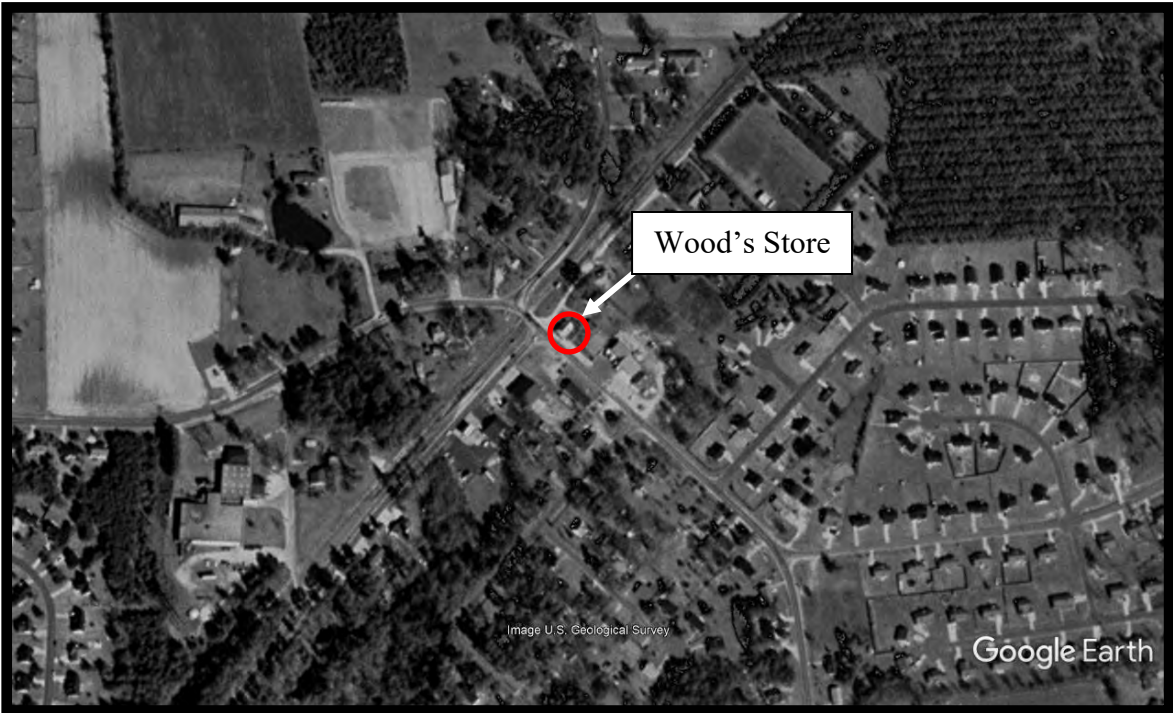
Figure 17: 1999 Aerial Image, Showing Wood's Store and Residential Development (Google Earth Pro).

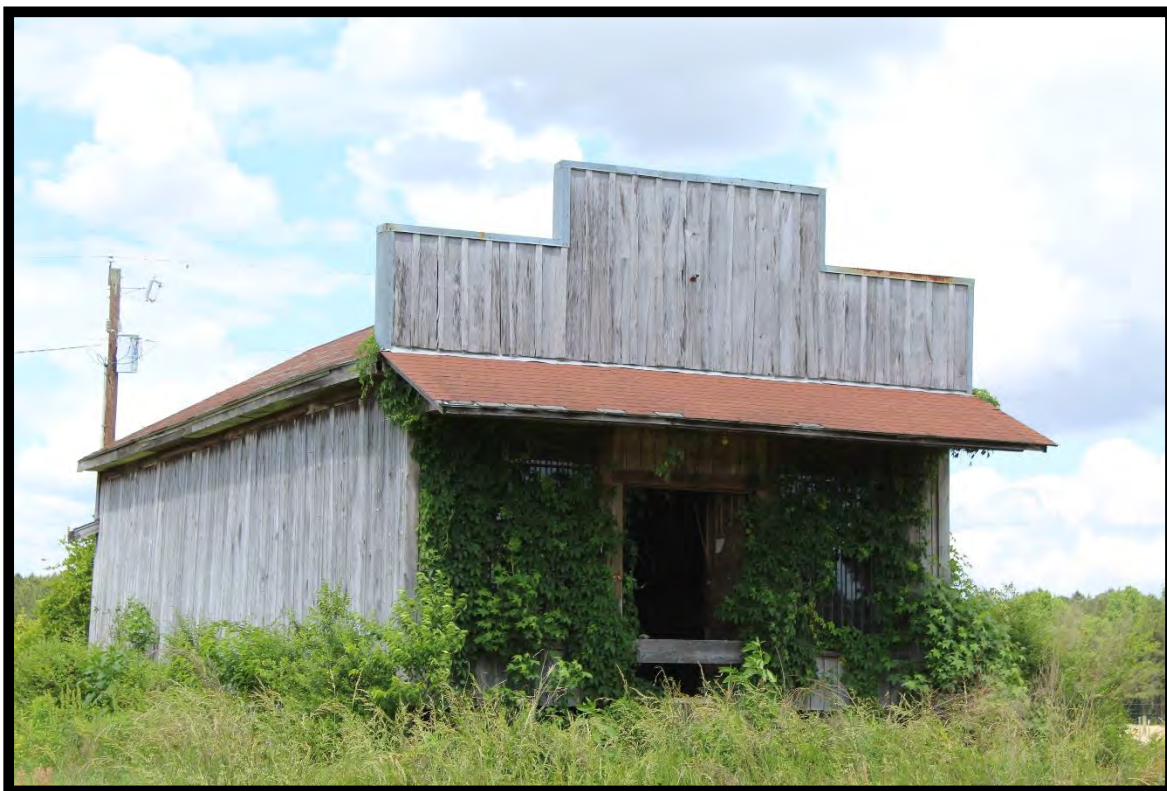
One similarly scaled example is a store at 7635 Rhodes Pond Road (CD1483, Figure 18). Surveyed in conjunction with a ca. 1920 Craftsman-style dwelling, the store has been moved twice, once from Sampson County to Rhodes Pond, where it served as a shop, then to its current location in the early 2000s.<sup>20</sup> The frame store was likely constructed between the late nineteenth and early twentieth century, has a “boomtown” façade with a stepped-gable, and is similar in scale and massing to Wood’s Store. It has a central entrance flanked by barred window openings under a one-story porch. Like Wood’s Store, its original siding is still intact along with some

Figure 18: Rhodes Pond Store (CD1483), Looking North.

original fenestration and doorways. The front doors of the store have been left open, and while the ceiling and walls of the interior appear to be intact, the floor is overgrown with vines and scattered with debris. Though the Rhodes Pond Store was not evaluated as a primary resource, the property overall was recommended not eligible due to its lack of physical integrity. Wood's Store has remained in its original location since its construction but has fallen into a deeper state of disrepair than the Rhodes Pond Store and thus retains even less integrity than this ineligible resource.

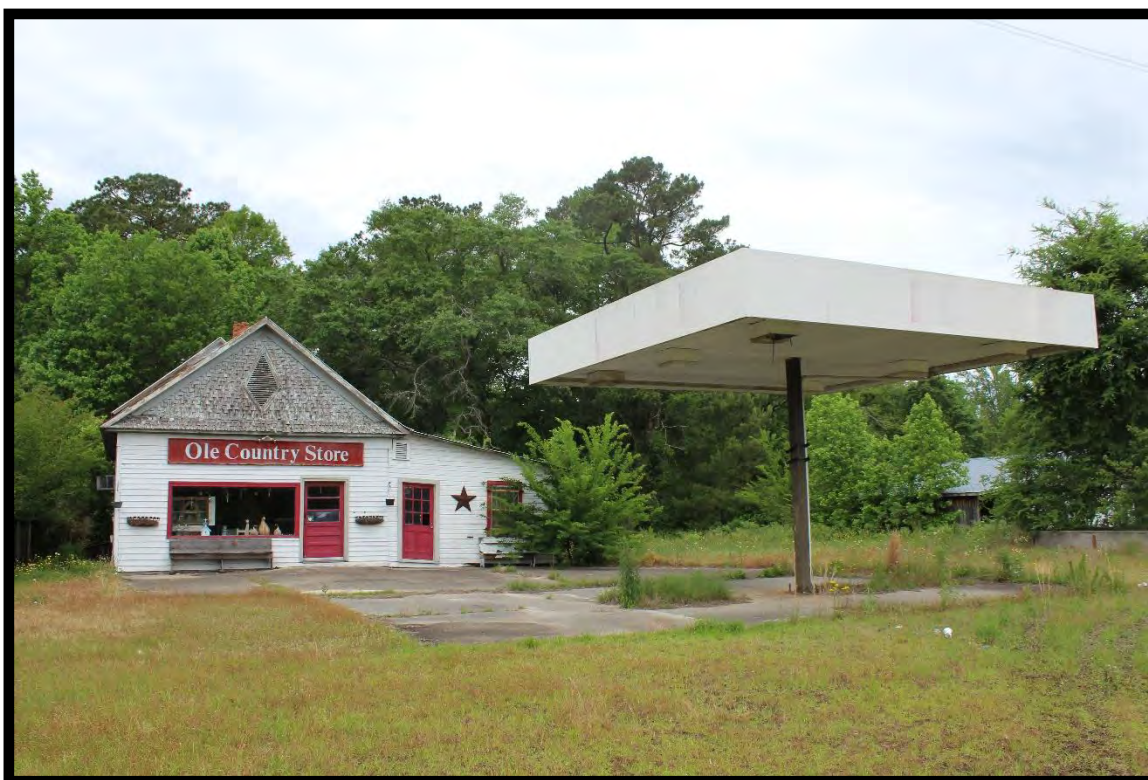
Another comparison property was found in the White Oak Business District (BL0253) in Bladen County (Figure 19). Similar to Rockfish, White Oak is a small crossroads community with a handful of rural commercial buildings and residences rather than a densely concentrated downtown core. The 1897 wooden frame store is similar to Wood's Store both in scale and form, though the White Oak store has a small shed-roofed addition, while Wood's Store has maintained its original footprint.<sup>21</sup> The White Oak store, which dons the name "Ole Country Store," also has been modernized with a poured concrete slab in front of the store and a cantilevered awning indicating its later use as a fueling station. Though it is a different articulation of the rural store and filling station, the White Oak store is a more intact example of a late nineteenth/early twentieth century commercial resource in a rural area and serves as a better example of a building associated with the evolution of early twentieth century commerce.

Figure 19: Store (BL0253), Looking North.

It is also a part of a collection of rural commercial structures providing it with even greater integrity in terms of setting, feeling and association.

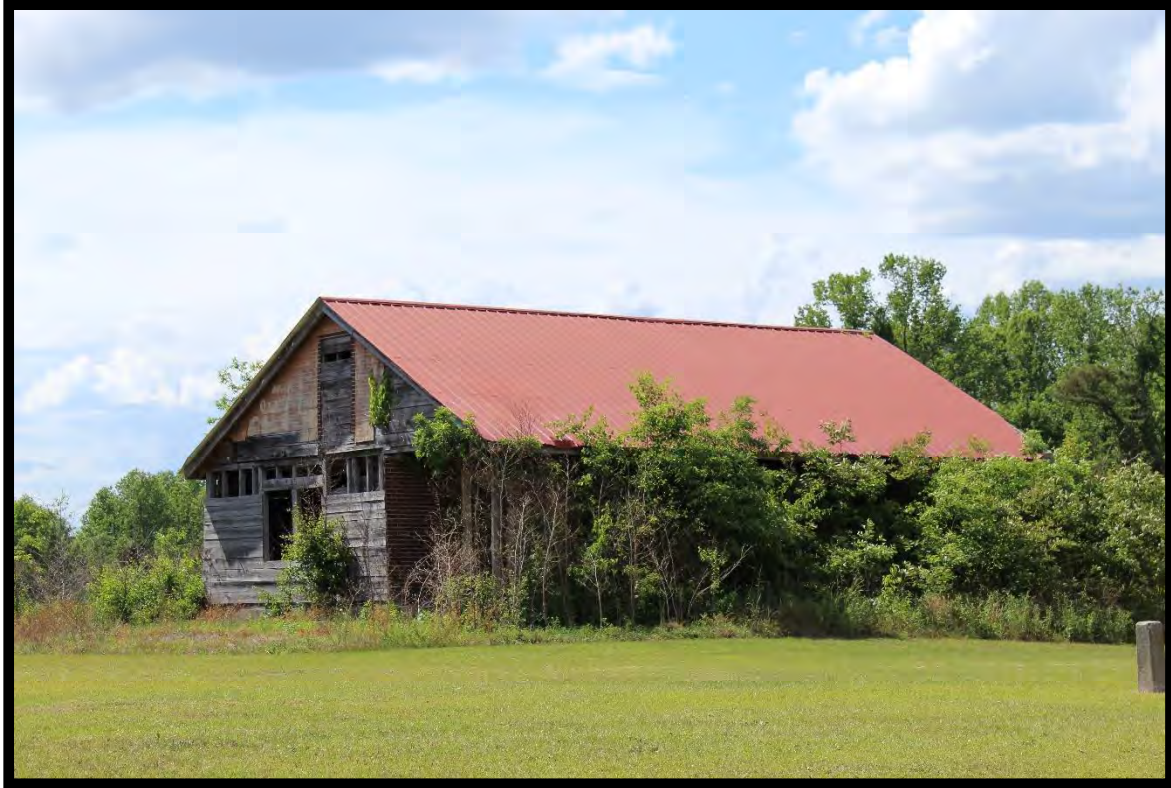
Figure 20: Store (CD1441), Looking Southeast.

A final example found in the region is CD1441 just south of Fayetteville (Figure 20). The 1928 store is similar to Wood's Store in that it has a frame structure and is clad with weatherboard siding but differs in that it is side gabled and has an integral full-width front porch. This side-gabled form is relatively unusual for the building type but displays how stores were constructed to fit the needs of their site or the preferences of their owners. Additionally, this store does not exhibit any evidence of a detached canopy, which could suggest that it was never fitted for fuel service, or that the fuel pumps were either sheltered by the porch or unsheltered. HPOWeb notes that the building has an undetermined eligibility and an associated report states that additional study is needed to determine eligibility. Although it appears to be missing windows and doors, the overall structure seems sound with intact openings and in terms of integrity it is a better representation of early-twentieth century commercial activity in the area.<sup>22</sup>
