ER 19-3123

# ARCHITECTURAL SURVEY CONSOLIDATION OF SCHOOLS COLUMBUS COUNTY, NORTH CAROLINA ER 19-3123

# ARCHITECTURAL EVALUATION, CONSOLIDATION OF SCHOOLS, CERRO GORDO AND TABOR CITY, COLUMBUS COUNTY, NORTH CAROLINA ER 19-3123

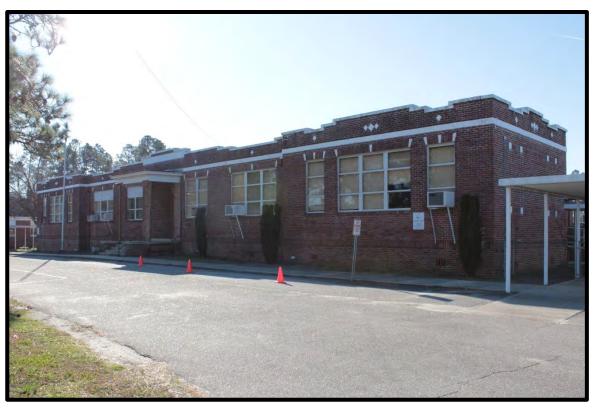
Figure 3: Cerro Gordo School, Looking South.

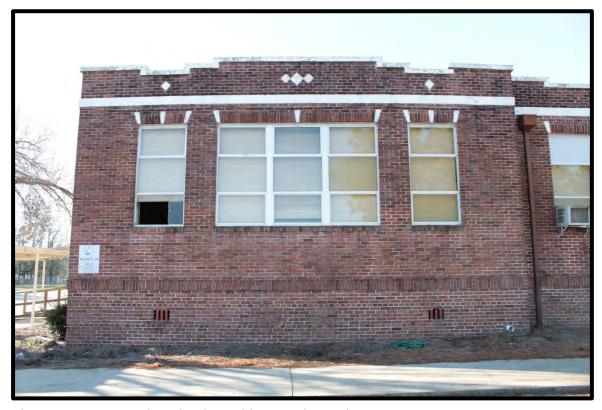
Figure 4: Cerro Gordo School, Looking South-Southwest.

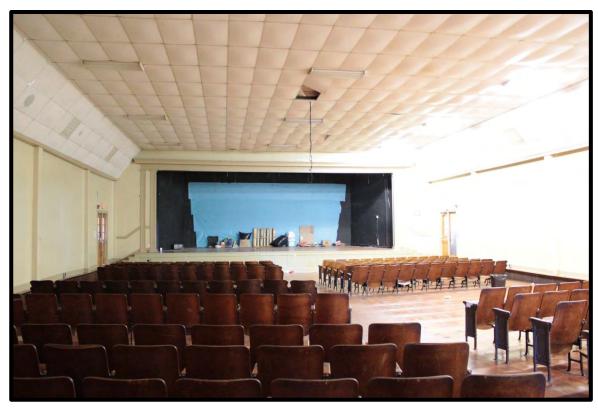
Figure 9: Cerro Gordo School, Auditorium.

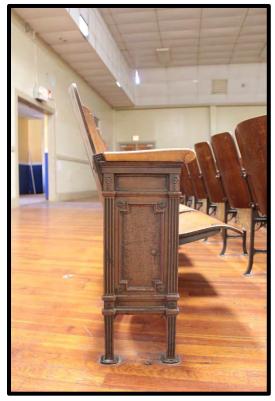
<sup>&</sup>lt;sup>3</sup> Note: Some of the seating in the auditorium was sold at a memorabilia sale held by the school system.

Figure 10: Cerro Gordo School, Detail of Auditorium Seating.

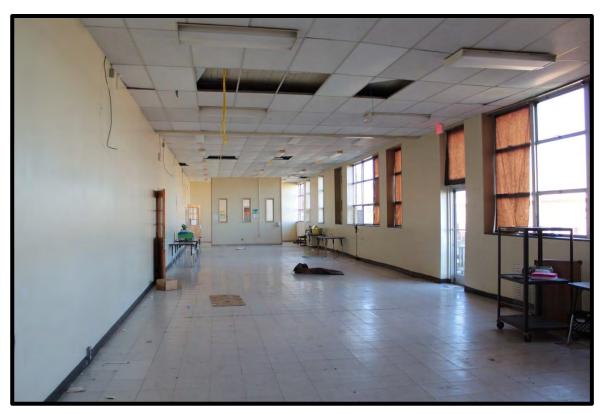
Figure 12: Cerro Gordo School, Cafeteria, Originally Two Classrooms.

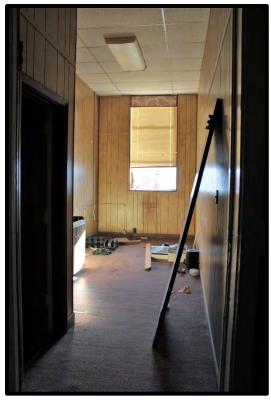
Figure 14: Cerro Gordo School, Divided Office Space with Paneling.

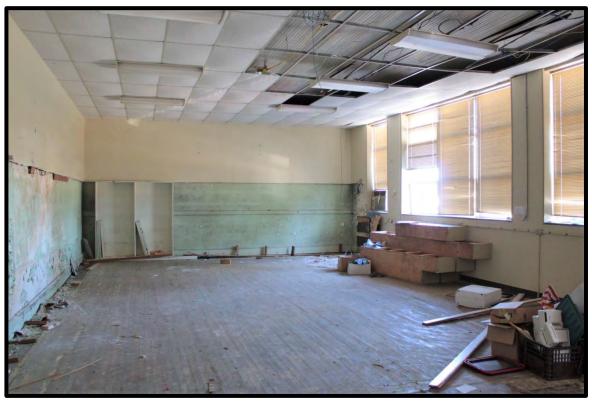
Figure 16: Cerro Gordo School, Classroom with Original Wooden Flooring, Plaster Walls, and Wooden Beadboard Ceiling Exposed.

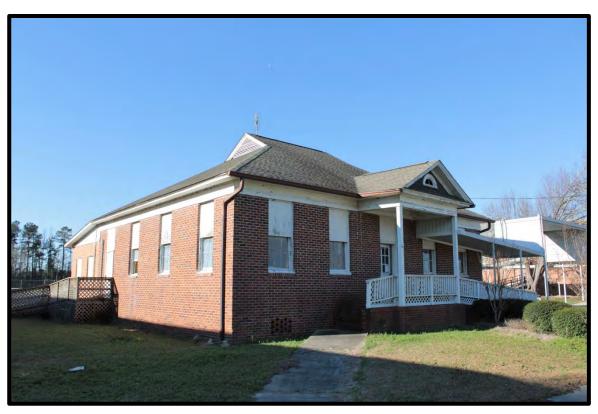
Figure 17: Cerro Gordo School, Agricultural Building, Looking Southwest.

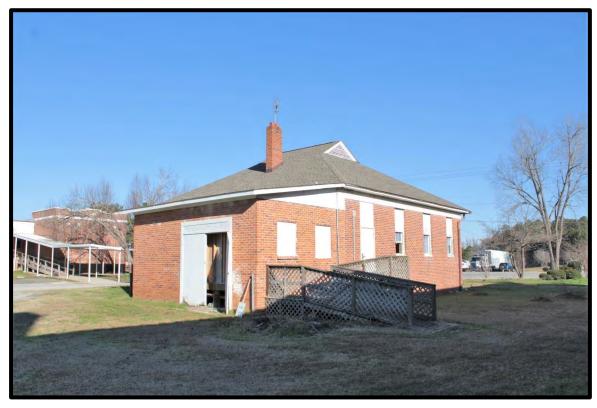
The 1936 Agricultural Building stands to the east of the original school building and is a one-story brick structure with a hipped asphalt shingle roof. Like the auditorium of the original school, two small vented gables rise from the east and west (side) slopes of the roof. The façade is symmetrical with a gabled portico supported by slender square posts and sheltering a single-leaf entry door with a multi-pane window and a square boarded-over transom. A small fanlight is placed in the gable, and a shallow pent roof slopes from below the window to the cornice. The deck of the portico is accessed by steps on the east and by a ramp on the west. Both are lined with a lattice structure layered over a simple balustrade, and the ramp is sheltered by a metal canopy that leads to the east elevation of the original school building. The portico is flanked by four windows that were likely six-over-six, double hung, wooden sashes. The upper sashes, however, have been covered to accommodate a lower acoustic tile ceiling on the interior. A deep cornice wraps the building above the windows (Figure 17).

Figure 18: Cerro Gordo School, Agricultural Building, Looking North.

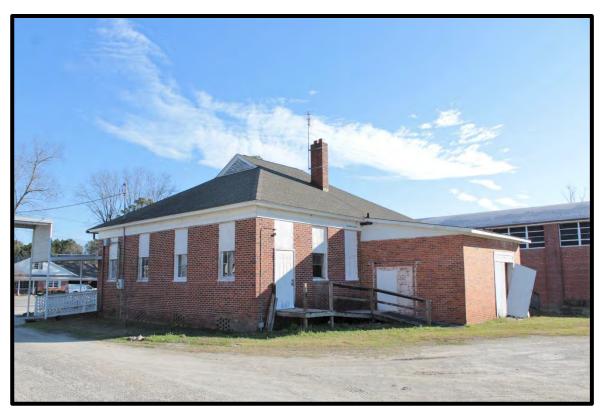
Figure 19: Cerro Gordo School, Agricultural Building, Looking Southwest.

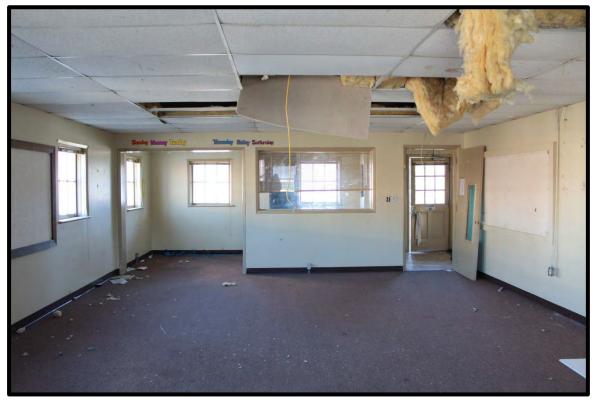
Figure 20: Cerro Gordo School, Agricultural Building, Classroom, Small Front Room and Entry Bay.

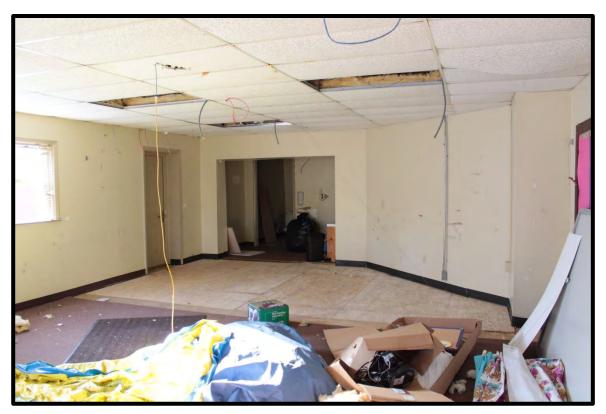
The interior of the building has been rearranged and is now divided into two large classrooms with a small room at the front and restrooms and storage at the rear. It has also been remodeled with tile and carpet flooring, drywall, and an acoustic tile ceiling. The upper sash of the windows was covered with drywall, and the ceiling was significantly lowered during the remodel (Figures 20 and 21).

Figure 21: Cerro Gordo School, Agricultural Building, Classroom and Rear Storage Area.

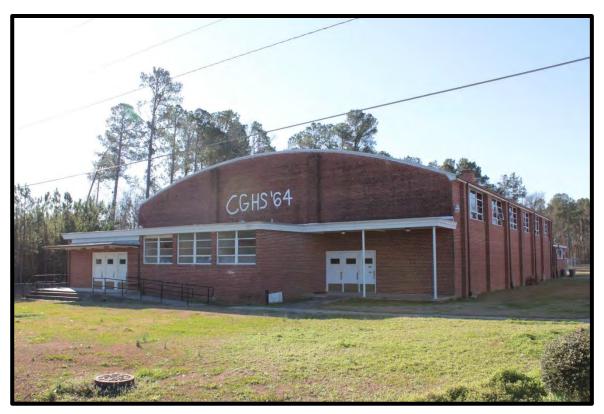
The gymnasium has been sold to a nearby property owner and the interior of the building could not be accessed.

Figure 22: Cerro Gordo School, Gymnasium, Looking South.

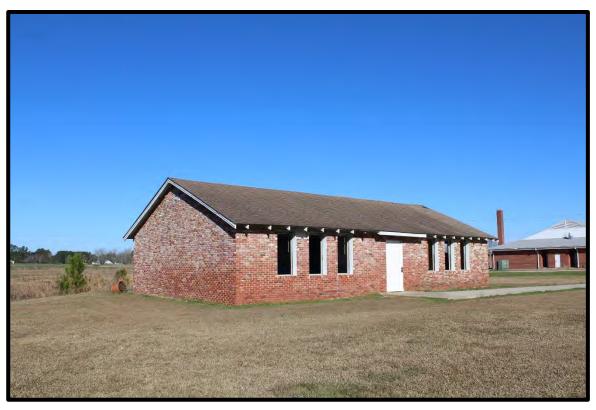
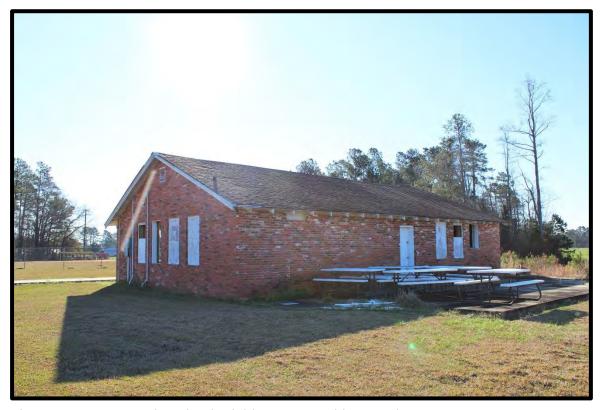
A 1939 building referred to as a field house, storage shed, and elective building stands southwest of the original school building.<sup>4</sup> The brick structure faces east toward a baseball field at the southeast corner of the school property and has a side-gabled asphalt shingle roof with exposed rafter tails. The façade is symmetrical with a single leaf entry door flanked by three windows on each side. The sashes have been removed from the window openings. The north (side) elevation is lit by four windows, three of which are either fully or partially covered and one of which is also missing its sash. The west (rear) elevation has an entry door placed near the center of the elevation and flanked on the south by two windows that are fully or partially covered and one that is missing its sash. A small cornice-height window or vent is also covered north of the entry door. The south (side) elevation is blind (Figures 25 and 26).

Figure 25: Cerro Gordo School, Field House, Looking North.

Figure 26: Cerro Gordo School, Field House, Looking South.

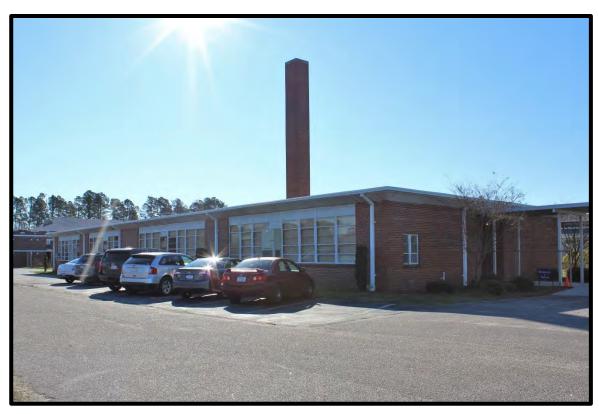
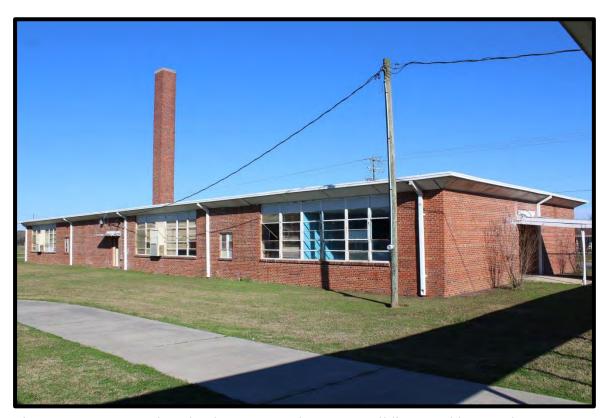
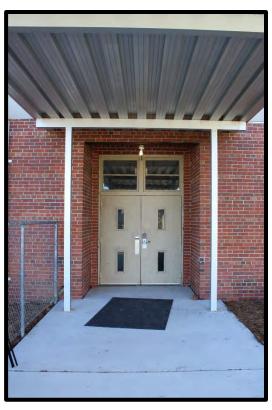
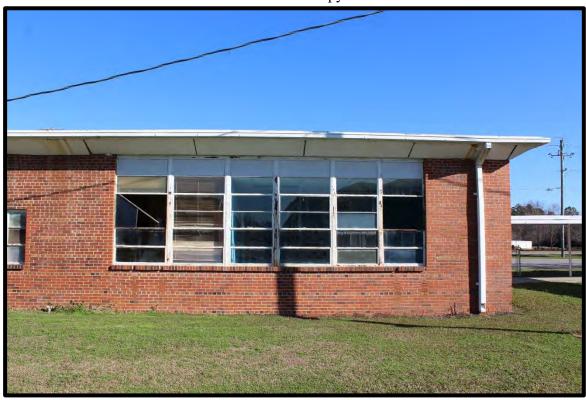
A ca. 1950 classroom building stands to the west of the original school building. The one-story building is clad with brick in a common bond pattern, has a flat roof, and is entered by double-leaf doors with narrow lights and large transoms on the east and west (side) elevations. The façade faces north toward Andrew Jackson Highway and is lit by banks of steel-framed windows. The south (rear) elevation is similarly lit but also has two small multi-light windows, a single-leaf entry door, and some bricked-in openings. The eave of the building has an interesting upward angle reflective of its 1950s design, and a tall interior brick chimney rises from the roof (Figures 29 through 32).

Figure 29: Cerro Gordo School, Ca. 1950 Classroom Building, Looking South.

Figure 30: Cerro Gordo School, Ca. 1950 Classroom Building, Looking North.

Figure 31: Cerro Gordo School, Ca. 1950 Classroom Building, Exterior Doors Below Metal Canopy.

Figure 32: Cerro Gordo School, Ca. 1950 Classroom Building, Typical Windows.

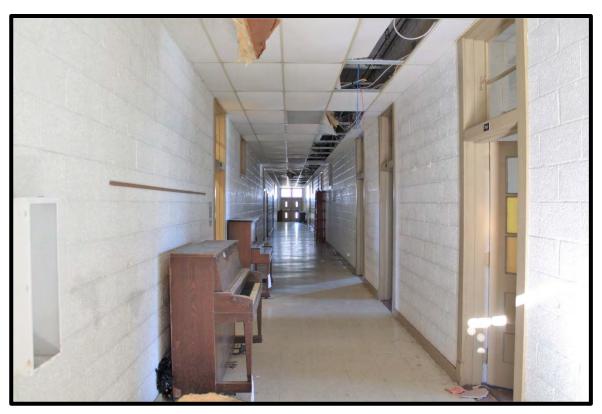
The interior of the building consists of a double-loaded corridor with classrooms and offices. Originally designed for lower-grade students, the classrooms once shared small restrooms between them. Over time, those spaces were converted to storage, and shared restrooms were added off of the corridor. The spaces are finished with tile flooring or carpet, acoustic tile ceilings, and painted concrete block walls. Original wooden doors with windows and large transoms have been retained as have additional transom-height windows that allow extra light to pass between the classrooms and hallway (Figures 33 through 35).

Figure 33: Cerro Gordo School, Ca. 1950 Classroom Building, Double-Loaded Corridor.

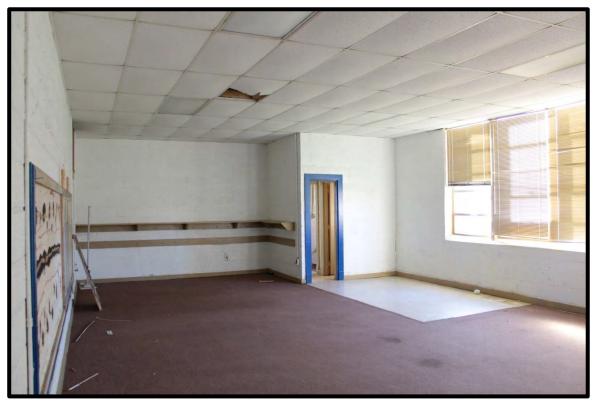
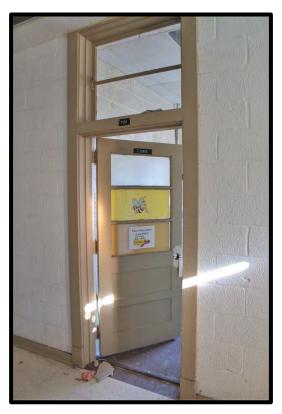
Figure 34: Cerro Gordo School, Ca. 1950 Classroom Building, Typical Classroom with Attached Restroom.

Figure 35: Cerro Gordo School, Ca. 1950 Classroom Building, Typical Interior Door and Transom.

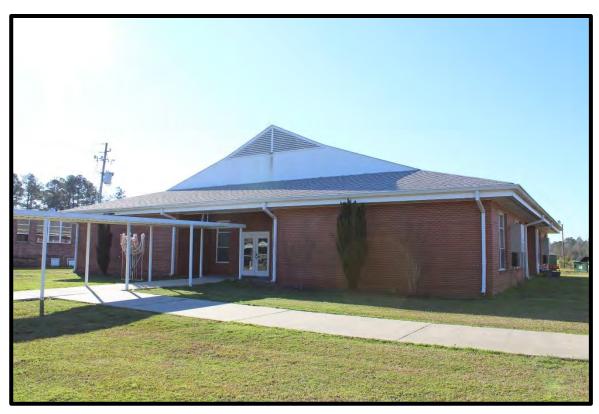
Non-Historic buildings on the campus include a one-story, brick, "pod" -style building with a predominantly hipped roof with gables that rise from the north and south hips. Constructed in 1999, the four-classroom building stands west of the original school and south of the ca. 1950 school. It is accessed by exterior doors on each elevation, though a double-leaf entry door on the north façade serves as the main entrance. Like the other entrances, it is recessed. It is also flanked by tall three-light windows. Two single-leaf entry doors are located on each of the side and rear elevations. The doors on the east and west (side) elevations have single-pane windows, and their recess is flanked by four paired windows like those on the façade. The doors on the south (rear) elevation are separated by a storage area that has its own entry door. None of these doors have windows and the remainder of the elevation is blind. Like on the facade, the gable that rises above the south elevation is clad with wide, board-and-batten-like panels and has a large vent in its peak. The slope of the gable is steeper along the edge of the vent and slightly flatter below it (Figures 36 through 38).

Figure 36: Cerro Gordo School, "Pod" -Style Classroom Building, Looking South.

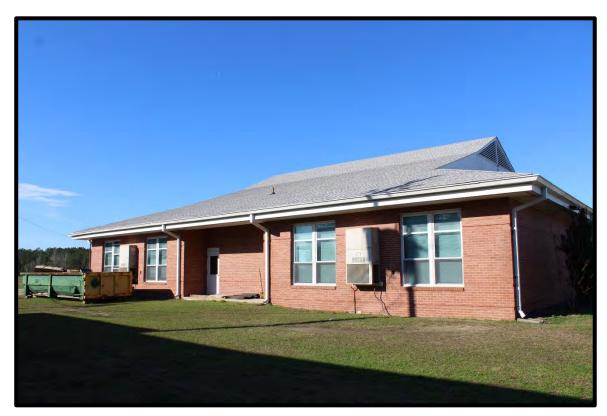
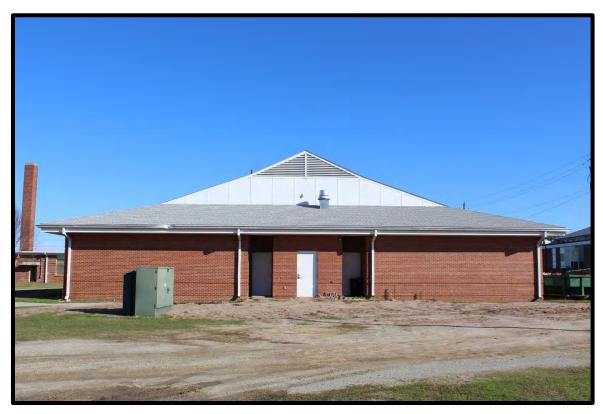
Figure 37: Cerro Gordo School, "Pod" -Style Classroom Building, Looking East.

Figure 38: Cerro Gordo School, "Pod" -Style Classroom Building, Looking Northeast.

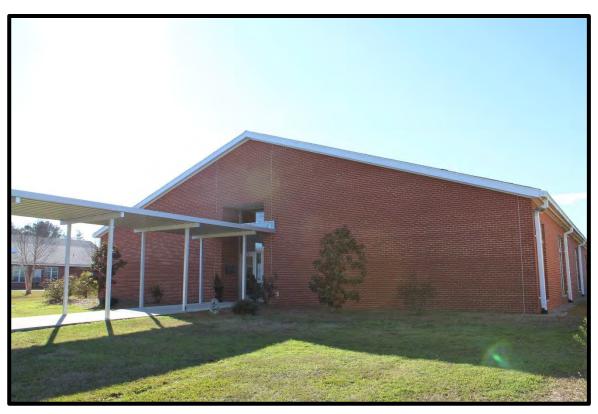
The second non-historic building was constructed in 2014 and is the westernmost building on the campus. It is L-shaped and is composed of two red-bricked sections connected by an L-shaped hyphen clad with off-white brick. The red-brick sections both have gabled asphalt shingle roofs. The first section faces north toward Andrew Jackson Highway and has a façade with a centered recess with two entry doors divided by a single-pane sidelight and spanned by a large, singlepane transom. The doors are lit by large, single panes of glass and a metal canopy extends from the façade and turns east to connect to the ca. 1950 classroom building. Its east and west (side) elevations are lit by six large, fixed-pane windows, each with two small, transom-like windows above four large panes. The center four windows are arranged as pairs. The hyphen connects to the south (rear) elevation of the first section and has a hipped roof that is not as tall as the red brick sections. Its west (side) elevation has two panels that appear to be part of the ventilation system, a tall window composed of three horizontal panes, and two single-pane windows that are placed high on the elevation and replicate the pane size of the tall window. Its south (rear) elevation has an off-center, double-leaf entry door below a single-pane transom. The hyphen wraps the northeast corner of the third section, which is oriented roughly east-west, and extends across a large portion of its north (front) elevation. This section of the hyphen has a shed roof, is lit by large, fixed-pane windows and has a recessed entrance on its east elevation. The third section of the building rises above the shed roof and has a row of wide, paired and tripled, singlepane windows that act as clerestory windows. This section is similar in scale to the first section, but has an asymmetrical roof created by pushing the north elevation back and allowing space for the hyphen. Its east (side) elevation is blind and its south (rear) elevation is lit by windows like those on the east and west (side) elevations of the first section (Figures 39 through 42).

Figure 39: Cerro Gordo School, 2014 Classroom Building, Looking South.

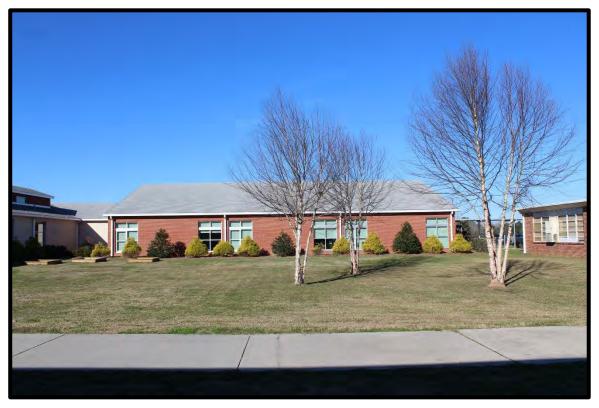
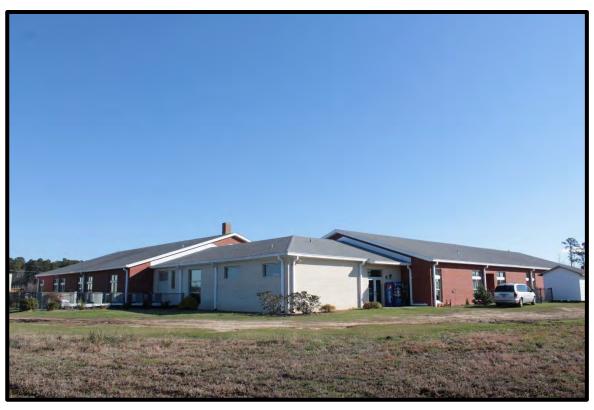
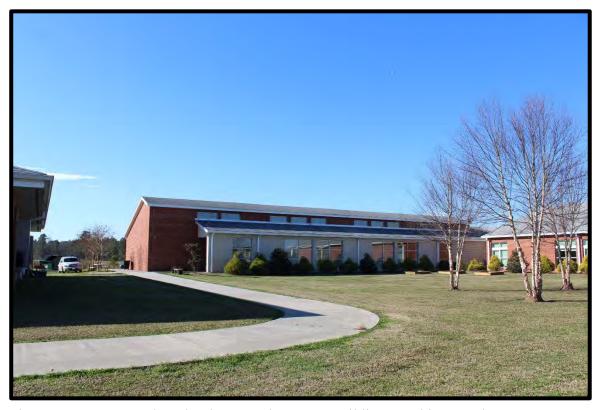
Figure 40: Cerro Gordo School, 2014 Classroom Building, Looking West-Northwest.

Figure 41: Cerro Gordo School, 2014 Classroom Building, Looking Northeast.

Figure 42: Cerro Gordo School, 2014 Classroom Building, Looking Southwest.

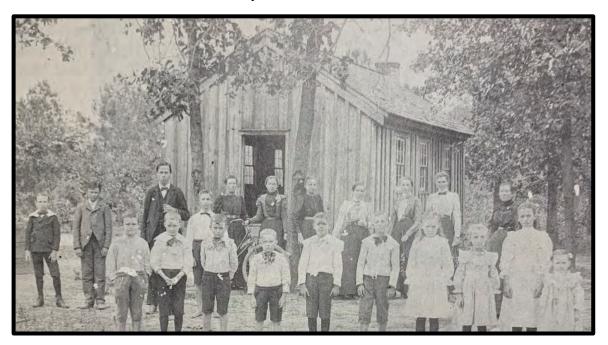
Historic Context: Prior to the construction of the studied property, the Cerro Gordo community was served by a ca. 1880 school. Indicative of how other schools in the county were designed, the school was clad with vertical board-and-batten siding, lit by six-over-six double-hung windows, and heated by a fireplace with a brick chimney (Figure 43). This school was replaced in the early 1900s by a frame building with four classrooms and an auditorium (Figure 44). Due to the rise in population spurred by the mill established by the Williamson and Brown Land & Lumber Company, this larger school was remodeled and enlarged twice. It served 1<sup>st</sup> through 10<sup>th</sup> grade students with some upper-level students attending from nearby community schools that did not offer high school curriculum. The school served the community for roughly 25 years, during which time it acted as more than just an educational facility but also as the center of the town's social activity. During this time, its auditorium hosted plays, piano recitals and community dinners. It even served as the headquarters for the local Red Cross during WWI.<sup>6</sup>

Figure 43: Ca. 1880 One-Room School Building for Cerro Gordo Community (Little, 191).

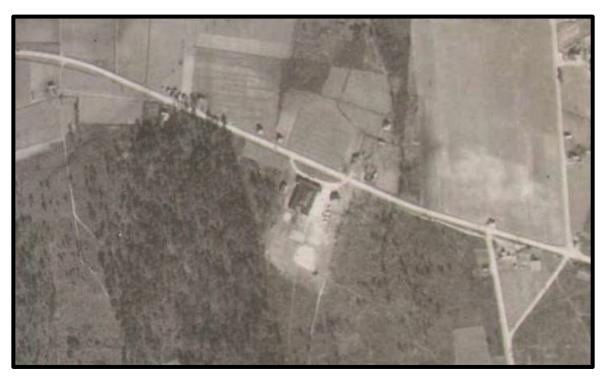
Figure 45: 1938 Aerial Image of Cerro Gordo School Showing the 1926 School, the 1936 Agricultural Building, and a Smaller Structure to the West, Possibly the Home Economics Building (http://www2.columbusco.org/OldAerials).

In 1937, a frame structure that once stood west of the main building and is no longer extant was adapted for use as a home economics building (Figure 45). Next, in 1938, a corrugated tin gymnasium that is also no longer extant was constructed with funding from the Works Progress Administration (WPA).<sup>12</sup> In 1939, a building that served as a lunchroom was constructed southwest of the school. It had a wood burning stove, tables and benches and allowed the students to enjoy hot lunches on the campus. This building was later remodeled and used for vocational training classes, a field house, and most recently art and band classrooms. The second lunchroom was housed in a frame building to the east main building that was originally used for first grade classrooms. Then, in 1965, the lunchroom was moved into the west wing of the main building where three classrooms were combined and remodeled.<sup>13</sup>

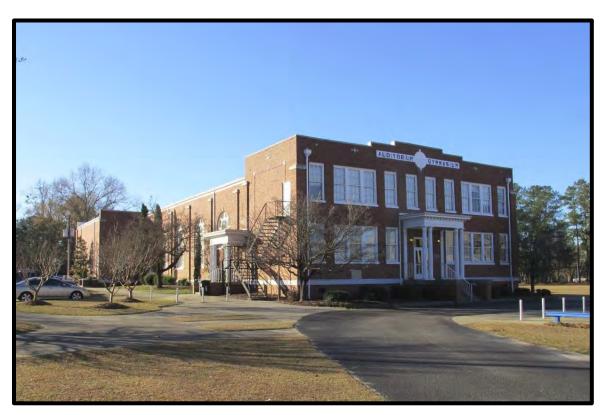
Two other examples of Boney's educational buildings can be found in Columbus County: Tabor City School (CB1365) and an auditorium at Whiteville High School (CB0205). The building on Tabor City School's campus was constructed around the same time as the original building on Cerro Gordo's campus and has a nearly identical façade and plan. It is the subject of the following section of this report. The ca. 1927 auditorium (Figure 51) and potentially a ca. 1921 agricultural building are the surviving buildings designed by Boney on the Whiteville High School campus. Other buildings that stood on the campus include a ca. 1921 two-story school with a full-height, pedimented entry bay and a ca. 1936 gymnasium, which were demolished in

Figure 51: Whiteville High School Auditorium, Looking Southwest.

1976 and 2020, respectively.<sup>19</sup> The two-story auditorium also has classical details including a stepped parapet and a flat-roofed entry portico that retains its original columns and emulates the design of the Cerro Gordo School's portico before its columns were removed. Though the auditorium's windows and entry doors have been replaced, the windows retain their original configuration.

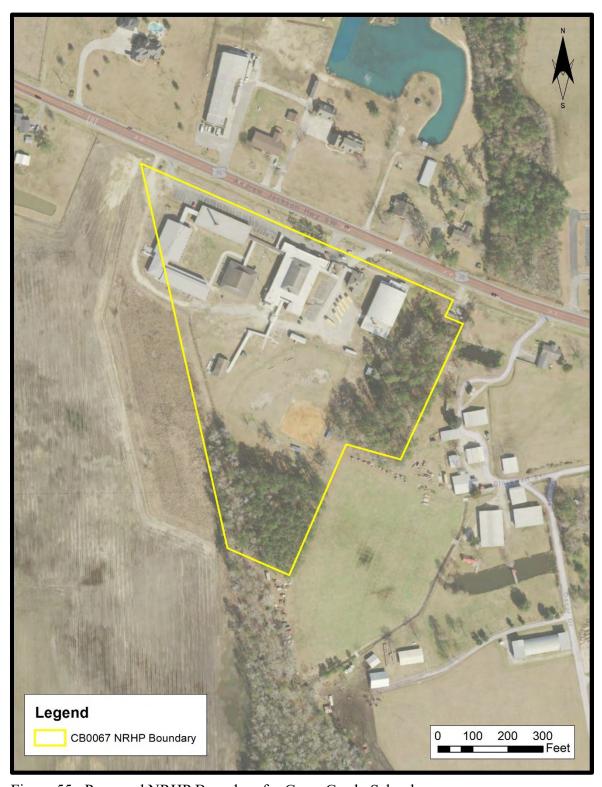
The proposed NRHP Boundary is based on the historic tax parcel as depicted in Columbus County plat book 76, page 93 minus a small section that was sold to the Town of Boardman. The boundary contains the original classroom building, agricultural building, gymnasium, field house, 1950s classroom building, 1999 classroom building, and baseball field as well as a portion of the 2014 classroom building (12.71 acres; part of Columbus County Parcel ID 062062) (Figure 55).

Figure 55: Proposed NRHP Boundary for Cerro Gordo School.

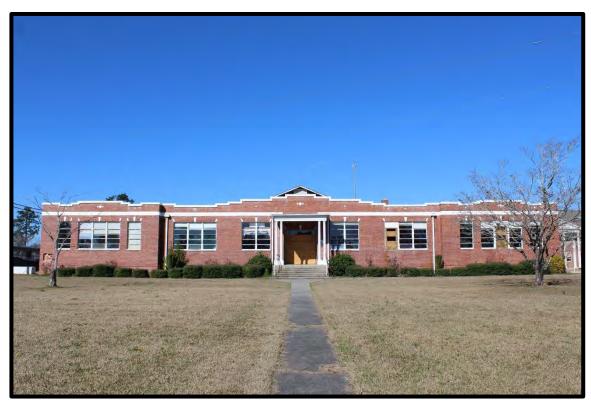
Figure 57: Tabor City School, Looking Northwest.

soldier bricks spans the elevations roughly mid-way between the windows and ground as well (Figure 57).<sup>22</sup>

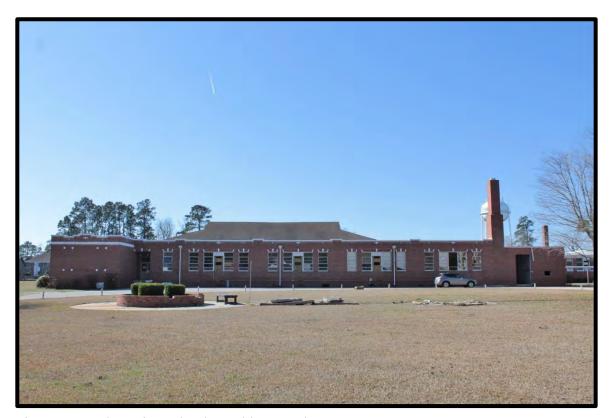
Figure 58: Tabor City School, Looking Southwest.

The northeast and southwest (side) elevations of the projecting bays project forward of the northeast and southwest elevations of the main body of the school and are finished with brick and stone details. North of the bays, the side elevations are lit by windows that are similar to the facade. The northeast elevation is more orderly, with a double-leaf, recessed entry door, a single individual window, four bays of tripled windows flanked with individual windows, and entrance that accesses a rear addition and was once covered by a large roll-top door. The southwest elevation contains a recessed entry door and a less orderly arrangement of individual, paired and tripled windows before ending with a second set of entry doors and a rear addition that projects forward of the elevation and contains three bays of tripled windows flanked by individual windows. The windows on the addition have one large sash over a small sash and appear to be vinyl. A parapet with a single crenellated step between each bay of windows caps the elevations of the original portion, and similar diamond and keystone details exist above each window. There is also a course of header and soldier bricks in place of the façade's white belt course (Figures 58 and 59).

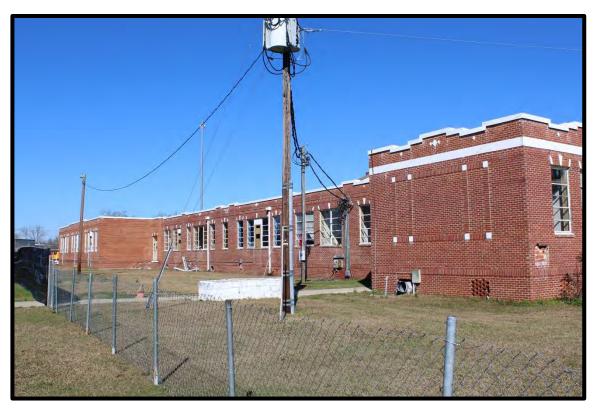
Figure 59: Tabor City School, Looking North.

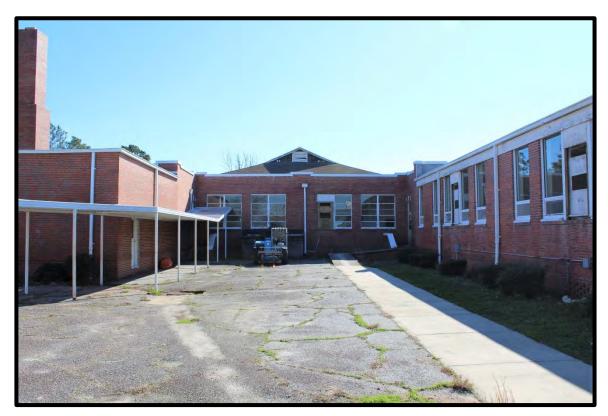
Figure 60: Tabor City School, Looking Southeast.

Two additions extend from the northwest (rear) elevation of the school and have a small open space between them. The east addition was added in 1966 and is blind on each elevation, except for the previously mentioned entrance, and has a tall brick chimney. The portion of the original school that is visible between the additions is lit by paired windows that are typical of the original block. The west addition was added shortly after the construction of the building, likely in the 1930s, and has tripled windows flanked by individual windows on its northeast elevation. The windows are like those on other elevations except they have one large sash over a small sash and appear to be vinyl. A small hip-roofed addition with a recessed entrance flanked by oneover-one, metal sash windows projects from its northwest elevation (Figure 60).

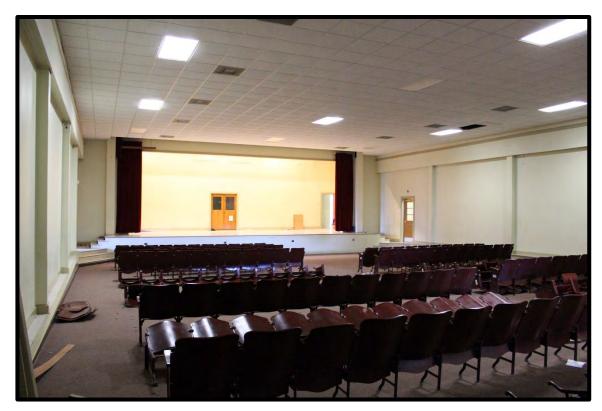
Figure 61: Tabor City School, Auditorium.

The interior of the school features a U-shaped corridor that wraps the northeast, southeast and southwest sides of the auditorium with classrooms and offices arranged along the exterior walls. The interior has been remodeled at least twice with paneling added over the original plaster walls in the 1960s or 1970s and drywall added sometime after 1990.<sup>23</sup> Other updates to the building include adding acoustic tile ceilings and tile and carpet flooring and enlarging or dividing classroom and office spaces to accommodate new functions. Some original elements remain including the stage and most of the seating in the auditorium, some wooden moldings and baseboards, and other original materials concealed or partially concealed by new materials (Figures 61through 64).

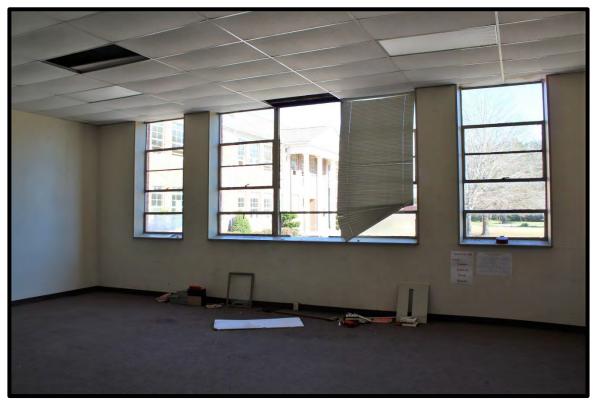
Figure 62: Tabor City School, Typical Classroom Showing how Exterior Window Pattern Relates to Classrooms.

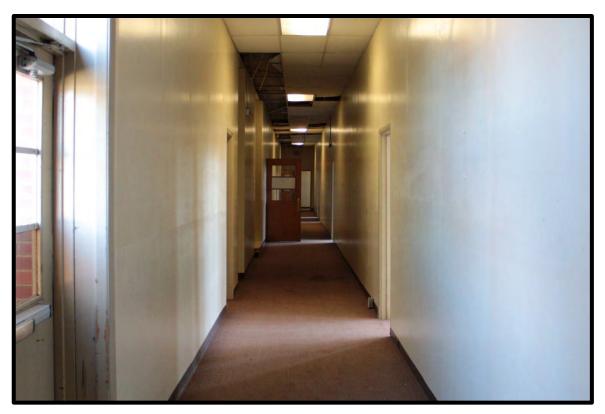
Figure 63: Tabor City School, Hallway. Note Drywall, Acoustic Tile Ceiling, Carpeting and Absence of Transoms from Classrooms.

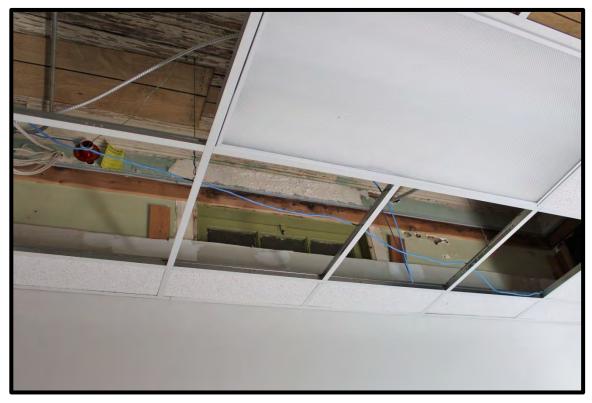
Figure 64: Tabor City School, Original Beadboard Ceiling, Wooden Trim, and Transom Concealed by Modern Materials.

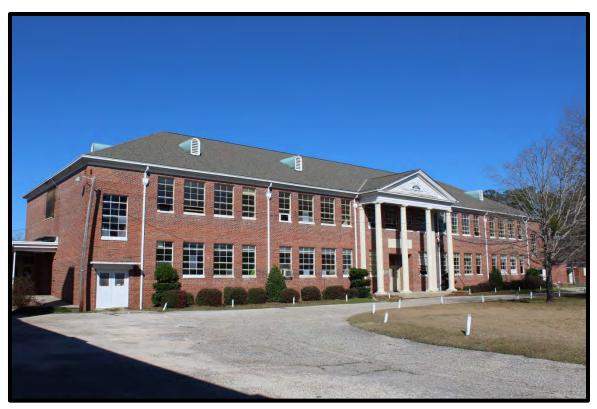
Figure 65: Tabor City School, 1948 High School, Looking North.

East of the 1927 classroom building is the 1948 Tabor City High School building. The two-story building is constructed with brick laid in a common bond pattern and sheltered by a hipped, asphalt shingle roof. It has a symmetrical, seven-bay façade that is classically inspired and centers on a full-height, portico with four stone Doric columns and engaged pilasters that support a gabled pediment. The pediment is finished with plain weatherboard siding, a small fanlight, and a dentilled cornice. The portico shelters a recessed double-leaf entry door flanked by three-pane sidelights over panels and toped with a tall multi-light transom. Above the recess is a cast stone signage panel inscribed with "Tabor City High School 1948." The recess is flanked by large multi-light, steel-frame windows that are five panes tall and three panes wide with cast stone sills. Four identical windows span the upper portion of the façade below the pediment. The portico is flanked on each side by two bays of four windows. The bays are composed of two windows like those flanking the entry flanked by narrower (two panes wide) windows on each story. The final bays contain simple double-leaf doors with a single large light that are sheltered by a minimal, flat awning below large steel-frame windows that are six panes tall and three panes wide. Four arched, dormer vents span the forward slope of the roof (Figures 65 and 66).

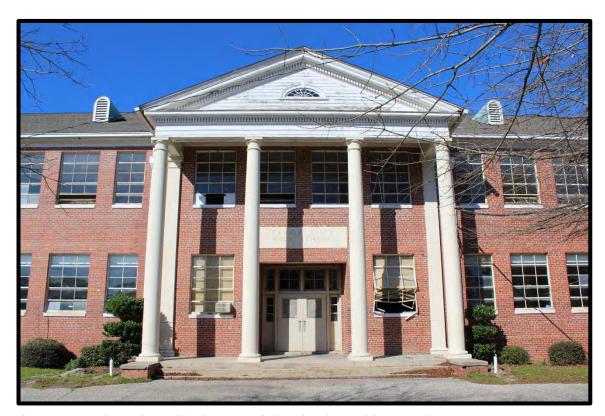
Figure 66: Tabor City School, 1948 High School, Looking Northwest.

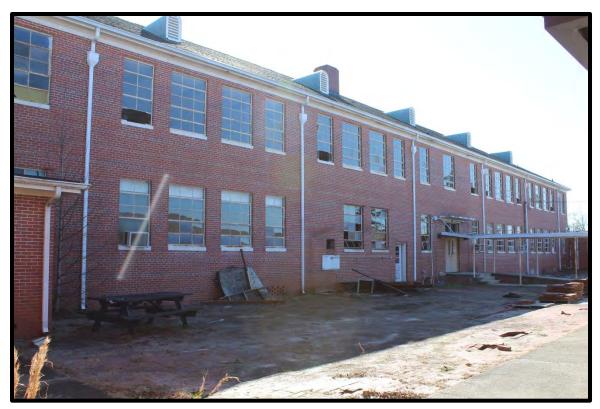
The northwest (rear) elevation of the main block of the building mirrors the façade, but with a simpler entry bay composed of a double-leaf door below a transom and a simple, flat awning. It is flanked by narrow (two panes wide) windows. This pattern is reflected on the upper story with only one window above the entry door. The bay immediately north of the entry bay differs as well with a wooden entry door that accesses a boiler room in place of the right-most window. The left-most widow is also missing, replaced by a small opening or chute. The exterior bays have one narrow (two panes wide) window on each story. Five arched dormer vents and one brick chimney rise from the rear slope of the roof (Figure 69).

Figure 69: Tabor City School, 1948 High School, Looking South-Southwest.

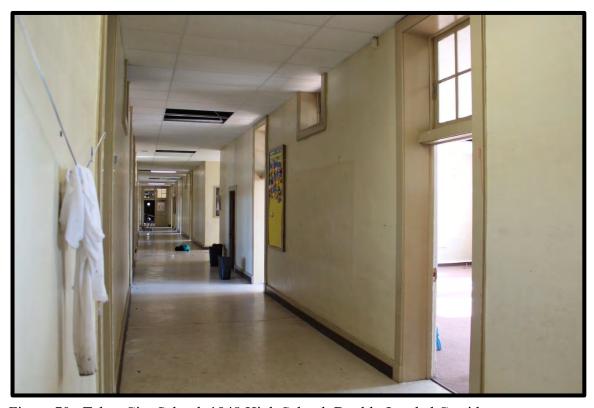
Figure 70: Tabor City School, 1948 High School, Double-Loaded Corridor.

The interior of the building is composed of a double-loaded corridor that is intersected by a shorter corridor that connects the front and rear entrances. Classrooms, a teacher's lounge, and the boiler room are located along the double-loaded corridor while offices (now used for storage) were located near the front entrance. The classrooms have an unusual arrangement with two entry doors, both with transoms, and an additional transom centered between them. The wooden doors have nine lights of frosted glass over horizontal panels, and along with the transoms, served as a passive method for lighting the interior hallway. Unlike the 1927 classroom building, this building's plaster walls have not been covered and more of the original woodwork (trim, moldings, etc.) has been left exposed as well. It is unclear what the original ceiling material may have been, but the second story, which was abandoned in the 1990s due to the difficulty and expense of making it handicap accessible, displays small square tiles, while the first story has a drop ceiling with acoustic tiles. Tile (both stories) and carpeting (first story) covers the floor. Over time, some spaces have changed in function or configuration, including removing a wall to create a library on the second floor and creating additional storage space. At each end of the school is a semi-exterior space with a stairwell on the southeast side and restrooms (first and second story) on the northwest side. Due to its semi-exterior state, these areas are not heated (Figures 70 through 75).

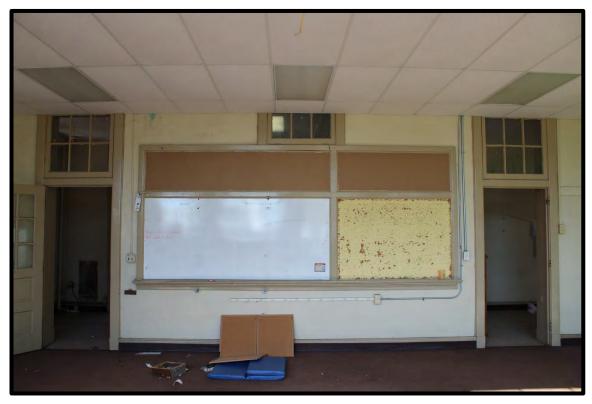
Figure 72: Tabor City School, 1948 High School, Original Layout with Two Entry Doors, a Transom, and a Built-In Lesson Board.

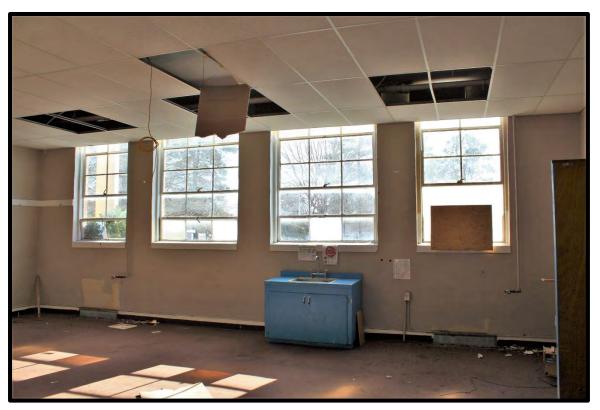
Figure 73: Tabor City School, 1948 High School, Interior of a Classroom Showing how Outside Window Configuration Relates to Interior Spaces.

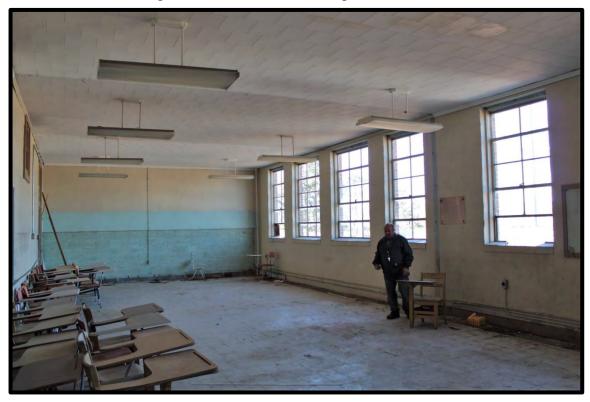
Figure 74: Tabor City School, 1948 High School, Interior of Second Floor Library Which was Created by Combining Two Classrooms. Also Note Earlier Materials.

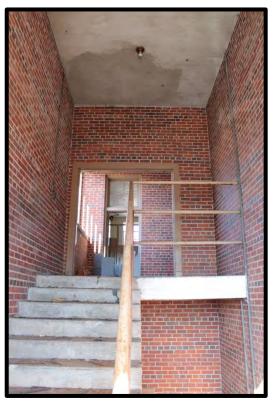
Figure 75: Tabor City School, 1948 High School, West Stairwell. Note Entrance to Restroom in Background.

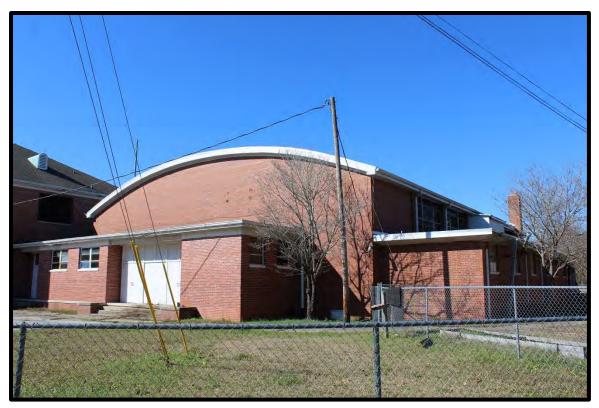
Figure 76: Tabor City School, Gymnasium, Looking Northwest.

The northeast (side) elevation reflects the southwest (side) elevation with a brick hyphen in place of the recessed bay (See Figure 76).

The gymnasium is connected to the northeast (side) elevation of the high school by a one-story, flat-roofed hyphen clad with brick laid in a stretcher bond pattern. The hyphen has plain doubleleaf doors with a large, two-light transom near the classroom building; two paired, steel-framed windows set near the cornice; and a recessed bay with two double-leaf doors that is roughly centered with the gymnasium. The doors are separated by a space that may have once held an additional door or a window, and a long transom spans the space above them. The doors and windows are painted the same shade of cream. The blind façade of the barrel-roofed gymnasium, which is constructed of brick laid in a common bond pattern and has a metal-truss roof system, rises from behind the hyphen. A small, flat-roofed wing that houses locker rooms spans its northeast (side) elevation and is lit by six steel-frame windows that are located just below the enclosed eave. A small addition at the north end (rear) of the wing has been tampered with, revealing a concrete block structure clad with brick. It has a small steel-frame window and may have served as an auxiliary space or additional entrance. Above the wing, the gymnasium is lit by four banks of tripled, steel-frame windows. At the center of the windows is an announcer's box that projects from the elevation. It is clad with aluminum siding. An exterior brick chimney rises from the elevation just past the north bank of windows (Figure 76).

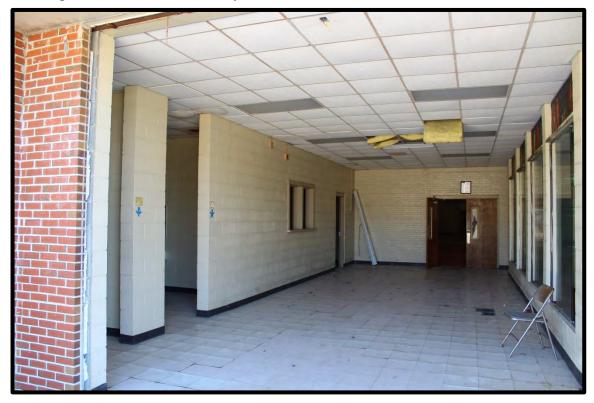
Figure 81: Tabor City School, Gymnasium, Rear Addition Added to Provide a Handicap-Accessible Entrance and Restrooms.

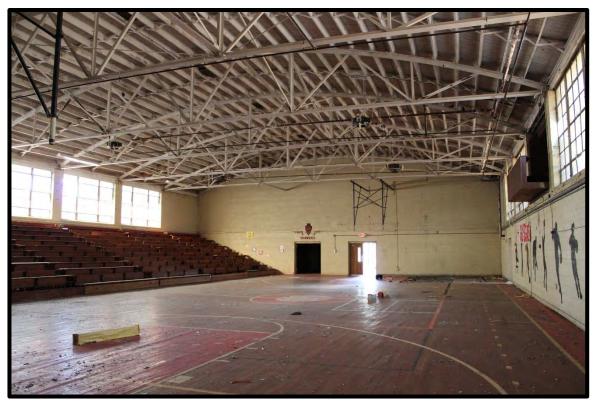
Figure 82: Tabor City School, Gymnasium Showing Hardwood Floor, Built-In Bleachers, and Added Announcer's Box (Right Elevation).

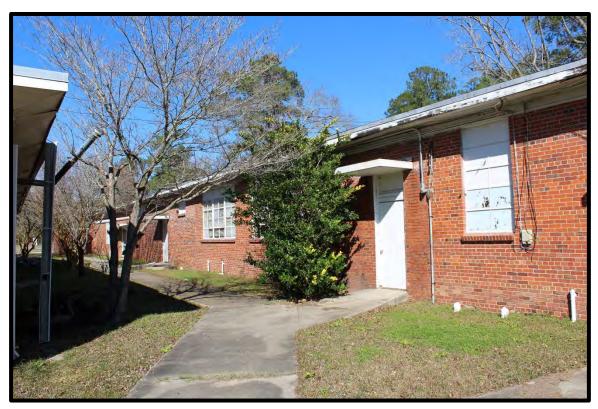
Figure 83: Tabor City School, Occupational Trades Building, Looking North.

East of the gymnasium is a one-story, flat-roofed, building that is constructed of concrete block and clad with brick. The building was constructed in multiple phases between 1950 and 1970 and was originally used for occupational trade and woodwork classes but most recently for prekindergarten classes.<sup>25</sup> The south block of the building was constructed first and contained two classrooms, each with an exterior entrance on the southwest (rear) elevation, offices, and storage space.<sup>26</sup> Overall, the southwest elevation contains, from south to north, an entry door with a transom and flat awning, a narrow steel-frame window, a second similar entry door, and two banks of tripled steel-frame windows. A seam in the brick pattern indicates the second building phase. From there the elevation contains a small, cornice-height window; an entry door that is similar to the first two; and a second cornice-height window. A second seam and change in brick pattern indicate the third addition. This elevation contains an entry door that is paired with a large window and sheltered by a flat awning. A pipe, possibly associated with an exhaust or gutter system, protrudes from the elevation above and to the right of the entry door. North of the door is a steel-frame window and north of this is a garage/shop section that projects forward of the elevation and has an entry door sheltered by a flat awning on its southeast (side) elevation. This section was used at some point for mechanics classes, but most recently by the maintenance department (Figures 83 and 84).<sup>27</sup>

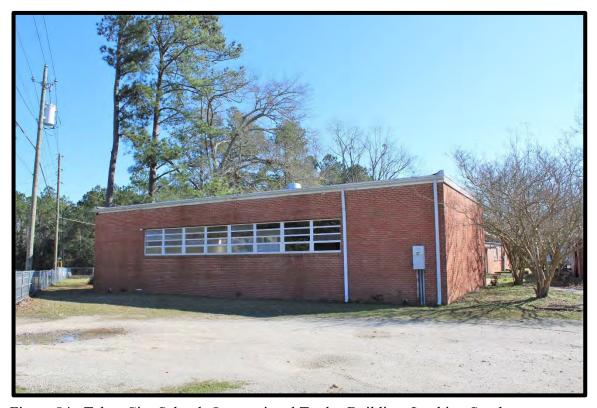
Figure 84: Tabor City School, Occupational Trades Building, Looking Southeast.

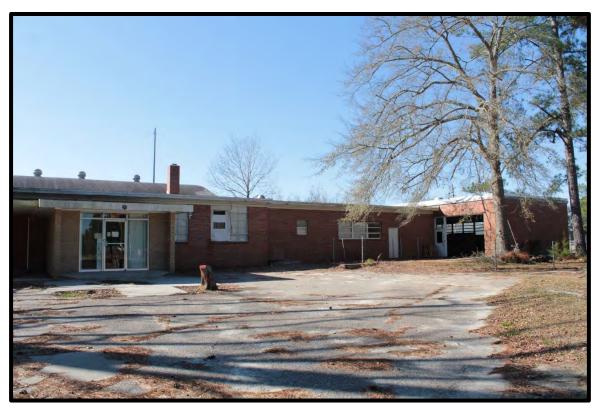
Figure 85: Tabor City School, Occupational Trades Building, Looking West.

The southwest (rear) elevation of the garage/shop section is blind, and its northwest (side) elevation is lit by a long bank of steel- or possibly aluminum-frame windows. Its northeast (front) elevation projects forward and is blind, and the resulting southeast (side) elevation contains a garage door paired with an entry door and transom. Like the southwest (rear) elevation the remainder of the northeast (front) elevation is a composite of multiple building phases. From north to south this includes an entry door; a tripled bank of steel- or aluminum-frame windows; a small one-over-one window (building break); two paired steel-frame windows (one altered); a projecting bay clad with cream colored brick and containing an aluminum-and-glass door, sidelight, and transom component; an entry door below a flat-roofed porch; and two tripled steel-frame windows, one of which is altered and the other nearly entirely removed. Two similar windows light the southeast (side) elevation (Figures 85 and 86).

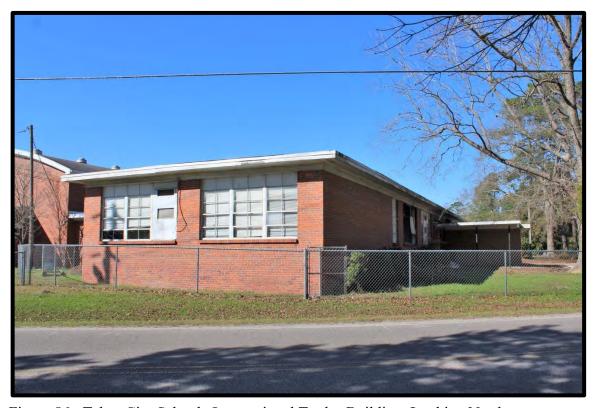
Figure 86: Tabor City School, Occupational Trades Building, Looking Northwest.

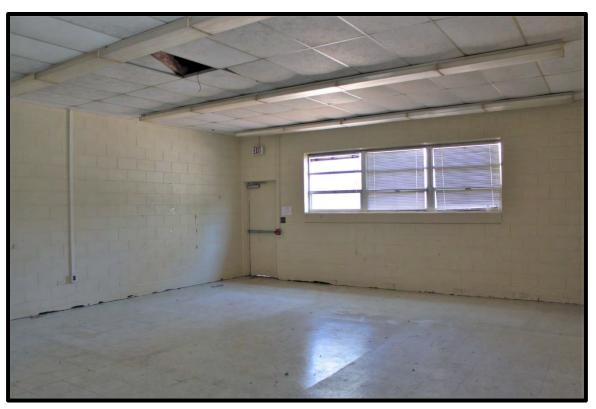
Figure 87: Tabor City School, Occupational Trades Building, Classroom.

The interior of the building consists of four classrooms with doors that lead from one to another and have their own exterior entrances. Most of the classrooms have painted concrete block walls, acoustic tile ceilings, and tile floors, though one of the southern rooms displays a beadboard ceiling. Constructed for trade and woodworking classes, it is likely that the concrete floors remained uncovered until the space was converted for pre-kindergarten students. Originally, the classroom spaces were divided by office and storage spaces but has been remodeled to accommodate more classroom spaces. The garage/shop section remains utilitarian in finish with exposed concrete floors and ceiling structure (Figures 87 through 89).

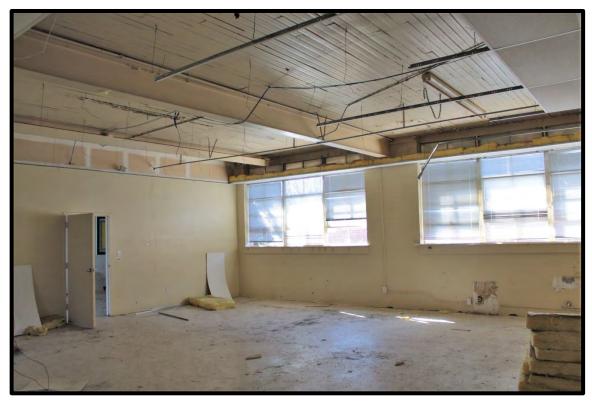
Figure 88: Tabor City School, Occupational Trades Building, Original Portion of Building Showing Exposed Original Material.

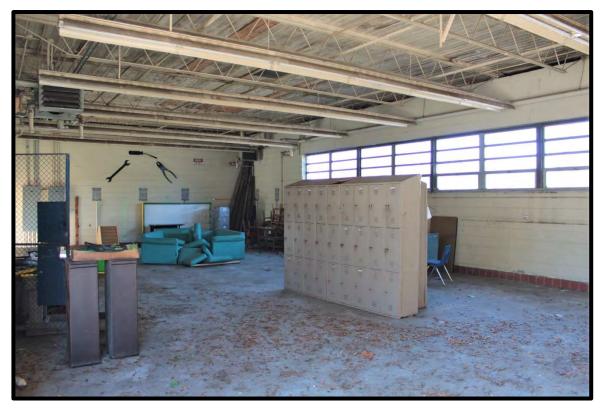
Figure 89: Tabor City School, Occupational Trades Building, Garage/Shop Rear Addition.

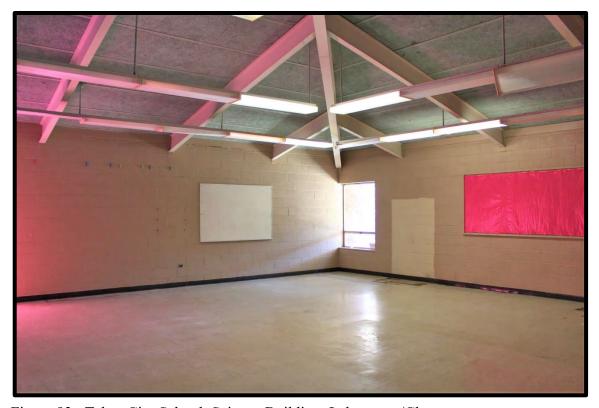
Figure 93: Tabor City School, Science Building, Laboratory/Classroom.

The interior of the science building contains a foyer/corridor that accesses four classroom/lab spaces divided by storage and office spaces. The interior finishes, which include painted drywall and concrete walls, tile flooring, and a ceiling with exposed I-beams, appear to be original (Figures 93 and 94).

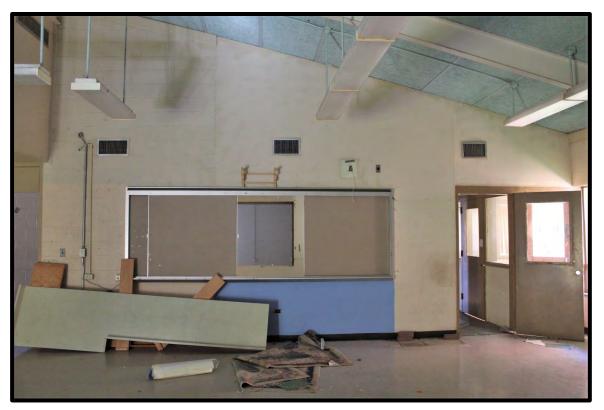
Figure 94: Tabor City School, Science Building, Laboratory/Classroom. Note Sliding Lesson Board and Pass-Through Between the Supply Room and Laboratories.
