ER 19-3123

# ARCHITECTURAL SURVEY CONSOLIDATION OF SCHOOLS COLUMBUS COUNTY, NORTH CAROLINA ER 19-3123

# ARCHITECTURAL EVALUATION, CONSOLIDATION OF SCHOOLS, CERRO GORDO AND TABOR CITY, COLUMBUS COUNTY, NORTH CAROLINA ER 19-3123

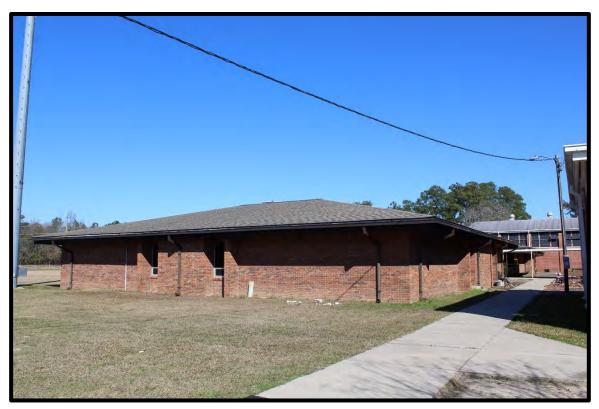
The façade of the media center faces west to the science building and mirrors its door and window configuration. Its northwest and southeast (side) elevations also mirror the science building's side elevations, except that they are longer, and the east doors are replaced by windows similar to those on the façade. The doors are also different with two-pane lights and a thin sidelight over a panel (Figure 95). The southwest (rear) elevation reflects the side elevations but with two windows instead of a door and window (Figure 96).

Figure 96: Tabor City School, Media Center, Looking Northeast.

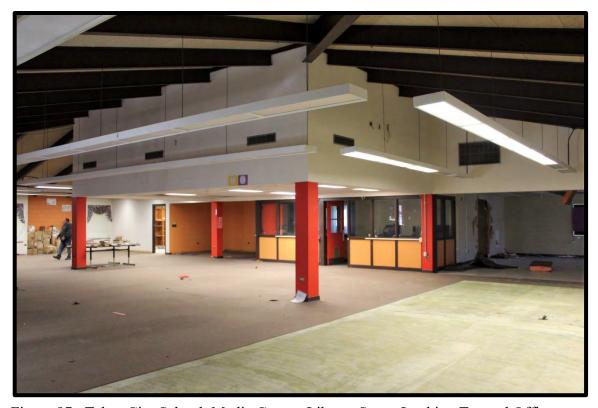
Figure 97: Tabor City School, Media Center, Library Space Looking Toward Office.

The interior of the media center is defined by a large open space with offices, a classroom, storage space, and a dark room along the northwest elevation. Its interior finishes include painted concrete block and drywall walls, carpet and tile flooring, and a ceiling with exposed I-beams (Figure 97).

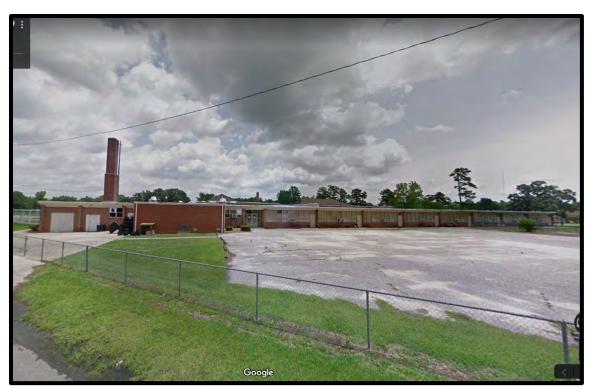
Figure 98: Tabor City School, 1950s Classroom Building, Looking West. The surveyor could not take an overall photograph of the elevation due to temporary classroom units on the property (Google Street View).

The last building on the campus is a linear classroom building that was constructed in the mid-1950s and stands to the west of the 1927 classroom building. It is a one-story, flat-roofed building clad with brick laid in a stretcher bond pattern. Indicative of its mid-century design, it has few decorative details but does have interesting eaves that angle up to meet the edge of the roof. Its facade faces southwest and is composed of four overall sections. The first section relates to a hallway of classrooms at the south end of the building and is defined by eight bays of steel-frame windows with a solid panel entry door and a transom on the south side of each bay. Each bay is separated by a brick pilaster. The next section contains a recessed entry bay with a double-leaf, wooden entry door with two square lights on each leaf and surrounded by sidelights and a transom. Deep pilasters frame the recess and a bank of three steel-frame windows exist to its north. The third section is a 1973 addition that projects from the façade and is blind on its southeast (side) and southwest (front) elevations. The addition provides extra storage for the kitchen.<sup>29</sup> On the northwest elevation, it has an entry door with two panels that is flanked on the west by a tall vent and sheltered by a flat awning. The remaining section of the façade contains, from south to north, a one-over-one steel-frame window, an entry door with two panels, paired one-over-one steel-frame windows, an entry door, and a slatted gate that fills an opening the size of a garage door. Brick pilasters divide the section into three parts (Figures 98 through 100).

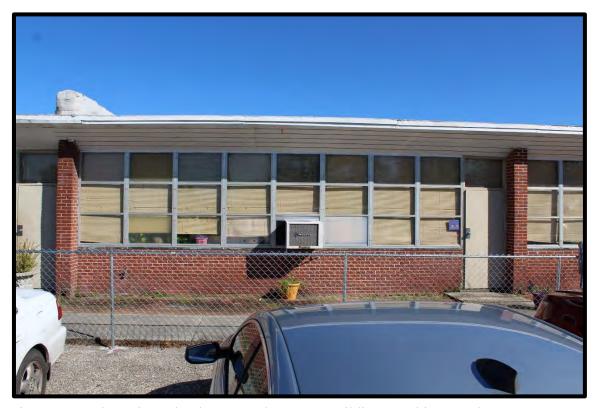
Figure 99: Tabor City School, 1950s Classroom Building, Looking Northeast.

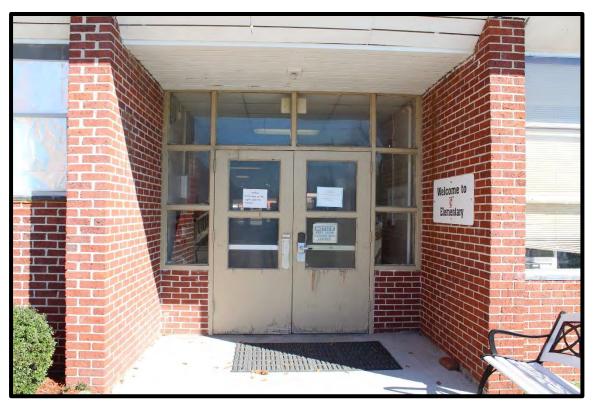
Figure 100: Tabor City School, 1950s Classroom Building, Looking Northeast.

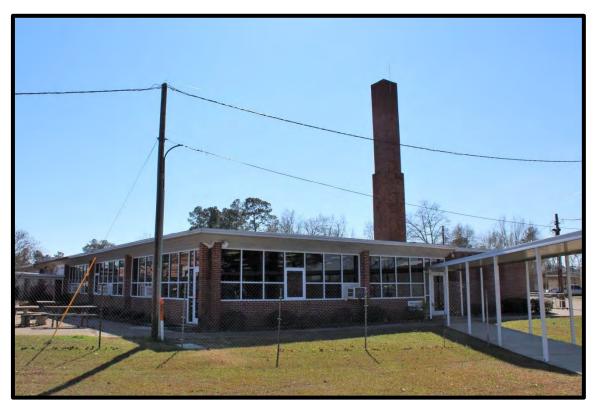
Figure 101: Tabor City School, 1950s Classroom Building, Looking South.

The north end of the building contains a cafeteria and its northwest (side) elevation has three bays. The two eastern bays are filled with banks of windows that appear to have aluminum or vinyl sashes and the center bay also includes a door with a large light on its east side. The westernmost bay is blind. The northeast (rear) elevation of the cafeteria is lit by three bays of similar windows. An entry door exists on the north side of the northernmost bay. On both elevations, the bays are separated by brick pilasters. A tall brick chimney rises from this portion of the building as well (Figure 101).

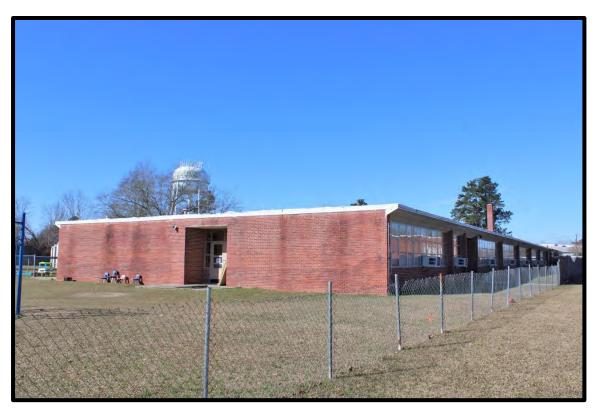
Figure 102: Tabor City School, 1950s Classroom Building, Looking East-Northeast.

Just south of the cafeteria is a recessed entrance that is similar to the façade entrance. South of the recess, the elevation contains bays of steel-frame windows like those on façade but without entry doors. The southeast (side) elevation contains a centered recessed entrance with an entry door and surround like that on the façade except that it is not flanked by brick pilasters (Figure 102).

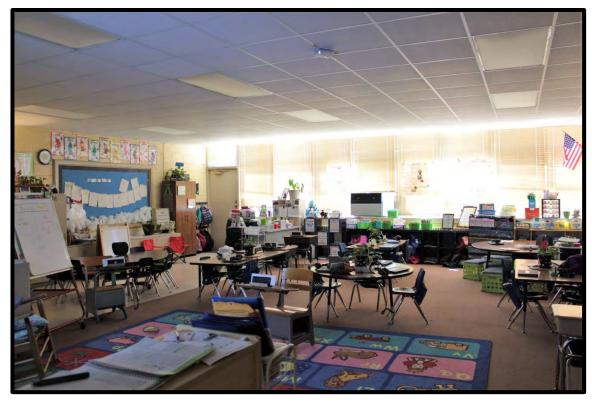
Figure 104: Tabor City School, 1950s Classroom Building, Typical Classroom. Note Exterior Door at Far Corner.

The interior of the building is broken into three primary spaces, a cafeteria at the north end, an office section, and classrooms at the south end. The cafeteria was not observed due to students eating lunch, but the offices and some classrooms were. These spaces display interior finishes including painted concrete block walls, acoustic tile ceilings, and tile and carpet flooring. The classrooms and offices are arranged along a double-loaded corridor. An interesting feature of this section is the incorporation of window- and door-sized openings with an operable transom, a large pane of textured glass, and a vent. These units serve to passively light the hallway and to provide ventilation between the hallway and classrooms. The classrooms are accessed by doors with two horizontal lights and a transom (Figures 103 through 106).

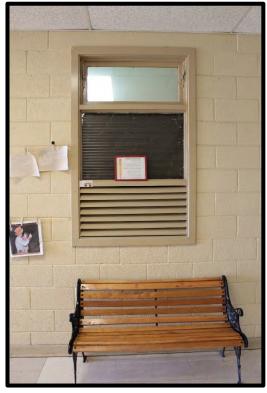
Figure 105: Tabor City School, 1950s Classroom Building, Vent/Transom Unit.

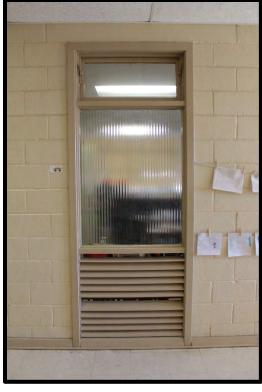
Figure 106: Tabor City School, 1950s Classroom Building, Vent/Transom Unit.

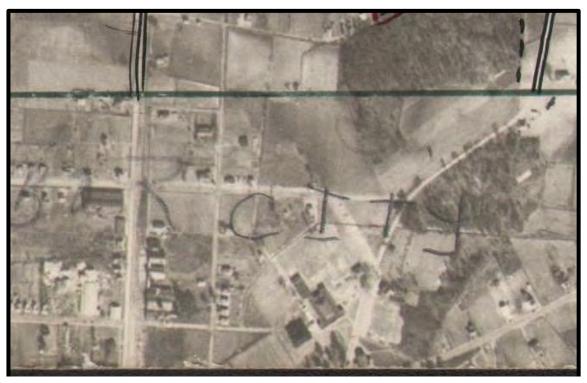
Figure 110: 1938 Aerial Image Showing the 1927 Classroom Building and the 1914 School to its West (http://www2.columbusco.org/OldAerials).

program through the receipt of a tin-roofed gymnasium in either the late 1920s or 1930s.<sup>38</sup> An aerial image from 1938 shows the campus including the 1927 classroom building with the six-classroom rear wing and the 1914 school (Figure 110).

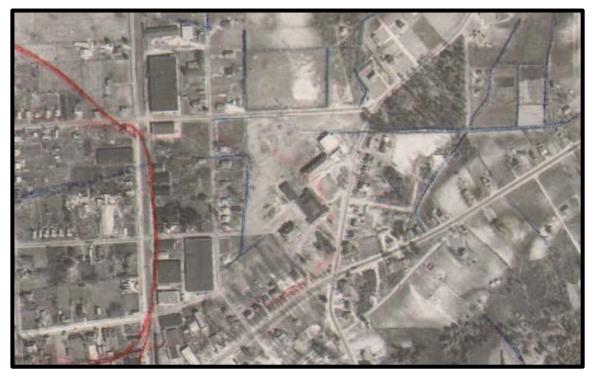
Figure 111: 1951 Aerial Image Showing the 1927 Classroom Building, 1948 High School, Gymnasium and the 1914 School (http://www2.columbusco.org/OldAerials).

To further accommodate the growing campus, the Board of Education purchased additional parcels from Pridgen & Pridgen in 1936 and 1939.<sup>39</sup> It also purchased less than one acre from Forney Norris in 1939 and six acres from J. O. and Myrtie McKaskill Prince in 1944.<sup>40</sup> These parcels were purchased in preparation for the construction of the 1948 high school, but also came to accommodate the current gymnasium and the occupational trades building (Figure 111).

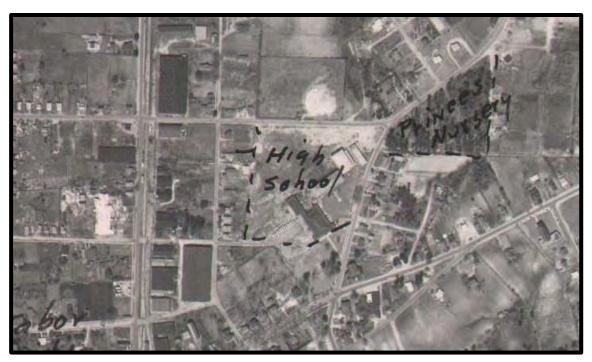
Figure 112: 1955 Aerial Image Showing the Addition of the Occupational Trades Building to the Campus (http://www2.columbusco.org/OldAerials).

In the late 1940s the original gymnasium was destroyed by a fire and in 1954 the current gymnasium was constructed east of the 1948 high school.<sup>41</sup> The 1914 school was also lost to fire around this time.<sup>42</sup> In 1955, the campus was enlarged again with the first portion of the occupational trades building east of the new gymnasium and a one-story elementary school building, which housed a new cafeteria, constructed on the site of the 1914 school. The first stages of this expansion are visible on a 1955 aerial image of the campus, while a 1958 aerial shows the completed elementary school building and the home economics wing, which also contained administrative offices and a storeroom (Figures 112 and 113).<sup>43</sup>

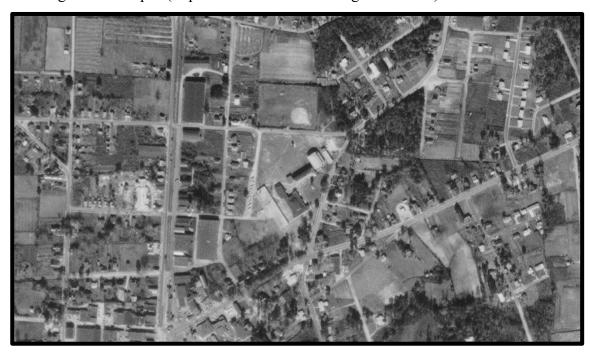
Figure 113: 1958 Aerial Image Showing the Addition of the 1950s Classroom Building (EarthExplorer).

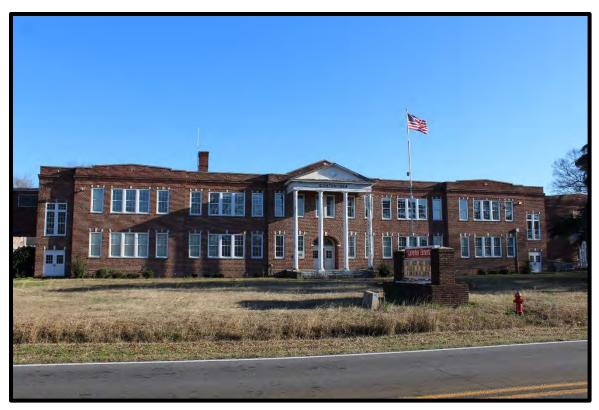
Figure 116: Contentnea School (LR0800), Looking South.

An example of a school building that is similar to both the 1927 classroom building and the Tabor City High School building is Contentnea School (LR0800, Figure 116). Located in Lenoir County, the 1924 school was designed by Boney and was determined eligible for the NRHP in 2010. Though two stories, the school displays the same arrangement of tripled windows flanked by individual windows and finished with contrasting stone details as the 1927 classroom building. It also has a similar parapet, though composed of brick instead of stone, and bays that projecting and recess across the façade. Contentnea, however, is a more fully executed example of the Classical Revival style with six-over-six, double-hung window sashes that, though they appear to be replacements, better embody the architectural style.

Contentnea is similar in form to Tabor City High School with its full-height, pedimented entry portico supported by four columns. The schools also share entry bays at the far ends of their façades with interior stairwells indicated by large windows placed between the first and second story. This similarity in form displays the commonality of the Tabor City High School building,

while their differences, such as the previously mentioned stone details and double-hung windows, set Contentnea apart as a more finely detailed Classical Revival-style school.

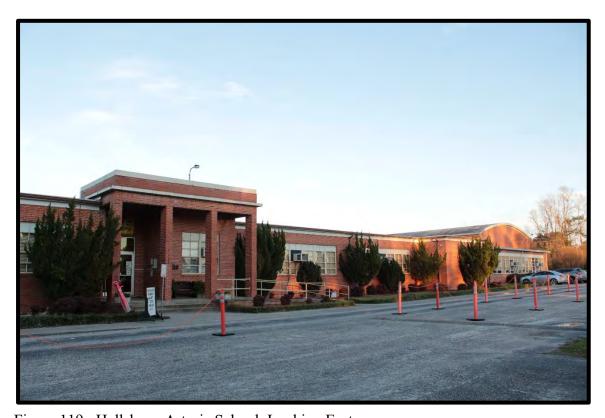
features of the 1950s classroom building—one story, flat roofed with large banks of steel-frame windows—can be observed on the campuses of Acme-Delco Middle School, Evergreen Elementary School, and Hallsboro-Artesia School (Figure 119) as well. Together, the campus's collection of buildings exhibits the evolution of educational building design from the era of consolidation through the integration of the school system.

Figure 119: Hallsboro-Artesia School, Looking East.
