SUBJECT: Historic Structures Survey Report, B-5985, Replace Bridges 125 and 175 on NC 41/NC72 and SR 1600 over the Lumbee River, PA 17-12-0065, Robeson County, ER 19-3125

**HISTORIC STRUCTURES SURVEY REPORT
REPLACE BRIDGES NO 125 & 175 ON NC 41/NC 72 AND SR 1600
OVER LUMBER RIVER, ROBESON COUNTY, NORTH CAROLINA**

The North Carolina Department of Transportation (NCDOT) proposes to replace bridges No. 125 and 175 on NC 41/NC 72 and SR 1600 over the Lumber River in Robeson County, North Carolina. The Area of Potential Effects (APE) equates with the study area and spans east from the Y-shaped intersection of West 2nd Street and West 5th Street to North Chestnut Street. The project is included in the North Carolina State Transportation Improvement Plan (STIP) as Project Number B-5985 and is state funded. Federal permits are anticipated.

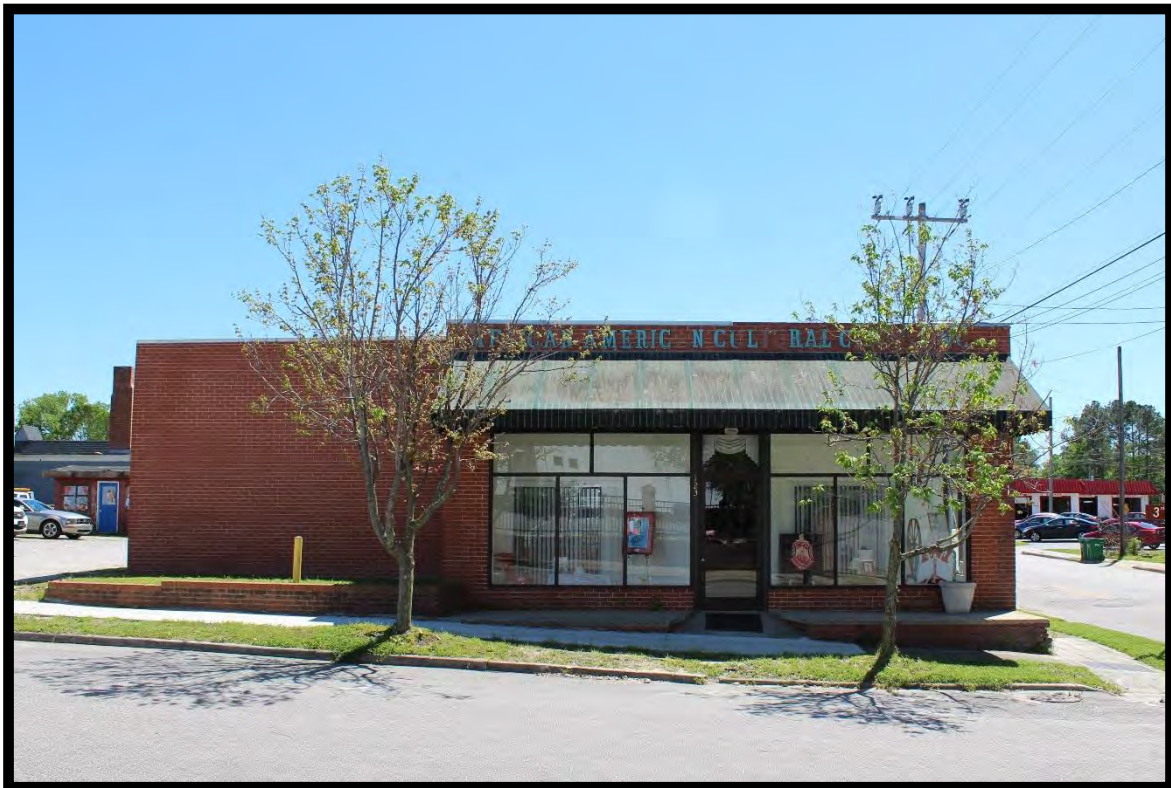
Figure 3: Whitley Furniture Company, Looking South.

The 1953 one-story building has a rectangular footprint and is clad with brick veneer and sheltered by a flat roof. Along its east (side) elevation is a 2014 brick veneered addition that also has a flat roof. The original aluminum and glass storefront was five bays wide with large display windows, a centered entry door below a transom, and a nearly full-width awning that was suspended from the façade by rods. At some point after the building's original survey in 1979, the windows were replaced with five-pane configurations consisting of three large panes below two transoms. These configurations still flank a centered entry door with a transom. A cloth awning shades the apertures and the words "African American Cultural Center" span the façade above the awning. Below each window is a concrete pad edged with brick. The façade of the addition is set back from the primary façade and is blind. A small retaining wall extends from east corner of the primary façade and frames a grassy area in front of the addition (Figure 3).

In conclusion, the replacement of the store's primary feature, its façade windows, with windows arranged in a more modern configuration and within frames that do not replicate its original materials has compromised its association with its period of construction. Furthermore, the building does not represent the work of a master; possess high artistic value; or represent a significant and distinguishable entity. For these reasons, the Whitley Furniture Company is recommended not eligible for listing in the NRHP under Criterion C for architecture.

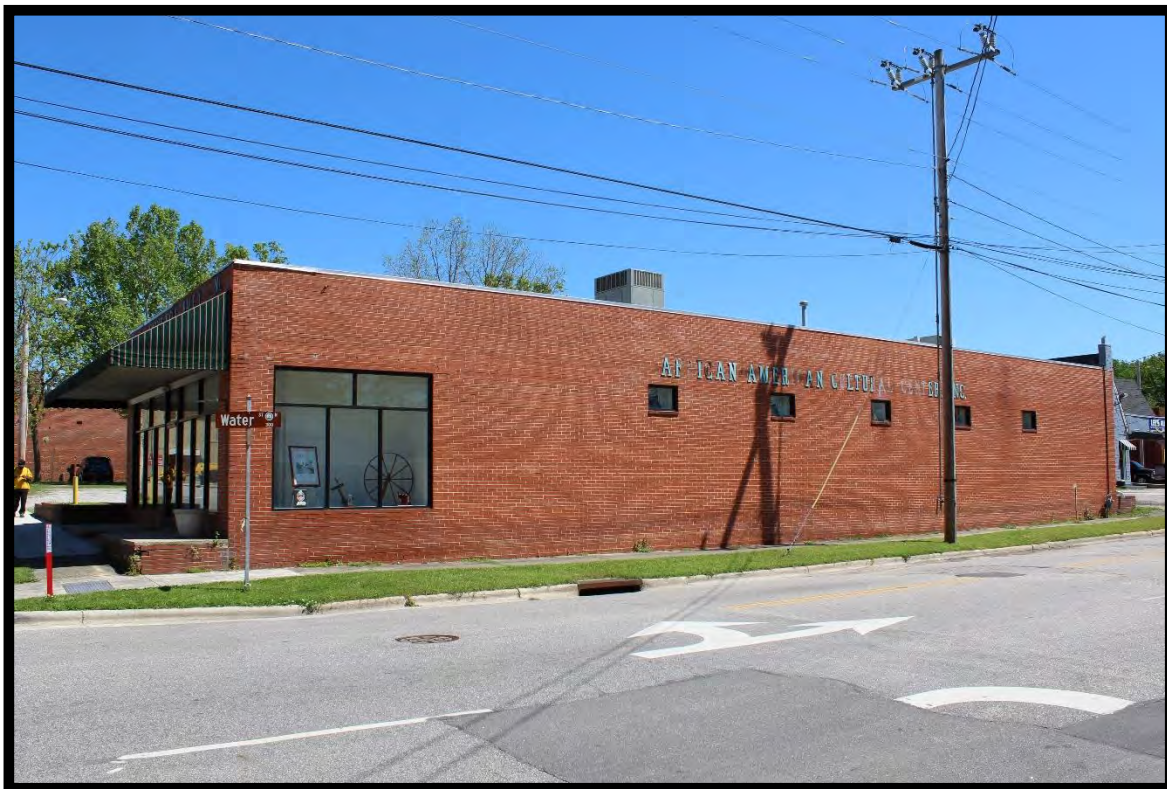
Figure 5: Whitley Furniture Company, Looking Southeast.

The west (side) elevation contains a large display window near the north corner. This aperture was originally filled with two panes of glass but is now filled with five panes configured like those on the façade. Five small windows span the remainder of the elevation; they are located along the upper portion of the wall (Figure 5).

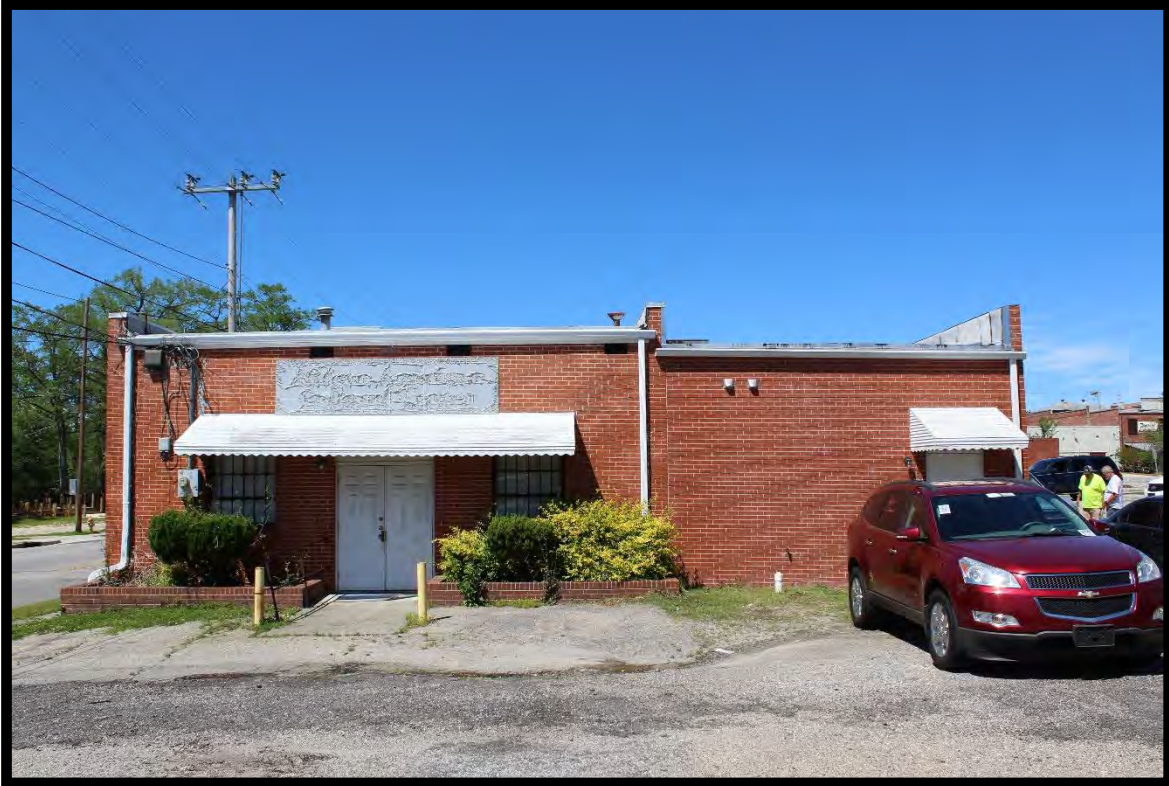
Figure 6: Whitley Furniture Company, Looking North.

windows. A metal awning shelters the apertures and above the awning is the remnants of a sign. The south (rear) elevation of the addition is flush with the original portion of the building and contains a door near the east corner. The door is also sheltered by a metal awning (Figure 6).

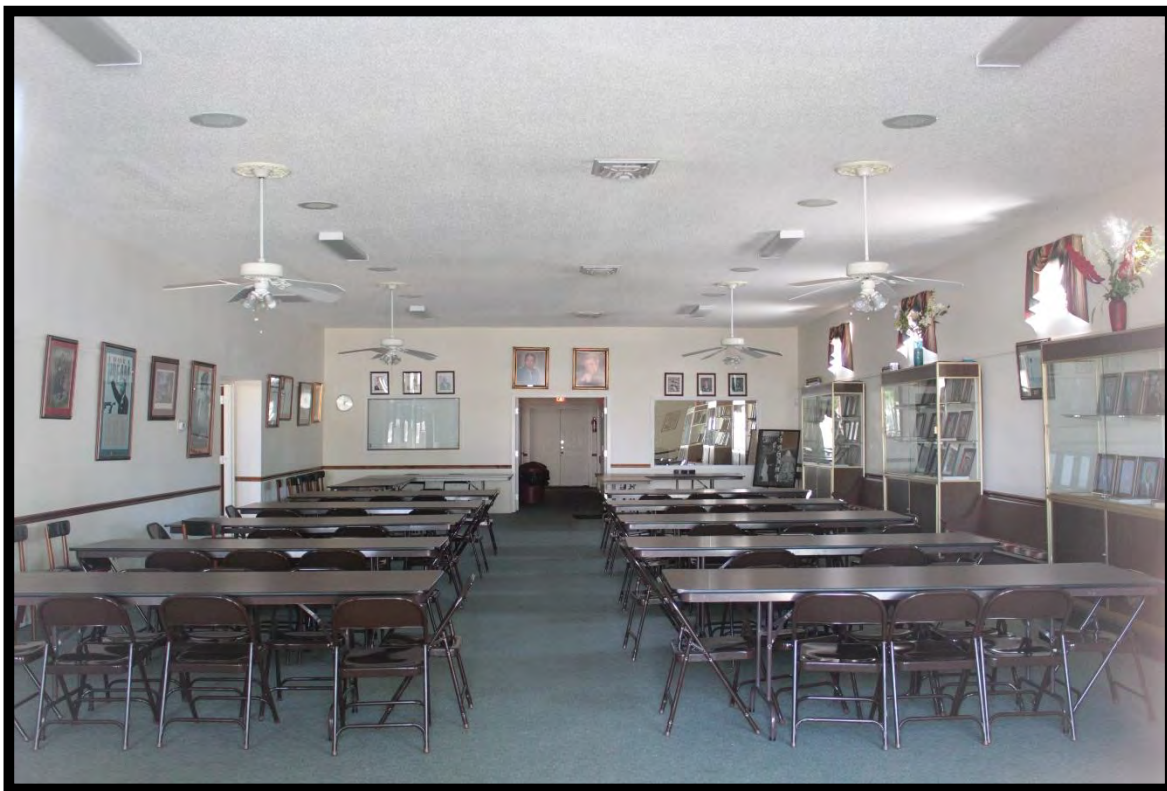
Figure 8: Whitley Furniture Company, Interior, Looking South.

According to W. C. Washington, the treasurer of the African American Cultural Center and a downtown business owner, the building has been renovated twice since it was purchased in the 1980s. The most recent renovation coincided with the construction of a 2014 addition.¹³ A view through the entry door reveals that the space has a popcorn ceiling with new light fixtures and fans, drywalled elevations, and low-pile carpet. It is divided into a large front section with small rooms at the rear and a hall that extends to the rear entry. An opening on the east elevation of the large room connects with the addition (Figure 8).

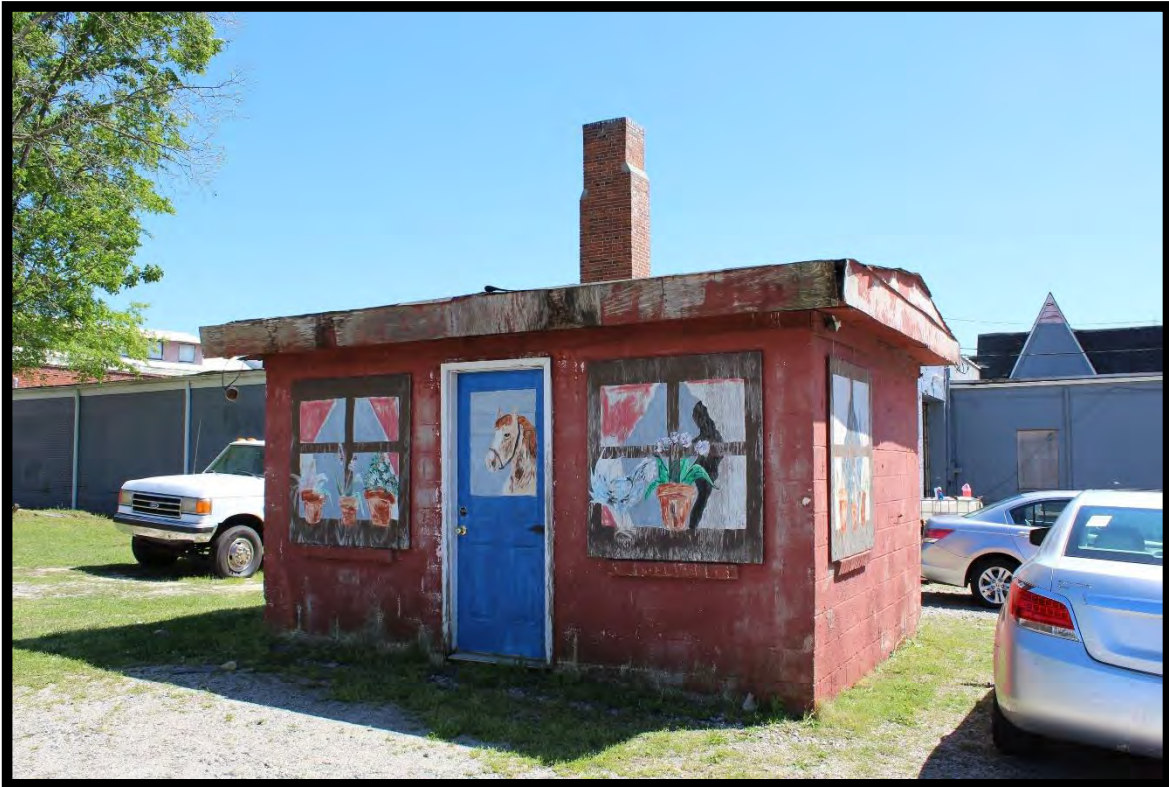
Figure 9: Whitley Furniture Company, Shed, Looking Southeast.

There is a small, concrete block, side-gabled shed near the south boundary of the parcel. It has an entry door on the north (front) elevation that is flanked by windows that are covered by panels. Off-center windows are also located on the east and west (side) elevations and a centered window is located on the south (rear) elevation. All of the windows are covered by panels that are painted to look like windows with scenes of the interior. The entry door is painted as if it is looking into a horse stable (Figure 9).

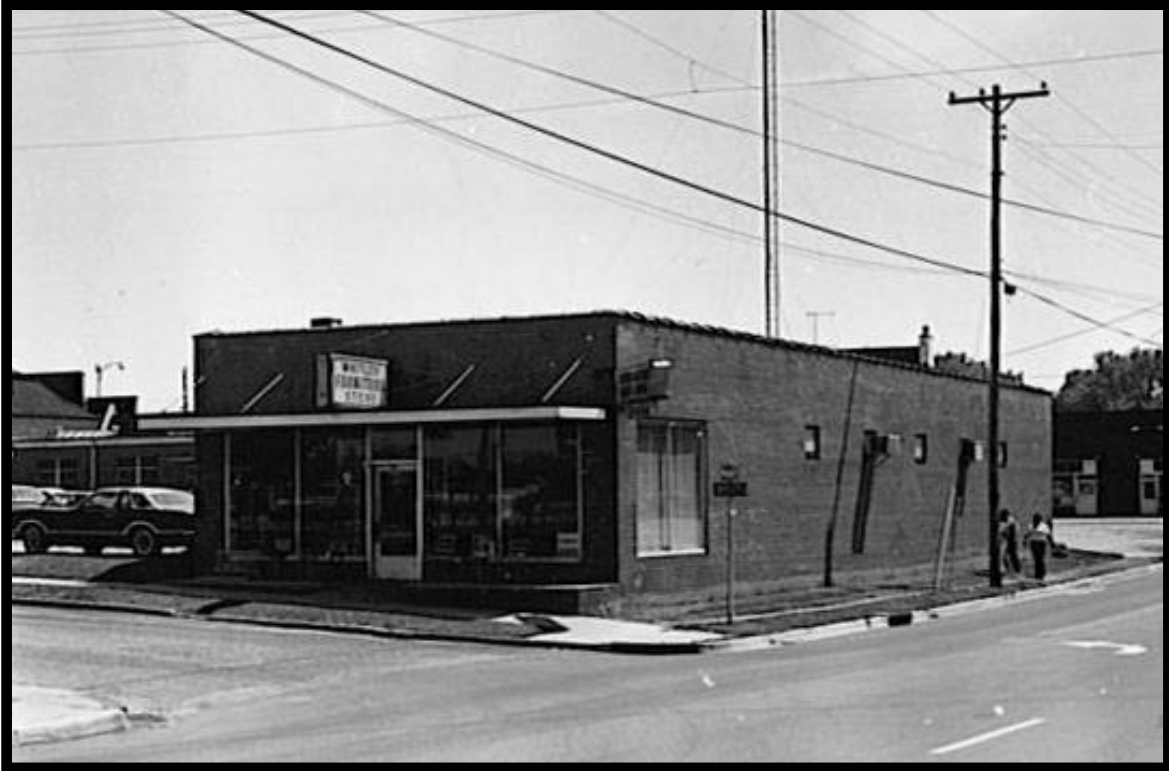
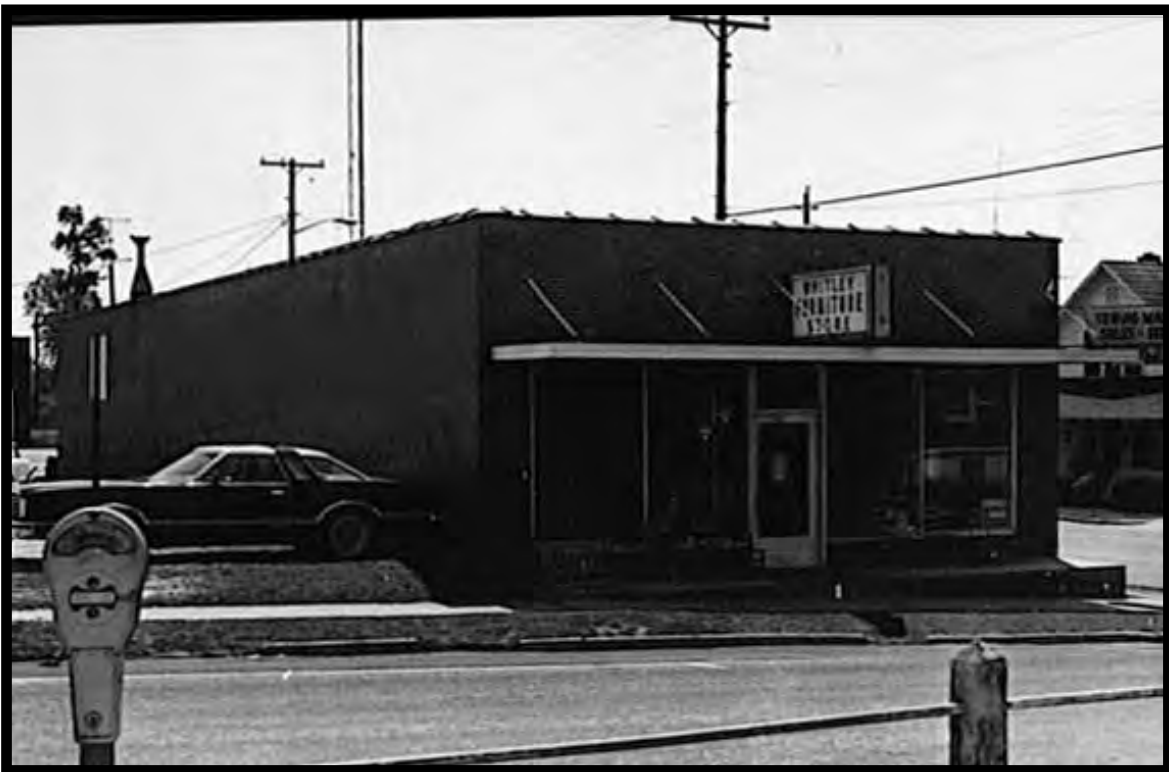
In 1979, when the building was first surveyed, it was still marked as the Whitley Furniture Company. At the time, it was described as a one-story, brick commercial building with a modern storefront and an aluminum awning (Figures 12 and 13).²⁰

Figure 12: Whitley Furniture Company, Looking Southeast (Survey File, RB0234, 1979).

Figure 13: Whitley Furniture Company, Looking Southwest (Survey File, RB0234, 1979).

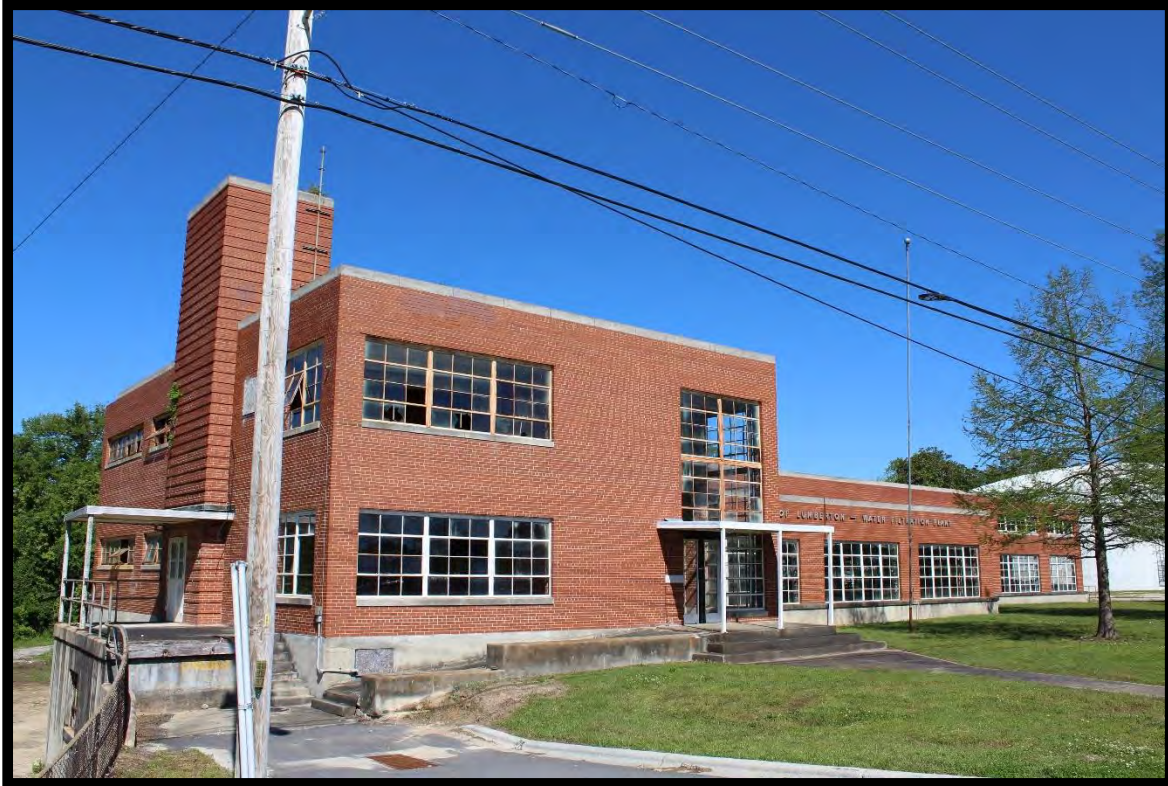
Figure 17: Lumberton Water Treatment Plant, Looking Northwest.

The 1952 Lumberton Water Treatment Plant is constructed of brick laid in a common bond pattern and has a tall concrete foundation and a flat roof encompassed by a parapet with concrete coping. The building is composed of a two-story main block with a walkout basement, a three-story tower, and a one-story wing that extends from its north elevation and was expanded in 1959.²⁸

The wing is composed of three sections that run parallel to one another and to North Water Street. Like the two-story block, the wing has a tall concrete foundation. The wing's foundation, however, is capped with a concrete belt course that also serves as a sill for the windows on its facade. The section closest to the road is not as long as the second and third sections and contains three banks of steel-framed windows on its façade (Figure 21). The second and third sections were originally the same length as the front section but were lengthened in 1959. They extend past the first section with four banks of steel-framed windows along their façade. The second section is taller than the other sections with ribbons of clerestory windows above the lower windows and above the shorter section. The north (side) elevation of this section contains a tall, two-bay bank of steel-framed windows above a set of subterranean steps that access the basement. It is also flush with the north elevation of the third section, which is significantly shorter, and while the belt course completely wraps the second section, it terminates at the beginning of the third section, which is blind. The north elevation of the first section is blind as well (Figure 22). The north elevation of the two-story block is visible above the wing and contains a steel-framed window near its western corner as well as a long, clerestory-like window above the center section of the wing.

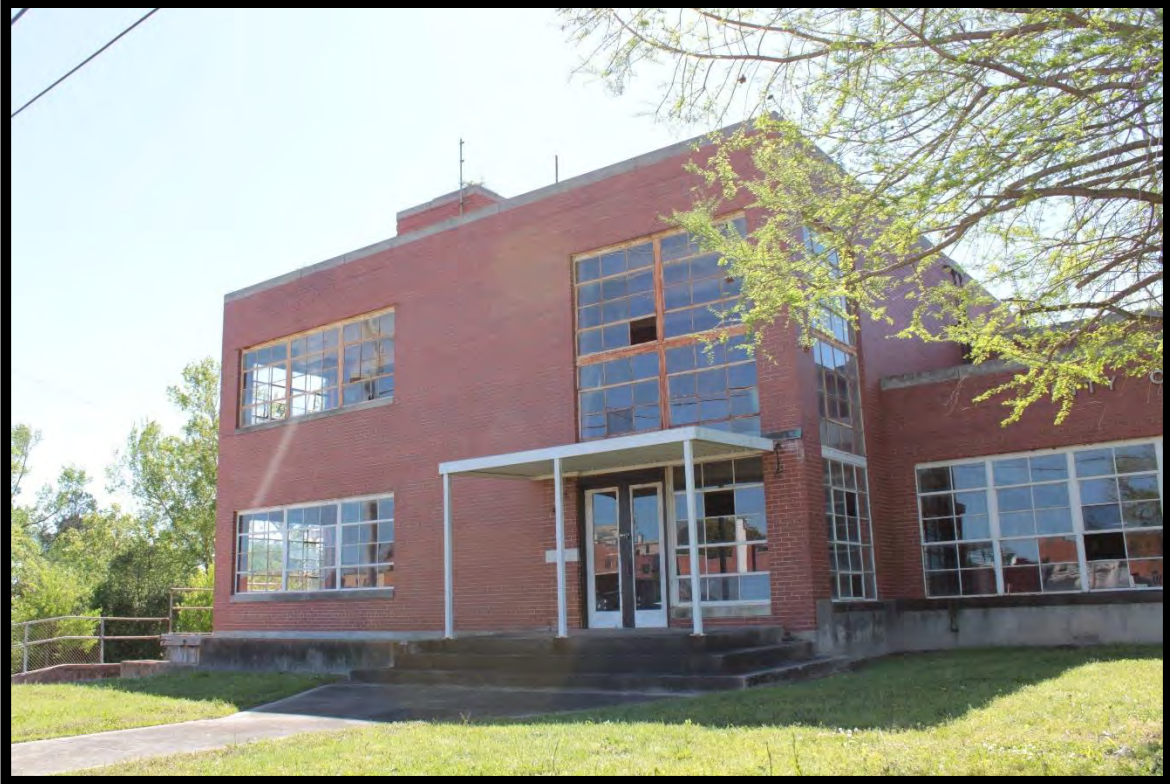
Figure 20: Lumberton Water Treatment Plant, Looking Southwest.

The façade of the two-story section contains a two-bay, nearly floor-to-ceiling bank of steel-framed windows with a double-leaf, glass and metal entry door in its lower left corner. A concrete slab porch with steps on the north and east sides and a ramp on the south side projects forward from below the bank of windows. The porch has a flat roof supported by thin metal poles and shelters the first story of the window bank, including the entry door. It appears, however, that it may have once been sheltered by a cantilevered roof supported by I-beams that projected from the façade, a portion of which are still visible to the left and right of the flat roof. Just south of the entry doors is a white marble marker that dedicates the building to the McNeil Family. South of the window bank there are two ribbons of tripled steel-framed windows, one on each story. The north (side) elevation of the building contains a one-bay, nearly floor-to-ceiling bank of steel-framed windows near the north east corner (Figure 20).

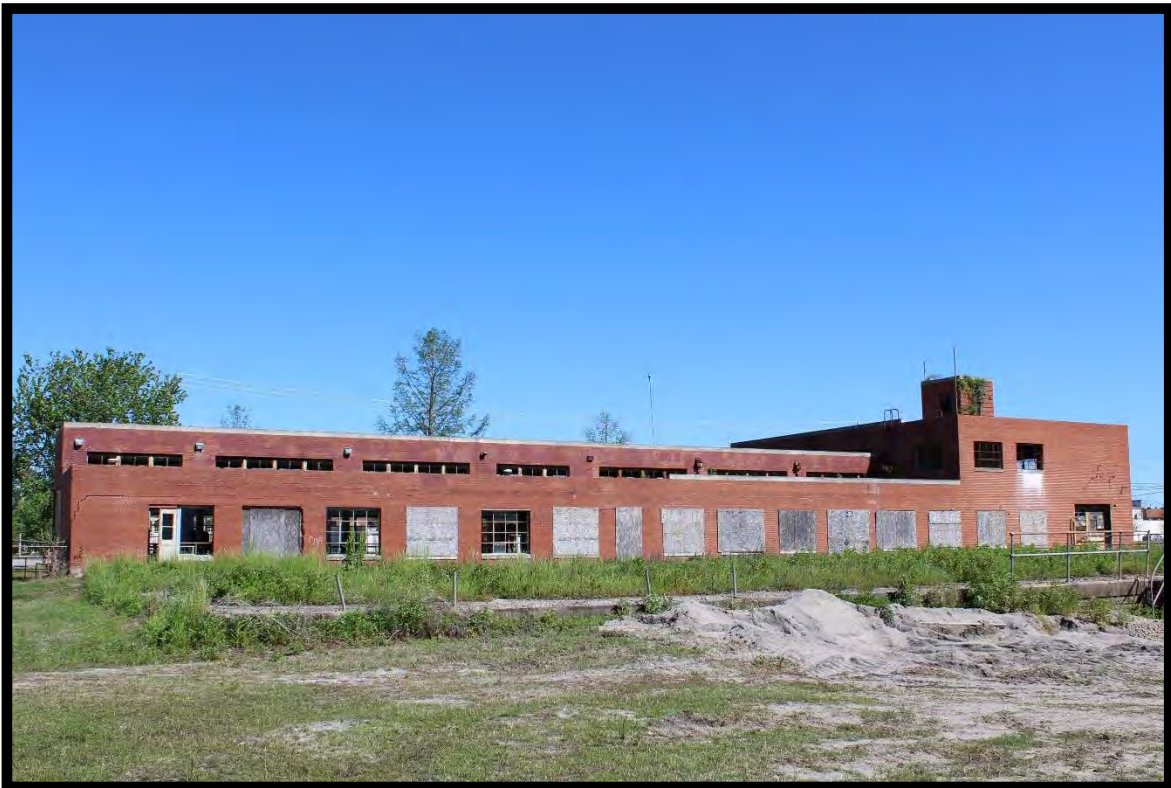
Figure 24: Lumberton Water Treatment Plant, Looking Southeast.

above the roof of the rear section of the wing (Figure 24). The rear elevation of the main block contains two steel-framed windows near the north corner of the second story and two boarded over openings, likely windows, aligned below them on the first story. South of the second story windows is a pair of steel doors with eight lights over a large panel. An identical door is aligned below this one on the basement level. The retaining wall of the water tanks extends west from the elevation, just north of the lower entrance. The south (side) elevation of the main block contains ribbons of steel-framed windows on each level, including the basement level. Those on the upper levels are narrower than the building's typical window, and though slightly larger, the ones on the basement window are smaller as well. East of center on the elevation is an elevator tower. The tower is constructed of brick laid in rhythmic pattern with every fourth row of bricks recessed. The shadows created by the recessed row give the tower a striped effect. There is a double-leaf entry door on the first story of the tower. The entry door opens onto a concrete porch with a flat roof supported by thin metal poles. The porch is also the roof of a small room that projects from the building's basement level. This room has a metal entry door on the west (rear) elevation and a single steel-framed window centered on the south (side) elevation. A retaining wall that supports a driveway leading to the southeast corner of the main building extends from the east side of the small room. East of the tower on the second story is a small opening covered with plywood and east of this opening on both the first and second floors are two-bay steel-framed windows (Figures 25 and 26).

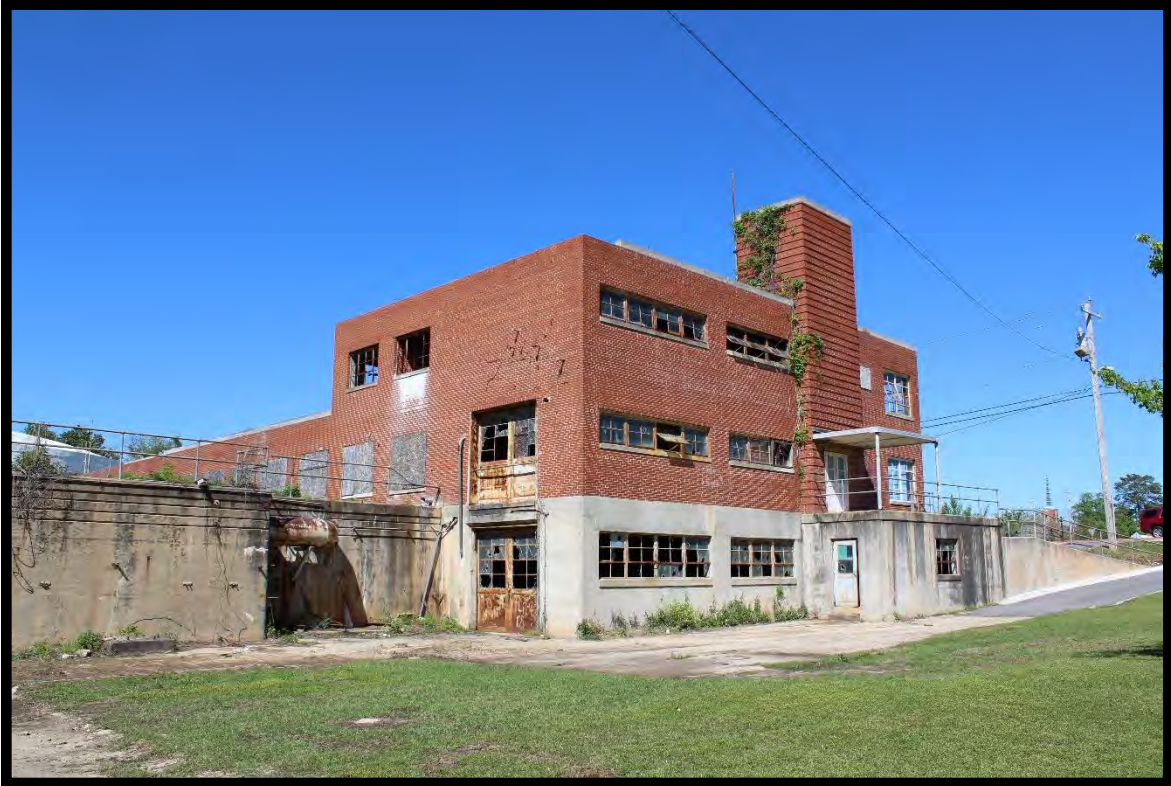
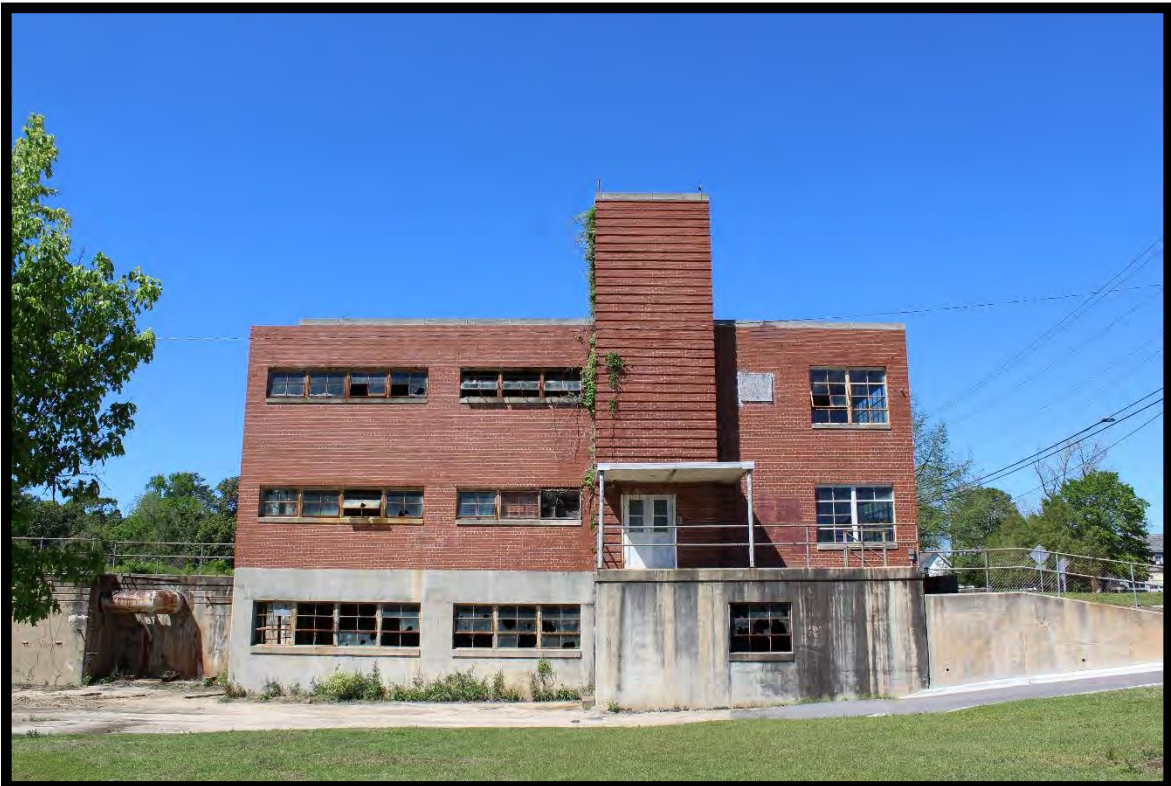
Figure 25: Lumberton Water Treatment Plant, Looking Northeast.

Figure 26: Lumberton Water Treatment Plant, Looking North.

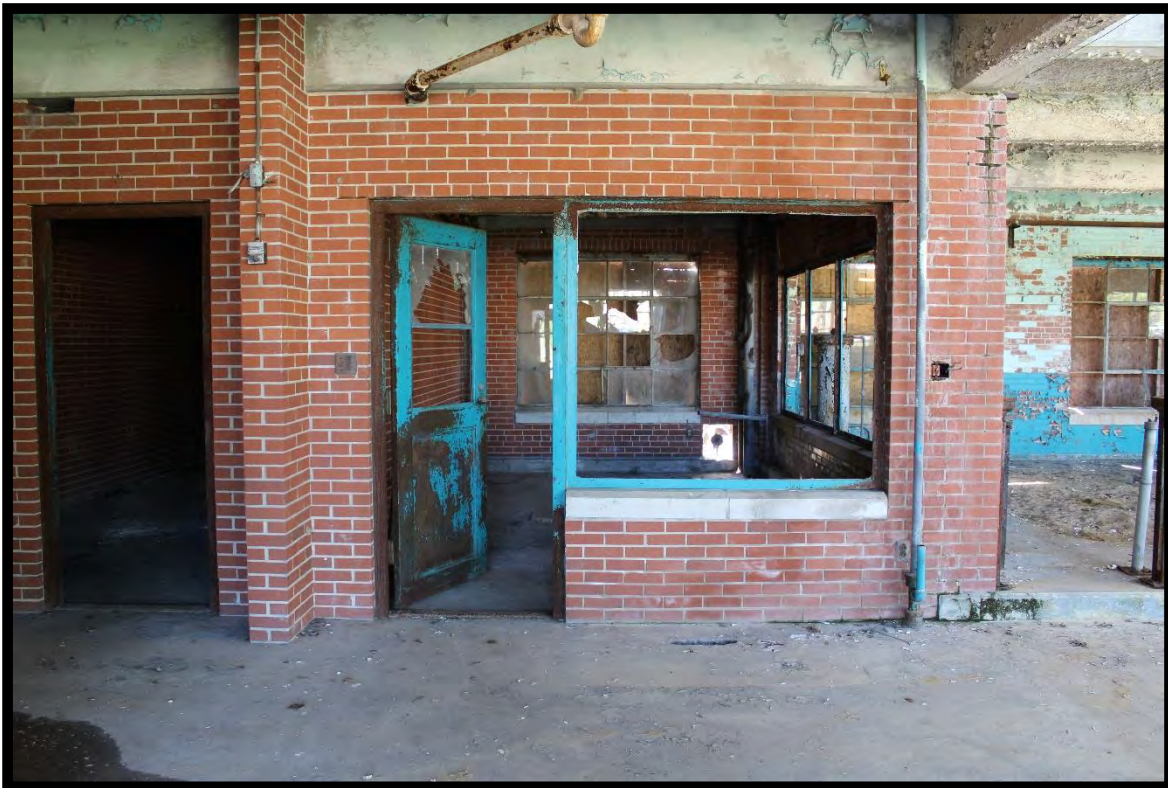
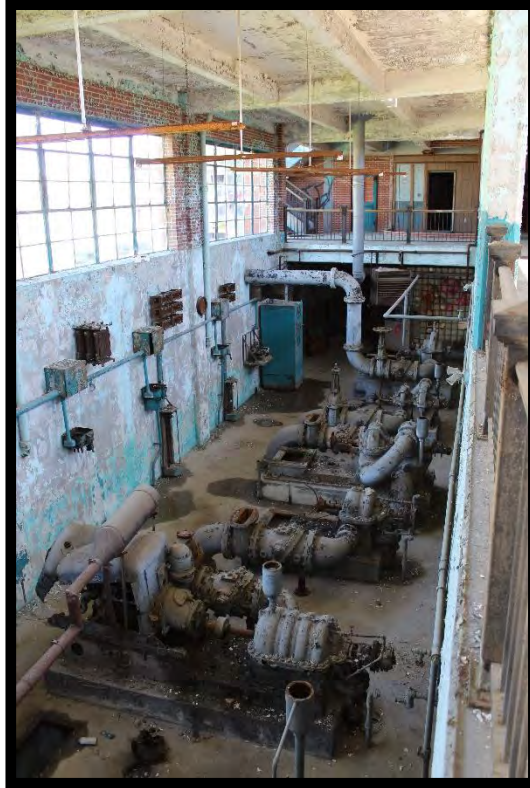
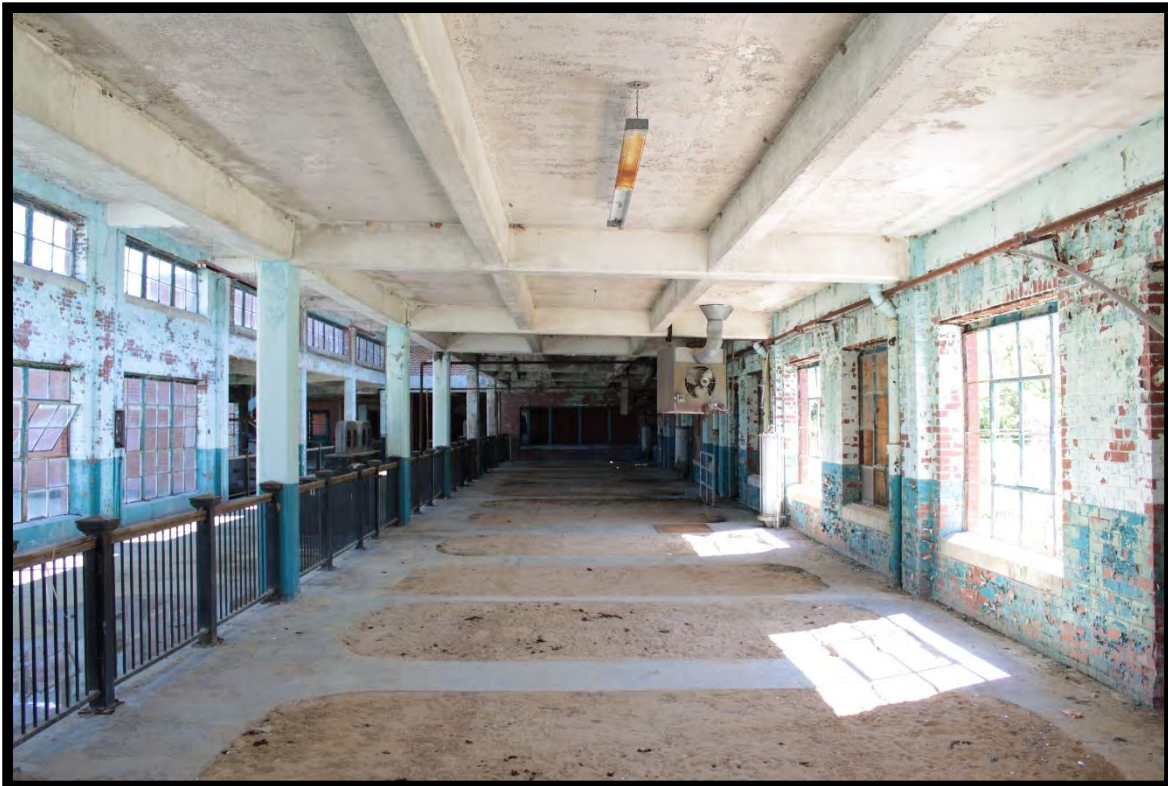
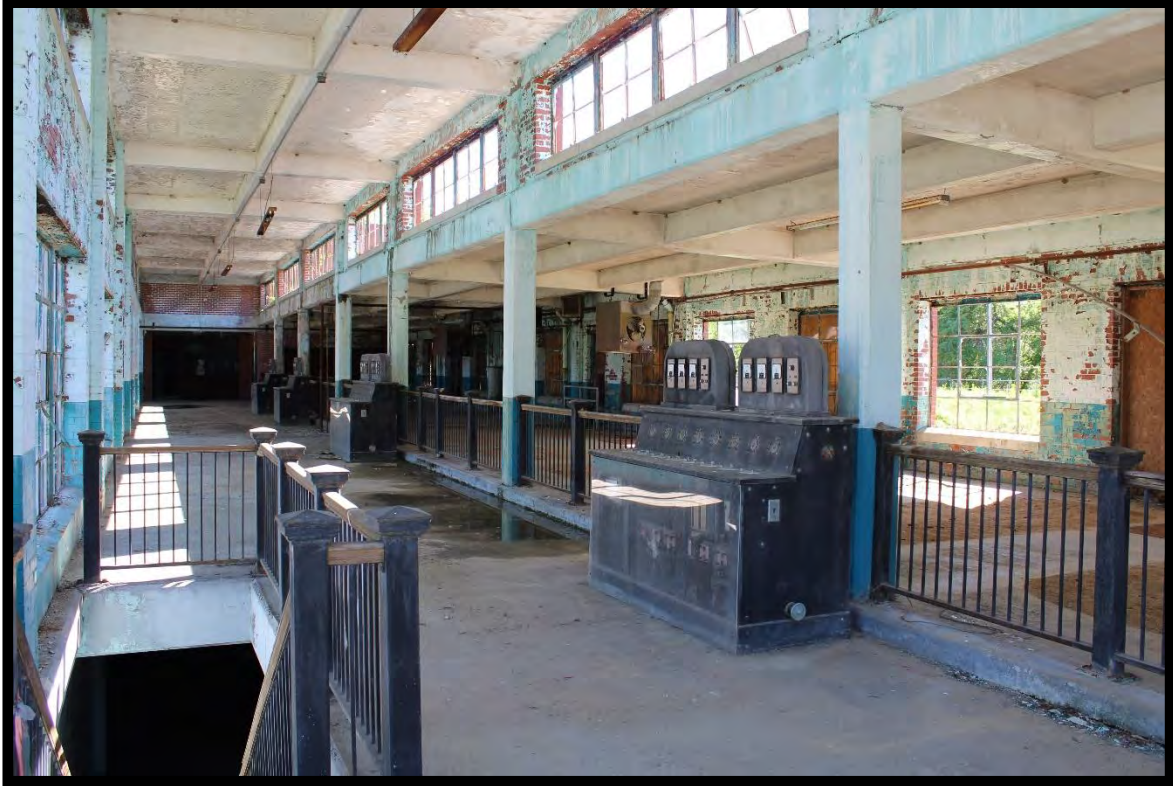
Through the front doors of the building is a two-story atrium with an open staircase in the southeast corner that leads to a balcony and second-story spaces as well as to the basement. On the first story, there is a room that appears to have served as an office located directly opposite of the entry doors, and south of the office it appears that there are additional rooms of an unknown use. On the north, the atrium is open to the plant's mechanical area. A railed-off section looks into the basement where piping and mechanical equipment are still present. West of the railed-off section is a space with small water basins, now filled with dirt, set in the floor. Control cabinets stand along the edge of the tanks (Figures 27 through 31).

Figure 28: Lumberton Water Treatment Plant, Interior, Office.

Figure 29: Lumberton Water Treatment Plant, Interior, Mechanical Equipment.

Figure 30: Lumberton Water Treatment Plant, Interior, Filled Water Basins.

Figure 31: Lumberton Water Treatment Plant, Interior, Control Cabinets.

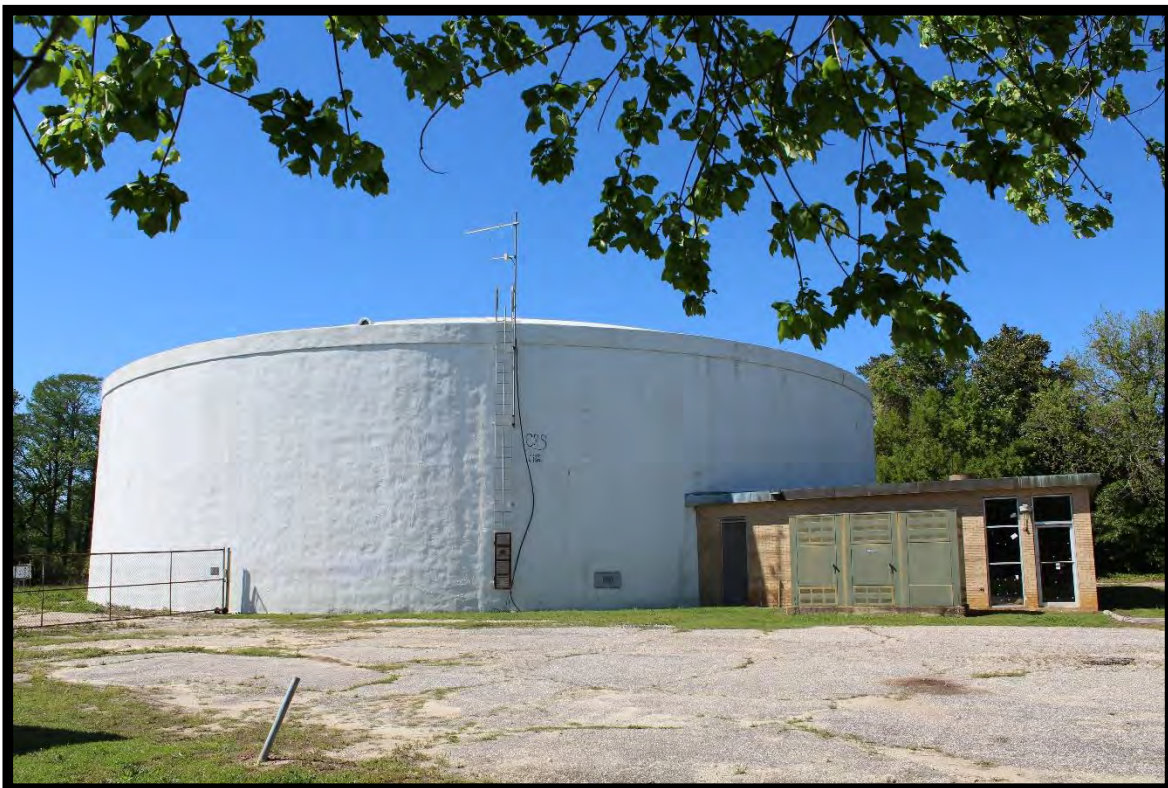
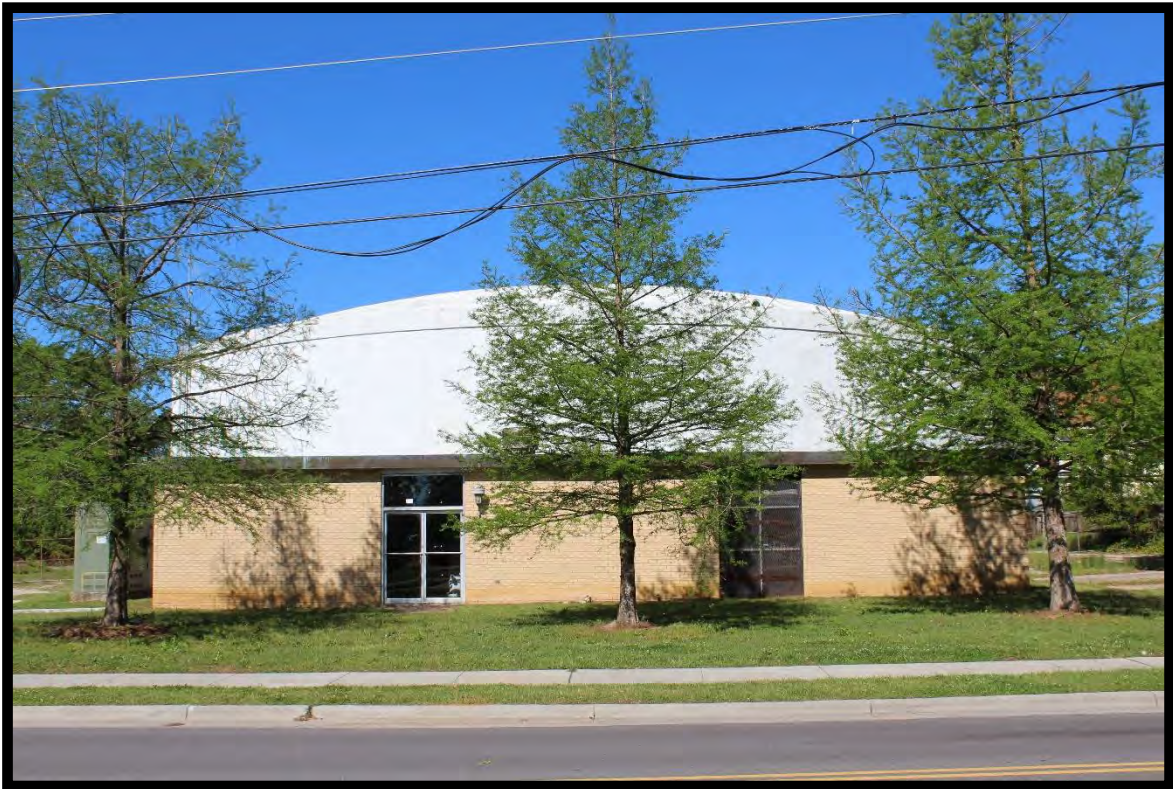
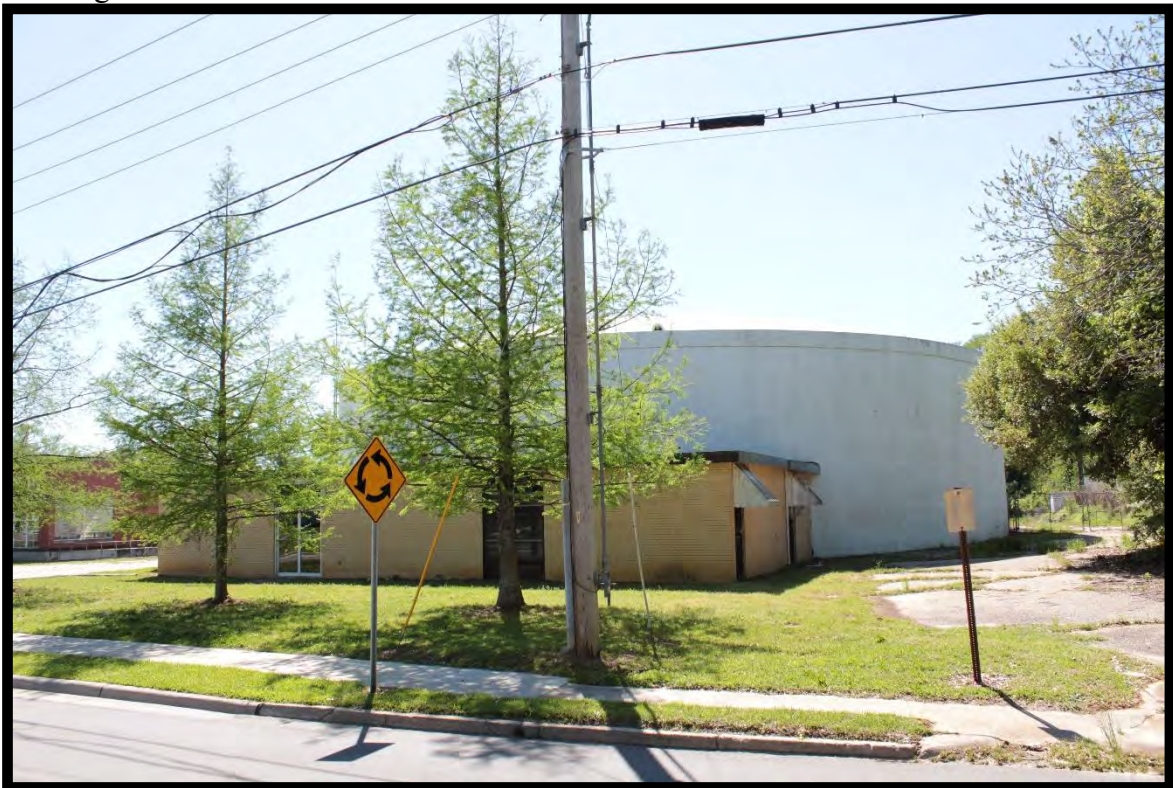
North of the 1946 plant is a ca. 1972 concrete water tank with a one-million-gallon capacity.²⁹ The cylindrical tank is shorter than it is wide and has a slightly domed roof. Attached to the east side of the tank is a one-story brick building that houses a mechanical room. The building has a flat roof with a metal cornice and its façade, which faces east to North Water Street, contains two apertures that mirror one another. The southern aperture is a double-leaf, glazed door with a transom that completely fills the space between the door and the cornice while the northern aperture is a full-height, six-pane window that mirrors the scale and arrangement of the entry door. The north (side) elevation contains two single-leaf entry doors with transoms set near the east corner and center of the elevation. Both are sheltered by metal awnings, though one is deteriorated. The south (side) elevation contains a single-leaf entry door with a transom and a full-height, three-pane window near the east corner. Near the west corner is a nearly full-height louvered vent. A large mechanical box stands forward of the building near the center of the elevation (Figures 32 through 34).

Figure 32: Lumberton Water Treatment Plant, Water Tank and Mechanical Building, Looking Northwest.

Figure 33: Lumberton Water Treatment Plant, Water Tank and Mechanical Building, Looking West.

Figure 34: Lumberton Water Treatment Plant, Water Tank and Mechanical Building, Looking Northwest.

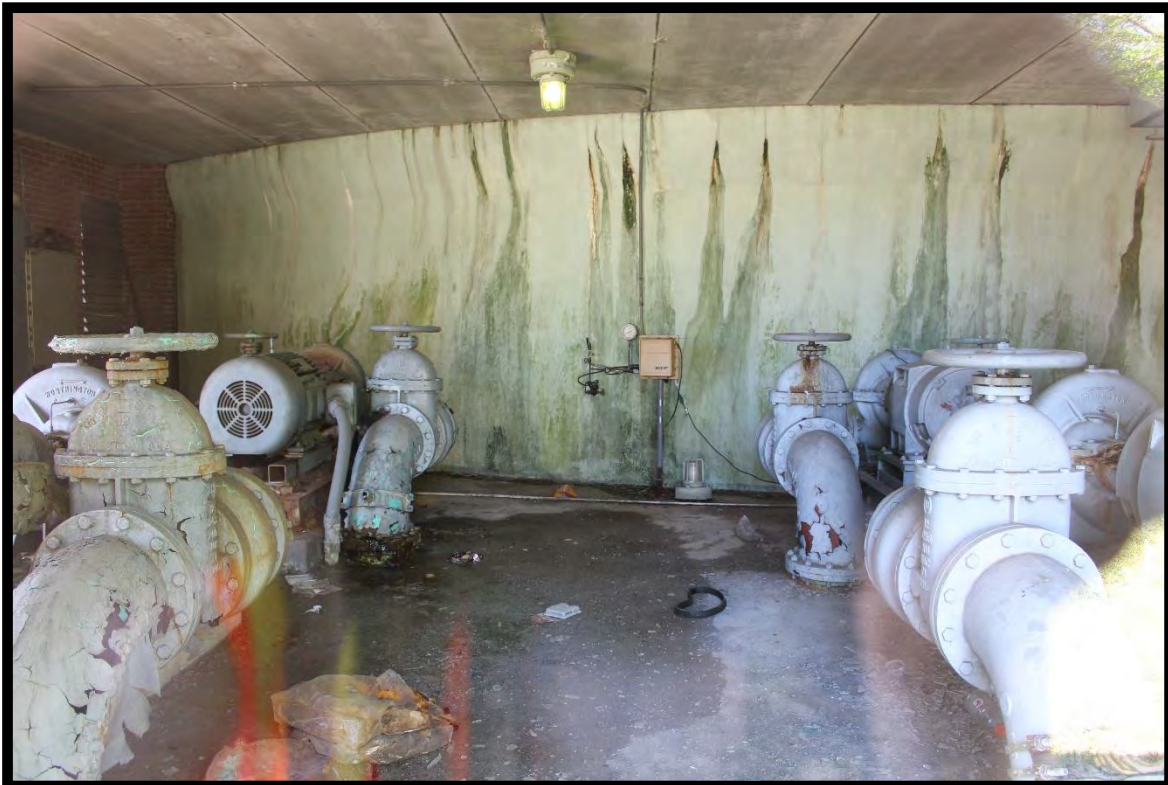
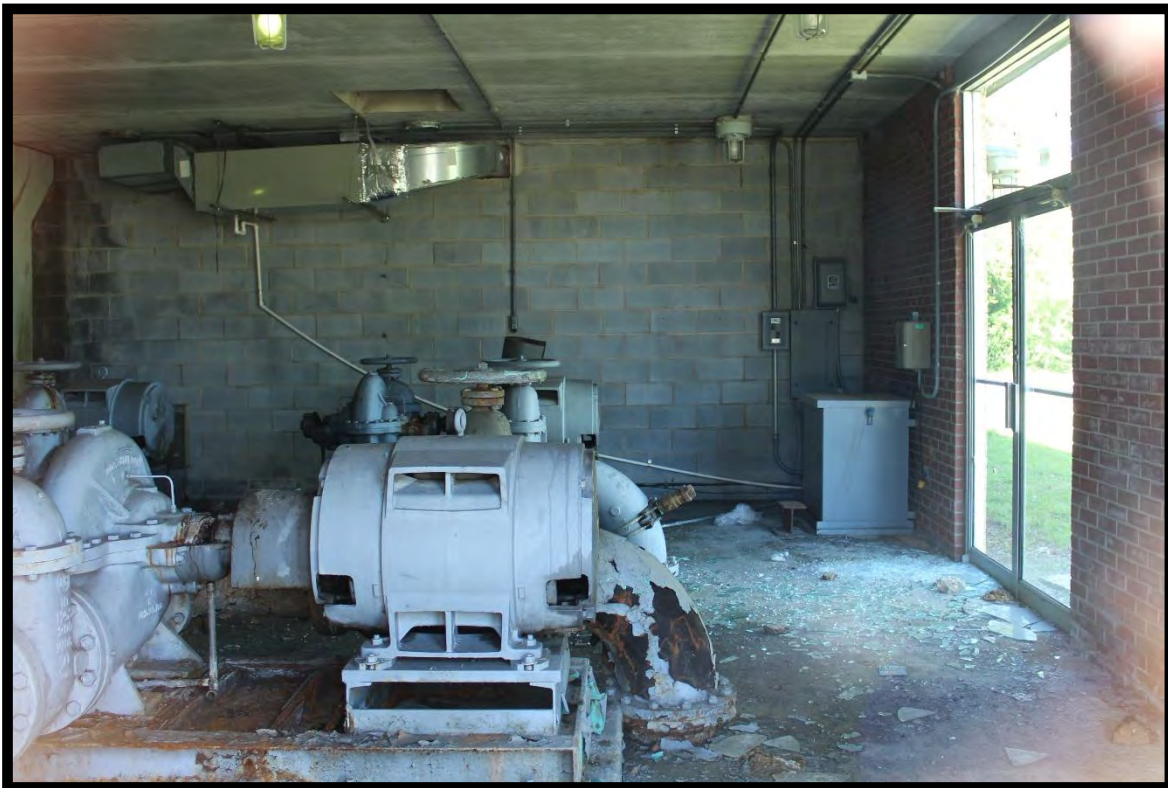
The interior is divided into at least two rooms by a concrete block wall and while the use of the northern room(s) is unknown, the southern room contains pumping equipment (Figures 35 and 36).

Figure 35: Lumberton Water Treatment Plant, Mechanical Building, Interior. Note curved wall of water tank.

Figure 36: Lumberton Water Treatment Plant, Mechanical Building, Interior. Note concrete block dividing wall.
