SUBJECT: Historic Structures Survey Report, B-5985, Replace Bridges 125 and 175 on NC 41/NC72 and SR 1600 over the Lumbee River, PA 17-12-0065, Robeson County, ER 19-3125

**HISTORIC STRUCTURES SURVEY REPORT
REPLACE BRIDGES NO 125 & 175 ON NC 41/NC 72 AND SR 1600
OVER LUMBER RIVER, ROBESON COUNTY, NORTH CAROLINA**

The North Carolina Department of Transportation (NCDOT) proposes to replace bridges No. 125 and 175 on NC 41/NC 72 and SR 1600 over the Lumber River in Robeson County, North Carolina. The Area of Potential Effects (APE) equates with the study area and spans east from the Y-shaped intersection of West 2nd Street and West 5th Street to North Chestnut Street. The project is included in the North Carolina State Transportation Improvement Plan (STIP) as Project Number B-5985 and is state funded. Federal permits are anticipated.

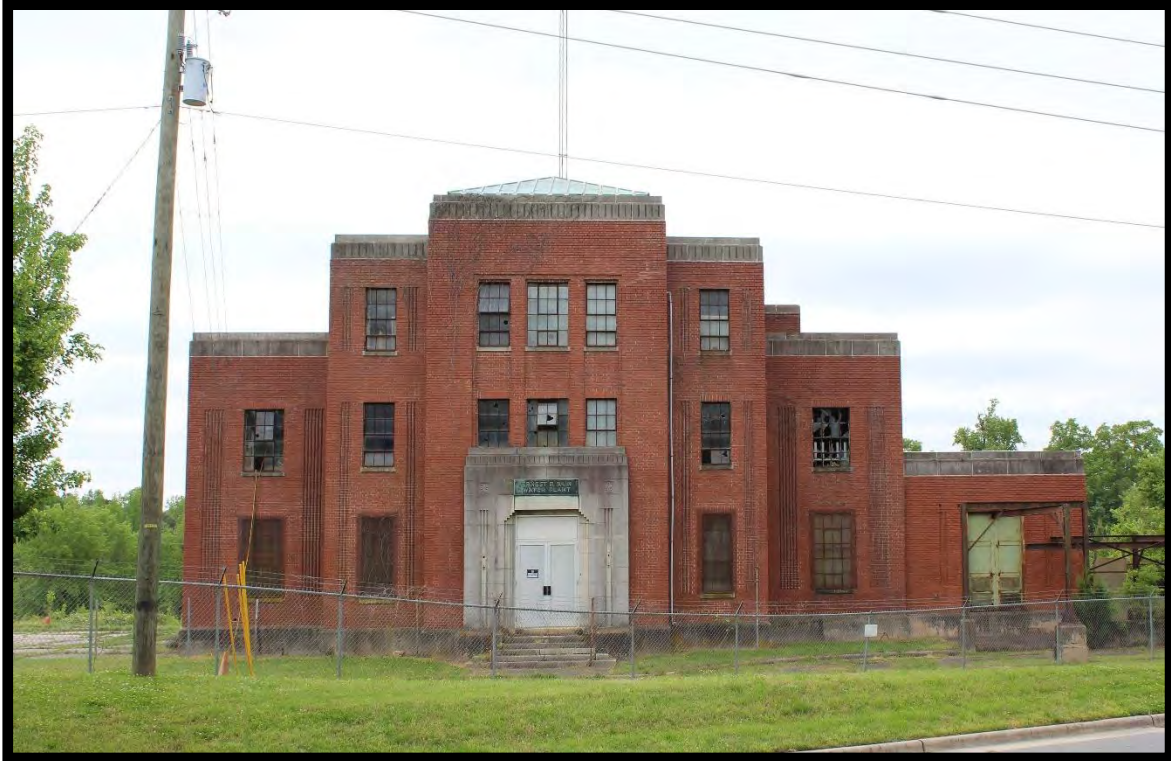
Figure 40: E. B. Bain Water Treatment Plant, 1810 South Fayetteville Street, Raleigh, North Carolina (RB0246), Looking South.

While both plants were integral to the distribution of water in their communities during the twentieth century, they have since been decommissioned and replaced with more modern facilities. Like the Lumberton plant the E. B. Bain plant retains a large amount of historic materials but also exhibits broken windows and overgrown treatment basins. An example of a mid-century water plant that is still in use is the Glenville Water Treatment Plant in Fayetteville (Figure 41). Constructed in 1942, the plant has a form that is similar to, though more reserved than, the E. B. Bain plant with a tall center section. The center section is also stepped slightly at the forward corners in a manner that is different from but similar to the recessed brick effect of the Lumberton plant's tower. Over time, the plant has been expanded to increase its capacity,

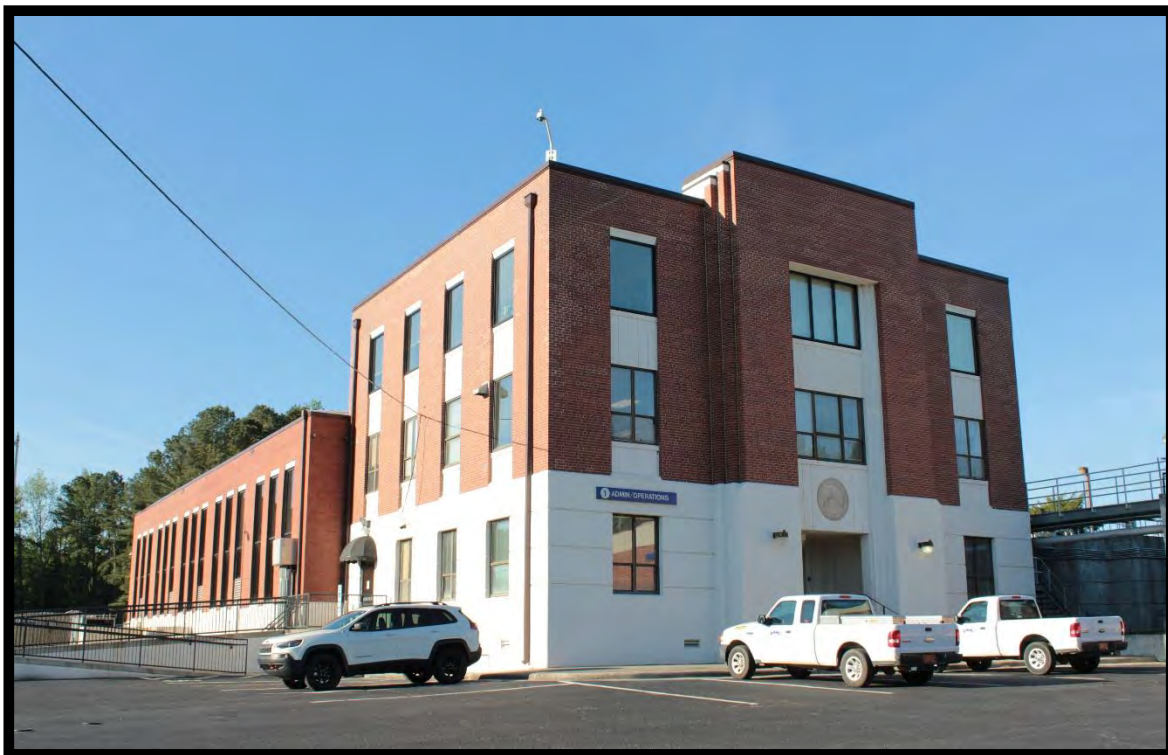
Figure 41: Glenville Water Treatment Plant, 628 Filter Plant Drive, Fayetteville, North Carolina, Looking Northeast.

growing from a three-million-gallon facility to an 18-million-gallon facility.⁶⁵ The expansions required enlarging the plant with a large rear addition, but the left the façade wholly unaffected. Despite this, the façade and west (side) elevation windows have been replaced with large single pane and one-over-one pane windows in heavy dark sashes that greatly compromise the character of the building.

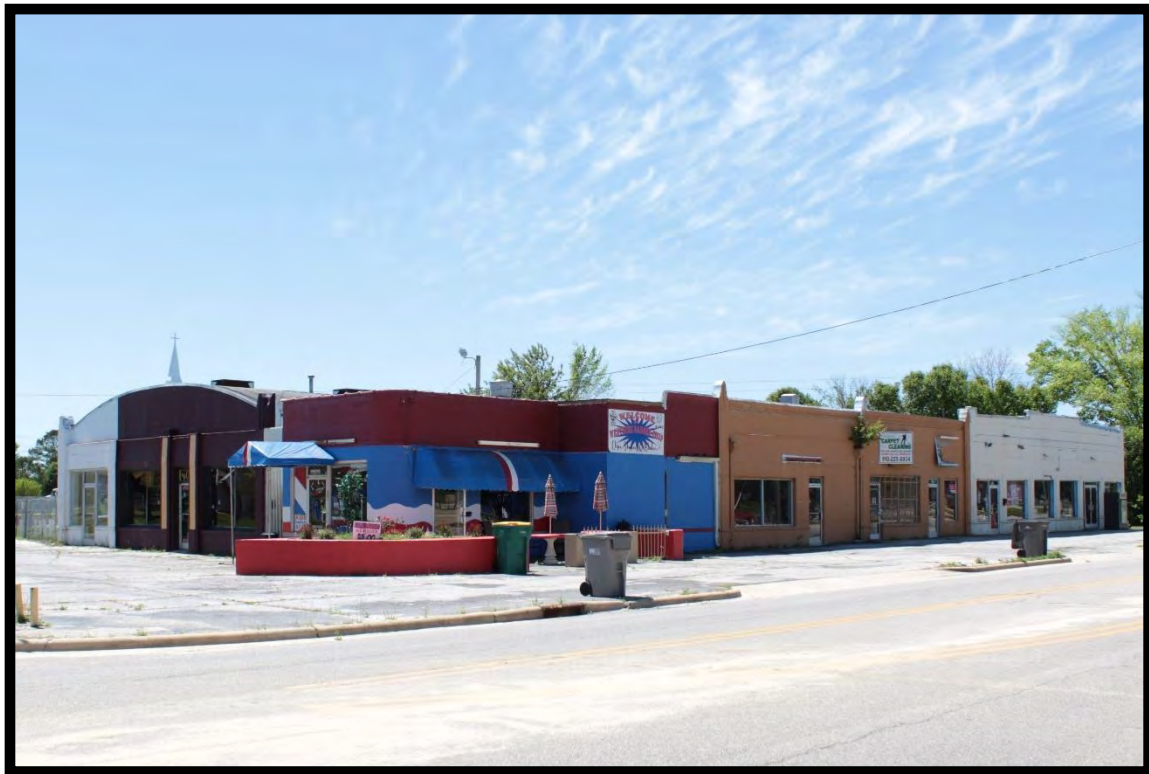
Figure 43: West Fifth Street Stores, Looking Southwest.

The one-story, stuccoed building is composed of roughly three buildings with various additions added over time (Figure 43). Buildings one and two, the largest of the three, have barrel roofs covered with standing seam metal and asphalt sheets, respectively, and serve as end caps to the L-shaped building. The first building faces north and has a six-bay façade with a parapet. The six bays are divided between three storefronts with, from west to east, a combined door and window surround, double-leaf entry doors, three large windows, and another combined door and window surround. All of the doors and windows contain a single pane of glass and are set in aluminum surrounds. A low, stuccoed belt course spans the elevation and doubles as window sills, and pilasters rise to just above the height of the windows and separate each bay. The ghost marks of various signs and awnings exist above the doors and windows and five light fixtures – one each above the second and fourth bays from the west and three above the fifth and sixth bays – light the elevation (Figure 45). The building's parapet wraps the northwest corner of the building before dropping to the roofline along the west (side) elevation. Though this elevation is blind, cracks in the stucco and a mid-height belt course suggest that it once had windows set high along the elevation. A roughly eight-foot break in the belt course paired with a just-above-grade threshold suggests that there was once a large opening near the southern corner of the elevation as well (Figure 46). The belt course wraps the south (rear) elevation of the building which has a centered loading dock with a modern garage door covered by metal bars (Figure 47). The building projects further south than the rest of the building creating a short, blind east (side) elevation (Figure 48).

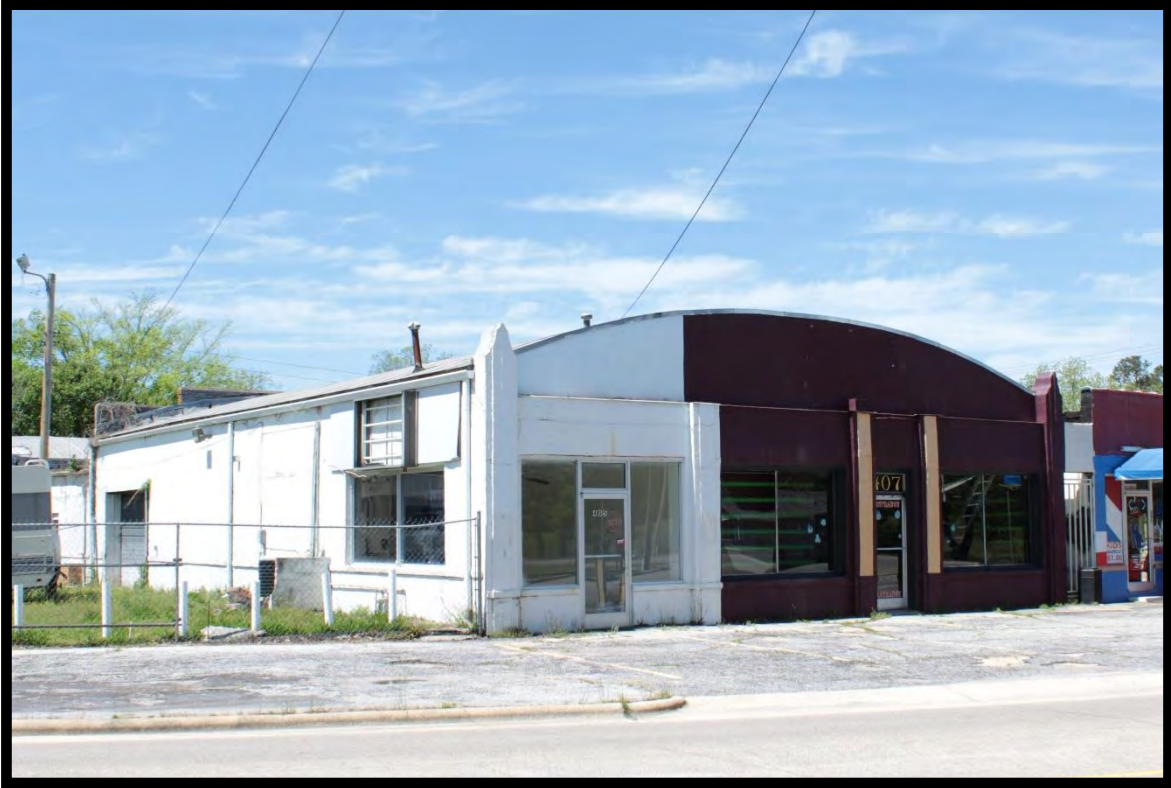
Figure 49: West Fifth Street Stores, Looking Northwest.

The primary elevation of the second barrel-roofed building, which is covered with asphalt sheets, faces east and has four bays capped at the ends by pilasters that extend above the roofline and have bell-shaped tops. The pilasters exhibit a somewhat Art Deco motif with a raised center and an additional raised vein that is centered near the top of each pilaster. Simpler versions with flat tops and only raised centers separate the bays and a low, stuccoed belt course spans the elevation and duals as window sills. This portion of the elevation is flat between the end caps and appears to have been placed over the original elevation, which displays the curve of the barrel roof and rises above the stuccoed section. A small vacant storefront occupies the southernmost bay and is composed of a glazed entry door and transom flanked by large, single-pane windows in an aluminum-framed surround. The second storefront spans the remaining three bays and is also vacant. Its center bay is narrow with only a glazed entry door and transom while the flanking bays contain large, two-pane windows. Each arrangement is set in an aluminum frame. The south (rear) elevation of this section would have originally acted as its side elevation. Today it contains a large, two-pane window near the southeast corner that looks into the smaller store and a large garage door near the barrel-roofed building's original southwest corner. A belt course, slightly higher than that on the east elevation, spans the building and also serves as a window sill. Of note is a brick parapet that rises from the original west elevation of the building indicating that it may have acted as the building's original façade. It also faces toward the other barrel-roofed building, a characteristic that seems somewhat illogical, and may indicate that it pre-dates the other barrel-roofed building and that the western half of the lot was originally open to Lincoln Street (Figure 49).

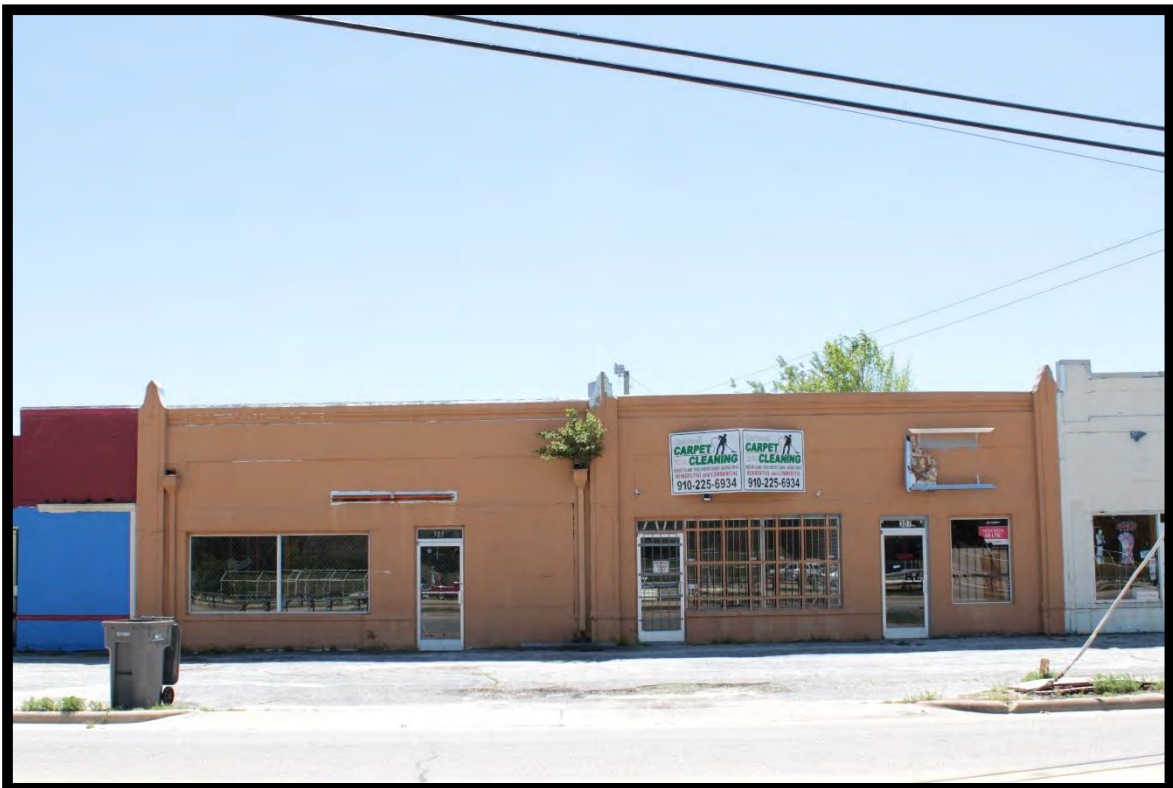
Figure 51: West Fifth Street Stores, Looking South.

Sandwiched between these buildings is an L-shaped building that spans from the north (front) elevation to the south (rear) elevation of the building. Its south (rear) elevation contains two metal entry doors with a small recessed opening between them. It also has a belt course that intermittently spans the elevation (Figure 50). The north (front) elevation is broken into two sections by three tall pilasters that are similar to those on the east (side) elevation. The two sections appear to have originally had the same configuration with a large, two-pane window to the east of a glazed entry door with a small transom and a single-pane window. However, the single-pane window on the east section has been filled and on the west section a door is integrated into the east side of the two-pane window configuration and the windows are narrower. Each section has a stuccoed, corbelled cornice; a long recess that may have once displayed a business name; and a low belt course that doubles as window sills. The remnants of signs are visible above the left and right storefronts while a two-part sign projects from above the center storefront (Figure 51).

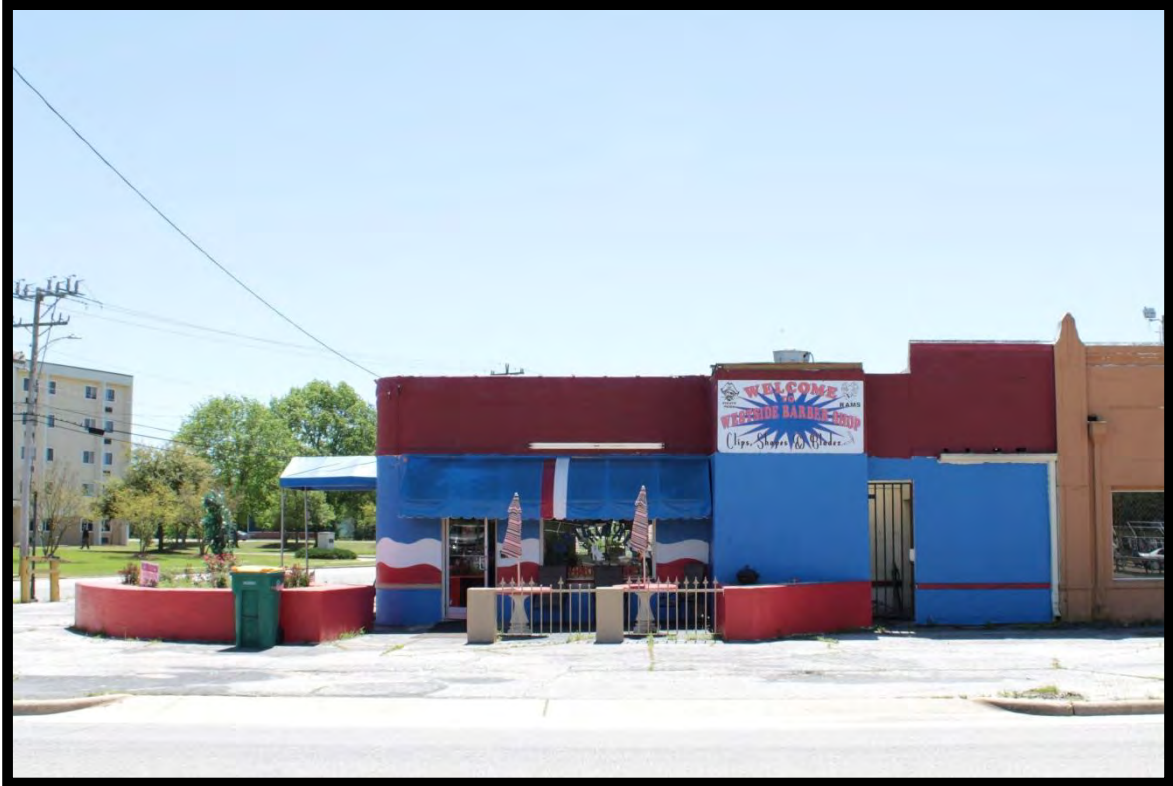
Figure 52: West Fifth Street Stores, Looking South.

Both elevations of the store are spanned by a low belt course that doubles as window sills and by a ceiling-height belt course. On the north side of the store is a patio enclosed by a metal fence with concrete pilasters between two concrete flower beds, the western of which is triangular and the eastern of which is wedge-shaped with an exterior edge that mirrors the curve of the building (Figures 52 and 53).

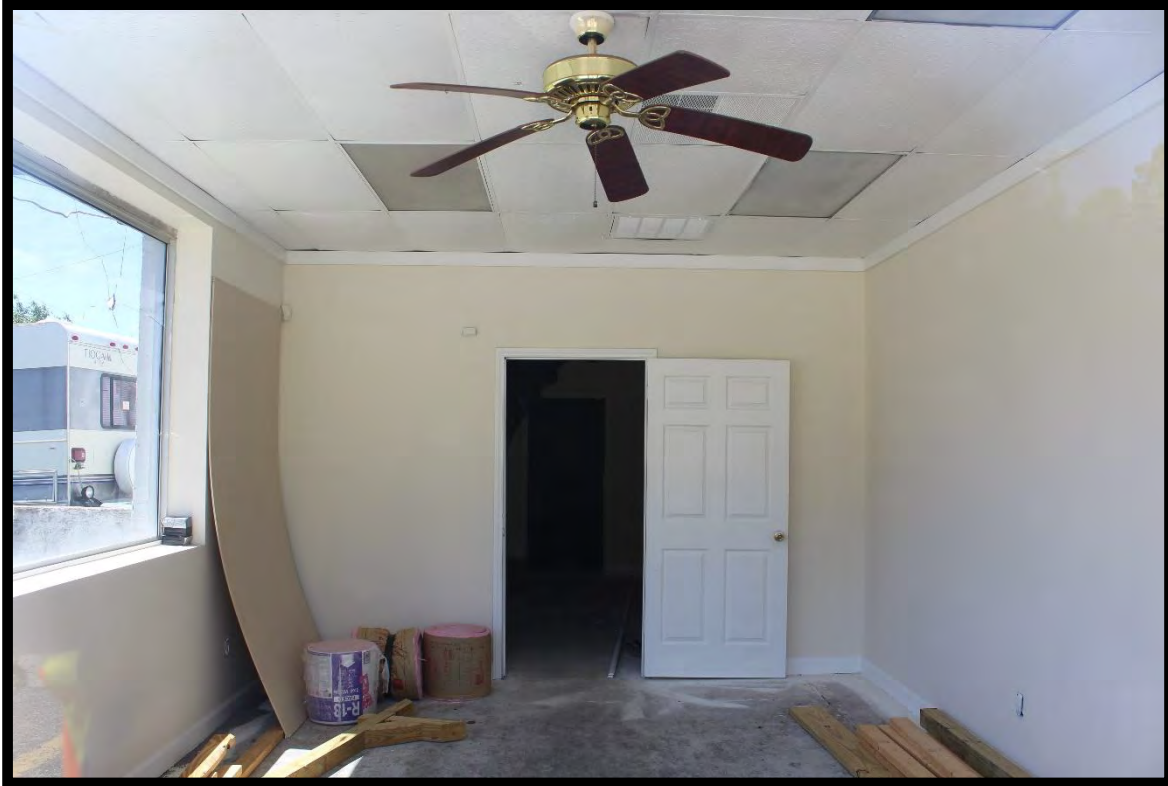
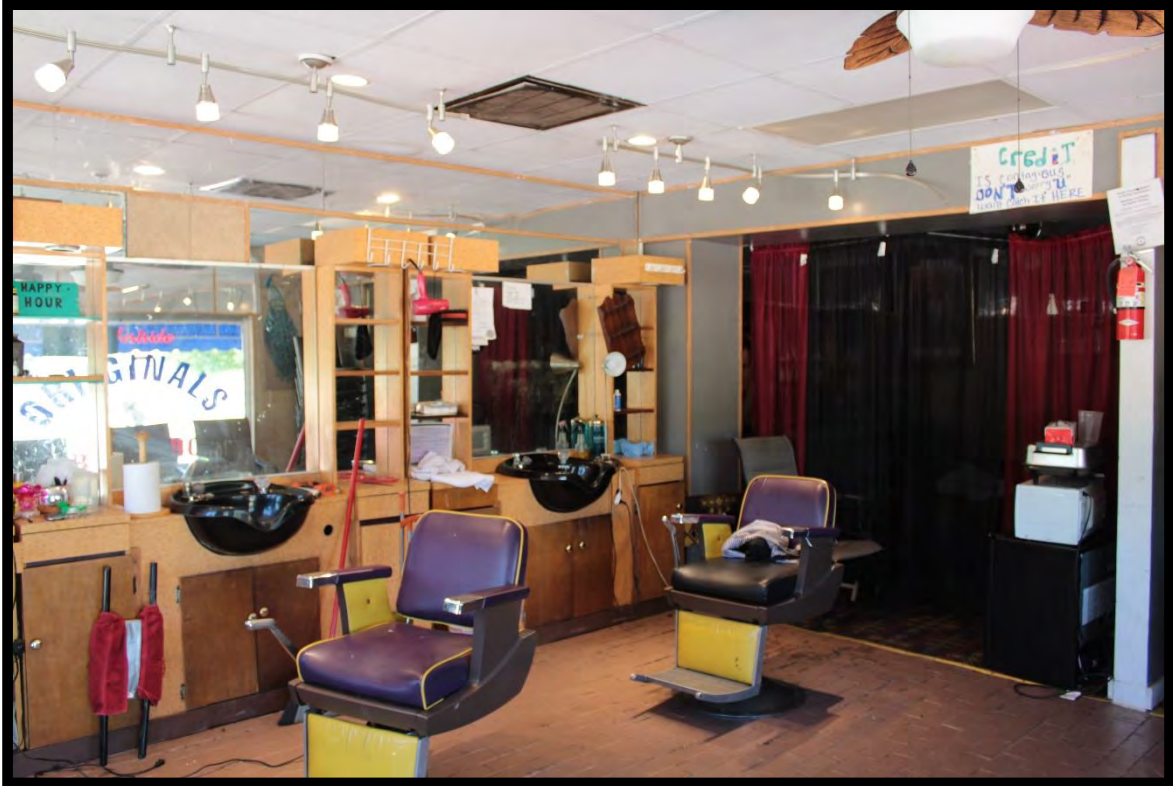
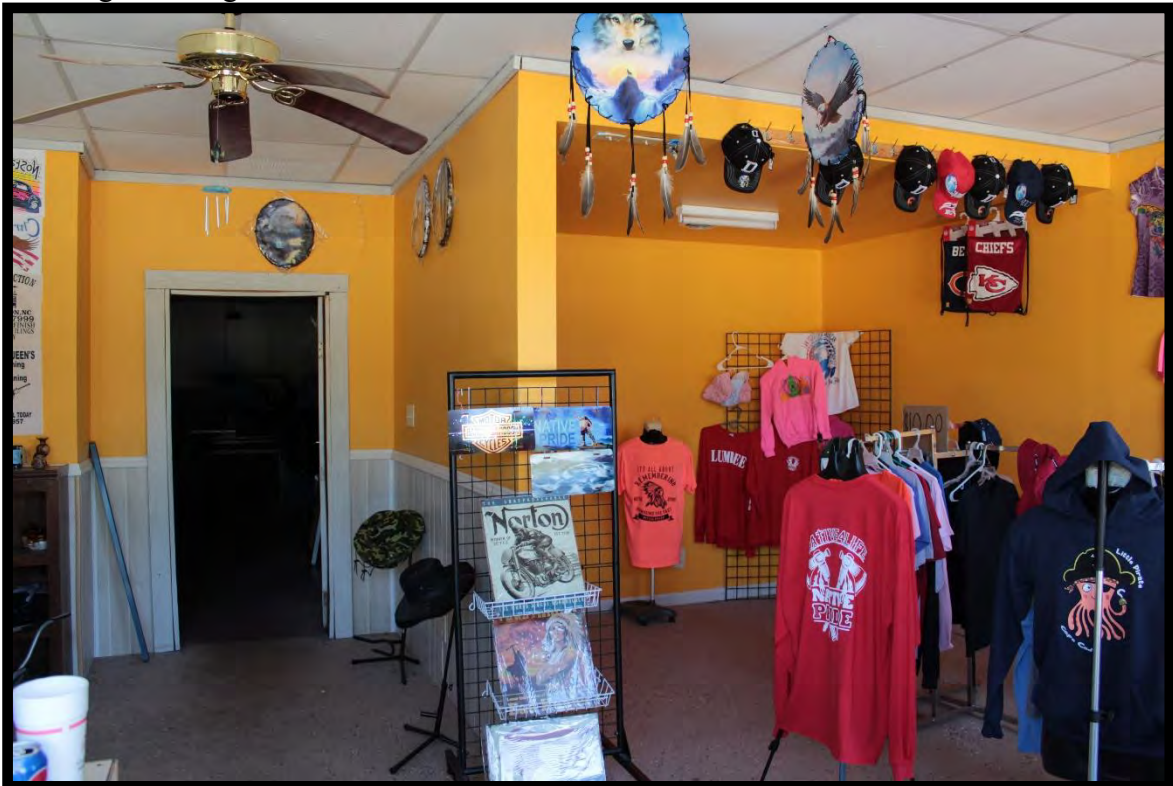
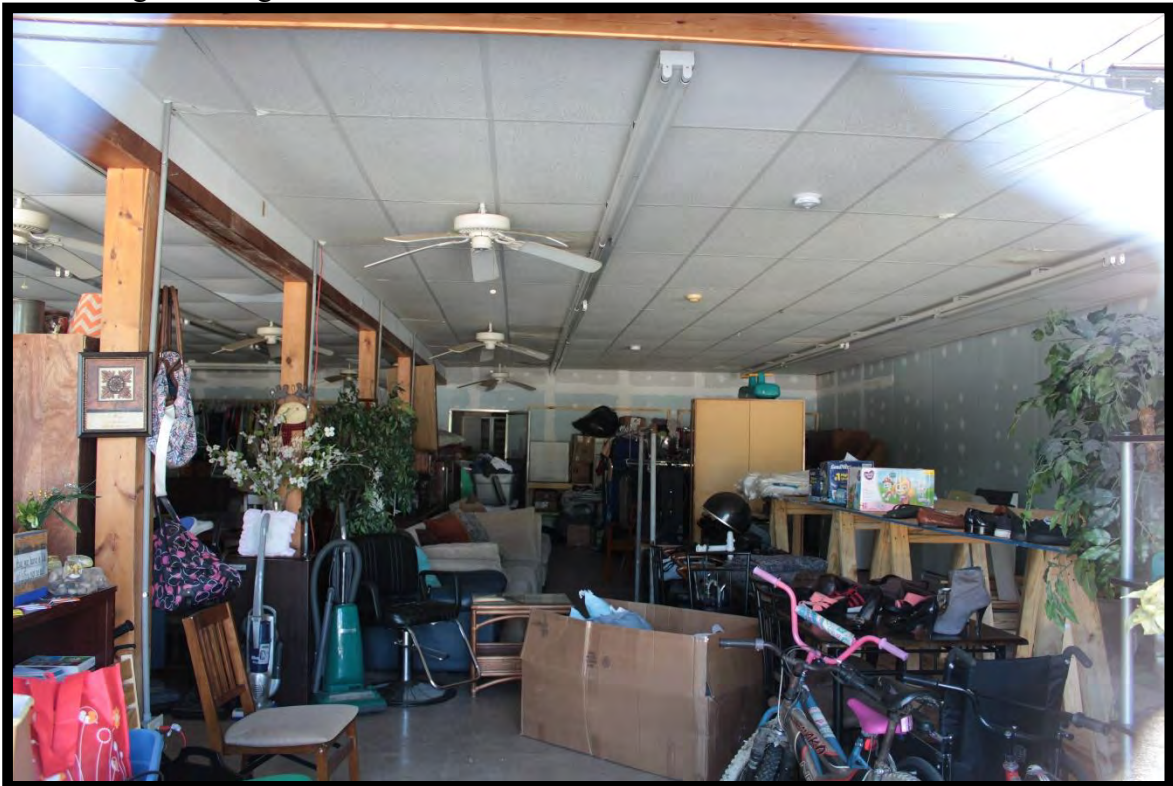
The building is broken into seven retail spaces and one restaurant space, each of which appear to have been altered with modern materials such as drywall, acoustic drop-tile ceilings, wooden paneling, and new flooring materials (Figures 54 through 59).

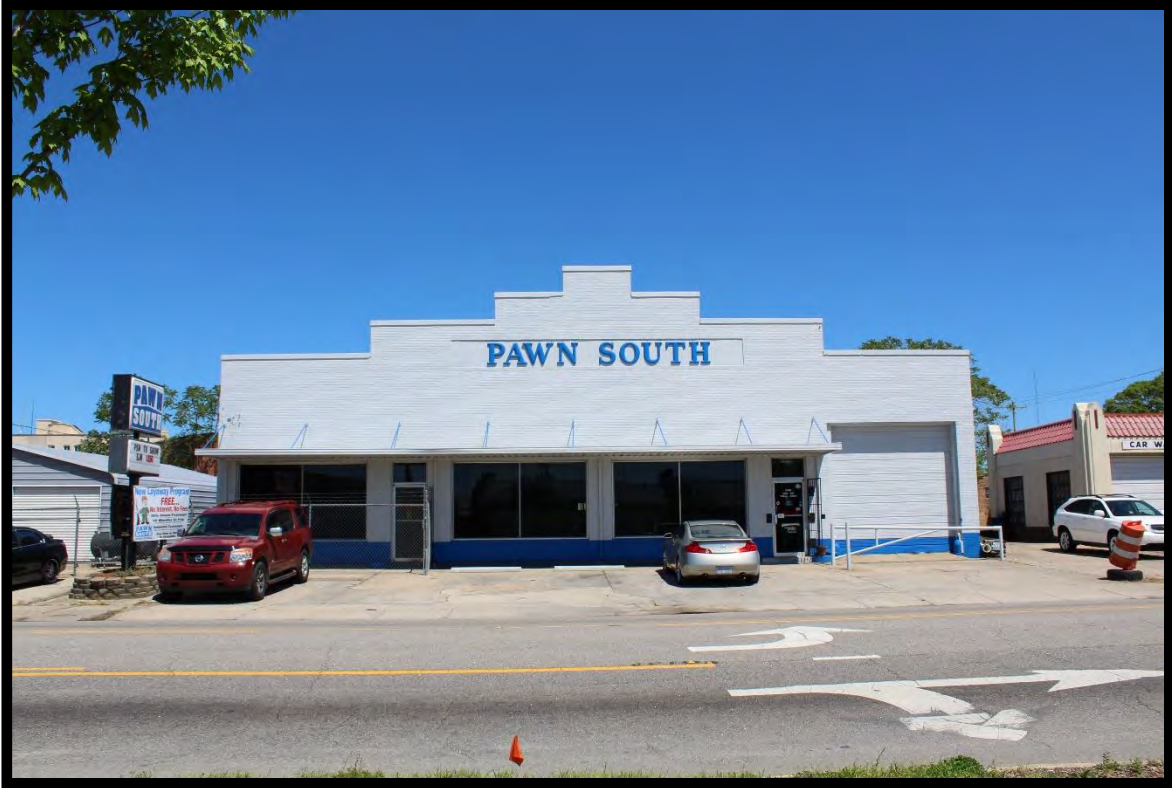
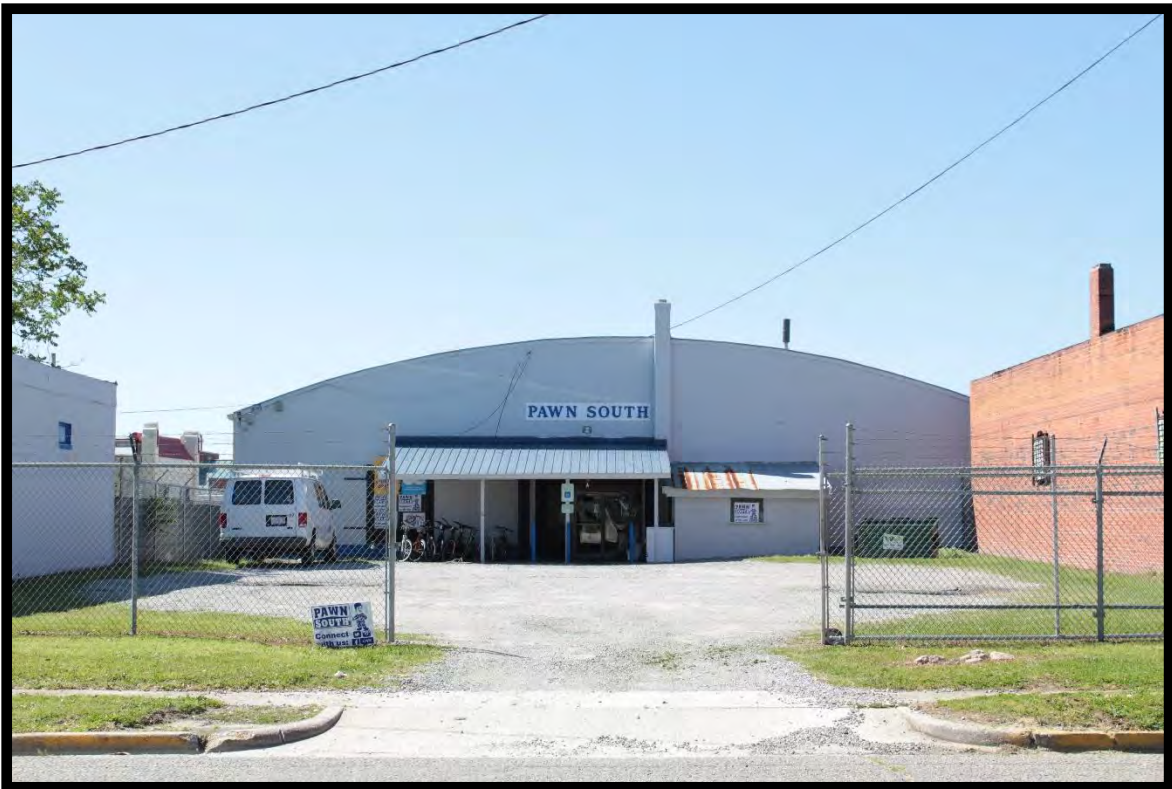
A Lumberton property that exhibits a barrel roof and, though larger, is likely similar to the original appearance of the barrel-roofed buildings is a ca. 1935 store (RB0229) on East 2nd Street (Figures 62 and 63). The building is constructed of brick which has been painted and has a stepped parapet on its south (front) elevation but no parapet on its north (rear) elevation, exposing its curved roof. A metal awning, likely a replacement, is suspended from the façade and shelters windows and doors set in aluminum frames. While aluminum frames did come into popularity in the 1930s, it is likely that these are replacements as well. To the east of the doors and windows is a large modern garage door and above the awning is a recess in the brick façade that proudly displays the name of the store's current tenant. Despite some alterations, the building has retained its original scale and form, and presents as a well-preserved representation of early twentieth-century commercial architecture and contributes to the Lumberton Commercial Historic District (RB0476).

Figure 62: Store (RB0229), Looking North.

Figure 63: Store (RB0229), Looking South.

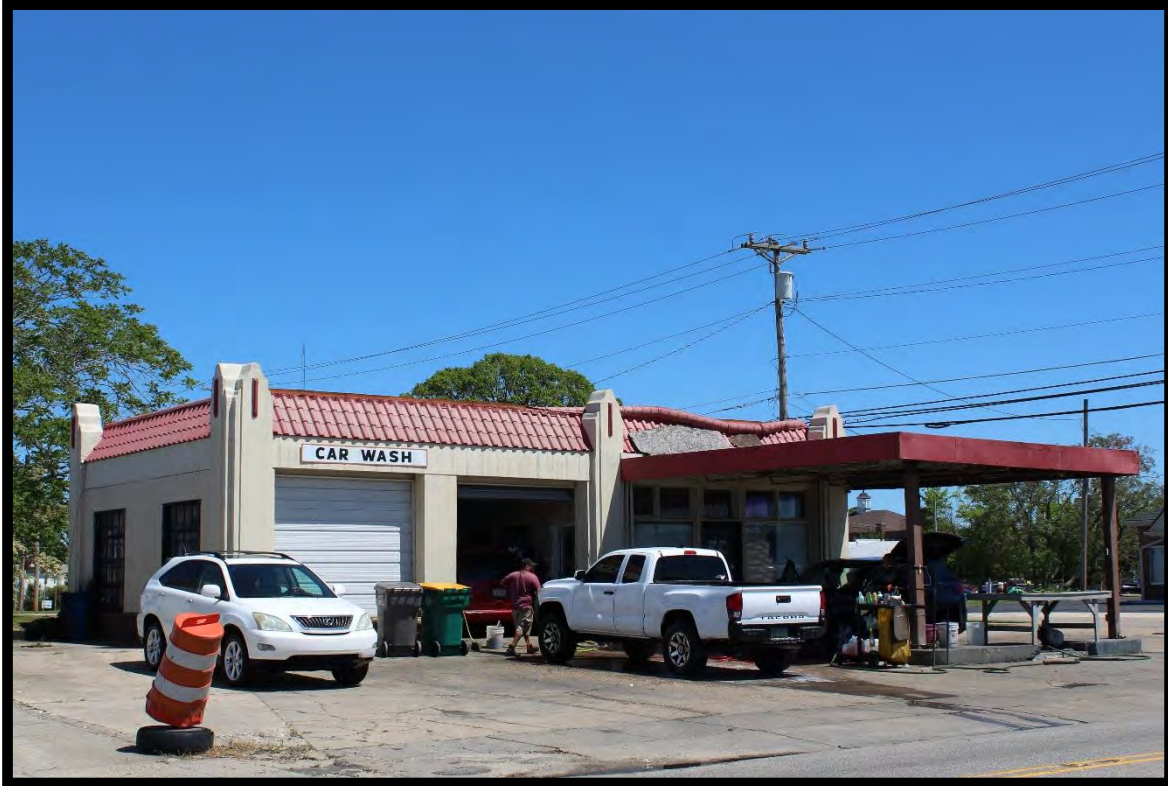
Figure 64: Gas Station (RB0230), Looking Northeast.

Next door to the store is a ca. 1935 gas station (RB0230) that also contributes to the historic district and exhibits pilasters with bell-shaped tops like those on two of the studied building's elevations (Figure 64). Though its fuel pumps have been removed, the station is still used for the auto industry as a car wash. Architecturally, it retains a wooden storefront with a centered entry door and large display windows below a row of transom windows. Its car port appears to be an early addition as does its mansard roof, which is covered with a material designed to emulate terracotta tiles. The building provides a glimpse of 1930s roadside architecture, which was

designed to capture the eye of the driver by standing out from the more traditional styles that characterized the late nineteenth century and the early years of the twentieth century. Furthermore, it stands as a purer example of the style, in contrast with the studied building, which began as a series of more simplistic, industrial buildings and has been greatly altered over time.

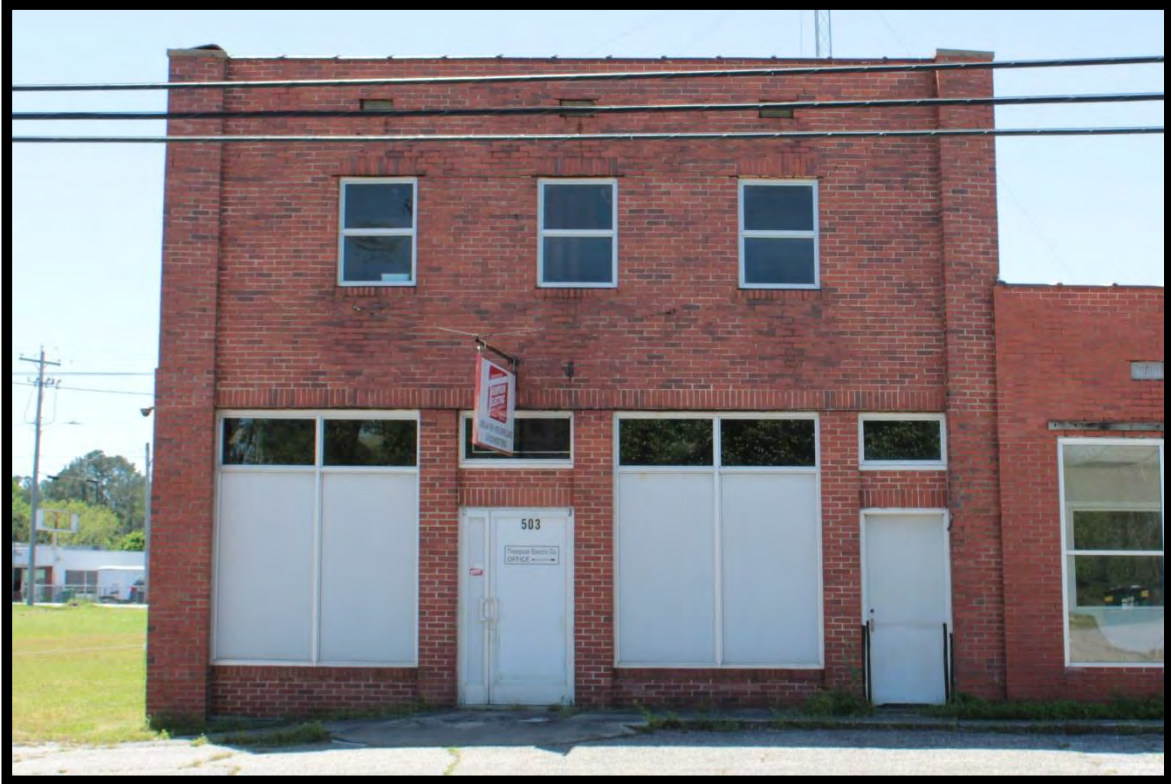
Figure 67: Thompson Electric Company, Looking South.

The concrete block building is composed of a ca. 1945 two-story section with a ca. 1965 one-story addition and has a trapezoidal shape caused by angling the brick veneered façade to be parallel with West 5th Street. The façade of the ca. 1945 building is capped with metal coping and bookended by shallow brick pilasters with concrete caps. Its first-story façade contains four bays that are separated by brick pilasters. The first and third bays, from the east, are filled with paired display windows with brick sills and transoms. The second bay contains a glazed entry door that is flanked by a narrow sidelight on the east and has a brick lintel. Slightly above the lintel is a transom that is in line with the transoms above the windows. The fourth bay contains a solid entry door that is also topped with a brick lintel and transom, similar to the glazed door. All of the apertures are set in replacement surrounds. A course of soldier bricks spans the midline of the building just above the transom windows and a Thompson Electric Company sign projects perpendicular to the building. Three one-over-one, vinyl or metal sash windows with brick sills and lintels span the second-story façade. Centered above each one is a small rectangular vent (Figure 67).

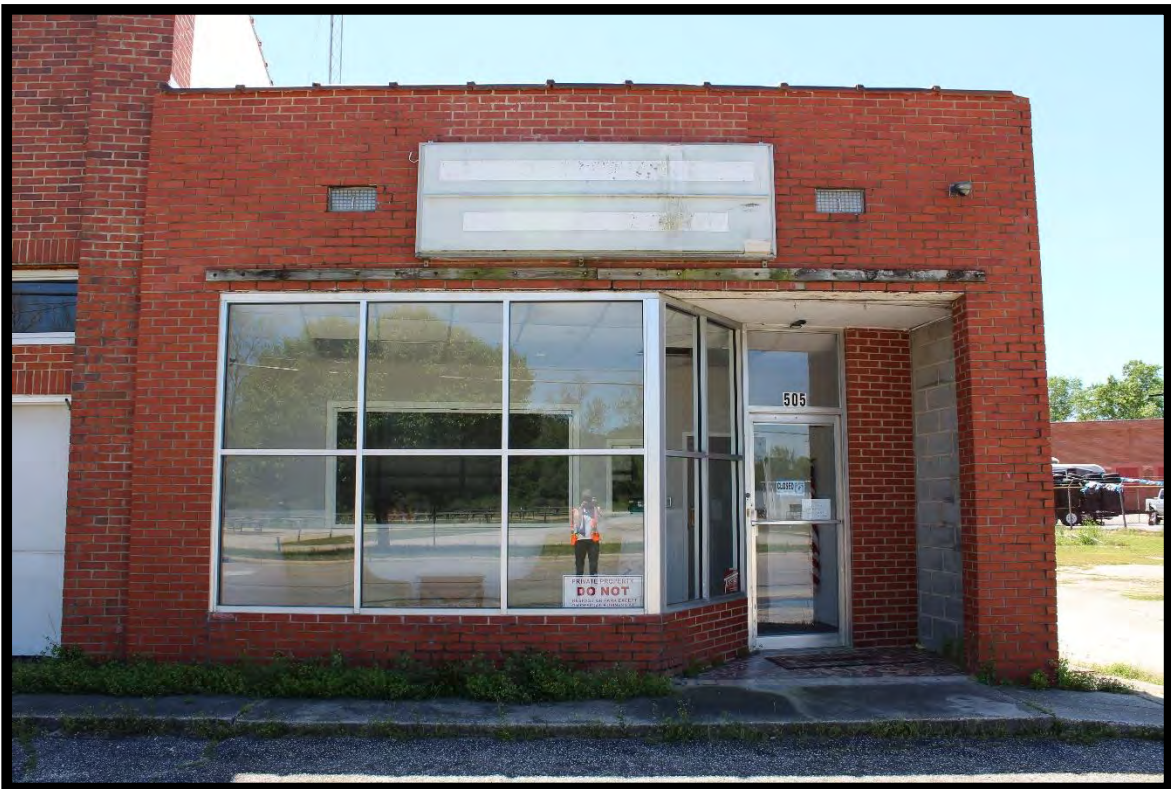
Figure 68: Thompson Electric Company, Looking South.

The ca. 1965 building stands to the west of the earlier building and shares its western wall. Its one-story façade is capped with metal coping and contains a large display window that has six panes that are flush with the façade and four panes that angle inward toward a recessed glazed door with a transom that is located near the western wall of the building. The western interior elevation of the recess reveals a concrete wall and indicates that the building is of concrete block construction with a brick veneer façade. A wooden element spans the façade just above the window and likely supported a porch or awning at some point. Above this is a large sign that no longer identifies the occupying business. It is flanked by small rectangular vents with a small light or surveillance camera to its west (Figure 68).

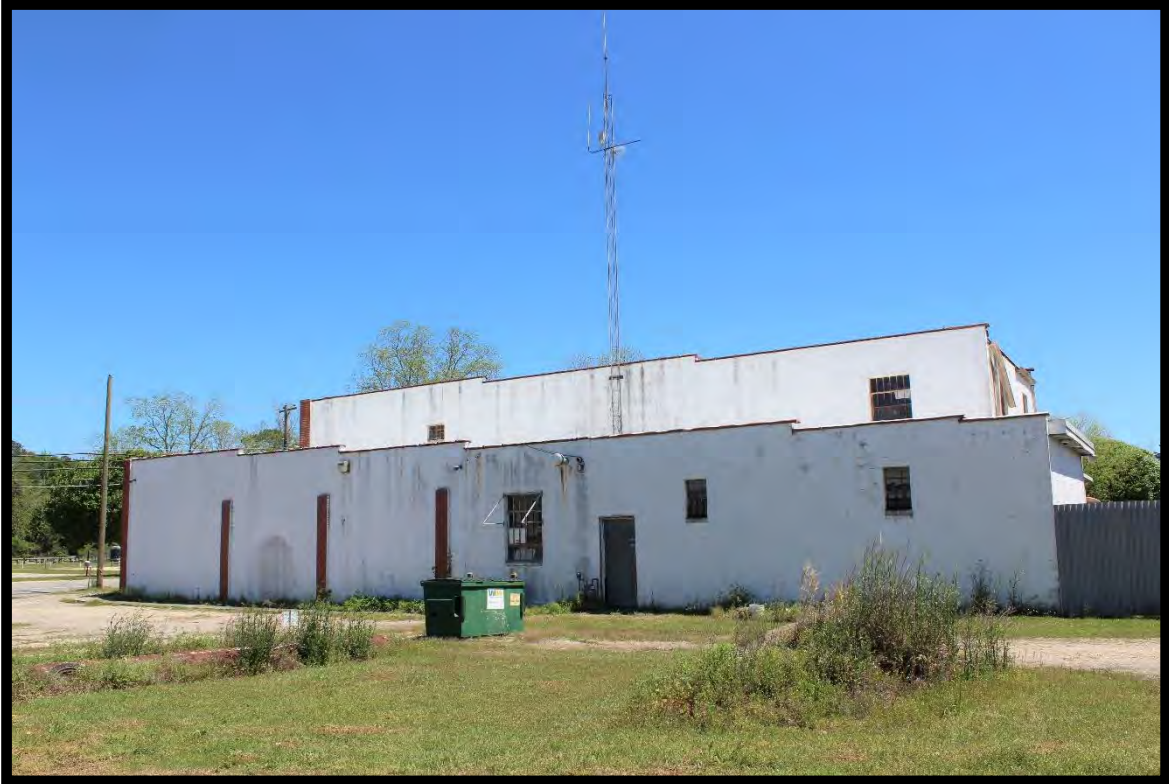
Figure 69: Thompson Electric Company, Looking Northeast.

The west (side) elevation of the ca. 1965 building is painted white and its parapet wall is stepped from the north (front) elevation to the south (rear) elevation. The parapet is finished with metal coping. The elevation has three tall brick piers that act as buttresses and line up with the first three steps of the parapet. Beyond the buttresses, the wall contains a multi-pane, metal sash window. The frame of a missing awning still projects from the left and right of the window. Continuing south, there is a metal entry door, and two small six-over-six, likely metal sash, windows. The second-story elevation of the earlier building is visible above the one-story building and contains one large and one small multi-pane, metal sash window (Figure 69).

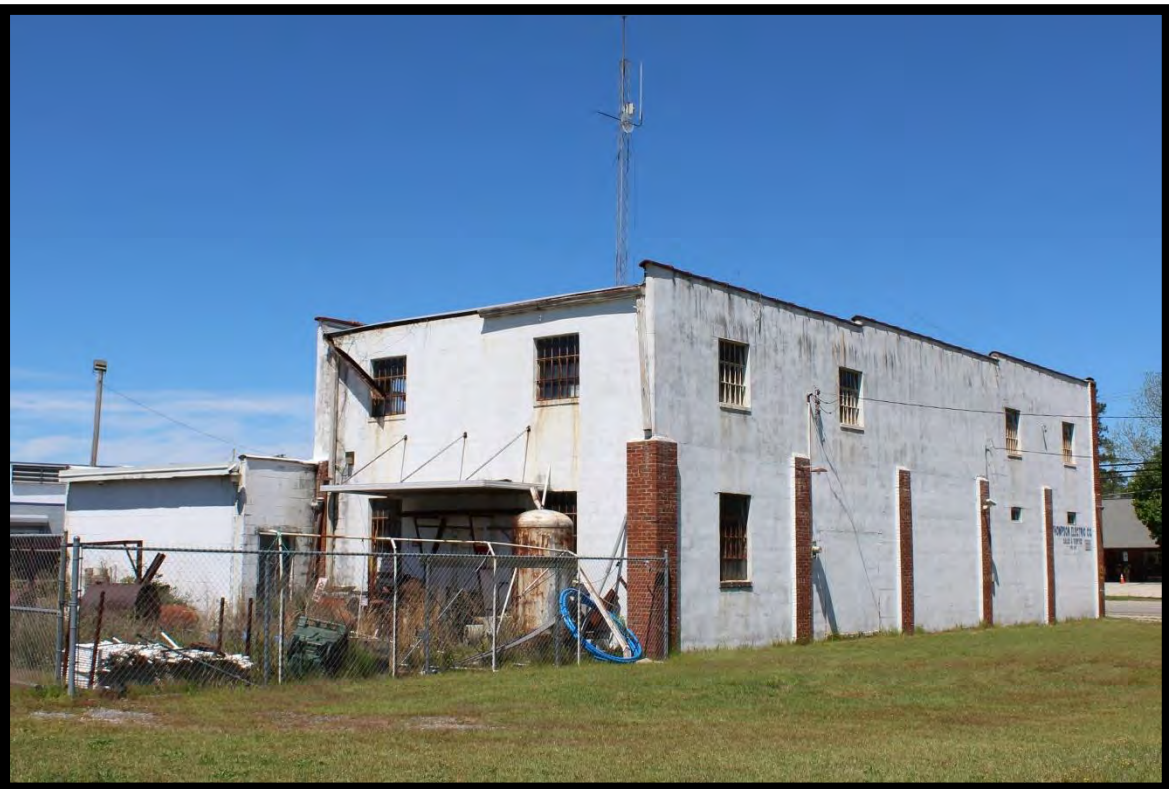
Figure 70: Thompson Electric Company, Looking Northwest.

The south (rear) elevation of the one-story building projects roughly five feet beyond the south elevation of the two-story building and is blind, and the brief east (side) elevation created by the projection contains an entry door. The south elevation of the two-story building contains a modern six-panel entry door that is flanked by two large multi-pane, metal sash windows. A flat metal awning is suspended from the façade by rods and shelters the door and part of the windows. The second-story façade is also lit by large multi-pane, metal sash windows that are aligned above the lower windows. One-story height, brick piers support the corners of the elevation (Figure 70).

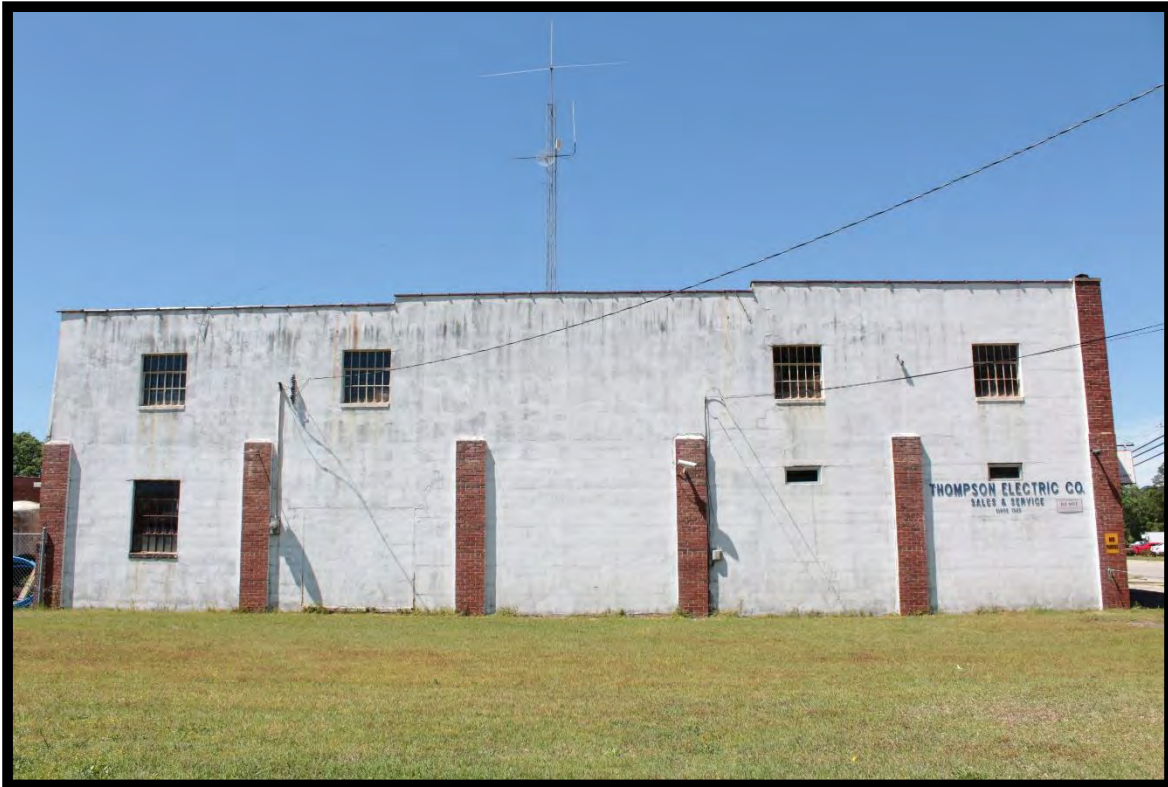
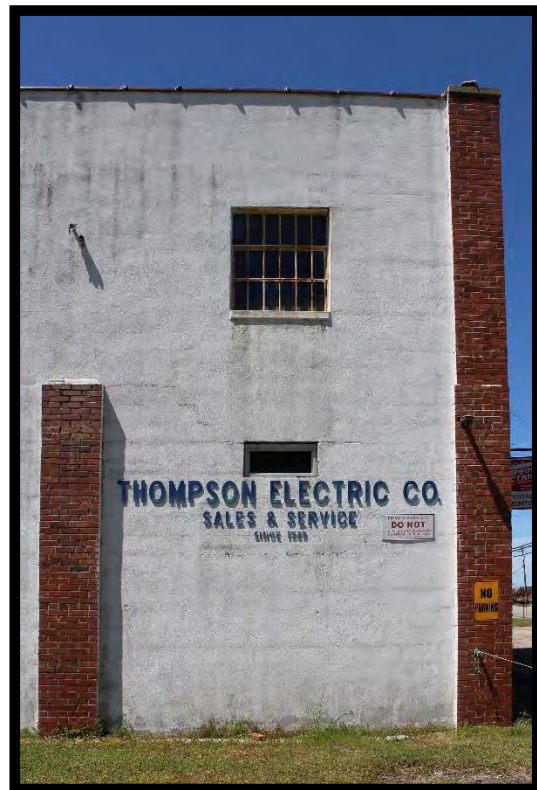
The east (side) elevation is broken into five bays by a series of one-story height, brick piers/buttresses and like the west elevation its roofline is stepped and finished with metal coping. There is one multi-pane, metal sash window on the first story in the southern-most bay. The second bay from the south appears to have had a garage-sized door that is now filled in and the last two bays contains small rectangular windows that are placed near ceiling height. The last bay also contains an applied metal sign that reads “Thompson Electric Co. Sales & Service Since 1929.” Four multi-pane, metal sash windows exist on the second story and light all but the center bay. The brick façade wraps the northeast corner of the building giving the impression of a pilaster (Figures 71 and 72).

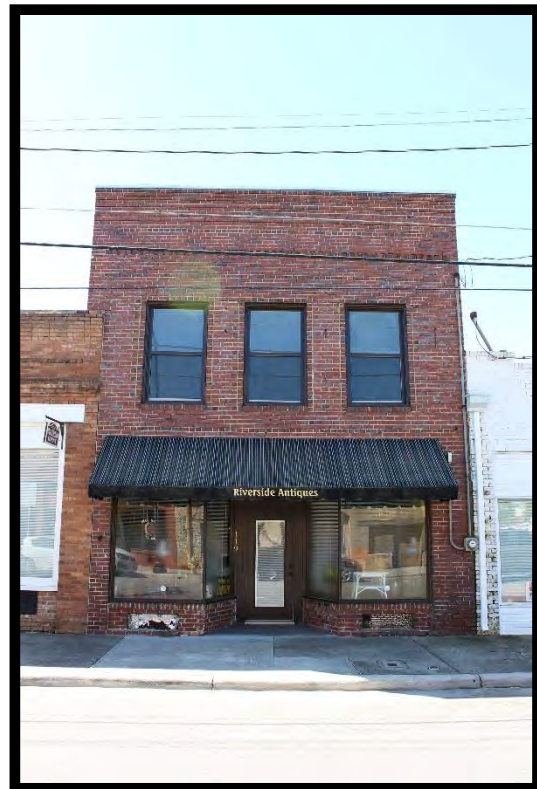
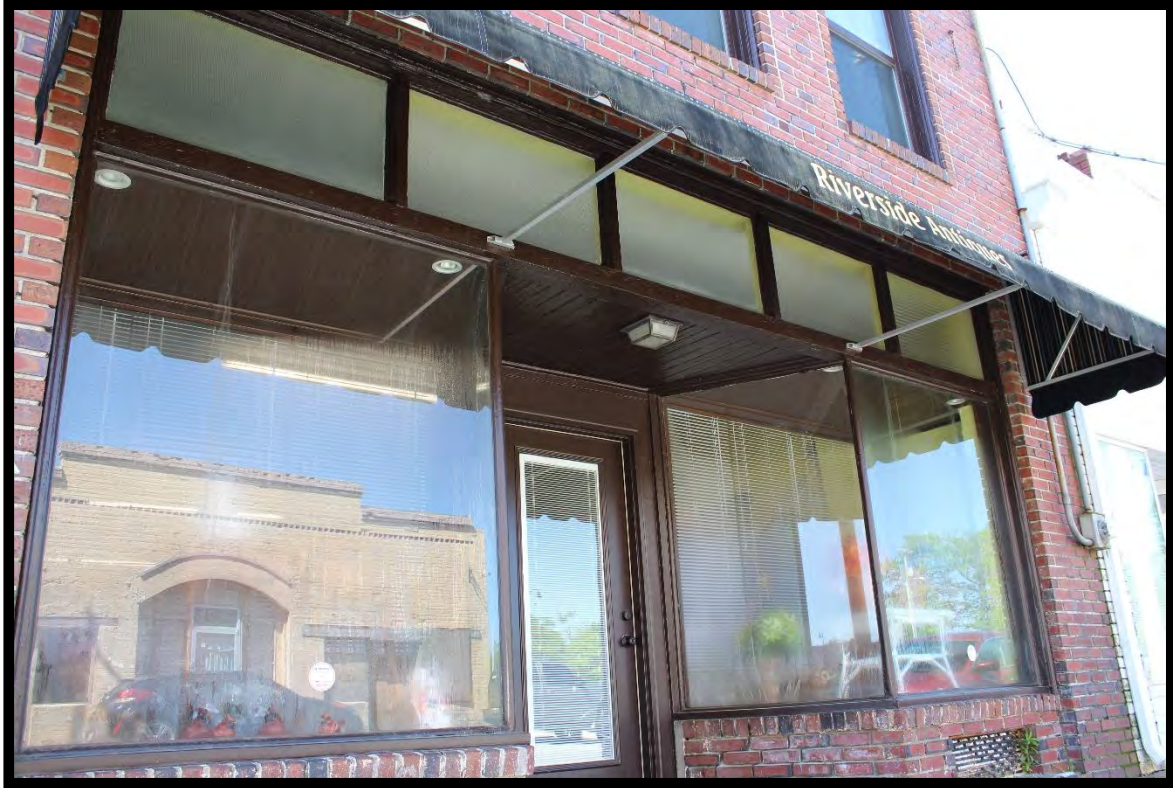
A building that is similar to the original building can be found in downtown Lumberton (Figures 76 and 77, RB0239). Constructed earlier in the twentieth century, the brick store has a wooden storefront across the first-story façade and three wooden sash replacement windows across the second story. It also retains its row of transom windows with textured glass. Because the original portion of the studied building was likely constructed later in the century, it is possible that its original storefront surround material was wood or aluminum. In either case, however, the first-story windows would more likely have been filled with a single large pane than their current two panes and had textured-glass transoms. The integrity of the downtown building is also improved by the presence of similar buildings in its vicinity, a factor that led to it being considered contributing to the Lumberton Commercial Historic District (RB0476).
