SUBJECT: Historic Structures Survey Report, B-5985, Replace Bridges 125 and 175 on NC 41/NC72 and SR 1600 over the Lumbee River, PA 17-12-0065, Robeson County, ER 19-3125

**HISTORIC STRUCTURES SURVEY REPORT
REPLACE BRIDGES NO 125 & 175 ON NC 41/NC 72 AND SR 1600
OVER LUMBER RIVER, ROBESON COUNTY, NORTH CAROLINA**

The North Carolina Department of Transportation (NCDOT) proposes to replace bridges No. 125 and 175 on NC 41/NC 72 and SR 1600 over the Lumber River in Robeson County, North Carolina. The Area of Potential Effects (APE) equates with the study area and spans east from the Y-shaped intersection of West 2nd Street and West 5th Street to North Chestnut Street. The project is included in the North Carolina State Transportation Improvement Plan (STIP) as Project Number B-5985 and is state funded. Federal permits are anticipated.

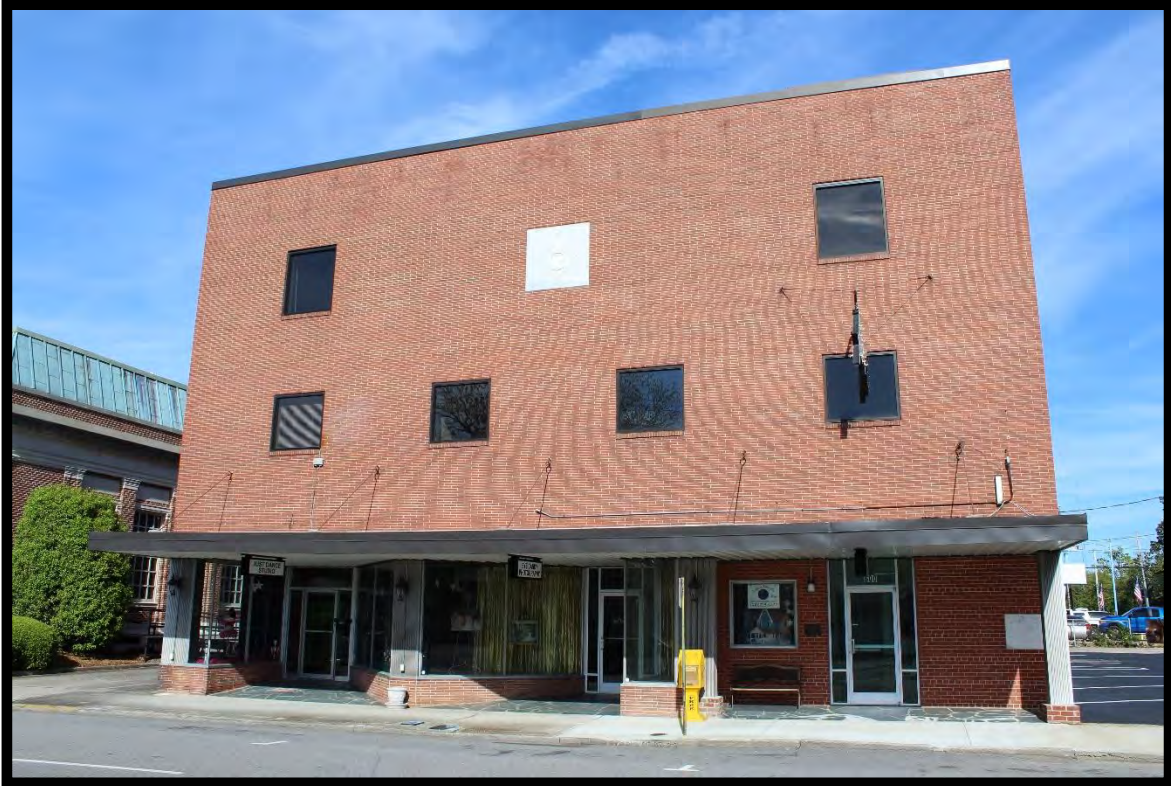
Figure 78: Masonic Building (RB0164), Looking Northeast.

A second building, constructed in between the construction of the two portions of the Thompson Electric Company building, is a Masonic Building (RB0164) on North Elm Street (Figure 78). Larger than the studied building, it contains three storefronts across its façade, two of which appear to be fairly original and that share a similar configuration of angled display windows and recessed doors with the ca. 1965 building. The building also has a suspended awning that may emulate the no longer extant awning of the ca. 1965 building. Its second and third story windows appear to be replacements exhibiting dark frames with single panes of tinted glass. Nonetheless, the standalone building near the northern boundary of the historic district represents the growth of the commercial core, as well as the town's social institutions, into the second half of the twentieth century.

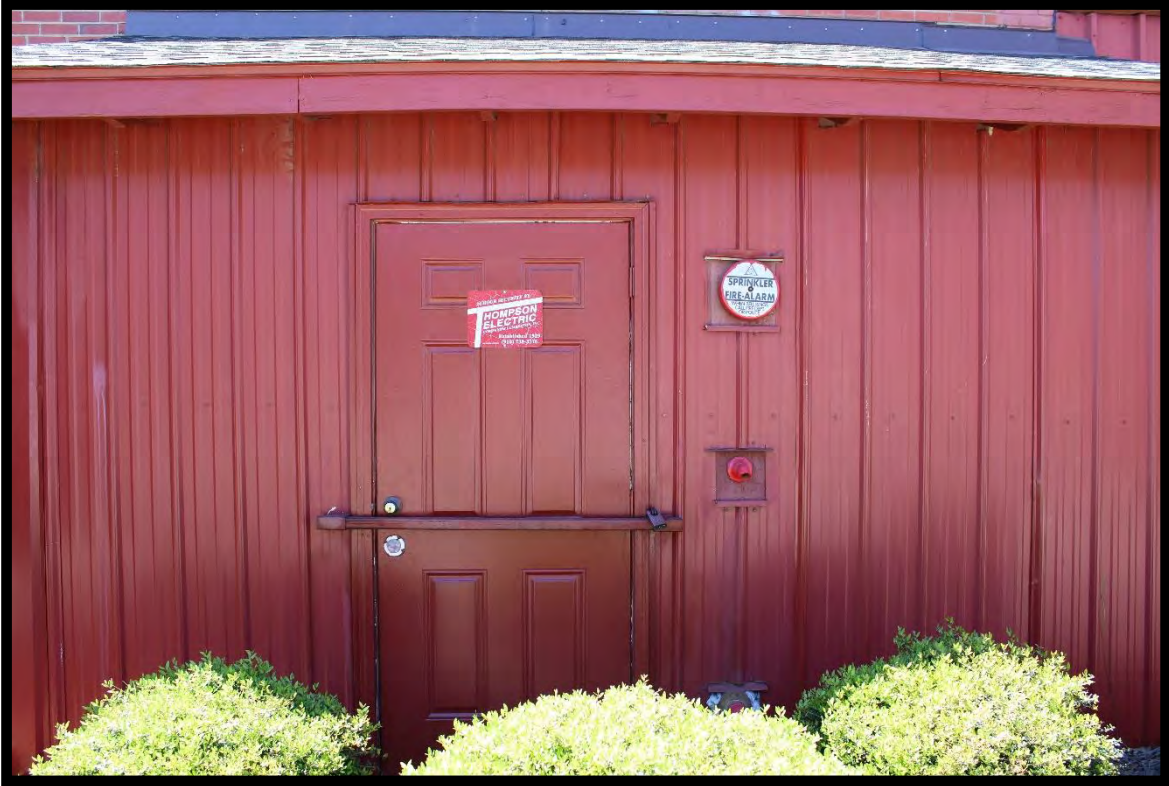
Figure 81: Planters Warehouse, Typical Door, Looking Southwest.

The irregularly shaped brick building was constructed in two phases, likely in the 1940s and 1950s. The two sections are very similar with brick laid in a common bond pattern, flat roofs and various-sized openings that span each elevation. The northeast, primary, elevation has a parapet with metal coping that conceals its roof while the east and west elevations have mansard-like asphalt shingled roofs. The rear elevation does not appear to have a parapet but rather terminates at the juncture of the wall and roof. The northeast elevation of the earlier building is pierced, from east to west, by a window, an entry door, a covered garage opening, three windows, an operable garage door, a window, an entry door, a small shed roofed room, four windows, an operable garage door, an entry door, a small shed roofed room, a covered garage opening, and a window. All of the windows and covered garage openings are covered with red standing seam metal panels (Figure 79). The shed-roofed rooms project from the elevation and are also clad with standing seam metal. They have asphalt shingled roofs and modern six-panel entry doors. The rooms appear to serve a purpose related to fire prevention or security (Figure 81).

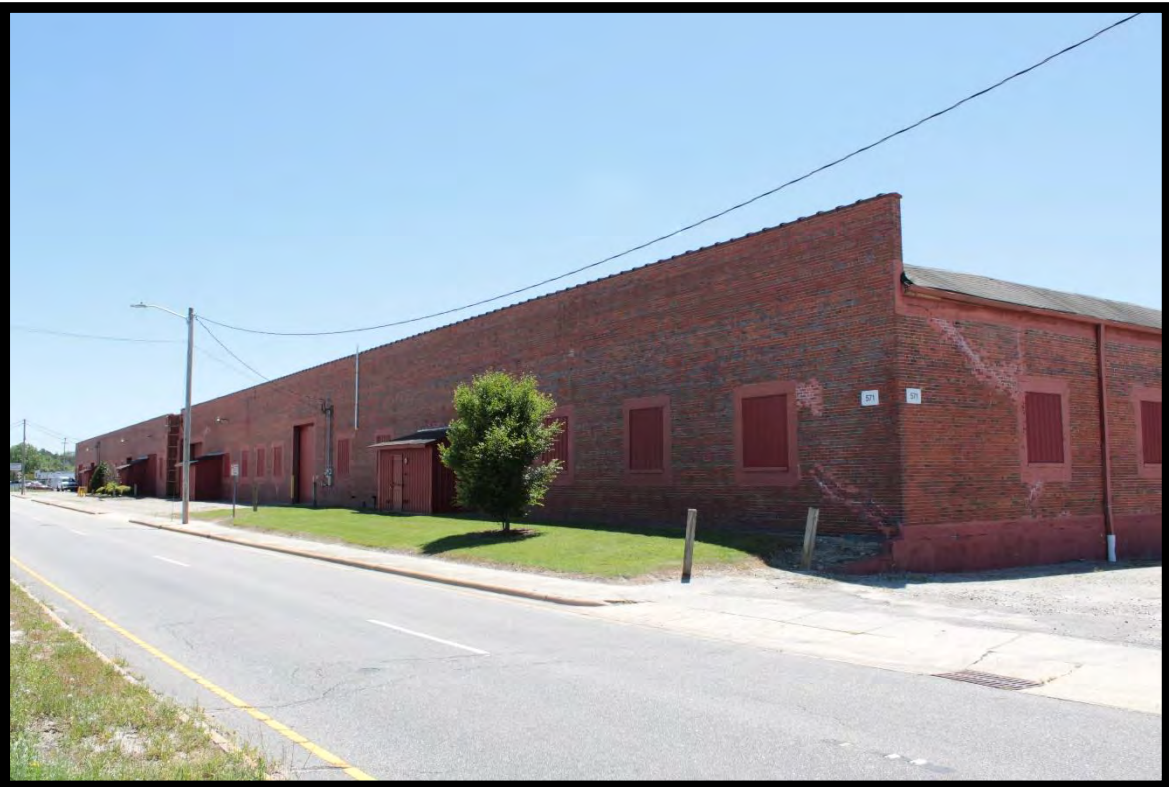
Figure 82: Planters Warehouse, Looking Southeast.

The second building is set back slightly from the first and has a slightly higher roof line. A number of braces and pipes are present at the juncture and may serve as gutters for the building's roof. Its elevation is pierced by features identical to the earlier elevation, including from east to west, an operable garage door, a small shed roofed room, a window, an entry door, three windows, an operable garage door, two windows, a small shed-roofed room, an entry door, and three windows (Figure 82).

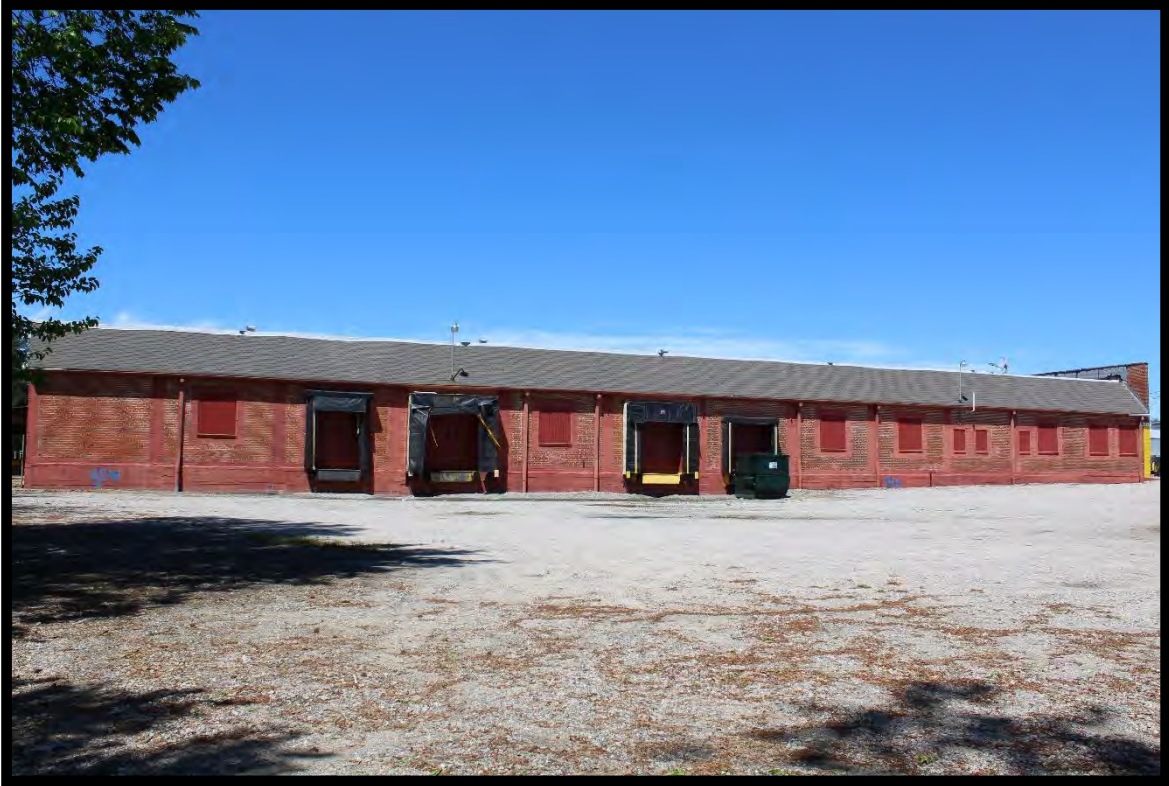
Figure 83: Planters Warehouse, Looking Northwest.

The southeast (side) elevation serves as a loading dock and is pierced, from south to north, by a window, two loading docks, a window, two loading docks and eight windows. Three of the windows in the center of the span of eight are smaller than the building's typical windows (Figure 83).

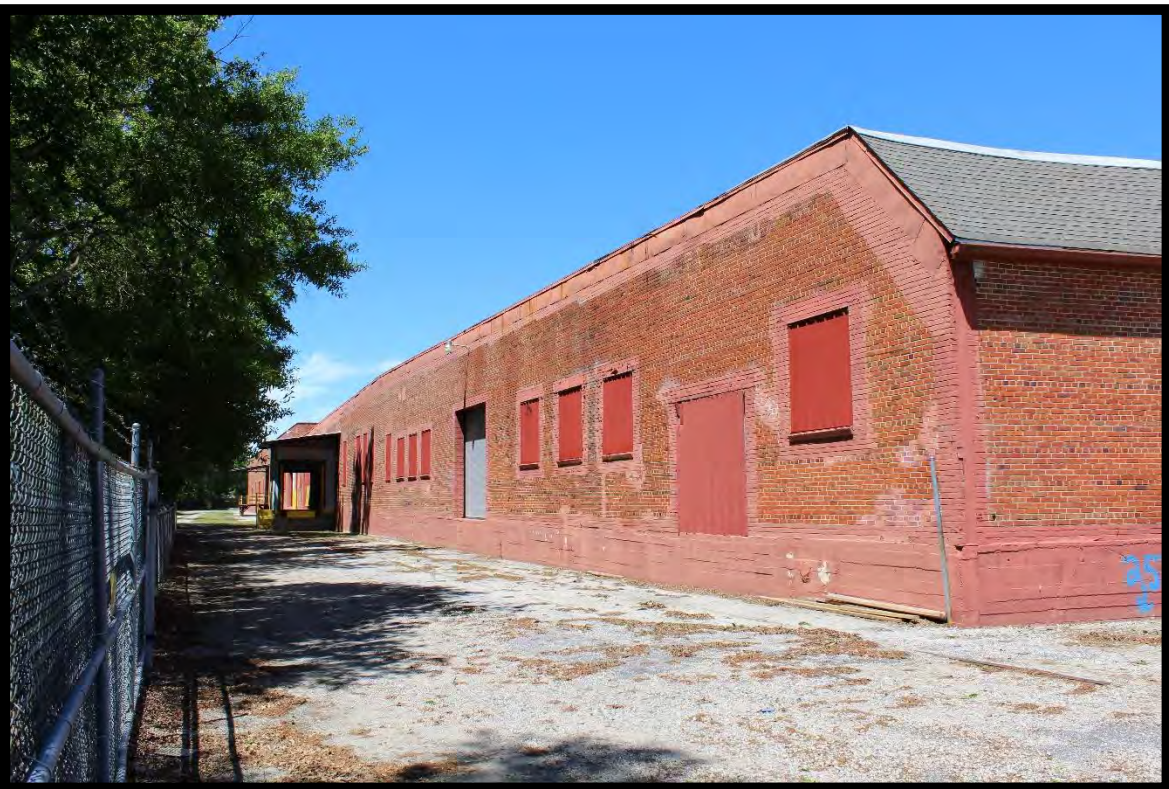
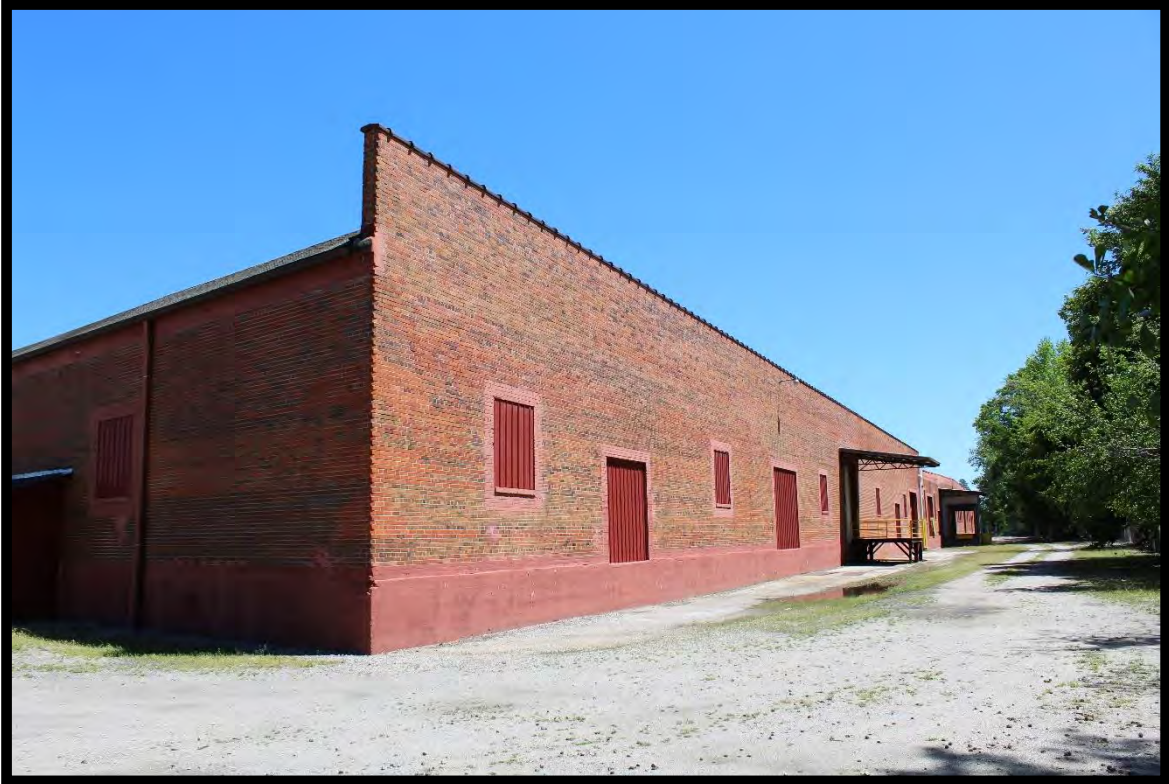
The southwest (rear) elevation is also pierced by covered and functional apertures as well as a loading dock and a platform that project from the building (Figures 84 and 85). The loading dock opens perpendicular to the main building and has a standing seam metal shed roof, standing seam metal and plywood cladding, and concrete foundation. Its southwest elevation has a metal entry door approached by concrete steps. The platform has a metal deck with metal supports and is sheltered by a shed-roofed awning with metal braces (Figures 86 and 87). This elevation also exhibits the building's form poured concrete foundation and an abandoned railroad spur follows the elevation as well (Figure 88).

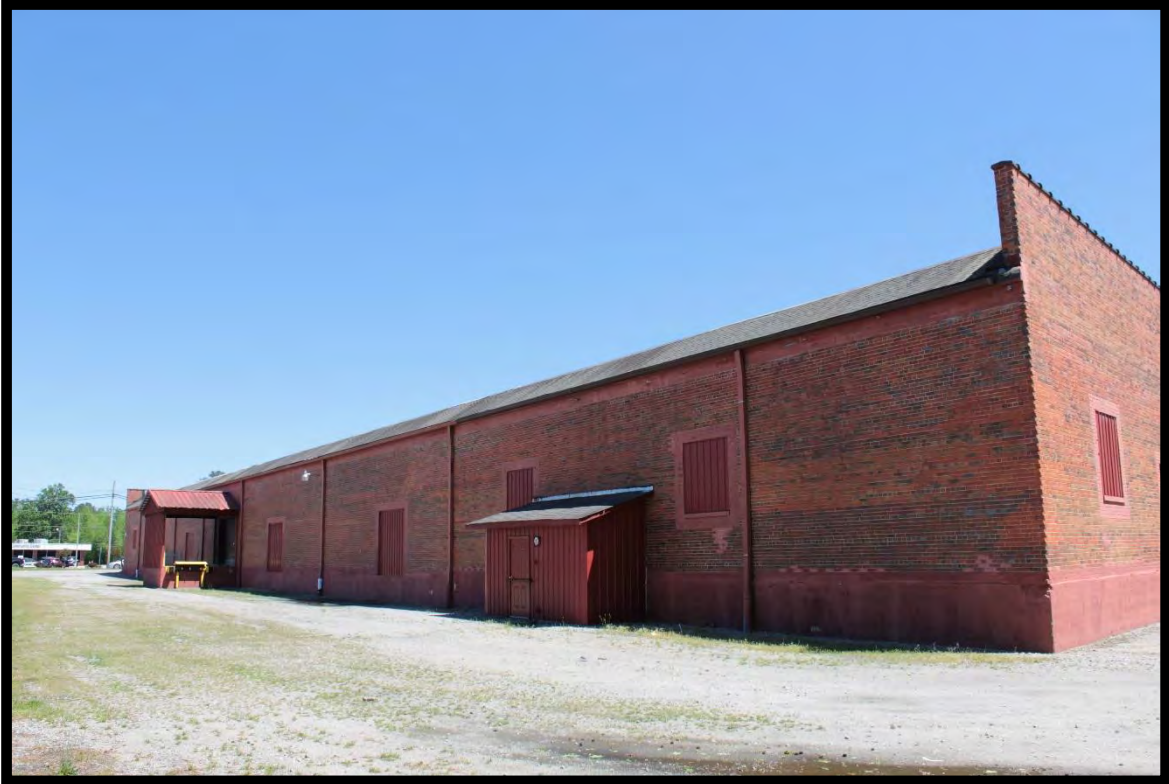
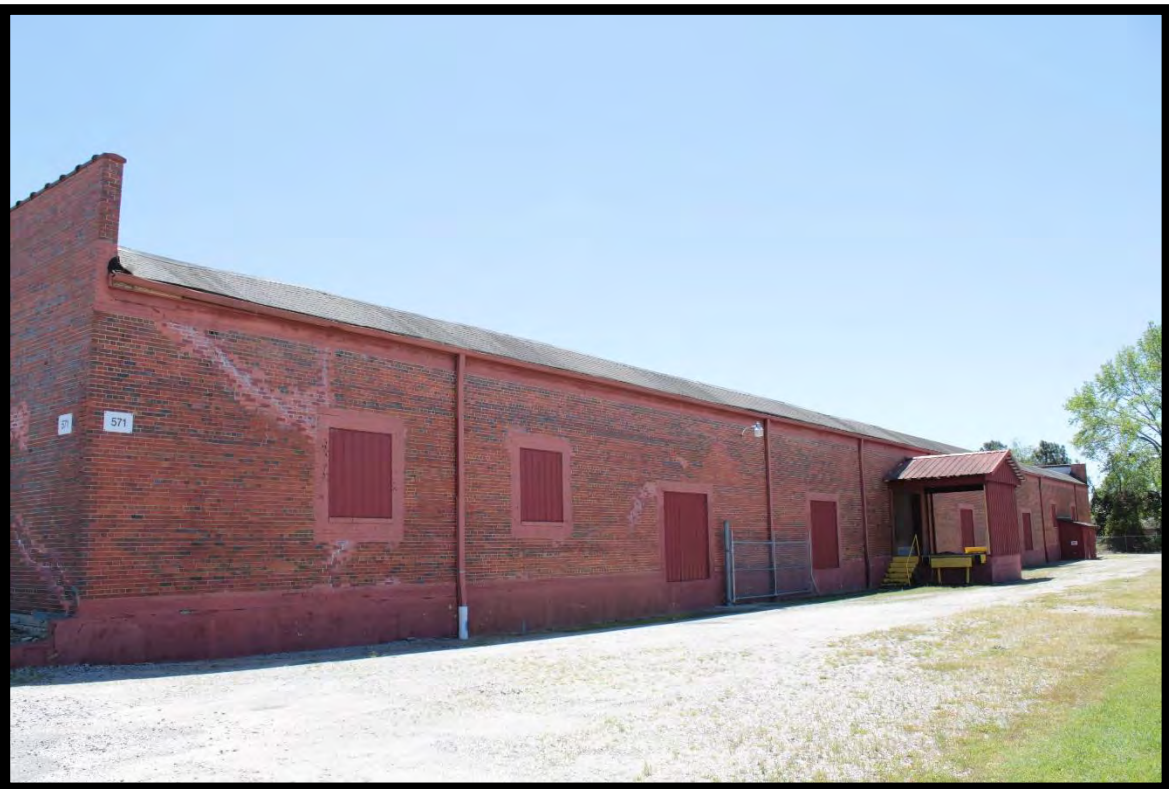
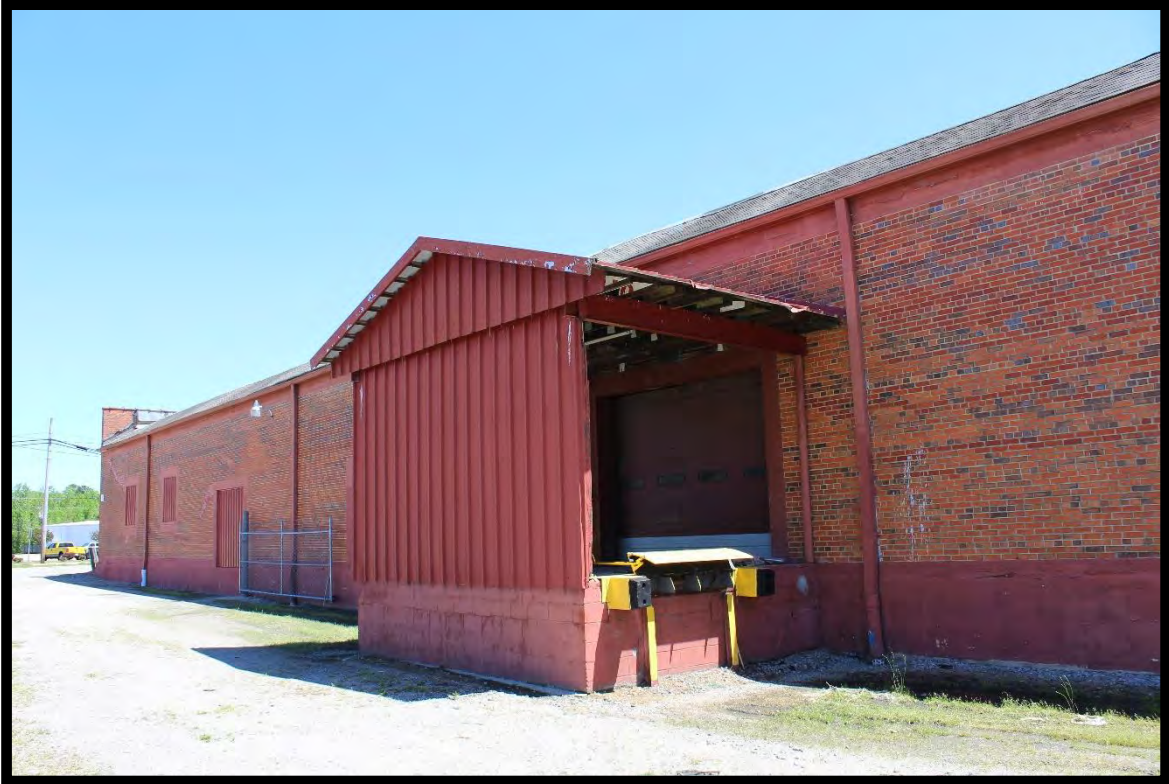
The northwest elevation has a roughly symmetrical façade with four small loading dock openings and four window openings that flank a garage door with a projecting platform. The small loading dock openings and windows are all covered. The garage door is sheltered by a gable-roofed structure that is open on the northeast and southwest, clad with standing seam metal on the northwest, and has a concrete block foundation. A set of concrete block steps lead to the northeast side and it is used as a loading dock. A shed-roofed structure, like on the northeast elevation, also projects from the elevation near the southernmost windows (Figures 89 through 91).

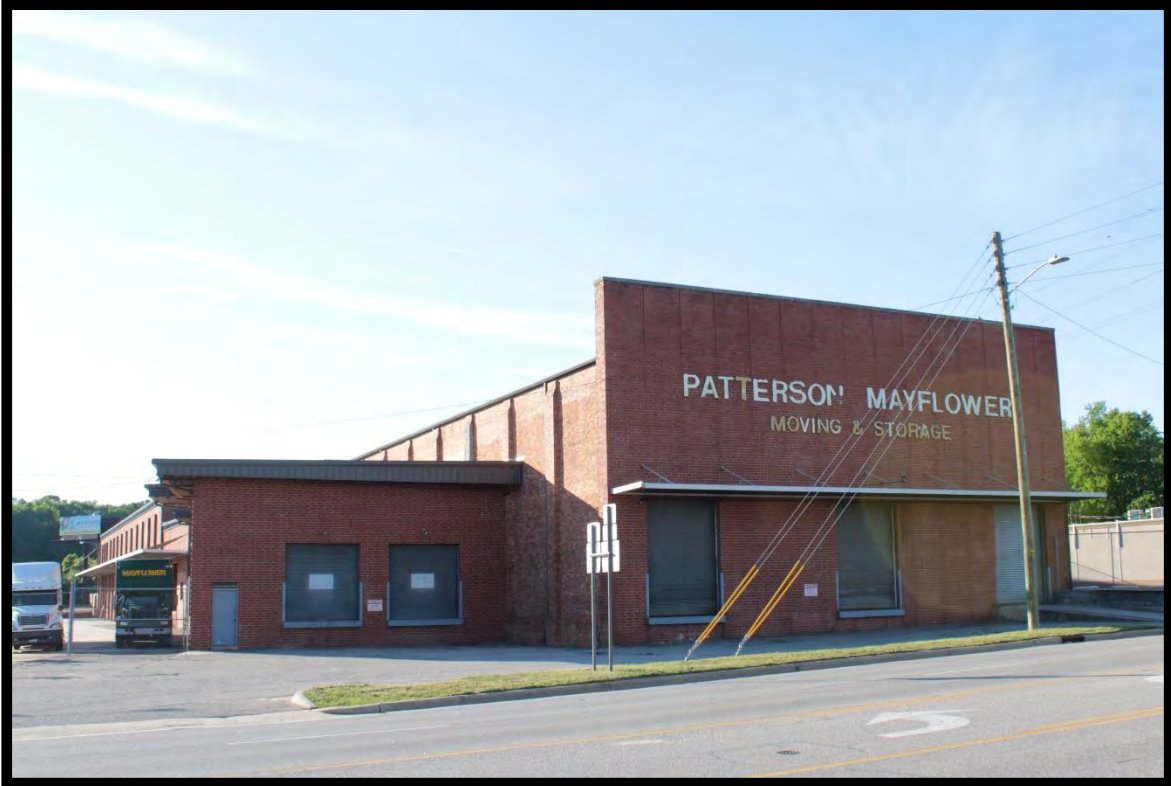
Figure 97: Patterson Mayflower Moving & Storage, 472 Robeson Street, Fayetteville, North Carolina, Looking Northwest.

Though not in Robeson County, an outstanding example of a ca. 1950 warehouse can be found at 472 Robeson Street in Fayetteville. Now used as a storage warehouse for Patterson Mayflower Moving and Storage, the building has been expanded with a large rear warehouse and a small, one-story loading area. However, the building's tall, parapet façade with slender columns of raised bricks that guide the viewer's eye up and give the façade a striped look is still indicative of the period in which it was constructed. A suspended, flat-roofed awning and pilaster-like buttresses on the side elevations harken to this period as well (Figure 97).

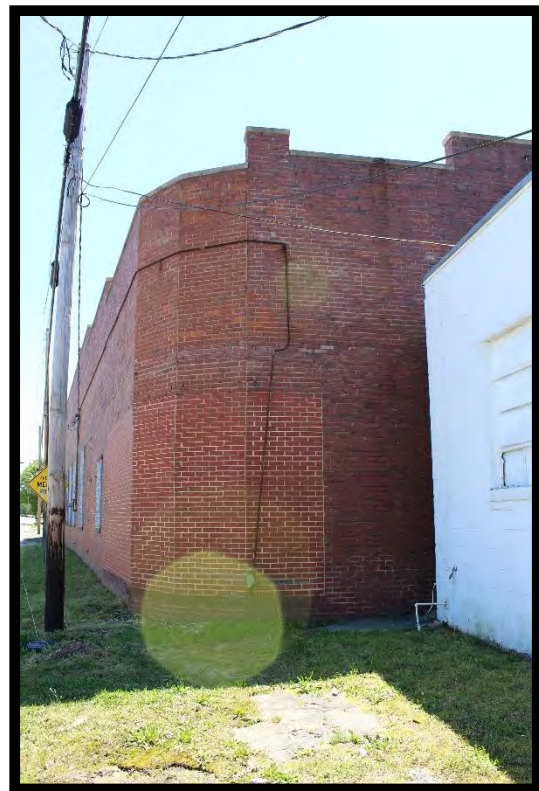
Figure 100: Automobile Sales Center, Looking Southeast.

The primary façade of the one-story, brick sales center faces west to the Y-intersection of West 5th and West 2nd Streets and has a large stepped parapet that conceals a flat roof. The façade is interesting in that it is partially concealed by a small ca. 1945 filling station but is still clearly visible to the east bound traffic approaching the intersection. The tiers of the parapet, including four small crenellations near the corners and center of the elevation, are capped with concrete coping and there is a large faded painted sign centered on the elevation. A more modern sign for the Heafner Tire Company is placed above the painted sign and almost entirely covers a small circle of brickwork that decorates the top tier of the parapet. Due to the shape of the parcel, the building has an irregular, trapezoid-like shape and this elevation is significantly shorter in width than the north and south (side) elevations as well as the east (rear) elevation, which is the widest. Also, though the elevation is large and impressive, it doesn't appear to have had an entry door at any point suggesting that its lower portion has always been concealed by the filling station (Figure 98). Another distinguishing feature of the west elevation is that its corners are curved and appear to have once contained large display windows, which would have been highly visible to traffic at the Y-intersection. The windows are also characteristic of mid-century automobile sales centers. Today, the windows are filled with brick (Figure 100).

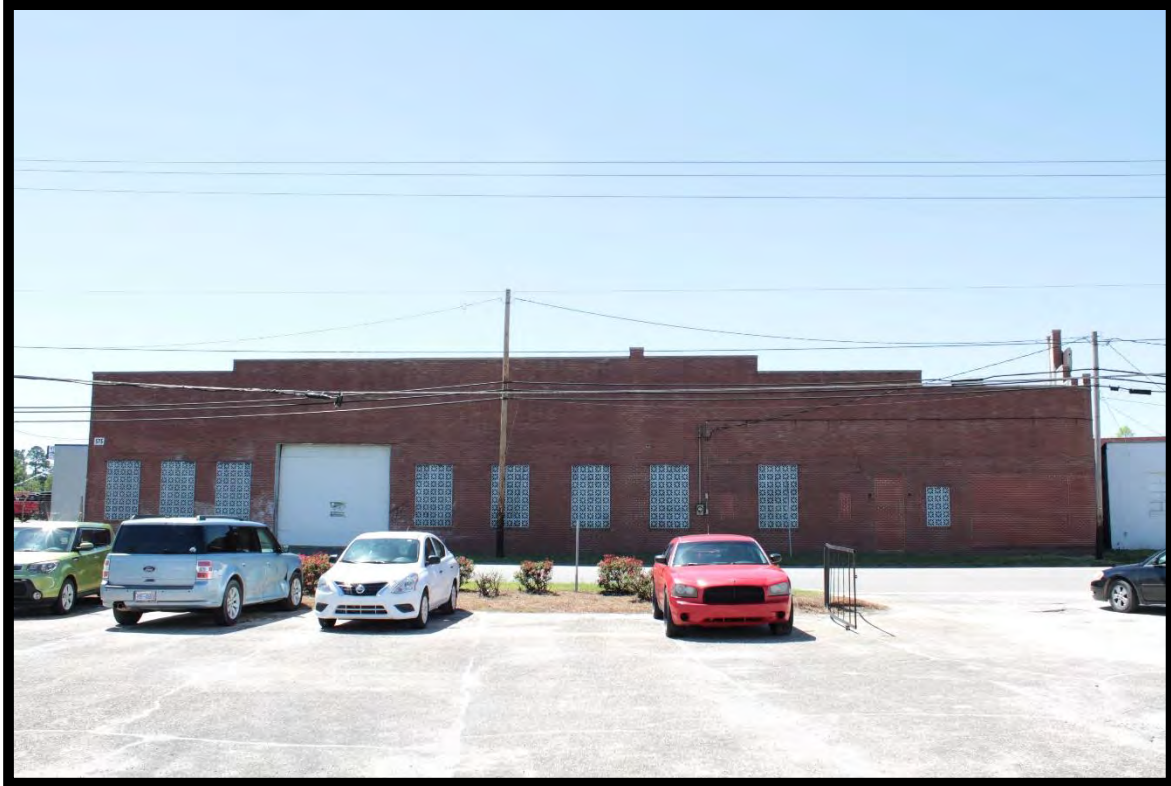
Figure 101: Automobile Sales Center, Looking South.

The north (side) elevation has a stepped parapet as well though it contains less tiers and does not rise as high as the west elevation. It's pierced by eight windows that have been filled with decorative concrete block screens. Between the third and fourth windows, from the east, there is a large modern garage door. Small windows filled with brick flank the eighth window as well and a doorway filled with brick exists to its west. There is also an additional small window filled with a decorative concrete block screen between the filled doorway and the filled windows at the northwest corner of the building (Figures 101 and 102).

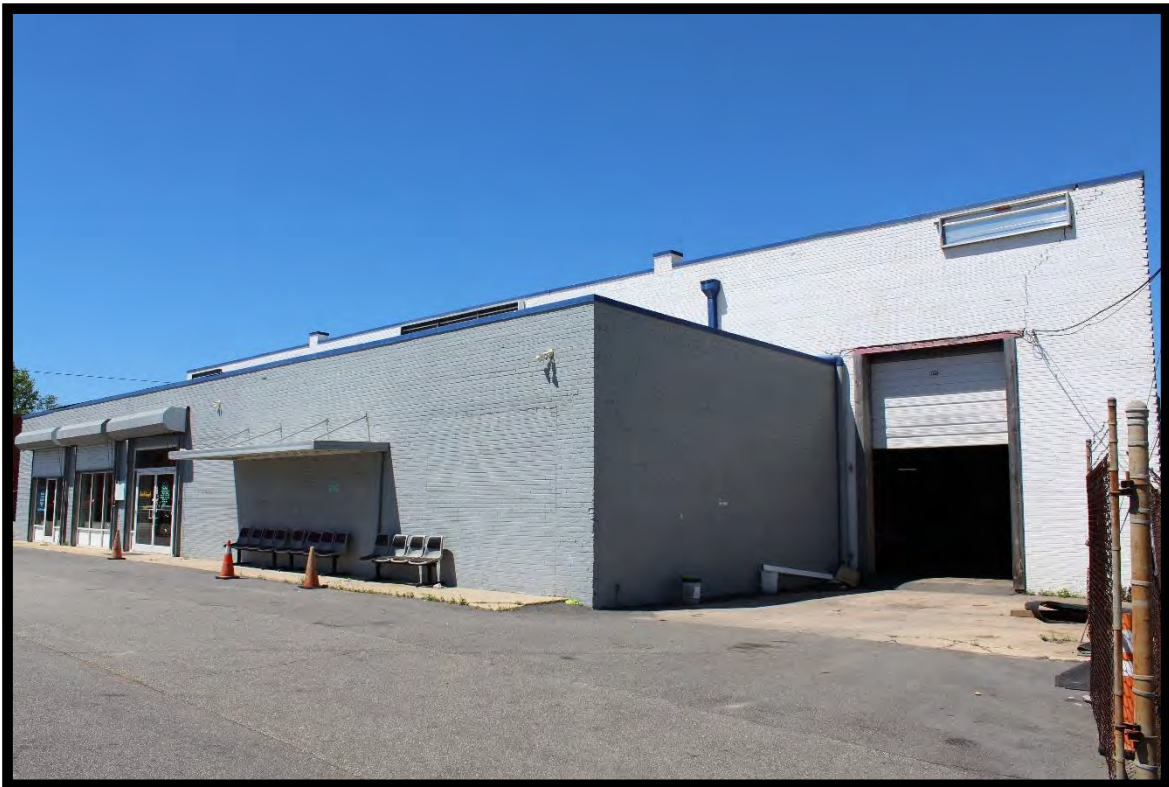
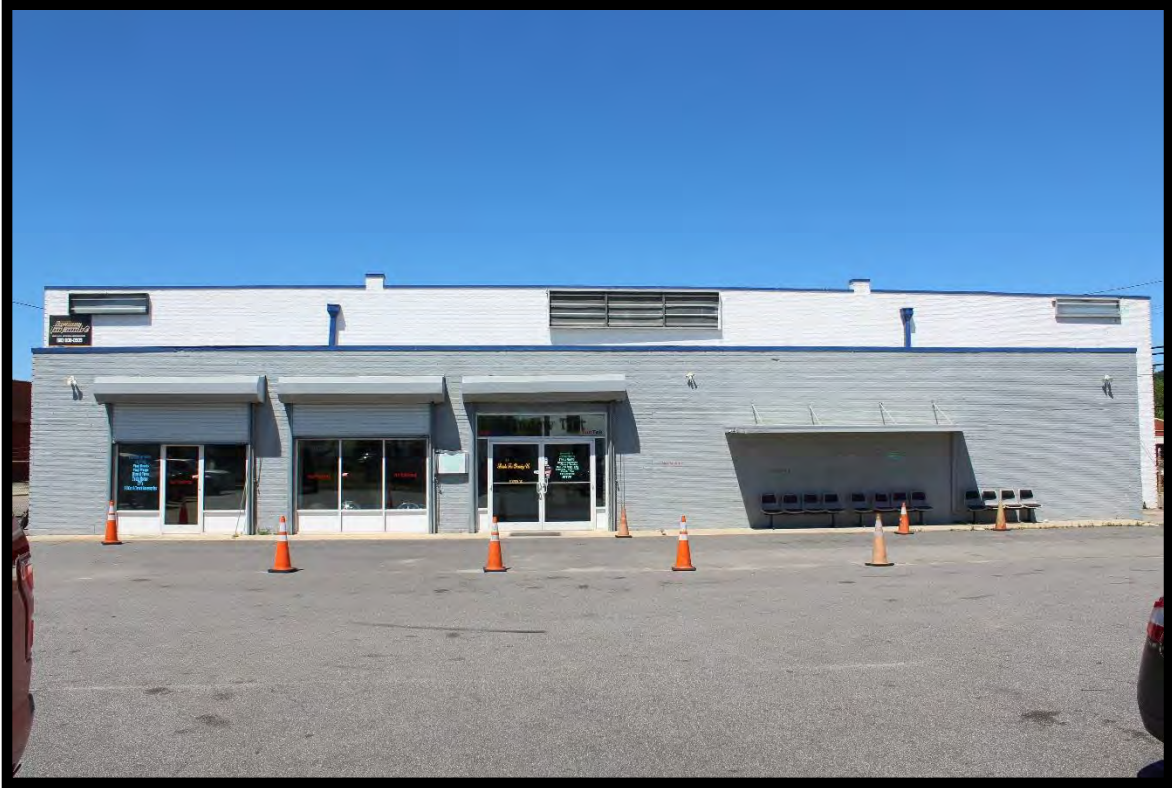
display windows, three display windows, and a double-leaf entry door flanked by narrow side lights and a two-pane transom window. All of the windows are above panels and the space above those with without transoms is filled with metal or vinyl. North of the apertures is a waiting area sheltered by a flat metal awning that is suspended from the elevation. Irregularities in the brick suggest that there were originally two to three garage doors in this vicinity as well as an entry door south of the existing apertures. The north (side) elevation of the addition is blind while the south (side) elevation contains a large window or screen filled with decorative concrete blocks (Figures 103 and 104).

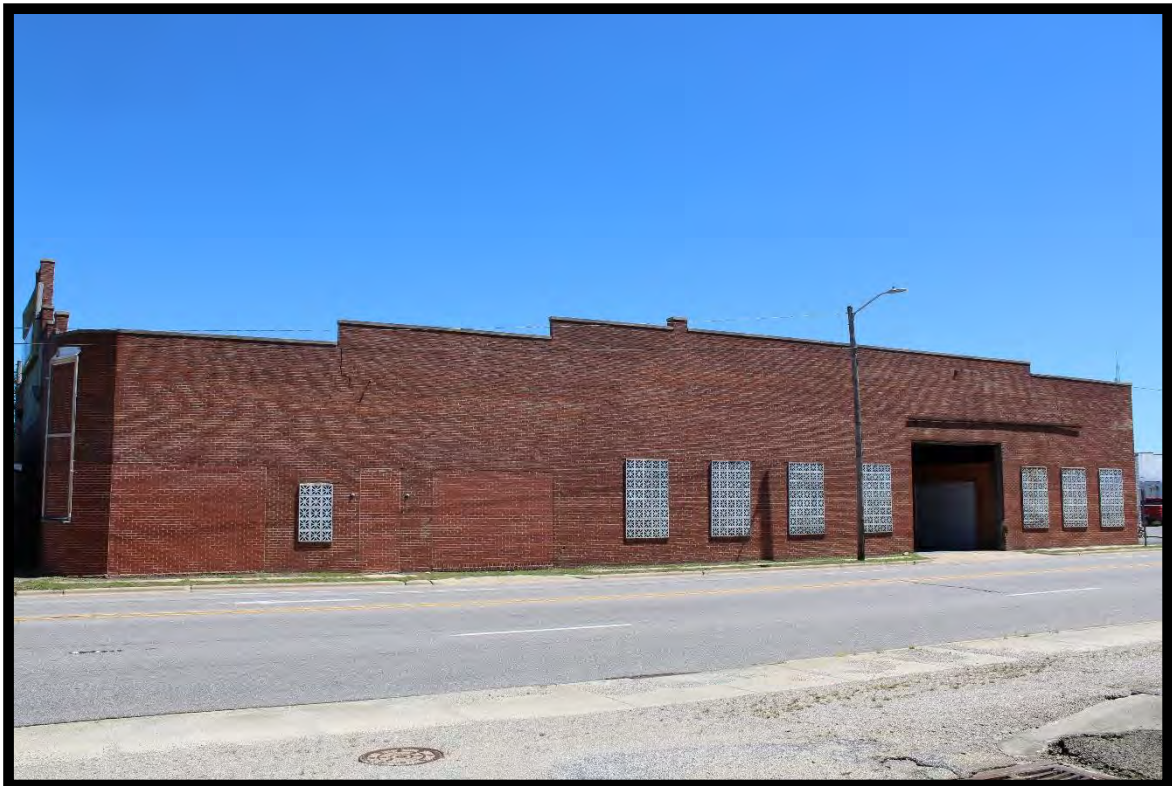
Figure 105: Automobile Sales Center, Looking Northeast.

The south (side) elevation has a stepped parapet like the north elevation and is pierced by seven windows with decorative concrete block screens. There is a large modern garage door between the third and fourth windows from the west. West of the windows is a garage-sized opening filled with bricks, an entry door filled with bricks, a small window filled with decorative concrete block, and a portion of the display window at the southwest corner, which is also filled with bricks. The remnants of original light fixtures are noticeable above the garage door and flanking the filled in entry door (Figure 105).

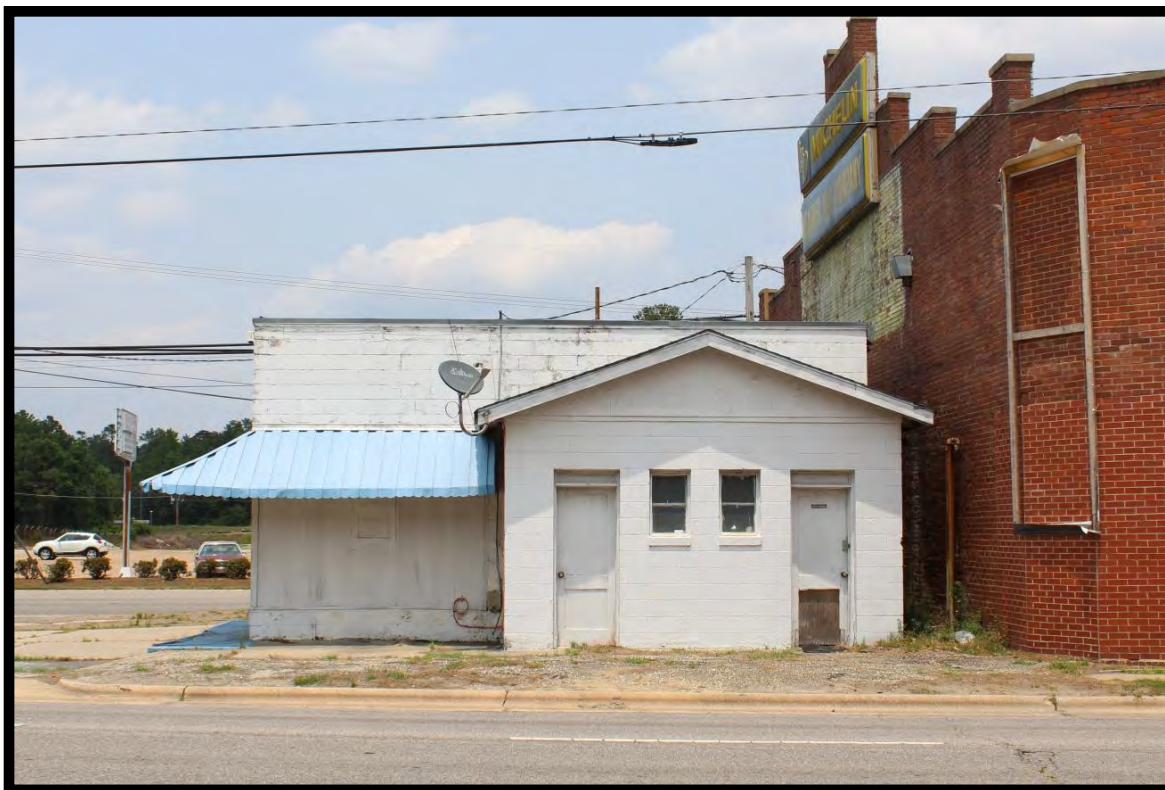
Figure 115: Filling Station, Looking North.

The ca. 1945 one-story concrete block building has a flat roof concealed by a parapet and displays a typical mid-century garage form with two large replacement garage doors and a storefront on the west (front) elevation. The storefront consists of an entry door flanked on the south by a large display window that wraps the southeast corner of the building and is covered with beadboard (Figure 113). There is a small opening that is now filled with plywood in the south facing portion of the window. The storefront is sheltered by a metal awning that also wraps the corner. On the south (side) elevation, beyond the display window, a gabled restroom wing projects from the building. It contains two wooden entry doors that flank small wooden sash, one-over-one windows (Figure 115).

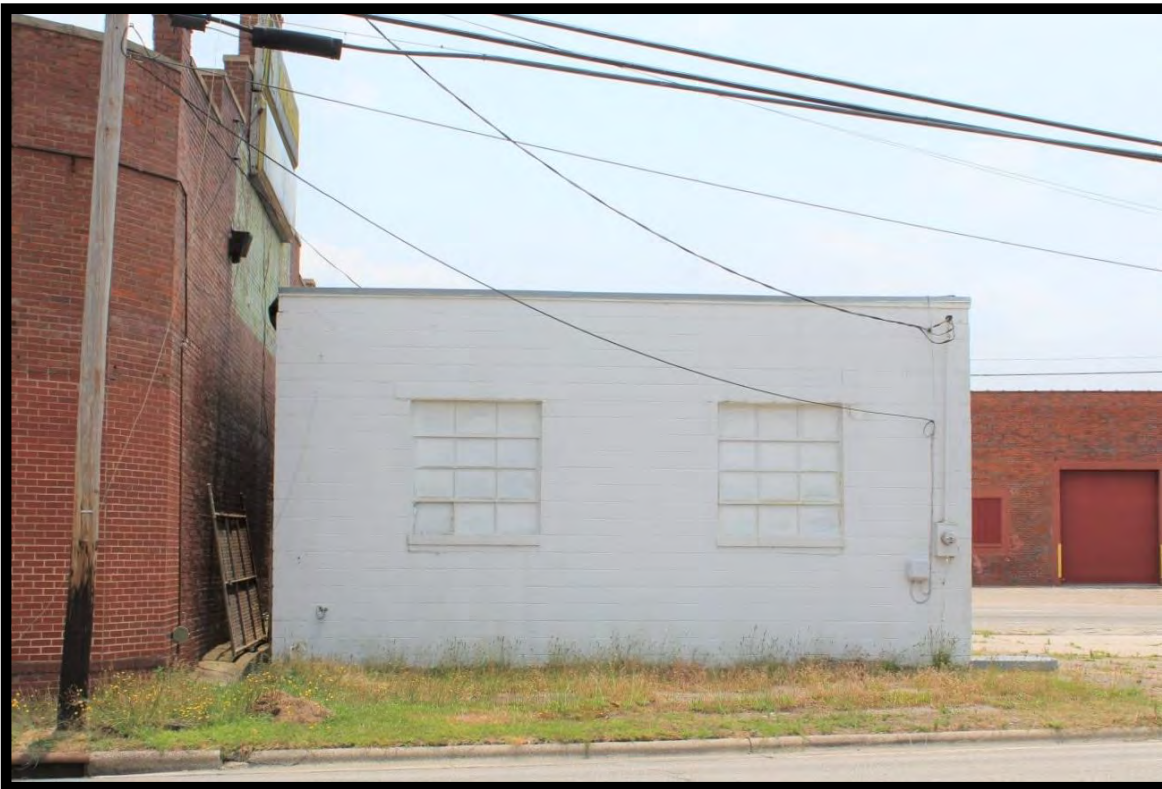
Figure 118: Filling Station, Looking South.

The east (rear) elevation contains a metal sash window that likely lights an office and two linear, metal sash windows that are placed near the roofline and light the building's garage space. According to a deed, the building is placed six inches from the parcel line.¹¹⁴ The neighboring building is also placed near the property line visually obstructing the elevation (Figures 116 and 117). The north (side) elevation contains two multi-pane steel sash windows (Figure 118).

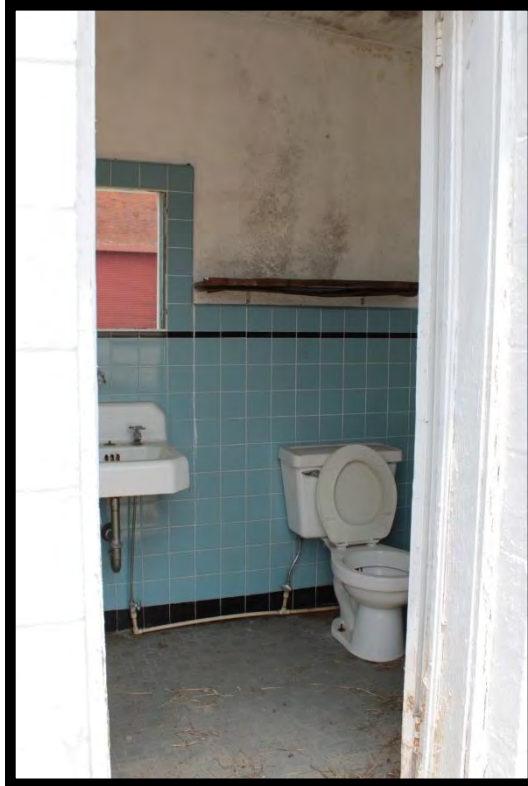
Figure 119: Filling Station, Restroom, Looking Northeast.

Attempts to contact the owner were unsuccessful and the surveyor was unable to gain access to the interior of the core of the building. The interior of the core, however, is most likely divided into two spaces: a two-bay garage space and an office/retail area. One of the restrooms on the south elevation of the building was accessible and has a tiled interior with a porcelain toilet and sink and mirrors. The second restroom likely mirrors this arrangement (Figure 119).

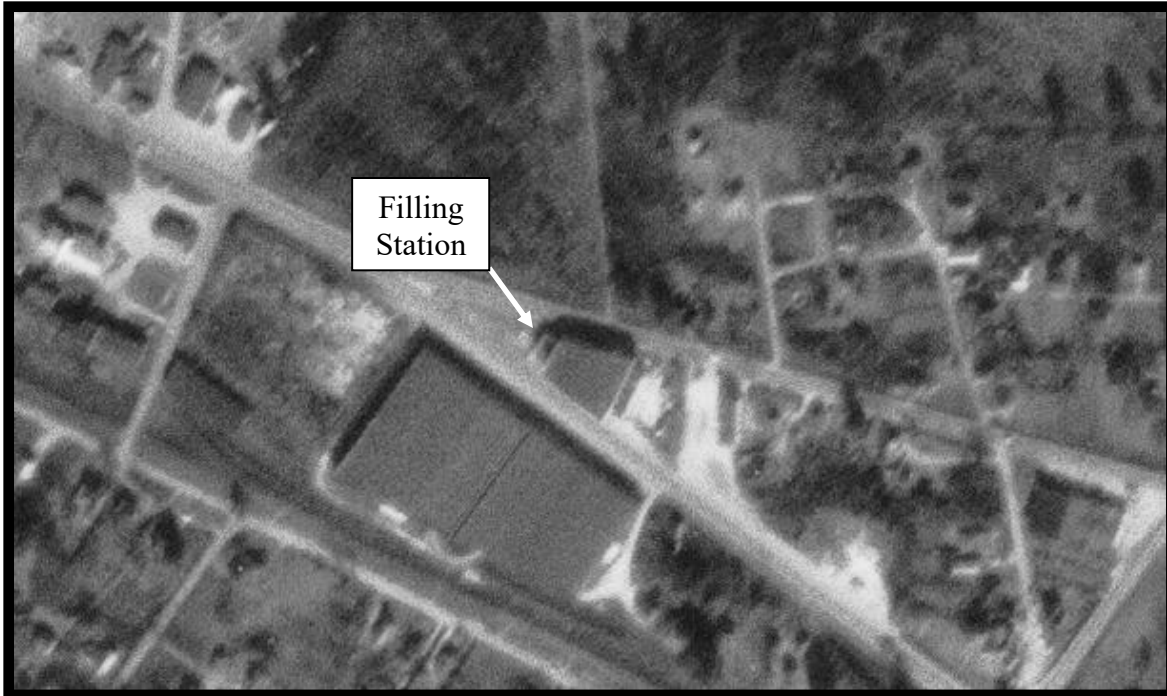
Figure 120: 1958 USGS Aerial Showing Location of Filling Station (Source EarthExplorer).

It is likely that Wade purchased the parcel in Lumberton with plans to expand his Pembroke business though no businesses are listed at the address in the available city directories from the 1930s and 1940s. In August 1945 Wade sold the Pembroke business to O. Clinton Norment and Cutlar Moore who changed the name from Tyner Motor Co. to Pembroke Motor Company.¹²⁰ At the same time, possibly as part of the sale, the Tyners sold the eastern portion of the Lumberton parcel, which now contains an Automobile Sales Center (RB0719), to Norment. Norment was already well established as an automobile dealer in Lumberton, operating Norment Motor Co. Inc. The deed confirms the existence of the filling station at this time stating that the new parcel lied “6 inches east of the east wall of a one-story filling station.”¹²¹ The small building is also visible on a 1958 aerial photograph of Lumberton (Figure 120).

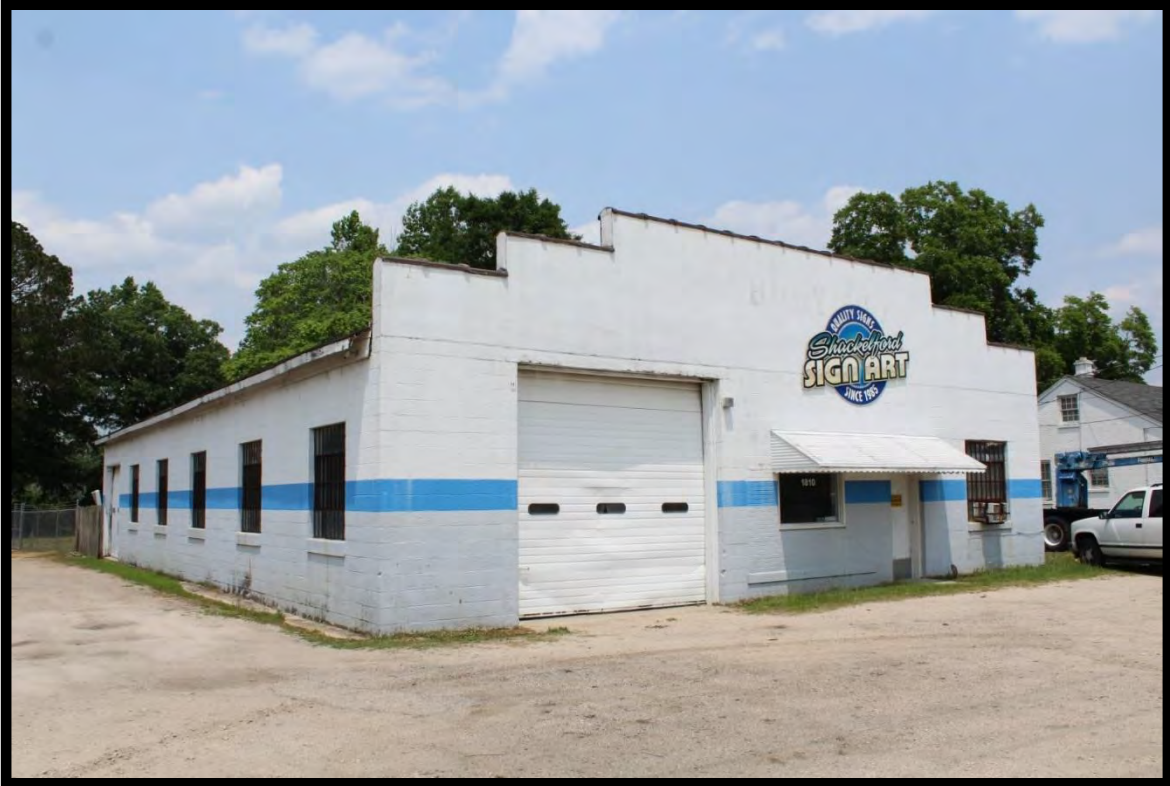
Figure 122: 1810 West 5th Street, Lumberton, NC, Looking East.

A comparable resource in Lumberton is located roughly one mile west of the filling station at 1810 West 5th Street (Figure 122). Now used as a sign shop, the building is described in the Robeson County tax records as a ca. 1940 Auto Service Garage. Like the studied filling station, it is a concrete block building with a large garage bay and an office/retail space. The building differs, however, in that it does not exhibit the quintessential oblong-box form, only has one garage bay, and has a stepped parapet roof. It also does not appear that it was used as a filling station but was constructed to meet service needs. Because it does not follow the typical filling or service station form, the building is more representative of a one-off, independently owned business rather than one owned by or mimicking a corporate brand. This distinction also makes it more representative of this area of Lumberton, which is defined by a variety of building types, most of which reflect utilitarian functions versus a particular architectural styles or design motifs.

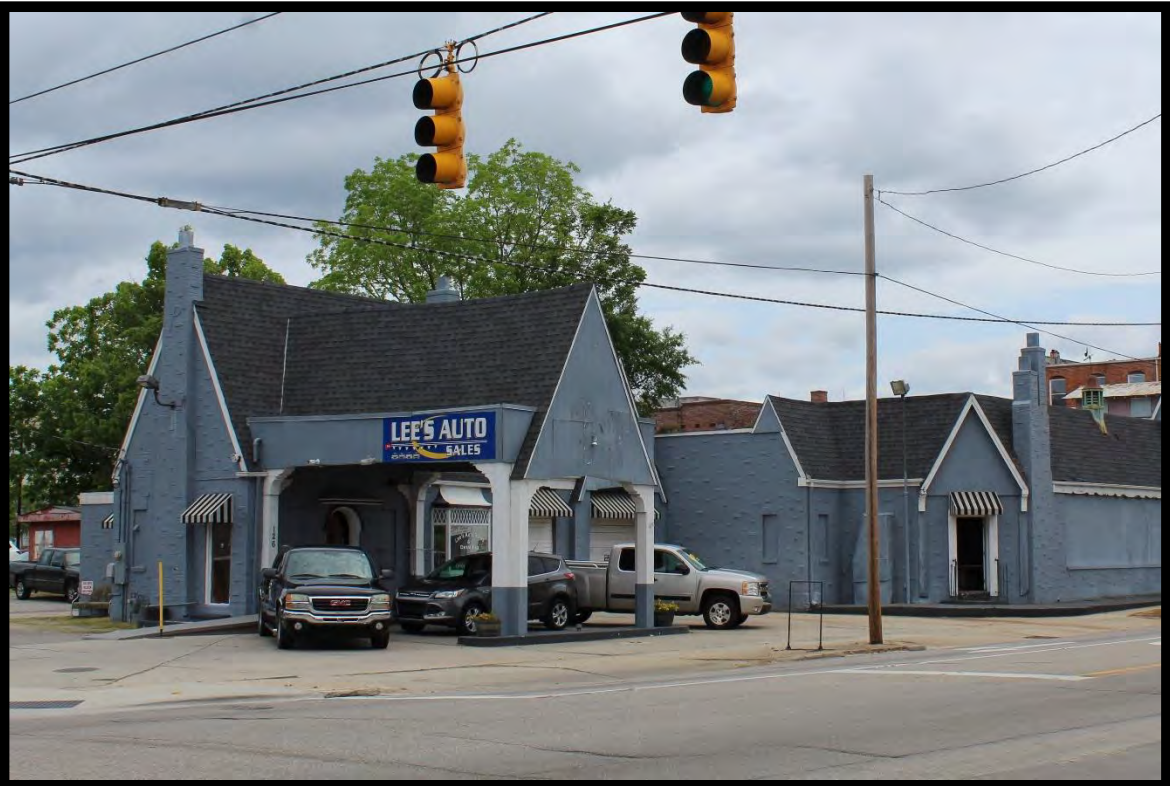
Figure 123: Pure Oil Filing Station (RB0180), Looking Northeast.

In contrast, two filling stations east of the Lumber River are still highly representative of their original designs and are easily linked with the fuel companies that established them. These stations include the 1947 Pure Oil Filling Station (RB0180, Figure 123) on West 2nd Street and a ca. 1935 gas station (RB0230, Figure 124) on East 2nd Street, both of which contribute to the NRHP-listed Lumberton Commercial Historic District (RB0476). The Pure Oil station is an intact example of the company’s use of a residential design with Tudor Revival-style influences and identifiable colors. The second gas station was likely an Esso station based on its tiled pent roof, stuccoed elevations, and art deco pilasters.¹³⁴ Due to the retention of these character-defining features, these resources serve as better examples of intact filling stations and are more closely associated with the periods in which they were constructed.
