SUBJECT: Historic Structures Survey Report, B-5985, Replace Bridges 125 and 175 on NC 41/NC72 and SR 1600 over the Lumbee River, PA 17-12-0065, Robeson County, ER 19-3125

**HISTORIC STRUCTURES SURVEY REPORT
REPLACE BRIDGES NO 125 & 175 ON NC 41/NC 72 AND SR 1600
OVER LUMBER RIVER, ROBESON COUNTY, NORTH CAROLINA**

The North Carolina Department of Transportation (NCDOT) proposes to replace bridges No. 125 and 175 on NC 41/NC 72 and SR 1600 over the Lumber River in Robeson County, North Carolina. The Area of Potential Effects (APE) equates with the study area and spans east from the Y-shaped intersection of West 2nd Street and West 5th Street to North Chestnut Street. The project is included in the North Carolina State Transportation Improvement Plan (STIP) as Project Number B-5985 and is state funded. Federal permits are anticipated.

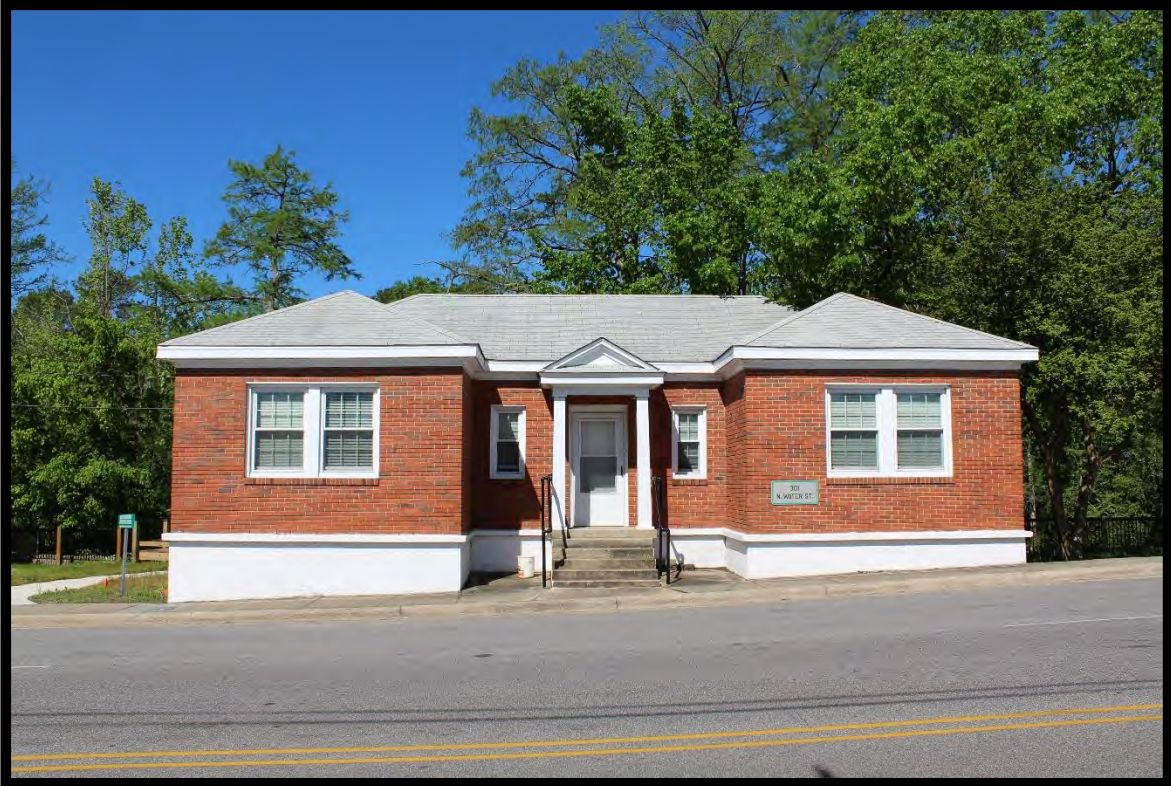
Figure 125: NCDOT Office, Looking West.

The ca. 1950 one-story brick building has a U-shaped footprint, rests on a tall parged brick or concrete foundation, is sheltered by an asphalt-shingled hipped roof with shallows eaves, and is lit by vinyl sash windows. Its façade is symmetrical with hip-roofed wings that extend forward framing a recessed entrance. The wings are lit by paired six-over-six windows that are centered on each elevation. The entrance consists of a solid entry door and screen door sheltered by a pedimented porch supported by two slightly tapered square posts clad with vinyl. Because the building is raised, the porch is accessed by a set of five concrete steps lined with a metal pipe railing. The entry door is flanked by small four-over-four windows (Figure 125).

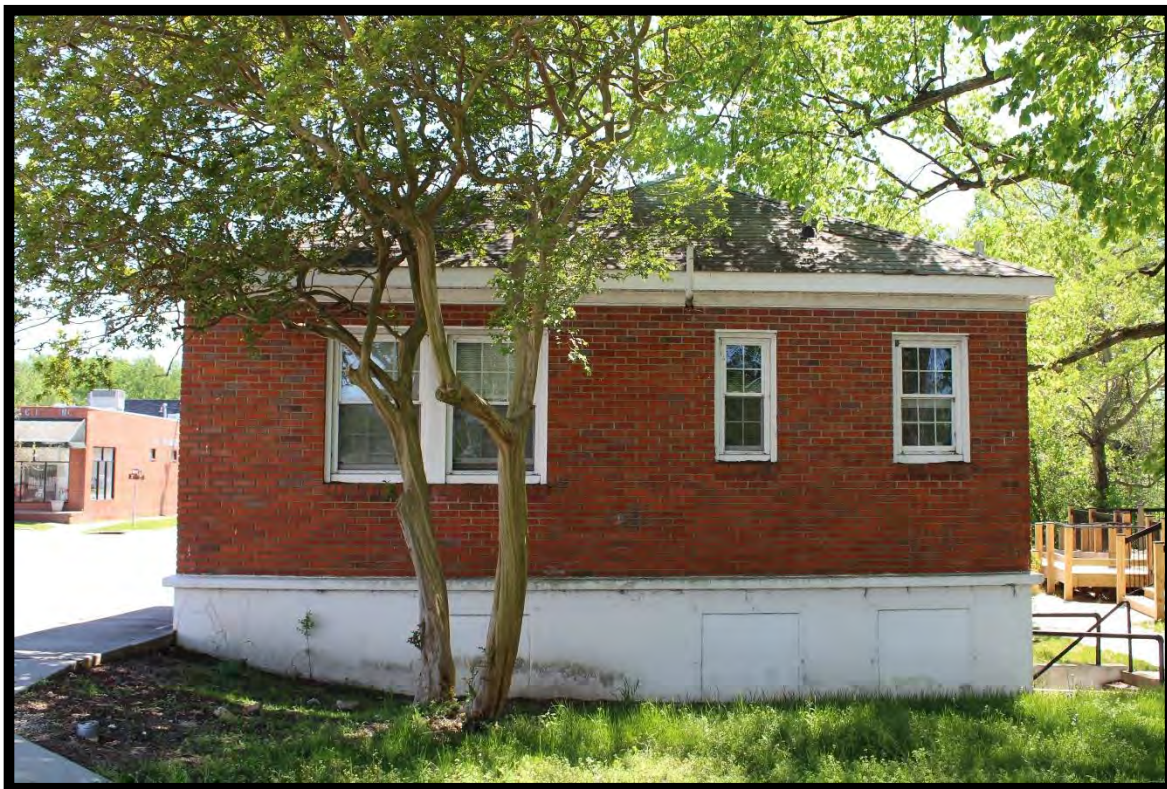
Figure 127: NCDOT Office, Looking South.

The north (side) elevation contains, from east to west, paired six-over-six windows, a small four-over-four window, and a single six-over-six window. Three panels fill openings in the foundation that may have originally acted as windows as well (Figure 127).

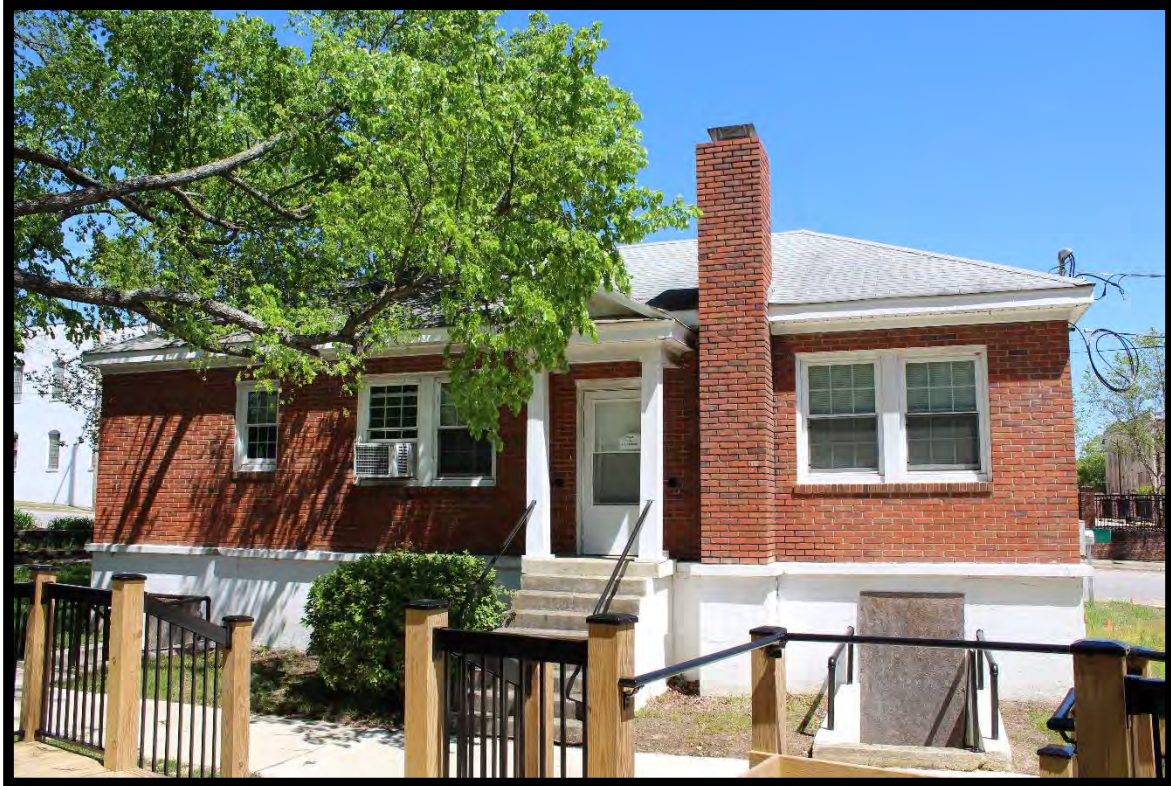
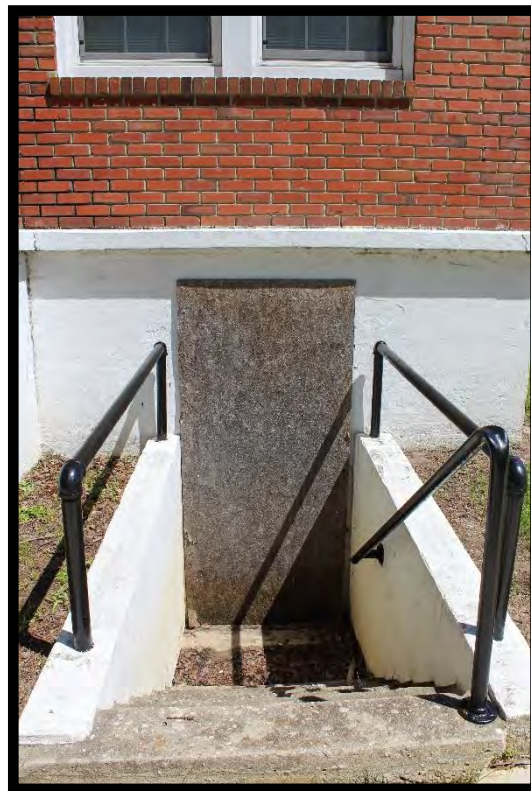
The west (rear) elevation contains, from north to south, a six-over-six window, paired six-over-six windows, an entry door with a pedimented porch that mirrors the configuration of the front entrance, an exterior brick chimney, and paired six-over-six windows. Two doorways covered with plywood pierce the foundation at each end of the elevation. They are both accessed by subterranean concrete steps (Figures 128 and 129).

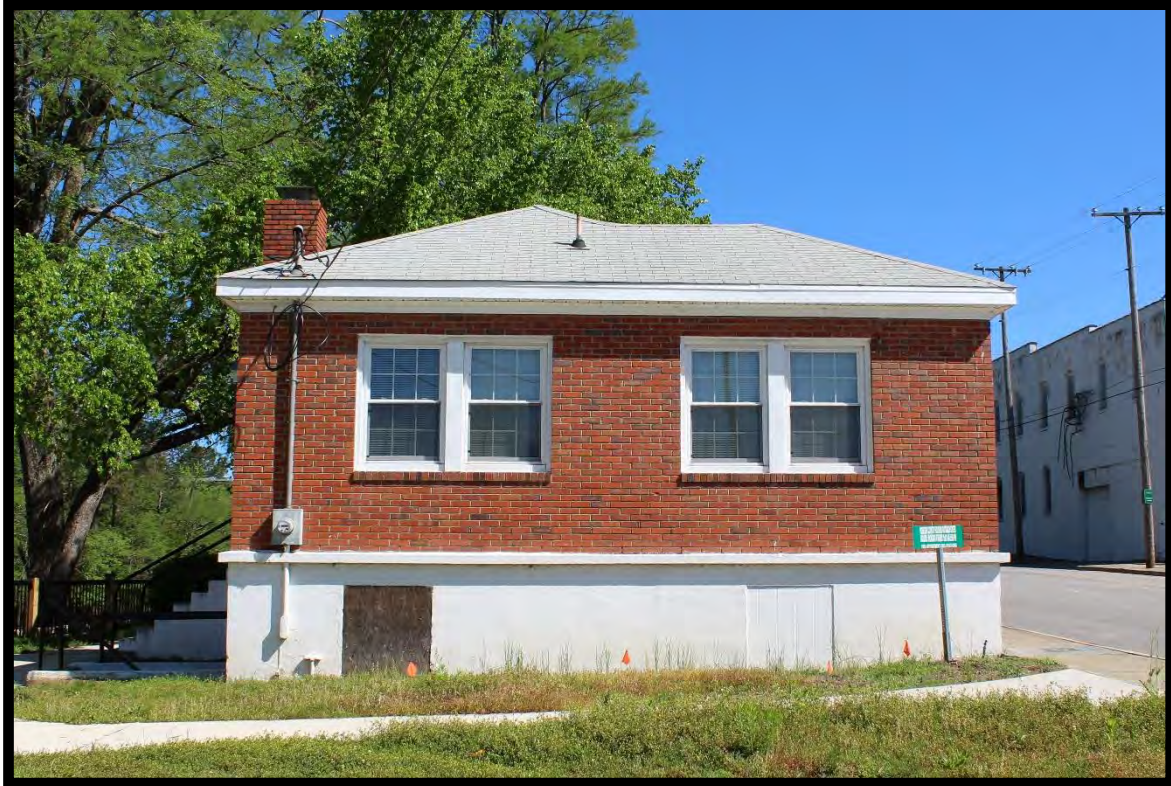
Figure 130: NCDOT Office, Looking North.

The south (side) elevation contains two sets of paired six-over-six windows that are evenly distributed on the elevation. Two panels fill openings in the foundation that may have originally acted as windows (Figure 130).

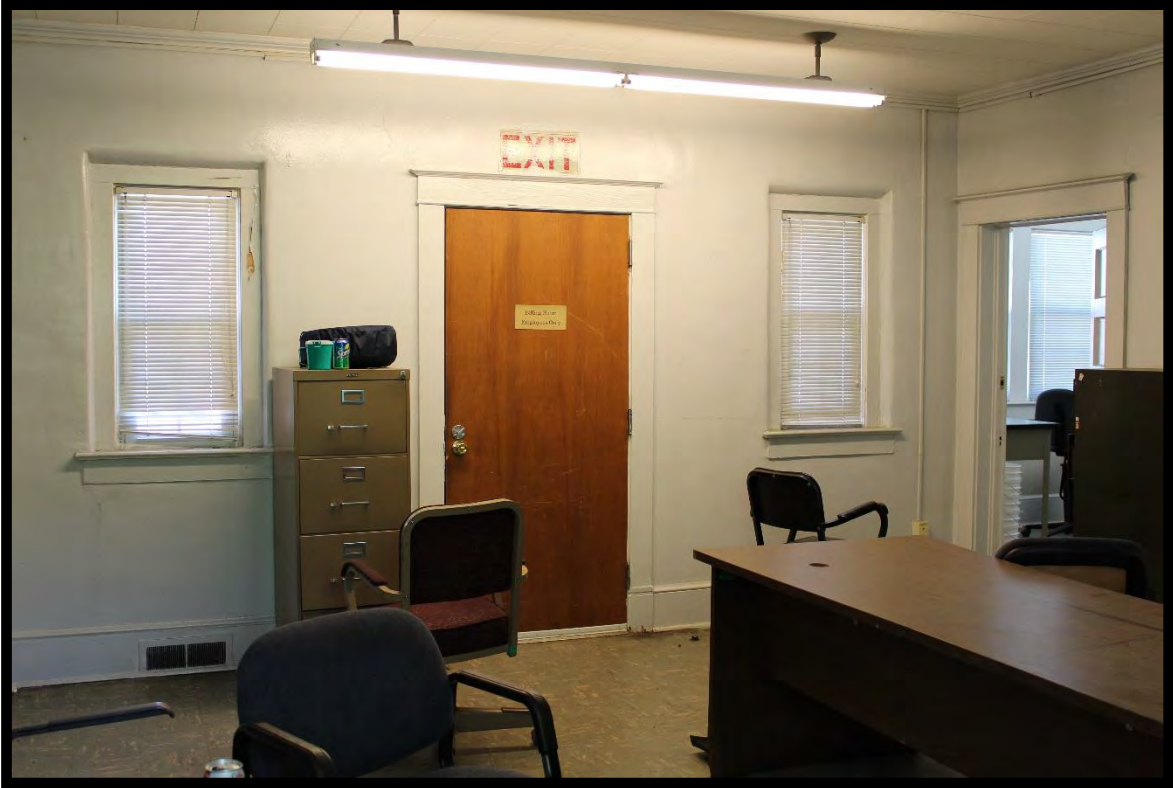
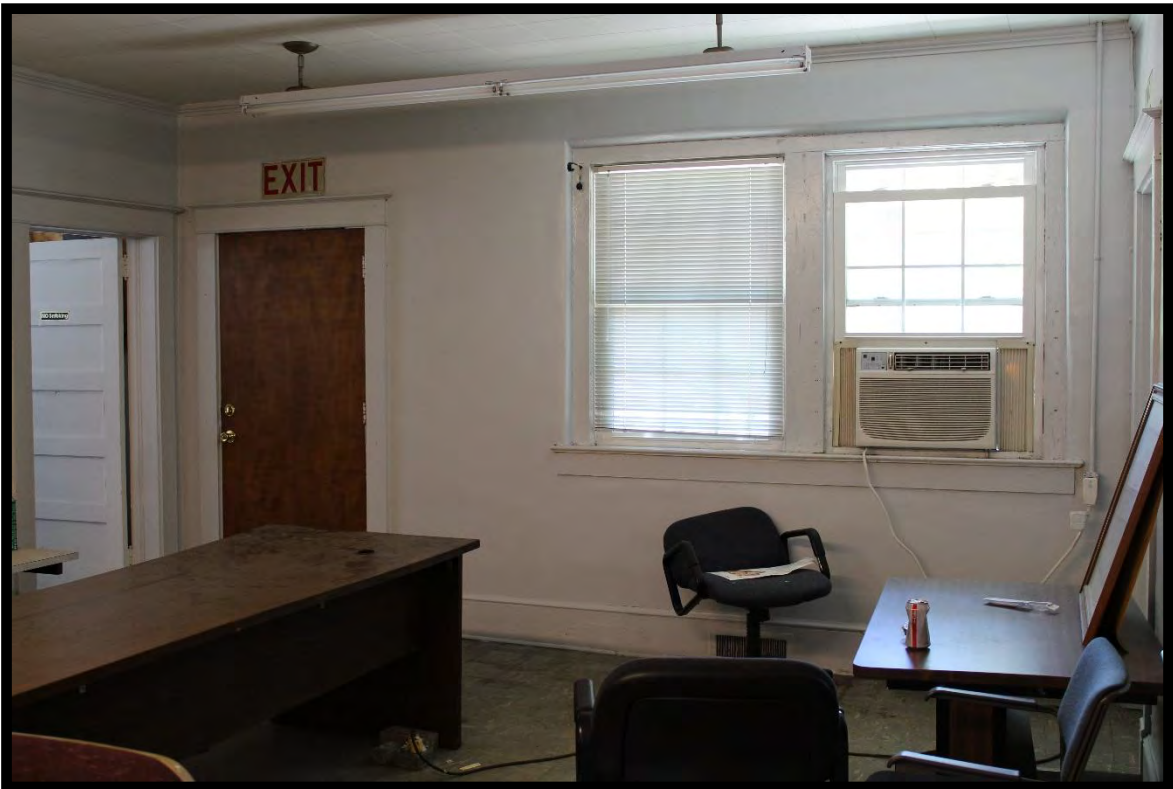
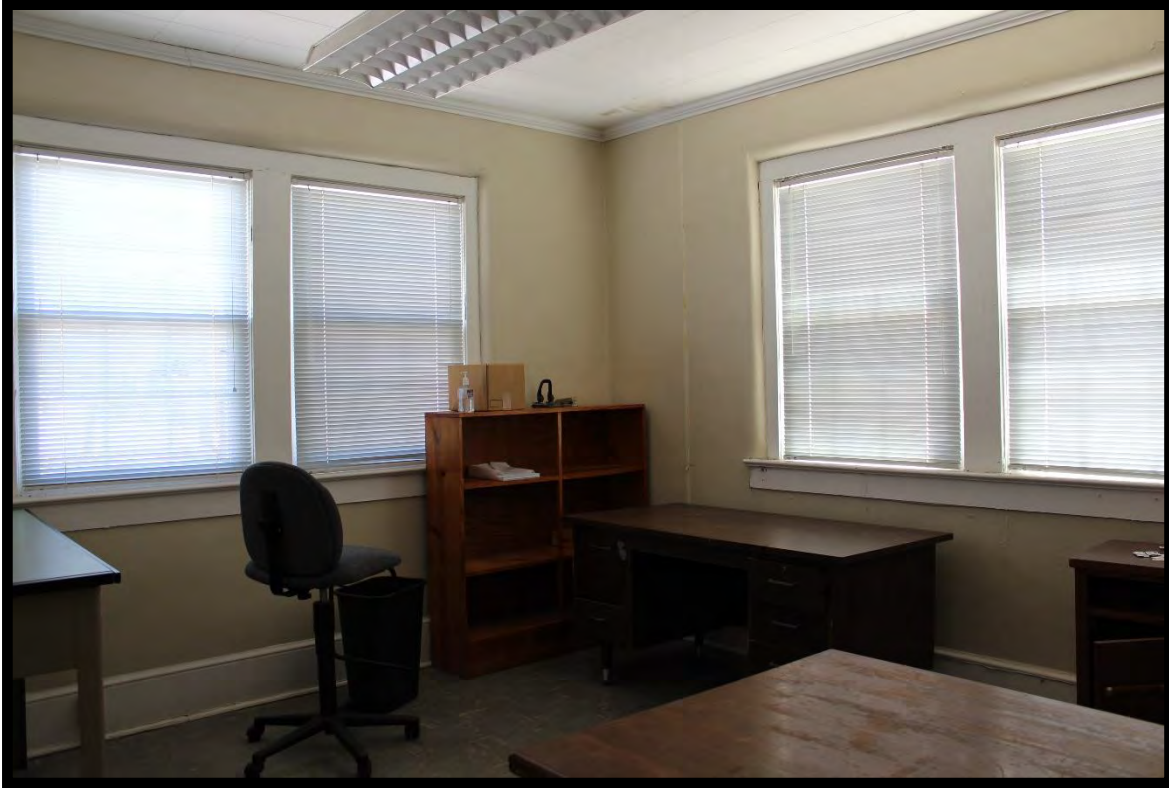
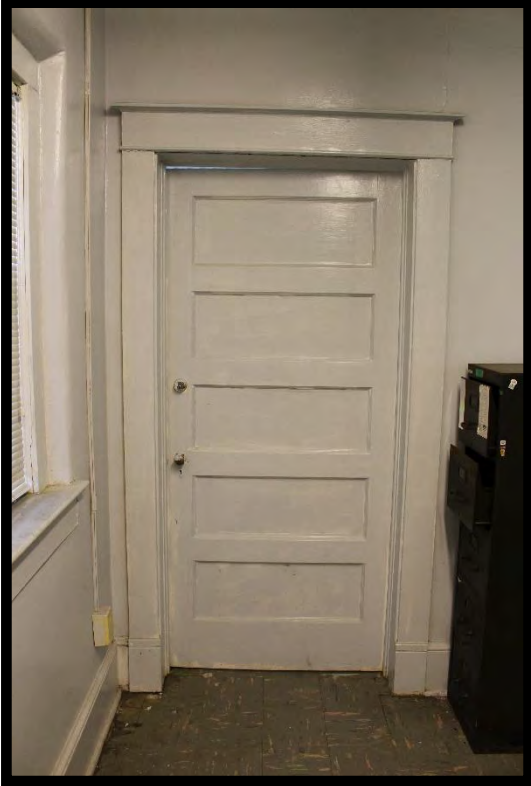
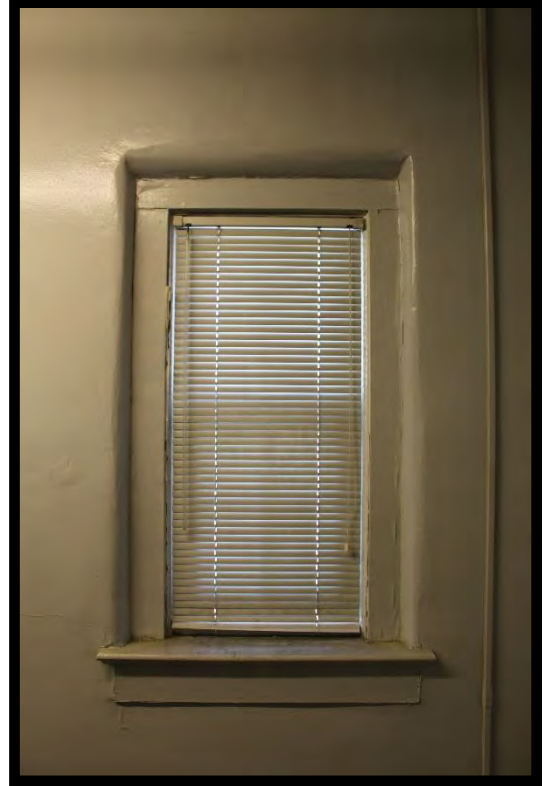
The interior of the building consists of three offices and a breakroom/restroom area that are centered around a wide center hall that likely served as a reception space or additional office. The spaces are characterized by original woodwork, including doors, window and door surrounds, baseboards, and crown molding. The floors are finished with asbestos floor tiles and the ceilings are finished with acoustic tiles (Figures 131 through 136).

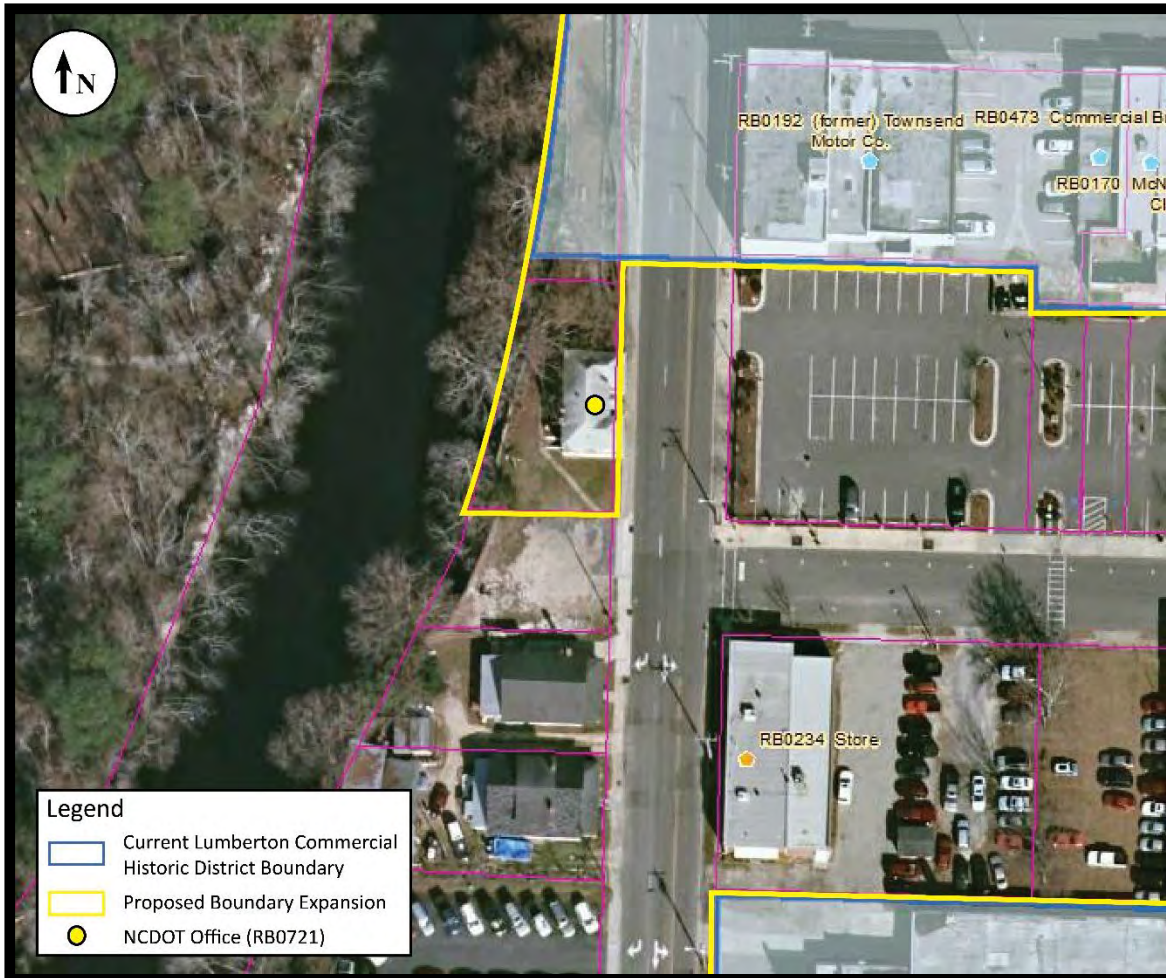
Figure 140: Lumberton Commercial Historic District (RB0476) Boundary Expansion.

The proposed NRHP boundary expansion for the Lumberton Commercial Historic District (RB0476) has been drawn according to the guidelines of National Register Bulletin 21, *Defining Boundaries for National Register Properties*. The expansion, which adjoins the western boundary of the current district, is drawn to include the office and its associated parcel. The proposed NRHP boundary expansion contains approximately 0.17 acres and is identified as parcel 939166631200 (Robeson County Parcel ID).

In contrast with the other NCDOT buildings, the office does not stand out as a significant architectural resource. It does, however, remain as an intact example of an early to mid-twentieth century office building, and while recommended not individually eligible under Criterion C, the office retains a high enough level of integrity to be considered as an addition to the current NRHP-listed Lumberton Commercial Historic District (RB0476) (Figure 140).
