RE: Project Ranger, Asheville, Buncombe County, ER 19-4972

# HISTORIC STRUCTURES SURVEY REPORT

## THE BILTMORE WEST TRACT FOR PROJECT RANGER SITE

Asheville, Buncombe County, North Carolina

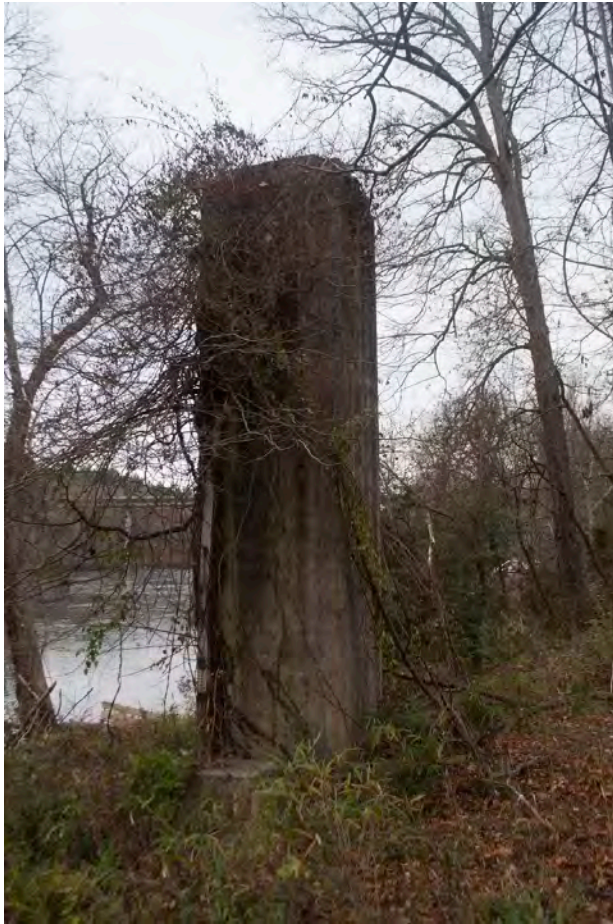
Plate 4.1: North and west sides of the French Broad River Gaging Station.

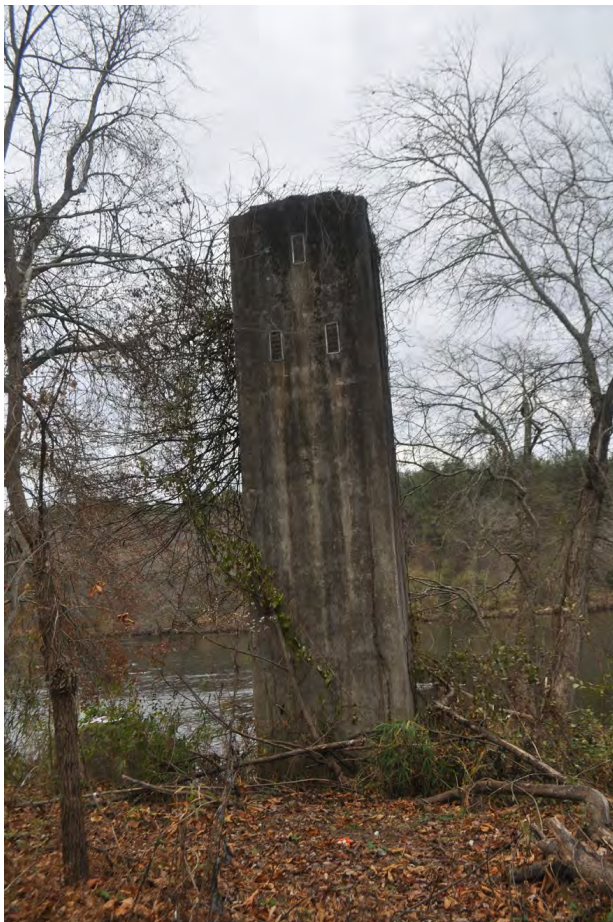
Plate 4.2: West side of the French Broad River Gaging Station.

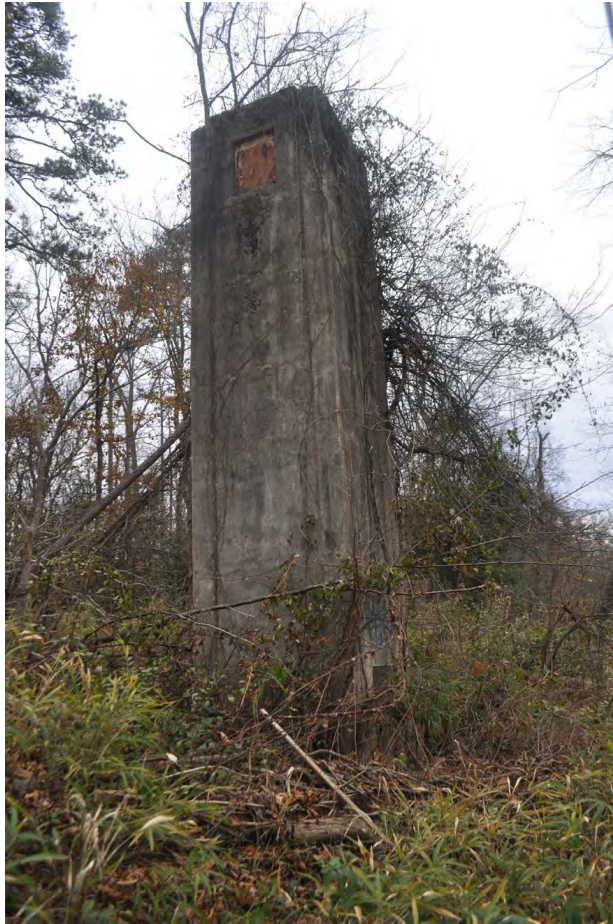
Plate 4.3: South and east sides of the French Broad River Gaging Station.

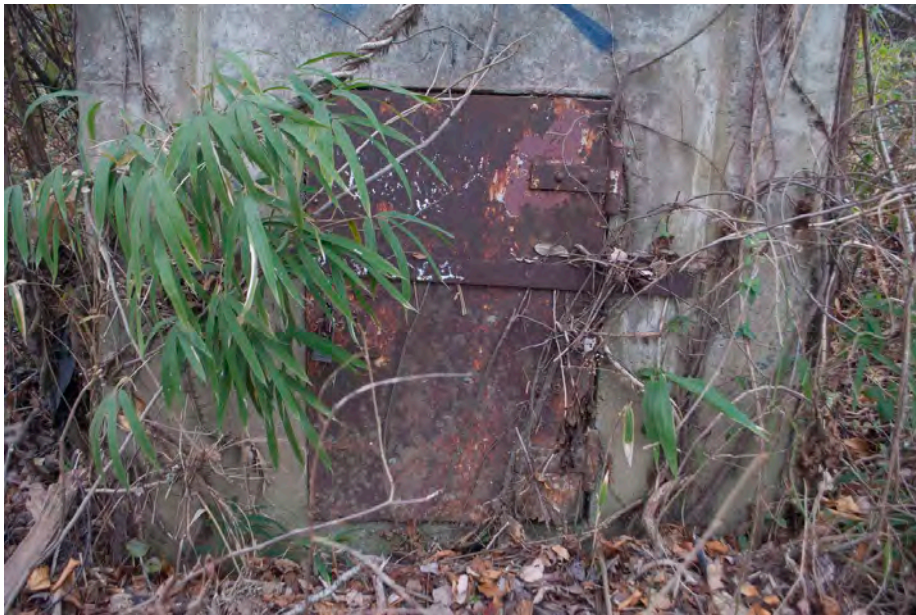
Plate 4.4: Door at the base of the east side of the French Broad River Gaging Station.

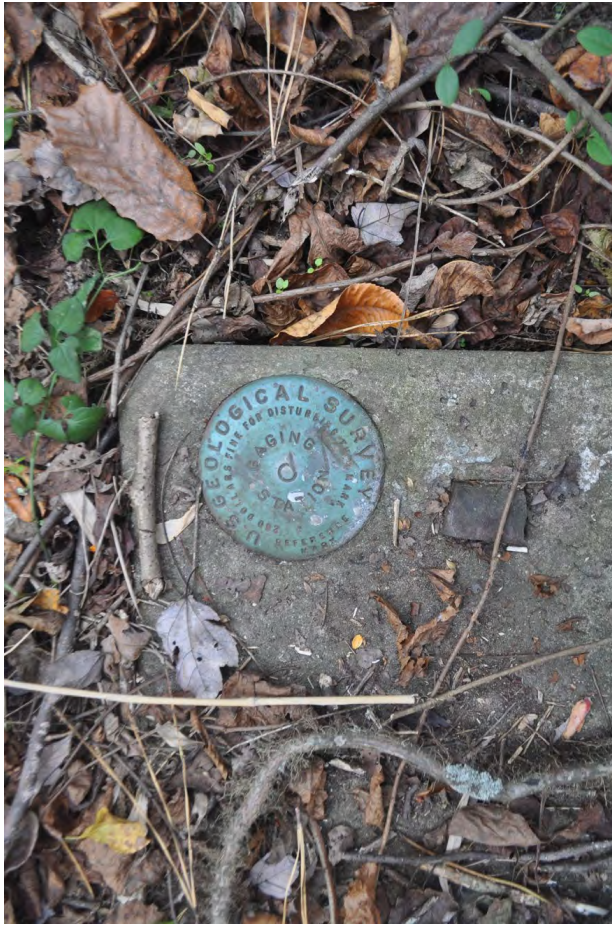
Plate 4.5: U.S. Geological Survey benchmark at French Broad River Gaging Station.

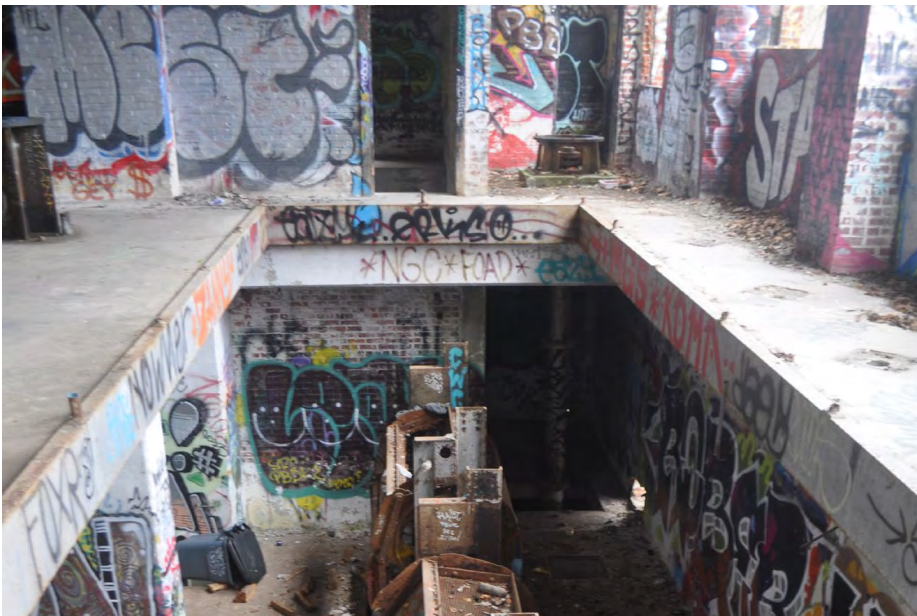
Plate 5.8: American ENKA Corporation Water Intake interior equipment.

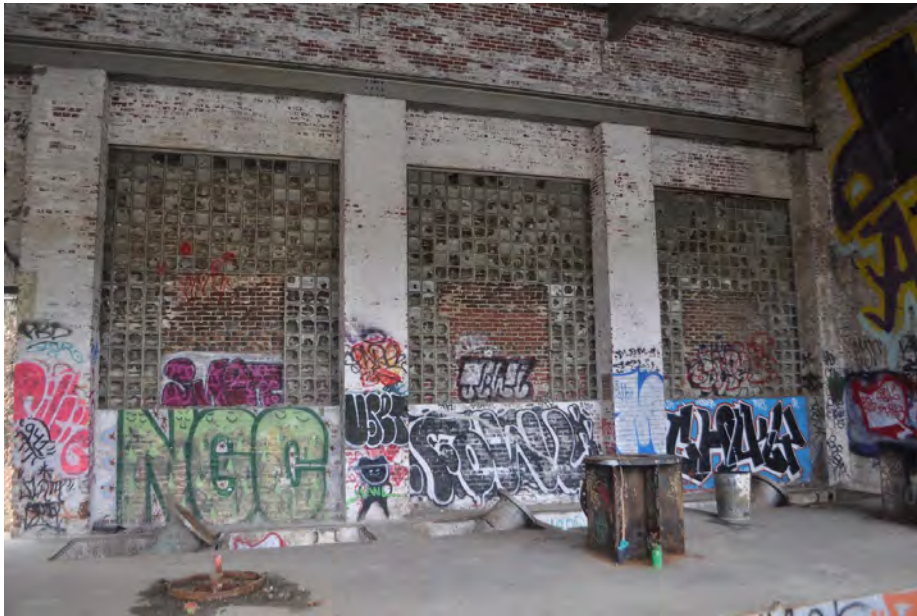
Plate 5.10: American ENKA Corporation Water Intake interior showing glass block windows infilled with brick.

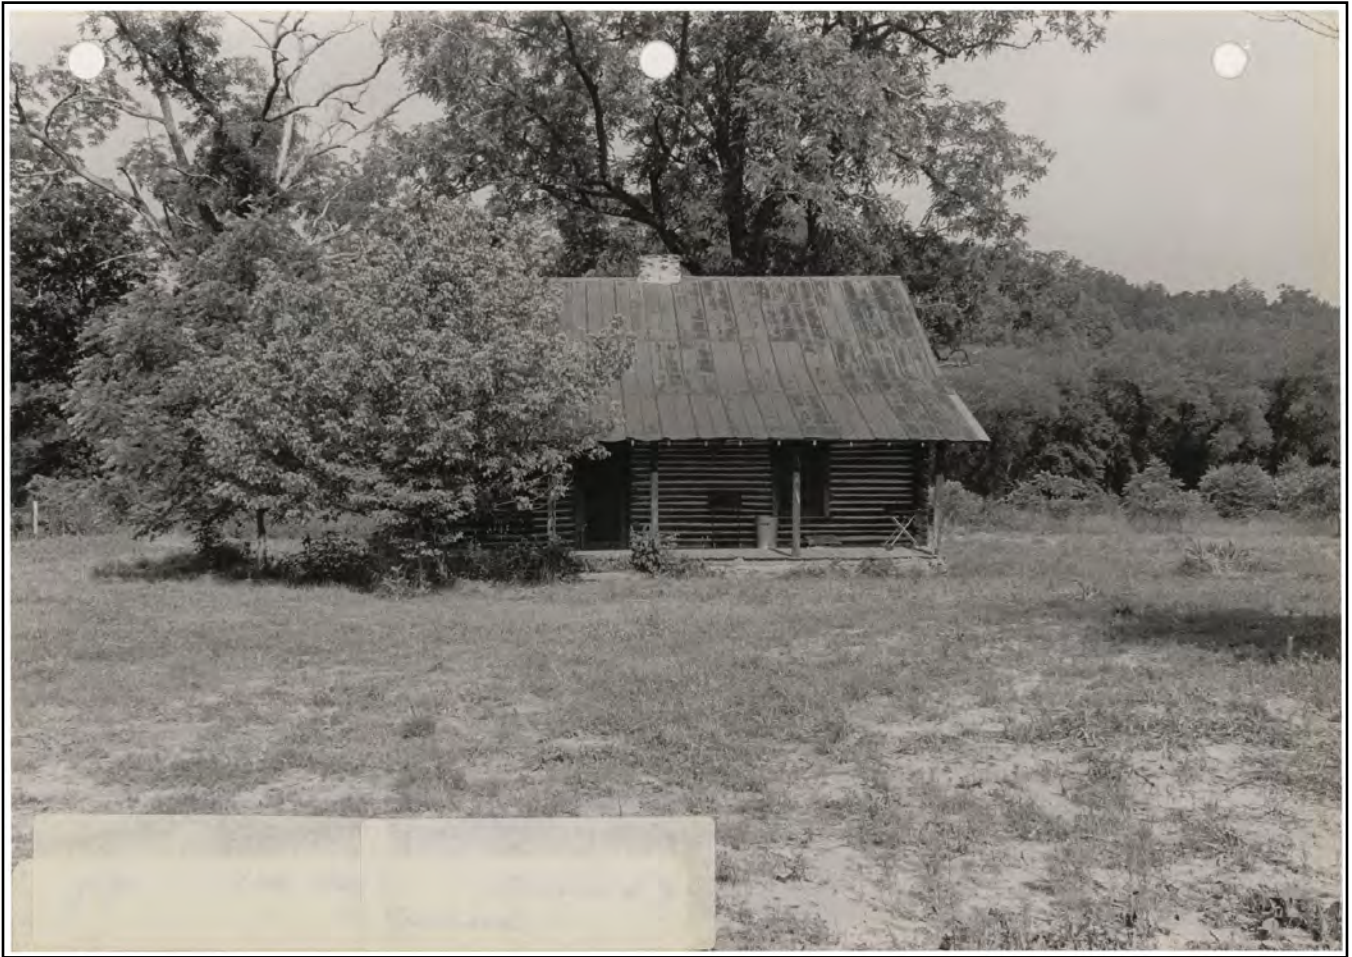
The side-gable, four-room log house has a full-façade shed front porch. The house was documented as “Riverside Dwelling No. 70” by the Biltmore Company in 1980 (Figure 6.2). The house is oriented roughly east-west and faces east; it is constructed of small diameter round logs chinked with cement. Wood shingles cover the gables. The roof is covered with metal. The building sits on stacked stone piers. No window sashes remain in place. The interior consists of four principal rooms organized around a central stone chimney. The two rear rooms are partially collapsed. Beadboard covers the walls and ceilings of the front two rooms. A five-panel door connects the two rooms. The fireplace consists of exposed stone over a simple shelf over the firebox. The house is in a deteriorated condition. The roof has failed, and the rear rooms are in a state of collapse.

Figure 6.2: Riverside Dwelling No. 70.  
(Image BHA4-07777r, permission of the Biltmore Company, Asheville, North Carolina. PENDING.)

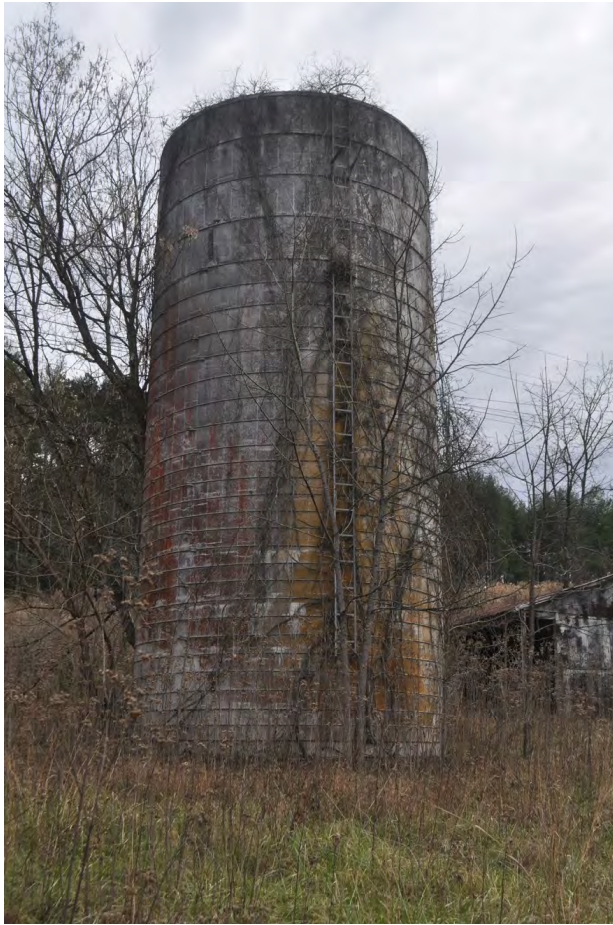
This round silo is constructed of poured concrete belted with metal bands. The silo is in good condition.

Plate 6.1: Silo.

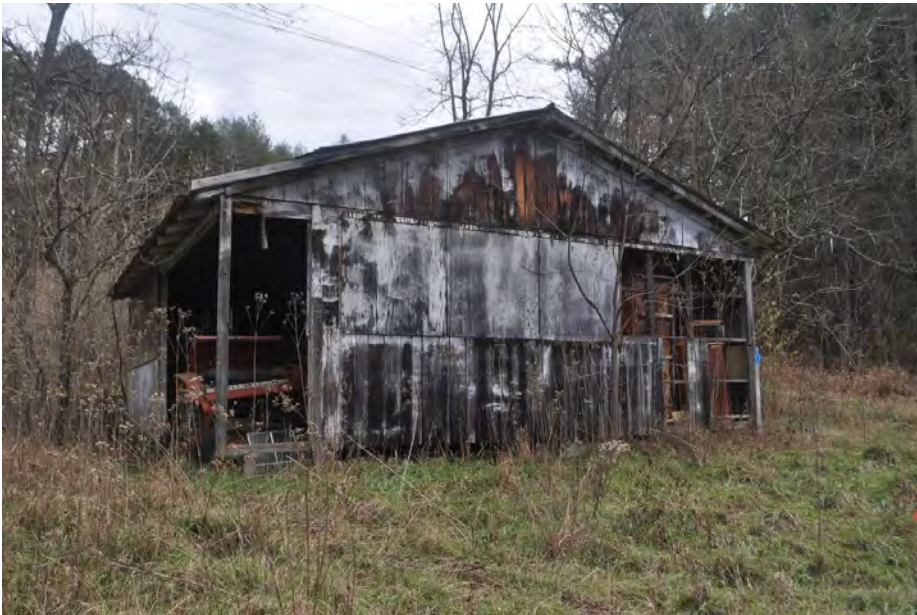
This front-gabled, frame shed is built of dimensional lumber and prefabricated roof trusses. The exterior is sheathed with a combination of vertical planks and plywood sheets. The roof is covered with 5-V metal. The shed sits on a composite foundation of posts, woodblocks, and low brick piers. A low brick wall, approximately two feet in height runs southeast of the shed and is wall parged with cement. The shed is in fair condition.

Plate 6.2: Shed.

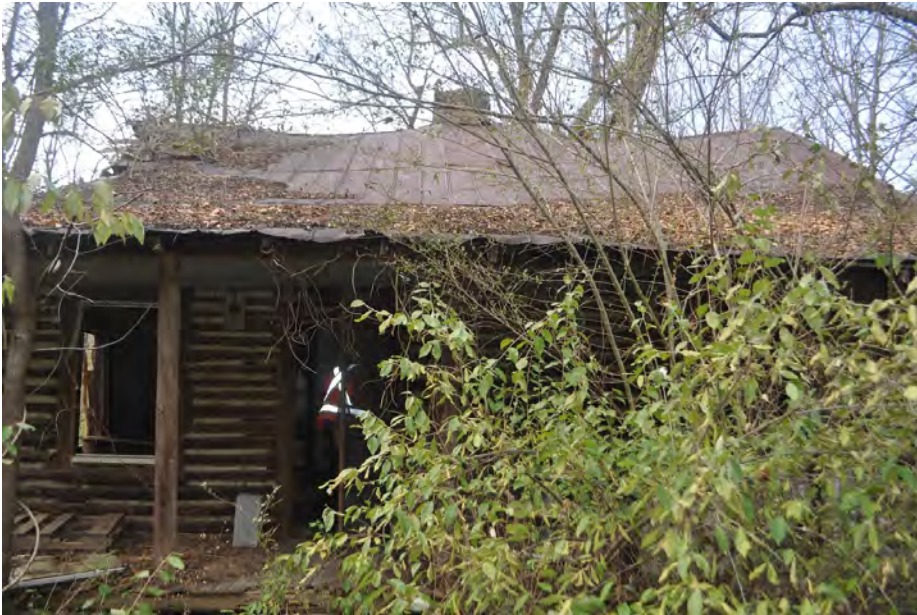
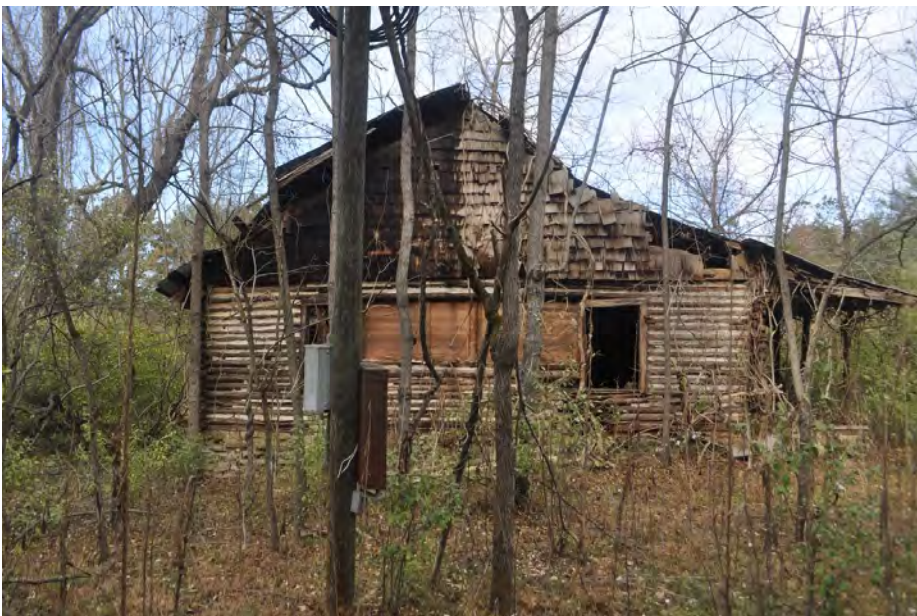
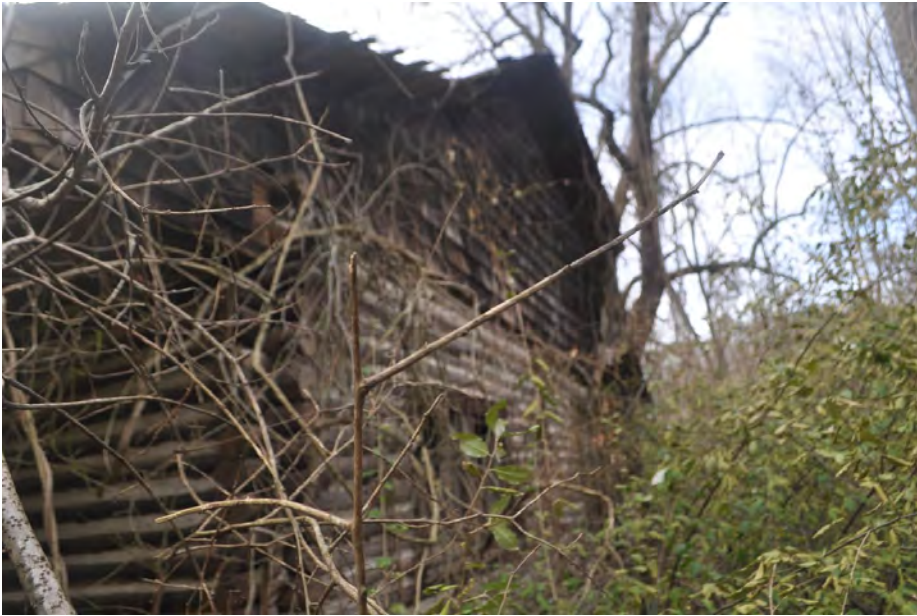
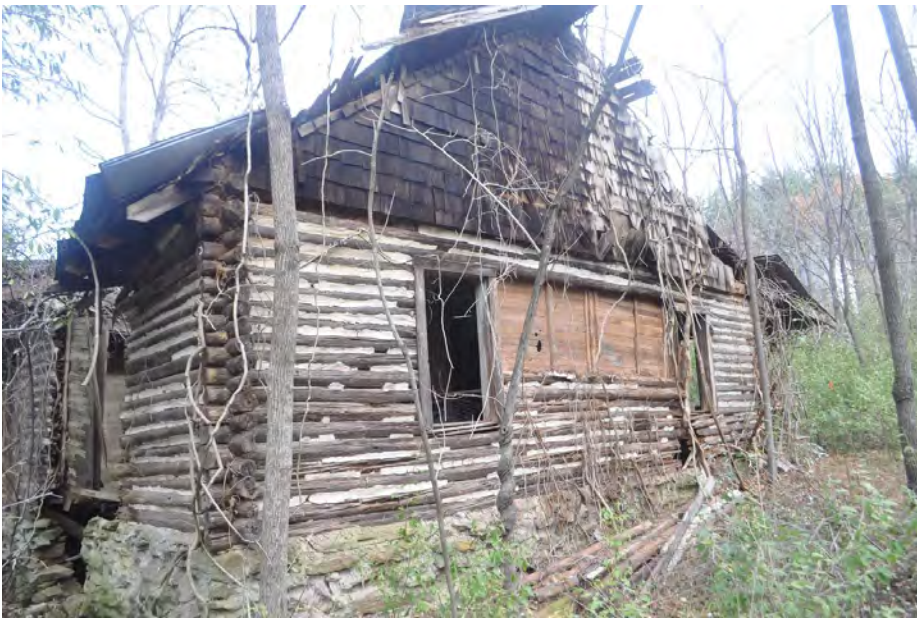
Plate 6.4: Front of Log House.  
Photo view: West  
Photographer: Ellen Turco  
Date: November 20, 2019

Plate 6.5: South side of Log House.  
Photo view: North  
Photographer: Ellen Turco  
Date: November 20, 2019

Plate 6.6: North side of Log House.

Plate 6.7: South and west sides of Log House.

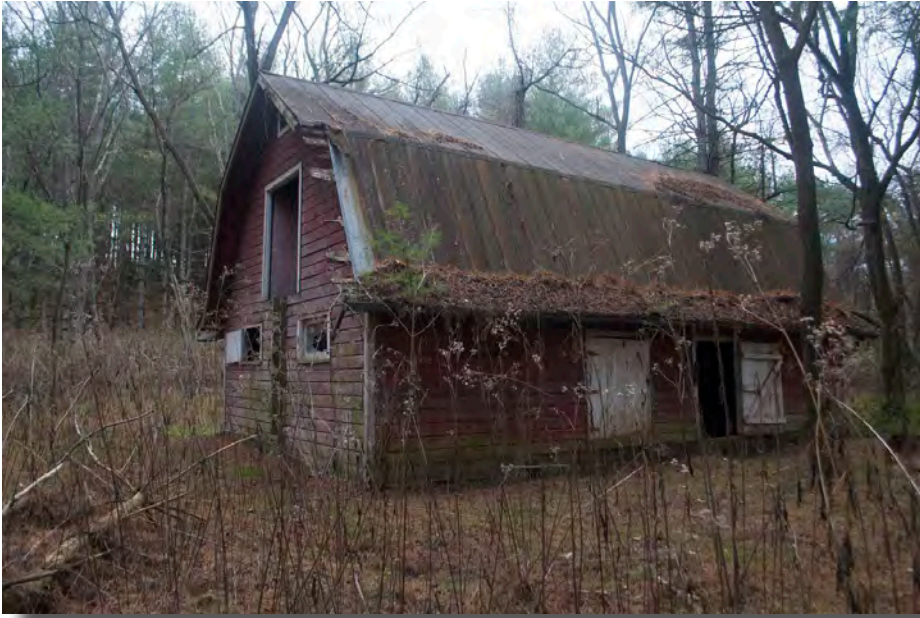
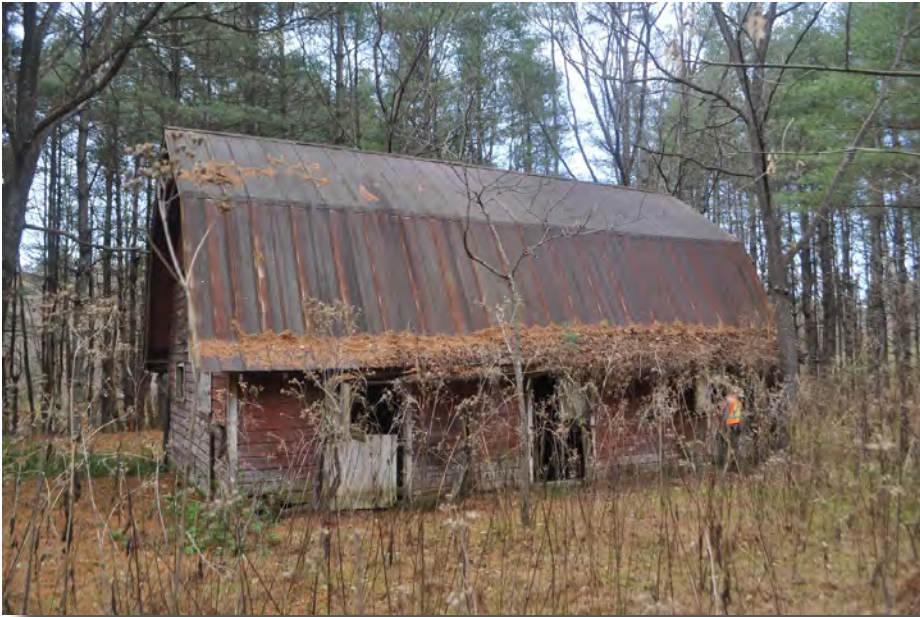
Plate 6.9: North and west sides of Barn.

Plate 6.10: East side of Barn.

The gambrel roof, frame barn is approximately 250 feet south of the log house. The barn was documented as “Riverside Bldg. No. 68” by the Biltmore Company in 1980 (Figure 6.3). The exterior walls are sheathed with German siding, which has been painted a dark red color. The roof is covered with 5-V tin. The foundation is poured concrete. The interior of the barn has five stalls and a storage area in the northwest corner. There is a second level hayloft. Each stall, as well as the storage area, is accessed directly from the exterior; there is no interior hallway. There are two Z-batten doors on the north elevation and three on the south side. A rectangular opening in each gable end accesses the hayloft.

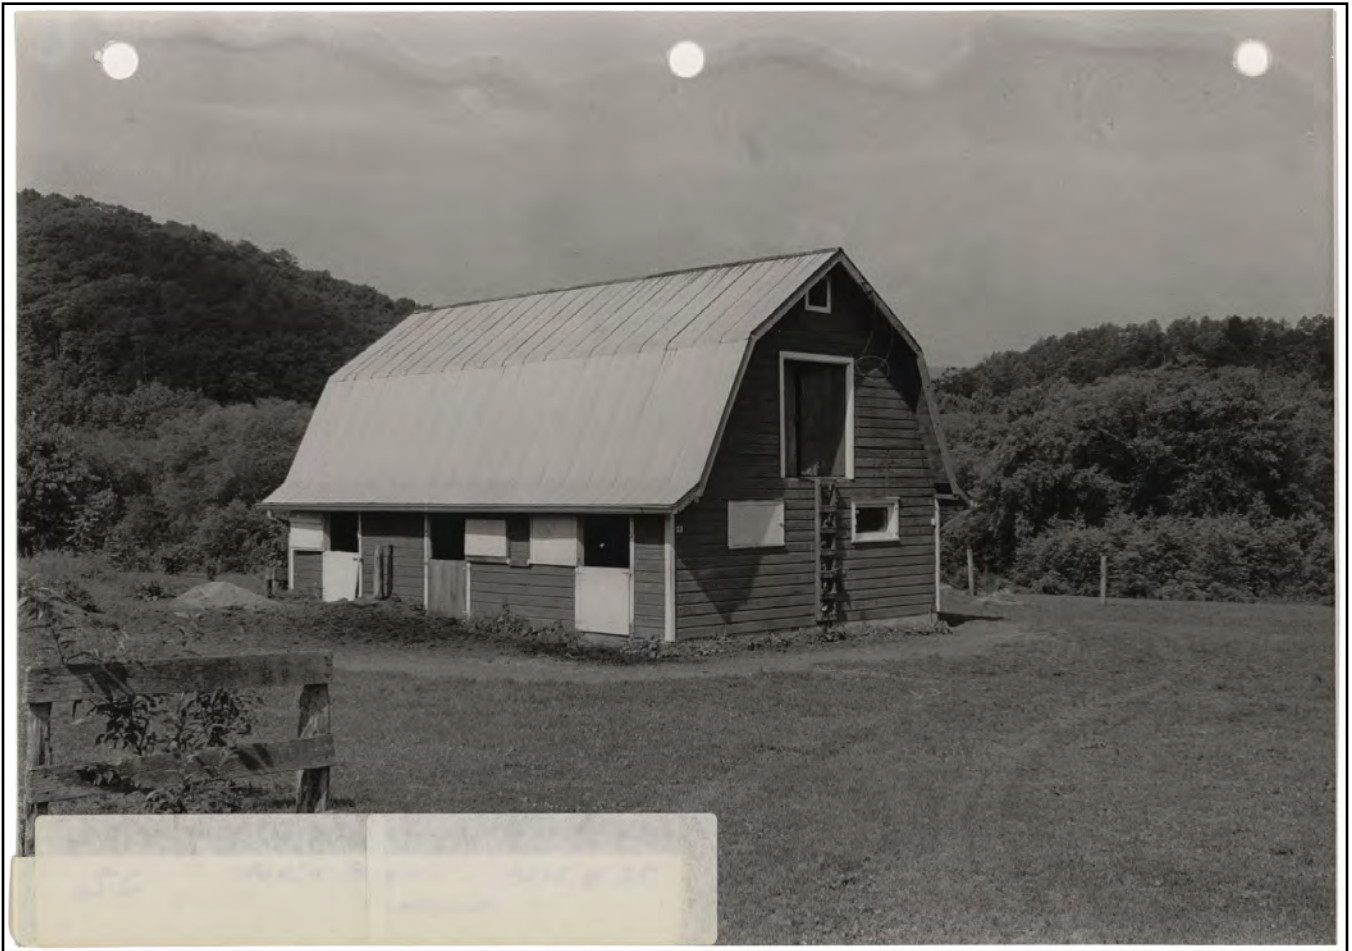
Figure 6.3: Riverside Building No. 68.  
(Image BHA4-07777r, permission of the Biltmore Company, Asheville, North Carolina. PENDING.)
