HISTORIC STRUCTURES SURVEY REPORT

WARD MILL DAM REMOVAL

**Ward Mill Dam, Sugar Grove, Laurel Creek Township,
Watauga County, North Carolina**

Technical Report # 2020-077NC

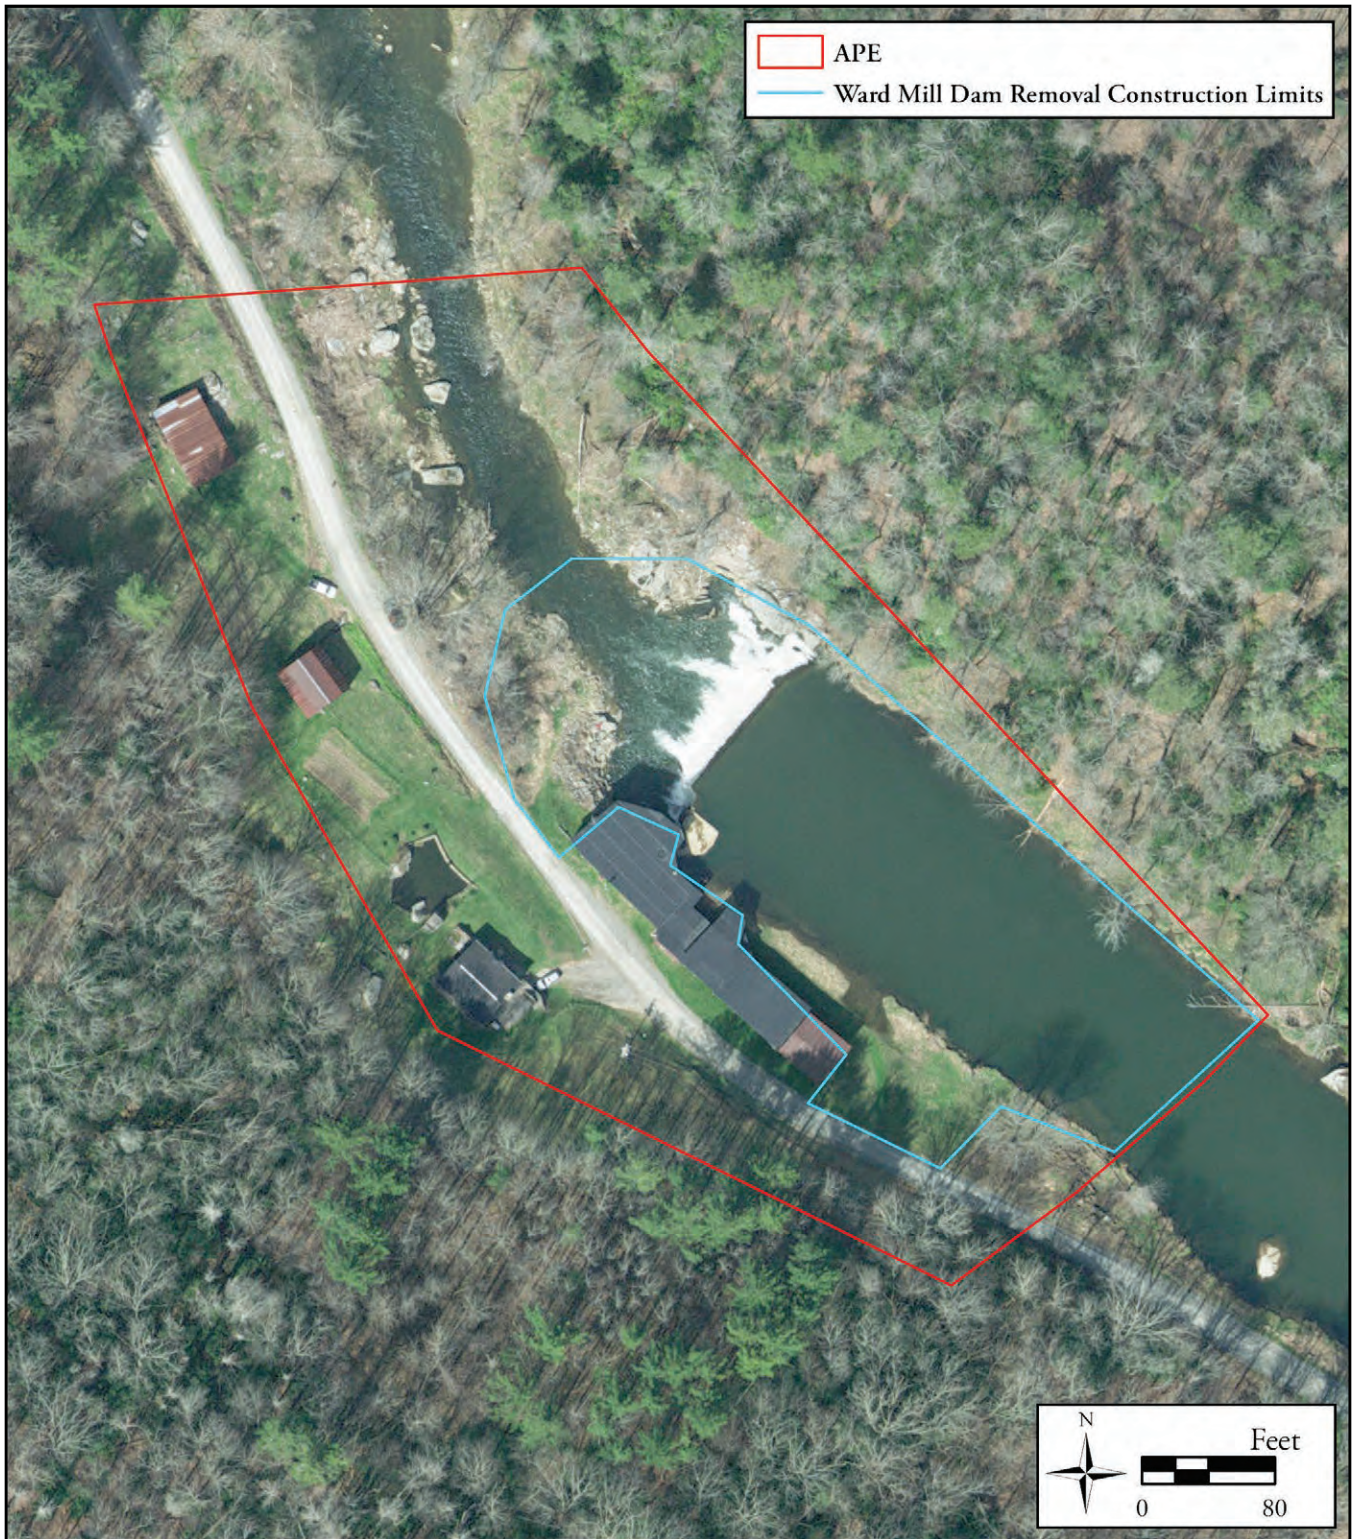
Figure 2.4: Area of Potential Effects Map
(World Imagery, ESRI 2020). The limits of construction depicted as a blue line on this map reflects the most recent limits provided Wildlands Engineering in July of 2020.

an undertaking and may be different for different kinds of effects caused by the undertaking.” The recommended APE for the project consists of approximately five acres of the 59-acre tax parcel and includes the limits of construction for the dam removal as well as the viewshed from the dam (Figure 2.4) (see Figure 2.3). The recommended APE was expanded beyond the limits of construction to encompass the historically associated buildings and structures visible from the dam. Together, these buildings and structures are known as the B.O. Ward House and Mill Complex (WT0358).

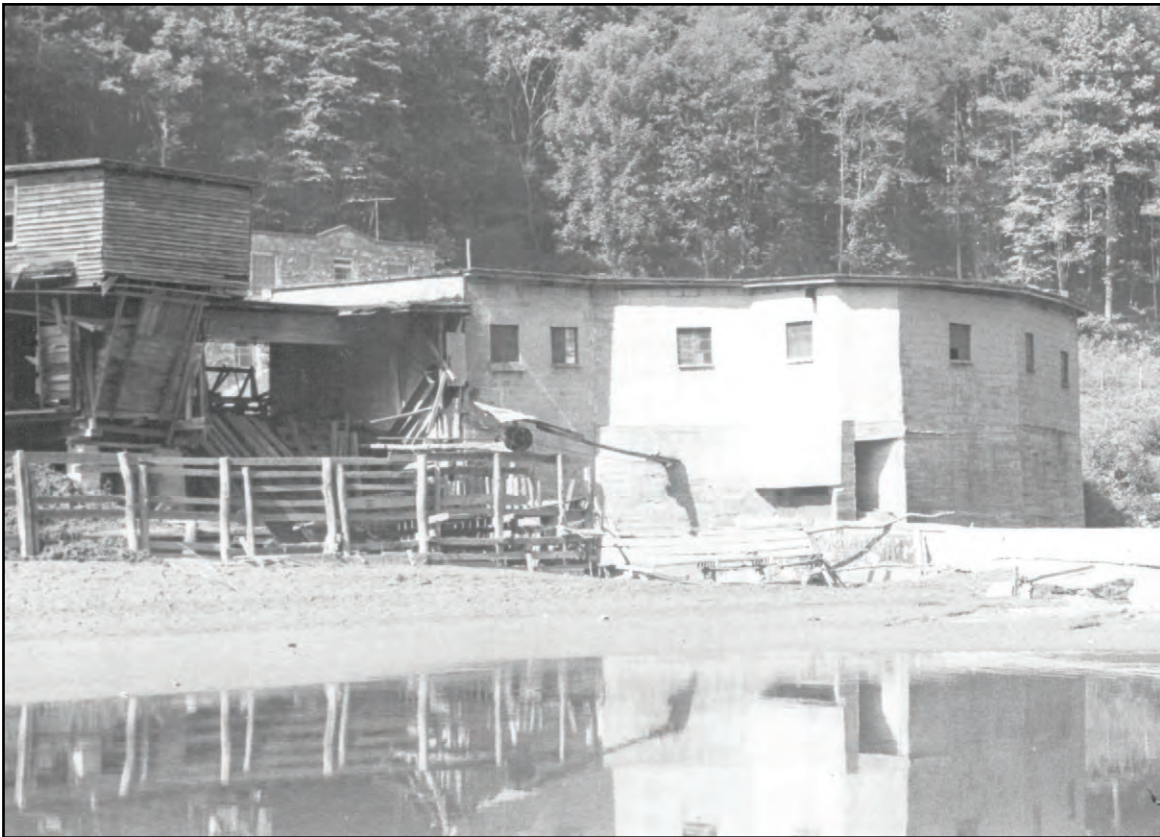
Figure 3.3: View of the Machine Shop's Waterhouse Section looking west from the Watauga River, circa 1975 (Courtesy of The Foxfire Museum).

Between 1941 and 1963, Ward ran the sawmill. In 1957, he replaced the 1941 four-foot sawblade with a larger six-foot blade he made himself in the shop (Givens 2014: E.6). In August of 1963, Ward shut off the turbines, dismantled the 1905 log dam and began construction on the current rock and concrete dam which he designed and built himself with the labor of 18 local men. The dam was completed along with the machine shop just short of a year later in June 1964 (Wigginton 1985: 336-338) (Figures 3.3 and 3.4).

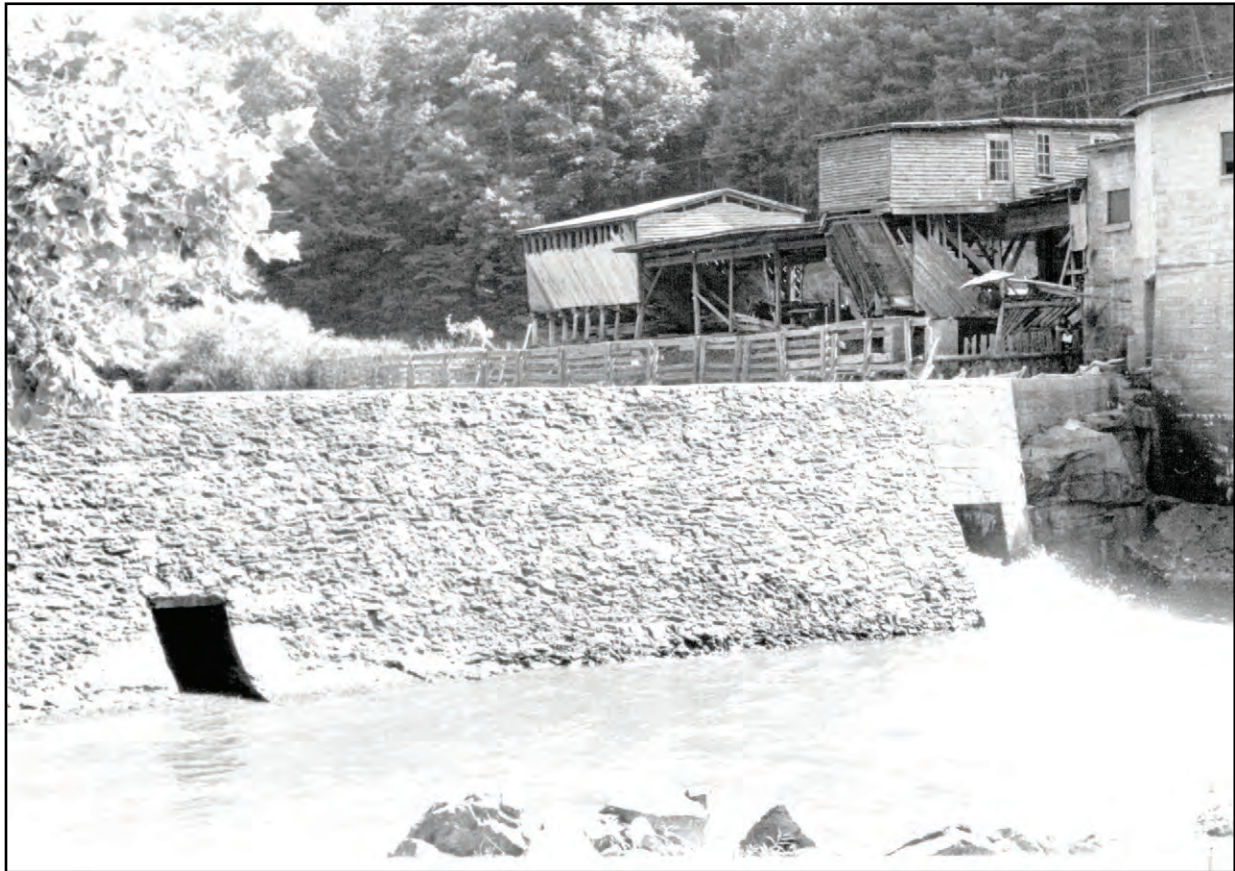
Figure 3.4: View of the Sawmill, Log Pond, and Machine Shop looking south from the Watauga River (Courtesy of The Foxfire Museum).

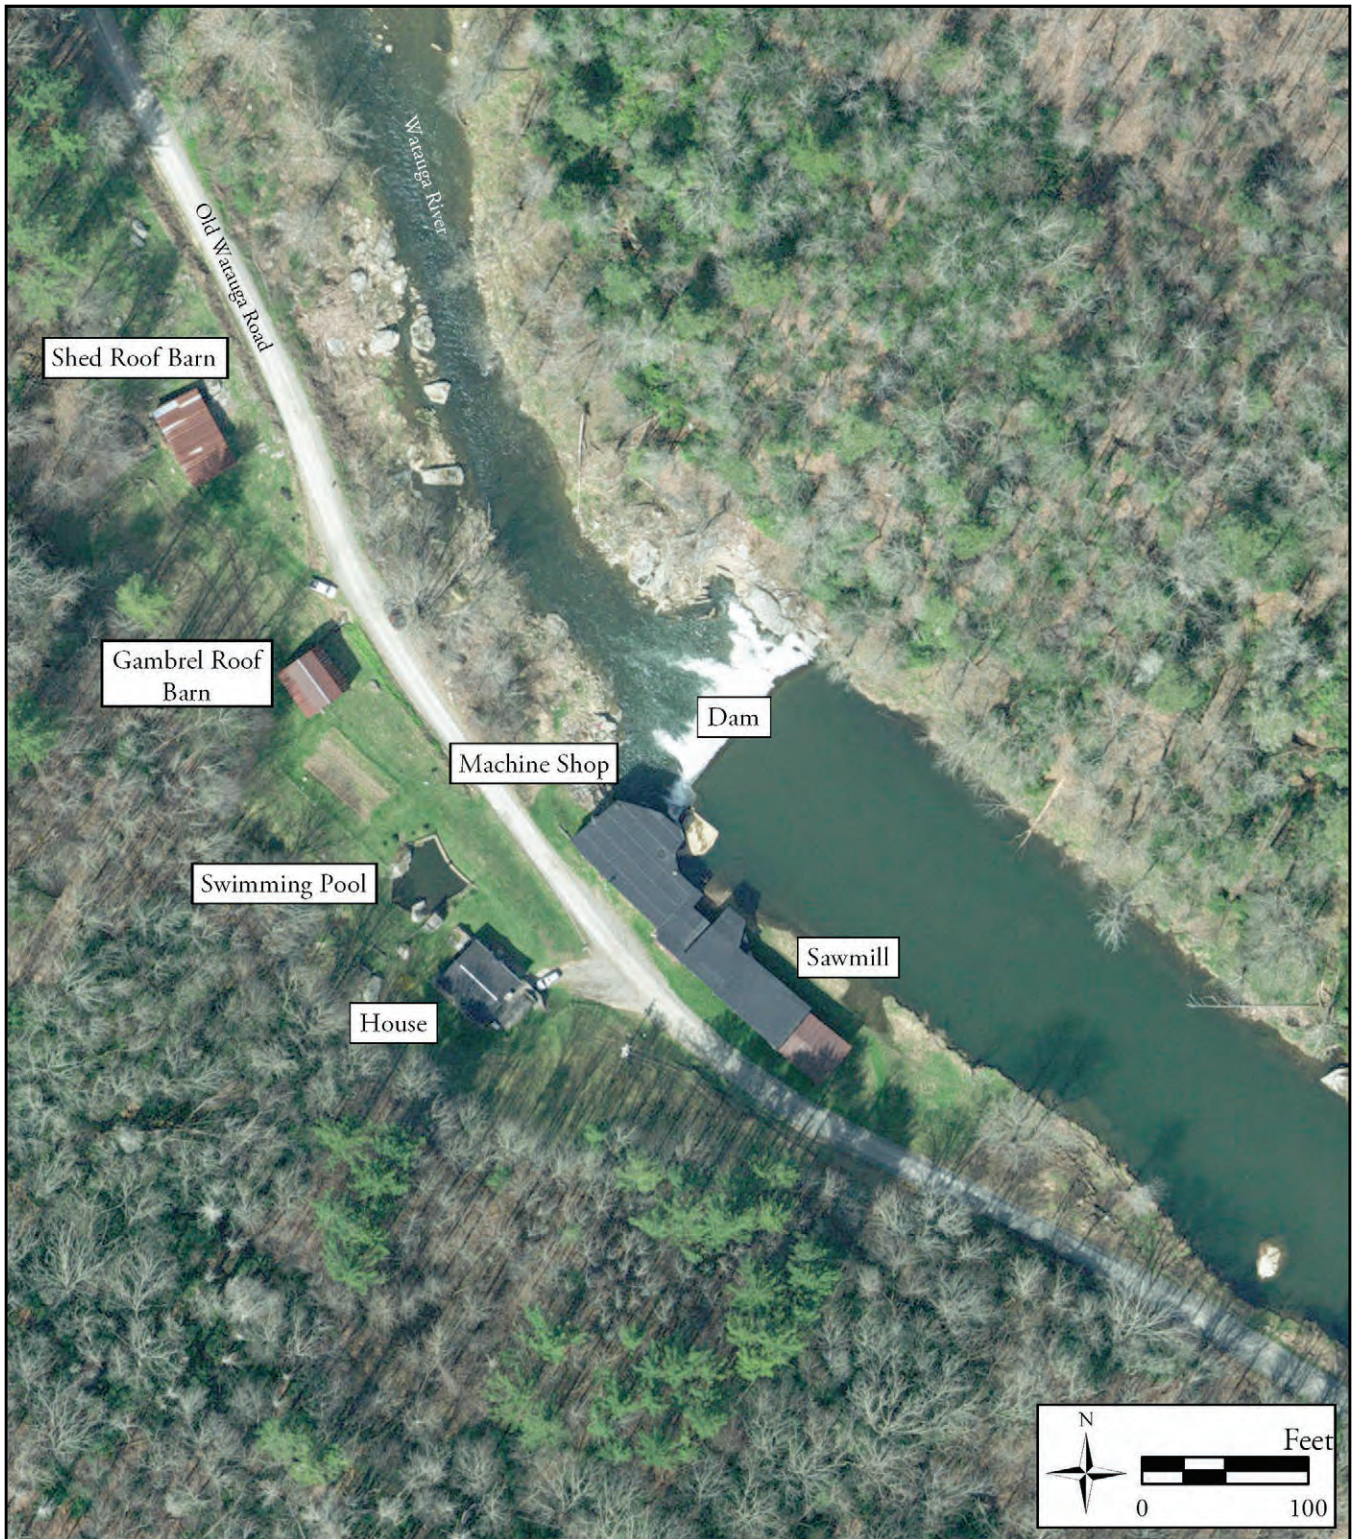
Figure 4.1: Aerial map showing the B.O. Ward House and Mill Complex and House (WT0358) (World Imagery, ESRI 2020).

The B.O. Ward House and Mill Complex is situated on the slopes of the west bank of the Watauga River (Figure 4.1). The complex of seven buildings and structures straddles Old Watauga River Road. The site is anchored by the stone B.O. Ward House, erected circa 1939 on the downward slope of Long Ridge on the west side of the road. On the east side of the road is the hydroelectric and milling complex, which is comprised of the dam, machine shop and powerhouse, and the band sawmill (Figure 4.2). Two frame barns are in a pasture north of the house.

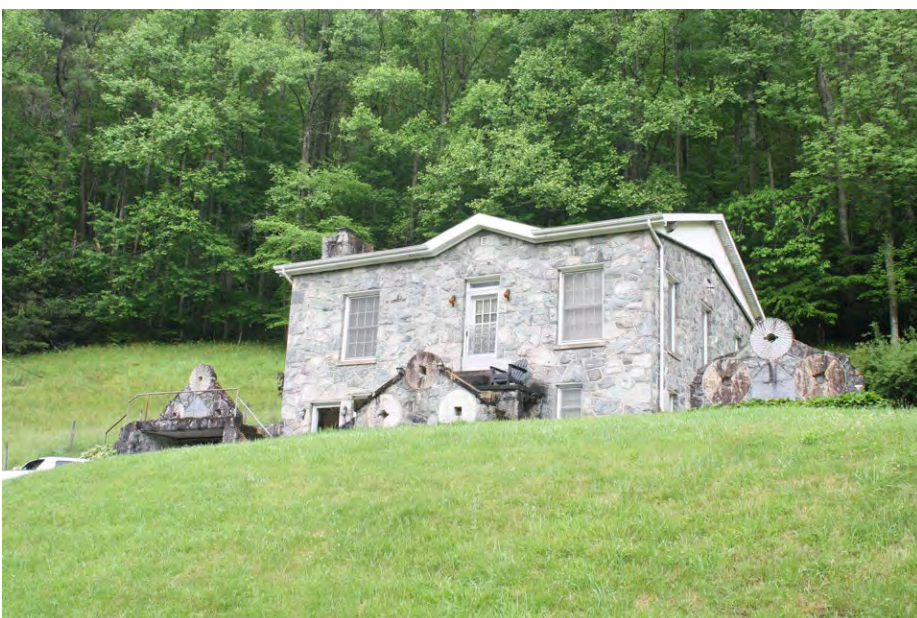
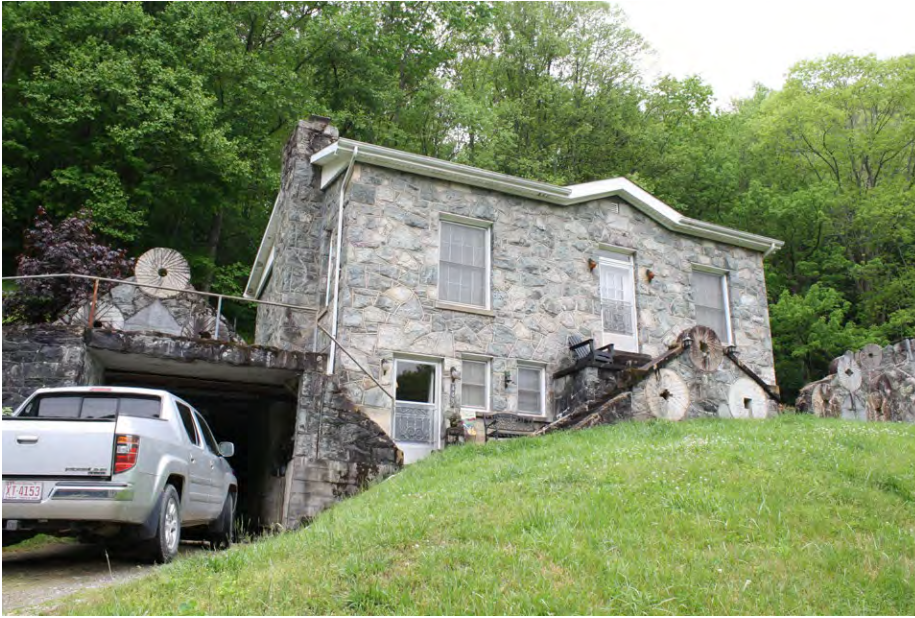
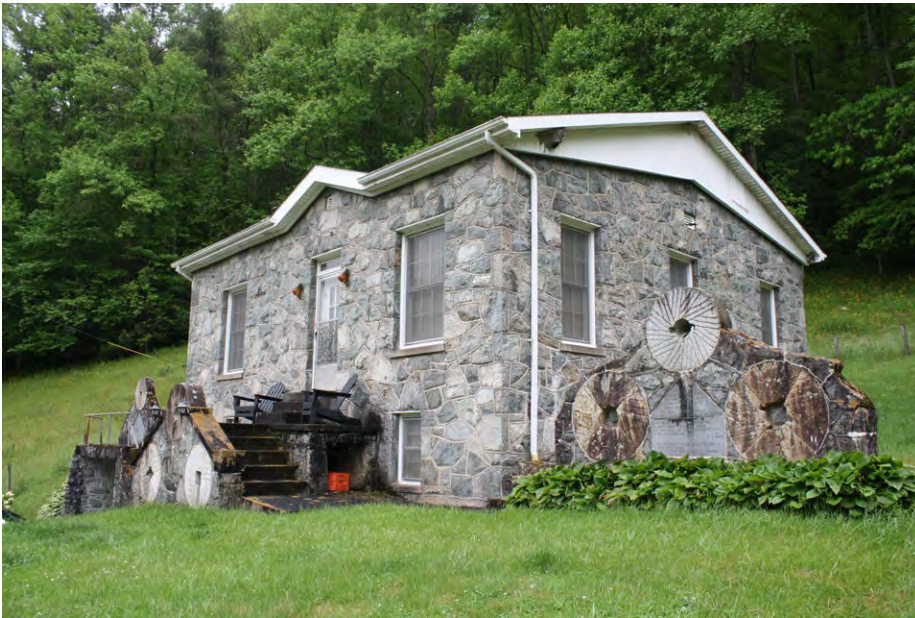
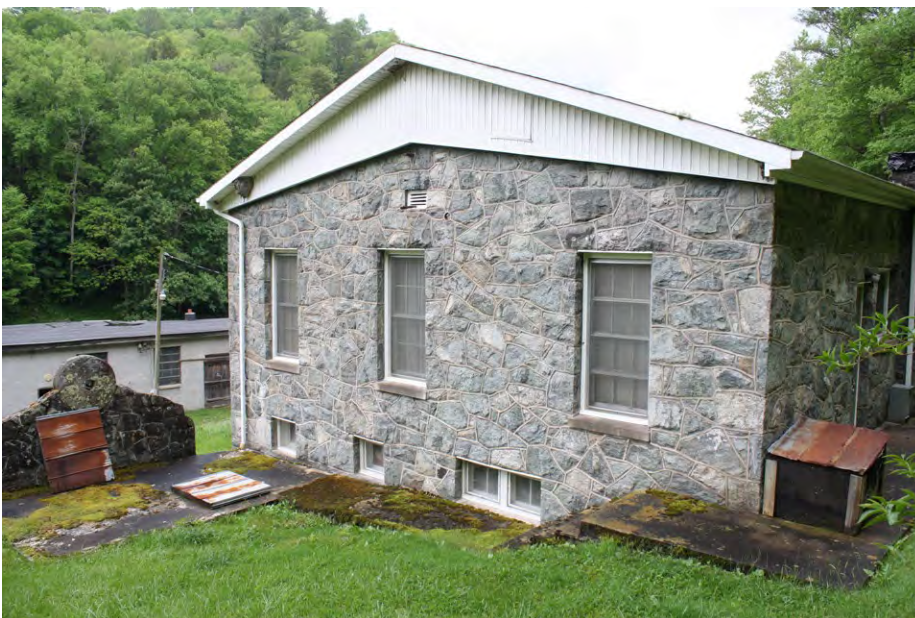
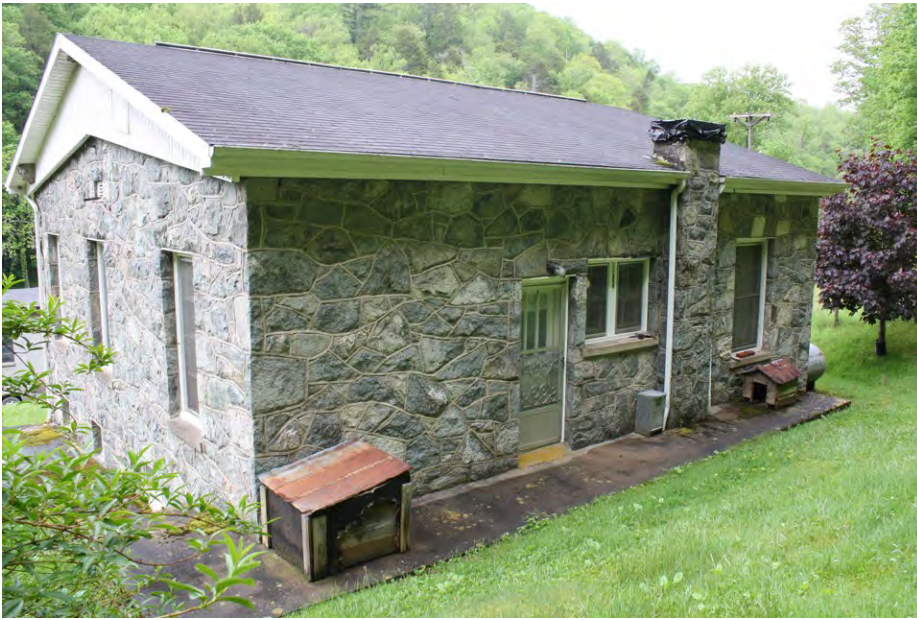
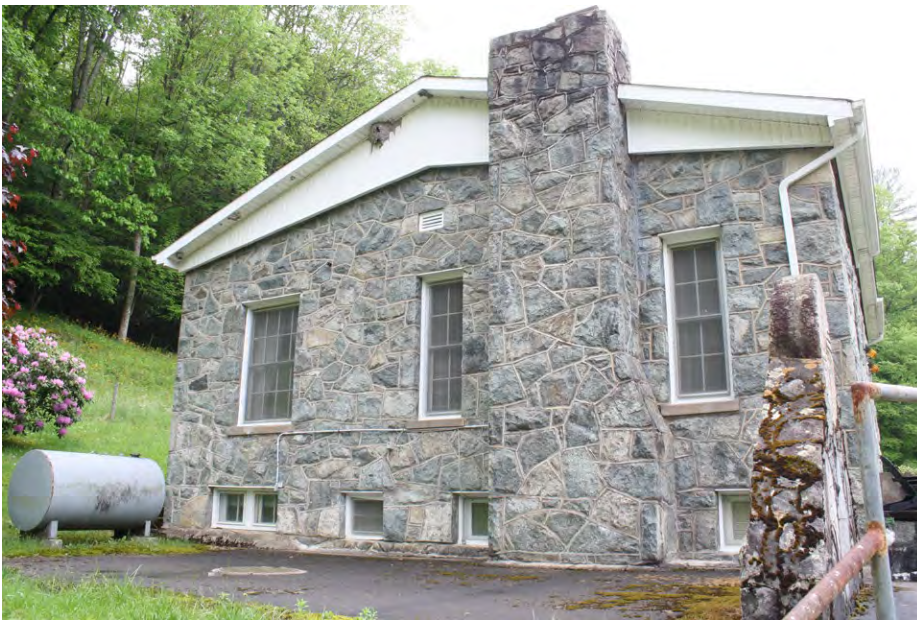
Plate 4.3: View of the House.

Plate 4.4: View of the House.

Plate 4.5: View of the House.

Plate 4.6: View of the House.

Plate 4.7: View of the House.

Plate 4.8: View of the House.

The house is a one-story, side-gable dwelling on a partial basement built into the hillside. It faces east overlooking the Watauga River. Its character-defining features are its exterior masonry of local irregular granite with raised mortar joints and the grist milling stones that are integrated into the design. The milling stones were installed after Ben Ward's death in 1970, but at his request and based on his directions (Wigginton 1985: 359). The gable roof is covered with composite shingles. Sometime after 1975, the original shallow-pitched roof was replaced with the present one with a higher ridgeline extended with overhangs on all four sides. The eaves are covered with vinyl siding. On the south side of the house is a concrete terrace under which is a below grade one-bay garage constructed of poured concrete and faced with granite.

The three-bay front (east) elevation consists of a slightly off-center wood multi-light door flanked by original wood eight-over-eight windows. The door is positioned under a slight front gable peak. The entry is accessed by a concrete and granite split stair landing that leads to a landing and is inset with large stone millstones on the east wall. These are three of the nine mill stones that are used as decorative elements on the exterior, an eccentric feature of the house. South of the stairs is a basement door that functions as the house's day-to-day entry. One of two, four-over-four wood sash windows and one replacement window are set between the door and the front entry stair. The other four-over-four woodsash windows is north of the front entry stair.

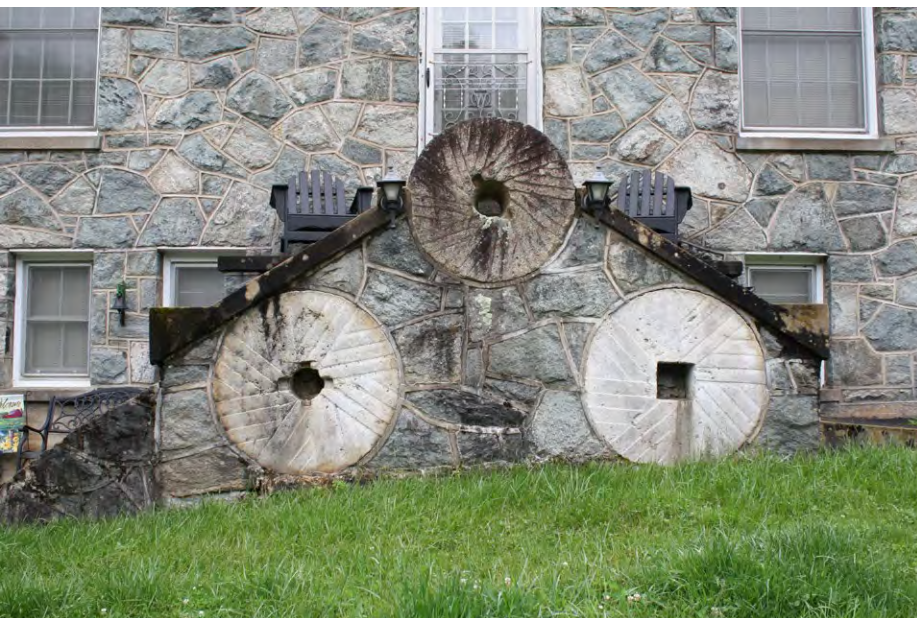
Plate 4.9: Millstone wall at the front entrance.

A wing wall projecting from the north, front elevation contains millstones and granite-inscribed plaques with quotes from B.O. Ward, Thomas Jefferson, and Voltaire. The date on the inscriptions is 1967 indicating that the wall is not original, although it is in keeping with the house's theme. Three

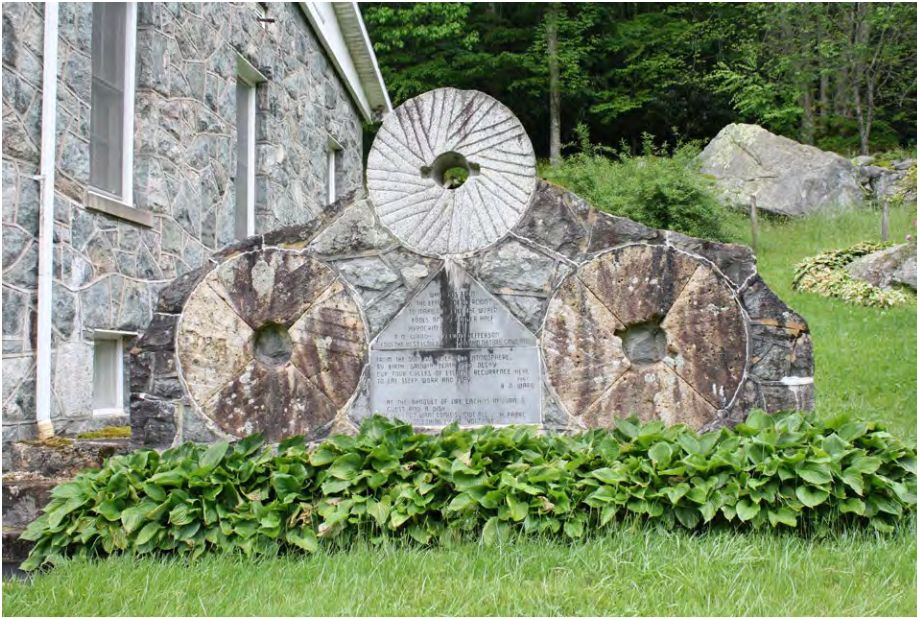
Plate 4.10: Millstone wall on the north side of the House.

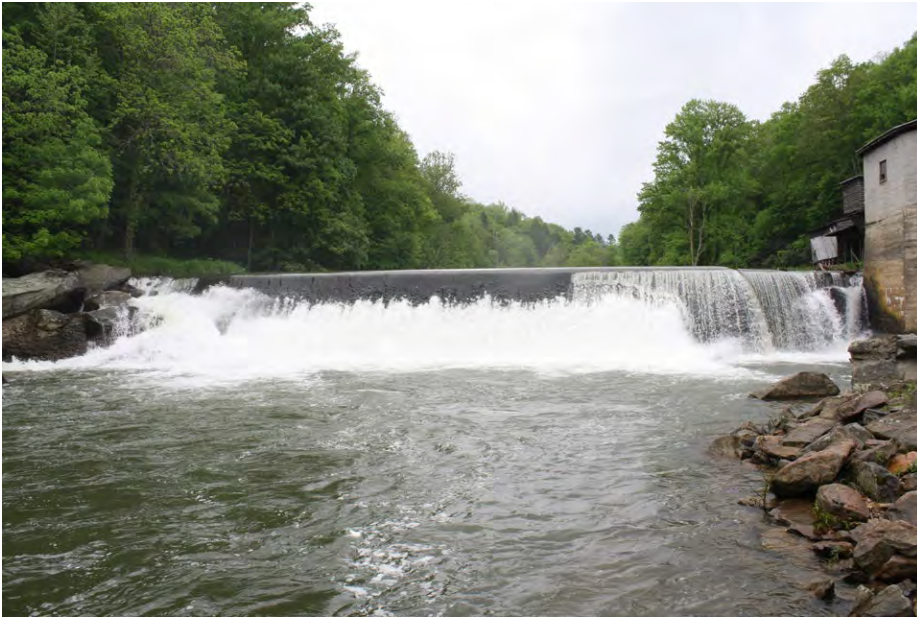
Plate 4.13: Dam from
Watauga River.

The 1964 concrete and rock dam is approximately 20 feet high, 110 feet wide across, and 21 feet wide at the base. It sits on a foundation of natural bedrock. One-inch diameter vertical steel rods are placed approximately every four feet across the interior structure of the dam. These rods are imbedded two-and-one-half feet into the bedrock with reinforced steel running horizontally through the interior of the dam (Givens 2014). The west end of the dam attaches to the waterhouse section of the machine shop building.

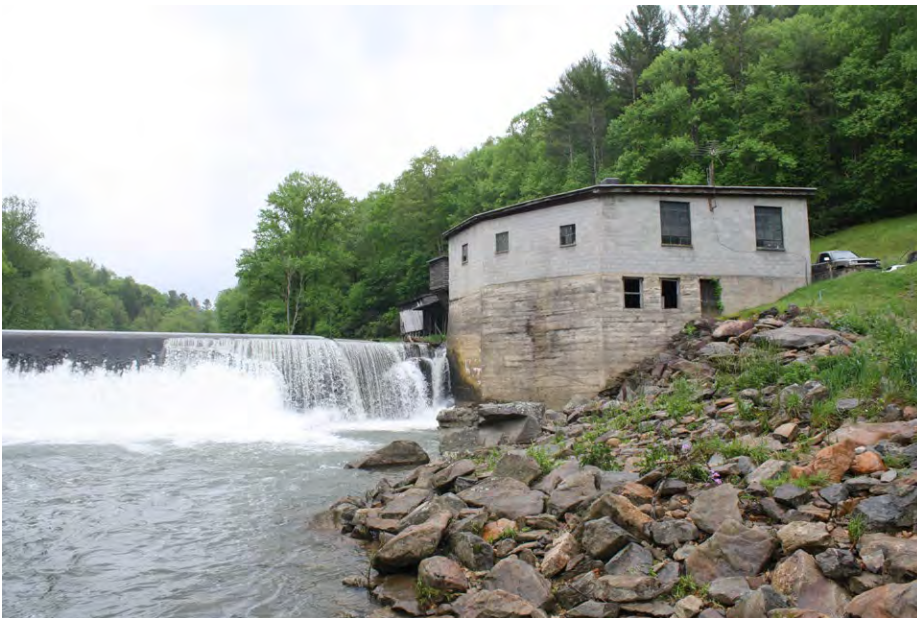
Plate 4.14: View of the Dam
and Machine Shop.

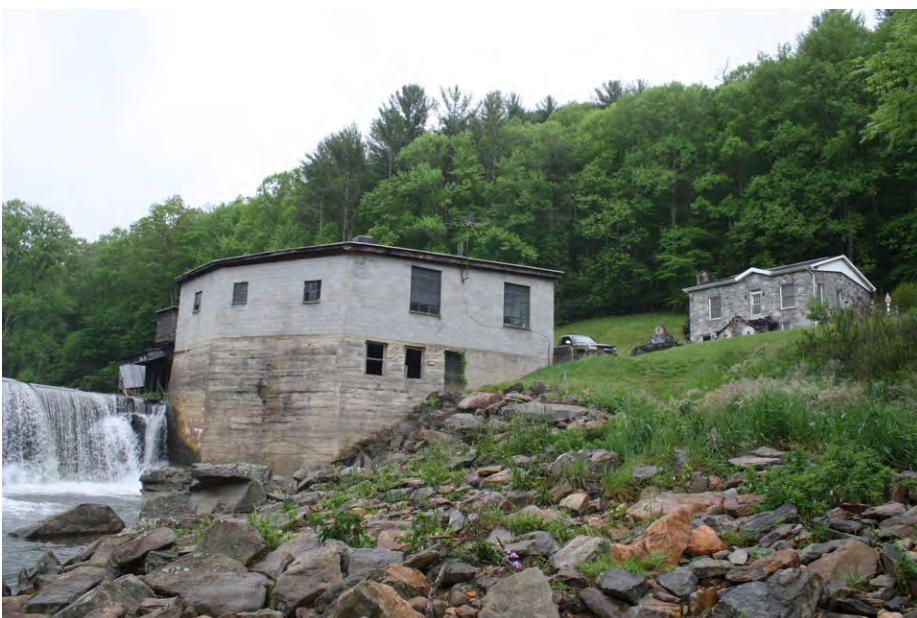
Plate 4.15: Machine Shop
from riverbank with
waterhouse section on right
side.

Note, the Ward House in the
background.

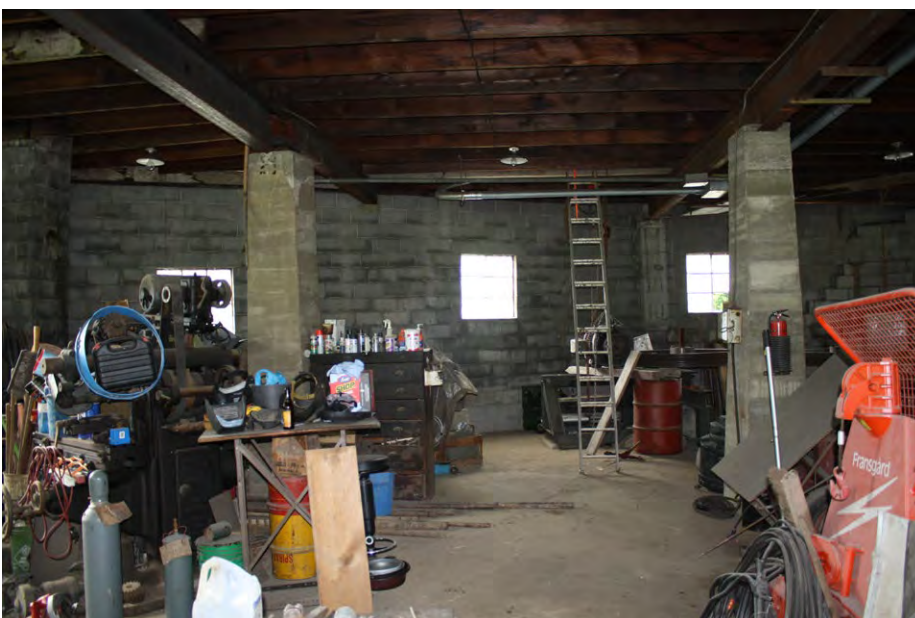
Plate 4.18: Machine Shop
interior showing the
pyramidal piers that support
waterhouse section.

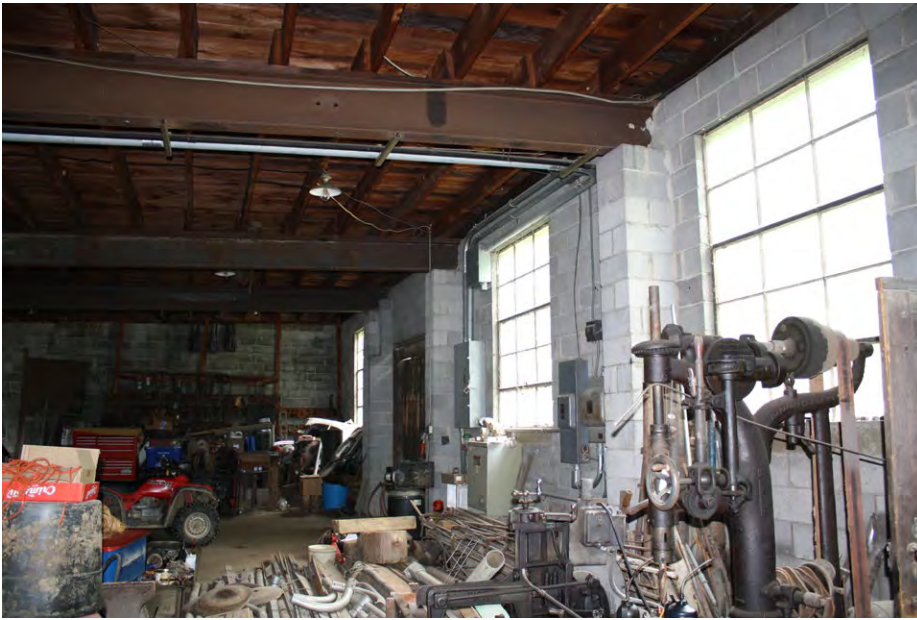
Plate 4.19: Machine Shop interior showing I-beams and wood roof decking.

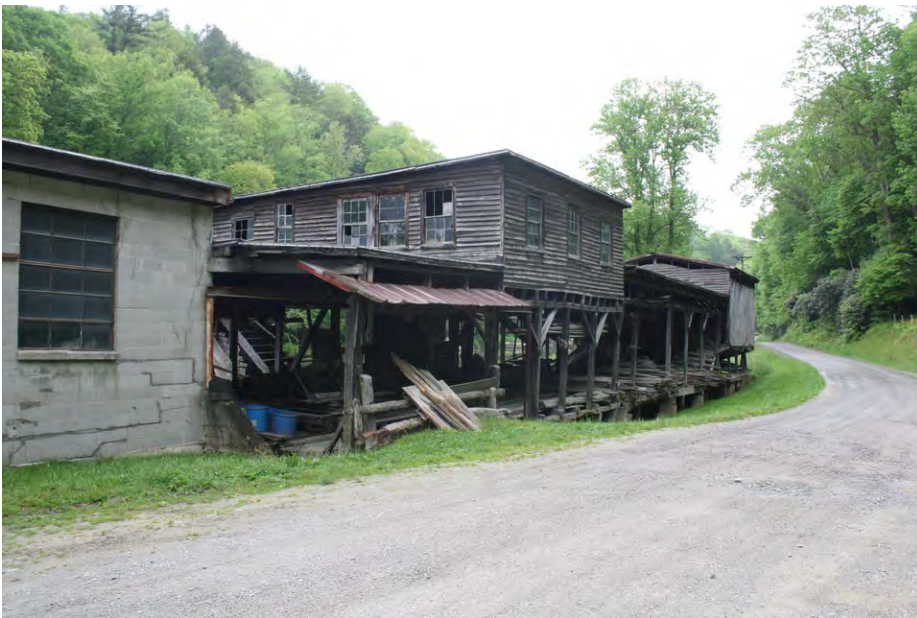
Plate 4.20: Sawmill with the Machine Shop in foreground.

The lumber sawmill was constructed by Ben Ward to replace an earlier one destroyed by floodwaters in 1940. The heavily framed, four-part structure has metal covered shed and gable rooflines, which are arranged in a linear fashion. Each section sits on trapezoidal piers of poured concrete which elevate the building above the wet and flood-prone riverbank. The open shed at the north end attaches to the machine shop and three subsequent sections extend to the south. The two-story file room section comes next. It is an open shed surmounted by a shed-roofed, weatherboard-covered file room with original six-over-six windows that light the interior work room. This room, which was accessed from a wood staircase in the shed, contains the saw grinder, a tool vitally important to the mill's function. The saw blade was pulled up for maintenance through a trap door in the file room floor. South of the file

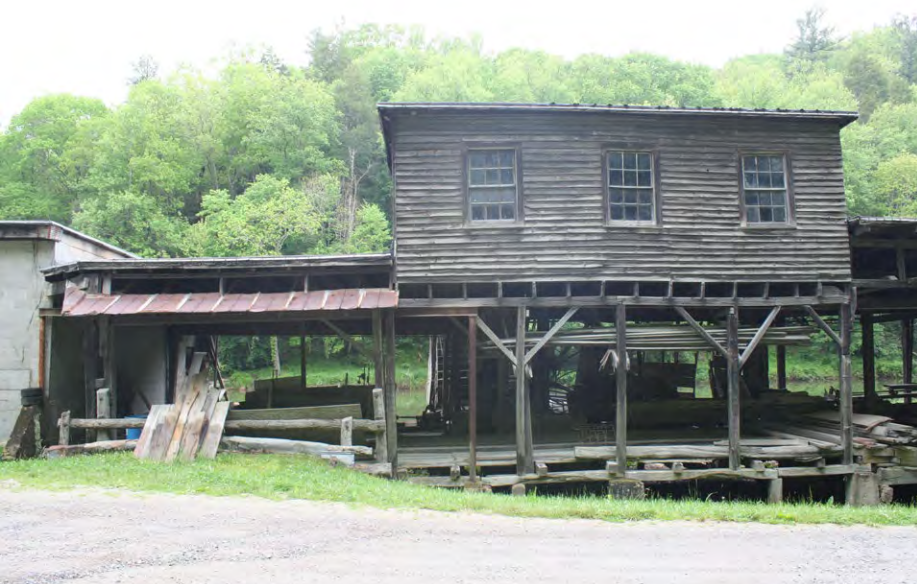
Plate 4.21: Sawmill north the shed and file room sections.

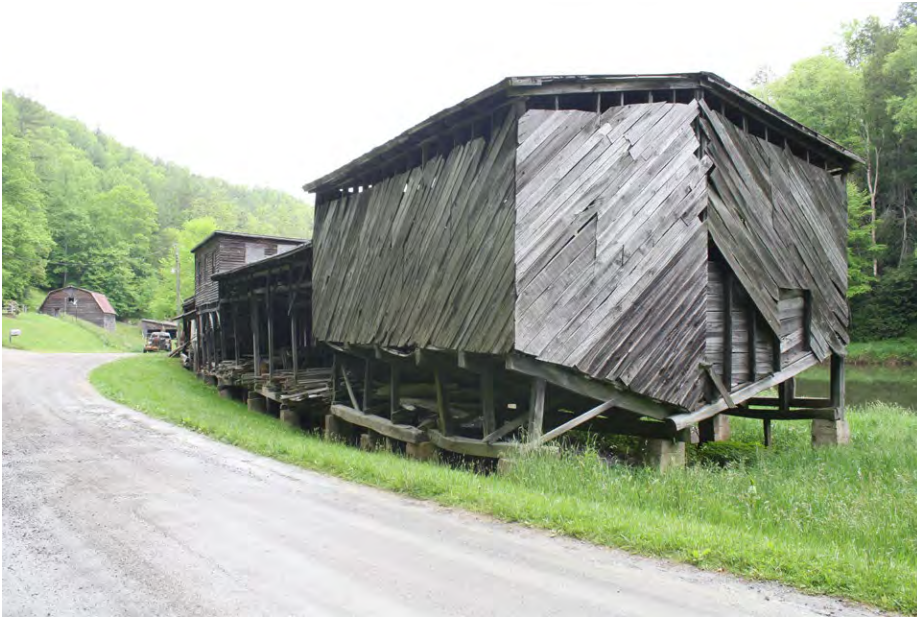
Plate 4.22: Sawmill storage bin section from the roadside.

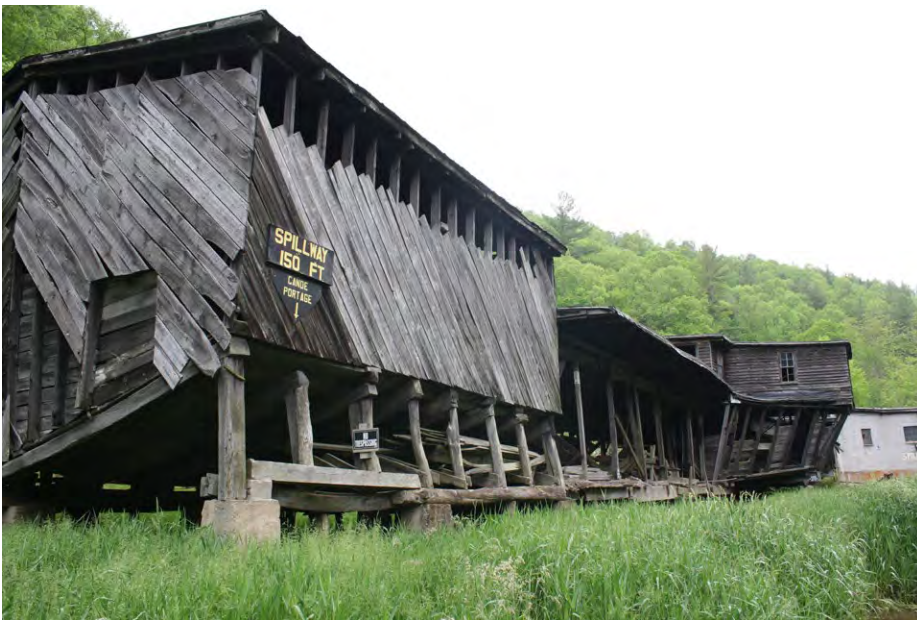
Plate 4.23: Sawmill storage bin section from the riverside.

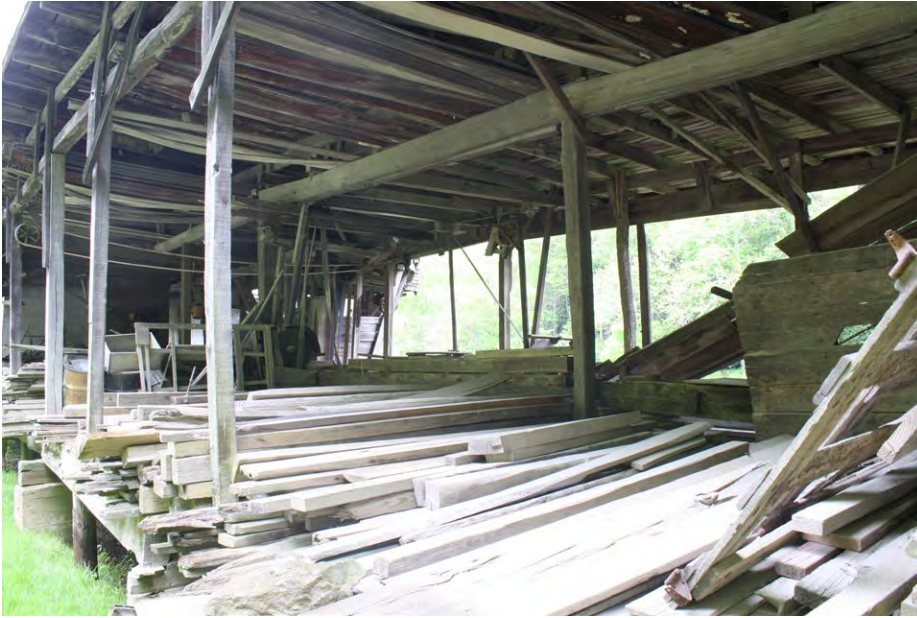
Plate 4.28: Sawmill interior looking toward the Machine Shop.

The four-part sawmill structure houses Ben Ward's milling machinery. Originally, a four-foot saw blade was powered by a system of wheels, belts, pulleys, shafts, and recycled truck transmissions that were mechanized by the turbines at the base of the waterhouse, a complex and clever system devised and built by Ward. Power was conveyed along the main line drive which ran under the floor of the sawmill structure and operated the machinery, including the incline-operated log buggy, which plucked logs from the "log pond" sectioned off from the river; the carriage, which transported the logs to the saw blade on a sled; the saw blade itself; Ward's patented log turner; and edgers and rollers that shaped the logs into lumber (Figures 4.3 and 4.4). In 1953, Ward replaced the original four-foot 1941 saw blade with a larger six-foot blade he crafted in the adjacent machine shop (Wigginton 1985: 335). The six-foot blade remains in place today as does most of the other sawmill machinery.²

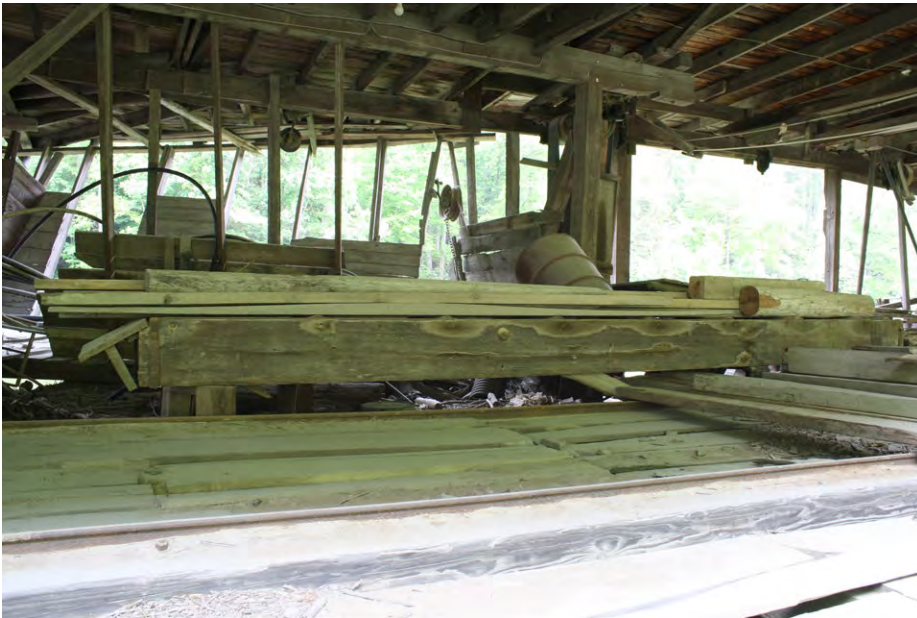
Plate 4.29: Sawmill carriage tracks which transported the logs to the saw blade on a sled.

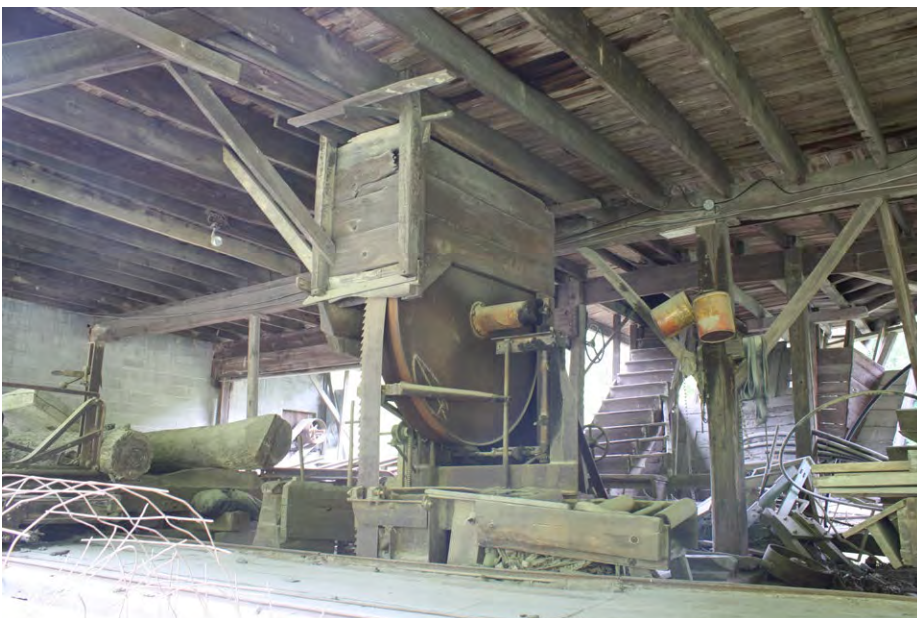
Plate 4.30: View of the saw blade.

Note, tracks on floor that carried the logs to the blade on sleds. Also note stair to file room.

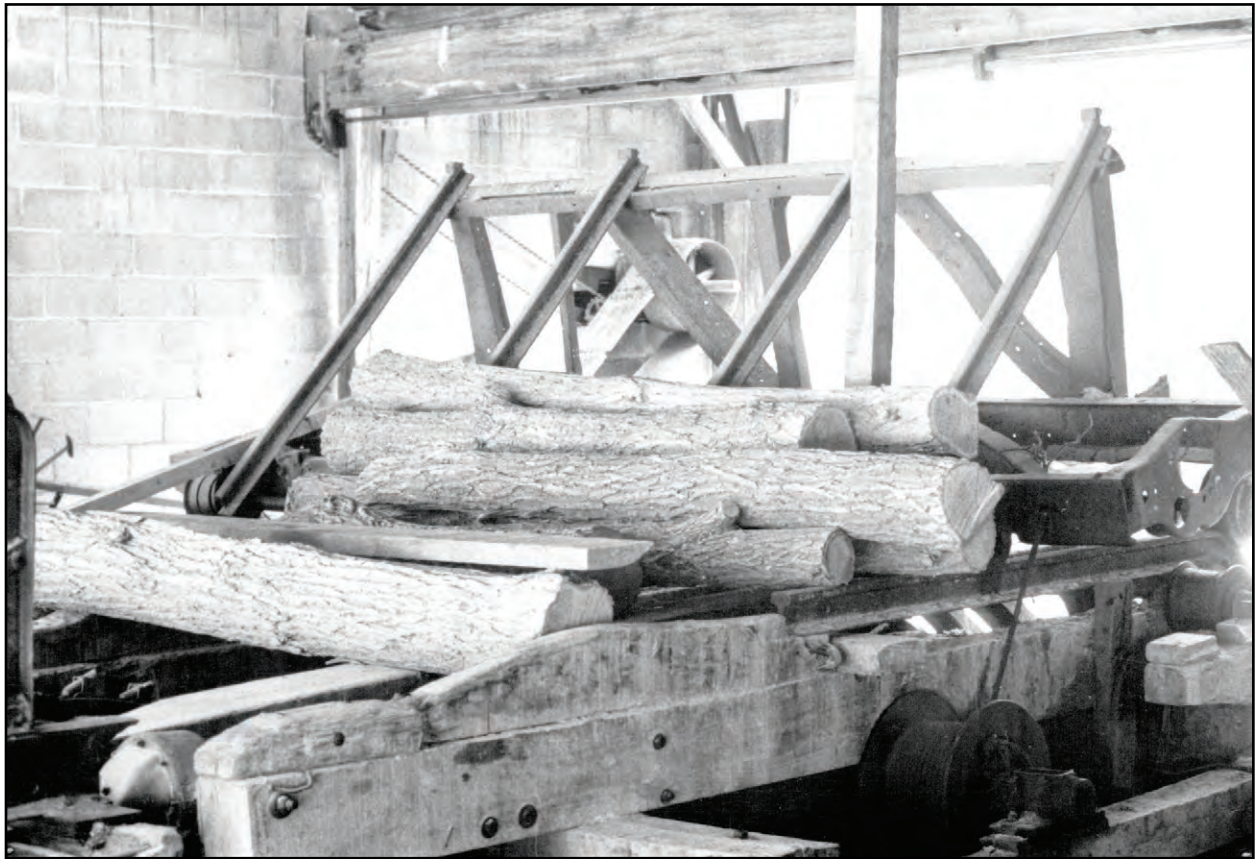
Figure 4.3: Log Buggy in the Sawmill Building after Picking Up Logs from the Log Pond, circa 1975
(Courtesy of The Foxfire Museum).

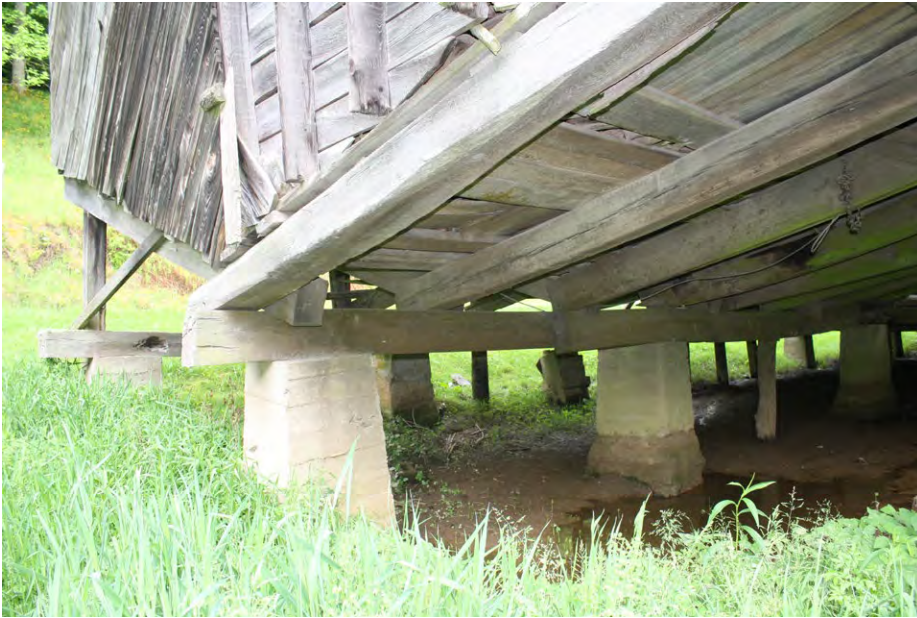
Plate 4.25: Storage bin floor system.

Note, v-shaped floor and pyramidal concrete piers.

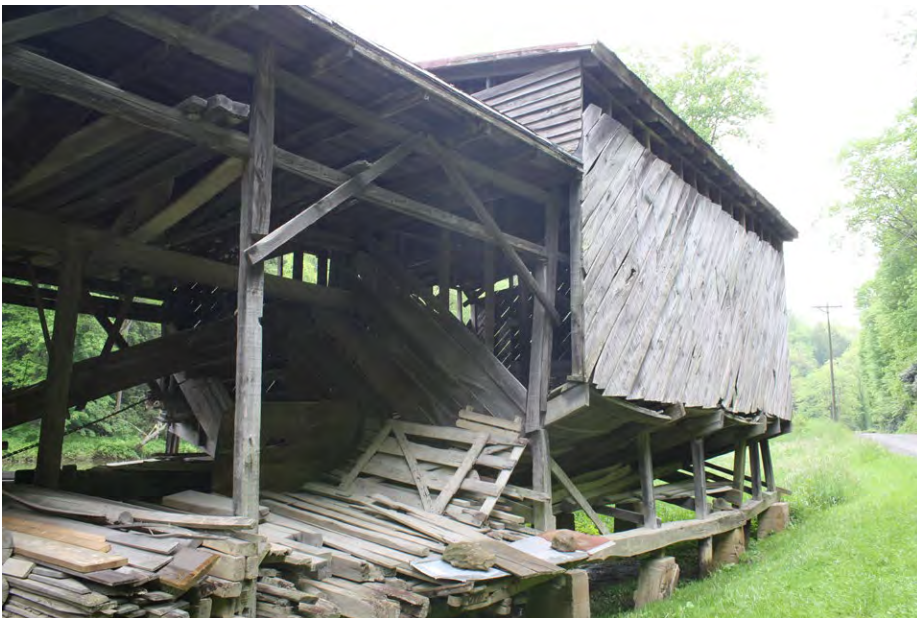
Plate 4.26: Storage bin and wood chute section.

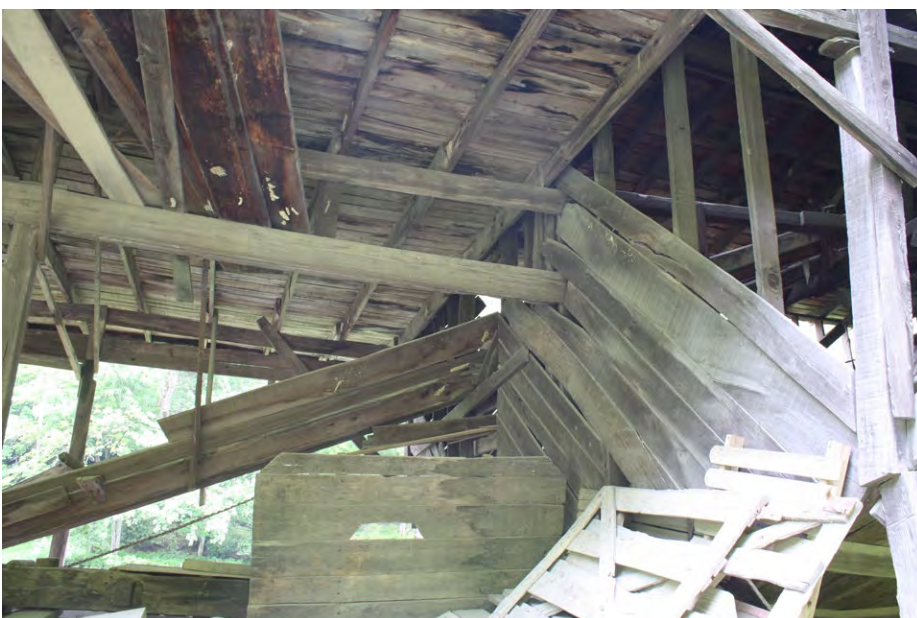
Plate 4.27: V-shaped wood chute leading up to the storage bin.

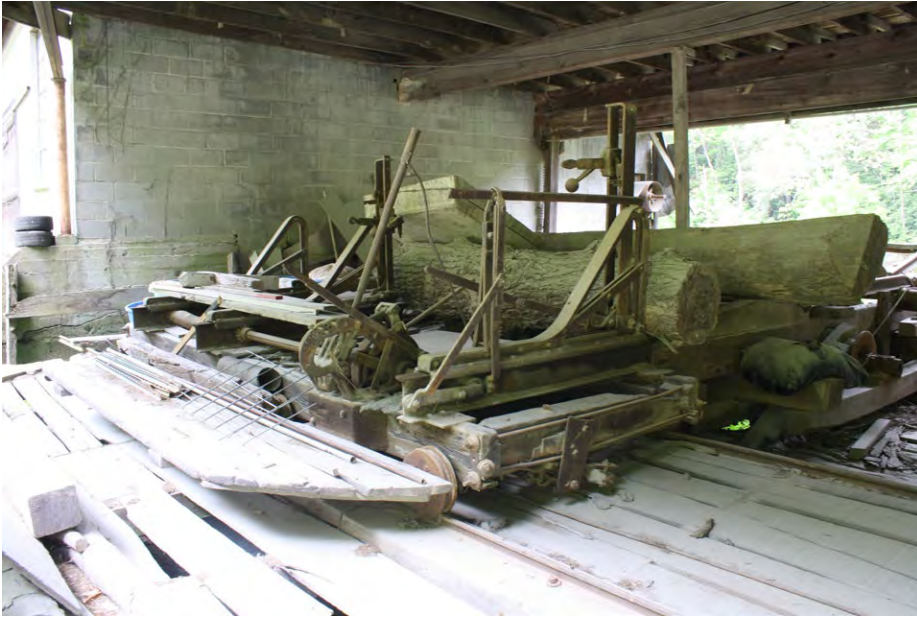
Plate 4.31: View of Ben Ward's patented log turner.
