HISTORIC STRUCTURES SURVEY REPORT

WARD MILL DAM REMOVAL

**Ward Mill Dam, Sugar Grove, Laurel Creek Township,
Watauga County, North Carolina**

Technical Report # 2020-077NC

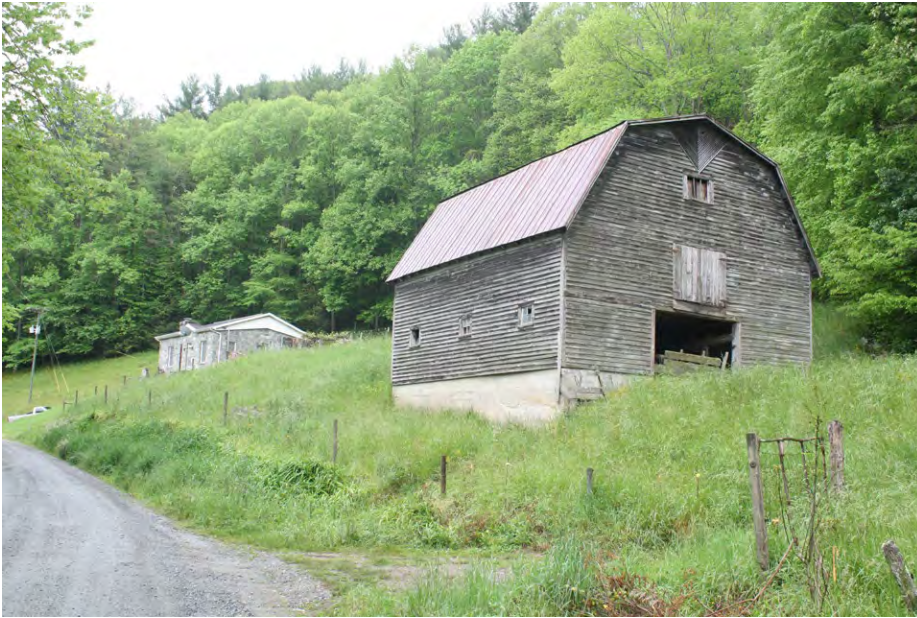
Plate 4.34: View of the
Gambrel Roof Barn.

This frame gambrel-roofed frame barn sits on a poured concrete foundation that is partially built into the hillside. Plain weatherboards cover the exterior walls and the roof slopes are covered with 5-V metal. The interior has a central hall flanked by livestock stalls on the first level and hay lofts on the upper level. The loft is ventilated by lattice in the gable ends. A stream, bridged by a concrete slab, passes under the barn's north entry. The stream continues downhill, under Old Watauga River Road, and into the Watauga River.

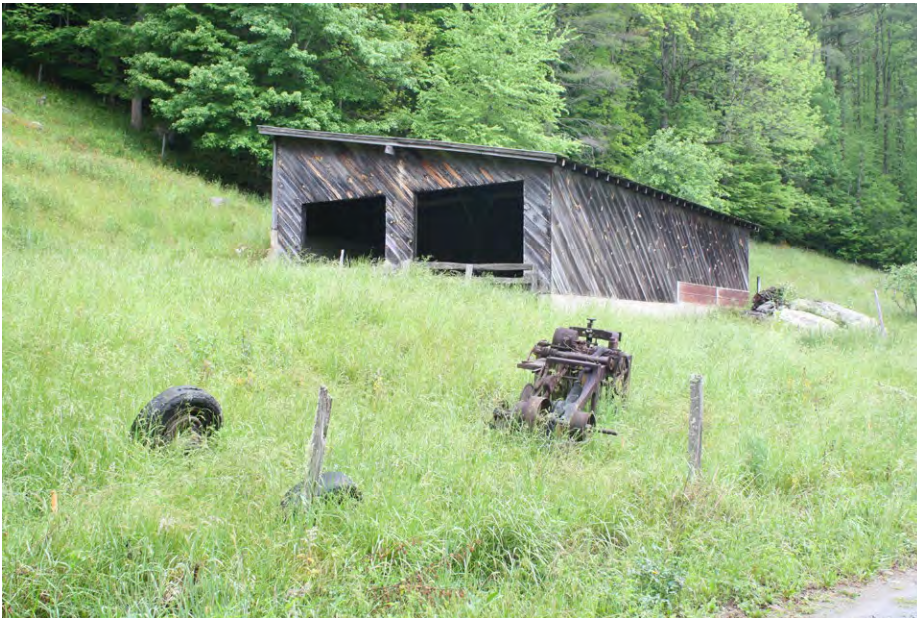
Plate 4.35: View of the Shed
Roof Barn.

The shed roof barn is accessed by two open bays in the south wall. The roof has exposed rafter ends and is covered with metal and the walls are covered with diagonal wood sheathing. The barn sits on a poured concrete foundation.

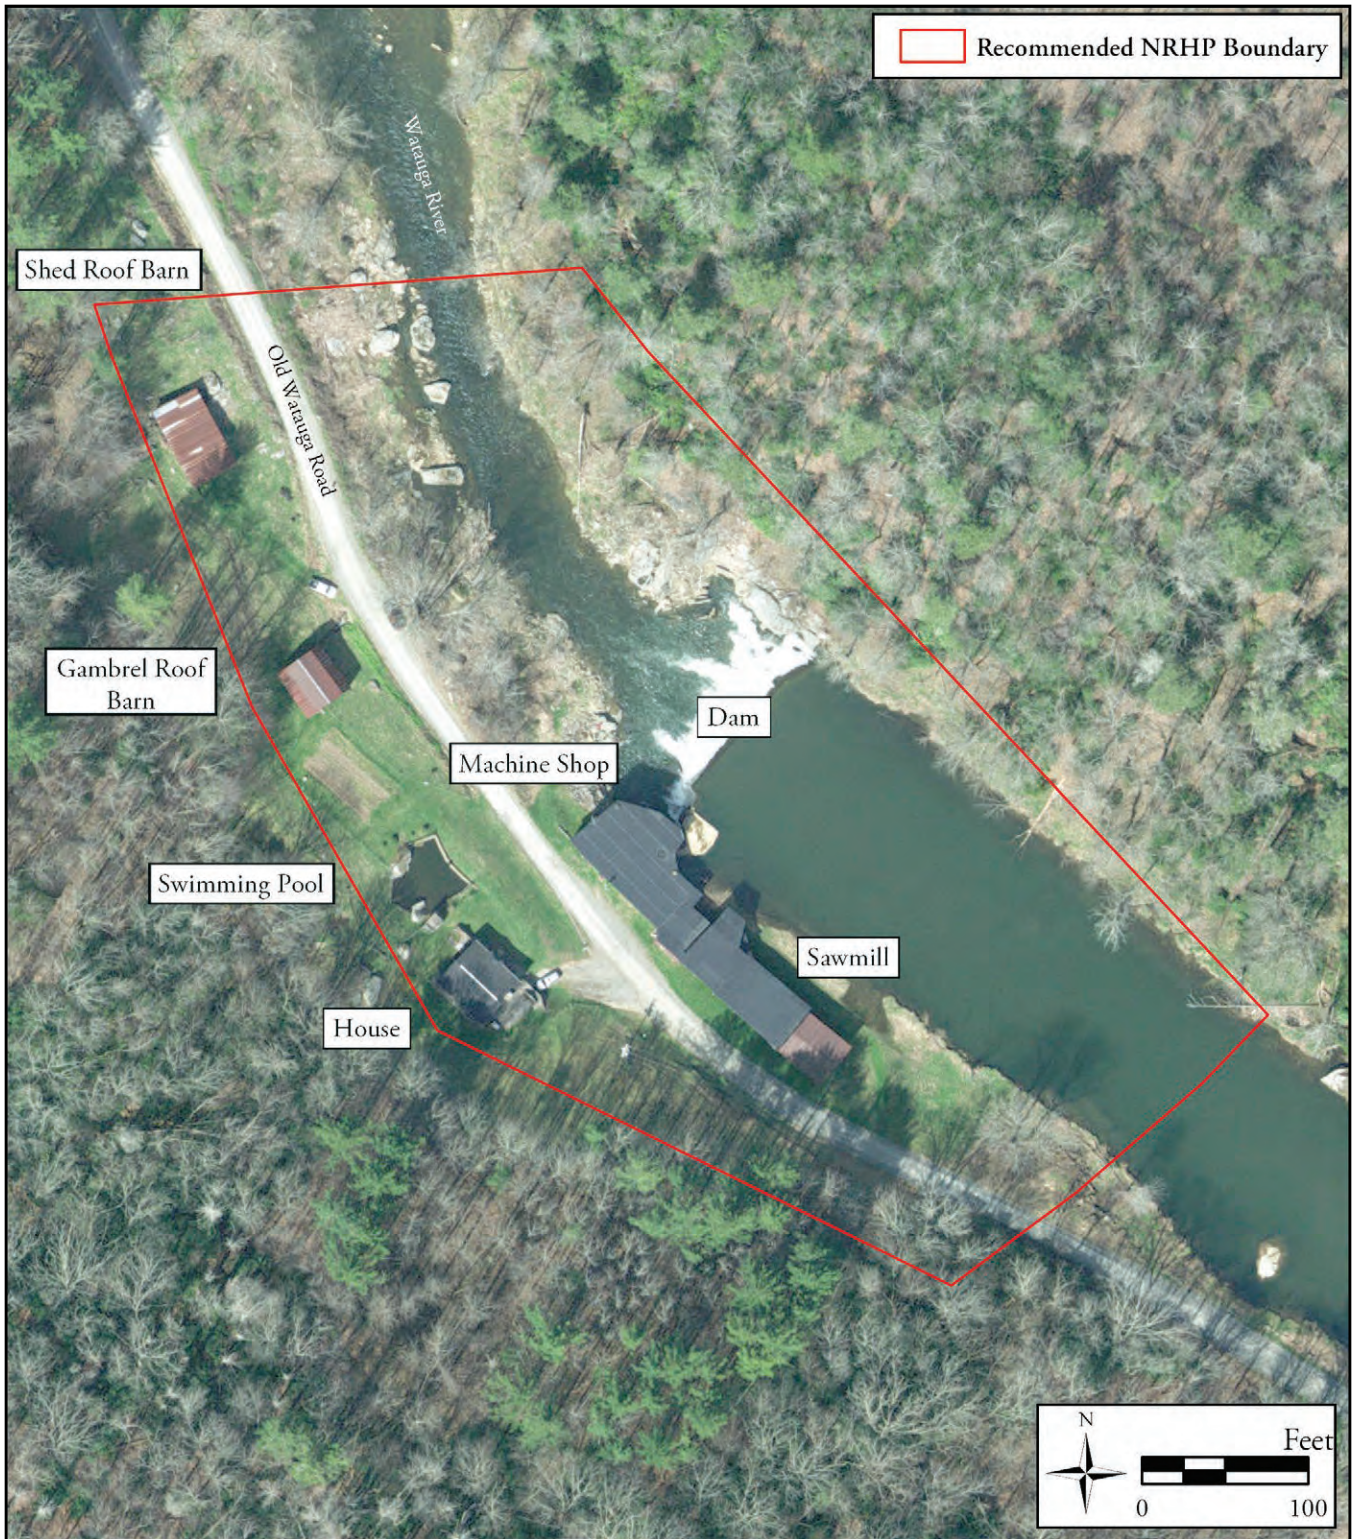
Figure 4.5: Recommended NRHP boundary for the B.O. Ward House and Mill Complex (WT0358) (World Imagery, ESRI 2020).

The recommended NRHP boundary for the B.O. Ward House and Mill Complex contains approximately five acres and includes the house, swimming pool, dam, machine shop, sawmill structure, sawmilling equipment, and two barns (Figure 4.5). These buildings straddle the east and west sides of Old Watauga River Road, which parallels the west bank of the Watauga River. The recommended boundary is drawn to capture the historical and natural setting of the property.
