SUBJECT: HSSR for U-6223, Extend NC 42 East to connect to SR 1563 (Little Creek Church Road) and improve intersection of SR 1563/SR1560 (Rand Road), PA 19-05-0013, Johnston County, ER 20-0791

**HISTORIC STRUCTURES SURVEY REPORT
EXTEND NC 42 EAST TO CONNECT TO SR 1563 (LITTLE CREEK CHURCH ROAD)
AND IMPROVE INTERSECTION OF SR 1563/SR1560 (RAND ROAD) IN
JOHNSTON COUNTY, NORTH CAROLINA**

**TIP PROJECT U-6223
WBS NO. 48332.1.1
PA TRACKING NO. 19-05-0013**

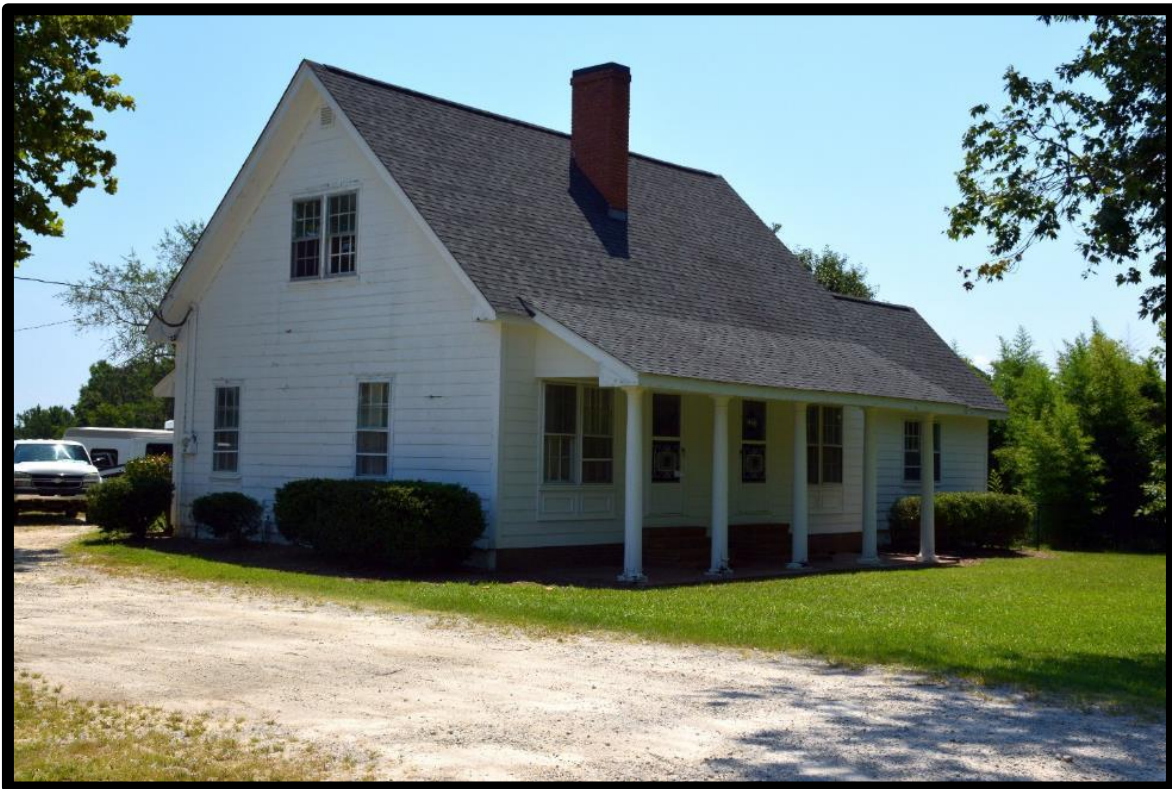
Figure 3: Ellis Tenant House, Looking Southeast.

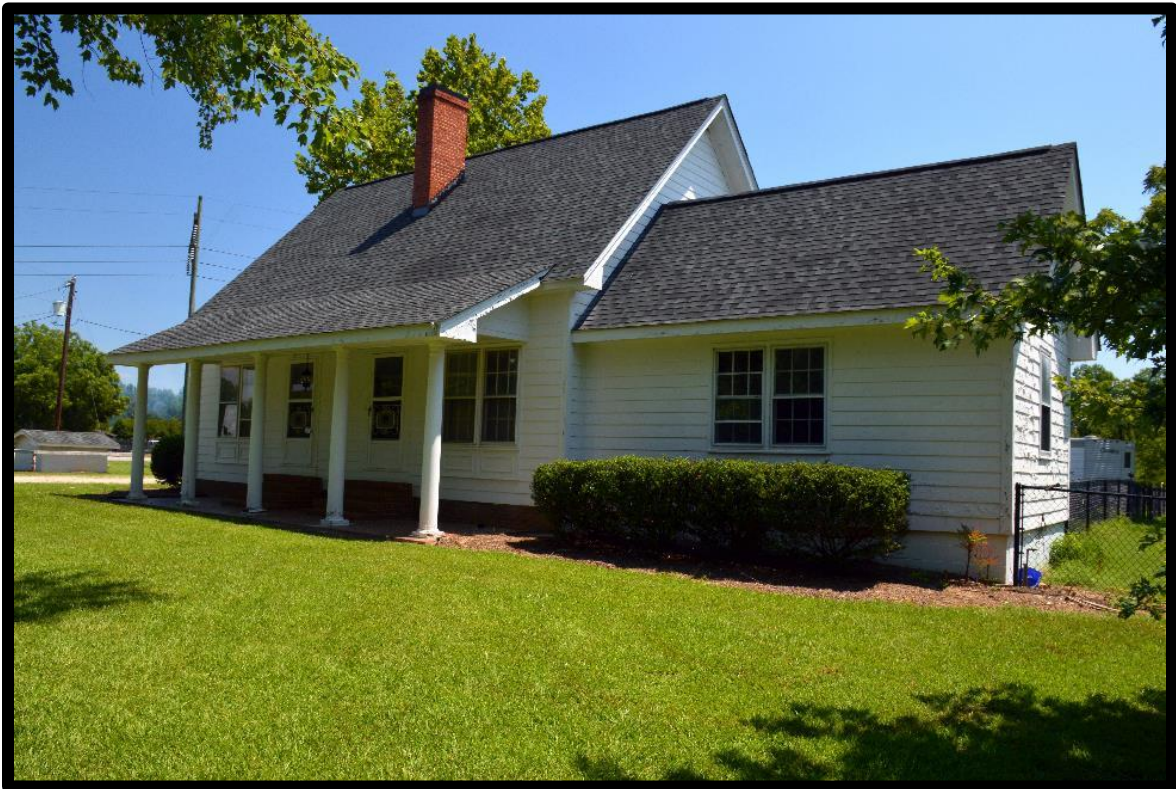
The Ellis Tenant House is a one-and-one-half story, side-gabled saddlebag house clad in fiberboard siding with an asphalt-shingled side-gabled roof. The exterior also features simple cornerboards. The foundation is brick piers with concrete block infill. The core has a rectangular footprint that measures four bays wide and two bays deep. A stretcher bond, brick chimney rises through the center of the front roof slope. A one-story, side-gabled addition with a continuous concrete block foundation extends from the south gable end of the core. This addition measures one bay wide and one bay deep (Figure 5). A shed-roofed porch extends across most of the façade, while along the rear elevation a similar porch has been enclosed. The roof of the front porch is supported by wooden Tuscan columns and its original floor has been removed and replaced with a ground-level slab paved with tile. The west elevation of foundation is clad with brick. The two centrally placed entry doors are modern, paneled, wooden doors with fanlights. They have simple fluted surrounds (Figure 6). The doors are reached by flights of brick steps that rise from the porch floor. The façade windows have paired, six-over-six, double-hung wooden window sashes and there is a decorative wooden panel under each window. The panels appear to have been applied after the porch was lowered as they extend just below the threshold of the entry doors and would have interfered with the plane of the original porch (Figure 7).

Figure 5: Ellis Tenant House, Looking Northeast.

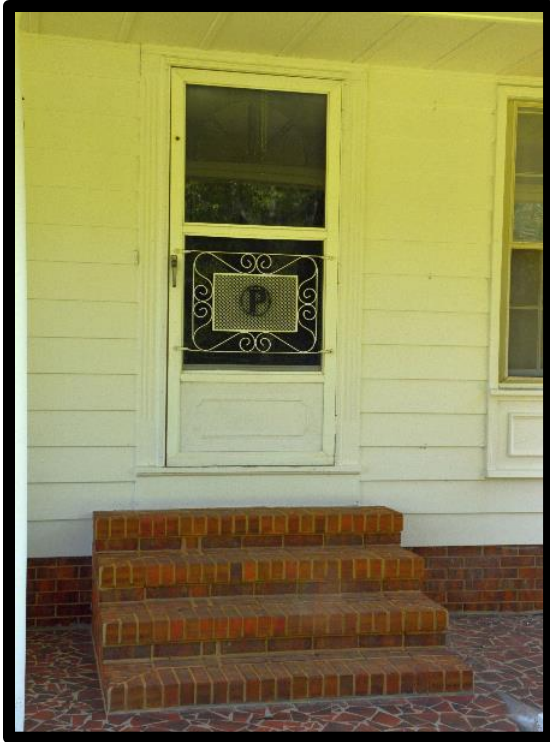
Figure 6: Ellis Tenant House, Entry Detail.

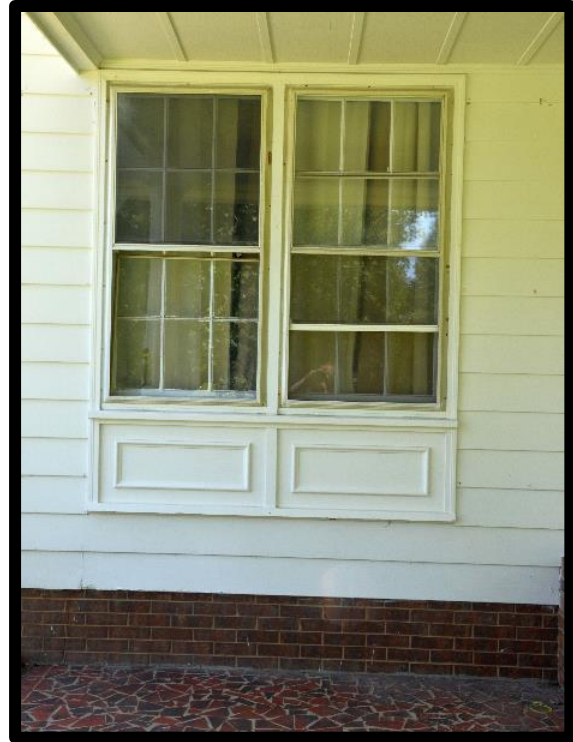
Figure 7: Ellis Tenant House, Window Detail.

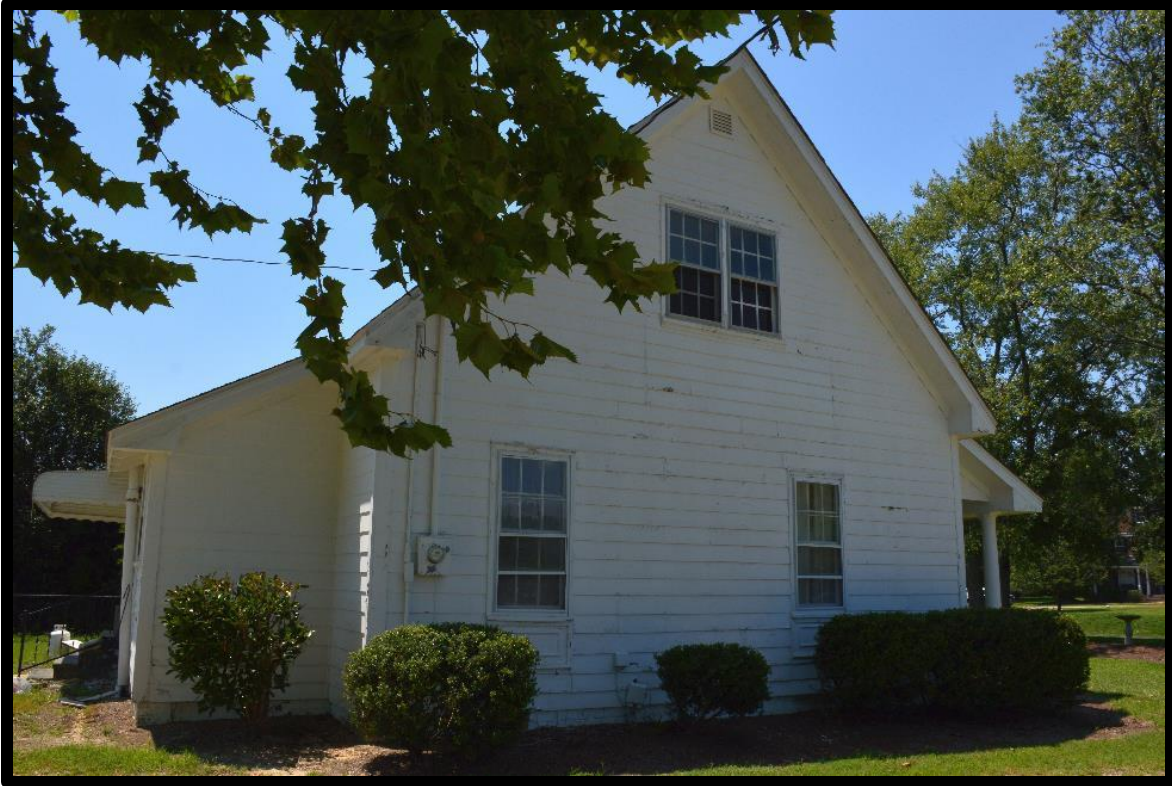
The north (side) elevation is a gable of the core. A small louvered vent is immediately below the gable. A pair of six-over-six, double-hung, wooden sash windows light the second floor. There are two six-over-six, double-hung, wooden sash windows on the first floor. These windows have decorative wooden panels below the sill, like the windows on the façade. The eaves are boxed (Figure 8).

Figure 8: Ellis Tenant House, Looking South.

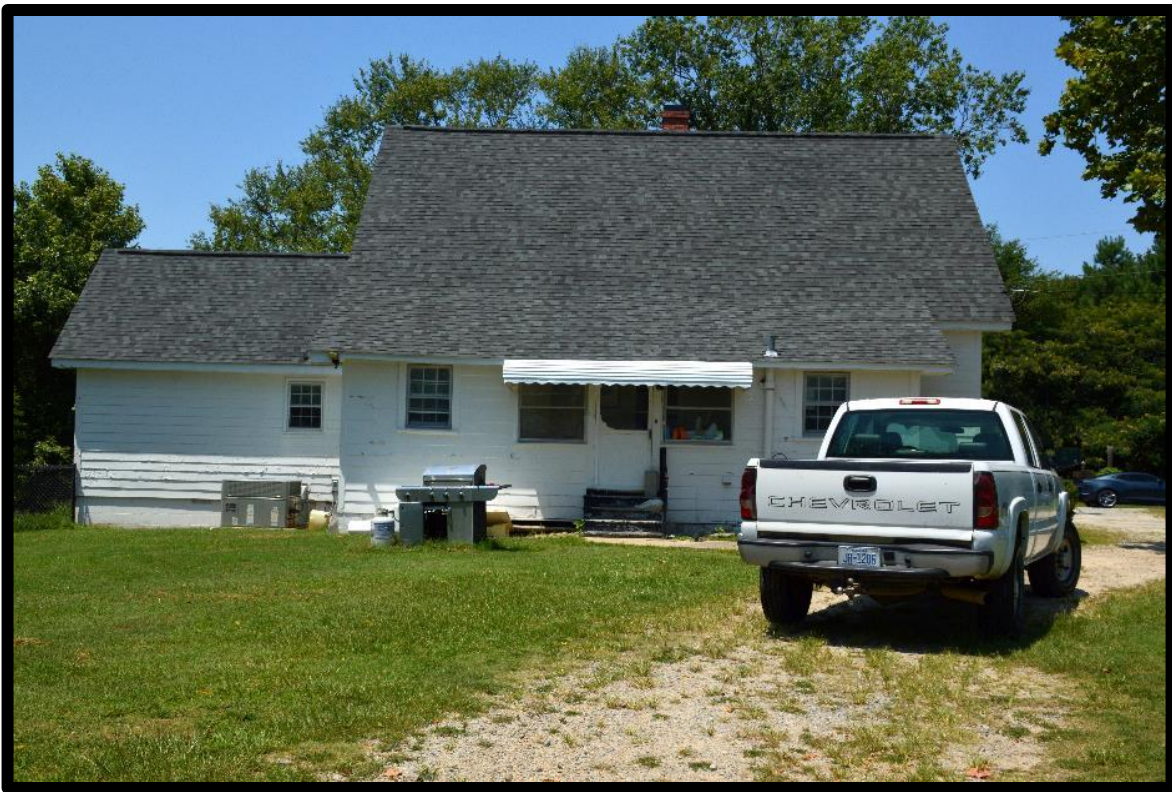
The east (rear) elevation has an enclosed shed roof porch stretching across much of its length. This elevation has a central entry door flanked by one-over-one, double-hung, wooden sash windows. At the northern and southern ends of this enclosed porch are single, six-over-six, double-hung, wooden sash windows. A metal awning shelters the entry, which is reached by a flight of concrete steps with cast metal railing. Set back from the rear elevation is the east elevation of the one-story addition. This features a single, double-hung, wooden sash window with faux muntins (Figure 9).

Figure 9: Ellis Tenant House, View West.

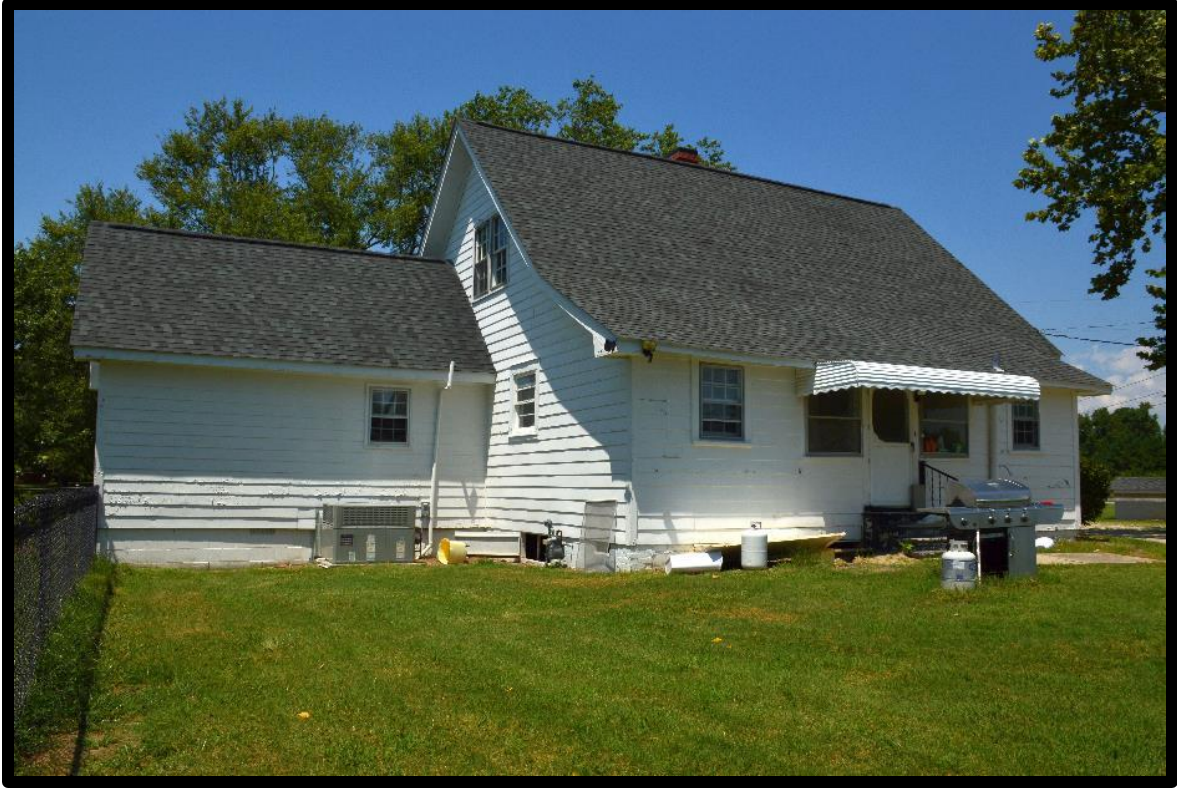
The south (side) elevation has two components: the south elevation of the core and the one-story, gabled addition. The west wall of the addition is flush with the façade and the addition extends for approximately half the depth of the south elevation. The elevation of the core features a pair of six-over-six, double-hung, wooden sash windows on the second floor. A two-over-two, horizontally divided wooden sash window is on the first floor of the core. The addition has a concrete block foundation. The exterior is fiberboard siding and the side-gabled roof is covered with asphalt shingles. The windows on the addition are one-over-one, double-hung sashes with faux muntins (Figure 10).

Figure 10: Ellis Tenant House, Looking Northwest.

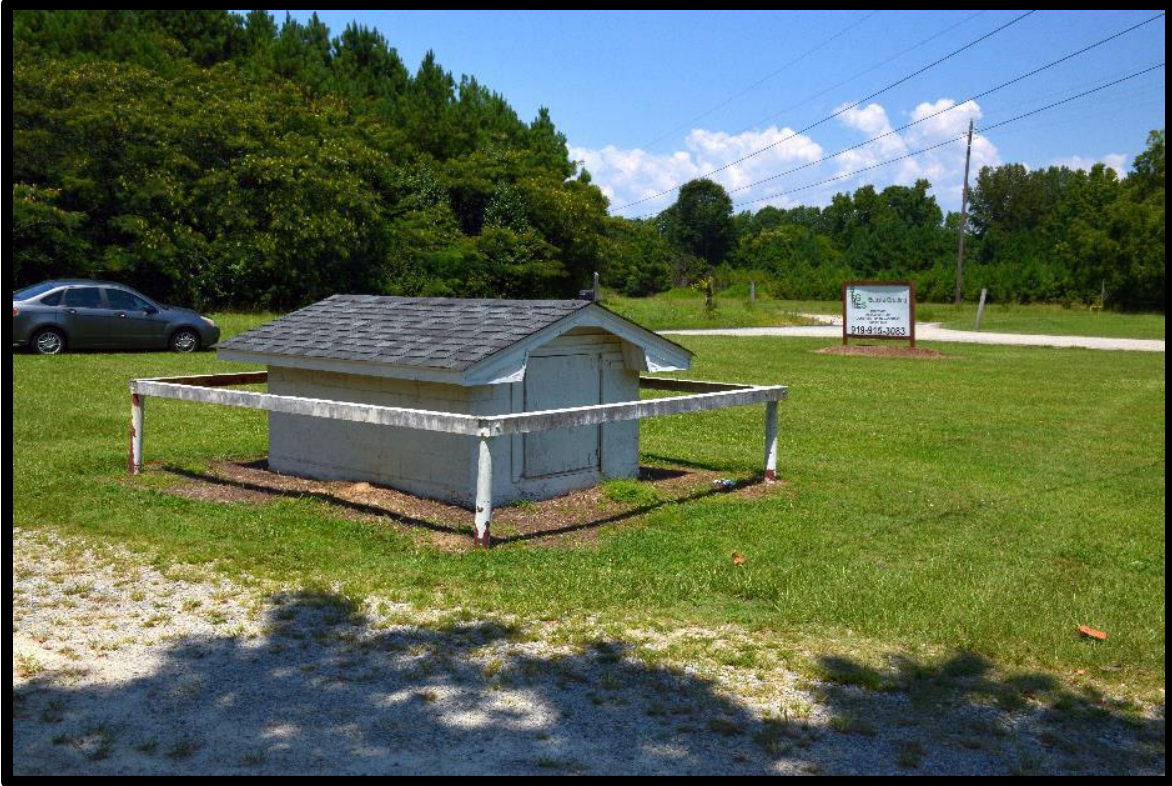
Standing north of the house and the circular driveway is a ca. 1960 concrete block well house. This small structure has low walls, and an asphalt-shingled, front-gabled roof. A small access door is found on the south elevation. Surrounding this structure is a fence made from angle iron supported by metal pipe posts (Figure 11).

Figure 11: Ellis Tenant House, Well House, Looking Northeast.

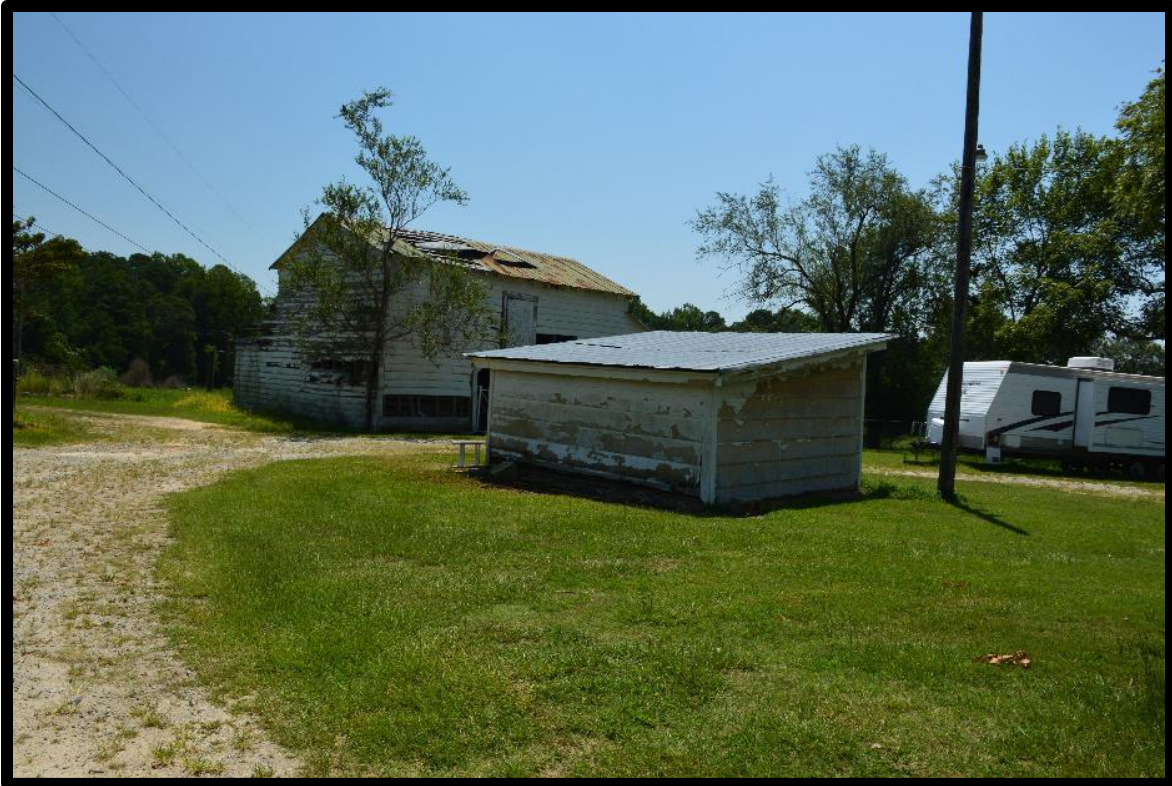
East of the house is a small ca. 1900 chicken house. This frame building has a roughly square plan and is clad with fiberboard siding. The shed roof is covered with corrugated metal. The only fenestration is on the south elevation and consists of a wooden, paneled door abutting a row of square, fixed sash windows (Figures 12 and 13).

Figure 12: Ellis Tenant House, Chicken House (right) and Barn (left), Looking Southwest.

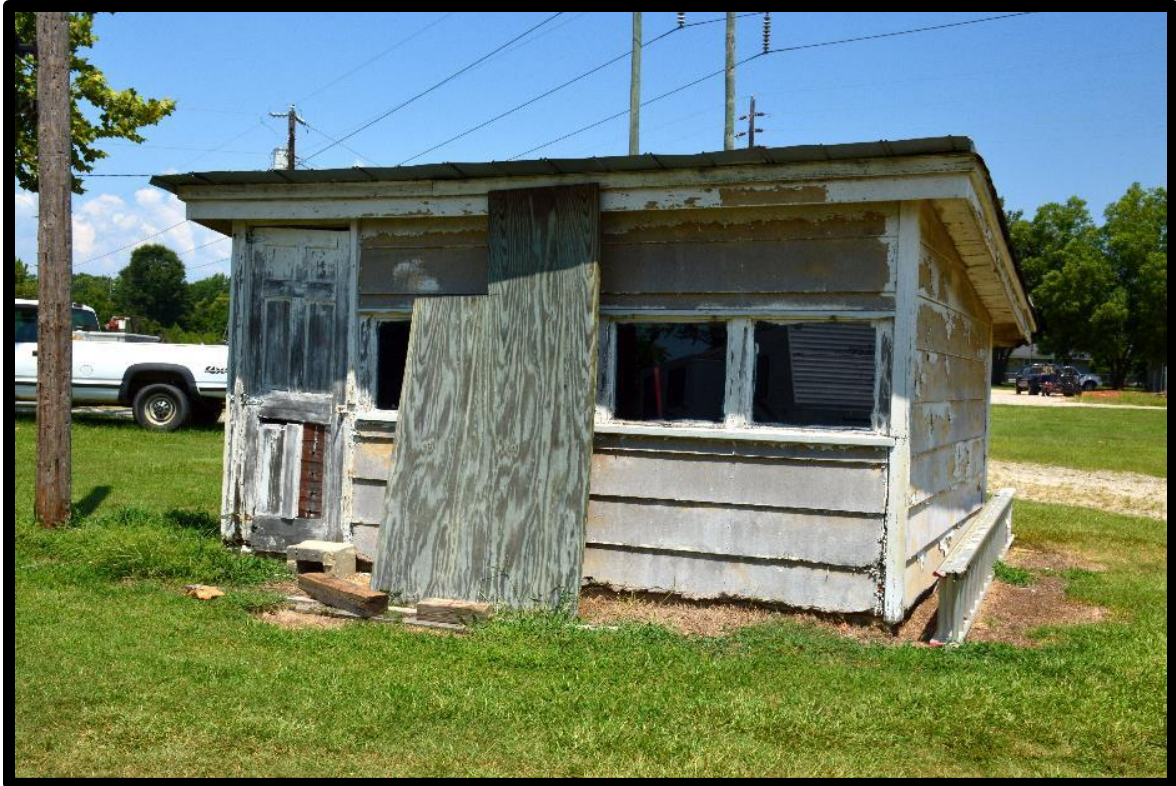
Figure 13: Ellis Tenant House, Chicken House, Looking Northwest. The Electrical Transmission Lines are Visible Overhead.

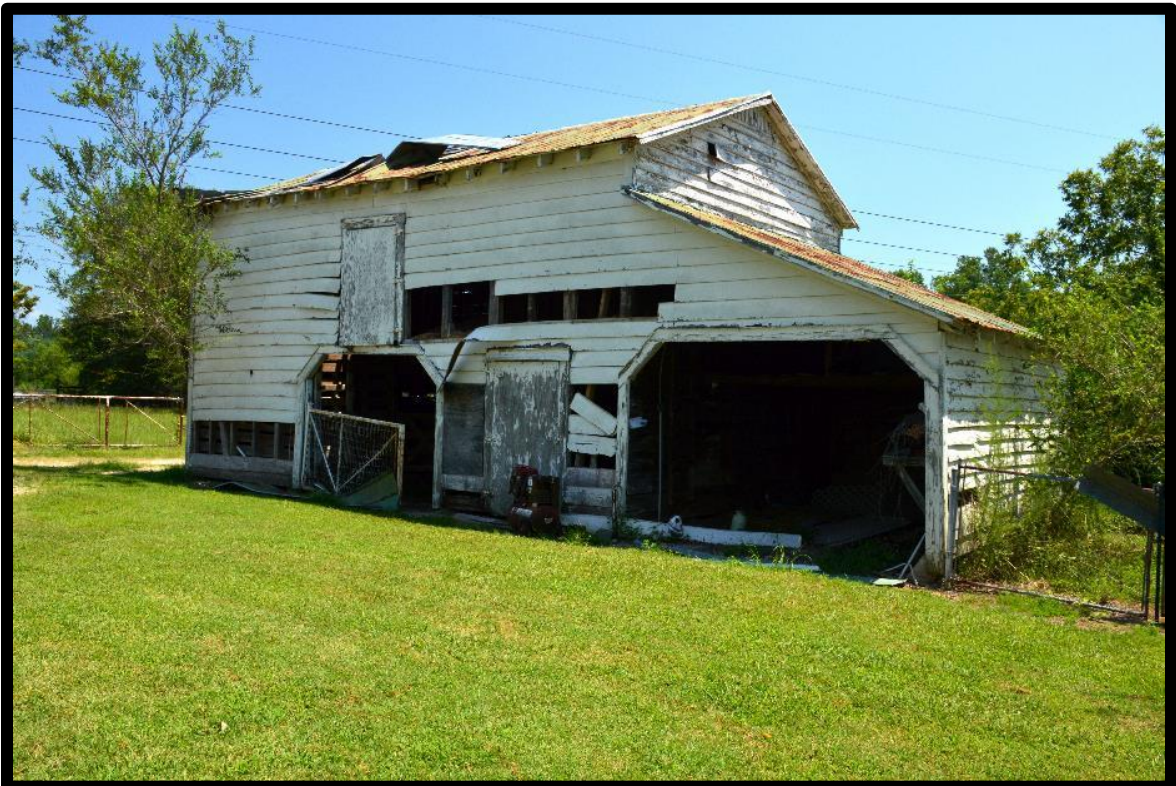
East of the dwelling is a ca. 1900 two-story, frame livestock barn that is clad with fiberboard siding and covered by a corrugated metal, side-gabled roof. The barn is in poor condition with missing sections of siding and roofing. The two-story core of the barn is rectangular with one-story, shed-roofed extensions on the south gable end and east elevation. The ground floor has a central alleyway with canted-corner openings on either end. Animal pens, with board fences, line this alleyway. The upper level hayloft is accessed by a door centered on the east elevation. The southern shed-roofed addition is currently used for storage with a built-in ladder accessing the hayloft in the core of the barn (Figures 14 and 15). Electrical lines angle across the parcel from its northwest corner past the barn (Figure 16).

Figure 14: Ellis Tenant House, Barn, Looking Northeast.

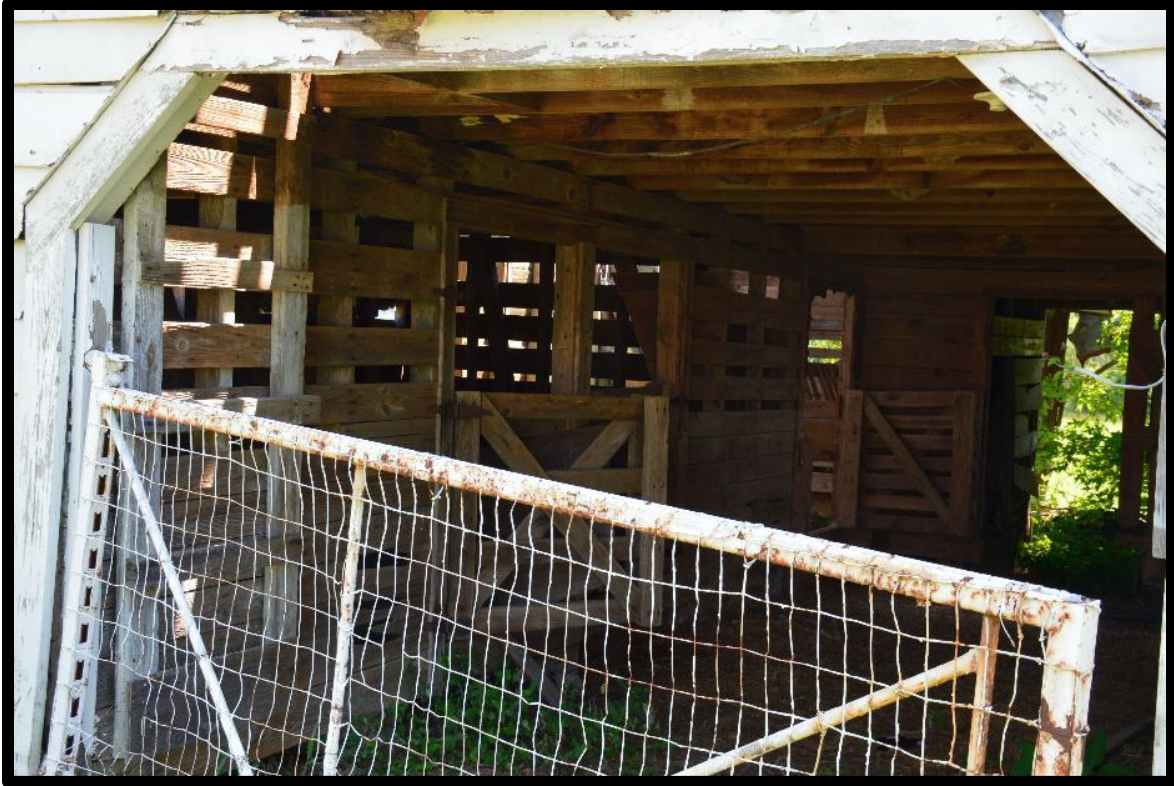
Figure 15: Ellis Tenant House, Barn, Interior of Ground Floor Showing Animal Pens Along the Side of the Alleyway.

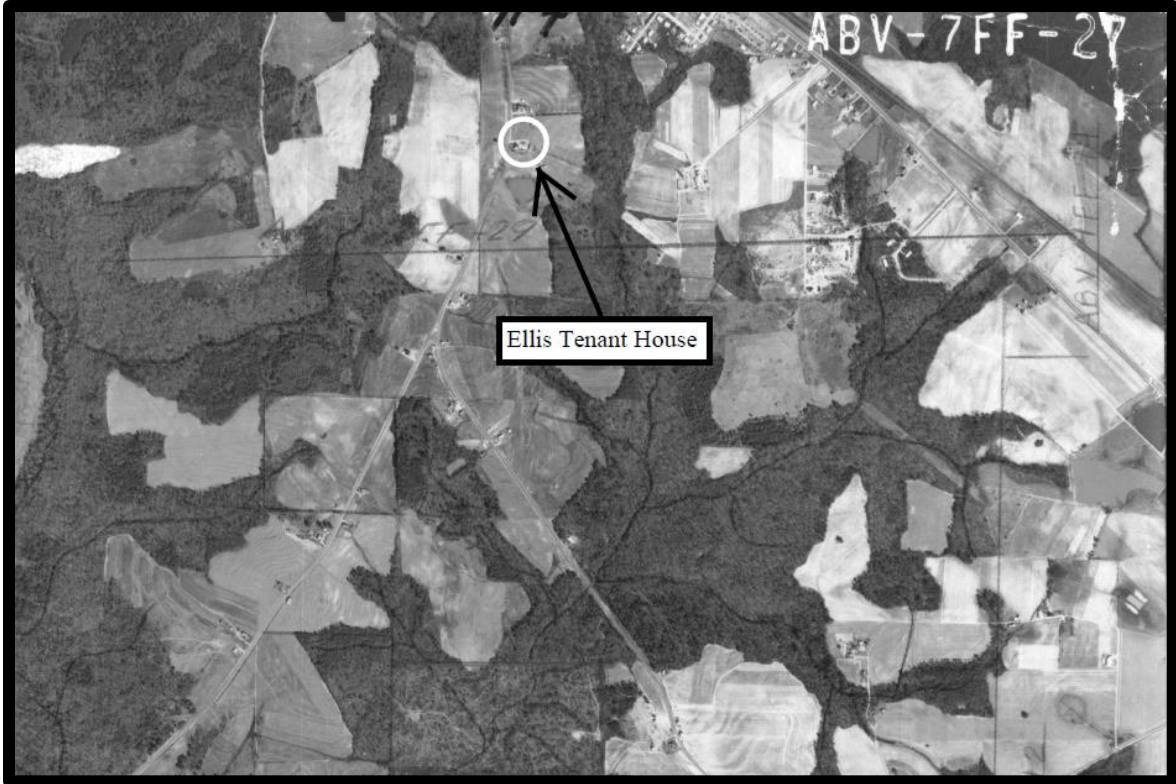
Figure 19: Detail of a 1965 Aerial Photo (Johnston County GIS).

Raymond Pounds purchased 78 acres of this property in August 1947.¹⁴ An aerial photograph from 1965 shows that the property had achieved its current layout, including circular driveway and outbuildings, by that date (Figure 19). The aerial also shows the property surrounded by large swaths of cleared land, which was likely cultivated. A majority of the 78 acres appears to have remained in the Pounds family with Revis Brian Pounds being the owner of the studied parcel and a 10.25-acre parcel to its north and other members of the Pounds family owning parcels to the north and south. These divisions have left the studied parcel as 3.9 acres (Figure 20).¹⁵ As the family divided the property among themselves, some of its cultivated fields have been lost to enlarged domestic yards or new development. However, despite these changes,

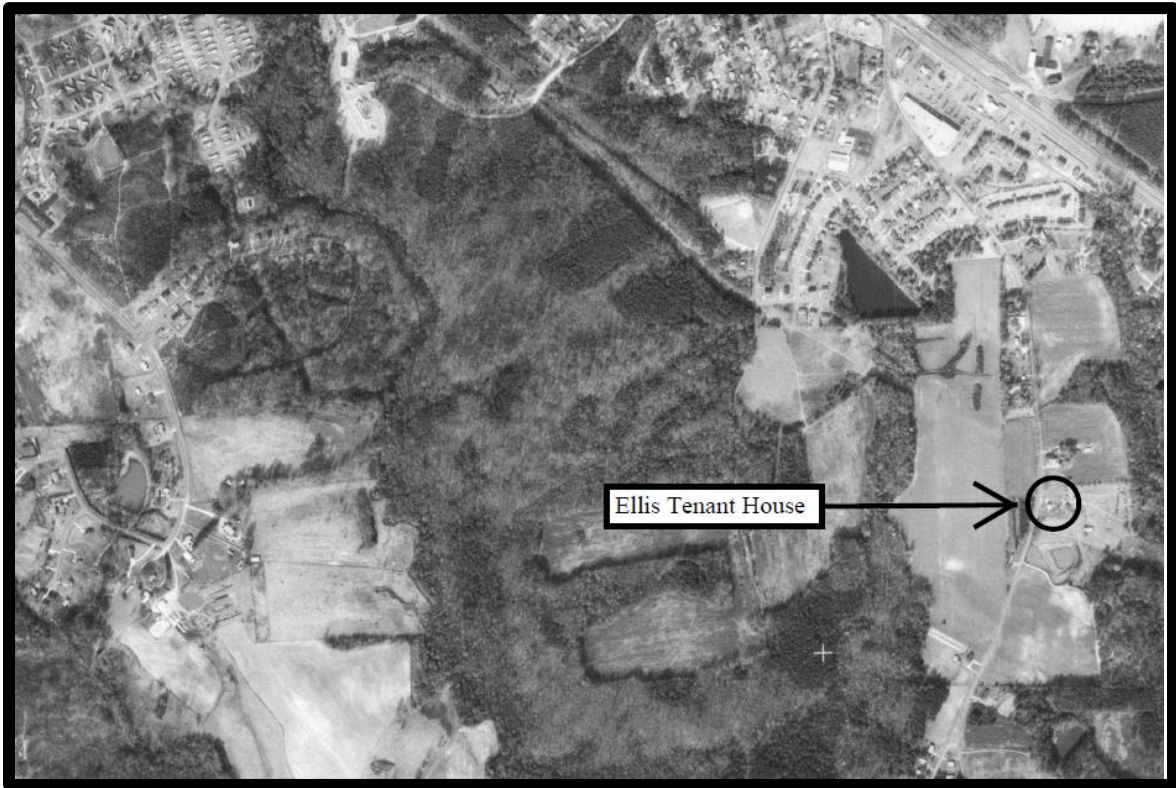
Figure 20: Detail of a 1988 Aerial Photograph (Johnston County GIS).

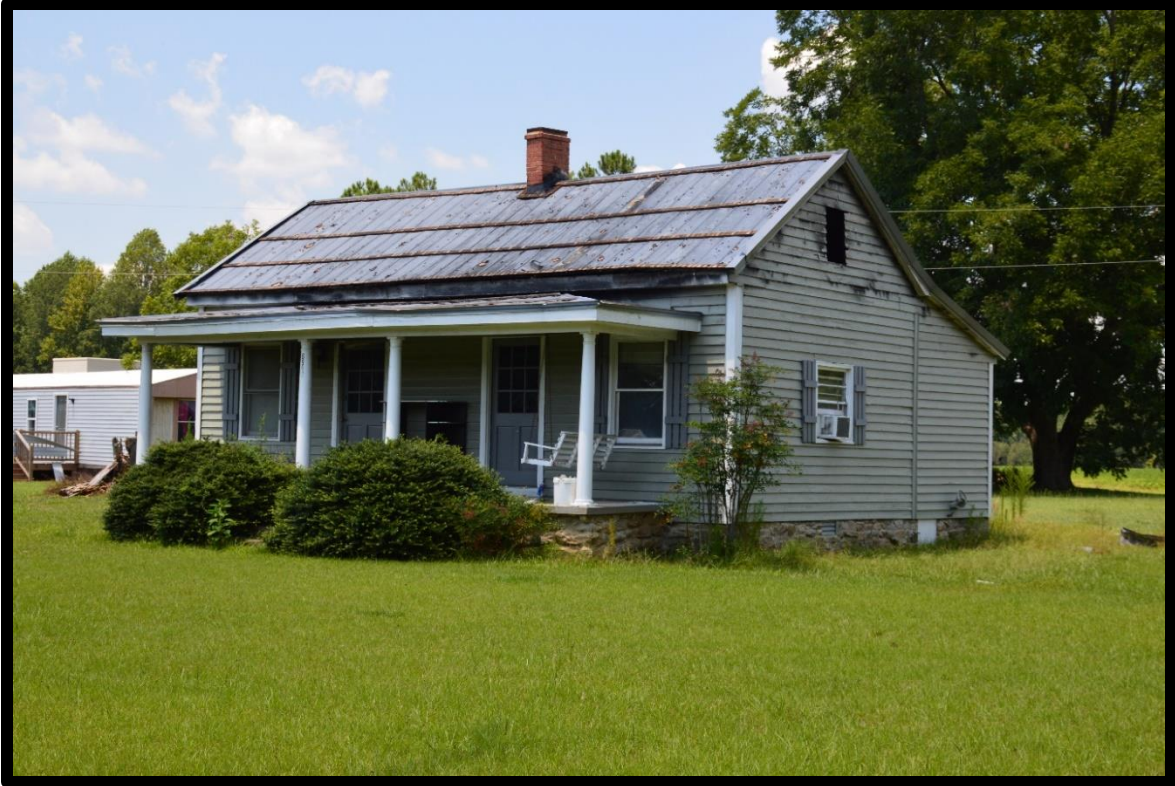
A similar resource that has retained more linkages to its agricultural association is the house on Covered Bridge Road (JT1987, Figure 21). This house is a single-pile form with a gabled rear addition. While this dwelling is still associated with some actively farmed land, it has experienced alterations to its setting with the addition of mobile homes to the same parcel and the construction of a fire station on the parcel immediately to the south. This house has also experienced compromised integrity due to the replacement of some of its windows and the replacement of its porch with a concrete slab. The Ellis House has replacement exterior siding and alterations to the front porch as well as the addition to the south elevation. The house on Covered Bridge Road is a more well-preserved example of the saddlebag form than the Ellis Tenant House.¹⁸

Figure 21: Wall House, 6602 Covered Bridge Road (JT1987).

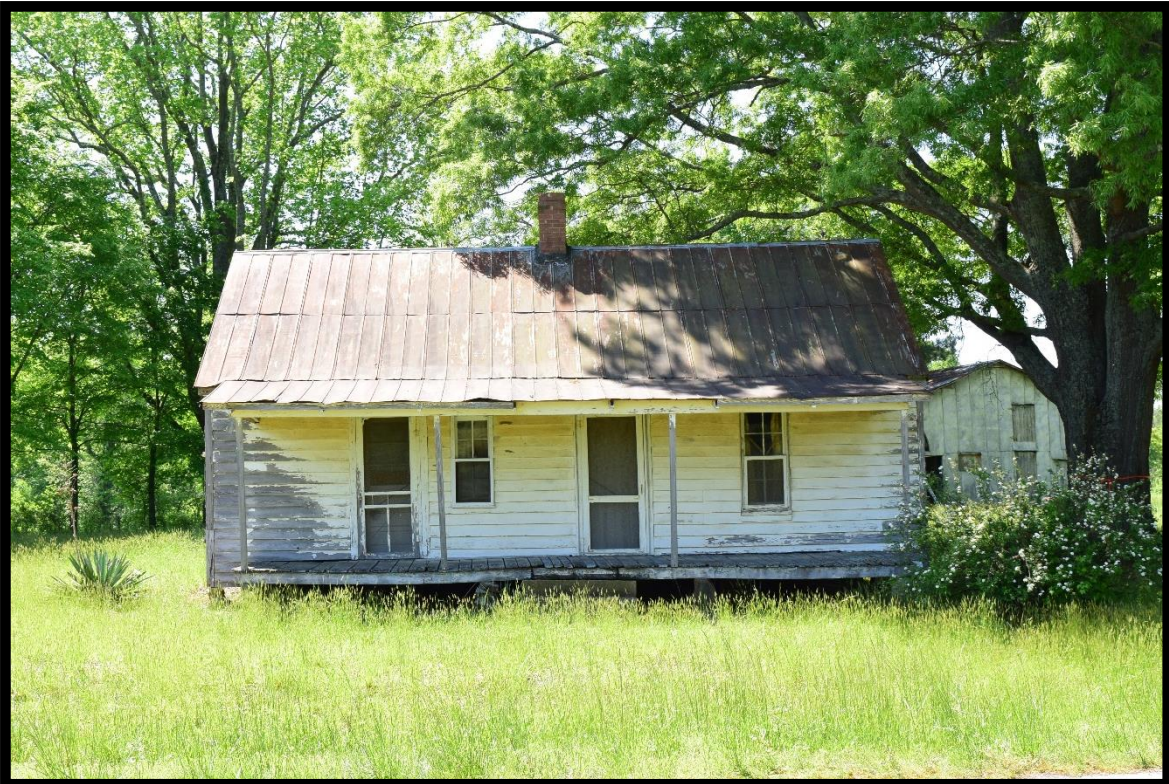
Figure 22: Farm Complex, 719 New Bethel Road (JT1702).

Dwellings with two front doors are not well-represented in Johnston County with only a few found in the northwest part of the county. One example is a dwelling on Covered Bridge Road (JT1987, Figure 21). Others include a farm complex on New Bethel Road (JT1702, Figure 22) and an early-twentieth century example with a Craftsman-style front porch on Highway 96 (Figure 23). Each of these dwellings differ slightly in fenestration pattern and chimney placement, as well as in age, with the houses on Covered Bridge Road and New Bethel Road attributed to the nineteenth century, while the house on Highway 96 was built in the early twentieth century, similar to the Ellis Tenant House.

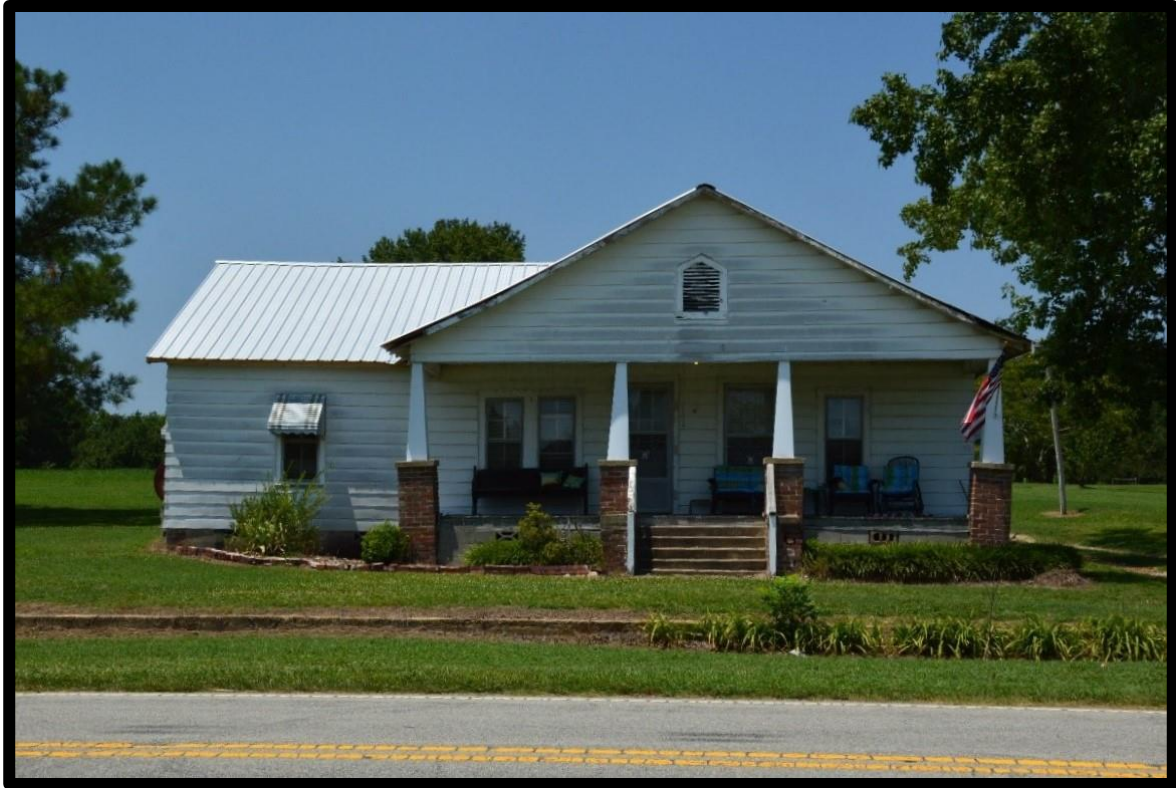
The one most comparable in form is a dwelling on the west side of Highway 96 in Zebulon (see Figure 23). This house, while only one-story tall, has a double-pile core with a side-gabled wing.

The front porch is inset under the gabled roof and features Craftsman-style battered posts on brick piers. This house stands in a more agricultural area than the Ellis Tenant house with agricultural fields on the other side of Highway 96 and at the rear of the house. In comparison with the Ellis Tenant House, both have replacement exterior siding, while the Ellis Tenant House has a modern addition and greater alteration to the front porch. The Ellis Tenant House also has a more suburban setting and has lost its associated agricultural land.

Figure 23: 13327 NC Highway 96.
